# Visual Site Inspection Report

<b>Project Name</b>	H-600 Pipeline Spread H	<b>AFE</b>	124300138	<b>Spread</b>	H-600 Pipeline Spread H	
<b>Contractor</b>	Precision			<b>Report #</b>	14374	
<b>Inspector</b>	Pat Davis			<b>Date/Time</b>	9/7/2020 4:04 PM	
<b>Permit #</b>	TBD	<b>Inspection Type</b>	VA SWPP	<b>Station Begin</b>	+0	
<b>State</b>	VA	<b>Inspection Area</b>	Partial	<b>Station End</b>	+0	
<b>County</b>	Montgomery	<b>Ground</b>	Damp	<b>Temperature (°F)</b>	82.00	
<b>Municipality</b>	N/A	<b>Weather</b>	Sunny	<b>Rain Gauge (in)</b>	0.00	
				<b>Rain Accumulation Time (days)</b>	0.00

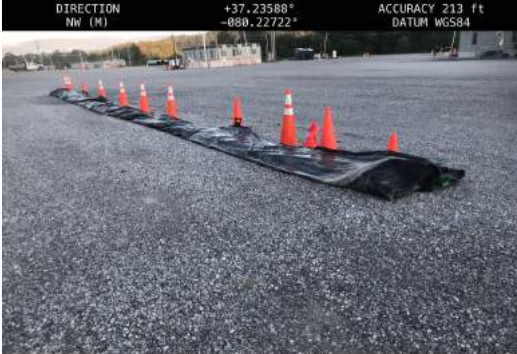
<p>DIRECTION NW (M) +37.23588° -080.22722° ACCURACY 213 ft DATUM WGS84</p> <p>MVP-PY-006_090720 Secondary containment on site for tankers 2020-09-07 07:22:38-04:00</p>

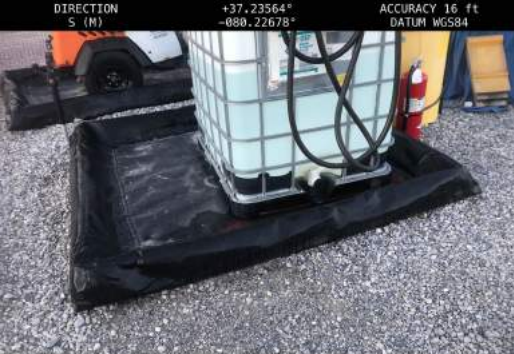
<p>DIRECTION S (M) +37.23564° -080.22678° ACCURACY 16 ft DATUM WGS84</p> <p>MVP-PY-006_090720 Condition of containment 2020-09-07 07:22:41-04:00</p>			
<b>GPS Location</b>	MVP-PY-006 See photo for gps data		<b>GPS Location</b>	MVP-PY-006 See photo for gps data	
<b>Field Station#</b>	+0		<b>Field Station#</b>	+0	
<b>Pic 7 Desc.</b>	Secondary containment on site for tankers offloading fuel into Blue Bulk fuel tanks. Looking NW.		<b>Pic 8 Desc.</b>	Condition of containment under DEF container. Looking S.

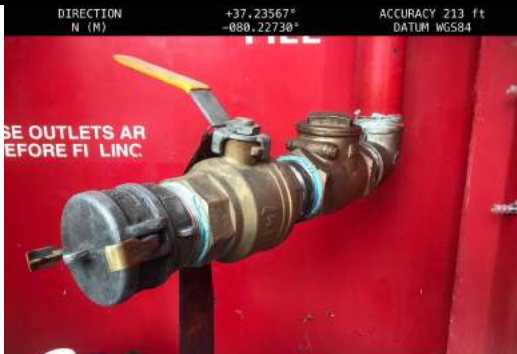
<p>DIRECTION N (M) +37.23567° -080.22730° ACCURACY 213 ft DATUM WGS84</p> <p>MVP-PY-006_090720 No leaky internal fittings 2020-09-07 07:23:36-04:00</p>

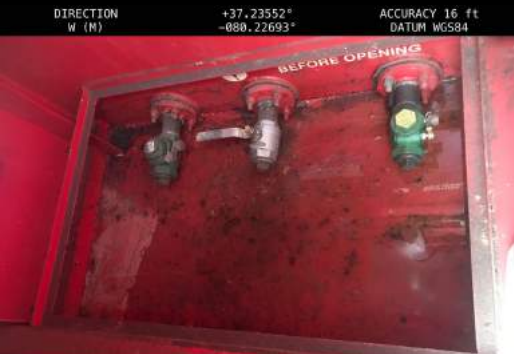
<p>DIRECTION W (M) +37.23552° -080.22693° ACCURACY 16 ft DATUM WGS84</p> <p>MVP-PY-006_090720 Condition of internal drip pan 2020-09-07 07:24:19-04:00</p>

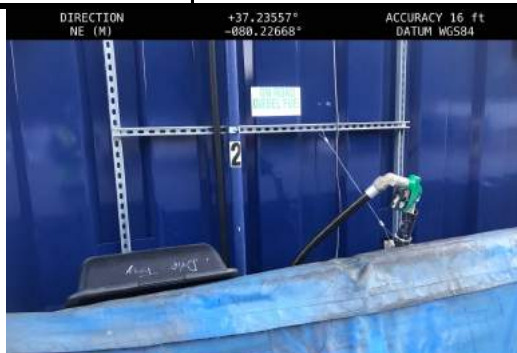
<p>DIRECTION NE (M) +37.23557° -080.22668° ACCURACY 16 ft DATUM WGS84</p> <p>MVP-PY-006_090720 No leaky fittings or nozzles 2020-09-07 07:25:00-04:00</p>

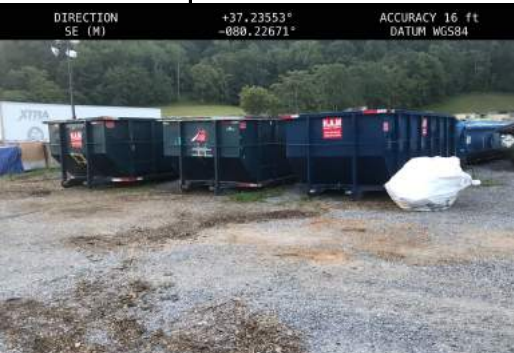
<p>DIRECTION SE (M) +37.23553° -080.22671° ACCURACY 16 ft DATUM WGS84</p> <p>MVP-PY-006_090720 No loose trash around dumpsters 2020-09-07 07:25:13-04:00</p>			
<b>GPS Location</b>	MVP-PY-006 See photo for gps data		<b>GPS Location</b>	MVP-PY-006 See photo for gps data	
<b>Field Station#</b>	+0		<b>Field Station#</b>	+0	
<b>Pic 11 Desc.</b>	Blue Bulk Fuel tanks no leaky fittings or nozzles. Looking NE.		<b>Pic 12 Desc.</b>	No loose trash around dumpsters. Looking SE.

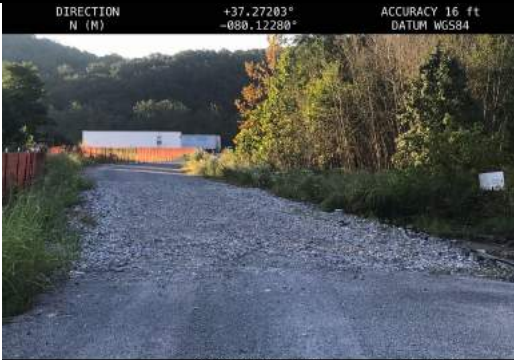
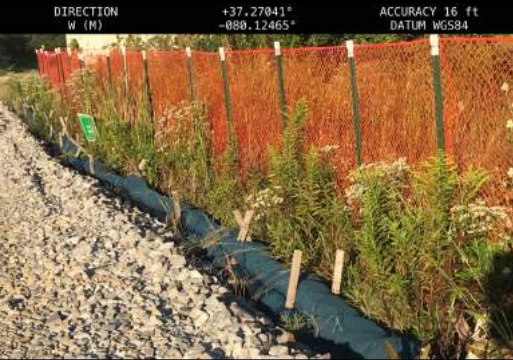
<b>GPS Location</b>	MVP-LY-049 See photo for gps data		<b>GPS Location</b>	MVP-LY-049 See photo for gps data	
<b>Field Station#</b>	+0		<b>Field Station#</b>	+0	
<b>Pic 1 Desc.</b>	Condition of rock entrance. No sediment on stone surface. Looking S.		<b>Pic 2 Desc.</b>	Condition of compost filter sock and safety fence along feature W-CV21A. Looking W.

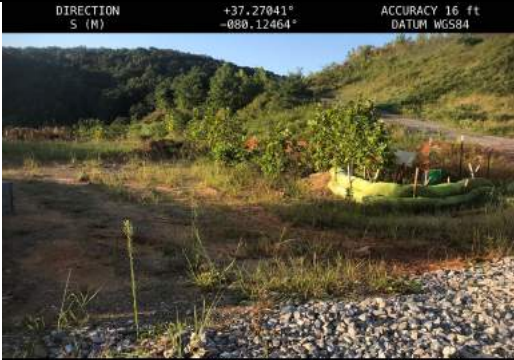
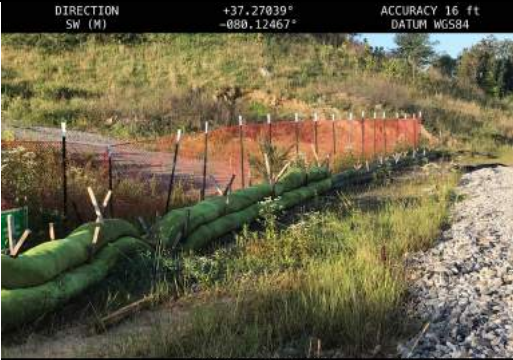
<b>GPS Location</b>	MVP-LY-049 See photo for gps data		<b>GPS Location</b>	MVP-LY-049 See photo for gps data	
<b>Field Station#</b>	+0		<b>Field Station#</b>	+0	
<b>Pic 3 Desc.</b>	Landowner disturbance along compost filter sock and feature W-CV21B. No impacts. Looking S.		<b>Pic 4 Desc.</b>	Landowner disturbance within 66' of feature W-CV21B.

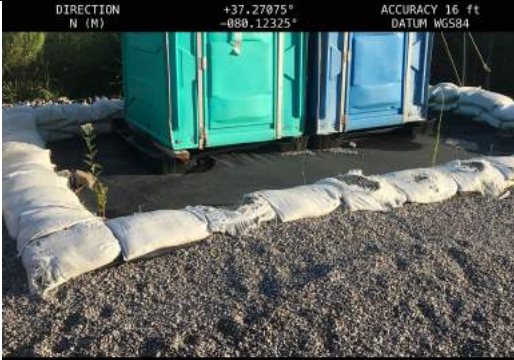
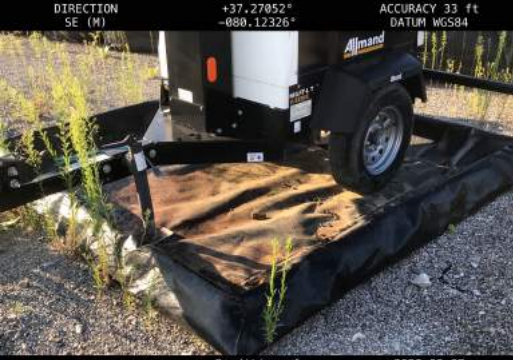
<b>Field Station#</b>	+0		<b>Field Station#</b>	+0	
<b>Pic 5 Desc.</b>	Condition of trays and containment under toilets. Looking N.		<b>Pic 6 Desc.</b>	Condition of containment under light plant. Free of stormwater. Looking SE.

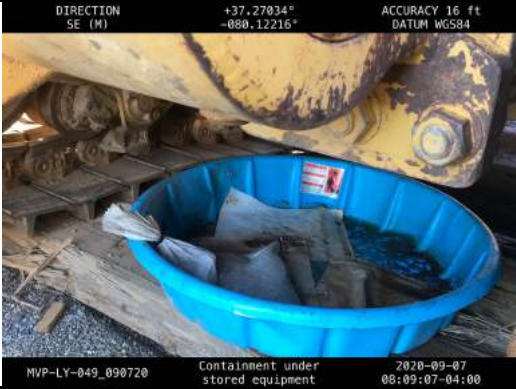
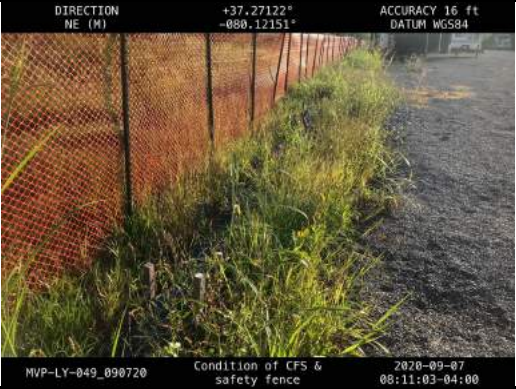
<b>GPS Location</b>	MVP-LY-049 See photo for gps data		<b>GPS Location</b>	MVP-LY-049 See photo for gps data	
<b>Field Station#</b>	+0		<b>Field Station#</b>	+0	
<b>Pic 13 Desc.</b>	Condition of containment under stored equipment. Looking SE.		<b>Pic 14 Desc.</b>	Condition of compost filter sock and safety fence along north LOD. CFS over grown with vegetation. Looking E.

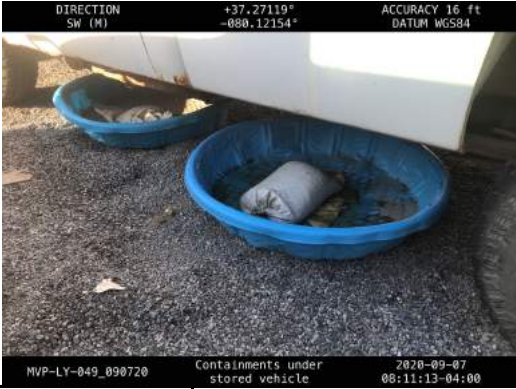
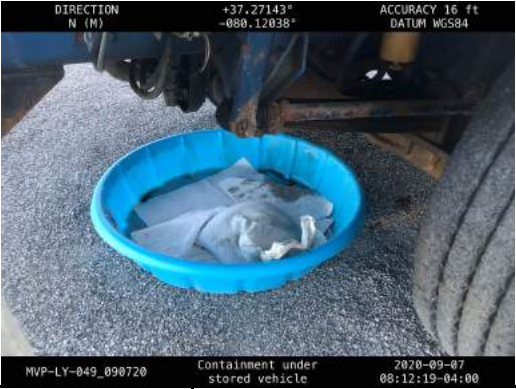
<b>GPS Location</b>	MVP-LY-049 See photo for gps data		<b>GPS Location</b>	MVP-LY-049 See photo for gps data	
<b>Field Station#</b>	+0		<b>Field Station#</b>	+0	
<b>Pic 15 Desc.</b>	Condition of containment under stored vehicle. Looking SW.		<b>Pic 16 Desc.</b>	Condition of containment under stored vehicle. Looking NE.

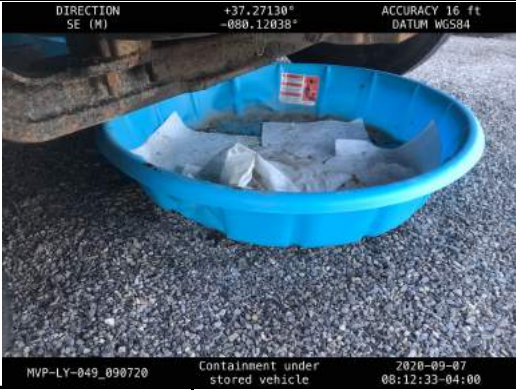
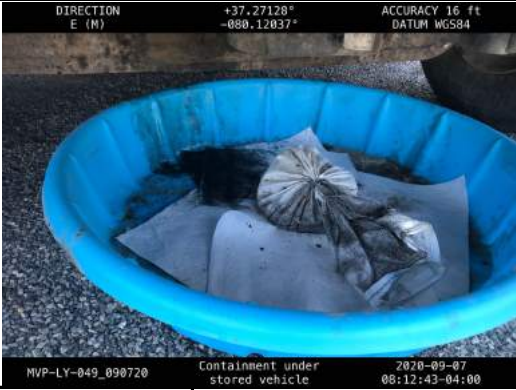
<b>Field Station#</b>	+0		<b>Field Station#</b>	+0	
<b>Pic 17 Desc.</b>	Condition of containment under stored vehicle. Looking SE.		<b>Pic 18 Desc.</b>	Condition of containment under stored equipment. Looking E.

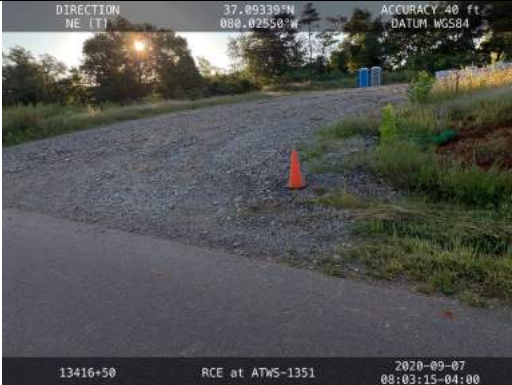
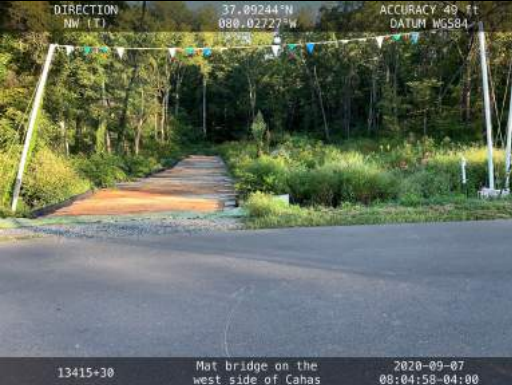
<b>GPS Location</b>	See photo for gps location data.		<b>GPS Location</b>	See photo for gps location data.	
<b>Field Station#</b>	13416+50		<b>Field Station#</b>	13415+30	
<b>Pic 1 Desc.</b>	Photo shows the RCE at ATWS-1351.		<b>Pic 2 Desc.</b>	Photo shows the mat bridge on the west side of Cahas.

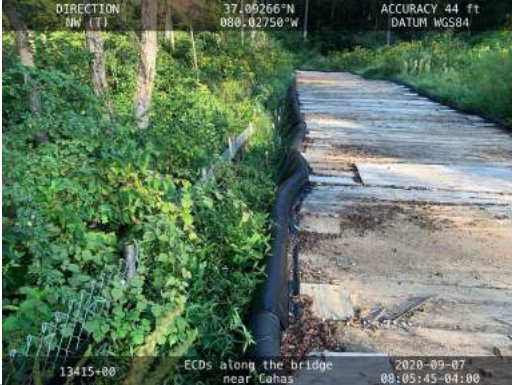
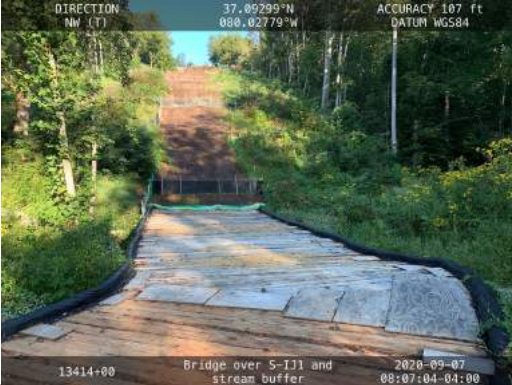
<b>GPS Location</b>	See photo for gps location data.		<b>GPS Location</b>	See photo for gps location data.	
<b>Field Station#</b>	13415+00		<b>Field Station#</b>	13414+00	
<b>Pic 3 Desc.</b>	Photo shows the ECDs along the mat bridge near Cahas.		<b>Pic 4 Desc.</b>	Photo shows the bridge over stream S-IJ1 and adjacent stream buffer.

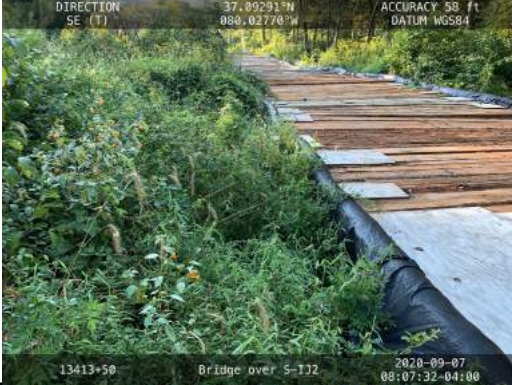
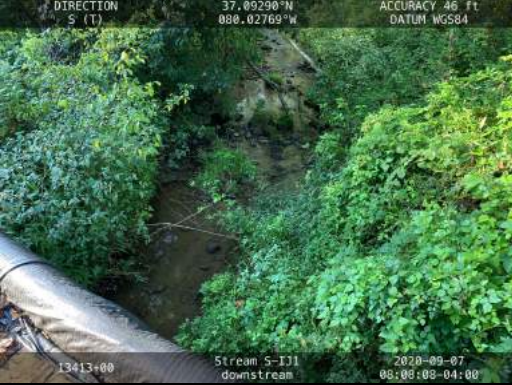
<b>Pic 5 Desc.</b>	Photo shows the bridge over stream S-IJ2.		<b>Pic 6 Desc.</b>	Photo shows stream S-IJ1 downstream from the bridge.

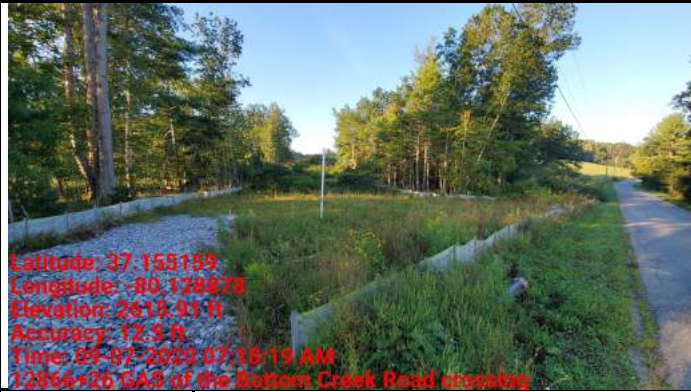
<p>Latitude: 37.155159 Longitude: -80.128878 Elevation: 2612.91 ft Accuracy: 12.5 ft Time: 09-07-2020 07:18:19 AM 12866+26 GAS of the Bottom Creek Road crossing</p>

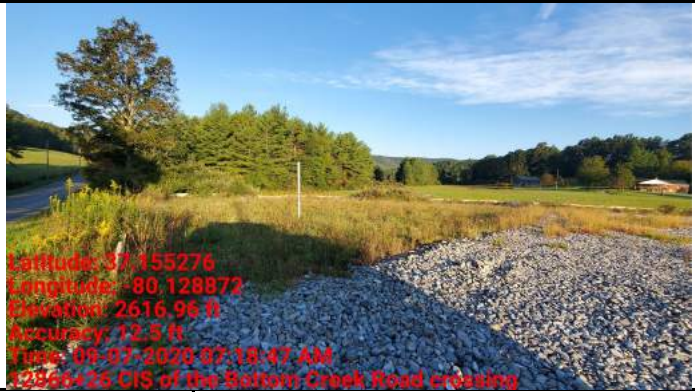
<p>Latitude: 37.155276 Longitude: -80.128872 Elevation: 2616.96 ft Accuracy: 12.5 ft Time: 09-07-2020 07:18:47 AM 12866+26 CIS of the Bottom Creek Road crossing</p>		
GPS Location	See pic for GPS location		GPS Location	See pic for GPS location	
Field Station#	12866+26		Field Station#	12866+26	
Pic 1 Desc.	GAS of the Bottom Creek Road crossing		Pic 2 Desc.	CIS of the Bottom Creek Road crossing

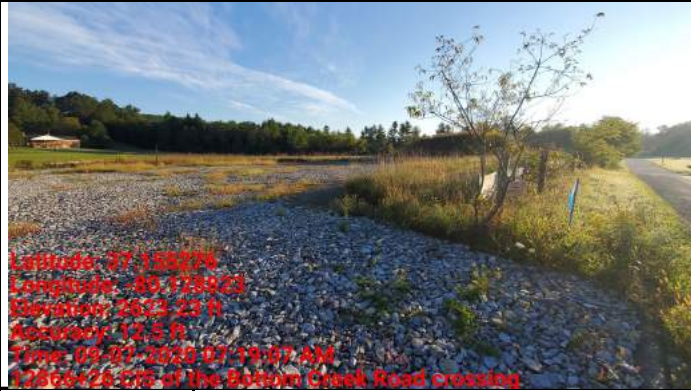
<p>Latitude: 37.155274 Longitude: -80.128923 Elevation: 2623.23 ft Accuracy: 12.5 ft Time: 09-07-2020 07:19:07 AM 12866+26 CIS of the Bottom Creek Road crossing</p>

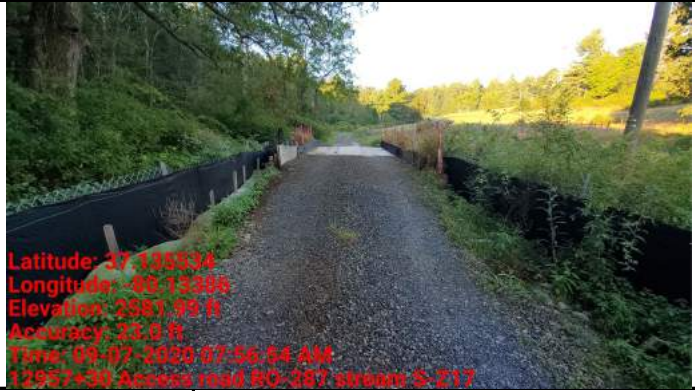
<p>Latitude: 37.135334 Longitude: -80.13396 Elevation: 2587.93 ft Accuracy: 12.5 ft Time: 09-07-2020 07:56:54 AM 12957+30 Access road RO-287 stream S-Z17</p>

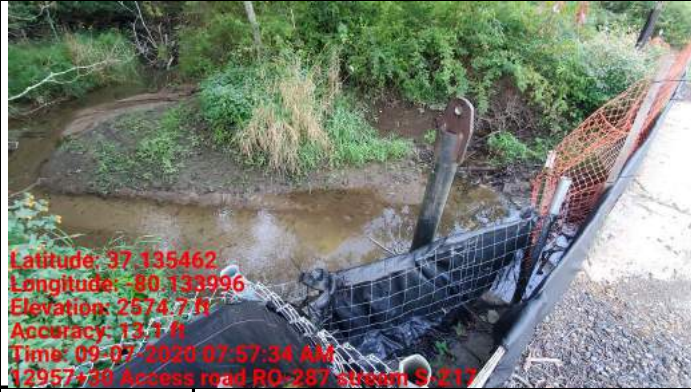
<p>Latitude: 37.135462 Longitude: -80.133996 Elevation: 2574.7 ft Accuracy: 12.5 ft Time: 09-07-2020 07:57:34 AM 12957+30 Access road RO-287 stream S-Z17</p>

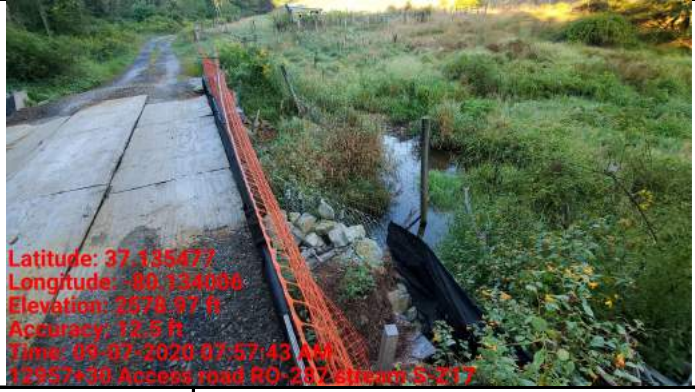
<p>Latitude: 37.135477 Longitude: -80.134066 Elevation: 2578.87 ft Accuracy: 12.5 ft Time: 09-07-2020 07:57:43 AM 12957+30 Access road RO-287 stream S-Z17</p>		
GPS Location	See pic for GPS location		GPS Location	See pic for GPS location	
Field Station#	12957+30		Field Station#	12957+30	
Pic 5 Desc.	Access road RO-287 at stream S-Z17.		Pic 6 Desc.	Access road RO-287 at stream S-Z17.

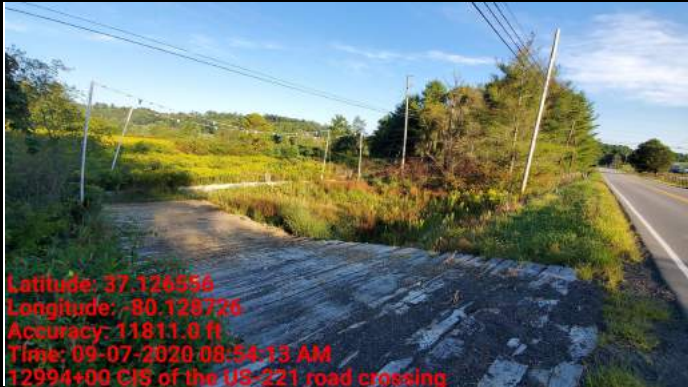
<p>Latitude: 37.126556 Longitude: -80.128726 Accuracy: 11811.0 ft Time: 09-07-2020 08:54:13 AM 12994+00 CIS of the US-221 road crossing</p>

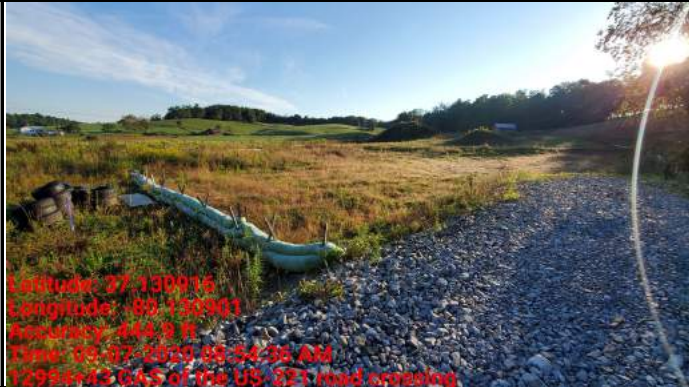
<p>Latitude: 37.130916 Longitude: -80.130901 Accuracy: 444.9 ft Time: 09-07-2020 08:54:36 AM 12994+43 GAS of the US-221 road crossing</p>		
<b>GPS Location</b>	See pic for GPS location		<b>GPS Location</b>	See pic for GPS location	
<b>Field Station#</b>	12994+00		<b>Field Station#</b>	12994+43	
<b>Pic 13 Desc.</b>	CIS of the US-221 road crossing.		<b>Pic 14 Desc.</b>	GAS of the US-221 road crossing.

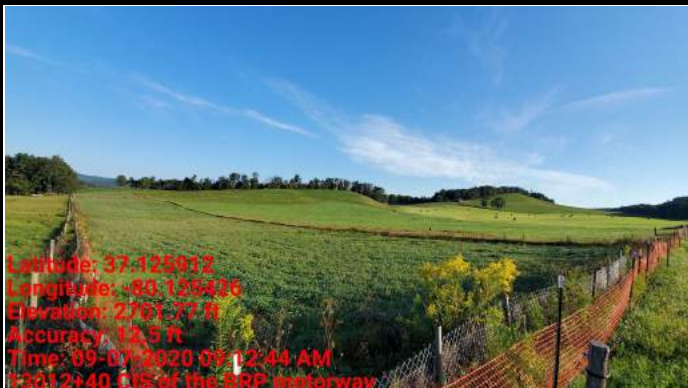
<p>Latitude: 37.125912 Longitude: -80.125426 Elevation: 2701.77 ft Accuracy: 12.5 ft Time: 09-07-2020 09:12:44 AM 13012+40 CIS of the BRP motorway</p>

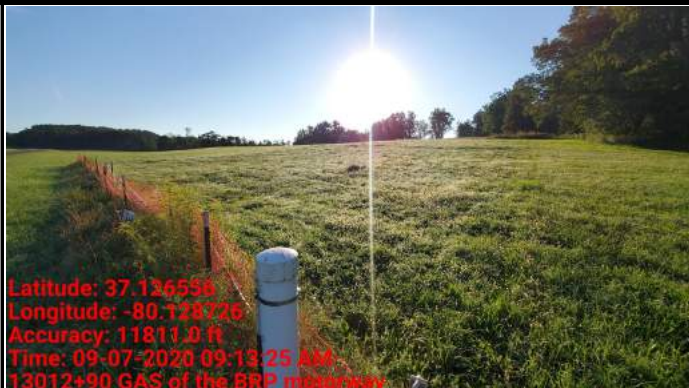
<p>Latitude: 37.136596 Longitude: -80.128726 Accuracy: 11811.0 ft Time: 09-07-2020 09:13:25 AM 13012+90 GAS of the BRP motorway</p>

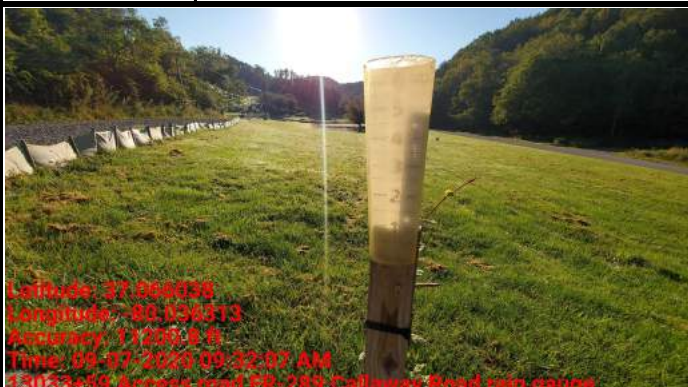
<p>Latitude: 37.064036 Longitude: -80.036313 Accuracy: 11258.9 ft Time: 09-07-2020 09:32:07 AM 13033+59 Access road FR-289 Callaway Road rain gauge</p>

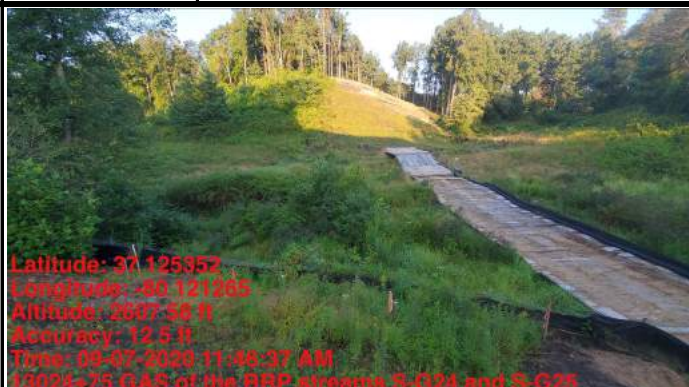
<p>Latitude: 37.125352 Longitude: -80.121265 Altitude: 2607.38 ft Accuracy: 12.5 ft Time: 09-07-2020 11:48:37 AM 13024+75 GAS of the BRP streams S-G24 and S-G25</p>		
<b>GPS Location</b>	See pic for GPS location		<b>GPS Location</b>	See pic for GPS location	
<b>Field Station#</b>	13033+59		<b>Field Station#</b>	13024+75	
<b>Pic 17 Desc.</b>	Callaway Road rain gauge. 0.0" total precipitation.		<b>Pic 18 Desc.</b>	Streams S-G24 and S-G25 on the CIS of access road FR-289.

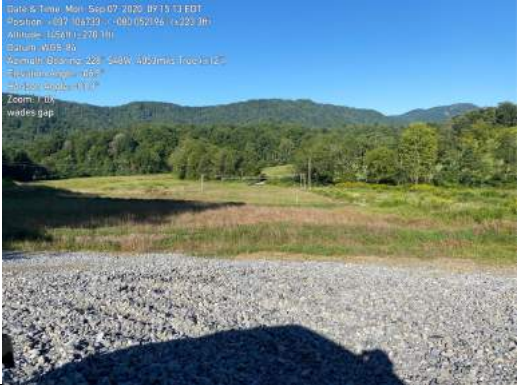
<b>GPS Location</b>	See photo for coordinates.		<b>GPS Location</b>	See photo for coordinates.	
<b>Field Station#</b>	13314+50		<b>Field Station#</b>	13313+00	
<b>Pic 13 Desc.</b>	CIS Wades Gap, ROW stable with good vegetative cover.		<b>Pic 14 Desc.</b>	Good vegetative cover in area.

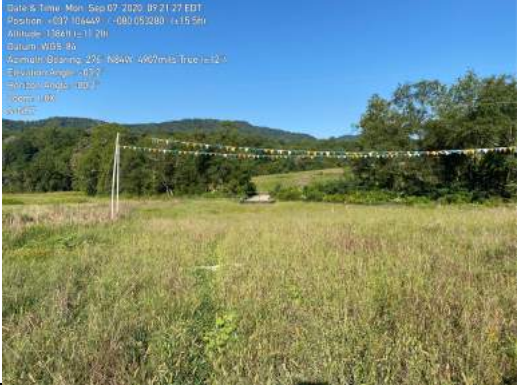
<b>GPS Location</b>	See photo for coordinates.		<b>GPS Location</b>	See photo for coordinates.	
<b>Field Station#</b>	13312+00		<b>Field Station#</b>	13309+09	
<b>Pic 15 Desc.</b>	Good vegetative cover across LOD.		<b>Pic 16 Desc.</b>	S-GH7, downstream, no changes noted to stream bed or banks.	
<p>Date/Time: Mon, Sep 07, 2020 09:21:55 EDT  Position: -037.104591, -080.054481, 1224.051  Altitude: 1070 ft (326.11 m)  Datum: WGS 84  Azimuth Bearing: 251.521W, 4907 m/s True (a12)  Elevation Angle: -03.7  Horizon Angle: -03.7  Zoom: 1.0X  S-BIT: Downstream</p>

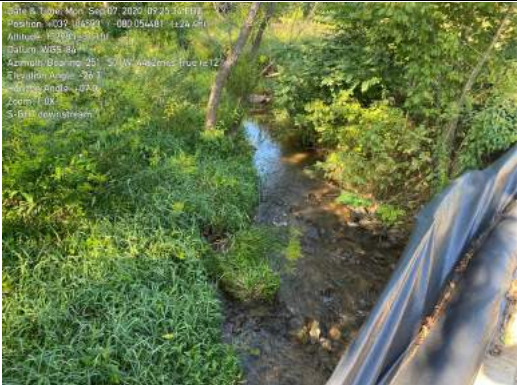
<b>GPS Location</b>	See photo for coordinates.		<b>GPS Location</b>	See photo for coordinates.	
<b>Field Station#</b>	13309+09		<b>Field Station#</b>	13309+09	
<b>Pic 17 Desc.</b>	S-GH7, downstream, no turbidity observed.		<b>Pic 18 Desc.</b>	S-GH7, upstream, no changes noted to bed or banks.

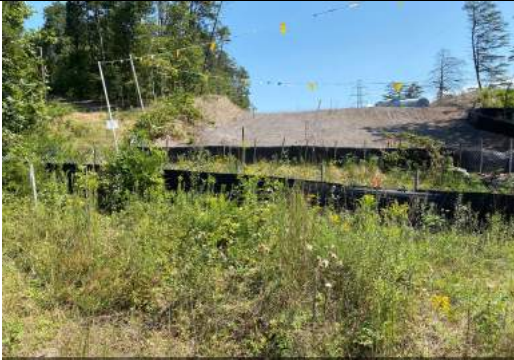
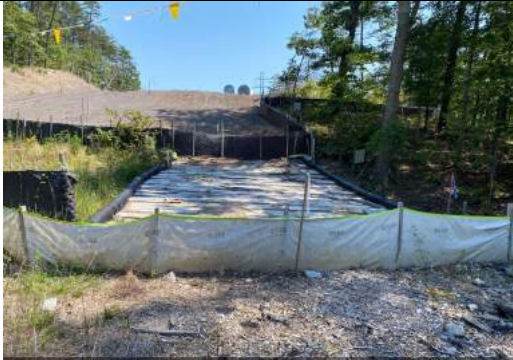
<small>S-F16A/B (12112+13) All ECDs acceptable 2020-09-07 08:45:23-04:00</small>		<small>S-F16A/B (12112+13) All ECDs acceptable 2020-09-07 08:45:33-04:00</small>			
<b>GPS Location</b>	See photo GPS for location		<b>GPS Location</b>	See photo GPS for location	
<b>Field Station#</b>	12112+13		<b>Field Station#</b>	12112+13	
<b>Pic 1 Desc.</b>	All ECDs are in acceptable condition.		<b>Pic 2 Desc.</b>	All ECDs are in acceptable condition.

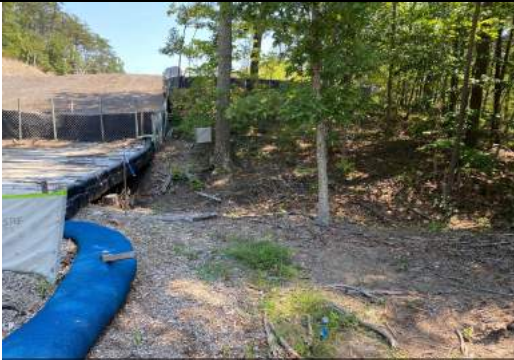
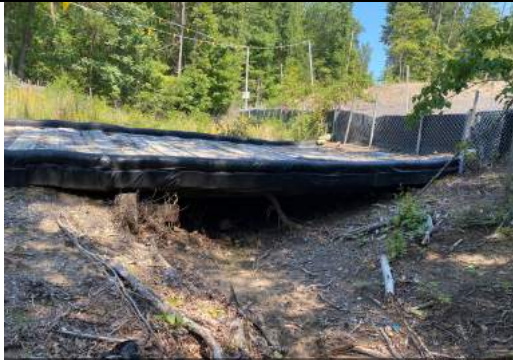
<small>S-F16A/B (12112+13) All ECDs acceptable 2020-09-07 08:45:43-04:00</small>		<small>S-F16A/B (12112+13) All ECDs acceptable 2020-09-07 08:45:59-04:00</small>			
<b>GPS Location</b>	See photo GPS for location		<b>GPS Location</b>	See photo GPS for location	
<b>Field Station#</b>	12112+13		<b>Field Station#</b>	12112+13	
<b>Pic 3 Desc.</b>	All ECDs are in acceptable condition.		<b>Pic 4 Desc.</b>	All ECDs are in acceptable condition.

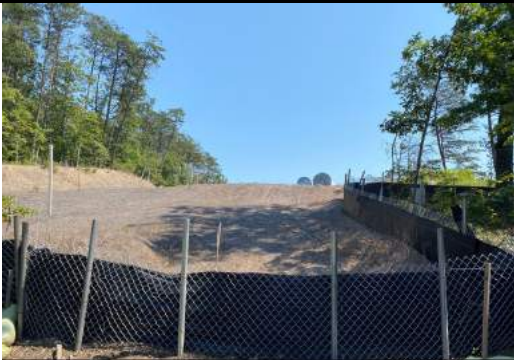
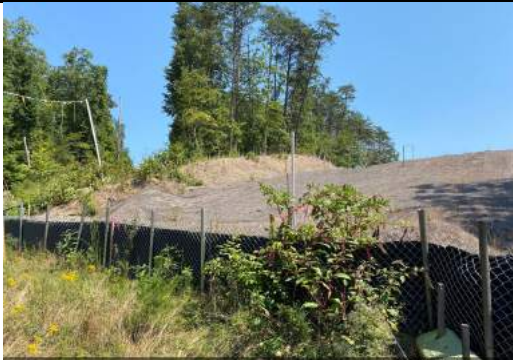
<small>S-F16A/B (12112+13) All ECDs acceptable 2020-09-07 08:46:14-04:00</small>		<small>S-F16A/B (12112+13) All ECDs acceptable 2020-09-07 08:46:20-04:00</small>			
<b>GPS Location</b>	See photo GPS for location		<b>GPS Location</b>	See photo GPS for location	
<b>Field Station#</b>	12112+13		<b>Field Station#</b>	12112+13	
<b>Pic 5 Desc.</b>	All ECDs are in acceptable condition.		<b>Pic 6 Desc.</b>	All ECDs are in acceptable condition.

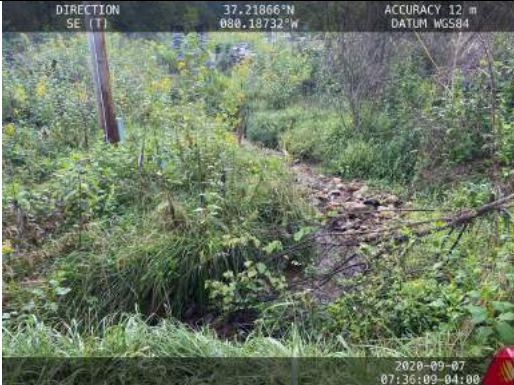
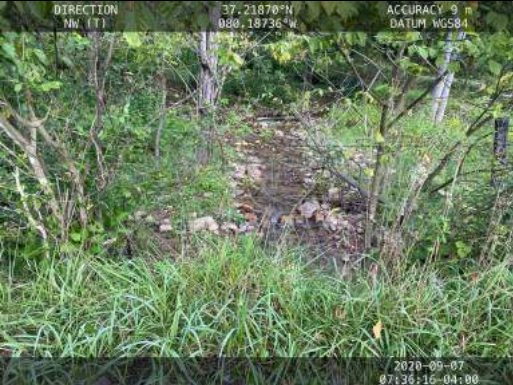
<b>GPS Location</b>	See photo		<b>GPS Location</b>	See photo	
<b>Field Station#</b>	12543+56		<b>Field Station#</b>	12543+56	
<b>Pic 1 Desc.</b>	Stream S-KL32, facing southeast from Yellow Finch Road, upstream		<b>Pic 2 Desc.</b>	Stream S-KL32, facing northwest from Yellow Finch Road, downstream

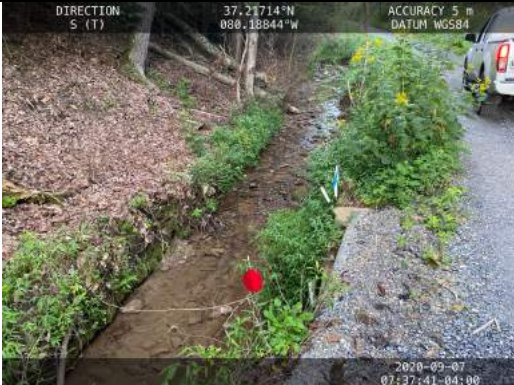
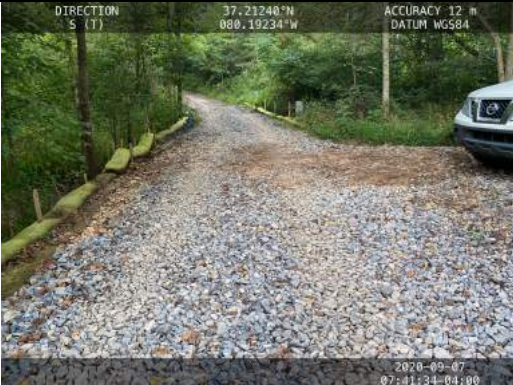
<b>GPS Location</b>	See photo		<b>GPS Location</b>	See photo	
<b>Field Station#</b>	12543+56		<b>Field Station#</b>	12543+56	
<b>Pic 3 Desc.</b>	Stream S-EF20b, facing south from Yellow Finch Road, upstream		<b>Pic 4 Desc.</b>	Yellow Finch Road at the turnaround, facing south.

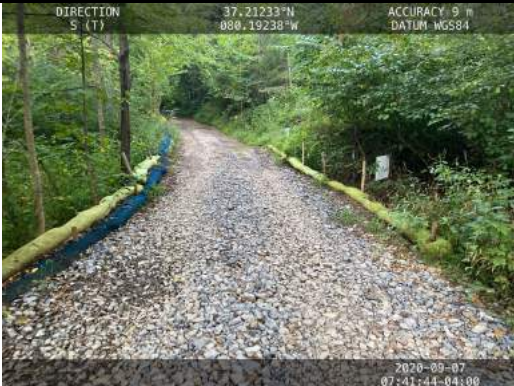
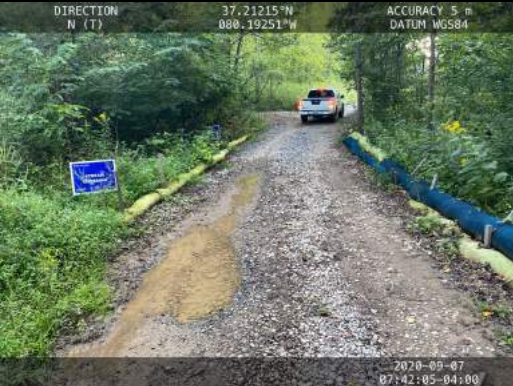
<b>GPS Location</b>	See photo		<b>GPS Location</b>	See photo	
<b>Field Station#</b>	12543+56		<b>Field Station#</b>	12543+56	
<b>Pic 5 Desc.</b>	Stream S-EF54 on Yellow Finch Road, facing south		<b>Pic 6 Desc.</b>	Stream S-EF54 on Yellow Finch Road, facing north

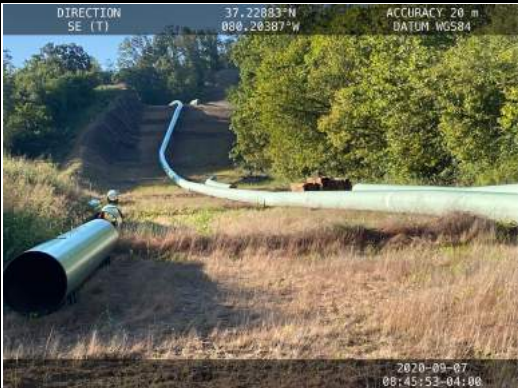
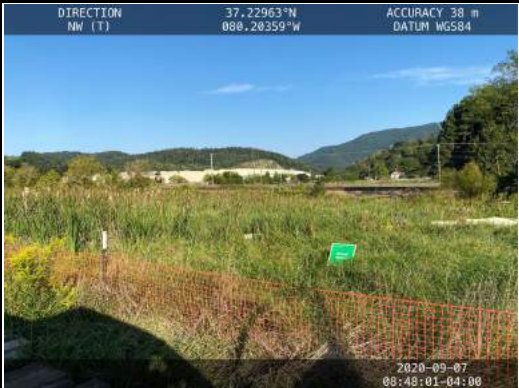
<b>GPS Location</b>	See photo		<b>GPS Location</b>	See photo	
<b>Field Station#</b>	12470+00		<b>Field Station#</b>	12461+00	
<b>Pic 15 Desc.</b>	ROW stable		<b>Pic 16 Desc.</b>	Wetland W-KL58, facing northwest

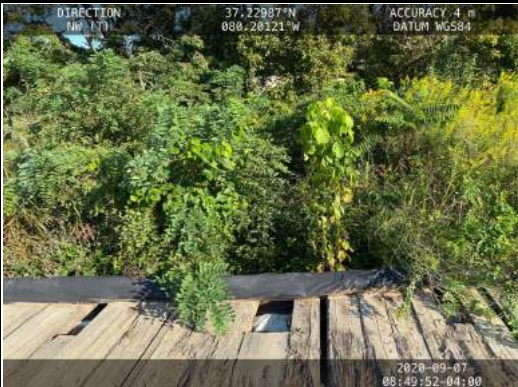
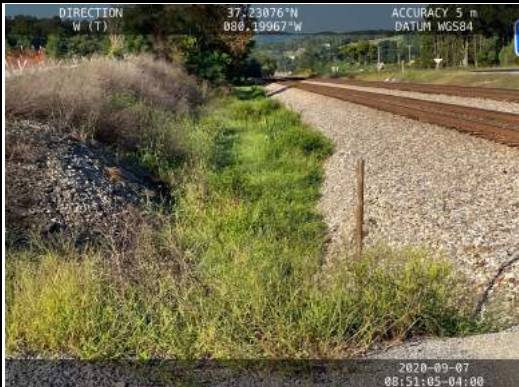
<b>GPS Location</b>	See photo		<b>GPS Location</b>	See photo	
<b>Field Station#</b>	12455+21		<b>Field Station#</b>	12444+94	
<b>Pic 17 Desc.</b>	Stream S-CD12, facing northwest, downstream		<b>Pic 18 Desc.</b>	Stream S-I1, facing west, upstream

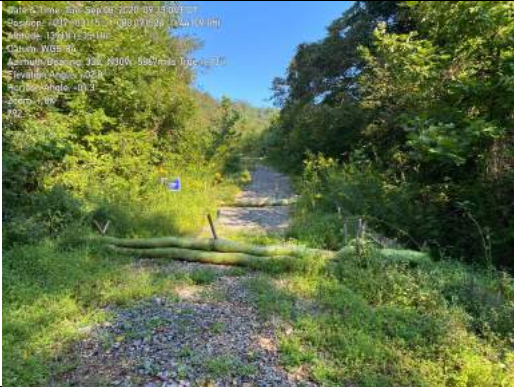
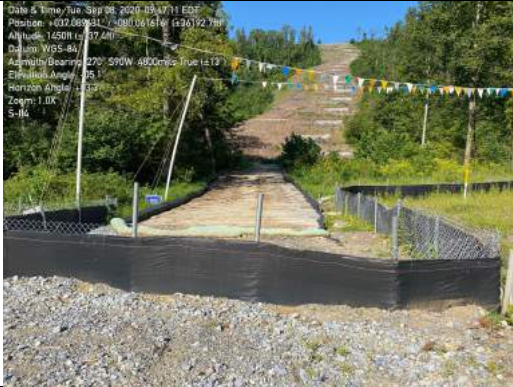
<b>GPS Location</b>	See photo for coordinates.		<b>GPS Location</b>	See photo for coordinates.	
<b>Field Station#</b>	13142+00		<b>Field Station#</b>	13261+25	
<b>Pic 1 Desc.</b>	MVP-FR-292, access road in acceptable condition, ECDs along old logging road on ROW functioning acceptably.		<b>Pic 2 Desc.</b>	S-II4, ECDs along bridge in acceptable condition.

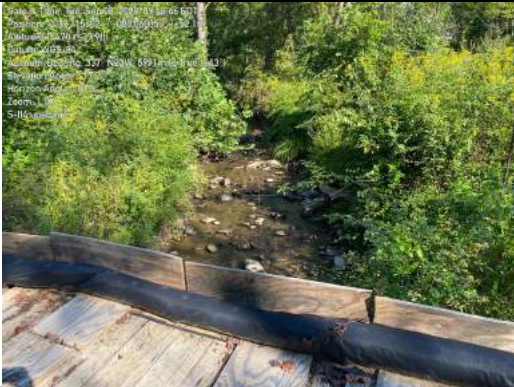
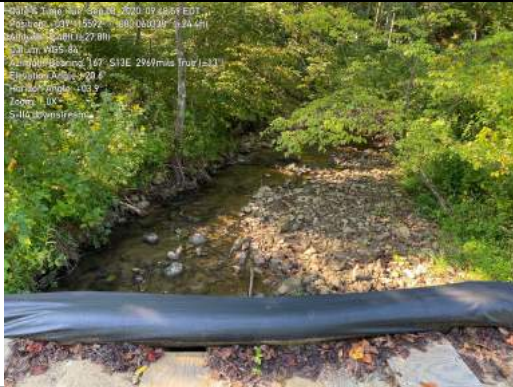
<b>GPS Location</b>	See photo for coordinates.		<b>GPS Location</b>	See photo for coordinates.	
<b>Field Station#</b>	13260+60		<b>Field Station#</b>	13260+60	
<b>Pic 3 Desc.</b>	S-II4, upstream, no changes noted to stream bed or banks.		<b>Pic 4 Desc.</b>	S-II4, downstream, no changes to stream bed or banks.

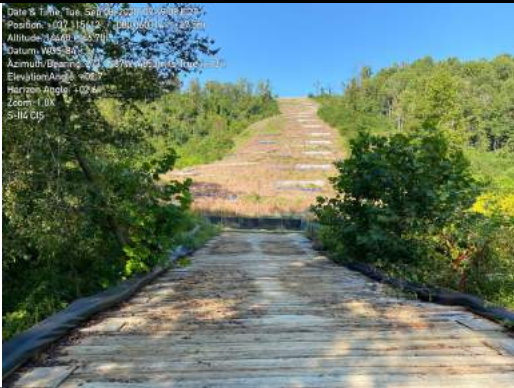
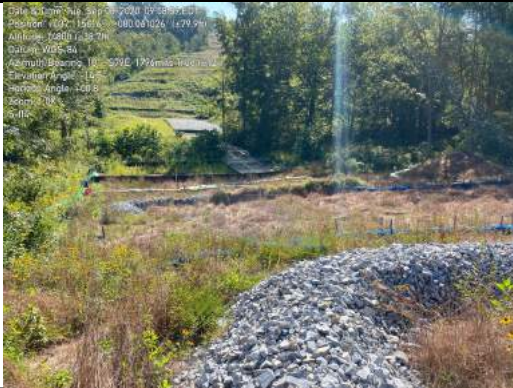
<b>Pic 5 Desc.</b>	CIS S-II4, ROW stable with vegetative cover across LOD.		<b>Pic 6 Desc.</b>	CIS S-II4, ROW stable with vegetative cover across LOD.

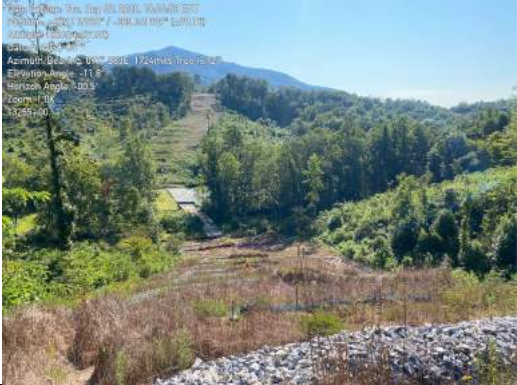
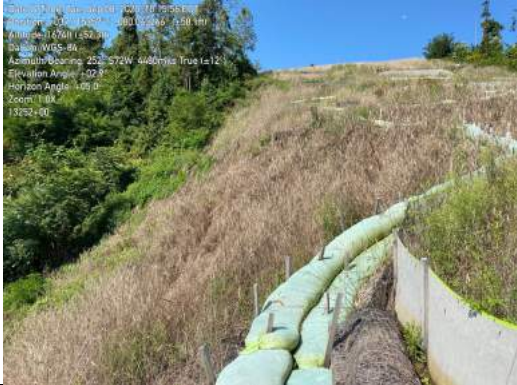
<b>GPS Location</b>	See photo for coordinates.		<b>GPS Location</b>	See photo for coordinates.	
<b>Field Station#</b>	13255+00		<b>Field Station#</b>	13252+00	
<b>Pic 7 Desc.</b>	ROW stable with vegetative cover across LOD.		<b>Pic 8 Desc.</b>	ROW stable with vegetative cover across LOD.

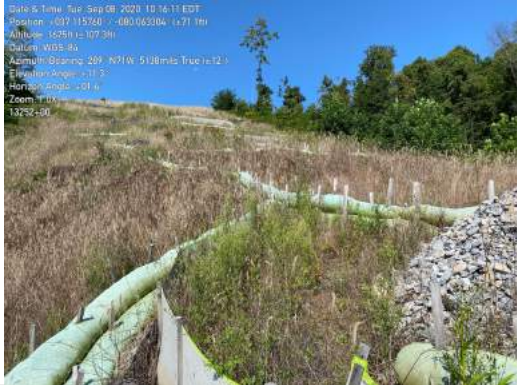
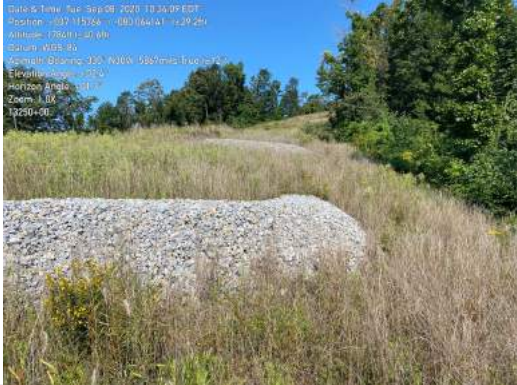
<b>GPS Location</b>	See photo for coordinates.		<b>GPS Location</b>	See photo for coordinates.	
<b>Field Station#</b>	13252+00		<b>Field Station#</b>	13250+00	
<b>Pic 9 Desc.</b>	ROW stable with vegetative cover across LOD.		<b>Pic 10 Desc.</b>	ROW stable with vegetative cover across LOD.

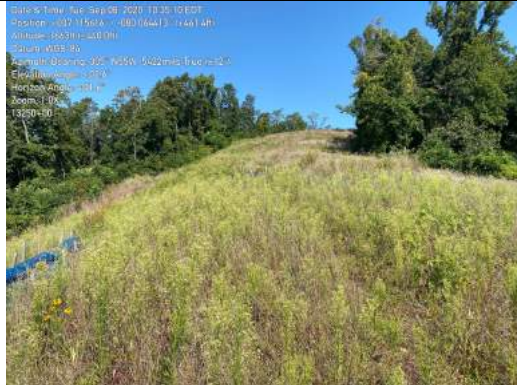
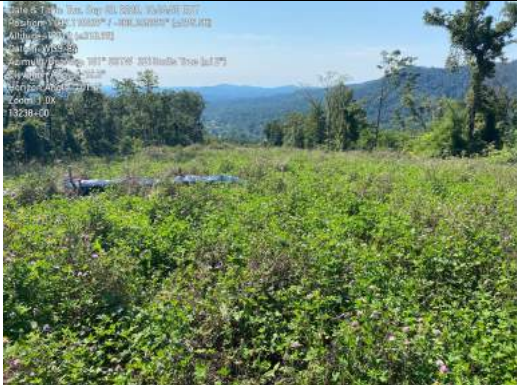
<b>GPS Location</b>	See photo for coordinates.		<b>GPS Location</b>	See photo for coordinates.	
<b>Field Station#</b>	13250+00		<b>Field Station#</b>	13238+00	
<b>Pic 11 Desc.</b>	ROW stable with vegetative cover across LOD.		<b>Pic 12 Desc.</b>	ROW stable with vegetative cover across LOD.

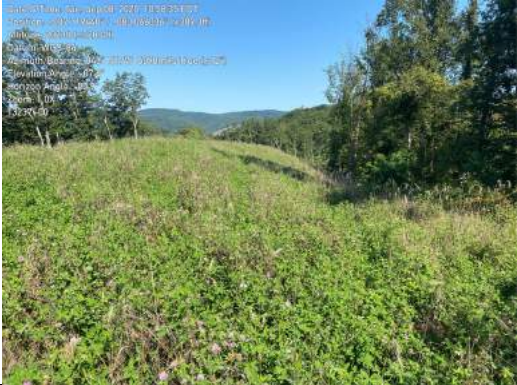
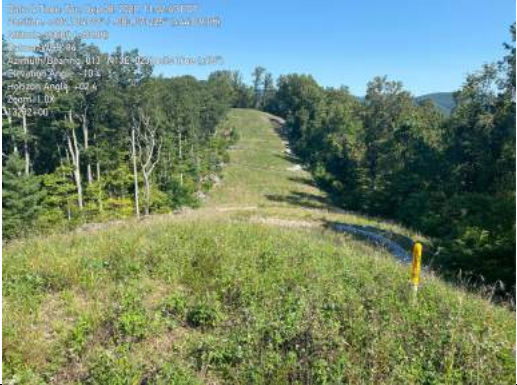
<b>GPS Location</b>	See photo for coordinates.		<b>GPS Location</b>	See photo for coordinates.	
<b>Field Station#</b>	13237+00		<b>Field Station#</b>	13232+00	
<b>Pic 13 Desc.</b>	ROW stable with vegetative cover across LOD.		<b>Pic 14 Desc.</b>	ROW stable with vegetative cover across LOD.

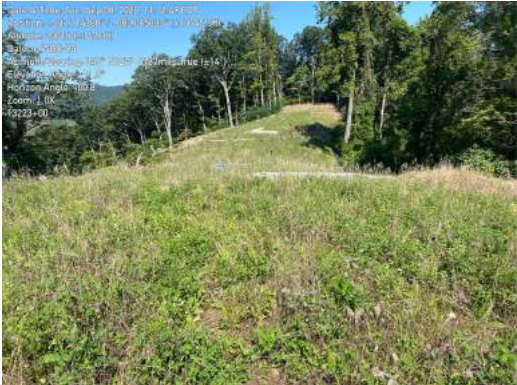
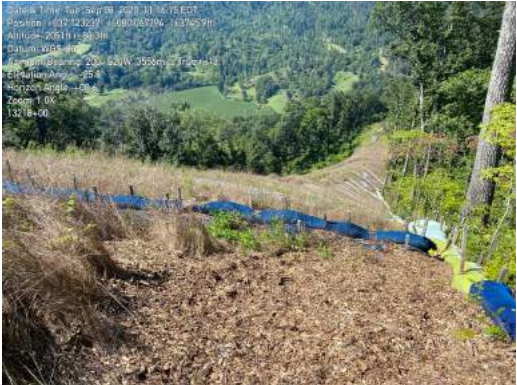
<b>GPS Location</b>	See photo for coordinates.		<b>GPS Location</b>	See photo for coordinates.	
<b>Field Station#</b>	13223+00		<b>Field Station#</b>	13218+00	
<b>Pic 15 Desc.</b>	ROW stable with vegetative cover across LOD.		<b>Pic 16 Desc.</b>	ROW stable.

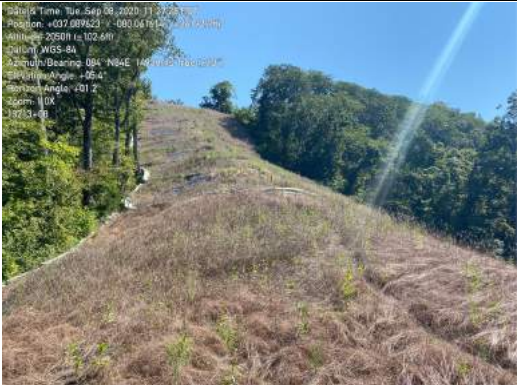
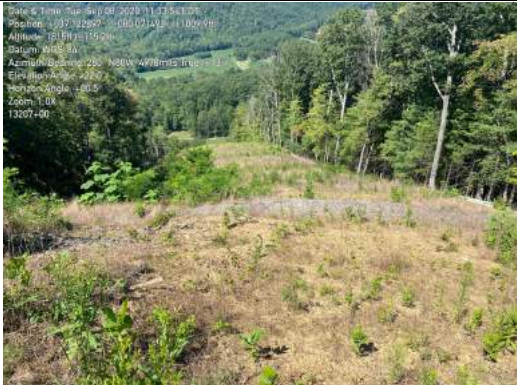
<b>GPS Location</b>	See photo for coordinates.		<b>GPS Location</b>	See photo for coordinates.	
<b>Field Station#</b>	13213+00		<b>Field Station#</b>	13207+00	
<b>Pic 17 Desc.</b>	ROW stable with vegetative cover across LOD.		<b>Pic 18 Desc.</b>	ROW stabilized with vegetative cover across LOD.

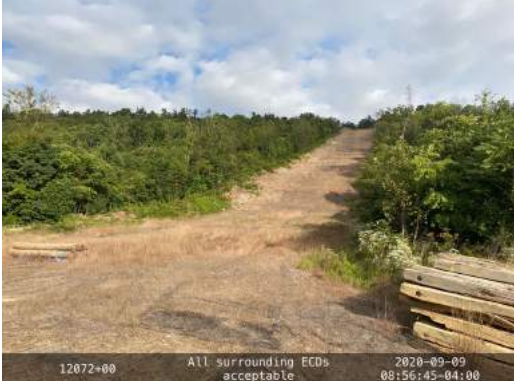
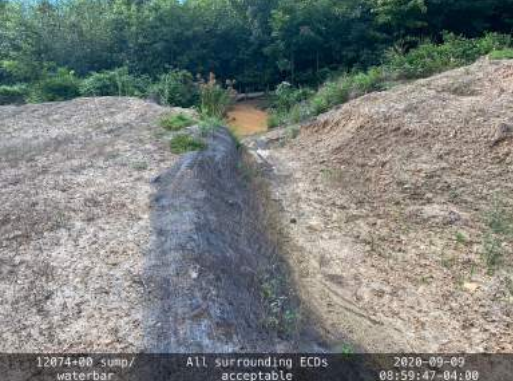
<b>GPS Location</b>	See photo GPS for location		<b>GPS Location</b>	See photo GPS for location	
<b>Field Station#</b>	12072+00		<b>Field Station#</b>	12074+00	
<b>Pic 1 Desc.</b>	All surrounding ECDs are in acceptable condition.		<b>Pic 2 Desc.</b>	All surrounding ECDs are in acceptable condition.

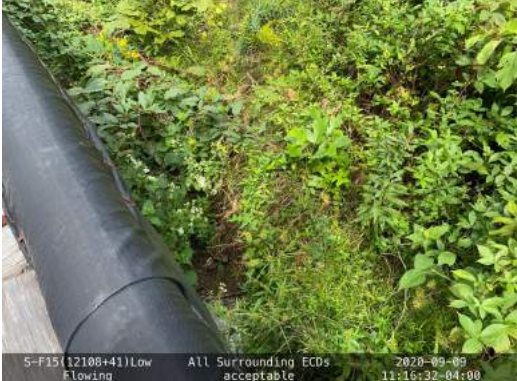
<p>S-F15(12106+41)Low Flowing All Surrounding ECDs acceptable 2020-09-09 11:16:32-04:00</p>

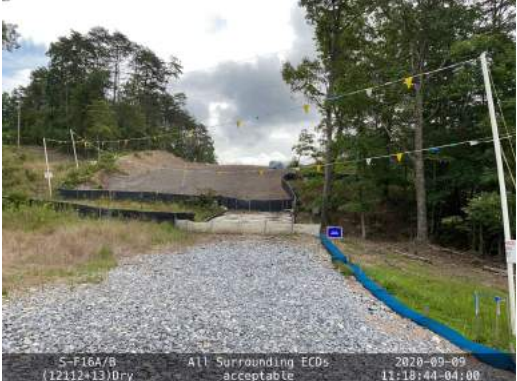
<p>S-F16A/B (12112+13)Dry All Surrounding ECDs acceptable 2020-09-09 11:18:44-04:00</p>			
<b>GPS Location</b>	See photo GPS for location		<b>GPS Location</b>	See photo GPS for location	
<b>Field Station#</b>	12108+41		<b>Field Station#</b>	12112+13	
<b>Pic 13 Desc.</b>	All surrounding ECDs are in acceptable condition.		<b>Pic 14 Desc.</b>	All surrounding ECDs are in acceptable condition.

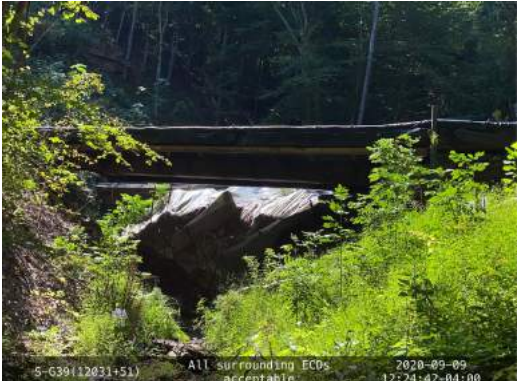
<p>S-G39(12031+51) All surrounding ECDs acceptable 2020-09-09 12:24:42-04:00</p>

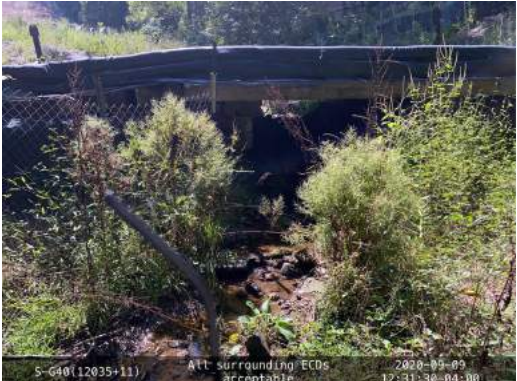
<p>S-G40(12035+11) All surrounding ECDs acceptable 2020-09-09 12:31:30-04:00</p>			
<b>GPS Location</b>	See photo GPS for location		<b>GPS Location</b>	See photo GPS for location	
<b>Field Station#</b>	12031+51		<b>Field Station#</b>	12035+11

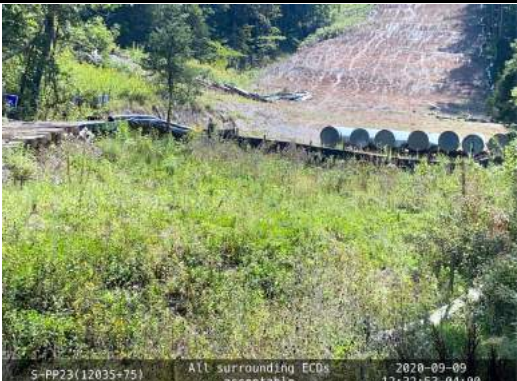
<p>S-PP23(12035+75) All surrounding ECDs acceptable 2020-09-09 12:32:53-04:00</p>

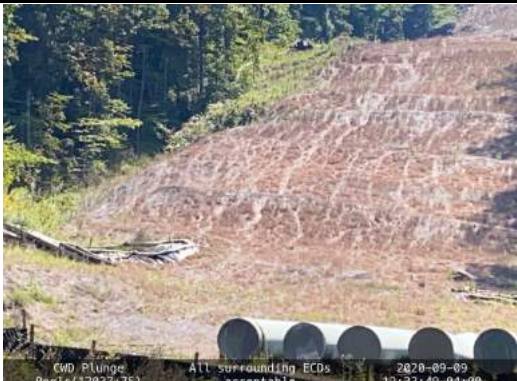
<p>GMD Plunge Pools(12037+75) All surrounding ECDs acceptable 2020-09-09 12:33:49-04:00</p>			
<b>GPS Location</b>	See photo GPS for location		<b>GPS Location</b>	See photo GPS for location	
<b>Field Station#</b>	12035+75		<b>Field Station#</b>	12037+75	
<b>Pic 17 Desc.</b>	All surrounding ECDs are in acceptable condition.		<b>Pic 18 Desc.</b>	All surrounding ECDs are in acceptable condition.

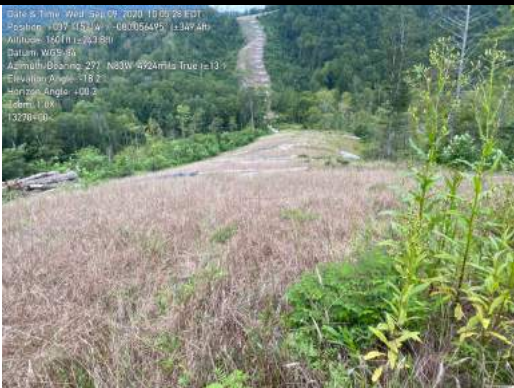
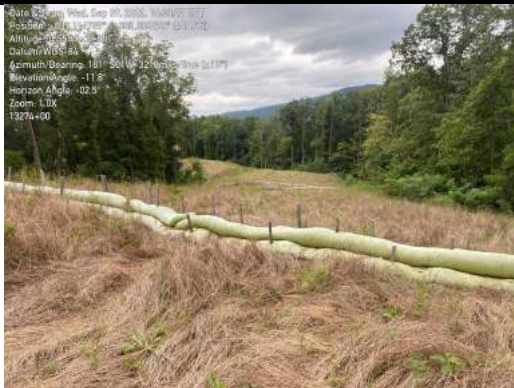
<b>Field Station#</b>	13270+00		<b>Field Station#</b>	13274+00	
<b>Pic 5 Desc.</b>	ROW stable, vegetative cover noted across LOD.		<b>Pic 6 Desc.</b>	ROW stable, vegetative cover noted across LOD.

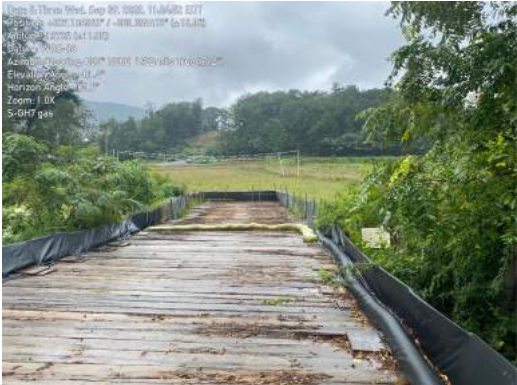
<p>Photo 15: Three View, Sep 09, 2020, 11:46:00 EDT. Position: 33° 11' 54.00" N, 82° 52' 13.00" W. Altitude: 1378 ft. Datum: WGS 84. Azimuth/Bearing: 240.56° W. Elevation angle: 12.5°. Horizon angle: 131.0°. Zoom: 1.0X. S-GH7 gas.</p>

<b>GPS Location</b>	See photo for coordinates.		<b>GPS Location</b>	See photo for coordinates.	
<b>Field Station#</b>	13309+09		<b>Field Station#</b>	13312+00	
<b>Pic 15 Desc.</b>	GAS S-GH7, bridge in acceptable condition.		<b>Pic 16 Desc.</b>	Current vegetation on ROW.

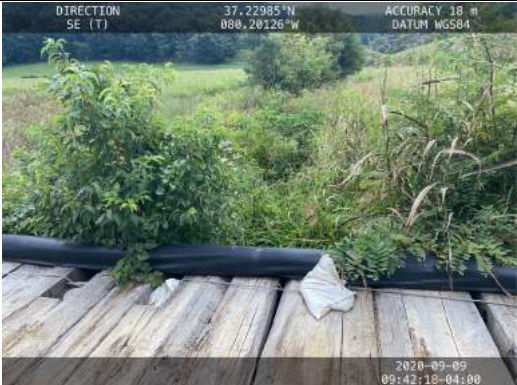
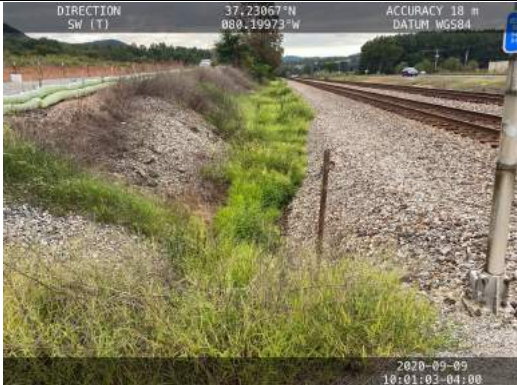
<b>Pic 17 Desc.</b>	Stream S-CD12, facing southeast, upstream		<b>Pic 18 Desc.</b>	Stream S-I1, facing southwest, upstream

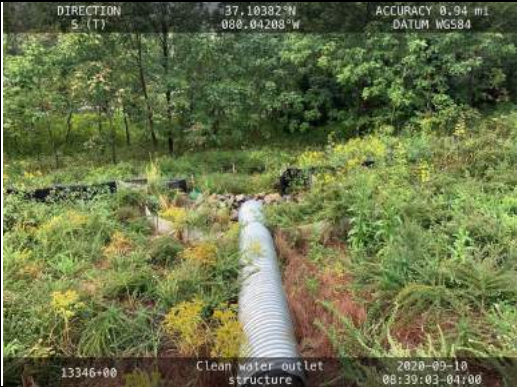
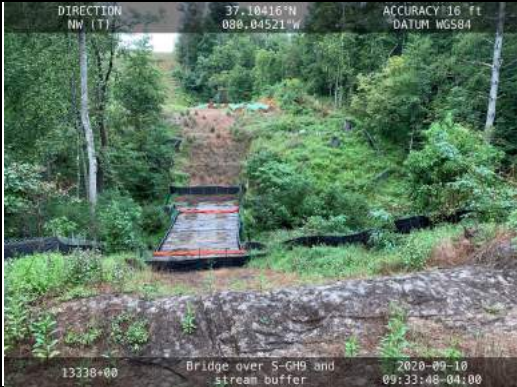
<b>GPS Location</b>	See photo for gps location data.		<b>GPS Location</b>	See photo for gps location data.	
<b>Field Station#</b>	13346+00		<b>Field Station#</b>	13338+00	
<b>Pic 13 Desc.</b>	Photo shows the clean water outlet structure.		<b>Pic 14 Desc.</b>	Photo shows the bridge over stream S-GH9 and adjacent stream buffer.
