# Visual Site Inspection Report

<b>Project Name</b>	H-600 Pipeline Spread H	<b>AFE</b>	124300138	<b>Spread</b>	H-600 Pipeline Spread H	
<b>Contractor</b>	Precision			<b>Report #</b>	14374	
<b>Inspector</b>	Pat Davis			<b>Date/Time</b>	9/7/2020 4:04 PM	
<b>Permit #</b>	TBD	<b>Inspection Type</b>	VA SWPP	<b>Station Begin</b>	+0	
<b>State</b>	VA	<b>Inspection Area</b>	Partial	<b>Station End</b>	+0	
<b>County</b>	Montgomery	<b>Ground</b>	Damp	<b>Temperature (°F)</b>	82.00	
<b>Municipality</b>	N/A	<b>Weather</b>	Sunny	<b>Rain Gauge (in)</b>	0.00	
				<b>Rain Accumulation Time (days)</b>	0.00

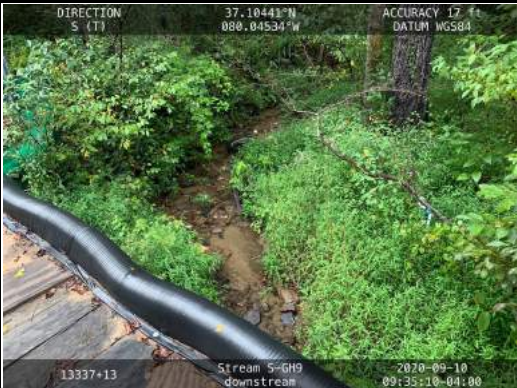
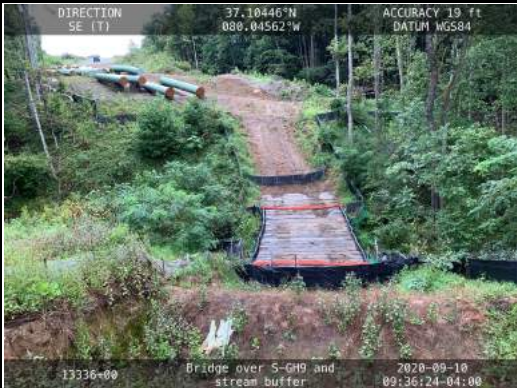
<b>GPS Location</b>	See photo for gps location data.		<b>GPS Location</b>	See photo for gps location data.	
<b>Field Station#</b>	13337+13		<b>Field Station#</b>	13336+00	
<b>Pic 15 Desc.</b>	Photo shows stream S-GH9 downstream from the bridge.		<b>Pic 16 Desc.</b>	Photo shows the bridge over stream S-GH9 and adjacent stream buffer.

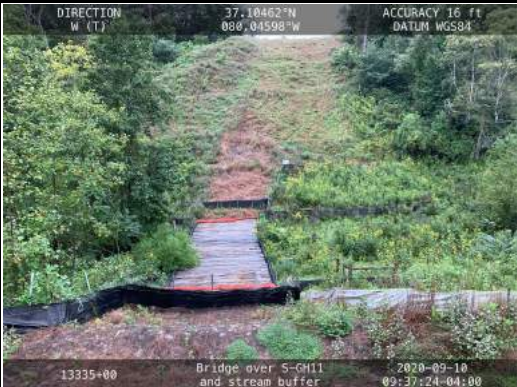
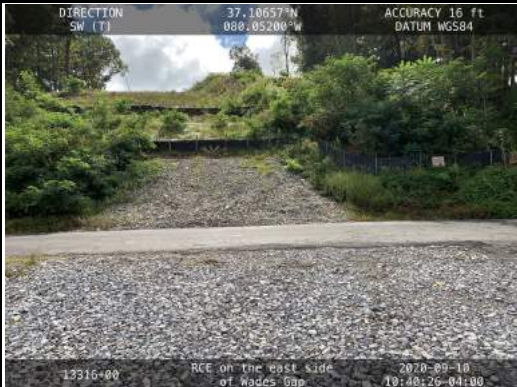
<b>Field Station#</b>	13335+00		<b>Field Station#</b>	13316+00	
<b>Pic 17 Desc.</b>	Photo shows the bridge over stream S-GH11 and adjacent stream buffer.		<b>Pic 18 Desc.</b>	Photo shows the RCE on the east side of Wades Gap Road.

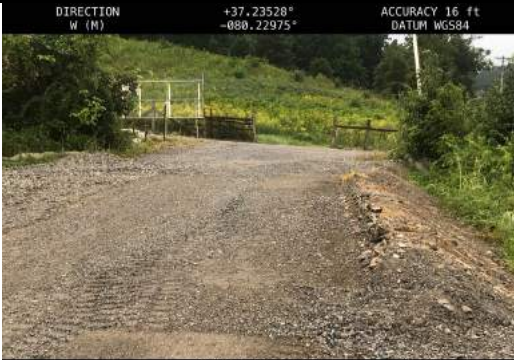
<p>DIRECTION W (N) +37.23528° -080.22975° ACCURACY 16 ft DATUM WGS84</p> <p>MVP-PY-006_091020 Condition of rock entrance 2020-09-10 08:12:14-04:00</p>		  <p>DIRECTION N (N) +37.23560° -080.22876° ACCURACY 16 ft DATUM WGS84</p> <p>MVP-LY-006_091020 Condition of signage and buffer flagging 2020-09-10 08:13:35-04:00</p>			
<b>GPS Location</b>	MVP-Y-006 See photo for gps data		<b>GPS Location</b>	MVP-Y-006 See photo for gps data	
<b>Field Station#</b>	+0		<b>Field Station#</b>	+0	
<b>Pic 1 Desc.</b>	Condition of west rock entrance. No sediment on stone surface. Looking W.		<b>Pic 2 Desc.</b>	Condition of signage and buffer flagging for feature W-008. Looking N.

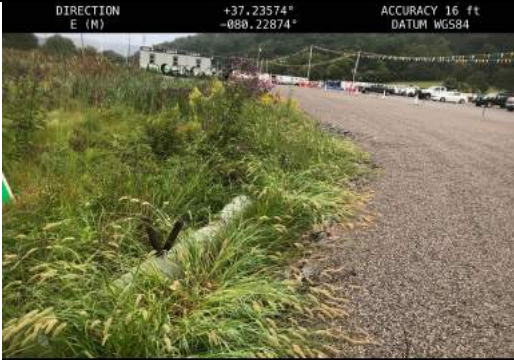
<p>DIRECTION E (N) +37.23574° -080.22874° ACCURACY 16 ft DATUM WGS84</p> <p>MVP-PY-006_091020 Condition of CFS along edge of feature 2020-09-10 08:13:55-04:00</p>		  <p>DIRECTION E (N) +37.23543° -080.22879° ACCURACY 16 ft DATUM WGS84</p> <p>MVP-PY-006_091020 Condition of containment 2020-09-10 08:14:26-04:00</p>

<b>GPS Location</b>	MVP-Y-006 See photo for gps data		<b>GPS Location</b>	MVP-Y-006 See photo for gps data	
<b>Field Station#</b>	+0		<b>Field Station#</b>	+0	
<b>Pic 3 Desc.</b>	Condition of compost filter sock along the south edge of feature. Looking E.		<b>Pic 4 Desc.</b>	Condition of containment under light plant. Holding some stormwater. Looking E.	
  <p>DIRECTION W (N) +37.23568° -080.22715° ACCURACY 16 ft DATUM WGS84</p> <p>MVP-PY-006_091020 No fuel spills south of tanks 2020-09-10 08:16:28-04:00</p>

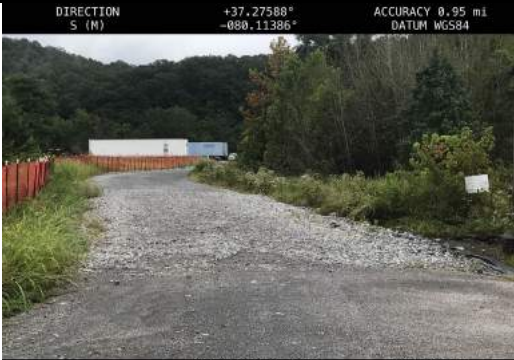
<b>GPS Location</b>	MVP-LY-049 See photo for gps data	<b>GPS Location</b>	MVP-LY-049 See photo for gps data		
<b>Field Station#</b>	+0	<b>Field Station#</b>	+0		
<b>Pic 1 Desc.</b>	Condition of rock entrance on center drive. No sediment on stone surface. Looking S.	<b>Pic 2 Desc.</b>	Condition of containment under light plant, holding some stormwater. Looking S.

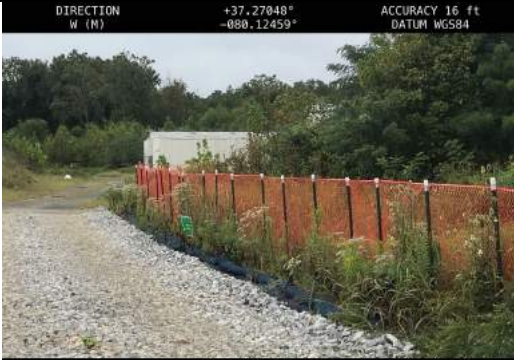
<b>GPS Location</b>	MVP-LY-049 See photo for gps data	<b>GPS Location</b>	MVP-LY-049 See photo for gps data		
<b>Field Station#</b>	+0	<b>Field Station#</b>	+0		
<b>Pic 3 Desc.</b>	Condition of compost filter sock and safety fence along feature W-CV21A. Looking W.	<b>Pic 4 Desc.</b>	Landowner disturbance along compost filter sock and feature W-CV21B. Area no stabilized. No impacts. Looking S.

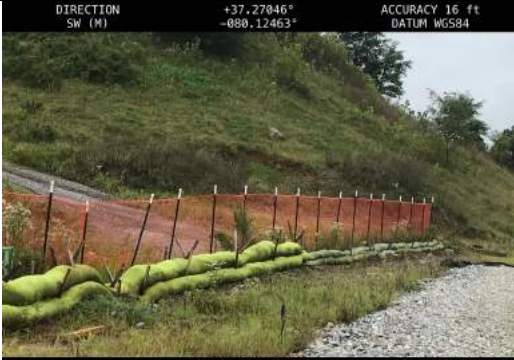
<b>Field Station#</b>	+0	<b>Field Station#</b>	+0		
<b>Pic 5 Desc.</b>	Condition of compost filter sock and safety fence along feature W-CV21B. Looking SW.	<b>Pic 6 Desc.</b>	Condition of temporary trash transfer pit. Debris inside boundary of pit. Looking W.

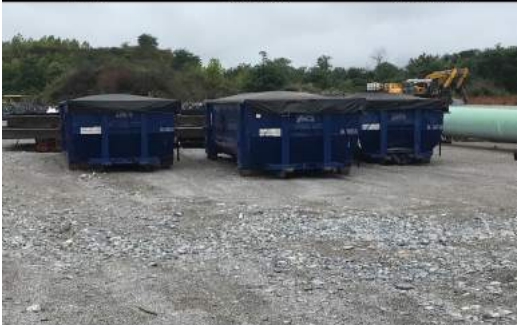
MVP-LY-049_091020 No debris around hazardous waste ... 2020-09-10 09:47:46-04:00		MVP-LY-049_091020 No loose trash around south dumpsters 2020-09-10 09:48:25-04:00			
<b>GPS Location</b>	MVP-LY-049 See photo for gps data		<b>GPS Location</b>	MVP-LY-049 See photo for gps data	
<b>Field Station#</b>	+0		<b>Field Station#</b>	+0	
<b>Pic 7 Desc.</b>	No debris around hazardous waste dumpsters. Looking NW.		<b>Pic 8 Desc.</b>	No loose trash around south dumpsters. Looking SE.	
DIRECTION NE (M) +37.27024° -080.12224° ACCURACY 16 ft DATUM WGS84

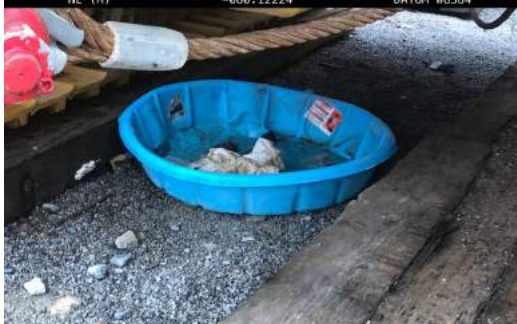
MVP-LY-049_091020 Containment under stored equipment 2020-09-10 09:50:51-04:00		MVP-LY-049_091020 Containments under stored equipment 2020-09-10 09:51:11-04:00

<b>GPS Location</b>	MVP-LY-049 See photo for gps data		<b>GPS Location</b>	MVP-LY-049 See photo for gps data	
<b>Field Station#</b>	+0		<b>Field Station#</b>	+0	
<b>Pic 9 Desc.</b>	Condition of containment under stored equipment. Looking SW.		<b>Pic 10 Desc.</b>	Condition of containment under stored equipment. Looking E.	
DIRECTION S (M) +37.27036° -080.12216° ACCURACY 16 ft DATUM WGS84

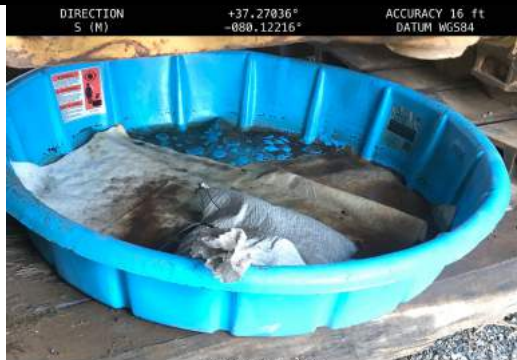
MVP-LY-049_091020 Containment under stored equipment 2020-09-10 09:51:24-04:00		MVP-LY-049_091020 Condition of CF5 around sand pile 2020-09-10 09:56:49-04:00			
<b>GPS Location</b>	MVP-LY-049 See photo for gps data		<b>GPS Location</b>	MVP-LY-049 See photo for gps data	
<b>Field Station#</b>	+0		<b>Field Station#</b>	+0	
<b>Pic 11 Desc.</b>	Condition of containment under stored equipment. Looking S.		<b>Pic 12 Desc.</b>	Condition of compost filter sock around sand pile. Looking SW.

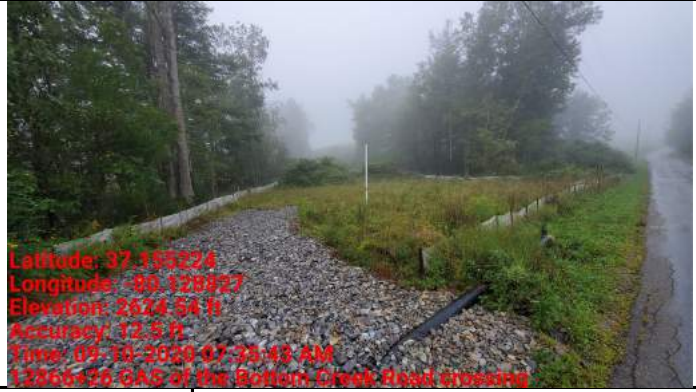
<p>Latitude: 37.135324 Longitude: -80.128827 Elevation: 2614.54 ft Accuracy: 12.5 ft Time: 09-10-2020 07:35:43 AM 12866+26 GAS of the Bottom Creek Road crossing</p>

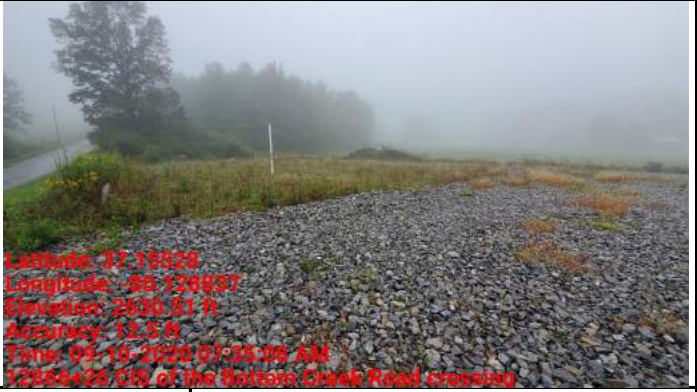
<p>Latitude: 37.135328 Longitude: -80.128837 Elevation: 2630.51 ft Accuracy: 12.5 ft Time: 09-10-2020 07:35:08 AM 12866+26 CIS of the Bottom Creek Road crossing</p>			
<b>GPS Location</b>	See pic for GPS location		<b>GPS Location</b>	See pic for GPS location	
<b>Field Station#</b>	12866+26		<b>Field Station#</b>	12866+26	
<b>Pic 1 Desc.</b>	GAS of the Bottom Creek Road crossing		<b>Pic 2 Desc.</b>	CIS of the Bottom Creek Road crossing

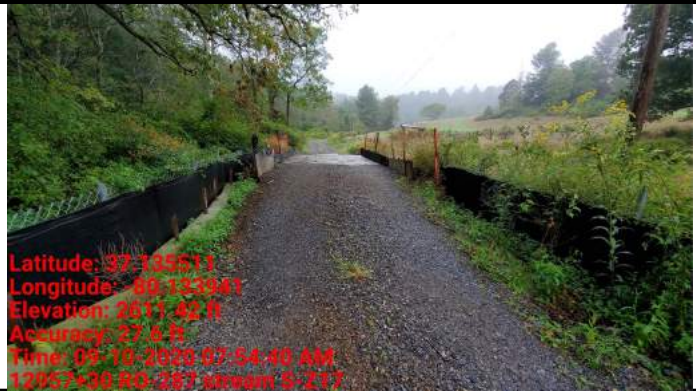
<p>Latitude: 37.135511 Longitude: -80.131841 Elevation: 2611.42 ft Accuracy: 27.5 ft Time: 09-10-2020 07:54:40 AM 12957+30 RO-287 stream S-Z17</p>

<b>GPS Location</b>	See pic for GPS location		<b>GPS Location</b>	See pic for GPS location	
<b>Field Station#</b>	12957+30		<b>Field Station#</b>	12957+30	
<b>Pic 3 Desc.</b>	Access road RO-287 at stream S-Z17.		<b>Pic 4 Desc.</b>	Access road RO-287 at stream S-Z16.

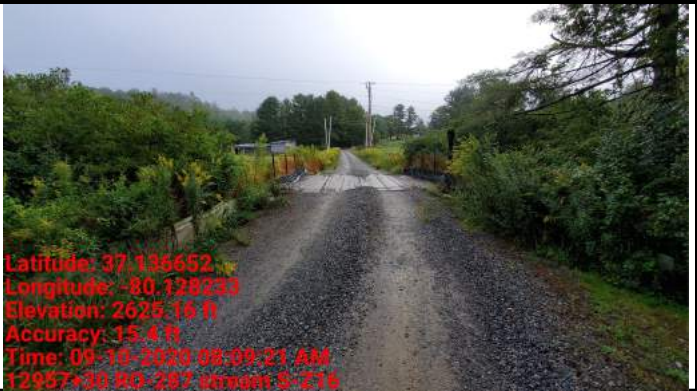
<p>Latitude: 37.135652 Longitude: -80.128253 Elevation: 2625.16 ft Accuracy: 15.4 ft Time: 09-10-2020 08:09:21 AM 12957+30 RO-287 stream S-Z16</p>

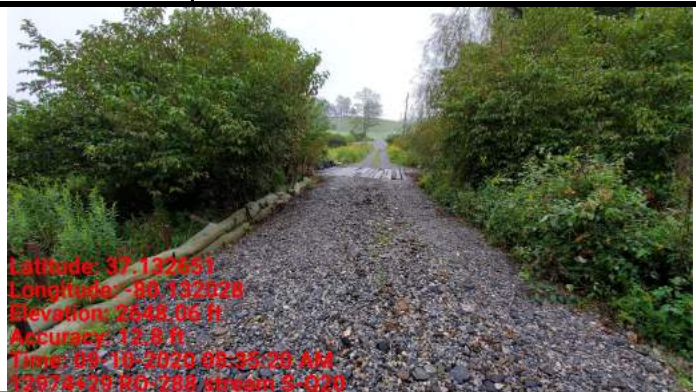
<p>Latitude: 37.122451 Longitude: -80.132028 Elevation: 2448.06 ft Accuracy: 12.5 ft Time: 09-10-2020 08:35:29 AM 12974+29 RO-288 stream S-Q20</p>

<p>Latitude: 37.128414 Longitude: -80.130528 Elevation: 2654.99 ft Accuracy: 12.5 ft Time: 09-10-2020 08:48:12 AM 12994+02 CIS of the US-221 road crossing</p>			
<b>GPS Location</b>	See pic for GPS location		<b>GPS Location</b>	See pic for GPS location	
<b>Field Station#</b>	12974+29		<b>Field Station#</b>	12994+02	
<b>Pic 5 Desc.</b>	Access road RO-288 at stream S-Q20.		<b>Pic 6 Desc.</b>	CIS of the US-221 road crossing.

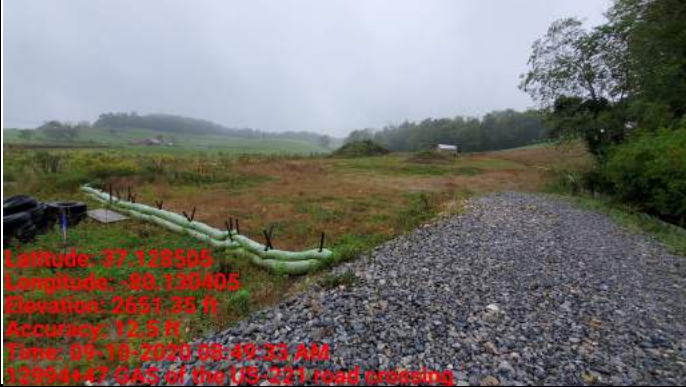
<b>GPS Location</b>	See pic for GPS location		<b>GPS Location</b>	See pic for GPS location	
<b>Field Station#</b>	12994+47		<b>Field Station#</b>	13012+40	
<b>Pic 7 Desc.</b>	GAS of the US-221 road crossing.		<b>Pic 8 Desc.</b>	CIS of the BRP motorway.

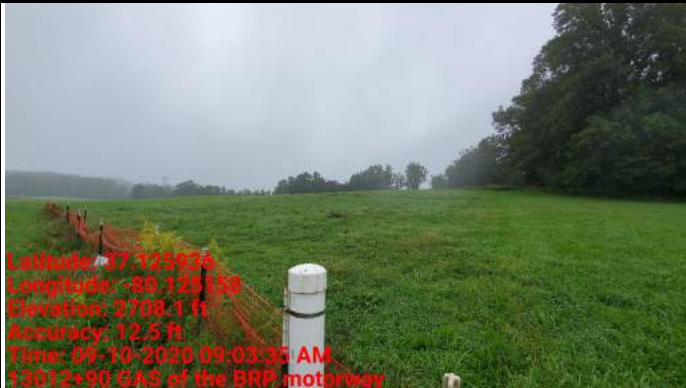
<b>GPS Location</b>	See pic for GPS location		<b>GPS Location</b>	See pic for GPS location	
<b>Field Station#</b>	13012+90		<b>Field Station#</b>	13033+59	
<b>Pic 9 Desc.</b>	GAS of the BRP motorway.		<b>Pic 10 Desc.</b>	Access road FR-289 Callaway Road rain gauge. 0.5" total precipitation.

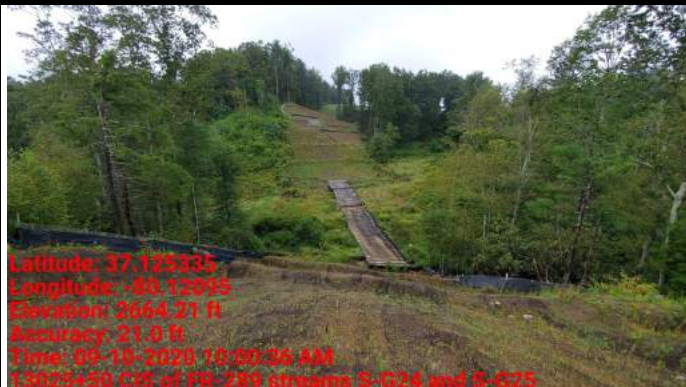
<b>GPS Location</b>	See pic for GPS location		<b>GPS Location</b>	See pic for GPS location	
<b>Field Station#</b>	13025+50		<b>Field Station#</b>	13040+00	
<b>Pic 11 Desc.</b>	Streams S-G24 and S-G25 on the GAS of the BRP and the CIS of FR-289.		<b>Pic 12 Desc.</b>	Streams S-H1 on the GAS of access road FR-289.
