Visual Site Inspection Report

| Project Name H-600 Pipeline Spread G | | AFE 124300137 | Spread H-600 Pipeline Spread G |
| Contractor Precision | | Report # 19131 | |
| Inspector Len Kruizenga | | Date/Time 1/18/2021 8:35 AM | |

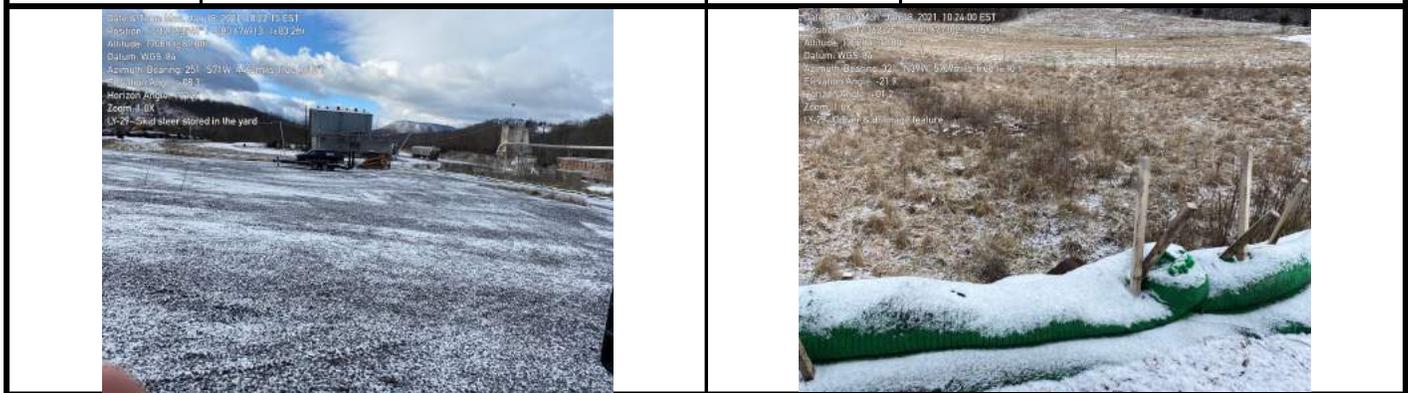
| Pic 3 Desc. | LY29- welders are in the yard | Pic 4 Desc. | LY29- CFS triple stack perimeter controls |

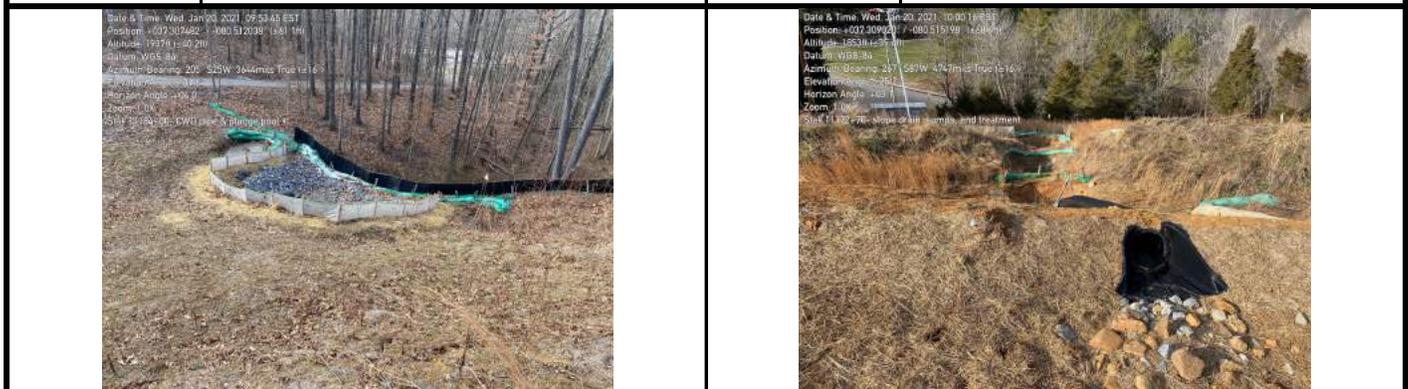
| Pic 3 Desc. | CFS perimeter controls | Pic 4 Desc. | Sensitive resource area, drainage feature. |

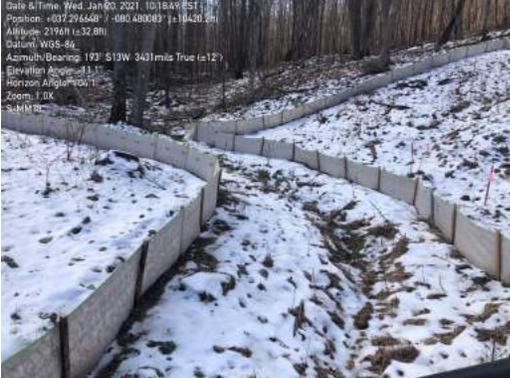
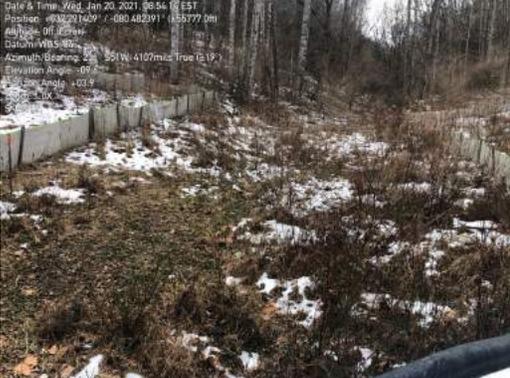
| AFE 124300137 | | Date/Time 1/20/2021 1:52 PM | | Report # | | | |
|--|--|---|--|---|--|---|--|
| Pic 1 Desc. S-MM18 and controls. | | Pic 2 Desc. S-NN12 and controls. | | | | | |

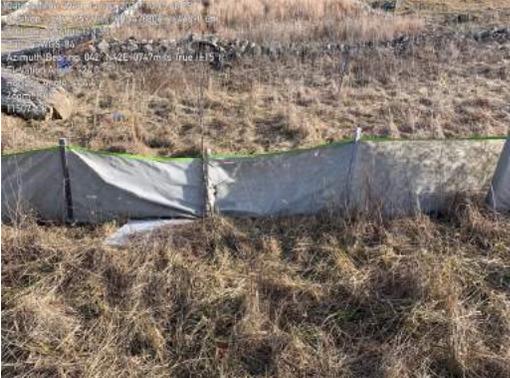
| AFE 124300137 | | Date/Time 1/20/2021 2:44 PM | | Report # | |
|---|---|--|---|---|--|
| Pic 1 Desc. | Broken priority one silt fence stake. | | Pic 2 Desc. | Clean water diversion pipe and plunge pool in place. | |

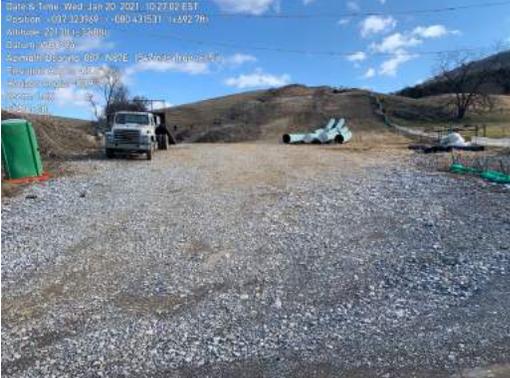
| AFE 124300137 | | Date/Time 1/20/2021 2:44 PM | | Report # | |
|---|---|--|---|---|--|
| Pic 3 Desc. | RCE in place at Stevers Gap Road. | | Pic 4 Desc. | Sensitive resource buffer in place at stream S-0012 and S-0013. | |

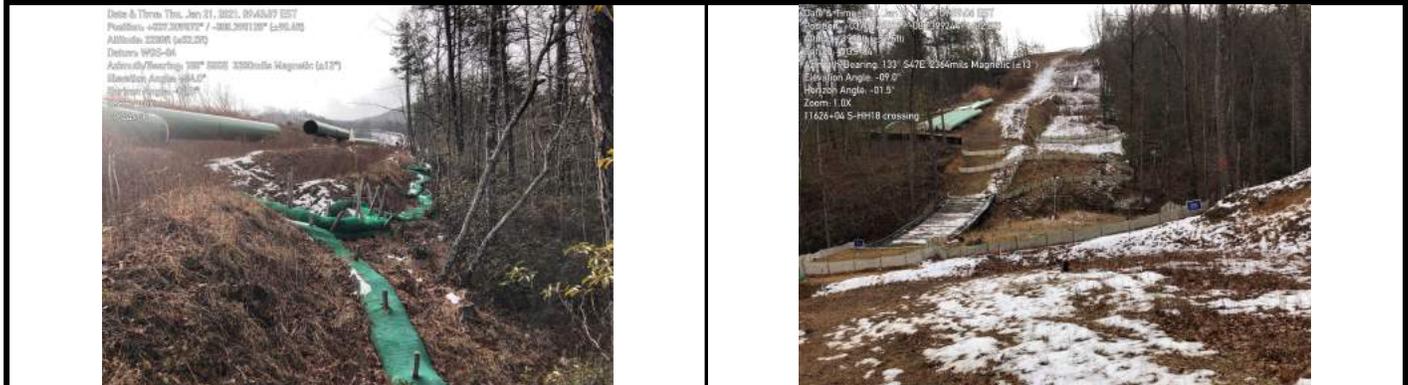
| Pic 3 Desc. | Perimeter controls in place. No erosion. | Pic 4 Desc. | ROW currently stable. Environmental controls are in place. |

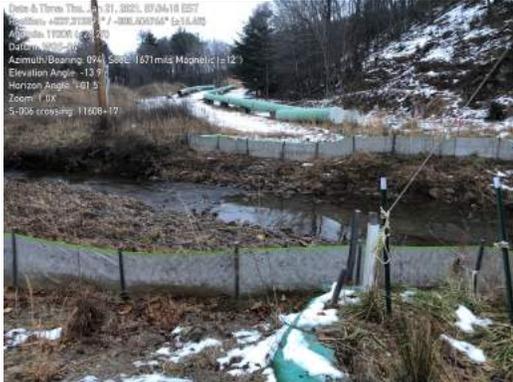
| AFE 124300137 | | Date/Time 1/21/2021 11:15 AM | | Report # | |
|--|---|---|---|---|--|
| Field Station# | 11608+17 | Field Station# | | | |

| AFE 124300137 | | Date/Time 1/21/2021 11:15 AM | | Report # | |
|--|---|---|---|---|--|
| <p><small>Date & Time: Thu, Jan 21, 2021, 09:04:18 EST Position: +037.270817 / -080.400764 (+515.6ft) Altitude: 1708ft (+129.2m) Datum: WGS-84 Azimuth/Bearing: 094.580E 1671mils Magnetic (+12°) Elevation Angle: -13.9° Horizon Angle: -101.5° Zoom: 1.0x S-006 crossing, 11608+17</small></p> | | | | Insert image here | |

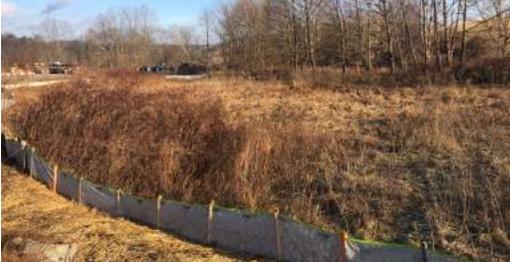
| AFE 124300137 | | Date/Time 1/22/2021 8:27 AM | | Report # | | | |
|---|--|---|--|--|--|--|--|
| Pic 1 Desc. W-KL24 and controls. | | Pic 2 Desc. W-IJ81 and controls. | | | | | |

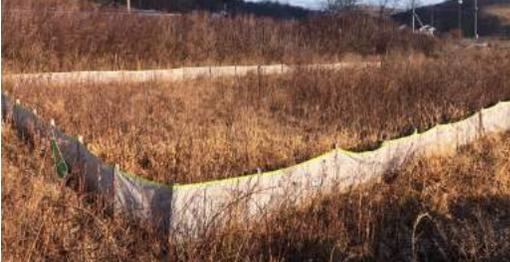
| AFE 124300137 | | Date/Time 1/22/2021 8:27 AM | | Report # | | | |
|---|--|---|--|--|--|--|--|
| Pic 3 Desc. W-IJ82 and controls. | | Pic 4 Desc. Overview of the lower section of LDY 37. | | | | | |
