Visual Site Inspection Report

Project Name H-600 Pipeline Spread I		AFE 124300139	Spread H-600 Pipeline Spread I
Contractor Precision		Report # 19136	
Inspector Justin Burch		Date/Time 1/18/2021 11:25 AM	
Permit # TBD	Inspection Type VA SWPP	Station Begin 15063+85	
State VA	Inspection Area Full	Station End 15142+66	
County Pittsylvania	Ground Wet	Temperature (°F) 43.00	
Municipality Chatham	Weather Cloudy	Rain Gauge (in) 0.10	
			Rain Accumulation Time (days) 6.00

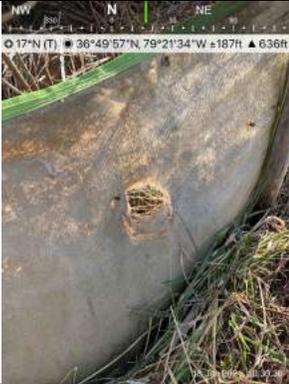
GPS Location	O		GPS Location	O	
Field Station#	15964+50		Field Station#	15965+00	
Pic 1 Desc.	Observing P1 that requires maintenance		Pic 2 Desc.	Observing temporary vegetation, sump and end treatment

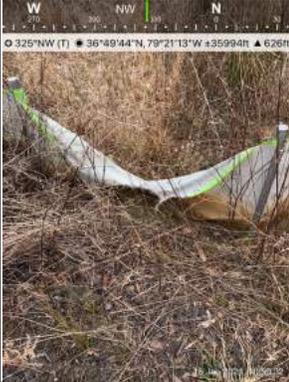
Performed SWPPP Inspection on this section. There were issues identified and added to the punch list. The damaged P1 at 16004+94 was caused by wildlife. The Contractor is working on repairing the identified items. Other than that there were no issues to report at the time of Inspection.

GPS Location	O	GPS Location	O		
Field Station#	16004+94	Field Station#	16004+94		
Pic 7 Desc.	Observing P1 that requires maintenance. (was damaged by wildlife)		Pic 8 Desc.	Observing P1 that requires maintenance. (Was damaged by wildlife)	
Insert image here			Insert image here		
GPS Location		GPS Location			
Field Station#		Field Station#			
Pic 9 Desc.		Pic 10 Desc.			
Insert image here			Insert image here		
GPS Location		GPS Location			
Field Station#		Field Station#			
Pic 11 Desc.		Pic 12 Desc.

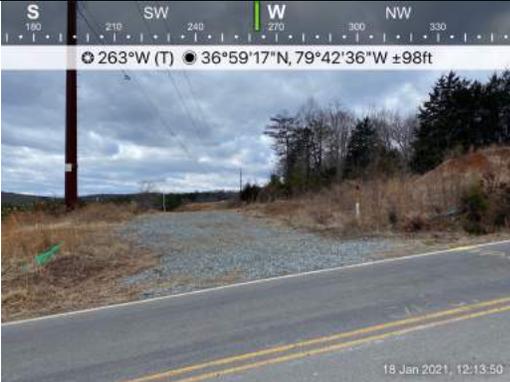
GPS Location	0	GPS Location	0
Field Station#	14694+50	Field Station#	14690+50
Pic 1 Desc.	Approximately 14694+50. Overview of road crossing and RCE. RCE installed and appears to be functioning correctly at time of inspection.	Pic 2 Desc.	Approximately 14690+50. Overview of ROW.

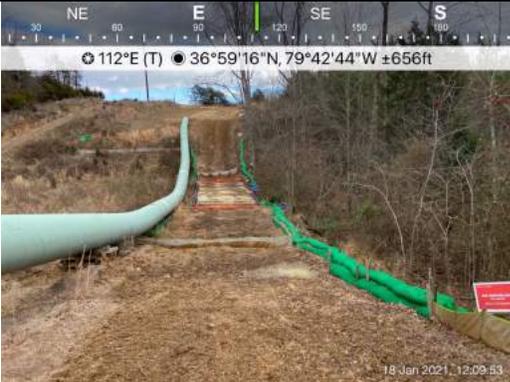
GPS Location	0	GPS Location	0
Field Station#	14689+36	Field Station#	14673+10
Pic 3 Desc.	Approximately 14689+36. Overview of stream crossing, equipment bridge and ECDs at stream S-H34.	Pic 4 Desc.	Approximately 14673+10. Upstream view of stream S-H37. Damage to stream bank and stream bed observed during inspection due to livestock traffic in area. Livestock tracks.

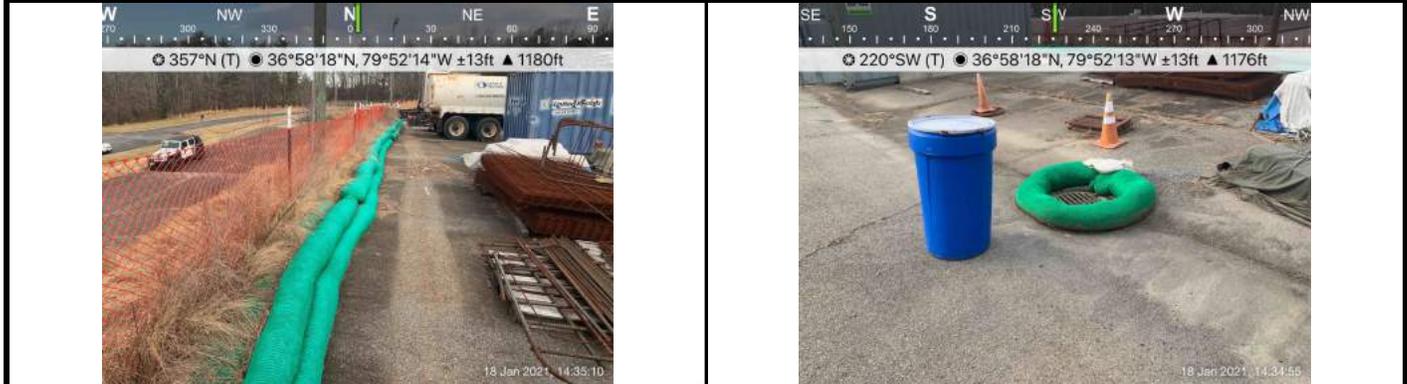
GPS Location	000000000000	GPS Location	000000000000
Field Station#	0000+00	Field Station#	0000+00
Pic 1 Desc.	Perimeter ECD's on west side of paved yard in good condition	Pic 2 Desc.	Inlet protection for parking lot drains in the paved yard were in acceptable condition.

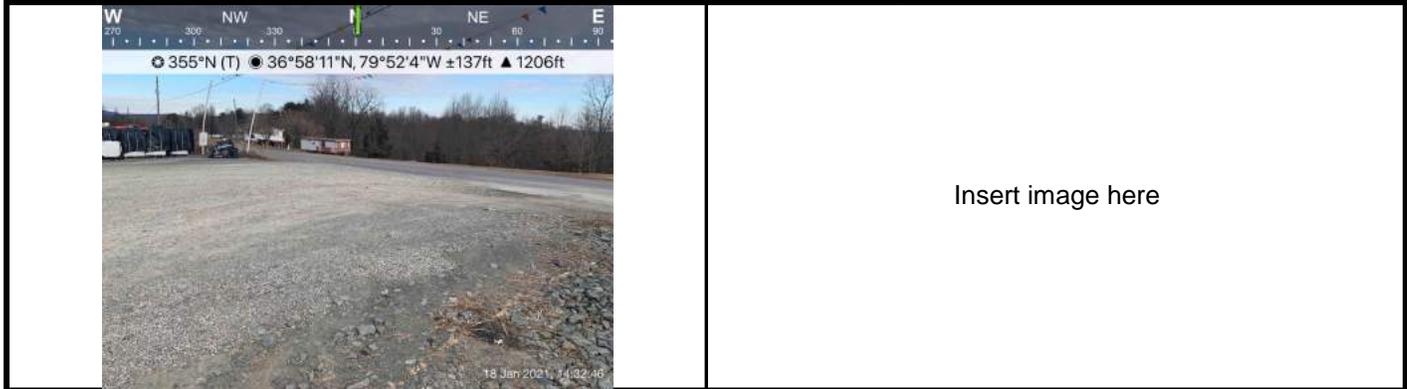
GPS Location	000000000000	GPS Location	
Field Station#	0000+00	Field Station#	
Pic 5 Desc.	RCE at gravel yard in good condition.	Pic 6 Desc.

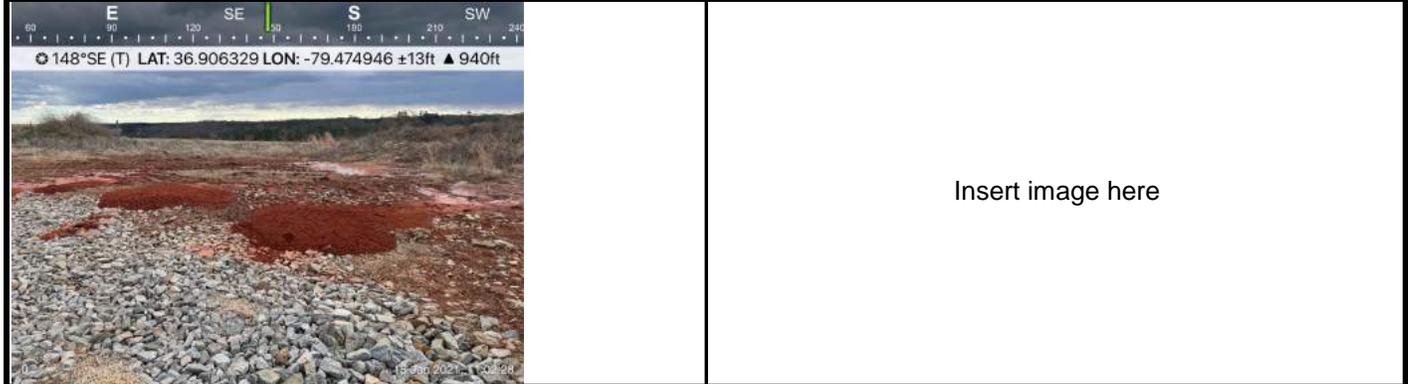
Pic 7 Desc.	Unknown 3rd party dumping material in RCE at Climax Rd.	Pic 8 Desc.	
--------------------	---	--------------------	--

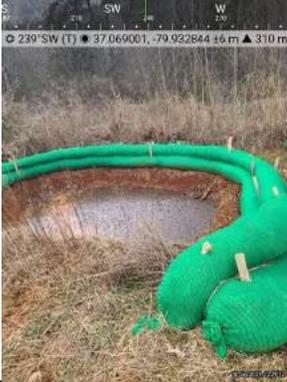
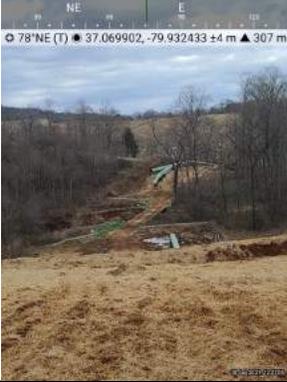
GPS Location 00000		GPS Location 00000			
Field Station# 13784+34		Field Station# 13785+90			
Pic 5 Desc. The EI observed sump pits and end treatment while conducting row inspection today, no environmental issues observed at the time of inspection.		Pic 6 Desc. Photo showing stabilization and water bars in place and functioning, no environmental issues observed at time of inspection.

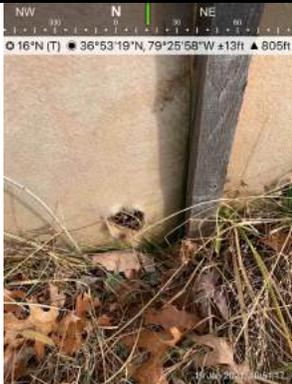
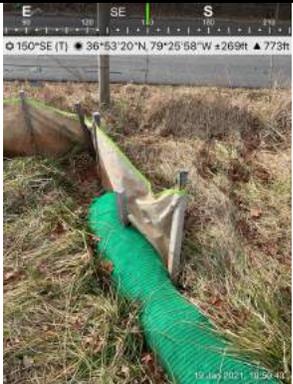
GPS Location	O		GPS Location	O	
Field Station#	15646+80		Field Station#	15646+80	
Pic 1 Desc.	Observing P1 that requires maintenance		Pic 2 Desc.	Observing P1 that requires maintenance

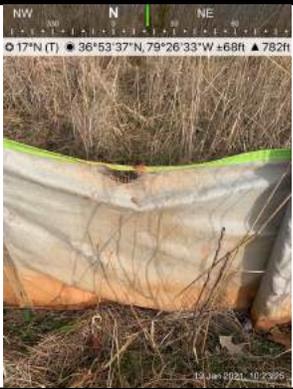
Performed SWPPP Inspection on this section. There were issues identified and added to the punch list. The Contractor is working on repairing the identified issues. The damaged P1 at 15607+00 was damaged by wildlife (deer trail). Other than what was identified there were no issues to report at the time of Inspection.

GPS Location	O		GPS Location	O	
Field Station#	15632+00		Field Station#	15607+00	
Pic 5 Desc.	Observing temporary stabilization, CWD outlet and ECD's		Pic 6 Desc.	Observing P1 that requires maintenance/was damaged by wildlife

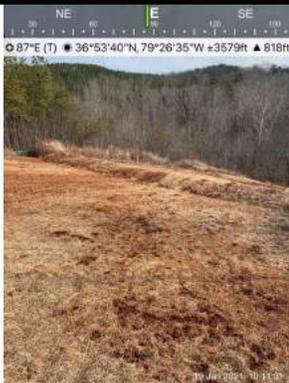
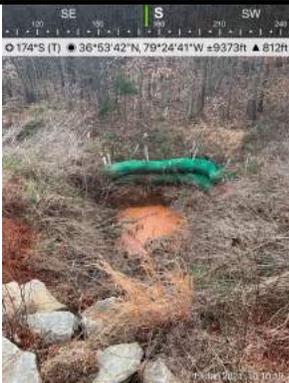
<p>ert image here</p>	
GPS Location O		GPS Location O			
Field Station# 15593+50		Field Station# 15591+00			
Pic 9 Desc. Observing temporary stabilization and water bar		Pic 10 Desc. Observing temporary stabilization, sump and end treatment			
<p>Insert image here</p>			<p>Insert image here</p>		
GPS Location		GPS Location			
Field Station#		Field Station#			
Pic 11 Desc.		Pic 12 Desc.

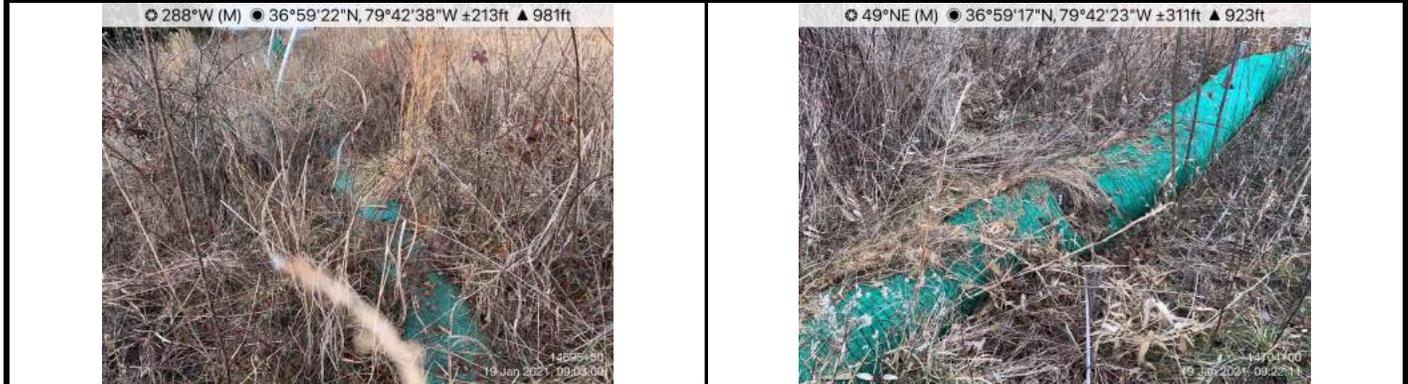
GPS Location	0	GPS Location	0
Field Station#	14695+50	Field Station#	14704+00
Pic 1 Desc.	CFS requiring maintenance	Pic 2 Desc.	CFS requiring maintenance from 14702+50 to 14704+00

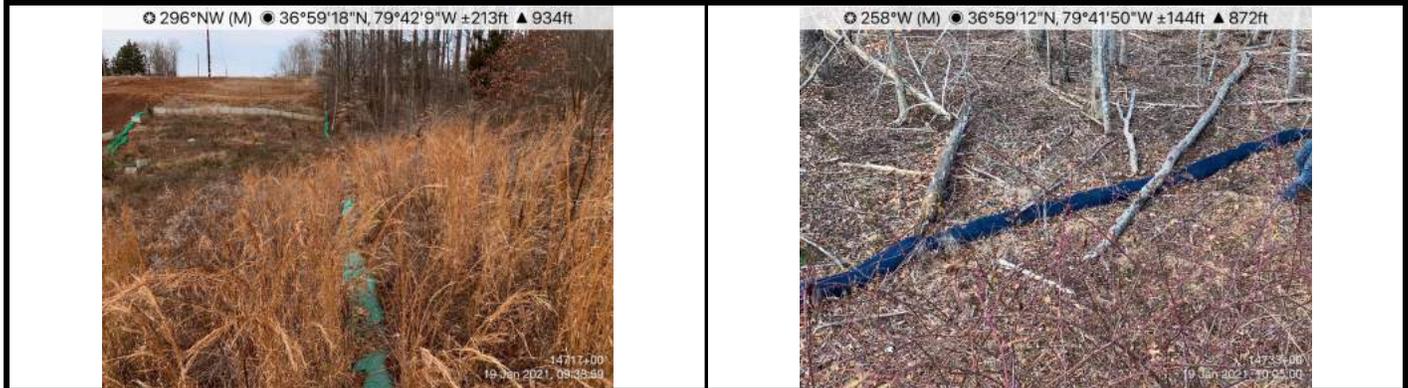
GPS Location	0	GPS Location	0
Field Station#	14717+00	Field Station#	14733+00
Pic 3 Desc.	CFS requiring maintenance from 14716+50 to 14717+00	Pic 4 Desc.	CFS requiring maintenance

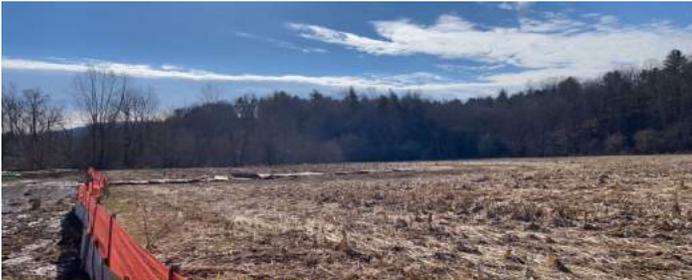
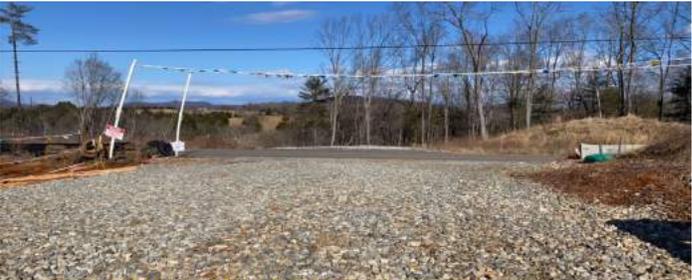
GPS Location 3		GPS Location 4			
Field Station# 13912+00		Field Station# 13892+45			
Pic 3 Desc. Bridge mats remain off ROW and in farm field CIS S-II2.		Pic 4 Desc. RCE at Iron Ridge Rd in good condition.

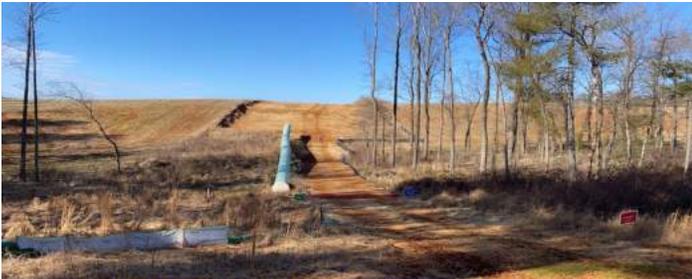
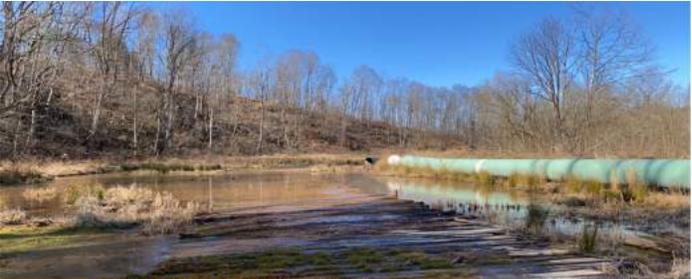
<small>37°2'51" N 79°53'49" W 270°W COURSE 46° GPS 184 Foggy Ridge Rd, Rocky Mount, VA 24151, United States 01.19.2021 11:00:49 Accur +/-31.7 Ft ALT 1077 Ft</small>			<small>37°3'20" N 79°54'39" W 4°N COURSE 63° GPS 1112-1336 Iron Ridge Rd, Rocky Mount, VA 24151, United States 01.19.2021 11:36:02 Accur +/-37.7 Ft ALT 1017 Ft</small>		
GPS Location 5		GPS Location 6			
Field Station# 13949+70		Field Station# 13886+00			
Pic 5 Desc. Equipment bridge and surrounding ECDs in place and functional at stream crossing.		Pic 6 Desc. Bridge mats CIS Iron Ridge Rd remain mostly underwater. No environmental issues observed.

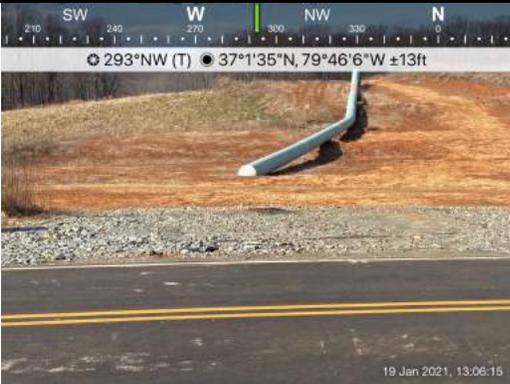
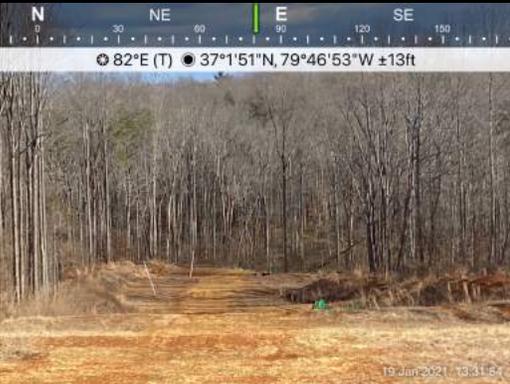
<p>GPS: 82°E (T) ● 37°1'51"N, 79°46'53"W ±13ft 19 Jan 2021, 13:41:54</p>			
GPS Location	0	GPS Location	0		
Field Station#	14454+00	Field Station#	14414+00		
Pic 1 Desc.	Approximately 14454+00. Overview of road crossing and RCE. RCE installed and appears to be functioning correctly at time of inspection.		Pic 2 Desc.	Approximately 14414+00. Overview of ROW.

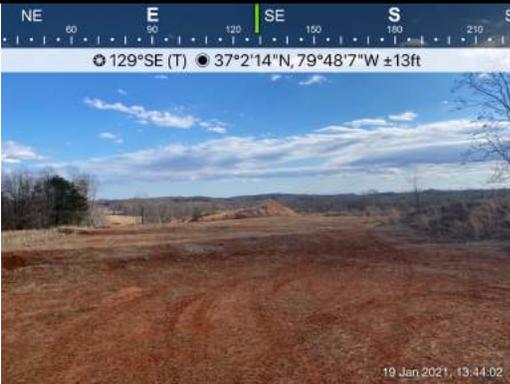
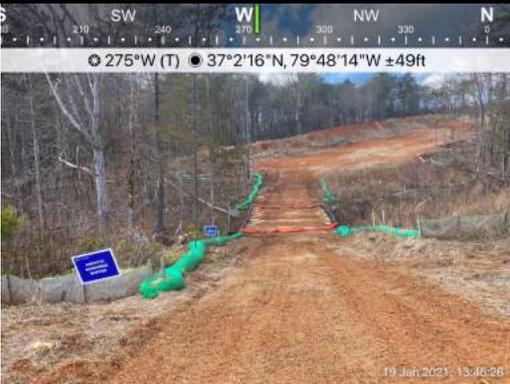
<p>GPS: 275°W (T) ● 37°2'16"N, 79°48'14"W ±49ft 19 Jan 2021, 13:46:26</p>			
GPS Location	0	GPS Location	0		
Field Station#	14346+00	Field Station#	14338+56		
Pic 3 Desc.	Approximately 14346+00. Overview of ROW.		Pic 4 Desc.	Approximately 14338+56. Overview of stream crossing, equipment bridge and ECDs at stream S-A36.

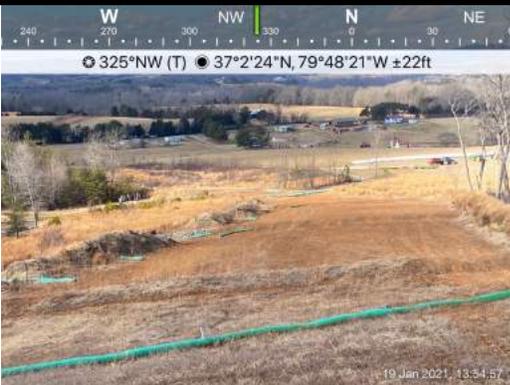
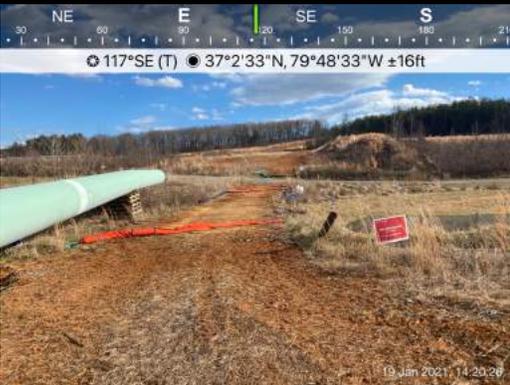
<p>GPS: 117°SE (T) ● 37°2'33"N, 79°48'33"W ±16ft 19 Jan 2021, 14:20:26</p>			
GPS Location	0	GPS Location	0		
Field Station#	14324+00	Field Station#	14314+79		
Pic 5 Desc.	Approximately 14324+00. Overview of ROW.		Pic 6 Desc.	Approximately 14314+79. Overview of stream crossing, equipment bridge and ECDs at stream S-GG4.

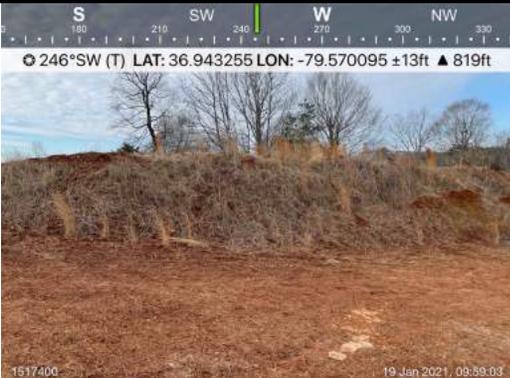
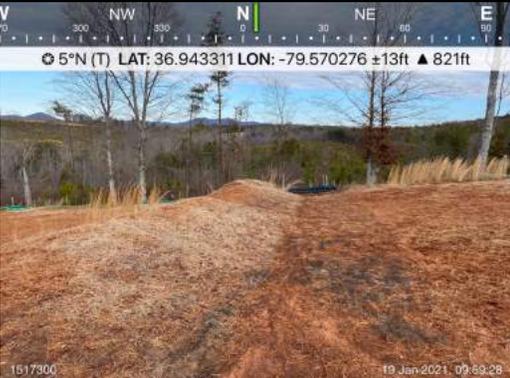
GPS Location	See photo	GPS Location	See photo
Field Station#	15174+00	Field Station#	15173+00
Pic 5 Desc.	Stockpiles remain stabilized.	Pic 6 Desc.	Waterbars in good condition and functioning.

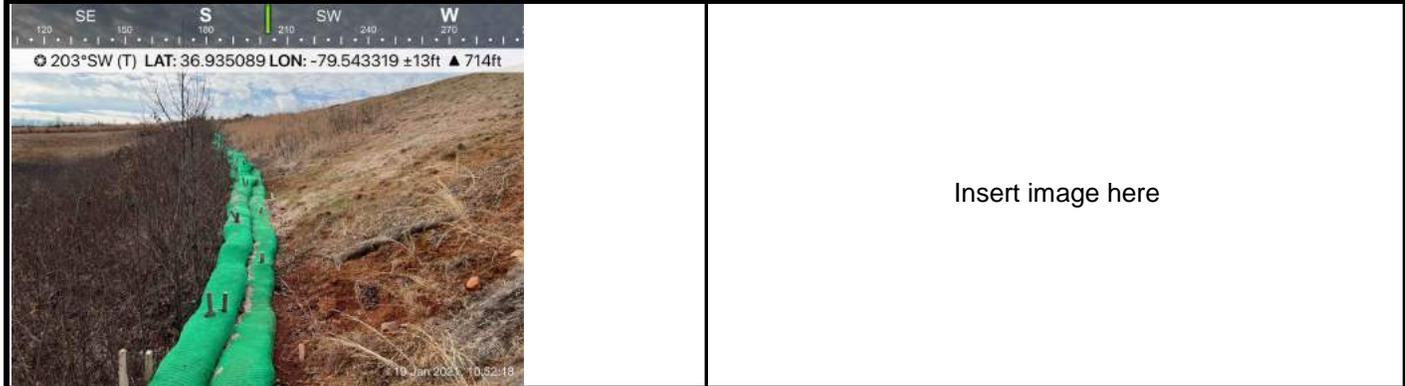
Pic 7 Desc.	Perimeter CFS in good condition.	Pic 8 Desc.	
--------------------	----------------------------------	--------------------	--

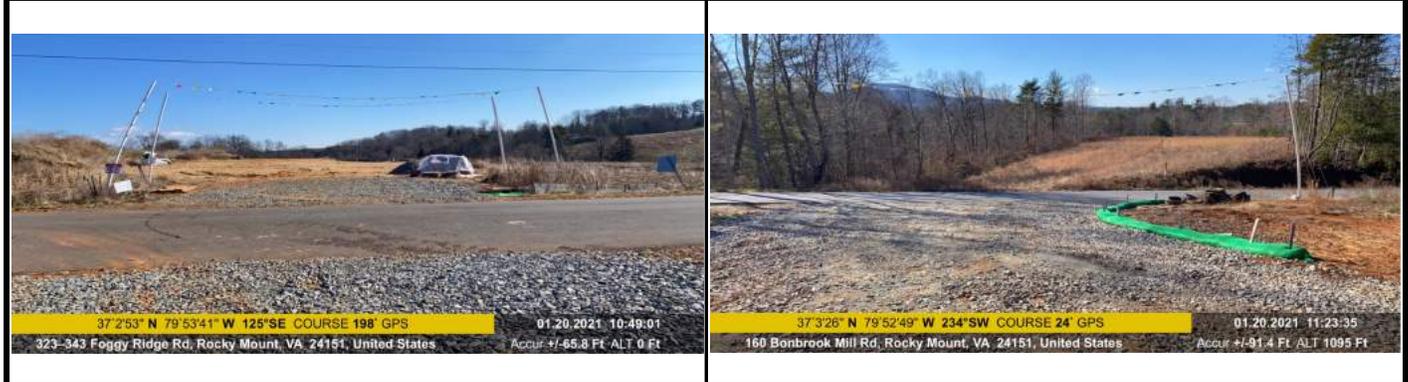
GPS Location	1	GPS Location	2
Field Station#	13958+31	Field Station#	14018+47
Pic 1 Desc.	RCE at Foggy Ridge Rd in good condition	Pic 2 Desc.	RCE at Bonbrook Mill RC1 in good condition

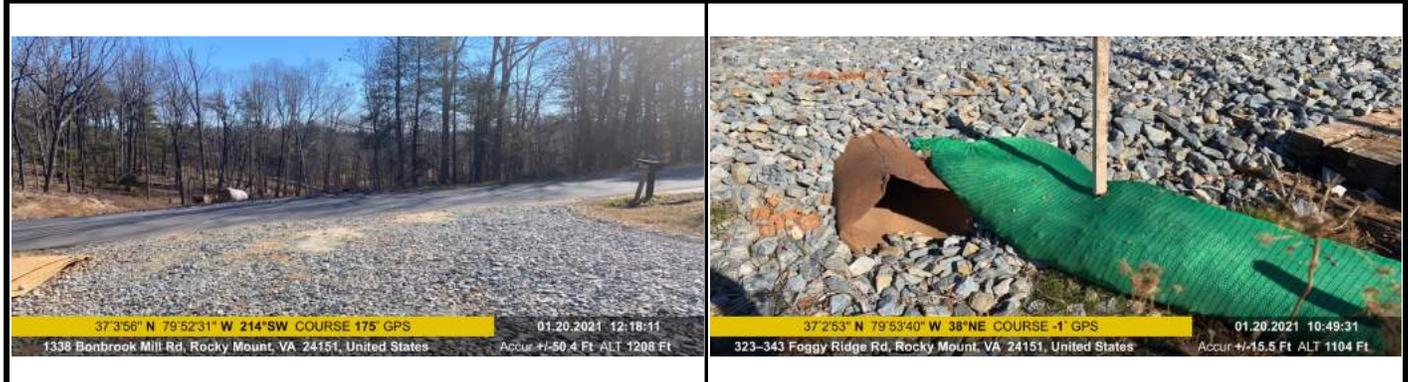
GPS Location	3	GPS Location	4
Field Station#	14062+17	Field Station#	13958+40
Pic 3 Desc.	RCE at Bonbrook Mill RC2 in good condition	Pic 4 Desc.	Culvert at road crossing unobstructed and functioning as intended

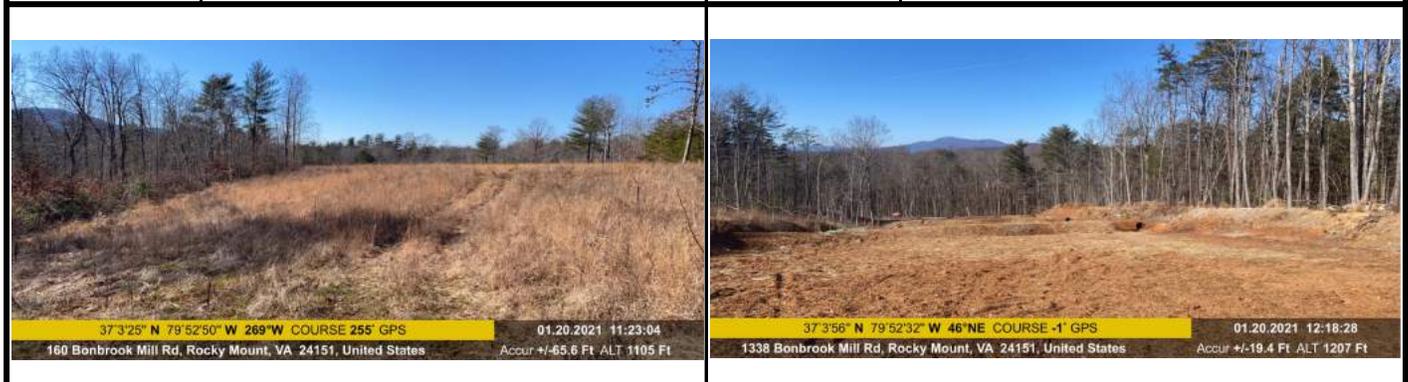
GPS Location	5	GPS Location	6
Field Station#	14016+00	Field Station#	14059+00
Pic 5 Desc.	Final cleanup area CIS Bonbrook Mill RC1. Perimeter ECDs in place and functional. No environmental issues observed.	Pic 6 Desc.	Temporary stabilized area along ROW. Area is stabilized with straw mulch but no vegetation observed. Minor erosion beginning to occur. Will continue to monitor area.

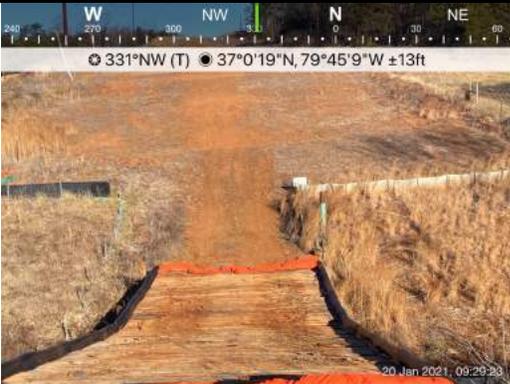
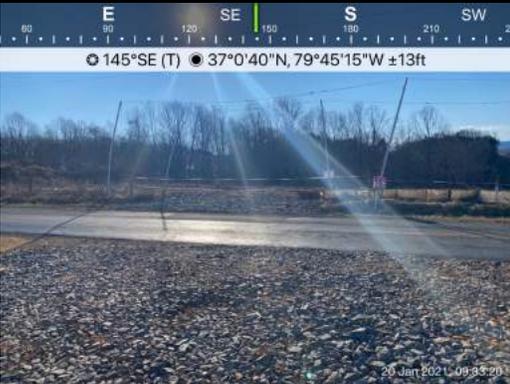
GPS Location	0	GPS Location	0		
Field Station#	14546+33	Field Station#	14524+50		
Pic 1 Desc.	Approximately 14546+33. Overview of stream crossing, equipment bridge and ECDs at stream S-G17.		Pic 2 Desc.	Approximately 14524+50. Overview of road crossing and RCEs. RCEs installed and appears to be functioning correctly at time of inspection.

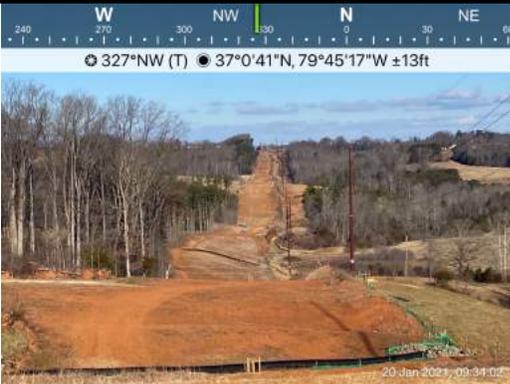
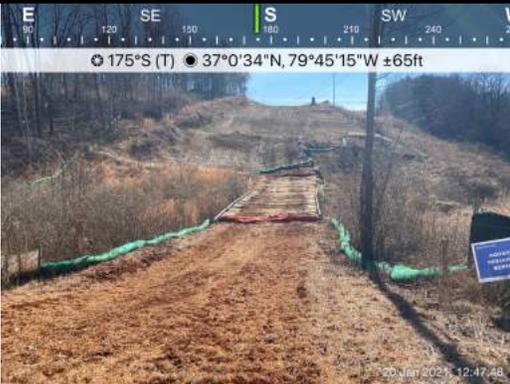
GPS Location	0	GPS Location	0		
Field Station#	14519+00	Field Station#	14531+58		
Pic 3 Desc.	Approximately 14519+00. Overview of ROW.		Pic 4 Desc.	Approximately 14531+58. Overview of stream crossing, equipment bridge and ECDs at stream S-G18.

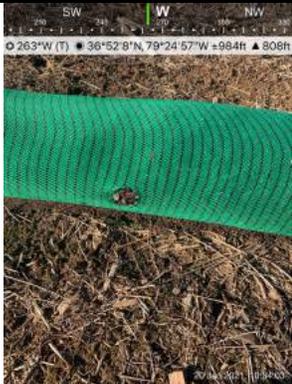
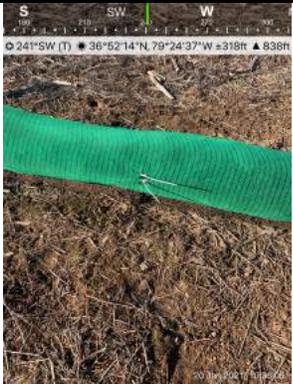
GPS Location	O		GPS Location	O	
Field Station#	15735+00		Field Station#	15735+00	
Pic 1 Desc.	Observing CFS that required maintenance		Pic 2 Desc.	Observing CFS that received maintenance

E&S BMPs	Compliance Level	Corrective Action	Corrective Time Frame	Date Repaired
Compost Filter Sock	Communication	CFS was maintained	Immediate	1/20/2021
Silt Fence (Reinforced Filter Fabric Fence)	Communication	Fabric was attached to fence	Immediate	1/20/2021

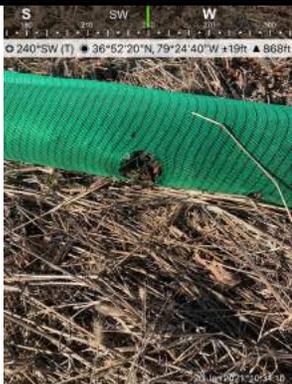
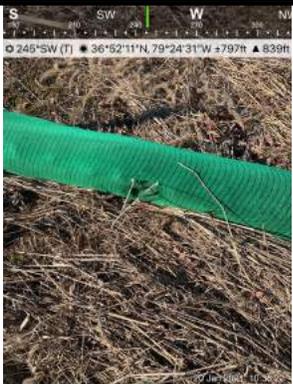
GPS Location	O		GPS Location	O	
Field Station#	15735+00		Field Station#	15735+00	
Pic 3 Desc.	Observing CFS that required maintenance		Pic 4 Desc.	Observing CFS that received maintenance

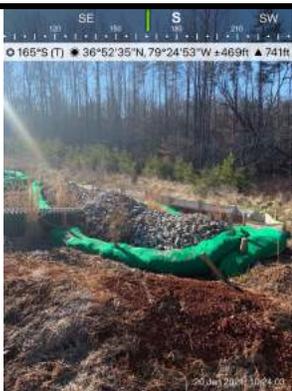
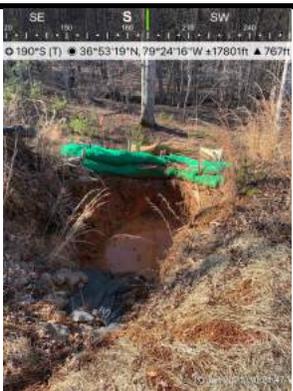
GPS Location	O		GPS Location	O	
Field Station#	15721+00		Field Station#	15719+00	
Pic 5 Desc.	Observing CWD outlet and ECD's		Pic 6 Desc.	Observing sump and end treatment

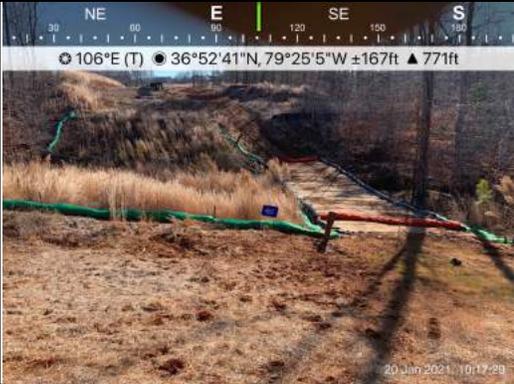
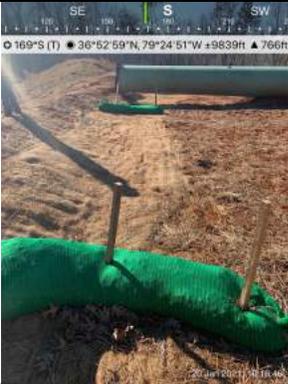
GPS Location	O	GPS Location	O		
Field Station#	15713+52	Field Station#	15710+00		
Pic 7 Desc.	Observing signage,buffer, equipment crossing and ECD's	Pic 8 Desc.	Observing erosion control blanket and CFS checks

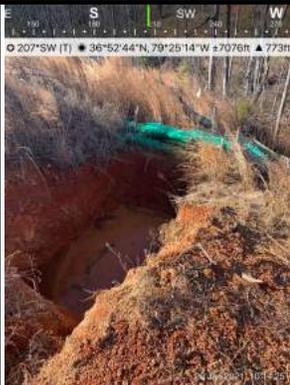
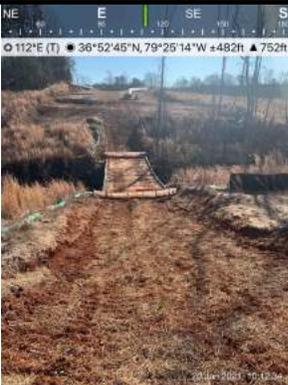
GPS Location	O	GPS Location	O		
Field Station#	15701+50	Field Station#	15700+40		
Pic 9 Desc.	Observing sump and end treatment	Pic 10 Desc.	Observing temporary stabilization,buffer, equipment crossing and ECD's		
<p style="text-align: center;">Insert image here</p>			<p style="text-align: center;">Insert image here</p>		
GPS Location		GPS Location			
Field Station#		Field Station#			
Pic 11 Desc.		Pic 12 Desc.

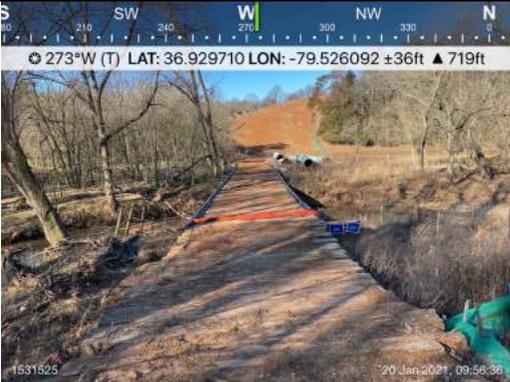
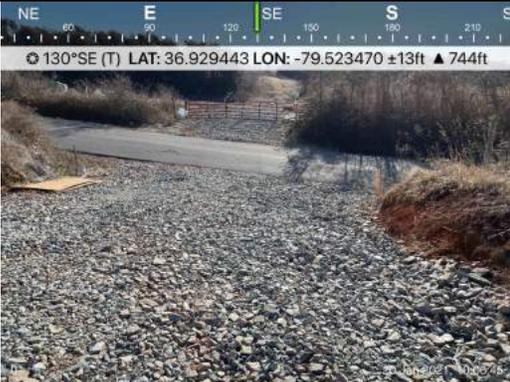
GPS Location See photo		GPS Location See photo			
Field Station# 15315+25		Field Station# 15323+24			
Pic 3 Desc. Equipment bridge ECDs are in place and functioning at all stream and wetland crossings.		Pic 4 Desc. RCEs are in good condition at all road crossings.

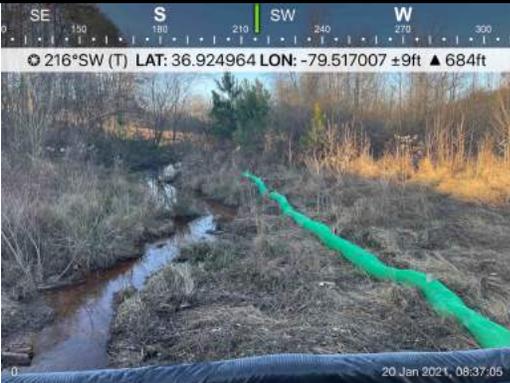
GPS Location See photo		GPS Location See photo			
Field Station# 15346+70		Field Station# 15349+98			
Pic 5 Desc. CFS in good condition along ROW perimeter and waterbody buffers.		Pic 6 Desc. Waterbars in good condition and functioning.

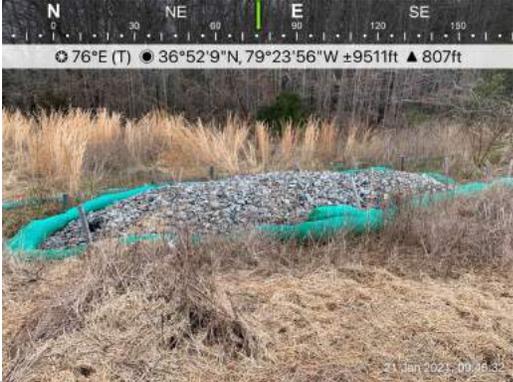
<p>Insert image here</p>			
GPS Location O		GPS Location O			
Field Station# 15787+00		Field Station# 15786+00			
Pic 7 Desc. Observing safety fence that required maintenance.		Pic 8 Desc. Observing temporary stabilization, CWD outlet and ECD's

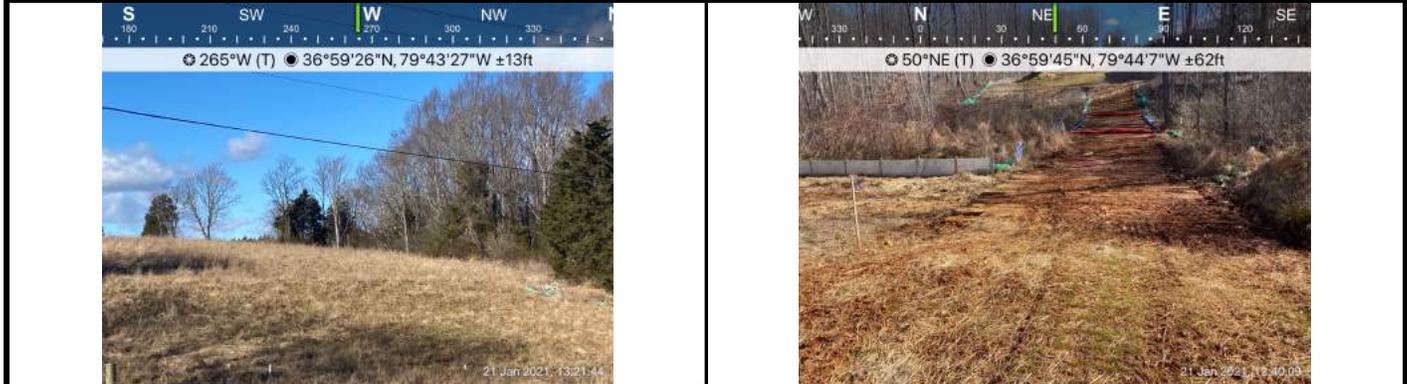
Pic 1 Desc.	Approximately 14647+00. Overview of ROW.	Pic 2 Desc.	Approximately 14611+27. Overview of stream crossing, equipment bridge and ECDs at stream S-E14.
--------------------	--	--------------------	---

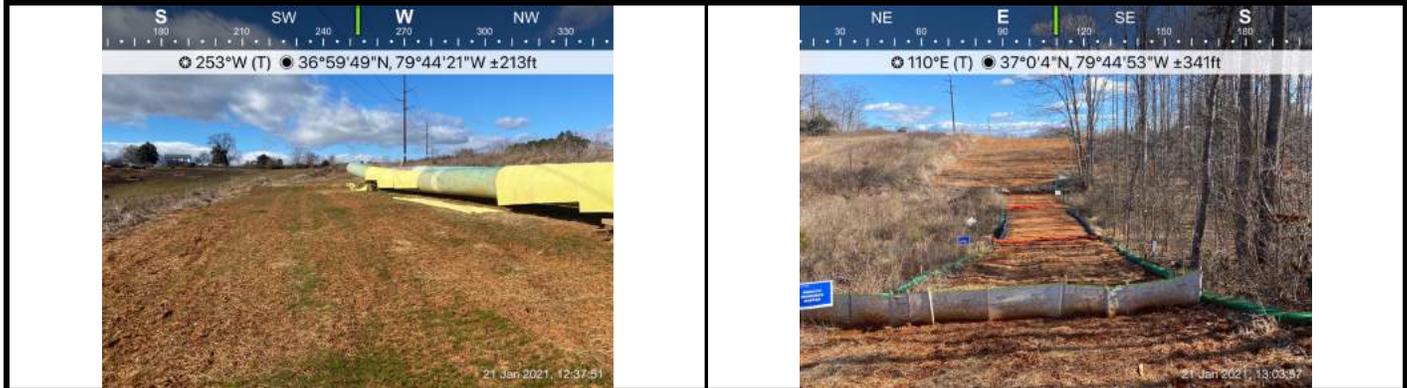
Pic 3 Desc.	Approximately 14604+00. Overview of ROW.	Pic 4 Desc.	Approximately 14568+10. Overview of stream crossing, equipment bridge and ECDs at stream S-E18.
--------------------	--	--------------------	---

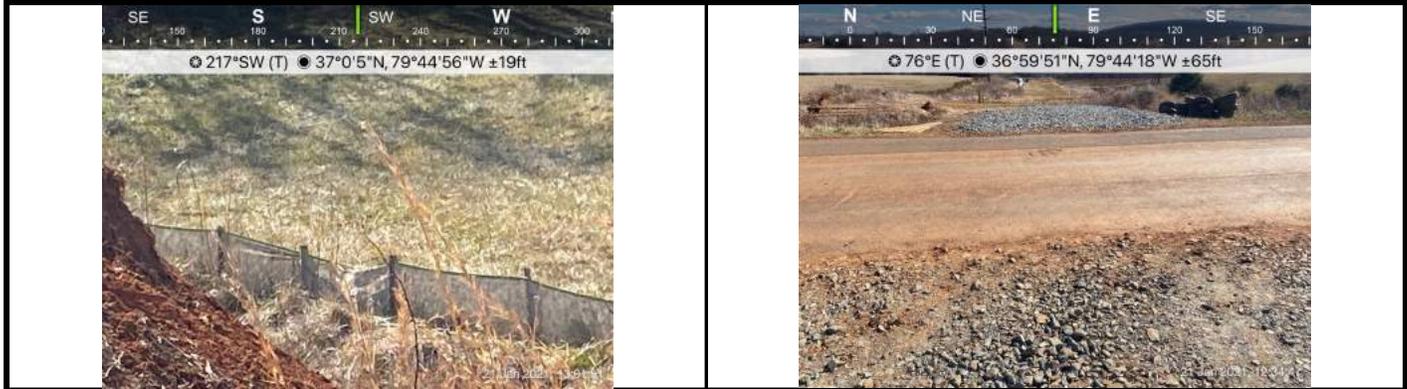
Pic 5 Desc.	Approximately 14563+82. P-1 requires maintenance. P-1 appears to be damaged by wildlife.	Pic 6 Desc.	Approximately 14599+50. Overview of road crossing and RCEs. RCEs installed and appears to be functioning correctly at time of inspection.
--------------------	--	--------------------	---

E&S BMPs	Compliance Level	Corrective Action	Corrective Time Frame	Date Repaired
3rd Party Damages	Communication	Repair p-1 damaged by wildlife		
Compost Filter Sock	Acceptable			
Equipment Bridge	Acceptable			
Rock Construction Entrance	Acceptable			
Sensitive Resource Buffer	Acceptable			
Sensitive Resource Signage	Acceptable			
Silt Fence (Filter Fabric Fence)	Communication	Repair p-1 damaged by wildlife		
Vegetative Stabilization (Temporary)	Acceptable

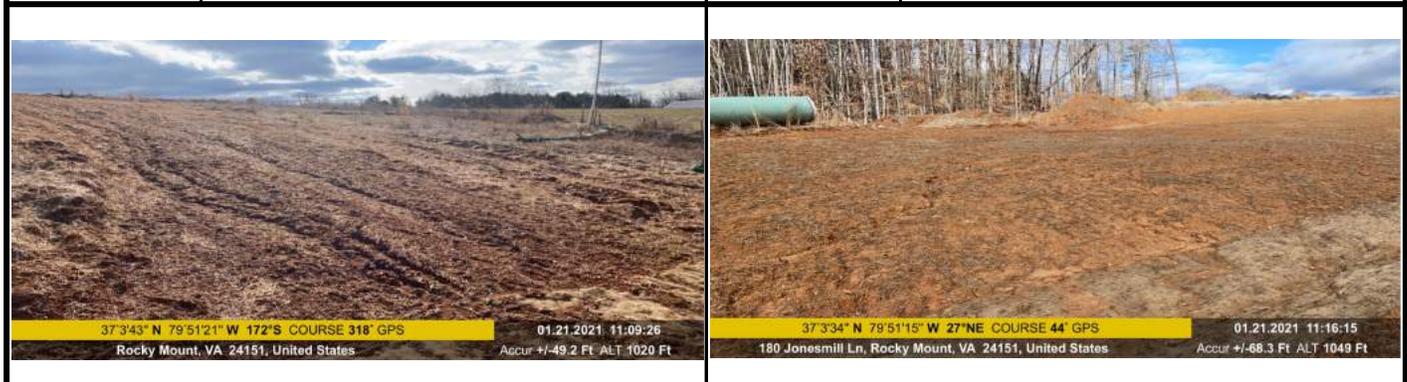
GPS Location	5	GPS Location	6
Field Station#	14128+00	Field Station#	14139+50
Pic 5 Desc.	Signs of erosion beginning to occur in areas along ROW. Will monitor area in subsequent inspections to check for signs of worsening.	Pic 6 Desc.	Signs of erosion beginning to occur in areas along ROW. Will monitor area in subsequent inspections to check for signs of worsening.

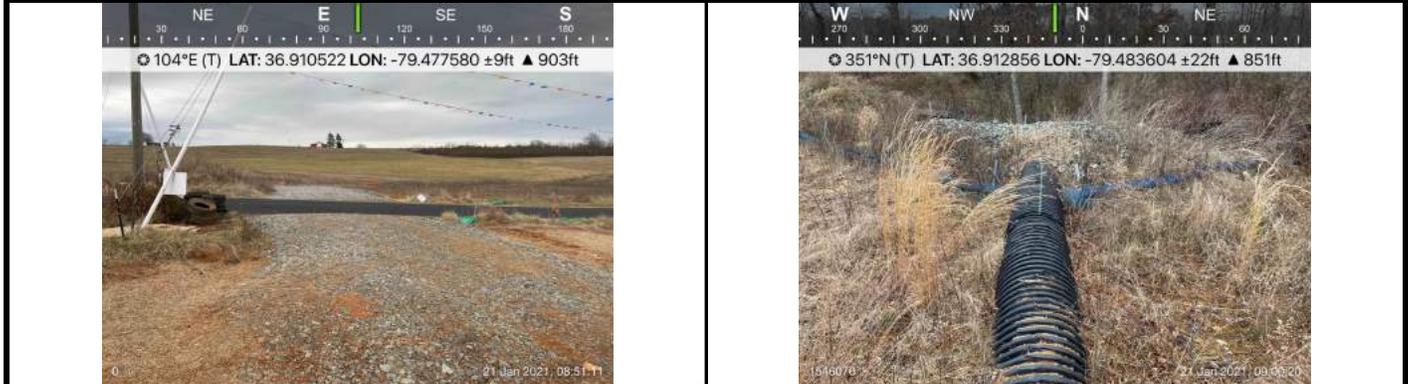
GPS Location	See photo	GPS Location	See photo
Field Station#	15480+67	Field Station#	15460+76
Pic 1 Desc.	RCEs in good condition and functioning.	Pic 2 Desc.	CEDs functioning as intended.

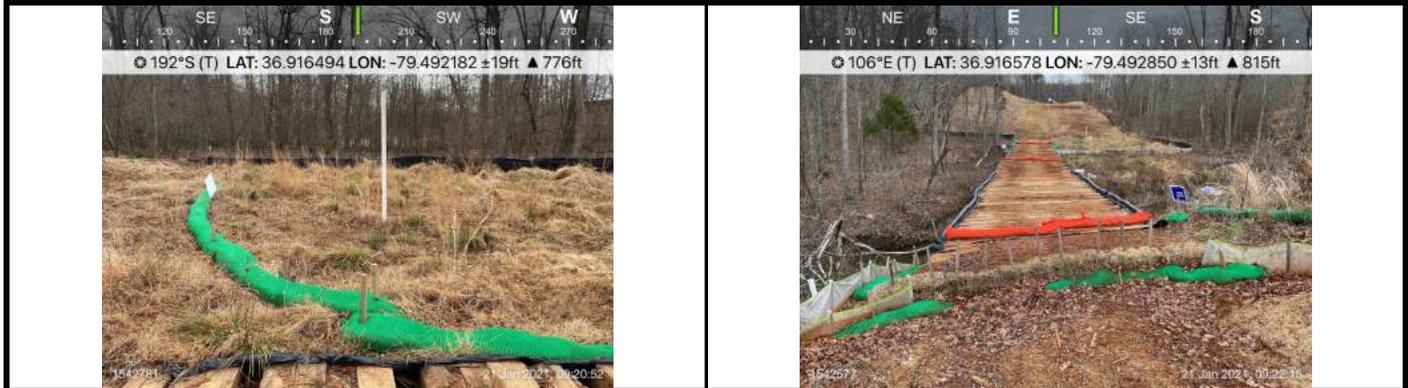
GPS Location	See photo	GPS Location	See photo
Field Station#	15427+81	Field Station#	15425+77
Pic 3 Desc.	ECDs in place at all stream and wetland buffers.	Pic 4 Desc.	Equipment bridge ECDs in place and functioning.

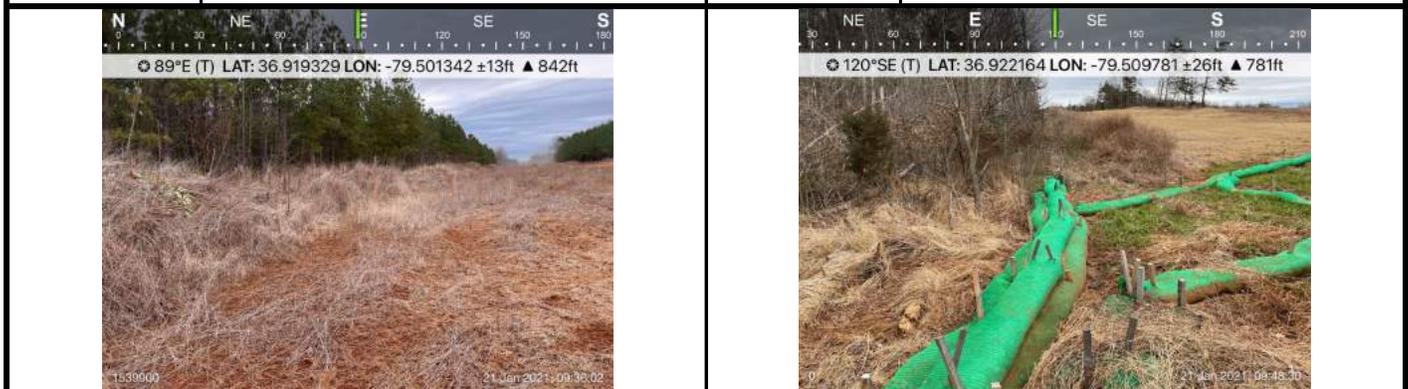
GPS Location	See photo	GPS Location	See photo
Field Station#	15399+00	Field Station#	15373+00
Pic 5 Desc.	Stockpiles remain stabilized.	Pic 6 Desc.	CFS in good condition at this drainage.

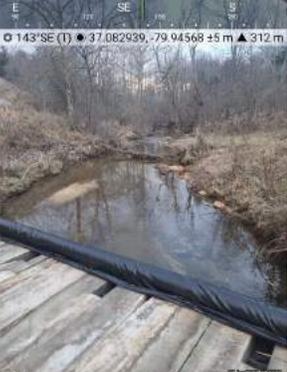
GPS Location	000000	GPS Location	000000	
Field Station#	13705+07	Field Station#	13705+07	
Pic 1 Desc.	Stream observation photo facing downstream during the EI's inspection today. No environmental issues observed.		Pic 2 Desc.

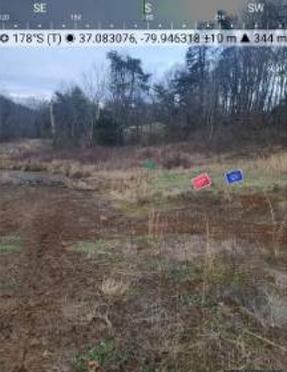
GPS Location	0000	GPS Location	0000	
Field Station#	13703+90	Field Station#	13705+07	
Pic 3 Desc.	Photo showing stream/wetland signs in place at crossings.		Pic 4 Desc.

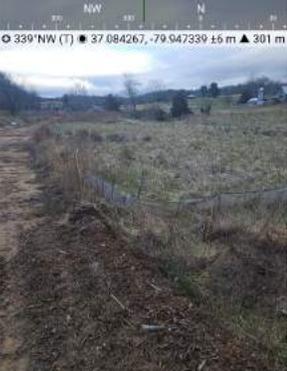
GPS Location	00000	GPS Location	00000	
Field Station#	13696+06	Field Station#	13698+45	
Pic 5 Desc.	The EI monitored ECDs around wetland boundary with no environmental issues observed at the time of inspection today.		Pic 6 Desc.

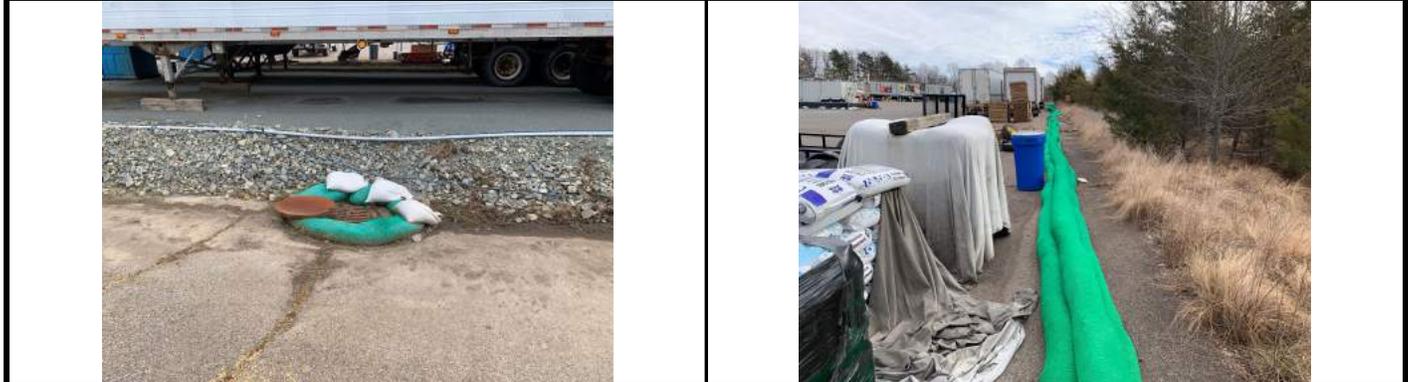
GPS Location	00000000000	GPS Location	00000000000
Field Station#	0000+00	Field Station#	0000+00
Pic 1 Desc.	Inlet protection for parking lot drain near storage building in acceptable condition	Pic 2 Desc.	Perimeter ECD's on south end of paved yard in good condition.

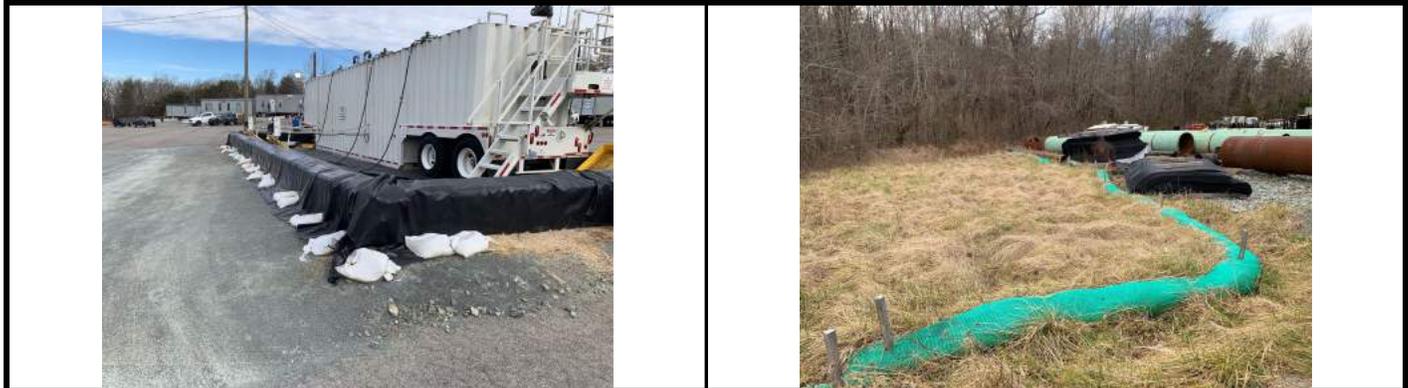
GPS Location	00000000000	GPS Location	00000000000
Field Station#	0000+00	Field Station#	0000+00
Pic 3 Desc.	Secondary containment structure for fuel cell in acceptable condition.	Pic 4 Desc.	Perimeter ECD's on west side of gravel yard in good condition.

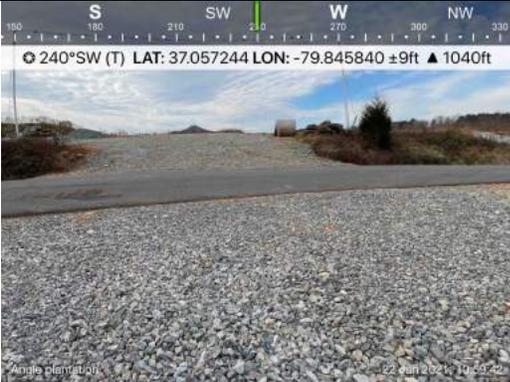
GPS Location	1	GPS Location	2
Field Station#	14171+36	Field Station#	14181+00
Pic 1 Desc.	RCE at Angle Plantation Rd in good condition	Pic 2 Desc.	Perimeter SSF in place and functional.

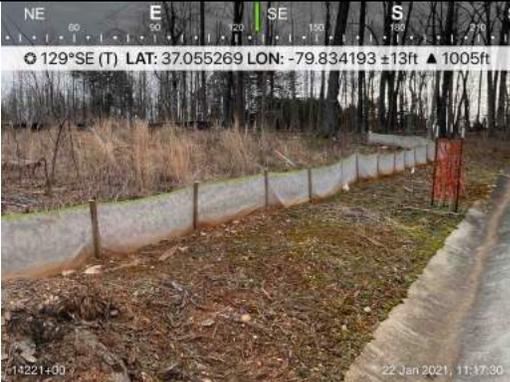
GPS Location	3	GPS Location	4
Field Station#	14221+00	Field Station#	14220+58
Pic 3 Desc.	P1 silt fence down AR in place and functional.	Pic 4 Desc.	ROW stabilized in temporary area. Vegetation has died off and limited vegetation observed in travel lane.

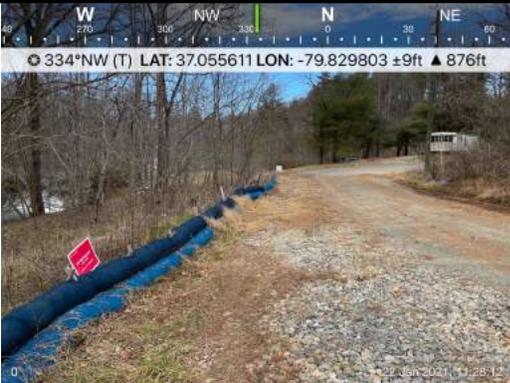
GPS Location	5	GPS Location	6
Field Station#	14235+19	Field Station#	14233+12
Pic 5 Desc.	Perimeter CFS in place and functional at AR.	Pic 6 Desc.	Equipment bridge and surrounding ECDs in place and functional at stream crossing.

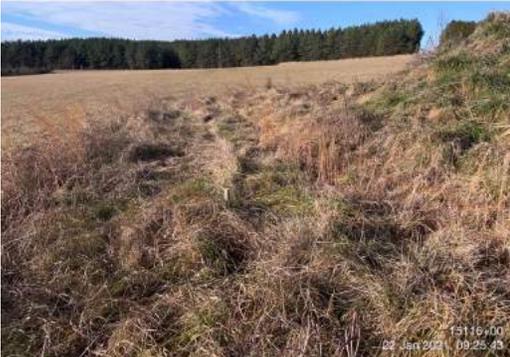
GPS Location 0			GPS Location 0		
Field Station# 15111+50			Field Station# 15116+00		
Pic 3 Desc. CFS on waterbar sumps are plugged with sediment from 15109+00 to 15112+00			Pic 4 Desc. CFS at MVP-ATWS-384A requires maintenance

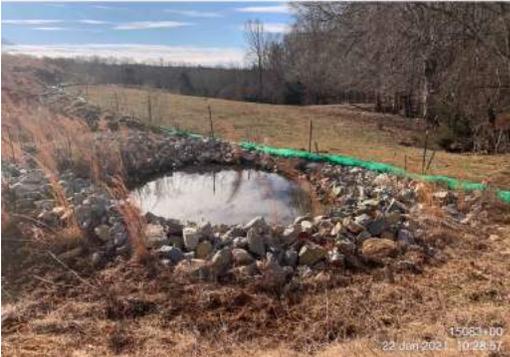
GPS Location 0			GPS Location 0		
Field Station# 15085+00			Field Station# 15136+00		
Pic 5 Desc. Clean water diversion plunge pool in acceptable condition			Pic 6 Desc. Waterbar in acceptable condition

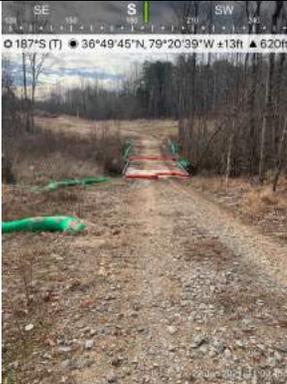
GPS Location O		GPS Location O			
Field Station# 12+65		Field Station# 11+00			
Pic 1 Desc. Observing equipment crossing and ECD's		Pic 2 Desc. Observing temporary vegetation and signage

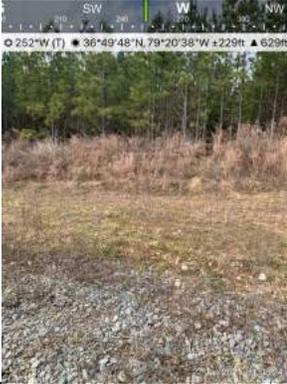
GPS Location O		GPS Location O			
Field Station# 7+00		Field Station# 6+00			
Pic 3 Desc. Observing temporary vegetation		Pic 4 Desc. Observing access road and temporary vegetation			
Insert image here			Insert image here		
GPS Location		GPS Location			
Field Station#		Field Station#			
Pic 5 Desc.		Pic 6 Desc.

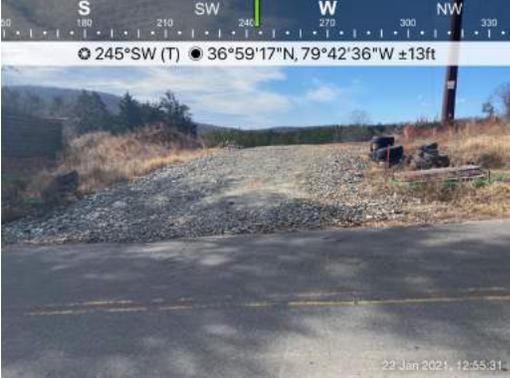
GPS Location	0	GPS Location	0		
Field Station#	14694+50	Field Station#	14692+00		
Pic 1 Desc.	Approximately 14694+50. Overview of road crossing and RCE. RCE installed and appears to be functioning correctly at time of inspection.		Pic 2 Desc.	Approximately 14692+00. Overview of ROW.

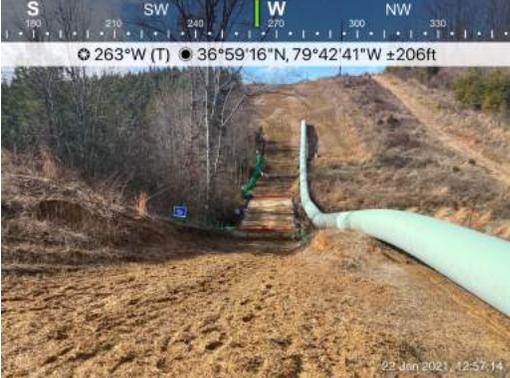
GPS Location	0	GPS Location	0		
Field Station#	14689+36	Field Station#	14680+40		
Pic 3 Desc.	Approximately 14689+36. Overview of stream crossing, equipment bridge and ECDs at stream S-H34.		Pic 4 Desc.	Approximately 14680+40. Overview of stream crossing, equipment bridge and ECDs at stream S-H36.

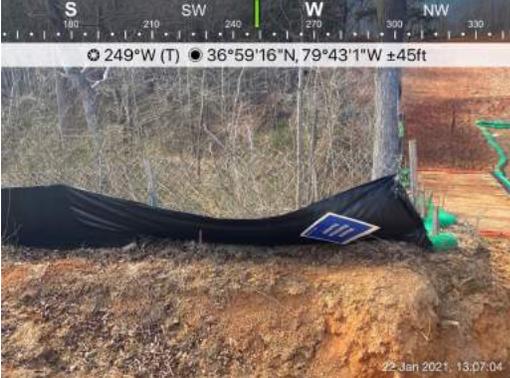
GPS Location	0	GPS Location	0		
Field Station#	14674+00	Field Station#	14655+00		
Pic 5 Desc.	Approximately 14674+00. SSF requires maintenance.		Pic 6 Desc.	Approximately 14655+00. Overview of ROW.
