Visual Site Inspection Report

Project Name H-600 Pipeline Spread I		AFE 124300139	Spread H-600 Pipeline Spread I
Contractor Precision		Report # 19136	
Inspector Justin Burch		Date/Time 1/18/2021 11:25 AM	
Permit # TBD	Inspection Type VA SWPP	Station Begin 15063+85	
State VA	Inspection Area Full	Station End 15142+66	
County Pittsylvania	Ground Wet	Temperature (°F) 43.00	
Municipality Chatham	Weather Cloudy	Rain Gauge (in) 0.10	
			Rain Accumulation Time (days) 6.00

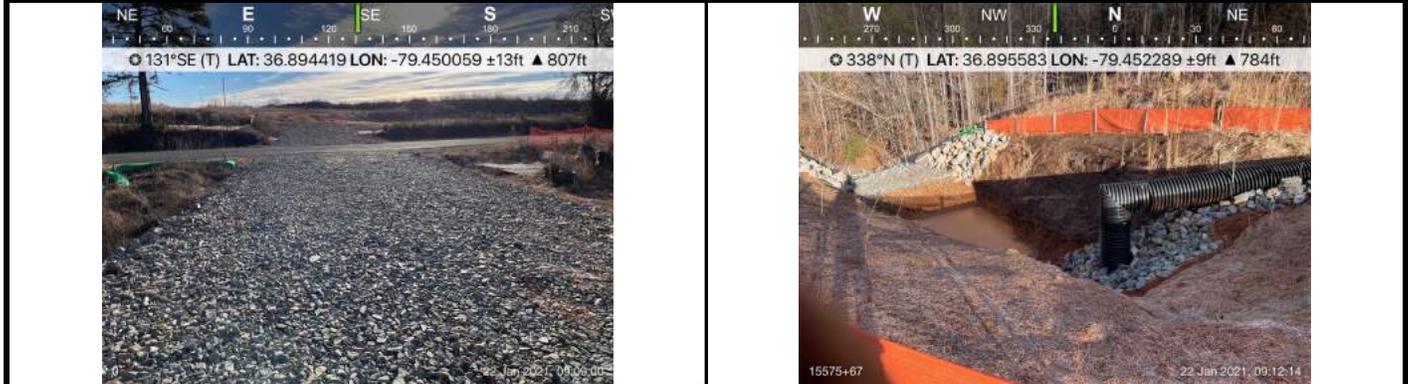
GPS Location	See photo	GPS Location	See photo
Field Station#	15584+00	Field Station#	15575+67
Pic 1 Desc.	RCEs are in good condition at all road crossings.	Pic 2 Desc.	Slope drain is in good condition and functioning.

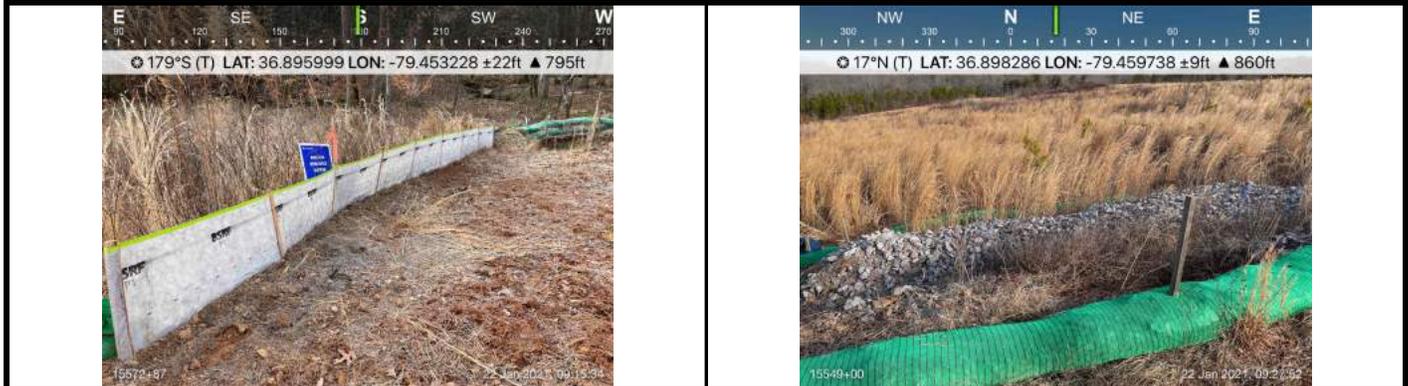
GPS Location	See photo	GPS Location	See photo
Field Station#	15572+87	Field Station#	15549+00
Pic 3 Desc.	P1 is in good condition at all stream and wetland buffers.	Pic 4 Desc.	CWDs are functioning as intended.

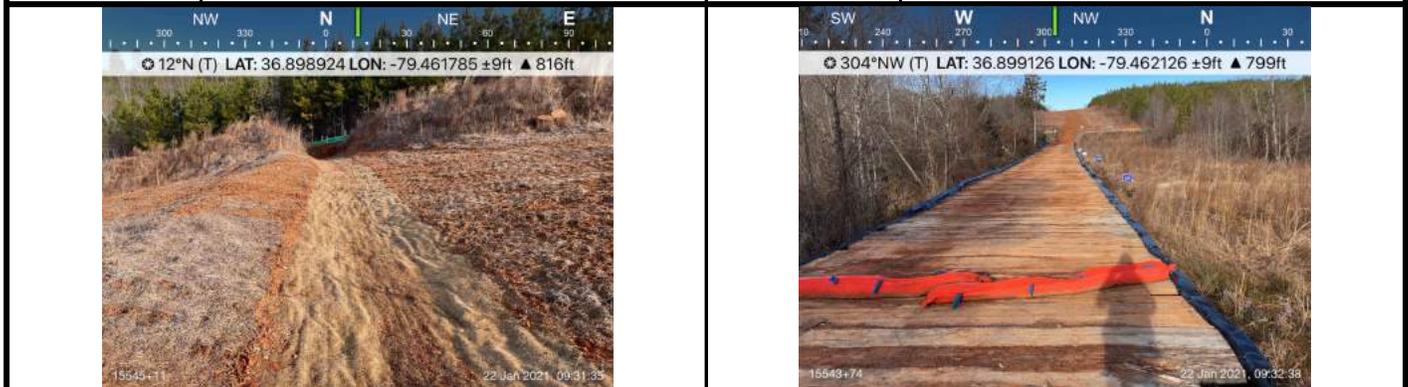
GPS Location	See photo	GPS Location	See photo
Field Station#	15545+11	Field Station#	15543+74
Pic 5 Desc.	Waterbars are functioning throughout this section.	Pic 6 Desc.	Equipment bridge ECDs are in place.

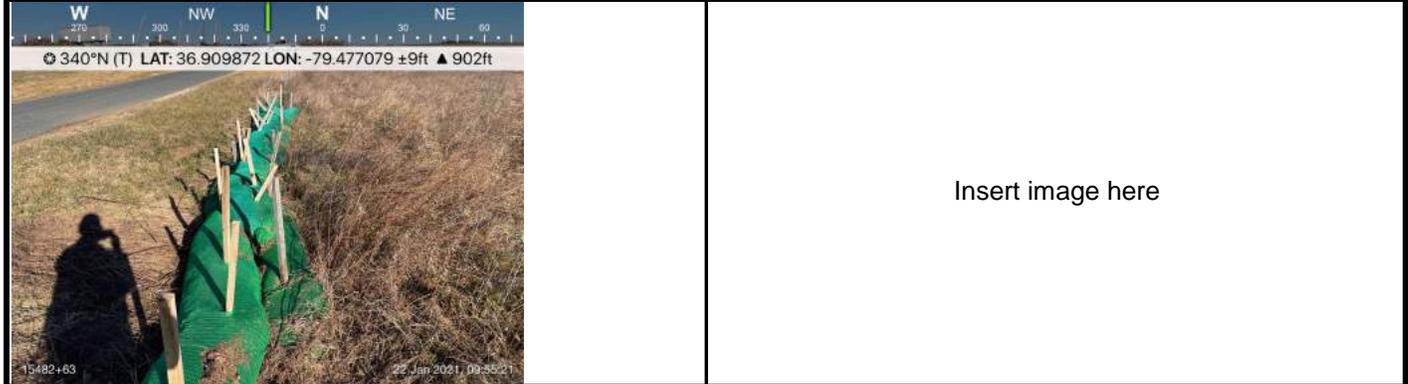
Field Station#	15482+63	Field Station#	
-----------------------	----------	-----------------------	--

Pic 7 Desc.	Perimeter CFS is in good condition.	Pic 8 Desc.	
--------------------	-------------------------------------	--------------------	--

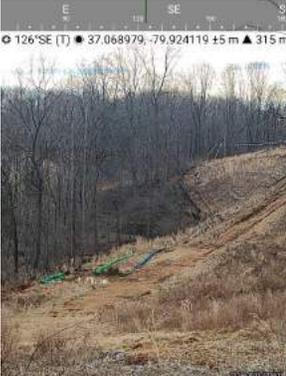
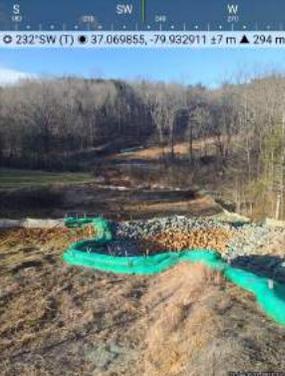
GPS Location	00000	GPS Location	00000	
Field Station#	13815+12	Field Station#	13784+34	
Pic 1 Desc.	During the EI's travel today the EI monitored ECDs and plunge pool locations, no environmental issues observed at the time of inspection.		Pic 2 Desc.	The ei monitored plunge pool and rock lined channel on bottom side of sump pit, no issues observed at the time of inspection.

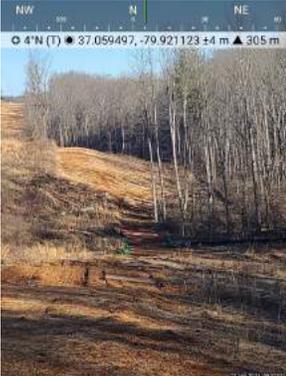
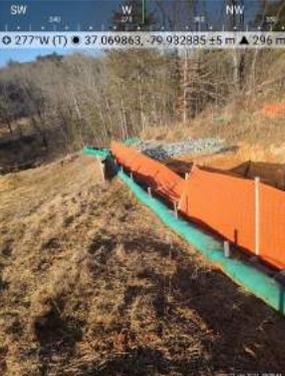
GPS Location	00000	GPS Location	00000	
Field Station#	13852+77	Field Station#	13784+60	
Pic 3 Desc.	Row photo taken by the EI showing equipment bridge in place, erosion control blanket, st stock piled in place, erosion control blanket, st stock piled in place. No environmental issues observed at the time of inspection.		Pic 4 Desc.	During today's inspection by the EI the EI noticed the safety fence around a sump pit was down due to wind gust, documented and sent in to be added to the punch list.

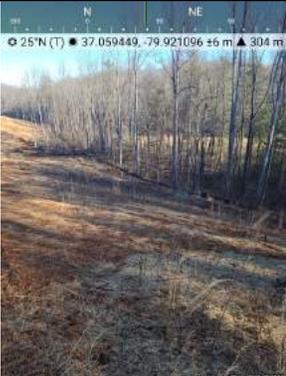
GPS Location	0000	GPS Location	00000	
Field Station#	13853+67	Field Station#	13784+60	
Pic 5 Desc.	Row photo showing vegetation and water bars with end treatment, no environmental issues observed at the time of inspection.		Pic 6 Desc.	During today's inspection by the EI the EI noticed the safety fence around a sump pit was down due to wind gust, documented and sent in to be added to the punch list.

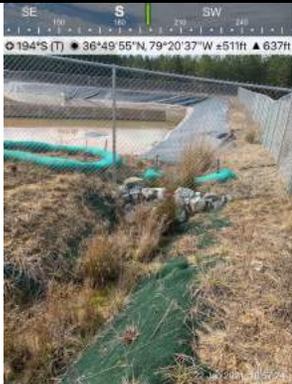
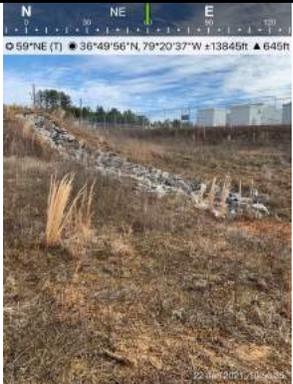
GPS Location	O
GPS Location	O	GPS Location	O	Field Station#	00+00
Field Station#	00+00	Field Station#	00+00	Pic 1 Desc.	Observing rock check dam, erosion control blanket, temporary vegetation and CFS.
Pic 1 Desc.	Observing rock check dam, erosion control blanket, temporary vegetation and CFS.	Pic 2 Desc.	Observing rock drain	GPS Location	O
