Visual Site Inspection Report

Project Name	H-600 Pipeline Spread I	AFE	124300139	Spread	H-600 Pipeline Spread I
Contractor	Precision			Report #	18683
Inspector	Charles Head			Date/Time	1/4/2021 10:15 AM
Permit #	TBD	Inspection Type	VA SWPP	Station Begin	14454+22
State	VA	Inspection Area	Full	Station End	14546+75
County	Franklin	Ground	Muddy	Temperature (°F)	41.00
Municipality	N/A	Weather	Cloudy	Rain Gauge (in)	0.40
				Rain Accumulation Time (days)	2.00

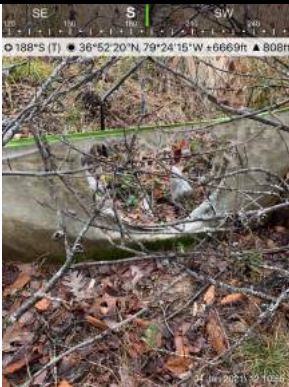
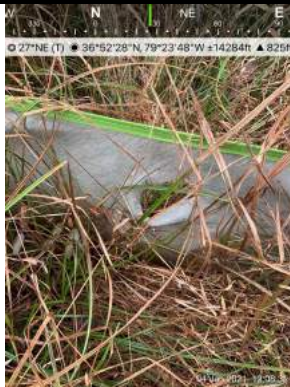
GPS Location	O	GPS Location	O		
Field Station#	15750+00	Field Station#	15752+00		
Pic 1 Desc.	Observing p1 that requires maintenance	Pic 2 Desc.	Observing p1 that requires maintenance

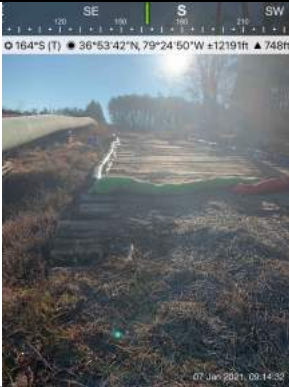
GPS Location	O	GPS Location	O		
Field Station#	15632+00	Field Station#	15623+00		
Pic 1 Desc.	Observing temporary stabilization and ECD's	Pic 2 Desc.	Observing CWD outlet and ECD's

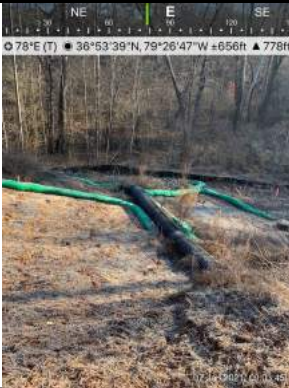
GPS Location	O	GPS Location	O		
Field Station#	15614+94	Field Station#	15628+00		
Pic 3 Desc.	Observing equipment crossing and ECD's	Pic 4 Desc.	Observing sump and end treatment
