# Visual Site Inspection Report

<b>Project Name</b>	H-600 Pipeline Spread I	<b>AFE</b>	124300139	<b>Spread</b>	H-600 Pipeline Spread I
<b>Contractor</b>	Precision			<b>Report #</b>	18320
<b>Inspector</b>	Justin Burch			<b>Date/Time</b>	12/21/2020 11:06 AM
<b>Permit #</b>	TBD	<b>Inspection Type</b>	VA SWPP	<b>Station Begin</b>	14802+19
<b>State</b>	VA	<b>Inspection Area</b>	Full	<b>Station End</b>	14928+52
<b>County</b>	Franklin	<b>Ground</b>	Wet	<b>Temperature (°F)</b>	56.00
<b>Municipality</b>	N/A	<b>Weather</b>	Sunny	<b>Rain Gauge (in)</b>	1.20
				<b>Rain Accumulation Time (days)</b>	6.00

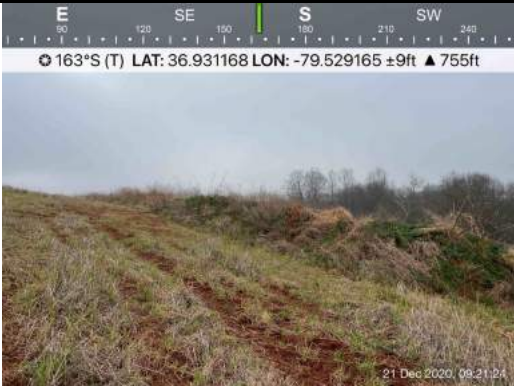
<b>GPS Location</b>	See photo		<b>GPS Location</b>	See photo	
<b>Field Station#</b>	15302+00		<b>Field Station#</b>	15314+00	
<b>Pic 5 Desc.</b>	Stockpiles remain stabilized.		<b>Pic 6 Desc.</b>	Equipment bridge ECDs are in place and functioning at all stream and wetland crossings.

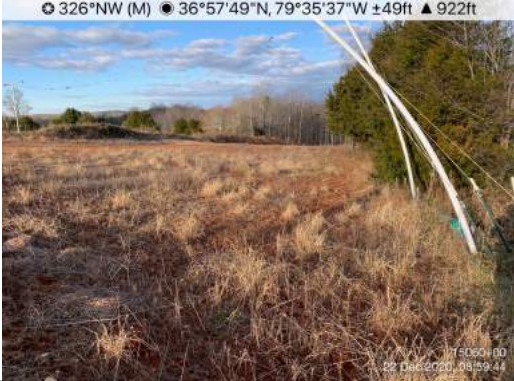
<b>GPS Location</b>	0	<b>GPS Location</b>	0		
<b>Field Station#</b>	14967+00	<b>Field Station#</b>	14930+00		
<b>Pic 5 Desc.</b>	Equipment bridge in acceptable condition	<b>Pic 6 Desc.</b>	Waterbar in acceptable condition

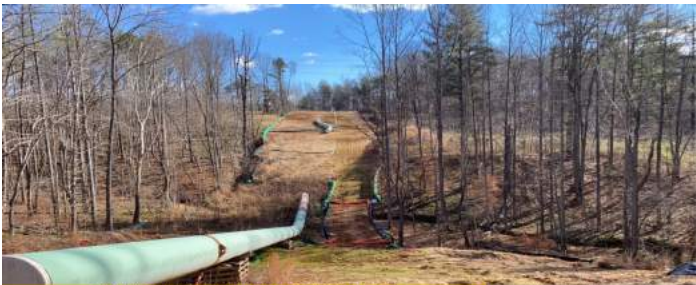
Field Station#	14102+68	Field Station#	14141+00		
Pic 3 Desc.	Curlex installed in throat of water bar to help prevent future erosion issues.		Pic 4 Desc.	ROW stabilized through area during inspection. Equipment bridge and surrounding ECDs in place and functional.

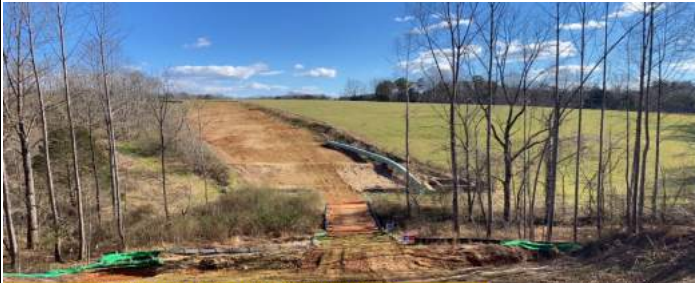
37°3'22" N 79°51'3" W 160°S COURSE 218' GPS Rocky Mount, VA 24151, United States 12.22.2020 12:21:09 Accur +/-92.1 Ft ALT 1008 Ft			37°3'22" N 79°50'55" W 133°SE COURSE 107' GPS Rocky Mount, VA 24151, United States 12.22.2020 12:24:27 Accur +/-29.3 Ft ALT 996 Ft		
GPS Location	5	GPS Location	6		
Field Station#	14157+00	Field Station#	14166+00		
Pic 5 Desc.	ROW stabilized through area during inspection. Equipment bridge and surrounding ECDs in place and functional.		Pic 6 Desc.	Final cleanup area CIS Angle Plantation Rd. Perimeter controls in place and functional.

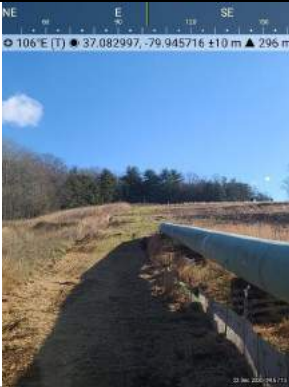
<b>GPS Location</b>	00000	<b>GPS Location</b>	00000		
<b>Field Station#</b>	13706+00	<b>Field Station#</b>	13705+07		
<b>Pic 3 Desc.</b>	Photo showing new vegetation growth on hill side where travel lane was recently over seeded		<b>Pic 4 Desc.</b>	Monitored equipment bridge and protection, no issues observed at the time of inspection

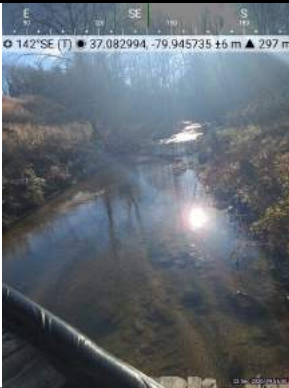
<b>Pic 5 Desc.</b>	Stream observation photo facing downstream during routine inspection today, no environmental issues observed at the time of inspection		<b>Pic 6 Desc.</b>	Stream observation photo facing upstream during routine inspection today. No issues observed at the time of inspection

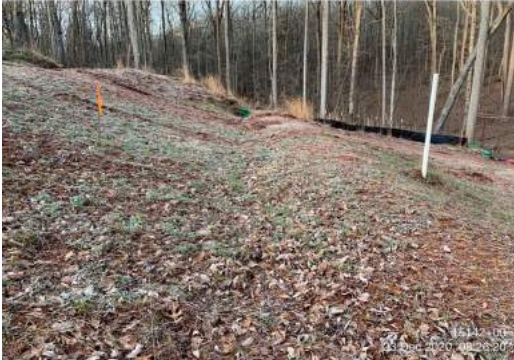
<b>GPS Location</b>	0	<b>GPS Location</b>	0		
<b>Field Station#</b>	15142+00	<b>Field Station#</b>	15142+00		
<b>Pic 1 Desc.</b>	Waterbar in acceptable condition	<b>Pic 2 Desc.</b>	Waterbar end treatment in acceptable condition

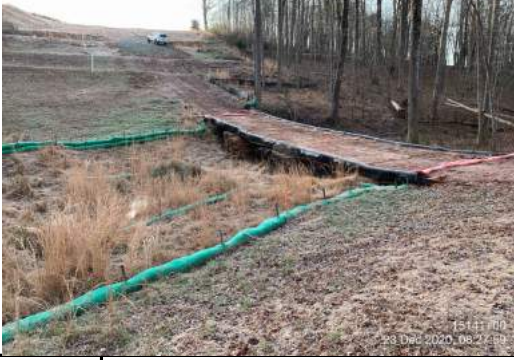
<b>GPS Location</b>	0	<b>GPS Location</b>	0		
<b>Field Station#</b>	15141+00	<b>Field Station#</b>	15095+00		
<b>Pic 3 Desc.</b>	Equipment bridge in acceptable condition	<b>Pic 4 Desc.</b>	Permanent vegetative stabilization in acceptable condition

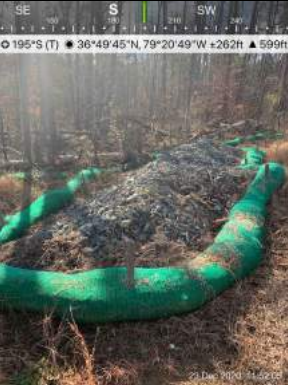
<b>GPS Location</b>	O	<b>GPS Location</b>	O		
<b>Field Station#</b>	16010+00	<b>Field Station#</b>	16017+30		
<b>Pic 1 Desc.</b>	Observing CWD outlet and ECD's	<b>Pic 2 Desc.</b>	Observing temporary vegetation, signage and buffer

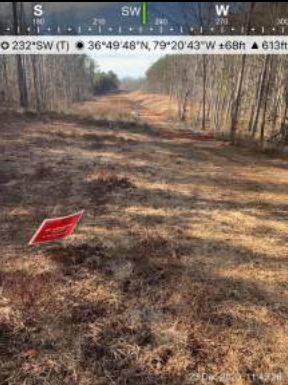
<b>GPS Location</b>	O	<b>GPS Location</b>	O		
<b>Field Station#</b>	16017+50	<b>Field Station#</b>	16019+00		
<b>Pic 3 Desc.</b>	Observing temporary stabilization, signage and equipment crossing	<b>Pic 4 Desc.</b>	Observing sump and end treatment

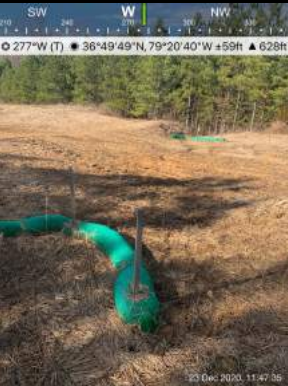
<b>GPS Location</b>	O	<b>GPS Location</b>	O		
<b>Field Station#</b>	16021+00	<b>Field Station#</b>	16022+00		
<b>Pic 5 Desc.</b>	Observing water bar and cfs checks	<b>Pic 6 Desc.</b>	Observing sump and end treatment

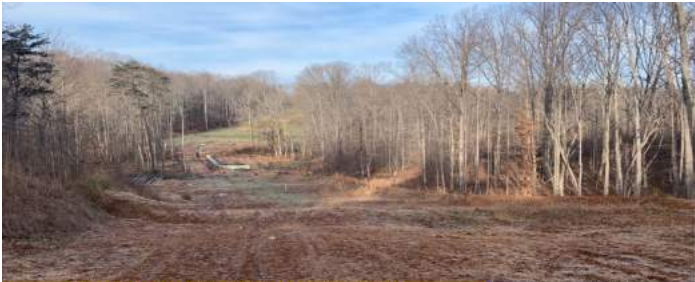
36°59'24" N 79°43'24" W 176°S COURSE 144° GPS 12.23.2020 09:07:29 Accur +/-50.1 Ft ALT 974 Ft			36°59'20" N 79°43'14" W 339°NW COURSE 133° GPS Sorry no results found 12.23.2020 09:13:09 Accur +/-86.6 Ft ALT 975 Ft		
GPS Location	1		GPS Location	2	
Field Station#	14652+00		Field Station#	14664+00	
Pic 1 Desc.	ROW frozen but vegetation growing in final cleanup area. Perimeter ECDs in place and functional.		Pic 2 Desc.	ROW stabilized in temporary area of ROW. Ground frozen during inspection.

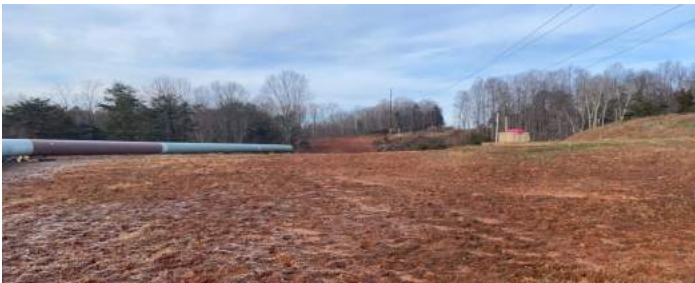
Pic 3 Desc.	Routine maintenance. Remove ineffective P1 silt fence.		Pic 4 Desc.	ROW stabilized in temporary area of ROW. Ground frozen during inspection.

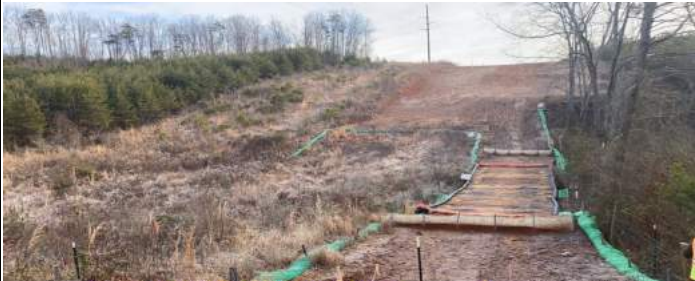
36°59'17" N 79°42'57" W 96°E COURSE 118° GPS Union Hall, VA 24176, United States 12.23.2020 09:25:31 Accur +/-483.6 Ft ALT 971 Ft			36°59'17" N 79°42'49" W 346°N COURSE 118° GPS Union Hall, VA 24176, United States 12.23.2020 09:28:14 Accur +/-142.7 Ft ALT 971 Ft		
GPS Location	5		GPS Location	6	
Field Station#	14689+36		Field Station#	14692+00	
Pic 5 Desc.	Equipment bridge and surrounding ECDs in place and functional at stream crossing.		Pic 6 Desc.	ROW stabilized in temporary area of ROW. Ground frozen during inspection.

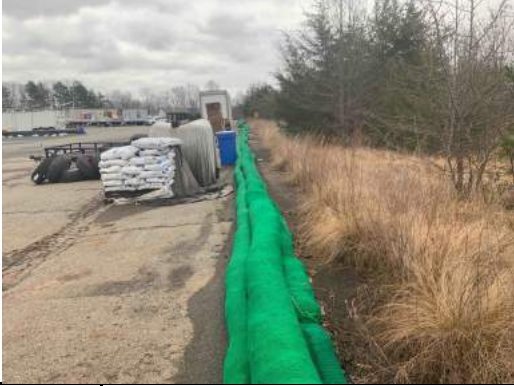
<b>GPS Location</b>	Perimeter ECD's on north end of paved yard in	<b>GPS Location</b>	000000000000		
<b>Field Station#</b>	0000+00	<b>Field Station#</b>	0000+00		
<b>Pic 1 Desc.</b>	Perimeter ECD's on north end of paved yard in good condition.	<b>Pic 2 Desc.</b>	Perimeter ECD's on north end of paved yard in good condition

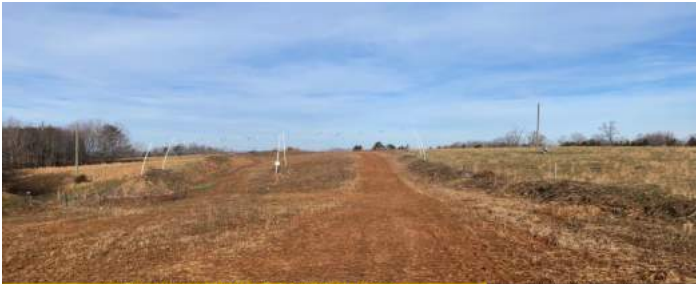
<b>GPS Location</b>	1	<b>GPS Location</b>	2	<b>Field Station#</b>	14294+57
<b>Field Station#</b>	14307+00	<b>Field Station#</b>	14294+57	<b>Pic 1 Desc.</b>	ROW stabilized. Limited vegetation observed and noticeable use of travel lane.
<b>Pic 1 Desc.</b>	Equipment bridge and surrounding ECDs in place and functional at stream crossing of S-9

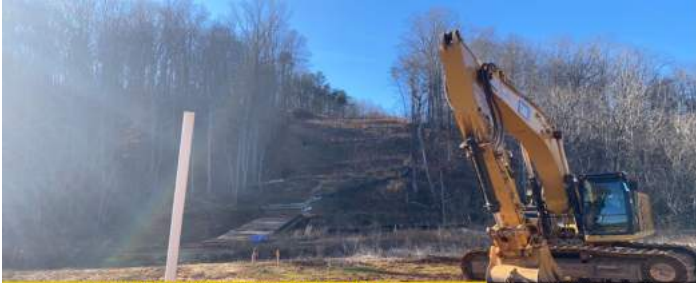
<b>GPS Location</b>	3	<b>GPS Location</b>	4	<b>Field Station#</b>	14209+75
<b>Field Station#</b>	14279+08	<b>Field Station#</b>	14209+75	<b>Pic 3 Desc.</b>	Equipment bridge and surrounding ECDs in place and functional at stream crossing of S-F9B
<b>Pic 3 Desc.</b>	View of RCE and ROW at Hwy 122 crossing.

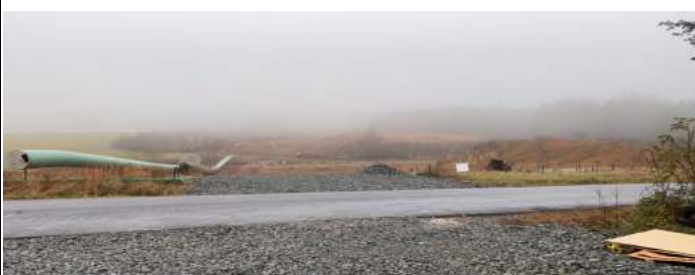
37°2'34" N 79°48'36" W 168°S COURSE 322° GPS Glade Hill, VA 24092, United States 12.24.2020 08:13:23 Accur +/-357.8 Ft ALT 1182 Ft			37°2'20" N 79°48'19" W 351°N COURSE 243° GPS Glade Hill, VA 24092, United States 12.24.2020 08:10:30 Accur +/-86.2 Ft ALT 1105 Ft		
<b>GPS Location</b>	1	<b>GPS Location</b>	2		
<b>Field Station#</b>	14311+57	<b>Field Station#</b>	14333+27		
<b>Pic 1 Desc.</b>	RCE at Farm View Rd in good condition.	<b>Pic 2 Desc.</b>	RCE at Golden View Rd in good condition.

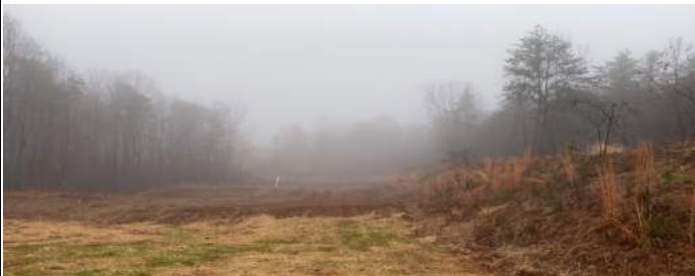
<b>Field Station#</b>	14336+00	<b>Field Station#</b>	14345+53		
<b>Pic 3 Desc.</b>	ROW stabilized in temporary area. Spoil pile also stabilized.	<b>Pic 4 Desc.</b>	MVP-AR-313.01 in good condition. Perimeter CFS in place and functional.

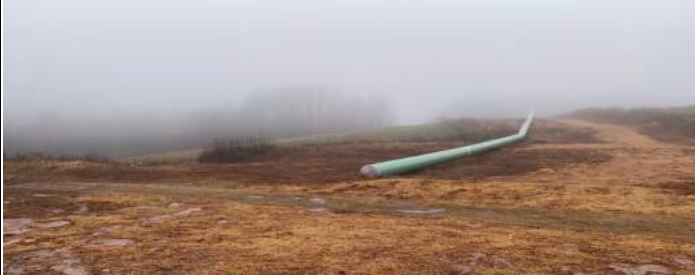
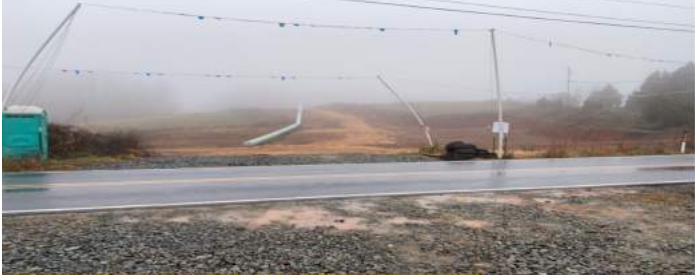
37°1'36" N 79°46'7" W 267°W COURSE 243° GPS 2750 Webster Rd, Glade Hill, VA 24092, United States 12.24.2020 08:00:51 Accur +/-15.4 Ft ALT 1105 Ft			37°1'35" N 79°46'6" W 317°NW COURSE 198° GPS 2750 Webster Rd, Glade Hill, VA 24092, United States 12.24.2020 08:00:15 Accur +/-27.6 Ft ALT 1111 Ft		
<b>GPS Location</b>	5	<b>GPS Location</b>	6		
<b>Field Station#</b>	14451+00	<b>Field Station#</b>	14454+22		
<b>Pic 5 Desc.</b>	Curlex installed in throat of water bar to prevent further erosion issues. Travel lane recently seeded and stabilized with straw mulch.	<b>Pic 6 Desc.</b>	RCE at Webster Rd in good condition.

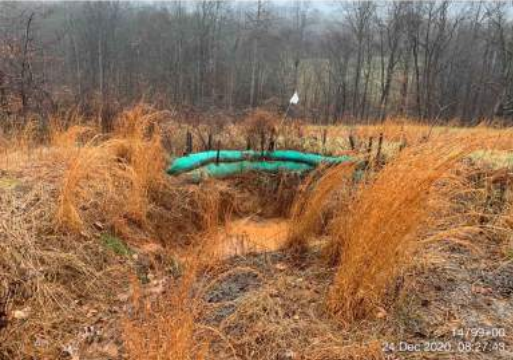
<b>GPS Location</b>	0	<b>GPS Location</b>	0		
<b>Field Station#</b>	14799+00	<b>Field Station#</b>	14799+00		
<b>Pic 1 Desc.</b>	Waterbar in acceptable condition		<b>Pic 2 Desc.</b>	Waterbar end treatment in acceptable condition

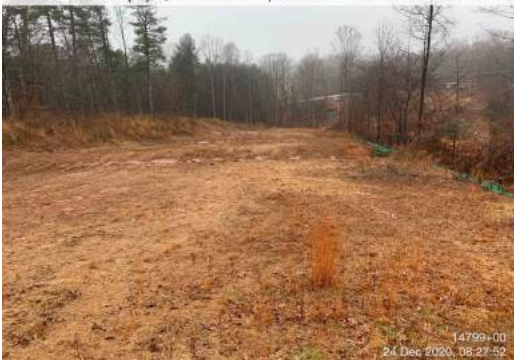
<b>GPS Location</b>	0	<b>GPS Location</b>	0		
<b>Field Station#</b>	14799+00	<b>Field Station#</b>	14794+00		
<b>Pic 3 Desc.</b>	Temporary vegetative stabilization in acceptable condition		<b>Pic 4 Desc.</b>	Equipment bridge in acceptable condition

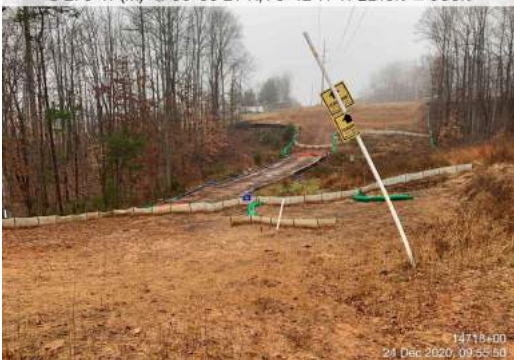
<b>GPS Location</b>	0	<b>GPS Location</b>	0		
<b>Field Station#</b>	14718+00	<b>Field Station#</b>	14721+00		
<b>Pic 5 Desc.</b>	P1 silt fence in acceptable condition		<b>Pic 6 Desc.</b>	Sump pit in acceptable condition

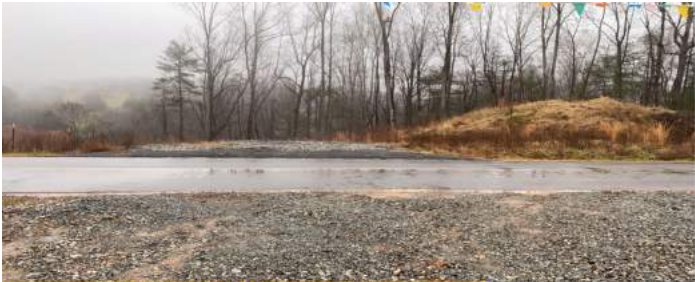
37°2'34" N 79°48'36" W 350°N COURSE -1° GPS 955 Greenway Rd, Glade Hill, VA 24092, United States 12.24.2020 09:52:10 Accur +/-4094.1 Ft ALT 1064 Ft			37°3'15" N 79°54'36" W 29°NE COURSE 175° GPS 985 Iron Ridge Rd, Rocky Mount, VA 24151, United States 12.24.2020 09:52:30 Accur +/-45.7 Ft ALT 1138 Ft		
GPS Location	1	GPS Location	2		
Field Station#	13886+00	Field Station#	13892+45		
Pic 1 Desc.	Slope stabilized in temporary area. Bridge mats down in area typically underwater. No issues observed.		Pic 2 Desc.	RCE at Iron Ridge Rd in good condition.

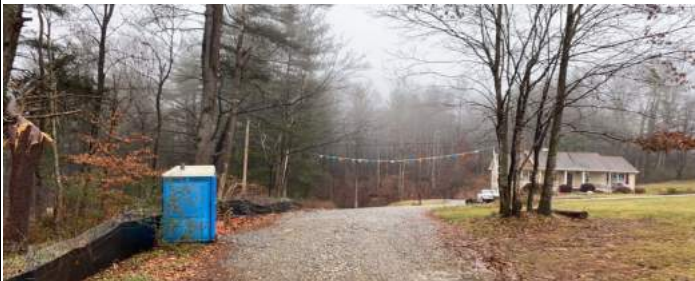
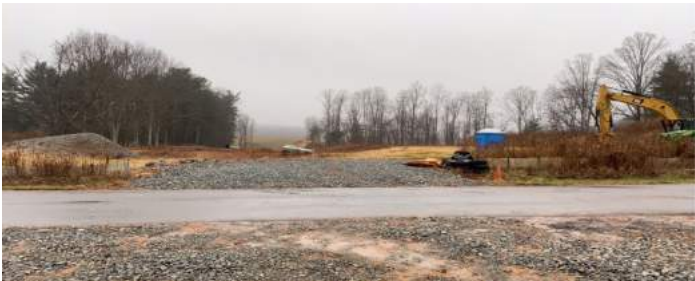
37°3'0" N 79°54'4" W 16°N COURSE 284° GPS 1112-1336 Iron Ridge Rd, Rocky Mount, VA 24151, United States 12.24.2020 09:56:40 Accur +/-128.4 Ft ALT 1148 Ft			37°3'0" N 79°54'4" W 353°N COURSE 284° GPS 1112-1336 Iron Ridge Rd, Rocky Mount, VA 24151, United States 12.24.2020 09:58:38 Accur +/-389.9 Ft ALT 1148 Ft		
GPS Location	5	GPS Location	6		
Field Station#	13939+50	Field Station#	13958+31		
Pic 5 Desc.	MVP-FR-305 in good condition,		Pic 6 Desc.	RCE at Foggy Ridge Rd in good condition.
