Visual Site Inspection Report

Project Name H-600 Pipeline Spread G		AFE 124300137	Spread H-600 Pipeline Spread G
Contractor Precision		Report # 19584	
Inspector Chris Burns		Date/Time 2/1/2021 11:46 AM	
Permit # TBD	Inspection Type VA SWPP	Station Begin 11254+99	
State VA	Inspection Area Partial	Station End 11353+67	
County Giles	Ground Frozen	Temperature (°F) 36.00	
Municipality N/A	Weather Cloudy	Rain Gauge (in) 0.00	
			Rain Accumulation Time (days) 1.00

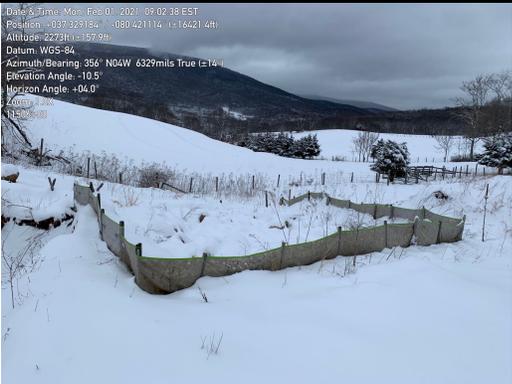
<p><small>Date & Time: Mon, Feb 01, 2021 09:02:38 EST Position: +037 329184 / -080 421114 / +16421.4ft Altitude: 2234ft (+152.9m) Datum: WGS-84 Azimuth/Bearing: 183° S08W 3253mils True (+14°) Elevation Angle: -02.9° Horizon Angle: -00.4° Zoom: 1.0X 11506+00</small></p>		
GPS Location	See photo for GPS location.	GPS Location	See photo for GPS location.	
Field Station#	11506+00	Field Station#	11506+00	
Pic 1 Desc.	Clean water diversion pipe and plunge pool in place.	Pic 2 Desc.	Clean water diversion pipe and clean water diversion berm in place.

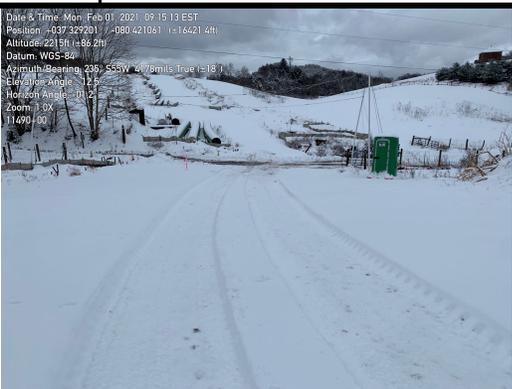
GPS Location	See photo for GPS location.	GPS Location	See photo for GPS location.	
Field Station#	11490+00	Field Station#	11473+00	
Pic 3 Desc.	RCE in place at Stevers Gap Road.	Pic 4 Desc.	Slope drains in place over two-tone.

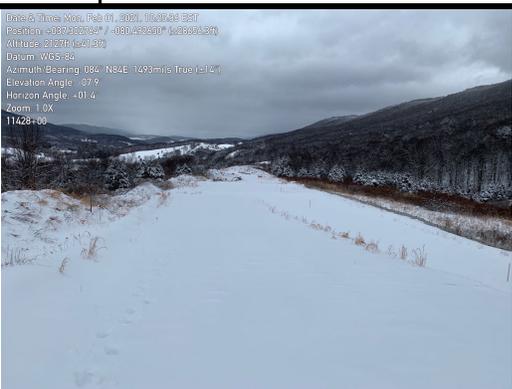
Pic 5 Desc.	ROW frozen and snow covered.	Pic 6 Desc.	Triple barrier ECDs in place at off ROW karst feature.

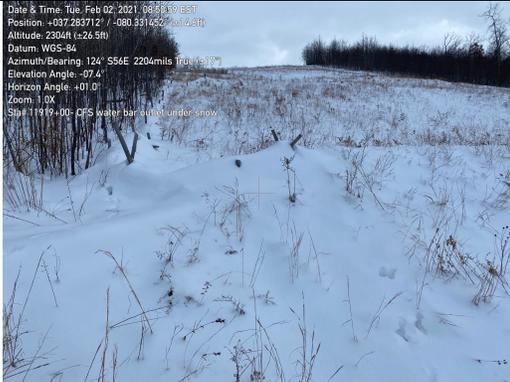
<p>Date & Time: Tue, Feb 02, 2021, 08:39:19 EST Position: +037.237712 / -080.331452 (-124.9ft) Altitude: 2204ft (-24.5m) Datum: WGS-84 Azimuth/Bearing: 124° S56E 2204mils True (+16°) Elevation Angle: -07.4° Horizon Angle: +07.0° Stair# 11919+00- CFS water bar outlet under snow</p>			
GPS Location	See photo GPS	GPS Location	See photo GPS		
Field Station#	11900+00	Field Station#	11919+00		
Pic 1 Desc.	AR-266.00 is snow covered	Pic 2 Desc.	CFS water bar outlet protection is under snow

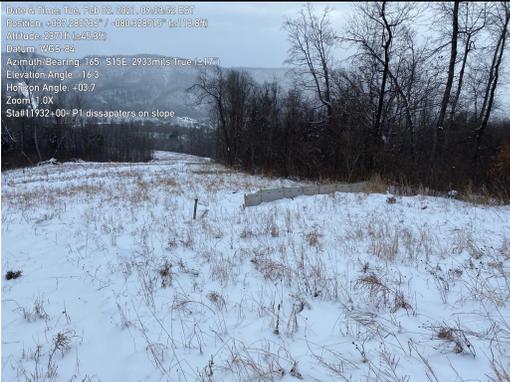
<p>Date & Time: Tue, Feb 02, 2021, 09:45:05 EST Position: +039.283554° / +080.328107° (-121.8ft) Altitude: 2271ft (-65.3ft) Datum: WGS-84 Azimuth/Bearing: 165° S15E 2933mils True (+16°) Elevation Angle: -16.3° Horizon Angle: +03.7° Stair# 11932+00- P1 dissipaters on slope</p>

GPS Location	See photo GPS	GPS Location	See photo GPS		
Field Station#	11932+00	Field Station#	11942+00		
Pic 3 Desc.	P1 dissipater,s on slope	Pic 4 Desc.	Karst ECD's

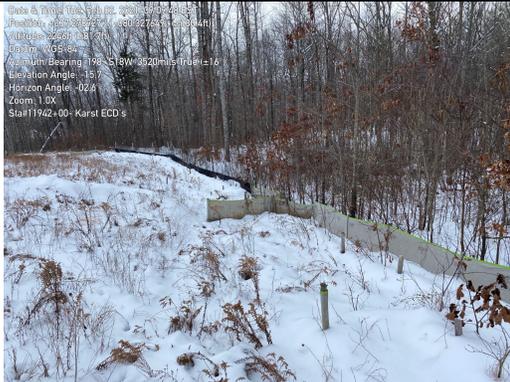
<p>Date & Time: Tue, Feb 02, 2021, 09:45:05 EST Position: +039.283554° / +080.328107° (-121.8ft) Altitude: 2271ft (-65.3ft) Datum: WGS-84 Azimuth/Bearing: 165° S15E 2933mils True (+16°) Elevation Angle: -16.3° Horizon Angle: +03.7° Stair# 11942+00- Karst ECD's</p>

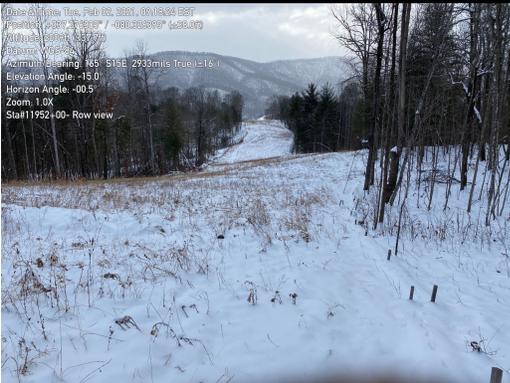
<p>Date & Time: Tue, Feb 02, 2021, 09:35:07 EST Position: +037.270121 / -080.323148 (-875.6ft) Altitude: 1713ft (-247.9ft) Datum: WGS-84 Azimuth/Bearing: 165° S15E 2933mils True (+16°) Elevation Angle: -15.0° Horizon Angle: +00.5° Stair# 11952+00- Row view</p>

<p>Date & Time: Tue, Feb 02, 2021, 09:35:07 EST Position: +037.270121 / -080.323148 (-875.6ft) Altitude: 1713ft (-247.9ft) Datum: WGS-84 Azimuth/Bearing: 160° S40E 2689mils True (+16°) Elevation Angle: -18.0° Horizon Angle: +00.8° Stair# 11977+00- Karst ECD's</p>			
GPS Location	See photo GPS	GPS Location	See photo GPS		
Field Station#	11952+00	Field Station#	11977+00		
Pic 5 Desc.	Broad view of the row	Pic 6 Desc.	Karst ECD's and sensitive resource signage.

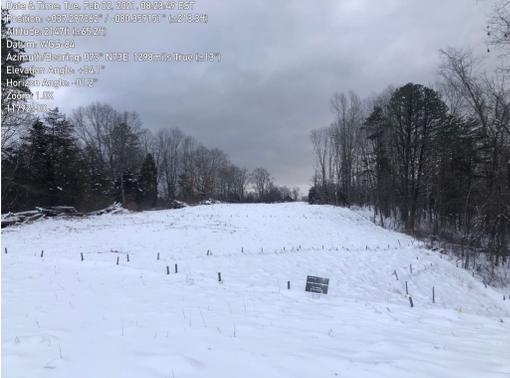
GPS Location	1	GPS Location	2		
Field Station#	11792+00	Field Station#	11818+00		
Pic 1 Desc.	Section of restored RoW showing conditions and controls.	Pic 2 Desc.	Section of restored RoW showing conditions and controls.

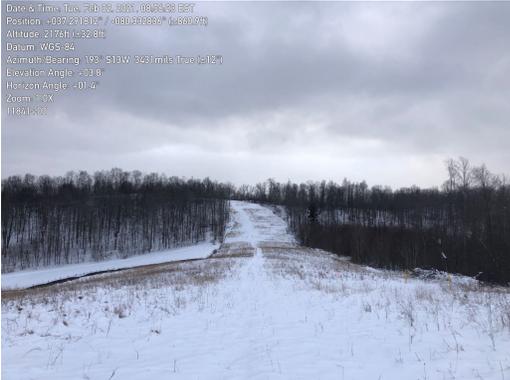
GPS Location	3	GPS Location	4		
Field Station#	11841+00	Field Station#	11863+65		
Pic 3 Desc.	Section of restored RoW showing conditions and controls.	Pic 4 Desc.	P-KL2.

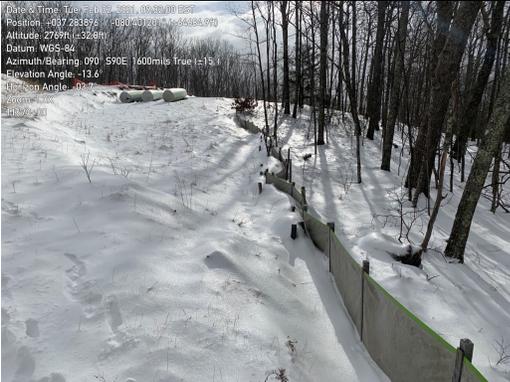
GPS Location		See photo for GPS location.		GPS Location		See photo for GPS location.	
Field Station#		11670+00		Field Station#		11672+00	
Pic 1 Desc.		ECDs in place along LOD.		Pic 2 Desc.		ROW frozen and snow covered.	
GPS Location		See photo for GPS location.		GPS Location		See photo for GPS location.	
Field Station#		11687+40		Field Station#		11733+00	
Pic 3 Desc.		Sensitive resource buffer in place at stream S-MN21.		Pic 4 Desc.		ROW frozen and snow covered. Waterbars in place.

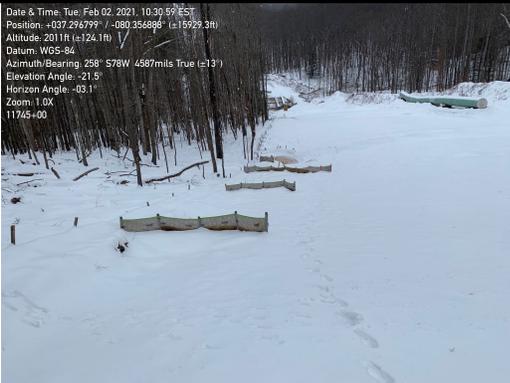
GPS Location		See photo for GPS location.		GPS Location		See photo for GPS location.	
Field Station#		11745+00		Field Station#		11775+00	
Pic 5 Desc.		Priority one silt fence checks in place.		Pic 6 Desc.		Clean water diversion pipe and plunge pool in place.

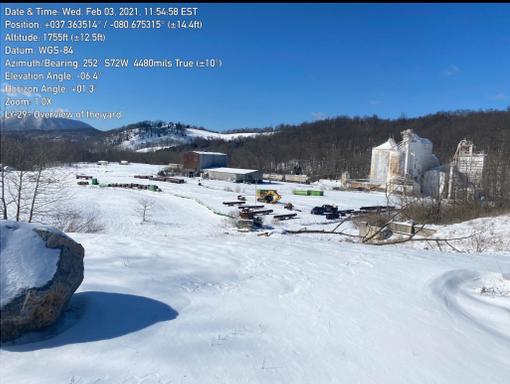
<p>Date & Time: Wed, Feb 03, 2021, 11:54:58 EST Position: +037.363214 / -080.675315 (±14.4ft) Altitude: 1255ft (±12.5ft) Datum: WGS-84 Azimuth/Bearing: 252° S72W 448ftmils True (±10°) Elevation Angle: -06.4° Horizon Angle: -01.3° Zoom: 1.0X LY29- Overhead view of the yard</p>

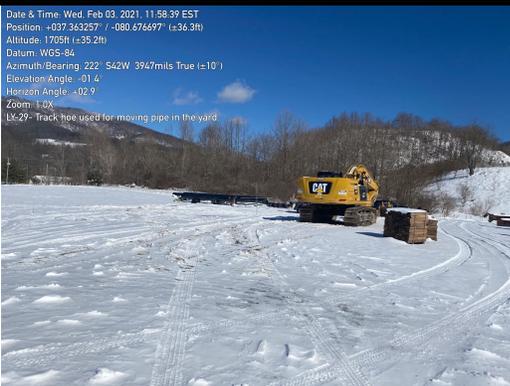
GPS Location	See photo GPS	GPS Location	See photo GPS
Field Station#	12005+00	Field Station#	12005+00	Pic 1 Desc.	AR-238.00 and RCE	Pic 2 Desc.	LY29- Overhead view of the yard.
<p>Date & Time: Wed, Feb 03, 2021, 11:58:39 EST Position: +037.363257 / -080.676697 (±36.3ft) Altitude: 1705ft (±35.2ft) Datum: WGS-84 Azimuth/Bearing: 222° S42W 394ftmils True (±10°) Elevation Angle: -01.4° Horizon Angle: -02.9° Zoom: 1.0X LY29- Track hoe used for moving pipe in the yard</p>

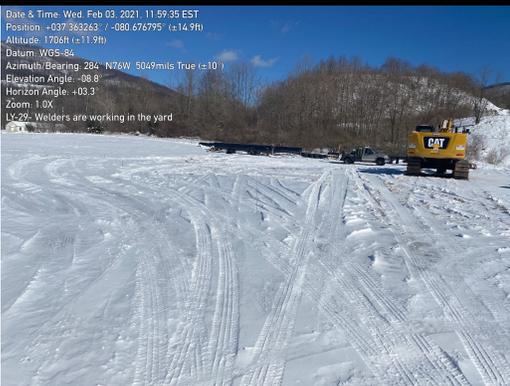
<p>Date & Time: Wed, Feb 03, 2021, 11:59:35 EST Position: +037.363263 / -080.676795 (±14.9ft) Altitude: 1706ft (±11.9ft) Datum: WGS-84 Azimuth/Bearing: 286° N76W 504ftmils True (±10°) Elevation Angle: -08.8° Horizon Angle: +03.3° Zoom: 1.0X LY29- Welders are working in the yard</p>

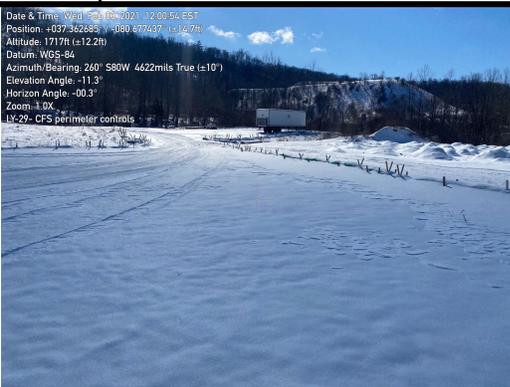
Field Station#	12005+00	Field Station#	12005+00	Pic 3 Desc.	LY29- Track hoe staged in the yard for welders moving pipe	Pic 4 Desc.	LY29- welders are in the yard
<p>Date & Time: Wed, Feb 03, 2021, 12:00:50 EST Position: +037.362083 / -080.677437 (±14.2ft) Altitude: 1717ft (±12.2ft) Datum: WGS-84 Azimuth/Bearing: 260° S80W 462ftmils True (±10°) Elevation Angle: -11.3° Horizon Angle: -00.3° Zoom: 1.0X LY29- CFS perimeter controls</p>

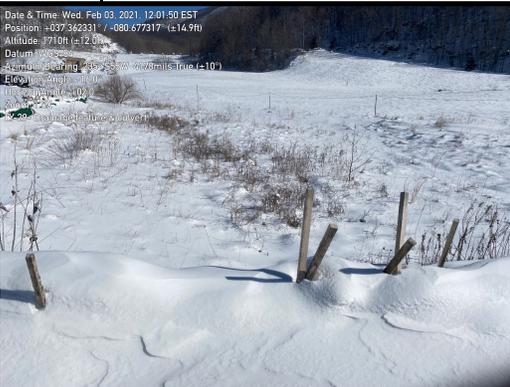
<p>Date & Time: Wed, Feb 03, 2021, 12:01:50 EST Position: +037.362311 / -080.677317 (±14.9ft) Altitude: 1710ft (±12.2ft) Datum: WGS-84 Azimuth/Bearing: 266° S59W 460ftmils True (±10°) Elevation Angle: -11.0° Horizon Angle: -00.0° Zoom: 1.0X LY29- Culvert and drainage feature</p>

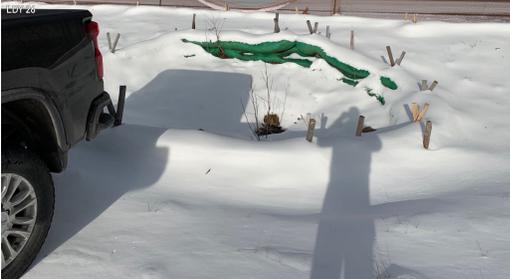
<p>Date & Time: Wed, Feb 03, 2021, 09:28:00 EST Position: -037.319323, -080.658457 (±115.4ft) Altitude: 1891ft (±31.7ft) Datum: WGS-84 Azimuth/Bearing: 85° S27W 4569mils True (±10°) Elevation Angle: -07.3° Horizon Angle: -02.6° Zoom: 1.0X LDY: 26</p>		
GPS Location	See photo for GPS location.	GPS Location	See photo for GPS location.	
Field Station#	12005+00	Field Station#	12005+00	
Pic 1 Desc.	Triple stack cfs in place around drainage.	Pic 2 Desc.	RCE in place at LDY 26 entrance.

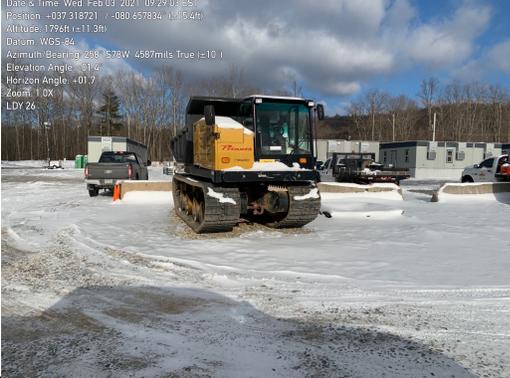
<p>Date & Time: Wed, Feb 03, 2021, 09:29:34 EST Position: -037.318249, -080.657634 (±115.4ft) Altitude: 1821ft (±11.3ft) Datum: WGS-84 Azimuth/Bearing: 245° S65W 4350mils True (±10°) Elevation Angle: -03.9° Horizon Angle: -00.6° Zoom: 1.0X LDY: 26</p>		
GPS Location	See photo for GPS location.	GPS Location	See photo for GPS location.	
Field Station#	12005+00	Field Station#	12005+00	
Pic 5 Desc.	Checked staged equipment for leaks.	Pic 6 Desc.	Secondary containment in place under fuel.

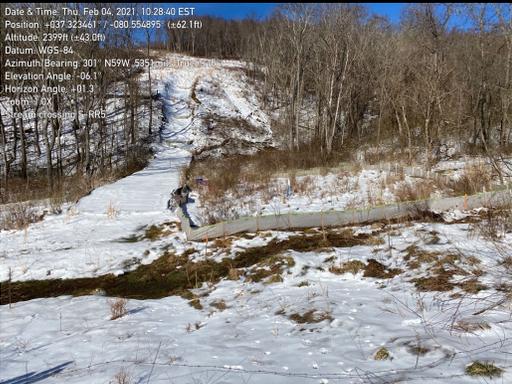
<p><small>Date & Time: Thu, Feb 04, 2021, 10:28:40 EST Position: +037.322461 / -080.554895 (-62.110) Altitude: 2399ft (-73.0m) Datum: WGS-84 Azimuth/Bearing: 301° N5W, 5353mils True (-10) Elevation Angle: -06.1 Horizon Angle: -01.3 Zoom: 1.0x Stn: 10917+00 - Stream crossing S-RR5</small></p>			
GPS Location	See photo GPS	GPS Location	See photo GPS		
Field Station#	11023+88	Field Station#	11017+00		
Pic 1 Desc.	Stream crossing S-IJ18	Pic 2 Desc.	Stream crossing S-RR5

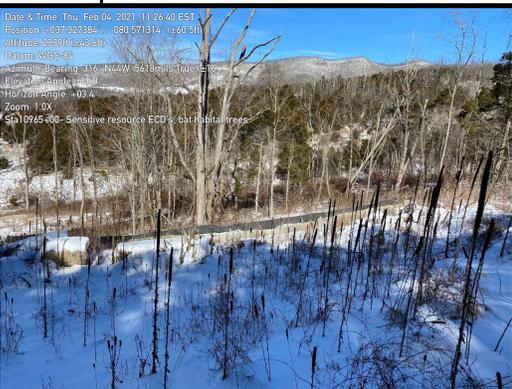
<p><small>Date & Time: Thu, Feb 04, 2021, 11:26:40 EST Position: +037.327084 / -080.571014 (-62.303hr) Altitude: 2398ft (-73.0m) Datum: WGS-84 Azimuth/Bearing: 310° N4W, 5418mils True (-15) Elevation Angle: -14.3 Horizon Angle: -09.4 Zoom: 1.0x Stn: 10965+00 - Sensitive resource area, bat habitat trees</small></p>			
GPS Location	See photo GPS	GPS Location	See photo GPS		
Field Station#	10985+00	Field Station#	10965+00

Pic 5 Desc.	Stream S- E24, bridge and ECD's.	Pic 6 Desc.	Sensitive resource area, bat habitat trees.

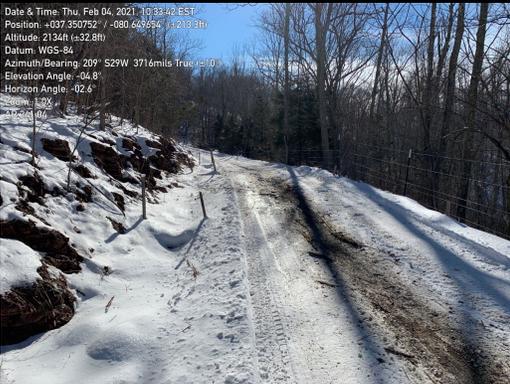
<p><small>Date & Time: Thu, Feb 04, 2021, 10:33:42 EST Position: +037.350753 / -080.648454 (±113.3ft) Altitude: 2134ft (±32.8ft) Datum: WGS-84 Azimuth/Bearing: 209.529W 3716mils True (±10°) Elevation Angle: -04.8° Horizon Angle: -02.6° Zoom: 1.0X 10710+00</small></p>		
GPS Location	See photo for GPS location.	GPS Location	See photo for GPS location.	
Field Station#	10712+50	Field Station#	10710+00	
Pic 1 Desc.	Sensitive resource buffer in place at stream S-G33.	Pic 2 Desc.	CFS in place along access road 241.04.

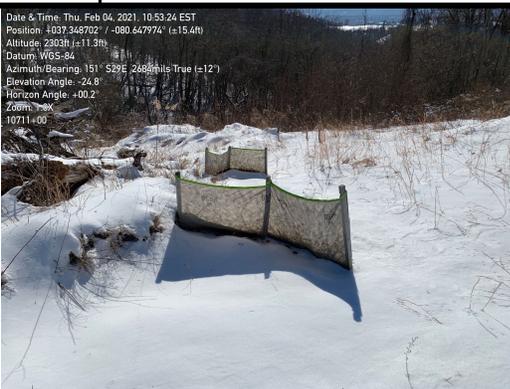
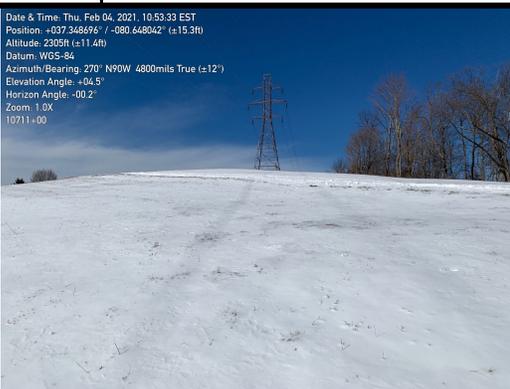
GPS Location	See photo for GPS location.	GPS Location	See photo for GPS location.	
Field Station#	10711+00	Field Station#	10711+00	
Pic 3 Desc.	Priority one silt fence checks in place.	Pic 4 Desc.	ROW stabilized with natural vegetation growth. Currently snow covered and frozen.

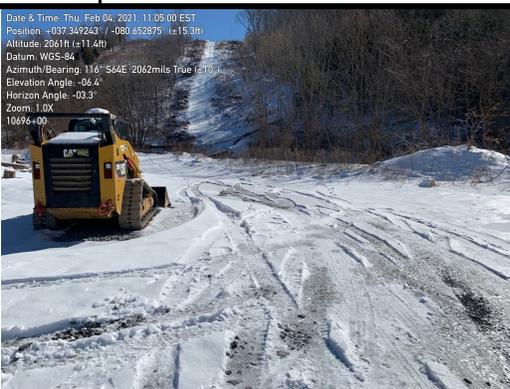
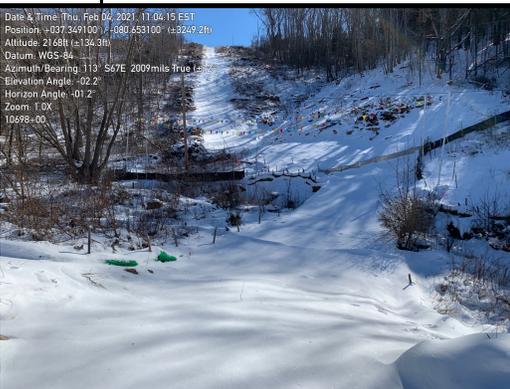
Field Station#	10696+00	Field Station#	10698+00	
Pic 5 Desc.	RCE in place at Buffalo Anklets Road.	Pic 6 Desc.	Sensitive resource buffer in place at stream S-G32.

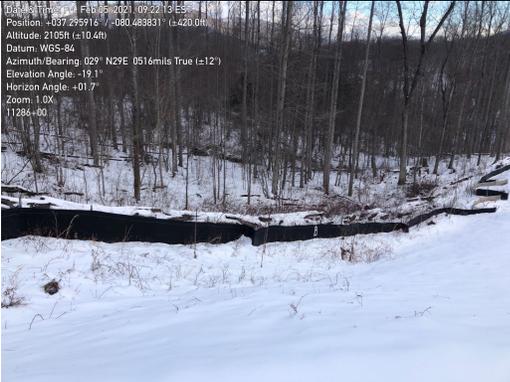
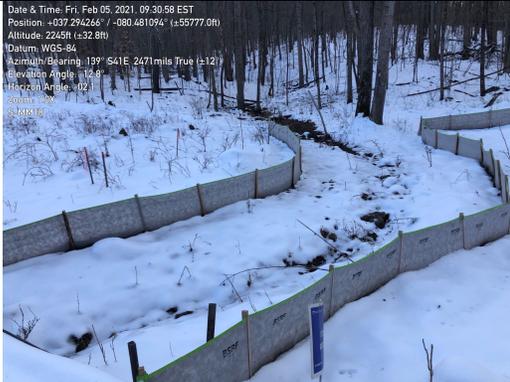
<p>Date & Time: Fri, Feb 05, 2021, 09:30:58 EST Position: +037.242265° / +080.481094° (+55777.0ft) Altitude: 2245ft (+32.8ft) Datum: WGS-84 Azimuth/Bearing: 139° S41E 2471mils True (±12°) Elevation Angle: -12.8° Horizon Angle: +02.1° Zoom: 1.0X 11292+80</p>		<p>GPS Location 1</p> <p>Field Station# 11286+00</p> <p>Pic 1 Desc. Perimeter controls functional.</p>		<p>GPS Location 2</p> <p>Field Station# 11292+80</p> <p>Pic 2 Desc. S-MM18 and controls.</p>

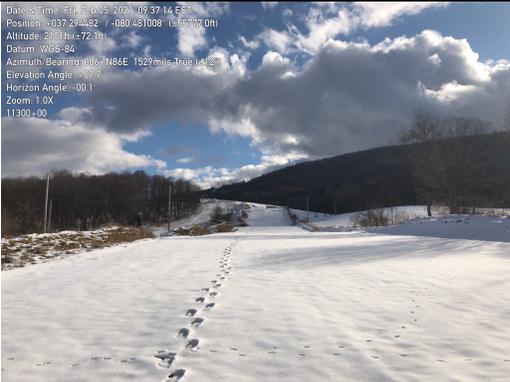
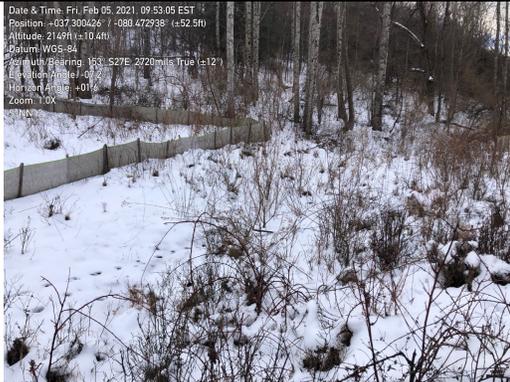
<p>Date & Time: Fri, Feb 05, 2021, 09:53:05 EST Position: +037.300426° / +080.472938° (+52.5ft) Altitude: 2149ft (+10.4ft) Datum: WGS-84 Azimuth/Bearing: 163° S27E 2720mils True (±12°) Elevation Angle: -1.0° Horizon Angle: +01.1° Zoom: 1.0X 11327+85</p>		<p>GPS Location 3</p> <p>Field Station# 11300+00</p> <p>Pic 3 Desc. Section of RoW showing conditions and controls.</p>		<p>GPS Location 4</p> <p>Field Station# 11327+85</p> <p>Pic 4 Desc. S-NN12 and controls.</p>

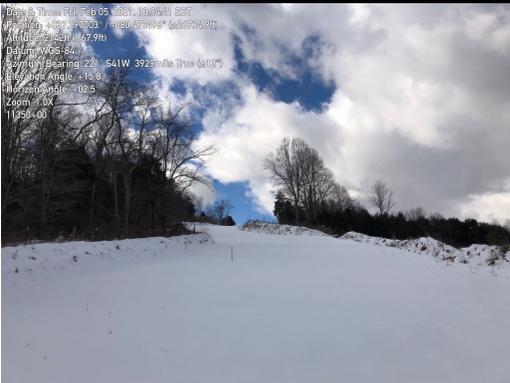
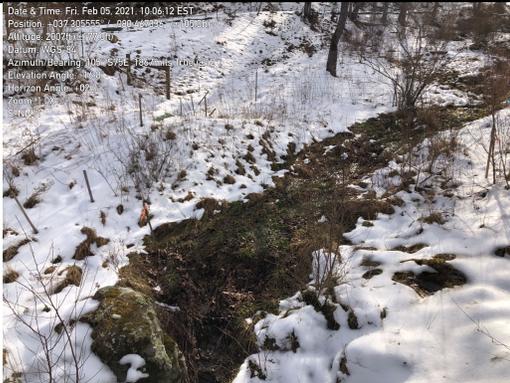
<p>Date & Time: Fri, Feb 05, 2021, 10:06:12 EST Position: +037.235555° / +080.576999° (+43379.0ft) Altitude: 2171ft (+7.9ft) Datum: WGS-84 Azimuth/Bearing: 104° S78E 1802mils True Elevation Angle: +13.8° Horizon Angle: +02.5° Zoom: 1.0X 11352+97</p>		<p>GPS Location 5</p> <p>Field Station# 11350+00</p> <p>Pic 5 Desc. Section of RoW showing conditions and controls.</p>		<p>GPS Location 6</p> <p>Field Station# 11352+97</p> <p>Pic 6 Desc. S-NN11.</p>

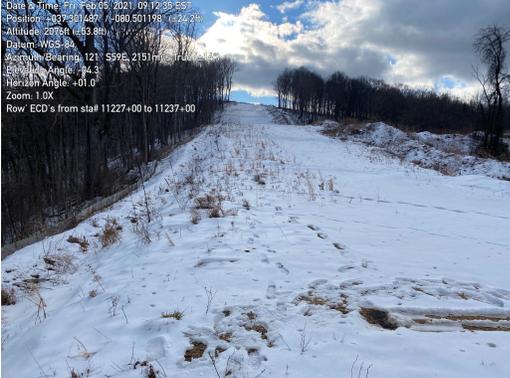
<p>Date & Time: Fri, Feb 05, 2021, 09:12:35 EST Position: +037.301521 / -080.501193 (+31.6°) Altitude: 2071ft (+633m) Datum: WGS-84 Azimuth Bearing: 121 S59E 215ft True (+17°) Elevation Angle: +34.3° Horizon Angle: +01.0° Zoom: 1.0X Sta# 11237+00 - Row and ECD's from sta# 11227+00 to 11237+00</p>

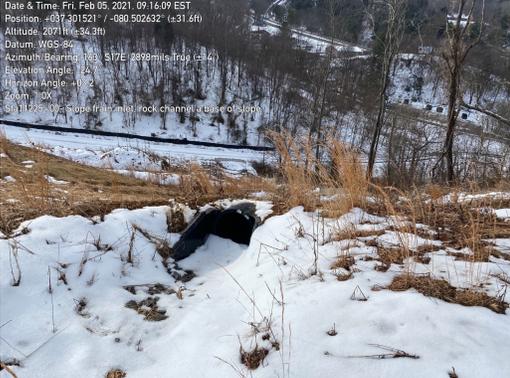
<p>Date & Time: Fri, Feb 05, 2021, 09:16:09 EST Position: +037.301521 / -080.502632 (+31.6°) Altitude: 2071ft (+633m) Datum: WGS-84 Azimuth Bearing: 163 S17E 289ft True (+17°) Elevation Angle: +22.2° Horizon Angle: +00.8° Zoom: 1.0X Sta# 11225+00 - Slope drain inlet, rock channel at the base of the slope.</p>		<p>GPS Location See photo GPS</p> <p>Field Station# 11237+00</p> <p>Pic 1 Desc. Row and ECD's</p>		<p>GPS Location See photo GPS</p> <p>Field Station# 11225+00</p> <p>Pic 2 Desc. Slope drain inlet, rock channel at the base of the slope.</p>

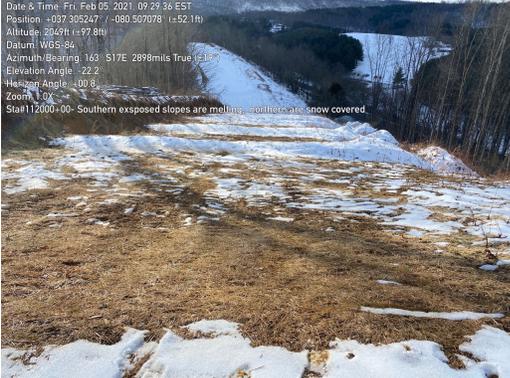
<p>Date & Time: Fri, Feb 05, 2021, 09:29:36 EST Position: +037.305247 / -080.507078 (+32.1ft) Altitude: 2049ft (+97.8ft) Datum: WGS-84 Azimuth Bearing: 163 S17E 289ft True (+17°) Elevation Angle: +22.2° Horizon Angle: +00.8° Zoom: 1.0X Sta# 11200+00 - Southern exposed slopes are melting, southern side snow covered.</p>

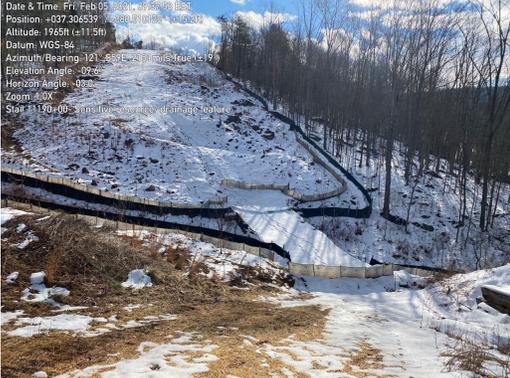
<p>Date & Time: Fri, Feb 05, 2021, 09:54:08 EST Position: +037.306539 / -080.510103 (+32.0ft) Altitude: 1965ft (+115ft) Datum: WGS-84 Azimuth Bearing: 121 S59E 231ft True (+17°) Elevation Angle: +02.2° Horizon Angle: +00.8° Zoom: 1.0X Sta# 11190+00 - Sensitive resource area, drainage feature.</p>		<p>GPS Location See photo GPS</p> <p>Field Station# 11200+00</p> <p>Pic 3 Desc. Snow melting on south facing slopes, snow remains on north facing slopes.</p>		<p>GPS Location See photo GPS</p> <p>Field Station# 11190+00</p> <p>Pic 4 Desc. Sensitive resource area, drainage feature.</p>

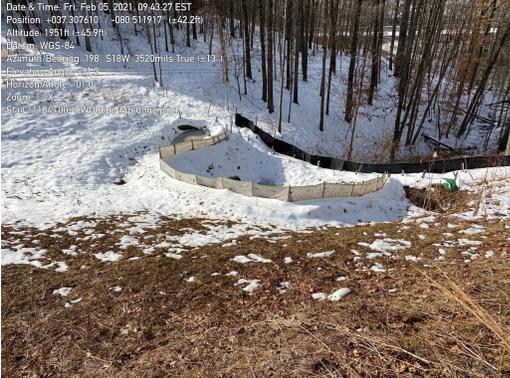
<p>Date & Time: Fri, Feb 05, 2021, 09:43:27 EST Position: +037.307411 / -080.511917 (+42.2ft) Altitude: 1951ft (+143.9ft) Datum: WGS-84 Azimuth Bearing: 198 S18W 352ft True (+13°) Elevation Angle: +31.2° Horizon Angle: +01.0° Zoom: 1.0X Sta# 11184+00 - CWD pipe and plunge pool.</p>

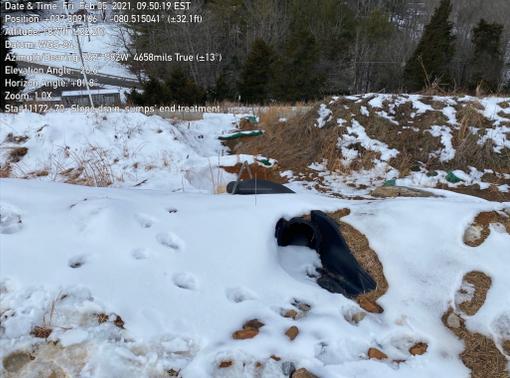
<p>Date & Time: Fri, Feb 05, 2021, 09:50:19 EST Position: +037.307993 / -080.515041 (+32.1ft) Altitude: 1951ft (+143.9ft) Datum: WGS-84 Azimuth Bearing: 121 S59E 231ft True (+17°) Elevation Angle: +02.2° Horizon Angle: +00.8° Zoom: 1.0X Sta# 11172+70 - Slope drain, sump, end treatment.</p>		<p>GPS Location See photo GPS</p> <p>Field Station# 11184+00</p> <p>Pic 5 Desc. CWD pipe and plunge pool.</p>		<p>GPS Location See photo GPS</p> <p>Field Station# 11172+70</p> <p>Pic 6 Desc. Slope drain, sump, end treatment.</p>

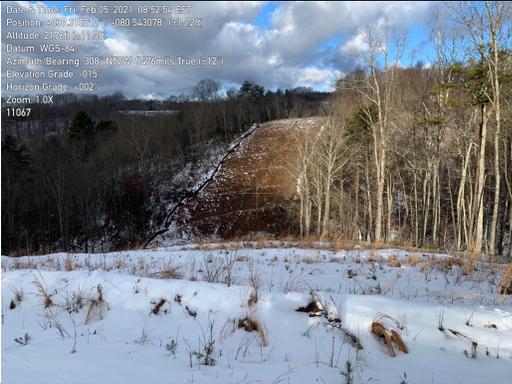
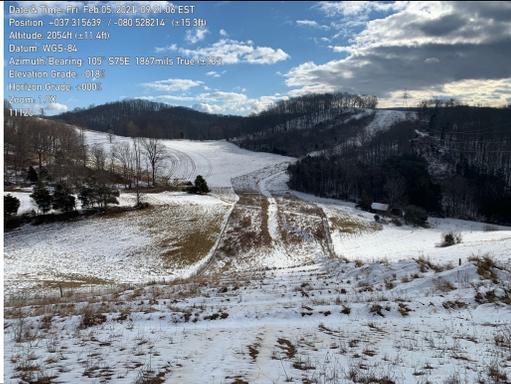
GPS Location	See picture above for GPS coordinates	GPS Location	See picture above for GPS coordinates
Field Station#	11067+00	Field Station#	11120+00
Pic 1 Desc.	ECD's and row conditions	Pic 2 Desc.	ECD's and row conditions

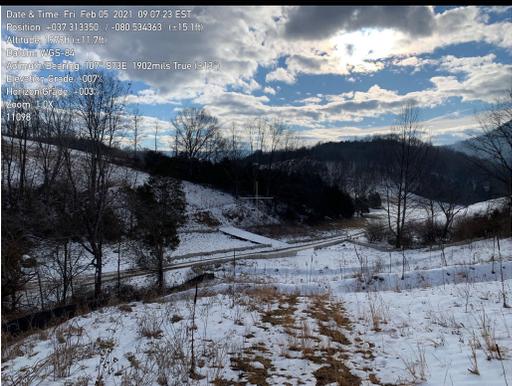
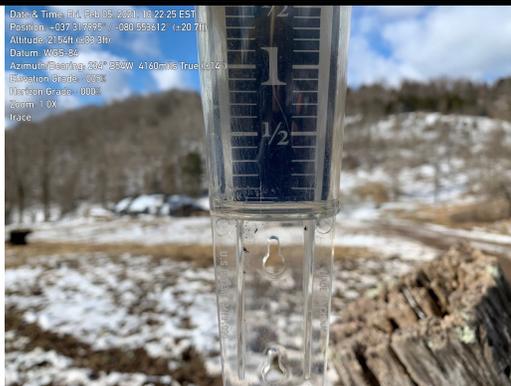
GPS Location	See picture above for GPS coordinates	GPS Location	See picture above for GPS coordinates
Field Station#	11098+00	Field Station#	+1
Pic 3 Desc.	ECD's and row conditions	Pic 4 Desc.	Trace recorded

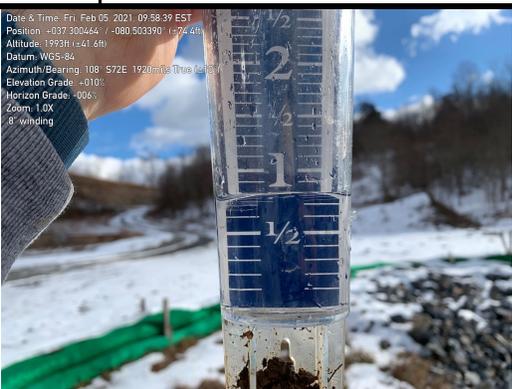
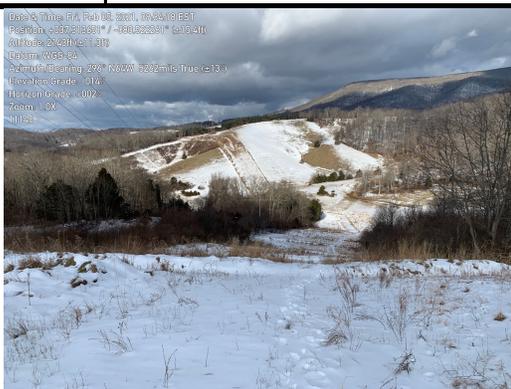
GPS Location	See picture above for GPS coordinates	GPS Location	See picture above for GPS coordinates
Field Station#	+1	Field Station#	11140+00
Pic 5 Desc.	.8" of rain recorded	Pic 6 Desc.	ECD's and row conditions

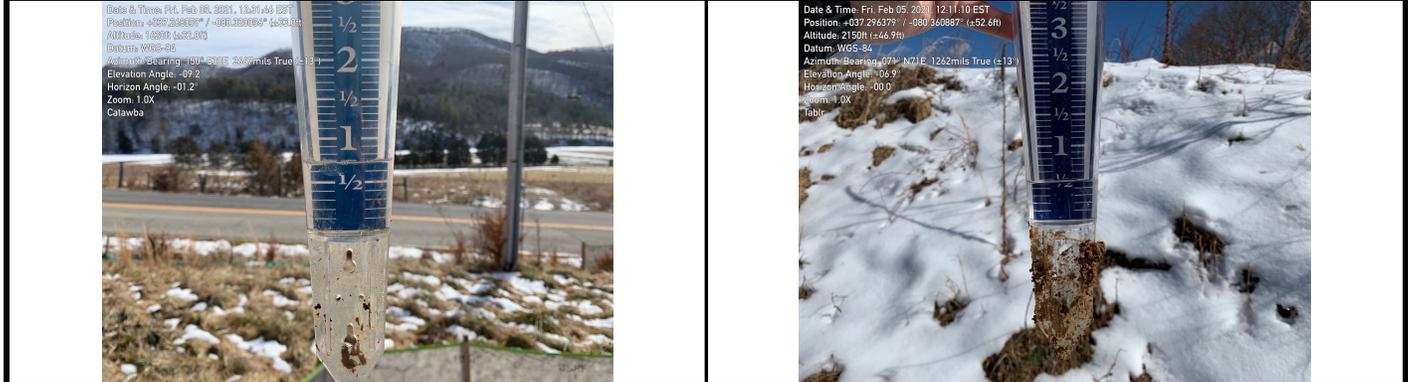
Field Station# 11767+00	Field Station# 11990+00
--------------------------------	--------------------------------

Pic 1 Desc. Rain gauge at Catawba Road reads 0.7 inches.	Pic 2 Desc. Rain gauge at Mount Tabor Road reads 0.5 inches.
---	---

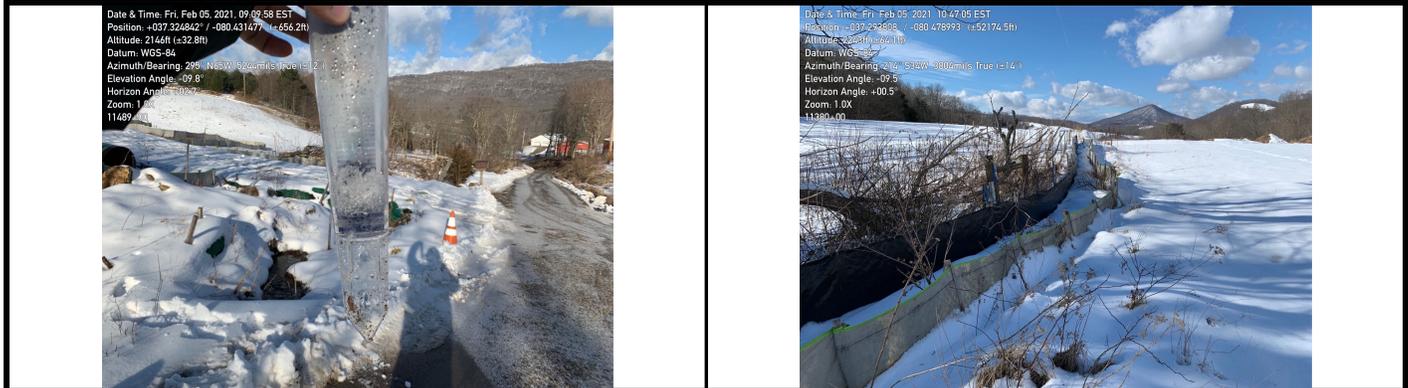
Field Station# 11489+00	Field Station# 11380+00
--------------------------------	--------------------------------

Pic 3 Desc. Rain gauge at Stevers Gap Road reads 0.3 inches.	Pic 4 Desc. Triple barrier ECDs in place at off ROW karst feature.
---	---
