Visual Site Inspection Report

Project Name	H-600 Pipeline Spread G	AFE	124300137	Spread	H-600 Pipeline Spread G
Contractor	Precision			Report #	22157
Inspector	Len Kruizenga			Date/Time	4/12/2021 7:57 AM
Permit #	TBD	Inspection Type	VA SWPP	Station Begin	12005+00
State	VA	Inspection Area	Full	Station End	12005+00
County	Giles	Ground	Wet	Temperature (°F)	61.00
Municipality	N/A	Weather	Sunny	Rain Gauge (in)	0.00
				Rain Accumulation Time (days)	1.00

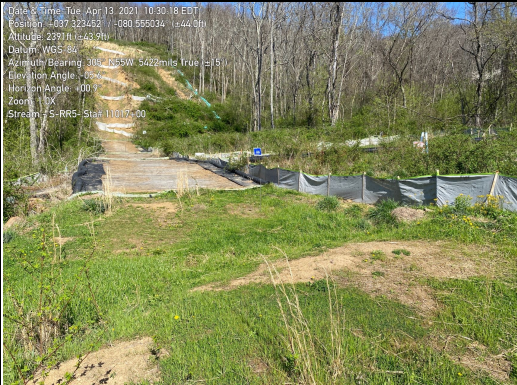
AFE 124300137		Date/Time 4/13/2021 8:28 AM		Report #	
Pictures					
<p>Date & Time: Tue Apr 13 2021 10:30:18 EDT Position: +039 322452 / -080 555034 / 1544 ft Altitude: 2391 ft / 729 m Datum: WGS 84 Azimuth/Bearing: 117° S63W 542 mils True ± 5 Elevation Angle: -00.5 Horizon Angle: +00.7 Zoom: 1.0X Stream: S-RR5- Stan 11017+00</p>

GPS Location		See photo GPS		GPS Location	
Field Station#		11017+00		Field Station#	
Pic 7 Desc.		Stream S-RR5		Pic 8 Desc.	
				Vegetation, perimeter controls, water bars.	
<p>Date & Time: Tue Apr 13 2021 10:58:23 EDT Position: +039 322452 / -080 544024 / 1545 ft Altitude: 2391 ft / 729 m Datum: WGS 84 Azimuth/Bearing: 117° S63E 2080 mils True ± 5 Elevation Angle: -00.5 Horizon Angle: +02.2 Zoom: 1.0X Stream: S-E25- bridge, buffers, signage</p>

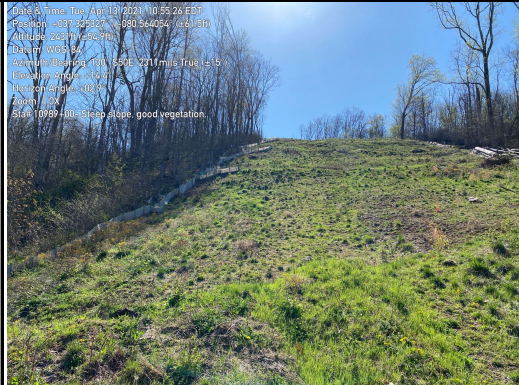
<p>Date & Time: Tue Apr 13 2021 10:55:26 EDT Position: +039 322452 / -080 544024 / 1545 ft Altitude: 2391 ft / 729 m Datum: WGS 84 Azimuth/Bearing: 117° S63E 2411 mils True ± 5 Elevation Angle: -00.5 Horizon Angle: +02.2 Zoom: 1.0X Stream: 10989+00- steep slope, good vegetation.</p>

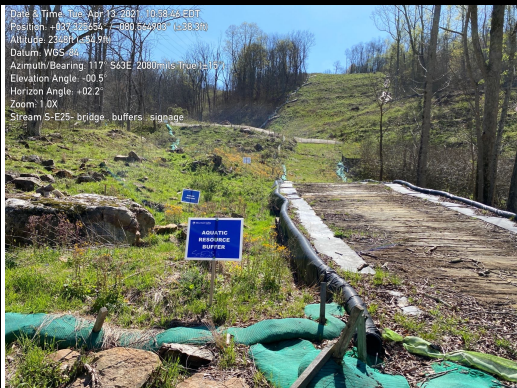
GPS Location		See photo GPS		GPS Location	
Field Station#		10986+00		Field Station#	
Pic 9 Desc.		Stream S- E25		Pic 10 Desc.	
				Stream S- E24	
<p>Date & Time: Tue Apr 13 2021 11:44:05 EDT Position: +039 322452 / -080 565145 / 1556 ft Altitude: 2391 ft / 729 m Datum: WGS 84 Azimuth/Bearing: 117° S33E 2413 mils True ± 5 Elevation Angle: -00.5 Horizon Angle: +02.2 Zoom: 1.0X Stan 10986+00- P1 stream buffer, debris</p>

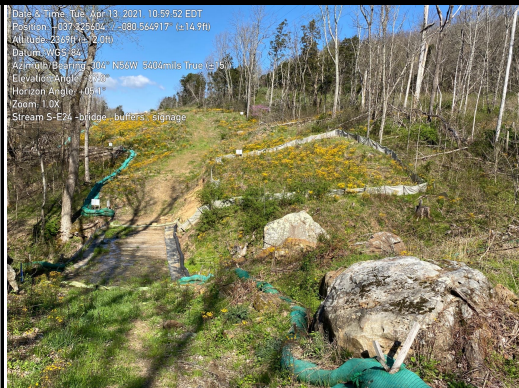
<p>Date & Time: Tue Apr 13 2021 10:59:52 EDT Position: +039 322452 / -080 544117 / 1545 ft Altitude: 2391 ft / 729 m Datum: WGS 84 Azimuth/Bearing: 117° S63W 940 mils True ± 5 Elevation Angle: -00.5 Horizon Angle: +02.2 Zoom: 1.0X Stream: S-E24- bridge, buffers, signage</p>

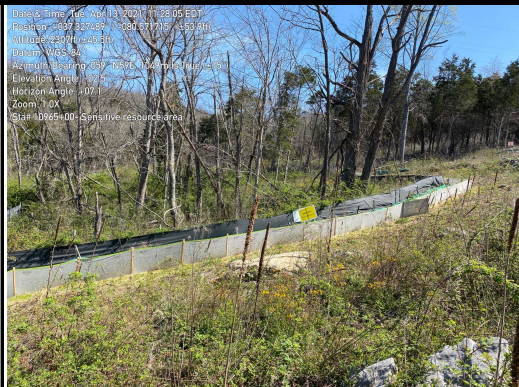
<p>Date & Time: Tue Apr 13 2021 11:28:05 EDT Position: +039 322452 / -080 571115 / 1539 ft Altitude: 2391 ft / 729 m Datum: WGS 84 Azimuth/Bearing: 117° S33E 2413 mils True ± 5 Elevation Angle: -00.5 Horizon Angle: +02.2 Zoom: 1.0X Stan 10965+00- sensitive resource area</p>

GPS Location		See photo GPS		GPS Location	
Field Station#		10985+00		Field Station#	
Pic 11 Desc.		Stream S-E24 silt fence buffer is down, contractor notified and items added to the punch list.		Pic 12 Desc.

Sensitive resource area ECD's.

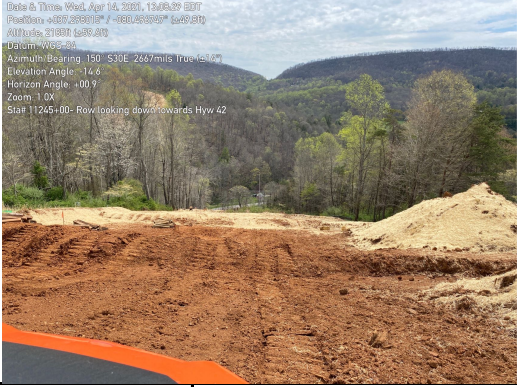
GPS Location		See photo GPS		GPS Location	
Field Station#		11245+00		Field Station#	
Pic 13 Desc.		Row looking down towards Hyw. 42.		Pic 14 Desc.	
Insert image here		Insert image here		Insert image here	
GPS Location				GPS Location	
Field Station#				Field Station#	
Pic 15 Desc.				Pic 16 Desc.	
Insert image here		Insert image here		Insert image here	
GPS Location				GPS Location	
Field Station#				Field Station#	
Pic 17 Desc.				Pic 18 Desc.

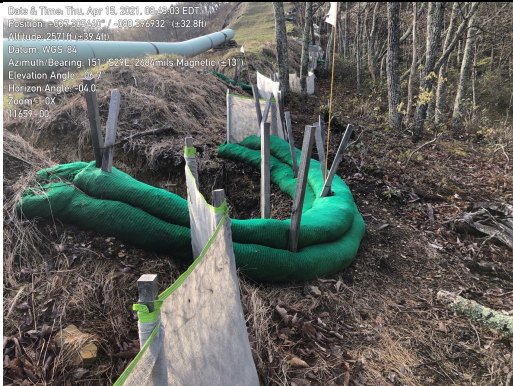
<p>Date & Time: Thu, Apr 15, 2021, 09:57:34 EDT Position: +321.31095° / +88.397340° (+16.4ft) Altitude: 2116ft (+19.2ft) Datum: WGS 84 Azimuth Bearing: 113.5° 0897mils Magnetic (+14) Elevation Angle: -36.2 Horizon Angle: +02.3 Zoom: 1.0X 11638+50</p>

<p>Date & Time: Thu, Apr 15, 2021, 09:57:03 EDT Position: +321.31095° / +88.397340° (+16.4ft) Altitude: 2116ft (+19.2ft) Datum: WGS 84 Azimuth Bearing: 113.5° 0897mils Magnetic (+14) Elevation Angle: -36.2 Horizon Angle: +02.3 Zoom: 1.0X 11638+50</p>					
GPS Location		On photo		GPS Location		On photo	
Field Station#		11663+50		Field Station#		11659+00	
Pic 5 Desc.		End treatments and perimeter controls.		Pic 6 Desc.		End treatments and perimeter controls.

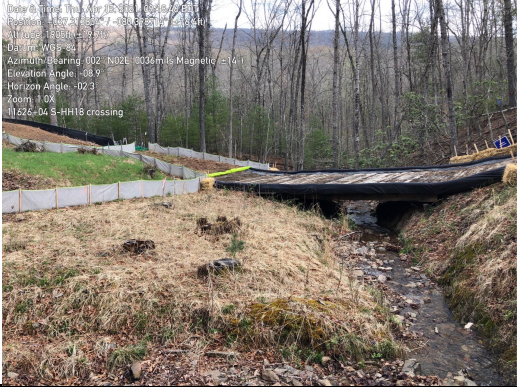
AFE	124300137	Date/Time	4/15/2021 1:36 PM	Report #	
Pictures					
  <p>Date & Time Thu, Apr 15, 2021, 08:52:41 EDT Position: +027.313537, -83.0042202 (+13.64ft) Altitude: 1922ft (+39.4ft) Datum: WGS 84 Azimuth/Bearing: 002.7026 (+0.034mils Magnetic (+14.1)) Elevation Angle: -02.9 Horizon Angle: -02.3 Zoom: 1.0X 11624+00 S-HH18 crossing</p>

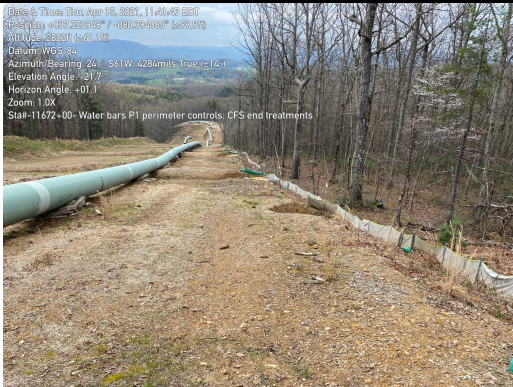
<p>Date & Time: Thu Apr 15, 2021, 11:41:49 EDT Position: +037 299845 / -080 391556 (+44.9ft) Altitude: 2456ft (+44.9ft) Datum: WGS-84 Azimuth-Bearing: 051° NS/E 428mils True (+14°) Elevation-Angle: +21.7 Horizon-Angle: +01.1 Zoom: 1.0X Stn: 11672+00: Water bars P1 perimeter controls, CFS end treatments</p>

<p>Date & Time: Thu Apr 15, 2021, 11:48:28 EDT Position: +037 299845 / -080 391556 (+44.9ft) Altitude: 2456ft (+44.9ft) Datum: WGS-84 Azimuth-Bearing: 130° S/E 3074mils True (+14°) Elevation-Angle: -02.3 Horizon-Angle: -00.2 Zoom: 1.0X Stn: 11676+25: P1 perimeter controls under cut</p>			
GPS Location	See photo GPS	GPS Location	See photo GPS		
Field Station#	11672+00	Field Station#	11676+25		
Pic 1 Desc.	Water bars, P1 perimeter controls, CFS end treatments.	Pic 2 Desc.	P1 perimeter controls are under cut, issue punch listed.

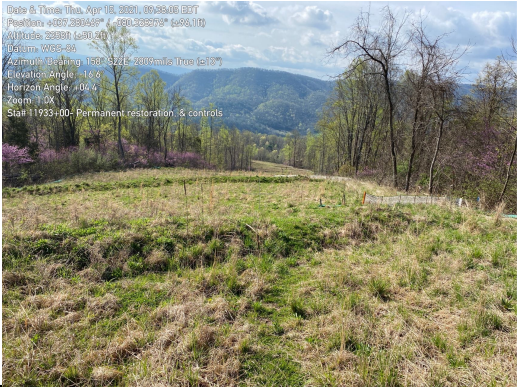
<p>Date & Time: Thu, Apr 15, 2021, 09:55:16 EDT Position: +487.23244° / -080.32217° (+26.31°) Altitude: 2360ft (+726.30) Datum: WGS-84 Azimuth Bearing: 188° S121° 289.4mils True (+13°) Elevation Angle: -10.6° Horizon Angle: -00.4° Zoom: 1.0X Stail: 11933+00- Permanent restoration - S controls</p>

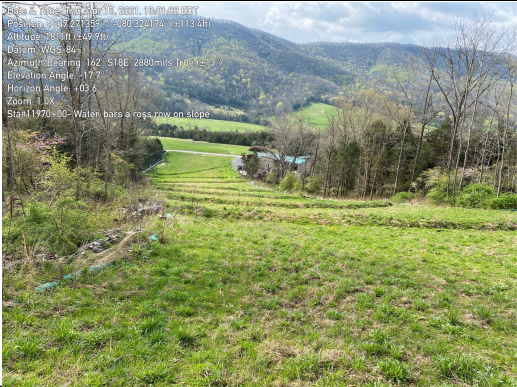
<p>Date & Time: Thu, Apr 15, 2021, 09:55:57 EDT Position: +487.23244° / -080.32217° (+26.31°) Altitude: 2360ft (+726.30) Datum: WGS-84 Azimuth Bearing: 171° S105° 304.4mils True (+13°) Elevation Angle: -15.5° Horizon Angle: -00.2° Zoom: 1.0X Stail: 11942+00- Karst ECD's</p>  			
GPS Location	See photo GPS	GPS Location	See photo GPS		
Field Station#	11933+00	Field Station#	11942+00		
Pic 15 Desc.	Permanent restoration & controls.	Pic 16 Desc.	Karst ECD's.		
<p>Date & Time: Thu, Apr 15, 2021, 10:05:48 EDT Position: +487.27012° / -080.32207° (+26.31°) Altitude: 2788ft (+850.00) Datum: WGS-84 Azimuth Bearing: 143° S370° 254.2mils True (+13°) Elevation Angle: -13.0° Horizon Angle: -05.4° Zoom: 1.0X Stail: 11970+00- Water bars across row on slope</p>

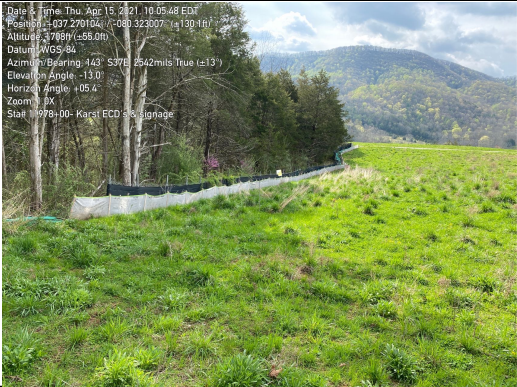
<p>Date & Time: Thu, Apr 15, 2021, 10:05:48 EDT Position: +487.27012° / -080.32207° (+26.31°) Altitude: 2788ft (+850.00) Datum: WGS-84 Azimuth Bearing: 143° S370° 254.2mils True (+13°) Elevation Angle: -13.0° Horizon Angle: -05.4° Zoom: 1.0X Stail: 11978+00- Karst ECD's & signage</p>

GPS Location	See photo GPS	GPS Location	See photo GPS		
Field Station#	11970+00	Field Station#	11978+00		
Pic 17 Desc.	Temporary water bars across row.	Pic 18 Desc.	Karst ECD's and signage.
