Visual Site Inspection Report

Project Name	H-600 Pipeline Spread G	AFE	124300137	Spread	H-600 Pipeline Spread G
Contractor	Precision			Report #	22407
Inspector	Patrick Shields			Date/Time	4/19/2021 7:05 AM
Permit #	TBD	Inspection Type	VA SWPP	Station Begin	10674+81
State	VA	Inspection Area	Partial	Station End	10929+62
County	Giles	Ground	Dry	Temperature (°F)	61.00
Municipality	N/A	Weather	Cloudy	Rain Gauge (in)	0.00
				Rain Accumulation Time (days)	1.00

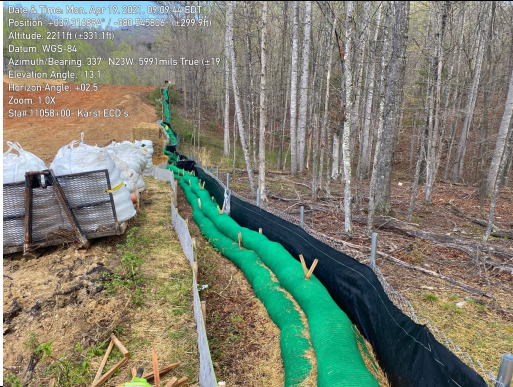
GPS Location	See photo GPS	GPS Location	See photo GPS		
Field Station#	11064+53	Field Station#	11058+00		
Pic 1 Desc.	Backend of row grading, end treatments on slope.	Pic 2 Desc.	Karst ECD's		
<p>Date & Time: Mon, Apr 19, 2021, 09:10:08 EDT Position: +037.318201, -080.547610, (+108.4ft) Altitude: 2103ft (+315.9ft) Datum: WGS 84 Azimuth/Bearing: 218° N42W 565mils True (±19°) Elevation Angle: +19.3° Horizon Angle: +01.5° Zoom: 1.0x Stream S-1J16B- Stream S-1J16B-50</p>

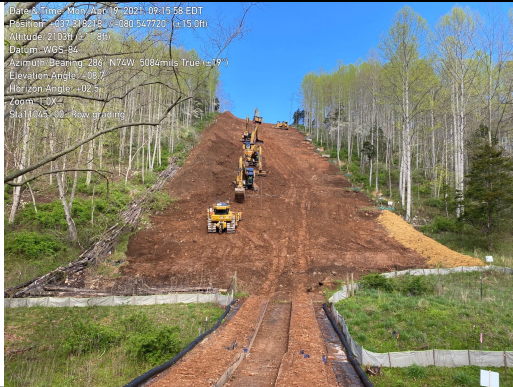
GPS Location	See photo GPS	GPS Location	See photo GPS		
Field Station#	11049+50	Field Station#	11045+00		
Pic 3 Desc.	Stream S-1J16B- Equipment bridge buffers.	Pic 4 Desc.	Row grading working on slope above stream.		
<p>Date & Time: Mon, Apr 19, 2021, 09:41:36 EDT Position: +037.224125, -080.552186, (+125.0ft) Altitude: 2637ft (+46.1ft) Datum: WGS 84 Azimuth/Bearing: 307° N53W 545mils True (±19°) Elevation Angle: +16.5° Horizon Angle: +01.5° Zoom: 1.0x Star: 11025+00 - Stream S-1J18- Bridge & buffers</p>

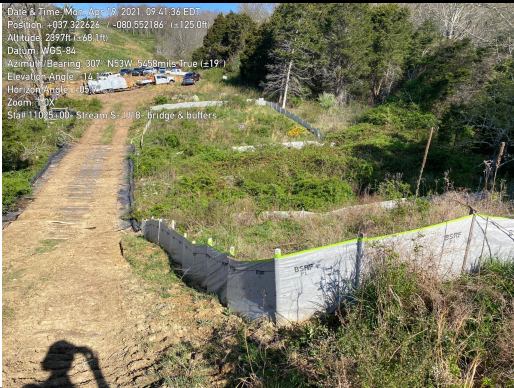
Pic 5 Desc.	Stream S-1J18- Equipment bridge, buffers	Pic 6 Desc.	Stream S- RR5- Bridge, buffers, signage.

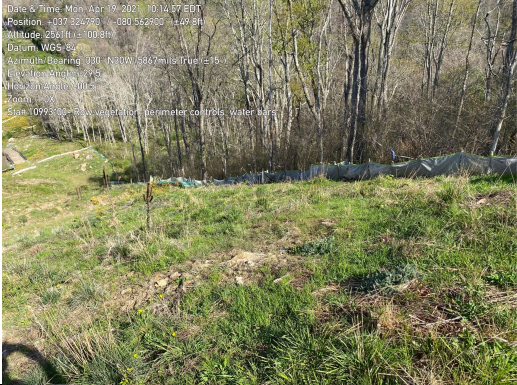
GPS Location	See photo GPS	GPS Location	See photo GPS		
Field Station#	10993+00	Field Station#	10986+00		
Pic 7 Desc.	Row vegetation, P1 perimeter controls water bars on slope.	Pic 8 Desc.	Stream S- E25- Bridge, buffers, signage.		
<p>Date & Time: Mon Apr 19 2021 11:04:46 EDT Position: +037.331293 / -080.582849 / 115.1m Altitude: 2130ft (±11.4m) Datum: WGS-84 Azimuth Bearing: 301° N59W 5351mils True (±13°) Elevation Angle: -13.9 Horizontal Angle: +05.7 Zoom: 1.0X Stream S-Y2- Bridge#8</p>

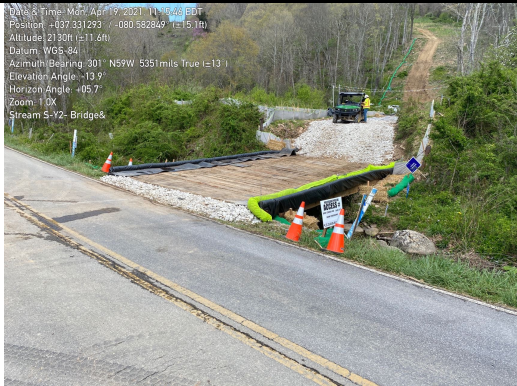
GPS Location	See photo GPS	GPS Location	See photo GPS		
Field Station#	10929+62	Field Station#	10985+00		
Pic 9 Desc.	Equipment bridge over stream S-Y2.	Pic 10 Desc.	Stream S- E24- Bridge, buffers		
<p>Date & Time: Mon Apr 19 2021 10:24:51 EDT Position: +037.326203 / -080.552071 / 140.8m Altitude: 256ft (±100.8m) Datum: WGS-84 Azimuth Bearing: 050° N58E 1037mils True (±15°) Elevation Angle: -03.5 Horizontal Angle: -08.5 Zoom: 1.0X Staff: 10965+00- Sensitive resource ECDs & signage</p>

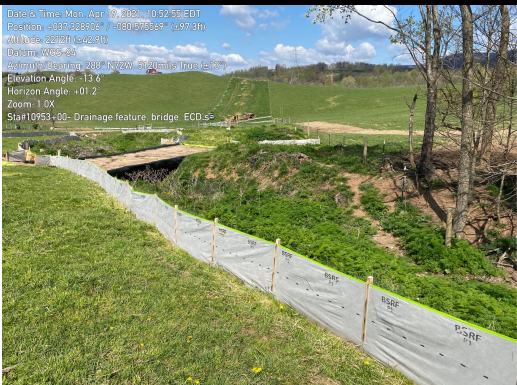
GPS Location	See photo GPS	GPS Location	See photo GPS		
Field Station#	10965+00	Field Station#	10953+00		
Pic 11 Desc.	Sensitive resource area, bat habitat, ECD's, signage.	Pic 12 Desc.	Drainage feature, bridge, ECD's

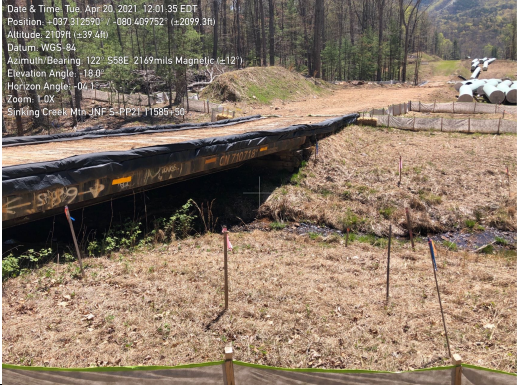
<p><small>Date & Time Thu, Apr 20, 2021 12:01:39 EDT Position: +037.512590 / +090.409752 (+2099.3ft) Altitude: 2109ft (+39.4m) Datum: WGS-84 Azimuth/Bearing: 122.558E 2169mils Magnetic (+12°) Elevation Angle: +16.0° Horizon Angle: +0° Zoom: 1.0X Sinking Creek Mtn JNF S-PP21 11585+50</small></p>			
GPS Location	On photo	GPS Location	On photo		
Field Station#	11585+50	Field Station#	11588+50		
Pic 7 Desc.	S-PP21 crossing stable.	Pic 8 Desc.	S-PP20 crossing stable.

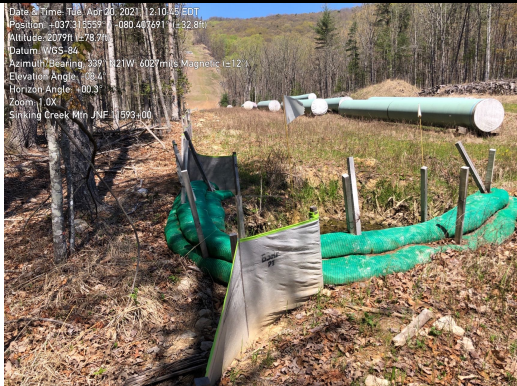
GPS Location	On photo	GPS Location			
Field Station#	11593+00	Field Station#			
Pic 9 Desc.	Perimeter controls functional.	Pic 10 Desc.			
<p style="text-align: center;">Insert image here</p>		<p style="text-align: center;">Insert image here</p>			
GPS Location		GPS Location			
Field Station#		Field Station#			
Pic 11 Desc.		Pic 12 Desc.

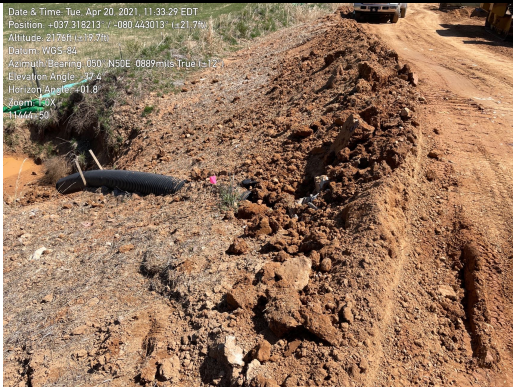
<p>Date & Time: Tue, Apr 20, 2021, 09:03:39 EDT Position: +037.316213, -080.443013, +221.7m Altitude: 2194ft (+221.7m) Datum: WGS 84 Azimuth Bearing: 050. NSSE 0889mils True (+2.4°) Elevation Angle: -32.4° Horizon Angle: -00.6° Zoom: 1.0x 11293+00</p>			
GPS Location				See photo				GPS Location				See photo			
Field Station#				11444+50				Field Station#				111293+00			
Pic 1 Desc.				Flow path slope drain needs cleared				Pic 2 Desc.				Bridge needs repaired

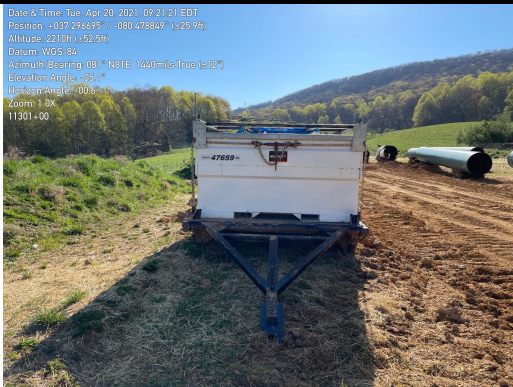
GPS Location				See photo				GPS Location				See photo			
Field Station#				11301+00				Field Station#				11452+66			
Pic 3 Desc.				Precision fuel cell				Pic 4 Desc.				Hole in P1

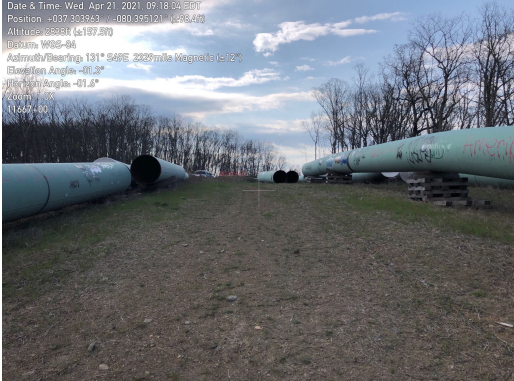
GPS Location		On photo		GPS Location	
Field Station#		11667+00		Field Station#	
Pic 1 Desc.		Top of Brush Mountain stable. No evidence of vandalism.		Pic 2 Desc.	
				Communication; fabric to be re-attached to chain link	
<p>Date & Time: Wed Apr 21, 2021, 09:40:00 EDT Position: +037.39424° / -680.37584° (-68.618°) Altitude: 2391 ft (-729.100) Datum: WGS-84 Azimuth/Bearing: 237° 59' 10" N23E 2684mils Magnetic (-12°) Elevation Angle: -33.4° Horizon Angle: -02.6° Zoom: 1.0X 11664+00</p>

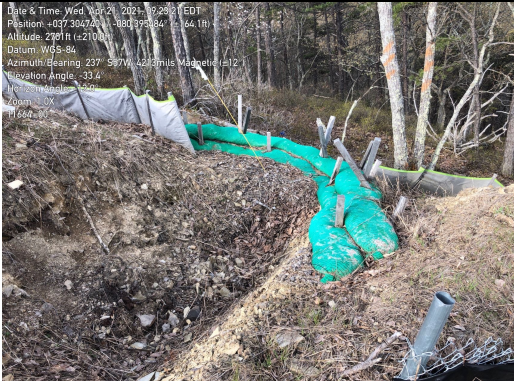
GPS Location		On photo		GPS Location	
Field Station#		11664+00		Field Station#	
Pic 3 Desc.		End treatments in place and functional.		Pic 4 Desc.	
				Surface stable. Slope breakers effective.	
<p>Date & Time: Wed Apr 21, 2021, 09:47:17 EDT Position: +037.31231° / -680.45537° (-68.759°) Altitude: 2651 ft (-808.500) Datum: WGS-84 Azimuth/Bearing: 234° 35' 40" N21W 5620mils Magnetic (-12°) Elevation Angle: -17.7° Horizon Angle: -07.2° Zoom: 1.0X 11661+00, repair</p>

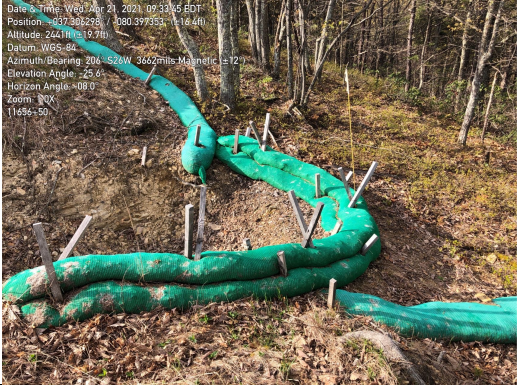
GPS Location	On photo	GPS Location	On photo		
Field Station#	11656+50	Field Station#	11651+30		
Pic 7 Desc.	End treatment functional.	Pic 8 Desc.	Perimeter ECDs in place.		
<p>Date & Time: Wed Apr 21, 2021 09:39:58 EDT Position: +037.310369° / -080.397064° (-18.4ft) Altitude: 2268ft (-18.4ft) Datum: WGS-84 Azimuth/Bearing: 184° S44W 3271mils Magnetic (-12°) Elevation Angle: +03.5° Horizon Angle: +00.0° Zoom: 1.0X 11648+00</p>

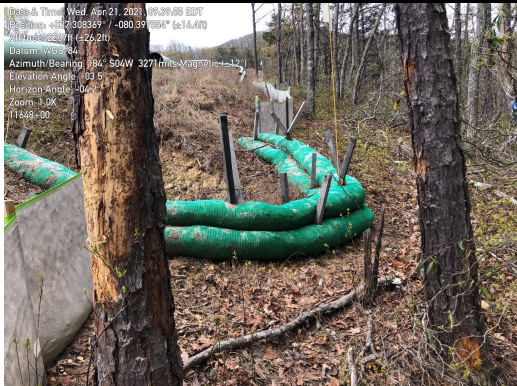
GPS Location	On photo	GPS Location	On photo		
Field Station#	11648+00	Field Station#	11626+75		
Pic 9 Desc.	End treatment functional.	Pic 10 Desc.	Communication; fabric to be re-attached to chain link.		
<p>Date & Time: Wed Apr 21, 2021 10:10:59 EDT Position: +037.314081° / -080.398849° (-18.4ft) Altitude: 1908ft (-39.4ft) Datum: WGS-84 Azimuth/Bearing: 116° S64E 2062mils Magnetic (-13°) Elevation Angle: +09.8° Horizon Angle: +01.4° Zoom: 1.0X 11626+04, S-HH18 crossing</p>

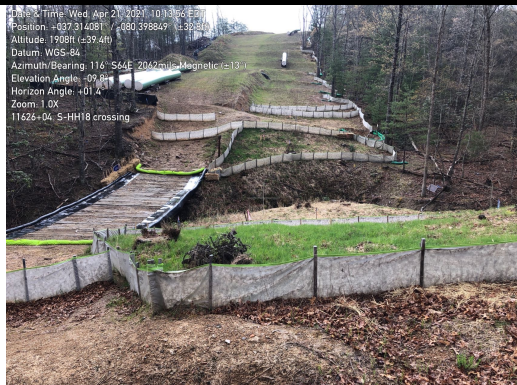
GPS Location	On photo	GPS Location	On photo		
Field Station#	11626+04	Field Station#	11608+17		
Pic 11 Desc.	S-HH18 crossing and buffers stable with ECDs in place.	Pic 12 Desc.	S-006 crossing and buffers stable with ECDs in place.

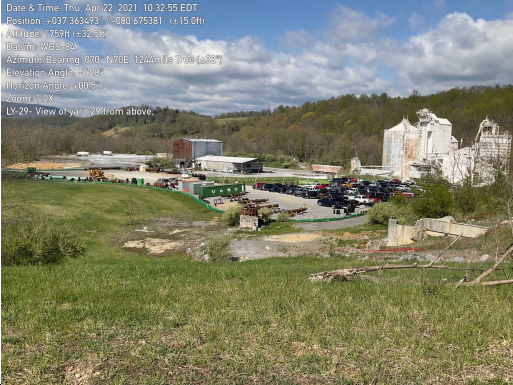
<p>Date & Time: Thu, Apr 22, 2021, 10:32:55 EDT Position: +037 363182 - +080 675381 (+15.0ft) Altitude: 1259ft (+228ft) Datum: WGS-84 Azimuth/Bearing: 070° 04' 00" 1224mils True (+33.7°) Elevation Angle: +4.9° Horizon Angle: -00.5° Zoom: 1.0X LY-29- View of yard 29 from above</p>

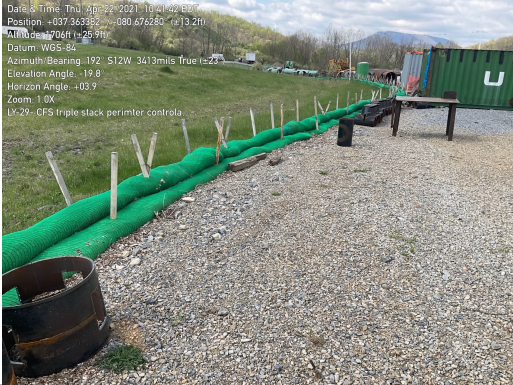
GPS Location	See photo GPS	GPS Location	See photo GPS		
Field Station#	12005+00	Field Station#	12005+00		
Pic 3 Desc.	LY29- Side boom stored in the yard.	Pic 4 Desc.	LY29- CFS triple stack perimeter controls.		
<p>Date & Time: Thu, Apr 22, 2021, 10:45:00 EDT Position: +037 363482 - +080 676313 (+13.5ft) Altitude: 1703ft (+262ft) Datum: WGS-84 Azimuth/Bearing: 219° 58' 00" 383mils True (+27.7°) Elevation Angle: -08.9° Horizon Angle: +00.1° Zoom: 1.0X LY-29- Employee parking for people affiliated with pipeline welding.</p>

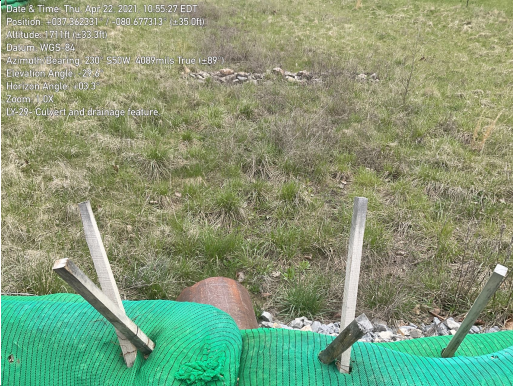
Pic 5 Desc.	LY29- Employee parking for people affiliated with pipeline welding.	Pic 6 Desc.	LY29- Culvert and drainage feature.

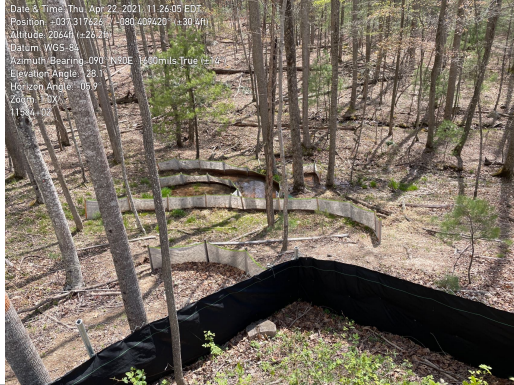
GPS Location	See photo	GPS Location	See photo		
Field Station#	11566+07	Field Station#	11584+02		
Pic 3 Desc.	P1 silt fence perimeter control in place	Pic 4 Desc.	Sediment built up on P1 needs replaced

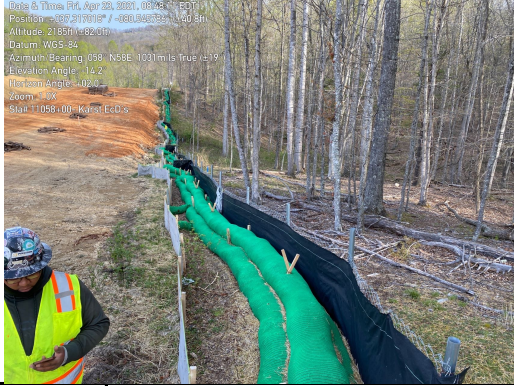
<p>Date & Time: Fri, Apr 23, 2021, 08:54:17 EDT Position: +037°31'58.171" / -080°54'28.0" (+42.7m) Altitude: 21850 (+42.2m) Datum: WGS-84 Azimuth/Bearing: 058° N58E 1031mils True (+1.9) Elevation Angle: +1.2° Horizon Angle: -02.2° Zoom: 1.0X Sta# 11058+00- Karst ECD's</p>			
GPS Location	See photo GPS	GPS Location	See photo GPS		
Field Station#	11064+00	Field Station#	11058+00		
Pic 1 Desc.	Row, perimeter controls.	Pic 2 Desc.	Karst ECD's.

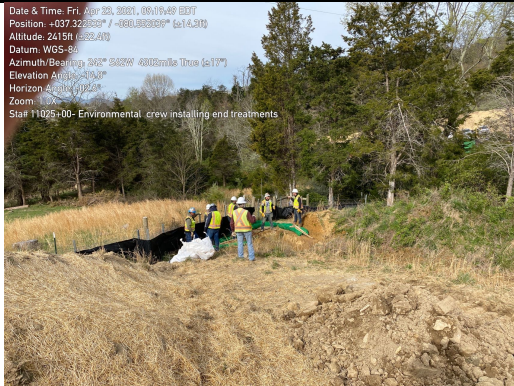
<p>Date & Time: Fri, Apr 23, 2021, 09:16:49 EDT Position: +037°32'03.512" / -080°55'20.0" (+50.9m) Altitude: 24158 (+52.4m) Datum: WGS-84 Azimuth/Bearing: 316° N316E 600mils True (+17°) Elevation Angle: -17.3° Horizon Angle: -08.9° Zoom: 1.0X Sta# 11025+00- Environmental crew installing end treatments</p>			
GPS Location	See photo GPS	GPS Location	See photo GPS		
Field Station#	11025+00	Field Station#	11025+00		
Pic 5 Desc.	Stream S- IJ18, buffers, bridge, signage.	Pic 6 Desc.	Environmental crew installing end treatments.

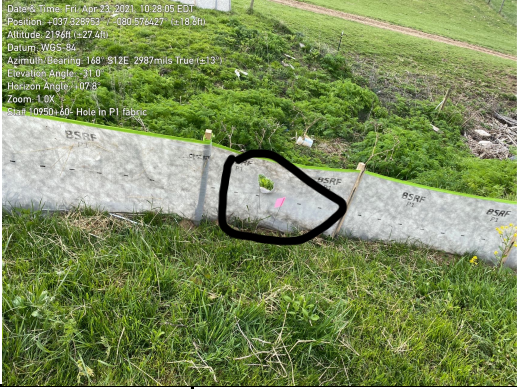
GPS Location	See photo GPS	GPS Location			
Field Station#	10950+60	Field Station#			
Pic 13 Desc.	Hole on P1 fabric at drainage feature.	Pic 14 Desc.			
Insert image here		Insert image here			
GPS Location		GPS Location			
Field Station#		Field Station#			
Pic 15 Desc.		Pic 16 Desc.			
Insert image here		Insert image here			
GPS Location		GPS Location			
Field Station#		Field Station#			
Pic 17 Desc.		Pic 18 Desc.

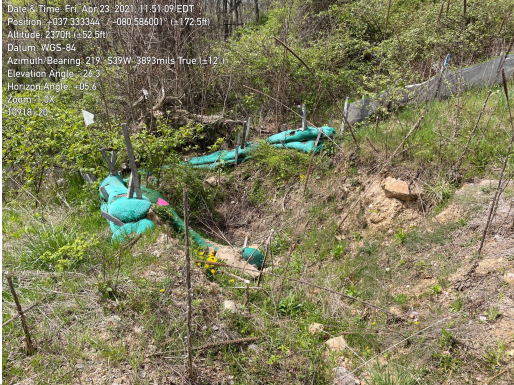
GPS Location	See photo	GPS Location	See photo		
Field Station#	10918+20	Field Station#	10916+48		
Pic 3 Desc.	End treatment falling into sump	Pic 4 Desc.	P1 perimeter controls in place
