Visual Site Inspection Report

Project Name	H-600 Pipeline Spread G	AFE	124300137	Spread	H-600 Pipeline Spread G
Contractor	Precision			Report #	22674
Inspector	Patrick Shields			Date/Time	4/26/2021 6:55 AM
Permit #	TBD	Inspection Type	VA SWPP	Station Begin	11254+99
State	VA	Inspection Area	Partial	Station End	11524+16
County	Giles	Ground	Muddy	Temperature (°F)	72.00
Municipality	N/A	Weather	Sunny	Rain Gauge (in)	0.00
				Rain Accumulation Time (days)	1.00

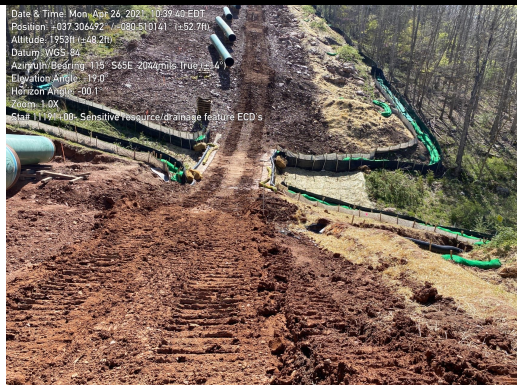
Pic 11 Desc.	Sensitive resource area/drainage feature and ECD's.	Pic 12 Desc.	Rock channel, sump, Winding Way access road.

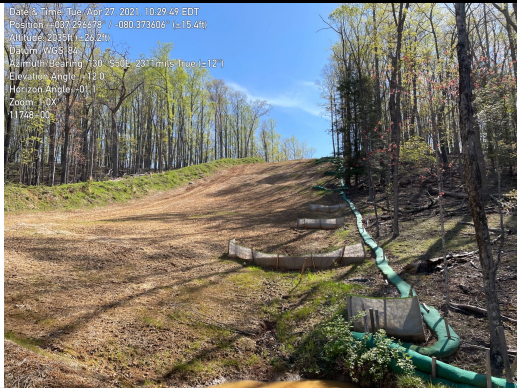
GPS Location	See photo	GPS Location	See photo		
Field Station#	11748+00	Field Station#	11771+00		
Pic 9 Desc.	End treatments in place. Topsoil pile has good vegetation	Pic 10 Desc.	Supersilt fence perimeter controls in place		
<p>Date & Time: Tue, Apr 27, 2021, 11:10:44 EDT Position: +037 298525 / -080 382099 (±11 6ft) Altitude: 2040ft (±36 2ft) Datum: WGS-84 Azimuth Bearing: 148 / S32E 2031mils True (±121) Elevation Angle: ±16.9 Horizon Angle: ±06.1 Zoom: 1.0X 11768+30</p>

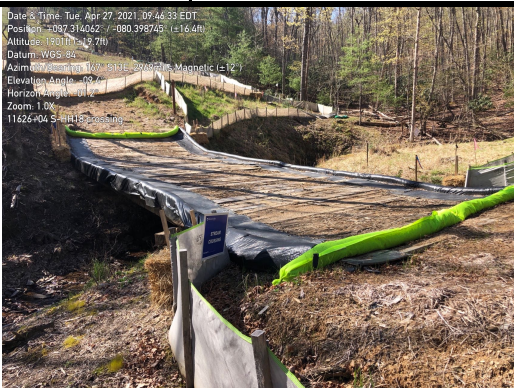
GPS Location	On photo		GPS Location	On photo	
Field Station#	11626+04		Field Station#	11614+20	
Pic 9 Desc.	S-HH18 crossing is stable.		Pic 10 Desc.	S-RR14 crossing is stable.	
<div><div><div><div><div><div></div><div></div></div></div><div><div><div></div><div></div></div></div><div><div><div></div></div></div></div></div><div><div>Date & Time: Tue, Apr 27, 2021, 07:16:50 EDT Position: +037.314836 / -080.402847 (+16.4ft) Altitude: 1907ft (+39.4ft) Datum: WGS-84 Azimuth/Bearing: 165° S15E 2933mils Magnetic (+13°) Elevation Angle: +0.1° Horizon Angle: -02.5° Zoom: 1.0X S-RR13 access road 258.04 11613+69</div><div>

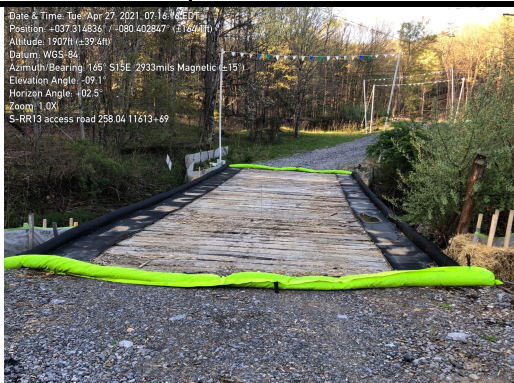
GPS Location	On photo		GPS Location	On photo	
Field Station#	11613+69		Field Station#	11608+17	
Pic 11 Desc.	S-RR13 crossing at access road MN-258.04 is stable.		Pic 12 Desc.	S-006 crossing is stable.

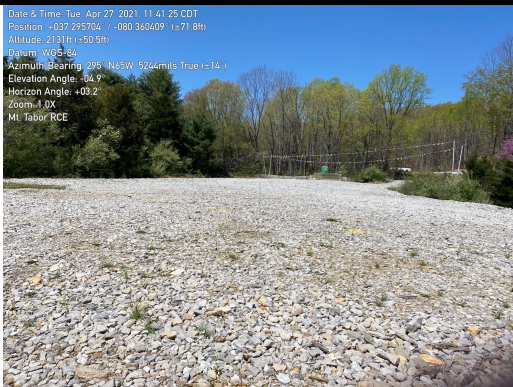
<p>Date & Time: Tue, Apr 27, 2021, 11:47:32 CDT Position: +037 232704 / -080 365409 / +71.8ft Altitude: 2131ft (+50.5m) Datum: WGS 84 Azimuth/Bearing: 110 S70E 1954mils True (+15.1) Elevation Angle: -05.8 Horizon Angle: +00.4 Zoom: 1.0X Star: 1803+00- Permanent restoration vegetation is very good</p>			
GPS Location	See photo GPS		GPS Location	See photo GPS	
Field Station#	11792+00		Field Station#	11803+00	
Pic 1 Desc.	MT Tabor RCE		Pic 2 Desc.	Permanent restoration vegetation is very good.

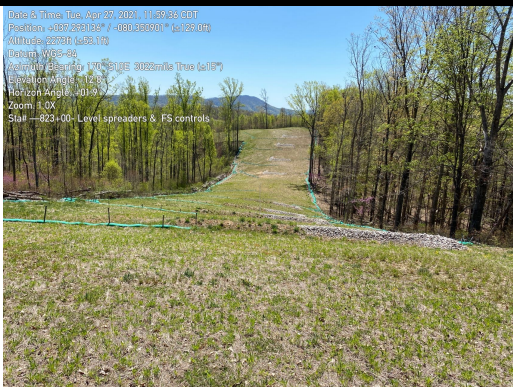
<p>Date & Time: Tue, Apr 27, 2021, 11:45:49 CDT Position: +037 232704 / -080 365409 / +71.8ft Altitude: 2131ft (+50.5m) Datum: WGS 84 Azimuth/Bearing: 175 S75E 3023mils True (+15.7) Elevation Angle: -11.2 Horizon Angle: +01.9 Zoom: 1.0X Star: 11823+00- Level spreaders & FS controls</p>

GPS Location	See photo GPS		GPS Location	See photo GPS	
Field Station#	11823+00		Field Station#	11838+00	
Pic 3 Desc.	Level spreaders and CFS controls.		Pic 4 Desc.	Perimeter controls & CFS on slope.

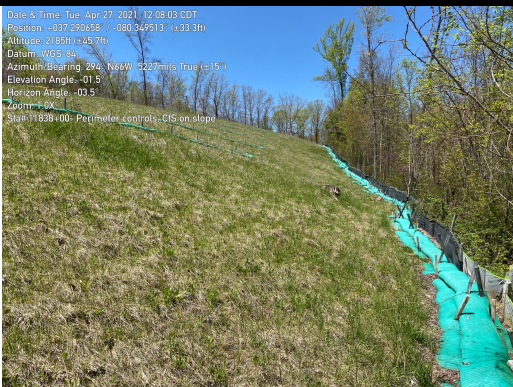
<p>Date & Time: Tue, Apr 27, 2021, 12:08:03 CDT Position: +037 2326558 / -080 364513 / +33.3ft Altitude: 2185ft (+65.7m) Datum: WGS 84 Azimuth/Bearing: 292 NSW 522mils True (+15.7) Elevation Angle: -01.5 Horizon Angle: -03.5 Zoom: 1.0X Star: 11838+00- Perimeter controls: CIS on slope</p>

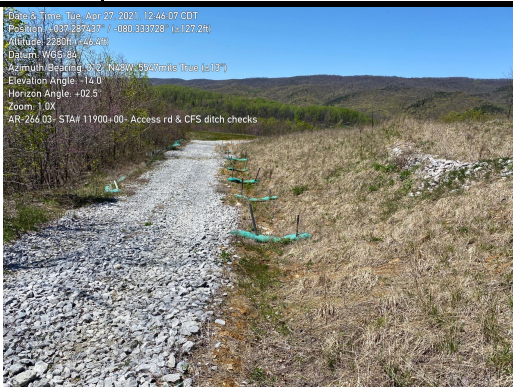
<p>Date & Time: Tue, Apr 27, 2021, 12:45:07 CDT Position: +037 232704 / -080 335728 / +127.2ft Altitude: 2280ft (+69.2m) Datum: WGS 84 Azimuth/Bearing: 112 NSW 530mils True (+15.7) Elevation Angle: -14.0 Horizon Angle: +02.5 Zoom: 1.0X Star: AR-266.03- STAR 11900+00- Access rd & CFS ditch checks</p>

Field Station#	11900+00		Field Station#	11924+00	
Pic 5 Desc.	AR-266.03- Access road & CFS ditch checks		Pic 6 Desc.	Level spreaders on permanent row, water bars on temporary row.

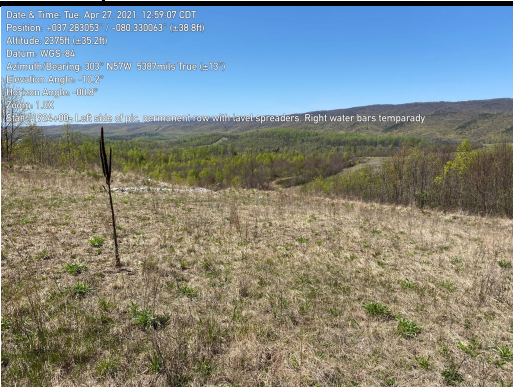
<p>Date & Time: Tue, Apr 27, 2021, 12:59:07 CDT Position: +037 2326553 / -080 330653 / +38.8ft Altitude: 2275ft (+69.2m) Datum: WGS 84 Azimuth/Bearing: 303 NSW 508mils True (+15.7) Elevation Angle: -10.2 Horizon Angle: -00.0 Zoom: 1.0X Star: 11924+00- Left side of rd, permanent row with level spreaders. Right water bars temporary</p>			
GPS Location	See photo GPS		GPS Location	See photo GPS

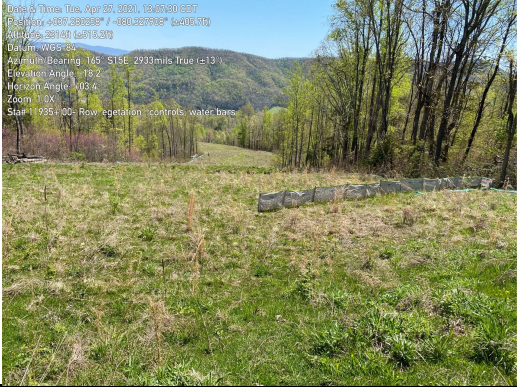
GPS Location	See photo GPS	GPS Location	See photo GPS		
Field Station#	11935+00	Field Station#	11942+00		
Pic 7 Desc.	Row vegetation, controls and water bars.	Pic 8 Desc.	Karst ECD's.		
<p><small>Date & Time: Tue, Apr 27, 2021, 13:30:59 CDT Position: +037 271521° / -080 322276° (+417.5ft) Altitude: 1987ft (+56.91ft) Datum: WGS-84 Azimuth/Bearing: 162° S18E, 2880mils True (+13°) Elevation Angle: +21.0° Horizon Angle: +01.5° Zoom: 1.0X Star: 11970+00- Water bars and row have excellent vegetation.</small></p>

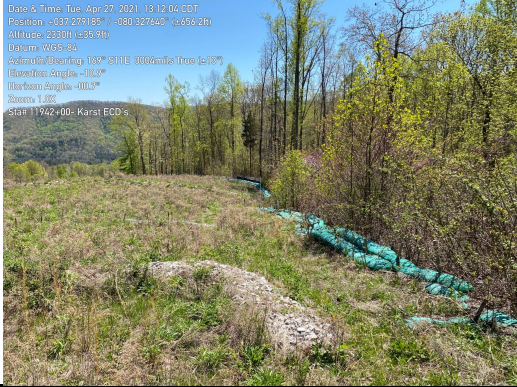
<p><small>Date & Time: Tue, Apr 27, 2021, 13:12:04 CDT Position: +037 378183° / -080 327455° (+466.2ft) Altitude: 2330ft (+55.91ft) Datum: WGS-84 Azimuth/Bearing: 100° S11E, 3800mils True (+18°) Elevation Angle: +16.0° Horizon Angle: +01.3° Zoom: 1.0X Star: 11942+00- Karst ECD's</small></p>

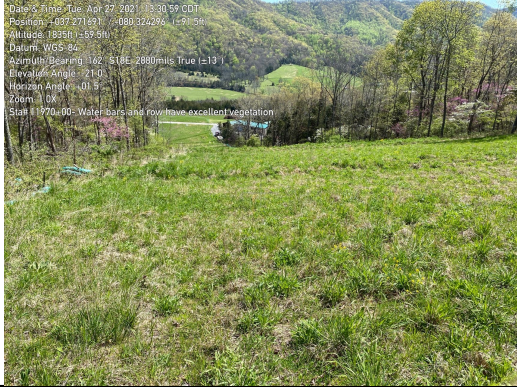
GPS Location	See photo GPS	GPS Location	See photo GPS		
Field Station#	11970+00	Field Station#	11977+00		
Pic 9 Desc.	Water bars and row have excellent vegetation.	Pic 10 Desc.	Karst ECD's and signage.		
<p><small>Date & Time: Tue, Apr 27, 2021, 13:41:55 CDT Position: +037 265745° / -080 321573° (+5220.6ft) Altitude: 1631ft (+55.91ft) Datum: WGS-84 Azimuth/Bearing: 139° S41E, 2471mils True (+13°) Elevation Angle: +12.3° Horizon Angle: +02.1° Zoom: 1.0X Star: 11986+00- Drainage feature with pyramid dikes.</small></p>  		<p><small>Date & Time: Tue, Apr 27, 2021, 13:44:58 CDT Position: +037 268490° / -080 320590° (+4151.9ft) Altitude: 1635ft (+55.91ft) Datum: WGS-84 Azimuth/Bearing: 021° N21E, 0373mils True (+13°) Elevation Angle: +02.4° Horizon Angle: +01.1° Zoom: 1.0X AR-266.00- Access rd & rock ditch check dams</small></p>

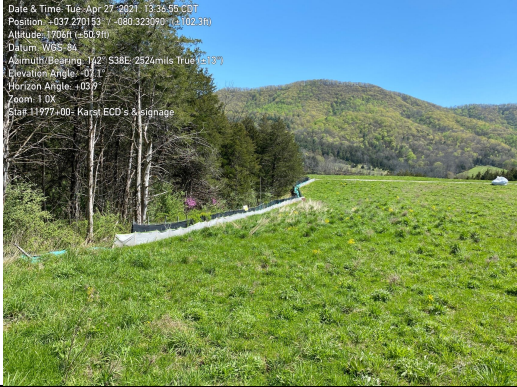
<p><small>Date & Time: Tue, Apr 27, 2021, 13:36:55 CDT Position: +037 270153° / -080 322370° (+4107.3ft) Altitude: 700ft (+55.91ft) Datum: WGS-84 Azimuth/Bearing: 142° S38E, 2524mils True (+13°) Elevation Angle: +01.1° Horizon Angle: +03.9° Zoom: 1.0X Star: 11977+00- Karst ECD's & signage</small></p>

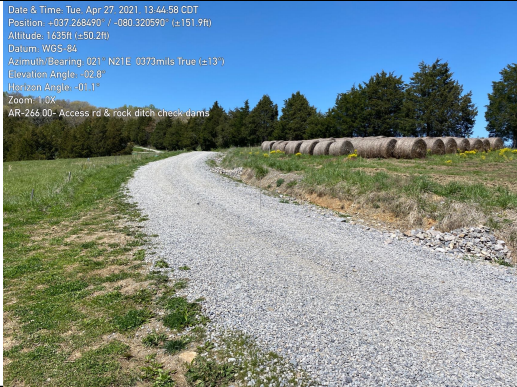
Pic 11 Desc.	Drainage feature with pyramid dikes.	Pic 12 Desc.	AR-266.00- Access road & rock ditch check dams.

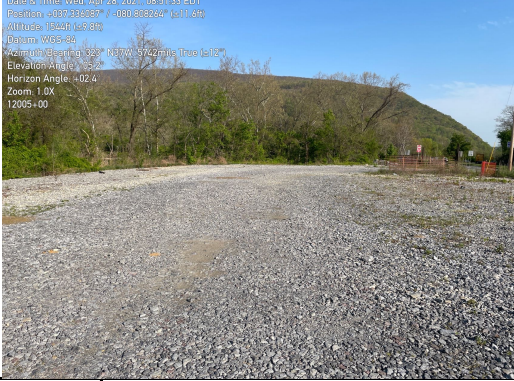
<p>Date & Time: Wed Apr 28, 2021 08:14:51 EDT Position: +037.334325° / -080.893167° lat/long Altitude: 1553ft lat/long Datum: WGS-84 Azimuth/Bearing: 133° SNE 3300mils True (s12°) Elevation Angle: -03.1° Horizon Angle: -02.4° Zoom: 1.0X 12005+00</p>			
GPS Location	See photo		GPS Location	See photo	
Field Station#	12005+00		Field Station#	12005+00	
Pic 1 Desc.	RCE in place		Pic 2 Desc.	Secondary containments in place

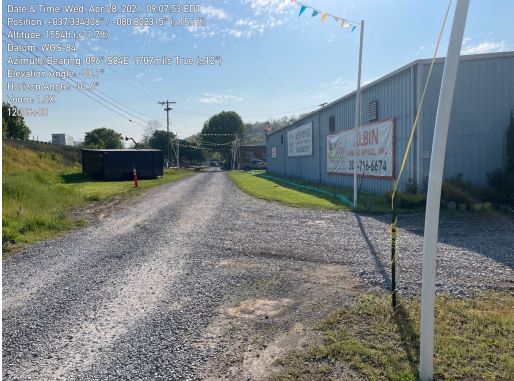
GPS Location	See photo		GPS Location	See photo	
Field Station#	12005+00		Field Station#	12005+00	
Pic 3 Desc.	ECDs in place		Pic 4 Desc.	Containments in place

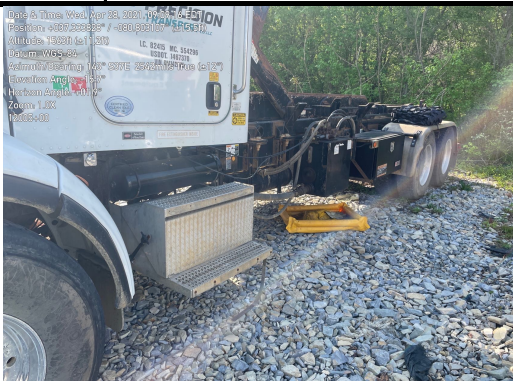
<p>Date & Time: Wed Apr 28, 2021 09:08:55 EDT Position: +037.334325° / -080.893167° lat/long Altitude: 1553ft lat/long Datum: WGS-84 Azimuth/Bearing: 114° SNE 3300mils True (s12°) Elevation Angle: -02.4° Horizon Angle: -00.1° Zoom: 1.0X 12005+00</p>			
GPS Location	See photo		GPS Location	See photo	
Field Station#	12005+00		Field Station#	12005+00	
Pic 5 Desc.	Waste management containers in place		Pic 6 Desc.	Containment in place

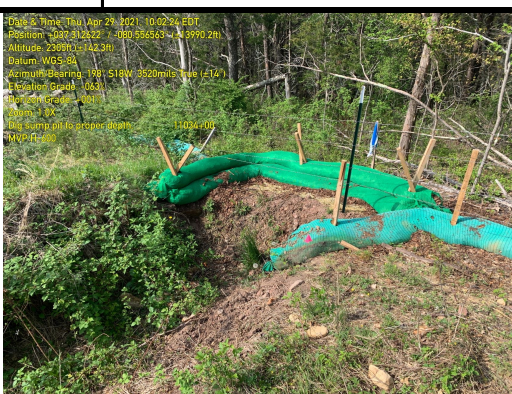
<p>Date & Time: Thu, Apr 29, 2021, 10:02:26 EDT Position: 4071.512329, -88.550459 (e=25.8ft) Altitude: 2309ft (e=72.3m) Datum: WGS-84 Azimuth Bearing: 212.532W 3769mils True (e=14.1) Elevation Grade: -037 Horizontal Grade: -003 Zoom: 1.0X Scale: 1:1000 Install and treatment: MVP H-606</p>			
GPS Location	See photo		GPS Location	See photo	
Field Station#	11003+60		Field Station#	11019+46	
Pic 1 Desc.	Install to spec water bar end treatment.		Pic 2 Desc.	Remove old CFS j-hook and extend CFS 12" perimeter control to CWDB. eliminate the potential for water to run back onto ROW.

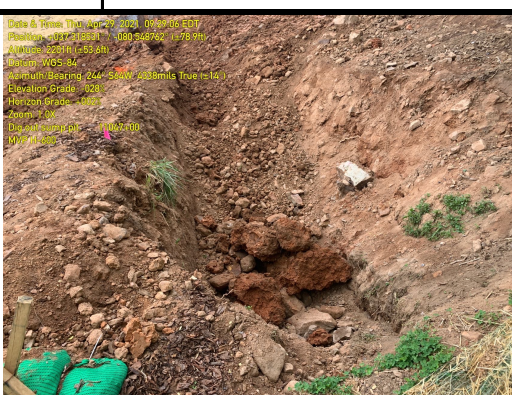
<p>Date & Time: Thu, Apr 29, 2021, 10:02:26 EDT Position: 4071.512329, -88.550459 (e=25.8ft) Altitude: 2309ft (e=72.3m) Datum: WGS-84 Azimuth Bearing: 212.532W 3769mils True (e=14.1) Elevation Grade: -037 Horizontal Grade: -003 Zoom: 1.0X Scale: 1:1000 Install and treatment: MVP H-606</p>			
GPS Location	See photo		GPS Location	See photo	
Field Station#	11034+00		Field Station#	11041+00	
Pic 3 Desc.	Dig sump pit to proper depth.		Pic 4 Desc.	Low area on CFS triple stack end treatment would get caught by perimeter CFS and not discharged off LOD.

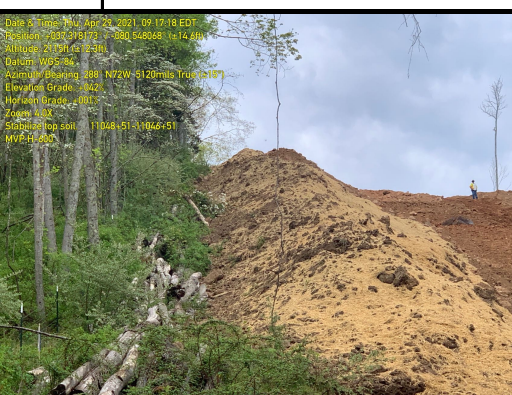
GPS Location	See photo		GPS Location	See photo	
Field Station#	11047+00		Field Station#	11048+51	
Pic 5 Desc.	Remove dirt clogs from sump pit.		Pic 6 Desc.	Stabilize top soil stockpile. Mulch is sparse.

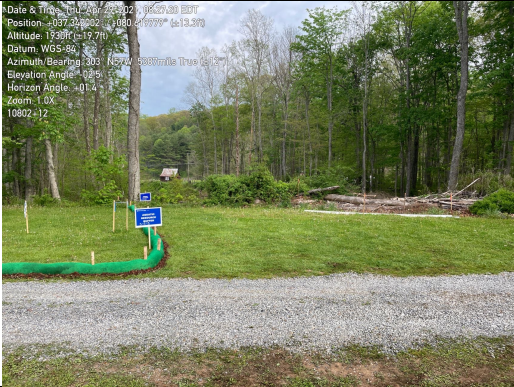
<p>Date & Time: Thu Apr 29, 2021, 05:45:00 EDT Position: 43° 23' 00" N / -80° 07' 00" W (-81.270) Altitude: 1930 ft (588.3 m) Datum: WGS-84 Azimuth/Bearing: 303° 30' 00" (330°) (true) (s15°) Elevation Angle: -05.5° Horizon Angle: +01.4° Zoom: 1.0X 10819+08</p>		GPS Location	See photo
Field Station#	10802+12	Field Station#	10819+08	GPS Location	See photo
Pic 1 Desc.	End of disturbance	Pic 2 Desc.	AR-241.03 under construction

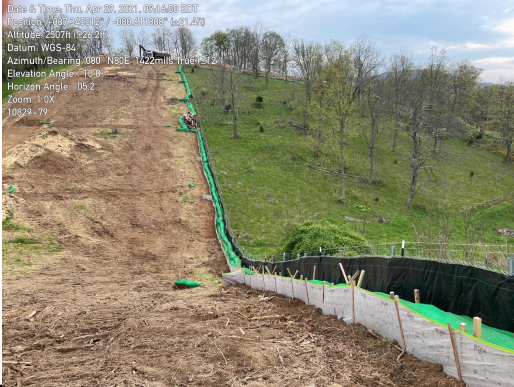
Field Station#	10829+79	Field Station#	10845+47	GPS Location	See photo
Pic 3 Desc.	Triple protection in place at karst	Pic 4 Desc.	Orange safety fence around tower buffer

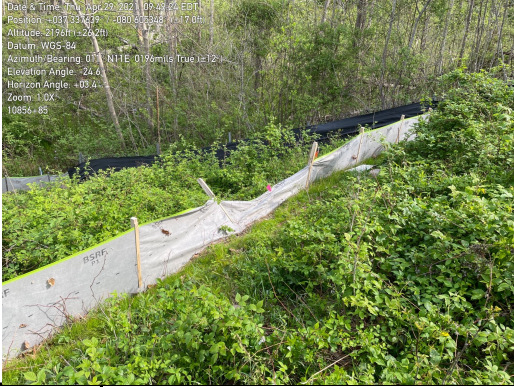
<p>Date & Time: Thu Apr 29, 2021, 05:45:00 EDT Position: 43° 23' 00" N / -80° 07' 00" W (-81.270) Altitude: 2170 ft (661.2 m) Datum: WGS-84 Azimuth/Bearing: 321° 30' 00" (341°) (true) (s15°) Elevation Angle: -24.6° Horizon Angle: +03.4° Zoom: 1.0X 10864+50</p>		GPS Location	See photo
Field Station#	10856+85	Field Station#	10864+50	GPS Location	See photo
Pic 5 Desc.	P1 damaged by wildlife	Pic 6 Desc.	Supersilt perimeter control in place

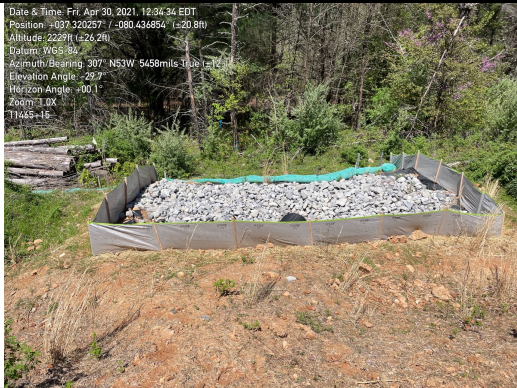
GPS Location		See photo		GPS Location	
Field Station#		11465+15		Field Station#	
Pic 9 Desc.		Plunge pool in place		Pic 10 Desc.	
<p>Date & Time: Fri, Apr 30, 2021, 12:50:00 EDT Position: -037.323644 / -080.426385 (-122.8ft) Altitude: 2231ft (+39.4ft) Datum: WGS-84 Azimuth/Bearing: 050° N56E 5398mils True (+12°) Elevation Angle: -06.4° Horizon Angle: -00.0° Zoom: 1.0X 11483+50</p>

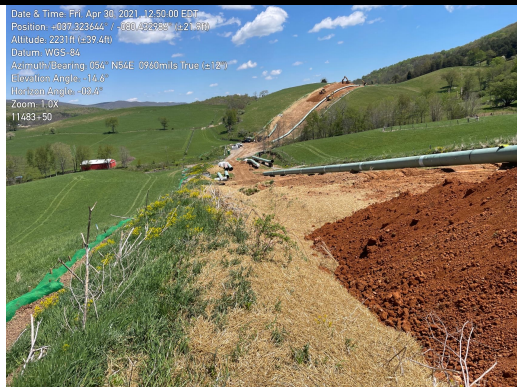
GPS Location		See photo		GPS Location	
Field Station#		11483+50		Field Station#	
Pic 11 Desc.		6" mulch buffer on top soil in place		Pic 12 Desc.

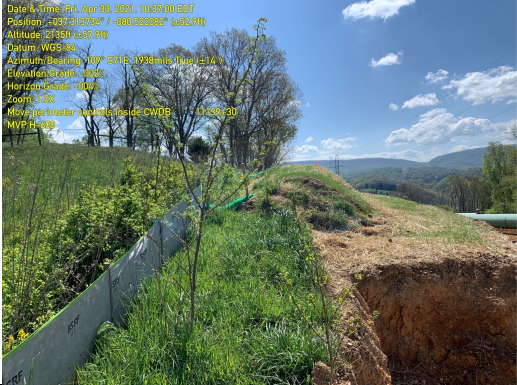
GPS Location	See photo	GPS Location	See photo		
Field Station#	11149+30	Field Station#	11148+00		
Pic 7 Desc.	Divert water off LOD from clean water diversion berm.	Pic 8 Desc.	Stabilize sub soil stockpile.		
<small> Date & Time: Fri Apr 30 2021 12:50:00 EDT Position: -93° 31'48.68" / -90° 49'23.68" (±57.50ft) Altitude: 1133ft (±38.8ft) Datum: WGS-84 Azimuth Bearing: 026° N26E 1042mils True (±15°) Elevation Grade: -013° Horizon Grade: -008° Zoom: 1.0X VA SWPPP INSPECTION MVP H-100 </small>

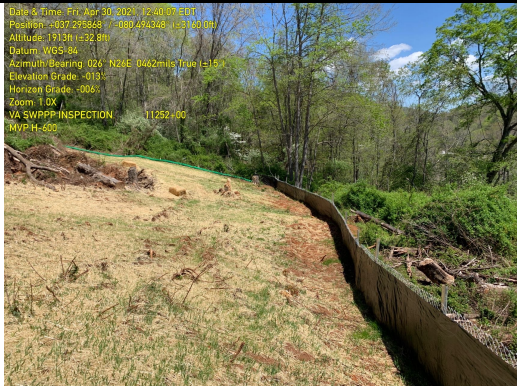
GPS Location	See photo	GPS Location			
Field Station#	11152+00	Field Station#			
Pic 9 Desc.	VA SWPPP INSPECTION.	Pic 10 Desc.			
Insert image here		Insert image here			
GPS Location		GPS Location			
Field Station#		Field Station#			
Pic 11 Desc.		Pic 12 Desc.
