Visual Site Inspection Report

Project Name H-600 Pipeline Spread G		AFE 124300137	Spread H-600 Pipeline Spread G
Contractor Precision		Report # 21906	
Inspector Len Kruizenga		Date/Time 4/5/2021 12:46 PM	
Permit # TBD	Inspection Type VA SWPP	Station Begin 11788+53	
State VA	Inspection Area Full	Station End 12005+00	
County Montgomery	Ground Dry	Temperature (°F) 61.00	
Municipality N/A	Weather Sunny	Rain Gauge (in) 0.00	
			Rain Accumulation Time (days) 1.00

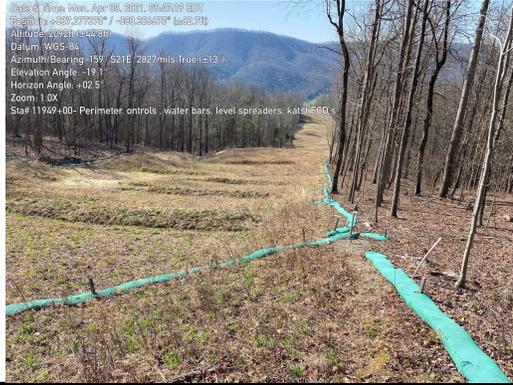
<p><small>Date & Time: Mon, Apr 05, 2021, 09:47:09 EDT Position: +37.231635° / -80.334331° (-29.47ft) Altitude: 2242ft (-68.31ft) Datum: WGS-84 Azimuth Bearing: 159.521E, 2827mils True (+13°) Elevation Angle: -19.1° Horizon Angle: +02.5° Zoom: 1.0X Staff: 11949+00- Perimeter controls, water bars, level spreaders, karst ECD's</small></p>

Field Station#	11949+00	Field Station#	11977+00
Pic 11 Desc.	Perimeter controls, water bars, level spreaders, karst ECD's.	Pic 12 Desc.	Karst ECD's & signage

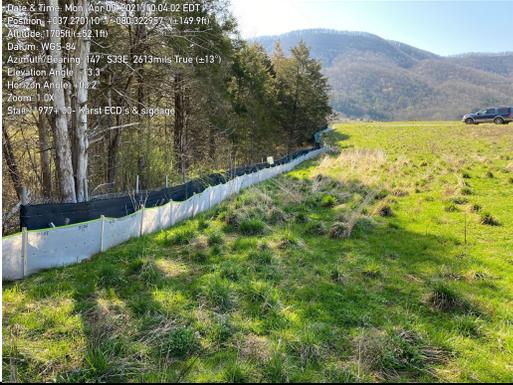
<p><small>Date & Time: Mon, Apr 05, 2021, 10:04:02 EDT Position: +37.270110° / -80.322327° (-149.9ft) Altitude: 1735ft (-52.1ft) Datum: WGS-84 Azimuth Bearing: 167° S33E, 2613mils True (+13°) Elevation Angle: -13.7° Horizon Angle: +15.2° Zoom: 1.0X Staff: 11977+00- Karst ECD's & signage</small></p>	
GPS Location	See photo GPS	GPS Location	See photo GPS

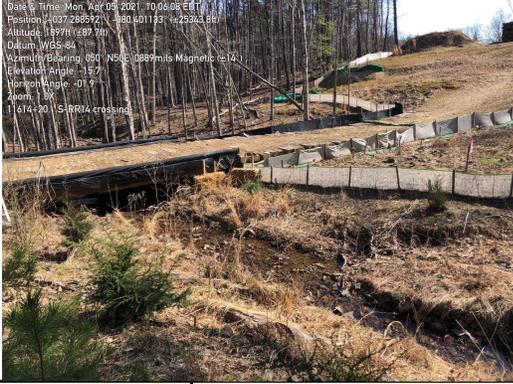
GPS Location	On photo		GPS Location	On photo	
Field Station#	11626+04		Field Station#	11614+20	
Pic 7 Desc.	S-HH18 crossing stable with ECDs in place.		Pic 8 Desc.	S-RR14 crossing stable with ECDs in place.

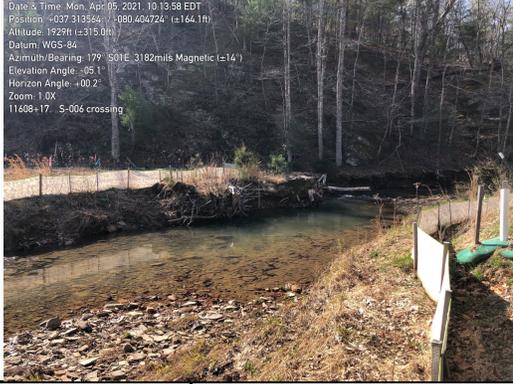
Insert image here		
GPS Location	On photo		GPS Location		
Field Station#	11608+17		Field Station#		
Pic 9 Desc.	S-006 crossing stable with ECDs in place.		Pic 10 Desc.		
Insert image here			Insert image here		
GPS Location			GPS Location		
Field Station#			Field Station#		
Pic 11 Desc.			Pic 12 Desc.

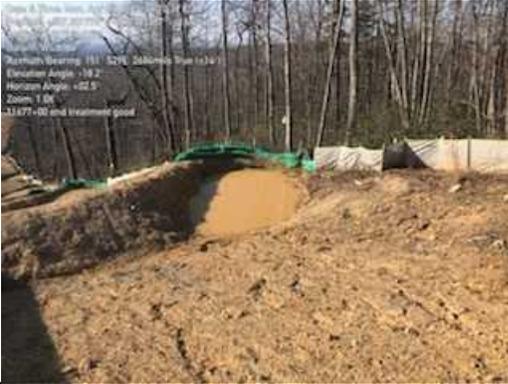
GPS Location see photo		GPS Location see photo			
Field Station# 11677+00		Field Station# 11675+00			
Pic 3 Desc. installed sump and end treatment		Pic 4 Desc. installed sump and end treatment			
Insert image here		Insert image here			
GPS Location see photo		GPS Location see photo			
Field Station#		Field Station#			
Pic 5 Desc.		Pic 6 Desc.

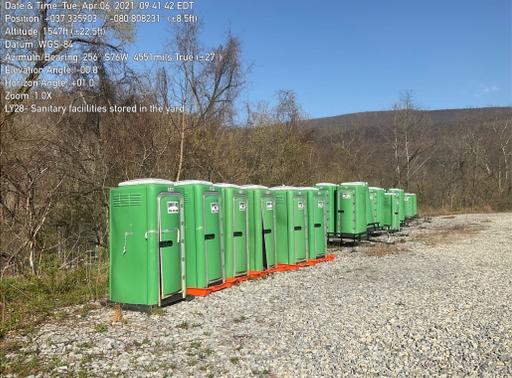
<p><small>Date & Time: Tue, Apr 06, 2021, 09:41:42 EDT Position: +037 334001 / -080 803041 (+8.51ft) Altitude: 15671 (+21.1ft) Datum: WGS 84 Azimuth Bearing: 256.526W 4051mils True (+27) Elevation Angle: +00.8 Horizon Angle: +00.8 Zoom: 1.0X LY28- Sanitary facilities stored in the yard.</small></p>		
GPS Location	See photo GPS	GPS Location	See photo GPS	
Field Station#	12005+00	Field Station#	12005+00	
Pic 1 Desc.	LY28- Secondary containment under transport buses.		Pic 2 Desc.	LY28- Sanitary facilities stored in the yard.

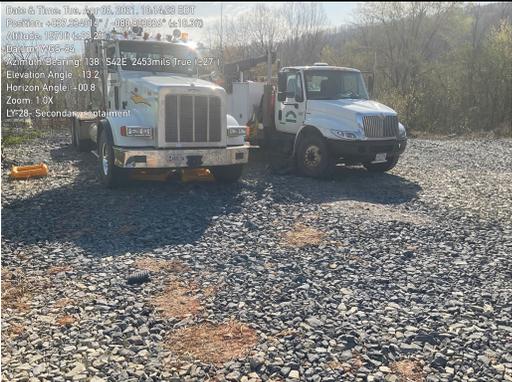
<p><small>Date & Time: Tue, Apr 06, 2021, 10:14:35 EDT Position: +037 334001 / -080 803041 (+8.51ft) Altitude: 15671 (+21.1ft) Datum: WGS 84 Azimuth Bearing: 132.542E 2453mils True (+27) Elevation Angle: +00.8 Horizon Angle: +00.8 Zoom: 1.0X LY28- Secondary containment.</small></p>

<p><small>Date & Time: Tue, Apr 06, 2021, 10:15:00 EDT Position: +037 334001 / -080 803041 (+8.51ft) Altitude: 15688 (+21.1ft) Datum: WGS 84 Azimuth Bearing: 216.536W 3840mils True (+20) Elevation Angle: +01.4 Horizon Angle: +00.8 Zoom: 1.0X LY28- Trucks & trailer storage.</small></p>		
GPS Location	See photo GPS	GPS Location	See photo GPS	
Field Station#	12005+00	Field Station#	12005+00	
Pic 3 Desc.	LY-28- Secondary containment under truck.		Pic 4 Desc.	LY-28- Truck and trailer storage yard.

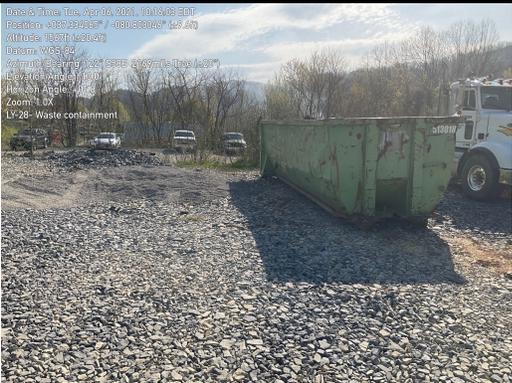
<p><small>Date & Time: Tue, Apr 06, 2021, 10:16:03 EDT Position: +037 334001 / -080 803041 (+8.51ft) Altitude: 15671 (+21.1ft) Datum: WGS 84 Azimuth Bearing: 132.542E 2453mils True (+27) Elevation Angle: +00.8 Horizon Angle: +00.8 Zoom: 1.0X LY28- Waste containment.</small></p>

GPS Location	See photo GPS	GPS Location	See photo GPS	
Field Station#	12005+00	Field Station#	12005+00	
Pic 5 Desc.	LY28- waste containment.		Pic 6 Desc.	LY28- CFS perimeter controls.

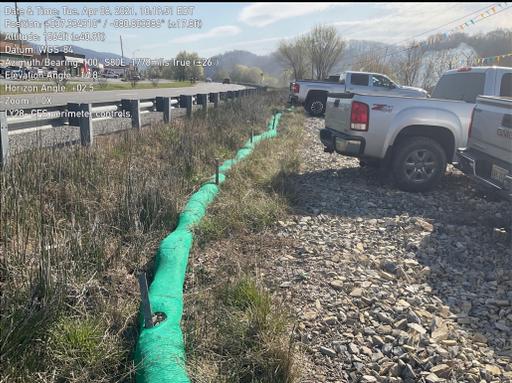
<p><small>Date & Time: Tue, Apr 06, 2021, 10:17:01 EDT Position: +037 334001 / -080 803041 (+8.51ft) Altitude: 15641 (+20.8ft) Datum: WGS 84 Azimuth Bearing: 100.568E 1770mils True (+26) Elevation Angle: +00.8 Horizon Angle: +00.8 Zoom: 1.0X LY28- CFS perimeter controls.</small></p>

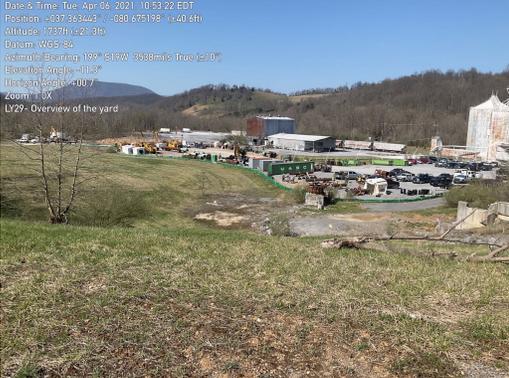
<p><small>Date & Time: Tue Apr 06 2021 10:53:22 EDT Position: +037.363112 / -080.676193 / 1540.6ft Altitude: 1537ft (L=21.3ft) Datum: WGS 84 Azimuth Bearing: 189° S16W 3688mils True (±10°) Elevation Angle: -11.3° Horizon Angle: -100.7° Zoom: 1.0X LY29- Overview of the yard.</small></p>		
GPS Location	See photo GPS	GPS Location	See photo GPS	
Field Station#	12005+00	Field Station#	12005+00	
Pic 1 Desc.	AR-238.00- Access road and RCE serving LY-29		Pic 2 Desc.	LY29- overview of the yard.

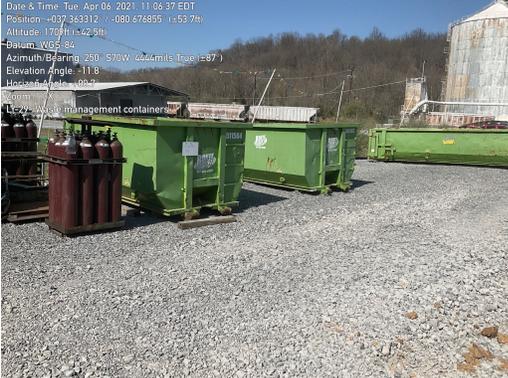
<p><small>Date & Time: Tue Apr 06 2021 11:04:37 EDT Position: +037.363112 / -080.676859 / 1563.7m Altitude: 1795ft (L=42.5ft) Datum: WGS 84 Azimuth Bearing: 250.570W 4444mils True (±10°) Elevation Angle: -11.8° Horizon Angle: -09.2° Zoom: 1.0X LY29- Waste management containers.</small></p>

GPS Location	See photo GPS	GPS Location	See photo GPS	
Field Station#	12005+00	Field Station#	12005+00	
Pic 3 Desc.	LY29- Waste containers		Pic 4 Desc.	CFS triple stack perimeter controls.

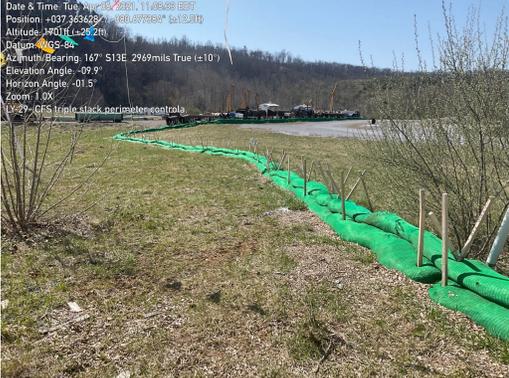
<p><small>Date & Time: Tue Apr 06 2021 11:05:58 EDT Position: +037.3636232 / -080.677288° (±13.8ft) Altitude: 1701ft (L=26.2ft) Datum: WGS 84 Azimuth Bearing: 167° S19E 2969mils True (±10°) Elevation Angle: -09.9° Horizon Angle: -01.5° Zoom: 1.0X LY29- CFS triple stack perimeter controls.</small></p>

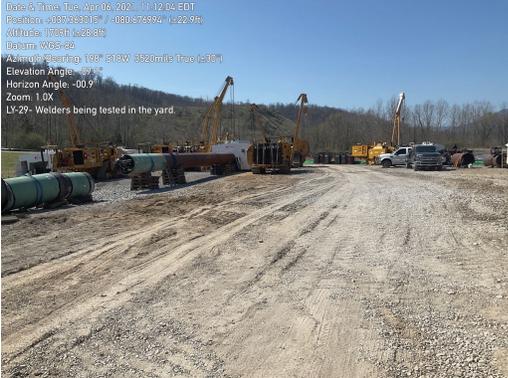
<p><small>Date & Time: Tue Apr 06 2021 11:12:04 EDT Position: +037.363112 / -080.676994 / 1522.9m Altitude: 1693ft (L=28.3ft) Datum: WGS 84 Azimuth Bearing: 193° S18W 3533mils True (±10°) Elevation Angle: -09.7° Horizon Angle: -00.9° Zoom: 1.0X LY29- Welders being tested in the yard.</small></p>

<p><small>Date & Time: Tue Apr 06 2021 11:13:46 EDT Position: +037.362255 / -080.677204 / 1510.6ft Altitude: 1504ft (L=26.7ft) Datum: WGS 84 Azimuth Bearing: 84° N11W 4200mils True (±10°) Elevation Angle: -12.0° Horizon Angle: -05.3° Zoom: 1.0X LY29- Culvert & drainage feature.</small></p>		
GPS Location	See photo GPS	GPS Location	See photo GPS	
Field Station#	12005+00	Field Station#	12005+00	
Pic 5 Desc.	LY29-welders and equipment being tested in the yard.		Pic 6 Desc.	LY29- Culvert and drainage feature.

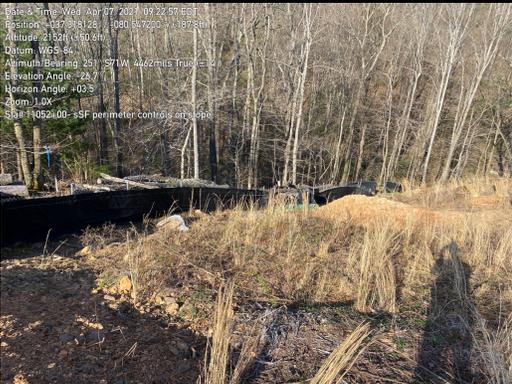
<p>Date & Time: Wed Apr 07 2021 09:22:57 EDT Position: 4877.91126, -880.542201, 1167.566 Altitude: 2150.1 (400 ft) Datum: WGS 84 Azimuth/Bearing: 251.571 W, 44.22 miles True (±12.7) Elevation Angle: -28.7 Horizon Angle: -10.3 Zoom: 1.0X Star: 11052+00 - SSF Perimeter controls, water bars, end treatments.</p>			
GPS Location	See photo GPS	GPS Location	See photo GPS		
Field Station#	11058+00	Field Station#	11052+00		
Pic 1 Desc.	Karst ECD's	Pic 2 Desc.	SSF perimeter controls, water bars, end treatments.

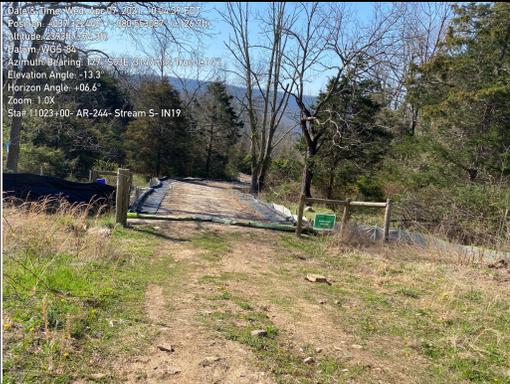
GPS Location	See photo GPS
Field Station#	11023+00
Pic 7 Desc.	AR-244.00- Stream S- IJ19

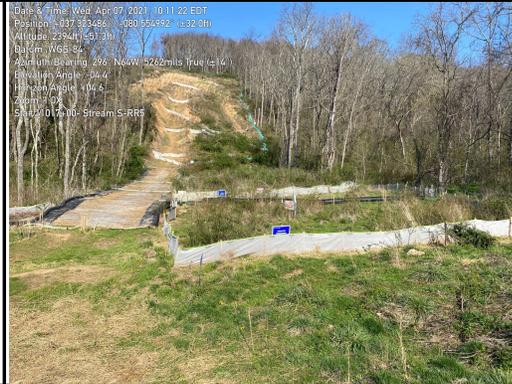
GPS Location	See photo GPS
Field Station#	11017+00
Pic 8 Desc.	Stream S- RR5- Bridge, buffers, signage.

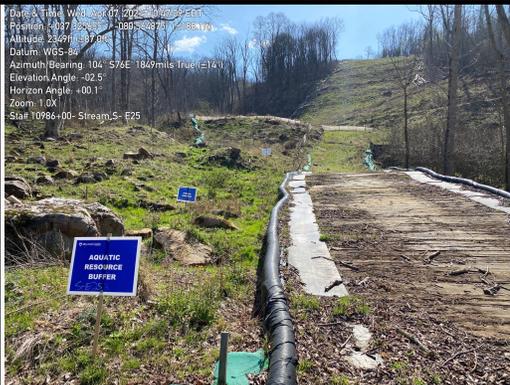
GPS Location	See photo GPS
Field Station#	10986+00
Pic 9 Desc.	Stream S-E25- Signage, buffers, equipment bridge.

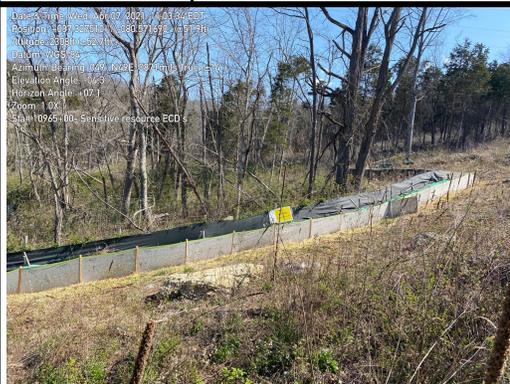
GPS Location	See photo GPS
Field Station#	10965+00
Pic 11 Desc.	Sensitive resource area ECD's.

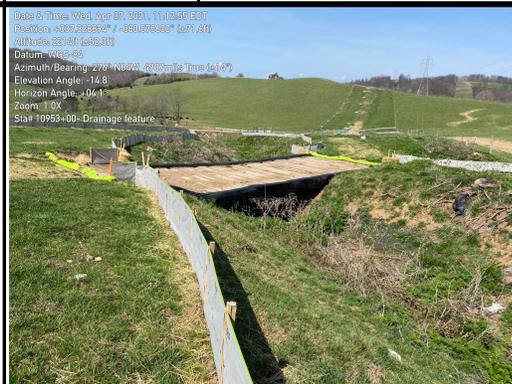
GPS Location	See photo GPS
Field Station#	10953+00
Pic 12 Desc.	Drainage feature and ECD's.

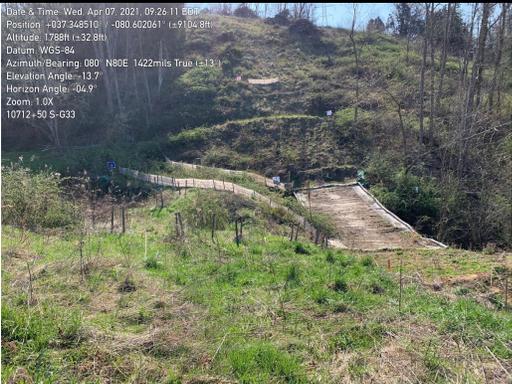
<p>Date & Time: Wed Apr 07 2021 09:26:11 EDT Position: +037 342511N / -080 6022041 W (-91.0430W) Altitude: 1788ft (545.2m) Datum: WGS-84 Azimuth/Bearing: 080 N80E 1422mils True (±13.1°) Elevation Angle: -13.7° Horizon Angle: -04.9° Zoom: 1.0X 10712+50 S-G33</p>

<p>Date & Time: Wed Apr 07 2021 09:26:58 EDT Position: +037 342751N / -080 647802 W (-85.97W) Altitude: 2109ft (642.1m) Datum: WGS-84 Azimuth/Bearing: 265 S85W 4711mils True (±13.1°) Elevation Angle: -03.9° Horizon Angle: -00.7° Zoom: 1.0X 10710+00</p>		
GPS Location	See photo for GPS location.	GPS Location	See photo for GPS location.	
Field Station#	10712+50	Field Station#	10710+00	
Pic 1 Desc.	Sensitive resource buffer in place at stream S-G33.	Pic 2 Desc.	ROW stabilized with natural vegetation growth.

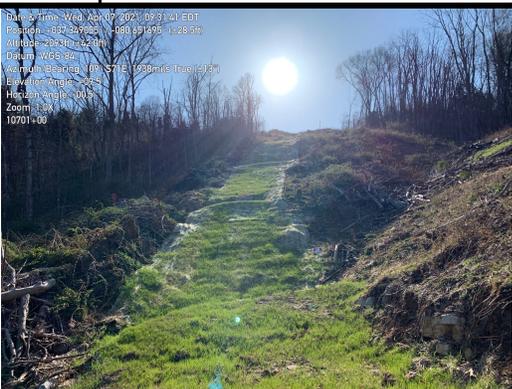
<p>Date & Time: Wed Apr 07 2021 09:31:01 EDT Position: +037 342752N / -080 651495 W (-85.2830W) Altitude: 2053ft (625.9m) Datum: WGS-84 Azimuth/Bearing: 109 S71E 1930mils True (±13.1°) Elevation Angle: -25.5° Horizon Angle: -00.5° Zoom: 1.0X 10701+00</p>

GPS Location	See photo for GPS location.	GPS Location	See photo for GPS location.	
Field Station#	10701+00	Field Station#	10698+00	
Pic 3 Desc.	Steep slope stabilized with ECB and vegetation growth.	Pic 4 Desc.	Sensitive resource buffer in place at stream S-G32.

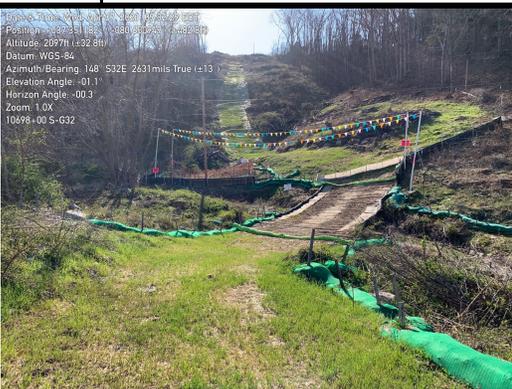
<p>Date & Time: Wed Apr 07 2021 09:31:01 EDT Position: +037 342752N / -080 651495 W (-85.2830W) Altitude: 2097ft (639.2m) Datum: WGS-84 Azimuth/Bearing: 140 S32E 2631mils True (±13.1°) Elevation Angle: -01.1° Horizon Angle: -00.3° Zoom: 1.0X 10698+00 S-G32</p>

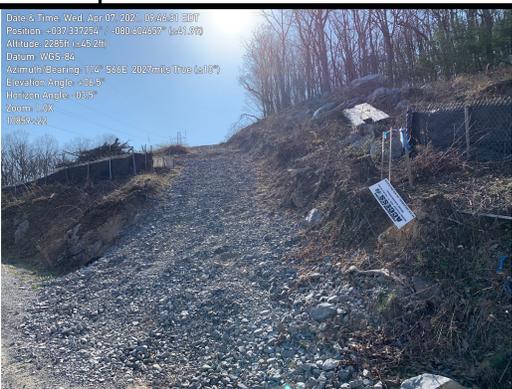
<p>Date & Time: Wed Apr 07 2021 09:36:51 EDT Position: +037 337224N / -080 634857W (-85.9157W) Altitude: 2285ft (696.5m) Datum: WGS-84 Azimuth/Bearing: 114 S53E 2029mils True (±13.1°) Elevation Angle: -33.5° Horizon Angle: -03.5° Zoom: 1.0X 10859+22</p>

Pic 5 Desc.	RCE in place at Kow Camp Road.	Pic 6 Desc.	Waterbar, sump pit and end treatment in place.

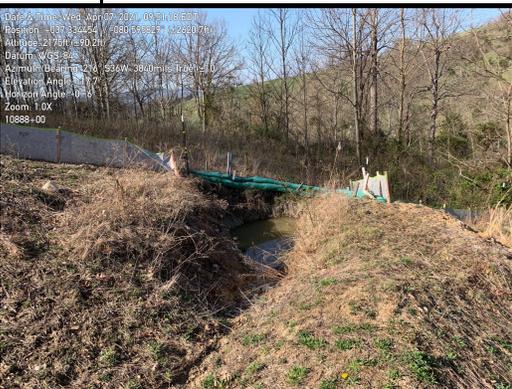
<p>Date & Time: Wed Apr 07 2021 09:37:18 EDT Position: +037 342544N / -080 656857W (-85.9430W) Altitude: 2177ft (663.2m) Datum: WGS-84 Azimuth/Bearing: 224 S26W 3640mils True (±13.1°) Elevation Angle: -03.5° Horizon Angle: -00.3° Zoom: 1.0X 10888+00</p>		
GPS Location	See photo for GPS location.	GPS Location	See photo for GPS location.	
Field Station#	10859+22	Field Station#	10888+00

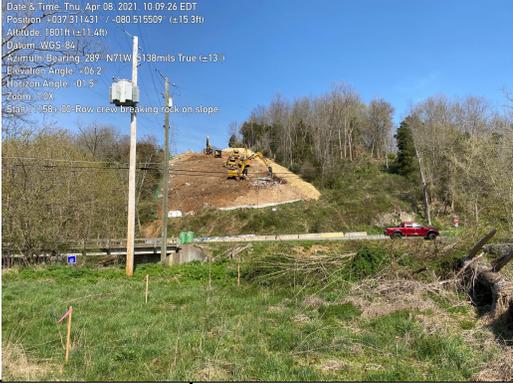
<p><small>Date & Time: Thu, Apr 08, 2021, 10:18:03 EDT Position: +037 339655 / -080 514746 (+52.9ft) Altitude: 1885ft (+35.9ft) Datum: WGS-84 Azimuth Bearing: 332° N28W 5902mils True (+13°) Elevation Angle: +18.1° Horizon Angle: +03.4° Zoom: 1.0X Start: 11170+00-Water bar, slope drain inlet</small></p>

GPS Location	See photo GPS	GPS Location	See photo GPS
Field Station#	11158+00	Field Station#	11170+00
Pic 7 Desc.	Row crew breaking rock on slope.	Pic 8 Desc.	Water bar and slope drain inlet.
<p><small>Date & Time: Thu, Apr 08, 2021, 10:27:47 EDT Position: +037 307241 / -080 511947 (+247.5ft) Altitude: 1329ft (+66.3ft) Datum: WGS-84 Azimuth Bearing: 207° S11E 2966mils True (+13°) Elevation Angle: -27.3° Horizon Angle: +09.7° Zoom: 1.0X Start: 11184+00-Slope drains, CWD Pipe and plunge pool</small></p>

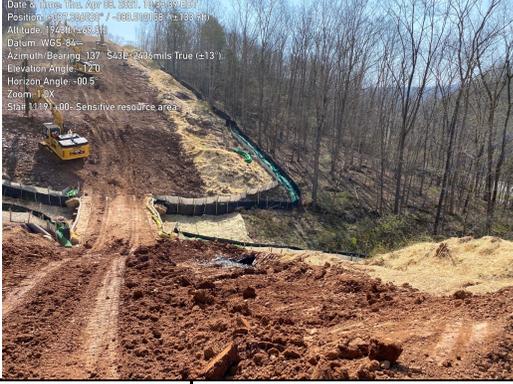
<p><small>Date & Time: Thu, Apr 08, 2021, 10:43:50 EDT Position: +037 309207 / -080 510135 (+130.6ft) Altitude: 1401ft (+69.3ft) Datum: WGS-84 Azimuth Bearing: 137° S42E 2240mils True (+13°) Elevation Angle: -12.0° Horizon Angle: +00.5° Zoom: 1.0X Start: 11191+00-Sensitive resource area</small></p>

GPS Location	See photo GPS	GPS Location	See photo GPS
Field Station#	11184+00	Field Station#	11191+00
Pic 9 Desc.	Slope drains, CWD Pipe and plunge pool.	Pic 10 Desc.	Sensitive resource area
<p><small>Date & Time: Thu, Apr 08, 2021, 11:05:00 EDT Position: +037 301282 / -080 502831 (+104.4ft) Altitude: 2042ft (+54.2ft) Datum: WGS-84 Azimuth Bearing: 163° S17E 2898mils True (+21°) Elevation Angle: +30.4° Horizon Angle: +00.1° Zoom: 1.0X Start: 11225+00-Rock channel</small></p>

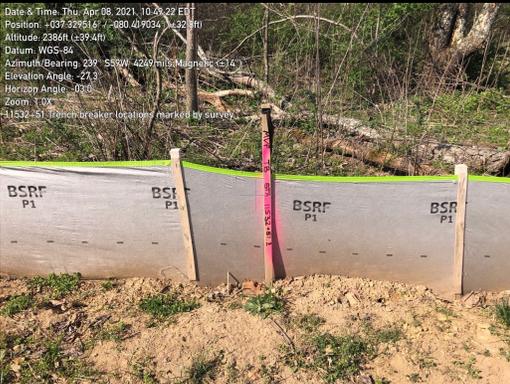
<p><small>Date & Time: Thu, Apr 08, 2021, 10:28:05 EDT Position: +037.327693, -080.417680 (+98.4ft) Altitude: 2557ft (+850ft) Datum: WGS-84 Azimuth (Bearing): 239° 55'W 420mils Magnetic (+14°) Elevation Angle: -21.3° Horizon Angle: -00.0° Zoom: 1.0x 11532+51 trench breaker locations marked by survey.</small></p>

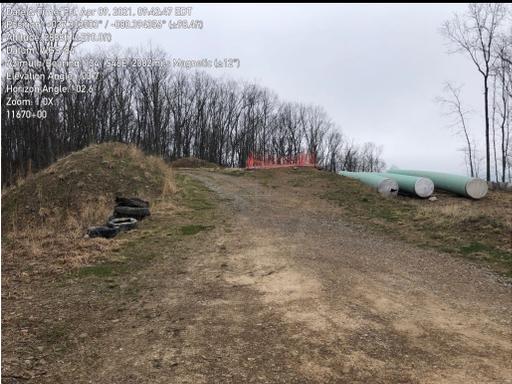
<p><small>Date & Time: Fri, Apr 09, 2021, 09:42:47 EDT Position: +037.395554° / -080.375722° (-16.44) Altitude: 2561ft (-52.8) Datum: WGS-84 Azimuth/Bearing: 001° S10W 3662mils Magnetic (+12°) Elevation Angle: -03.2 Horizon Angle: -03.2 Zoom: 1.0X 11670+00</small></p>

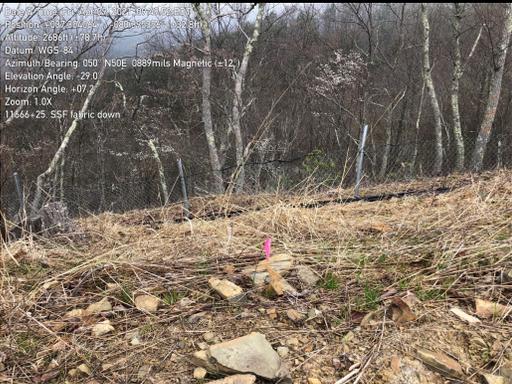
<p><small>Date & Time: Fri, Apr 09, 2021, 10:07:09 EDT Position: +4057.310171° / -4860.377463° (-1298.41) Altitude: 21459ft (-137.3) Datum: WGS-84 Azimuth/Bearing: 199° S10W 3337mils Magnetic (+14°) Elevation Angle: -03.4 Horizon Angle: -03.4 Zoom: 1.0X 11666+25</small></p>		GPS Location	On photo	GPS Location	On photo
Field Station#	11670+00	Field Station#	11666+25	Pic 1 Desc.	Top of Brush Mountain at FS188 crossing. ROW stable.	Pic 2 Desc.	Communication: Fabric to be re-attached to chain link SSF.

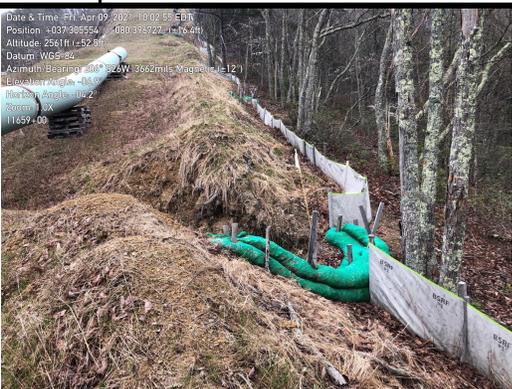
<p><small>Date & Time: Fri, Apr 09, 2021, 10:02:55 EDT Position: +037.395554° / -080.375722° (-16.44) Altitude: 2561ft (-52.8) Datum: WGS-84 Azimuth/Bearing: 001° S10W 3662mils Magnetic (+12°) Elevation Angle: -03.2 Horizon Angle: -03.2 Zoom: 1.0X 11659+00</small></p>

Field Station#	11659+00	Field Station#	11641+00	Pic 3 Desc.	Perimeter controls are in place.	Pic 4 Desc.	Perimeter controls are in place.

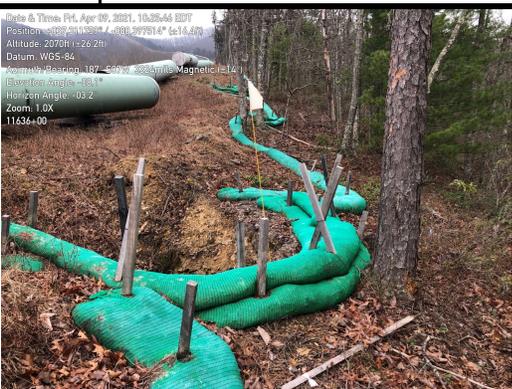
<p><small>Date & Time: Fri, Apr 09, 2021, 10:35:45 EDT Position: +037.395554° / -080.375722° (-16.44) Altitude: 2070ft (-26.2) Datum: WGS-84 Azimuth/Bearing: 187° S01W 3663mils Magnetic (+12°) Elevation Angle: -03.1 Horizon Angle: -03.2 Zoom: 1.0X 11636+00</small></p>

<p><small>Date & Time: Fri, Apr 09, 2021, 10:33:39 EDT Position: +0377.312450° / -080.378204° (-178.41) Altitude: 1935ft (-185.0) Datum: WGS-84 Azimuth/Bearing: 020° N20E 0356mils Magnetic (+12°) Elevation Angle: -35.1 Horizon Angle: 103.9 Zoom: 1.0X 11628+00</small></p>		GPS Location	On photo	GPS Location	On photo
Field Station#	11636+00	Field Station#	11628+00	Pic 5 Desc.	Perimeter controls are in place.	Pic 6 Desc.	Communication: Re-attach fabric to chain link SSF.

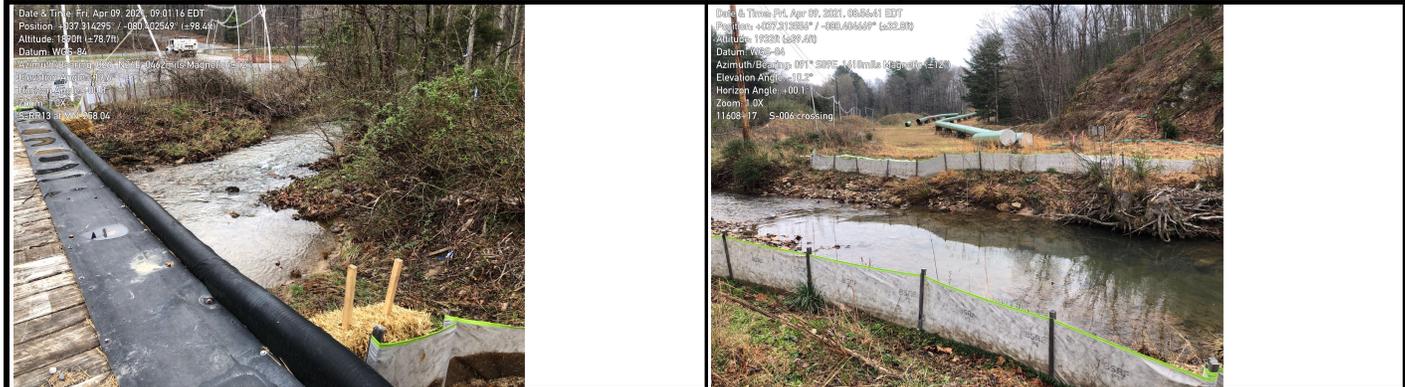
GPS Location	On photo	GPS Location	On photo
Field Station#	11613+69	Field Station#	11608+17
Pic 9 Desc.	The S-RR13 bridge at access road MN-258.04 is stable.	Pic 10 Desc.	The S-006 crossing is stable with ECDs in place.

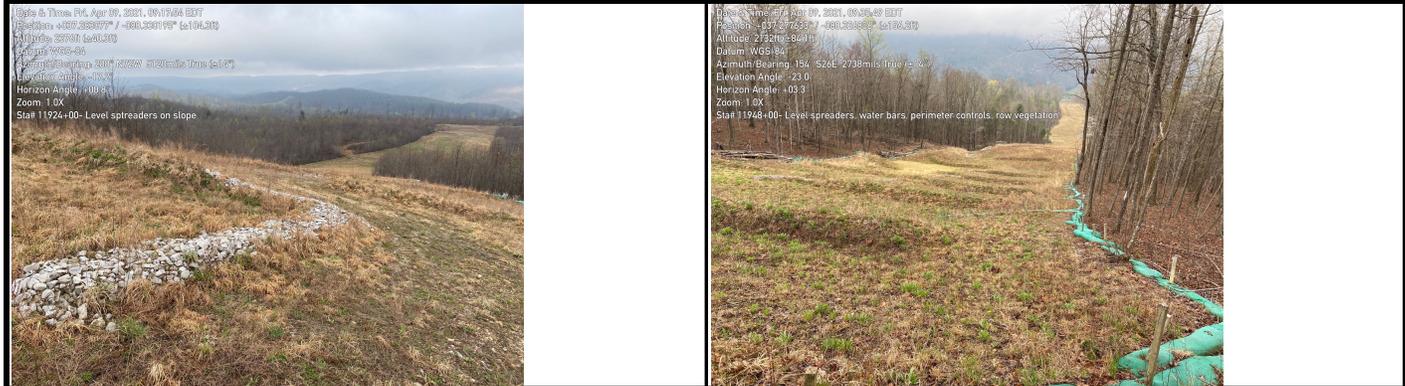
GPS Location	See photo GPS	GPS Location	See photo GPS
Field Station#	11924+00	Field Station#	11958+00
Pic 7 Desc.	Level spreaders on slope.	Pic 8 Desc.	Level spreaders,water bars,perimeter controls,row vegetation.

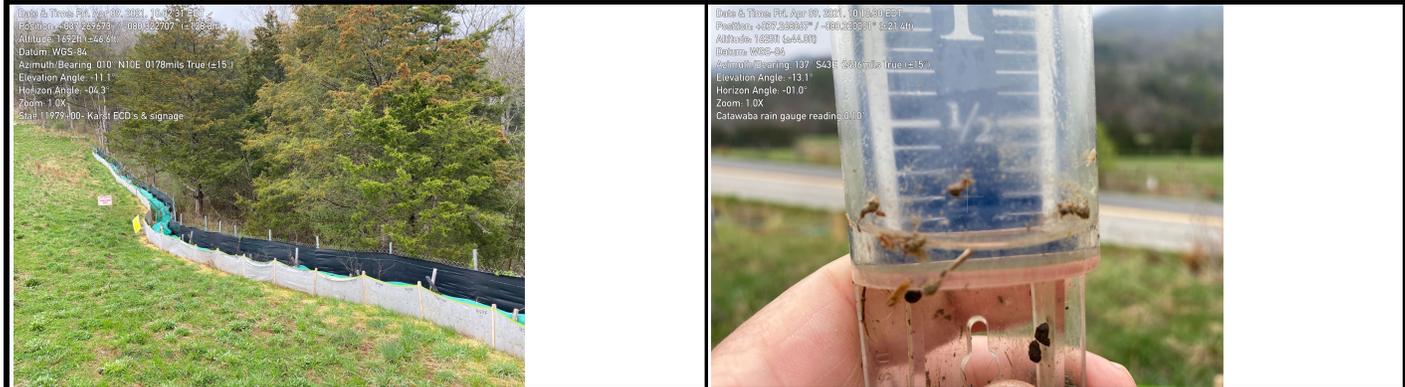
GPS Location	See photo GPS	GPS Location	See photo GPS
Field Station#	11979+00	Field Station#	11989+00
Pic 9 Desc.	Karst's and Karst ECD's and signage.	Pic 10 Desc.	Catawba rain gauge reading- 0.10"

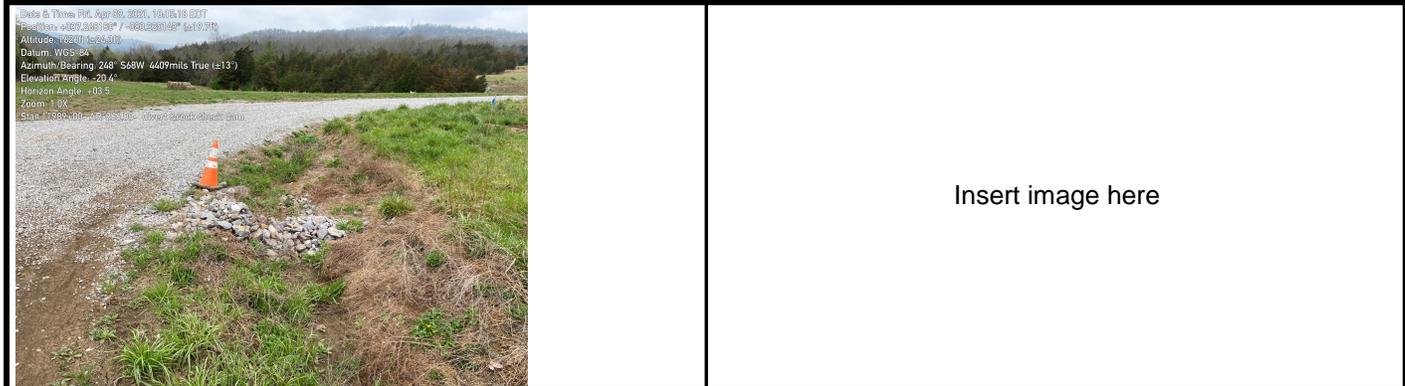
GPS Location	See photo GPS	GPS Location	
Field Station#	11987+00	Field Station#	
Pic 11 Desc.	AR-266.00- Rock check dam and culvert.	Pic 12 Desc.

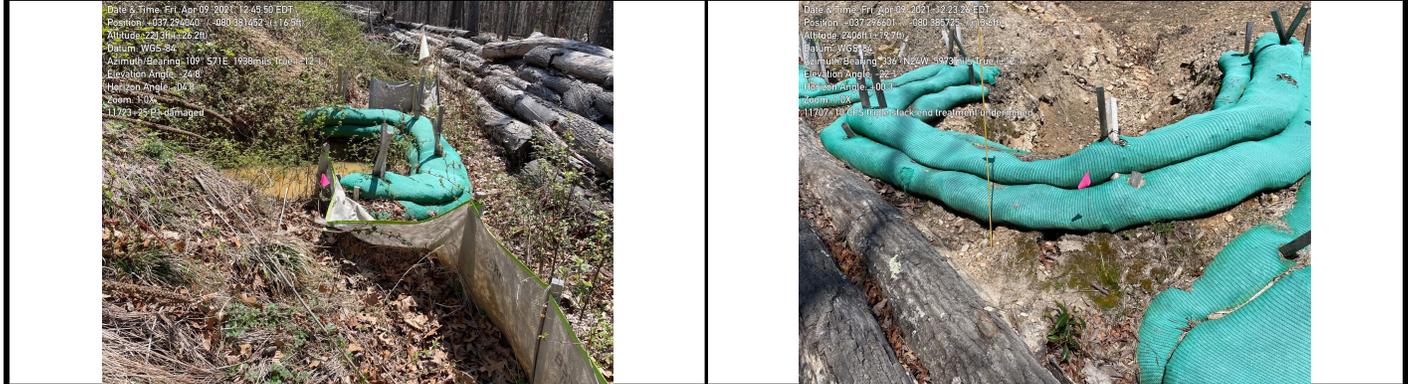
GPS Location	1	GPS Location	2
Field Station#	11723+25	Field Station#	11707+10
Pic 1 Desc.	Damaged P-1	Pic 2 Desc.	Undermined end treatment.

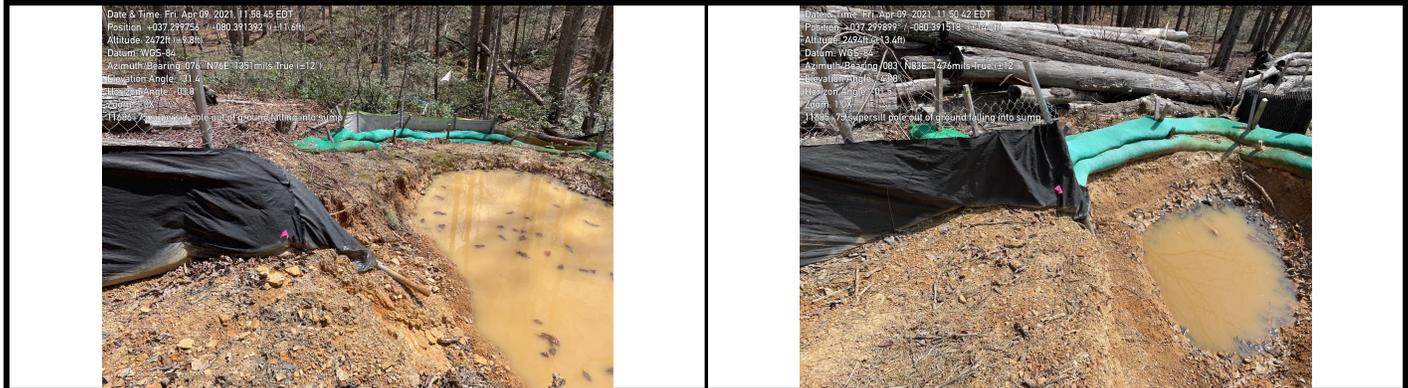
GPS Location	3	GPS Location	4
Field Station#	11686+75	Field Station#	11685+75
Pic 3 Desc.	SSF pipe falling into sump.	Pic 4 Desc.	SSF pipe falling into sump.

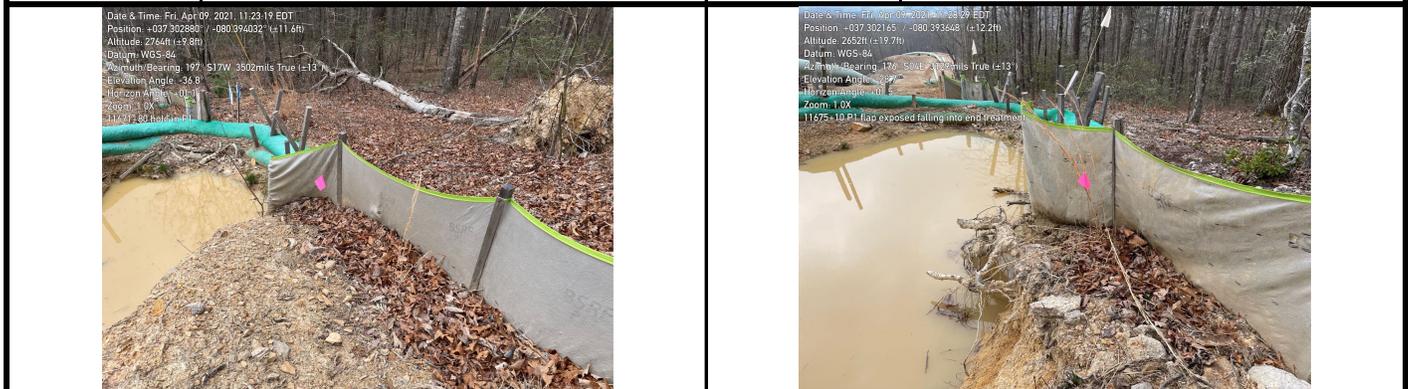
GPS Location	5	GPS Location	6
Field Station#	11671+80	Field Station#	11675+10
Pic 5 Desc.	Hole in P-1.	Pic 6 Desc.	P-1 flap exposed, re-trench.
