# Visual Site Inspection Report

<b>Project Name</b>	H-600 Pipeline Spread G	<b>AFE</b>	124300137	<b>Spread</b>	H-600 Pipeline Spread G
<b>Contractor</b>	Precision			<b>Report #</b>	23196
<b>Inspector</b>	Patrick Shields			<b>Date/Time</b>	5/10/2021 2:05 PM
<b>Permit #</b>	TBD	<b>Inspection Type</b>	VA SWPP	<b>Station Begin</b>	12005+00
<b>State</b>	VA	<b>Inspection Area</b>	Partial	<b>Station End</b>	12005+00
<b>County</b>	Giles	<b>Ground</b>	Damp	<b>Temperature (°F)</b>	60.00
<b>Municipality</b>	N/A	<b>Weather</b>	Cloudy	<b>Rain Gauge (in)</b>	0.15
				<b>Rain Accumulation Time (days)</b>	1.00

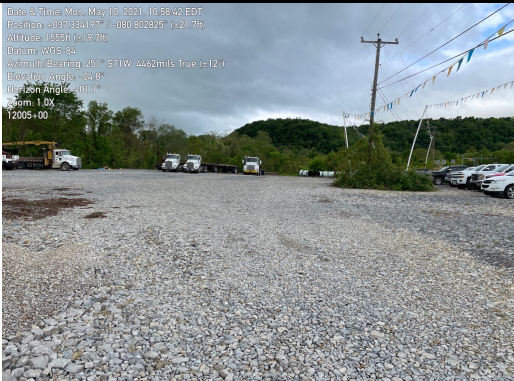
<b>GPS Location</b>	See photo	<b>GPS Location</b>	See photo		
<b>Field Station#</b>	12005+00	<b>Field Station#</b>	12005+00		
<b>Pic 5 Desc.</b>	RCE in place	<b>Pic 6 Desc.</b>	CFS perimeter control in place

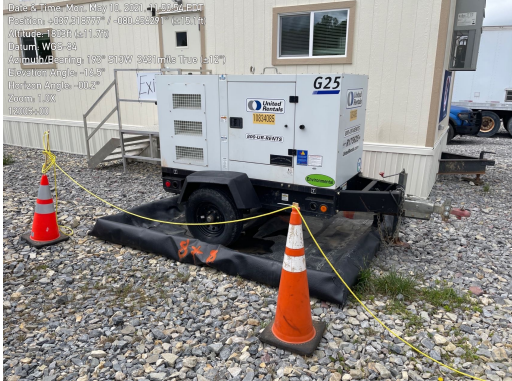
<p>Date &amp; Time: Mon, May 10, 2021, 11:53:29 EDT Position: +377319552° / +800658112° (+15.51) Altitude: 1772ft (+532ft) Datum: WGS-84 Azimuth Bearing: 121° 39'45" 357mils True (+12°) Elevation Angle: -06.7° Horizon Angle: +00.1° Zoom: 1.0X 12005+00</p>			
GPS Location	See photo		GPS Location	See photo	
Field Station#	12005+00		Field Station#	12005+00	
Pic 1 Desc.	Secondary containment in place		Pic 2 Desc.	Employee parking

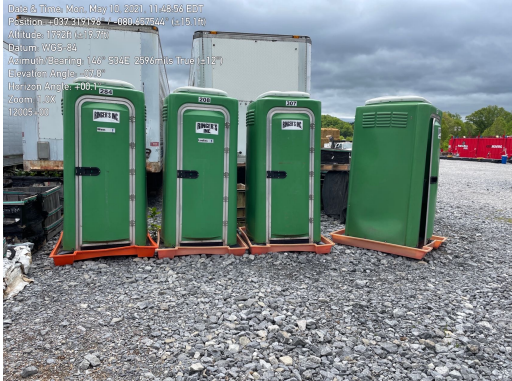
GPS Location	See photo		GPS Location	See photo	
Field Station#	12005+00		Field Station#	12005+00	
Pic 3 Desc.	Secondary containment in place		Pic 4 Desc.	Fuel island in place

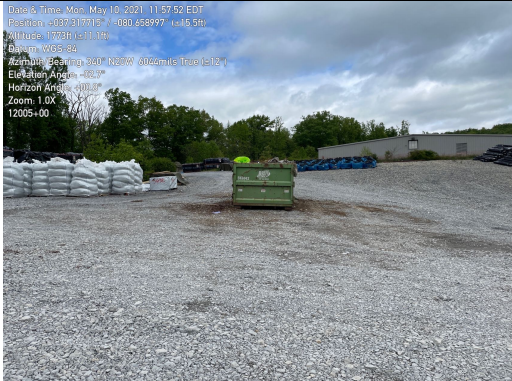
<p>Date &amp; Time: Mon, May 10, 2021, 12:01:45 EDT Position: +377319552° / +800658112° (+15.51) Altitude: 1772ft (+532ft) Datum: WGS-84 Azimuth Bearing: 055° N55E 0978mils True (+12°) Elevation Angle: -07.4° Horizon Angle: +02.4° Zoom: 1.0X 12005+00</p>			
GPS Location	See photo		GPS Location	See photo	
Field Station#	12005+00		Field Station#	12005+00	
Pic 5 Desc.	Dumpster in place		Pic 6 Desc.	CFS perimeter control in place

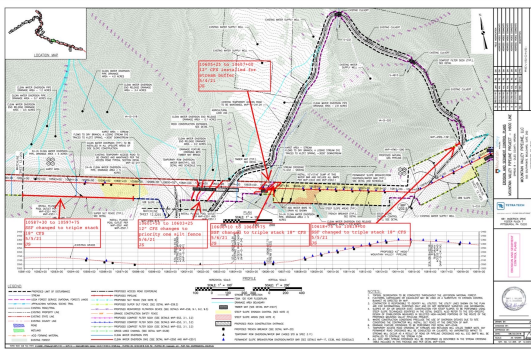
<p>Date &amp; Time: Mon, May 10, 2021, 10:53:51 EDT Position: +037.345221° / -080.610344° (±32.6m) Altitude: 2311ft (±12.7m) Datum: WGS-84 Azimuth/Bearing: 180° 551W 4107mils True (±12°) Elevation Angle: +07.6° Horizon Angle: +94.9° Zoom: 1.0x 10831+00 Jared Saunders</p>			
GPS Location	See photo for GPS location.		GPS Location	See photo for GPS location.	
Field Station#	12005+00		Field Station#	10728+40	
Pic 1 Desc.	Redline drawing.		Pic 2 Desc.	Northern Clearing burn pile.

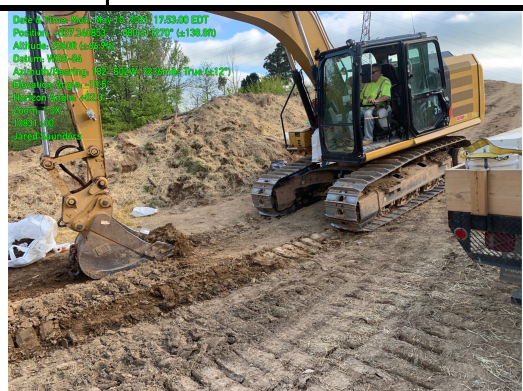
Field Station#	10831+00		Field Station#	10831+00	
Pic 5 Desc.	Excavator removing contaminated soils.		Pic 6 Desc.	Contaminated soils being placed in super sacks to be hauled off.

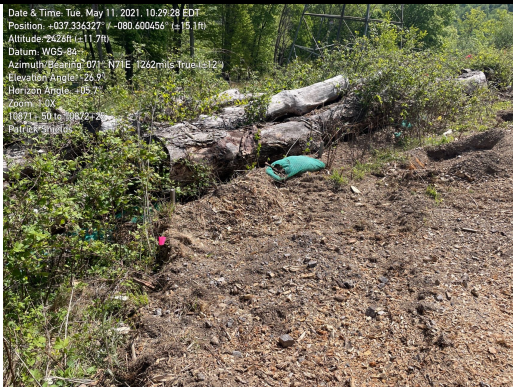
GPS Location		See photo		GPS Location	
Field Station#		10871+50		Field Station#	
Pic 3 Desc.		CFS perimeter control is badly damaged		Pic 4 Desc.	
				CFS triple stack perimeter control is badly damaged	
<p>Date &amp; Time: Tue, May 11, 2021, 09:44:34 EDT Position: -037.355307° -080.658153° (+17.540) Altitude: 2426ft (+11.770) Datum: WGS 84 Azimuth Bearing: 154° S26E 2138/mils True (+12) Elevation Angle: -19.3° Horizon Angle: -00.2° Zoom: 1.0x 10848+00 Patrick Shields</p>

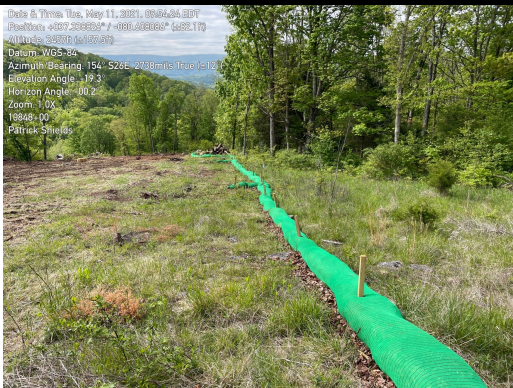
GPS Location		See photo		GPS Location	
Field Station#		10848+00		Field Station#	
Pic 5 Desc.		CFS perimeter control in place		Pic 6 Desc.	
				Buffer in place

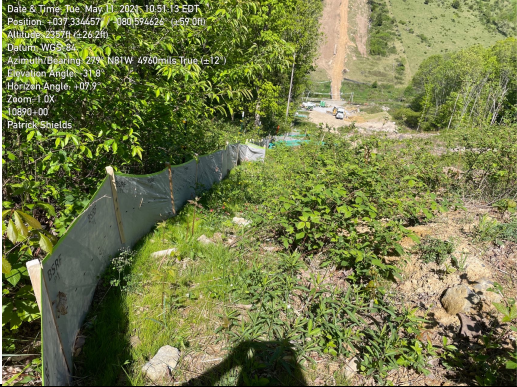
<b>GPS Location</b>	See photo	<b>GPS Location</b>	See photo		
<b>Field Station#</b>	10890+00	<b>Field Station#</b>	10898+00		
<b>Pic 7 Desc.</b>	P1 perimeter control in place	<b>Pic 8 Desc.</b>	Clean water diversion berm is in place and mulched

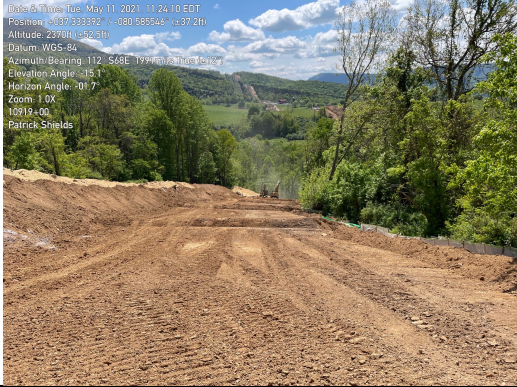
<b>GPS Location</b>	See photo	<b>GPS Location</b>	See photo		
<b>Field Station#</b>	10905+00	<b>Field Station#</b>	10919+00		
<b>Pic 9 Desc.</b>	Topsoil pile has been stabilized	<b>Pic 10 Desc.</b>	Waterbars in place		
<p><small>Date &amp; Time: Tue, May 11, 2021, 13:39:53 EDT Position: +037.347854, -080.643704 (+22.0ft) Altitude: 2346ft (+26.2ft) Datum: WGS-84 Azimuth/Bearing: 150° S26E 2020mils True (+12°) Elevation Angle: -11.4° Horizon Angle: -10.8° Zoom: 1.0X 10725+42 Patrick Shields</small></p>

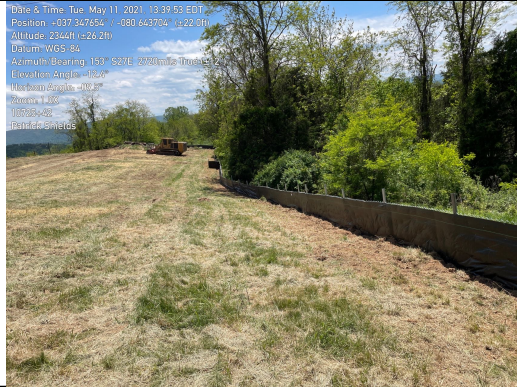
<b>GPS Location</b>	See photo	<b>GPS Location</b>	See photo		
<b>Field Station#</b>	10725+42	<b>Field Station#</b>	10691+46		
<b>Pic 11 Desc.</b>	Supersilt perimeter control in place	<b>Pic 12 Desc.</b>	CFS perimeter control in place

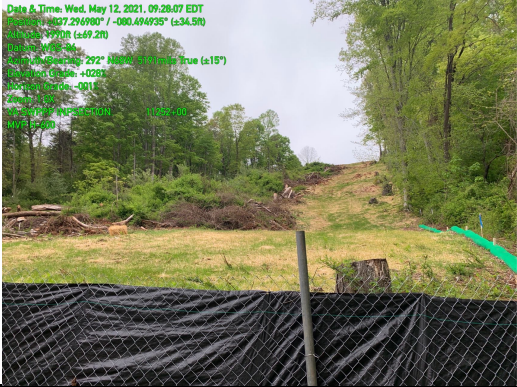
<b>GPS Location</b>	See photo	<b>GPS Location</b>	See photo		
<b>Field Station#</b>	11252+00	<b>Field Station#</b>	11172+58		
<b>Pic 7 Desc.</b>	Check below last ECD placed before buffer on highway 42 and high flood mark.	<b>Pic 8 Desc.</b>	Inspect slope drain and end treatment.

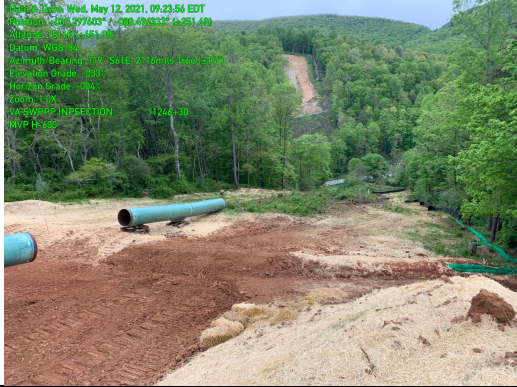
<b>GPS Location</b>	See photo	<b>GPS Location</b>	See photo		
<b>Field Station#</b>	11246+30	<b>Field Station#</b>	11206+00		
<b>Pic 9 Desc.</b>	Inspection of water bar installation. Stabilization of stockpiles with straw mulch. ROW stabilized with no visual erosion.	<b>Pic 10 Desc.</b>	Sensitive resource with orange construction safety fencing.		
<p><small>Date &amp; Time: Wed, May 12, 2021, 09:05:07 EDT Position: +427.307744° / -080.520395° (±56.51.91) Datum: WGS-84 Azimuth/Bearing: 072° N72E 1280mile True (±17°) Elevation Grade: -001% Horizon Grade: +003% Zoom: 1.0X AR249.01 SWPPP INSPECTION 11191+00</small></p>

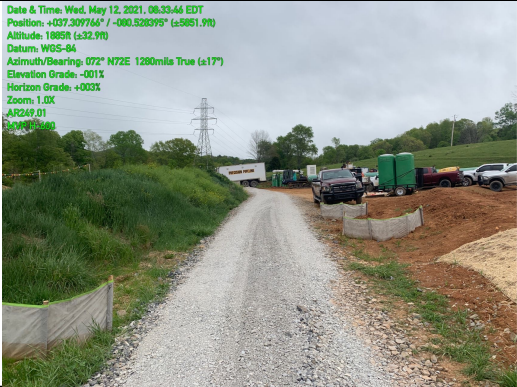
<b>GPS Location</b>	See photo	<b>GPS Location</b>	See photo		
<b>Field Station#</b>	11191+00	<b>Field Station#</b>	11167+83		
<b>Pic 11 Desc.</b>	Previous Punch list item from last SWPP inspection. No issues.	<b>Pic 12 Desc.</b>	AR249.01

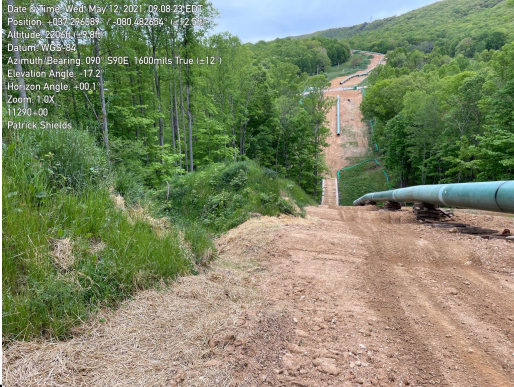
<b>GPS Location</b>	See photo	<b>GPS Location</b>	See photo		
<b>Field Station#</b>	11290+00	<b>Field Station#</b>	11302+00		
<b>Pic 3 Desc.</b>	Waterbars in place	<b>Pic 4 Desc.</b>	Good vegetation on topsoil piles		
<p>Date &amp; Time: Wed May 12, 2021, 09:53:22 EDT  Position: +037.288076° / -080.472708° (±20.5m)  Altitude: 2153ft (±19.4m)  Datum: WGS-84  Azimuth/Bearing: 349° N11W 6204mils True (±17°)  Elevation Angle: -11.3°  Horizon Angle: +02.1°  Zoom: 1.0x  11328+75  Patrick Shields</p>

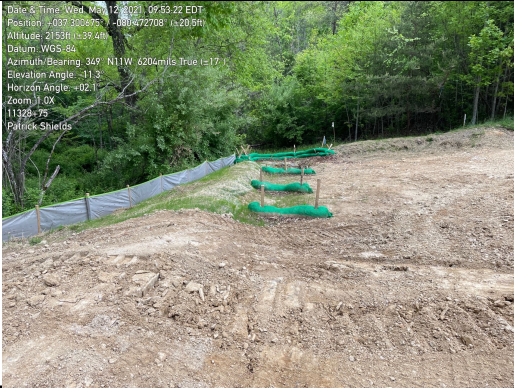
<b>Pic 5 Desc.</b>	CFS checks in place	<b>Pic 6 Desc.</b>	P1 perimeter control in place

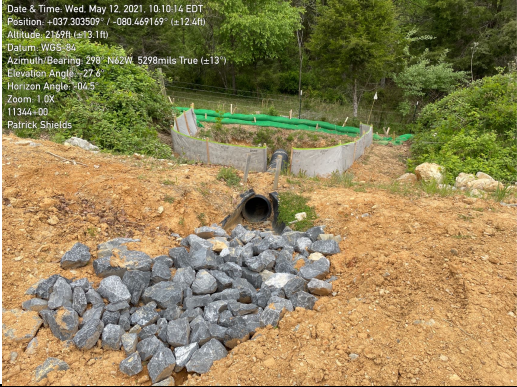
<b>GPS Location</b>	See photo	<b>GPS Location</b>	See photo		
<b>Field Station#</b>	11344+00	<b>Field Station#</b>	11413+00		
<b>Pic 7 Desc.</b>	Rock inlet in place	<b>Pic 8 Desc.</b>	End treatments in place		
<p>Date &amp; Time: Wed, May 12, 2021, 11:54:11 EDT  Position: +037.210861° / -080.466401° (±12.4ft)  Altitude: 2190ft (±13.7ft)  Datum: WGS-84  Azimuth/Bearing: 330° S47W 407ftmils True (±13°)  Elevation Angle: +01.3°  Horizon Angle: +08.0°  Zoom: 1.0X  11432+88  Patrick Shields</p>

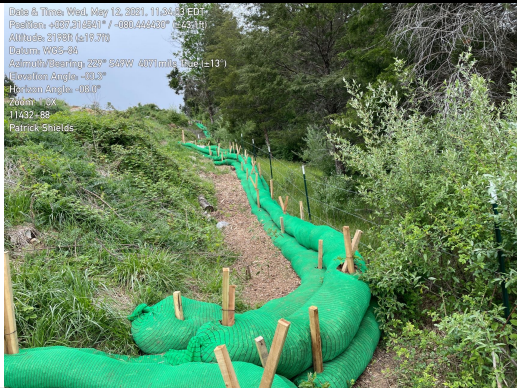
<b>GPS Location</b>	See photo	<b>GPS Location</b>	See photo		
<b>Field Station#</b>	11432+88	<b>Field Station#</b>	11468+00		
<b>Pic 9 Desc.</b>	CFS triple stack perimeter control in place	<b>Pic 10 Desc.</b>	Triple protection in place at karst feature		
<p>Date &amp; Time: Wed, May 12, 2021, 13:11:23 EDT  Position: +037.223511° / -080.434465° (±12.4ft)  Altitude: 2235ft (±37.4ft)  Datum: WGS-84  Azimuth/Bearing: 189° S08W 334ftmils True (±14°)  Elevation Angle: -02.6°  Horizon Angle: -01.5°  Zoom: 1.0X  11512+50  Patrick Shields</p>

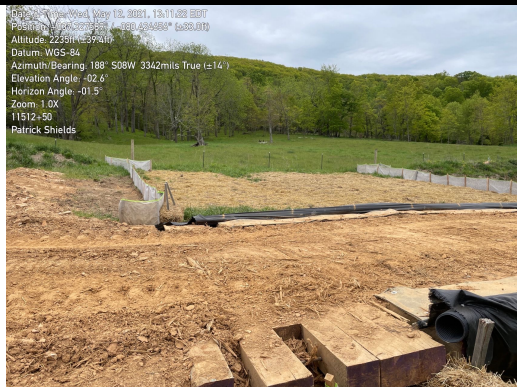
<b>Pic 11 Desc.</b>	Clean water drainage feature stabilized	<b>Pic 12 Desc.</b>	Buffer in place

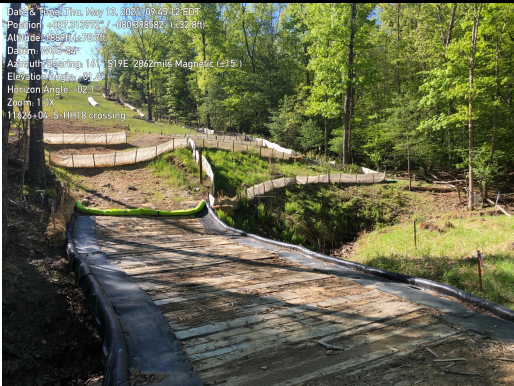
<b>GPS Location</b>	On photo	<b>GPS Location</b>	On photo		
<b>Field Station#</b>	11626+04	<b>Field Station#</b>	11614+75		
<b>Pic 5 Desc.</b>	S-HH18 crossing is stable with no impact.	<b>Pic 6 Desc.</b>	End treatments functioning properly.

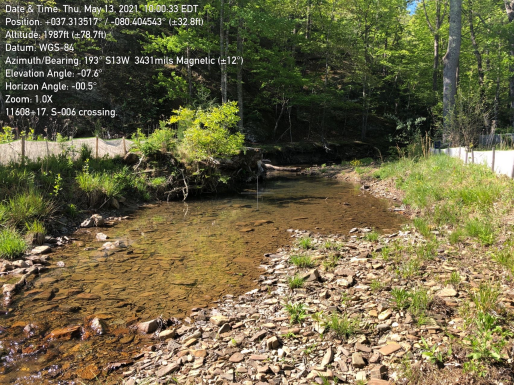
<p><small>Date &amp; Time: Thu, May 13, 2021, 10:00:33 EDT Position: +037 313517 / -080 404543 (±32.8ft) Altitude: 1987ft (±78.7m) Datum: WGS-84 Azimuth/Bearing: 193° S13W 3431mils Magnetic (±12°) Elevation Angle: -07.5° Horizon Angle: -00.5° Zoom: 1.0X 11608+17 S-006 crossing</small></p>			
<b>GPS Location</b>	On photo	<b>GPS Location</b>	On photo		
<b>Field Station#</b>	11613+69	<b>Field Station#</b>	11608+17		
<b>Pic 7 Desc.</b>	The S-RR13 crossing at access road MN-258.04 is stable. ECDs in place.		<b>Pic 8 Desc.</b>	The S-006 crossing is stable with no impact at resource.

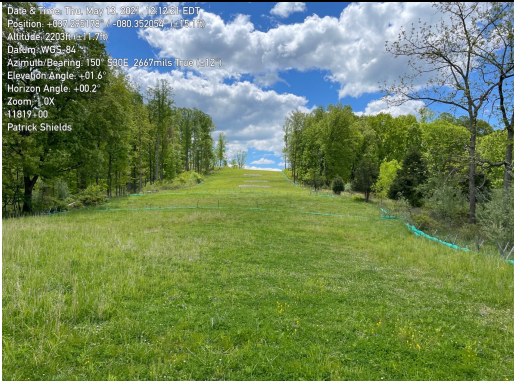
<b>GPS Location</b>	See photo	<b>GPS Location</b>	See photo		
<b>Field Station#</b>	11819+00	<b>Field Station#</b>	11831+00		
<b>Pic 3 Desc.</b>	ECDs in place	<b>Pic 4 Desc.</b>	Level spreaders in place

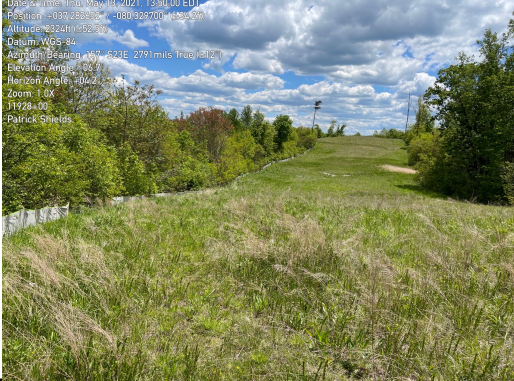
<b>GPS Location</b>	See photo	<b>GPS Location</b>	See photo		
<b>Field Station#</b>	11928+00	<b>Field Station#</b>	11901+00		
<b>Pic 5 Desc.</b>	P1 perimeter control in place	<b>Pic 6 Desc.</b>	CFS checks in place

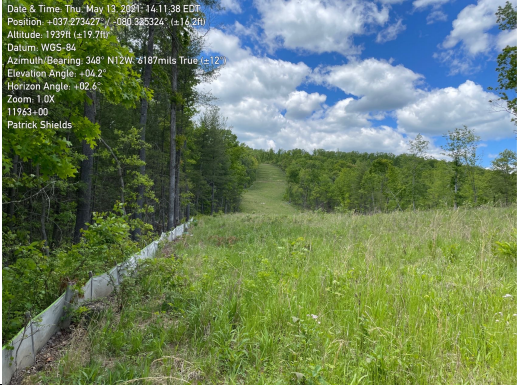
<b>GPS Location</b>	See photo	<b>GPS Location</b>	See photo		
<b>Field Station#</b>	11963+00	<b>Field Station#</b>	11957+00		
<b>Pic 7 Desc.</b>	P1 perimeter control in place	<b>Pic 8 Desc.</b>	12" CFS in place		
<p>Date &amp; Time: Thu, May 13, 2021 16:01:22 EDT  Position: +037.2709991, -080.3229234 (+39.81)  Altitude: 2121ft (+64.2ft)  Datum: WGS-84  Azimuth/Bearing: 163° S11E 2406mils True (+12)  Elevation Angle: +11.0  Horizon Angle: +01.5  Zoom: 1.0X  11947+00  Patrick Shields</p>

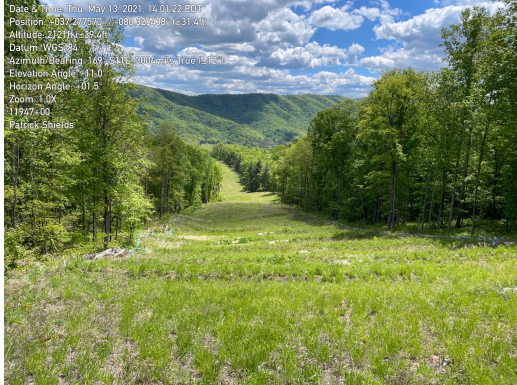
<b>GPS Location</b>	See photo	<b>GPS Location</b>	See photo		
<b>Field Station#</b>	11947+00	<b>Field Station#</b>	11970+00		
<b>Pic 9 Desc.</b>	Waterbars in place	<b>Pic 10 Desc.</b>	Waterbars in place		
<p>Date &amp; Time: Thu, May 13, 2021 14:22:43 EDT  Position: +037.2703387, -080.3229234 (+39.81)  Altitude: 1661ft (+50.7ft)  Datum: WGS-84  Azimuth/Bearing: 159° S21E 2827mils True (+12)  Elevation Angle: +06.6  Horizon Angle: +06.4  Zoom: 1.0X  11977+00  Patrick Shields</p>

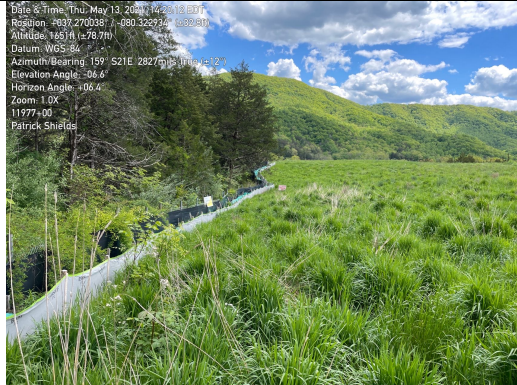
<b>GPS Location</b>	See photo	<b>GPS Location</b>	See photo		
<b>Field Station#</b>	11977+00	<b>Field Station#</b>	11982+00		
<b>Pic 11 Desc.</b>	Triple protection at karst feature in place	<b>Pic 12 Desc.</b>	P1 perimeter control in place

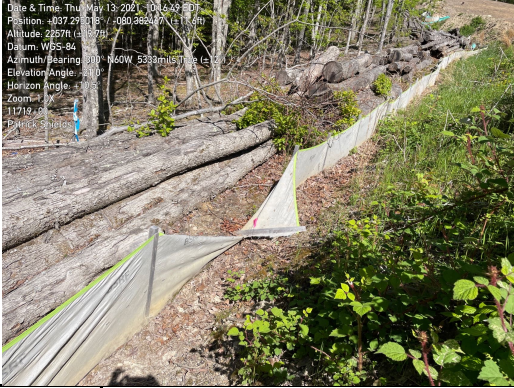
<p>Date &amp; Time: Thu May 13 2021 11:52:55 EDT Position: +837.231221° / +880.368655° (+42.3ft) Altitude: 2529ft (+863.7ft) (+803.66ft) Datum: WGS-84 Azimuth/Bearing: 210.153W 3733mils True (+12°) Elevation Angle: -18.5° Horizon Angle: -00.5° Zoom: 1.0X 11760+45 Patrick Shields</p>			
<b>GPS Location</b>	See photo	<b>GPS Location</b>	See photo		
<b>Field Station#</b>	11719+00	<b>Field Station#</b>	11760+45		
<b>Pic 1 Desc.</b>	Silt fence damaged by wildlife	<b>Pic 2 Desc.</b>	Sediment built up on end treatment

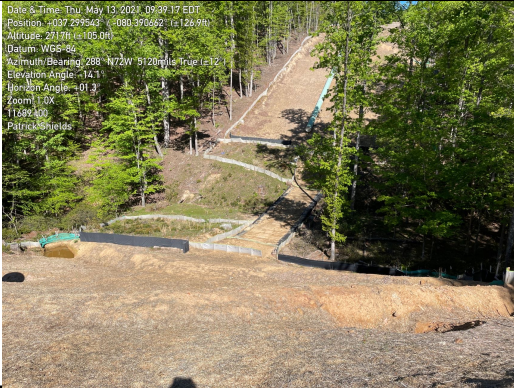
<p>Date &amp; Time: Thu May 13 2021 08:55:40 EDT Position: +837.231221° / +880.368655° (+42.3ft) Altitude: 2512ft (+863.7ft) (+803.66ft) Datum: WGS-84 Azimuth/Bearing: 139.541E 2471mils True (+12°) Elevation Angle: -20° Horizon Angle: -04.5° Zoom: 1.0X 11685+00 Patrick Shields</p>			
<b>GPS Location</b>	See photo	<b>GPS Location</b>	See photo		
<b>Field Station#</b>	11672+00	<b>Field Station#</b>	11685+00		
<b>Pic 3 Desc.</b>	End treatments in place	<b>Pic 4 Desc.</b>	Waterbars in place

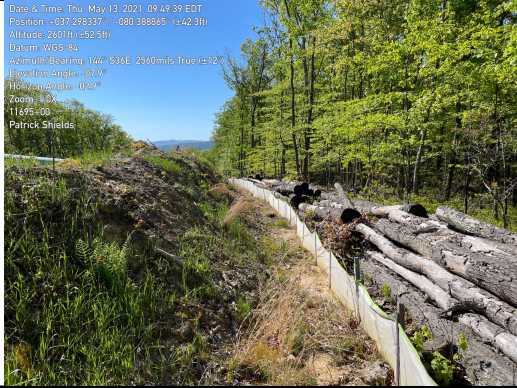
<b>GPS Location</b>	See photo	<b>GPS Location</b>	See photo		
<b>Field Station#</b>	11689+00	<b>Field Station#</b>	11695+00		
<b>Pic 5 Desc.</b>	Stream buffer in place	<b>Pic 6 Desc.</b>	P1 perimeter control in place

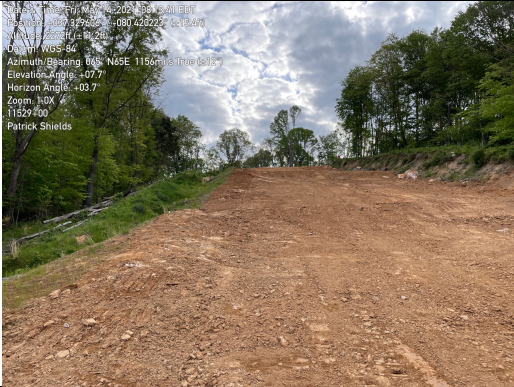
<p> <small> Date &amp; Time: Fri, May 14, 2021, 05:30:00 EDT  Position: +36° 22' 51.1" / -80° 42' 22.2" (+21.8 ft)  Altitude: 2331 ft (+29.20 m)  Datum: WGS-84  Azimuth/Bearing: 147° 53E 2613m True (+12°)  Elevation Angle: +04.3  Horizon Angle: +03.8  Zoom: 1.0x  11532+00  Patrick Shields </small> </p>			
<b>GPS Location</b>	See photo		<b>GPS Location</b>	See photo	
<b>Field Station#</b>	11529+00		<b>Field Station#</b>	11532+00	
<b>Pic 1 Desc.</b>	ROW restored to subgrade		<b>Pic 2 Desc.</b>	Perimeter controls in place

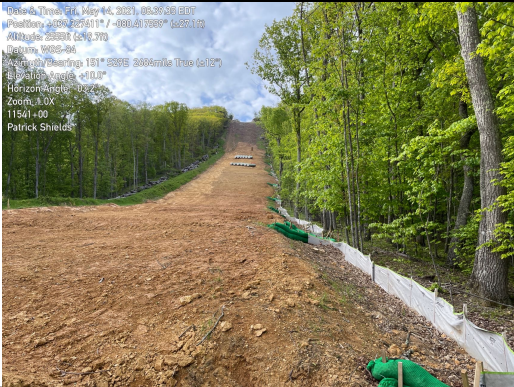
<p> <small> Date &amp; Time: Fri, May 14, 2021, 05:30:00 EDT  Position: +36° 22' 51.1" / -80° 42' 22.2" (+21.8 ft)  Altitude: 2331 ft (+29.20 m)  Datum: WGS-84  Azimuth/Bearing: 187° 28SE 2971m True (+12°)  Elevation Angle: +00.0  Horizon Angle: +00.4  Zoom: 1.0x  11553+40  Patrick Shields </small> </p>			
<b>GPS Location</b>	See photo		<b>GPS Location</b>	See photo	
<b>Field Station#</b>	11541+00		<b>Field Station#</b>	11553+40	
<b>Pic 3 Desc.</b>	End treatments in place		<b>Pic 4 Desc.</b>	Waterbars in place

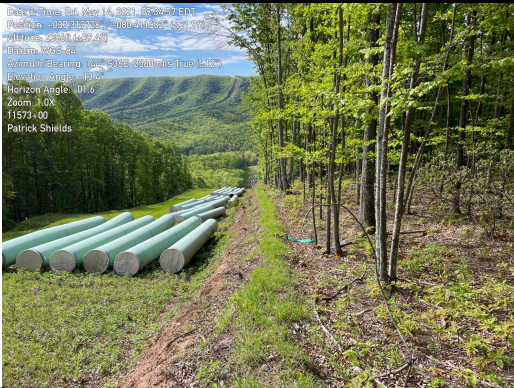
<b>GPS Location</b>	See photo		<b>GPS Location</b>	See photo	
<b>Field Station#</b>	11573+00		<b>Field Station#</b>	11588+00	
<b>Pic 5 Desc.</b>	Clean water diversion berm in place		<b>Pic 6 Desc.</b>	Buffer in place

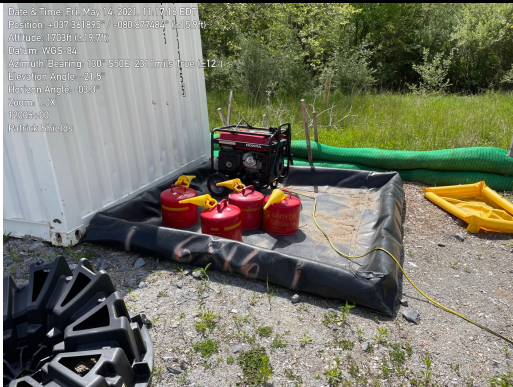
GPS Location	See photo		GPS Location	See photo	
Field Station#	12005+00		Field Station#	12005+00	
Pic 1 Desc.	Secondary containment in place		Pic 2 Desc.	CFS triple stack perimeter control in place	
<p>Date &amp; Time: Fri, May 14, 2021, 11:09:25 EDT Position: -037.34262° / -080.677261° (-15.6ft) Altitude: 1707ft (-11.1ft) Datum: WGS-84 Azimuth/Bearing: 145° 53SE 2578mils True (±12°) Elevation Angle: -03.7° Horizon Angle: -00.6° Zoom: 1.0X 12005+00 Patrick Shields</p>

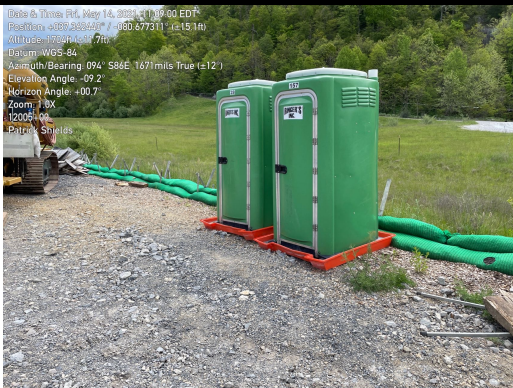
GPS Location	See photo		GPS Location	See photo	
Field Station#	12005+00		Field Station#	12005+00	
Pic 5 Desc.	Secondary containment in place		Pic 6 Desc.	Culver in place

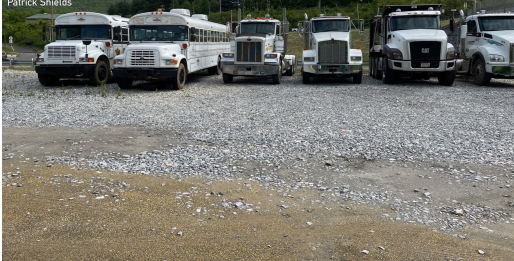
<b>GPS Location</b>	See photo	<b>GPS Location</b>	See photo		
<b>Field Station#</b>	12005+00	<b>Field Station#</b>	12005+00		
<b>Pic 1 Desc.</b>	Vehicles being stored at yard	<b>Pic 2 Desc.</b>	RCE in place		
<p>Date &amp; Time: Fri, May 14, 2021, 10:35:01 EDT  Position: 439033.593N / -680335.229W (a15.5ft)  Altitude: 1558ft (a11.2ft)  Datum: WGS-84  Azimuth/Bearing: 197° S17W 3502mils True (a10.1)  Elevation Angle: -09.6°  Horizon Angle: -01.2°  Zoom: 1.0X  12005+00  Patrick Shields</p>

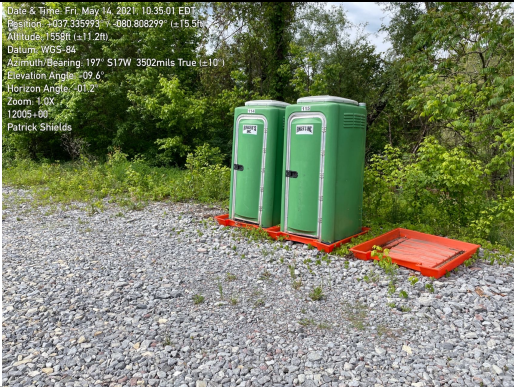
<b>GPS Location</b>	See photo	<b>GPS Location</b>	See photo		
<b>Field Station#</b>	12005+00	<b>Field Station#</b>	12005+00		
<b>Pic 3 Desc.</b>	Secondary containment in place	<b>Pic 4 Desc.</b>	Dumpster in place		
<p>Date &amp; Time: Fri, May 14, 2021, 10:42:15 EDT  Position: 439033.593N / -680335.229W (a15.5ft)  Altitude: 1558ft (a11.2ft)  Datum: WGS-84  Azimuth/Bearing: 188° S88E 1700mils True (a10.1)  Elevation Angle: -04.0°  Horizon Angle: -01.8°  Zoom: 1.0X  12005+00  Patrick Shields</p>

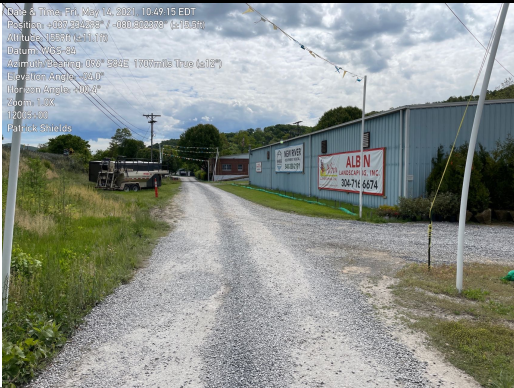
<b>Pic 5 Desc.</b>	CFS perimeter control in place	<b>Pic 6 Desc.</b>	RCE in place

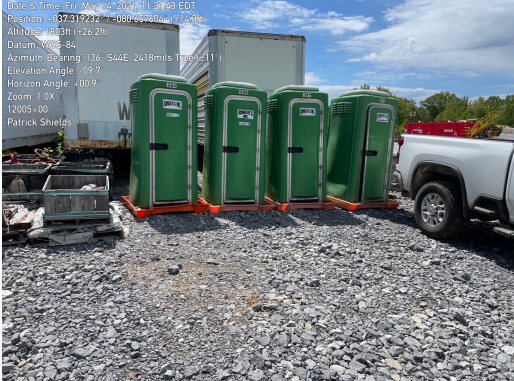
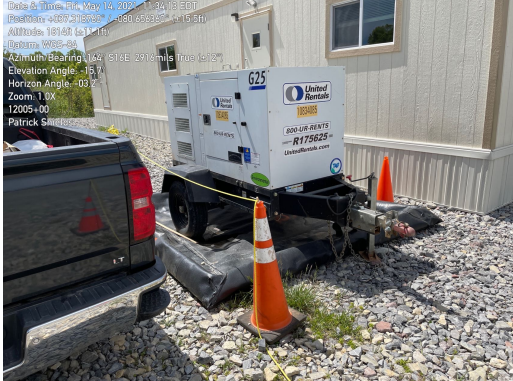
<b>GPS Location</b>	See photo	<b>GPS Location</b>	See photo		
<b>Field Station#</b>	12005+00	<b>Field Station#</b>	12005+00		
<b>Pic 1 Desc.</b>	Secondary containment in place	<b>Pic 2 Desc.</b>	Secondary containment in place

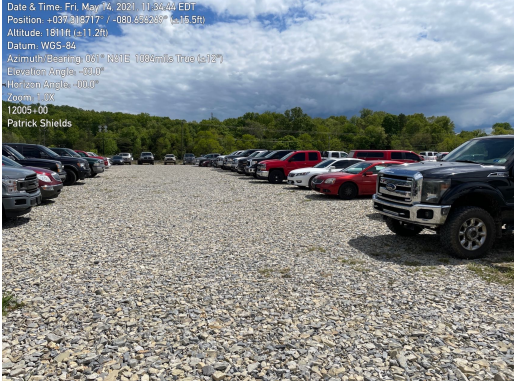
<b>GPS Location</b>	See photo	<b>GPS Location</b>	See photo		
<b>Field Station#</b>	12005+00	<b>Field Station#</b>	12005+00		
<b>Pic 3 Desc.</b>	Employee parking	<b>Pic 4 Desc.</b>	Fuel island in place

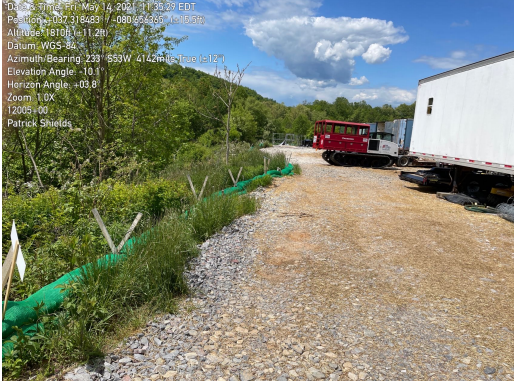
<b>GPS Location</b>	See photo	<b>GPS Location</b>	See photo		
<b>Field Station#</b>	12005+00	<b>Field Station#</b>	12005+00		
<b>Pic 5 Desc.</b>	CFS triple stack perimeter control in place	<b>Pic 6 Desc.</b>	Dumpsters in place
