# Visual Site Inspection Report

<b>Project Name</b>	H-600 Pipeline Spread G	<b>AFE</b>	124300137	<b>Spread</b>	H-600 Pipeline Spread G
<b>Contractor</b>	Precision			<b>Report #</b>	23484
<b>Inspector</b>	Len Kruizenga			<b>Date/Time</b>	5/17/2021 4:44 PM
<b>Permit #</b>	TBD	<b>Inspection Type</b>	VA SWPP	<b>Station Begin</b>	11064+52
<b>State</b>	VA	<b>Inspection Area</b>	Full	<b>Station End</b>	10929+62
<b>County</b>	Giles	<b>Ground</b>	Dry	<b>Temperature (°F)</b>	56.00
<b>Municipality</b>	N/A	<b>Weather</b>	Cloudy	<b>Rain Gauge (in)</b>	0.00
				<b>Rain Accumulation Time (days)</b>	1.00

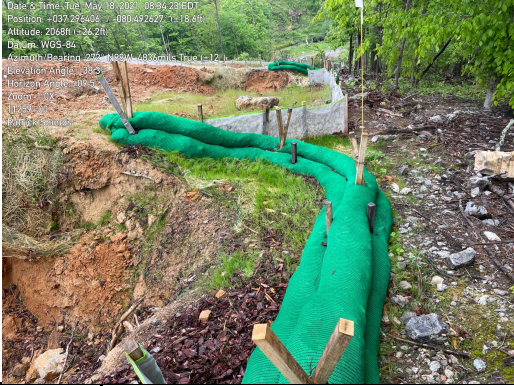
<b>GPS Location</b>	See photo	<b>GPS Location</b>	See photo		
<b>Field Station#</b>	11259+00	<b>Field Station#</b>	11269+75		
<b>Pic 1 Desc.</b>	Good Vegetation at discharge point of end treatment	<b>Pic 2 Desc.</b>	Rock inlet protection in place at slope drain

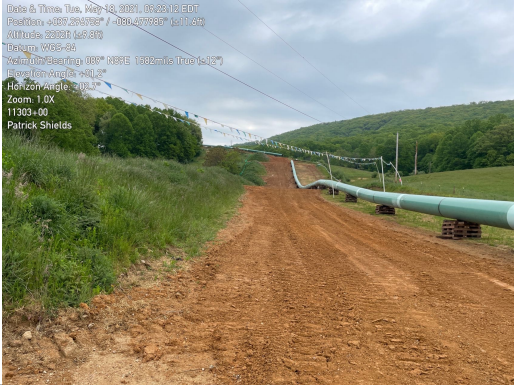
<b>GPS Location</b>	See photo	<b>GPS Location</b>	See photo		
<b>Field Station#</b>	11303+00	<b>Field Station#</b>	11364+00		
<b>Pic 3 Desc.</b>	Good vegetation on topsoil piles	<b>Pic 4 Desc.</b>	Mulching morooka blowing straw on topsoil piles		
<p>Date &amp; Time: Tue, May 18, 2021, 10:20:13 EDT  Position: -83.720704 / -80.482397 (±21.0m)  Altitude: 2044ft (±39.4m)  Datum: WGS-84  Azimuth/Bearing: 138° 54'E 2453mils True (±13°)  Elevation Angle: -12.1°  Horizontal Angle: -00.9°  Zoom: 1.0x  11375+00  Patrick Shields</p>

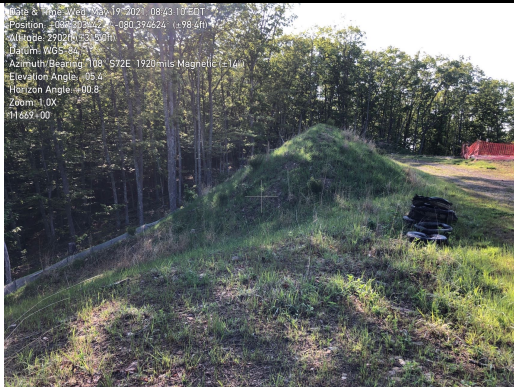
GPS Location		On photo		GPS Location		On photo	
Field Station#		11626+75		Field Station#		11669+00	
Pic 1 Desc.		Communication; fabric will be re-attached to chain link SSF.		Pic 2 Desc.		Top of Brush Mountain at FS188 is stable.

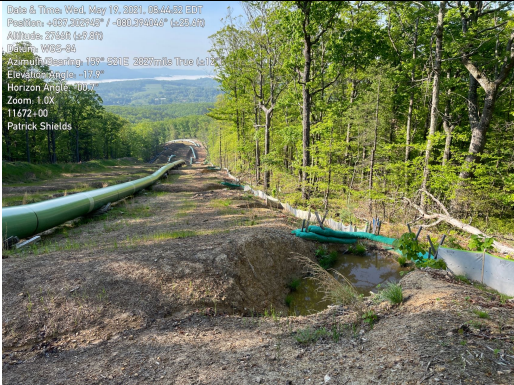
<b>GPS Location</b>	See photo	<b>GPS Location</b>	See photo		
<b>Field Station#</b>	11672+00	<b>Field Station#</b>	11696+95		
<b>Pic 1 Desc.</b>	End treatments in place	<b>Pic 2 Desc.</b>	Buffer in place

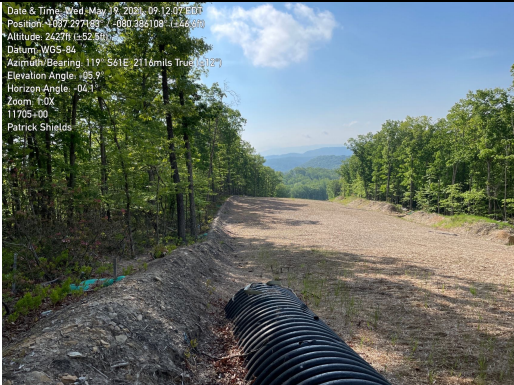
<b>GPS Location</b>	See photo	<b>GPS Location</b>	See photo		
<b>Field Station#</b>	11705+00	<b>Field Station#</b>	11734+00		
<b>Pic 3 Desc.</b>	Clean water diversion berm in place	<b>Pic 4 Desc.</b>	Sock checks in place

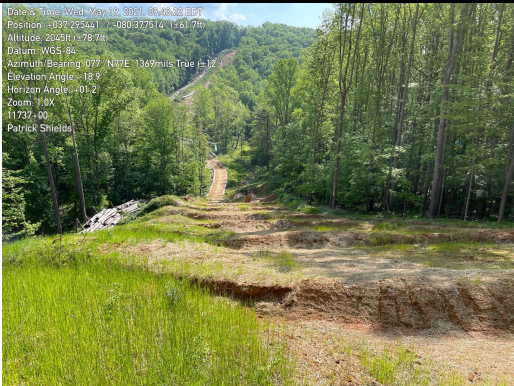
<b>GPS Location</b>	See photo	<b>GPS Location</b>	See photo		
<b>Field Station#</b>	11737+00	<b>Field Station#</b>	11765+00		
<b>Pic 5 Desc.</b>	Waterbars in place	<b>Pic 6 Desc.</b>	RCE in place

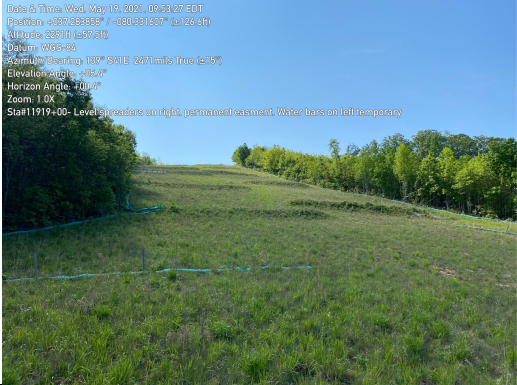
AFE	124300137	Date/Time	5/19/2021 4:28 PM	Report #	
Pictures					
<p>Date &amp; Time: Wed, May 19, 2021, 10:21:57 EDT  Position: +367.233333° / -080.091333° (±26.4m)  Altitude: 2327ft (±54.1m)  Datum: WGS-84  Azimuth/Bearing: 100° 29'11" S 291ft True (±5°)  Elevation Angle: +0.7°  Horizon Angle: +09.0°  Zoom: 1.0X  Sta#11919+00 - Level spreaders on right, permanent easement. Water bars on left temporary</p>

<b>GPS Location</b>	See photo GPS		<b>GPS Location</b>	See photo GPS	
<b>Field Station#</b>	11919+00		<b>Field Station#</b>	11929+00	
<b>Pic 7 Desc.</b>	Level spreaders on right, permanent easement. Water bars on the left, temporary.		<b>Pic 8 Desc.</b>	Row vegetation and ECD's.

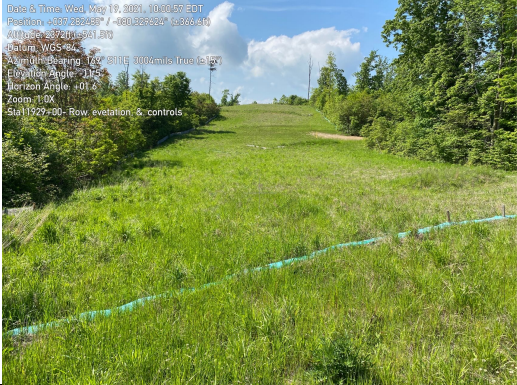
<p>Date &amp; Time: Wed, May 19, 2021, 10:29:40 EDT  Position: +367.233333° / -080.091333° (±26.4m)  Altitude: 2327ft (±54.1m)  Datum: WGS-84  Azimuth/Bearing: 100° 29'11" S 291ft True (±5°)  Elevation Angle: +0.7°  Horizon Angle: +01.2°  Zoom: 1.0X  Sta#11929+00 - Row elevation &amp; controls</p>

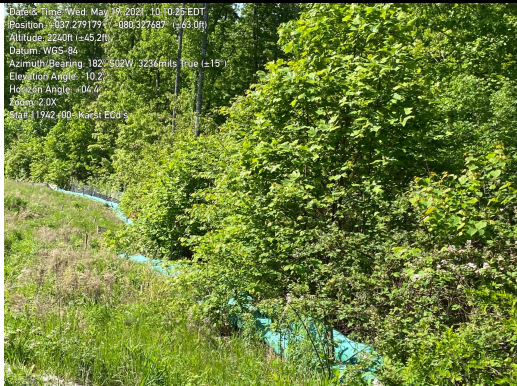
<p>Date &amp; Time: Wed, May 19, 2021, 10:10:25 EDT  Position: +337.279179° / -080.327887° (±43.0m)  Altitude: 2260ft (±45.2m)  Datum: WGS-84  Azimuth/Bearing: 182° 50'21" W 323ft True (±15°)  Elevation Angle: -10.2°  Horizon Angle: +06.0°  Zoom: 2.0X  Sta#11942+00 - Karst ECD's</p>

<b>GPS Location</b>	See photo GPS		<b>GPS Location</b>	See photo GPS	
<b>Field Station#</b>	11942+00		<b>Field Station#</b>	11950+00	
<b>Pic 9 Desc.</b>	Karst ECD's		<b>Pic 10 Desc.</b>	Karst controls in run off.	
<p>Date &amp; Time: Wed, May 19, 2021, 10:35:33 EDT  Position: +337.270150° / -080.323005° (±259.3m)  Altitude: 1847ft (±276.9m)  Datum: WGS-84  Azimuth/Bearing: 148° 53'21" E 263ft True (±15°)  Elevation Angle: +0.5°  Horizon Angle: +05.4°  Zoom: 2.0X  Sta#11977+00 - Karst ECD's</p>

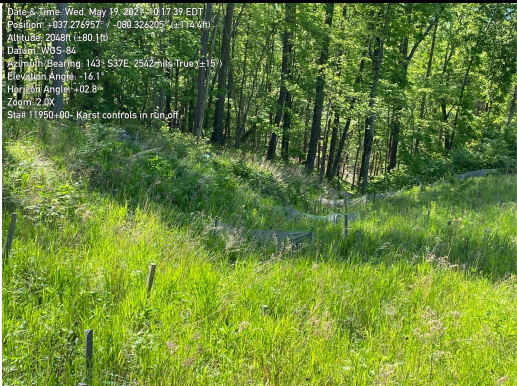
<p>Date &amp; Time: Wed, May 19, 2021, 10:17:39 EDT  Position: +337.276957° / -080.326205° (±11.4m)  Altitude: 2260ft (±45.2m)  Datum: WGS-84  Azimuth/Bearing: 143° 53'21" E 254Z True (±15°)  Elevation Angle: -16.1°  Horizon Angle: +02.8°  Zoom: 2.0X  Sta#11950+00 - Karst controls in run off</p>

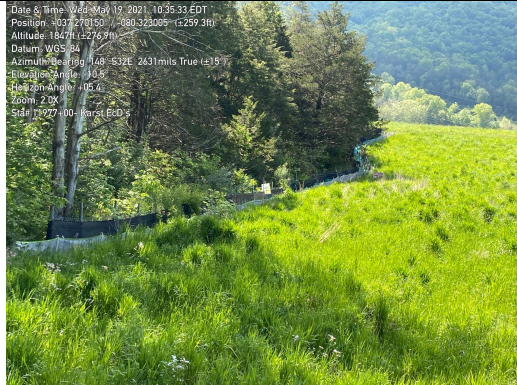
<b>GPS Location</b>	See photo GPS		<b>GPS Location</b>	See photo GPS	
<b>Field Station#</b>	11977+00		<b>Field Station#</b>	11988+00	
<b>Pic 11 Desc.</b>	Karst ECD's and signage.		<b>Pic 12 Desc.</b>	AR- 266.00 - Access road and rock check dams.

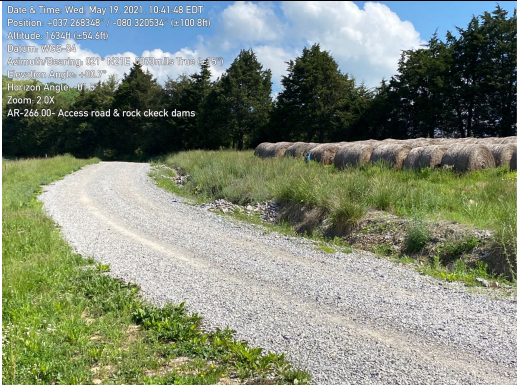
<p>Date &amp; Time: Wed, May 19, 2021, 10:41:48 EDT  Position: +337.268348° / -080.320934° (±100.8m)  Altitude: 1634ft (±54.5m)  Datum: WGS-84  Azimuth/Bearing: 001° 02'11" S 163ft True (±15°)  Elevation Angle: +00.0°  Horizon Angle: +01.1°  Zoom: 2.0X  AR-266.00 - Access road &amp; rock check dams</p>

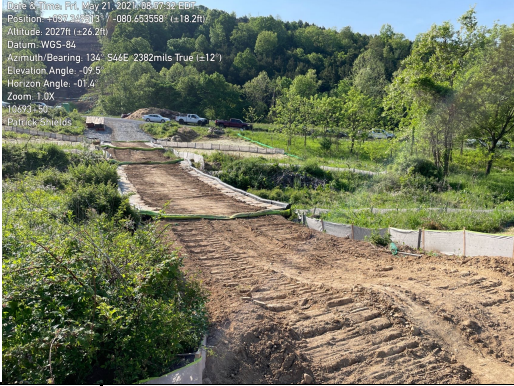
<b>GPS Location</b>	See photo	<b>GPS Location</b>	See photo		
<b>Field Station#</b>	10693+50	<b>Field Station#</b>	10707+21		
<b>Pic 1 Desc.</b>	Clean water drainage features in place	<b>Pic 2 Desc.</b>	Topsoil stock pile stabilized

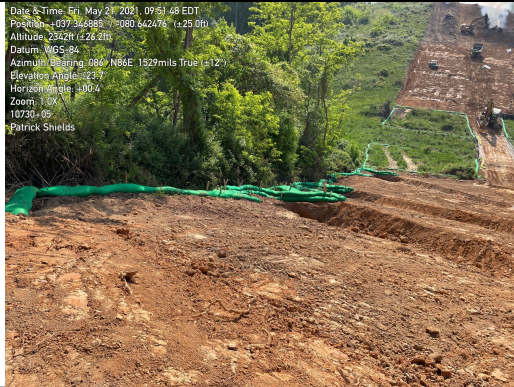
<b>GPS Location</b>	See photo	<b>GPS Location</b>	See photo		
<b>Field Station#</b>	10725+36	<b>Field Station#</b>	10730+05		
<b>Pic 3 Desc.</b>	Rock inlet protection in place	<b>Pic 4 Desc.</b>	End treatments in place		
<p> <small> Date &amp; Time: Fri, May 21, 2021 10:39:53 EDT  Position: -080.631430 / -38.063143 (±22.3ft)  Altitude: 2174ft (±19.7ft)  Datum: WGS-84  Azimuth/Bearing: 081° N81E 1440mils True (±12°)  Elevation Angle: -11.7°  Horizon Angle: -04.2°  Zoom: 1.0X  10764+52  Patrick Shields </small> </p>

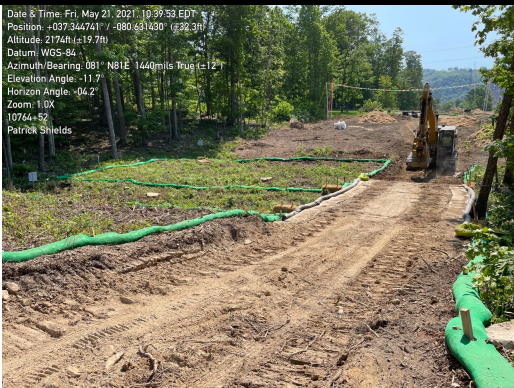
<b>GPS Location</b>	See photo	<b>GPS Location</b>	See photo		
<b>Field Station#</b>	10764+52	<b>Field Station#</b>	10792+41		
<b>Pic 5 Desc.</b>	Buffer in place	<b>Pic 6 Desc.</b>	Perimeter controls in place

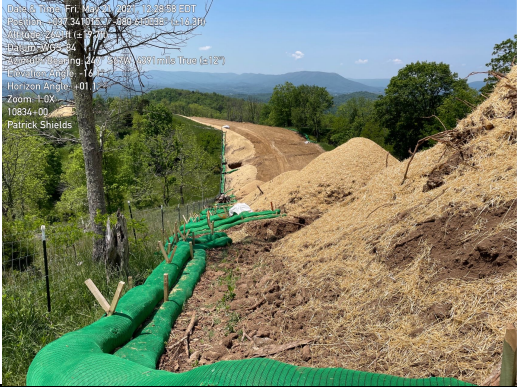
<b>GPS Location</b>	See photo		<b>GPS Location</b>	See photo	
<b>Field Station#</b>	10834+00		<b>Field Station#</b>	10819+00	
<b>Pic 7 Desc.</b>	Perimeter controls in place		<b>Pic 8 Desc.</b>	Topsoil piles stabilized

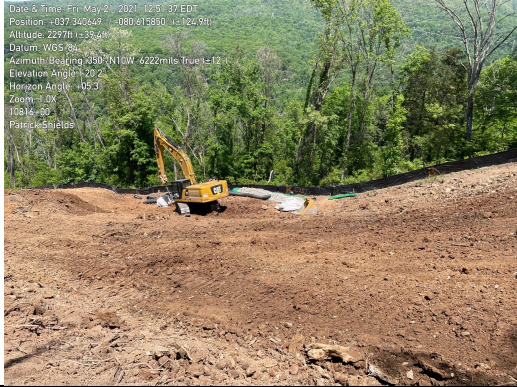
<b>GPS Location</b>	See photo		<b>GPS Location</b>	See photo	
<b>Field Station#</b>	10816+00		<b>Field Station#</b>	10752+00	
<b>Pic 9 Desc.</b>	Constructing clean water level spreader		<b>Pic 10 Desc.</b>	Waterbars in place

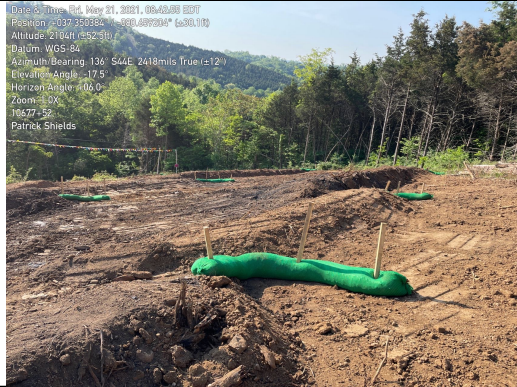
<b>GPS Location</b>	See photo		<b>GPS Location</b>	See photo	
<b>Field Station#</b>	10677+52		<b>Field Station#</b>	10826+00	
<b>Pic 11 Desc.</b>	Temporary waterbars in place with end treatments		<b>Pic 12 Desc.</b>	Supersilt fence perimeter control in place

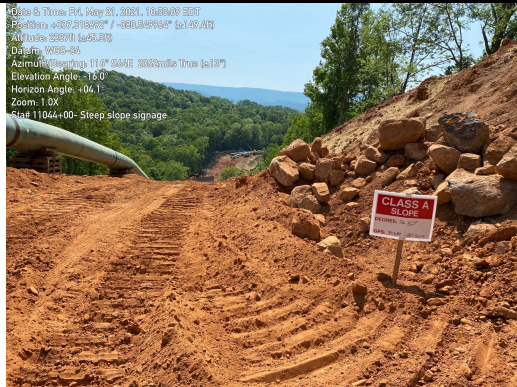
<b>Pic 11 Desc.</b>	Steep slope signage	<b>Pic 12 Desc.</b>	Steep slope controls.

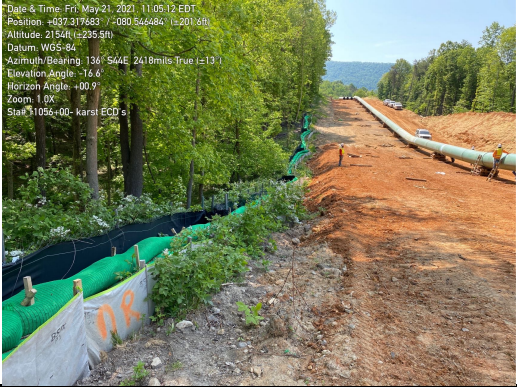
<b>GPS Location</b>	See photo GPS	<b>GPS Location</b>	See photo GPS		
<b>Field Station#</b>	11049+50	<b>Field Station#</b>	11056+00		
<b>Pic 13 Desc.</b>	Stream S- IJ16B	<b>Pic 14 Desc.</b>	Karst ECD's.		
Insert image here		Insert image here
