Visual Site Inspection Report

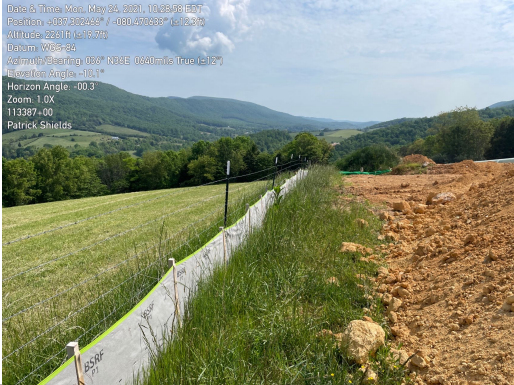
<p>Date & Time: Mon, May 24, 2021, 11:30:00 EDT Position: +089.298337° / +089.298337° (-112.41°) Altitude: 21305 ft (+6470 ft) Datum: WGS-84 Azimuth/Bearing: 006° / 000° 1300mils True (+13°) Elevation Angle: -02.4° Horizon Angle: -00.9° Zoom: 1.0X 11305+00 Patrick Shields</p>			
GPS Location	See photo	GPS Location	See photo		
Field Station#	11261+00	Field Station#	11305+00		
Pic 1 Desc.	End treatments in place	Pic 2 Desc.	CFS perimeter control in place

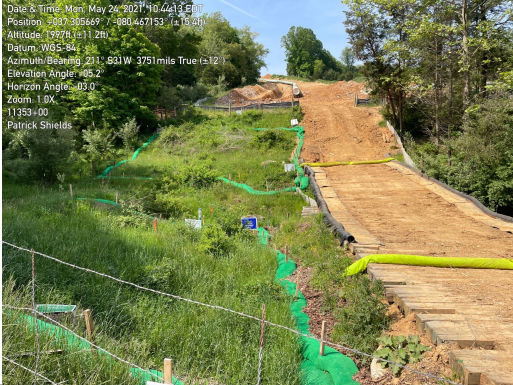
GPS Location	See photo	GPS Location	See photo		
Field Station#	11387+00	Field Station#	11353+00		
Pic 3 Desc.	P1 perimeter control in place	Pic 4 Desc.	Buffer in place

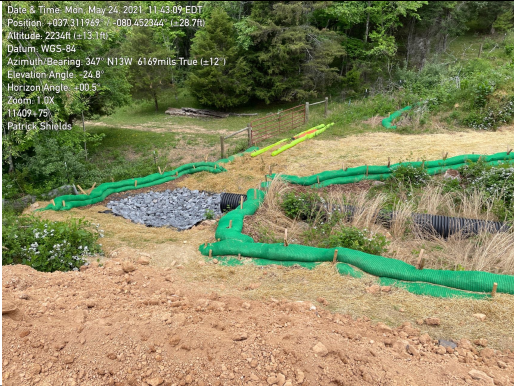
<p>Date & Time: Mon, May 24, 2021, 11:51:49 EDT Position: +087.311409° / +080.448629° (-129.51°) Altitude: 22698 ft (+6948 ft) Datum: WGS-84 Azimuth/Bearing: 341° / N19W 6042mils True (+12°) Elevation Angle: -24.9° Horizon Angle: -101.7° Zoom: 1.0X 11422+50 Patrick Shields</p>			
GPS Location	See photo	GPS Location	See photo		
Field Station#	11409+75	Field Station#	11422+50		
Pic 5 Desc.	Plunge pool in place	Pic 6 Desc.	Rock inlet protection in place

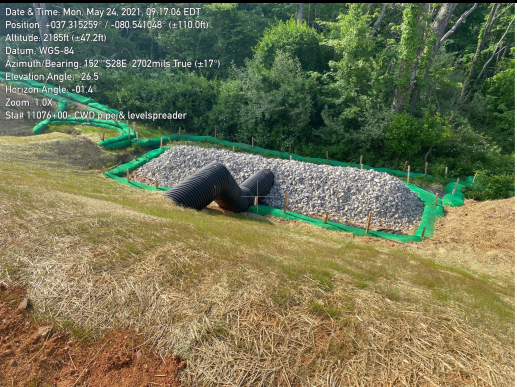
GPS Location	See photo GPS		GPS Location	See photo GPS	
Field Station#	11064+53		Field Station#	11076+00	
Pic 1 Desc.	Signage showing slope class.		Pic 2 Desc.	CWD pipe and level spreader.

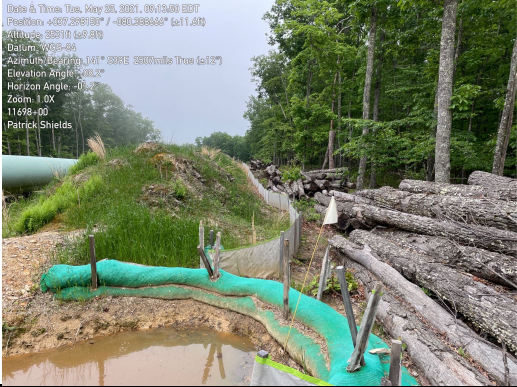
GPS Location	See photo		GPS Location	See photo	
Field Station#	11698+00		Field Station#	11787+50	
Pic 7 Desc.	P1 perimeter control in place		Pic 8 Desc.	RCE in place	
<p>Date & Time: Tue, May 25, 2021, 09:45:40 EDT Position: +437.293172° / -88.339252° (±13.04) Altitude: 2110ft (±6.42) Datum: WGS-84 Azimuth/Bearing: 069° N49E 1227mils True (±12°) Elevation Angle: -19.4° Horizon Angle: -02.0° Zoom: 1.0X 11735+00 Patrick Shields</p>

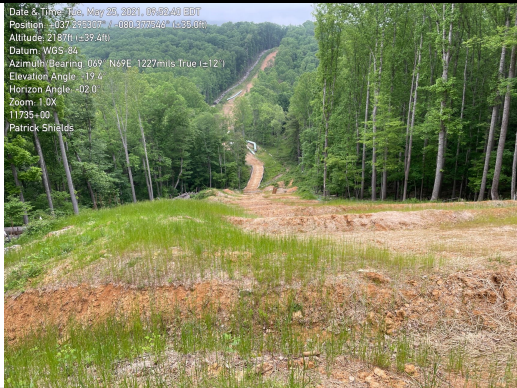
GPS Location	See photo		GPS Location	See photo	
Field Station#	11735+00		Field Station#	11767+26	
Pic 9 Desc.	Waterbars in place		Pic 10 Desc.	Buffer in place	
<p>Date & Time: Tue, May 25, 2021, 10:04:01 EDT Position: +437.293462° / -88.345879° (±18.817.83) Altitude: 2039ft (±6.53m) Datum: WGS-84 Azimuth/Bearing: 180° N80E 1428mils True (±12°) Elevation Angle: +10.4° Horizon Angle: -00.8° Zoom: 1.0X 11747+72 Patrick Shields</p>

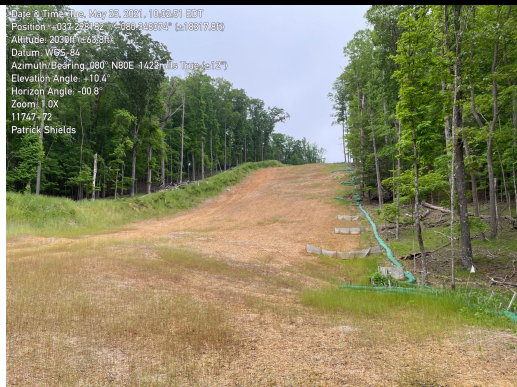
GPS Location	See photo		GPS Location	See photo	
Field Station#	11747+72		Field Station#	11761+03	
Pic 11 Desc.	Good vegetation on topsoil piles		Pic 12 Desc.	CFS perimeter control in place

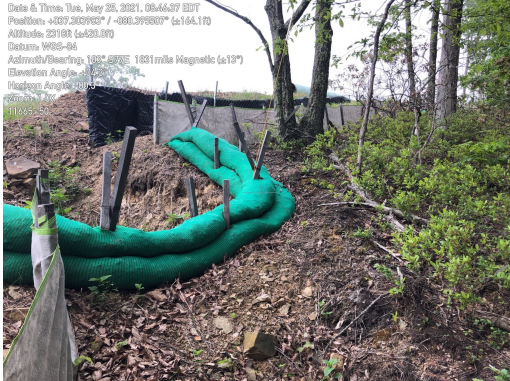
<p><small>Date & Time: Tue, May 25, 2021, 08:50:00 EDT Position: +037.306949° / -080.397522° (+16.4ft) Altitude: 2251ft (+689.0ft) Datum: WGS-84 Azimuth/Bearing: 122° N12°W 5849mils Magnetic (+12.1°) Elevation Angle: +21.2° Horizon Angle: -05.1° Zoom: 1.0X 11663+00</small></p>			
GPS Location	On photo of		GPS Location	On photo	
Field Station#	11665+50		Field Station#	11663+00	
Pic 1 Desc.	End treatment functional.		Pic 2 Desc.	Slope breakers are effective.

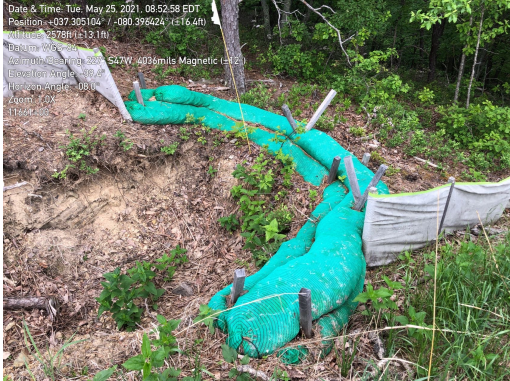
GPS Location	On photo		GPS Location	On photo	
Field Station#	11661+00		Field Station#	11653+00	
Pic 3 Desc.	End treatment in place, functional.		Pic 4 Desc.	Perimeter controls are in place.

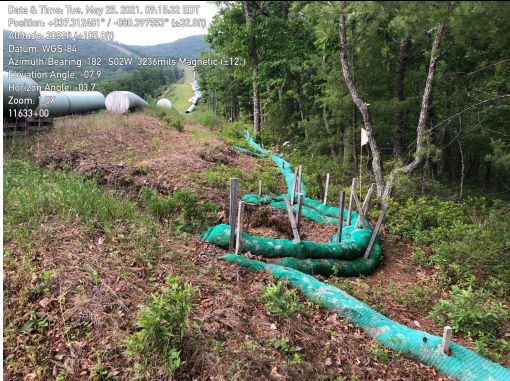
<p><small>Date & Time: Tue, May 25, 2021, 09:26:09 EDT Position: +037.312489° / -080.397708° (+16.4ft) Altitude: 1961ft (+597.5ft) Datum: WGS-84 Azimuth/Bearing: 140° S40°E 2489mils Magnetic (+11.1°) Elevation Angle: +00.0° Horizon Angle: -00.2° Zoom: 1.0X 11628+00</small></p>			
GPS Location	On photo		GPS Location	On photo	
Field Station#	11633+00		Field Station#	11628+00	
Pic 5 Desc.	Perimeter controls are in place.		Pic 6 Desc.	Perimeter ECDs in place.

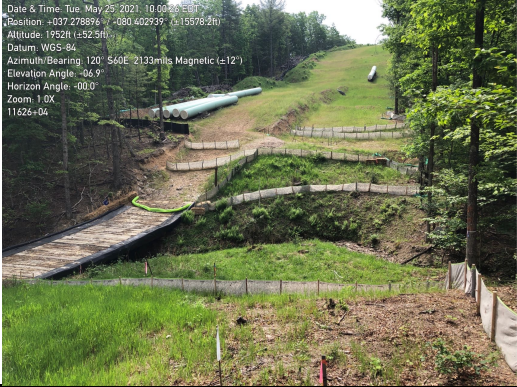
GPS Location	On photo	GPS Location	On photo		
Field Station#	11626+04	Field Station#	11619+00		
Pic 7 Desc.	S-HH18 crossing is stable.	Pic 8 Desc.	ROW stable ECDs in place.		
<p>Date & Time: Tue, May 25, 2021, 10:05:19 EDT Position: +037.313877° / -080.402409° (+164.1ft) Altitude: 1926ft (+57.5ft) Datum: WGS-84 Azimuth/Bearing: 250° S70W 4444mils Magnetic (+12°) Elevation Angle: -00.7° Horizon Angle: -02.0° Zoom: 1.0X 11614+20</p>

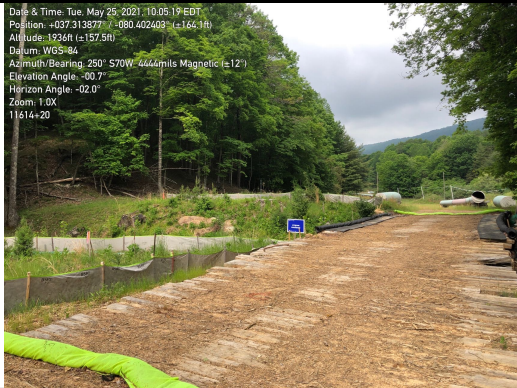
GPS Location	On photo	GPS Location	On photo		
Field Station#	11614+20	Field Station#	11608+17		
Pic 9 Desc.	S-RR14 crossing is stable.	Pic 10 Desc.	The S-006 crossing is stable.		
<p>Date & Time: Tue, May 25, 2021, 10:10:04 EDT Position: +037.313395° / -080.405415° (+56.4ft) Altitude: 1937ft (+58.5ft) Datum: WGS-84 Azimuth/Bearing: 281° S27W 4665mils Magnetic (+14°) Elevation Angle: -00.3° Horizon Angle: -00.0° Zoom: 1.0X 11605+00</p>

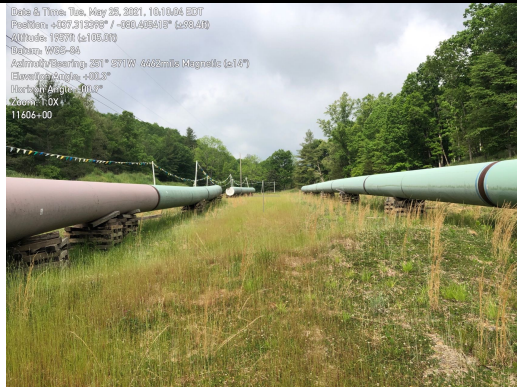
GPS Location	On photo	GPS Location	On photo		
Field Station#	11606+00	Field Station#	11600+50		
Pic 11 Desc.	ROW stable on private lands.	Pic 12 Desc.	ROW stable. ECDs are in place.

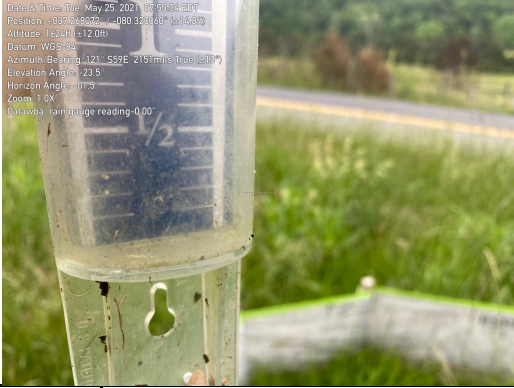
GPS Location	See photo GPS		GPS Location	See photo GPS	
Field Station#	11989+00		Field Station#	11788+50	
Pic 1 Desc.	Catawba rain gauge reading- 0.00"		Pic 2 Desc.	Tabor rain gauge reading- 0.00"

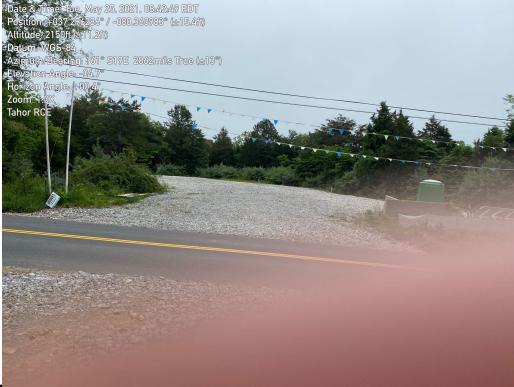
GPS Location	See photo GPS		GPS Location	See photo GPS	
Field Station#	11788+52		Field Station#	11832+00	
Pic 3 Desc.	Tabor RCE.		Pic 4 Desc.	Level spreaders,perimeter controls, karst at base of slopes.

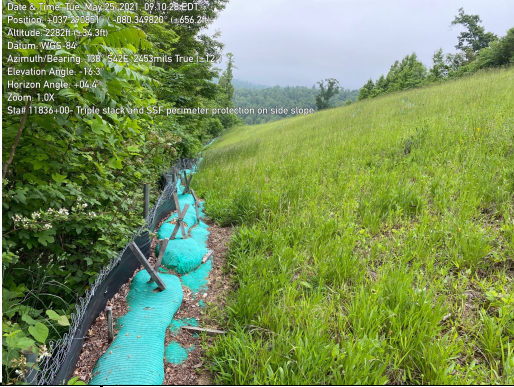
GPS Location	See photo GPS		GPS Location	See photo GPS	
Field Station#	11836+00		Field Station#	11848+00	
Pic 5 Desc.	Triple stack and SSF perimeter controls at base of side slope.		Pic 6 Desc.	Multiple level spreaders and perimeter controls.

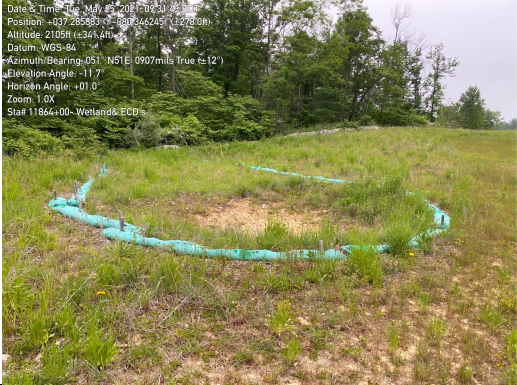
GPS Location	See photo GPS	GPS Location	See photo GPS		
Field Station#	11864+00	Field Station#	11900+81		
Pic 7 Desc.	Wetland and ECD's.	Pic 8 Desc.	AR-266.03		
<p><small>Date & Time: Tue, May 25, 2021, 10:05:00 EDT Position: +037.265883° / -080.46245° (+123.00) Altitude: 2090ft (+160.70) Datum: WGS-84 Azimuth/Bearing: 130° S(E) 3450mils True (+12°) Elevation Angle: +08.3° Horizon Angle: +02.0° Zoom: 1.0X Staff: 11919+00- Level spreaders on permanent, water bars on temporary easement.</small></p>

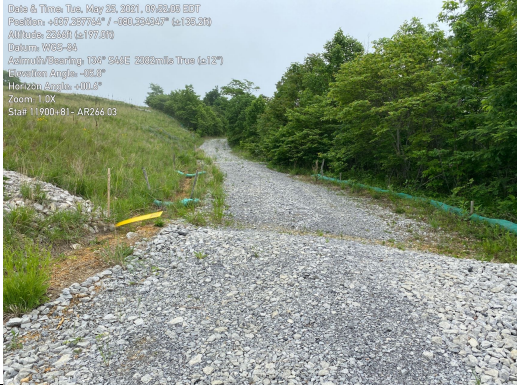
<p><small>Date & Time: Tue, May 25, 2021, 09:55:00 EDT Position: +037.26774° / -080.53545° (+136.50) Altitude: 2348ft (+197.00) Datum: WGS-84 Azimuth/Bearing: 134° S(E) 3300mils True (+12°) Elevation Angle: +05.3° Horizon Angle: +00.0° Zoom: 1.0X Staff: 11900+81- AR266.03</small></p>

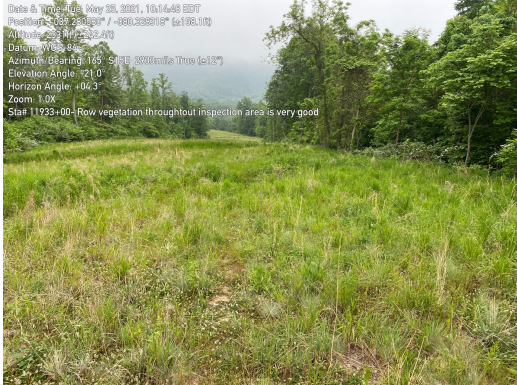
<p><small>Date & Time: Tue, May 25, 2021, 10:44:00 EDT Position: +037.26774° / -080.53545° (+136.50) Altitude: 2348ft (+197.00) Datum: WGS-84 Azimuth/Bearing: 145° S(E) 3300mils True (+12°) Elevation Angle: +21.0° Horizon Angle: +04.3° Zoom: 1.0X Staff: 11933+00- Row vegetation throughout inspection area is very good</small></p>

GPS Location	See photo GPS	GPS Location	See photo GPS		
Field Station#	11919+00	Field Station#	11933+00		
Pic 9 Desc.	Level spreaders on permanent easement, water bars on temporary easement.	Pic 10 Desc.	Row vegetation throughout inspection area is very good.		
<p><small>Date & Time: Tue, May 25, 2021, 10:44:00 EDT Position: +037.26774° / -080.53545° (+136.50) Altitude: 2051ft (+150.50) Datum: WGS-84 Azimuth/Bearing: 192° S(W) 3413mils True (+12°) Elevation Angle: +16.8° Horizon Angle: +02.1° Zoom: 1.0X Staff: 11942+00- Karst ECD's</small></p>

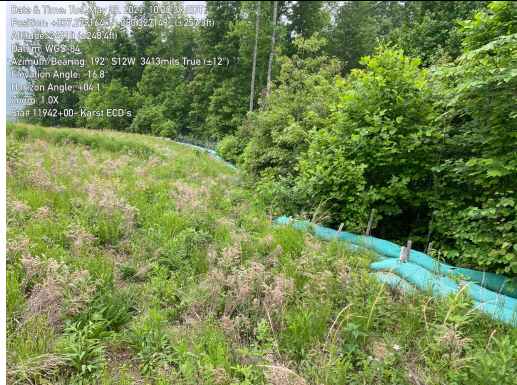
Field Station#	11942+00	Field Station#	11978+00		
Pic 11 Desc.	Karst and Karst ECD's.	Pic 12 Desc.	Karst ECD's and signage.

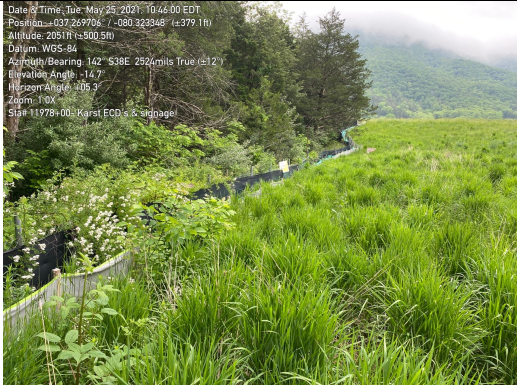
<p><small>Date & Time: Tue, May 25, 2021, 10:44:00 EDT Position: +037.26774° / -080.53545° (+136.50) Altitude: 2051ft (+150.50) Datum: WGS-84 Azimuth/Bearing: 142° S(E) 252mils True (+12°) Elevation Angle: +14.7° Horizon Angle: +05.3° Zoom: 1.0X Staff: 11978+00- Karst ECD's & signage</small></p>

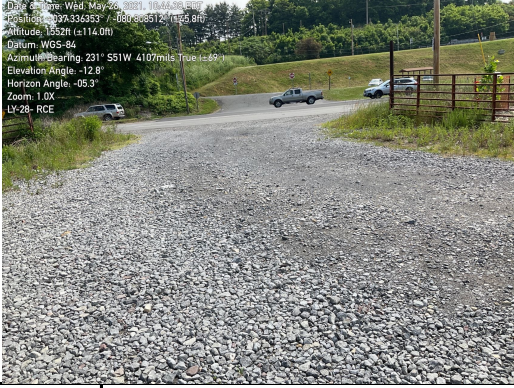
<p>Date & Time: Wed, May 26, 2021, 10:36:41 EDT Position: +037.334333° / -080.808171° (+37.010) Altitude: 1551ft (+46.0m) Datum: WGS-84 Azimuth Bearing: 231° S51W 4107mils True (+180°) Elevation Angle: -12.8° Horizon Angle: -05.3° Zoom: 1.0X LY 28- RCE</p>

<p>Date & Time: Wed, May 26, 2021, 10:36:20 EDT Position: +037.334333° / -080.808171° (+37.010) Altitude: 1551ft (+46.0m) Datum: WGS-84 Azimuth Bearing: 241° S61W 4246mils True (+180°) Elevation Angle: -13.5° Horizon Angle: -05.1° Zoom: 1.0X LY 28- Secondary containment units under buses</p>			
GPS Location	See photo GPS		GPS Location	See photo GPS	
Field Station#	12005+00		Field Station#	12005+00	
Pic 1 Desc.	LY 28- RCE		Pic 2 Desc.	LY 28- Secondary containment units under buses.

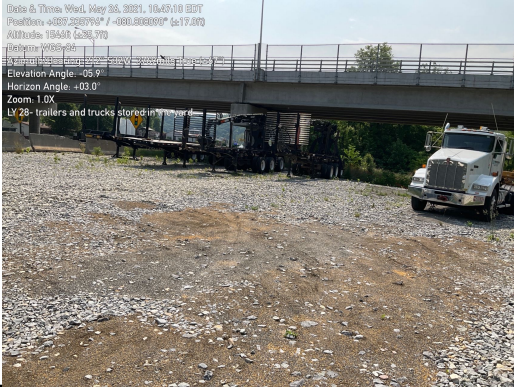
<p>Date & Time: Wed, May 26, 2021, 10:45:18 EDT Position: +037.334615° / -080.800973° (+37.010) Altitude: 1564ft (+48.0m) Datum: WGS-84 Azimuth Bearing: 026° N24E 0427mils True (+180°) Elevation Angle: -05.9° Horizon Angle: +03.0° Zoom: 1.0X LY 28- trailers and trucks stored in the yard.</p>

GPS Location	See photo GPS		GPS Location	See photo GPS	
Field Station#	12005+00		Field Station#	12005+00	
Pic 3 Desc.	LY 28- Trailers and trucks stored in the yard.		Pic 4 Desc.	LY 28- CFS perimeter controls.

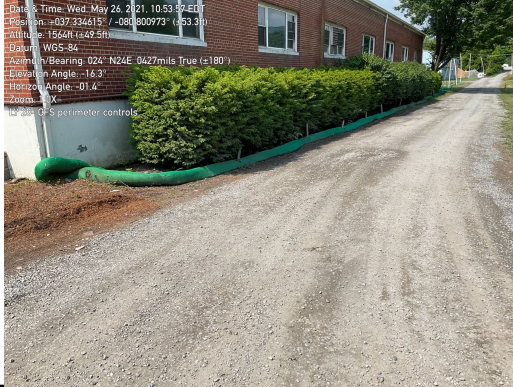
<p>Date & Time: Wed, May 26, 2021, 10:53:19 EDT Position: +037.334615° / -080.800973° (+37.010) Altitude: 1564ft (+48.0m) Datum: WGS-84 Azimuth Bearing: 026° N24E 0427mils True (+180°) Elevation Angle: -16.3° Horizon Angle: -01.4° Zoom: 1.0X LY 28- CFS perimeter controls.</p>

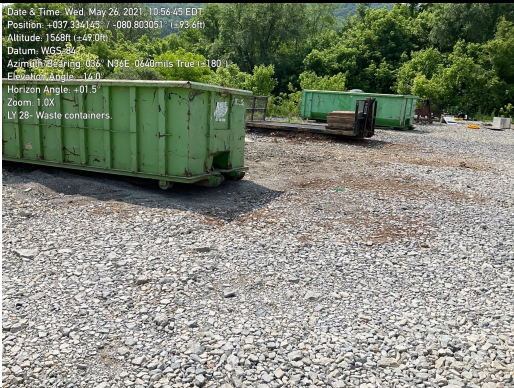
<p>Date & Time: Wed, May 26, 2021, 10:56:43 EDT Position: +037.334615° / -080.803292° (+37.010) Altitude: 1568ft (+48.0m) Datum: WGS-84 Azimuth Bearing: 026° N24E 0540mils True (+180°) Elevation Angle: -14.0° Horizon Angle: +01.5° Zoom: 1.0X LY 28- Waste containers.</p>

Pic 5 Desc.	LY 28- Waste containers.		Pic 6 Desc.	LY 28- This portion of the yard is primarily used for truck parking.

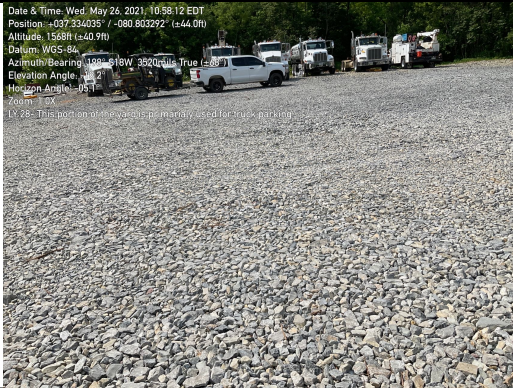
<p>Date & Time: Wed, May 26, 2021, 10:58:12 EDT Position: +037.334615° / -080.803292° (+37.010) Altitude: 1568ft (+48.0m) Datum: WGS-84 Azimuth Bearing: 026° N24E 0540mils True (+180°) Elevation Angle: -14.0° Horizon Angle: +01.5° Zoom: 1.0X LY 28- This portion of the yard is primarily used for truck parking.</p>			
GPS Location	See photo GPS		GPS Location	See photo GPS	
Field Station#	12005+00		Field Station#	12005+00

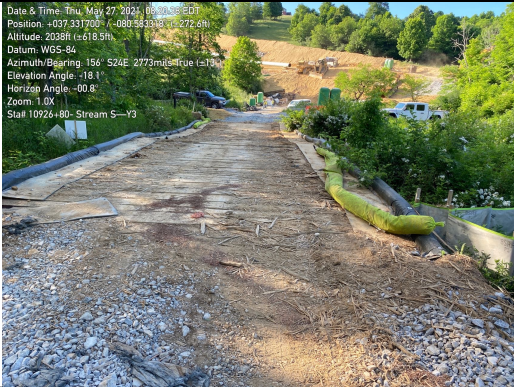
GPS Location	See photo GPS	GPS Location	See photo GPS		
Field Station#	10926+80	Field Station#	10926+26		
Pic 3 Desc.	Stream S-Y3	Pic 4 Desc.	Stream S- Y2

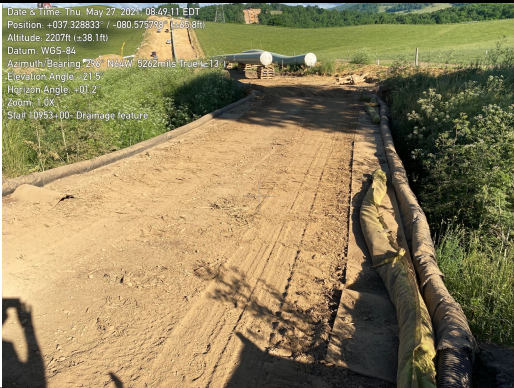
GPS Location	See photo GPS	GPS Location	See photo GPS		
Field Station#	10953+00	Field Station#	10965+00		
Pic 5 Desc.	Drainage feature	Pic 6 Desc.	Sensitive resource area ECD's.

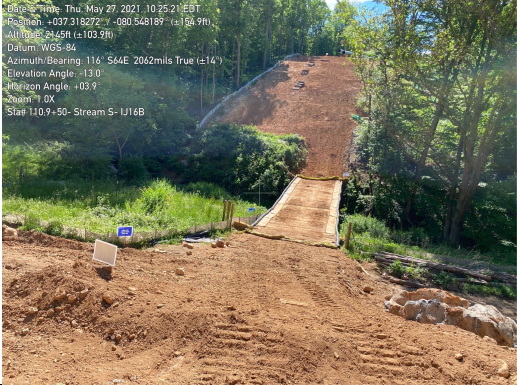
<p><small>Date & Time: Thu, May 27, 2021, 10:25:21 EDT Position: +037.318272° / -080.548189° (±156.9M) Altitude: 2145ft (±103.9M) Datum: WGS-84 Azimuth/Bearing: 116° S44E 2062mils True (±14°) Elevation Angle: -13.0° Horizon Angle: -03.9° Zoom: 1.0X Stall: 11049+50- Stream S- IJ16B</small></p>		  <p><small>Date & Time: Thu, May 27, 2021, 10:34:37 EDT Position: +037.317593° / -080.546491° (±170.7M) Altitude: 2118ft (±196.3M) Datum: WGS-84 Azimuth/Bearing: 153° S47E 2364mils True (±14°) Elevation Angle: -20.1° Horizon Angle: -06.1° Zoom: 1.0X Stall: 11056+00- Karst ECD's</small></p>			
GPS Location	See photo GPS	GPS Location	See photo GPS		
Field Station#	11049+50	Field Station#	11056+00		
Pic 13 Desc.	Stream S- IJ16B	Pic 14 Desc.	Karst ECD's

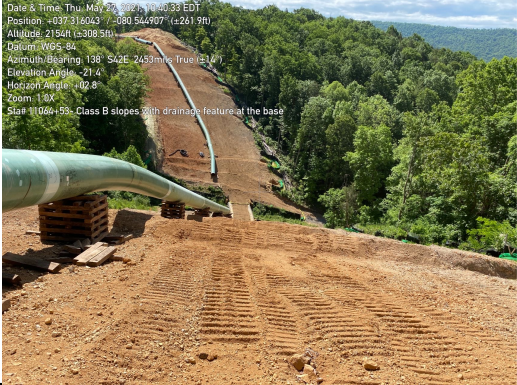
<p><small>Date & Time: Thu, May 27, 2021, 10:30:33 EDT Position: +037.316043° / -080.544707° (±261.9M) Altitude: 2150ft (±308.5M) Datum: WGS-84 Azimuth/Bearing: 138° S42E 2453mils True (±14°) Elevation Angle: -21.4° Horizon Angle: -02.8° Zoom: 1.0X Stall: 11064+53- Class B slopes with drainage feature at the base</small></p>		<div style="text-align: center;">Insert image here</div>

GPS Location	See photo GPS	GPS Location			
Field Station#	11064+53	Field Station#			
Pic 15 Desc.	Class B slope with water bars and drainage feature at the base of slopes.	Pic 16 Desc.			
<div style="text-align: center;">Insert image here</div>		<div style="text-align: center;">Insert image here</div>			
GPS Location		GPS Location			
Field Station#		Field Station#			
Pic 17 Desc.		Pic 18 Desc.

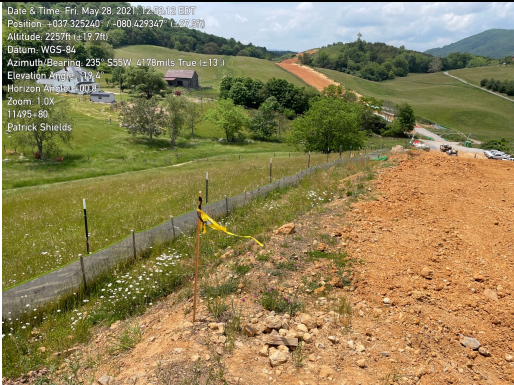
GPS Location	See photo	GPS Location	See photo		
Field Station#	11495+80	Field Station#	11451+25		
Pic 3 Desc.	P1 perimeter control in place	Pic 4 Desc.	Geotextile fabric needs reattached		
<p>Date & Time: Fri, May 28, 2021, 11:46:00 EDT Position: +037.31893° / -080.44098° (-18.40) Altitude: 2118ft (-26.2ft) Datum: WGS-84 Azimuth/Bearing: 330° SSW 4438mils True (-12.1) Elevation Angle: -08.2° Horizon Angle: -08.2° Zoom: 1.0X 11442+00 Patrick Shields</p>

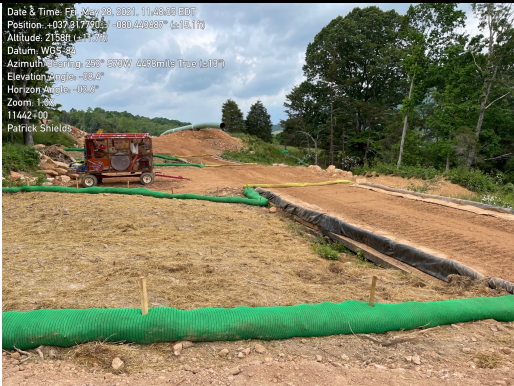
GPS Location	See photo	GPS Location	See photo		
Field Station#	11442+00	Field Station#	11429+25		
Pic 5 Desc.	Clean water drainage feature in place	Pic 6 Desc.	Slope drain needed

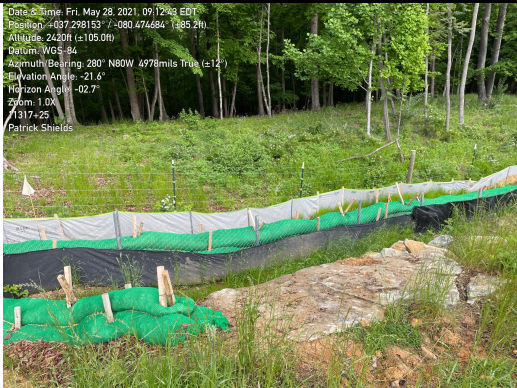
GPS Location	See photo	GPS Location	See photo		
Field Station#	11328+63	Field Station#	11317+25		
Pic 9 Desc.	Stream buffer in place	Pic 10 Desc.	Triple protection in place at karst feature		
<p>Date & Time: Fri, May 28, 2021, 09:13:43 EDT Position: +037.294101° / -080.468555° (-18.5671) Altitude: 3300ft (±187.8ft) Datum: WGS-84 Azimuth/Bearing: 257° S77W 6500mils True (±12°) Elevation Angle: -18.0° Horizon Angle: -15.0° Zoom: 1.0X 11287+50 Patrick Shields</p>  		<p>Date & Time: Fri, May 28, 2021, 08:29:31 EDT Position: +037.274294° / -080.492150° (-18.2721) Altitude: 2131ft (±9.8ft) Datum: WGS-84 Azimuth/Bearing: 280° N80W 5307mils True (±12°) Elevation Angle: -10.9° Horizon Angle: -02.5° Zoom: 1.0X 11260+00 Patrick Shields</p>

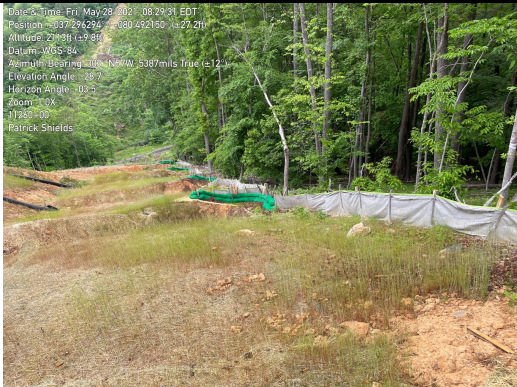
GPS Location	See photo	GPS Location	See photo		
Field Station#	11287+50	Field Station#	11260+00		
Pic 11 Desc.	Slope stabilized	Pic 12 Desc.	End treatments in place
