# Visual Site Inspection Report

<b>Project Name</b>	H-600 Pipeline Spread G	<b>AFE</b>	124300137	<b>Spread</b>	H-600 Pipeline Spread G
<b>Contractor</b>	Precision			<b>Report #</b>	22933
<b>Inspector</b>	Patrick Shields			<b>Date/Time</b>	5/3/2021 8:30 AM
<b>Permit #</b>	TBD	<b>Inspection Type</b>	VA SWPP	<b>Station Begin</b>	11670+00
<b>State</b>	VA	<b>Inspection Area</b>	Partial	<b>Station End</b>	11788+52
<b>County</b>	Montgomery	<b>Ground</b>	Wet	<b>Temperature (°F)</b>	65.00
<b>Municipality</b>	N/A	<b>Weather</b>	Light Rain	<b>Rain Gauge (in)</b>	0.00
				<b>Rain Accumulation Time (days)</b>	1.00

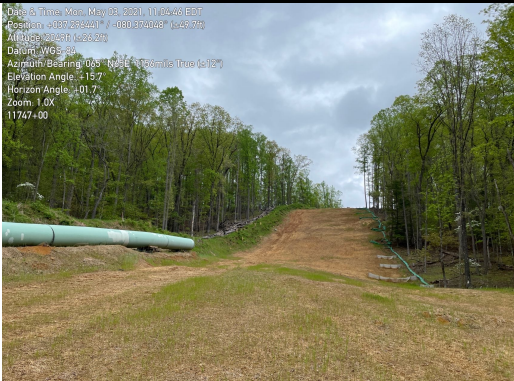
<b>GPS Location</b>	See photo	<b>GPS Location</b>	See photo		
<b>Field Station#</b>	11747+00	<b>Field Station#</b>	11764+01		
<b>Pic 5 Desc.</b>	Good vegetation on topsoil piles	<b>Pic 6 Desc.</b>	RCE in place

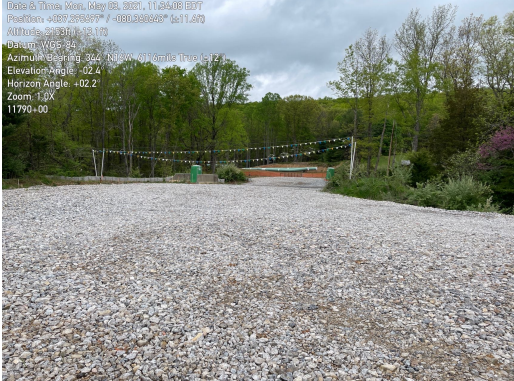
<b>GPS Location</b>	See photo	<b>GPS Location</b>	See photo		
<b>Field Station#</b>	11790+00	<b>Field Station#</b>	11796+00		
<b>Pic 1 Desc.</b>	RCE in place	<b>Pic 2 Desc.</b>	ECDs in place

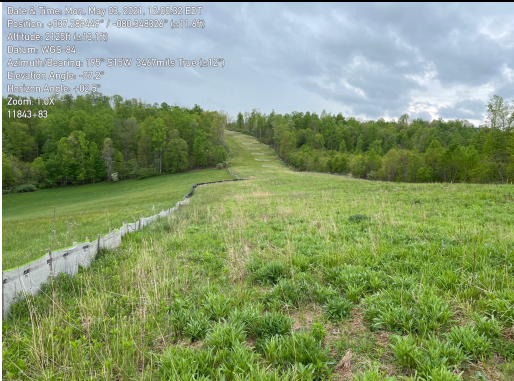
<b>GPS Location</b>	See photo	<b>GPS Location</b>	See photo		
<b>Field Station#</b>	11843+83	<b>Field Station#</b>	11833+00		
<b>Pic 3 Desc.</b>	P1 and supersilt perimeter controls in place	<b>Pic 4 Desc.</b>	Waterbars and level spreaders in place

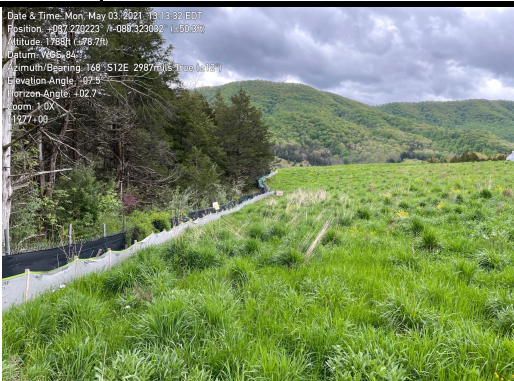
<b>GPS Location</b>	See photo	<b>GPS Location</b>	See photo		
<b>Field Station#</b>	11977+00	<b>Field Station#</b>	11200+00		
<b>Pic 5 Desc.</b>	Triple protection in place at karst	<b>Pic 6 Desc.</b>	Vegetation on ROW

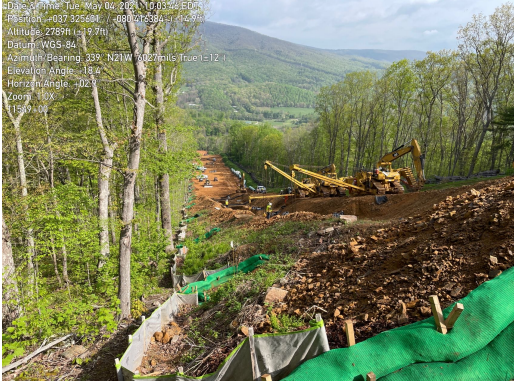
<b>GPS Location</b>	See photo	<b>GPS Location</b>	See photo		
<b>Field Station#</b>	11549+00	<b>Field Station#</b>	11549+55		
<b>Pic 1 Desc.</b>	End treatments in place	<b>Pic 2 Desc.</b>	Slope drains in place

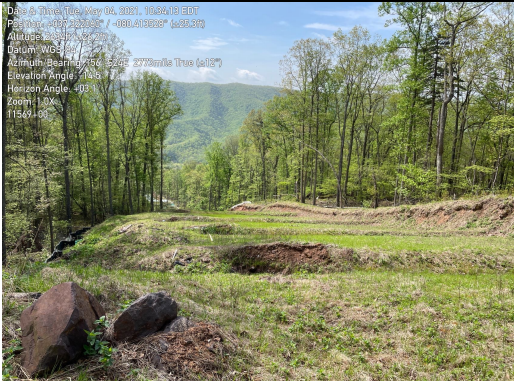
<b>GPS Location</b>	See photo	<b>GPS Location</b>	See photo		
<b>Field Station#</b>	11569+00	<b>Field Station#</b>	11573+77		
<b>Pic 3 Desc.</b>	Waterbars in place	<b>Pic 4 Desc.</b>	Clean water diversion berm in place

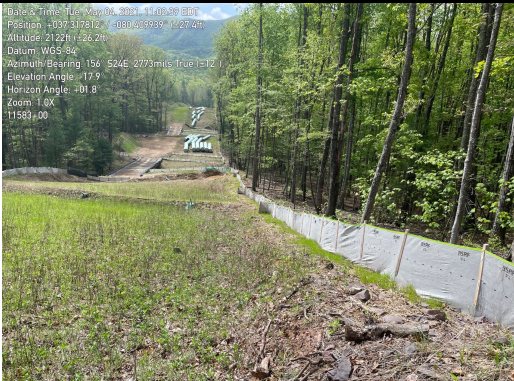
<b>GPS Location</b>	See photo	<b>GPS Location</b>	See photo		
<b>Field Station#</b>	11583+00	<b>Field Station#</b>	11588+00		
<b>Pic 5 Desc.</b>	P1 perimeter control in place	<b>Pic 6 Desc.</b>	Buffer in place

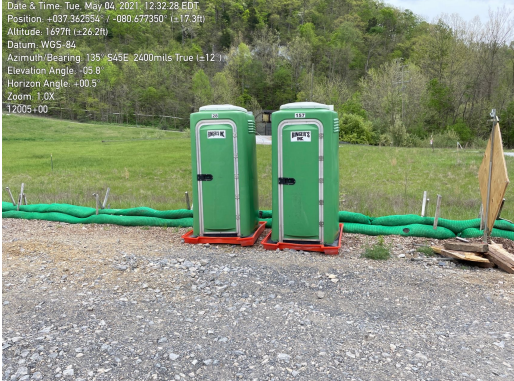
<b>GPS Location</b>	See photo		<b>GPS Location</b>	See photo	
<b>Field Station#</b>	12005+00		<b>Field Station#</b>	12005+00	
<b>Pic 1 Desc.</b>	Secondary containment in place		<b>Pic 2 Desc.</b>	Culvert in place	
<p>Date &amp; Time: Tue, May 04, 2021, 12:05:16 EDT  Position: +037.342272° / -080.676920° (+16.24)  Altitude: 1706ft (+11.20)  Datum: WGS-84  Azimuth/Bearing: 171° S09E 3050mils True (+13°)  Elevation Angle: -03.3°  Horizon Angle: +01.6°  Zoom: 1.0X  12005+00</p>

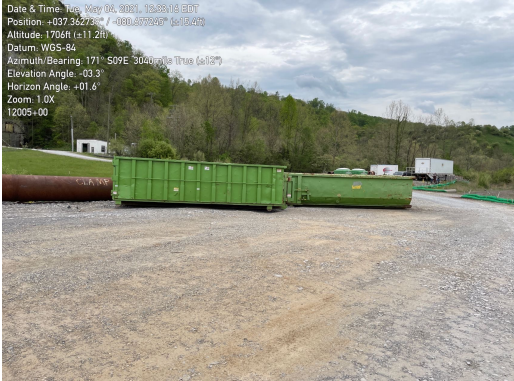
<b>GPS Location</b>	See photo		<b>GPS Location</b>	See photo	
<b>Field Station#</b>	12005+00		<b>Field Station#</b>	12005+00	
<b>Pic 3 Desc.</b>	Waste bins in place		<b>Pic 4 Desc.</b>	Employee parking	
<p>Date &amp; Time: Tue, May 04, 2021, 12:04:37 EDT  Position: +037.342262° / -080.676920° (+16.24)  Altitude: 1706ft (+11.20)  Datum: WGS-84  Azimuth/Bearing: 133° S03E 3370mils True (+13°)  Elevation Angle: -07.1°  Horizon Angle: +00.6°  Zoom: 1.0X  12005+00</p>

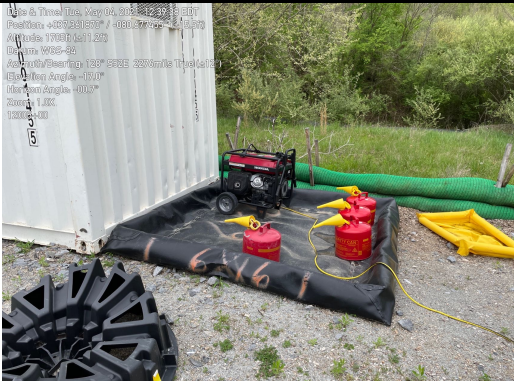
<b>GPS Location</b>	See photo		<b>GPS Location</b>	See photo	
<b>Field Station#</b>	12005+00		<b>Field Station#</b>	12005+00	
<b>Pic 5 Desc.</b>	Secondary containment in place		<b>Pic 6 Desc.</b>	CFS triple stack perimeter control in place

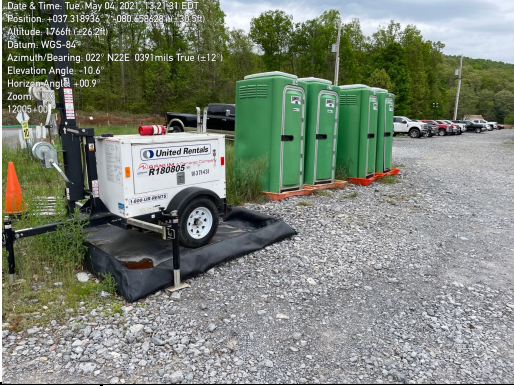
<b>GPS Location</b>	See photo	<b>GPS Location</b>	See photo		
<b>Field Station#</b>	12005+00	<b>Field Station#</b>	12005+00		
<b>Pic 1 Desc.</b>	Secondary containment in place	<b>Pic 2 Desc.</b>	CFS triple stack perimeter control in place

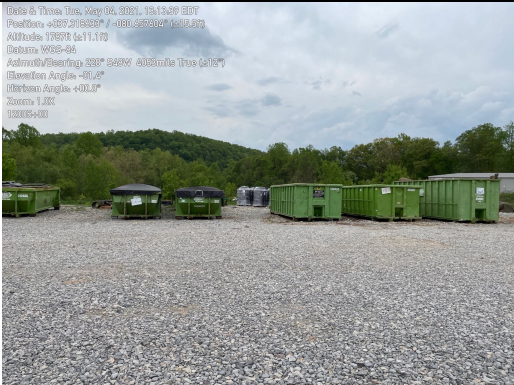
<b>GPS Location</b>	See photo	<b>GPS Location</b>	See photo		
<b>Field Station#</b>	12005+00	<b>Field Station#</b>	12005+00		
<b>Pic 3 Desc.</b>	Waste bins in place	<b>Pic 4 Desc.</b>	Fuel island in place

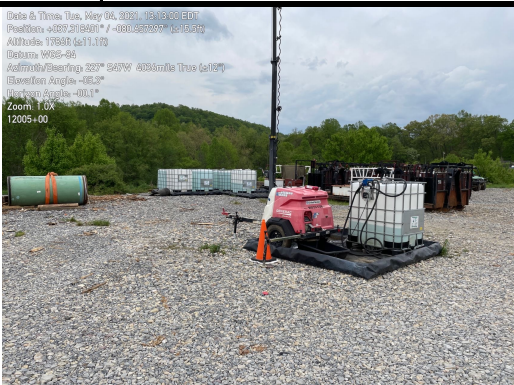
<b>GPS Location</b>	See photo	<b>GPS Location</b>	See photo		
<b>Field Station#</b>	12005+00	<b>Field Station#</b>	12005+00		
<b>Pic 5 Desc.</b>	Secondary containment in place	<b>Pic 6 Desc.</b>	Safety fence in place

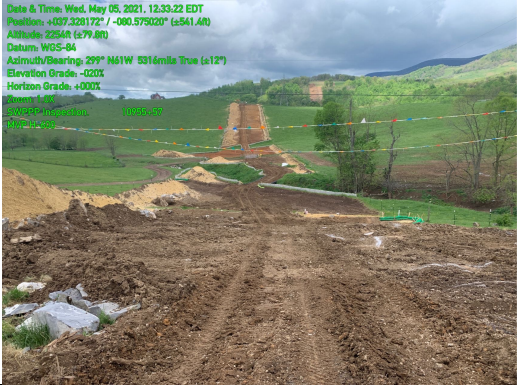
<p><small>Date &amp; Time: Wed, May 05, 2021, 12:33:22 EDT Position: +037.320172° / -080.575020° (s=541.40) Altitude: 2254ft (s=79.80) Datum: WGS-84 Azimuth/Bearing: 299° N61W 5314mils True (s=12°) Elevation Grade: -02% Horizon Grade: +000% Elevation: 10955+57 SWPPP Inspection: 10955+57 MVP H-600</small></p>			
<b>GPS Location</b>	See photo	<b>GPS Location</b>	See photo		
<b>Field Station#</b>	10966+00	<b>Field Station#</b>	10955+57		
<b>Pic 7 Desc.</b>	Pull soil back from P1 filter fence around Karst feature.	<b>Pic 8 Desc.</b>	VA SWPPP INSPECTION

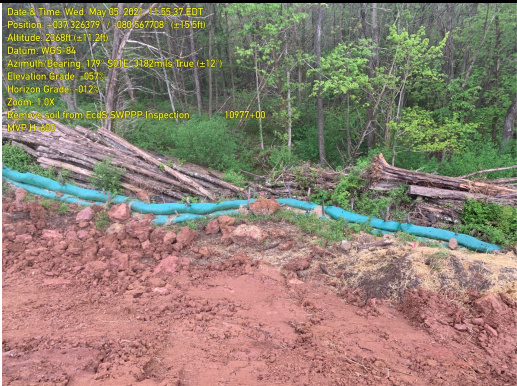
<p><small>Date &amp; Time: Wed, May 05, 2021, 12:34:37 EDT Position: +037.326574° / -080.577758° (s=18.50) Altitude: 2401ft (s=37.30) Datum: WGS-84 Azimuth/Bearing: 119° S68E 5332mils True (s=12°) Elevation Grade: -02% Horizon Grade: -01% Elevation: 10977+00 SWPPP Inspection: 10977+00 MVP H-600</small></p>			
<b>GPS Location</b>	See photo	<b>GPS Location</b>	See photo		
<b>Field Station#</b>	10966+00	<b>Field Station#</b>	10978+00		
<b>Pic 9 Desc.</b>	VA SWPPP INSPECTION	<b>Pic 10 Desc.</b>	Pull soil back from CFS.		
Insert image here		Insert image here			
<b>GPS Location</b>		<b>GPS Location</b>

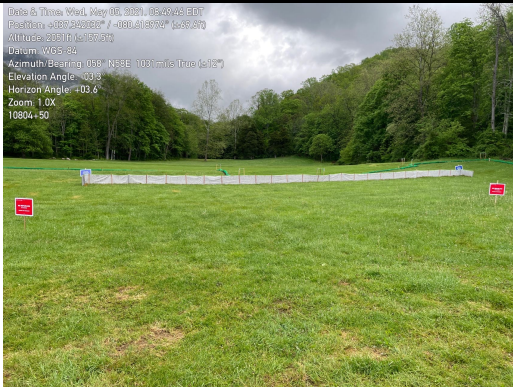
<p>Date &amp; Time: Wed, May 05, 2021, 10:24:50 EDT Position: 400° 29' 33.92" N / -80° 51' 40.92" W Altitude: 2570 ft (+19.7m) Datum: WGS 84 Azimuth/Bearing: 281° N29W 4996mils True (+12°) Elevation Angle: -33.0 Horizon Angle: +00.6 Zoom: 1.0X 10822+57</p>					
GPS Location		See photo		GPS Location		See photo	
Field Station#		10804+50		Field Station#		10822+57	
Pic 1 Desc.		Sensitive resource signage on display		Pic 2 Desc.		CFS perimeter control in place

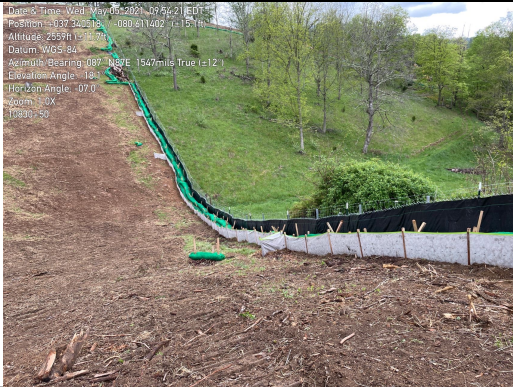
GPS Location		See photo		GPS Location		See photo	
Field Station#		10830+50		Field Station#		10839+00	
Pic 3 Desc.		Triple protection for karst in place		Pic 4 Desc.		Triple stack CFS perimeter control in place

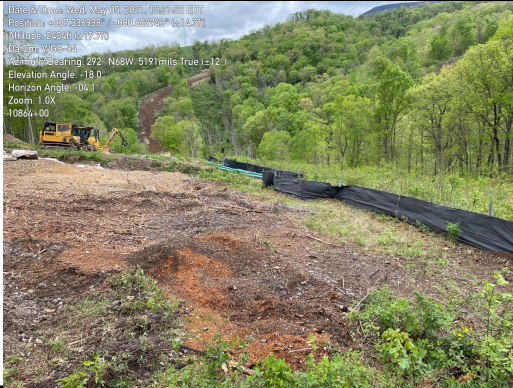
<p>Date &amp; Time: Wed, May 05, 2021, 10:24:50 EDT Position: 403° 33' 52.71" N / -80° 52' 14.31" W Altitude: 2168 ft (+9.8ft) Datum: WGS 84 Azimuth/Bearing: 138° S42E 2453mils True (+12°) Elevation Angle: +13.4 Horizon Angle: +00.5 Zoom: 1.0X 10882+00</p>					
GPS Location		See photo		GPS Location		See photo	
Field Station#		10864+00		Field Station#		10882+00	
Pic 5 Desc.		Perimeter control supersilt in place		Pic 6 Desc.		Buffer in place

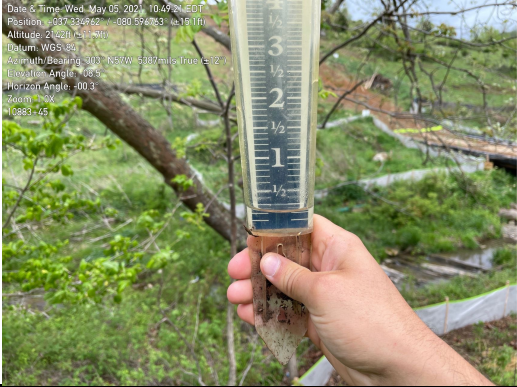
<b>GPS Location</b>	See photo	<b>GPS Location</b>	See photo		
<b>Field Station#</b>	10883+45	<b>Field Station#</b>	10886+00		
<b>Pic 7 Desc.</b>	Kow camp rain gauge measures 0.3"	<b>Pic 8 Desc.</b>	End treatments on hill in place

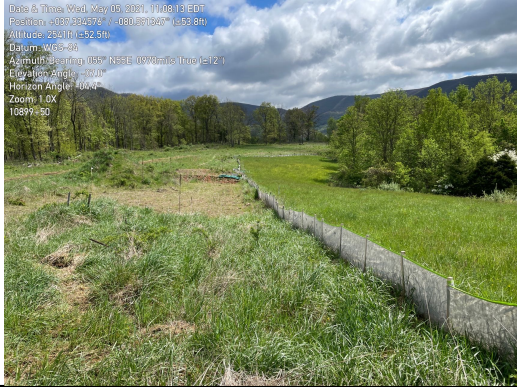
<b>GPS Location</b>	See photo	<b>GPS Location</b>	See photo		
<b>Field Station#</b>	10899+50	<b>Field Station#</b>	10745+67		
<b>Pic 9 Desc.</b>	Perimeter control silt fence in place	<b>Pic 10 Desc.</b>	Vegetation on ROW

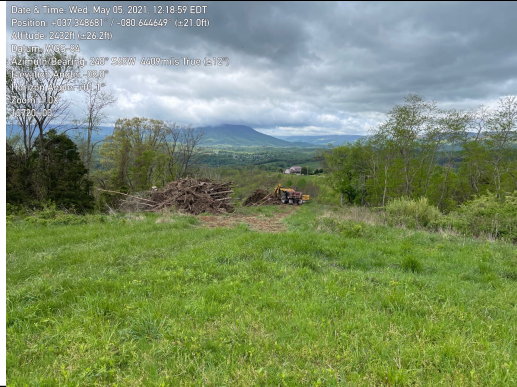
<b>GPS Location</b>	See photo	<b>GPS Location</b>	See photo		
<b>Field Station#</b>	10720+00	<b>Field Station#</b>	10679+71		
<b>Pic 11 Desc.</b>	Northern building brush piles	<b>Pic 12 Desc.</b>	Replaced CFS buffer

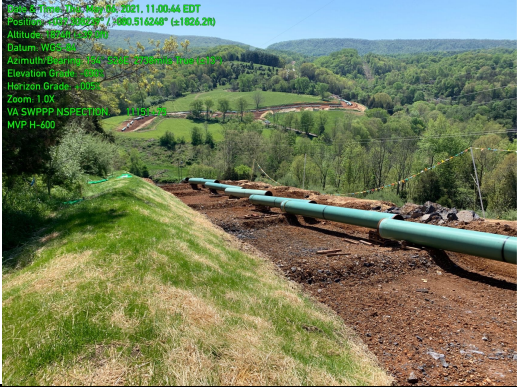
<p>Date &amp; Time: Thu, May 06, 2021, 09:41:43 EDT Position: +037.309551° / -080.560788° (s13780.22) Altitude: 1902ft (s31.40) Datum: WGS-84 Azimuth/Bearing: 300° 00'1W 0402mils True (s10°) Elevation Grade: +010X Horizon Grade: +000X Zoom: 1.0X VA SWPPP INSPECTION 11068+00 MVP H-600</p>			
<b>GPS Location</b>	See photo	<b>GPS Location</b>	See photo		
<b>Field Station#</b>	11151+25	<b>Field Station#</b>	11068+00		
<b>Pic 7 Desc.</b>	CWDB was stabilized. Water bars functional.	<b>Pic 8 Desc.</b>	Water bars functional.

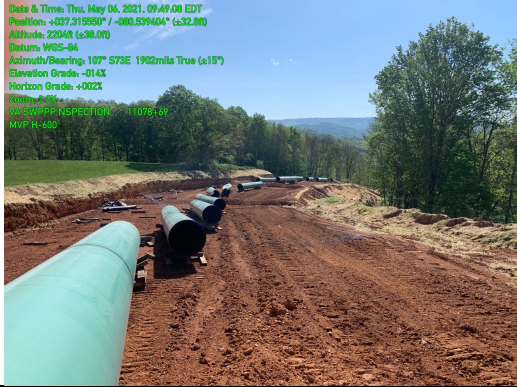
<p>Date &amp; Time: Thu, May 06, 2021, 09:49:08 EDT Position: +037.215550° / -080.539404° (s32.88) Altitude: 2204ft (s38.00) Datum: WGS-84 Azimuth/Bearing: 107° 57'3E 1902mils True (s15°) Elevation Grade: +014X Horizon Grade: +002X Zoom: 1.0X VA SWPPP INSPECTION 11078+69 MVP H-600</p>			
<b>GPS Location</b>	See photo	<b>GPS Location</b>	See photo		
<b>Field Station#</b>	11078+69	<b>Field Station#</b>	11078+69		
<b>Pic 9 Desc.</b>	Construction berm along grade functional.	<b>Pic 10 Desc.</b>	Stockpiles & CWDB stabilized.

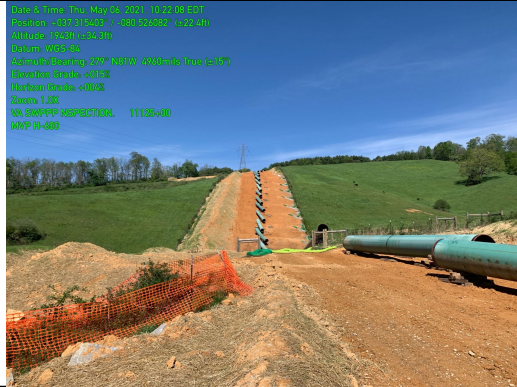
<b>GPS Location</b>	See photo	<b>GPS Location</b>	See photo		
<b>Field Station#</b>	11125+00	<b>Field Station#</b>	11188+00		
<b>Pic 11 Desc.</b>	Soil stockpiles stabilized. Waddles in place between gaps.	<b>Pic 12 Desc.</b>	Clean slope drain inlet. PL item

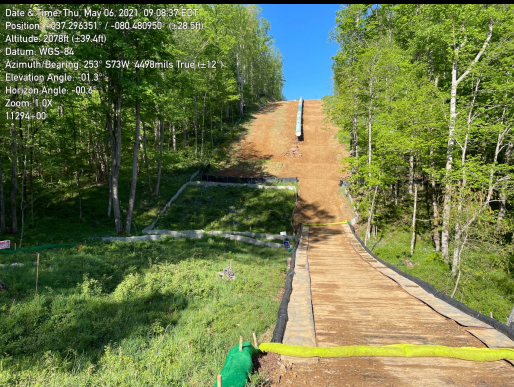
GPS Location	See photo	GPS Location	See photo		
Field Station#	11294+00	Field Station#	11342+70		
Pic 7 Desc.	Stream buffer in place	Pic 8 Desc.	Rock inlet in place		
<p>Date &amp; Time: Thu, May 06, 2021, 10:53:08 EDT Position: +037.319563° / -080.443018° (+28.1ft) Altitude: 2093ft (+29.7ft) Datum: WGS-84 Azimuth/Bearing: 303° N57W 5387mils True (+12°) Elevation Angle: -27.1° Horizon Angle: -00.5° Zoom: 1.0X 11373+80</p>

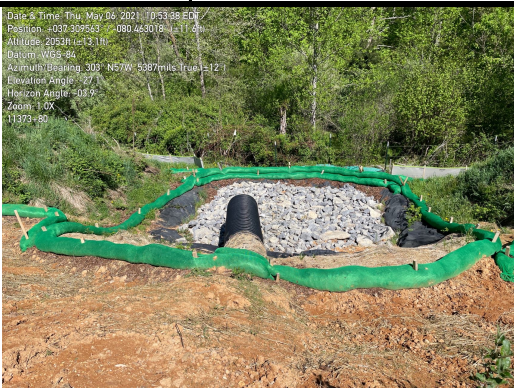
GPS Location	See photo	GPS Location	See photo		
Field Station#	11373+80	Field Station#	11446+55		
Pic 9 Desc.	Plunge pool in place	Pic 10 Desc.	6" buffer of mulch on topsoil pile		
<p>Date &amp; Time: Thu, May 06, 2021, 12:37:49 EDT Position: +037.321953° / -080.435807° (+34.4ft) Altitude: 2270ft (+39.7ft) Datum: WGS-84 Azimuth/Bearing: 100° N05E 5037mils True (+12°) Elevation Angle: -03.2° Horizon Angle: -06.0° Zoom: 1.0X 11472+43</p>

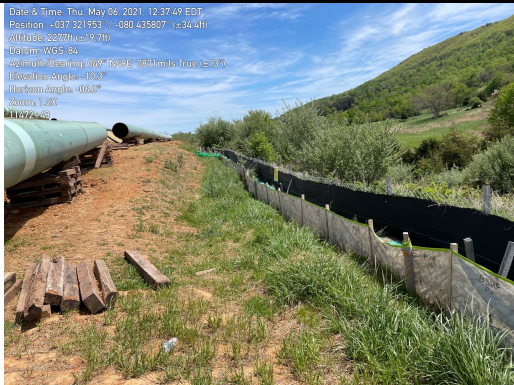
GPS Location	See photo	GPS Location	See photo		
Field Station#	11472+43	Field Station#	11484+00		
Pic 11 Desc.	Karst triple protection ECDs in place	Pic 12 Desc.	CFS perimeter control in place

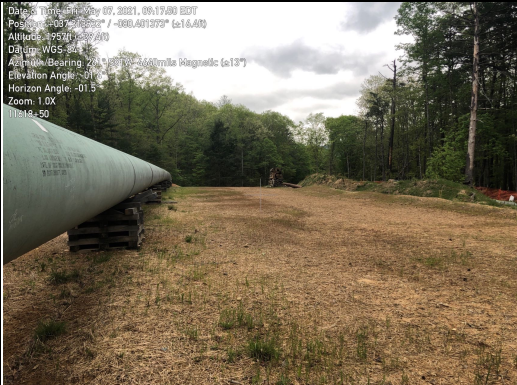
<p>Date &amp; Time: Fri, May 07, 2021, 09:19:53 EDT Position: +037.313887° / -080.402337° (±98.4ft) Altitude: 1998ft (±78.7ft) Datum: WGS-84 Azimuth/Bearing: 277° N83W 4924mils Magnetic (±13°) Elevation Angle: -18.4° Horizon Angle: -03.3° Zoom: 1.0X 11614+20 S-RR14 crossing</p>			
GPS Location	On photo	GPS Location	On photo		
Field Station#	11618+50	Field Station#	11614+20		
Pic 7 Desc.	ROW stable.	Pic 8 Desc.	Buffers stable at the S-RR14 crossing.

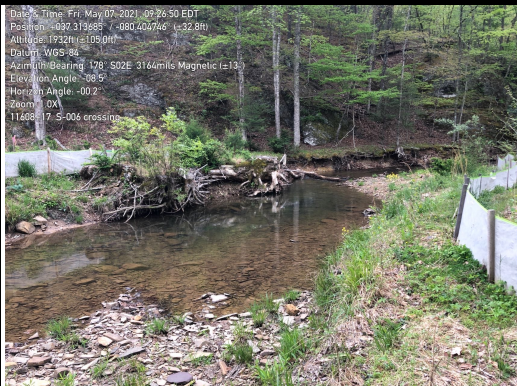
GPS Location	On photo	GPS Location	On photo		
Field Station#	11608+17	Field Station#	11605+00		
Pic 9 Desc.	The S-006 crossing is stable.	Pic 10 Desc.	ROW is stable.

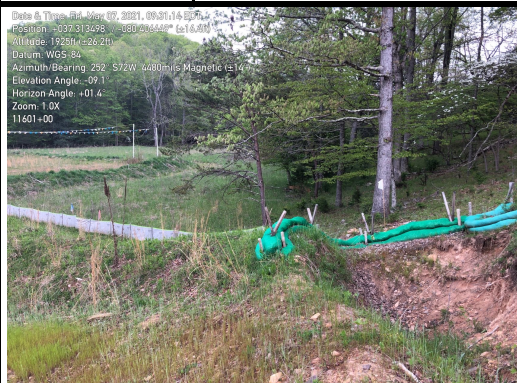
<p>Date &amp; Time: Fri, May 07, 2021, 09:31:14 EDT Position: +037.313498° / -080.264488° (±16.6ft) Altitude: 1925ft (±76.2ft) Datum: WGS-84 Azimuth/Bearing: 289° S72W 4480mils Magnetic (±13°) Elevation Angle: -09.1° Horizon Angle: +01.4° Zoom: 1.0X 11601+00</p>		Insert image here			
GPS Location	On photo			GPS Location	
Field Station#	11601+00	Field Station#			
Pic 11 Desc.	Perimeter ECDs in place. ROW currently stable.	Pic 12 Desc.

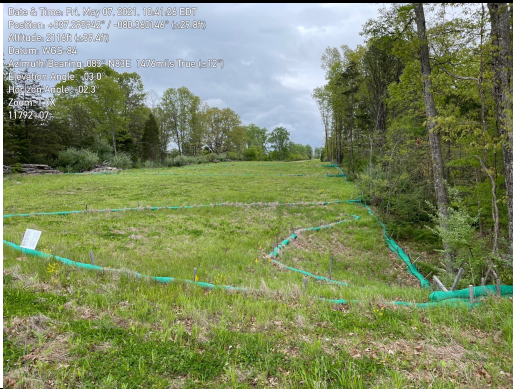
GPS Location				See photo				GPS Location				See photo			
Field Station#				11792+07				Field Station#				11826+00			
Pic 1 Desc.				CFS controls in place				Pic 2 Desc.				Waterbars/ level spreaders in place

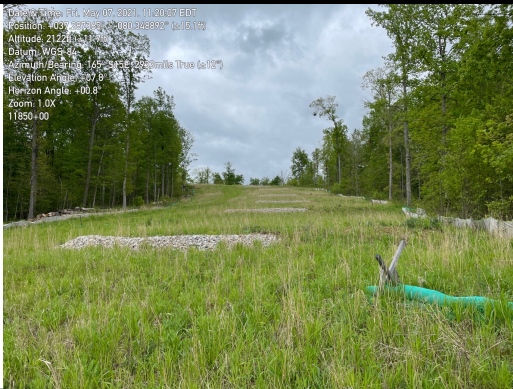
GPS Location				See photo				GPS Location				See photo			
Field Station#				11850+00				Field Station#				11929+00			
Pic 3 Desc.				Level spreaders in place				Pic 4 Desc.				P1 perimeter control in place

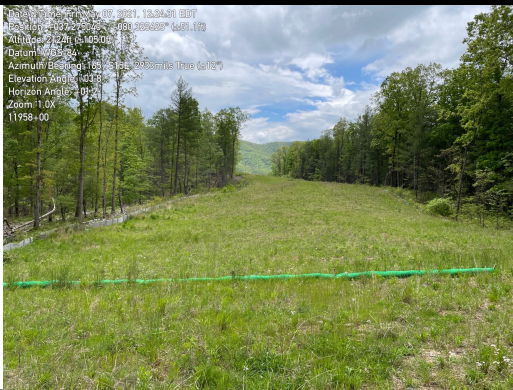
GPS Location				See photo				GPS Location				See photo			
Field Station#				11958+00				Field Station#				11971+00			
Pic 5 Desc.				Good vegetation on ROW				Pic 6 Desc.				Waterbars in place

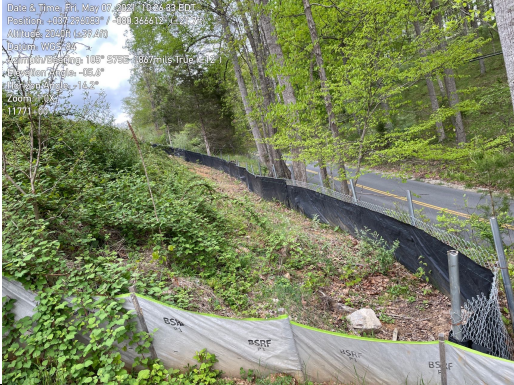
<p>Date &amp; Time: Fri, May 07, 2021, 09:04:55 EDT Position: +037 294322° / -85° 380764° (-28.846°) Altitude: 2215ft (+39.4ft) Datum: WGS-84 Azimuth/Bearing: 113° 50E (200mils True) (-2°) Elevation Angle: +0.3° Horizon Angle: +0.3° Zoom: 1.0X 11705+50</p>			
<b>GPS Location</b>	See photo	<b>GPS Location</b>	See photo		
<b>Field Station#</b>	11771+00	<b>Field Station#</b>	11705+50		
<b>Pic 1 Desc.</b>	Supersilt perimeter control in place	<b>Pic 2 Desc.</b>	ROW stabilized

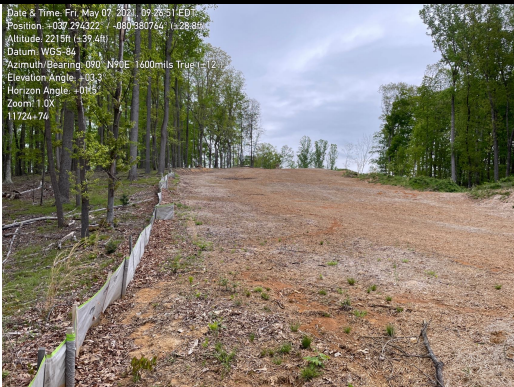
<b>GPS Location</b>	See photo	<b>GPS Location</b>	See photo		
<b>Field Station#</b>	11724+74	<b>Field Station#</b>	11787+00		
<b>Pic 3 Desc.</b>	P1 perimeter control in place	<b>Pic 4 Desc.</b>	RCE in place

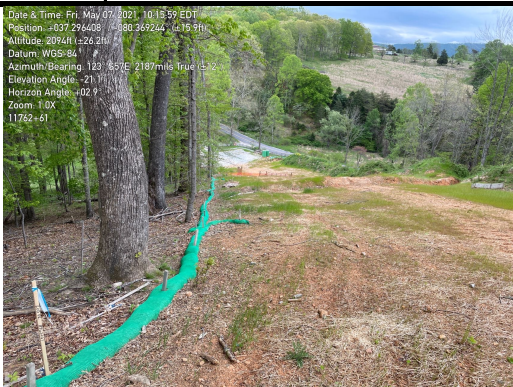
<p>Date &amp; Time: Fri, May 07, 2021, 10:13:39 EDT Position: +037 294322° / -85° 367244° (-15.51ft) Altitude: 2094ft (+26.2ft) Datum: WGS-84 Azimuth/Bearing: 123° 55E (2187mils True) (-12°) Elevation Angle: +0.3° Horizon Angle: +0.3° Zoom: 1.0X 11762+61</p>			
<b>GPS Location</b>	See photo	<b>GPS Location</b>	See photo		
<b>Field Station#</b>	11740+79	<b>Field Station#</b>	11762+61		
<b>Pic 5 Desc.</b>	Buffer in place	<b>Pic 6 Desc.</b>	CFS perimeter control in place
