Visual Site Inspection Report

Project Name	H-600 Pipeline Spread G	AFE	124300137	Spread	H-600 Pipeline Spread G
Contractor	Precision			Report #	23992
Inspector	Len Kruizenga			Date/Time	6/1/2021 5:23 PM
Permit #	TBD	Inspection Type	VA SWPP	Station Begin	11788+53
State	VA	Inspection Area	Full	Station End	12005+00
County	Montgomery	Ground	Dry	Temperature (°F)	71.00
Municipality	N/A	Weather	Sunny	Rain Gauge (in)	0.60
				Rain Accumulation Time (days)	2.00

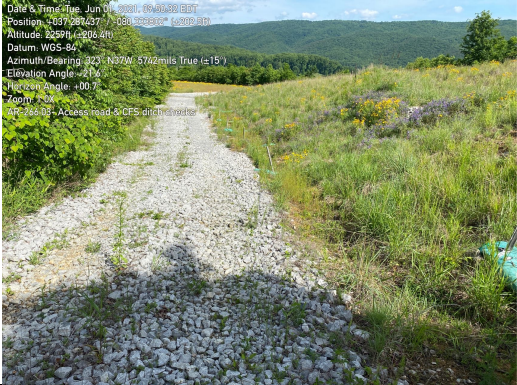
AFE 124300137		Date/Time	6/1/2021 5:23 PM	Report #	
Pictures					
<p>Date & Time: Tue, Jun 01, 2021 10:48:09 EDT Position: +037.287437° / -080.228321° (+296.5M) Altitude: 2299ft (+296.5m) Datum: WGS-84 Azimuth/Bearing: 323° N37W 57.2mils True (+15°) Elevation Angle: +00.7° Horizon Angle: +00.7° Zoom: 1.0x Stat: 266.03 - Access road & CFS ditch checks</p>

GPS Location		See photo GPS		GPS Location	
Field Station#		11900+00		Field Station#	
Pic 7 Desc.		Access road 266.03 and CFS ditch checks		Pic 8 Desc.	
<p>Date & Time: Tue, Jun 01, 2021 10:16:09 EDT Position: +037.277935° / -080.327224° (+296.5M) Altitude: 2299ft (+296.5m) Datum: WGS-84 Azimuth/Bearing: 318° N42W 10.5mils True (+15°) Elevation Angle: +25.1° Horizon Angle: +05.5° Zoom: 1.0x Stat: 11940+00 - Karst ECD's & 12' perimeter controls</p>

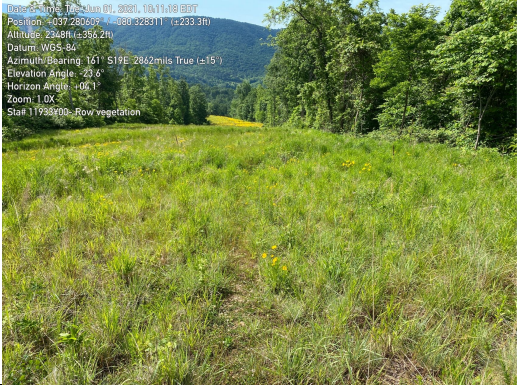
<p>Date & Time: Tue, Jun 01, 2021 10:48:09 EDT Position: +037.280597° / -080.328311° (+233.3M) Altitude: 2348ft (+355.2m) Datum: WGS-84 Azimuth/Bearing: 161° S19E 28.2mils True (+15°) Elevation Angle: +20.5° Horizon Angle: +00.1° Zoom: 1.0x Stat: 11933+00 - Row vegetation</p>

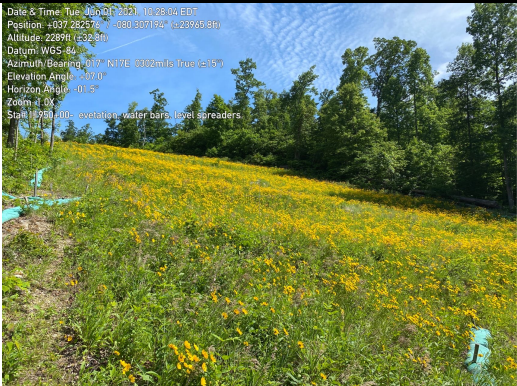
<p>Date & Time: Tue, Jun 01, 2021 10:28:00 EDT Position: +037.282374° / -080.327124° (+296.5M) Altitude: 2299ft (+296.5m) Datum: WGS-84 Azimuth/Bearing: 167° N75E 30.0mils True (+15°) Elevation Angle: +21.0° Horizon Angle: +01.5° Zoom: 1.0x Stat: 11950+00 - Row vegetation, water bars, level spreaders</p>

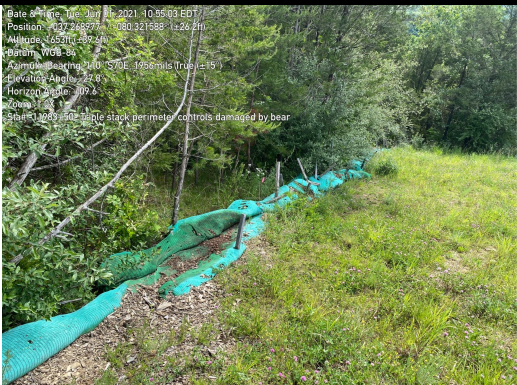
<p>Date & Time: Tue, Jun 01, 2021 10:55:03 EDT Position: +037.288771° / -080.321038° (+26.2M) Altitude: 4659ft (+59.5m) Datum: WGS-84 Azimuth/Bearing: 160° S30E 19.5mils True (+15°) Elevation Angle: +24.9° Horizon Angle: +09.2° Zoom: 1.0x Stat: 11983+50 - Triple stack perimeter controls damaged by bear</p>

GPS Location		See photo GPS		GPS Location	
Field Station#		11977+00		Field Station#	
Pic 11 Desc.		Karst ECD's and signage.		Pic 12 Desc.	
				Triple stack perimeter controls damaged by bear.

E&S BMPs	Compliance Level	Corrective Action	Corrective Time Frame	Date Repaired
Broad-Based Dip	Acceptable			
Compost Filter Sock	Communication	Repair damaged sock	24 Hours	
Rock Check Dam	Acceptable			
Rock Construction Entrance	Acceptable			
Sensitive Resource Signage	Acceptable			
Silt Fence (Filter Fabric Fence)	Communication	Repair damaged silt fence	24 Hours	
Vegetative Stabilization (Permanent)	Acceptable			
Waterbar	Acceptable			
Waterbar Outlet Protection	Acceptable

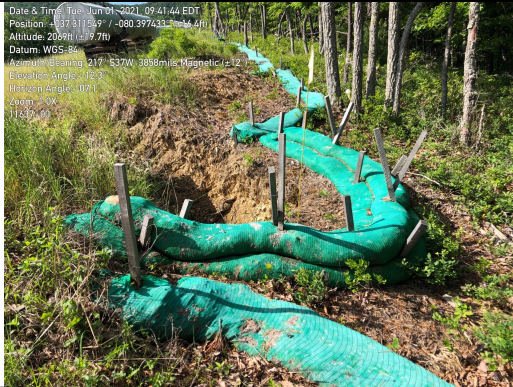
GPS Location	On photo	GPS Location	On photo		
Field Station#	11657+00	Field Station#	11637+00		
Pic 3 Desc.	Sumps and end treatments are functional.		Pic 4 Desc.	End treatments and sumps are functioning.

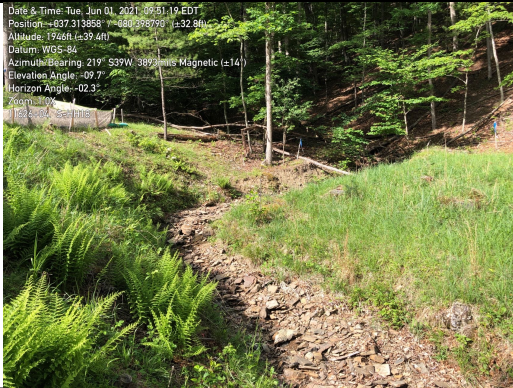
<p>Date & Time: Tue, Jun 01, 2021 09:51:19 EDT Position: +037.312868° / -080.395356° (-16.4m) Altitude: 1926ft (-39.4m) Datum: WGS-84 Azimuth/Bearing: 219° 53'40" 308mils Magnetic (-14°) Elevation Angle: -09.7° Horizon Angle: -02.3° Zoom: 1.00 11626+04</p>			
GPS Location	On photo	GPS Location	On photo		
Field Station#	11627+50	Field Station#	11626+04		
Pic 5 Desc.	ROW stable. ECDs in place.		Pic 6 Desc.	The S-HH18 crossing is stable. No impact.

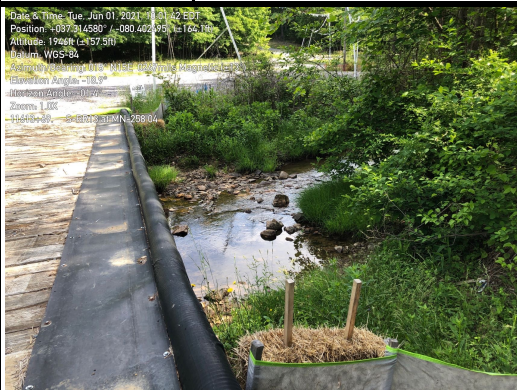
GPS Location	On photo		GPS Location	On photo	
Field Station#	11613+69		Field Station#	11608+17	
Pic 9 Desc.	The S-RR13 crossing at access road 258.04 is stable.		Pic 10 Desc.	The S-006 crossing is stable. No impact.	
<div><div><div><div><div><div>Date & Time: Tue, Jun 01, 2021, 10:10:40 EDT</div><div>Position: +037.313826° / -080.405253° (+32.8ft)</div><div>Altitude: 1918ft (+26.2ft)</div><div>Datum: WGS-84</div><div>Azimuth/Bearing: 240° S80W 0760mils Magnetic (+10°)</div><div>Elevation Angle: +00.9°</div><div>Horizon Angle: +00.8°</div><div>Zoom: 1.0X</div><div>11607+00</div></div></div><div>

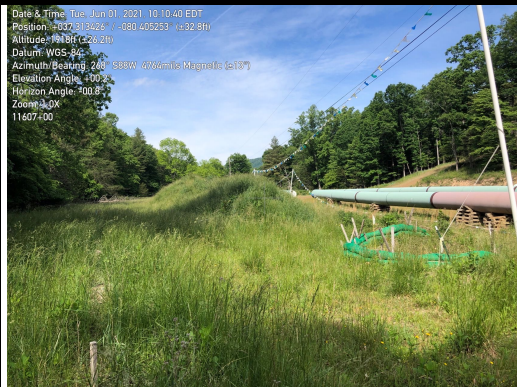
</div></div></div></div>		<div>Insert image here</div>			
GPS Location	On photo		GPS Location		
Field Station#	11607+00		Field Station#		
Pic 11 Desc.	ROW stable. Adequate ECDs in place.		Pic 12 Desc.

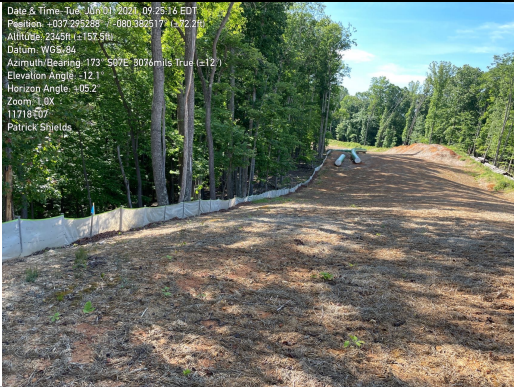
GPS Location	See photo	GPS Location	See photo		
Field Station#	11718+07	Field Station#	11749+00		
Pic 3 Desc.	P1 perimeter control in place	Pic 4 Desc.	Good vegetation on topsoil piles		
<p>Date & Time: Tue Jun 01, 2021, 09:57:23 EDT Position: -037.232319, -080.349239 (+30.4ft) Altitude: 2391ft (+28.2ft) Datum: WGS-84 Azimuth/Bearing: -159° S21E 2827mils True (+13°) Elevation Angle: -17.1° Horizon Angle: -02.7° Zoom: 1.0X 11761+03 Patrick Shields</p>

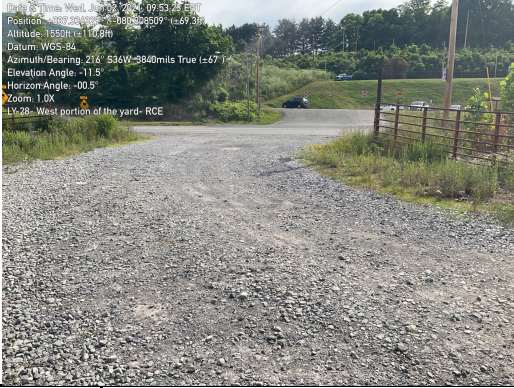
<p>Date & Time: Wed, Jun 02, 2021, 09:53:25 EDT Position: +337.530293° / -880.808171° (±12.12m) Altitude: 1550ft (±11.8m) Datum: WGS-84 Azimuth/Bearing: 216° 53'W 3840mils True (±67°) Elevation Angle: -11.5° Horizon Angle: -00.5° Zoom: 1.0X LY-28- West portion of the yard- RCE</p>

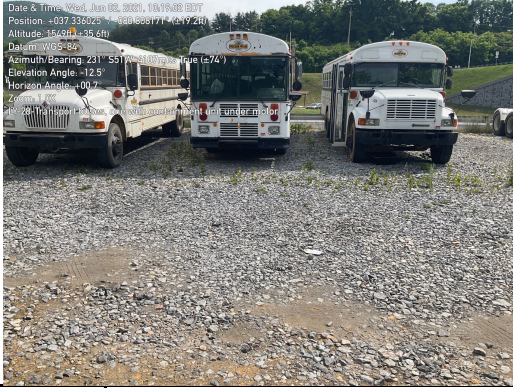
<p>Date & Time: Wed, Jun 02, 2021, 10:15:08 EDT Position: +337.530293° / -880.808171° (±12.12m) Altitude: 1549ft (±15.6m) Datum: WGS-84 Azimuth/Bearing: 231° 55'W 4110mils True (±74°) Elevation Angle: -12.5° Horizon Angle: -00.7° Zoom: 1.0X LY-28-Transport buses</p>			
GPS Location	See photo GPS	GPS Location	See photo GPS		
Field Station#	12005+00	Field Station#	12005+00		
Pic 1 Desc.	LY-28 East yard RCE.	Pic 2 Desc.	Transport buses, one with containment unit under motor.

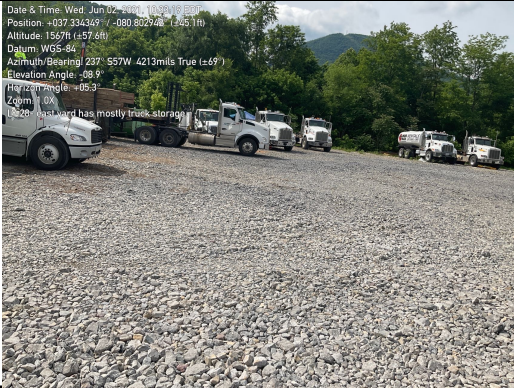
<p>Date & Time: Wed, Jun 02, 2021, 10:34:03 EDT Position: +337.534220° / -880.802652° (±14.3m) Altitude: 1572ft (±30.0m) Datum: WGS-84 Azimuth/Bearing: 218° 53'W 3876mils True (±25°) Elevation Angle: -14.8° Horizon Angle: -08.3° Zoom: 1.0X LY-28- east yard has mostly truck storage</p>

<p>Date & Time: Wed, Jun 02, 2021, 10:34:03 EDT Position: +337.534220° / -880.802652° (±14.3m) Altitude: 1572ft (±30.0m) Datum: WGS-84 Azimuth/Bearing: 218° 53'W 3876mils True (±25°) Elevation Angle: -14.8° Horizon Angle: -08.3° Zoom: 1.0X LY-28- east yard- Waste container</p>			
GPS Location	See photo GPS	GPS Location	See photo GPS		
Field Station#	12005+00	Field Station#	12005+00		
Pic 5 Desc.	LY-28- Mostly used for truck parking.	Pic 6 Desc.	LY-28- Waste container.

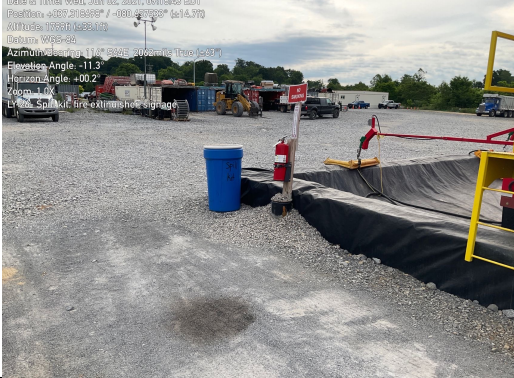
AFE	124300137	Date/Time	6/2/2021 8:46 AM	Report #	
Pictures					
<p>Date & Time: Wed, Jun 02, 2021, 09:16:29 EDT Position: +037.318348° / +080.656337° (+14.370) Altitude: 1800ft (+25.51ft) Datum: WGS-84 Azimuth/Bearing: 138° S42E 2453mils True (+55°) Elevation Angle: -11.3° Horizon Angle: +00.2° Zoom: 1.0x LY26- Spill kits, fire extinguishers, signage</p>

GPS Location	See photo GPS	GPS Location	See photo GPS		
Field Station#	12005+00	Field Station#	12005+00		
Pic 1 Desc.	LY26- Spill kits, fire extinguishers, signage	Pic 2 Desc.	LY26- Contractor fuel storage in containment.		
<p>Date & Time: Wed, Jun 02, 2021, 09:24:19 EDT Position: +037.318348° / +080.656337° (+14.370) Altitude: 1800ft (+25.51ft) Datum: WGS-84 Azimuth/Bearing: 138° S42E 2453mils True (+55°) Elevation Angle: -01.1° Horizon Angle: +01.1° Zoom: 1.0x LY26- Waste containers</p>

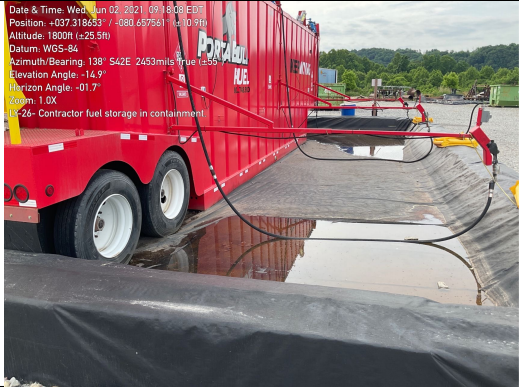
<p>Date & Time: Wed, Jun 02, 2021, 09:18:08 EDT Position: +037.318348° / +080.656337° (+14.370) Altitude: 1800ft (+25.51ft) Datum: WGS-84 Azimuth/Bearing: 138° S42E 2453mils True (+55°) Elevation Angle: -14.9° Horizon Angle: -01.7° Zoom: 1.0x LY26- Contractor fuel storage in containment</p>

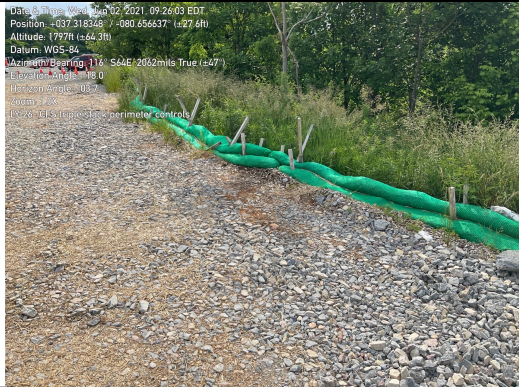
<p>Date & Time: Wed, Jun 02, 2021, 09:26:03 EDT Position: +037.318348° / +080.656337° (+14.370) Altitude: 1797ft (+54.31ft) Datum: WGS-84 Azimuth/Bearing: 116° S42E 2082mils True (+47°) Elevation Angle: -03.0° Horizon Angle: -03.0° Zoom: 1.0x LY26- CFS triple stack perimeter controls</p>

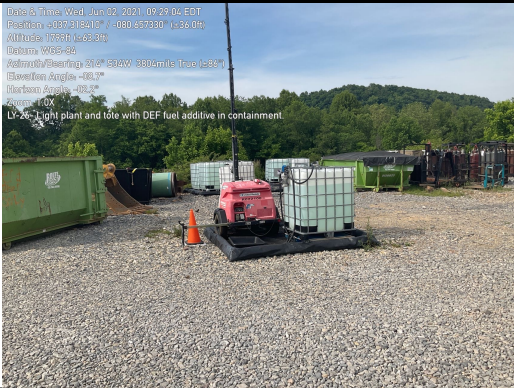
GPS Location	See photo GPS	GPS Location	See photo GPS		
Field Station#	12005+00	Field Station#	12005+00		
Pic 3 Desc.	LY-26- Waste containers.	Pic 4 Desc.	LY26- CFS triple stack perimeter controls.		
<p>Date & Time: Wed, Jun 02, 2021, 09:27:04 EDT Position: +037.318348° / +080.656337° (+14.370) Altitude: 1798ft (+54.31ft) Datum: WGS-84 Azimuth/Bearing: 212° S28W 358mils True (+28°) Elevation Angle: -01.1° Horizon Angle: -01.1° Zoom: 1.0x LY26- Light plant and tote with DEF fuel additive in containment.</p>

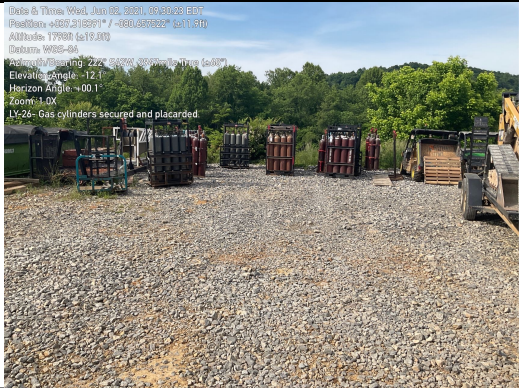
<p>Date & Time: Wed, Jun 02, 2021, 09:28:08 EDT Position: +037.318348° / +080.656337° (+14.370) Altitude: 1798ft (+54.31ft) Datum: WGS-84 Azimuth/Bearing: 222° S28W 358mils True (+28°) Elevation Angle: -12.1° Horizon Angle: -00.1° Zoom: 1.0x LY26- Gas cylinders secured and placarded</p>

Pic 5 Desc.	LY26- Light plant and tote with DEF fuel additive in containment.	Pic 6 Desc.	LY26- Gas cylinders are secured and placarded.

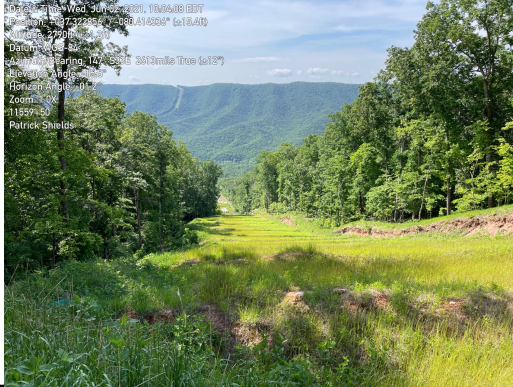
GPS Location	See photo	GPS Location	See photo		
Field Station#	11546+50	Field Station#	11559+50		
Pic 3 Desc.	P1 perimeter control damaged	Pic 4 Desc.	Waterbars in place

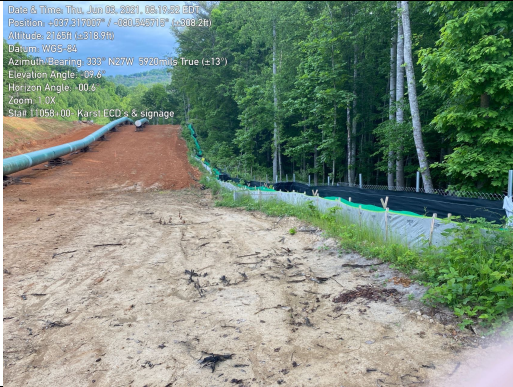
GPS Location	See photo GPS		GPS Location	See photo GPS	
Field Station#	11064+53		Field Station#	11058+00	
Pic 1 Desc.	Drainage feature, equipment bridge ECD's		Pic 2 Desc.	Karst ECD's.	
<p>Date & Time: Thu, Jun 03, 2021, 08:26:31 EDT Position: +037.218172° / +080.242700° (+20.1m) Altitude: 2207ft (+229.6m) Datum: WGS-84 Azimuth/Bearing: 291° N69W 507mils True (+13°) Elevation Angle: -02.0° Horizon Angle: -01.2° Zoom: 1.0X Stat: 11049+50: Stream S- IJ16B, stream is dry no flow</p>

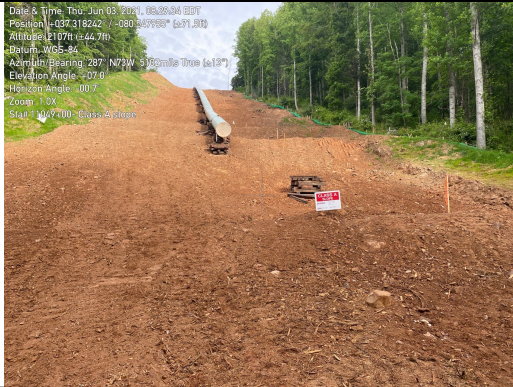
GPS Location	See photo GPS		GPS Location	See photo GPS	
Field Station#	11049+50		Field Station#	11049+00	
Pic 3 Desc.	Stream S- IJ16B		Pic 4 Desc.	Class A slope and row.	
<p>Date & Time: Thu, Jun 03, 2021, 08:06:36 EDT Position: +037.222041° / +080.251978° (+27.2m) Altitude: 2420ft (+244.4m) Datum: WGS-84 Azimuth/Bearing: 296° N64W 520mils True (+13°) Elevation Angle: -11.7° Horizon Angle: -03.4° Zoom: 1.0X Stat: 11025+00: Stream S-IJ18</p>

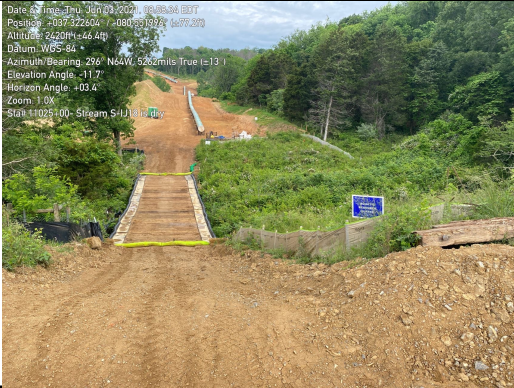
<p>Date & Time: Thu, Jun 03, 2021, 07:41:40 EDT Position: +037.222041° / +080.251978° (+27.2m) Altitude: 2417ft (+243.2m) Datum: WGS-84 Azimuth/Bearing: 317° S20W 300mils True (+13°) Elevation Angle: -01.2° Horizon Angle: -00.0° Zoom: 1.0X AR-244.00: Access road crosses two streams - S-IJ19 & S-IJ18</p>

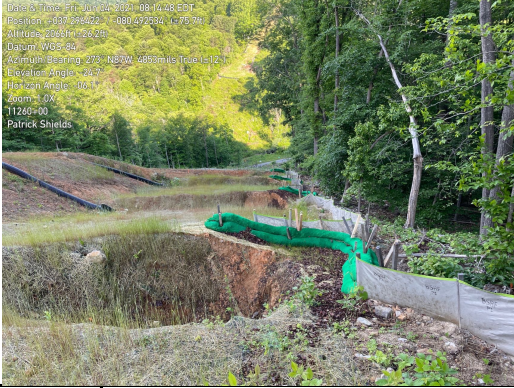
<p>Date & Time: Fri, Jun 4, 2021, 11:00:09 EDT Position: +037.250292 / -080.436601 (+71.6ft) Altitude: 2263ft (+69.1ft) Datum: WGS-84 Azimuth Bearing: 105.575E 1867mils True (+15) Elevation Angle: +19.4 Horizon Angle: -00.9 Zoom: 1.0X 11477+00 Patrick Shields</p>			
GPS Location		See photo		GPS Location	
Field Station#		11260+00		Field Station#	
Pic 1 Desc.		End treatments in place		Pic 2 Desc.

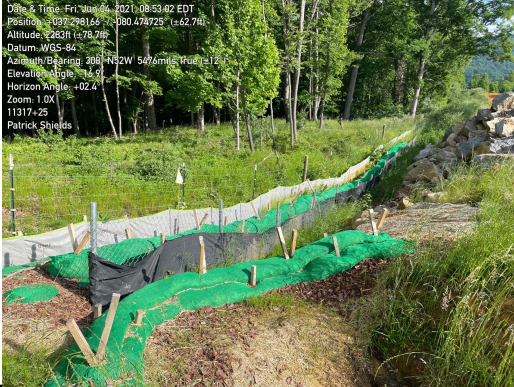
GPS Location		See photo		GPS Location	
Field Station#		11317+25		Field Station#	
Pic 3 Desc.		Triple protection in place at karst feature		Pic 4 Desc.

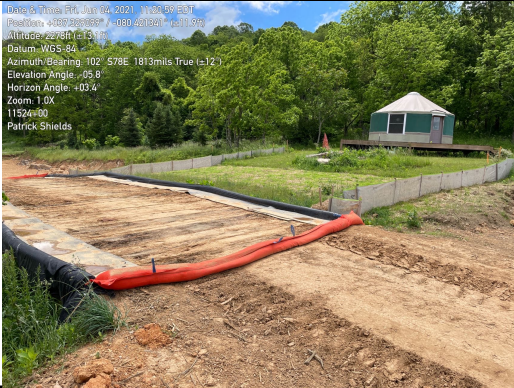
<p>Date & Time: Fri, Jun 4, 2021, 10:22:42 EDT Position: +037.219408 / -080.430104 (+74.0ft) Altitude: 2273ft (+69.1ft) Datum: WGS-84 Azimuth Bearing: 268.588W 476mils True (+12) Elevation Angle: +16.6 Horizon Angle: -02.8 Zoom: 1.0X 11466+00 Patrick Shields</p>			
GPS Location		See photo		GPS Location	
Field Station#		11524+00		Field Station#	
Pic 5 Desc.		Clean water drainage feature in place		Pic 6 Desc.

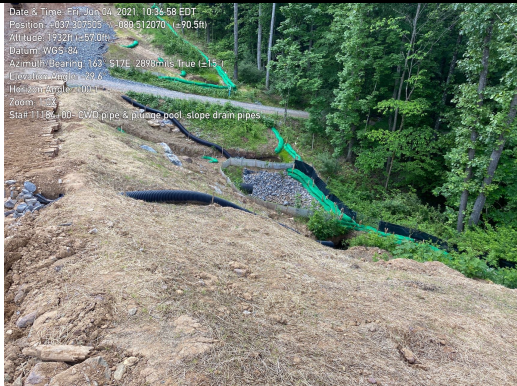
GPS Location	See photo GPS	GPS Location	See photo GPS		
Field Station#	11184+00	Field Station#	11184+50		
Pic 9 Desc.	CWD pipe and plunge pool and slope drains.	Pic 10 Desc.	AR-249.02- Access road and rock check dams, signage.		
<p>Date & Time: Fri Jun 04 2021 10:45:07 EDT Position: +037.306489 / -080.510145 (±200.4ft) Altitude: 1949ft (±45.2ft) Datum: WGS-84 Azimuth/Bearing: 116° S60E 2002mils True (±13°) Elevation Angle: -18.9° Horizon Angle: +02.3° Zoom: 1.0X Staff 11191+00- Sensitive resource drainage feature</p>  		<p>Date & Time: Fri Jun 04 2021 11:02:34 EDT Position: +037.304294 / -080.508835 (±200.4ft) Altitude: 2108ft (±344.3ft) Datum: WGS-84 Azimuth/Bearing: 191° S27E 2684mils True (±13°) Elevation Angle: -10.9° Horizon Angle: +00.8° Zoom: 1.0X Staff 11206+00- Ditch crew working</p>  			
GPS Location	See photo GPS	GPS Location	See photo GPS		
Field Station#	11191+00	Field Station#	11206+00

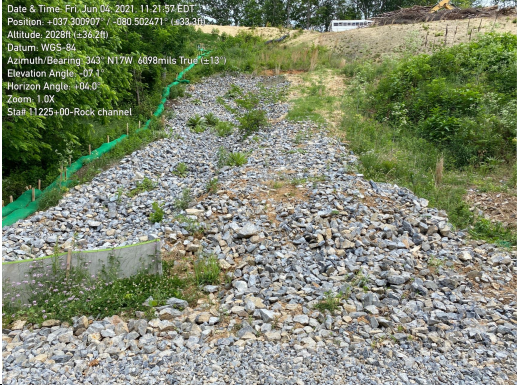
GPS Location		See photo GPS		GPS Location	
Field Station#		11225+00		Field Station#	
Pic 13 Desc.		Rock channel at base of slope.		Pic 14 Desc.	
Insert image here		Insert image here			
GPS Location				GPS Location	
Field Station#				Field Station#	
Pic 15 Desc.				Pic 16 Desc.	
Insert image here		Insert image here			
GPS Location				GPS Location	
Field Station#				Field Station#	
Pic 17 Desc.				Pic 18 Desc.
