# Visual Site Inspection Report

<b>Project Name</b>	H-600 Pipeline Spread G	<b>AFE</b>	124300137	<b>Spread</b>	H-600 Pipeline Spread G
<b>Contractor</b>	Precision			<b>Report #</b>	24186
<b>Inspector</b>	Rob Robertson			<b>Date/Time</b>	6/7/2021 7:03 AM
<b>Permit #</b>	TBD	<b>Inspection Type</b>	VA SWPP	<b>Station Begin</b>	11600+01
<b>State</b>	VA	<b>Inspection Area</b>	Full	<b>Station End</b>	11670+00
<b>County</b>	Montgomery	<b>Ground</b>	Damp	<b>Temperature (°F)</b>	77.00
<b>Municipality</b>	N/A	<b>Weather</b>	Cloudy	<b>Rain Gauge (in)</b>	0.05
				<b>Rain Accumulation Time (days)</b>	1.00

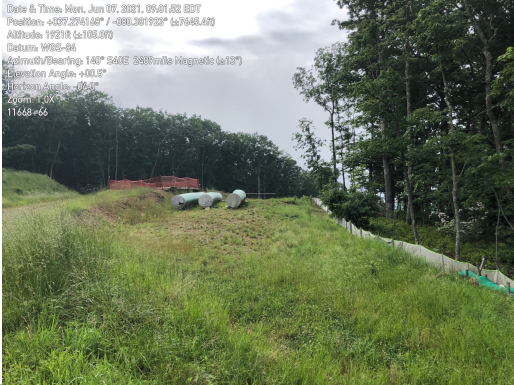
<p>Date &amp; Time: Mon, Jun 07, 2021, 09:41:48 EDT  Position: +037.276166 / -080.381928 (±32.8ft)  Altitude: 1921ft (±100.0ft)  Datum: WGS-84  Azimuth/Bearing: 140° 54W, 2445mils Magnetic (±12°)  Elevation Angle: +00.3°  Horizon Angle: -09.5°  Zoom: 1.0X  11668+66</p>

<b>GPS Location</b>	On photo	<b>GPS Location</b>	On photo		
<b>Field Station#</b>	11668+66	<b>Field Station#</b>	11662+50		
<b>Pic 3 Desc.</b>	ROW stable. ECDs in place.	<b>Pic 4 Desc.</b>	End treatment functional.		
<p>Date &amp; Time: Mon, Jun 07, 2021, 09:36:17 EDT  Position: +037.333704 / -080.397569 (±32.8ft)  Altitude: 2372ft (±39.4ft)  Datum: WGS-84  Azimuth/Bearing: 174.504W, 3120mils Magnetic (±12°)  Elevation Angle: +04.5°  Horizon Angle: -07.2°  Zoom: 1.0X  11653+00</p>

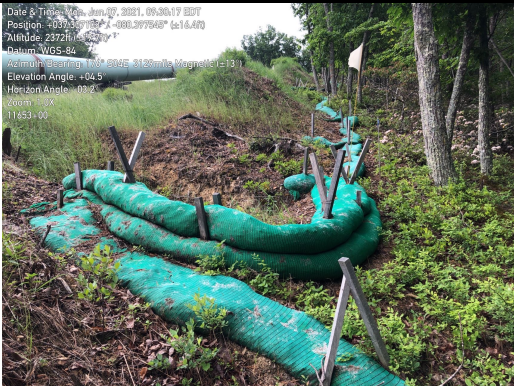
<b>GPS Location</b>	On photo	<b>GPS Location</b>	On photo		
<b>Field Station#</b>	11653+00	<b>Field Station#</b>	11626+50		
<b>Pic 5 Desc.</b>	Perimeter controls in place.	<b>Pic 6 Desc.</b>	Perimeter ECDs in place.

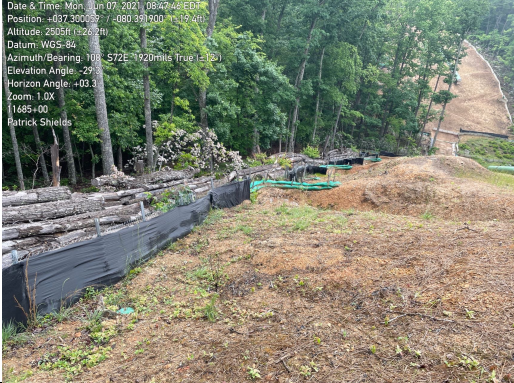
<p>Date &amp; Time: Mon, Jun 07, 2021, 08:47:43 EDT Position: +037.302337, -080.391700, 1169.30 ft Altitude: 2650 ft (1220 m) Datum: WGS-84 Azimuth/Bearing: 100° S 72° E 1920 mls True (±12°) Elevation Angle: -25° Horizon Angle: +03.1° Zoom: 1.0X 11685+00 Patrick Shields</p>

<p>Date &amp; Time: Mon, Jun 07, 2021, 09:16:53 EDT Position: +037.299777, -080.367666, 1172.10 ft Altitude: 2200 ft (670 m) Datum: WGS-84 Azimuth/Bearing: 100° S 72° E 1920 mls True (±12°) Elevation Angle: -25° Horizon Angle: +05.2° Zoom: 1.0X 11721+00 Patrick Shields</p>			
<b>GPS Location</b>	See photo	<b>GPS Location</b>	See photo		
<b>Field Station#</b>	11685+00	<b>Field Station#</b>	11721+00		
<b>Pic 1 Desc.</b>	Supersilt fence perimeter control in place	<b>Pic 2 Desc.</b>	P1 silt fence perimeter control in place

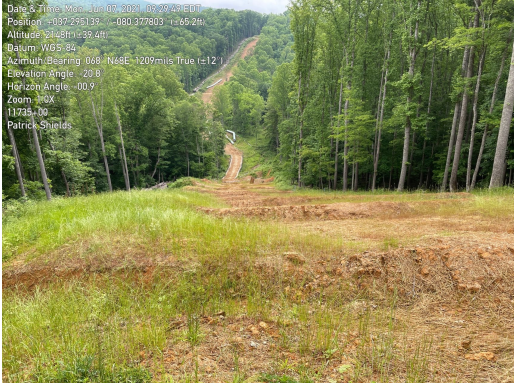
<p>Date &amp; Time: Mon, Jun 07, 2021, 09:57:54 EDT Position: +037.295139, -080.377803, 1173.50 ft Altitude: 2145 ft (654 m) Datum: WGS-84 Azimuth/Bearing: 068° N 68° E 1209 mls True (±12°) Elevation Angle: -20.8° Horizon Angle: -00.9° Zoom: 1.0X 11735+00 Patrick Shields</p>

<b>GPS Location</b>	See photo	<b>GPS Location</b>	See photo		
<b>Field Station#</b>	11735+00	<b>Field Station#</b>	11767+25		
<b>Pic 3 Desc.</b>	Waterbars in place	<b>Pic 4 Desc.</b>	Stream buffer in place

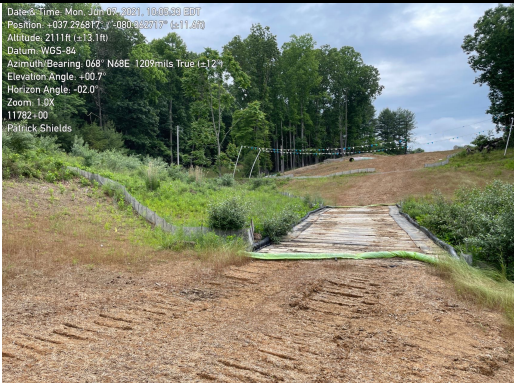
<p>Date &amp; Time: Mon, Jun 07, 2021, 10:06:20 EDT Position: +037.294912, -080.367137, 1178.20 ft Altitude: 2111 ft (643 m) Datum: WGS-84 Azimuth/Bearing: 068° N 68° E 1209 mls True (±12°) Elevation Angle: +00.7° Horizon Angle: -02.0° Zoom: 1.0X 11782+00 Patrick Shields</p>			
<b>GPS Location</b>	See photo	<b>GPS Location</b>	See photo		
<b>Field Station#</b>	11782+00	<b>Field Station#</b>	11788+00		
<b>Pic 5 Desc.</b>	Clean water drainage feature in place	<b>Pic 6 Desc.</b>	RCE in place

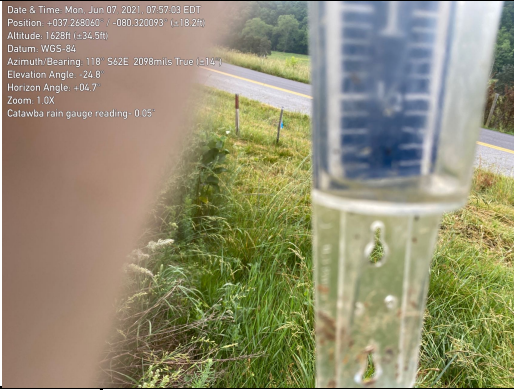
<p>Date &amp; Time: Mon, Jun 07, 2021, 08:00:00 EDT  Position: +037.23902° / +080.30973° (+32.1m)  Altitude: 2274ft (+69.3m)  Datum: WGS-84  Azimuth/Bearing: 122.501E 2096mils True (±10°)  Elevation Angle: -05.9  Horizon Angle: +01.3  Zoom: 1.0x  Mt. Tabor road RCE</p>

<b>GPS Location</b>	See photo GPS	<b>GPS Location</b>	See photo GPS		
<b>Field Station#</b>	11989+00	<b>Field Station#</b>	11788+52		
<b>Pic 1 Desc.</b>	Catawba rain gauge reading- 0.05"	<b>Pic 2 Desc.</b>	Mt. Tabor RCE		
<p>Date &amp; Time: Mon, Jun 07, 2021, 09:45:04 EDT  Position: +037.25301° / +080.30931° (+32.1m)  Altitude: 2190ft (+66.3m)  Datum: WGS-84  Azimuth/Bearing: 134° 09'25 2240mils True (±10°)  Elevation Angle: -09.0  Horizon Angle: +05.4  Zoom: 1.0x  Sta# 11796+00- Level spreaders, CFS controls</p>

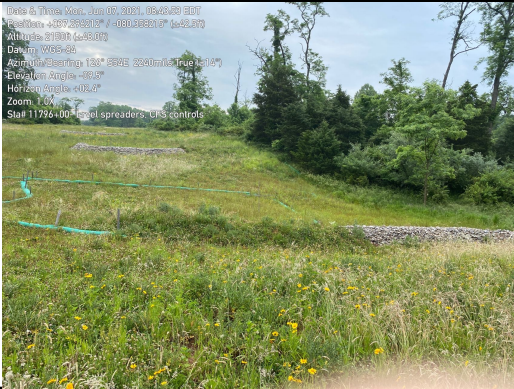
<p>Date &amp; Time: Mon, Jun 07, 2021, 09:46:04 EDT  Position: +037.25302° / +080.30973° (+32.1m)  Altitude: 2274ft (+69.3m)  Datum: WGS-84  Azimuth/Bearing: 135° 23'30 2240mils True (±10°)  Elevation Angle: -09.3  Horizon Angle: +05.1  Zoom: 1.0x  Sta# 11829+00- Level spreaders on both R slopes, karst at the base of slopes</p>

<b>GPS Location</b>	See photo GPS	<b>GPS Location</b>	See photo GPS		
<b>Field Station#</b>	11796+00	<b>Field Station#</b>	11829+00		
<b>Pic 3 Desc.</b>	Level spreaders and CFS controls.	<b>Pic 4 Desc.</b>	Level spreaders on both slopes, karst ECD's at base of slopes.		
<p>Date &amp; Time: Mon, Jun 07, 2021, 09:47:02 EDT  Position: +037.25106° / +080.30933° (+32.1m)  Altitude: 2223ft (+67.3m)  Datum: WGS-84  Azimuth/Bearing: 153° 53'15 2300mils True (±10°)  Elevation Angle: -13.3  Horizon Angle: +05.0  Zoom: 1.0x  Sta# 11836+00- Side slope is very heavily vegetated, controls at LOD.</p>

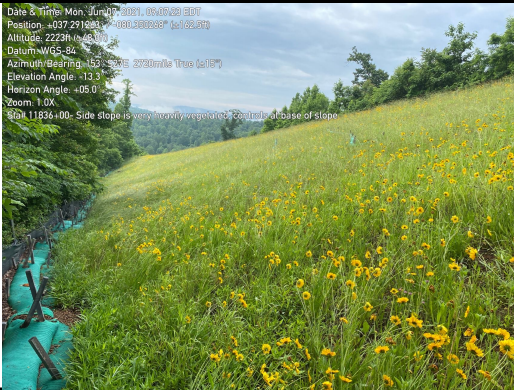
<p>Date &amp; Time: Mon, Jun 07, 2021, 09:47:02 EDT  Position: +037.25238° / +080.34018° (+373.7m)  Altitude: 2303ft (+70.4m)  Datum: WGS-84  Azimuth/Bearing: 051° N51E 0907mils True (±15°)  Elevation Angle: -15.8  Horizon Angle: -00.4  Zoom: 1.0x  Dyat 11864+00- Wetland is dry</p>

<b>Field Station#</b>	11836+00	<b>Field Station#</b>	11864+00		
<b>Pic 5 Desc.</b>	Side slope is very heavily vegetated, controls at LOD.	<b>Pic 6 Desc.</b>	Wetland is dry.

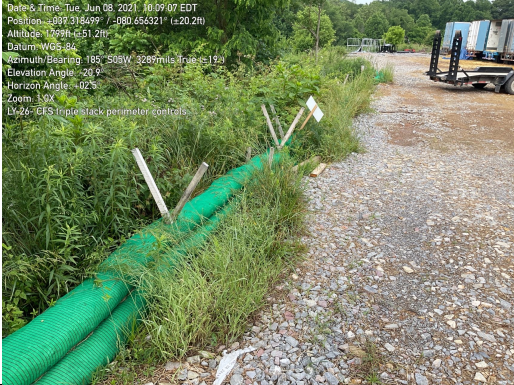
<p>Date &amp; Time: Tue, Jun 08, 2021, 10:09:07 EDT Position: +69° 31'49.9" / -90.65521" (-20.20) Altitude: 1793ft (-531.90) Datum: WGS-84 Azimuth/Bearing: 185° SSW 328mils True (-21) Elevation Angle: -23.7 Horizon Angle: -02.3 Zoom: 1.0X LY26- CFS triple stack perimeter controls.</p>

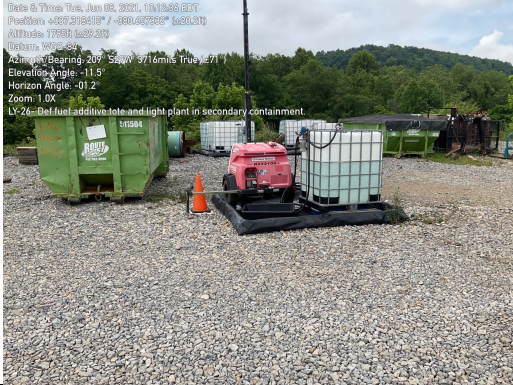
<p>Date &amp; Time: Tue, Jun 08, 2021, 10:10:55 EDT Position: +69° 31'49.9" / -90.65521" (-20.20) Altitude: 1793ft (-531.90) Datum: WGS-84 Azimuth/Bearing: 209° SSW 3716mils True (-21) Elevation Angle: -11.5 Horizon Angle: -01.2 Zoom: 1.0X LY26- Def fuel additive tote and light plant in secondary containment.</p>			
<b>GPS Location</b>	See photo GPS	<b>GPS Location</b>	See photo GPS		
<b>Field Station#</b>	12005+00	<b>Field Station#</b>	12005+00		
<b>Pic 1 Desc.</b>	LY26- CFS triple stack perimeter controls.	<b>Pic 2 Desc.</b>	LY26- Def fuel additive tote and light plant in secondary containment.

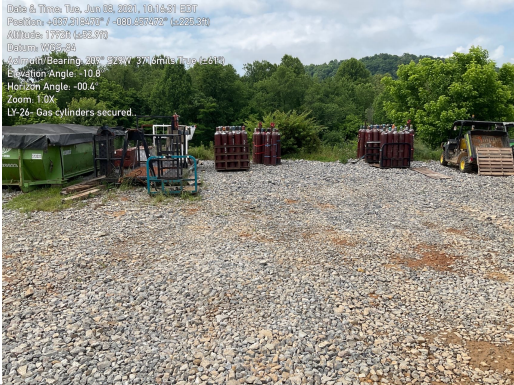
<p>Date &amp; Time: Tue, Jun 08, 2021, 10:15:31 EDT Position: +69° 31'49.9" / -90.65521" (-20.20) Altitude: 1793ft (-531.90) Datum: WGS-84 Azimuth/Bearing: 309° SSW 370mils True (-21) Elevation Angle: -10.6 Horizon Angle: -00.4 Zoom: 1.0X LY26- Gas cylinders secured.</p>

<p>Date &amp; Time: Tue, Jun 08, 2021, 10:16:13 EDT Position: +69° 31'49.9" / -90.65521" (-20.20) Altitude: 1793ft (-531.90) Datum: WGS-84 Azimuth/Bearing: 199° SSW 342mils True (-21) Elevation Angle: -10.3 Horizon Angle: -01.0 Zoom: 1.0X LY26- Waste containers.</p>			
<b>GPS Location</b>	See photo GPS	<b>GPS Location</b>	See photo GPS		
<b>Field Station#</b>	12005+00	<b>Field Station#</b>	12005+00		
<b>Pic 3 Desc.</b>	LY-26- Gas cylinders secured.	<b>Pic 4 Desc.</b>	LY-26- Waste containers.

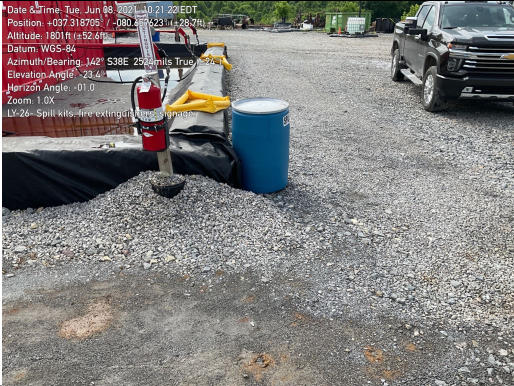
<p>Date &amp; Time: Tue, Jun 08, 2021, 10:21:22 EDT Position: +69° 31'49.9" / -90.65521" (-20.20) Altitude: 1801ft (-549.40) Datum: WGS-84 Azimuth/Bearing: 142° S38E 255mils True (-21) Elevation Angle: -23.4 Horizon Angle: -01.0 Zoom: 1.0X LY26- Spill kits, fire extinguishers, signage.</p>

<b>GPS Location</b>	See photo GPS	<b>GPS Location</b>	See photo GPS		
<b>Field Station#</b>	12005+00	<b>Field Station#</b>	12005+00		
<b>Pic 5 Desc.</b>	LY-26- Spill kit, fire extinguishers, signage.	<b>Pic 6 Desc.</b>	LY-26- Fuel storage tank in secondary containment.

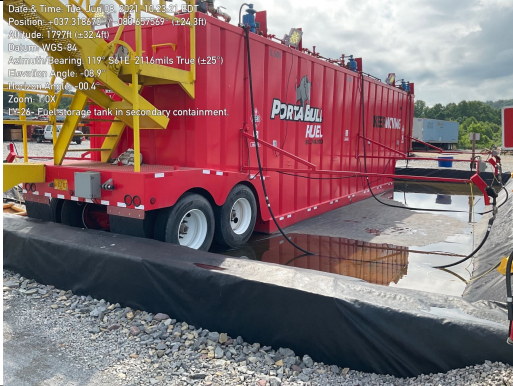
<p>Date &amp; Time: Tue, Jun 08, 2021, 10:22:01 EDT Position: +69° 31'49.9" / -90.65521" (-20.20) Altitude: 1797ft (-542.40) Datum: WGS-84 Azimuth/Bearing: 119° S41E 211mils True (-25) Elevation Angle: -08.9 Horizon Angle: -00.4 Zoom: 1.0X LY26- Fuel storage tank in secondary containment.</p>

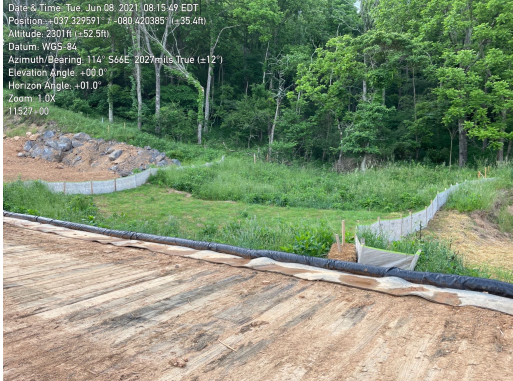
<p>Date &amp; Time: Tue, Jun 08, 2021, 08:15:49 EDT Position: +037.222591° N, -089.420385° W (+35.4ft) Altitude: 2301ft (+52.5ft) Datum: WGS-84 Azimuth/Bearing: 114.546E 202/mils True (+12°) Elevation Angle: +06.0° Horizon Angle: +01.0° Zoom: 1.0X 11527+00</p>

<p>Date &amp; Time: Tue, Jun 08, 2021, 08:35:00 EDT Position: +030.926339° N, -080.07671° W (+44.7ft) Altitude: 2380ft (+72.2ft) Datum: WGS-84 Azimuth/Bearing: 157° S01E 274/mils True (+2°) Elevation Angle: +13.2° Horizon Angle: +00.4° Zoom: 1.0X 11542+00</p>			
GPS Location				See photo				GPS Location				See photo			
Field Station#				11527+00				Field Station#				11542+00			
Pic 1 Desc.				Clean water drainage feature in place				Pic 2 Desc.				End treatments in place

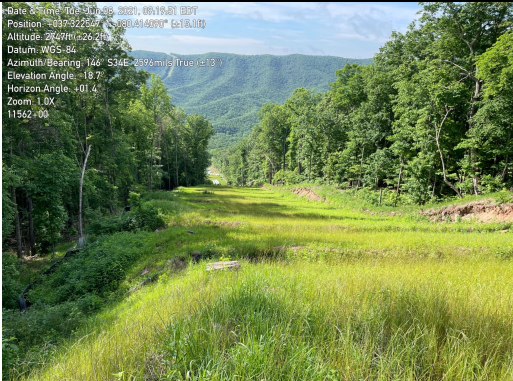
<p>Date &amp; Time: Tue, Jun 08, 2021, 09:16:00 EDT Position: +037.322527° N, -080.414797° W (+18.1ft) Altitude: 2827ft (+26.2ft) Datum: WGS-84 Azimuth/Bearing: 144° S34E 289/mils True (+13°) Elevation Angle: +18.7° Horizon Angle: +01.4° Zoom: 1.0X 11562+00</p>

GPS Location				See photo				GPS Location				See photo			
Field Station#				11555+00				Field Station#				11562+00			
Pic 3 Desc.				Waterbars in place				Pic 4 Desc.				Good vegetation across ROW

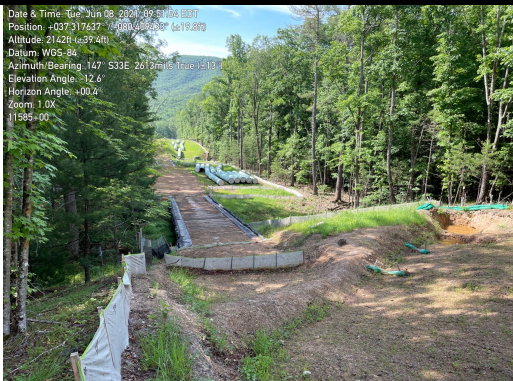
<p>Date &amp; Time: Tue, Jun 08, 2021, 09:16:00 EDT Position: +027.310439° N, -089.420385° W (+19.2ft) Altitude: 2142ft (+37.4ft) Datum: WGS-84 Azimuth/Bearing: 147° S33E 261/mils True (+13°) Elevation Angle: +12.6° Horizon Angle: +00.4° Zoom: 1.0X 11585+00</p>

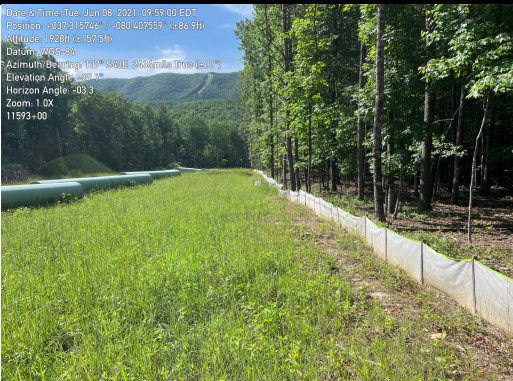
<p>Date &amp; Time: Tue, Jun 08, 2021, 09:19:00 EDT Position: +027.315742° N, -089.420753° W (+46.9ft) Altitude: 1938ft (+57.5ft) Datum: WGS-84 Azimuth/Bearing: 137° S01E 304/mils True (+17°) Elevation Angle: +11.4° Horizon Angle: +03.3° Zoom: 1.0X 11593+00</p>			
GPS Location				See photo				GPS Location				See photo			
Field Station#				11585+00				Field Station#				11593+00			
Pic 5 Desc.				Stream buffer in place				Pic 6 Desc.				P1 silt fence perimeter control in place

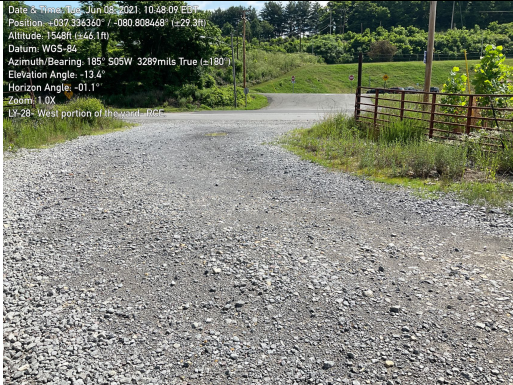
<p>Date &amp; Time: Tue Jun 08 2021 10:48:09 EDT Position: +037.334330° / +080.808468° (+29.30°) Altitude: 1548ft (+464.1m) Datum: WGS-84 Azimuth/Bearing: 185° S05W 3289mils True (+180°) Elevation Angle: -13.4° Horizon Angle: -01.1° Zoom: 1.0X LY-28- West portion of the yard- RCE.</p>

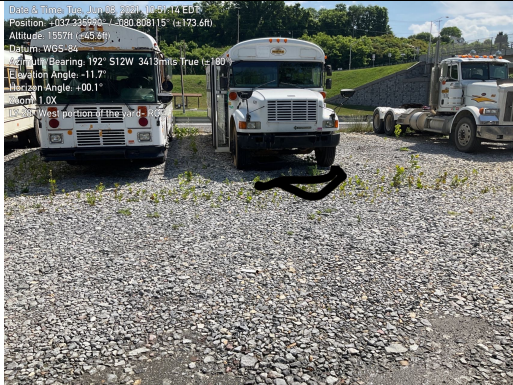
<p>Date &amp; Time: Tue Jun 08 2021 10:50:14 EDT Position: +037.334330° / +080.808115° (+17.6m) Altitude: 1557ft (+475.0m) Datum: WGS-84 Azimuth/Bearing: 192° S12W 3413mils True (+180°) Elevation Angle: -11.7° Horizon Angle: +00.1° Zoom: 1.0X LY-28- West portion of the yard- Transport bus with secondary containment.</p>			
GPS Location	See photo GPS		GPS Location	See photo GPS	
Field Station#	12005+00		Field Station#	12005+00	
Pic 1 Desc.	LY28- West portion of the yard- RCE.		Pic 2 Desc.	LY-28- West portion of the yard- Transport bus with secondary containment.

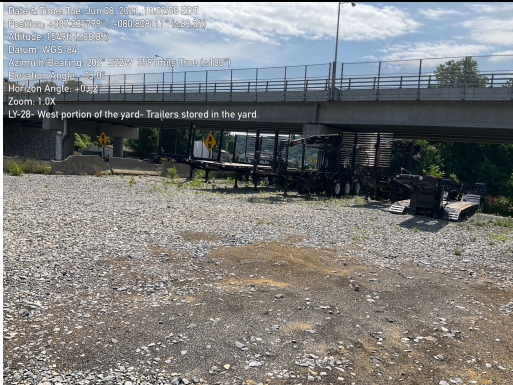
<p>Date &amp; Time: Tue Jun 08 2021 11:05:06 EDT Position: +037.334330° / +080.808111° (+28.4W) Altitude: 1547ft (+468.2m) Datum: WGS-84 Azimuth/Bearing: 302° S28W 3397mils True (+180°) Elevation Angle: -10.1° Horizon Angle: +0.5° Zoom: 1.0X LY-28- West portion of the yard- Trailers stored in the yard.</p>

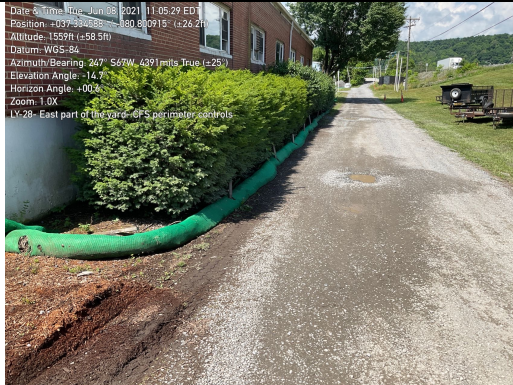
<p>Date &amp; Time: Tue Jun 08 2021 11:05:29 EDT Position: +037.334330° / +080.80915° (+26.2m) Altitude: 1559ft (+478.5m) Datum: WGS-84 Azimuth/Bearing: 247° S47W 4391mils True (+25°) Elevation Angle: -14.7° Horizon Angle: +00.3° Zoom: 1.0X LY-28- East part of the yard- CFS perimeter controls.</p>			
GPS Location	See photo GPS		GPS Location	See photo GPS	
Field Station#	12005+00		Field Station#	12005+00	
Pic 3 Desc.	LY-28- west portion of the yard- Trailers stored.		Pic 4 Desc.	LY-28- CFS perimeter controls.

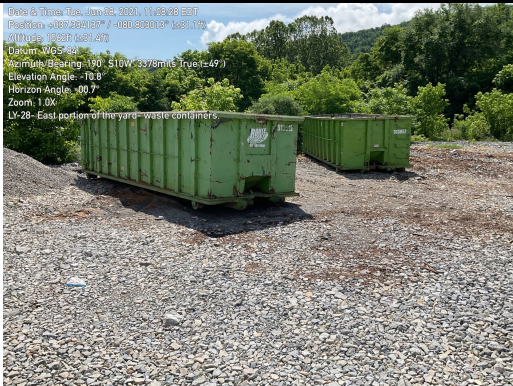
<p>Date &amp; Time: Tue Jun 08 2021 11:06:03 EDT Position: +037.334330° / +080.808012° (+29.1W) Altitude: 1553ft (+473.2m) Datum: WGS-84 Azimuth/Bearing: 190° S10W 3378mils True (+49°) Elevation Angle: -10.9° Horizon Angle: -00.7° Zoom: 1.0X LY-28- East portion of the yard- waste containers.</p>

GPS Location	See photo GPS		GPS Location	See photo GPS	
Field Station#	12005+00		Field Station#	12005+00	
Pic 5 Desc.	LY-28- East portion of the yard- Waste containers.		Pic 6 Desc.	LY-28- East side of the yard, trucks stored, secondary containment under motor.

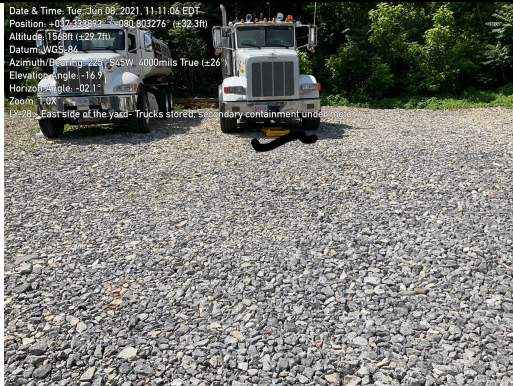
<p>Date &amp; Time: Tue Jun 08 2021 11:11:05 EDT Position: +037.334330° / +080.803276° (+29.3m) Altitude: 1538ft (+468.7m) Datum: WGS-84 Azimuth/Bearing: 223° S15W 4000mils True (+26°) Elevation Angle: -16.9° Horizon Angle: -02.1° Zoom: 1.0X LY-28- East side of the yard- Trucks stored, secondary containment under motor.</p>

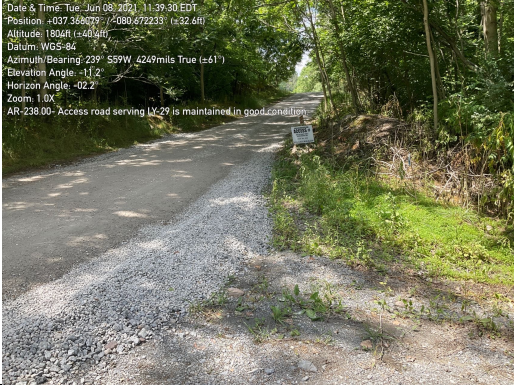
<b>A/E</b>	124300137	<b>Date/Time</b>	6/8/2021 11:20 AM	<b>Report #</b>	
<b>Pictures</b>					
<p>Date &amp; Time: Tue Jun 08 2021 11:39:30 EDT  Position: +037.362340 / -080.677233 (+32.6ft)  Altitude: 1890ft (+60.9ft)  Datum: WGS-84  Azimuth/Bearing: 239° S59W 4269mils True (+61°)  Elevation Angle: -11.2°  Horizon Angle: -02.2°  Zoom: 1.0x  LY29- AR-238.00- Access road serving LY29 is maintained in good condition.</p>

<b>GPS Location</b>	See photo GPS		<b>GPS Location</b>	See photo GPS	
<b>Field Station#</b>	12005+00		<b>Field Station#</b>	12005+00	
<b>Pic 1 Desc.</b>	LY29- AR-238.00 is maintained in acceptable condition.		<b>Pic 2 Desc.</b>	LY29- Overview of the yard.

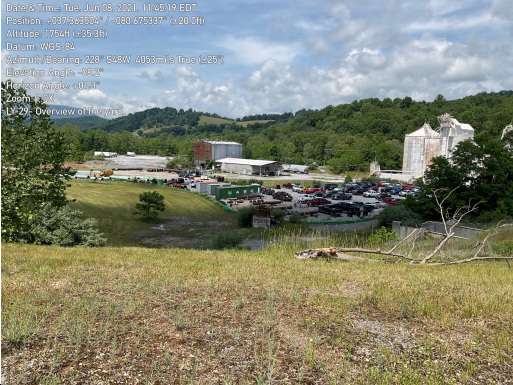
<p>Date &amp; Time: Tue Jun 08 2021 11:45:19 EDT  Position: +037.362340 / -080.677337 (+30.0ft)  Altitude: 1940ft (+59.3ft)  Datum: WGS-84  Azimuth/Bearing: 228° S64W 4036mils True (+23°)  Elevation Angle: -43.2°  Horizon Angle: -00.1°  Zoom: 1.0x  LY29- Overview of the yard.</p>

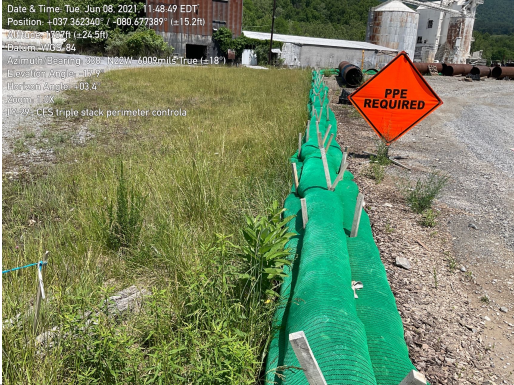
<p>Date &amp; Time: Tue Jun 08 2021 11:48:49 EDT  Position: +037.362340 / -080.677389 (+15.2ft)  Altitude: 1890ft (+60.9ft)  Datum: WGS-84  Azimuth/Bearing: 188° S88E 4009mils True (+18°)  Elevation Angle: -10.0°  Horizon Angle: -03.4°  Zoom: 1.0x  LY29- CFS triple stack perimeter controls.</p>

<b>GPS Location</b>	See photo GPS		<b>GPS Location</b>	See photo GPS	
<b>Field Station#</b>	12005+00		<b>Field Station#</b>	12005+00	
<b>Pic 3 Desc.</b>	LY29- CFS triple stack perimeter controls.		<b>Pic 4 Desc.</b>	LY29- Culvert and drainage feature.	
<p>Date &amp; Time: Tue Jun 08 2021 11:54:44 EDT  Position: +037.362467 / -080.677311 (+42.7ft)  Altitude: 1970ft (+60.2ft)  Datum: WGS-84  Azimuth/Bearing: 303° N33E 1564mils True (+22°)  Elevation Angle: -11.0°  Horizon Angle: -00.7°  Zoom: 1.0x  LY29- Waste containers.</p>

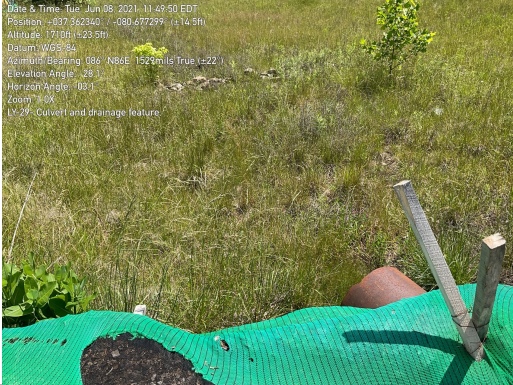
<p>Date &amp; Time: Tue Jun 08 2021 11:49:50 EDT  Position: +037.362340 / -080.677299 (+14.5ft)  Altitude: 1710ft (+52.3ft)  Datum: WGS-84  Azimuth/Bearing: 086° N86E 1529mils True (+22°)  Elevation Angle: -28.1°  Horizon Angle: -03.1°  Zoom: 1.0x  LY29- Culvert and drainage feature.</p>

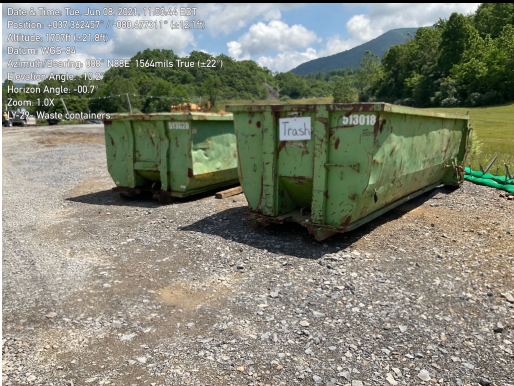
<b>GPS Location</b>	See photo GPS		<b>GPS Location</b>	See photo GPS	
<b>Field Station#</b>	12005+00		<b>Field Station#</b>	12005+00	
<b>Pic 5 Desc.</b>	LY29- Waste containers.		<b>Pic 6 Desc.</b>	LY29- Side boom and welding. Equipment stored in the yard.

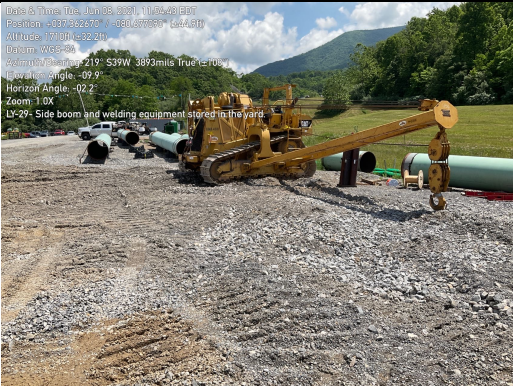
<p>Date &amp; Time: Tue Jun 08 2021 11:54:48 EDT  Position: +037.362470 / -080.677309 (+44.4ft)  Altitude: 1970ft (+60.2ft)  Datum: WGS-84  Azimuth/Bearing: 219° S39W 3893mils True (+20°)  Elevation Angle: -59.9°  Horizon Angle: -02.2°  Zoom: 1.0x  LY29- Side boom and welding equipment stored in the yard.</p>

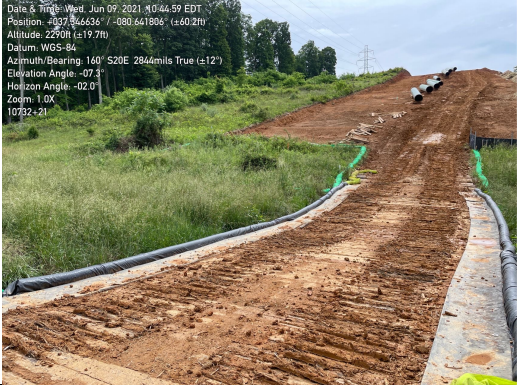
<b>GPS Location</b>	See photo		<b>GPS Location</b>	See photo	
<b>Field Station#</b>	10732+21		<b>Field Station#</b>	10848+00	
<b>Pic 7 Desc.</b>	Equipment bridge needs cleaned off		<b>Pic 8 Desc.</b>	CFS perimeter control in place	
<p><small>Date &amp; Time: Wed, Jun 09, 2021, 13:29:38 EDT Position: +037.14822° / -080.60619° (±12.4ft) Altitude: 2224ft (±19.7ft) Datum: WGS-84 Azimuth/Bearing: 000° N88E 1544mils True (±1.3°) Elevation Angle: -15.4° Horizon Angle: -04.1° Zoom: 1.0X 10854+05</small></p>

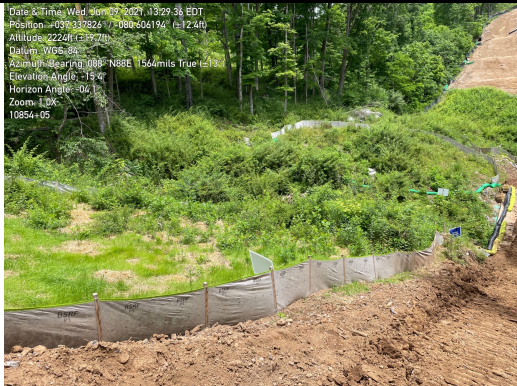
<b>GPS Location</b>	See photo		<b>GPS Location</b>	See photo	
<b>Field Station#</b>	10854+05		<b>Field Station#</b>	10833+00	
<b>Pic 9 Desc.</b>	Stream buffer in place		<b>Pic 10 Desc.</b>	Rock inlet protection in place	
<p><small>Date &amp; Time: Wed, Jun 09, 2021, 12:19:06 EDT Position: +037.34393° / -080.62472° (±14.0ft) Altitude: 2055ft (±19.7ft) Datum: WGS-84 Azimuth/Bearing: 172° S06E 3093mils True (±13.1°) Elevation Angle: -13.3° Horizon Angle: -02.7° Zoom: 1.0X 10786+50</small></p>

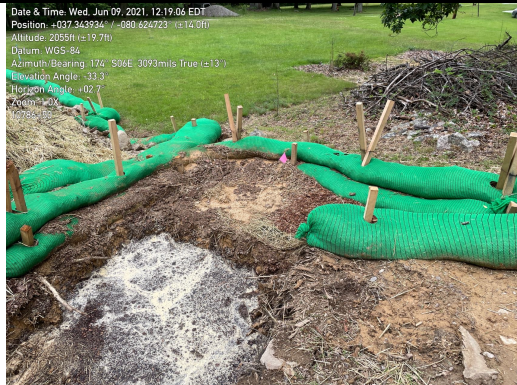
<b>Pic 11 Desc.</b>	CFS triple stack end treatment needs cleaned off		<b>Pic 12 Desc.</b>	Throat of waterbar and rock inlet needs cleaned out

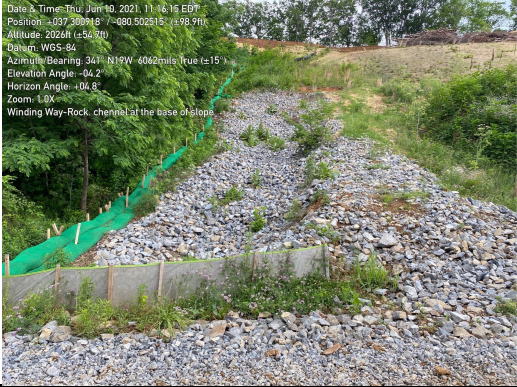
<b>AFE</b>	124300137	<b>Date/Time</b>	6/10/2021 4:58 PM	<b>Report #</b>	
<b>Pictures</b>					
<small>           Date &amp; Time: Thu Jun 10, 2021 11:46:16 EDT            Position: -037.300918° / -080.502515° 1598.9ft            Altitude: 2026ft (+56.7ft)            Datum: WGS-84            Azimuth Bearing: 341° N1°W 4062mils True (+15°)            Elevation Angle: -06.2°            Horizon Angle: -06.8°            Zoom: 1.0X            Winding Way-Rock channel at the base of slope         </small>

Insert image here	
<b>GPS Location</b>	See photo GPS	<b>GPS Location</b>			
<b>Field Station#</b>	11225+00	<b>Field Station#</b>			
<b>Pic 13 Desc.</b>	Winding Way access road, rock channel.	<b>Pic 14 Desc.</b>			
Insert image here		Insert image here			
<b>GPS Location</b>		<b>GPS Location</b>			
<b>Field Station#</b>		<b>Field Station#</b>			
<b>Pic 15 Desc.</b>		<b>Pic 16 Desc.</b>			
Insert image here		Insert image here

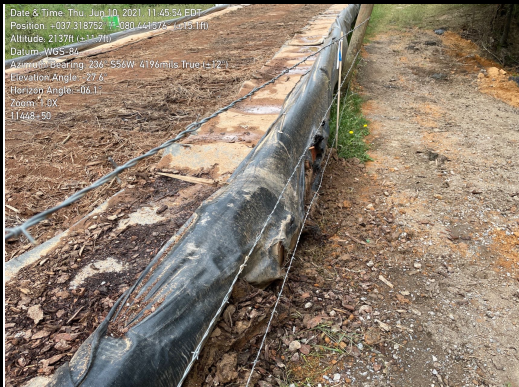
<p>Date &amp; Time: Thu, Jun 10, 2021, 12:22:28 EDT Position: +037.312225° / -080.430169° (+11.81) Altitude: 2201ft (+9.91) Datum: WGS-84 Azimuth/Bearing: 286°/SSW, 6179mils True (+14°) Elevation Angle: -02.1° Horizon Angle: -02.1° Zoom: 1.0X 11475+00</p>			
GPS Location	See photo		GPS Location	See photo	
Field Station#	11448+50		Field Station#	11475+00	
Pic 7 Desc.	Torn geo needs replaced		Pic 8 Desc.	Sump needs maintenance and end treatment needs cleaned off and holes repaired

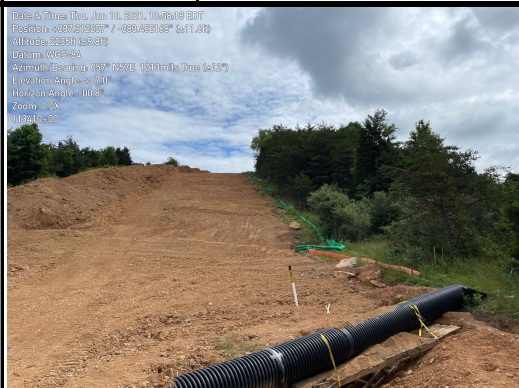
GPS Location	See photo		GPS Location	See photo	
Field Station#	11396+58		Field Station#	11410+00	
Pic 9 Desc.	Waterbars in place		Pic 10 Desc.	End treatments in place

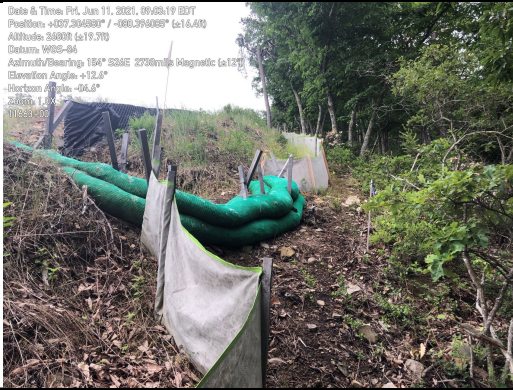
<p>Date &amp; Time: Fri, Jun 11, 2021, 08:55:53 EDT Position: +397.293397° / -080.374419° (+16.4ft) Altitude: 2617ft (+32.4ft) Datum: WGS-84 Azimuth/Bearing: 040° N56E 1067mils Magnetic (+13°) Elevation Angle: -25.7° Horizon Angle: -03.8° Zoom: 1.0x 11669+00, P1 down</p>

<p>Date &amp; Time: Fri, Jun 11, 2021, 09:03:19 EDT Position: +397.304897° / -080.374688° (+16.4ft) Altitude: 2680ft (+19.7ft) Datum: WGS-84 Azimuth/Bearing: 154° S34E 2730mils Magnetic (+13°) Elevation Angle: +12.6° Horizon Angle: -06.6° Zoom: 1.0x 11663+00, P1 down</p>			
<b>GPS Location</b>	On photo	<b>GPS Location</b>	On photo		
<b>Field Station#</b>	11669+00	<b>Field Station#</b>	11663+00		
<b>Pic 5 Desc.</b>	Communication; Replace worn P1 silt fence.	<b>Pic 6 Desc.</b>	Perimeter controls are in place.

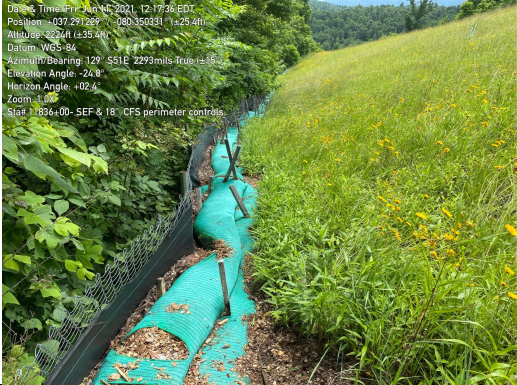
<b>AFE</b>	124300137	<b>Date/Time</b>	6/11/2021 4:51 PM	<b>Report #</b>	
<b>Pictures</b>					
<p>Date &amp; Time: Fri Jun 11, 2021, 12:17:25 EDT  Position: +037.291269° / -080.350331° (+25.4ft)  Altitude: 3224ft (+35.4ft)  Datum: WGS-84  Azimuth/Bearing: 129° S51E 2293mils True (+15°)  Elevation Angle: -26.8°  Horizon Angle: +02.4°  Zoom: 1.0X  Sta# 11836+00- SEP &amp; 18" CFS perimeter controls.</p>

<b>GPS Location</b>	See photo GPS	<b>GPS Location</b>	See photo GPS		
<b>Field Station#</b>	11836+00	<b>Field Station#</b>	11847+00		
<b>Pic 7 Desc.</b>	SSF and 18" CFS triple stack perimeter controls.	<b>Pic 8 Desc.</b>	Permanent restoration vegetation.

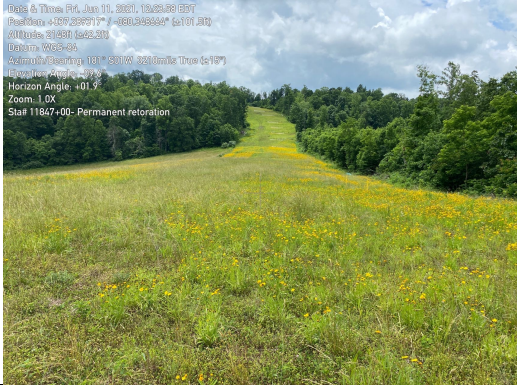
<p>Date &amp; Time: Fri Jun 11, 2021, 15:55:55 EDT  Position: +037.339717° / -080.393344° (+101.8ft)  Altitude: 3128ft (+35.3ft)  Datum: WGS-84  Azimuth/Bearing: 101° S50E 2553mils True (+10°)  Elevation Angle: -29.3°  Horizon Angle: +01.7°  Zoom: 1.0X  Sta# 11847+00- Permanent restoration</p>

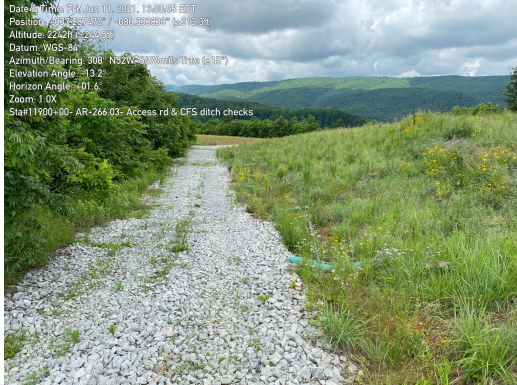
<p>Date &amp; Time: Fri Jun 11, 2021, 13:00:08 EDT  Position: +037.268332° / -080.322725° (+123.3ft)  Altitude: 2200ft (+25.7ft)  Datum: WGS-84  Azimuth/Bearing: 308° N32W 2600mils True (+15°)  Elevation Angle: -13.2°  Horizon Angle: -01.6°  Zoom: 1.0X  Sta# 11900+00- AR-266.03- Access rd &amp; CFS ditch checks</p>

<b>GPS Location</b>	See photo GPS	<b>GPS Location</b>	See photo GPS		
<b>Field Station#</b>	11900+00	<b>Field Station#</b>	11942+00		
<b>Pic 9 Desc.</b>	AR-266.03- Access road and CFS bar ditch checks.	<b>Pic 10 Desc.</b>	Karst ECD's.		
<p>Date &amp; Time: Fri Jun 11, 2021, 13:53:12 EDT  Position: +037.268332° / -080.322725° (+123.3ft)  Altitude: 1705ft (+23.9ft)  Datum: WGS-84  Azimuth/Bearing: 335° N05W 6311mils True (+15°)  Elevation Angle: -15.4°  Horizon Angle: +03.8°  Zoom: 1.0X  Sta# 11979+00- Karst ECD's</p>

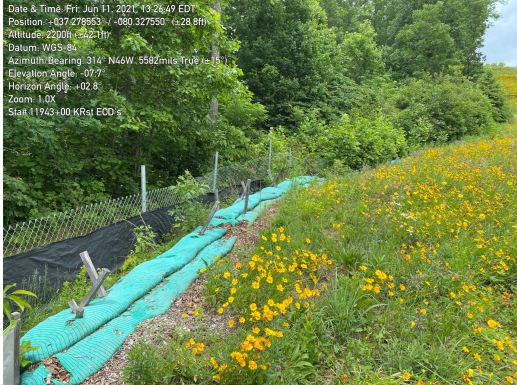
<p>Date &amp; Time: Fri Jun 11, 2021, 13:24:49 EDT  Position: +037.278953° / -080.327950° (+28.8ft)  Altitude: 2200ft (+25.7ft)  Datum: WGS-84  Azimuth/Bearing: 314° N46W 5582mils True (+15°)  Elevation Angle: -07.7°  Horizon Angle: +02.5°  Zoom: 1.0X  Sta# 11942+00 Karst ECD's</p>

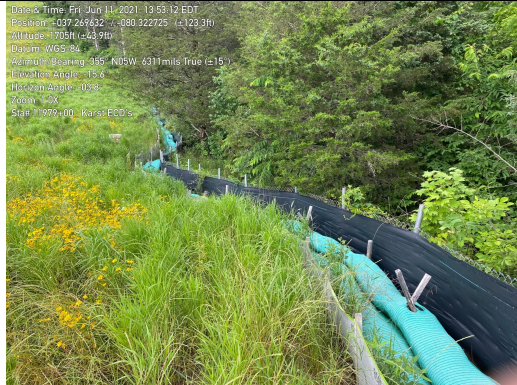
<b>GPS Location</b>	See photo GPS	<b>GPS Location</b>	See photo GPS		
<b>Field Station#</b>	11979+00	<b>Field Station#</b>	11986+00		
<b>Pic 11 Desc.</b>	Karst ECD's and signage.	<b>Pic 12 Desc.</b>	Drainage feature ECD's

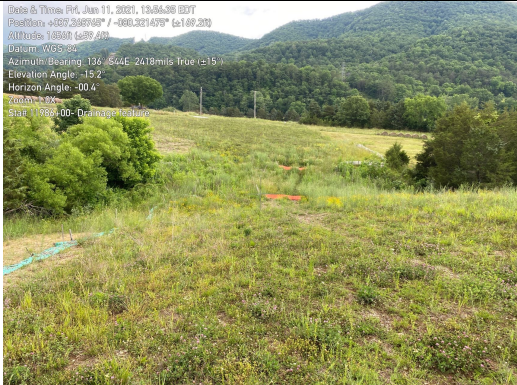
<p>Date &amp; Time: Fri Jun 11, 2021, 14:54:58 EDT  Position: +037.309748° / -080.321478° (+149.2ft)  Altitude: 1550ft (+23.9ft)  Datum: WGS-84  Azimuth/Bearing: 138° S44E 2478mils True (+15°)  Elevation Angle: -15.2°  Horizon Angle: -00.4°  Zoom: 1.0X  Sta# 11986+00- Drainage feature</p>

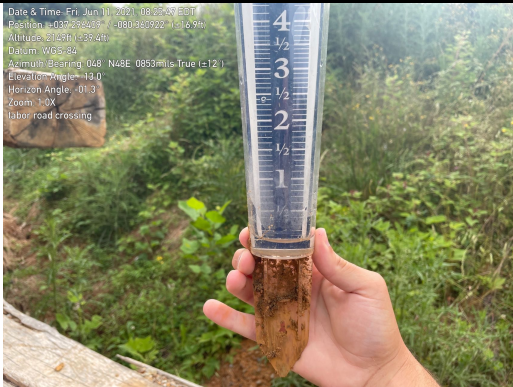
GPS Location		See photo				GPS Location		See photo			
Field Station#		11788+00				Field Station#		11672+00			
Pic 1 Desc.		Rain gauge measured 0.2"				Pic 2 Desc.		End treatments in place

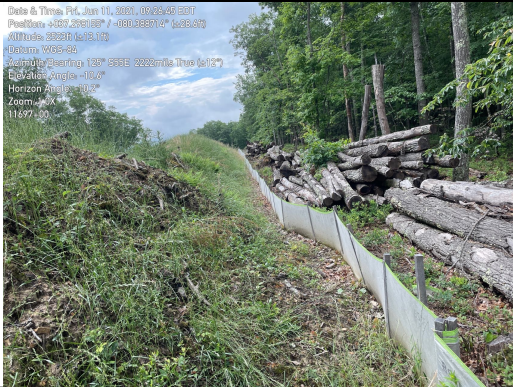
GPS Location		See photo				GPS Location		See photo			
Field Station#		11697+00				Field Station#		11736+00			
Pic 3 Desc.		P1 silt fence perimeter control in place				Pic 4 Desc.		Waterbars in place

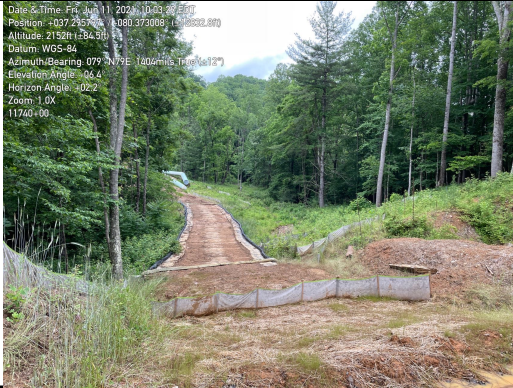
GPS Location		See photo				GPS Location		See photo			
Field Station#		11740+00				Field Station#		11767+26			
Pic 5 Desc.		Stream buffer in place				Pic 6 Desc.		Stream buffer in place

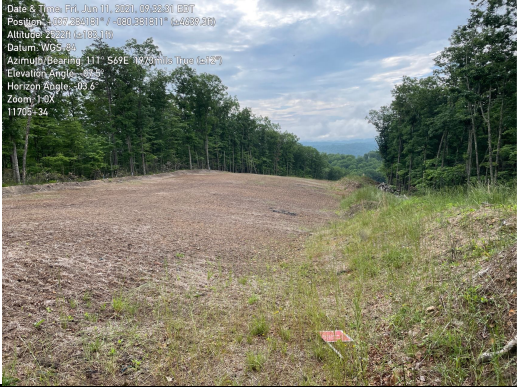
<b>GPS Location</b>	See photo		<b>GPS Location</b>	See photo	
<b>Field Station#</b>	11705+34		<b>Field Station#</b>	11788+00	
<b>Pic 7 Desc.</b>	ROW stabilized		<b>Pic 8 Desc.</b>	RCE in place	
<p>Date &amp; Time: Fri, Jun 11, 2021, 10:45:38 EDT  Position: +037.294488 / -080.363817 (-15.16)  Altitude: 2141ft (-37.4ft)  Datum: WGS-84  Azimuth/Bearing: 244° S44W 438mils True (-12°)  Elevation Angle: -14.6°  Horizon Angle: -07.5°  Zoom: 1.0X  11778+00</p>

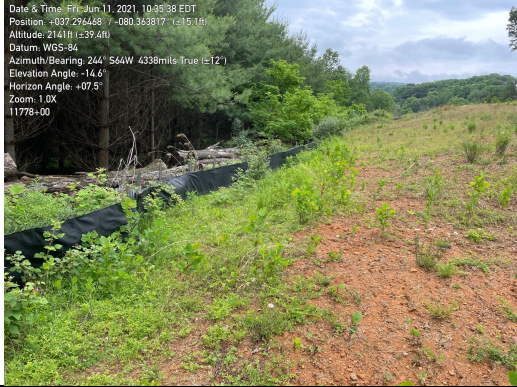
<b>GPS Location</b>	See photo		<b>GPS Location</b>	See photo	
<b>Field Station#</b>	11778+00		<b>Field Station#</b>	11747+72	
<b>Pic 9 Desc.</b>	Supersilt fence perimeter control in place		<b>Pic 10 Desc.</b>	End treatments in place	
<p>Date &amp; Time: Fri, Jun 11, 2021, 10:47:22 EDT  Position: +037.294488 / -080.363817 (-15.16)  Altitude: 2141ft (-37.4ft)  Datum: WGS-84  Azimuth/Bearing: 194° S16E 238mils True (-12°)  Elevation Angle: -10.2°  Horizon Angle: -07.5°  Zoom: 1.0X  11711+50</p>

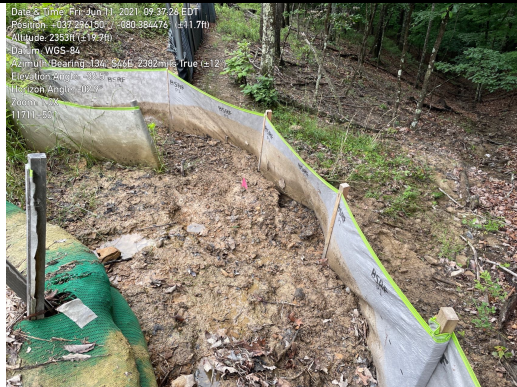
<b>GPS Location</b>	See photo		<b>GPS Location</b>	See photo	
<b>Field Station#</b>	11711+50		<b>Field Station#</b>	11760+55	
<b>Pic 11 Desc.</b>	P1 silt fence starting to undermine		<b>Pic 12 Desc.</b>	CFS end treatment needs cleaned off
