Visual Site Inspection Report

Project Name H-600 Pipeline Spread H		AFE 124300138	Spread H-600 Pipeline Spread H
Contractor Precision		Report # 21352	
Inspector John Brcic		Date/Time 3/22/2021 2:55 PM	
Permit # TBD	Inspection Type VA SWPP	Station Begin 12443+75	
State VA	Inspection Area Partial	Station End 12544+06	
County Montgomery	Ground Dry	Temperature (°F) 50.00	
Municipality N/A	Weather Sunny	Rain Gauge (in) 0.00	
Rain Accumulation Time (days)			3.00

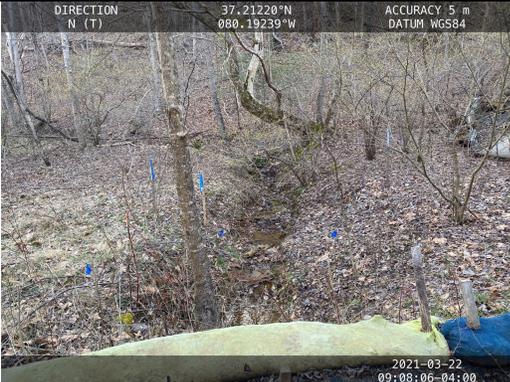
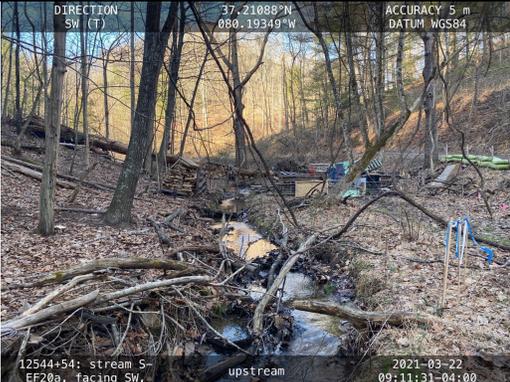
GPS Location	See photo		GPS Location	See photo	
Field Station#	12544+06		Field Station#	12544+54	
Pic 3 Desc.	Stream S-EF54, facing north, downstream		Pic 4 Desc.	Stream S-EF20a, facing southwest, upstream

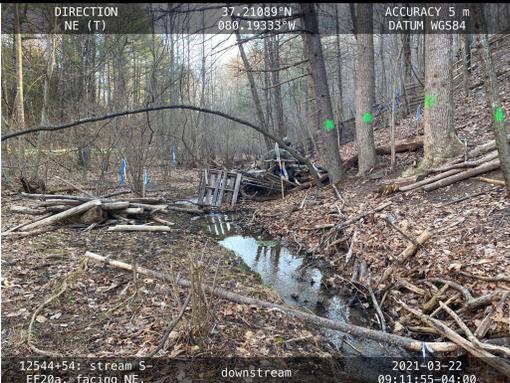
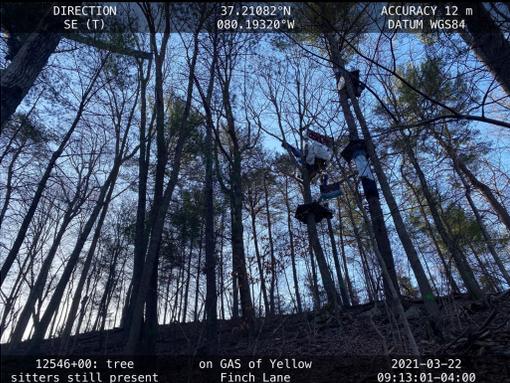
GPS Location	See photo		GPS Location	See photo	
Field Station#	12544+54		Field Station#	12546+00	
Pic 5 Desc.	Stream S-EF20a, facing northeast, downstream		Pic 6 Desc.	Tree sitters still present on going away side of Yellow Finch Lane.

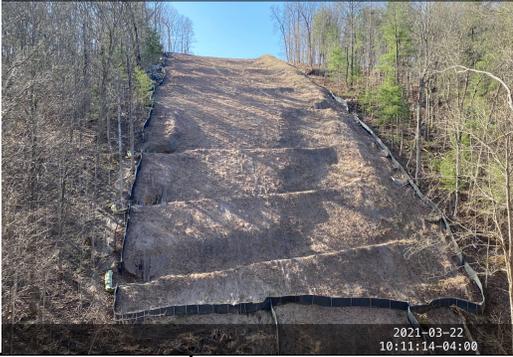
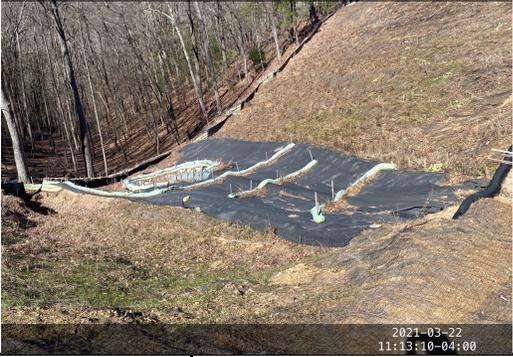
GPS Location	See photo	GPS Location	See photo
Field Station#	12523+00	Field Station#	12503+70
Pic 13 Desc.	Slope stable on going away side of stream S-EF19.	Pic 14 Desc.	Clean water diversion pipe is in good repair.
DIRECTION SE (T) 37.21871°N 080.20083°W ACCURACY 22 m DATUM WGS84

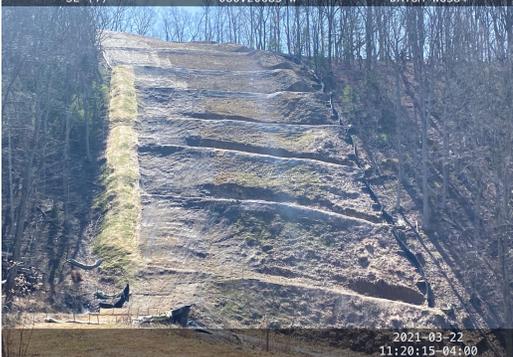
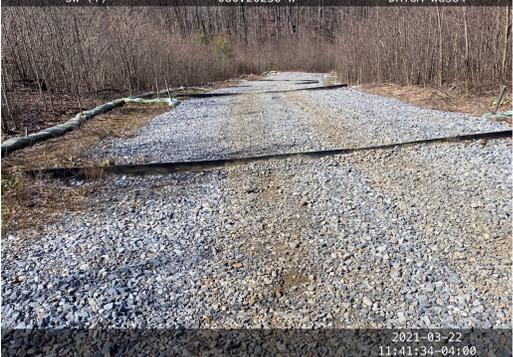
GPS Location	See photo	GPS Location	See photo
Field Station#	12506+00	Field Station#	12483+30
Pic 15 Desc.	The slope on the going away side of the clean water diversion pipe and Enbridge line crossing remains stable.	Pic 16 Desc.	The water deflectors on access road MVP-MLV-AR-28 remain in good repair.
DIRECTION N (T) 37.22982°N 080.20119°W ACCURACY 10 m DATUM WGS84

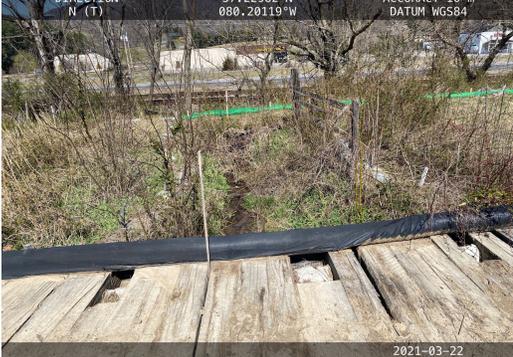
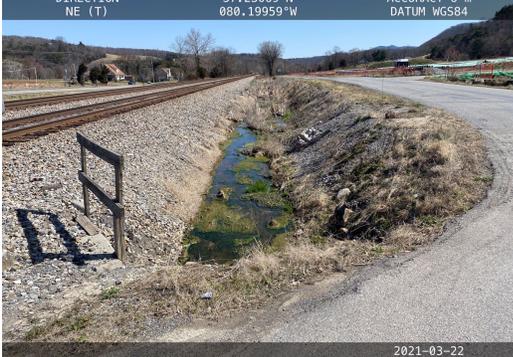
GPS Location	See photo	GPS Location	See photo
Field Station#	12455+21	Field Station#	12444+94
Pic 17 Desc.	Stream S-CD12, facing north, downstream	Pic 18 Desc.	Stream S-I1, facing northeast, downstream

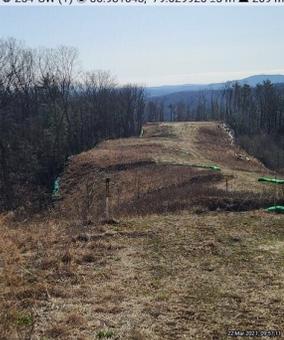
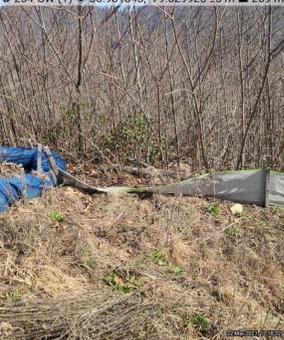
Throughout today's inspections the EI noticed a section of P1 required maintenance due to being weathered and torn , documented and sent in to be added to the punch list for maintenance repairs.

GPS Location 00000		GPS Location 00000			
Field Station# 13470+00		Field Station# 13459+10			
Pic 3 Desc. Row photo showing permanent vegetation with some new growth in the travel lane.		Pic 4 Desc. P1 requires maintenance due to being weathered and torn. Documented and added to the punch list.

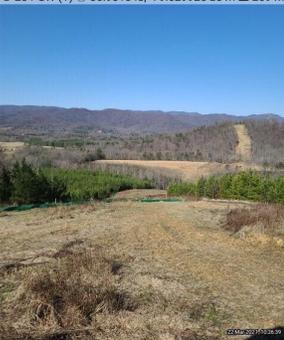
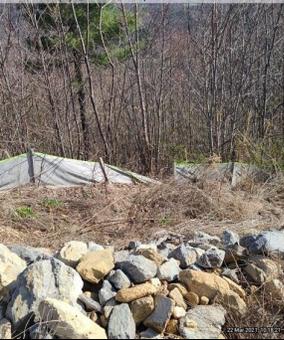
GPS Location 00000		GPS Location 0000			
Field Station# 13436+76		Field Station# 13459+10			
Pic 5 Desc. Vegetation observation photo while checking row conditions throughout.		Pic 6 Desc. P1 requires maintenance due to being weathered and torn. Documented and added to the punch list.

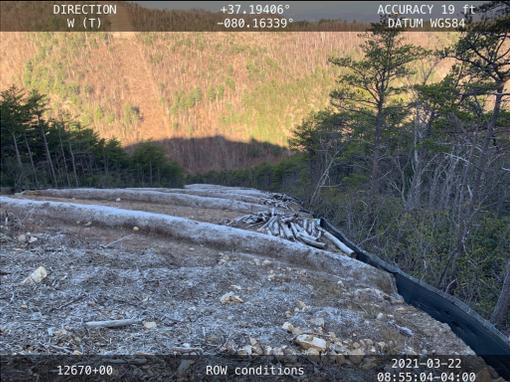
GPS Location		See photo for gps location data.		GPS Location	
Field Station#		12689+00		Field Station#	
Pic 1 Desc.		Photo shows the ROW condition from about 12686+00 to 12689+00.		Pic 2 Desc.

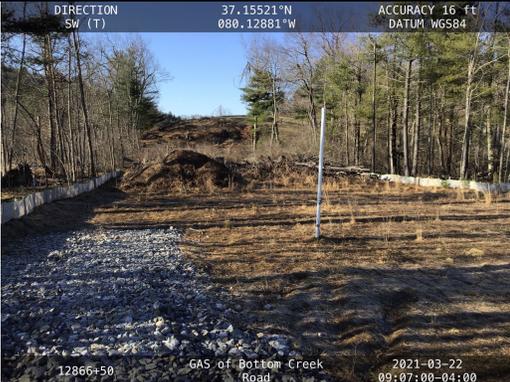
GPS Location		See photo for gps location data.		GPS Location	
Field Station#		12674+00		Field Station#	
Pic 3 Desc.		Photo shows the ECDs from about 12674+00 to 12676+00.		Pic 4 Desc.

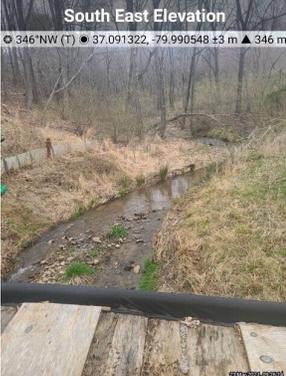
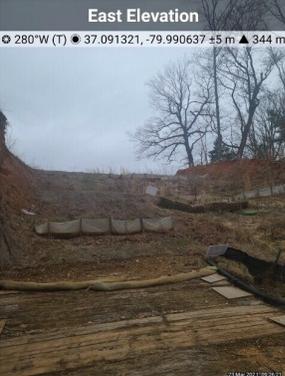
<p>East Elevation <small>280°W (T) 37.091321, -79.990637 ±5 m ▲ 344 m</small></p>	GPS Location	00000	GPS Location	00000
Field Station#	13659+04	Field Station#	13659+04	Pic 1 Desc.	Stream observation photo facing downstream during routine inspection today, no issues observed at the time of inspection.	Pic 2 Desc.	EI monitored ECDs and stabilization on hill side above stream crossing, no environmental issues observed at the time of inspection

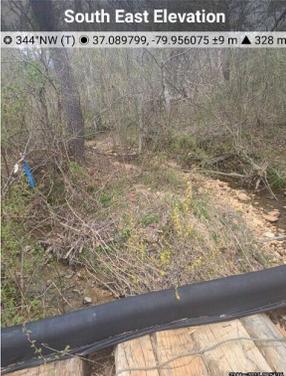
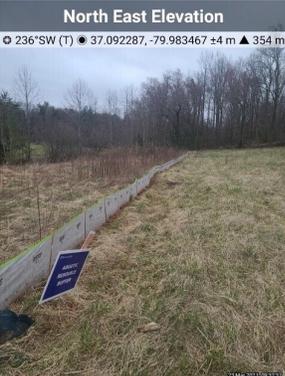
<p>North East Elevation <small>236°SW (T) 37.092287, -79.983467 ±4 m ▲ 354 m</small></p>	GPS Location	00000	GPS Location	00000
Field Station#	13659+04	Field Station#	13564+75	Pic 3 Desc.	Stream observation photo facing upstream during routine inspection today, no issues observed.	Pic 4 Desc.	EI monitored recently replaced P1 that was added to the punch list for maintenance repairs.

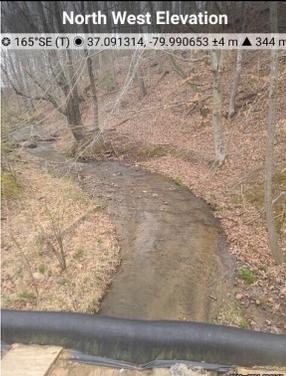
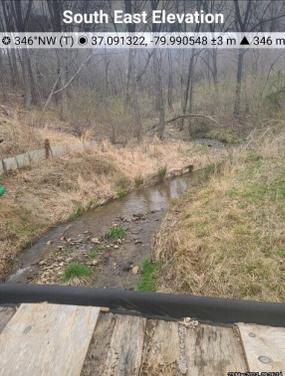
<p>South East Elevation <small>346°NW (T) 37.091322, -79.990548 ±3 m ▲ 346 m</small></p>	GPS Location	00000	GPS Location	00000
Field Station#	13543+72	Field Station#	13543+72	Pic 5 Desc.	Stream observation photo facing downstream during routine inspection today, no issues were observed at the time of inspection.	Pic 6 Desc.	Stream observation photo facing downstream during routine inspection today, no issues were observed at the time inspection.

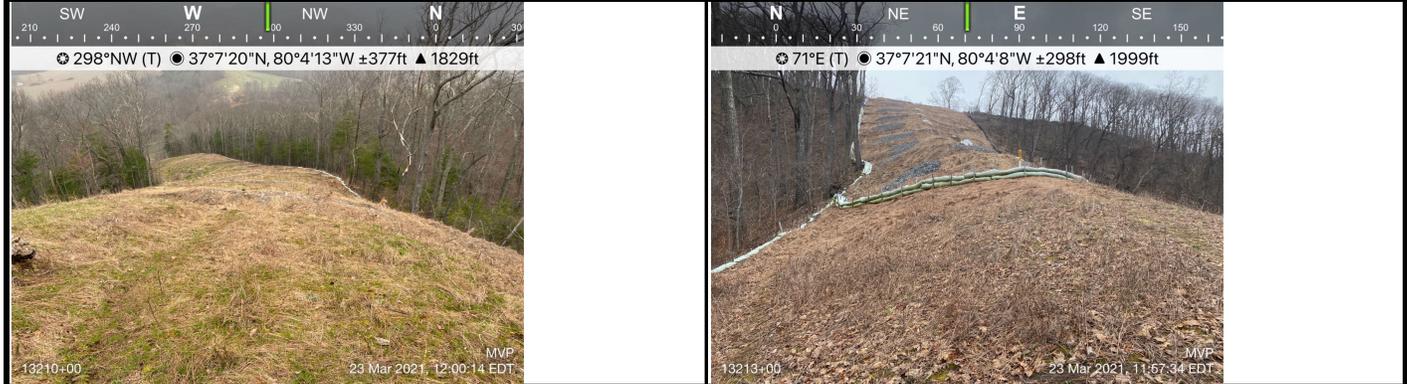
GPS Location	See photo for coordinates.	GPS Location	See photo for coordinates.
Field Station#	13210+00	Field Station#	13213+00
Pic 7 Desc.	ROW stable with vegetative cover across LOD.	Pic 8 Desc.	ROW stable with vegetative cover across LOD.

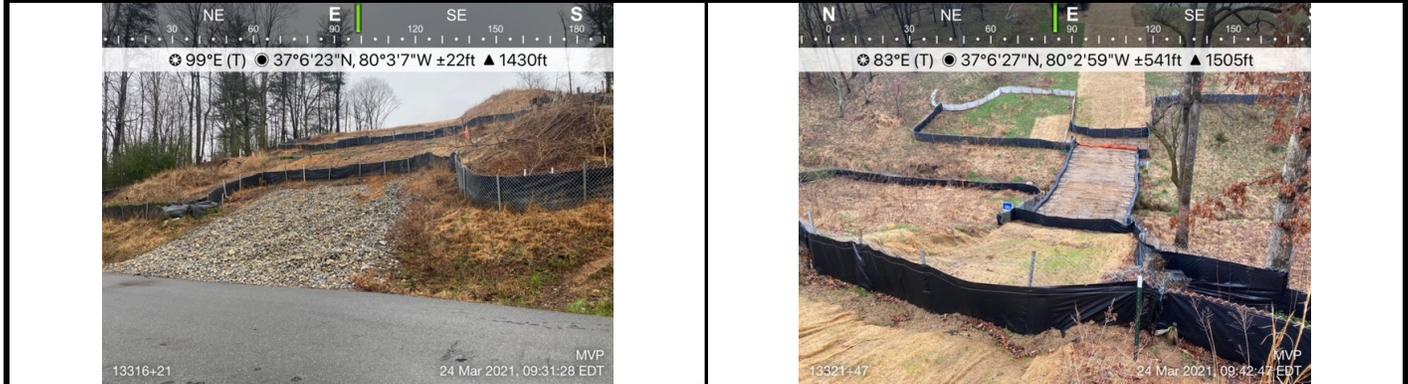
GPS Location	See Above	GPS Location	See Above
Field Station#	13316+21	Field Station#	13321+47
Pic 1 Desc.	Overview of Wades Gap Road ROW crossing. ECDs are functional and ROW is stable.	Pic 2 Desc.	Overview of Waterbody S-GH15. ECDs are functional and ROW is stable.

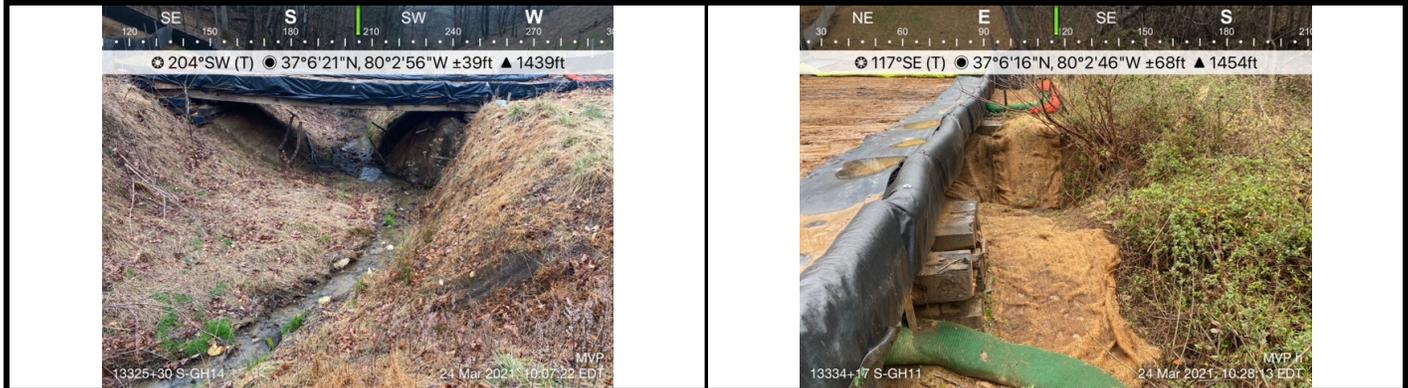
GPS Location	See Above	GPS Location	See Above
Field Station#	13325+30	Field Station#	13334+17
Pic 3 Desc.	Waterbody S-GH14. ECDs are functional and ROW is stable.	Pic 4 Desc.	Waterbody S-GH11. ECDs are functional and ROW is stable.

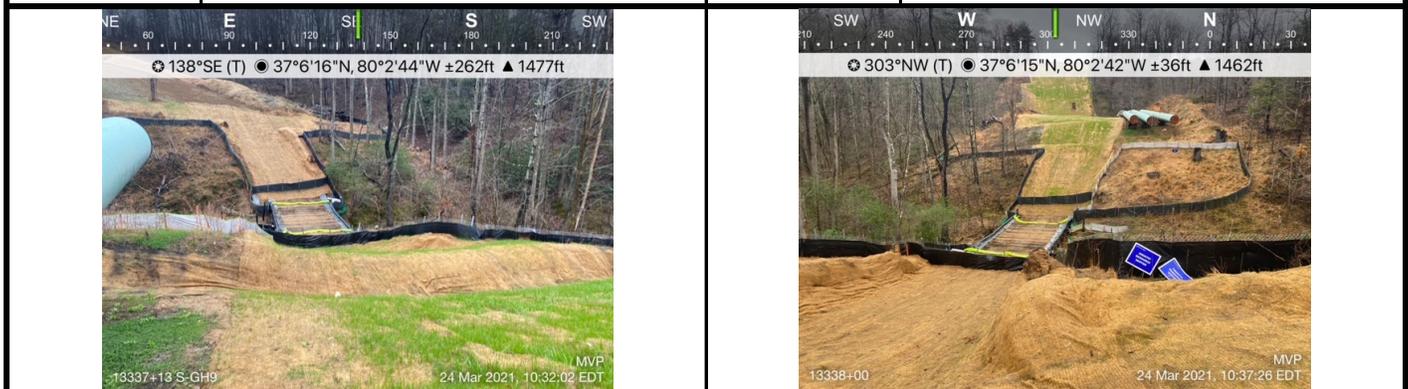
GPS Location	See Above	GPS Location	See Above
Field Station#	13337+13	Field Station#	13338+00
Pic 5 Desc.	Overview of Waterbody S-GH9. ECDs are functional and ROW is stable.	Pic 6 Desc.	ROW Overview. ECDs are functional and ROW is stable.

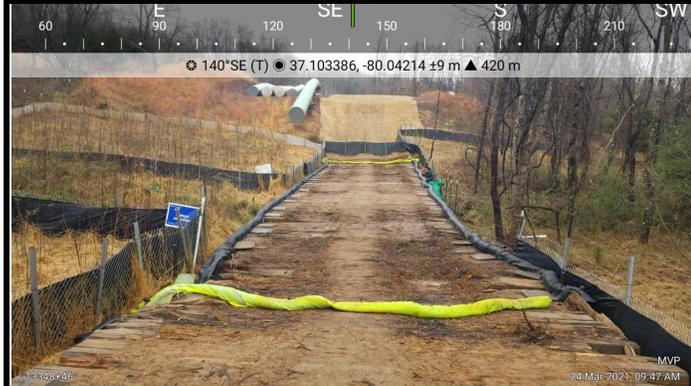
GPS Location	See Above
Field Station#	13348+46

Pic 13 Desc.	Overview of Waterbody S-RR08. ECDs are functional and ROW is stable.
---------------------	----------------------------------------------------------------------

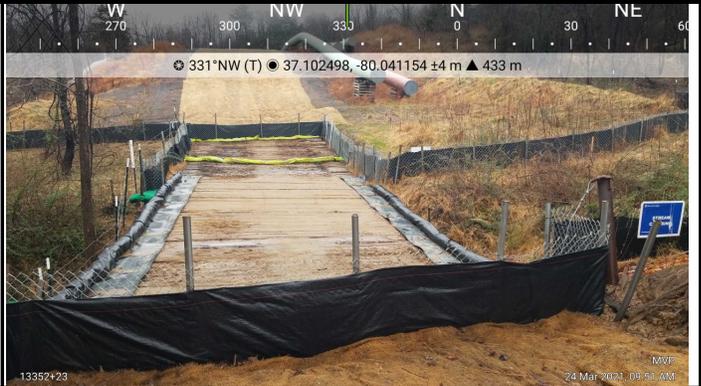
GPS Location	See Above
Field Station#	13352+23

Pic 14 Desc.	Overview of Waterbody S-RR09. ECDs are functional and ROW is stable.
---------------------	----------------------------------------------------------------------

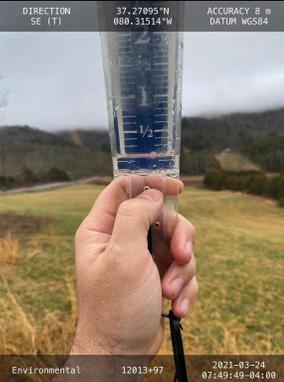
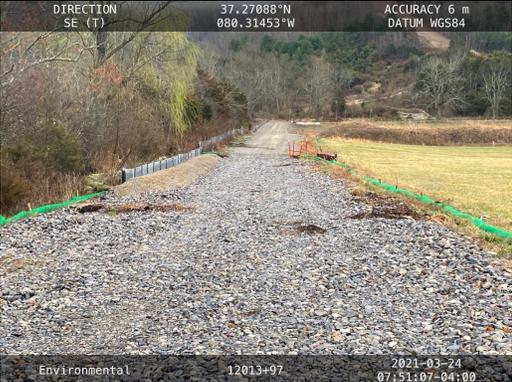
GPS Location See photo			GPS Location See photo		
Field Station# 12013+97			Field Station# 12013+97		
Pic 1 Desc. Rain gauge totals for Catawba			Pic 2 Desc. Access Road MVP-MN-268 in acceptable condition

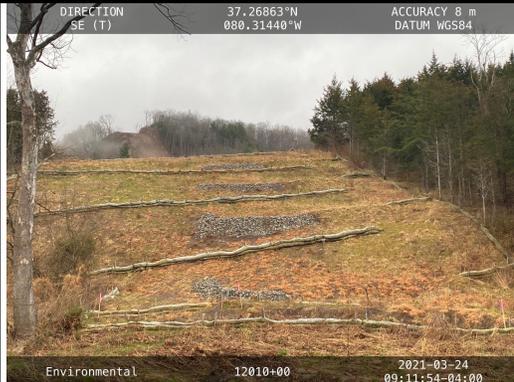
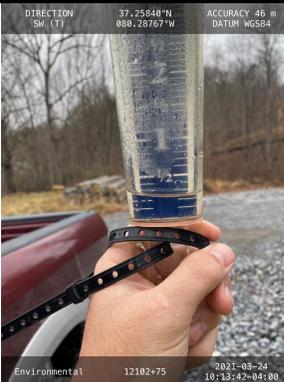
GPS Location See photo	GPS Location See photo
Field Station# 12010+00	Field Station# 12102+75
Pic 11 Desc. Stabilized slope in acceptable condition	Pic 12 Desc. Rain gauge totals for half acre of rock road

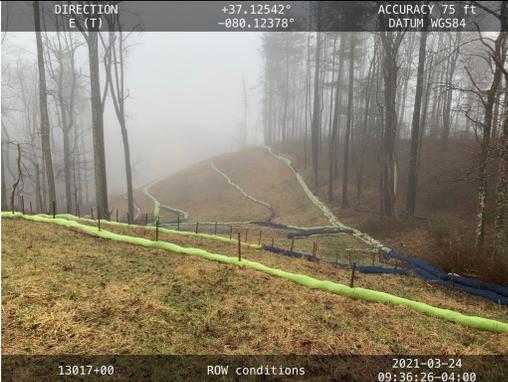
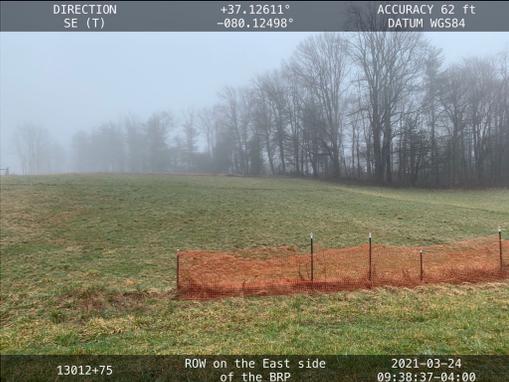
GPS Location	See pic for GPS location		GPS Location	See pic for GPS location	
Field Station#	13017+00		Field Station#	13012+75	
Pic 1 Desc.	Wooded portion of the BRP on the GAS of the motorway.		Pic 2 Desc.	GAS of the BRP motorway.

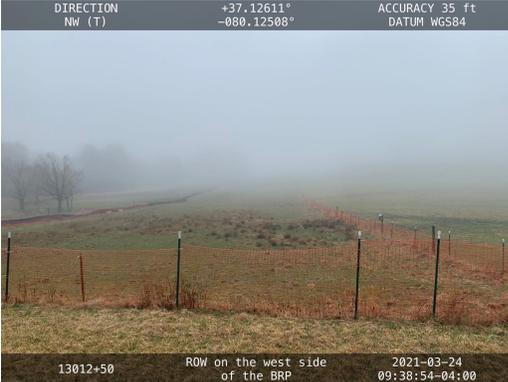
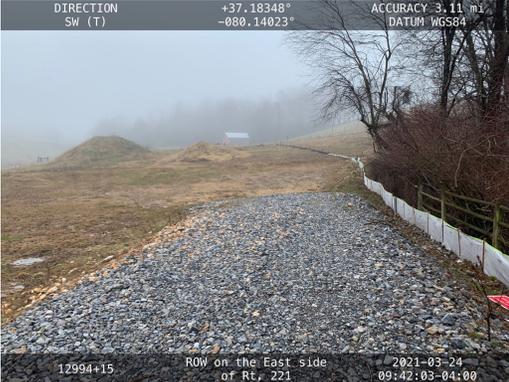
GPS Location	See pic for GPS location		GPS Location	See pic for GPS location	
Field Station#	12012+50		Field Station#	12994+15	
Pic 3 Desc.	CIS of the BRP motorway		Pic 4 Desc.	GAS of the US-221 road crossing.

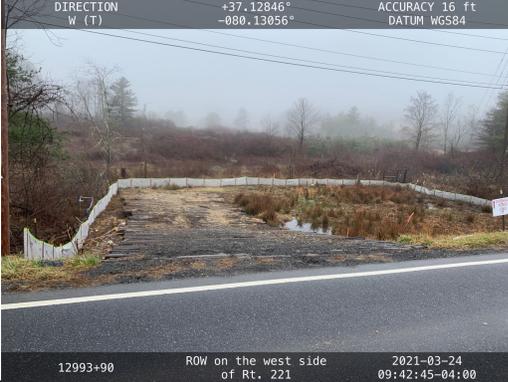
GPS Location	See pic for GPS location		GPS Location	See pic for GPS location	
Field Station#	12993+90		Field Station#	12974+29	
Pic 5 Desc.	CIS of the US-221 road crossing.		Pic 6 Desc.	Access RO-288 at stream S-Q20.

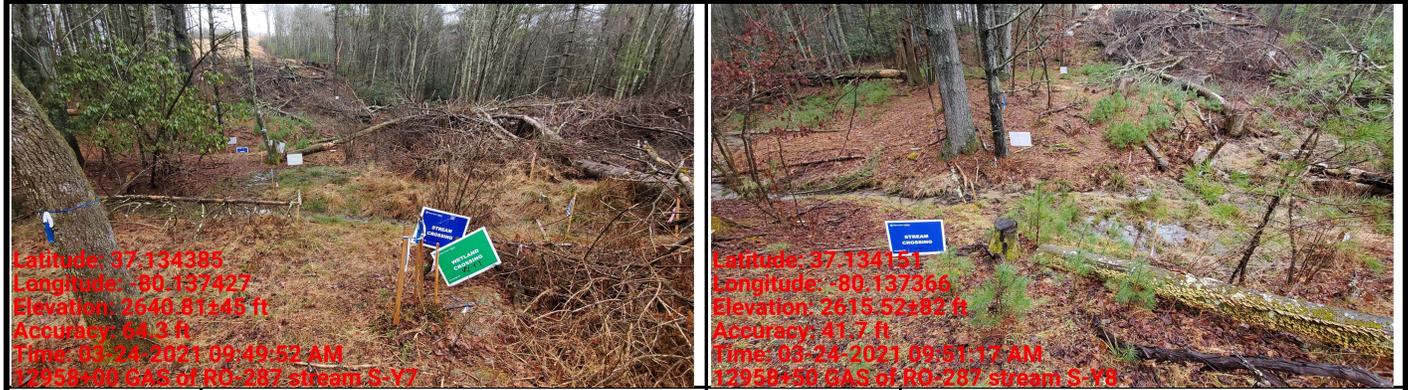
GPS Location	See pic for GPS location	GPS Location	See pic for GPS location
Field Station#	12958+00	Field Station#	12958+50
Pic 7 Desc.	Downstream side of stream S-Y7.	Pic 8 Desc.	Downstream side of stream S-Y8.

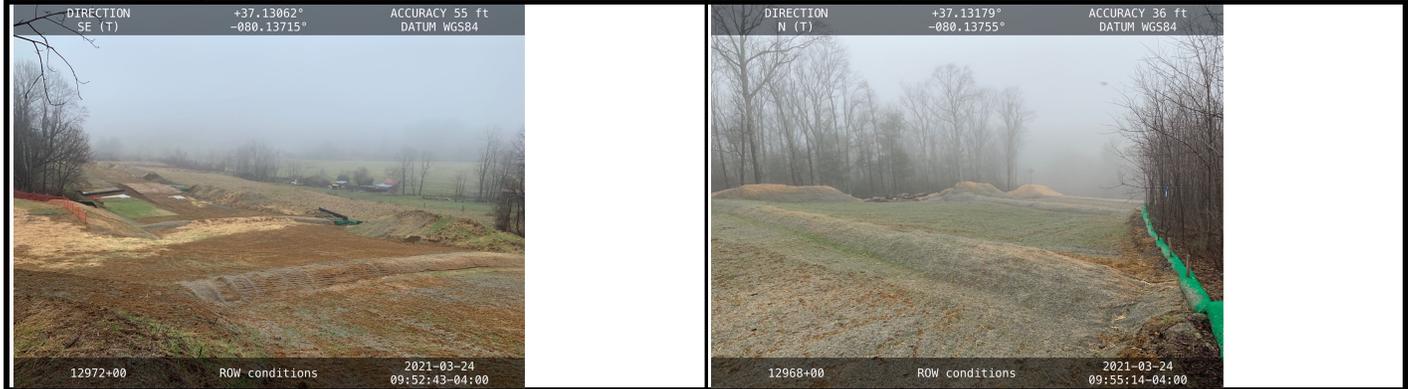
GPS Location	See pic for GPS location	GPS Location	See pic for GPS location
Field Station#	12972+00	Field Station#	12968+00
Pic 9 Desc.	ROW on the GAS of access RO-288.	Pic 10 Desc.	ROW on the GAS of access RO-287.

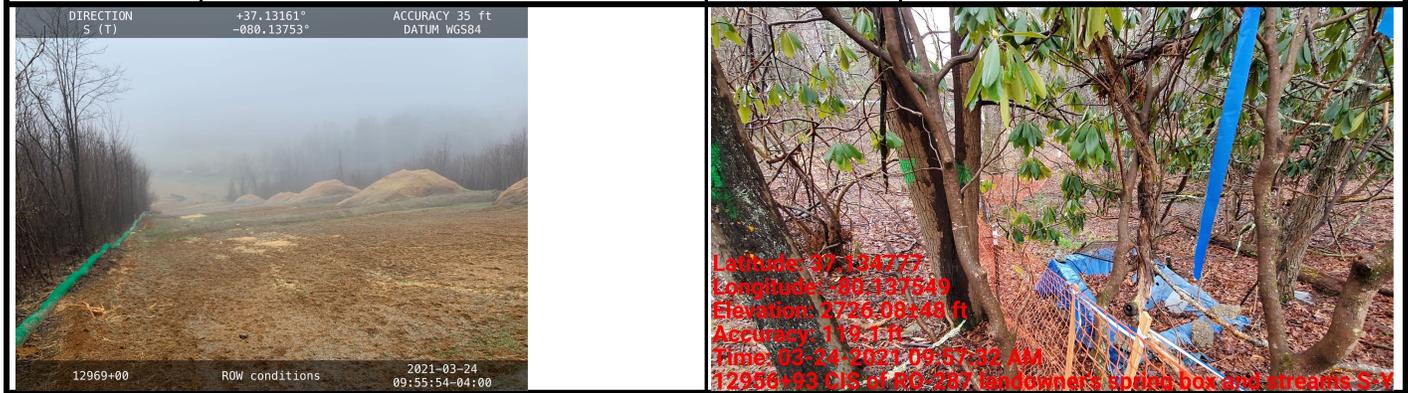
GPS Location	See pic for GPS location	GPS Location	See pic for GPS location
Field Station#	12969+00	Field Station#	12966+93
Pic 11 Desc.	ROW on the CIS of RO-288.	Pic 12 Desc.	Landowner's spring box at RO-287.

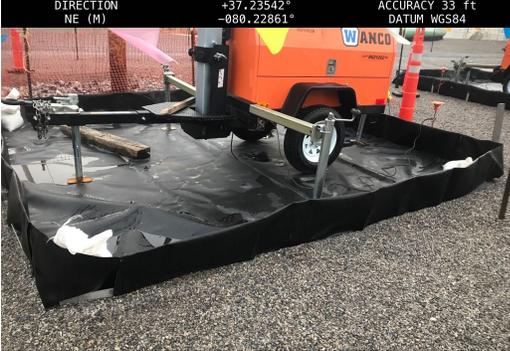
<p>DIRECTION NE (M) +37.23542° -080.22861° ACCURACY 33 ft DATUM WGS84</p> <p>MVP-PY-006_032521 Condition of containment 2021-03-25 07:54:31-04:00</p>

Pic 1 Desc.	Condition of containment under light plant. Free of stormwater. Looking NE.	Pic 2 Desc.	Condition of compost filter sock, signage, and buffer for feature W-008. Looking E.
--------------------	-----------------------------------------------------------------------------	--------------------	-------------------------------------------------------------------------------------

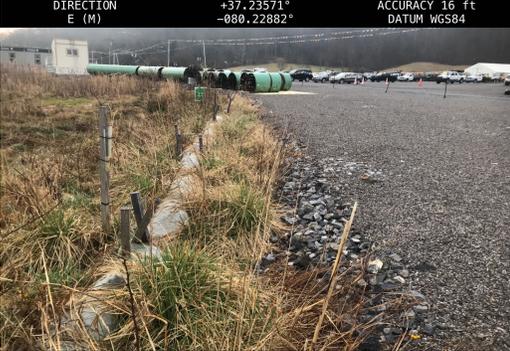
<p>DIRECTION E (M) +37.23571° -080.22882° ACCURACY 16 ft DATUM WGS84</p> <p>MVP-PY-006_032521 Condition of CFS, signage and ... 2021-03-25 07:55:20-04:00</p>
-----------------------------------------------------------------------------------------------------------------------------------------------------------------------------------------------------------------------------------------	--------------------------------------------------------------------------------------------------------------------------------------------------------------------------------------------------------------------------------------------------

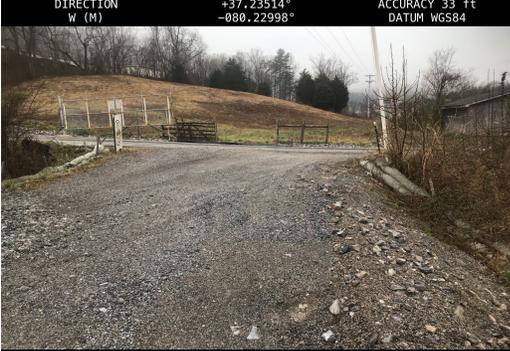
<p>DIRECTION W (M) +37.23514° -080.22998° ACCURACY 33 ft DATUM WGS84</p> <p>MVP-PY-006_032521 Condition of rock entrance 2021-03-25 07:57:49-04:00</p>

Pic 3 Desc.	Condition of rock entrance. No sediment on stone and no stone on roadway. Looking W.	Pic 4 Desc.	Condition of spoil pile on VDOT property adjacent to LOD. Pile not stabilized. Looking S.
--------------------	--------------------------------------------------------------------------------------	--------------------	-------------------------------------------------------------------------------------------

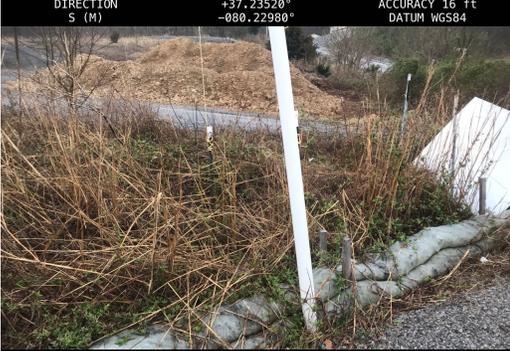
<p>DIRECTION S (M) +37.23520° -080.22980° ACCURACY 16 ft DATUM WGS84</p> <p>MVP-PY-006_032521 Condition of spoil pile adjacent to LOD 2021-03-25 07:58:18-04:00</p>
-------------------------------------------------------------------------------------------------------------------------------------------------------------------------------------------------------------------------------------------	---------------------------------------------------------------------------------------------------------------------------------------------------------------------------------------------------------------------------------------------------------

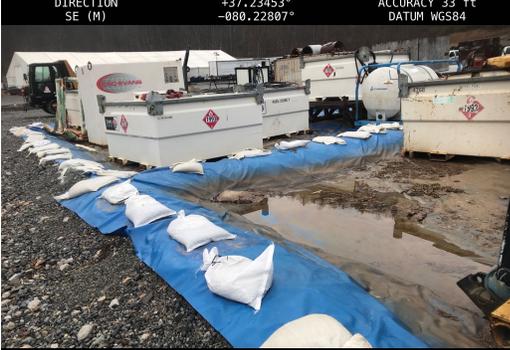
<p>DIRECTION SE (M) +37.23453° -080.22807° ACCURACY 33 ft DATUM WGS84</p> <p>MVP-PY-006_032521 Condition of poly lined containments 2021-03-25 08:05:36-04:00</p>

Pic 5 Desc.	Condition of poly lined rock berm containments. Hold some stormwater. Looking SE.	Pic 6 Desc.	Condition of trays and containment under toilets. Looking NE.
--------------------	-----------------------------------------------------------------------------------	--------------------	---------------------------------------------------------------

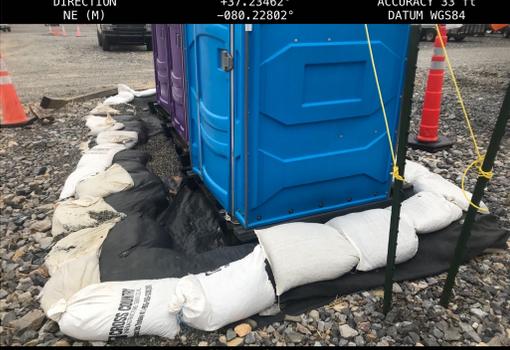
<p>DIRECTION NE (M) +37.23462° -080.22802° ACCURACY 33 ft DATUM WGS84</p> <p>MVP-PY-006_032521 Condition of trays & containment 2021-03-25 08:05:52-04:00</p>
-------------------------------------------------------------------------------------------------------------------------------------------------------------------------------------------------------------------------------------------------------	--------------------------------------------------------------------------------------------------------------------------------------------------------------------------------------------------------------------------------------------------------

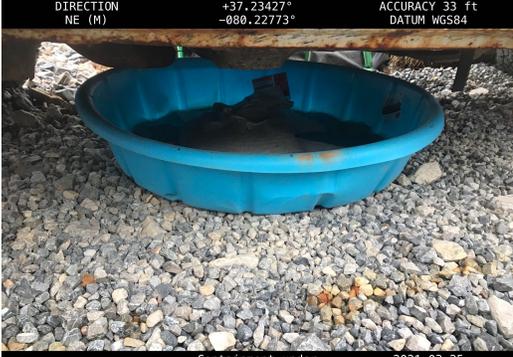
<p>DIRECTION NE (M) +37.23427° -080.22773° ACCURACY 33 ft DATUM WGS84</p> <p>MVP-PY-006_0325321 Containment under stored vehicle 2021-03-25 08:07:06-04:00</p>

GPS Location MVP-PY-006 See photo fo gps data	GPS Location MVP-PY-006 See photo fo gps data
Field Station# +0	Field Station# +0
Pic 7 Desc. Condition of containment under stored vehicle. Looking NE.	Pic 8 Desc. Condition of compost filter sock along south LOD. Looking SE.

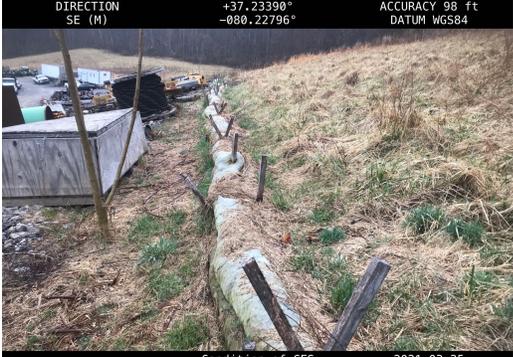
<p>DIRECTION SE (M) +37.23390° -080.22796° ACCURACY 98 ft DATUM WGS84</p> <p>MVP-PY-006_032521 Condition of CFS south LOD 2021-03-25 08:08:59-04:00</p>
--------------------------------------------------------------------------------------------------------------------------------------------------------------------------------------------------------------------------------------------------	--------------------------------------------------------------------------------------------------------------------------------------------------------------------------------------------------------------------------------------------

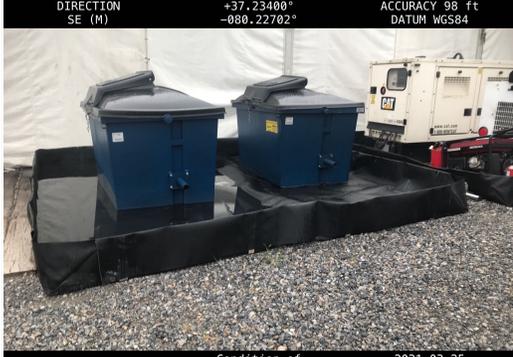
<p>DIRECTION SE (M) +37.23400° -080.22702° ACCURACY 98 ft DATUM WGS84</p> <p>MVP-PY-006_032521 Condition of containment 2021-03-25 08:10:34-04:00</p>

GPS Location MVP-PY-006 See photo fo gps data	GPS Location MVP-PY-006 See photo fo gps data
Field Station# +0	Field Station# +0
Pic 9 Desc. Condition of containment under hazardous waste dumpsters west of mechanics building. Holding stormwater. Looking SE.	Pic 10 Desc. Restoration supplies covered and protected from the elements. Looking S.

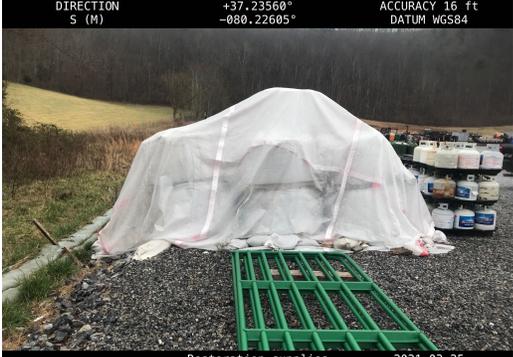
<p>DIRECTION S (M) +37.23560° -080.22605° ACCURACY 16 ft DATUM WGS84</p> <p>MVP-PY-006_032521 Restoration supplies covered 2021-03-25 08:12:34-04:00</p>
------------------------------------------------------------------------------------------------------------------------------------------------------------------------------------------------------------------------------------------	----------------------------------------------------------------------------------------------------------------------------------------------------------------------------------------------------------------------------------------------

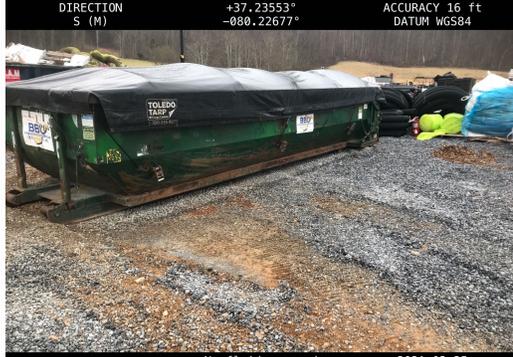
<p>DIRECTION S (M) +37.23553° -080.22677° ACCURACY 16 ft DATUM WGS84</p> <p>MVP-PY-006_032521 No fluids around hazardous waste ... 2021-03-25 08:13:43-04:00</p>

GPS Location MVP-PY-006 See photo fo gps data	GPS Location MVP-PY-006 See photo fo gps data
Field Station# +0	Field Station# +0
Pic 11 Desc. No fluids or deposits around hazardous waste dumpsters. Looking S.	Pic 12 Desc. No loose trash around dumpsters or in the yard. Looking SE.

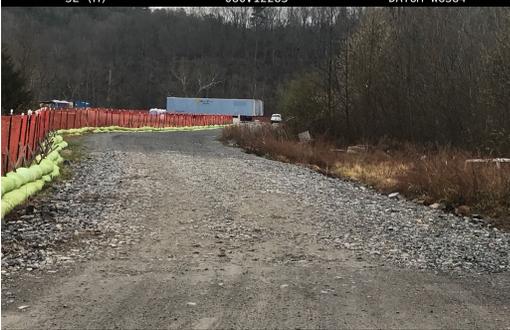
<p>MVP-LY-049_032521 Condition of rock entrance 2021-03-25 08:53:14-04:00</p>		<p>DIRECTION W (M) +37.27093° -080.12209° ACCURACY 16 ft DATUM WGS84</p>

<p>MVP-LY-049_032521 Condition of containment 2021-03-25 08:55:00-04:00</p>			
GPS Location MVP-LY-049 See photo for gps data		GPS Location MVP-LY-049 See photo for gps data			
Field Station# +0		Field Station# +0			
Pic 1 Desc. Condition of rock entrance. No sediment on stone. Looking SE.		Pic 2 Desc. Condition of containment under light plant. Free of stormwater. Looking W.			
<p>DIRECTION N (M) +37.27078° -080.12156° ACCURACY 328 ft DATUM WGS84</p>

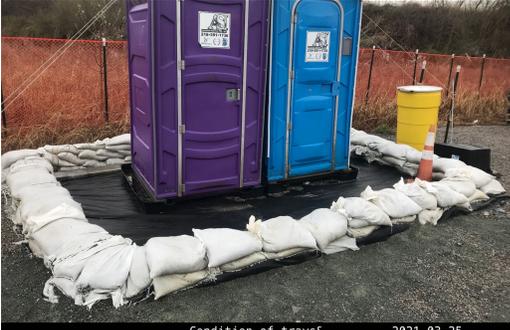
<p>MVP-LY-049_032521 Condition of trays& containment 2021-03-25 08:55:34-04:00</p>		<p>DIRECTION E (M) +37.27026° -080.12147° ACCURACY 33 ft DATUM WGS84</p>

GPS Location MVP-LY-049 See photo for gps data		GPS Location MVP-LY-049 See photo for gps data			
Field Station# +0		Field Station# +0			
Pic 3 Desc. Condition of trays and containment under toilets. Looking N.		Pic 4 Desc. No loose trash around south dumpsters. Looking SE.			
<p>DIRECTION S (M) +37.27021° -080.12161° ACCURACY 16 ft DATUM WGS84</p>

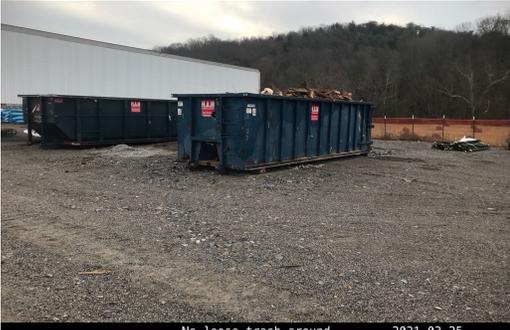
<p>MVP-LY-049_032521 No loose trash around south dumpsters 2021-03-25 08:56:16-04:00</p>

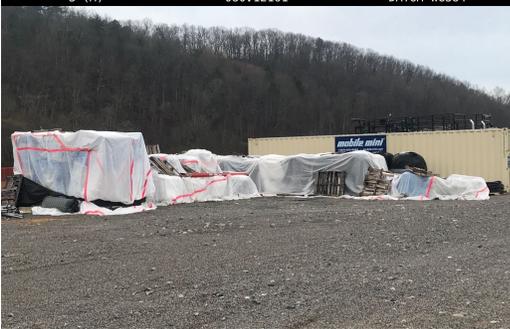
<p>MVP-LY-049_032521 Restoration supplies covered 2021-03-25 08:56:30-04:00</p>		<p>DIRECTION N (M) +37.27062° -080.12236° ACCURACY 33 ft DATUM WGS84</p>

<p>MVP-LY-049_032521 No fluids around hazardous waste ... 2021-03-25 08:58:05-04:00</p>			
GPS Location MVP-LY-049 See photo for gps data		GPS Location MVP-LY-049 See photo for gps data			
Field Station# +0		Field Station# +0			
Pic 5 Desc. Restoration supplies covered and protected from the elements. Looking S.		Pic 6 Desc. No fluids or deposits around hazardous waste dumpsters. Looking NW.

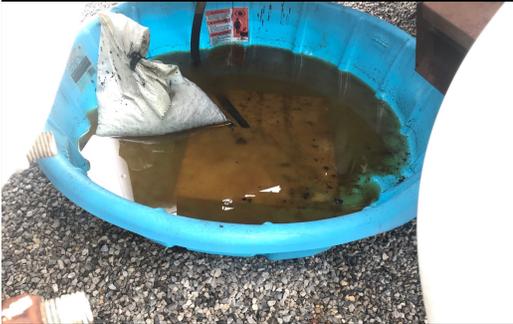
<p>MVP-LY-049_032521 Containment under stored vehicle 2021-03-25 08:59:37-04:00</p>	<p>DIRECTION S (M)</p> <p>+37.27050° -080.12251°</p> <p>ACCURACY 98 ft DATUM WGS84</p>

Pic 7 Desc. Condition of containment under stored vehicle. Looking NE.	Pic 8 Desc. Condition of containment under trailer. Looking S.
-------------------------------------------------------------------------------	-----------------------------------------------------------------------

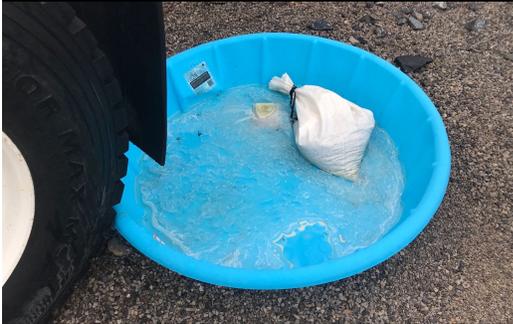
<p>MVP-LY-049_032521 Containment under stored trailer 2021-03-25 09:00:39-04:00</p>
-----------------------------------------------------------------------------------------------------------------------------------------------------------------------------------------------------------------------------------------------------------------------------------------------	-----------------------------------------------------------------------------------------------------------------------------------------------------------------------------------------------------------------------------------------------------------------------------------------------

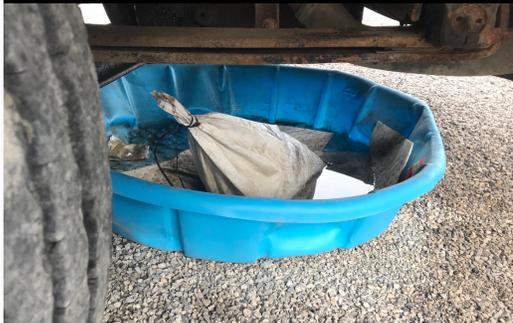
<p>MVP-LY-049_032521 Containment under stored vehicle 2021-03-25 09:00:59-04:00</p>	<p>DIRECTION N (M)</p> <p>+37.27022° -080.12361°</p> <p>ACCURACY 98 ft DATUM WGS84</p>

Pic 9 Desc. Condition of containment under stored vehicle. Looking NW.	Pic 10 Desc. Condition of temporary trash transfer pit. Most debris removed. Looking NW.
-------------------------------------------------------------------------------	-------------------------------------------------------------------------------------------------

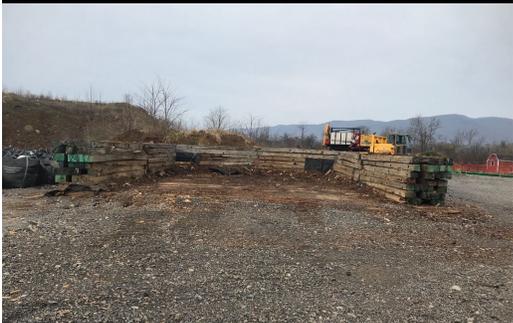
<p>MVP-LY-049_032521 Condition of temporary trash ... 2021-03-25 09:02:16-04:00</p>
------------------------------------------------------------------------------------------------------------------------------------------------------------------------------------------------------------------------------------------------------------------------------------------------	------------------------------------------------------------------------------------------------------------------------------------------------------------------------------------------------------------------------------------------------------------------------------------------------

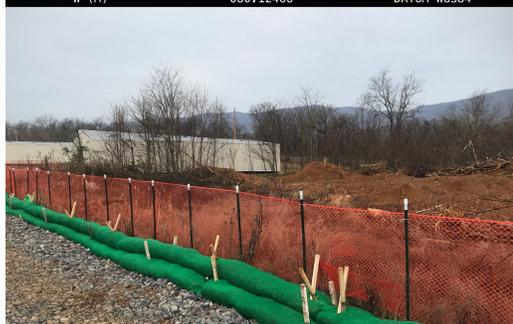
<p>MVP-LY-049_032521 Landowner disturbance along feature 2021-03-25 09:03:05-04:00</p>	<p>DIRECTION SW (M)</p> <p>+37.27042° -080.12463°</p> <p>ACCURACY 16 ft DATUM WGS84</p>

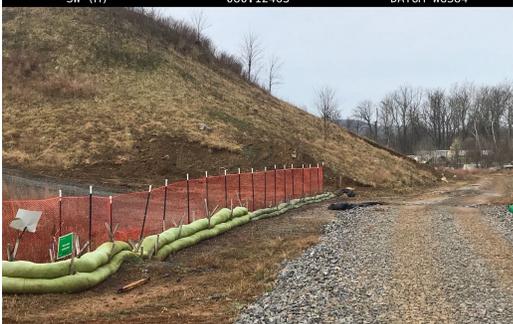
<p>MVP-LY-049_032521 Landowner disturbance within 66' of feature 2021-03-25 09:03:10-04:00</p>
---------------------------------------------------------------------------------------------------------------------------------------------------------------------------------------------------------------------------------------------------------------------------------------------------	-------------------------------------------------------------------------------------------------------------------------------------------------------------------------------------------------------------------------------------------------------------------------------------------------------------

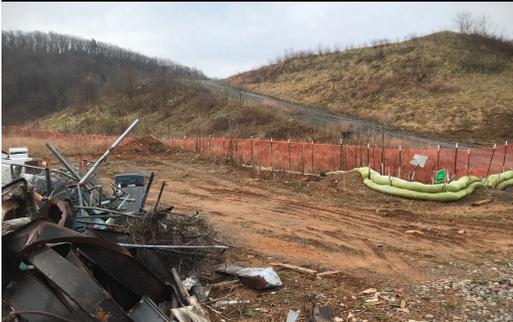
<p>MVP-LY-049_032521 Landowner disturbance along CFS & feature 2021-03-25 09:03:15-04:00</p>		<p>DIRECTION SE (M) +37.27052° -080.12422° ACCURACY 16 ft DATUM WGS84</p>

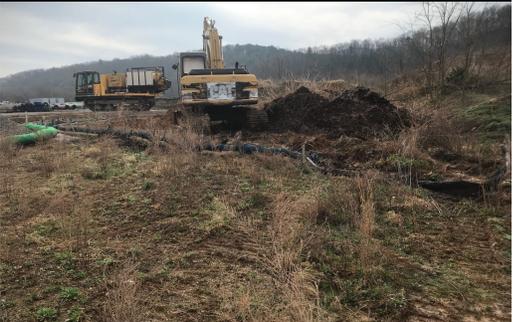
<p>MVP-LY-049_032521 Landowner damage to CFS 2021-03-25 09:04:29-04:00</p>	
GPS Location	MVP-LY-049 See photo for gps data	GPS Location	MVP-LY-049 See photo for gps data
Field Station#	+0	Field Station#	+0
Pic 13 Desc.	Landowner soil disturbance along compost filter sock and feature W-CV21B. Area not stabilized. No impacts. Looking S.	Pic 14 Desc.	Landowner damaged compost filter sock. Looking SE.
<p>DIRECTION SW (M) +37.27051° -080.12380° ACCURACY 16 ft DATUM WGS84</p>

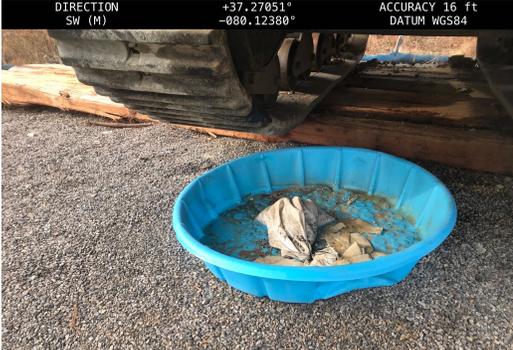
<p>MVP-LY-049_032521 Containment under stored equipment 2021-03-25 09:05:23-04:00</p>		<p>DIRECTION E (M) +37.26958° -080.12291° ACCURACY 33 ft DATUM WGS84</p>

GPS Location	MVP-LY-049 See photo for gps data	GPS Location	MVP-LY-049 See photo for gps data
Field Station#	+0	Field Station#	+0
Pic 15 Desc.	Condition of containment under stored equipment. Looking SW.	Pic 16 Desc.	Condition of containment under stored equipment. Looking E.
<p>DIRECTION W (M) +37.26957° -080.12291° ACCURACY 16 ft DATUM WGS84</p>

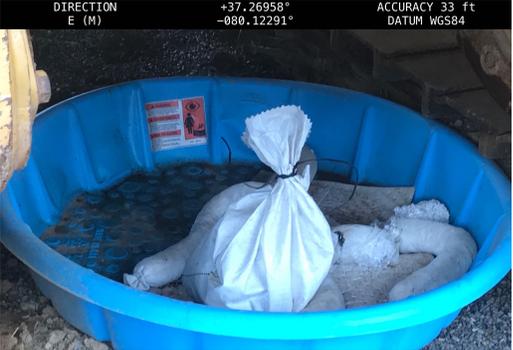
<p>MVP-LY-049_032521 Condition under stored equipment 2021-03-25 09:06:47-04:00</p>

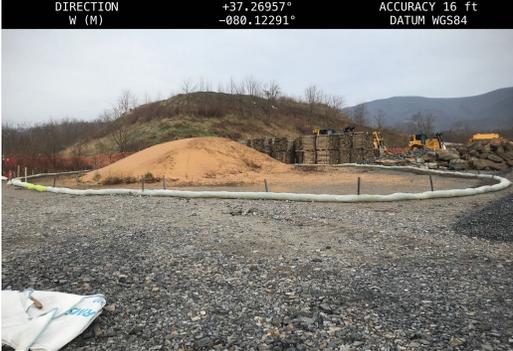
<p>MVP-LY-049_032521 Condition of CFS around sand pile 2021-03-25 09:07:29-04:00</p>		<p>DIRECTION E (M) +37.26972° -080.12206° ACCURACY 16 ft DATUM WGS84</p>

<p>MVP-LY-049_032521 Condition of CFS & safety fence 2021-03-25 09:13:19-04:00</p>	
GPS Location	MVP-LY-049 See photo for gps data	GPS Location	MVP-LY-049 See photo for gps data
Field Station#	+0	Field Station#	+0
Pic 17 Desc.	Condition of compost filter sock around sand pile. In place and functioning. Looking W.	Pic 18 Desc.	Condition of compost filter sock and safety fence along south LOD. Looking E.

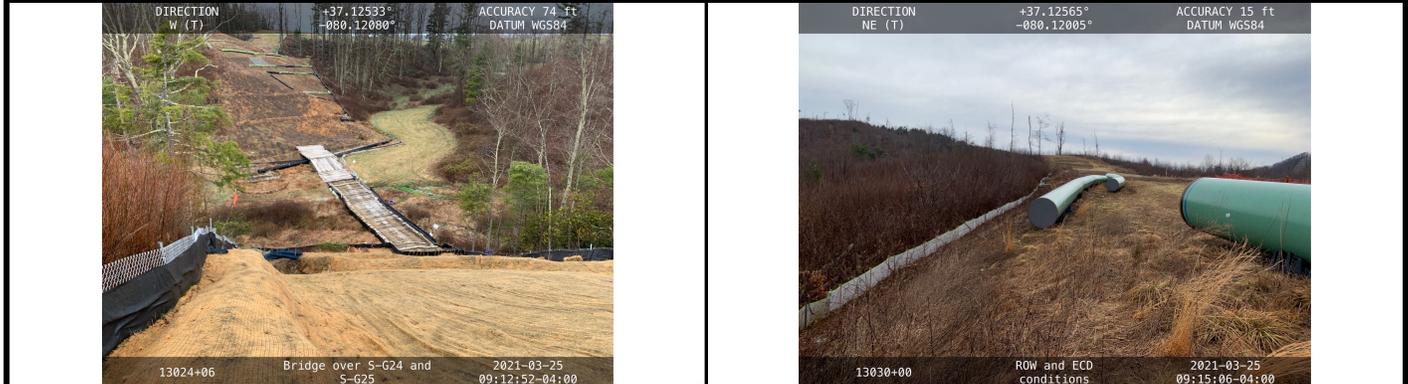
Pic 1 Desc.	Photo shows the bridge over streams S-G24 and S-G25.	Pic 2 Desc.	Photo shows the ROW and ECD conditions from about 13030+00 to 13032+00.
--------------------	------------------------------------------------------	--------------------	-------------------------------------------------------------------------

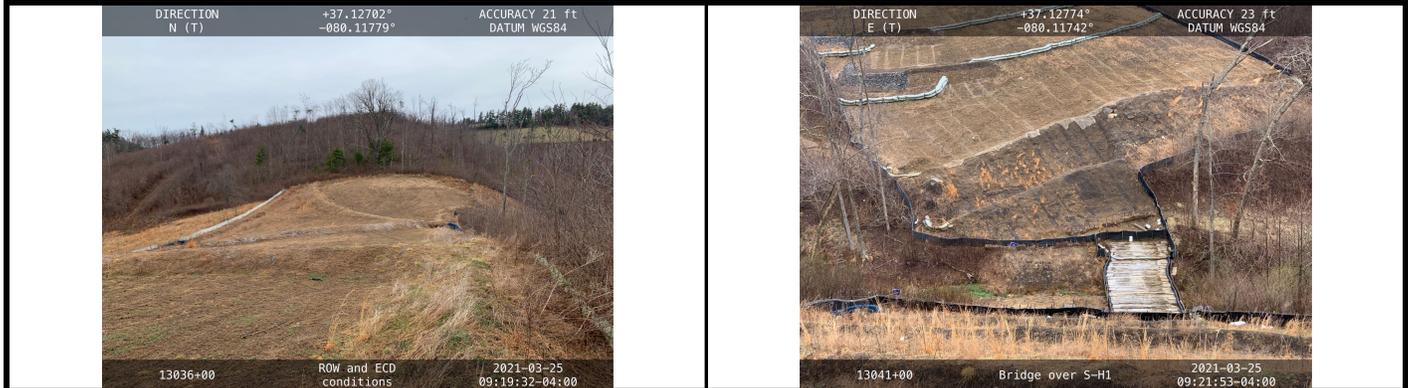
Pic 3 Desc.	Photo shows the ROW and ECD conditions from about 13036+00 to 13039+00.	Pic 4 Desc.	Photo shows the bridge over stream S-H1.
--------------------	-------------------------------------------------------------------------	--------------------	------------------------------------------

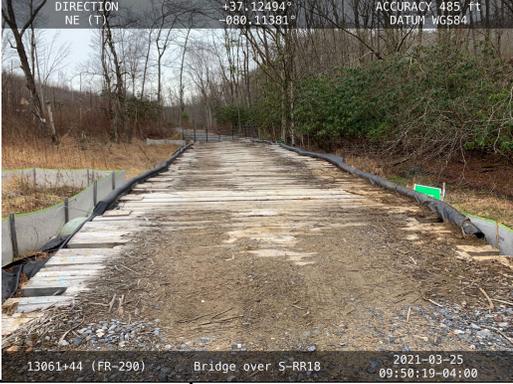
<p>DIRECTION NE (T) +37.12494° -080.11381° ACCURACY 485 ft DATUM WGS84 13061+44 (FR-290) Bridge over S-RR18 2021-03-25 09:50:19-04:00</p>

<p>DIRECTION S (T) +37.12516° -080.11362° ACCURACY 35 ft DATUM WGS84 13061+44 (FR-290) Stream S-RR18 downstream 2021-03-25 09:50:37-04:00</p>	
GPS Location	See photo for gps location data.	GPS Location	See photo for gps location data.
Field Station#	13061+44	Field Station#	13061+44
Pic 7 Desc.	Photo shows the bridge over stream S-RR18.	Pic 8 Desc.	Photo shows stream S-RR18 downstream of access road FR-290.

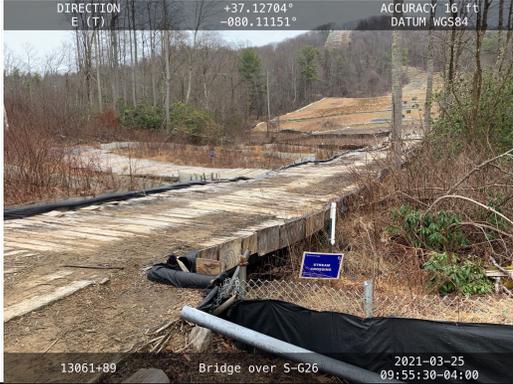
<p>DIRECTION E (T) +37.12704° -080.11151° ACCURACY 16 ft DATUM WGS84 13061+89 Bridge over S-G26 2021-03-25 09:55:30-04:00</p>

Field Station#	13061+89	Field Station#	13061+89
Pic 9 Desc.	Photo shows the bridge over stream S-G26.	Pic 10 Desc.	Photo shows stream S-G26 down stream from the bridge.

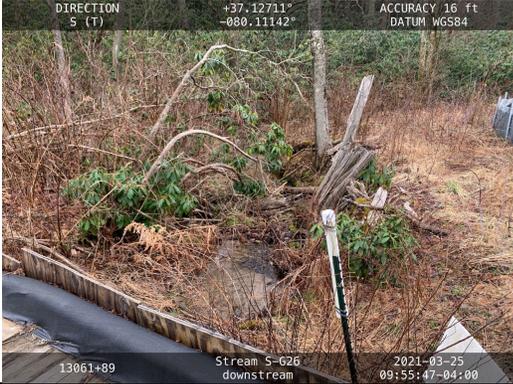
<p>DIRECTION S (T) +37.12711° -080.11142° ACCURACY 16 ft DATUM WGS84 13061+89 Stream S-G26 downstream 2021-03-25 09:55:47-04:00</p>	
GPS Location	See photo for gps location data.	GPS Location	See photo for gps location data.

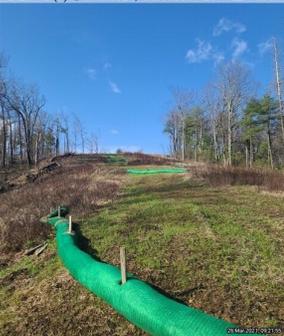
GPS Location 000000		GPS Location 000000			
Field Station# 13475+50		Field Station# 13452+34			
Pic 1 Desc. Row photo showing new vegetation growing , ECDs in place and functioning.		Pic 2 Desc. Photo showing vegetation growth in travel lane.			
		West Elevation <small>98°E (T) ● 37.086347, -80.016011 ±3 m ▲ 521 m</small>

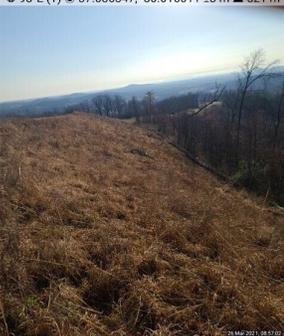
GPS Location 000000		GPS Location 000000			
Field Station# 13460+00		Field Station# 13476+00			
Pic 3 Desc. Monitored ECDs on row edge, no issues observed at time of inspection.		Pic 4 Desc. Row photo showing vegetation and ECDs in place and functioning.

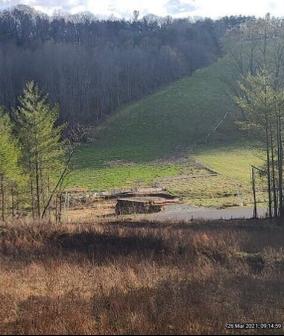
GPS Location 000000		GPS Location 000000			
Field Station# 13496+00		Field Station# 13478+00			
Pic 5 Desc. Vegetation observation photo facing down row , good permanent coverage.		Pic 6 Desc. Row photo showing new vegetation growing .

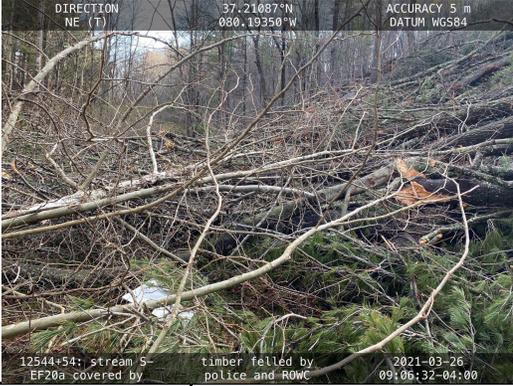
<p>DIRECTION NE (T) 37.21087°N 080.19350°W ACCURACY 5 m DATUM WGS84</p> <p>12544+54: stream S-EF20a covered by timber felled by police and ROW 2021-03-26 09:06:32-04:00</p>

<p>DIRECTION E (T) 37.21104°N 080.19390°W ACCURACY 5 m DATUM WGS84</p> <p>12544+06: Yellow Finch Ln viewed from slope on CIS of road 2021-03-26 09:13:41-04:00</p>	
GPS Location	See photo	GPS Location	See photo
Field Station#	12544+54	Field Station#	12543+00
Pic 7 Desc.	Stream S-EF20a, facing northeast, downstream	Pic 8 Desc.	Yellow Finch Lane viewed from slope on coming in side of the road.
