Visual Site Inspection Report

Project Name H-600 Pipeline Spread H		AFE 124300138	Spread H-600 Pipeline Spread H
Contractor Precision		Report # 21352	
Inspector John Brcic		Date/Time 3/22/2021 2:55 PM	
Permit # TBD	Inspection Type VA SWPP	Station Begin 12443+75	
State VA	Inspection Area Partial	Station End 12544+06	
County Montgomery	Ground Dry	Temperature (°F) 50.00	
Municipality N/A	Weather Sunny	Rain Gauge (in) 0.00	
Rain Accumulation Time (days)			3.00

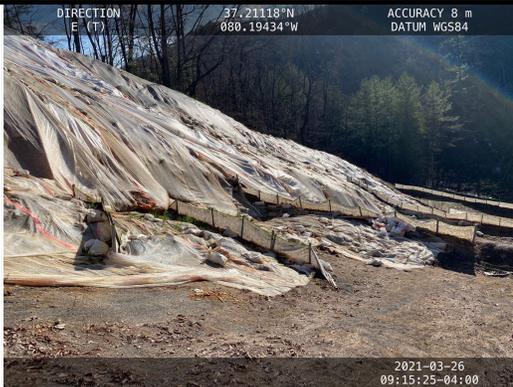
GPS Location	See photo	GPS Location	See photo
Field Station#	12542+00	Field Station#	12529+00
Pic 9 Desc.	Stockpiles stable on coming in side of Yellow Finch Lane.	Pic 10 Desc.	Stockpiles approximately 1500 feet from Yellow Finch Lane remain stable with blanket and plastic sheeting.

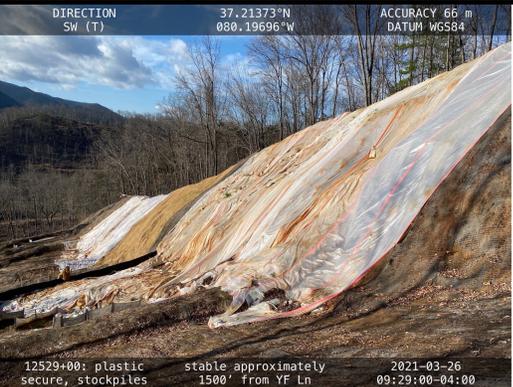
<p>DIRECTION SW (T) 37.21373°N 080.19696°W ACCURACY 66 m DATUM WGS84</p> <p>12529+00: plastic stockpiles stable approximately 1500' from YF Ln 2021-03-26 09:29:00-04:00</p>

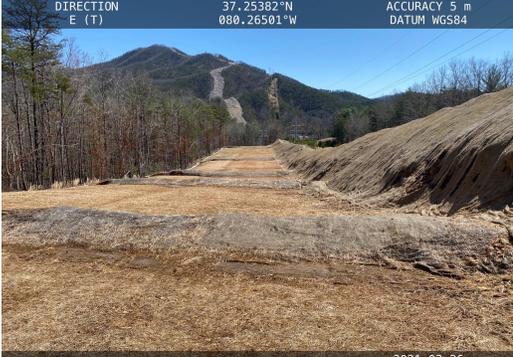
GPS Location	See photo	GPS Location	See photo
Field Station#	12172+00	Field Station#	12166+47
Pic 7 Desc.	Stabilized ROW in acceptable condition	Pic 8 Desc.	Bridge and ECDs crossing S-C24 in acceptable condition

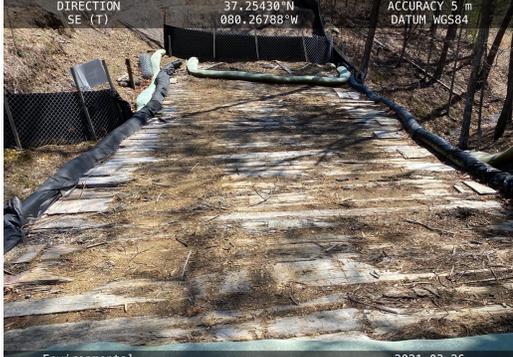
GPS Location	See photo	GPS Location	See photo
Field Station#	12163+03	Field Station#	12130+00
Pic 9 Desc.	Bridge and ECDs at stream crossing S-C25 in acceptable condition	Pic 10 Desc.	Stabilized ROW in acceptable condition

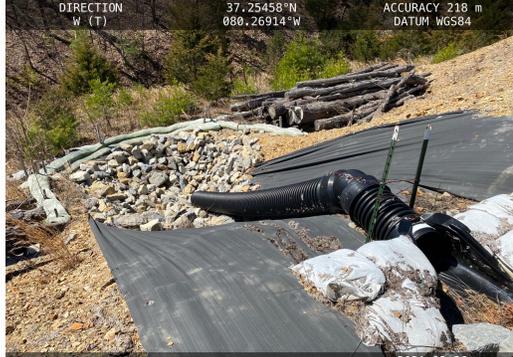
GPS Location	See photo	GPS Location	See photo
Field Station#	12160+00	Field Station#	12121+33
Pic 11 Desc.	Fill slope pipe drain in acceptable condition	Pic 12 Desc.	Bridge and ECDs at stream crossing S-C33 in acceptable condition

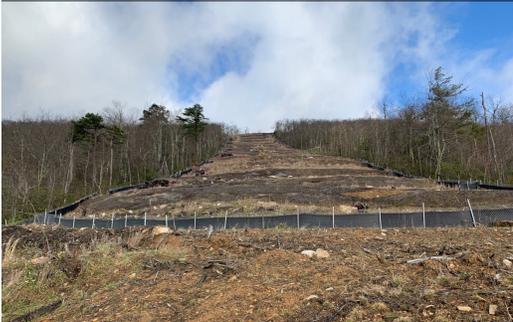
AFE 124300138		Date/Time 3/26/2021 5:39 PM		Report #	
Pictures					
GPS Location	See photo for gps location data.		GPS Location	See photo for gps location data.	
Field Station#	12689+00		Field Station#	12686+00	
Pic 1 Desc.	Photo shows the ROW and ECD conditions from about 12687+00 to 12689+00.		Pic 2 Desc.	Photo shows the ROW and ECD conditions from about 12683+00 to 12686+00.	
GPS Location	See photo for gps location data.		GPS Location	See photo for gps location data.	
Field Station#	12690+00		Field Station#	12692+00	
Pic 3 Desc.	Photo shows the RCE on the east side of Honeysuckle Road.		Pic 4 Desc.	Photo shows the ROW and ECD conditions from about 12692+00 to 12700+00.	
GPS Location	See photo for gps location data.		GPS Location	See photo for gps location data.	
Field Station#	12690+00		Field Station#	12703+00	
Pic 5 Desc.	Photo shows the RCE on the west side of Honeysuckle Road.		Pic 6 Desc.	Photo shows the ECDs along AtWS-1225.

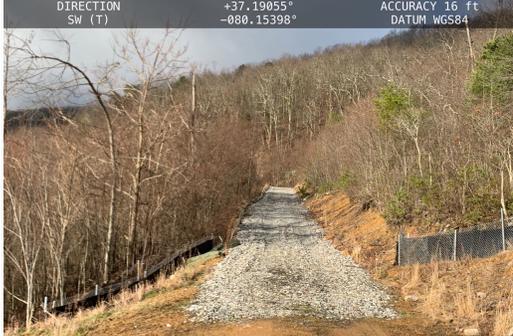
12702+00 ROW and ECD conditions 2021-03-26 08:50:15-04:00		12704+00 ROW and ECD conditions 2021-03-26 08:51:14-04:00			
GPS Location	See photo for gps location data.		GPS Location	See photo for gps location data.	
Field Station#	12702+00		Field Station#	12704+00	
Pic 7 Desc.	Photo shows the ROW and ECD conditions from about 12695+00 to 12702+00.		Pic 8 Desc.	Photo shows the ROW and ECD conditions from about 12704+00 to 12709+00.	
DIRECTION SW (T) +37.19055° ACCURACY 16 ft -080.15398° DATUM WGS84		DIRECTION S (T) 37.15557°N ACCURACY 16 ft 080.12869°W DATUM WGS84

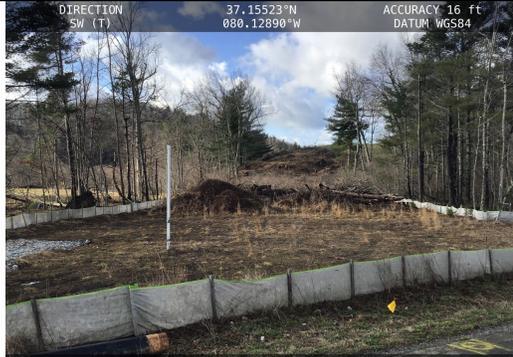
12703+00 RCE on RO-280 2021-03-26 08:52:55-04:00		12865+75 CIS of Bottom Creek Road 2021-03-26 09:05:37-04:00

GPS Location	See photo for gps location data.		GPS Location	See photo for gps location data.	
Field Station#	12703+00		Field Station#	12865+75	
Pic 9 Desc.	Photo shows the RCE on RO-280		Pic 10 Desc.	Photo shows the ECDs along AtWS-1326.	
DIRECTION SW (T) 37.15523°N ACCURACY 16 ft 080.12890°W DATUM WGS84		DIRECTION NE (T) +37.19301° ACCURACY 41 ft -080.17340° DATUM WGS84
