# Visual Site Inspection Report

<b>Project Name</b>	H-600 Pipeline Spread H	<b>AFE</b>	124300138	<b>Spread</b>	H-600 Pipeline Spread H
<b>Contractor</b>	Precision			<b>Report #</b>	22165
<b>Inspector</b>	Pat Davis			<b>Date/Time</b>	4/12/2021 4:00 PM
<b>Permit #</b>	TBD	<b>Inspection Type</b>	VA SWPP	<b>Station Begin</b>	+0
<b>State</b>	VA	<b>Inspection Area</b>	Partial	<b>Station End</b>	+0
<b>County</b>	Roanoke	<b>Ground</b>	Wet	<b>Temperature (°F)</b>	59.00
<b>Municipality</b>	N/A	<b>Weather</b>	Sunny	<b>Rain Gauge (in)</b>	0.00
				<b>Rain Accumulation Time (days)</b>	0.00

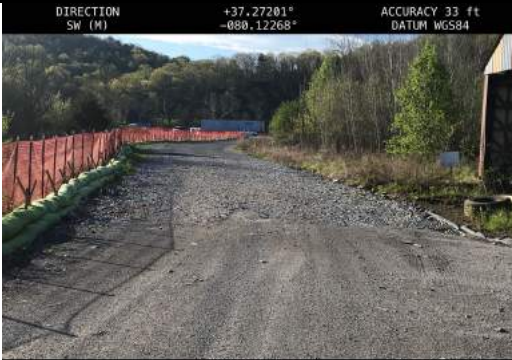
<p>DIRECTION SW (M) +37.27201° -080.12268° ACCURACY 33 ft DATUM WGS84</p> <p>MVP-LY-049_041221 Condition of rock entrance 2021-04-12 08:30:21-04:00</p>

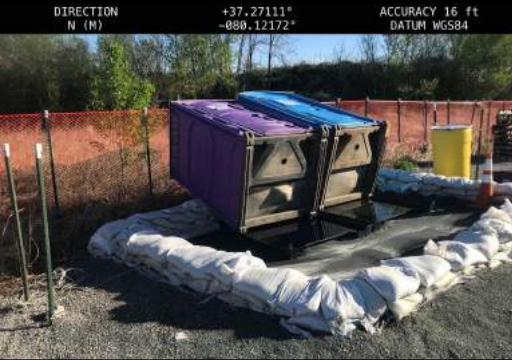
<p>DIRECTION N (M) +37.27111° -080.12172° ACCURACY 16 ft DATUM WGS84</p> <p>MVP-LY-049_041221 Toilets blew over rope snapped 2021-04-12 08:39:09-04:00</p>			
<b>GPS Location</b>	MVP-LY-049 See phot for gps data	<b>GPS Location</b>	MVP-LY-049 See phot for gps data		
<b>Field Station#</b>	+0	<b>Field Station#</b>	+0		
<b>Pic 1 Desc.</b>	Condition of Rock entrance on center driveway. No sediment on stone. Looking SE.	<b>Pic 2 Desc.</b>	Toilets blown over and rope broken. NO SPILL of blue chemical. Looking NE.

E&S BMPs	Compliance Level	Corrective Action	Corrective Time Frame	Date Repaired
Compost Filter Sock	Acceptable			
Housekeeping	Acceptable			
Rock Construction Entrance	Acceptable			
Waste Management	Acceptable	Reset toilets and secured. No spill	Immediate	4/12/2021
Sensitive Resource Buffer	Acceptable			
Sensitive Resource Signage	Acceptable			
Secondary Containment	Acceptable

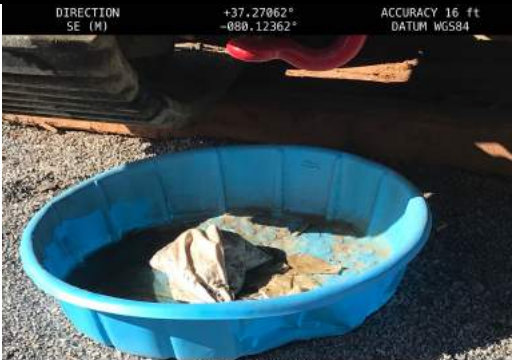
<p>DIRECTION SE (M) +37.27062° -080.12362° ACCURACY 16 ft DATUM WGS84</p> <p>MVP-LY-049_041221 Containment under stored equipment 2021-04-12 09:08:23-04:00</p>

<b>GPS Location</b>	MVP-LY-049 See phot for gps data	<b>GPS Location</b>	MVP-LY-049 See phot for gps data		
<b>Field Station#</b>	+0	<b>Field Station#</b>	+0		
<b>Pic 3 Desc.</b>	Condition of containment under stored vehicle. Looking SW.	<b>Pic 4 Desc.</b>	Toilets reset and secured with new rope. NO SPILL. Looking NE.

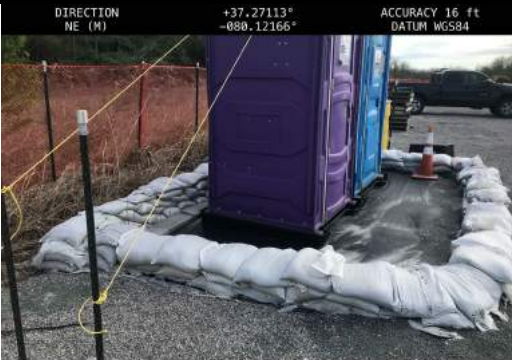
<p>DIRECTION NE (M) +37.27113° -080.12166° ACCURACY 16 ft DATUM WGS84</p> <p>MVP-LY-049_041221 Toilets reset and secured 2021-04-12 09:36:03-04:00</p>

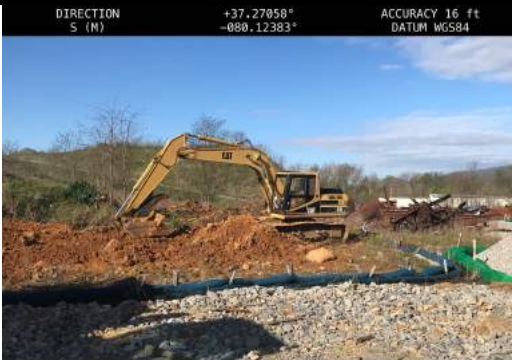
<p>DIRECTION S (M) +37.27058° -080.12383° ACCURACY 16 ft DATUM WGS84</p> <p>MVP-LY-049_041221 Landowner disturbance along CFS 2021-04-12 09:08:34-04:00</p>

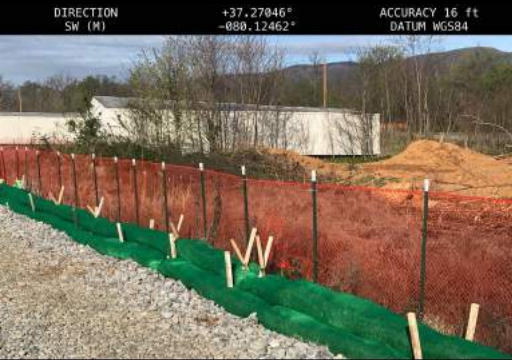
<p>DIRECTION SW (M) +37.27046° -080.12462° ACCURACY 16 ft DATUM WGS84</p> <p>MVP-LY-049_041221 Landowner disturbance along feature 2021-04-12 09:09:13-04:00</p>			
<b>GPS Location</b>	MVP-LY-049 See phot for gps data	<b>GPS Location</b>	MVP-LY-049 See phot for gps data		
<b>Field Station#</b>	+0	<b>Field Station#</b>	+0		
<b>Pic 5 Desc.</b>	Landowner soil disturbance along compost filter sock. Looking W.	<b>Pic 6 Desc.</b>	Landowner soil disturbance along north edge of feature W-CV21A. Looking NW.

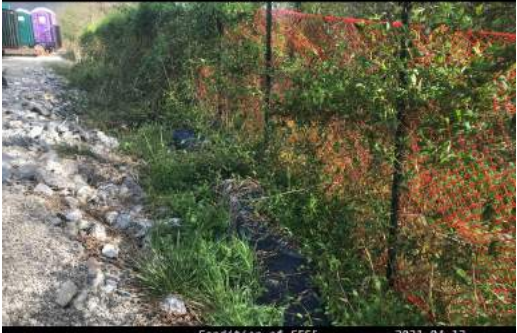
MVP-LY-049_041221 Condition of CFS & safety fence 2021-04-12 09:27:16-04:00		MVP-LY-049_041221 Condition of CFS & safety fence 2021-04-12 09:27:47-04:00			
<b>GPS Location</b>	MVP-LY-049 See phot for gps data		<b>GPS Location</b>	MVP-LY-049 See phot for gps data	
<b>Field Station#</b>	+0		<b>Field Station#</b>	+0	
<b>Pic 13 Desc.</b>	Condition of compost filter sock and safety fence along south LOD. Looking SW.		<b>Pic 14 Desc.</b>	Condition of compost filter sock and safety fence along east LOD. Looking N.	
DIRECTION S (M) +37.27035° -080.12156° ACCURACY 33 ft DATUM WGS84

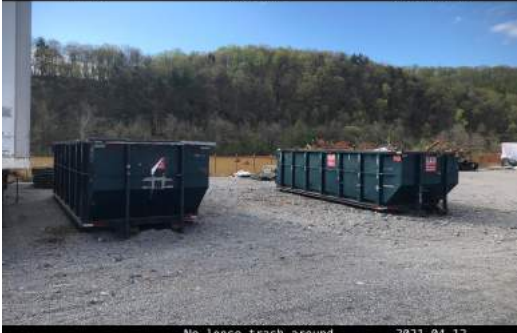
MVP-LY-049_041221 No loose trash around south dumpsters 2021-04-12 09:29:13-04:00		MVP-LY-049_041221 Restoration supplies covered 2021-04-12 09:29:47-04:00

<b>GPS Location</b>	MVP-LY-049 See phot for gps data		<b>GPS Location</b>	MVP-LY-049 See phot for gps data	
<b>Field Station#</b>	+0		<b>Field Station#</b>	+0	
<b>Pic 15 Desc.</b>	No loose trash around south dumpsters or in the yard. Looking S.		<b>Pic 16 Desc.</b>	Restoration supplies covered and protected from the elements. Looking SW.	
DIRECTION W (M) +37.26923° -080.12362° ACCURACY 16 ft DATUM WGS84

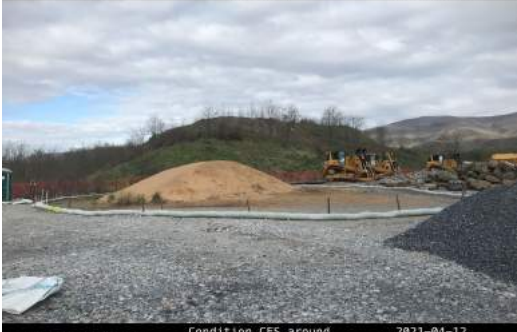
DIRECTION N (M) +37.27013° -080.12268° ACCURACY 16 ft DATUM WGS84  			
MVP-LY-049_041221 Condition CFS around sand pile 2021-04-12 09:32:07-04:00		MVP-LY-049_041221 Containment under stored vehicle 2021-04-12 09:33:41-04:00			
<b>GPS Location</b>	MVP-LY-049 See phot for gps data		<b>GPS Location</b>	MVP-LY-049 See phot for gps data	
<b>Field Station#</b>	+0		<b>Field Station#</b>	+0	
<b>Pic 17 Desc.</b>	Condition of compost filter sock around sand pile. In place and functioning. Looking W.		<b>Pic 18 Desc.</b>	Condition of containment under stored vehicle. Looking N.

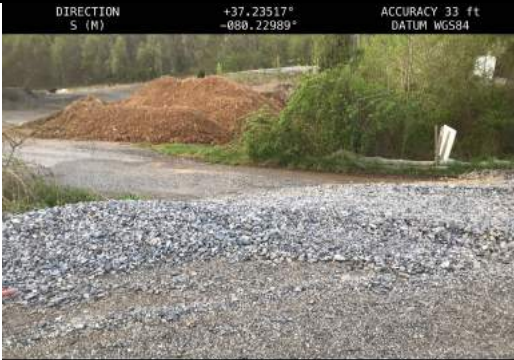
<p>DIRECTION S (N) +37.23517° -080.22989° ACCURACY 33 ft DATUM WGS84</p> <p>MVP-PY-006_041221 Condition of VDOT soil pile adjacent to LOD on VDOT property. Looking S. 2021-04-12 07:18:53-04:00</p>

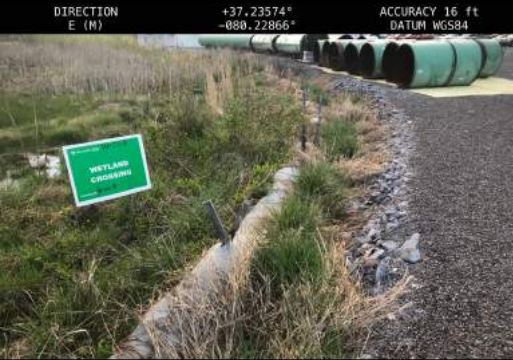
<p>DIRECTION E (N) +37.23574° -080.22866° ACCURACY 16 ft DATUM WGS84</p> <p>MVP-PY-006_041221 Condition of signage &amp; CFS at feature 2021-04-12 07:21:40-04:00</p>			
<b>GPS Location</b>	MVP-PY-006 See photo for gps data		<b>GPS Location</b>	MVP-PY-006 See photo for gps data	
<b>Field Station#</b>	+0		<b>Field Station#</b>	+0	
<b>Pic 1 Desc.</b>	Condition of non stabilized soil pile adjacent to LOD on VDOT property. Looking S.		<b>Pic 2 Desc.</b>	Condition of signage and compost filter sock along feature W-008. Looking E.

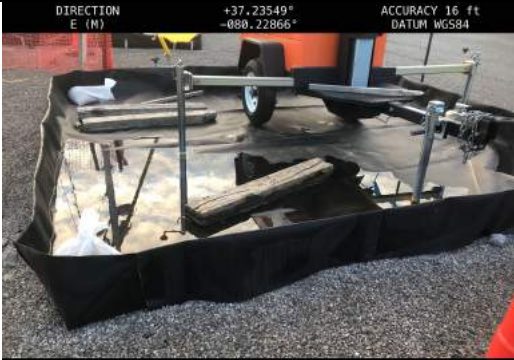
<p>DIRECTION E (N) +37.23549° -080.22866° ACCURACY 16 ft DATUM WGS84</p> <p>MVP-LY-006_041221 Condition of containment 2021-04-12 07:22:56-04:00</p>

<b>GPS Location</b>	MVP-PY-006 See photo for gps data		<b>GPS Location</b>	MVP-PY-006 See photo for gps data	
<b>Field Station#</b>	+0		<b>Field Station#</b>	+0	
<b>Pic 3 Desc.</b>	Condition of containment under light plant. Holding stormwater. Looking E.		<b>Pic 4 Desc.</b>	Condition of posted project documents at main entrance. Looking NW.

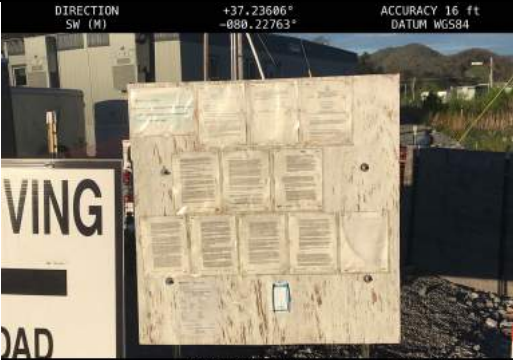
<p>DIRECTION SW (N) +37.23606° -080.22763° ACCURACY 16 ft DATUM WGS84</p> <p>MVP-PY-006_041221 Condition of posted project documents 2021-04-12 07:41:11-04:00</p>

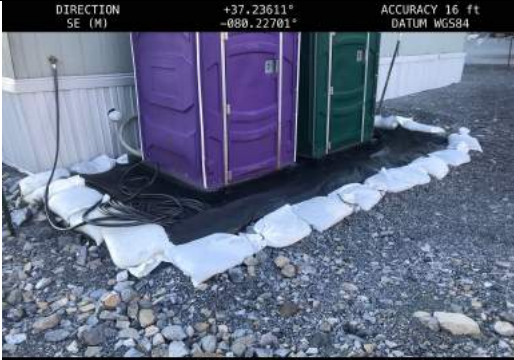
<p>DIRECTION SE (N) +37.23611° -080.22701° ACCURACY 16 ft DATUM WGS84</p> <p>MVP-PY-006_041221 Condition of trays &amp; containment 2021-04-12 07:42:31-04:00</p>

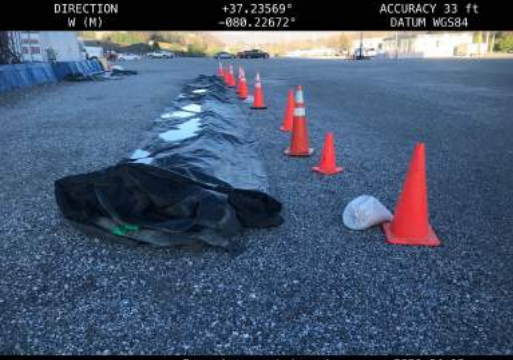
<p>DIRECTION W (N) +37.23569° -080.22672° ACCURACY 33 ft DATUM WGS84</p> <p>MVP-PY-006_041221 Secondary containment on site for tankers 2021-04-12 07:44:35-04:00</p>			
<b>GPS Location</b>	MVP-PY-006 See photo for gps data		<b>GPS Location</b>	MVP-PY-006 See photo for gps data	
<b>Field Station#</b>	+0		<b>Field Station#</b>	+0	
<b>Pic 5 Desc.</b>	Condition of trays and containment under toilets. Looking SE.		<b>Pic 6 Desc.</b>	Secondary containment on site for tankers offloading fuel. Looking W.

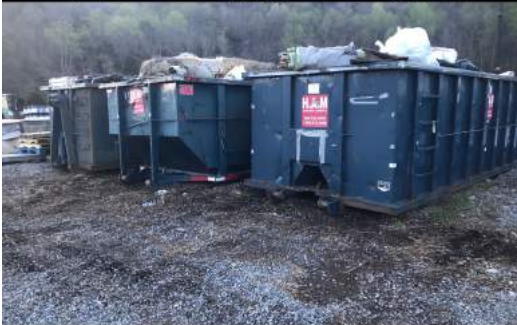
MVP-PY-006_041221 No loose trash around dumpsters 2021-04-12 07:48:29-04:00		DIRECTION E (M) +37.23572° -080.22612° ACCURACY 33 ft DATUM WGS84

MVP-PY-006_041221 Restoration supplies covered 2021-04-12 07:49:21-04:00			
<b>GPS Location</b>	MVP-PY-006 See photo for gps data		<b>GPS Location</b>	MVP-PY-006 See photo for gps data	
<b>Field Station#</b>	+0		<b>Field Station#</b>	+0	
<b>Pic 13 Desc.</b>	No loose trash around dumpsters or in the yard. Looking Se.		<b>Pic 14 Desc.</b>	Restoration supplies covered and protected from the elements. Looking E.	
DIRECTION SE (M) +37.23557° -080.22605° ACCURACY 33 ft DATUM WGS84

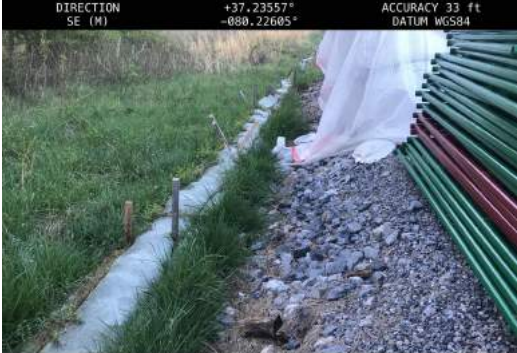
MVP-PY-006_041221 Condition of CFS along LOD 2021-04-12 07:49:48-04:00		DIRECTION SE (M) +37.23414° -080.22726° ACCURACY 16 ft DATUM WGS84

<b>GPS Location</b>	MVP-PY-006 See photo for gps data		<b>GPS Location</b>	MVP-PY-006 See photo for gps data	
<b>Field Station#</b>	+0		<b>Field Station#</b>	+0	
<b>Pic 15 Desc.</b>	Condition of compost filter sock along east LOD. Looking SE.		<b>Pic 16 Desc.</b>	Condition of containment under hazardous waste dumpsters, holding stormwater. Looking SE.	
DIRECTION NE (M) +37.23423° -080.22785° ACCURACY 16 ft DATUM WGS84

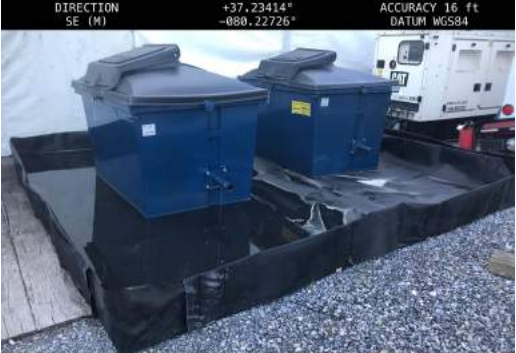
MVP-PY-006_041221 Containment under hazardous waste 2021-04-12 07:57:06-04:00

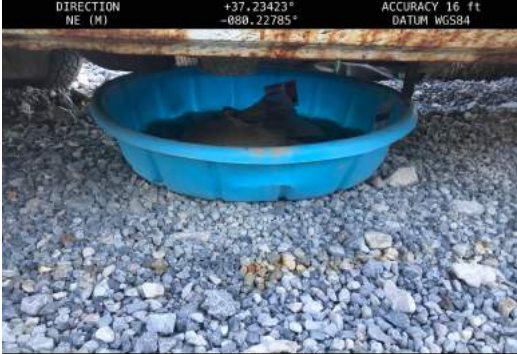
MVP-PY-006_041221 Containment under stored vehicle 2021-04-12 07:58:06-04:00		DIRECTION SE (M) +37.23583° -080.22773° ACCURACY 213 ft DATUM WGS84

MVP-PY-006_041221 Condition of poly lined containments 2021-04-12 07:59:17-04:00			
<b>GPS Location</b>	MVP-PY-006 See photo for gps data		<b>GPS Location</b>	MVP-PY-006 See photo for gps data	
<b>Field Station#</b>	+0		<b>Field Station#</b>	+0	
<b>Pic 17 Desc.</b>	Condition of containment under stored vehicle. Looking NE.		<b>Pic 18 Desc.</b>	Condition of poly lined rock berm containments, holding stormwater. Looking SE.

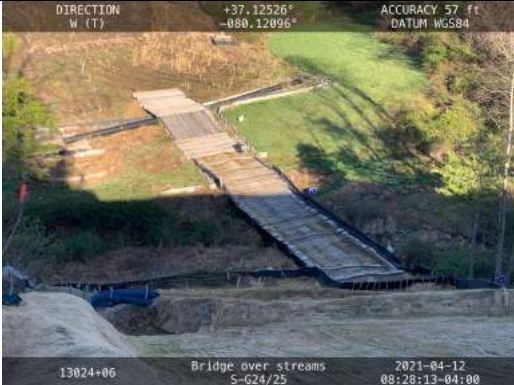
<b>GPS Location</b>	See pic for GPS location		<b>GPS Location</b>	See pic for GPS location	
<b>Field Station#</b>	13024+00		<b>Field Station#</b>	13026+00	
<b>Pic 1 Desc.</b>	Streams S-G24 and S-G25 from the GAS.		<b>Pic 2 Desc.</b>	Perimeter P1 along ROW on CIS of FR-289.

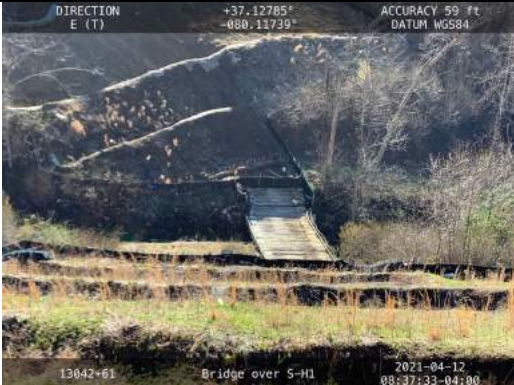
<b>GPS Location</b>	See pic for GPS location		<b>GPS Location</b>	See pic for GPS location	
<b>Field Station#</b>	12042+61		<b>Field Station#</b>	13115+97	
<b>Pic 3 Desc.</b>	Stream crossing S-H1 on the GAS of FR-289.		<b>Pic 4 Desc.</b>	Stream S-EF17 where it crosses FR-291.

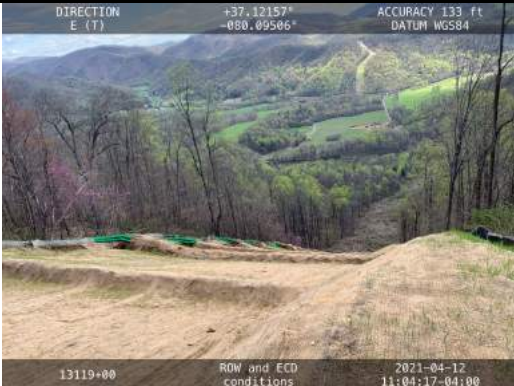
<b>GPS Location</b>	See pic for GPS location		<b>GPS Location</b>	See pic for GPS location	
<b>Field Station#</b>	13119+00		<b>Field Station#</b>	13114+00	
<b>Pic 5 Desc.</b>	Current ROW conditions on the GAS of FR-291.		<b>Pic 6 Desc.</b>	Current ROW conditions on the CIS of FR-291.

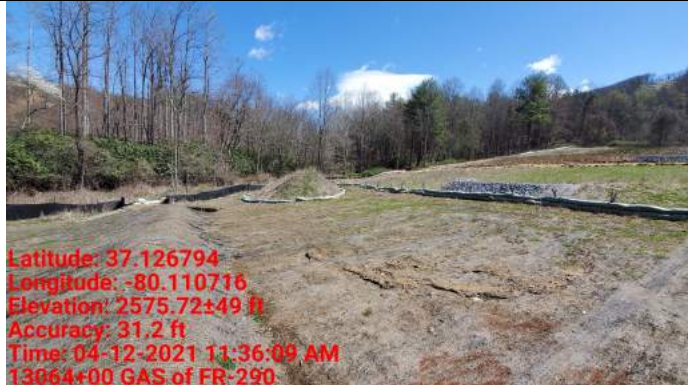
<b>Pic 11 Desc.</b>	Temporary stabilization at edge of restored area on GAS of FR-290.		<b>Pic 12 Desc.</b>	Upstream side of stream S-G27.

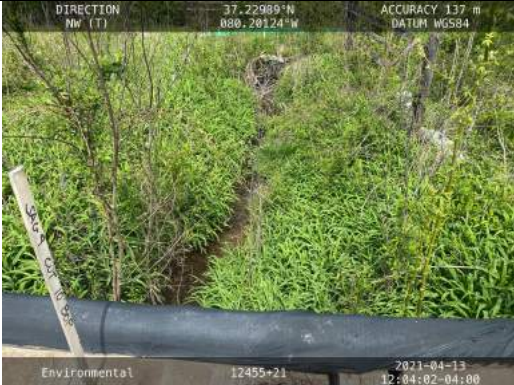
<b>GPS Location</b>	See photo		<b>GPS Location</b>	See photo	
<b>Field Station#</b>	12455+21		<b>Field Station#</b>	12461+81	
<b>Pic 1 Desc.</b>	Downstream of stream crossing S-CD12b in acceptable condition with no signs of impacts		<b>Pic 2 Desc.</b>	Wetland crossing W-KL58 in acceptable condition

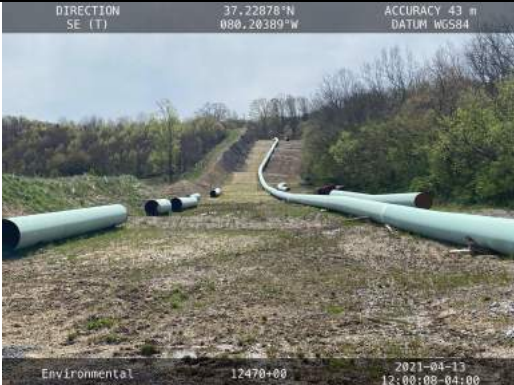
<b>GPS Location</b>	See photo		<b>GPS Location</b>	See photo	
<b>Field Station#</b>	12470+00		<b>Field Station#</b>	12582+67	
<b>Pic 3 Desc.</b>	Stabilized ROW in acceptable condition		<b>Pic 4 Desc.</b>	Access Road MLV-28 in acceptable condition

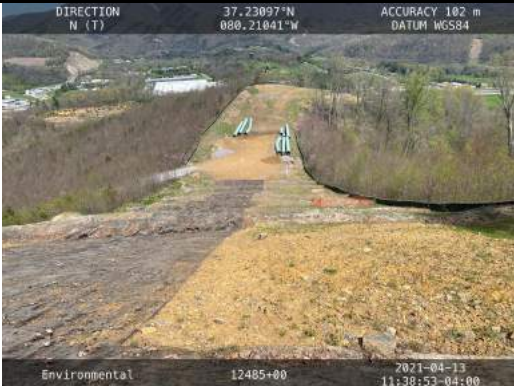
<b>GPS Location</b>	See photo		<b>GPS Location</b>	See photo	
<b>Field Station#</b>	12485+00		<b>Field Station#</b>	12500+00	
<b>Pic 5 Desc.</b>	Stabilized slope in acceptable condition		<b>Pic 6 Desc.</b>	Stabilized ROW in acceptable condition

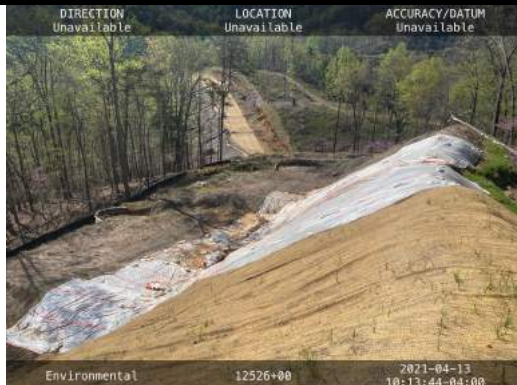
<b>GPS Location</b>	See photo		<b>GPS Location</b>	See photo	
<b>Field Station#</b>	12526+00		<b>Field Station#</b>	12532+70	
<b>Pic 11 Desc.</b>	Plastic covering spoil pile remains in place and stable.		<b>Pic 12 Desc.</b>	Clean water crossing pipe outlet in acceptable condition

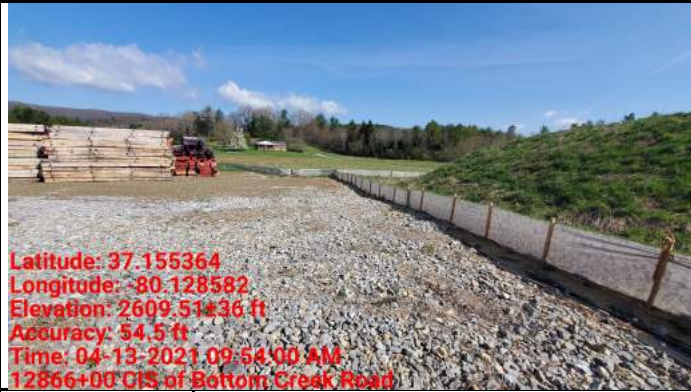
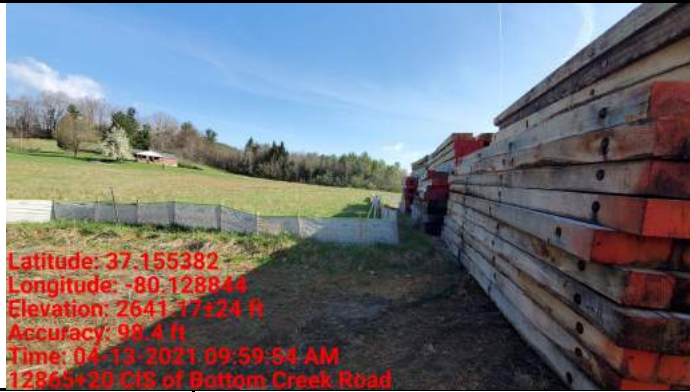
Latitude: 37.155364 Longitude: -80.128582 Elevation: 2609.51±36 ft Accuracy: 54.5 ft Time: 04-13-2021 09:54:00 AM 12866+00 CIS of Bottom Creek Road			Latitude: 37.155382 Longitude: -80.128844 Elevation: 2641.17±24 ft Accuracy: 98.4 ft Time: 04-13-2021 09:59:54 AM 12865+20 CIS of Bottom Creek Road		
GPS Location	See pic for GPS location		GPS Location	See pic for GPS location	
Field Station#	12866+00		Field Station#	12865+20	
Pic 1 Desc.	P1 silt fence installed at Bottom Creek Road crossing remains in acceptable condition.		Pic 2 Desc.	P1 silt fence installed at Bottom Creek Road crossing remains in acceptable condition.

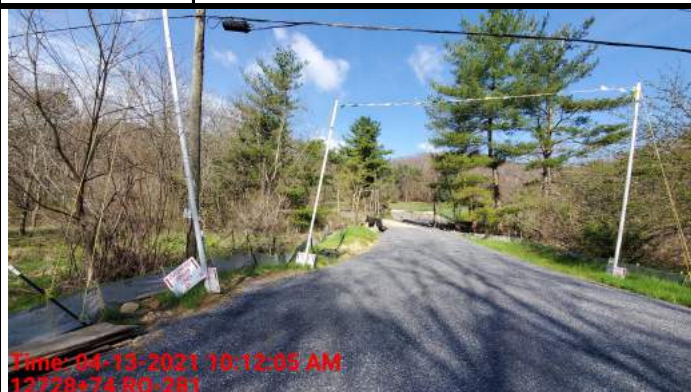
Time: 04-13-2021 10:12:05 AM 12728+74 RO-281			Latitude: 37.180421 Longitude: -80.140052 Elevation: 2746.98±54 ft Accuracy: 40.4 ft Time: 04-13-2021 10:12:51 AM 12728+74 RO-281 stream S-EF32		
GPS Location	See pic for GPS location		GPS Location	See pic for GPS location	
Field Station#	12728+74		Field Station#	12728+74	
Pic 5 Desc.	Access road RO-281 at Poor Mountain Road.		Pic 6 Desc.	Stream S-EF32 on RO-281.

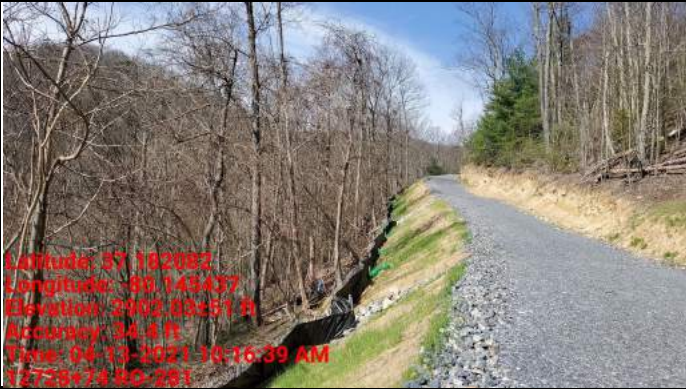
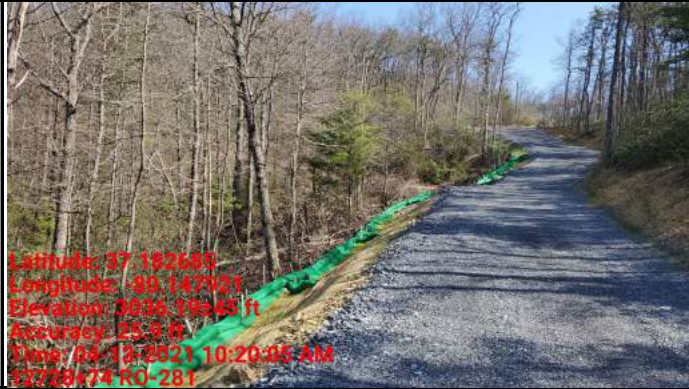
<p>Latitude: 37.182688 Longitude: -80.142921 Elevation: 3508.76±43 ft Accuracy: 23.6 ft Time: 04-13-2021 10:20:05 AM 12728+74 RO-281</p>		
GPS Location	See pic for GPS location		GPS Location	See pic for GPS location	
Field Station#	12728+74		Field Station#	12728+74	
Pic 7 Desc.	Current conditions of the access road RO-281.		Pic 8 Desc.	Current conditions of the access road RO-281.

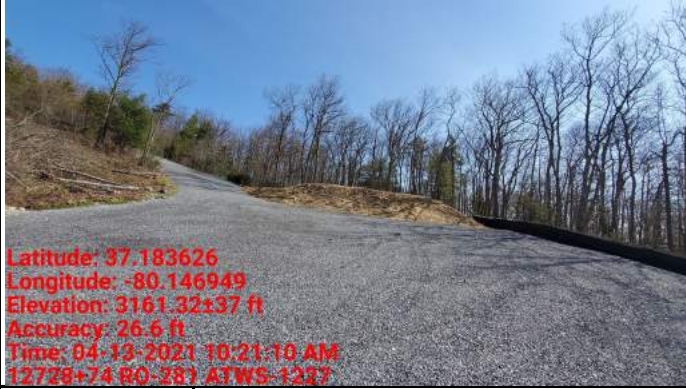
<p>Latitude: 37.183626 Longitude: -80.146949 Elevation: 3161.32±37 ft Accuracy: 26.6 ft Time: 04-13-2021 10:21:10 AM 12728+74 RO-281 ATWS-1227</p>

GPS Location	See pic for GPS location		GPS Location	See pic for GPS location	
Field Station#	12728+74		Field Station#	12728+74	
Pic 9 Desc.	Current conditions of the access road RO-281 ATWS-1227.		Pic 10 Desc.	Current conditions of the access road RO-281 ATWS-1536.

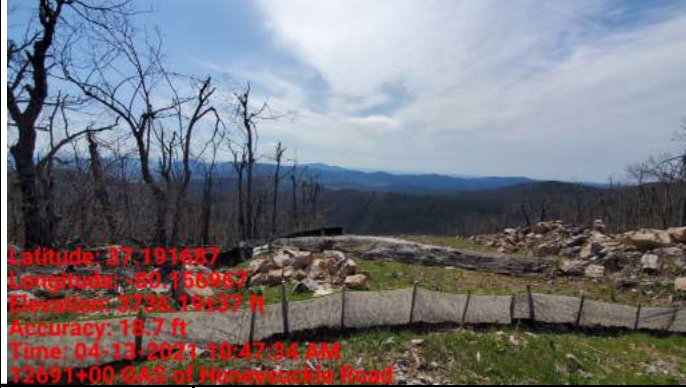
<p>Latitude: 37.191687 Longitude: -80.156957 Elevation: 3798.75±37 ft Accuracy: 18.7 ft Time: 04-13-2021 10:47:34 AM 12691+00 GAS of Honeysuckle Road</p>

<p>Latitude: 37.192033 Longitude: -80.157153 Elevation: 3833.76±52 ft Accuracy: 42.3 ft Time: 04-13-2021 10:49:17 AM 12690+00 CIS of Honeysuckle Road</p>		
GPS Location	See pic for GPS location		GPS Location	See pic for GPS location	
Field Station#	12691+00		Field Station#	12690+00	
Pic 11 Desc.	Current ROW conditions on the GAS of Honeysuckle Road.		Pic 12 Desc.	RCE on the CIS of Honeysuckle Road.

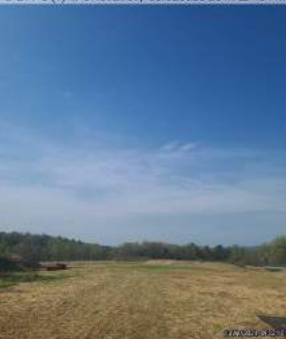
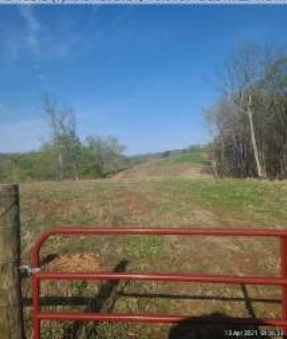
<b>GPS Location</b>	0000	<b>GPS Location</b>	0000		
<b>Field Station#</b>	13420+00	<b>Field Station#</b>	13512+55		
<b>Pic 1 Desc.</b>	Monitored new vegetation growth in work space that was recently stabilized.		<b>Pic 2 Desc.</b>	Row photo showing permanent vegetation growth. No issues observed at the time of inspection.	
	<b>South Elevation</b> <small>357°N (T) 37.090136, -79.998937 ±10 m ▲ 404 m</small>

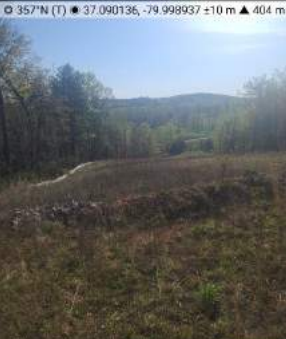
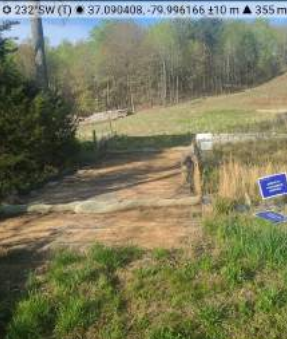
<b>GPS Location</b>	0000	<b>GPS Location</b>	0000		
<b>Field Station#</b>	13520+00	<b>Field Station#</b>	13525+20		
<b>Pic 3 Desc.</b>	Row photo showing permanent vegetation growth.		<b>Pic 4 Desc.</b>	Ei monitored equipment bridge and protection during routine inspection today.

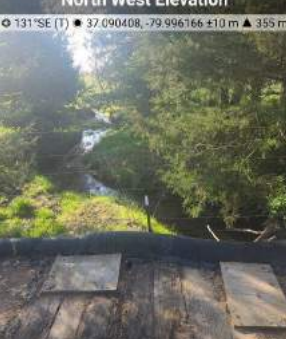
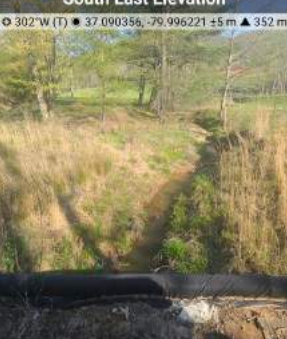
<b>GPS Location</b>	0000	<b>GPS Location</b>	00000		
<b>Field Station#</b>	13525+10	<b>Field Station#</b>	13525+10		
<b>Pic 5 Desc.</b>	Stream observation photo facing downstream during routine inspection today. No issues observed at the time of inspection.		<b>Pic 6 Desc.</b>	Stream observation photo facing upstream during routine inspection today. No issues observed at the time of inspection.

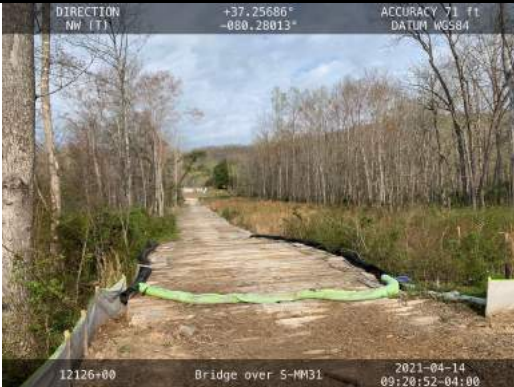
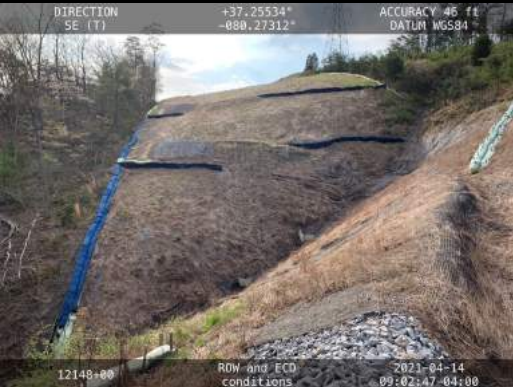
<b>GPS Location</b>	See photo		<b>GPS Location</b>	See photo	
<b>Field Station#</b>	12126+00		<b>Field Station#</b>	12148+00	
<b>Pic 1 Desc.</b>	Bridge and ECDs crossing stream S-MM31 in acceptable condition		<b>Pic 2 Desc.</b>	Stabilized drainage feature in acceptable condition

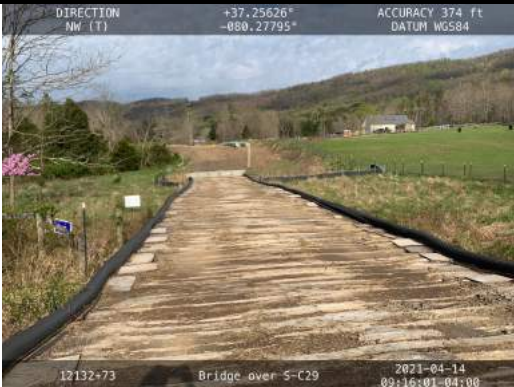
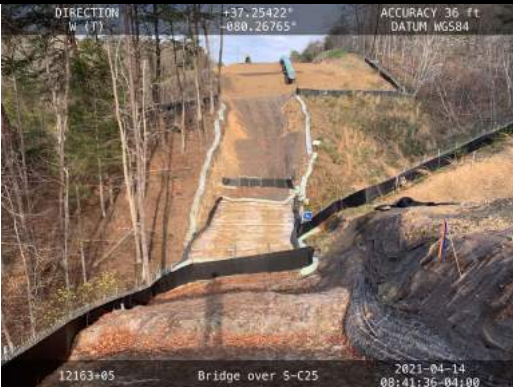
<b>GPS Location</b>	See photo		<b>GPS Location</b>	See photo	
<b>Field Station#</b>	12132+73		<b>Field Station#</b>	12163+05	
<b>Pic 3 Desc.</b>	Bridge and ECDs crossing stream S-C29 In Acceptable condition		<b>Pic 4 Desc.</b>	Bridge and ECDs crossing stream S-C25 in acceptable condition

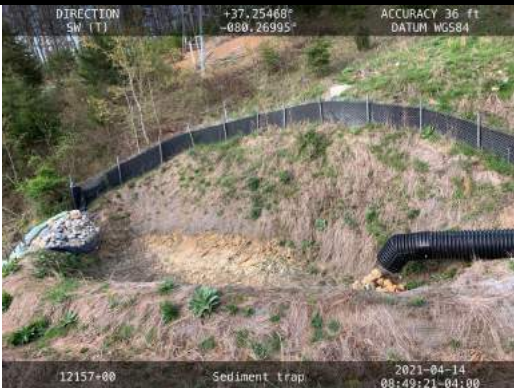
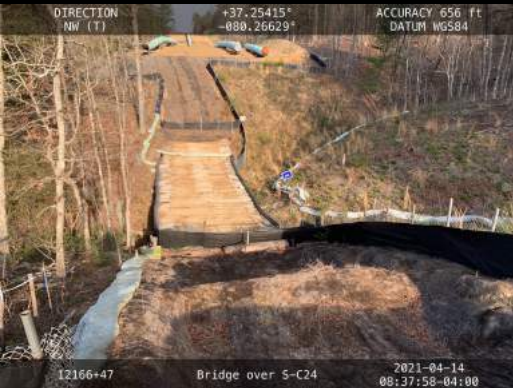
<b>GPS Location</b>	See photo		<b>GPS Location</b>	See photo	
<b>Field Station#</b>	12157+00		<b>Field Station#</b>	12166+47	
<b>Pic 5 Desc.</b>	Sediment trap In Acceptable condition		<b>Pic 6 Desc.</b>	Bridge and ECDs crossing stream S-C24 in acceptable condition

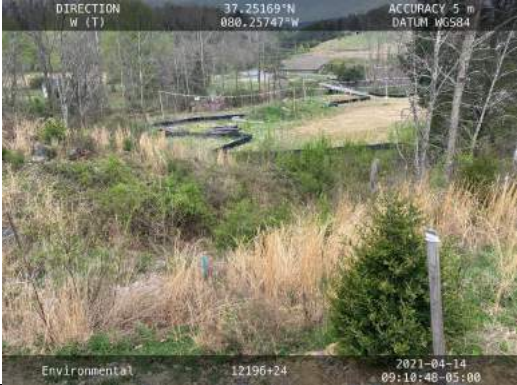
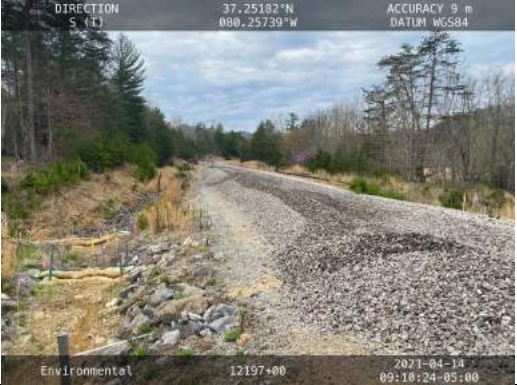
<b>GPS Location</b>	See photo		<b>GPS Location</b>	See photo	
<b>Field Station#</b>	12196+24		<b>Field Station#</b>	12197+00	
<b>Pic 13 Desc.</b>	S-OO11 on the West side of the rail road crossing in acceptable condition		<b>Pic 14 Desc.</b>	Rail road company blading the rocks to a more level and wider road.

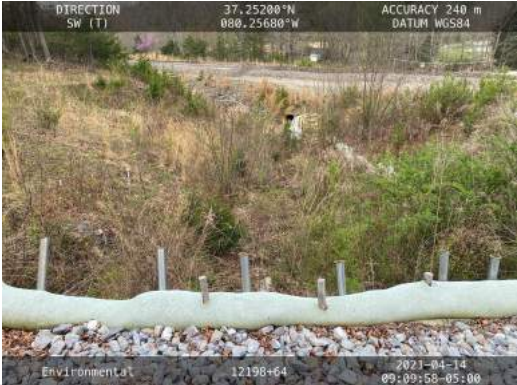
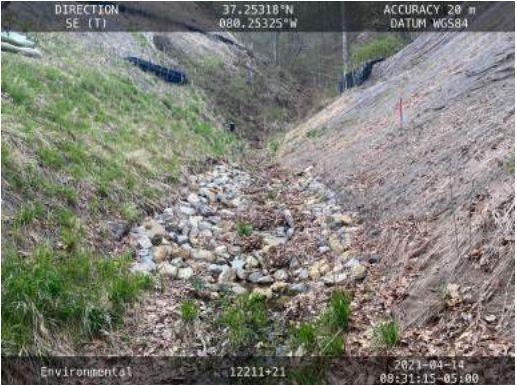
<b>GPS Location</b>	See photo		<b>GPS Location</b>	See photo	
<b>Field Station#</b>	12198+64		<b>Field Station#</b>	12211+21	
<b>Pic 15 Desc.</b>	S-OO11 on the east side of the railroad crossing in acceptable condition		<b>Pic 16 Desc.</b>	Rock lined channel in acceptable condition

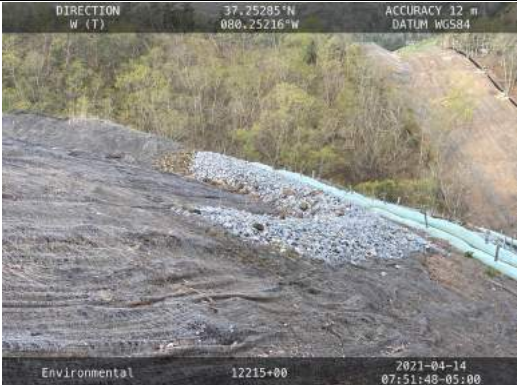
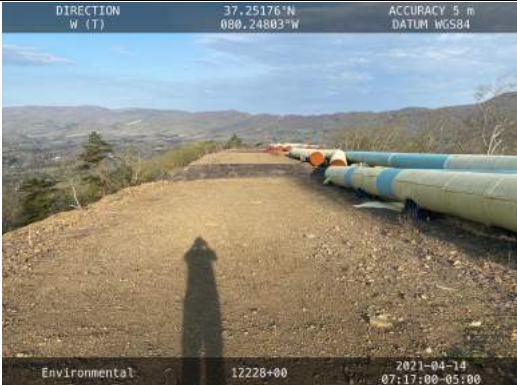
<b>GPS Location</b>	See photo		<b>GPS Location</b>	See photo	
<b>Field Station#</b>	12215+00		<b>Field Station#</b>	12228+00	
<b>Pic 17 Desc.</b>	Rock Weir in acceptable condition		<b>Pic 18 Desc.</b>	Stabilized ROW in acceptable condition

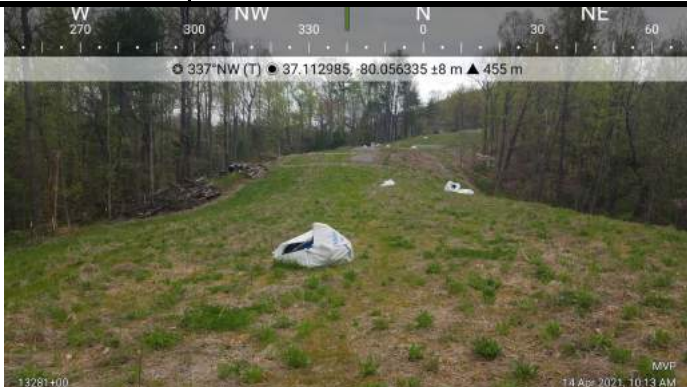
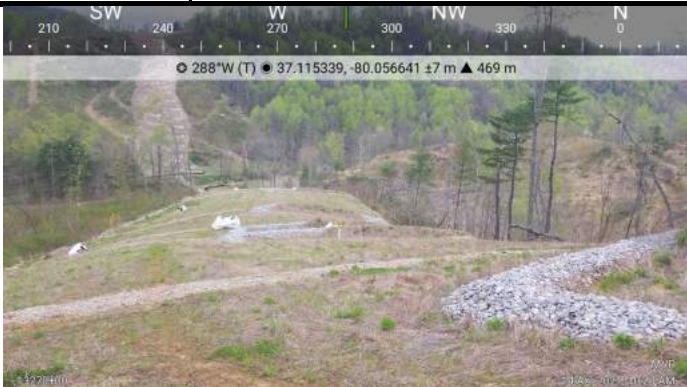
<b>Pic 5 Desc.</b>	ROW stable with vegetative cover noted across LOD.		<b>Pic 6 Desc.</b>	ROW stable with vegetative cover noted across LOD.

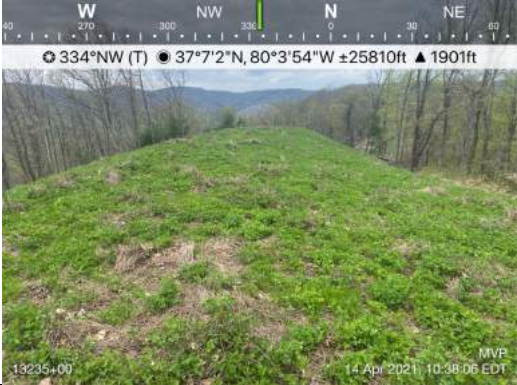
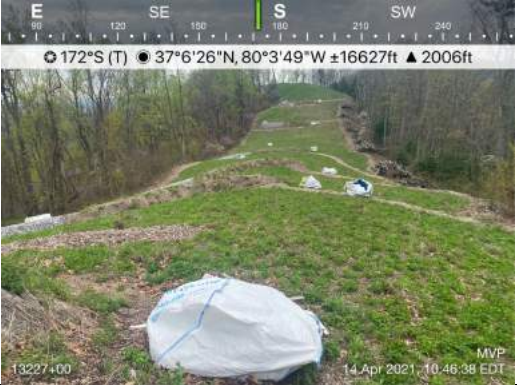
<b>GPS Location</b>	See photo for coordinates.		<b>GPS Location</b>	See photo for coordinates.	
<b>Field Station#</b>	13235+00		<b>Field Station#</b>	13227+00	
<b>Pic 13 Desc.</b>	ROW stable with vegetative cover noted across LOD.		<b>Pic 14 Desc.</b>	ROW stable with vegetative cover noted across LOD.

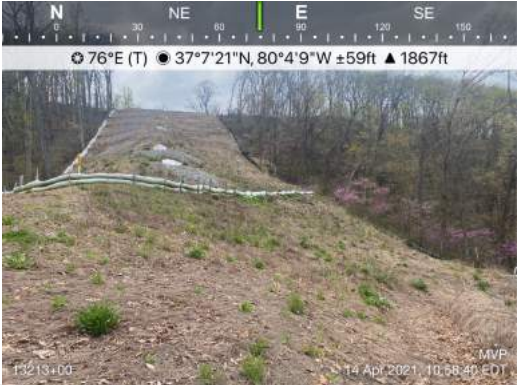
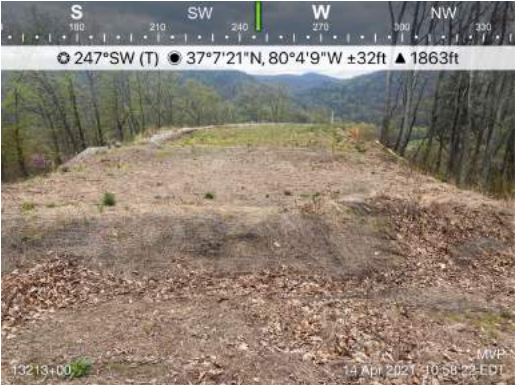
<b>GPS Location</b>	See photo for coordinates.		<b>GPS Location</b>	See photo for coordinates.	
<b>Field Station#</b>	13213+00		<b>Field Station#</b>	13213+00	
<b>Pic 15 Desc.</b>	ROW stable with vegetative cover noted across LOD.		<b>Pic 16 Desc.</b>	ROW stable with vegetative cover noted across LOD.

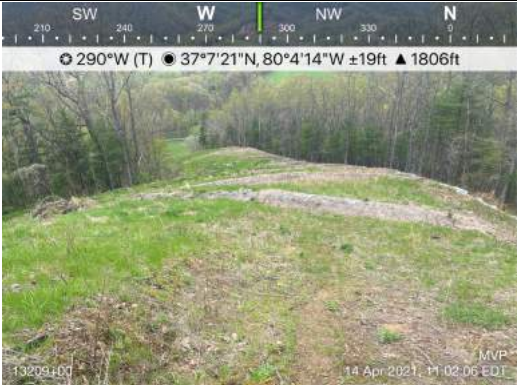
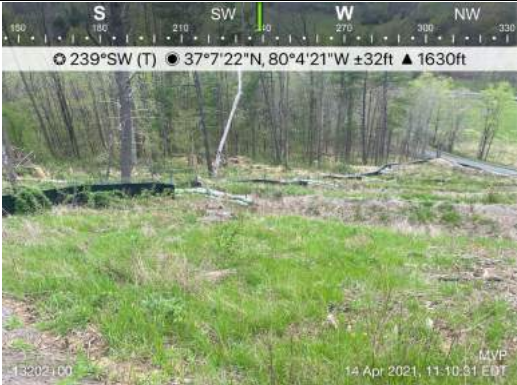
<b>GPS Location</b>	See photo for coordinates.		<b>GPS Location</b>	See photo for coordinates.	
<b>Field Station#</b>	13209+00		<b>Field Station#</b>	13202+00	
<b>Pic 17 Desc.</b>	ROW stable with vegetative cover noted across LOD.		<b>Pic 18 Desc.</b>	ROW stable with vegetative cover noted across LOD.

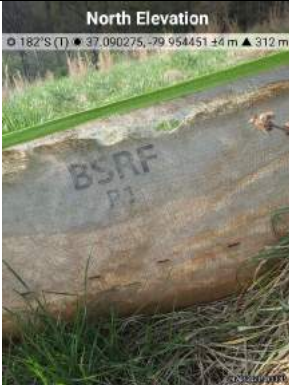
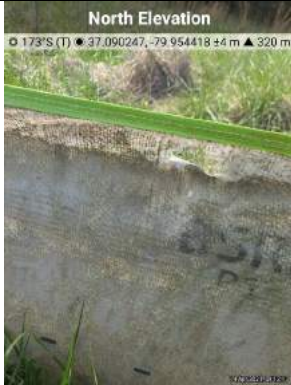
<b>A/E</b>	124300138	<b>Date/Time</b>	4/14/2021 3:43 PM	<b>Report #</b>	22264
<b>6. PCSM BMPs</b> (List BMPs and note if installed and maintained as per the plan. If corrective action is needed, a picture is required.)					
<b>PCSM BMPs</b>	<b>Compliance Level</b>	<b>Corrective Action</b>	<b>Corrective Time Frame</b>	<b>Date Repaired</b>	
<b>7. Identify all remedial measures that have been taken since the previous inspection was conducted.</b>					
<b>Comments</b> (Reference above questions as appropriate.)					
<p>The EI Traveled and inspected all ECDs throughout the row, monitored vegetation growth throughout.</p> <p>Inspected all stream and wetland crossings, checked equipment bridges and protection.</p> <p>Monitored RCEs and vegetation stabilization on spoil piles .</p> <p>Throughout today's inspections the EI noticed several areas with P1 that required maintenance due to being weathered and torn, documented and added to the punch list for repairs.</p>

<p>North Elevation  <small>173°S (T) 37.090247, -79.954418 ±4 m ▲ 320 m</small></p>	
<b>GPS Location</b>	00000	<b>GPS Location</b>	00000		
<b>Field Station#</b>	13658+08	<b>Field Station#</b>	13658+08		
<b>Pic 1 Desc.</b>	P1 requires maintenance maintenance due to being weathered and torn, recommended replacing entire section as needed due to multiple weathered areas.		<b>Pic 2 Desc.</b>	Additional photo showing P1 weathered and torn.

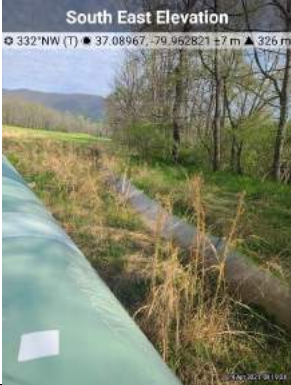
<p>Insert image here</p>		<p>Insert image here</p>	
<b>GPS Location</b>	00000	<b>GPS Location</b>			
<b>Field Station#</b>	13639+50	<b>Field Station#</b>			
<b>Pic 7 Desc.</b>	P1 requires maintenance due to being weathered and broken stakes, documented and added to the punch list for repair.		<b>Pic 8 Desc.</b>		
<p>Insert image here</p>		<p>Insert image here</p>			
<b>GPS Location</b>		<b>GPS Location</b>			
<b>Field Station#</b>		<b>Field Station#</b>			
<b>Pic 9 Desc.</b>		<b>Pic 10 Desc.</b>			
<p>Insert image here</p>		<p>Insert image here</p>			
<b>GPS Location</b>		<b>GPS Location</b>			
<b>Field Station#</b>		<b>Field Station#</b>			
<b>Pic 11 Desc.</b>		<b>Pic 12 Desc.</b>

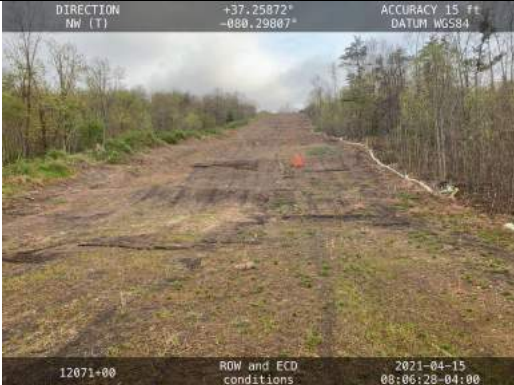
<b>GPS Location</b>	See photo for gps location data.		<b>GPS Location</b>	See photo for gps location data.	
<b>Field Station#</b>	12071+00		<b>Field Station#</b>	12076+50	
<b>Pic 1 Desc.</b>	Photo shows the ROW and ECD conditions from about 12065+00 to 12071+00.		<b>Pic 2 Desc.</b>	Photo shows the bridge over stream S-MM15.

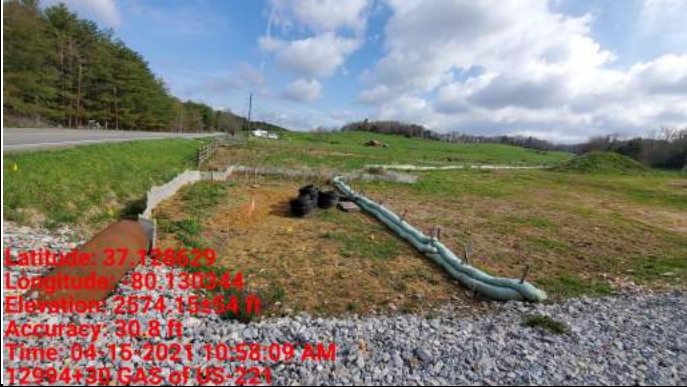
<p>Latitude: 37.128647 Longitude: -80.129682 Elevation: 2644.91±48 ft Accuracy: 112.9 ft Time: 04-15-2021 11:04:49 AM 12995+30 GAS of US-221</p>		
GPS Location	See pic for GPS location		GPS Location	See pic for GPS location	
Field Station#	12994+30		Field Station#	12995+30	
Pic 7 Desc.	GAS of the US-221 road crossing.		Pic 8 Desc.	Permanent restoration on the GAS of the US-221 road crossing.

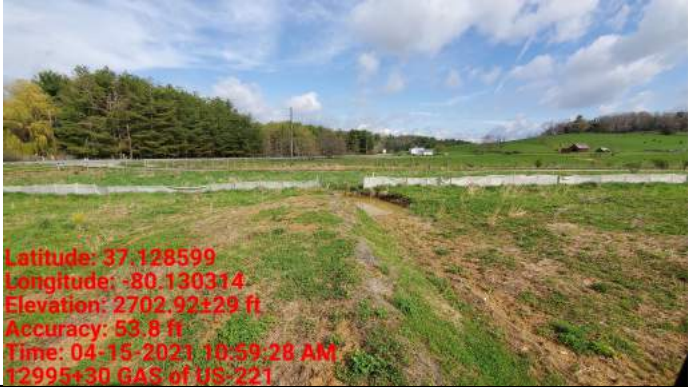
GPS Location	See pic for GPS location		GPS Location	See pic for GPS location	
Field Station#	12993+10		Field Station#	12995+30	
Pic 9 Desc.	CIS of the US-221 road crossing.		Pic 10 Desc.	Waterbars, sumps and end treatments remain in compliance.

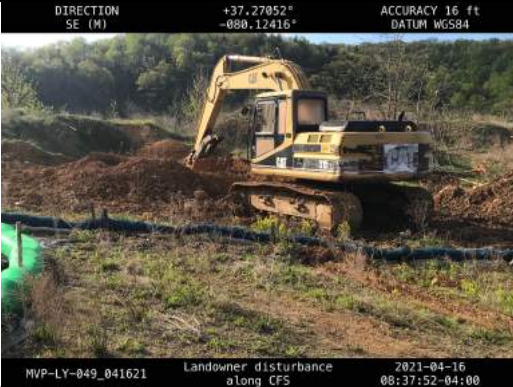
<b>GPS Location</b>	MVP-LY-049 See photo for gps data	<b>GPS Location</b>	MVP-LY-049 See photo for gps data		
<b>Field Station#</b>	+0	<b>Field Station#</b>	+0		
<b>Pic 3 Desc.</b>	Condition of compost filter sock and safety fence along north LOD. Looking W.	<b>Pic 4 Desc.</b>	Landowner soil disturbance along compost filter sock. Area not stabilized. No new damage to ECD's. Looking SW.

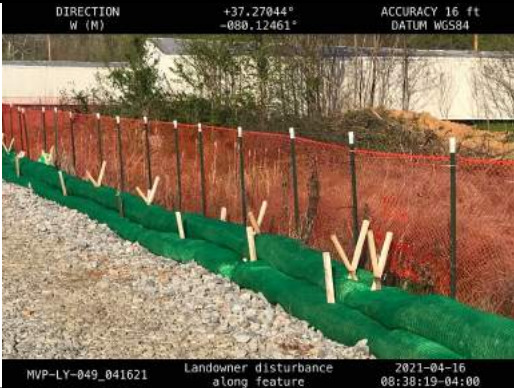
<b>Field Station#</b>	+0	<b>Field Station#</b>	+0		
<b>Pic 5 Desc.</b>	Landowner soil disturbance along north edge of feature W-CV21A. Area not stabilized. Looking NW.	<b>Pic 6 Desc.</b>	Landowner soil disturbance within 66' and 120' west of feature W-CV21B. Areas not stabilized. Looking SW.

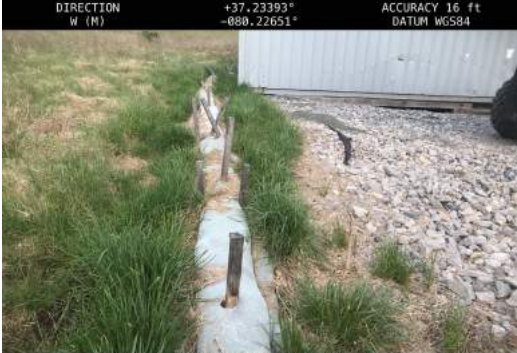
DIRECTION E (M) +37.23571° -080.22733° ACCURACY 295 ft DATUM WGS84  			
MVP-PY-006_041621 No fluids around hazardous waste ... 2021-04-16 07:20:24-04:00		MVP-PY-006_041621 Condition of CFS along LOD 2021-04-16 07:51:14-04:00			
<b>GPS Location</b>	MVP-PY-006 See photo for gps data		<b>GPS Location</b>	MVP-PY-006 See photo for gps data	
<b>Field Station#</b>	+0		<b>Field Station#</b>	+0	
<b>Pic 13 Desc.</b>	No fluids or deposits around hazardous waste dumpsters.		<b>Pic 14 Desc.</b>	Condition of compost filter sock along south LOD. Looking E.	
DIRECTION W (M) +37.23393° -080.22651° ACCURACY 16 ft DATUM WGS84

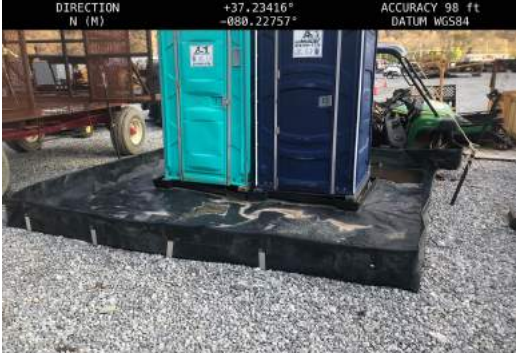
MVP-PY-006_041621 Condition of CFS along LOD 2021-04-16 07:51:20-04:00		MVP-PY-006_041621 Condition of trays & containment 2021-04-16 07:52:49-04:00

<b>GPS Location</b>	MVP-PY-006 See photo for gps data		<b>GPS Location</b>	MVP-PY-006 See photo for gps data	
<b>Field Station#</b>	+0		<b>Field Station#</b>	+0	
<b>Pic 15 Desc.</b>	Condition of compost filter sock along south LOD. Looking W.		<b>Pic 16 Desc.</b>	Condition of trays and containment under toilets. Looking N.	
DIRECTION E (M) +37.23440° -080.22733° ACCURACY 98 ft DATUM WGS84  		DIRECTION SE (M) +37.23460° -080.22801° ACCURACY 16 ft DATUM WGS84  			
MVP-PY-006_041621 Condition of containment 2021-04-16 07:54:22-04:00		MVP-PY-006_041621 Condition of poly lined containments 2021-04-16 07:55:34-04:00			
<b>GPS Location</b>	MVP-PY-006 See photo for gps data		<b>GPS Location</b>	MVP-PY-006 See photo for gps data	
<b>Field Station#</b>	+0		<b>Field Station#</b>	+0	
<b>Pic 17 Desc.</b>	Condition of containment under hazardous waste dumpsters west of mechanics building. Holding some stormwater. Looking E.		<b>Pic 18 Desc.</b>	Condition of poly lined containments holding some stormwater. Looking SE.

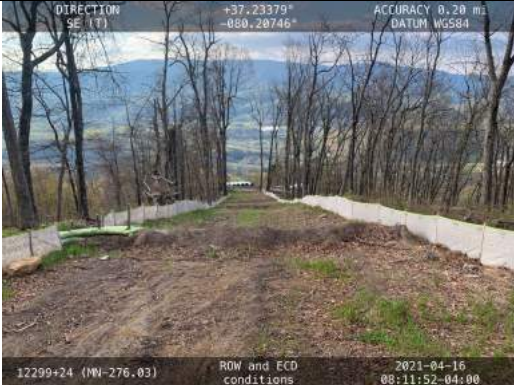
<b>GPS Location</b>	See photo for gps location data.		<b>GPS Location</b>	See photo for gps location data.	
<b>Field Station#</b>	12299+24		<b>Field Station#</b>	12293+00	
<b>Pic 1 Desc.</b>	Photo shows ROW and ECD conditions.		<b>Pic 2 Desc.</b>	Photo shows ROW and ECD conditions.

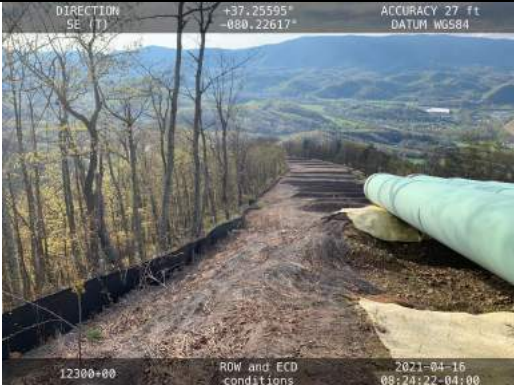
<b>GPS Location</b>	See photo for gps location data.		<b>GPS Location</b>	See photo for gps location data.	
<b>Field Station#</b>	12300+00		<b>Field Station#</b>	12307+00	
<b>Pic 3 Desc.</b>	Photo shows ROW and ECD conditions.		<b>Pic 4 Desc.</b>	Photo shows ROW and ECD conditions.

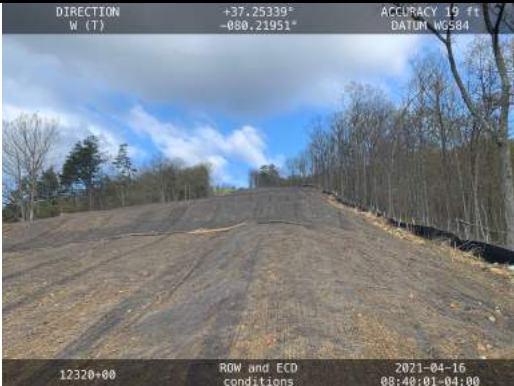
<b>GPS Location</b>	See photo for gps location data.		<b>GPS Location</b>	See photo for gps location data.	
<b>Field Station#</b>	12320+00		<b>Field Station#</b>	12326+00	
<b>Pic 5 Desc.</b>	Photo shows ROW and ECD conditions.		<b>Pic 6 Desc.</b>	Photo shows ROW and ECD conditions.

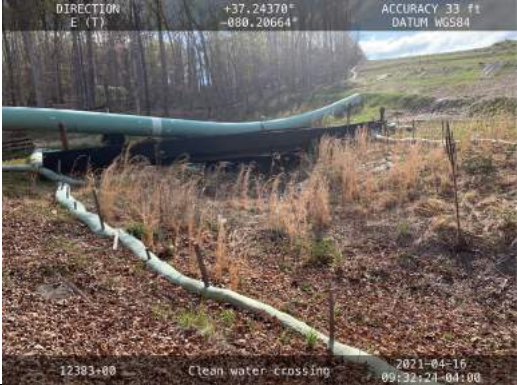
<p>DIRECTION: E (T) +37.24370° -880.20664° ACCURACY 33 ft DATUM WGS84 12383+00 Clean water crossing 2021-04-16 09:32:21-04:00</p>

<p>DIRECTION: SE (T) +37.24306° -880.20372° ACCURACY 25 ft DATUM WGS84 12394+00 ROW and ECD conditions 2021-04-16 09:39:35-04:00</p>			
<b>GPS Location</b>	See photo for gps location data.		<b>GPS Location</b>	See photo for gps location data.	
<b>Field Station#</b>	12383+00		<b>Field Station#</b>	12394+00	
<b>Pic 13 Desc.</b>	Photo shows the clean water crossing.		<b>Pic 14 Desc.</b>	Photo shows ROW and ECD conditions.

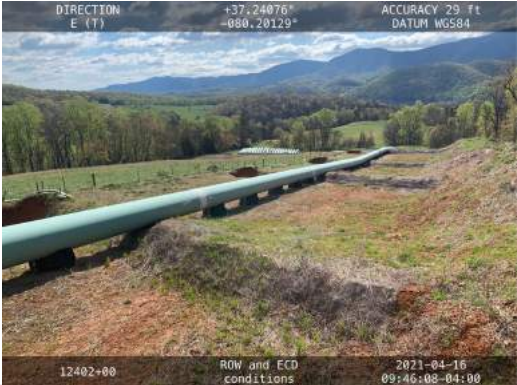
<p>DIRECTION: E (T) +37.24076° -880.20129° ACCURACY 29 ft DATUM WGS84 12402+00 ROW and ECD conditions 2021-04-16 09:46:08-04:00</p>

<b>GPS Location</b>	See photo for gps location data.		<b>GPS Location</b>	See photo for gps location data.	
<b>Field Station#</b>	12402+00		<b>Field Station#</b>	12410+50	
<b>Pic 15 Desc.</b>	Photo shows ROW and ECD conditions.		<b>Pic 16 Desc.</b>	Photo shows the clean water outlet structure.

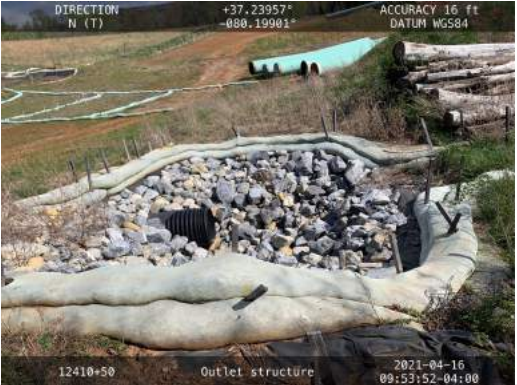
<p>DIRECTION: N (T) +37.23957° -880.19901° ACCURACY 16 ft DATUM WGS84 12410+50 Outlet structure 2021-04-16 09:53:52-04:00</p>

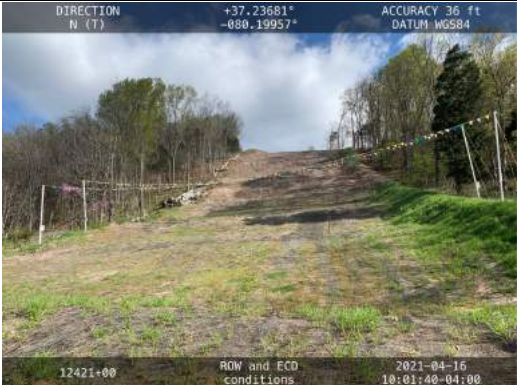
<p>DIRECTION: N (T) +37.23681° -880.19957° ACCURACY 36 ft DATUM WGS84 12421+00 ROW and ECD conditions 2021-04-16 10:01:40-04:00</p>

<p>DIRECTION: N (T) +37.23323° -880.19816° ACCURACY 15 ft DATUM WGS84 12435+46 Stream S-NN16 2021-04-16 10:11:17-04:00</p>			
<b>GPS Location</b>	See photo for gps location data.		<b>GPS Location</b>	See photo for gps location data.	
<b>Field Station#</b>	12421+00		<b>Field Station#</b>	12435+46	
<b>Pic 17 Desc.</b>	Photo shows ROW and ECD conditions.		<b>Pic 18 Desc.</b>	Photo shows the Roanoke River, S-NN16.
