Visual Site Inspection Report

Project Name	H-600 Pipeline Spread H	AFE	124300138	Spread	H-600 Pipeline Spread H
Contractor	Precision			Report #	22700
Inspector	Dawn McCullough			Date/Time	4/26/2021 3:33 PM
Permit #	TBD	Inspection Type	VA SWPP	Station Begin	13141+65
State	VA	Inspection Area	Partial	Station End	13316+21
County	Franklin	Ground	Damp	Temperature (°F)	74.00
Municipality	N/A	Weather	Sunny	Rain Gauge (in)	0.00
				Rain Accumulation Time (days)	1.00

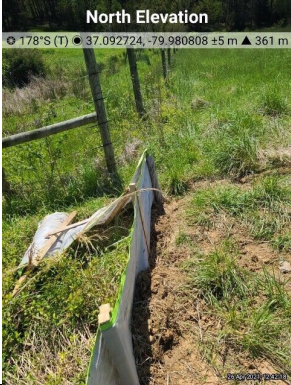
<p>North Elevation 178°S (T) • 37.092724, -79.980808 ±5 m ▲ 361 m</p>

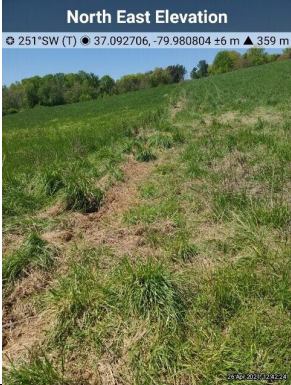
<p>North East Elevation 251°SW (T) • 37.092706, -79.980804 ±6 m ▲ 359 m</p>			
GPS Location	00000	GPS Location	0000		
Field Station#	13572+80	Field Station#	13572+70		
Pic 7 Desc.	3rd party damage to ECDs , added to the punch list for repair.		Pic 8 Desc.	Land owner removed all ECDs from row edge. Documented and added to the punch list for repair.

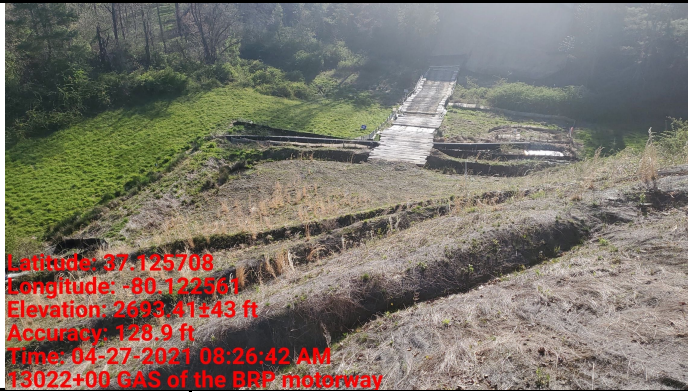
<p>Latitude: 37.12539 Longitude: -80.122491 Elevation: 2549.38±59 ft Accuracy: 113.2 ft Time: 04-27-2021 08:27:07 AM 13022+00 GAS of the BRP motorway</p>		
GPS Location	See pic for GPS location		GPS Location	See pic for GPS location	
Field Station#	13022+00		Field Station#	13022+00	
Pic 1 Desc.	Temporarily stabilized portion on the GAS of the BRP boundary.		Pic 2 Desc.	Permanent Slope Breakers and Rock Level Spreaders remain in compliance.

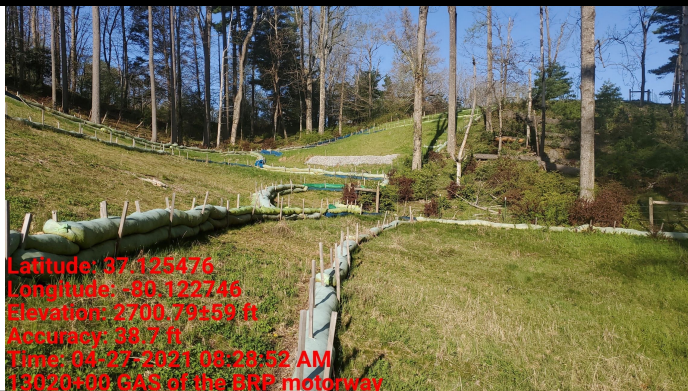
GPS Location	See pic for GPS location		GPS Location	See pic for GPS location	
Field Station#	13020+00		Field Station#	13018+00	
Pic 3 Desc.	Temporary CFS waterbars remain in acceptable condition.		Pic 4 Desc.	Wooded portion of the BRP.

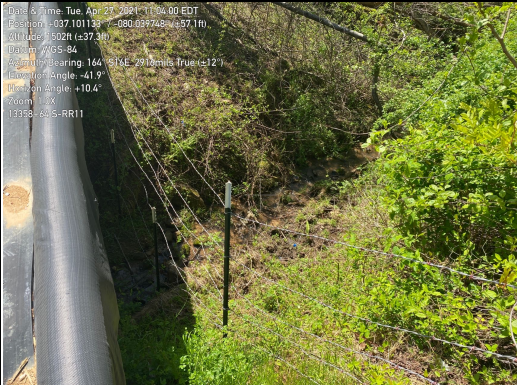
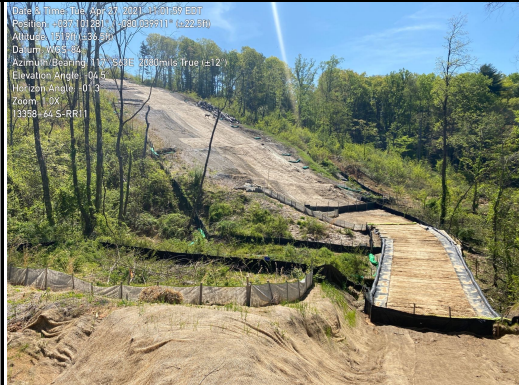
GPS Location See photo for coordinates.		GPS Location See photo for coordinates.			
Field Station# 13358+64		Field Station# 13358+64			
Pic 7 Desc. S-RR11, downstream, stream bed and banks appeared stable, no ROW impacts noted.		Pic 8 Desc. ROW appeared stable on both sides of S-RR11, perimeter controls were in acceptable condition.

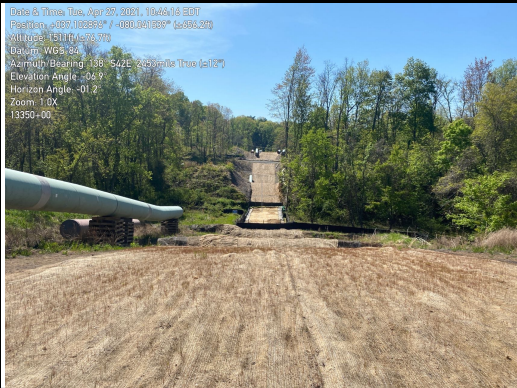
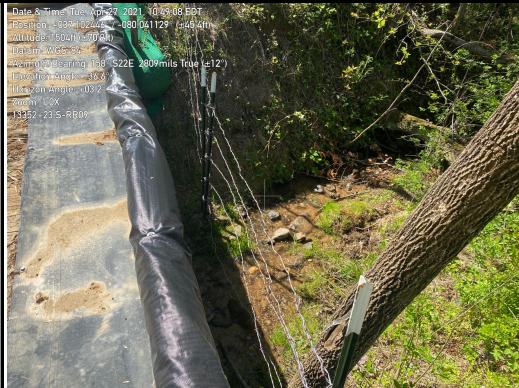
GPS Location See photo for coordinates.		GPS Location See photo for coordinates.			
Field Station# 13350+00		Field Station# 13352+23			
Pic 9 Desc. ROW stable with sparse vegetation establishing in curlexed travel lane.		Pic 10 Desc. S-RR09, downstream, bridge in acceptable condition, no impacts noted at stream crossing.

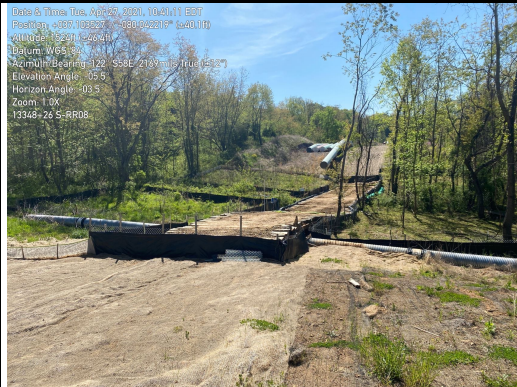
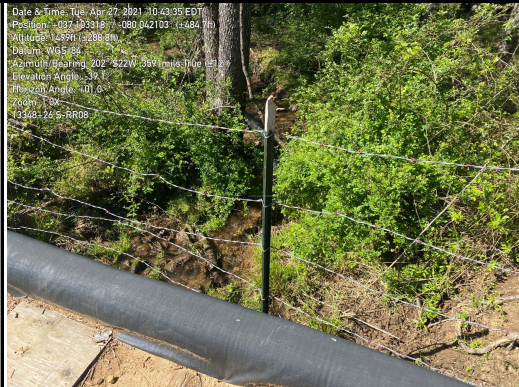
GPS Location See photo for coordinates.		GPS Location See photo for coordinates.			
Field Station# 13348+26		Field Station# 13348+26			
Pic 11 Desc. ROW stable on both sides of stream crossing S-RR08, perimeter controls in acceptable condition.		Pic 12 Desc. S-RR08, downstream, stream bed and banks appeared stable, water was flowing clear, no ROW impacts observed.

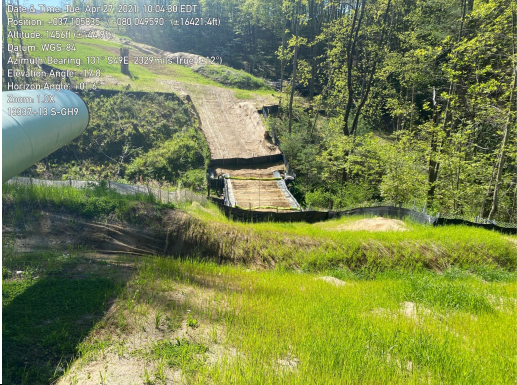
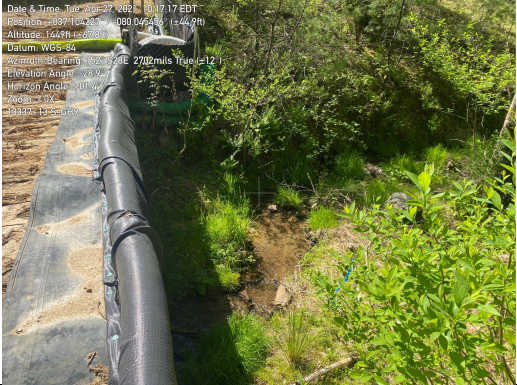
GPS Location	See photo for coordinates.		GPS Location	See photo for coordinates.	
Field Station#	13337+13		Field Station#	13337+13	
Pic 13 Desc.	S-GH9, ROW stable on both sides of stream crossing, vegetation establishing, perimeter controls in acceptable condition.		Pic 14 Desc.	S-GH9, downstream of equipment bridge, banks well vegetated, water flowing clear and unobstructed.

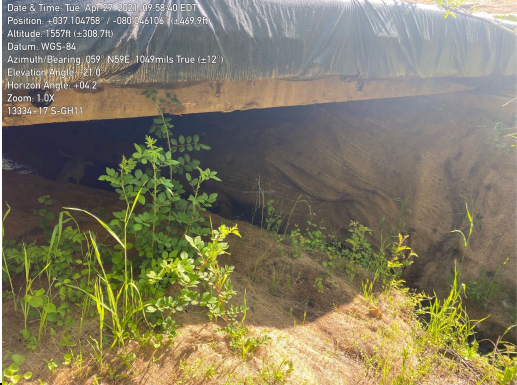
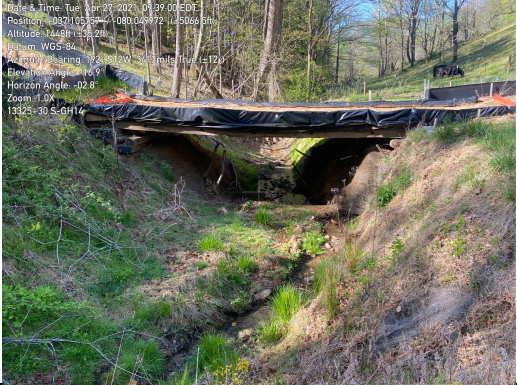
GPS Location	See photo for coordinates.		GPS Location	See photo for coordinates.	
Field Station#	13334+17		Field Station#	13325+30	
Pic 15 Desc.	S-GH11, downstream, banks under bridge stabilized, water flowing clear, a tree limb was noted in stream channel under bridge.		Pic 16 Desc.	S-GH14, upstream of equipment bridge, banks appeared stable, water flowing clear.

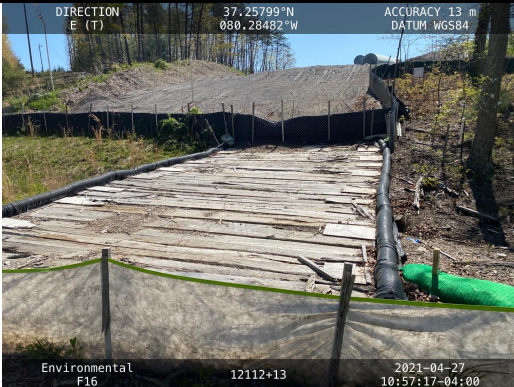
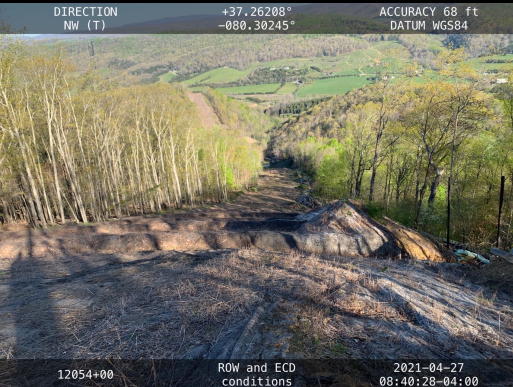
GPS Location	See photo		GPS Location	See photo	
Field Station#	12112+13		Field Station#	12054+00	
Pic 1 Desc.	Bridge and ECDs crossing S-F16A/B in acceptable condition		Pic 2 Desc.	Stabilized ROW in acceptable condition

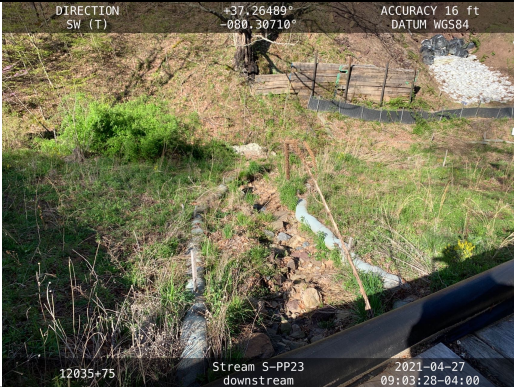
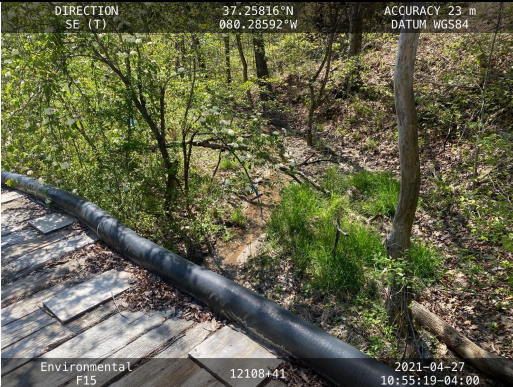
GPS Location	See photo		GPS Location	See photo	
Field Station#	12035+75		Field Station#	12108+41	
Pic 3 Desc.	Down stream of S-PP23 in acceptable condition		Pic 4 Desc.	Down stream of S-F15 in acceptable condition

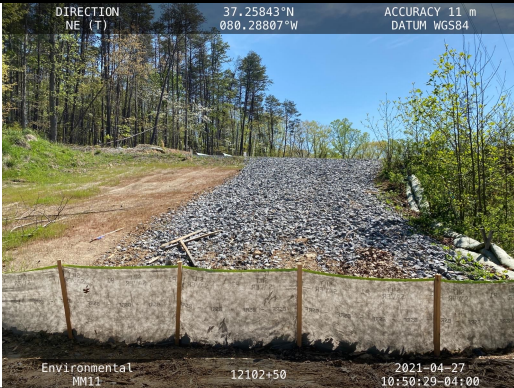
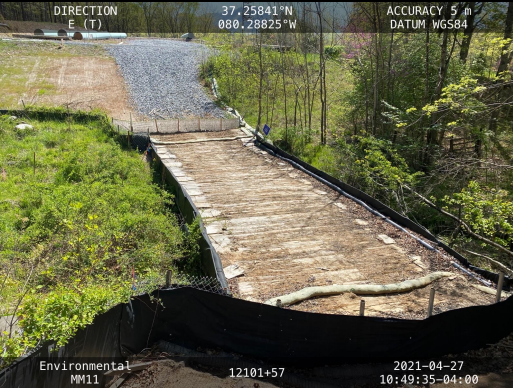
GPS Location	See photo		GPS Location	See photo	
Field Station#	12102+50		Field Station#	12101+57	
Pic 5 Desc.	RCE on the CIS of access road MVP-MN-270.01 in acceptable condition		Pic 6 Desc.	Bridge and ECDs crossing stream S-MM11 in acceptable condition

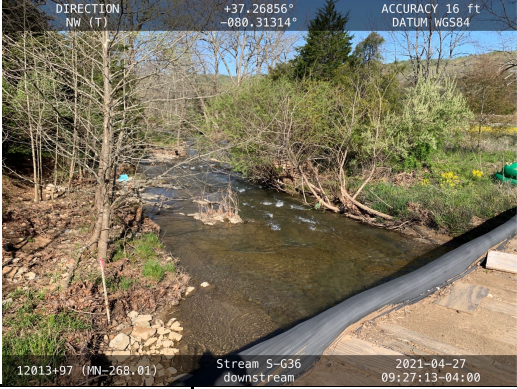
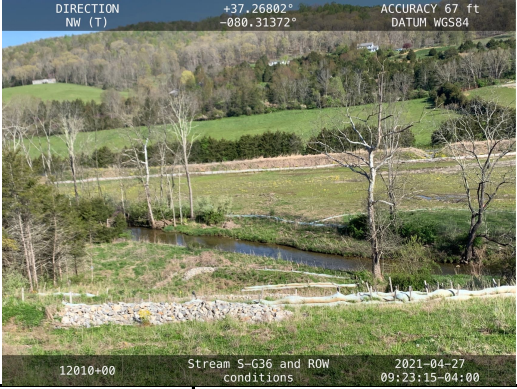
GPS Location	See photo		GPS Location	See photo	
Field Station#	12013+97		Field Station#	12010+00	
Pic 13 Desc.	Stream crossing S-G36 downstream in acceptable condition		Pic 14 Desc.	Stream S-G36 and ROW conditions in acceptable condition

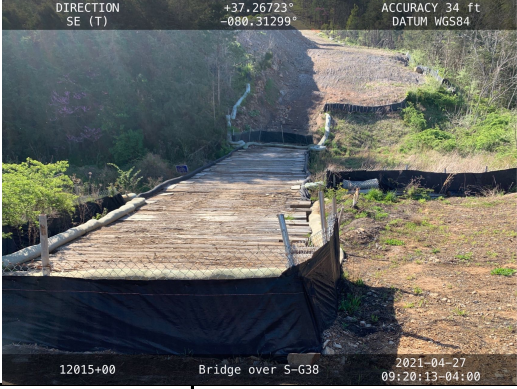
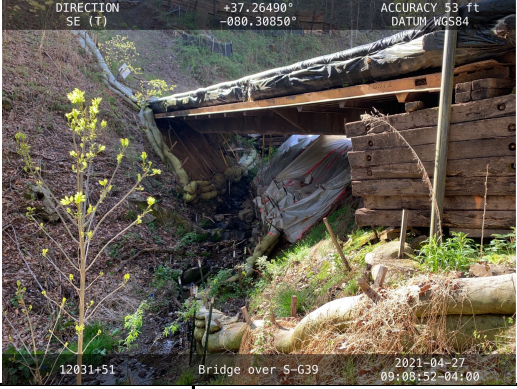
GPS Location	See photo		GPS Location	See photo	
Field Station#	12015+00		Field Station#	12031+51	
Pic 15 Desc.	Bridge and ECDs at stream crossing S-G38 in acceptable condition		Pic 16 Desc.	Bridge and ECDs crossing S-G39 in acceptable condition

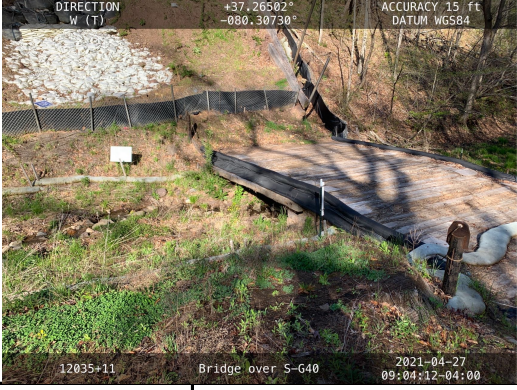
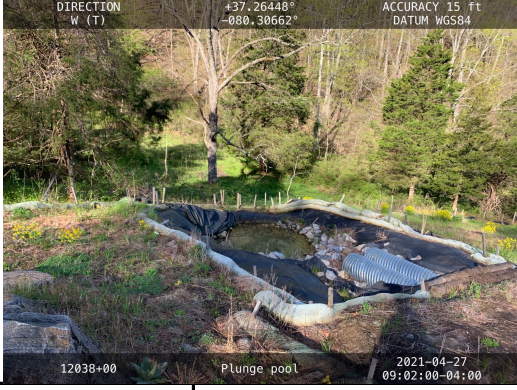
GPS Location	See photo		GPS Location	See photo	
Field Station#	12035+11		Field Station#	12038+00	
Pic 17 Desc.	Bridge and ECDs at stream crossing S-G40 in acceptable condition		Pic 18 Desc.	Clean water crossing outlet in acceptable condition

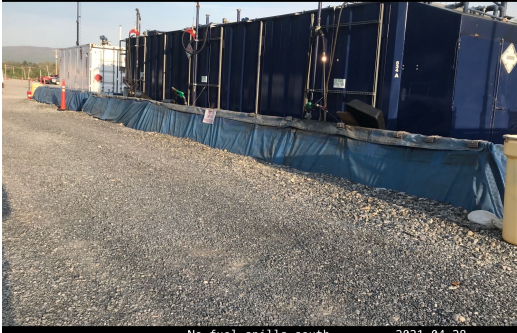
<p>MVP-PY-006_042821 No fuel spills south of tanks 2021-04-28 07:30:13-04:00</p>		<p>DIRECTION S (M) +37.23560° -080.22677° ACCURACY 33 ft DATUM WGS84</p>   <p>MVP-PY-006_042821 No fluids around hazardous waste 2021-04-28 07:44:59-04:00</p>			
GPS Location	MVP-PY-006 See photo for gps data		GPS Location	MVP-PY-006 See photo for gps data	
Field Station#	+0		Field Station#	+0	
Pic 7 Desc.	No fuel spills south of the Blue Bulk fuel tanks. Looking NW.		Pic 8 Desc.	No fluids or deposits around hazardous waste dumpsters. Looking S.	
<p>DIRECTION SW (M) +37.23558° -080.22673° ACCURACY 16 ft DATUM WGS84</p>

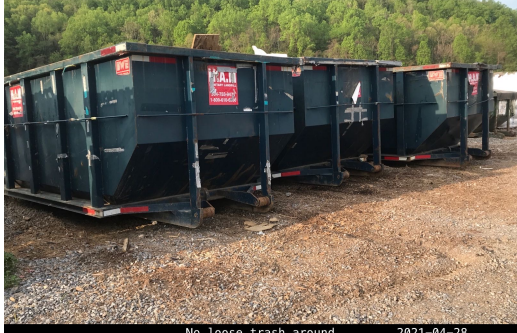
<p>MVP-PY-006_042821 No loose trash around dumpsters 2021-04-28 07:45:40-04:00</p>		<p>DIRECTION SW (M) +37.23589° -080.22730° ACCURACY 213 ft DATUM WGS84</p>

GPS Location	MVP-PY-006 See photo for gps data		GPS Location	MVP-PY-006 See photo for gps data	
Field Station#	+0		Field Station#	+0	
Pic 9 Desc.	No loose trash around dumpsters or in the yard. Looking SW.		Pic 10 Desc.	Secondary containment on site for tankers offloading fuel. Looking SW.	
<p>DIRECTION W (M) +37.23565° -080.22675° ACCURACY 16 ft DATUM WGS84</p>

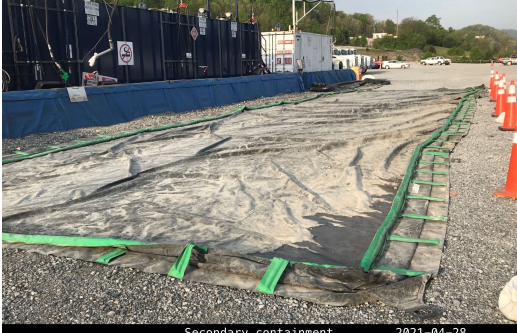
<p>MVP-PY-006_042821 Secondary containment on site 2021-04-28 07:46:09-04:00</p>

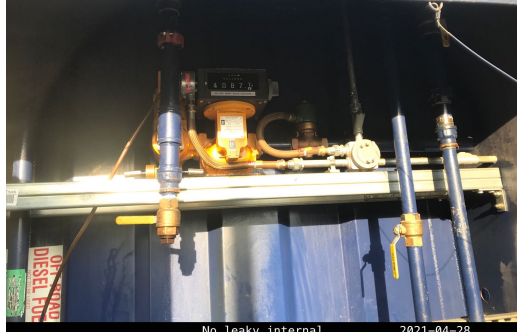
<p>MVP-PY-006_042821 No leaky internal fittings 2021-04-28 07:46:59-04:00</p>		<p>DIRECTION NW (M) +37.23561° -080.22680° ACCURACY 16 ft DATUM WGS84</p>

<p>MVP-PY-006_042821 Condition of internal drip pan 2021-04-28 07:48:26-04:00</p>			
GPS Location	MVP-PY-006 See photo for gps data		GPS Location	MVP-PY-006 See photo for gps data	
Field Station#	+0		Field Station#	+0	
Pic 11 Desc.	Blue Bulk Fuel tanks no leaky internal fittings. Looking W.		Pic 12 Desc.	Off Road Fuel condition of internal drip pan. Looking NW.

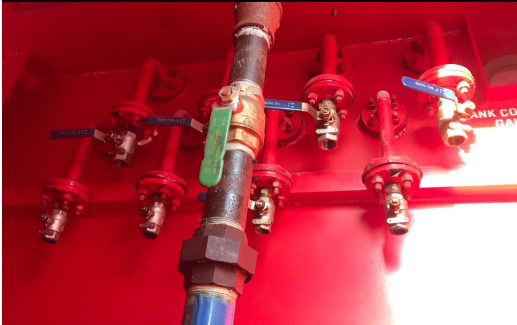
MVP-PY-006_042821 No leaky internal fittings 2021-04-28 07:48:31-04:00		DIRECTION N (M) +37.23558° -080.22686° ACCURACY 16 ft DATUM WGS84

MVP-PY-006_042821 No leaky fittings or nozzles 2021-04-28 07:49:06-04:00			
GPS Location	MVP-PY-006 See photo for gps data		GPS Location	MVP-PY-006 See photo for gps data	
Field Station#	+0		Field Station#	+0	
Pic 13 Desc.	Off Road Fuel unit no leaky internal fittings. Looking NW.		Pic 14 Desc.	Blue Bulk Fuel tanks no leaky fittings or nozzles. Looking N.	
DIRECTION E (M) +37.23557° -080.22619° ACCURACY 16 ft DATUM WGS84

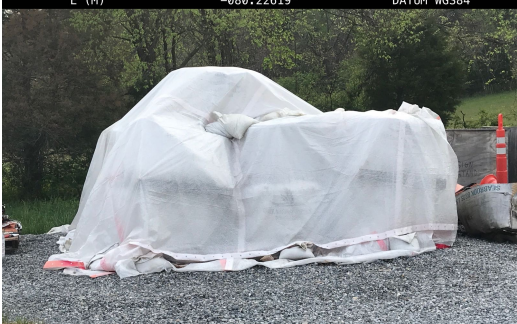
MVP-PY-006_042821 Restoration supplies covered 2021-04-28 07:50:06-04:00		DIRECTION SW (M) +37.23580° -080.22737° ACCURACY 16 ft DATUM WGS84

GPS Location	MVP-PY-006 See photo for gps data		GPS Location	MVP-PY-006 See photo for gps data	
Field Station#	+0		Field Station#	+0	
Pic 15 Desc.	Restoration supplies covered and protected from the weather. Looking E.		Pic 16 Desc.	Condition of containment under light plant. Looking SW.	
DIRECTION W (M) +37.23606° -080.22786° ACCURACY 16 ft DATUM WGS84

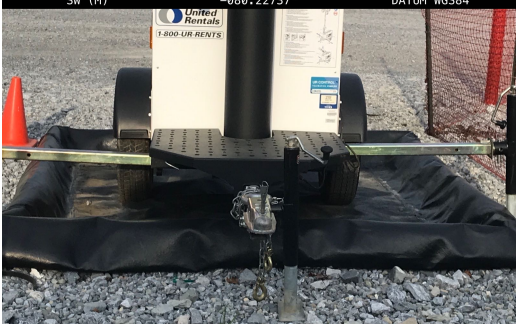
MVP-PY-006_042821 Condition of containment 2021-04-28 07:53:18-04:00

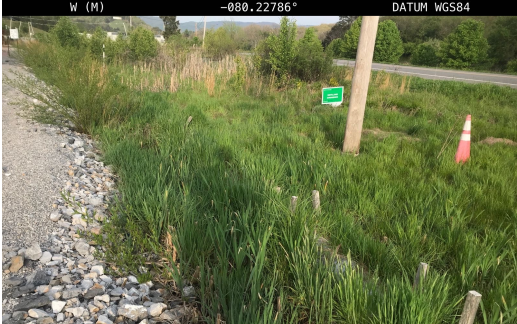
MVP-PY-006_042821 Condition of CFS & signage at feature 2021-04-28 07:54:36-04:00		DIRECTION SW (M) +37.23624° -080.22744° ACCURACY 16 ft DATUM WGS84

MVP-PY-006_042821 Condition of posted project documents 2021-04-28 07:55:10-04:00			
GPS Location	MVP-PY-006 See photo for gps data		GPS Location	MVP-PY-006 See photo for gps data	
Field Station#	+0		Field Station#	+0	
Pic 17 Desc.	Condition of signage and compost filter sock at feature W-008. Looking W.		Pic 18 Desc.	Condition of posted project documents at main entrance. Looking SW.

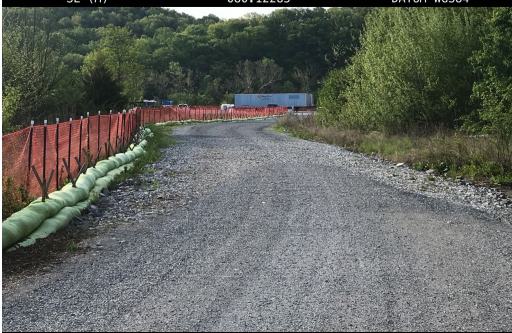
<p>DIRECTION SE (M) +37.27284° -080.12285° ACCURACY 33 ft DATUM WGS84</p> <p>MVP-LY-049_042821 Condition of rock entrance 2021-04-28 08:25:14-04:00</p>

<p>DIRECTION N (M) +37.27097° -080.12215° ACCURACY 16 ft DATUM WGS84</p> <p>MVP-LY-049_042821 Condition of containment 2021-04-28 08:26:27-04:00</p>			
GPS Location	MVP-LY-049 See photo for gps data	GPS Location	MVP-LY-049 See photo for gps data		
Field Station#	+0	Field Station#	+0		
Pic 1 Desc.	Condition of rock entrance on center drive. No sediment on stone. Looking SE.	Pic 2 Desc.	Condition of containment under light plant. Looking N.

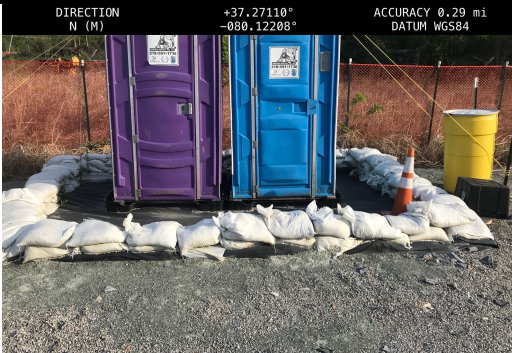
<p>DIRECTION N (M) +37.27110° -080.12208° ACCURACY 0.29 mi DATUM WGS84</p> <p>MVP-LY-049_042821 Condition of trays & containment 2021-04-28 08:27:46-04:00</p>

GPS Location	MVP-LY-049 See photo for gps data	GPS Location	MVP-LY-049 See photo for gps data		
Field Station#	+0	Field Station#	+0		
Pic 3 Desc.	Condition of trays and containment under toilets. Looking N.	Pic 4 Desc.	Condition of compost filter sock and safety fence along north LOD. Looking W.		
  <p>DIRECTION SE (M) +37.27150° -080.12031° ACCURACY 33 ft DATUM WGS84</p> <p>MVP-LY-049_042821 Condition of CFS & safety fence 2021-04-28 08:32:03-04:00</p>

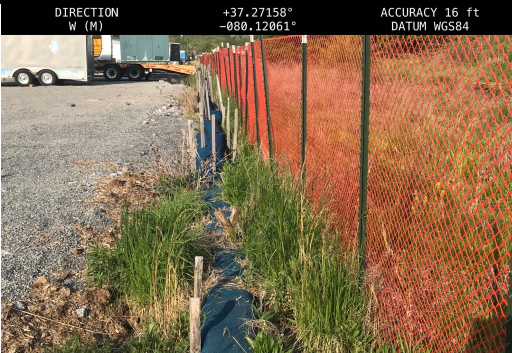
<p>DIRECTION W (M) +37.27158° -080.12061° ACCURACY 16 ft DATUM WGS84</p> <p>MVP-LY-049_042821 Condition of CFS & safety fence 2021-04-28 08:31:13-04:00</p>

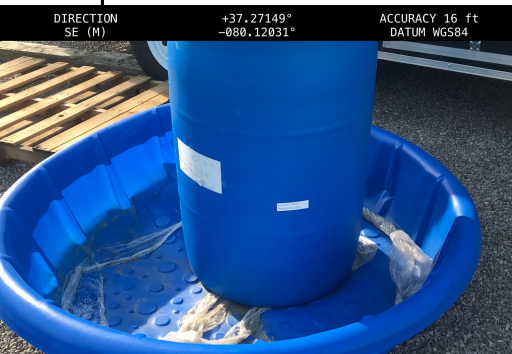
<p>DIRECTION SE (M) +37.27149° -080.12031° ACCURACY 16 ft DATUM WGS84</p> <p>MVP-LY-049_042821 Condition of containment 2021-04-28 08:32:54-04:00</p>			
GPS Location	MVP-LY-049 See photo for gps data	GPS Location	MVP-LY-049 See photo for gps data		
Field Station#	+0	Field Station#	+0		
Pic 5 Desc.	Condition of compost filter sock and safety fence along east LOD. Looking SE.	Pic 6 Desc.	Condition of containment under barrel of toilet chemical. Looking SE.

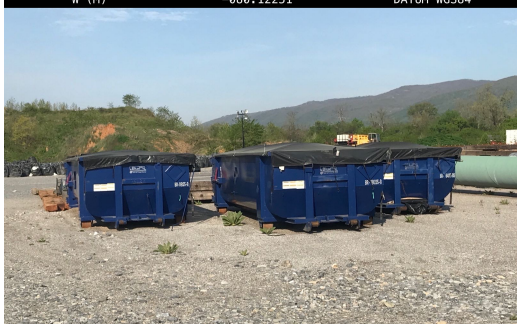
GPS Location	MVP-LY-049 See photo for gps data		GPS Location	MVP-LY-049 See photo for gps data	
Field Station#	+0		Field Station#	+0	
Pic 9 Desc.	No fluids or deposits around hazardous waste dumpsters. Looking W.		Pic 10 Desc.	Condition of temporary trash transfer pit. Most debris has been removed. Looking W.	
DIRECTION S (M) +37.27053° -080.12383° ACCURACY 16 ft DATUM WGS84

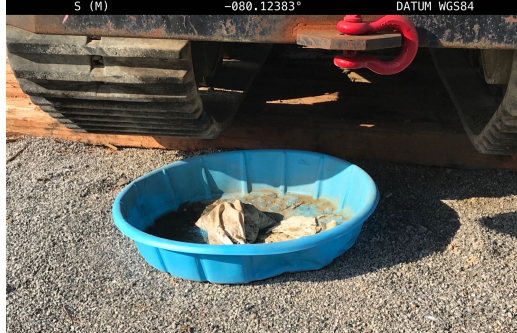
DIRECTION E (M) +37.26960° -080.12432° ACCURACY 16 ft DATUM WGS84	
MVP-LY-049_042821 Containment under stored equipment 2021-04-28 08:47:41-04:00		MVP-LY-049_042821 Containment under stored equipment 2021-04-28 08:49:08-04:00			
GPS Location	MVP-LY-049 See photo for gps data		GPS Location	MVP-LY-049 See photo for gps data	
Field Station#	+0		Field Station#	+0	
Pic 11 Desc.	Condition of containment under stored equipment. Looking S.		Pic 12 Desc.	Condition of containment under stored equipment. Looking E.

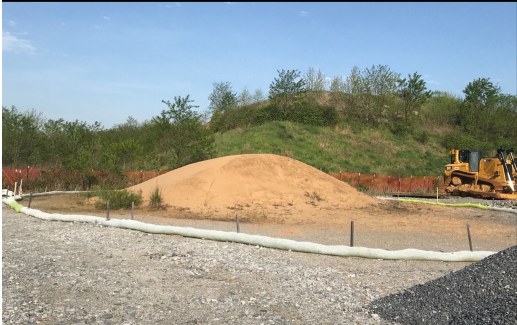
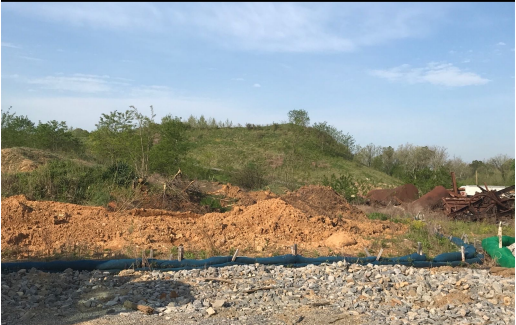
MVP-LY-049_042821 Condition of CFS around sand pile 2021-04-28 08:50:37-04:00		MVP-LY-049_042821 Landowner disturbance along CFS 2021-04-28 08:52:18-04:00			
GPS Location	MVP-LY-049 See photo for gps data		GPS Location	MVP-LY-049 See photo for gps data	
Field Station#	+0		Field Station#	+0	
Pic 13 Desc.	Condition of compost filter sock around sand pile. In place and functioning. Looking W.		Pic 14 Desc.	Landowner soil disturbance along compost filter sock. Area not stabilized. Looking SW.	
DIRECTION W (M) +37.27044° -080.12470° ACCURACY 16 ft DATUM WGS84		DIRECTION SW (M) +37.27043° -080.12467° ACCURACY 16 ft DATUM WGS84

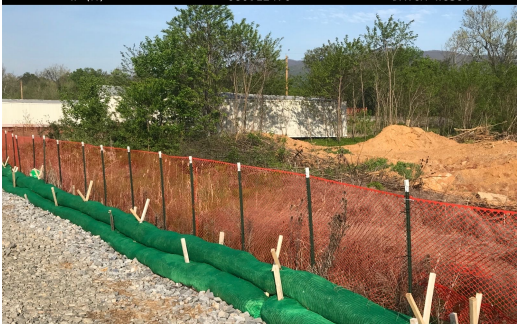
MVP-LY-049_042821 Landowner disturbance along feature 2021-04-28 08:53:02-04:00		MVP-LY-049_042821 Landowner disturbance within 66' of feature 2021-04-28 08:53:08-04:00

GPS Location	MVP-LY-049 See photo for gps data		GPS Location	MVP-LY-049 See photo for gps data	
Field Station#	+0		Field Station#	+0	
Pic 15 Desc.	Landowner soil disturbance along north edge of feature W-CV21A. Area not stabilized. Looking NW.		Pic 16 Desc.	Landowner soil disturbance within 66' and 120' west of feature W-CV21B. Area not stabilized. Looking SW.	
DIRECTION S (M) +37.27043° -080.12467° ACCURACY 16 ft DATUM WGS84		DIRECTION S (M) +37.27013° -080.12267° ACCURACY 16 ft DATUM WGS84

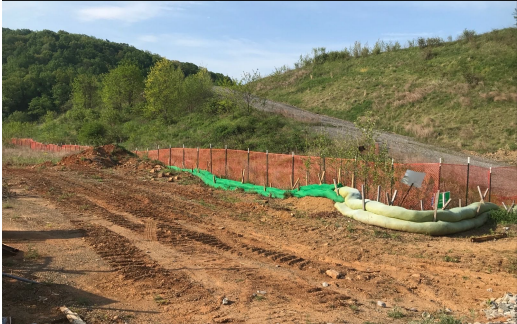
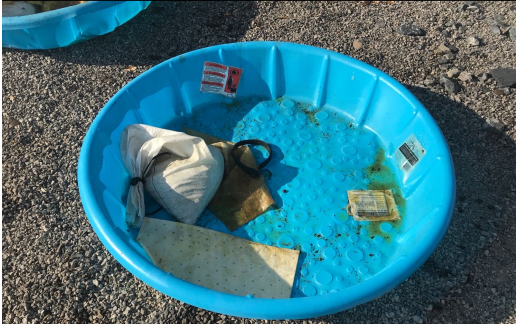
MVP-LY-049_042821 Landowner disturbance along CFS & feature 2021-04-28 08:53:38-04:00		MVP-LY-049_042821 Containment under stored trailer 2021-04-28 08:55:24-04:00			
GPS Location	MVP-LY-049 See photo for gps data		GPS Location	MVP-LY-049 See photo for gps data	
Field Station#	+0		Field Station#	+0	
Pic 17 Desc.	Landowner soil disturbance along compost filter sock and feature W-CV21B. Area not stabilized. Looking S.		Pic 18 Desc.	Condition of containment under stored trailer. Looking S.

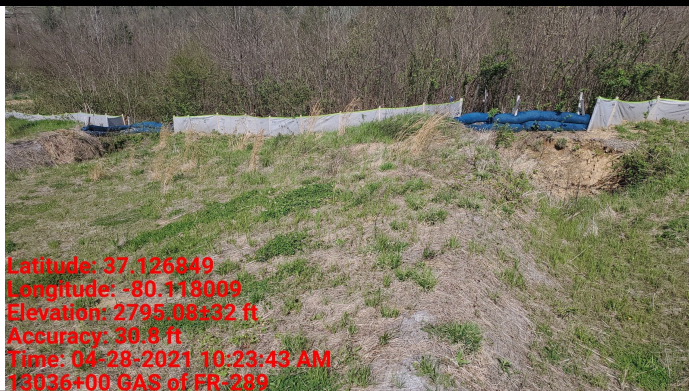
<p>Latitude: 37.126849 Longitude: -80.118009 Elevation: 2795.08±32 ft Accuracy: 30.8 ft Time: 04-28-2021 10:23:43 AM 13036+00 GAS of FR-289</p>			  <p>Latitude: 37.127414 Longitude: -80.117618 Elevation: 2658.37±43 ft Accuracy: 28.5 ft Time: 04-28-2021 10:26:30 AM 13040+50 GAS of FR-289 stream S-H1</p>

GPS Location	See pic for GPS location		GPS Location	See pic for GPS location	
Field Station#	13036+00		Field Station#	13040+50	
Pic 3 Desc.	Waterbars, sumps and end treatments remain in compliance throughout the area.		Pic 4 Desc.	Stream S-H1 on the GAS of FR-289.

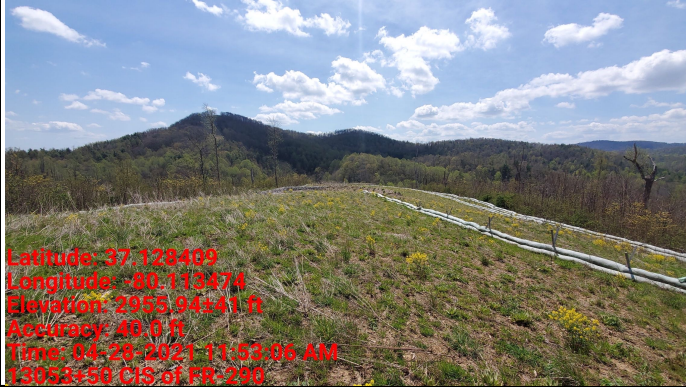
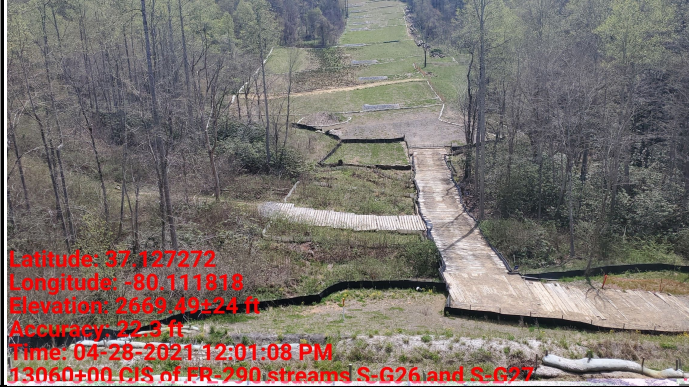
GPS Location	See pic for GPS location		GPS Location	See pic for GPS location	
Field Station#	13053+50		Field Station#	12060+00	
Pic 9 Desc.	Current ROW conditions on the CIS of FR-290.		Pic 10 Desc.	Streams S-G26 and S-G27 at FR-290 from the CIS slope.

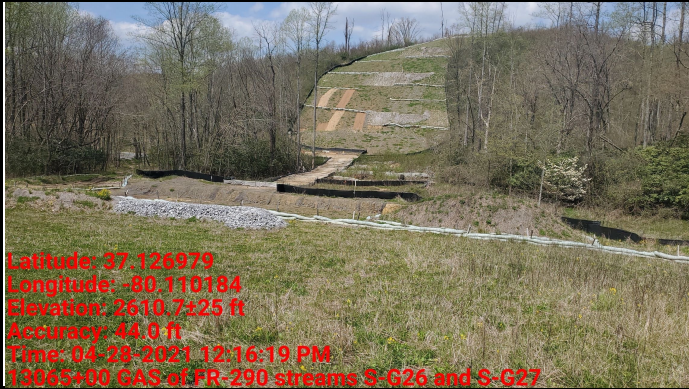
<p>Latitude: 37.126979 Longitude: -80.110184 Elevation: 2610.7±25 ft Accuracy: 44.0 ft Time: 04-28-2021 12:16:19 PM 13065+00 GAS of FR-290 streams S-G26 and S-G27</p>

<p>Latitude: 37.124882 Longitude: -80.113574 Elevation: 2600.2±38 ft Accuracy: 30.5 ft Time: 04-28-2021 12:28:57 PM 13061+44 FR-290 stream S-RR18 and wetland W-RR4</p>		
GPS Location	See pic for GPS location		GPS Location	See pic for GPS location	
Field Station#	13065+00		Field Station#	13061+44	
Pic 13 Desc.	Streams from the GAS.		Pic 14 Desc.	Downstream side of stream S-RR18.

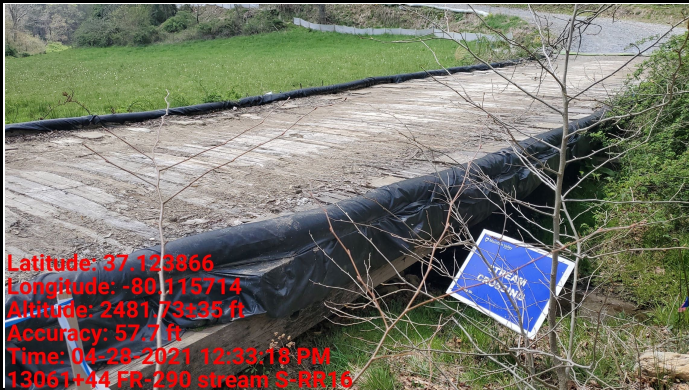
<p>Latitude: 37.123866 Longitude: -80.115714 Altitude: 2481.73±35 ft Accuracy: 57.7 ft Time: 04-28-2021 12:33:18 PM 13061+44 FR-290 stream S-RR16</p>

GPS Location	See pic for GPS location		GPS Location	See pic for GPS location	
Field Station#	13061+44		Field Station#	13116+00	
Pic 15 Desc.	Upstream side of stream S-RR16.		Pic 16 Desc.	GAS of FR-291 remains well stabilized with Curlex and vegetation.

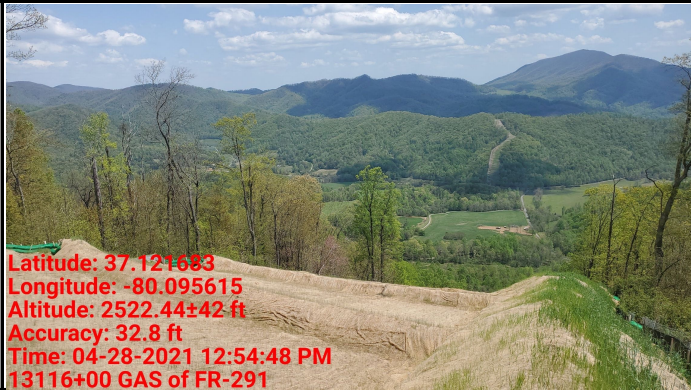
<p>Latitude: 37.121583 Longitude: -80.095615 Altitude: 2522.44±42 ft Accuracy: 32.8 ft Time: 04-28-2021 12:54:48 PM 13116+00 GAS of FR-291</p>

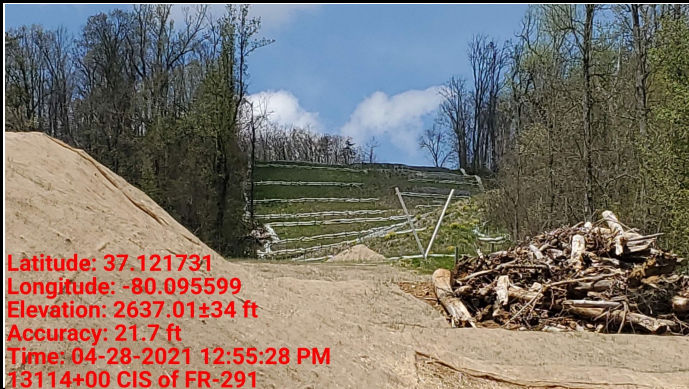
<p>Latitude: 37.121731 Longitude: -80.095599 Elevation: 2637.01±34 ft Accuracy: 21.7 ft Time: 04-28-2021 12:55:28 PM 13114+00 CIS of FR-291</p>

<p>Latitude: 37.117589 Longitude: -80.096069 Elevation: 2405.42±39 ft Accuracy: 32.5 ft Time: 04-28-2021 01:00:20 PM 13115+97 FR-291 stream S-EF17</p>		
GPS Location	See pic for GPS location		GPS Location	See pic for GPS location	
Field Station#	13114+00		Field Station#	13115+97	
Pic 17 Desc.	Current ROW conditions on the CIS of FR-291.		Pic 18 Desc.	Access road FR-291 at stream crossing S-EF17.

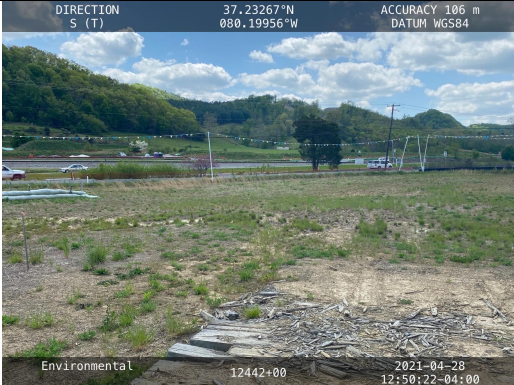
<p>DIRECTION S (T) 37.23267°N 080.19956°W ACCURACY 106 m DATUM WGS84</p> <p>Environmental 12442+00 2021-04-28 12:50:22-04:00</p>

<p>DIRECTION NE (T) 37.23334°N 080.19813°W ACCURACY 22 m DATUM WGS84</p> <p>Environmental 12435+50 2021-04-28 12:47:51-04:00</p>	
GPS Location	See photo		GPS Location	See photo	
Field Station#	12442+00		Field Station#	12435+50	
Pic 1 Desc.	Stabilized ROW in acceptable condition		Pic 2 Desc.	Stream crossing S-NN16 in acceptable condition

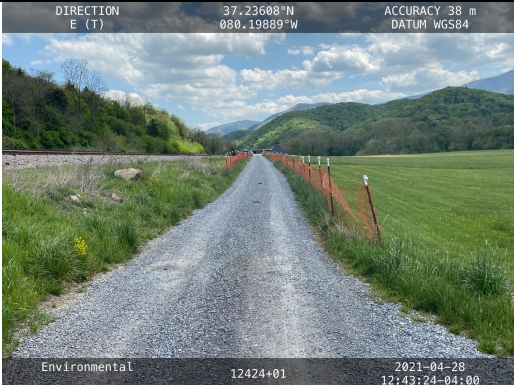
<p>DIRECTION E (T) 37.23608°N 080.19889°W ACCURACY 38 m DATUM WGS84</p> <p>Environmental 12424+01 2021-04-28 12:43:24-04:00</p>

Pic 3 Desc.	Access Road MVP-MN-279 in acceptable condition		Pic 4 Desc.	Clean water crossing outlet level spreader in acceptable condition

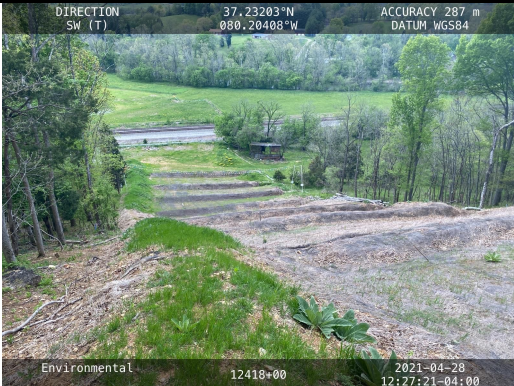
<p>DIRECTION SW (T) 37.23203°N 080.20488°W ACCURACY 287 m DATUM WGS84</p> <p>Environmental 12418+00 2021-04-28 12:27:21-04:00</p>

<p>DIRECTION E (T) 37.23996°N 080.19913°W ACCURACY 222 m DATUM WGS84</p> <p>Environmental 12410+20 2021-04-28 12:22:41-04:00</p>	
GPS Location	See photo		GPS Location	See photo	
Field Station#	12418+00		Field Station#	12410+20	
Pic 5 Desc.	Stabilized slope in acceptable condition		Pic 6 Desc.	Clean water crossing pipe outlet in acceptable condition

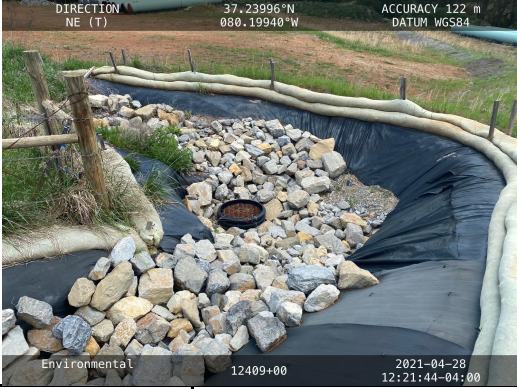
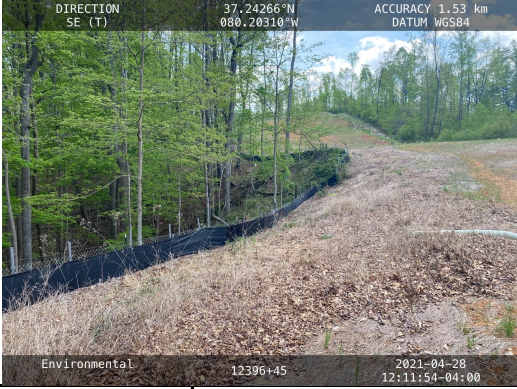
GPS Location	See photo		GPS Location	See photo	
Field Station#	12409+00		Field Station#	12396+45	
Pic 7 Desc.	Clean water crossing pipe inlet in acceptable condition		Pic 8 Desc.	SSF protecting off ROW karst features in acceptable condition

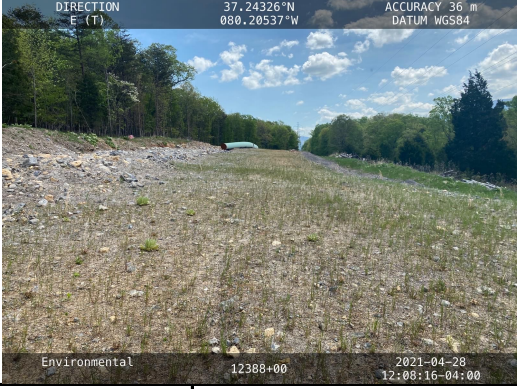
GPS Location	See photo		GPS Location	See photo	
Field Station#	12392+23		Field Station#	12388+00	
Pic 9 Desc.	Stabilized ROW in acceptable condition		Pic 10 Desc.	Stabilized Row In Acceptable condition

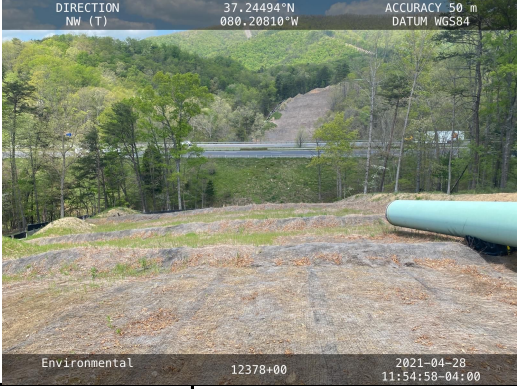
GPS Location	See photo		GPS Location	See photo	
Field Station#	12378+00		Field Station#	12374+16	
Pic 15 Desc.	Stabilized ROW In Acceptable condition		Pic 16 Desc.	Stream crossing S-0016 in acceptable condition

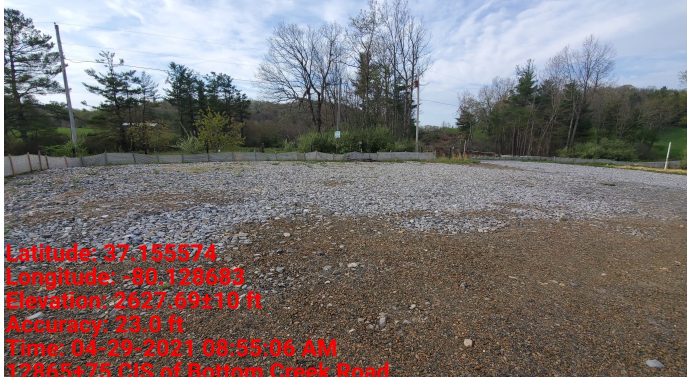
<p>Latitude: 37.155574 Longitude: -80.128683 Elevation: 2627.69±10 ft Accuracy: 23.0 ft Time: 04-29-2021 08:55:06 AM 12865+75 CIS of Bottom Creek Road</p>

<p>Latitude: 37.155437 Longitude: -80.128669 Elevation: 2630.95±10 ft Accuracy: 53.5 ft Time: 04-29-2021 08:56:32 AM 12865+75 CIS of Bottom Creek Road</p>		
GPS Location	See pic for GPS location		GPS Location	See pic for GPS location	
Field Station#	12865+75		Field Station#	12865+75	
Pic 1 Desc.	ATWS on the CIS of Bottom Creek Road.		Pic 2 Desc.	Current ROW conditions on the CIS of Bottom Creek Road.

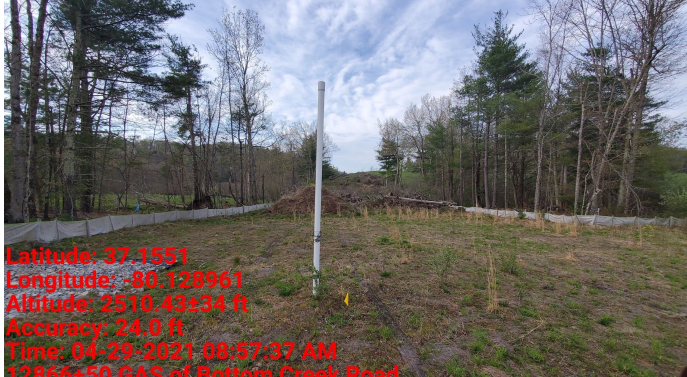
<p>Latitude: 37.1551 Longitude: -80.128951 Altitude: 2510.43±34 ft Accuracy: 24.0 ft Time: 04-29-2021 08:57:37 AM 12866+50 GAS of Bottom Creek Road</p>

GPS Location	See pic for GPS location		GPS Location	See pic for GPS location	
Field Station#	12866+50		Field Station#	12728+74	
Pic 3 Desc.	Current ROW conditions on the GAS of Bottom Creek Road.		Pic 4 Desc.	Access road RO-281 from Poor Mountain Road.

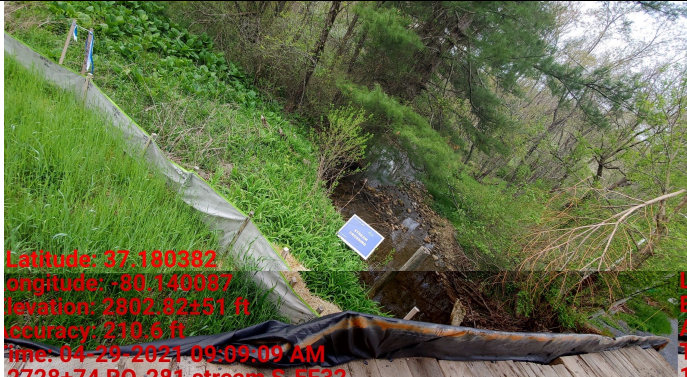
<p>Latitude: 37.190382 Longitude: -80.146987 Elevation: 2802.82±51 ft Accuracy: 230.5 ft Time: 04-29-2021 09:09:09 AM 12728+74 RO-281 stream S-EF32</p>

<p>Latitude: 37.186763 Longitude: -80.142684 Altitude: 2689.3±190 ft Accuracy: 7545.9 ft Time: 04-29-2021 09:15:04 AM 12728+74 Access road RO-281</p>		
GPS Location	See pic for GPS location		GPS Location	See pic for GPS location	
Field Station#	12728+74		Field Station#	12728+74	
Pic 5 Desc.	Stream S-EF32 on RO-280.		Pic 6 Desc.	ECD's along RO-280 remain in compliance.

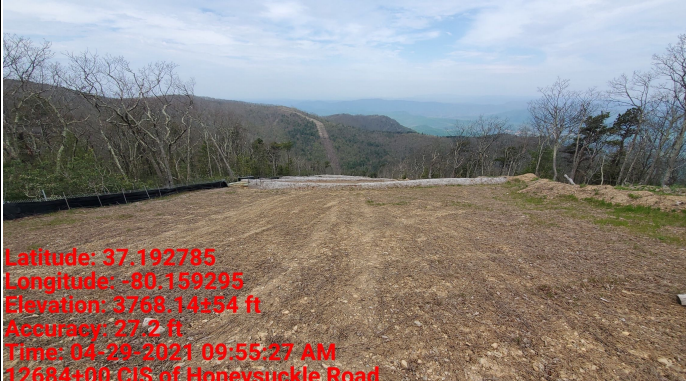
<p>Latitude: 37.192785 Longitude: -80.159295 Elevation: 3768.14±54 ft Accuracy: 27.2 ft Time: 04-29-2021 09:55:27 AM 12684+00 CIS of Honeysuckle Road</p>

<p>Latitude: 37.18372 Longitude: -80.160648 Elevation: 3742.49±87 ft Accuracy: 37.4 ft Time: 04-29-2021 10:02:59 AM 12703+04 RO-280 ATWS-1225</p>		
GPS Location	See pic for GPS location		GPS Location	See pic for GPS location	
Field Station#	12684+00		Field Station#	12703+04	
Pic 13 Desc.	Current ROW conditions on the CIS of Honeysuckle.		Pic 14 Desc.	ATWS-1225 on RO-280 and Honeysuckle Road.

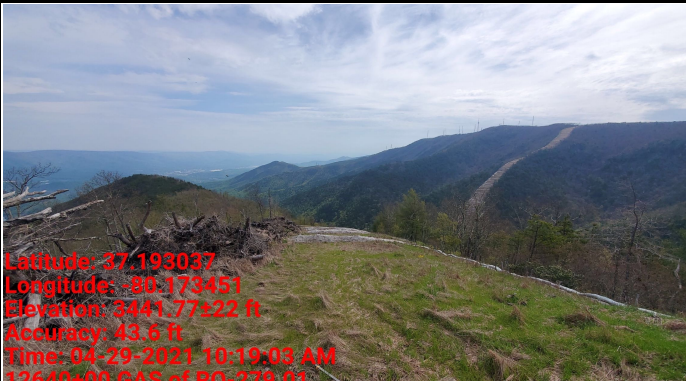
<p>Latitude: 37.193037 Longitude: -80.173451 Elevation: 2441.77±22 ft Accuracy: 43.6 ft Time: 04-29-2021 10:19:03 AM 12640+00 GAS of RO-279.01</p>

GPS Location	See pic for GPS location		GPS Location	See pic for GPS location	
Field Station#	12640+00		Field Station#	12703+04	
Pic 15 Desc.	Current ROW conditions on the GAS of RO-279.01.		Pic 16 Desc.	CFS replaced where deteriorating in ATWS at RO-280 and Honeysuckle Road.

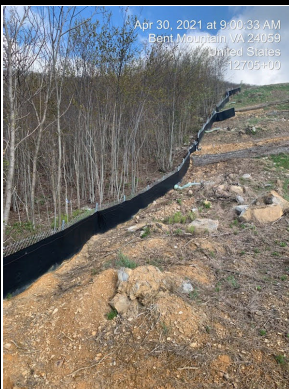
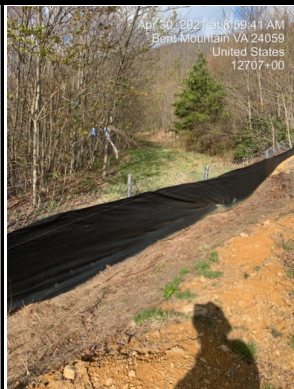
<p>Apr 30, 2021 at 9:09:41 AM Bent Mountain VA 24059 United States 12707+00</p>		
GPS Location	See pic for GPS location		GPS Location	See pic for GPS location	
Field Station#	12705+00		Field Station#	12707+00	
Pic 17 Desc.	SSF unattached from wind on GAS of RO-280. Repaired 4-30.		Pic 18 Desc.	SSF unattached from wind on GAS of RO-280. Repaired 4-30.

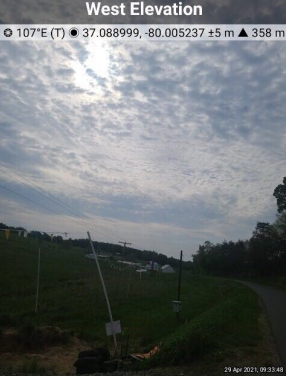
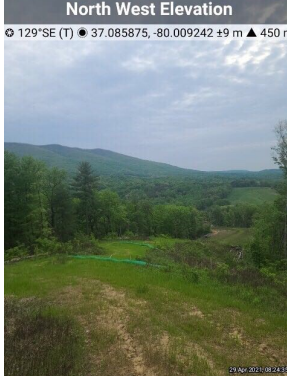
GPS Location	0000	GPS Location	00000		
Field Station#	13497+00	Field Station#	13480+00		
Pic 1 Desc.	Monitored vegetation and ECDs in anode bed location . No issues observed at the time of inspection.		Pic 2 Desc.	Monitored vegetation growth and ECDs while checking row conditions throughout.	
	North Elevation <small>169°S (T) 37.09077, -80.023816 ±8 m ▲ 428 m</small>

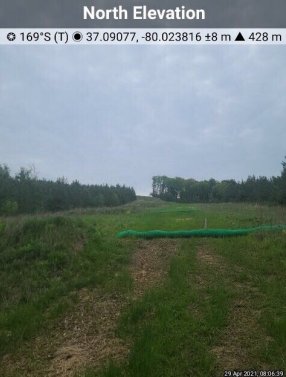
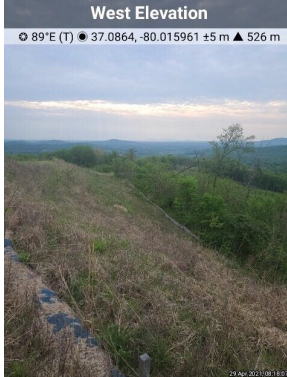
GPS Location	000000	GPS Location	000000		
Field Station#	13430+00	Field Station#	13460+00		
Pic 3 Desc.	Monitored vegetation growth and ECDs while checking row conditions throughout.		Pic 4 Desc.	Monitored vegetation growth and ECDs while checking row conditions throughout.

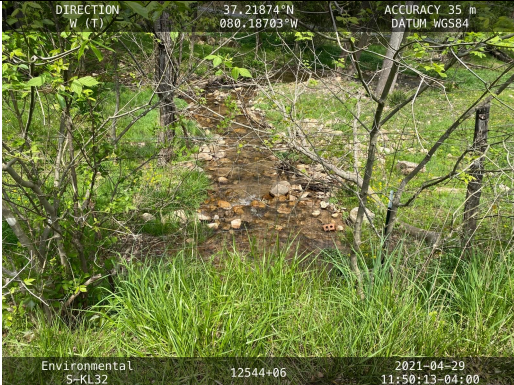
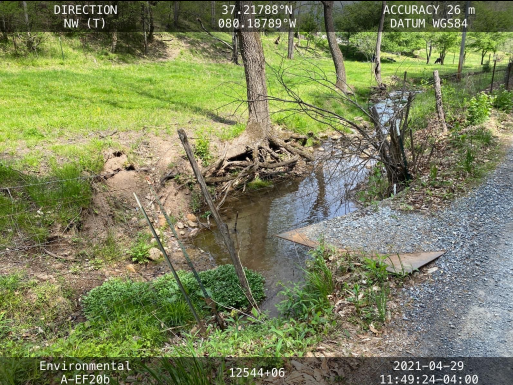
GPS Location	See photo		GPS Location	See photo	
Field Station#	12544+06		Field Station#	12544+06	
Pic 1 Desc.	Down stream of S-KL32 in acceptable condition		Pic 2 Desc.	Down stream of S-EF20b in acceptable condition

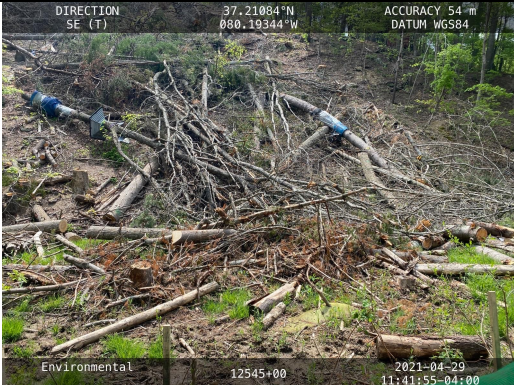
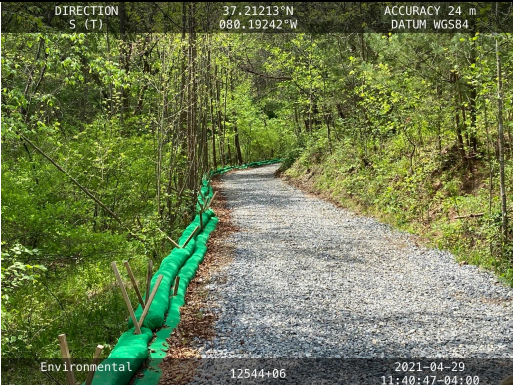
GPS Location	See photo		GPS Location	See photo	
Field Station#	12545+00		Field Station#	12544+06	
Pic 3 Desc.	ROW conditions		Pic 4 Desc.	ECDs along access road MVP-MN-278.01 in acceptable condition

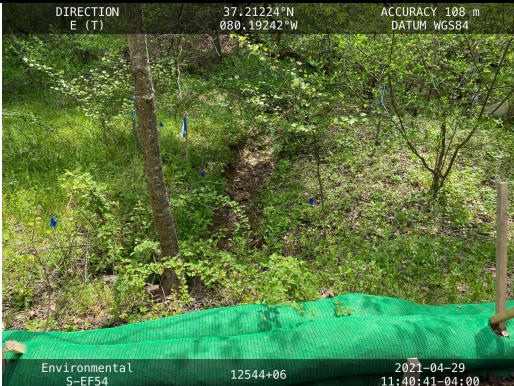
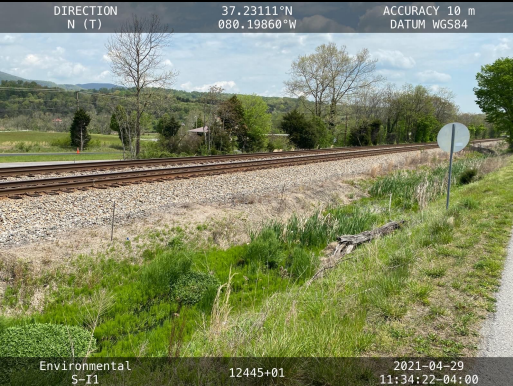
GPS Location	See photo		GPS Location	See photo	
Field Station#	12544+06		Field Station#	12445+01	
Pic 5 Desc.	Down stream of S-EF54 in acceptable condition		Pic 6 Desc.	Stream crossing S-I1 in acceptable condition

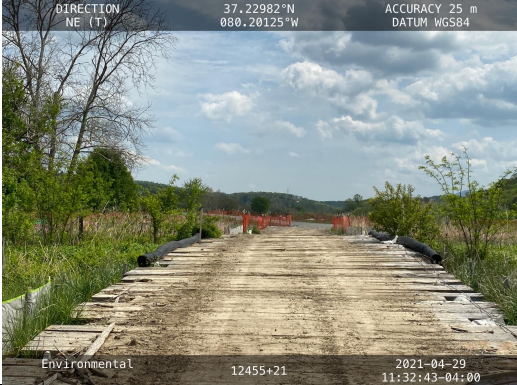
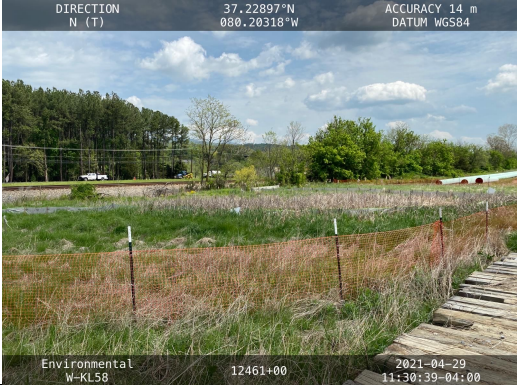
GPS Location	See photo		GPS Location	See photo	
Field Station#	12455+21		Field Station#	12461+00	
Pic 7 Desc.	Bridge and ECDs at stream crossing S-CD12b in acceptable condition		Pic 8 Desc.	Wetland W-KL58 in acceptable condition

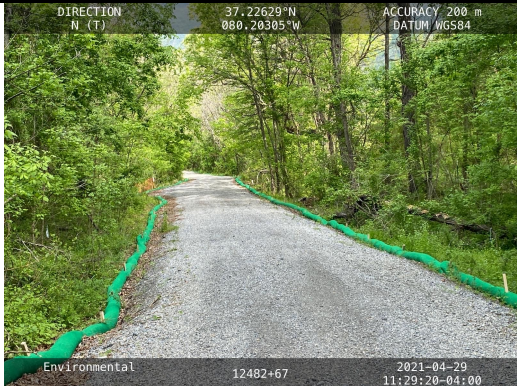
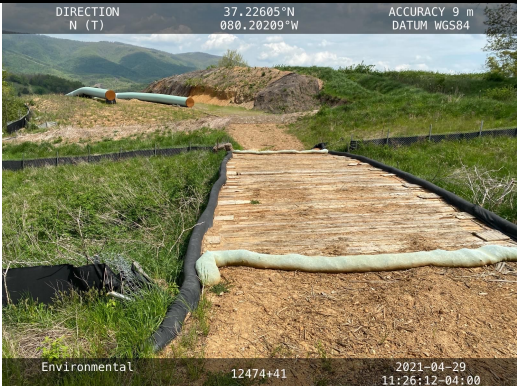
GPS Location	See photo		GPS Location	See photo	
Field Station#	12482+67		Field Station#	12474+41	
Pic 9 Desc.	ECDs along access road MVP-MLV-MN-28 in acceptable condition		Pic 10 Desc.	Bridge and ECDs protecting the clear water crossing in acceptable condition

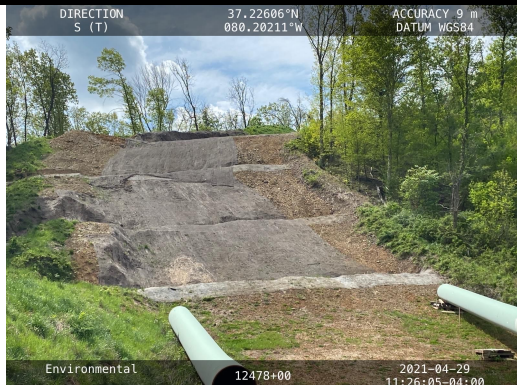
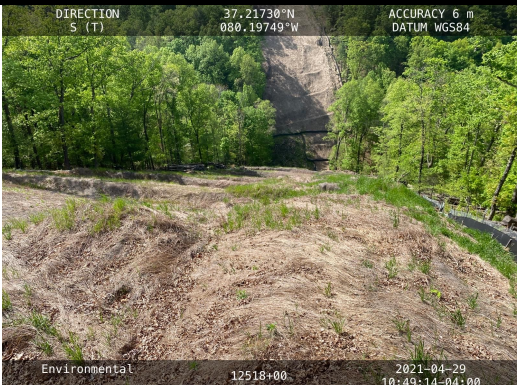
GPS Location	See photo		GPS Location	see photo	
Field Station#	12478+00		Field Station#	12518+00	
Pic 11 Desc.	Stabilized slope in acceptable condition		Pic 12 Desc.	Stabilized slope in acceptable condition

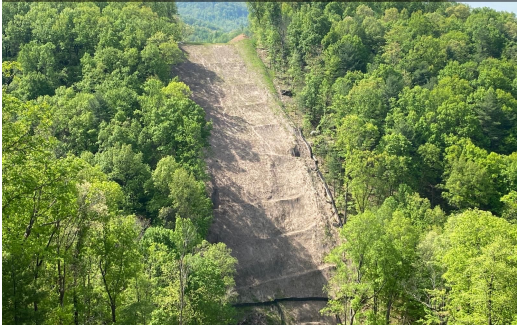
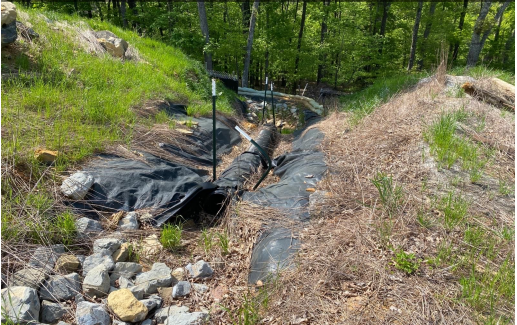
Environmental 12507+76 2021-04-29 10:42:22-04:00			
GPS Location	See photo		GPS Location	See photo	
Field Station#	12521+00		Field Station#	12507+76	
Pic 13 Desc.	Stabilized slope in acceptable condition		Pic 14 Desc.	Fill slope drain in acceptable condition	
DIRECTION SE (T) 37.21830°N 080.20037°W ACCURACY 5 m DATUM WGS84
