Visual Site Inspection Report

Project Name	H-600 Pipeline Spread H	AFE	124300138	Spread	H-600 Pipeline Spread H
Contractor	Precision			Report #	22700
Inspector	Dawn McCullough			Date/Time	4/26/2021 3:33 PM
Permit #	TBD	Inspection Type	VA SWPP	Station Begin	13141+65
State	VA	Inspection Area	Partial	Station End	13316+21
County	Franklin	Ground	Damp	Temperature (°F)	74.00
Municipality	N/A	Weather	Sunny	Rain Gauge (in)	0.00
				Rain Accumulation Time (days)	1.00

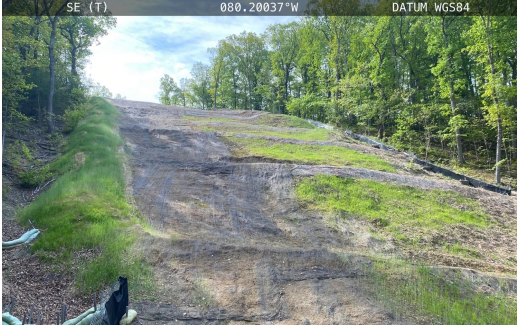
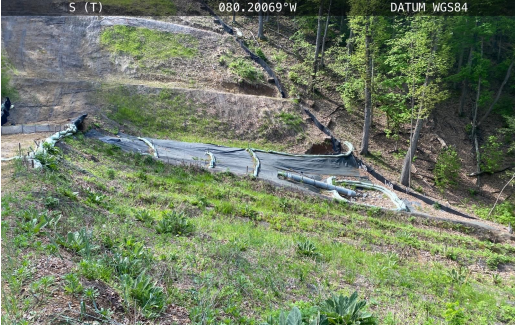
Environmental 12504+00 2021-04-29 10:28:42-04:00			
GPS Location	See photo		GPS Location	See photo	
Field Station#	12506+00		Field Station#	12504+00	
Pic 15 Desc.	Stabilized slope in acceptable condition		Pic 16 Desc.	Clean water crossing in acceptable condition

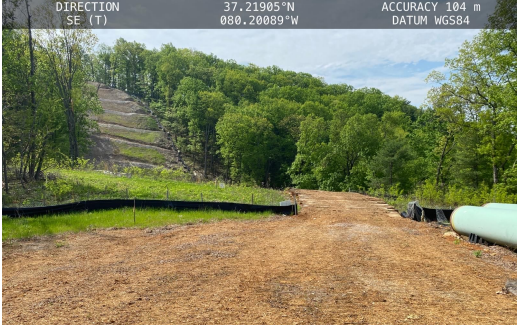
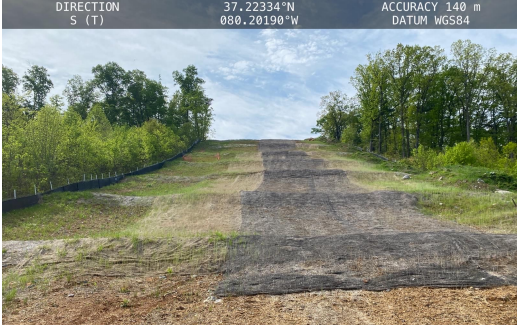
Environmental 12485+00 2021-04-29 10:14:30-04:00			
GPS Location	See photo		GPS Location	See photo	
Field Station#	12501+60		Field Station#	12485+00	
Pic 17 Desc.	Foreign pipeline crossing in acceptable condition		Pic 18 Desc.	Stabilized slope in acceptable condition

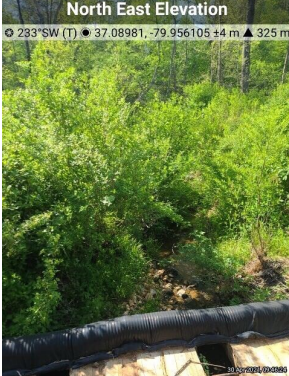
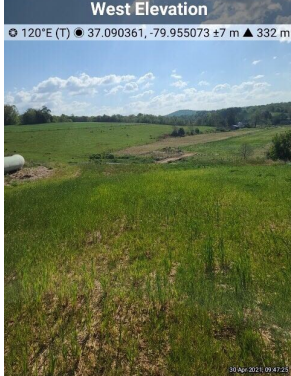
GPS Location	00000	GPS Location	00000		
Field Station#	13659+03	Field Station#	13664+15		
Pic 1 Desc.	Stream observation photo facing downstream during routine inspection today. No environmental issues observed at the time of inspection.		Pic 2 Desc.	Vegetation observation photo facing down row. No issues observed during inspection today.	
	South West Elevation <small>72°NE (T) 37.089769, -79.956167 ±4 m ▲ 323 m</small>

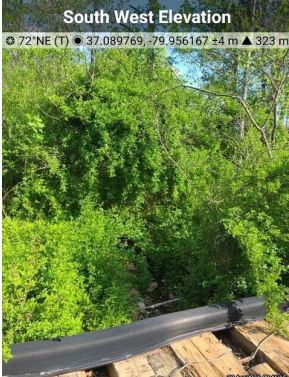
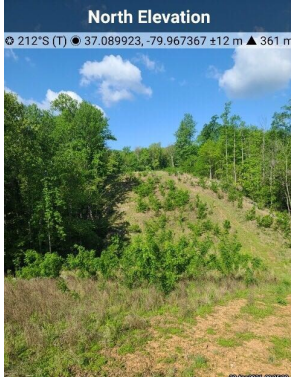
GPS Location	00000	GPS Location	00000		
Field Station#	13659+03	Field Station#	13611+00		
Pic 3 Desc.	Stream observation photo facing upstream during routine inspection today. No issues observed at the time of inspection.		Pic 4 Desc.	Row photo showing vegetation growth. No issues observed at the time of inspection.

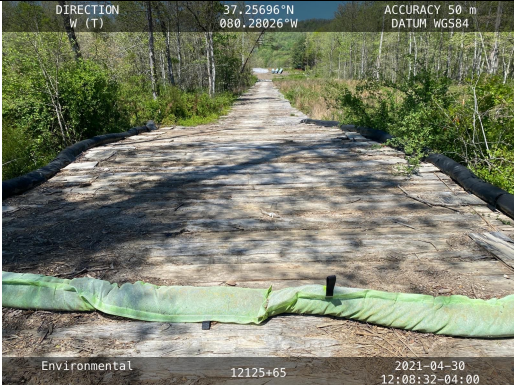
GPS Location	See photo		GPS Location	See photo	
Field Station#	12125+65		Field Station#	12132+73	
Pic 1 Desc.	Bridge and ECDs crossing stream S-MM31 in acceptable condition		Pic 2 Desc.	Bridge and ECDs crossing stream S-C29 in acceptable condition

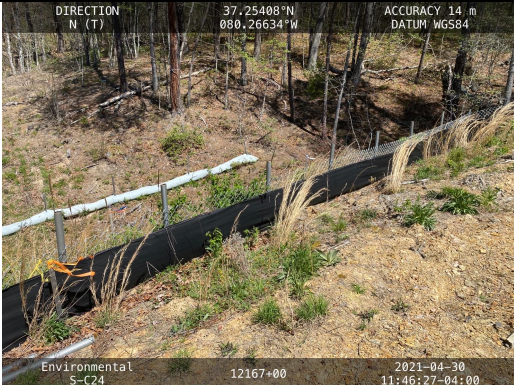
GPS Location	See photo		GPS Location	See photo	
Field Station#	12167+00		Field Station#	12167+00	
Pic 3 Desc.	SSF fabric reattached to the chain link.		Pic 4 Desc.	SSF not attached to chain link due to windy conditions

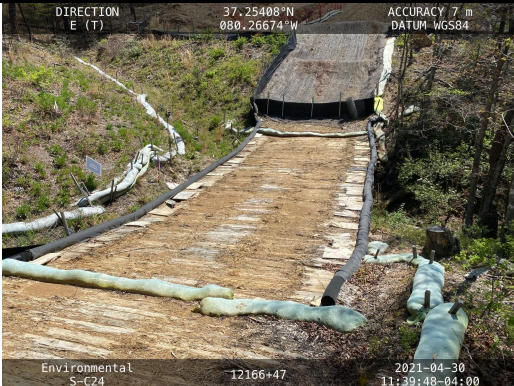
GPS Location	See photo		GPS Location	See photo	
Field Station#	12166+47		Field Station#	12163+05	
Pic 5 Desc.	Br and ECDs crossing stream S-C24 in acceptable condition		Pic 6 Desc.	Bridge and ECDs crossing S-C25 in acceptable condition

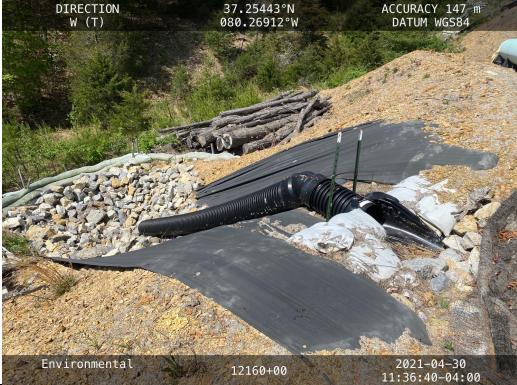
GPS Location	See photo		GPS Location	See photo	
Field Station#	12160+00		Field Station#	12156+80	
Pic 7 Desc.	Fill slope drain in acceptable condition		Pic 8 Desc.	Drop outlet in acceptable condition

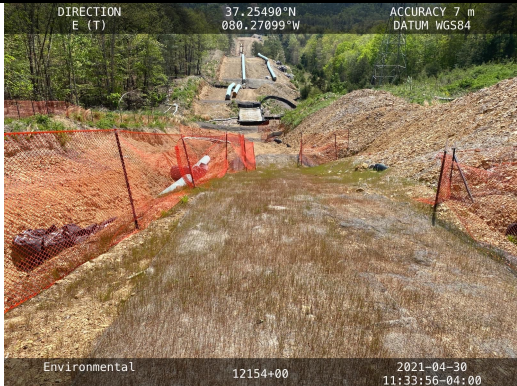
GPS Location	See photo		GPS Location	See photo	
Field Station#	12154+00		Field Station#	12203+00	
Pic 9 Desc.	Stabilized ROW in acceptable condition		Pic 10 Desc.	Stabilized ROW and water bar outlets in acceptable condition

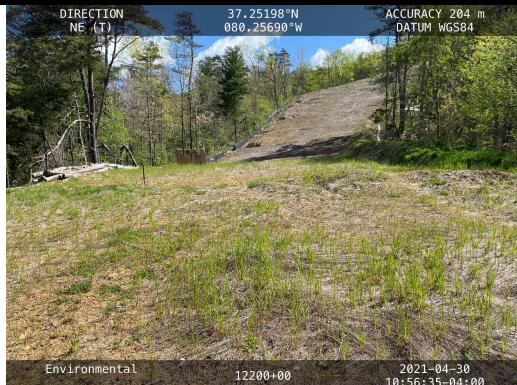
GPS Location	See photo		GPS Location	See photo	
Field Station#	12200+00		Field Station#	12198+64	
Pic 11 Desc.	Stabilized ROW in acceptable condition		Pic 12 Desc.	Stream crossing S-0011 on the east side of the railroad crossing in acceptable condition.

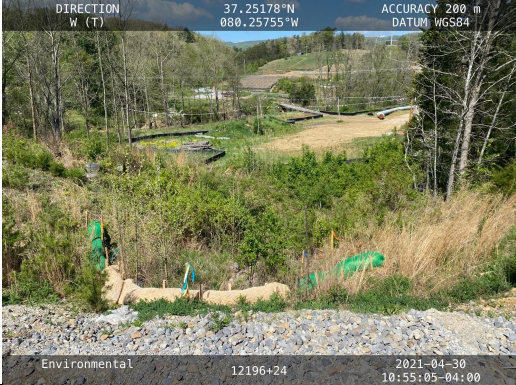
GPS Location	See photo		GPS Location	See photo	
Field Station#	12196+24		Field Station#	12198+90	
Pic 13 Desc.	Stream crossing S-OO11 on the west side of the railroad tracks in acceptable condition		Pic 14 Desc.	Access Road MVP-MN-275 in acceptable condition

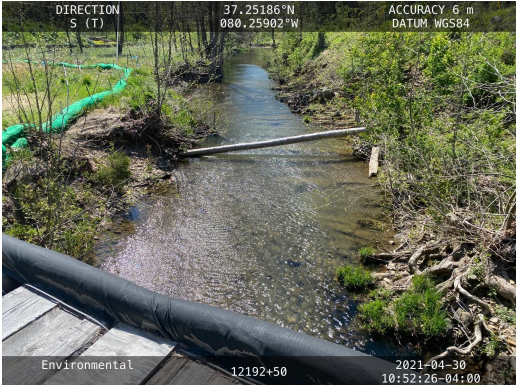
GPS Location	See photo		GPS Location	See photo	
Field Station#	12192+50		Field Station#	12192+50	
Pic 15 Desc.	Down stream of S-C21 in acceptable condition		Pic 16 Desc.	Bridge and ECDs crossing S-C21 in acceptable condition

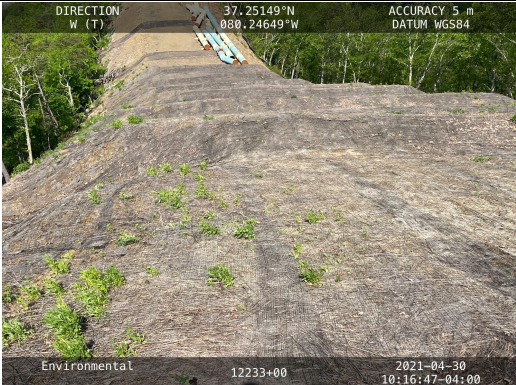
GPS Location	See photo		GPS Location	See photo	
Field Station#	12233+00		Field Station#	12236+00	
Pic 17 Desc.	Stabilized ROW in acceptable condition		Pic 18 Desc.	Stabilized slope in acceptable condition

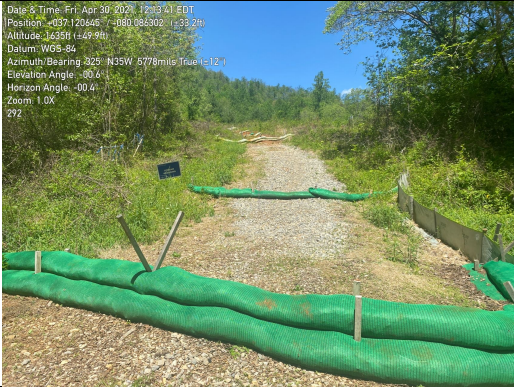
GPS Location	See photo for coordinates.		GPS Location	See photo for coordinates.	
Field Station#	13142+00		Field Station#	13142+00	
Pic 1 Desc.	MVP-FR-292, partially developed access road in acceptable condition, ECDs functioning acceptably.		Pic 2 Desc.	MVP-FR-292, S-D14, no flowing in stream at edge of access road.

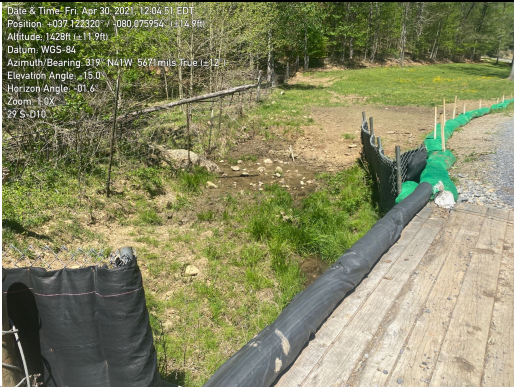
GPS Location	See photo for coordinates.		GPS Location	See photo for coordinates.	
Field Station#	13190+00		Field Station#	13197+50	
Pic 3 Desc.	MVP-AR-29, S-D10, upstream, typical cattle disturbance noted in stream bed and along banks, ECDs in acceptable condition.		Pic 4 Desc.	S-D8, no disturbance noted at stream crossing or adjacent field.

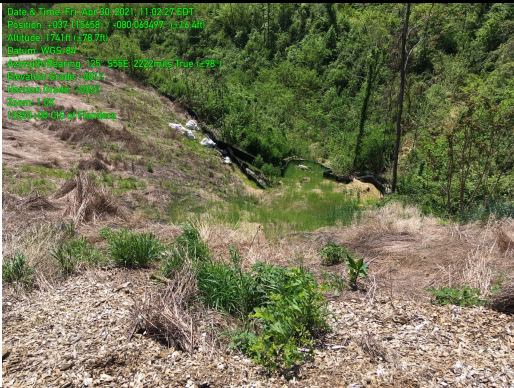
GPS Location	See photo for coordinates.		GPS Location	See photo for coordinates.	
Field Station#	13253+00		Field Station#	13253+00	
Pic 5 Desc.	Documented slip appeared stable, vegetation establishing along steep slope.		Pic 6 Desc.	ECDs above slip in acceptable condition.

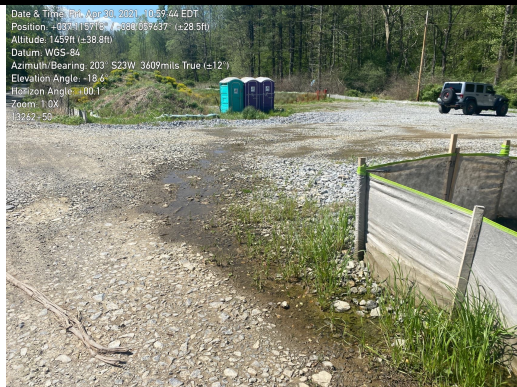
GPS Location	See photo for coordinates.	GPS Location	See photo for coordinates.		
Field Station#	13262+00	Field Station#	13262+50		
Pic 9 Desc.	ROW stable on the CIS and GAS of S-II4, ECDs in acceptable condition.	Pic 10 Desc.	MVP-FR-293.01, Flanders Road, road in acceptable condition, logging trucks using road to haul lumber.

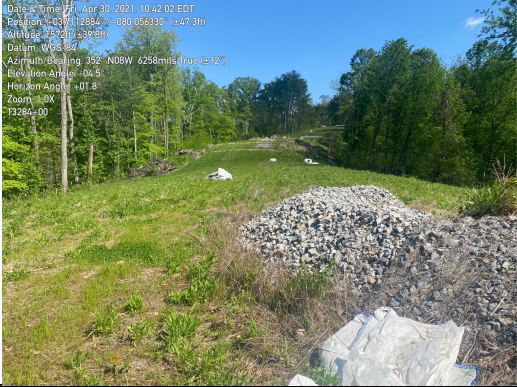
GPS Location		See photo for coordinates.		GPS Location	
Field Station#		13284+00		Field Station#	
Pic 13 Desc.		ROW stable with vegetative cover noted across LOD.		Pic 14 Desc.	
<p>Date & Time: Fri, Apr 30, 2021, 10:55:49 EDT Position: +037 133004, -080 056310, +4592m Altitude: 1579ft (+401m) Datum: WGS 84 Azimuth Bearing: 167° S17W 3880mils True (+12°) Elevation Angle: -17.6° Horizon Angle: -00.5° Zoom: 1.0X 13300+00</p>

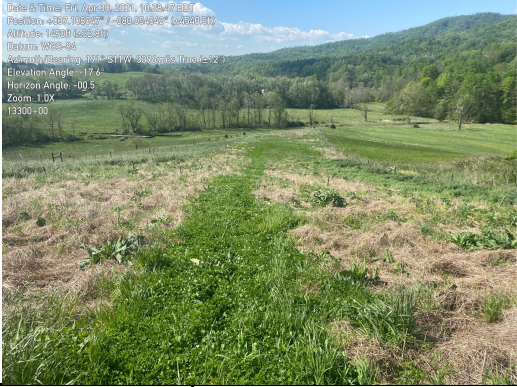
GPS Location		See photo for coordinates.		GPS Location	
Field Station#		13300+00		Field Station#	
Pic 15 Desc.		ROW stable with vegetative cover noted across LOD.		Pic 16 Desc.	
<p>Date & Time: Fri, Apr 30, 2021, 10:56:59 EDT Position: +037 133094, -080 056370, +4124m Altitude: 1375ft (+308m) Datum: WGS 84 Azimuth Bearing: 036° N66E 11073mils True (+12°) Elevation Angle: -16.3° Horizon Angle: -01.9° Zoom: 1.0X 13309 -09 S-GH7</p>

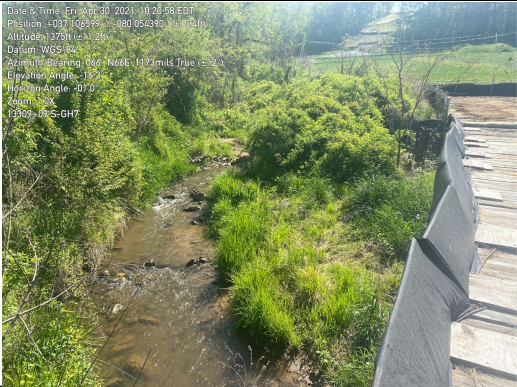
GPS Location		See photo for coordinates.		GPS Location	
Field Station#		13309+09		Field Station#	
Pic 17 Desc.		S-GH7, upstream, slight turbidity noted, no ROW impacts observed, banks well vegetated.		Pic 18 Desc.
