# Visual Site Inspection Report

<b>Project Name</b>	H-600 Pipeline Spread H	<b>AFE</b>	124300138	<b>Spread</b>	H-600 Pipeline Spread H
<b>Contractor</b>	Precision			<b>Report #</b>	21936
<b>Inspector</b>	Norm Kitchen			<b>Date/Time</b>	4/5/2021 5:00 PM
<b>Permit #</b>	TBD	<b>Inspection Type</b>	VA SWPP	<b>Station Begin</b>	13316+21
<b>State</b>	VA	<b>Inspection Area</b>	Partial	<b>Station End</b>	13422+00
<b>County</b>	Franklin	<b>Ground</b>	Damp	<b>Temperature (°F)</b>	68.00
<b>Municipality</b>	N/A	<b>Weather</b>	Sunny	<b>Rain Gauge (in)</b>	0.00
				<b>Rain Accumulation Time (days)</b>	1.00

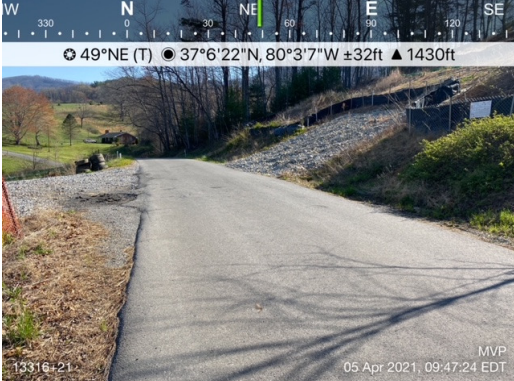
<b>GPS Location</b>	See Above	<b>GPS Location</b>	See Above		
<b>Field Station#</b>	13316+21	<b>Field Station#</b>	13321+00		
<b>Pic 1 Desc.</b>	Overview of Wades Gap Road ROW crossing. ECDs are functional and ROW is stable.	<b>Pic 2 Desc.</b>	ROW Overview. ECDs are functional and ROW is stable.

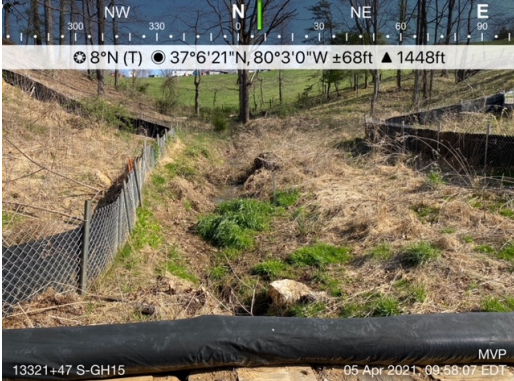
<b>GPS Location</b>	See Above	<b>GPS Location</b>	See Above		
<b>Field Station#</b>	13321+47	<b>Field Station#</b>	13325+30		
<b>Pic 3 Desc.</b>	Waterbody S-GH15. ECDs are functional and ROW is stable.	<b>Pic 4 Desc.</b>	Waterbody S-GH14. ECDs are functional and ROW is stable.

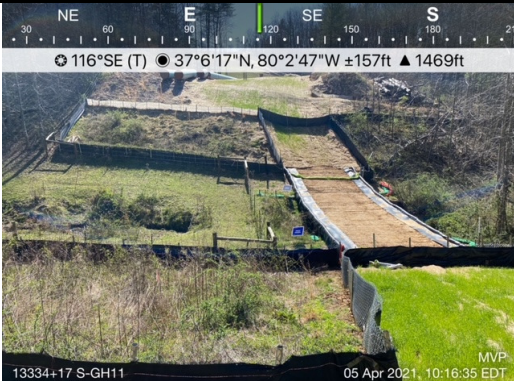
<b>GPS Location</b>	See Above	<b>GPS Location</b>	See Above		
<b>Field Station#</b>	13334+17	<b>Field Station#</b>	13337+17		
<b>Pic 5 Desc.</b>	Overview of Waterbody S-GH11. ECDs are functional and ROW is stable.	<b>Pic 6 Desc.</b>	Waterbody S-GH9. ECDs are functional and ROW is stable.

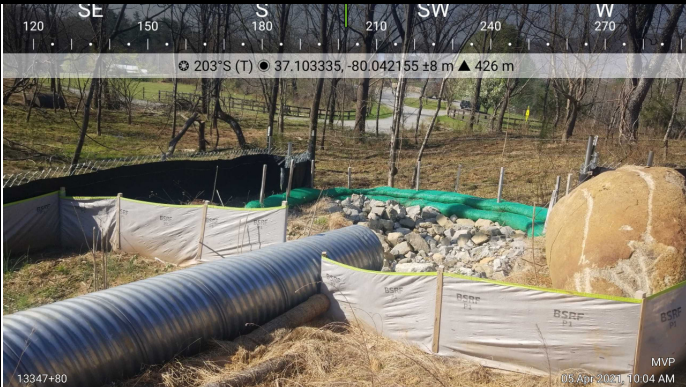
<b>GPS Location</b>	See Above		<b>GPS Location</b>	See Above	
<b>Field Station#</b>	13347+80		<b>Field Station#</b>	13348+46	
<b>Pic 7 Desc.</b>	ROW Overview. Cleanwater diversion pipe. ECDs are functional and ROW is stable.		<b>Pic 8 Desc.</b>	Overview of Waterbody S-RR08. ECDs are functional and ROW is stable.

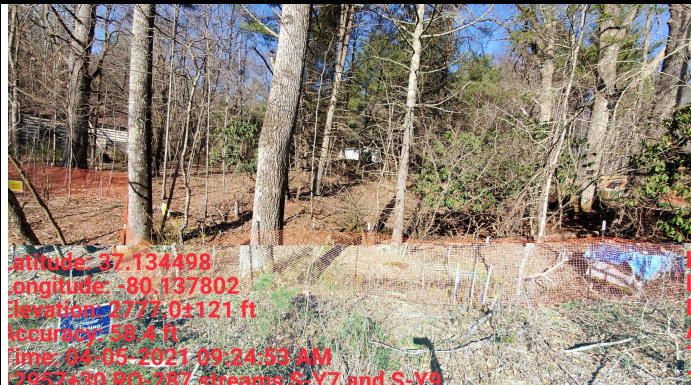
GPS Location	See pic for GPS location		GPS Location	See pic for GPS location	
Field Station#	12957+30		Field Station#	12955+50	
Pic 3 Desc.	Upstream side of stream S-Y7 and stream S-Y9 (landowner's spring box).		Pic 4 Desc.	Large sediment trap on the CIS of RO-287.

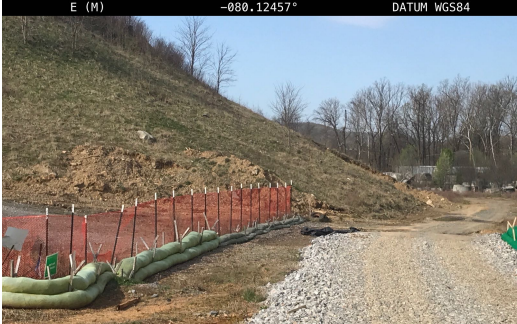
<small>MVP-LY-049_040621</small> <small>Landowner disturbance within 66' of feature</small> <small>2021-04-06 09:44:31-04:00</small>		<small>MVP-LY-049_040621</small> <small>Landowner disturbance along CFS &amp; feature</small> <small>2021-04-06 09:44:46-04:00</small>

<b>GPS Location</b>	MVP-LY-049 See photo for gps data		<b>GPS Location</b>	MVP-LY-049 See photo for gps data	
<b>Field Station#</b>	+0		<b>Field Station#</b>	+0	
<b>Pic 17 Desc.</b>	Landowner soil disturbance within 66' and 120' west of feature W-CV21B. Areas not stabilized. Looking W.		<b>Pic 18 Desc.</b>	Landowner soil disturbance along compost filter sock and feature W-CV21B. Area not stabilized no impacts. Looking SW.

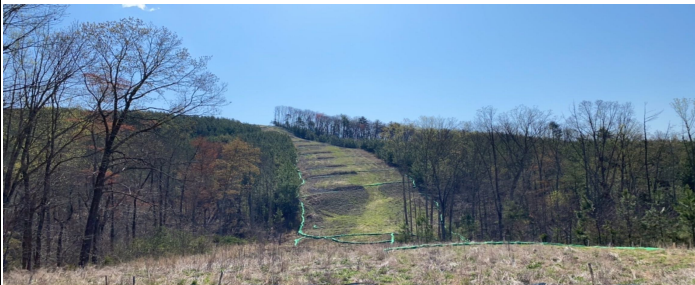
<b>GPS Location</b>	3	<b>GPS Location</b>	4		
<b>Field Station#</b>	13430+00	<b>Field Station#</b>	13446+00		
<b>Pic 3 Desc.</b>	ROW stabilized in final cleanup area. All ECDs in place and functional.		<b>Pic 4 Desc.</b>	ROW stabilized in final cleanup area. All ECDs in place and functional.

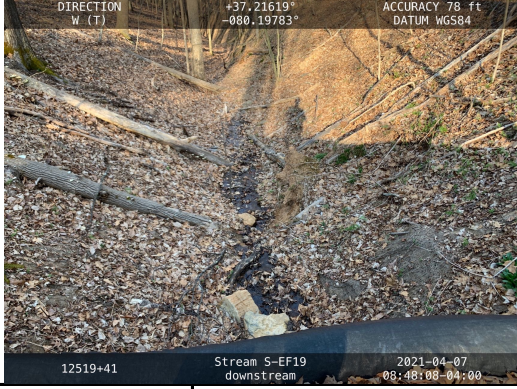
<b>GPS Location</b>	See photo for gps location data.		<b>GPS Location</b>	See photo for gps location data.	
<b>Field Station#</b>	12519+41		<b>Field Station#</b>	12519+41	
<b>Pic 9 Desc.</b>	Photo shows stream S-EF19 downstream from the bridge.		<b>Pic 10 Desc.</b>	Photo shows stream S-EF19 upstream from the bridge.

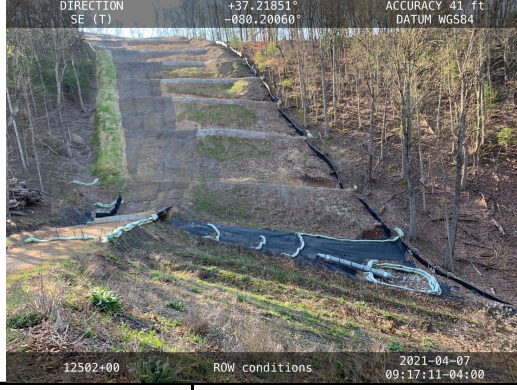
<b>Pic 11 Desc.</b>	Photo shows the ROW and ECD conditions from about 12502+00 to 12506+00.		<b>Pic 12 Desc.</b>	Photo shows the ROW and ECD conditions from about 12497+00 to 12493+00.

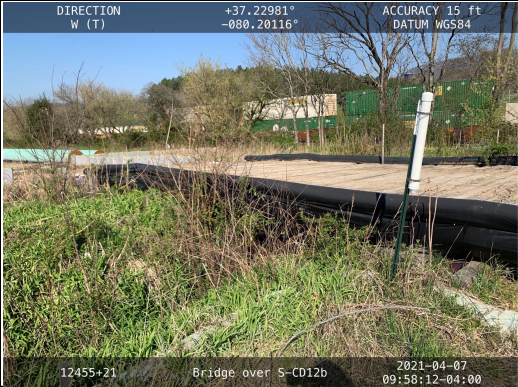
<b>Pic 17 Desc.</b>	Photo shows the bridge over stream S-CD12b.		<b>Pic 18 Desc.</b>	Photo shows stream S-EF20b downstream of access road.

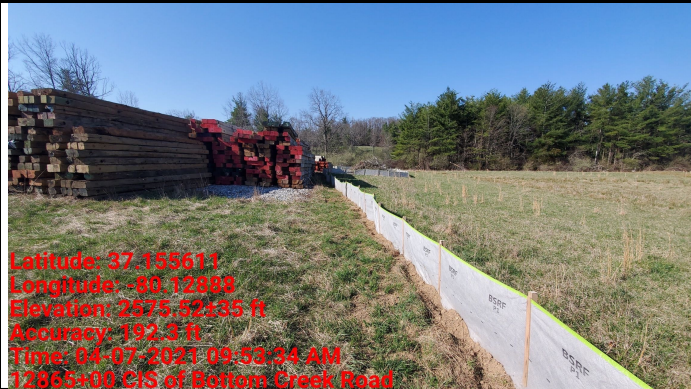
<p>Latitude: 37.155617 Longitude: -80.12883 Elevation: 2575.52±35 ft Accuracy: 19.3 ft Time: 04-07-2021 09:53:34 AM 12865+00 CIS of Bottom Creek Road</p>

<p>Latitude: 37.155787 Longitude: -80.128677 Elevation: 2544.38±62 ft Accuracy: 82.3 ft Time: 04-07-2021 09:54:19 AM 12865+50 CIS of Bottom Creek Road</p>		
GPS Location	See pic for GPS location		GPS Location	See pic for GPS location	
Field Station#	12865+00		Field Station#	12865+50	
Pic 1 Desc.	Bottom Creek Road CIS perimeter controls.		Pic 2 Desc.	Bottom Creek Road CIS perimeter controls.

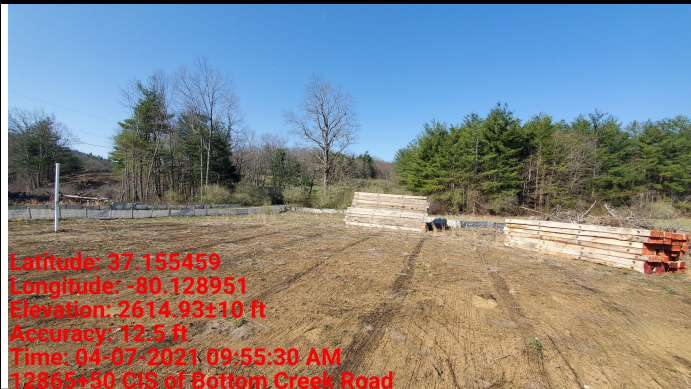
<p>Latitude: 37.155459 Longitude: -80.128951 Elevation: 2614.93±10 ft Accuracy: 12.5 ft Time: 04-07-2021 09:55:30 AM 12865+50 CIS of Bottom Creek Road</p>

GPS Location	See pic for GPS location		GPS Location	See pic for GPS location	
Field Station#	12865+50		Field Station#	12866+26	
Pic 3 Desc.	Current ROW conditions on the CIS of Bottom Creek Road.		Pic 4 Desc.	Current ROW conditions on the GAS of Bottom Creek Road.

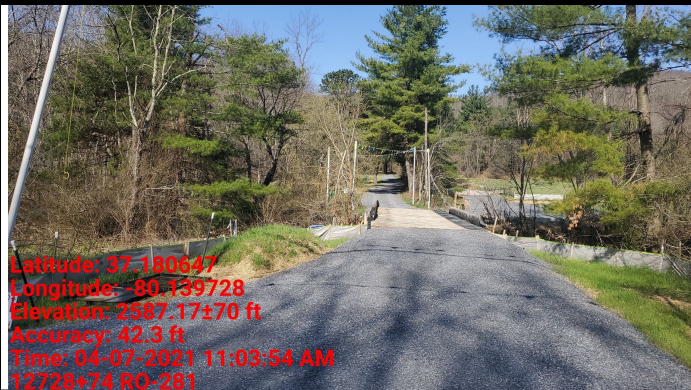
<p>Latitude: 37.180647 Longitude: -80.139728 Elevation: 2587.17±70 ft Accuracy: 42.3 ft Time: 04-07-2021 11:03:54 AM 12728+74 RO-281</p>

<p>Latitude: 37.180579 Longitude: -80.139768 Elevation: 2632.91±39 ft Accuracy: 39.7 ft Time: 04-07-2021 11:04:45 AM 12728+74 RO-281 stream S-EF32</p>		
GPS Location	See pic for GPS location		GPS Location	See pic for GPS location	
Field Station#	12728+74		Field Station#	12728+74	
Pic 5 Desc.	Access road RO-281 at Poor mountain road.		Pic 6 Desc.	Stream S-EF32 on the Downstream side of the equipment bridge.

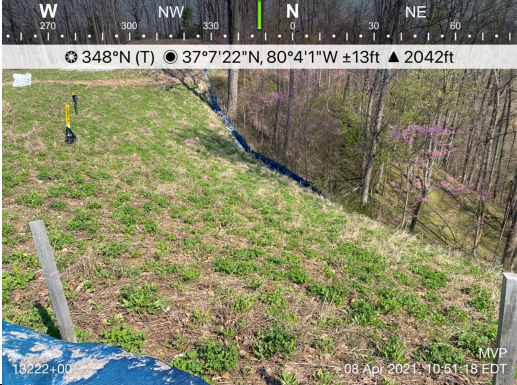
<b>GPS Location</b>	See photos for coordinates.		<b>GPS Location</b>	See photos for coordinates.	
<b>Field Station#</b>	13212+00		<b>Field Station#</b>	13222+00	
<b>Pic 7 Desc.</b>	ROW stable with vegetative cover noted across LOD.		<b>Pic 8 Desc.</b>	No changes noted at slip along LOD.

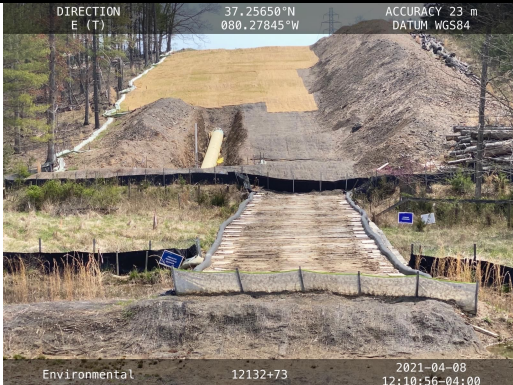
GPS Location	See photo		GPS Location	See photo	
Field Station#	12132+73		Field Station#	12135+00	
Pic 1 Desc.	Bridge and ECDS at stream crossing S-C29 in acceptable condition		Pic 2 Desc.	Stabilized slope in acceptable condition

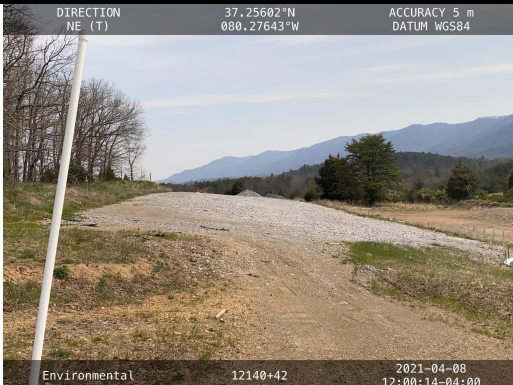
GPS Location	See photo		GPS Location	See photo	
Field Station#	12140+42		Field Station#	12139+91	
Pic 3 Desc.	Rocked ATWS in acceptable condition on access road MVP-MN-272		Pic 4 Desc.	Wetland crossing W-C6 in acceptable condition

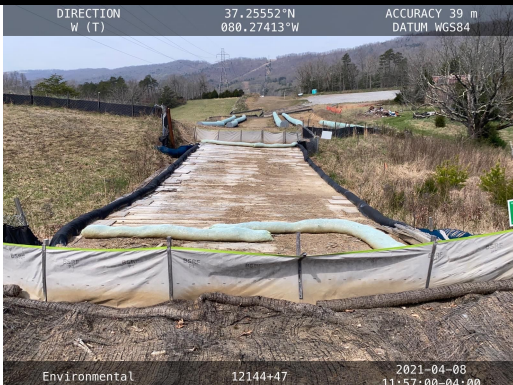
GPS Location	See photo		GPS Location	See photo	
Field Station#	12144+47		Field Station#	12150+95	
Pic 5 Desc.	Wetland crossing W-C5 in acceptable condition		Pic 6 Desc.	Stabilized drain in acceptable condition

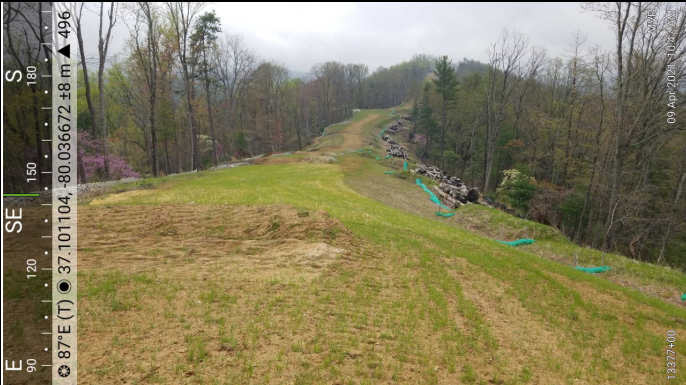
GPS Location	See Above		GPS Location	See Above	
Field Station#	13377+00		Field Station#	13390+00	
Pic 13 Desc.	ROW Overview. ECDs are functional and ROW is stable.		Pic 14 Desc.	ROW Overview. ECDs are functional and ROW is stable.

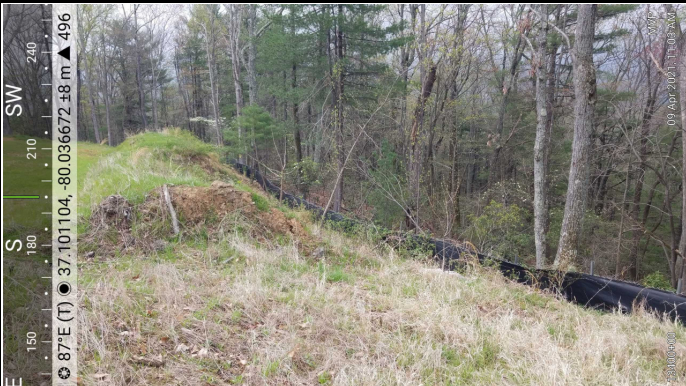
GPS Location	See Above		GPS Location	See Above	
Field Station#	13400+00		Field Station#	13413+01	
Pic 15 Desc.	ROW Overview. ECDs are functional and ROW is stable.		Pic 16 Desc.	Overview of Waterbody S-IJ1. ECDs are functional and ROW is stable.

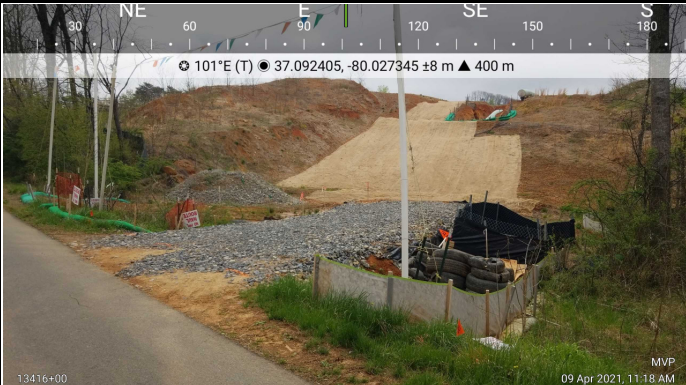
GPS Location	See Above		GPS Location	See Above	
Field Station#	13416+00		Field Station#	13422+00	
Pic 17 Desc.	ROW Overview. ECDs are functional and ROW is stable.		Pic 18 Desc.	ROW Overview. ECDs are functional and ROW is stable.

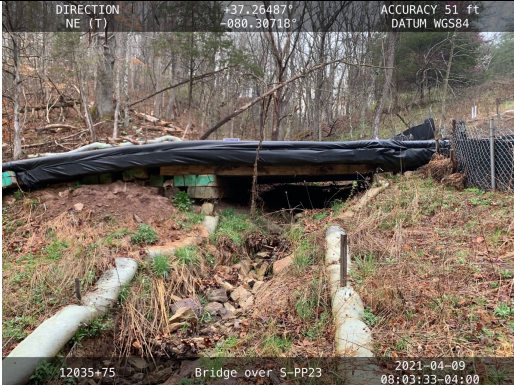
<b>GPS Location</b>	See photo		<b>GPS Location</b>	See photo	
<b>Field Station#</b>	12035+75		<b>Field Station#</b>	12031+51	
<b>Pic 1 Desc.</b>	Bridge and ECDs crossing S-PP23 in acceptable condition		<b>Pic 2 Desc.</b>	Bridge and ECDs crossing S-G39 in acceptable condition

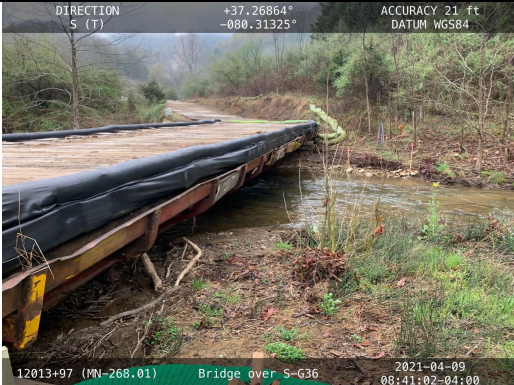
<b>GPS Location</b>	See photo		<b>GPS Location</b>	See photo	
<b>Field Station#</b>	12013+97		<b>Field Station#</b>	12008+75	
<b>Pic 3 Desc.</b>	Bridge crossing S-G36 along access road MVP-MN-268.01 in acceptable condition		<b>Pic 4 Desc.</b>	Stream crossing S-G36 in acceptable condition

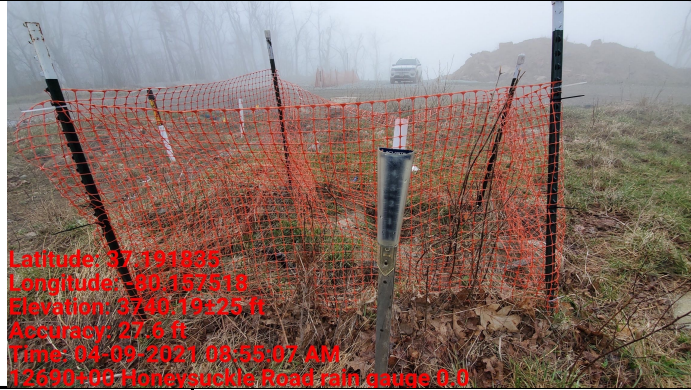
<p>Latitude: 37.191835 Longitude: -80.151518 Elevation: 2740.19±25 ft Accuracy: 25.6 ft Time: 04-09-2021 08:55:07 AM 12690+00 Honeysuckle Road rain gauge 0.0</p>

<p>Latitude: 37.128292 Longitude: -80.120878 Elevation: 2573.64±26 ft Accuracy: 17.7 ft Time: 04-09-2021 08:26:35 AM 13033+59 Callaway Road rain gauge 0.1"</p>			
<b>GPS Location</b>	See pic for GPS location	<b>GPS Location</b>	See pic for GPS location		
<b>Field Station#</b>	12690+00	<b>Field Station#</b>	13033+59		
<b>Pic 1 Desc.</b>	Honeysuckle Road rain gauge. 0.0"	<b>Pic 2 Desc.</b>	Callaway Road rain gauge 0.1"

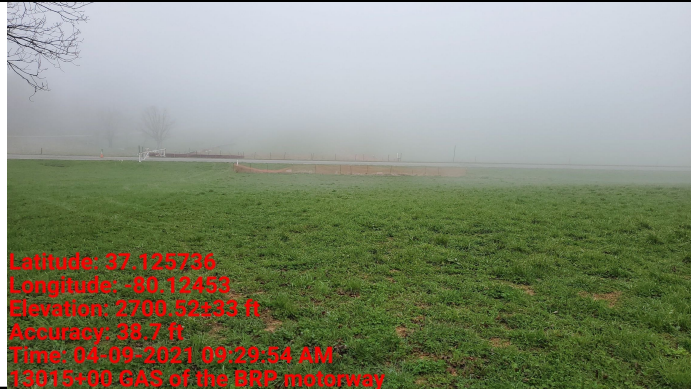
<p>Latitude: 37.125736 Longitude: -80.12452 Elevation: 2700.52±33 ft Accuracy: 38.7 ft Time: 04-09-2021 09:29:54 AM 13015+00 GAS of the BRP motorway</p>

<b>GPS Location</b>	See pic for GPS location	<b>GPS Location</b>	See pic for GPS location		
<b>Field Station#</b>	13015+00	<b>Field Station#</b>	13018+00		
<b>Pic 3 Desc.</b>	Current conditions of the BRP from the GAS of the motorway.	<b>Pic 4 Desc.</b>	Current conditions of the BRP wooded portion on the GAS of the motorway.

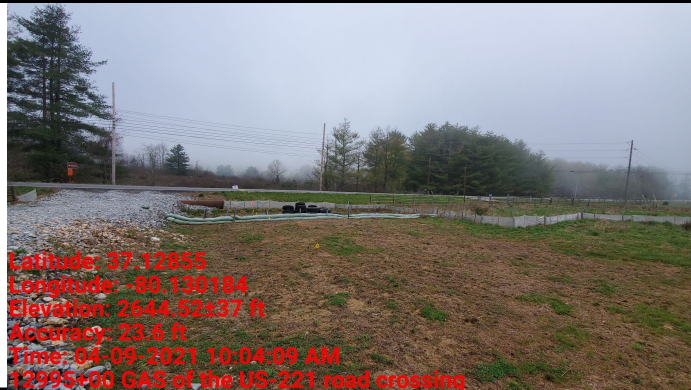
<p>Latitude: 37.12855 Longitude: -80.130184 Elevation: 2644.52±37 ft Accuracy: 23.6 ft Time: 04-09-2021 10:04:09 AM 12995+00 GAS of the US-221 road crossing</p>

<p>Latitude: 37.12888 Longitude: -80.130019 Elevation: 2615.78±52 ft Accuracy: 69.2 ft Time: 04-09-2021 10:04:51 AM 12995+00 GAS of the US-221 road crossing</p>			
<b>GPS Location</b>	See pic for GPS location	<b>GPS Location</b>	See pic for GPS location		
<b>Field Station#</b>	12995+00	<b>Field Station#</b>	12995+00		
<b>Pic 5 Desc.</b>	RCE on the GAS of the US-221 road crossing n.	<b>Pic 6 Desc.</b>	Current conditions of the ROW on the GAS of US-221.
