Visual Site Inspection Report

Project Name	H-600 Pipeline Spread H	AFE	124300138	Spread	H-600 Pipeline Spread H
Contractor	Precision			Report #	23186
Inspector	Dustin Lyons			Date/Time	5/10/2021 4:32 PM
Permit #	TBD	Inspection Type	VA SWPP	Station Begin	13024+00
State	VA	Inspection Area	Partial	Station End	13141+65
County	Franklin	Ground	Damp	Temperature (°F)	65.00
Municipality	N/A	Weather	Cloudy	Rain Gauge (in)	0.00
				Rain Accumulation Time (days)	1.00

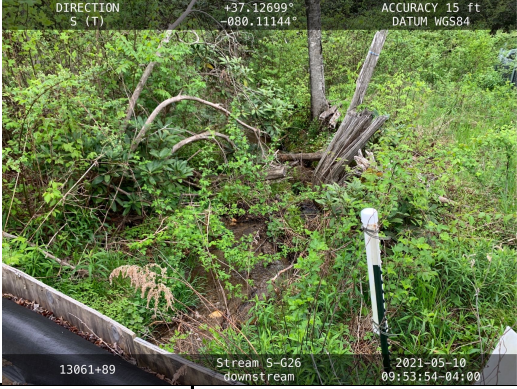
GPS Location	See photo for gps location data.		GPS Location	See photo for gps location data.	
Field Station#	13061+89		Field Station#	13061+44	
Pic 15 Desc.	Photo shows stream S-G26 downstream from the bridge.		Pic 16 Desc.	Photo shows the bridge over stream S-RR18.

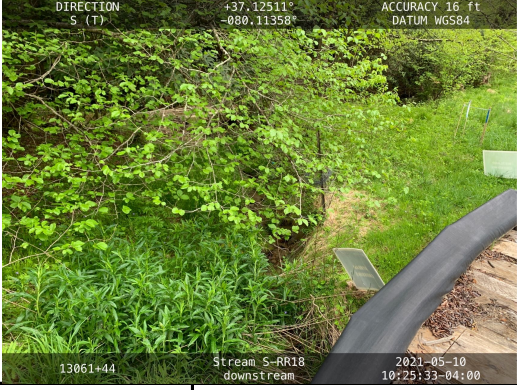
GPS Location	See photo for gps location data.		GPS Location	See photo for gps location data.	
Field Station#	13061+44		Field Station#	13061+44	
Pic 17 Desc.	Photo shows stream S-RR18 downstream from access road FR-290.		Pic 18 Desc.	Photo shows the bridge over stream S-RR16.

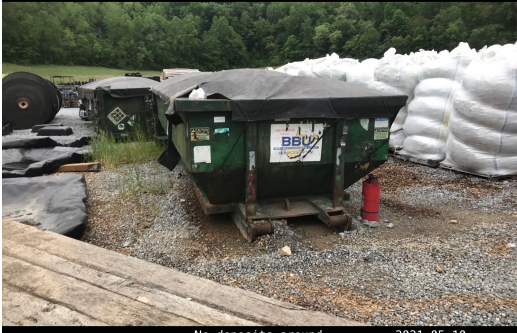
MVP-PY-006_051021 No deposits around hazardous waste dump... 2021-05-10 07:32:39-04:00		MVP-PY-006_051021 No loose trash around dumpsters 2021-05-10 07:32:43-04:00			
GPS Location	MVP-PY-006 See photo for gps data		GPS Location	MVP-PY-006 See photo for gps data	
Field Station#	+0		Field Station#	+0	
Pic 7 Desc.	No fluids or deposits around hazardous waste dumpsters. Looking S.		Pic 8 Desc.	No loose trash around dumpsters or in the yard. Looking SE.	
DIRECTION W (M) +37.23558° -080.22670° ACCURACY 16 ft DATUM WGS84

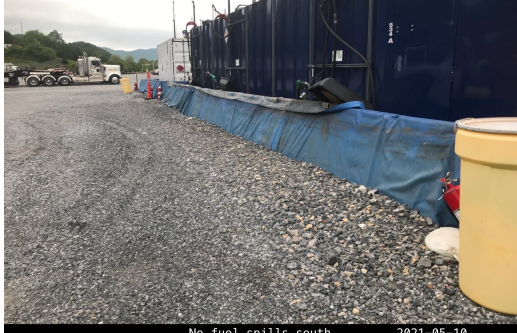
MVP-PY-006_051021 No fuel spills south of tanks 2021-05-10 07:32:54-04:00		MVP-PY-006_051021 No leaky internal fittings 2021-05-10 07:33:33-04:00

GPS Location	MVP-PY-006 See photo for gps data		GPS Location	MVP-PY-006 See photo for gps data	
Field Station#	+0		Field Station#	+0	
Pic 9 Desc.	No fuel spills south of the Blue Bulk fuel tanks. Looking W.		Pic 10 Desc.	Blue Bulk Fuel tanks no leaky internal fittings. Looking W.	
DIRECTION W (M) +37.23561° -080.22694° ACCURACY 16 ft DATUM WGS84

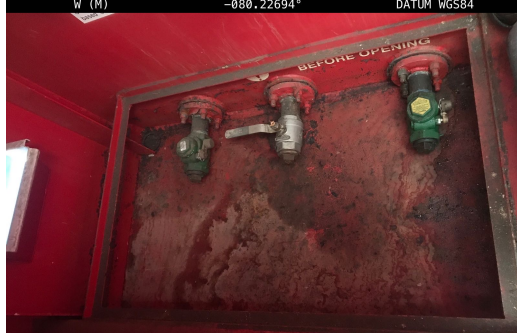
MVP-PY-006_051021 Condition of internal drip pan 2021-05-10 07:35:53-04:00		MVP-PY-006_051021 No leaky internal fittings 2021-05-10 07:35:55-04:00			
GPS Location	MVP-PY-006 See photo for gps data		GPS Location	MVP-PY-006 See photo for gps data	
Field Station#	+0		Field Station#	+0	
Pic 11 Desc.	Off Road Fuel unit condition of internal drip pan. Looking W.		Pic 12 Desc.	Off Road Fuel unit no leaky internal fittings. Looking NW.

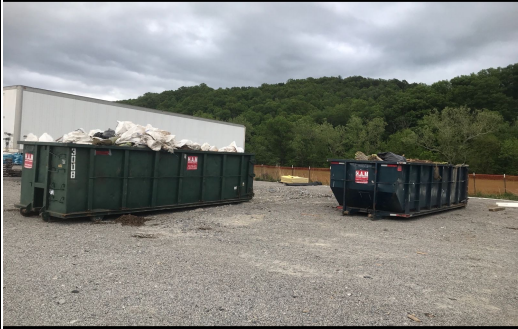
MVP-LY-049_051021 No loose trash around south dumpsters 2021-05-10 08:58:07-04:00				MVP-LY-049_051021 Restoration supplies covered 2021-05-10 08:58:19-04:00	
GPS Location	MVP-LY-049 See photo for gps data		GPS Location	MVP-LY-049 See photo for gps data	
Field Station#	+0		Field Station#	+0	
Pic 13 Desc.	No loose trash around south dumpsters or in the yard. Looking SE.		Pic 14 Desc.	Restoration supplies covered and protected from the elements. Looking S.	
DIRECTION W (M) +37.26925° ACCURACY 16 ft -080.12368° DATUM WGS84

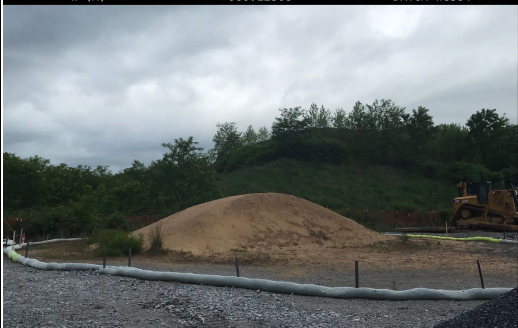
MVP-LY-049_051021 Condition of CFS around sand pile 2021-05-10 08:59:15-04:00				MVP-LY-049_051021 Containment under stored vehicle 2021-05-10 09:00:42-04:00

GPS Location	MVP-LY-049 See photo for gps data		GPS Location	MVP-LY-049 See photo for gps data	
Field Station#	+0		Field Station#	+0	
Pic 15 Desc.	Condition of compost filter sock around sand pile. In place and functioning. Looking W.		Pic 16 Desc.	Condition of containment under stored vehicle. Looking N.	
DIRECTION SW (M) +37.27012° ACCURACY 16 ft -080.12269° DATUM WGS84

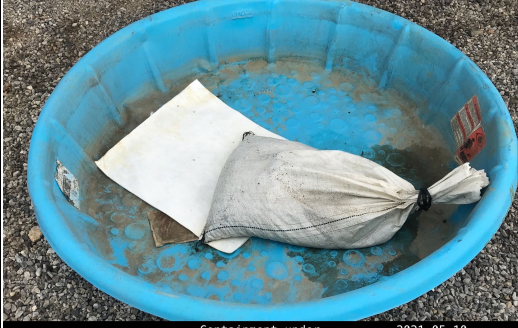
MVP-LY-049_051021 Containment under stored trailer 2021-05-10 09:00:55-04:00				MVP-LY-049_051021 Condition of containment 2021-05-10 09:02:28-04:00	
GPS Location	MVP-LY-049 See photo for gps data		GPS Location	MVP-LY-049 See photo for gps data	
Field Station#	+0		Field Station#	+0	
Pic 17 Desc.	Condition of containment under stored trailer. Looking SW.		Pic 18 Desc.	Condition of containment under barrel of toilet chemical. Free of stormwater. Looking SE.

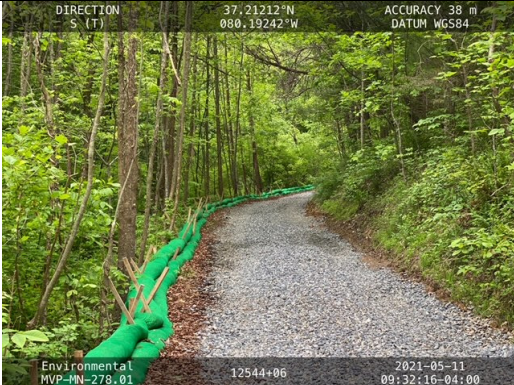
GPS Location	See Above		GPS Location	See Above	
Field Station#	12544+06		Field Station#	12544+06	
Pic 1 Desc.	Overview of Acc Rd 276.01 (Yellow Finch Lane). ECDs are functional and ROW is stable.		Pic 2 Desc.	Waterbody S-EF54 (Acc 276.01). ECDs are functional and area is stable.

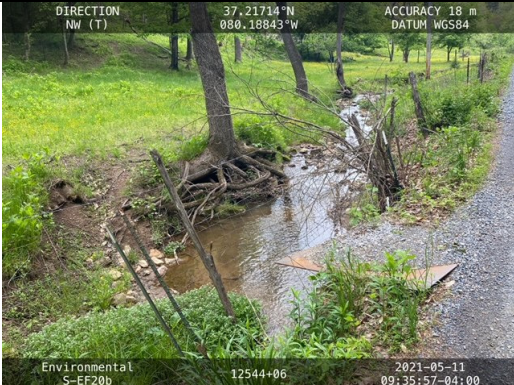
GPS Location	See Above		GPS Location	See Above	
Field Station#	12544+06		Field Station#	12544+06	
Pic 3 Desc.	Waterbody S-EF20b (Acc 276.01). ECDs are functional and area is stable.		Pic 4 Desc.	Waterbody S-KL32 (Acc 276.01). ECDs are functional and area is stable.

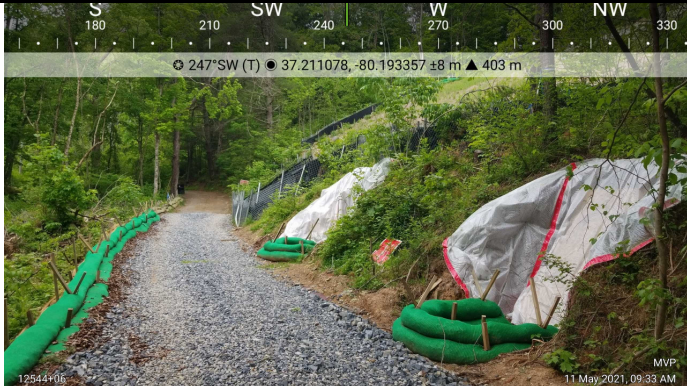
GPS Location	See Above		GPS Location	See Above	
Field Station#	12544+06		Field Station#	12543+00	
Pic 5 Desc.	Overview of Acc Rd 276.01 (Yellow Finch Lane). ECDs are functional and ROW is stable.		Pic 6 Desc.	ROW Overview. ECDs are functional and ROW is stable.

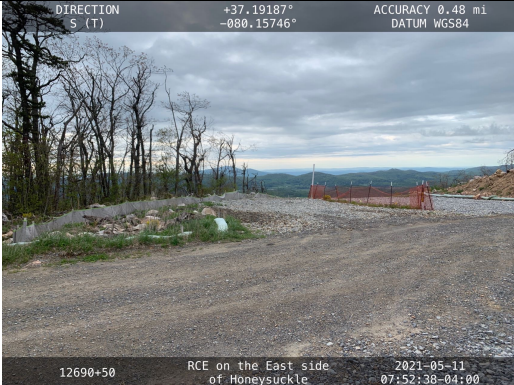
GPS Location	See photo for gps location data.		GPS Location	See photo for gps location data.	
Field Station#	12690+50		Field Station#	12678+00	
Pic 1 Desc.	Photo shows the RCE on the east side of Honeysuckle Road.		Pic 2 Desc.	Photo shows the ECDs and ROW conditions.

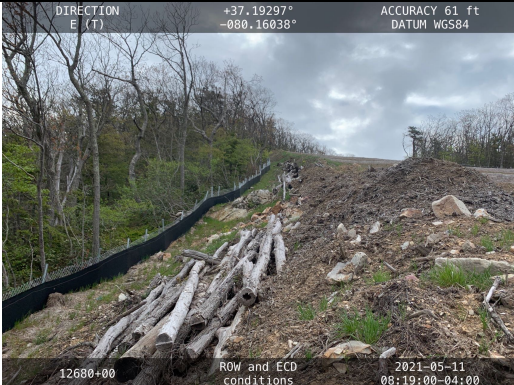
GPS Location	See photo for gps location data.		GPS Location	See photo for gps location data.	
Field Station#	12680+00		Field Station#	12692+00	
Pic 3 Desc.	Photo shows the ECDs and ROW conditions.		Pic 4 Desc.	Photo shows the ECDs and ROW conditions.

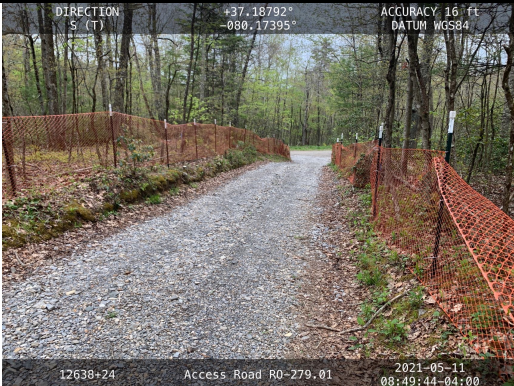
GPS Location	See photo for gps location data.		GPS Location	See photo for gps location data.	
Field Station#	12638+24		Field Station#	12639+00	
Pic 5 Desc.	Photo shows the RCE on access road RO-279.01.		Pic 6 Desc.	Photo shows the ECDs and ROW conditions.

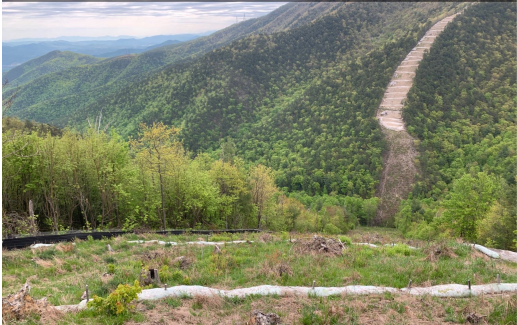
<div>12643+00</div> <div>ROW and ECD conditions</div> <div>2021-05-11 09:20:48-04:00</div> </div>		<div> <div>DIRECTION NE (T)</div> <div>+37.18423° -080.16069°</div> <div>ACCURACY 16 ft DATUM WGS84</div>

<div>12703+00</div> <div>ECDs along ATWS-1224</div> <div>2021-05-11 09:39:43-04:00</div> </div>			
GPS Location	See photo for gps location data.		GPS Location	See photo for gps location data.	
Field Station#	12643+00		Field Station#	12703+00	
Pic 7 Desc.	Photo shows the ECDs and ROW conditions.		Pic 8 Desc.	Photo shows ECDs along ATWS-1224.	
<div> <div>DIRECTION W (T)</div> <div>+37.19072° -080.15353°</div> <div>ACCURACY 15 ft DATUM WGS84</div>

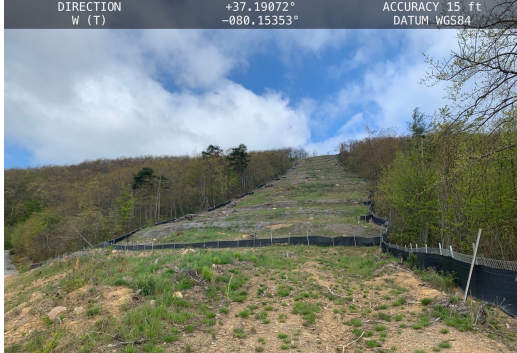
<div>12702+00</div> <div>ROW and ECD conditions</div> <div>2021-05-11 09:47:03-04:00</div> </div>		<div> <div>DIRECTION SE (T)</div> <div>+37.19062° -080.15318°</div> <div>ACCURACY 71 ft DATUM WGS84</div>

GPS Location	See photo for gps location data.		GPS Location	See photo for gps location data.	
Field Station#	12702+00		Field Station#	12704+00	
Pic 9 Desc.	Photo shows the ECDs and ROW conditions.		Pic 10 Desc.	Photo shows the ECDs and ROW conditions.	
<div> <div>DIRECTION W (T)</div> <div>+37.18047° -080.13999°</div> <div>ACCURACY 16 ft DATUM WGS84</div>

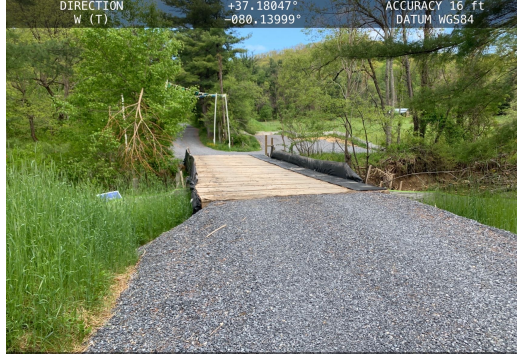
<div>12728+74</div> <div>Bridge over S-EF32</div> <div>2021-05-11 10:13:04-04:00</div> </div>		<div> <div>DIRECTION SW (T)</div> <div>+37.18051° -080.14014°</div> <div>ACCURACY 16 ft DATUM WGS84</div>

<div>12728+74</div> <div>Stream S-EF32 downstream</div> <div>2021-05-11 10:14:01-04:00</div> </div>			
GPS Location	See photo for gps location data.		GPS Location	See photo for gps location data.	
Field Station#	12728+74		Field Station#	12728+74	
Pic 11 Desc.	Photo shows the bridge over stream S-EF32		Pic 12 Desc.	Photo shows stream S-EF32 downstream from RO-281.

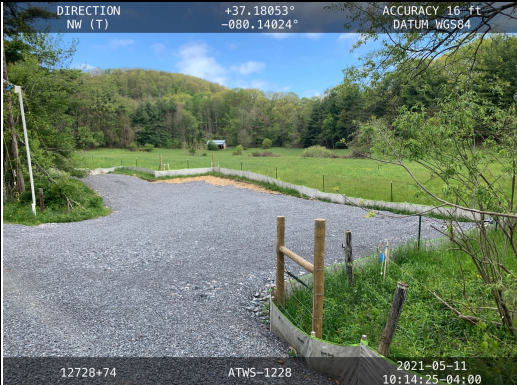
GPS Location	See photo for gps location data.		GPS Location	See photo for gps location data.	
Field Station#	12728+74		Field Station#	12728+74	
Pic 13 Desc.	Photo shows ATWS-1228.		Pic 14 Desc.	Photo shows the RCE on access road RO-281.

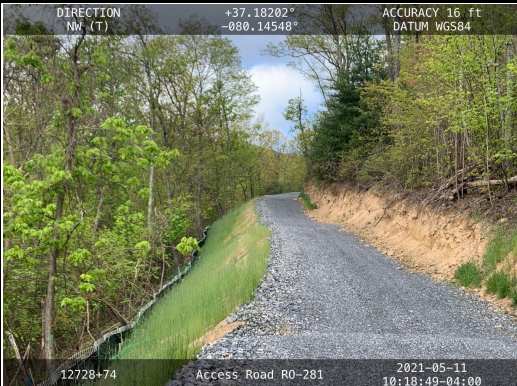
GPS Location	See photo for gps location data.		GPS Location	See photo for gps location data.	
Field Station#	12728+74		Field Station#	12728+74	
Pic 15 Desc.	Photo shows the ECDs along access road RO-281.		Pic 16 Desc.	Photo shows the ECDs in AtWS-1536.

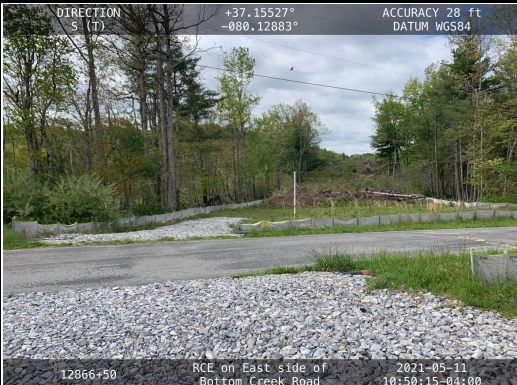
GPS Location	See photo for gps location data.		GPS Location	See photo for gps location data.	
Field Station#	12866+50		Field Station#	12866+25	
Pic 17 Desc.	Photo shows the ECDs and RCE on the east side of Bottom Creek Road.		Pic 18 Desc.	Photo shows the ECDs along ATWS-1326.

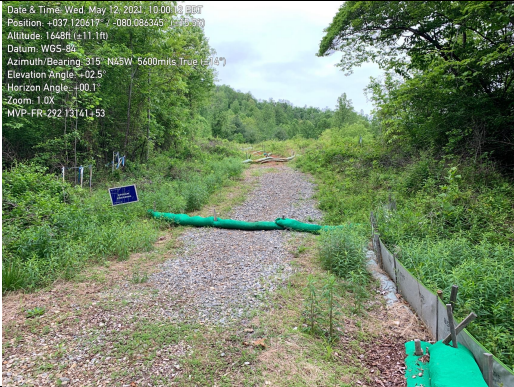
GPS Location	0	GPS Location	0		
Field Station#	13141+53	Field Station#	13196+31		
Pic 1 Desc.	MVP-FR-292/MVP-S-D17, in good condition		Pic 2 Desc.	MVP-S-D10/MVP-MLV-AR-29, stream in good condition, Cattle disturbance along access road.	
<p>Date & Time: Wed May 12, 2021, 10:59:42 EDT Position: +037.123037° / -080.074478° (+27.5ft) Altitude: 1453ft (+33.9ft) Datum: WGS-84 Azimuth/Bearing: 295° N45W 5244mils True (+12°) Elevation Angle: -02.2° Horizon Angle: -100.2° Zoom: 1.0x MVP-S-D10 13196+71</p>

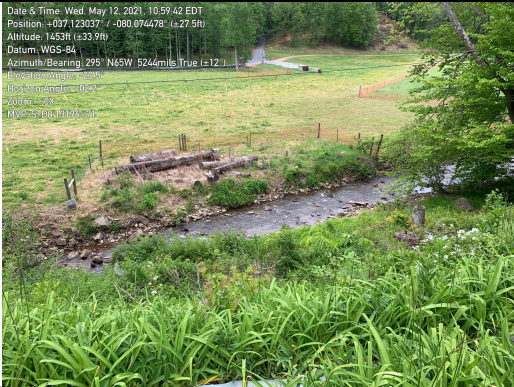
GPS Location	0	GPS Location	0		
Field Station#	13196+71	Field Station#	13197+55		
Pic 3 Desc.	MVP-S-D8, no ground disturbance in this area		Pic 4 Desc.	Dillion's Mill Road Crossing, in good condition. RCE in good condition and functioning properly.	
<p>Date & Time: Wed May 12, 2021, 11:24:44 EDT Position: +037.122887° / -080.071189° (+48.0m) Altitude: 1320ft (+48.0m) Datum: WGS-84 Azimuth/Bearing: 272° N38W 4836mils True (+12°) Elevation Angle: -14.1° Horizon Angle: -100.4° Zoom: 1.0x ROW and ECD Condition 13207+00</p>

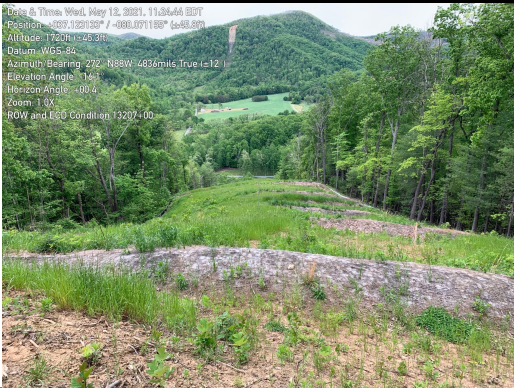
GPS Location	0	GPS Location	0		
Field Station#	13207+00	Field Station#	13218+00		
Pic 5 Desc.	ROW and ECDs in good condition, with good vegetation establishing across LOD.		Pic 6 Desc.	ROW and ECDs in good condition, with good vegetation establishing across LOD.

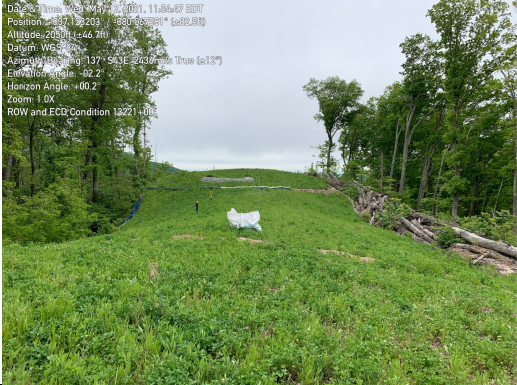
GPS Location	0	GPS Location	0		
Field Station#	13221+00	Field Station#	13230+70		
Pic 7 Desc.	ROW and ECDs in good condition, with good vegetation establishing across LOD.		Pic 8 Desc.	ROW and ECDs in good condition, with good vegetation establishing across LOD.	
<p>Date & Time: Wed, May 12, 2021, 13:31:06 EDT Position: +37.132457 / -80.013681° (±88.810) Altitude: 189ft (±45.7ft) Datum: WGS-84 Azimuth/Bearing: 152° S32E 2542mils True (±12°) Elevation Angle: +15.1° Horizon Angle: +00.5° Zoom: 1.0X ROW and ECD Condition 13245+00</p>

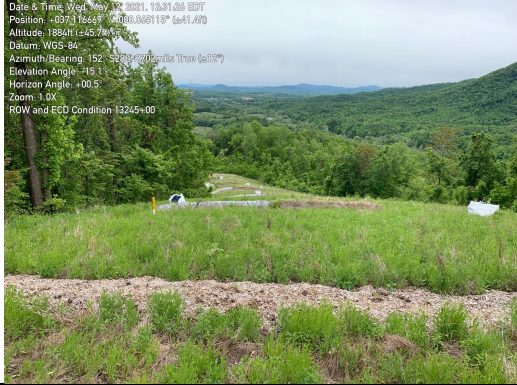
GPS Location	0	GPS Location	0		
Field Station#	13245+00	Field Station#	13251+00		
Pic 9 Desc.	ROW and ECDs in good condition, with good vegetation establishing across LOD.		Pic 10 Desc.	Slip observed to be stable, no notable changes, vegetation establishing.	
<p>Date & Time: Wed, May 12, 2021, 13:45:40 EDT Position: +37.132607 / -80.013681° (±88.810) Altitude: 147ft (±42.0ft) Datum: WGS-84 Azimuth/Bearing: 080° N80E 1422mils True (±12°) Elevation Angle: -07.9° Horizon Angle: +00.2° Zoom: 1.0X MVP-S-II4 13260+60</p>

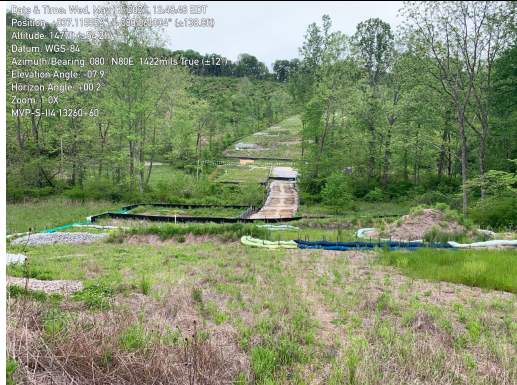
GPS Location	0	GPS Location	0		
Field Station#	13260+60	Field Station#	13260+60		
Pic 11 Desc.	MVP- S-II4, in good condition		Pic 12 Desc.	MVP-S-II4 Downstream, in good condition, no impacts to stream or corresponding buffer zone observed.

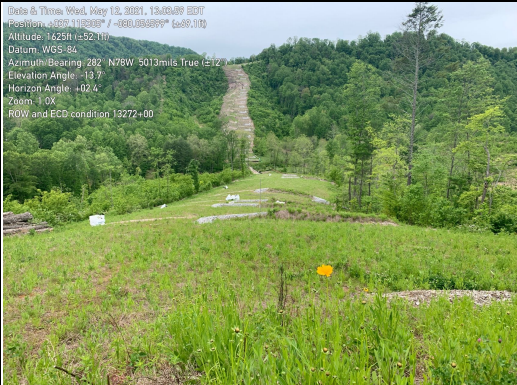
GPS Location		GPS Location			
0		0			
Field Station#		Field Station#			
13272+00		13285+00			
Pic 13 Desc.		Pic 14 Desc.			
ROW and ECDs in good condition, with good vegetation establishing across LOD.		ROW and ECDs in good condition, with good vegetation establishing across LOD.

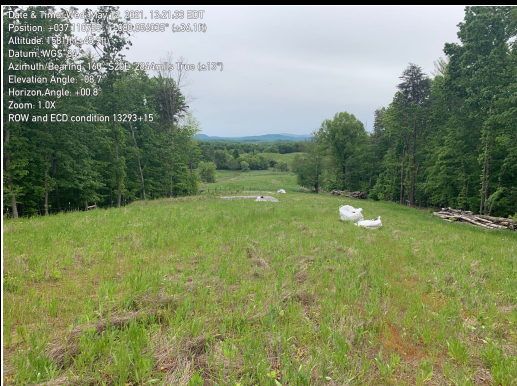
GPS Location		GPS Location			
0		0			
Field Station#		Field Station#			
13293+15		13309+09			
Pic 15 Desc.		Pic 16 Desc.			
ROW and ECDs in good condition, with good vegetation establishing across LOD.		MVP-S-GH7, in good condition			
<p>Date & Time: Wed, May 12, 2021, 13:47:50 EDT Position: +429.113587° / -680.086997° (s38.112) Altitude: 1378ft (s41.769) Datum: WGS-84 Azimuth/Bearing: 237° S72W 4567mils True (s12.7) Elevation Angle: +0.8 Horizon Angle: +00.4 Zoom: 1.0X MVP-S-GH7 13309+09 Downstream</p>

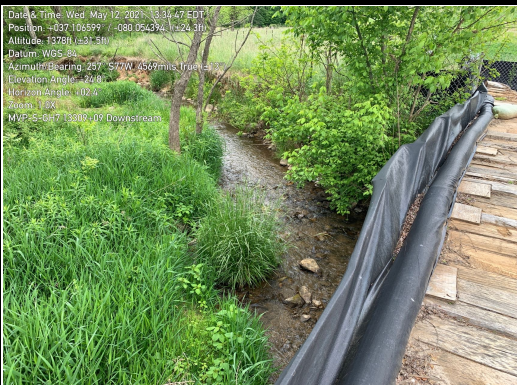
GPS Location		GPS Location			
0		0			
Field Station#		Field Station#			
13309+09		13312+80			
Pic 17 Desc.		Pic 18 Desc.			
MVP-S-GH7 Downstream, in good condition, no impacts to stream or corresponding buffer zone observed.		ROW and ECDs in good condition, with good vegetation establishing across LOD.

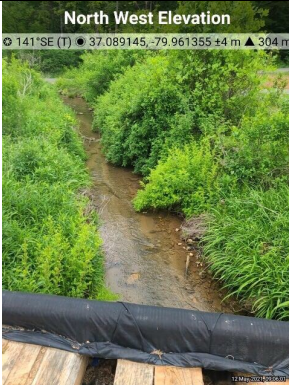
GPS Location	0000	GPS Location	0000		
Field Station#	13643+54	Field Station#	13573+00		
Pic 1 Desc.	Stream observation photo facing downstream during routine inspection today. No issues observed at the time of inspection.		Pic 2 Desc.	Monitored ECDs recently installed where 3rd party damages were repaired and replaced . No environmental issues observed at the time of inspection.	
	South East Elevation

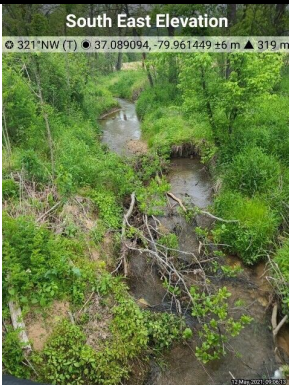
GPS Location	0000	GPS Location	00000		
Field Station#	13643+54	Field Station#	13655+56		
Pic 3 Desc.	Stream observation photo facing upstream during routine inspection today. No issues observed at the time of inspection.		Pic 4 Desc.	Row photo showing vegetation growth, good coverage observed. No environmental issues observed at the time of inspection.	
	North East Elevation

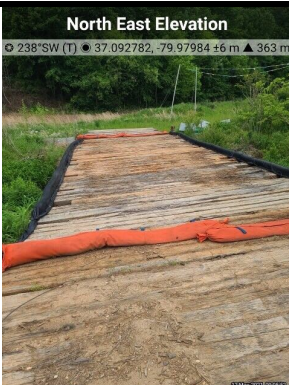
GPS Location	0000	GPS Location	0000		
Field Station#	13643+30	Field Station#	13561+18		
Pic 5 Desc.	Monitored equipment bridge and protection, all ECDs up to date and functioning at the time of inspection.		Pic 6 Desc.	CFS requires maintenance due to being weathered and torn, documented and added to the punch list for repairs by the contractor.

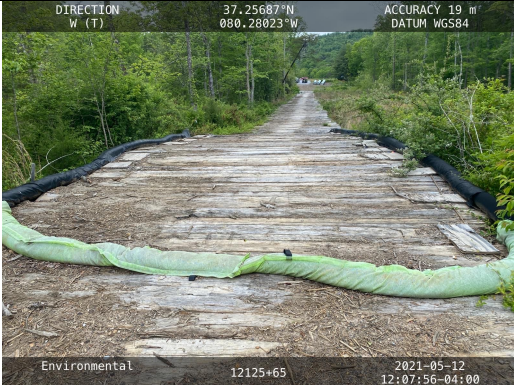
GPS Location	See photo		GPS Location	See photo	
Field Station#	12125+65		Field Station#	12132+73	
Pic 1 Desc.	Bridge and ECDs crossing multiple stream and wetlands in acceptable condition		Pic 2 Desc.	Bridge and ECDs at stream crossing S-C29 in acceptable condition

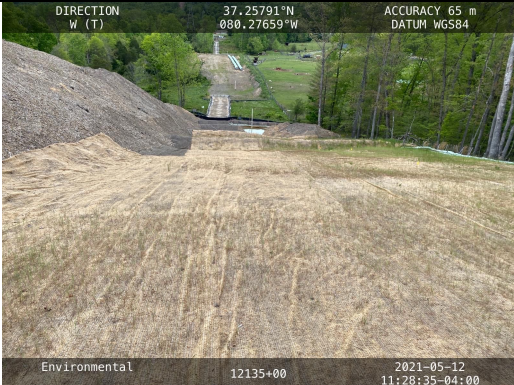
GPS Location	See photo		GPS Location	See photo	
Field Station#	12135+00		Field Station#	12139+91	
Pic 3 Desc.	Stabilized slope in acceptable condition		Pic 4 Desc.	Bridge and ECDs at wetland W-C6 in acceptable condition

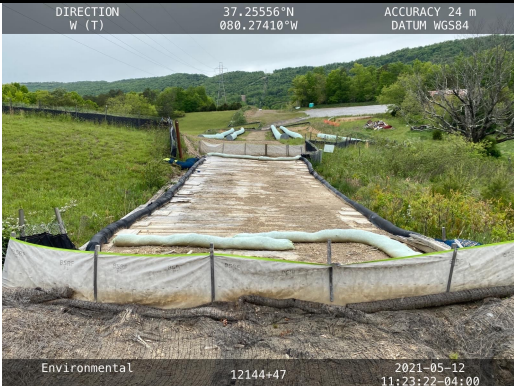
GPS Location	See photo		GPS Location	See photo	
Field Station#	12144+47		Field Station#	12150+95	
Pic 5 Desc.	Bridge and ECDs crossing W-C5 in acceptable condition		Pic 6 Desc.	Stabilized drainage feature in acceptable condition

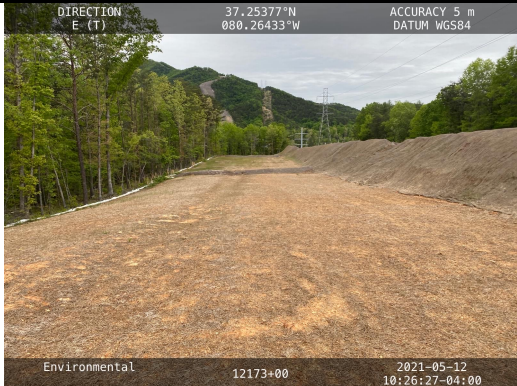
GPS Location	See photo		GPS Location	See photo	
Field Station#	12173+00		Field Station#	12192+50	
Pic 9 Desc.	Stabilized ROW In Acceptable condition		Pic 10 Desc.	Bridge and ECDs at stream crossing S-C21 in acceptable condition

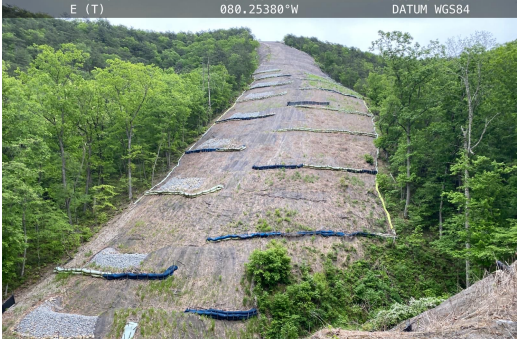
Environmental 12211+21 2021-05-12 09:33:31-04:00			
GPS Location	See photo		GPS Location	See photo	
Field Station#	12213+00		Field Station#	12211+21	
Pic 13 Desc.	Stabilized slope in acceptable condition		Pic 14 Desc.	Stabilized drainage feature in acceptable condition	
DIRECTION S (T) 37.25324°N 080.25354°W ACCURACY 31 m DATUM WGS84

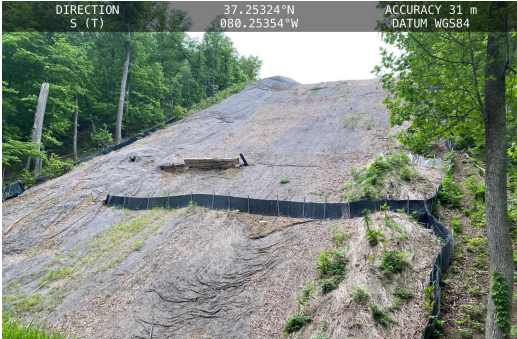
Environmental 12220+00 2021-05-12 08:58:56-04:00			
GPS Location	See photo		GPS Location	See photo	
Field Station#	12209+00		Field Station#	12220+00	
Pic 15 Desc.	Stabilized slope in acceptable condition		Pic 16 Desc.	SSF perimeter controls in acceptable condition

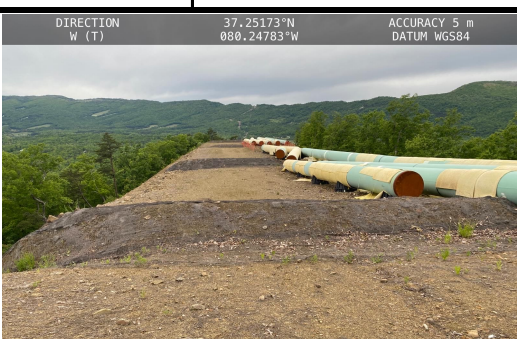
Environmental 12233+00 2021-05-12 08:39:42-04:00			
GPS Location	See photo		GPS Location	See photo	
Field Station#	12228+00		Field Station#	12233+00	
Pic 17 Desc.	Stabilized ROW in acceptable condition		Pic 18 Desc.	Stabilized ROW in acceptable condition

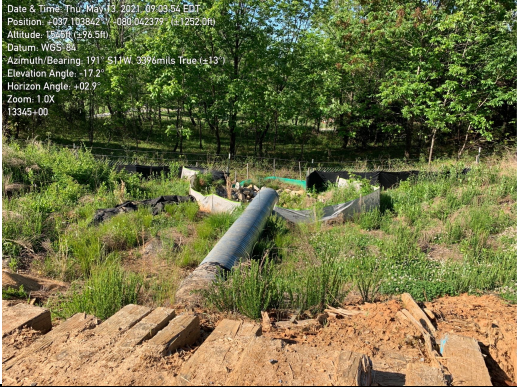
GPS Location		0		GPS Location	
Field Station#		13345+00		Field Station#	
Pic 7 Desc.		Clean water crossing in good condition		Pic 8 Desc.	
				S-RR08, in good condition	
<p>Date & Time: Thu, May 13, 2021, 09:05:53 EDT Position: +037.1335217° -080.040188° (±207 ft) Altitude: 13352 (±101.0ft) Datum: WGS-84 Azimuth/Bearing: 123° S47E 230mils True (±13°) Elevation Angle: +07.7° Horizon Angle: +01.0° Zoom: 1.0X 13352+23 S-RR09</p>

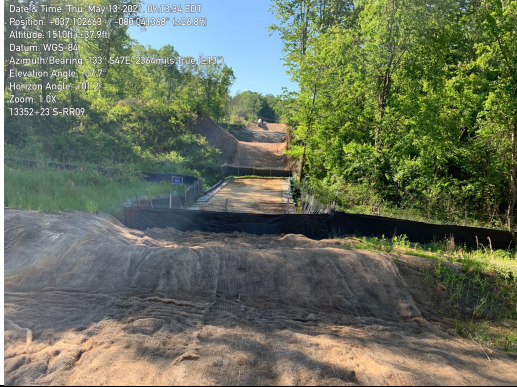
GPS Location		0		GPS Location	
Field Station#		13352+23		Field Station#	
Pic 9 Desc.		S-RR09, in good condition		Pic 10 Desc.	
				Gun Club road in good condition	
<p>Date & Time: Thu, May 13, 2021, 09:24:18 EDT Position: +037.1310468° -080.039399° (±154 ft) Altitude: 13358 (±101.0ft) Datum: WGS-84 Azimuth/Bearing: 191° S41E 243mils True (±12°) Elevation Angle: +17.3° Horizon Angle: +02.8° Zoom: 1.0X 13358+64 S-RR11</p>

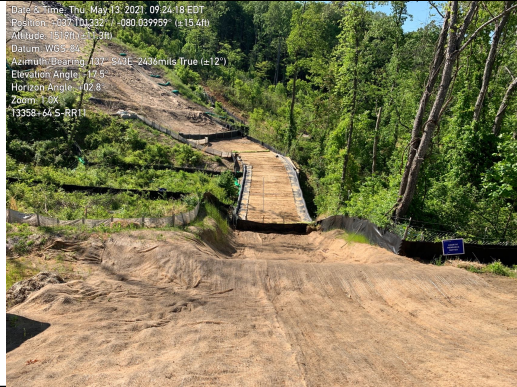
GPS Location		0		GPS Location	
Field Station#		13358+64		Field Station#	
Pic 11 Desc.		S-RR11, in good condition		Pic 12 Desc.	
				S-RR11 Downstream, in good condition

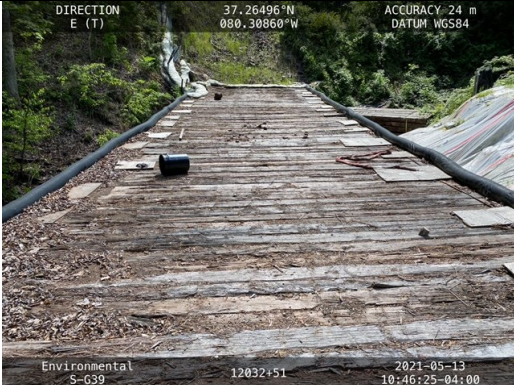
GPS Location	See Above		GPS Location	See Above	
Field Station#	12032+51		Field Station#	12038+00	
Pic 1 Desc.	Overview of Waterbody S-G39. ECDs are functional and ROW is stable.		Pic 2 Desc.	ROW Overview. ECDs (Cleanwater Diversion Pipe) are functional and ROW is stable.

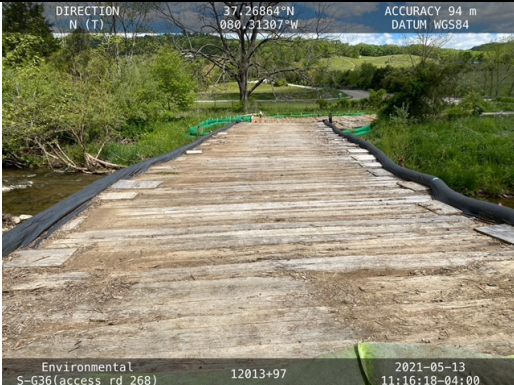
GPS Location	See Above		GPS Location	See Above	
Field Station#	12013+97		Field Station#	12015+84	
Pic 3 Desc.	Overview of Waterbody S-G36 (Acc Rd 268). ECDs are functional and ROW is stable.		Pic 4 Desc.	Overview of Waterbody S-G38. ECDs are functional and ROW is stable.

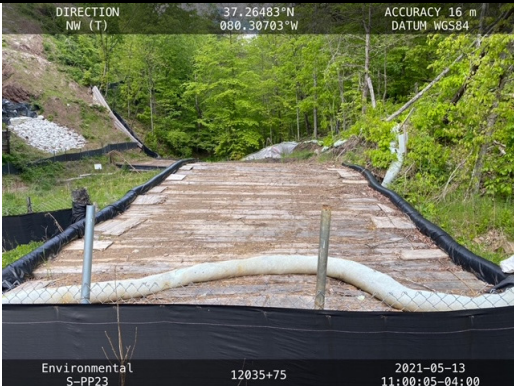
GPS Location	See Above		GPS Location	See Above	
Field Station#	12035+75		Field Station#	12035+11	
Pic 5 Desc.	Overview of Waterbody S-PP23. ECDs are functional and ROW is stable.		Pic 6 Desc.	Overview of Waterbody S-G40. ECDs are functional and ROW is stable.

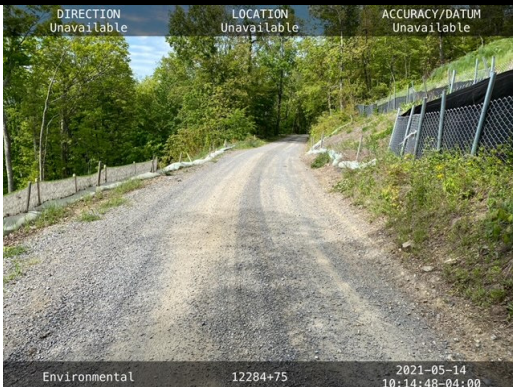
DIRECTION Unavailable LOCATION Unavailable ACCURACY/DATUM Unavailable Environmental 12284+75 2021-05-14 10:14:48-04:00			DIRECTION E (T) 37.23028°N 080.19742°W ACCURACY 2.69 Km DATUM WGS84 Environmental 12291+50 2021-05-14 10:36:32-04:00	
	GPS Location See Above Field Station# 12284+75 Pic 1 Desc. Overview of Acc. Rd. MN-276.03 ROW crossing. ECDs are functional and ROW is stable.			GPS Location See Above Field Station# 12291+50 Pic 2 Desc. ROW Overview. ECDs are functional and ROW is stable.

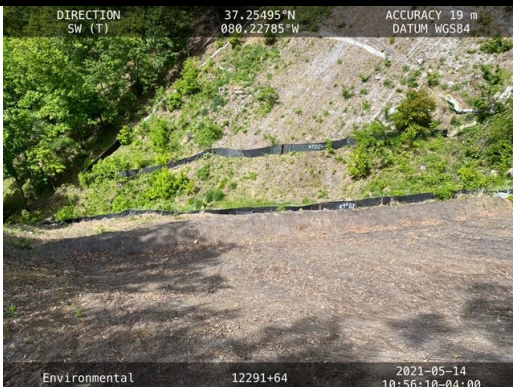
DIRECTION SW (T) 37.25495°N 080.22785°W ACCURACY 19 m DATUM WGS84 Environmental 12291+64 2021-05-14 10:56:10-04:00			DIRECTION S (T) 37.25617°N 080.22716°W ACCURACY 53 m DATUM WGS84 Environmental 12295+92 2021-05-14 11:07:05-04:00	
	GPS Location See Above Field Station# 12291+64 Pic 3 Desc. ROW Overview. ECDs are functional and ROW is stable.			GPS Location See Above Field Station# 12295+92 Pic 4 Desc. ROW Overview. ECDs are functional and ROW is stable.

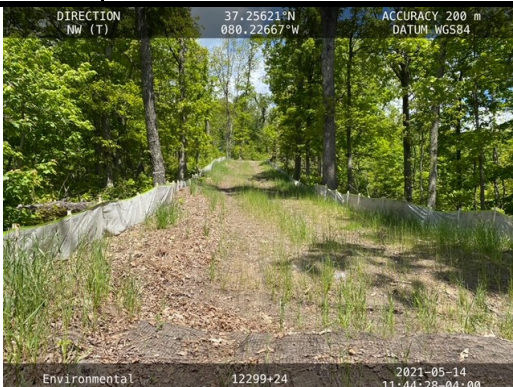
DIRECTION NW (T) 37.25621°N 080.22667°W ACCURACY 200 m DATUM WGS84 Environmental 12299+24 2021-05-14 11:44:28-04:00			DIRECTION W (T) 37.25663°N 080.22713°W ACCURACY 360 m DATUM WGS84 Environmental 12294+22 2021-05-14 11:48:23-04:00	
	GPS Location See Above Field Station# 12299+24 Pic 5 Desc. Overview of Acc. Rd. MN-276.03. ECDs are functional and ROW is stable.			GPS Location See Above Field Station# 12294+22 Pic 6 Desc. Overview of Acc. Rd. MN-276.03. ECDs are functional and ROW is stable.

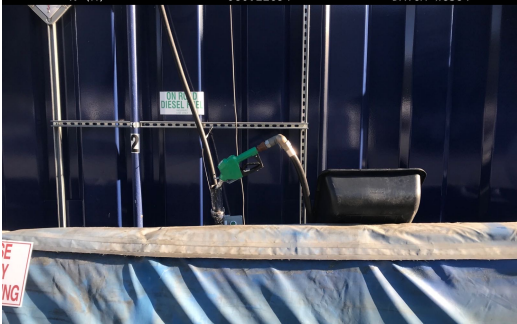
MVP-PY-006_051421 No leaky fittings or nozzles 2021-05-14 07:38:32-04:00		DIRECTION N (M) +37.23551° -080.22726° ACCURACY 98 ft DATUM WGS84

GPS Location	MVP-PY-006 See photo for gps data		GPS Location	MVP-PY-006 See photo for gps data	
Field Station#	+0		Field Station#	+0	
Pic 15 Desc.	Blue Bulk Fuel tanks no leaky fittings or nozzles. Looking N.		Pic 16 Desc.	Condition of containment under light plant. Free of stormwater. Looking N.	
DIRECTION NW (M) +37.23596° -080.22768° ACCURACY 16 ft DATUM WGS84

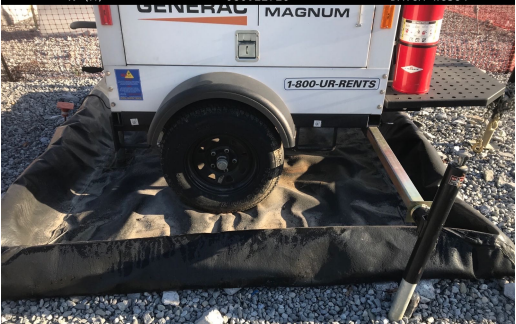
MVP-PY-006_051421 Condition of containment 2021-05-14 07:39:38-04:00

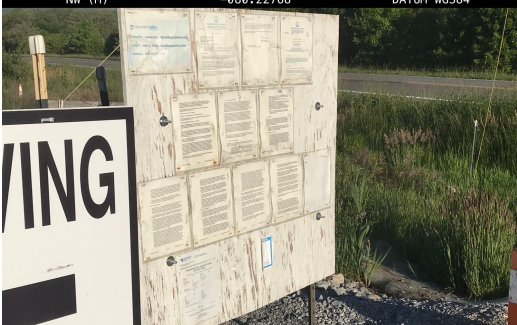
MVP-PY-006_051421 Posted project documents at entrance 2021-05-14 07:40:25-04:00		DIRECTION NW (M) +37.23603° -080.22785° ACCURACY 16 ft DATUM WGS84

MVP-PY-006_051421 Condition of CFS & signage at feature 2021-05-14 07:41:13-04:00			
GPS Location	MVP-PY-006 See photo for gps data		GPS Location	MVP-PY-006 See photo for gps data	
Field Station#	+0		Field Station#	+0	
Pic 17 Desc.	Condition of posted project documents at the main entrance. Looking NW.		Pic 18 Desc.	Condition of compost filter sock and signage at feature W-008. Looking NW.

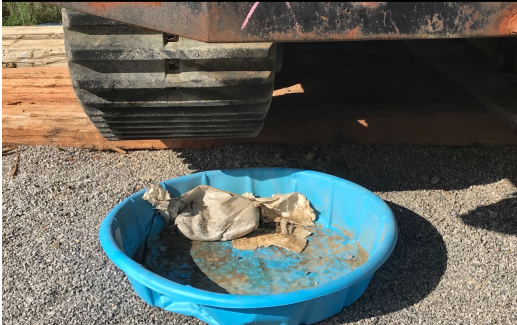
+37.27055° -080.12379° ACCURACY 16 ft DATUM WGS84			
MVP-LY-049_051421		Containment under stored equipment		2021-05-14 09:00:35-04:00	
GPS Location	MVP-LY-049 See photo for gps data				
Field Station#	+0				
Pic 7 Desc.	Condition of containment under stored equipment. Looking S.				
DIRECTION W (M)

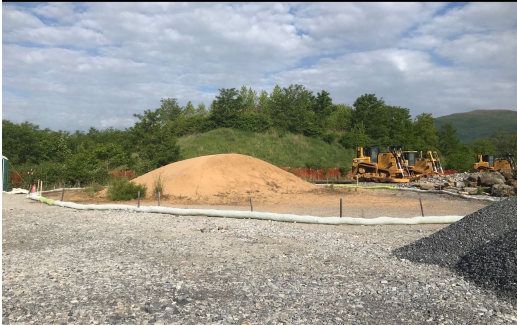
+37.26932° -080.12354° ACCURACY 33 ft DATUM WGS84			
MVP-LY-049_051421		Condition of CFS around sand pile		2021-05-14 08:45:42-04:00	
GPS Location	MVP-LY-049 See photo for gps data				
Field Station#	+0				
Pic 8 Desc.	Condition of compost filter sock around sand pile. Looking W.				
DIRECTION SW (M)

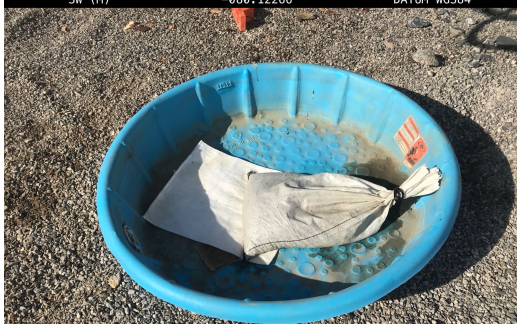
+37.27013° -080.12266° ACCURACY 33 ft DATUM WGS84			
MVP-LY-049_051421		Containment under stored trailer		2021-05-14 08:59:07-04:00	
GPS Location	MVP-LY-049 See photo for gps data				
Field Station#	+0				
Pic 9 Desc.	Condition of containment under stored trailer. Looking SW.

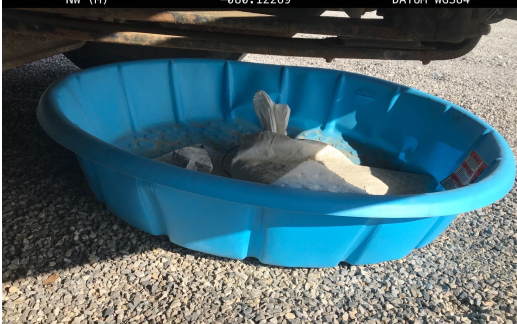
+37.27019° -080.12269° ACCURACY 16 ft DATUM WGS84			
MVP-LY-049_051421		Containment under stored vehicle		2021-05-14 08:59:18-04:00	
GPS Location	MVP-LY-049 See photo for gps data				
Field Station#	+0				
Pic 10 Desc.	Condition of containment under stored vehicle. Looking NW.				
DIRECTION S (M)

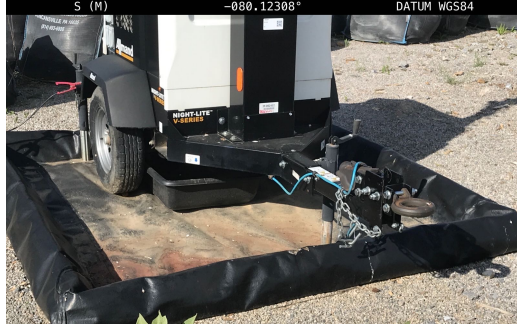
+37.27053° -080.12308° ACCURACY 33 ft DATUM WGS84			
MVP-LY-049_051421		Condition of containment		2021-05-14 09:00:07-04:00	
GPS Location	MVP-LY-049 See photo for gps data				
Field Station#	+0				
Pic 11 Desc.	Condition of containment under light plant. Free of stormwater. Looking S.				
DIRECTION SW (M)

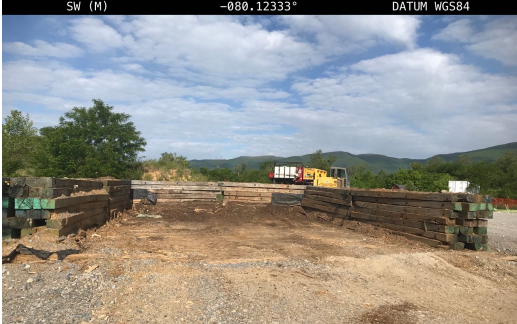
+37.27046° -080.12333° ACCURACY 16 ft DATUM WGS84			
MVP-LY-049_051421		Condition of temporary trash tran...		2021-05-14 09:00:15-04:00	
GPS Location	MVP-LY-049 See photo for gps data				
Field Station#	+0				
Pic 12 Desc.	Condition of temporary trash transfer pit. Most debris has been removed. Looking SW.

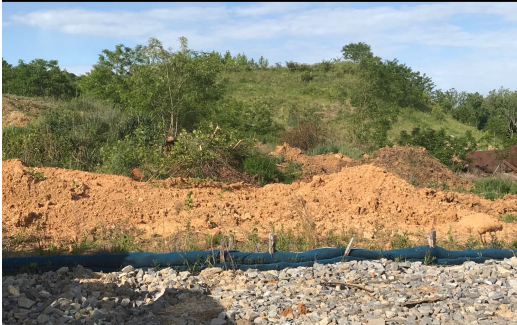
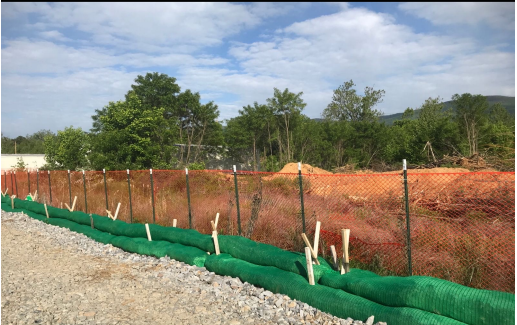
MVP-LY-049_051421 Landowner disturbance along CFS 2021-05-14 09:00:49-04:00		MVP-LY-049_051421 Landowner disturbance along feature 2021-05-14 09:01:29-04:00			
GPS Location	MVP-LY-049 See photo for gps data		GPS Location	MVP-LY-049 See photo for gps data	
Field Station#	+0		Field Station#	+0	
Pic 13 Desc.	Landowner soil disturbance along compost filter sock. No new damage to ECD's. Looking SW.		Pic 14 Desc.	Landowner soil disturbance along edge of feature W-CV21A. Area not stabilized. Looking NW.	
DIRECTION SW (M) +37.27042° -080.12460° ACCURACY 16 ft DATUM WGS84		DIRECTION S (M) +37.27043° -080.12464° ACCURACY 16 ft DATUM WGS84

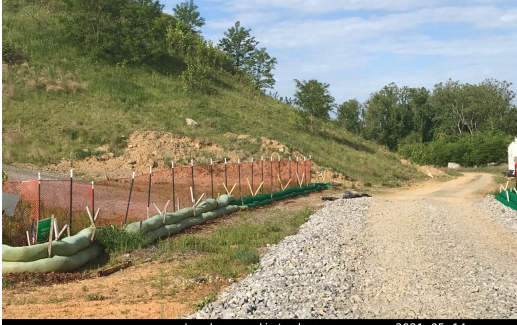
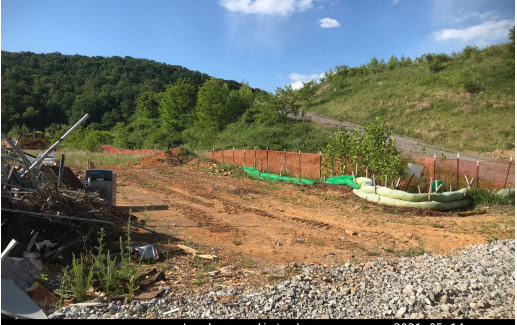
MVP-LY-049_051421 Landowner disturbance within 66' of feature 2021-05-14 09:01:33-04:00		MVP-LY-049_051421 Landowner disturbance along CFS & feature 2021-05-14 09:01:42-04:00

GPS Location	MVP-LY-049 See photo for gps data		GPS Location	MVP-LY-049 See photo for gps data	
Field Station#	+0		Field Station#	+0	
Pic 15 Desc.	Landowner soil disturbance within 66' and 120' west of feature W-CV21B. Areas not stabilized. Looking SW.		Pic 16 Desc.	Landowner soil disturbance along compost filter sock and east of feature W-CV21B. Area not stabilized. Looking S.	
DIRECTION N (M) +37.27087° -080.12361° ACCURACY 33 ft DATUM WGS84		DIRECTION N (M) +37.27150° -080.12318° ACCURACY 16 ft DATUM WGS84

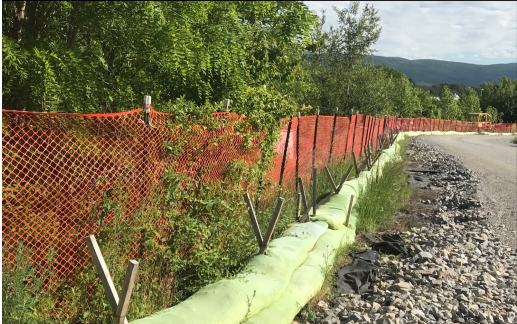
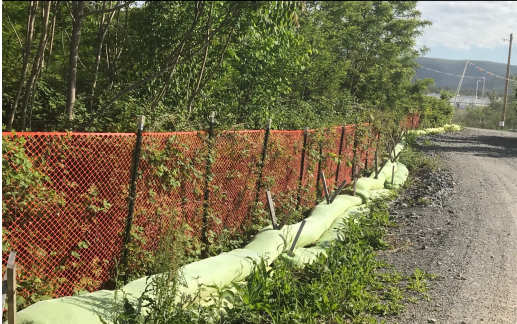
MVP-LY-049_051421 Condition of CFS & safety fence 2021-05-14 09:03:10-04:00		MVP-LY-049_051421 Condition of CFS & safety fence 2021-05-14 09:03:44-04:00			
GPS Location	MVP-LY-049 See photo for gps data		GPS Location	MVP-LY-049 See photo for gps data	
Field Station#	+0		Field Station#	+0	
Pic 17 Desc.	Condition of compost filter sock and safety fence along north LOD. Looking N.		Pic 18 Desc.	Condition of compost filter sock and safety fence along north LOD. Looking N.

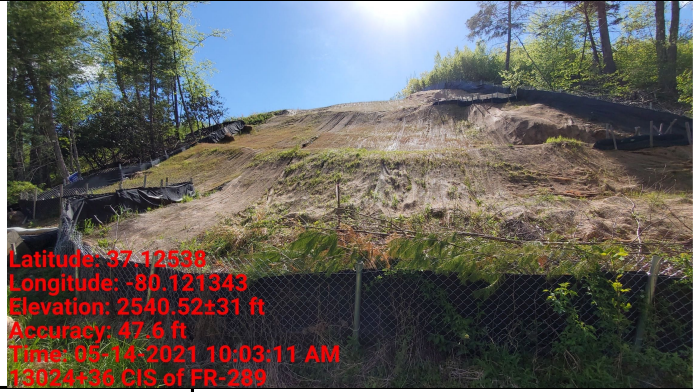
<p>Latitude: 37.125345 Longitude: -80.121344 Elevation: 2537.44±32 ft Accuracy: 26.9 ft Time: 05-14-2021 10:05:02 AM 13024+00 CIS of FR-289 stream S-G24</p>			
GPS Location	See pic for GPS location		GPS Location	See pic for GPS location	
Field Station#	13024+36		Field Station#	113024+00	
Pic 1 Desc.	Stabilized slope on GAS of streams S-G24 and S-G25.		Pic 2 Desc.	Downstream side of stream S-G24 on CIS of FR-289.

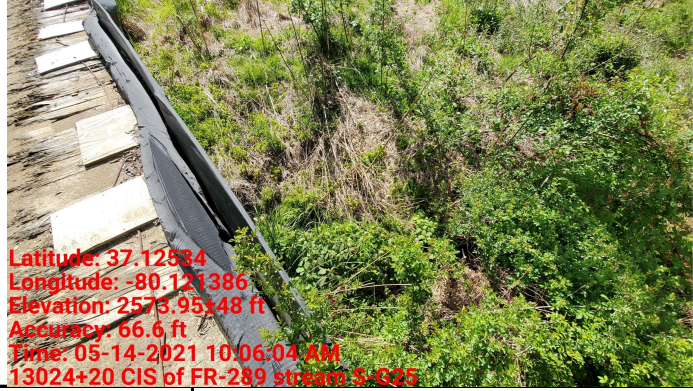
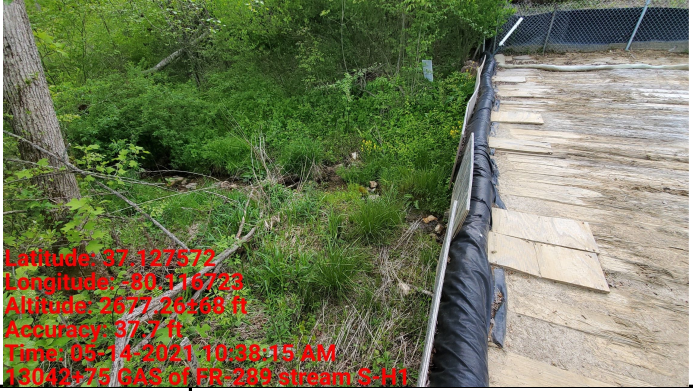
GPS Location	See pic for GPS location		GPS Location	See pic for GPS location	
Field Station#	13024+20		Field Station#	13042+75	
Pic 3 Desc.	Downstream side of stream S-G25 on CIS of FR-289.		Pic 4 Desc.	Downstream side of stream S-H1 on GAS of FR-289.

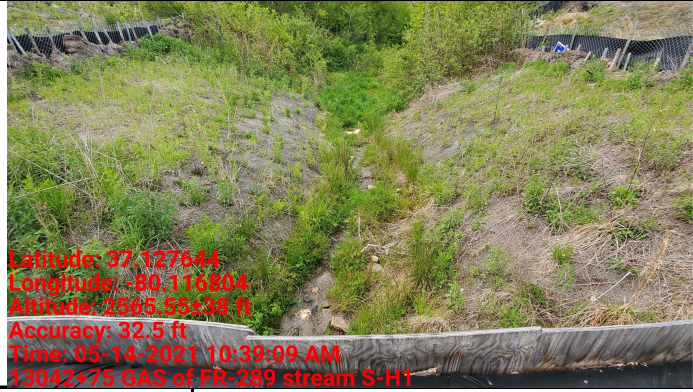
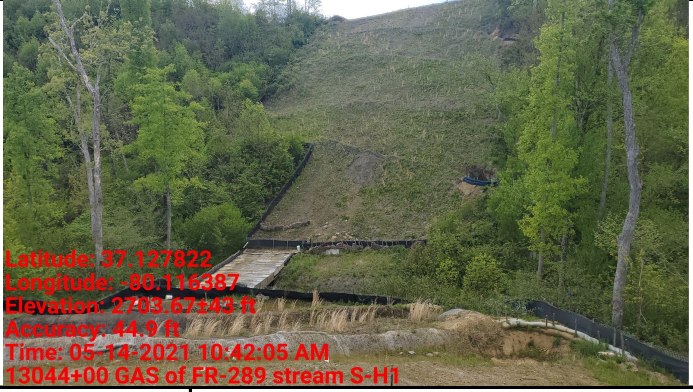
<p>Latitude: 37.127822 Longitude: -80.116387 Elevation: 2593.67±43 ft Accuracy: 44.9 ft Time: 05-14-2021 10:42:05 AM 13044+00 GAS of FR-289 stream S-H1</p>			
GPS Location	See pic for GPS location		GPS Location	See pic for GPS location	
Field Station#	13042+75		Field Station#	13044+00	
Pic 5 Desc.	Upstream side of stream S-H1 on GAS of FR-289.		Pic 6 Desc.	Stream S-H1 from GAS.

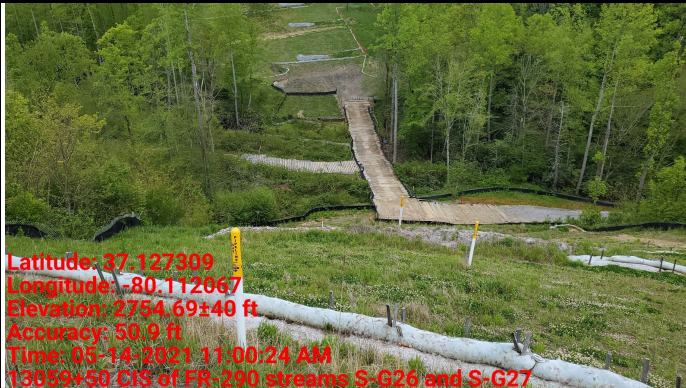
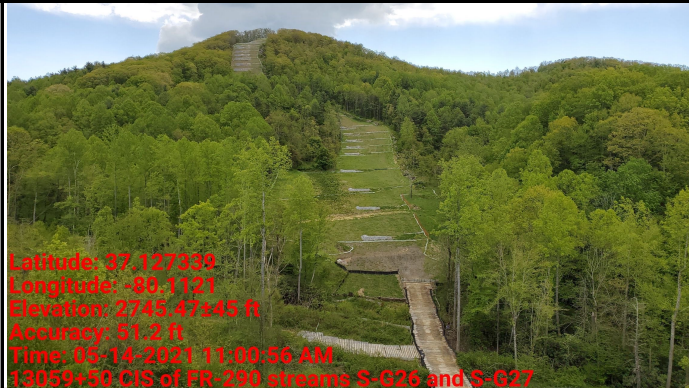
GPS Location	See pic for GPS location		GPS Location	See pic for GPS location	
Field Station#	13059+50		Field Station#	13059+50	
Pic 9 Desc.	Streams S-G26 and S-G27 from the top of the slope on the CIS of FR-290.		Pic 10 Desc.	Overview of the ROW on the GAS of FR-290.

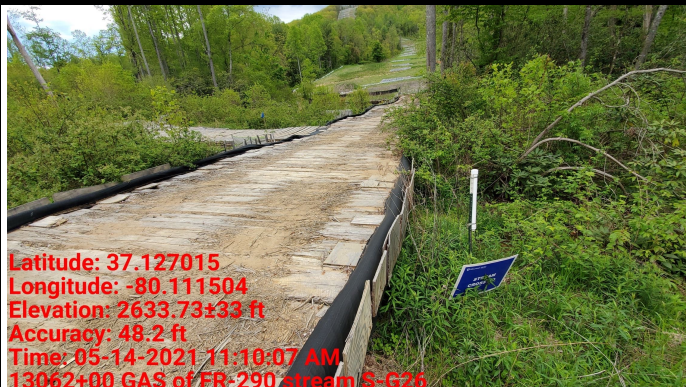
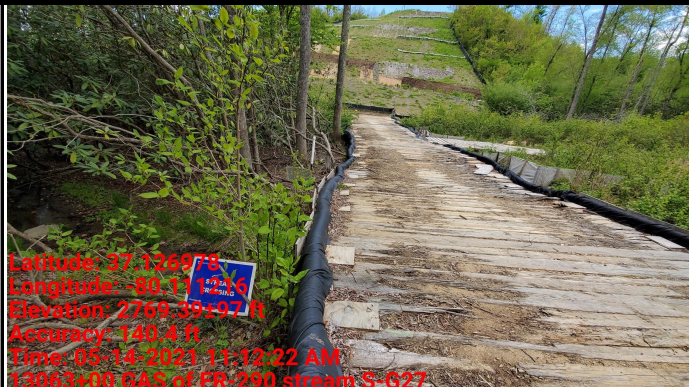
<p>Latitude: 37.126975 Longitude: -80.111506 Elevation: 2760.39±17 ft Accuracy: 140.4 ft Time: 05-14-2021 11:12:22 AM 13063+00 GAS of FR-290 stream S-G27</p>		
GPS Location	See pic for GPS location		GPS Location	See pic for GPS location	
Field Station#	13062+00		Field Station#	13063+00	
Pic 11 Desc.	Downstream side of stream S-G26.		Pic 12 Desc.	Downstream side of stream S-G27.

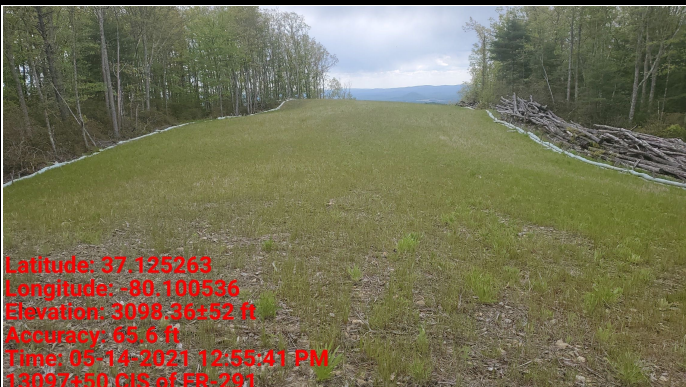
<p>Latitude: 37.124202 Longitude: -80.099701 Elevation: 2996.06±40 ft Accuracy: 31.5 ft Time: 05-14-2021 01:03:47 PM 13102+00 CIS of FR-291</p>		
GPS Location	See pic for GPS location		GPS Location	See pic for GPS location	
Field Station#	13097+50		Field Station#	13102+00	
Pic 17 Desc.	Current ROW conditions on the CIS of FR-291.		Pic 18 Desc.	Current ROW conditions on the CIS of FR-291.
