Visual Site Inspection Report

Project Name	H-600 Pipeline Spread H	AFE	124300138	Spread	H-600 Pipeline Spread H
Contractor	Precision			Report #	23722
Inspector	Logan Box			Date/Time	5/24/2021 3:21 PM
Permit #	TBD	Inspection Type	VA SWPP	Station Begin	13525+99
State	VA	Inspection Area	Partial	Station End	13670+00
County	Franklin	Ground	Dry	Temperature (°F)	85.00
Municipality	N/A	Weather	Sunny	Rain Gauge (in)	0.00
				Rain Accumulation Time (days)	0.00

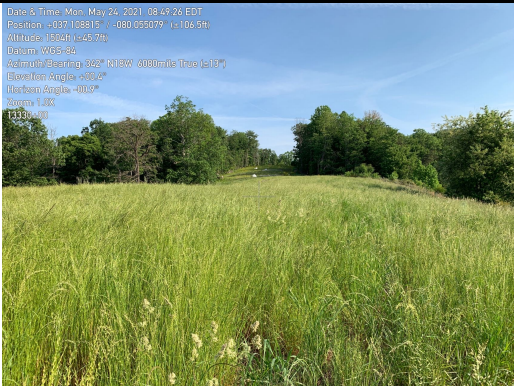
GPS Location	0	GPS Location	0		
Field Station#	13330+00	Field Station#	13262+60		
Pic 5 Desc.	ROW and ECDs in good condition, with good vegetation establishing across LOD		Pic 6 Desc.	ATWS-1055, in good condition, RCE is in good condition and functioning properly

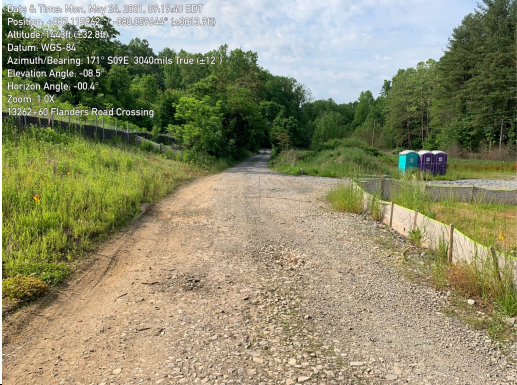
<p>Date & Time: Mon, May 24, 2021, 09:19:59 EDT Position: +037.115426° / -080.085444° (+3013.97) Altitude: 1420ft (+32.8ft) Datum: WGS-84 Azimuth/Bearing: 171° S09E 3040mils True (+12°) Elevation Angle: -08.5° Horizon Angle: -00.4° Zoom: 1.0X 13262-69 Flanders Road Crossing</p>

<p>Date & Time: Mon, May 24, 2021, 09:21:14 EDT Position: +037.115440° / -080.059974° (+28.4ft) Altitude: 1452ft (+32.2ft) Datum: WGS-84 Azimuth/Bearing: 258° S78°W 4587mils True (+12°) Elevation Angle: -04.2° Horizon Angle: -01.7° Zoom: 1.0X 13260-66 S-II4</p>			
GPS Location	0	GPS Location	0		
Field Station#	13262+60	Field Station#	13260+66		
Pic 7 Desc.	Flanders Road Crossing in good condition	Pic 8 Desc.	MVP-S-II4 in good condition

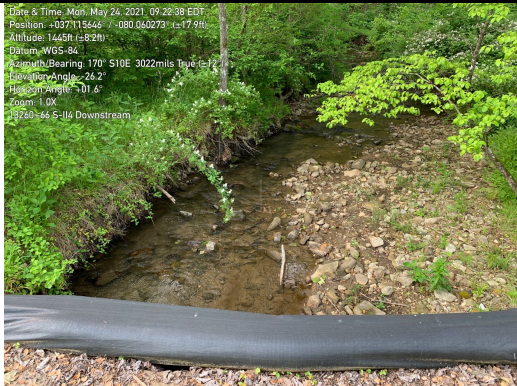
<p>Date & Time: Mon, May 24, 2021, 09:22:38 EDT Position: +037.115426° / -080.080273° (+17.9ft) Altitude: 1445ft (+32.8ft) Datum: WGS-84 Azimuth/Bearing: 170° S10E 3022mils True (+12°) Elevation Angle: -24.2° Horizon Angle: -01.6° Zoom: 1.0X 13260-66 S-II4 Downstream</p>

GPS Location	0	GPS Location	0		
Field Station#	13260+66	Field Station#	13251+00		
Pic 9 Desc.	MVP-S-II4 Downstream in good condition	Pic 10 Desc.	Slip observed to be stable, no notable changes, vegetation establishing.

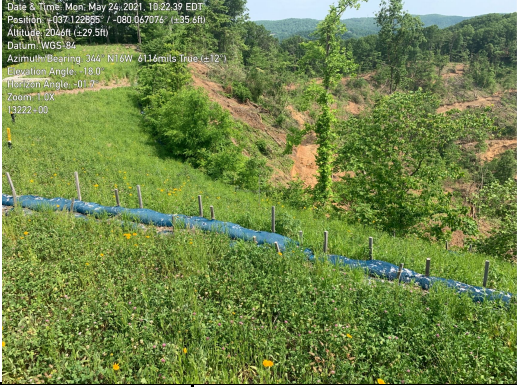
GPS Location	0	GPS Location	0		
Field Station#	13222+00	Field Station#	13210+00		
Pic 13 Desc.	ROW and ECDs in good condition, with good vegetation establishing across LOD		Pic 14 Desc.	ROW and ECD condition, in good condition and functioning properly	
<p>Date & Time: Mon, May 24, 2021, 10:11:58 EDT Position: +037.123069° / -080.074371° (+16.5ft) Altitude: 1459ft (+36.6ft) Datum: WGS-84 Azimuth/Bearing: 213° S33W 0.378mils True (+13.1°) Elevation Angle: -09.6° Horizon Angle: +01.7° Zoom: 1.0X 13197+55 Dillion's Mill Road Crossing</p>

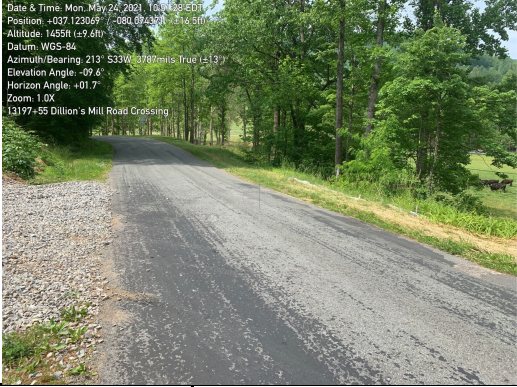
GPS Location	0	GPS Location	0		
Field Station#	13197+55	Field Station#	13196+79		
Pic 15 Desc.	Dillion's Mill Road Crossing, in good condition		Pic 16 Desc.	MVP-S-D8 in good condition, no earth disturbance in this area	
<p>Date & Time: Mon, May 24, 2021, 11:42:00 EDT Position: +037.135309° / -080.080375° (+15.5ft) Altitude: 1630ft (+31.1ft) Datum: WGS-84 Azimuth/Bearing: 262° S33W 0.958mils True (+12.1°) Elevation Angle: +00.0° Horizon Angle: +00.7° Zoom: 1.0X 13175+80</p>

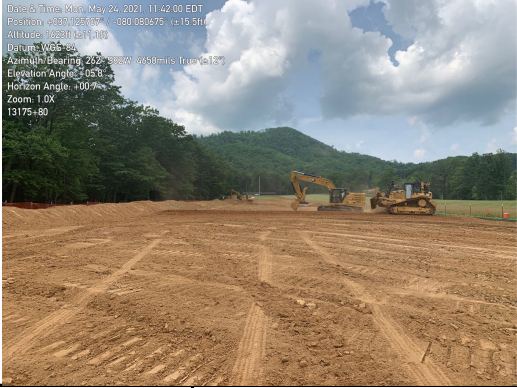
GPS Location	0	GPS Location	0		
Field Station#	13175+80	Field Station#	13168+80		
Pic 17 Desc.	ROW being cleared, ECD installed and functioning properly		Pic 18 Desc.	ROW being cleared, ECD installed and functioning properly

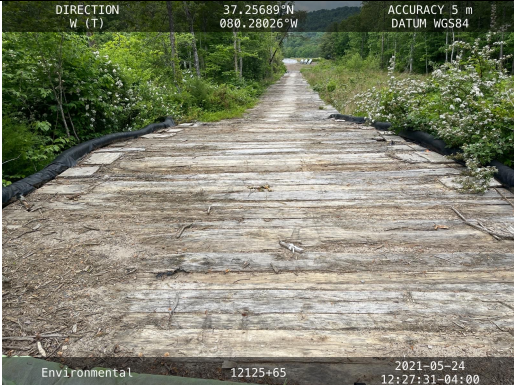
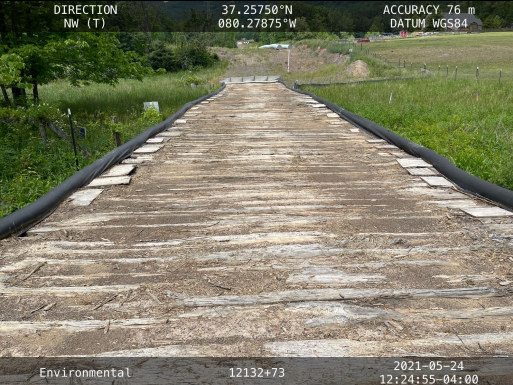
GPS Location	See photo		GPS Location	See photo	
Field Station#	12125+65		Field Station#	12131+73	
Pic 1 Desc.	Bridge and ECDs crossing stream S-MM31		Pic 2 Desc.	Bridge and ECDs crossing S-C29

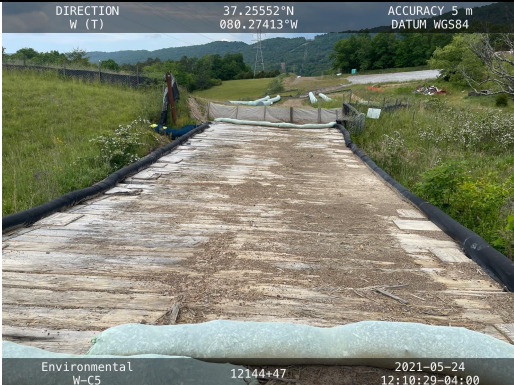
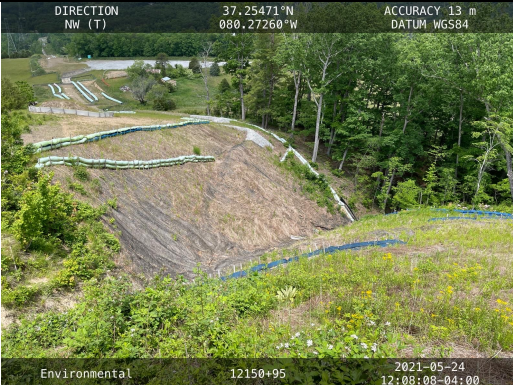
GPS Location	See photo		GPS Location	See photo	
Field Station#	12144+48		Field Station#	12150+95	
Pic 3 Desc.	Bridge and ECDs crossing wetland W-C5		Pic 4 Desc.	Stabilized drainage feature

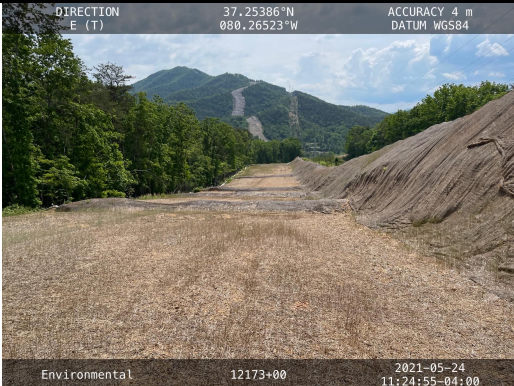
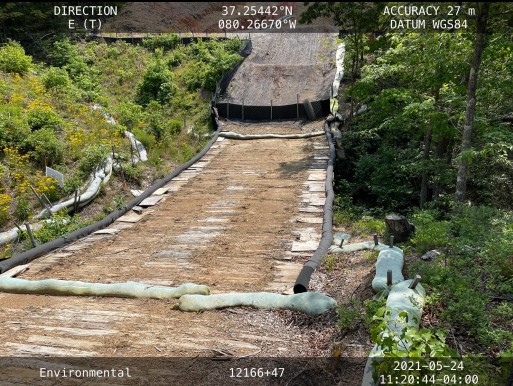
GPS Location	See photo		GPS Location	See photo	
Field Station#	12173+00		Field Station#	12166+47	
Pic 5 Desc.	Stabilized ROW in acceptable condition		Pic 6 Desc.	Bridge and ECDs crossing S-C24

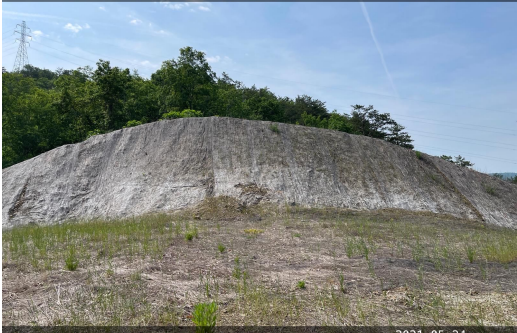
Environmental 12208+00 2021-05-24 10:42:22-04:00		DIRECTION E (T) 37.25163°N 080.25739°W ACCURACY 5 m DATUM WGS84

Environmental 12198+64 2021-05-24 10:31:23-04:00			
GPS Location	See photo		GPS Location	See photo	
Field Station#	12208+00		Field Station#	12198+64	
Pic 13 Desc.	Stabilized spoil pile in acceptable condition		Pic 14 Desc.	Stream crossing S-0011 on the GAS of the railroad crossing	
DIRECTION W (T) 37.25167°N 080.25745°W ACCURACY 5 m DATUM WGS84

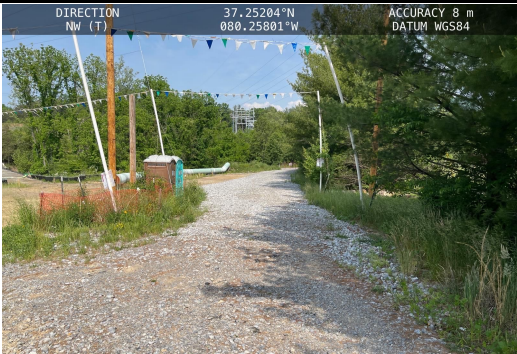
Environmental 12198+90 2021-05-24 10:29:55-04:00		DIRECTION NE (T) 37.25160°N 080.25930°W ACCURACY 5 m DATUM WGS84

Environmental 12192+50 2021-05-24 10:27:49-04:00			
GPS Location	See photo		GPS Location	See photo	
Field Station#	12198+90		Field Station#	12192+50	
Pic 17 Desc.	Access Road MVP-MN-275 in acceptable condition		Pic 18 Desc.	Bridge and ECDs crossing S-C21

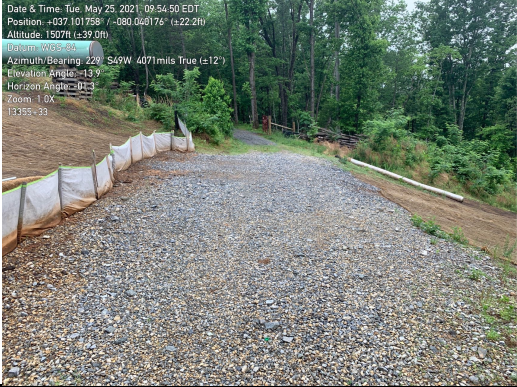
GPS Location	0	GPS Location	0		
Field Station#	13355+33	Field Station#	13352+23		
Pic 7 Desc.	Private road (Gun Club) in good condition		Pic 8 Desc.	MVP-S-RR09 in good condition	
<p>Date & Time: Tue, May 25, 2021 10:02:06 EDT Position: +037.103036° / -080.057038° (+22.9ft) Altitude: 1327ft (+23.0ft) Datum: WGS-84 Azimuth/Bearing: 321° N33W 3400mils True (+12°) Elevation Angle: -09.3° Horizon Angle: -00.7° Zoom: 2.0X 13348+26 S-RR08</p>		<p>Date & Time: Tue, May 25, 2021 10:08:54 EDT Position: +037.103036° / -080.042596° (+23.8ft) Altitude: 1327ft (+23.0ft) Datum: WGS-84 Azimuth/Bearing: 210° S30W 3733mils True (+12°) Elevation Angle: -19.6° Horizon Angle: -02.3° Zoom: 1.0X 13345+00</p>

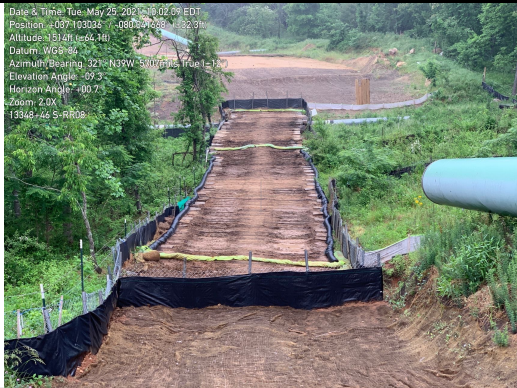
GPS Location	0	GPS Location	0		
Field Station#	13348+46	Field Station#	13345+00		
Pic 9 Desc.	MVP-S-RR08 in good condition		Pic 10 Desc.	Clean water diversion pipe and outlet in good condition	
<p>Date & Time: Tue, May 25, 2021 10:14:48 EDT Position: +037.099164° / -080.045867° (+18.6ft) Altitude: 1520ft (+41.0ft) Datum: WGS-84 Azimuth/Bearing: 207° N39W 4010mils True (+12°) Elevation Angle: -08.6° Horizon Angle: -01.7° Zoom: 1.0X 13342+57 Webster Road Crossing</p>		<p>Date & Time: Tue, May 25, 2021 10:19:06 EDT Position: +037.104221° / -080.045145° (+21.3ft) Altitude: 1438ft (+27.3ft) Datum: WGS-84 Azimuth/Bearing: 330° N38W 5000mils True (+12°) Elevation Angle: -16.5° Horizon Angle: -00.0° Zoom: 2.0X 13337+13 S-GH9</p>		 	
GPS Location	0	GPS Location	0		
Field Station#	13342+67	Field Station#	13337+13		
Pic 11 Desc.	Webster Corner Road Crossing in good condition, RCE in good condition and functioning properly		Pic 12 Desc.	MVP-S-GH9 in good condition

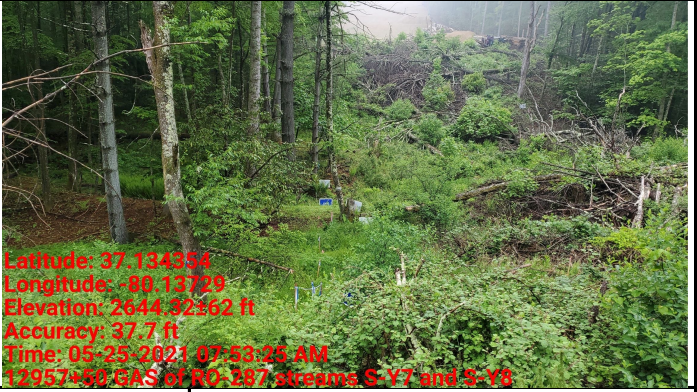
<p>Latitude: 37.134354 Longitude: -80.13729 Elevation: 2644.32±62 ft Accuracy: 37.7 ft Time: 05-25-2021 07:53:25 AM 12957+50 GAS of RO-287 streams S-Y7 and S-Y8</p>			
GPS Location	See pic for GPS location		GPS Location	See pic for GPS location	
Field Station#	13033+59		Field Station#	12957+50	
Pic 1 Desc.	0.3" total precipitation at Callaway Road.		Pic 2 Desc.	Downstream side of streams S-Y7 and S-Y8 on the GAS of RO-287.

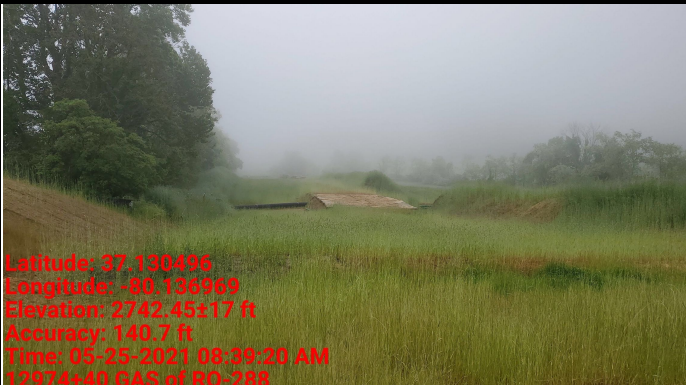
GPS Location	See pic for GPS location		GPS Location	See pic for GPS location	
Field Station#	12974+40		Field Station#	12974+20	
Pic 13 Desc.	Current ROW conditions on the GAS of RO-288.		Pic 14 Desc.	Current ROW conditions on the CIS of RO-288.

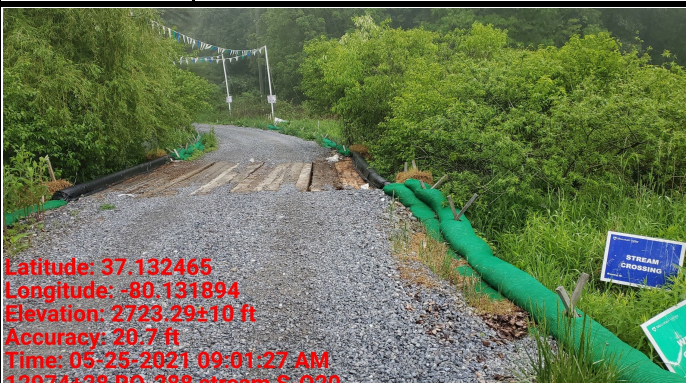
GPS Location	See pic for GPS location		GPS Location	See pic for GPS location	
Field Station#	12974+28		Field Station#	12996+00	
Pic 15 Desc.	Access road RO-288 at stream crossing S-Q20.		Pic 16 Desc.	Current ROW conditions on the GAS of US-221.

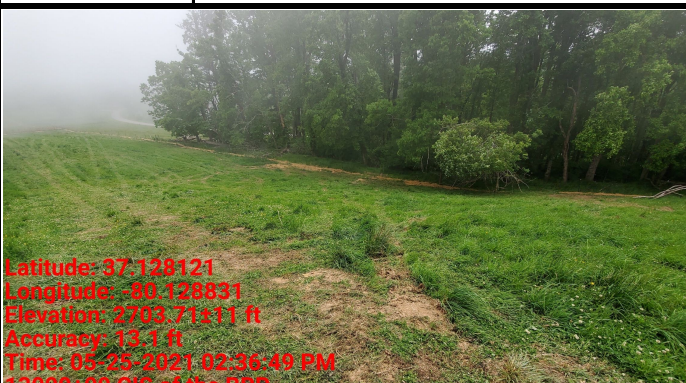
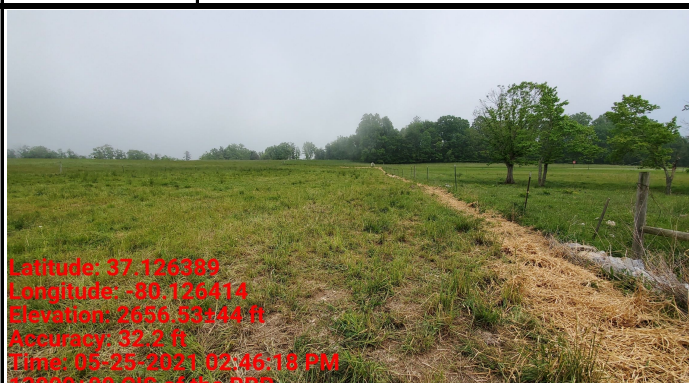
GPS Location	See pic for GPS location		GPS Location	See pic for GPS location	
Field Station#	13000+00		Field Station#	13089+00	
Pic 17 Desc.	BRP after removal of SSF on CIS of motorway.		Pic 18 Desc.	BRP after removal of SSF on CIS of motorway.

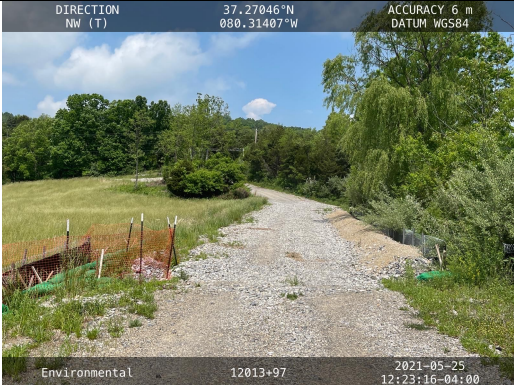
GPS Location	See photo		GPS Location	See photo	
Field Station#	12013+97		Field Station#	12013+97	
Pic 1 Desc.	Access Road MVP-MN-268 in acceptable condition		Pic 2 Desc.	Down stream of S-G36 in acceptable condition

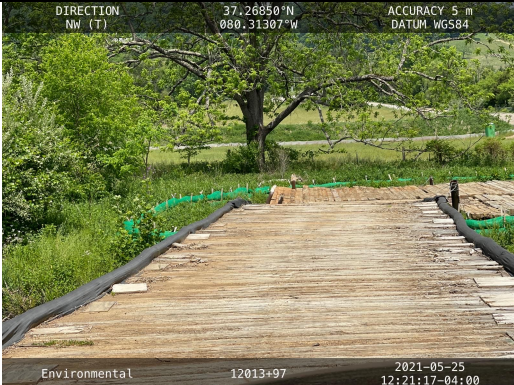
GPS Location	See photo		GPS Location	See photo	
Field Station#	12013+97		Field Station#	12015+84	
Pic 3 Desc.	Bridge and ECDs crossing stream S-G36 in acceptable condition		Pic 4 Desc.	Bridge and ECDs crossing S-G38 in acceptable condition

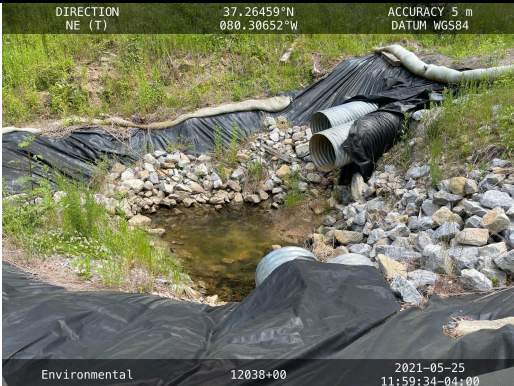
GPS Location	See photo		GPS Location	See photo	
Field Station#	12038+00		Field Station#	12038+00	
Pic 5 Desc.	Clean water crossing inlet in acceptable condition		Pic 6 Desc.	Clean water crossing outlet in acceptable condition

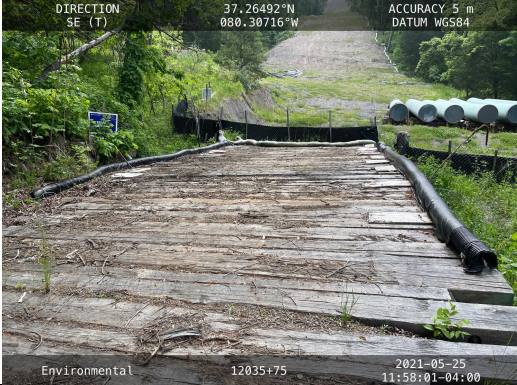
GPS Location	See photo		GPS Location	See photo	
Field Station#	12035+75		Field Station#	12035+11	
Pic 7 Desc.	Bridge and ECDs crossing stream S-PP23 in acceptable condition		Pic 8 Desc.	Bridge and ECDs crossing stream S-G40 in acceptable condition

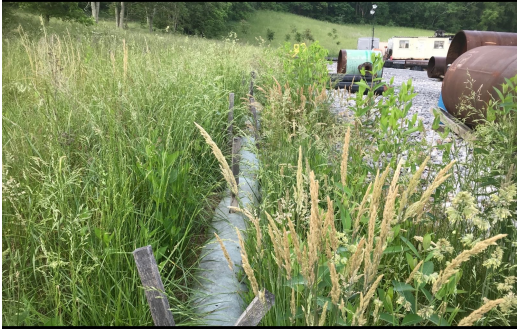
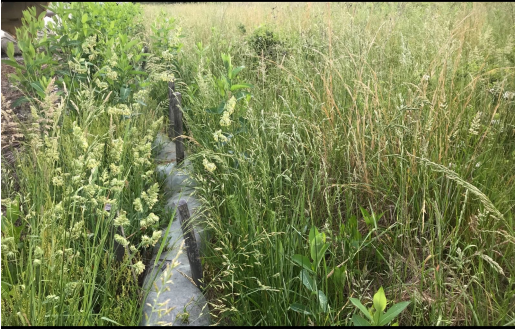
MVP-PY-006_052621 Condition of CFS along LOD 2021-05-26 07:36:26-04:00		MVP-PY-006_052621 Condition of CFS along LOD 2021-05-26 07:36:32-04:00			
GPS Location	MVP-PY-006 See photo for gps data		GPS Location	MVP-PY-006 See photo for gps data	
Field Station#	+0		Field Station#	+0	
Pic 13 Desc.	Condition of compost filter sock along east LOD. Looking.		Pic 14 Desc.	Condition of compost filter sock along east LOD. Looking N.	
DIRECTION SE (M) +37.23493° -080.22588° ACCURACY 2.02 m1 DATUM WGS84

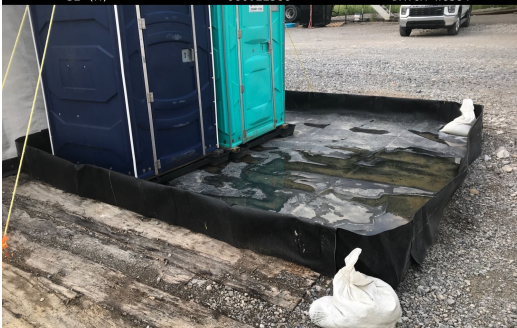
GPS Location	MVP-PY-006 See photo for gps data		GPS Location	MVP-PY-006 See photo for gps data	
Field Station#	+0		Field Station#	+0	
Pic 15 Desc.	Condition of trays and containment under toilets. Holding some stormwater. Looking SE.		Pic 16 Desc.	Condition of containment under hazardous waste dumpsters. Holding some stormwater. Looking E.	
DIRECTION E (M) +37.23418° -080.22707° ACCURACY 16 ft DATUM WGS84

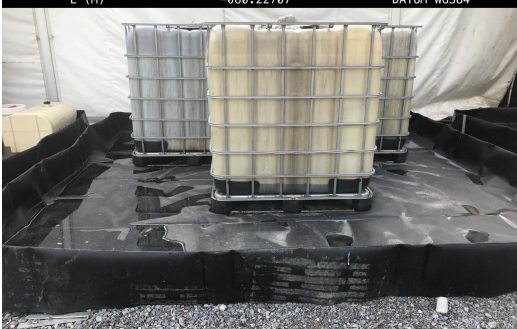
MVP-PY-006_052621 Condition of containment 2021-05-26 07:40:06-04:00		MVP-PY-006_052621 Condition of poly lined containments 2021-05-26 07:41:16-04:00			
GPS Location	MVP-PY-006 See photo for gps data		GPS Location	MVP-PY-006 See photo for gps data	
Field Station#	+0		Field Station#	+0	
Pic 17 Desc.	Condition of containment under used oil containers. Holding some stormwater. Looking E.		Pic 18 Desc.	Condition of poly lined rock berm containments. Holding some stormwater. Looking SE.

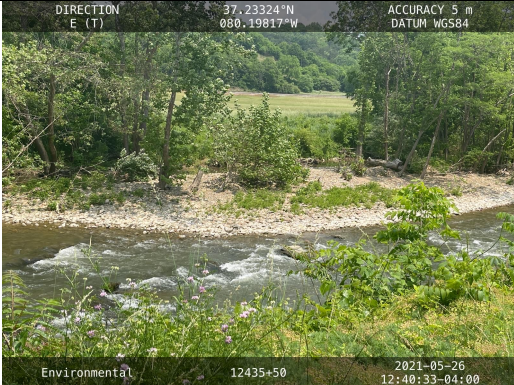
GPS Location	See photo		GPS Location	See photo	
Field Station#	12435+50		Field Station#	12424+01	
Pic 1 Desc.	Stream crossing S-NN16 in acceptable condition		Pic 2 Desc.	RCE on access road MVP-MN-279 in acceptable condition

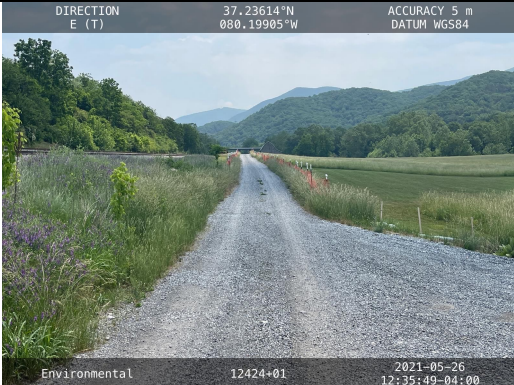
GPS Location	See photo		GPS Location	See photo	
Field Station#	12424+01		Field Station#	12421+00	
Pic 3 Desc.	Access Road MVP-MN-279 in acceptable condition		Pic 4 Desc.	Clean water crossing pipe inlet in acceptable condition

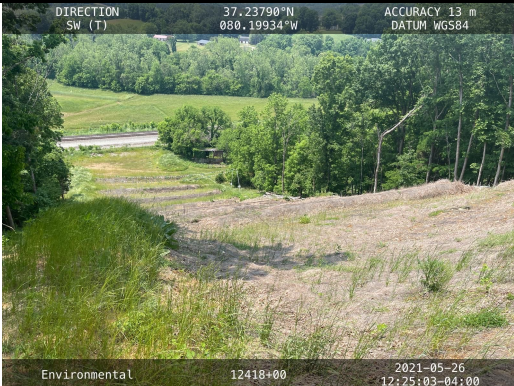
GPS Location	See photo		GPS Location	See photo	
Field Station#	12418+00		Field Station#	12410+20	
Pic 5 Desc.	Stabilized ROW in acceptable condition		Pic 6 Desc.	Clean water crossing outlet in acceptable condition

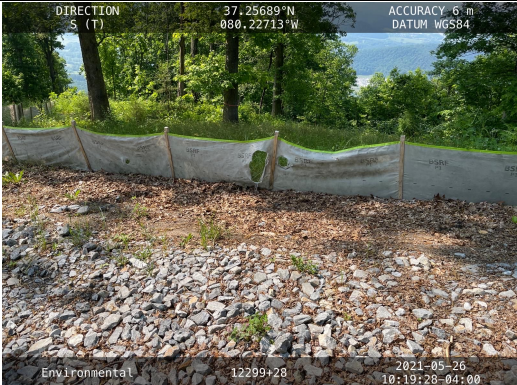
GPS Location	See photo		GPS Location	See photo	
Field Station#	12299+28		Field Station#	12299+24	
Pic 17 Desc.	P1 siltfence damaged and needs repaired.		Pic 18 Desc.	Stabilized access Road in acceptable condition

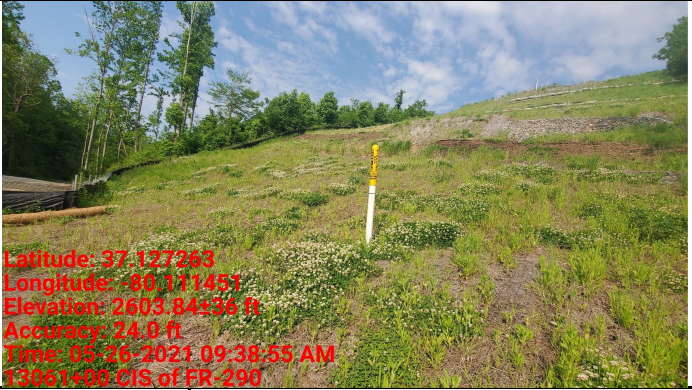
<p>Latitude: 37.127263 Longitude: -80.111451 Elevation: 2603.84±36 ft Accuracy: 24.0 ft Time: 05-26-2021 09:38:55 AM 13061+00 CIS of FR-290</p>		
GPS Location	See pic for GPS location		GPS Location	See pic for GPS location	
Field Station#	13033+59		Field Station#	13061+00	
Pic 1 Desc.	0.0" to report for Callaway Road.		Pic 2 Desc.	Slope on the CIS of FR-290.

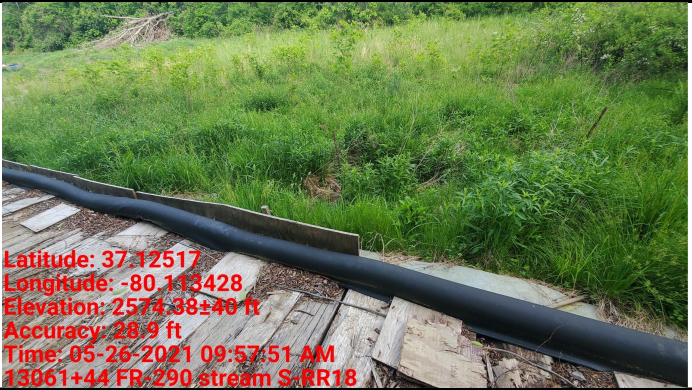
<p>Latitude: 37.12517 Longitude: -80.113428 Elevation: 2574.38±40 ft Accuracy: 28.9 ft Time: 05-26-2021 09:57:51 AM 13061+44 FR-290 stream S-RR16</p>		
GPS Location	See pic for GPS location		GPS Location	See pic for GPS location	
Field Station#	13064+00		Field Station#	13061+44	
Pic 5 Desc.	Current ROW conditions on the GAS of FR-290.		Pic 6 Desc.	Upstream side of stream S-RR16.

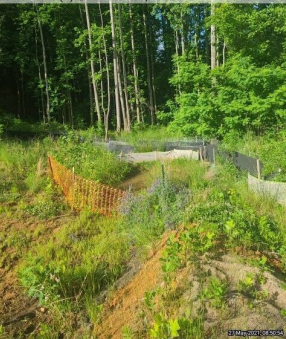
GPS Location	00000	GPS Location	0000		
Field Station#	13416+10	Field Station#	13525+10		
Pic 1 Desc.	EI monitored ECDs and sump pit . No environmental issues observed at the time of inspection		Pic 2 Desc.	Stream observation photo facing downstream during routine inspection today No issues observed at the time of inspection.	
	West Elevation

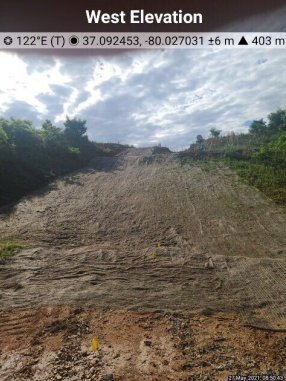
GPS Location	0000	GPS Location	00000		
Field Station#	13416+90	Field Station#	13524+30		
Pic 3 Desc.	Monitored erosion control blanket on hill side above road crossing. No issues observed at the time of inspection.		Pic 4 Desc.	Row photo showing permanent vegetation growth. Good coverage noted. Monitored ECDs in the area. No environmental issues observed at the time of inspection.	
	North East Elevation

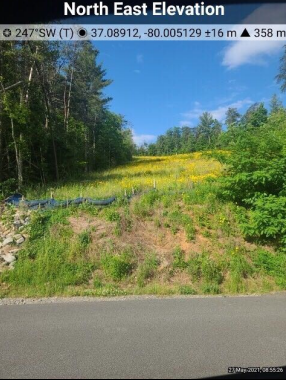
GPS Location	0000	GPS Location	0000		
Field Station#	13496+62	Field Station#	13525+10		
Pic 5 Desc.	Row photo showing vegetation growth in permanent area. Good coverage noted, monitored ECDs and rock lined channel .		Pic 6 Desc.	Stream observation photo facing upstream during routine inspection today No issues observed at the time of inspection

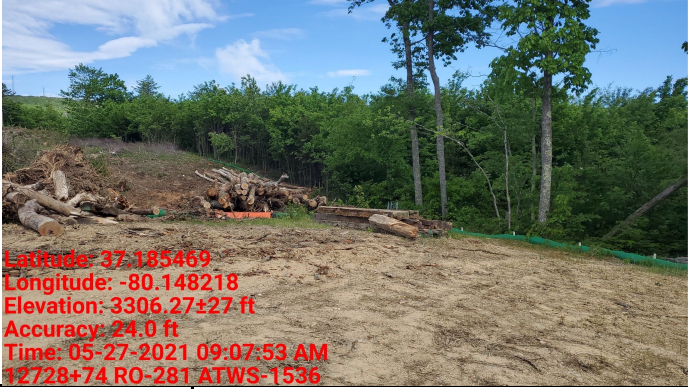
<p>Latitude: 37.185488 Longitude: -80.148244 Elevation: 3352.53±23 ft Accuracy: 60.7 ft Time: 05-27-2021 09:08:35 AM 12728+74 RO-281 ATWS-1536</p>			
GPS Location	See pic for GPS location		GPS Location	See pic for GPS location	
Field Station#	12728+74		Field Station#	12728+74	
Pic 7 Desc.	ROW from the ATWS-1536.		Pic 8 Desc.	Perimeter CFS installed in disturbed areas.

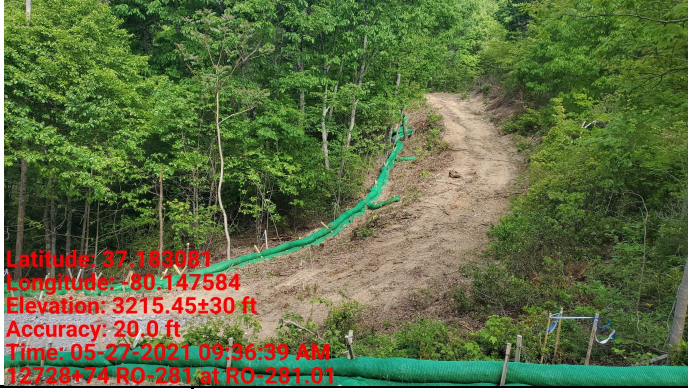
GPS Location	See pic for GPS location		GPS Location	See pic for GPS location	
Field Station#	12728+74		Field Station#	12711+50	
Pic 9 Desc.	CFS installed along access RO-281.01.		Pic 10 Desc.	Waterbars, sumps and end treatments remain in compliance throughout the area on the GAS of RO-280.

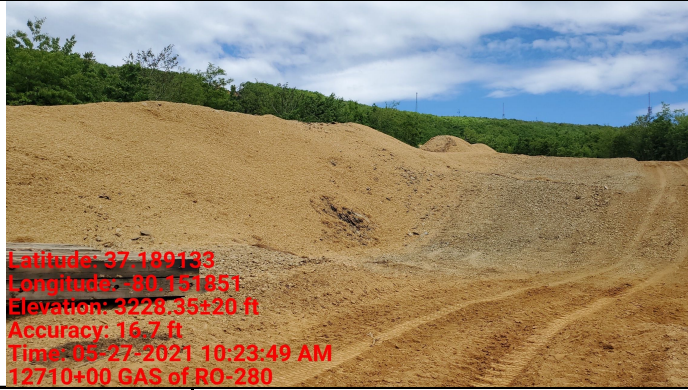
<p>Latitude: 37.192956 Longitude: -80.173429 Elevation: 3414.4±16 ft Accuracy: 26.2 ft Time: 05-27-2021 12:01:34 PM 12640+00 GAS of RO-279.01</p>			
GPS Location	See pic for GPS location		GPS Location	See pic for GPS location	
Field Station#	12710+00		Field Station#	12640+00	
Pic 11 Desc.	Subsoil and topsoil piles seeded and straw mulched per specifications.		Pic 12 Desc.	ROW stabilized and no maintenance issues or impacts observed in the area.

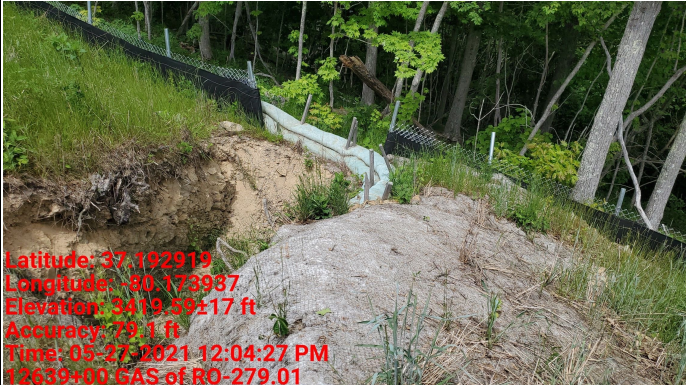
GPS Location	See pic for GPS location		GPS Location	See pic for GPS location	
Field Station#	12639+00		Field Station#	12638+24	
Pic 15 Desc.	Waterbars, sumps and end treatments remain in compliance.		Pic 16 Desc.	Access road RO-279.01.

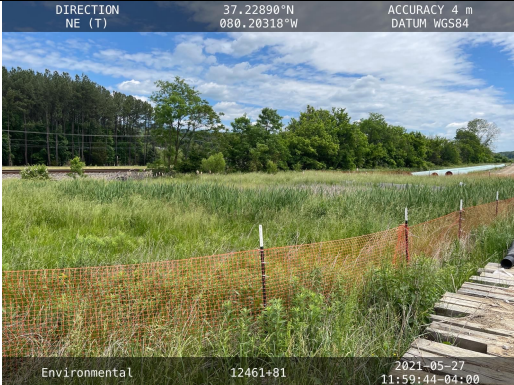
GPS Location	See photo		GPS Location	See photo	
Field Station#	12461+81		Field Station#	12468+00	
Pic 1 Desc.	Wetland W-KL58 in acceptable condition		Pic 2 Desc.	Stabilized ROW in acceptable condition

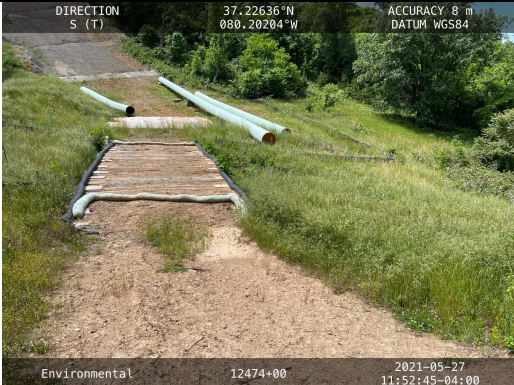
GPS Location	See photo		GPS Location	See photo	
Field Station#	12474+00		Field Station#	12478+00	
Pic 3 Desc.	Clean water crossing in acceptable condition		Pic 4 Desc.	Stabilized ROW in acceptable condition

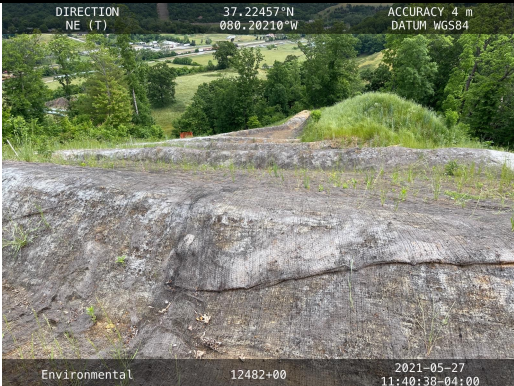
GPS Location	See photo		GPS Location	See photo	
Field Station#	12482+00		Field Station#	12482+87	
Pic 5 Desc.	Stabilized ROW in acceptable condition		Pic 6 Desc.	Water deflectors along access road MVP-MLV-AR-28 in acceptable condition

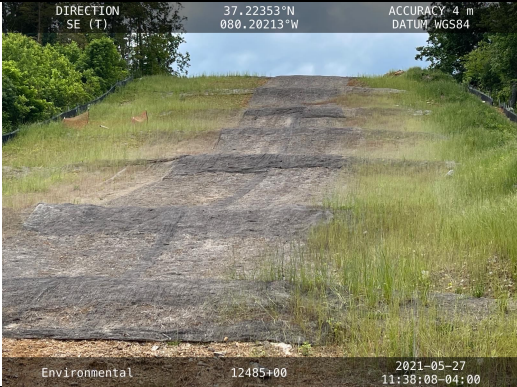
<p>DIRECTION S (T) 37.22742°N 080.20318°W ACCURACY 5 m DATUM WGS84</p> <p>Environmental 12482+87 2021-05-27 11:31:11-04:00</p>			
GPS Location	See photo		GPS Location	See photo	
Field Station#	12485+00		Field Station#	12482+87	
Pic 7 Desc.	Stabilized slope in acceptable condition		Pic 8 Desc.	Access Road MVP-MLV-AR-28 in acceptable condition

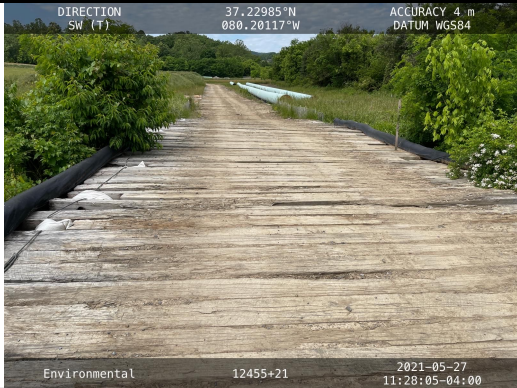
Pic 9 Desc.	Bridge and ECDs crossing S-CD12b in acceptable condition		Pic 10 Desc.	Stream crossing S-I1 in acceptable condition

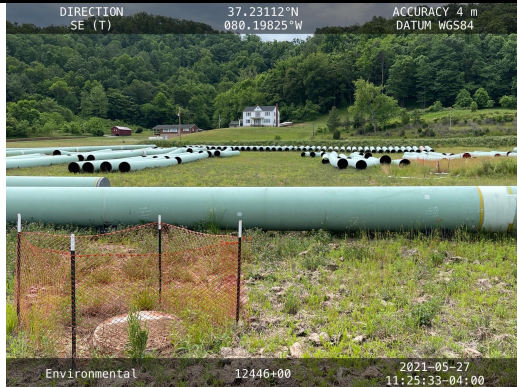
<p>DIRECTION SW (T) 37.23171°N 080.19693°W ACCURACY 6 m DATUM WGS84</p> <p>Environmental 12445+19 2021-05-27 11:24:57-04:00</p>			
GPS Location	See photo		GPS Location	See photo	
Field Station#	12446+00		Field Station#	12445+19	
Pic 11 Desc.	Stabilized ATWS with stored pipe in acceptable condition		Pic 12 Desc.	CFS checks along Cove Hollow Rd in acceptable condition

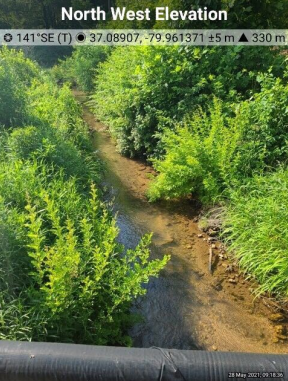
GPS Location	00000	GPS Location	0000		
Field Station#	13643+53	Field Station#	13643+53		
Pic 1 Desc.	Stream observation photo facing downstream during routine inspection today. No issues observed at the time of inspection.		Pic 2 Desc.	Stream observation photo facing upstream during routine inspection today. No issues observed at the time of inspection.	
	East Elevation

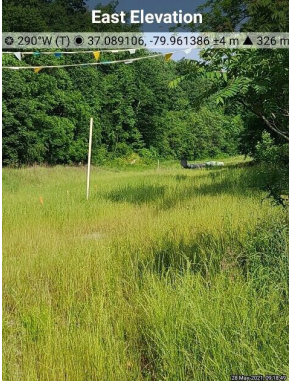
GPS Location	00000	GPS Location	0000		
Field Station#	13541+39	Field Station#	13643+10		
Pic 3 Desc.	Monitored stabilization on soil piles . No environmental issues observed at the time of inspection.		Pic 4 Desc.	Vegetation observation photo down row from stream crossing . No issues observed at the time of inspection.	
	North East Elevation

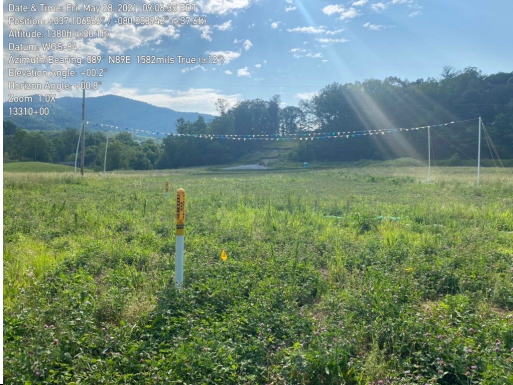
GPS Location				0		GPS Location				0			
Field Station#				13310+00		Field Station#				13309+09			
Pic 1 Desc.				ROW and ECDs in good condition, with good vegetation establishing across LOD				Pic 2 Desc.				MVP-S-GH7 Downstream in good condition	
<p>Date & Time: Fri, May 28, 2021, 09:14:45 AM Position: +33°06'00"N / -83°05'11"W (s=122.8 km) Altitude: 13306 (s=11.7 m) Datum: WGS-84 Azimuth/Bearing: 310° NWSE 3103mils True (s=10) Elevation Angle: +00.0° Horizon Angle: +00.0° Zoom: 1.0x 13306+00</p>

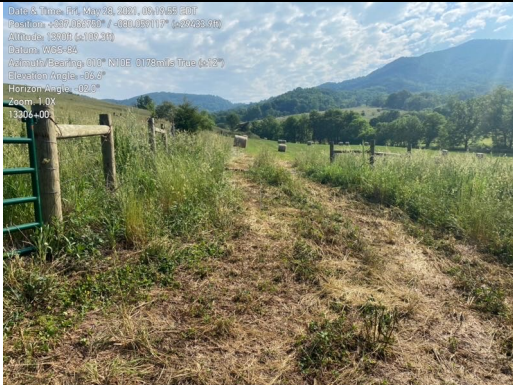
GPS Location				0		GPS Location				0			
Field Station#				13306+00		Field Station#				13292+00			
Pic 3 Desc.				Farmer crossing ROW for hay				Pic 4 Desc.				ROW and ECDs in good condition, with good vegetation establishing across LOD	
<p>Date & Time: Fri, May 28, 2021, 09:15:00 AM Position: +33°13'14"N / -83°05'00"W (s=122.8 km) Altitude: 13272 (s=11.7 m) Datum: WGS-84 Azimuth/Bearing: 300° NWSE 5333mils True (s=12) Elevation Angle: +17.1° Horizon Angle: +01.6° Zoom: 1.0x 13272+00</p>

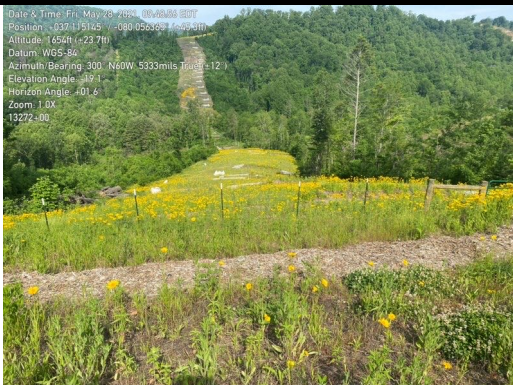
GPS Location				0		GPS Location				0			
Field Station#				13272+00		Field Station#				13262+62			
Pic 5 Desc.				ROW and ECDs in good condition, with good vegetation establishing across LOD				Pic 6 Desc.				Flanders Road Crossing in good condition. RCE in good condition

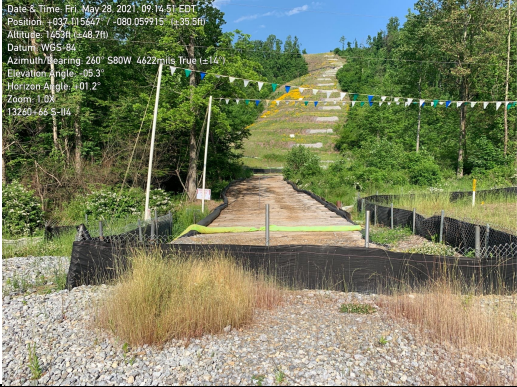
GPS Location 0		GPS Location 0			
Field Station# 13260+66		Field Station# 13260+66			
Pic 7 Desc. MVP-S-II4 in good condition		Pic 8 Desc. MVP-S-II4 Downstream in good condition			
<p>Date & Time: Fri, May 28, 2021, 09:25:55 EDT Position: +037.114438, -080.063020 (+39.5N) Altitude: 1453ft (+44.6m) Datum: WGS-84 Azimuth/Bearing: 270° S90W 4800mils True (+10°) Elevation Angle: +06.5° Horizon Angle: +03.9° Zoom: 1.0X 13253+00</p>

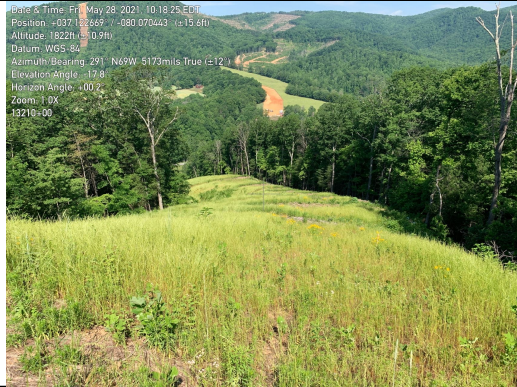
GPS Location 0		GPS Location 0			
Field Station# 13210+00		Field Station# 13197+55			
Pic 11 Desc. ROW and ECDs in good condition, with good vegetation establishing across LOD		Pic 12 Desc. Dillion's Mill Road Crossing in good condition

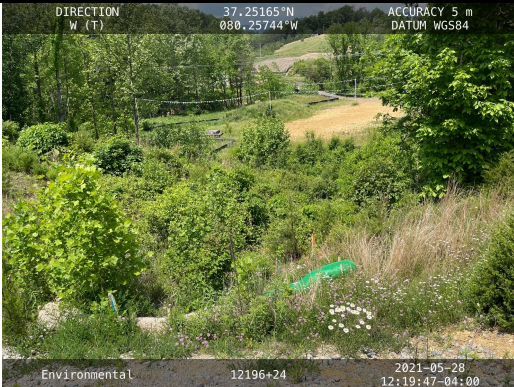
GPS Location	See photo		GPS Location	see photo	
Field Station#	12196+24		Field Station#	12198+64	
Pic 1 Desc.	Stream S-0011 on the West side of the previous location of the Railroad		Pic 2 Desc.	S-0011 on the East side of the railroad crossing

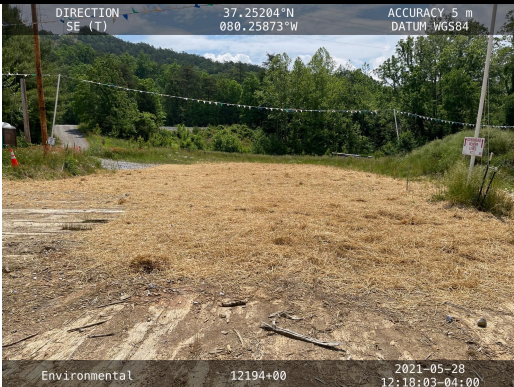
GPS Location	See photo		GPS Location	see photo	
Field Station#	12194+00		Field Station#	12192+50	
Pic 3 Desc.	Freshly stabilized ROW in acceptable condition		Pic 4 Desc.	Bridge and ECDs crossing S-C21 in acceptable condition

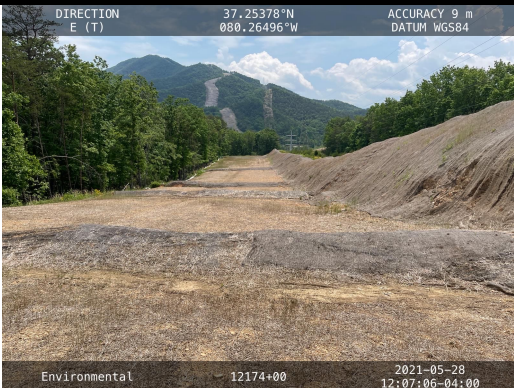
GPS Location	See photo		GPS Location	See photo	
Field Station#	12174+00		Field Station#	12166+47	
Pic 5 Desc.	Stabilized ROW In Acceptable condition		Pic 6 Desc.	Bridge and ECDs crossing S-C24 in acceptable condition

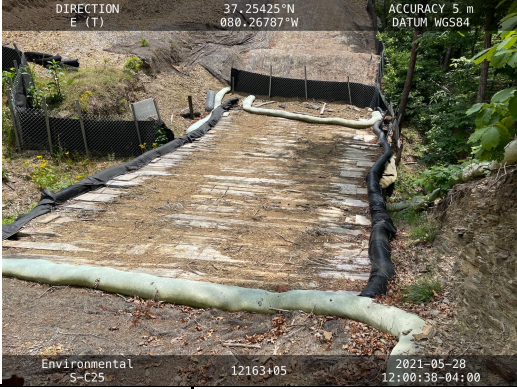
<p>DIRECTION E (T) 37.25425°N 080.26787°W ACCURACY 5 m DATUM WGS84</p> <p>Environmental S-C25 12163+05 2021-05-28 12:00:38-04:00</p>

<p>DIRECTION SW (T) 37.25422°N 080.26838°W ACCURACY 27 m DATUM WGS84</p> <p>Environmental 12160+00 2021-05-28 11:59:27-04:00</p>			
GPS Location	See photo		GPS Location	See photo	
Field Station#	12163+05		Field Station#	12160+00	
Pic 7 Desc.	Bridge and ECDs crossing stream S-C25 in acceptable condition		Pic 8 Desc.	Fill slope drain in acceptable condition

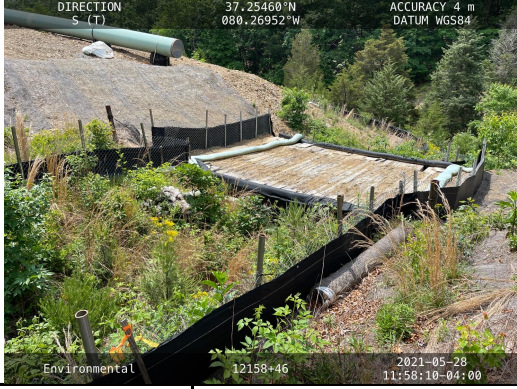
<p>DIRECTION S (T) 37.25460°N 080.26952°W ACCURACY 4 m DATUM WGS84</p> <p>Environmental 12158+46 2021-05-28 11:58:10-04:00</p>

Pic 9 Desc.	Clean water crossing in acceptable condition		Pic 10 Desc.	Bridge and ECDs crossing S-C33 in acceptable condition

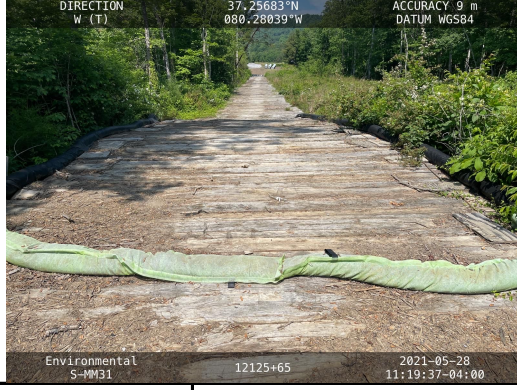
<p>DIRECTION W (T) 37.25683°N 080.28039°W ACCURACY 9 m DATUM WGS84</p> <p>Environmental S-MM31 12125+65 2021-05-28 11:19:37-04:00</p>

<p>DIRECTION W (T) 37.25546°N 080.27409°W ACCURACY 10 m DATUM WGS84</p> <p>Environmental W-C5 12144+47 2021-05-28 11:08:44-04:00</p>			
GPS Location	See photo		GPS Location	See photo	
Field Station#	12125+65		Field Station#	12144+47	
Pic 11 Desc.	Bridge and ECDs crossing S-MM31		Pic 12 Desc.	Bridge and ECDs crossing W-C5 in acceptable condition

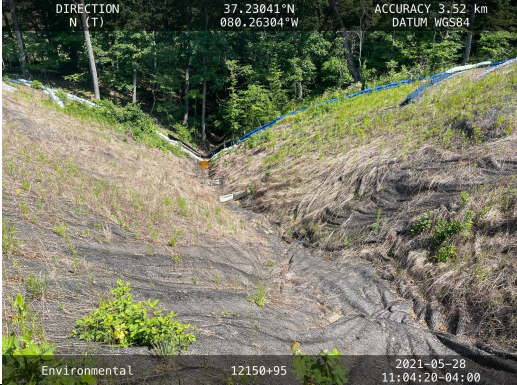
GPS Location	See photo		GPS Location	See photo	
Field Station#	12150+95		Field Station#	12230+00	
Pic 13 Desc.	Stabilized drainage feature in acceptable condition		Pic 14 Desc.	Stabilized ROW in acceptable condition

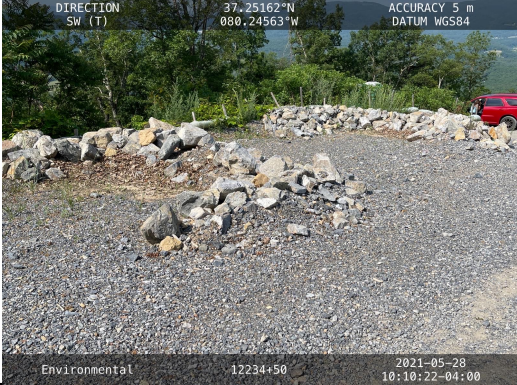
GPS Location	See photo		GPS Location	See photo	
Field Station#	12234+50		Field Station#	12236+00	
Pic 15 Desc.	Rock checks along access road MVP-MN-276.03 in acceptable condition		Pic 16 Desc.	Stabilized ROW in acceptable condition

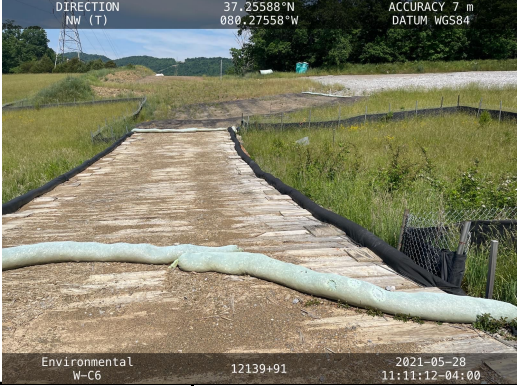
GPS Location	See photo		GPS Location	See photo	
Field Station#	12139+91		Field Station#	12132+73	
Pic 17 Desc.	Bridge and ECDs crossing W-C6 in acceptable condition		Pic 18 Desc.	Bridge and ECDs crossing S-C29 in acceptable condition
