Visual Site Inspection Report

Project Name	H-600 Pipeline Spread H	AFE	124300138	Spread	H-600 Pipeline Spread H
Contractor	Precision			Report #	24018
Inspector	Jason Nielsen			Date/Time	6/1/2021 6:46 PM
Permit #	TBD	Inspection Type	VA SWPP	Station Begin	12005+00
State	VA	Inspection Area	Partial	Station End	12119+17
County	Montgomery	Ground	Dry	Temperature (°F)	80.00
Municipality	N/A	Weather	Sunny	Rain Gauge (in)	0.00
				Rain Accumulation Time (days)	0.00

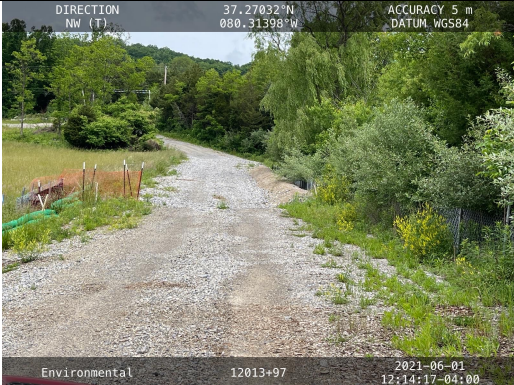
GPS Location	See photo		GPS Location	See photo	
Field Station#	12013+97		Field Station#	12007+00	
Pic 1 Desc.	Access Road MVP-MN-268 in acceptable condition		Pic 2 Desc.	Stabilized ROW In Acceptable condition

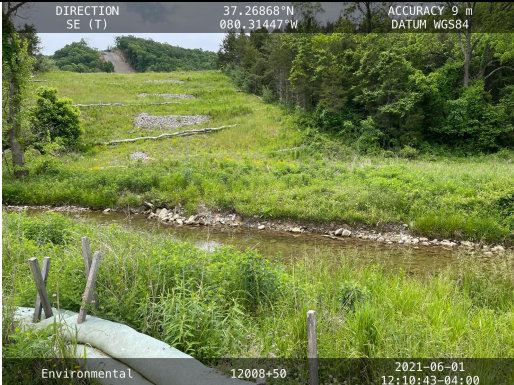
GPS Location	see photo		GPS Location	see photo	
Field Station#	12008+50		Field Station#	12013+97	
Pic 3 Desc.	Stream crossing S-G36 in acceptable condition		Pic 4 Desc.	Bridge and ECDs crossing S-G36 along access road MVP-MN-268 in acceptable condition

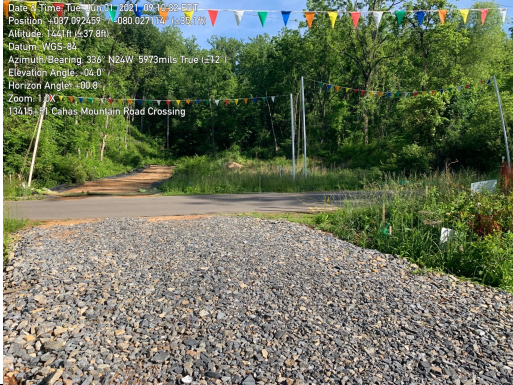
GPS Location	0	GPS Location	0		
Field Station#	13415+51	Field Station#	13413+05		
Pic 1 Desc.	Cahas Mountain Road Crossing and RCE in good condition and functioning properly		Pic 2 Desc.	MVP-S-IJ1 in good condition

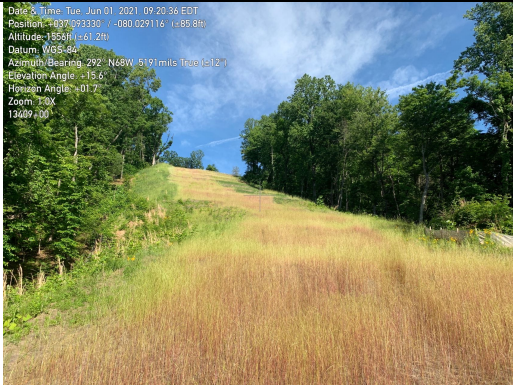
GPS Location	0	GPS Location	0		
Field Station#	13409+00	Field Station#	13379+00		
Pic 3 Desc.	ROW and ECDs in good condition, with good vegetation establishing across LOD		Pic 4 Desc.	ROW and ECDs in good condition, with good vegetation establishing across LOD

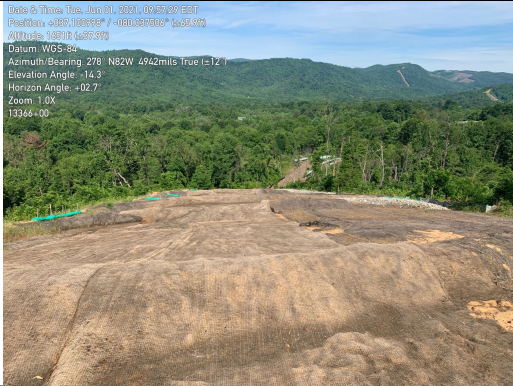
GPS Location	0	GPS Location	0		
Field Station#	13366+00	Field Station#	13358+64		
Pic 5 Desc.	ROW in good condition and stable		Pic 6 Desc.	MVP-S-RR11 in good condition

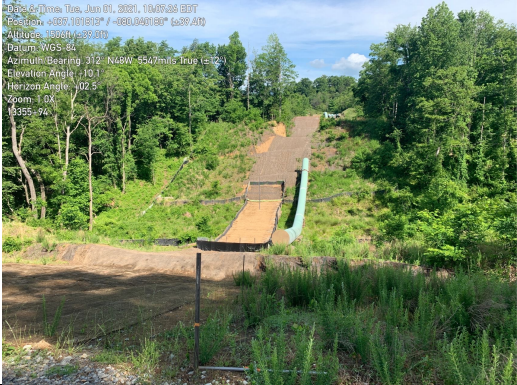
GPS Location	0	GPS Location	0		
Field Station#	13355+94	Field Station#	13352+23		
Pic 7 Desc.	ROW and ECDs in good condition, with good vegetation establishing across LOD		Pic 8 Desc.	MVP-S-RR09 in good condition	
<p>Date & Time: Tue, Jun 01, 2021, 10:14:45 EDT Position: +037.102023° / -080.040733° (-39.41) Altitude: 1503ft (-51.31) Datum: WGS-84 Azimuth/Bearing: 301° N24W 588mils True (-12.1) Elevation Angle: +18.0° Horizon Angle: +02.1° Zoom: 1.0X 13348+46</p>

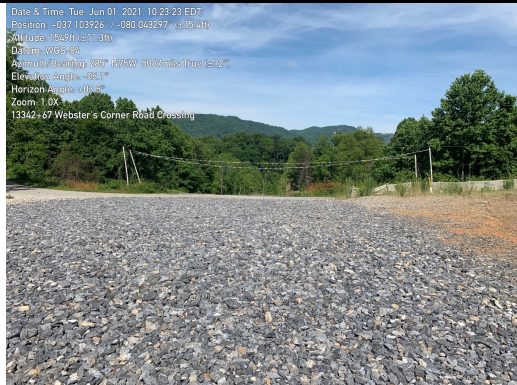
GPS Location	0	GPS Location	0		
Field Station#	13342+67	Field Station#	13342+32		
Pic 11 Desc.	Webster's Corner Road Crossing and RCE in good condition and functioning properly		Pic 12 Desc.	ROW and ECDs in good condition, with good vegetation establishing across LOD

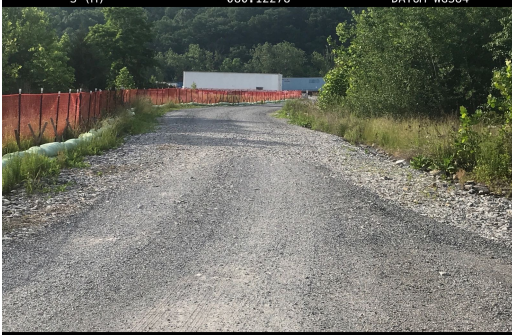
<div>MVP-LY-049_060221</div> <div>Condition of rock entrance</div> <div>2021-06-02 08:15:49-04:00</div> </div>		<div> <div>DIRECTION S (M)</div> <div>+37.27063° -080.12403°</div> <div>ACCURACY 98 ft DATUM WGS84</div>

<div>MVP-LY-049_060221</div> <div>Landowner disturbance along CFS</div> <div>2021-06-02 08:18:19-04:00</div> </div>			
GPS Location	MVP-LY-049 See photo for gps data		GPS Location	MVP-LY-049 See photo for gps data	
Field Station#	+0		Field Station#	+0	
Pic 1 Desc.	Condition of rock entrance on center drive. No sediment on stone. Looking S.		Pic 2 Desc.	Landowner soil disturbance along compost filter sock. Area no stabilized. No new damage to ECD's. Looking S.	
<div> <div>DIRECTION W (M)</div> <div>+37.27037° -080.12463°</div> <div>ACCURACY 16 ft DATUM WGS84</div>

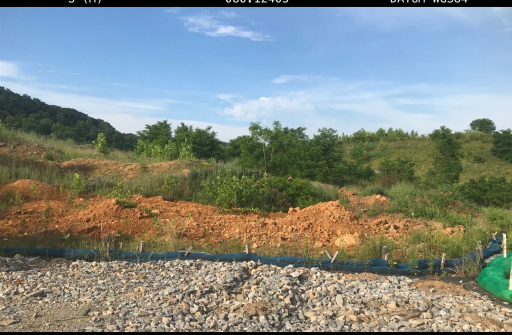
(Summary Spread 10) EI preformed SWPPP Inspection on Yard MVP-LY-049. Check raingauge and found 0 rainfall. Both rock entrances were in good condition, no sediment on the stone. EI observed the landowner has disturbed a soil pile along the compost filter sock. The area has not been stabilized. No damage to the ECD's. The Compost filter sock, safety fence, signage, and buffers at features W-CV21A, W-CV21B was functioning and being observed by contractor. The landowner has cleared brush and opened a soil pile a few feet north of feature W-CV21A. The area is not stabilized. The soil pile is not project related however it is on property the project has rented. The landowner used equipment approximately 66 feet and 120 feet west of the feature W-CV21B, leaving the soil disturbed. This area has not been stabilized. The landowner has used equipment next to the compost filter sock and feature W-CV21B leaving the area disturbed. The area has not been stabilized. No impacts to feature. EI will continue to monitor daily. EI check the equipment in the yard for leaks. No new leaks found. Containments have been placed under equipment with fluid drips. No vandalism to the equipment was noted. The containment under the light plants were in good condition, and free of stormwater. EI check the area around the temporary trash transfer pit. Most of the debris has been removed from the pit. The compost filter sock around the sand pile was in place and functioning. The trays and containments under the toilets were in good condition. EI checked the boundary of the LOD and found the triple stack compost filter sock and the safety fence were functioning, but showing signs of weathering. Grasses and other vegetation have over grown the compost filter sock along much the LOD. EI check the parked trucks and trailers for new leaks. No new leaks located. Containments have been placed under vehicles found to be dripping fluids. EI inspected around the three hazardous waste dumpsters, no fluids or debris were observed around the dumpsters. It was noted that 10 rubber trap straps were broken or missing from the hazardous waste dumpsters. EI found no loose trash around the south dumpsters, or in the yard. The restoration supplies were under cover. The containment for the barrel of toilet chemical was free of stormwater. No other environmental issues were noted during today's inspection.

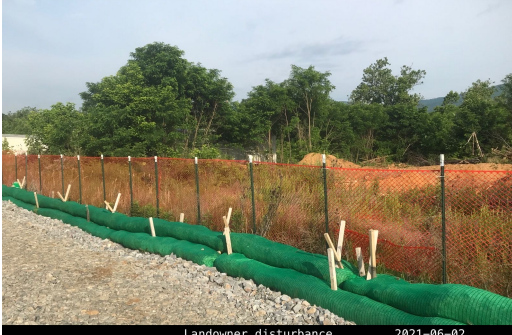
<div>MVP-LY-049_060221</div> <div>Landowner disturbance along feature</div> <div>2021-06-02 08:18:56-04:00</div> </div>		<div> <div>DIRECTION SW (M)</div> <div>+37.27040° -080.12466°</div> <div>ACCURACY 16 ft DATUM WGS84</div>

GPS Location	MVP-LY-049 See photo for gps data		GPS Location	MVP-LY-049 See photo for gps data	
Field Station#	+0		Field Station#	+0	
Pic 3 Desc.	Landowner soil disturbance along feature W-CV21A. Area not stabilized. Looking W.		Pic 4 Desc.	Landowner soil disturbance within 66' and 120' west of feature W-CV21B. Areas not stabilized. Looking SW.	
<div> <div>DIRECTION S (M)</div> <div>+37.27043° -080.12469°</div> <div>ACCURACY 16 ft DATUM WGS84</div>

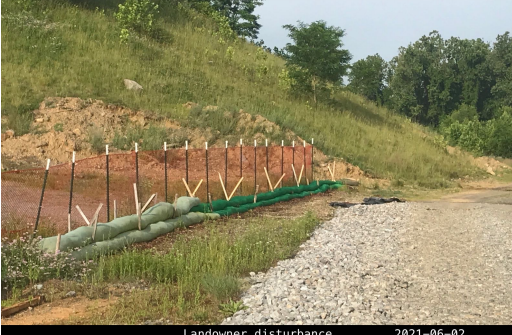
<div>MVP-LY-049_060221</div> <div>Landowner disturbance within 66' of feature</div> <div>2021-06-02 08:19:02-04:00</div> </div>

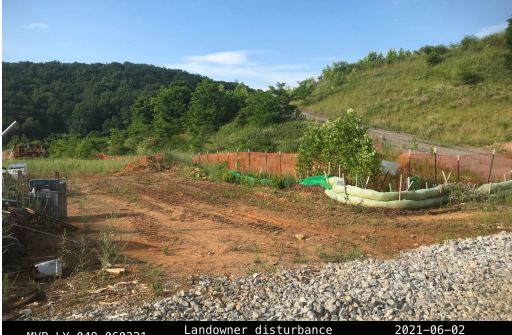
<div>MVP-LY-049_060221</div> <div>Landowner disturbance along CFS & feature</div> <div>2021-06-02 08:19:11-04:00</div> </div>		<div> <div>DIRECTION E (M)</div> <div>+37.26965° -080.12434°</div> <div>ACCURACY 33 ft DATUM WGS84</div>

Field Station#	+0		Field Station#	+0	
Pic 5 Desc.	Landowner soil disturbance along compost filter sock and east of feature W-CV21B. Area not stabilized.looking S.		Pic 6 Desc.	Condition of containment under stored equipment. Looking E.

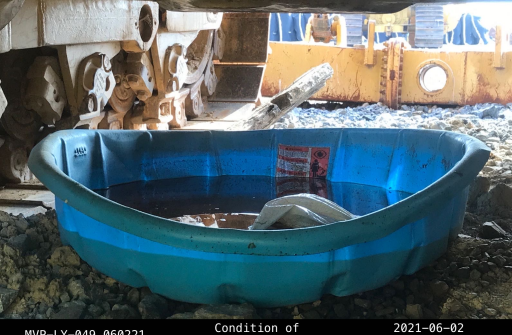
<div>MVP-LY-049_060221</div> <div>Condition of containment under st...</div> <div>2021-06-02 08:22:52-04:00</div> </div>			
GPS Location	MVP-LY-049 See photo for gps data		GPS Location	MVP-LY-049 See photo for gps data

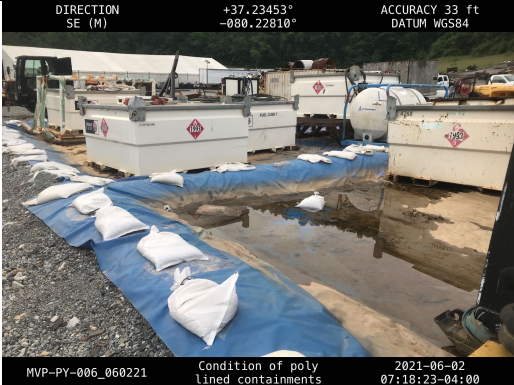
<p>DIRECTION SE (M) +37.23453° -080.22810° ACCURACY 33 ft DATUM WGS84</p> <p>MVP-PY-006_060221 Condition of poly lined containments 2021-06-02 07:18:23-04:00</p>

<p>DIRECTION E (M) +37.23465° -080.22804° ACCURACY 0.74 m1 DATUM WGS84</p> <p>MVP-PY-006_060221 Condition of containment 2021-06-02 07:19:55-04:00</p>			
GPS Location	MVP-PY-006 See photo for gps data		GPS Location	MVP-PY-006 See photo for gps data	
Field Station#	+0		Field Station#	+0	
Pic 1 Desc.	Condition of poly lined rock berm containments . Holding some stormwater. Looking SE.		Pic 2 Desc.	Condition of containment under used oil containers. Holding stormwater. Looking E.

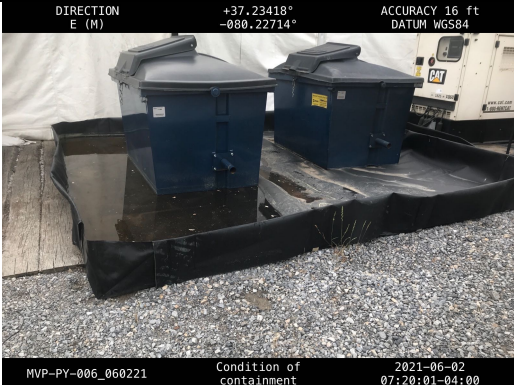
<p>DIRECTION E (M) +37.23418° -080.22714° ACCURACY 16 ft DATUM WGS84</p> <p>MVP-PY-006_060221 Condition of containment 2021-06-02 07:20:01-04:00</p>

GPS Location	MVP-PY-006 See photo for gps data		GPS Location	MVP-PY-006 See photo for gps data	
Field Station#	+0		Field Station#	+0	
Pic 3 Desc.	Condition of containment under hazardous waste dumpsters. Holding stormwater no sheen noted. Looking E.		Pic 4 Desc.	Condition of trays and containment under toilets. Holding stormwater. Looking SE.

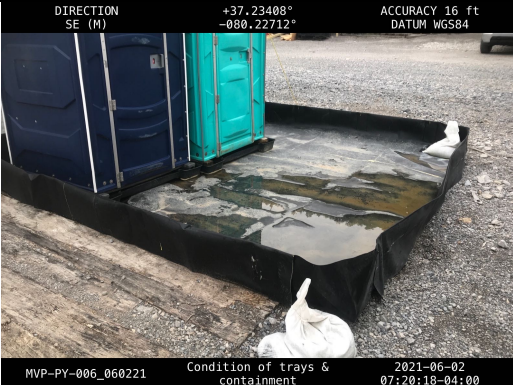
<p>DIRECTION SE (M) +37.23408° -080.22712° ACCURACY 16 ft DATUM WGS84</p> <p>MVP-PY-006_060221 Condition of trays & containment 2021-06-02 07:20:18-04:00</p>

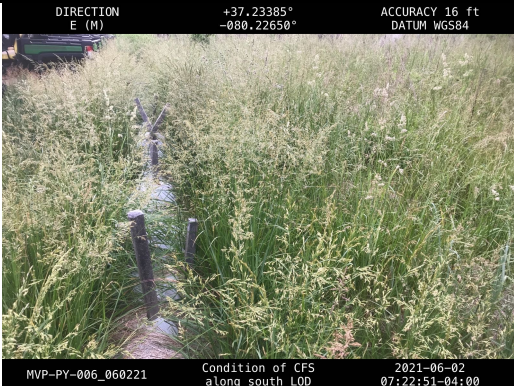
<p>DIRECTION E (M) +37.23385° -080.22658° ACCURACY 16 ft DATUM WGS84</p> <p>MVP-PY-006_060221 Condition of CFS along south LOD 2021-06-02 07:22:51-04:00</p>

<p>DIRECTION W (M) +37.23391° -080.22651° ACCURACY 16 ft DATUM WGS84</p> <p>MVP-PY-006_060221 Condition of CFS along south LOD 2021-06-02 07:23:02-04:00</p>			
GPS Location	MVP-PY-006 See photo for gps data		GPS Location	MVP-PY-006 See photo for gps data	
Field Station#	+0		Field Station#	+0	
Pic 5 Desc.	Condition of Compost filter sock along south LOD. Looking E.		Pic 6 Desc.	Condition of compost filter sock along south LOD. Looking W.

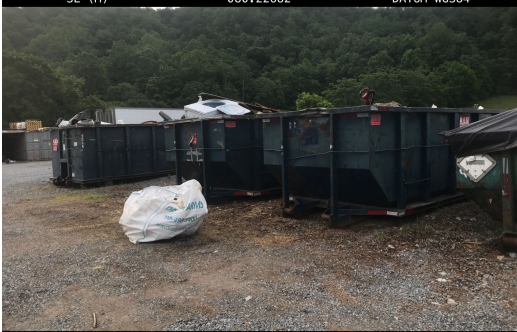
MVP-PY-006_060221 No loose trash around dumpsters 2021-06-02 07:31:21-04:00		MVP-PY-006_060221 Restoration supplies under cover 2021-06-02 07:32:02-04:00

GPS Location	MVP-PY-006 See photo for gps data		GPS Location	MVP-PY-006 See photo for gps data	
Field Station#	+0		Field Station#	+0	
Pic 15 Desc.	No loose trash around dumpsters. Looking SE.		Pic 16 Desc.	Restoration supplies under cover. Looking E.	
DIRECTION W (M) +37.23606° ACCURACY 16 ft -080.22782° DATUM WGS84		DIRECTION SW (M) +37.23609° ACCURACY 16 ft -080.22758° DATUM WGS84

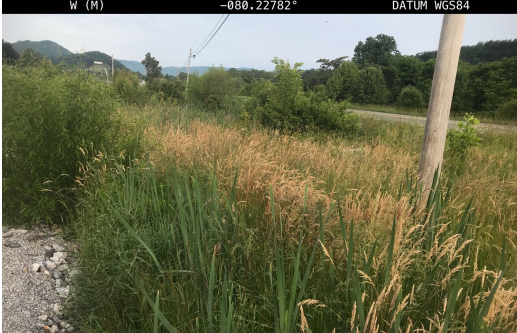
MVP-PY-006_060221 Condition of CFS & signage 2021-06-02 07:37:32-04:00		MVP-PY-006_060221 Condition of posted project documents 2021-06-02 07:38:20-04:00			
GPS Location	MVP-PY-006 See photo for gps data		GPS Location	MVP-PY-006 See photo for gps data	
Field Station#	+0		Field Station#	+0	
Pic 17 Desc.	Condition of compost filter sock and signage at feature W-008. Over grown with vegetation. Looking W.		Pic 18 Desc.	Condition of posted project documents at main entrance. Looking SW.

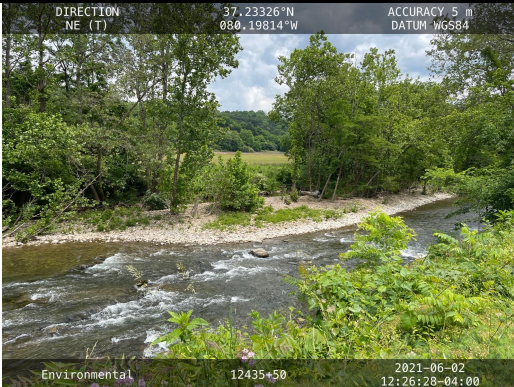
GPS Location	See photo		GPS Location	See photo	
Field Station#	12435+50		Field Station#	12437+70	
Pic 1 Desc.	Stream crossing S-NN16 in acceptable condition		Pic 2 Desc.	Stabilized slope in acceptable condition

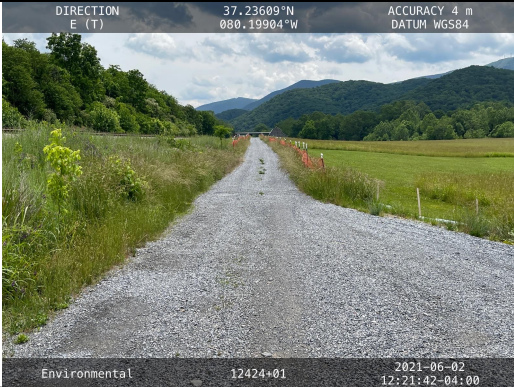
GPS Location	See photo		GPS Location	See photo	
Field Station#	12424+01		Field Station#	12418+00	
Pic 3 Desc.	Access Road MVP-MN-279 in acceptable condition		Pic 4 Desc.	Stabilized ROW in acceptable condition

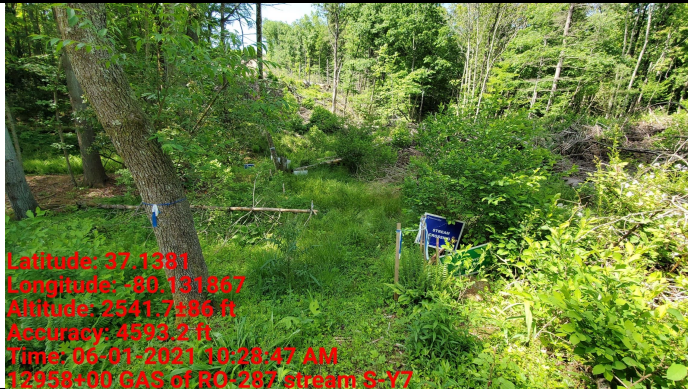
Latitude: 37.1381 Longitude: -80.131867 Altitude: 2541.7±86 ft Accuracy: 43.2 ft Time: 06-01-2021 10:28:47 AM 12958+00 GAS of RO-287 stream S-Y7			Latitude: 37.134294 Longitude: -80.137464 Elevation: 2703.87±49 ft Accuracy: 34.2 ft Time: 06-01-2021 10:29:43 AM 12958+50 GAS of RO-287 stream S-Y8		
GPS Location	See pic for GPS location		GPS Location	See pic for GPS location	
Field Station#	12958+00		Field Station#	12958+50	
Pic 1 Desc.	Downstream side of stream S-Y7.		Pic 2 Desc.	Downstream side of stream S-Y8.

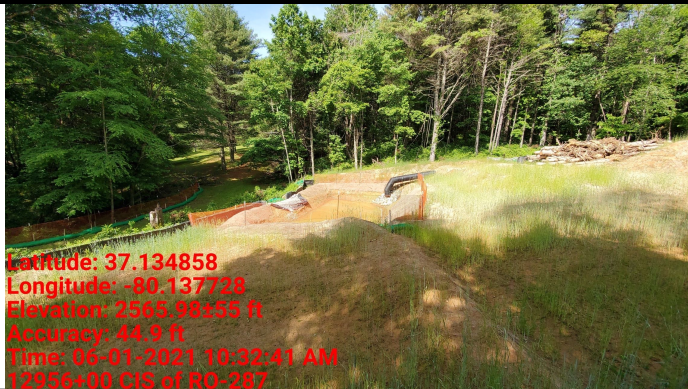
Field Station#	12956+00		Field Station#	12949+50	
Pic 3 Desc.	Waterbar and sediment trap on the CIS of RO-287.		Pic 4 Desc.	Current ROW conditions on the GAS of S-IJ43.

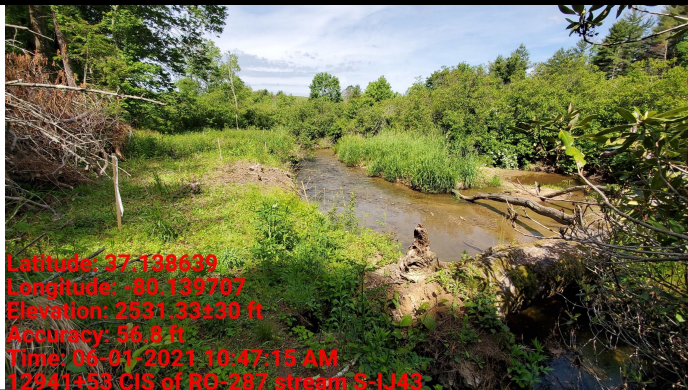
Latitude: 37.138639 Longitude: -80.139707 Elevation: 2531.33±30 ft Accuracy: 56.8 ft Time: 06-01-2021 10:47:15 AM 12941+53 CIS of RO-287 stream S-IJ43			Latitude: 37.134827 Longitude: -80.138049 Elevation: 2624.74±71 ft Accuracy: 34.4 ft Time: 06-01-2021 11:05:29 AM 12955+50 CIS of RO-287		
GPS Location	See pic for GPS location		GPS Location	See pic for GPS location	
Field Station#	12941+53		Field Station#	12955+50	
Pic 5 Desc.	Stream S-IJ43 from the GAS.		Pic 6 Desc.	Drain pipe for waterbars in cut on the CIS of RO-287.

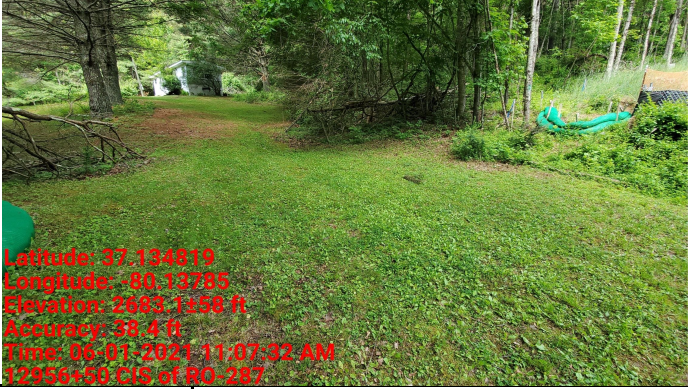
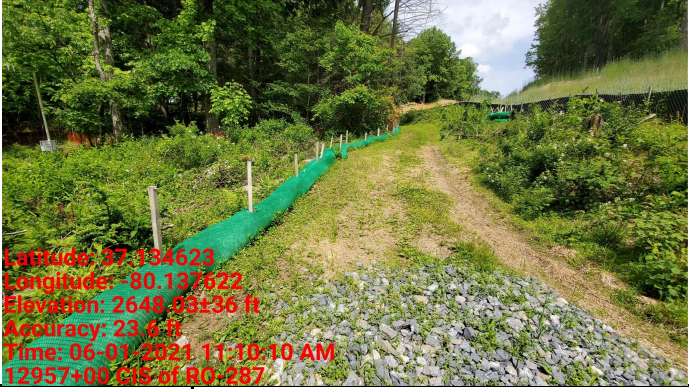
<p>Latitude: 37.134623 Longitude: -80.127622 Elevation: 2648.9±36 ft Accuracy: 23.4 ft Time: 06-01-2021 11:10:10 AM 12957+00 GIS of RO-287</p>			
GPS Location	See pic for GPS location		GPS Location	See pic for GPS location	
Field Station#	12956+50		Field Station#	12957+00	
Pic 7 Desc.	Landowner mowed area between 50' buffer ECD's and streams S-Y7 and S-Y9.		Pic 8 Desc.	Landowner mowed area between 50' buffer ECD's and streams S-Y7 and S-Y9.

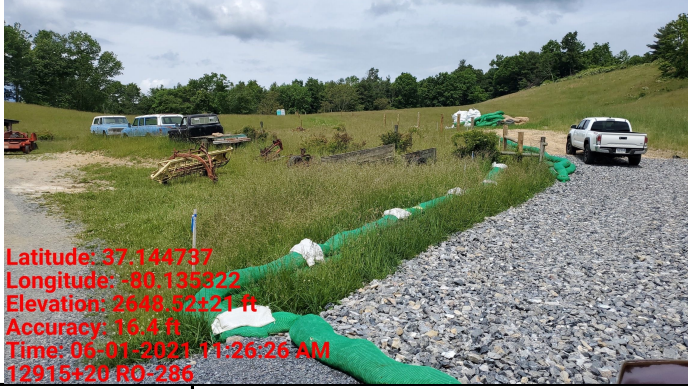
GPS Location	See pic for GPS location		GPS Location	See pic for GPS location	
Field Station#	12915+20		Field Station#	12915+20	
Pic 9 Desc.	Access road RO-286 at edge of driveway.		Pic 10 Desc.	Access road RO-286 near gate.

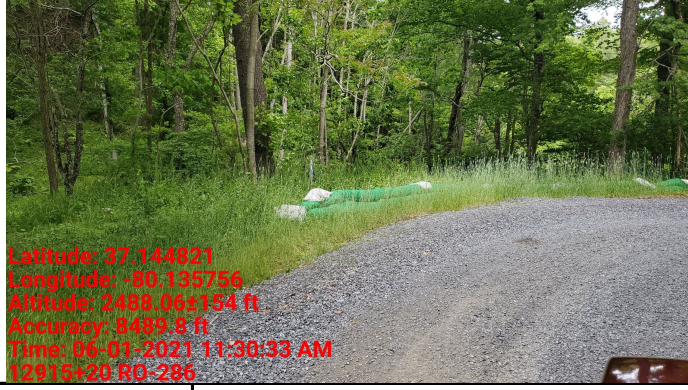
<p>Latitude: 37.129987 Longitude: -80.136302 Elevation: 2650.0±31 ft Accuracy: 43.3 ft Time: 06-01-2021 12:07:09 PM 12976+00 GAS of RO-288</p>			
GPS Location	See pic for GPS location		GPS Location	See pic for GPS location	
Field Station#	12915+20		Field Station#	12976+00	
Pic 11 Desc.	ECD's and BMP's along RO-286 remain in acceptable condition.		Pic 12 Desc.	CWDP and plunge pool on the GAS of RO-288.

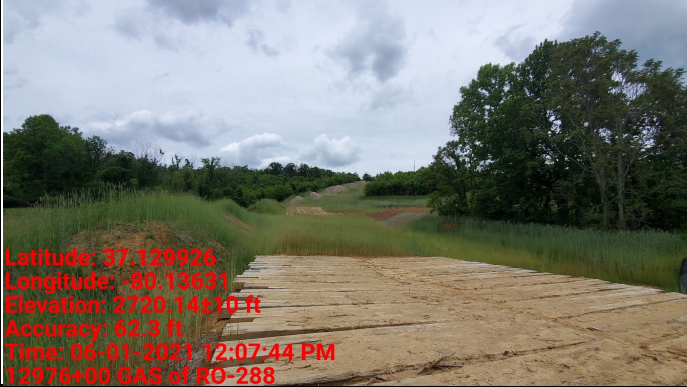
Latitude: 37.129926 Longitude: -80.13631 Elevation: 2720.14±10 ft Accuracy: 62.3 ft Time: 06-01-2021 12:07:44 PM 12976+00 GAS of RO-288			Latitude: 37.12993 Longitude: -80.1363 Elevation: 2725.85±10 ft Accuracy: 115.5 ft Time: 06-01-2021 12:08:02 PM 12976+00 GAS of RO-288		
GPS Location	See pic for GPS location		GPS Location	See pic for GPS location	
Field Station#	12976+00		Field Station#	12976+00	
Pic 13 Desc.	Current ROW conditions at RO-288.		Pic 14 Desc.	Current ROW conditions on the GAS of RO-288.

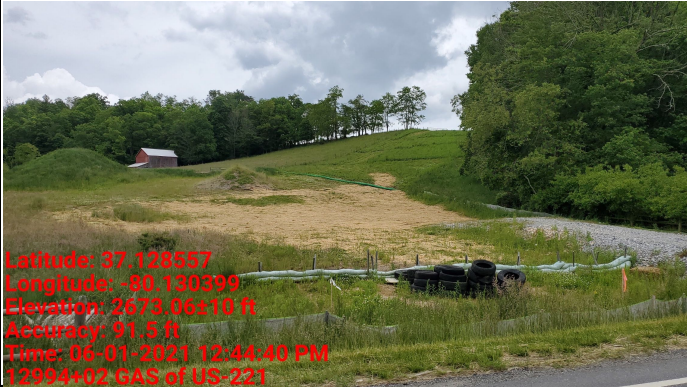
Field Station#	12994+02		Field Station#	13012+40	
Pic 15 Desc.	GAS of the US-221 road crossing.		Pic 16 Desc.	CIS of the BRP motorway.

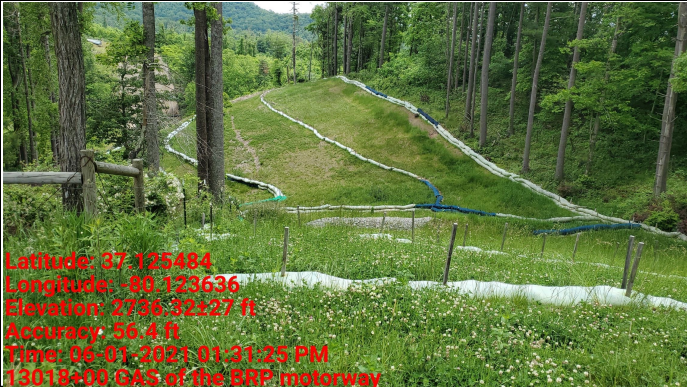
Latitude: 37.125484 Longitude: -80.123636 Elevation: 2736.32±10 ft Accuracy: 55.4 ft Time: 06-01-2021 01:31:25 PM 13018+00 GAS of the BRP motorway			Latitude: 37.125634 Longitude: -80.124586 Elevation: 2726.51±10 ft Accuracy: 28.5 ft Time: 06-01-2021 01:32:45 PM 13015+00 GAS of the BRP motorway		
GPS Location	See pic for GPS location		GPS Location	See pic for GPS location	
Field Station#	13018+00		Field Station#	13015+00	
Pic 17 Desc.	Wooded portion of the BRP.		Pic 18 Desc.	GAS of the BRP motorway.

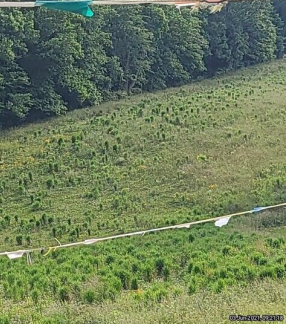
GPS Location	00000	GPS Location	00000		
Field Station#	13499+00	Field Station#	13421+60		
Pic 1 Desc.	Permanent vegetation photo showing good growth and coverage.		Pic 2 Desc.	Permanent vegetation area monitored , showing good coverage near stream crossing. No issues observed at the time of inspection.	
	South East Elevation <small>322°NW (T) • 37.091784, -80.025839 ±6 m ▲ 424 m</small>

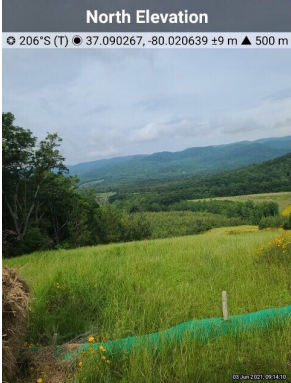
<p>Insert image here</p>		<p>Insert image here</p>	
GPS Location	0000	GPS Location			
Field Station#	13436+20	Field Station#			
Pic 7 Desc.	Vegetation observation photo facing down hill towards stream crossing with good coverage noted in permanent area by the EI.		Pic 8 Desc.		
<p>Insert image here</p>		<p>Insert image here</p>			
GPS Location		GPS Location			
Field Station#		Field Station#			
Pic 9 Desc.		Pic 10 Desc.			
<p>Insert image here</p>		<p>Insert image here</p>			
GPS Location		GPS Location			
Field Station#		Field Station#			
Pic 11 Desc.		Pic 12 Desc.

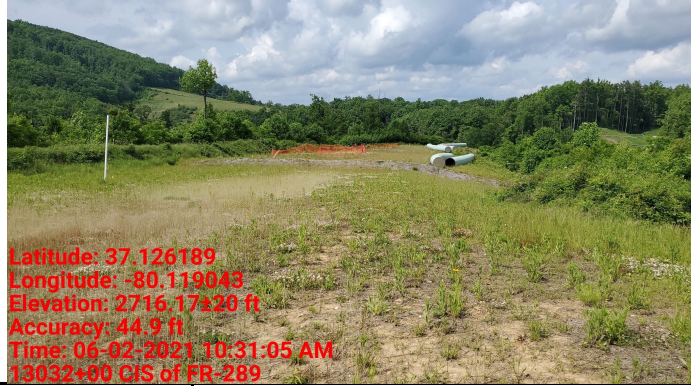
<p>Latitude: 37.125337 Longitude: -80.12098 Elevation: 2664.27±41 ft Accuracy: 29.2 ft Time: 06-02-2021 10:46:25 AM 13025+50 CIS of FR-289 streams S-G24 and S-G25</p>		
GPS Location	See pic for GPS location		GPS Location	See pic for GPS location	
Field Station#	13032+00		Field Station#	13025+50	
Pic 1 Desc.	Current temporary stabilization conditions on the CIS of FR-289.		Pic 2 Desc.	Stream crossing on the GAS of the BRP.

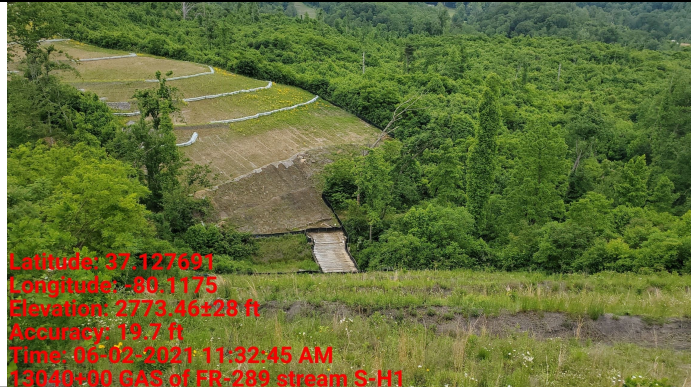
GPS Location	See pic for GPS location		GPS Location	See pic for GPS location	
Field Station#	13040+00		Field Station#	13063+50	
Pic 3 Desc.	Stream crossing S-H1 on the GAS of FR-289.		Pic 4 Desc.	Current ROW conditions on the GAS of FR-290.

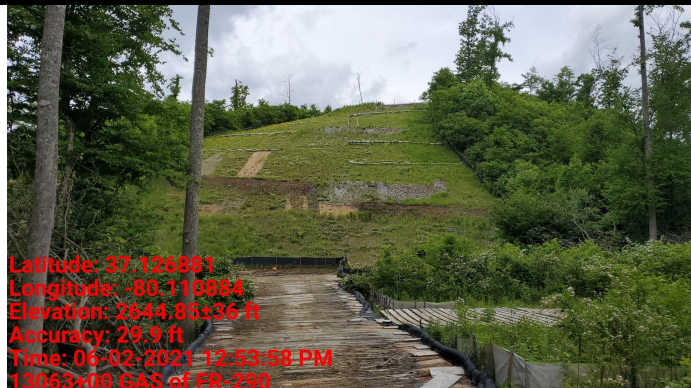
<p>Latitude: 37.126897 Longitude: -80.110929 Elevation: 2638.85±33 ft Accuracy: 28.9 ft Time: 06-02-2021 12:54:29 PM 13063+00 GAS of FR-290 stream S-G27</p>		
GPS Location	See pic for GPS location		GPS Location	See pic for GPS location	
Field Station#	13063+00		Field Station#	13063+00	
Pic 5 Desc.	Slope on the CIS of FR-290 from the GAS.		Pic 6 Desc.	Downstream side of stream S-G27.

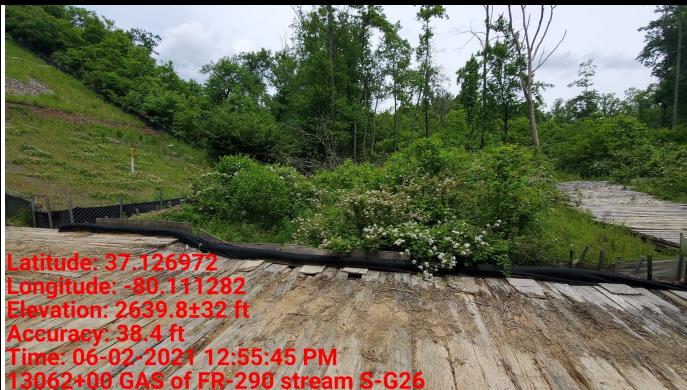
GPS Location	See pic for GPS location		GPS Location	See pic for GPS location	
Field Station#	13062+00		Field Station#	13061+44	
Pic 9 Desc.	Upstream side of stream S-G26.		Pic 10 Desc.	Downstream side of stream S-RR18.

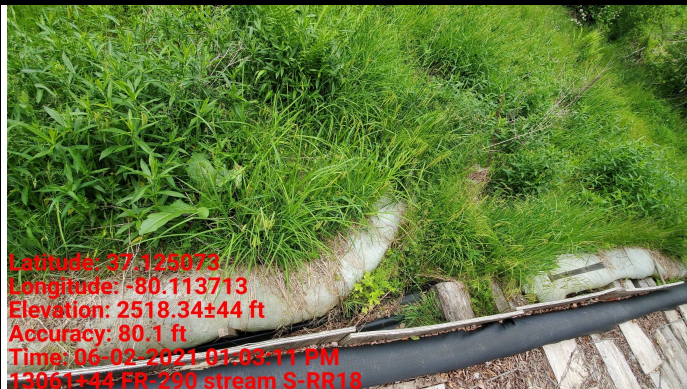
<p>Latitude: 37.123921 Longitude: -80.115509 Elevation: 2588.78±71 ft Accuracy: 173.9 ft Time: 06-02-2021 01:07:46 PM 13061+44 FR-290 stream S-RR16</p>		
GPS Location	See pic for GPS location		GPS Location	See pic for GPS location	
Field Station#	13061+44		Field Station#	13061+44	
Pic 11 Desc.	Upstream side of stream S-RR18.		Pic 12 Desc.	Downstream side of stream S-RR16.

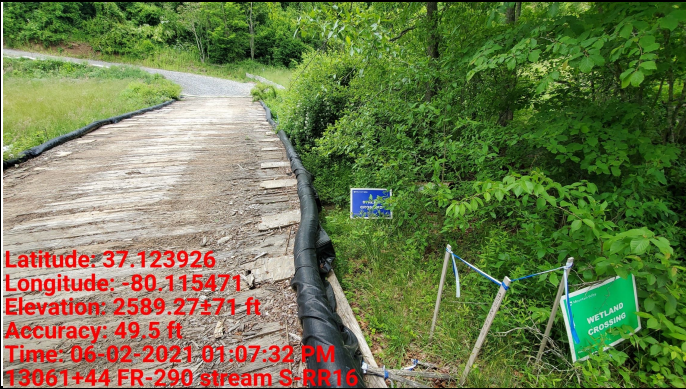
<p>Latitude: 37.123897 Longitude: -80.115615 Elevation: 2589.86132 ft Accuracy: 63.3 ft Time: 06-02-2021 01:08:22 PM 13061+44 FR-290 stream S-RR16</p>		
GPS Location	See pic for GPS location		GPS Location	See pic for GPS location	
Field Station#	13061+44		Field Station#	13061+44	
Pic 13 Desc.	Upstream side of stream S-RR16.		Pic 14 Desc.	Access FR-290 at stream crossing S-RR16.

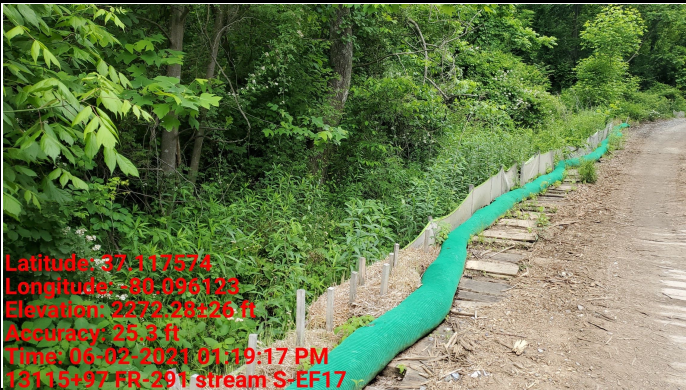
GPS Location	See pic for GPS location		GPS Location	See pic for GPS location	
Field Station#	13115+97		Field Station#	13113+00	
Pic 15 Desc.	Upstream side of stream S-EF17 on FR-291.		Pic 16 Desc.	Current restored ROW conditions on the CIS of FR-291.

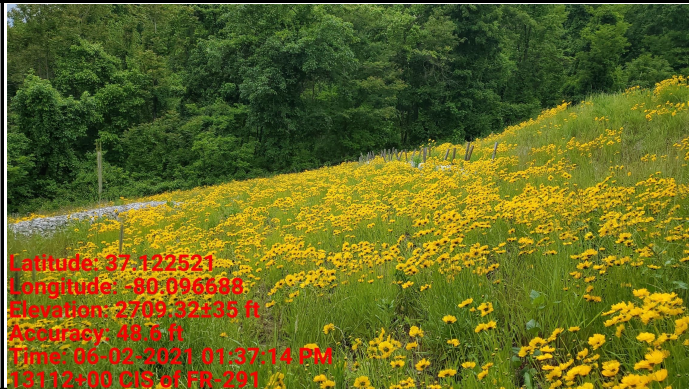
<p>Latitude: 37.122521 Longitude: -80.096888 Elevation: 2709.32136 ft Accuracy: 40.5 ft Time: 06-02-2021 01:37:14 PM 13112+00 CIS of FR-291</p>		
GPS Location	See pic for GPS location		GPS Location	See pic for GPS location	
Field Station#	13112+00		Field Station#	13112+00	
Pic 17 Desc.	Temporary CFS waterbars extensions remain in acceptable condition.		Pic 18 Desc.	Permanent Slope Breakers and Rock Level Spreaders remain in compliance throughout the area.

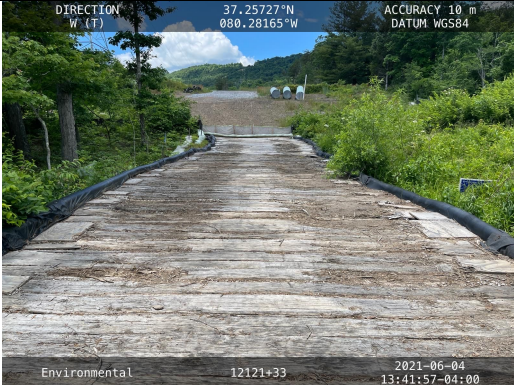
GPS Location	See photo		GPS Location	See photo	
Field Station#	12121+33		Field Station#	12125+65	
Pic 1 Desc.	Bridge and ECDs crossing at stream crossing S-C33 in acceptable condition		Pic 2 Desc.	Bridge and ECDs at stream crossing S-MM31 in acceptable condition

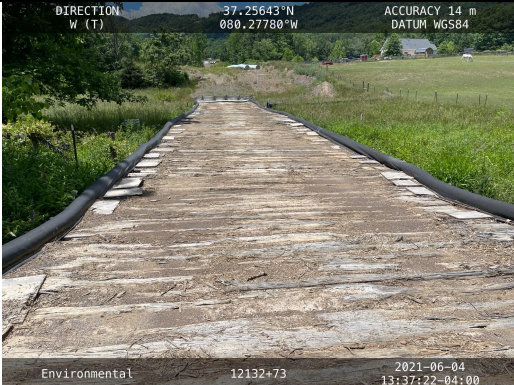
GPS Location	See photo		GPS Location	See photo	
Field Station#	12132+73		Field Station#	12139+91	
Pic 3 Desc.	Bridge and ECDs at stream crossing S-C29 in acceptable condition		Pic 4 Desc.	Bridge and ECDs crossing wetland W-C6 in acceptable condition

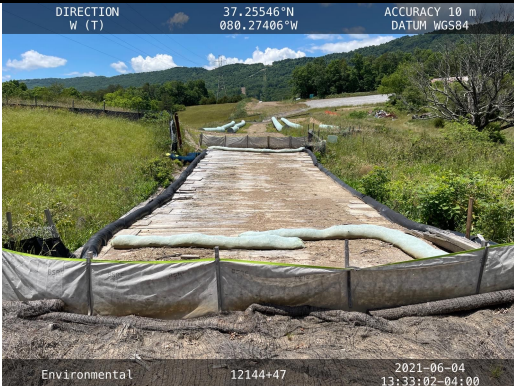
GPS Location	See photo		GPS Location	See photo	
Field Station#	12144+47		Field Station#	12150+95	
Pic 5 Desc.	Bridge and ECDs crossing wetland W-C5 in acceptable condition		Pic 6 Desc.	Stabilized drainage feature in acceptable condition

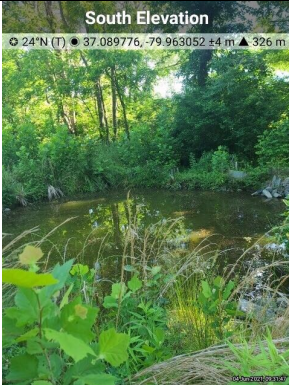
GPS Location	00000	GPS Location	0000		
Field Station#	13640+10	Field Station#	13541+50		
Pic 1 Desc.	Observed clean water diversions and plunge pools as well as outlet protection. No issues observed at the time of inspection I		Pic 2 Desc.	Monitored RCEs and vegetation while checking rain gauges . No issues observed at the time of inspection.	
	North West Elevation

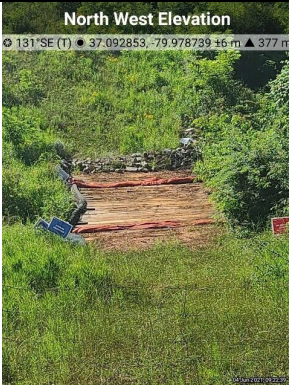
GPS Location	00000	GPS Location	0000		
Field Station#	13579+12	Field Station#	13580+30		
Pic 3 Desc.	Monitored equipment bridge and protection, inspected stream ECDs and vegetation. No issues observed at the time of inspection.		Pic 4 Desc.	Permanent vegetation area monitored during row inspection today. Good coverage noted. Black locust trees observed growing inside the	
	South West Elevation

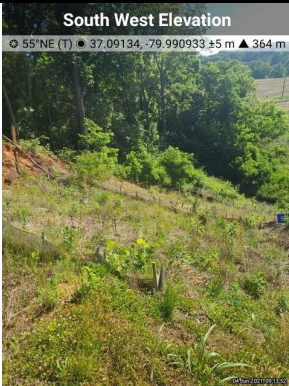
GPS Location	00000	GPS Location	00000		
Field Station#	13541+89	Field Station#	13541+90		
Pic 5 Desc.	Monitored ECDs and vegetation on hill side above stream crossing. Good stabilization noted. No issues observed at the time of inspection		Pic 6 Desc.	Monitored equipment bridge and protection, inspected stream ECDs and vegetation. No issues observed at the time of inspection.

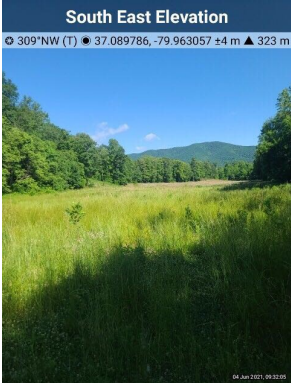
Insert image here		Insert image here	
GPS Location	00000	GPS Location			
Field Station#	13638+00	Field Station#			
Pic 7 Desc.	Vegetation observation photo facing up row from stream crossing. Good coverage noted. No environmental issues observed at the time of inspection.		Pic 8 Desc.		
Insert image here		Insert image here			
GPS Location		GPS Location			
Field Station#		Field Station#			
Pic 9 Desc.		Pic 10 Desc.			
Insert image here		Insert image here			
GPS Location		GPS Location			
Field Station#		Field Station#			
Pic 11 Desc.		Pic 12 Desc.

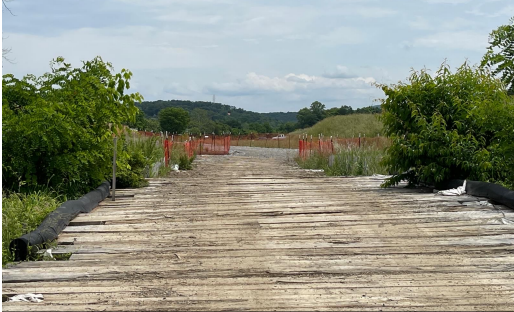
<div>Environmental 12478+00 2021-06-03 12:42:52-04:00</div> </div>			
GPS Location	See photo		GPS Location	See photo	
Field Station#	12455+21		Field Station#	12468+00	
Pic 1 Desc.	Bridge and ECDs crossing stream S-CD12b in acceptable condition		Pic 2 Desc.	Stabilized ROW in acceptable condition	
<div> <div>DIRECTION NW (T)</div> <div>37.22269°N 080.20165°W</div> <div>ACCURACY 7 m DATUM WGS84</div>

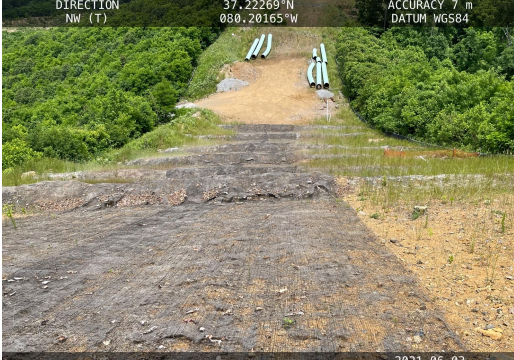
GPS Location	See photo		GPS Location	See photo	
Field Station#	12485+00		Field Station#	12495+00	
Pic 3 Desc.	Stabilized slope in acceptable condition		Pic 4 Desc.	Stabilized ROW in acceptable condition	
<div> <div>DIRECTION SE (T)</div> <div>37.21840°N 080.20036°W</div> <div>ACCURACY 7 m DATUM WGS84</div>

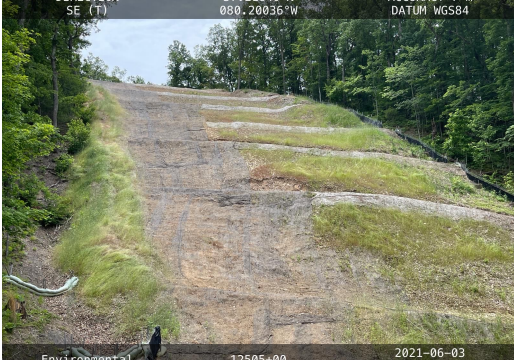
<div>Environmental 12504+00 2021-06-03 12:21:56-04:00</div> </div>			
GPS Location	See photo		GPS Location	See photo	
Field Station#	12505+00		Field Station#	12504+00	
Pic 5 Desc.	Stabilized slope in acceptable condition		Pic 6 Desc.	Clean water crossing pipe outlet in acceptable condition

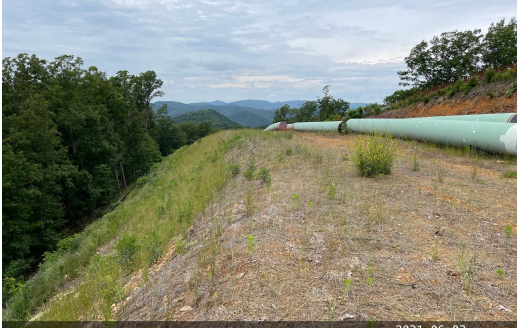
Environmental 12510+00 2021-06-03 12:02:07-04:00		Environmental 12521+00 2021-06-03 11:49:02-04:00			
GPS Location	See photo		GPS Location	See photo	
Field Station#	12510+00		Field Station#	12521+00	
Pic 7 Desc.	Stabilized ROW in acceptable condition		Pic 8 Desc.	Stabilized slope in GAS of S-EF19 in acceptable condition	
DIRECTION N (T) 37.19635°N 080.23235°W ACCURACY 2.00 km DATUM WGS84		DIRECTION N (T) 37.21530°N 080.19728°W ACCURACY 10 m DATUM WGS84

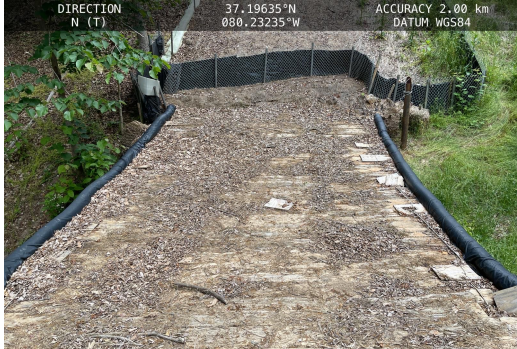
Environmental 12519+41 2021-06-03 11:42:04-04:00		Environmental 12516+00 2021-06-03 11:14:55-04:00			
GPS Location	See photo		GPS Location	See photo	
Field Station#	12519+41		Field Station#	12516+00	
Pic 9 Desc.	Bridge and ECDs crossing stream S-EF19 in acceptable condition		Pic 10 Desc.	Stabilized slope on the CIS of S-EF19 in acceptable condition

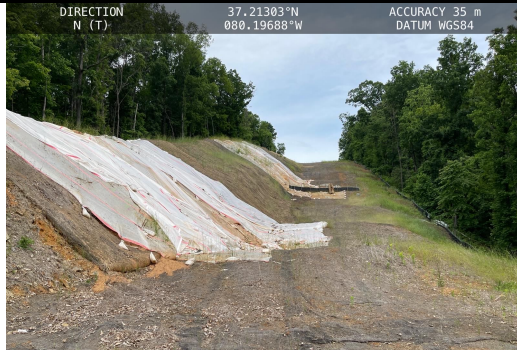
Environmental 12527+00 2021-06-03 10:57:32-04:00		Environmental 12530+00 2021-06-03 10:47:46-04:00			
GPS Location	See photo		GPS Location	See photo	
Field Station#	12527+00		Field Station#	12530+00	
Pic 11 Desc.	Plastic covered spoil pile and cut bank in acceptable condition		Pic 12 Desc.	Stabilized slope in acceptable condition

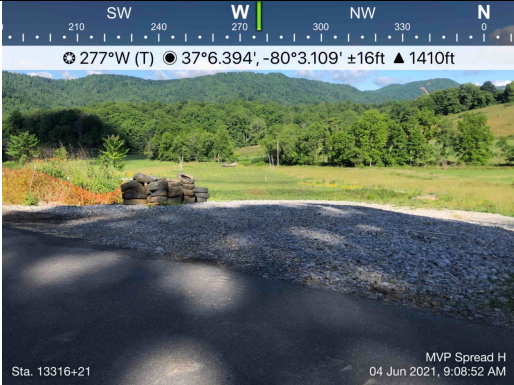
GPS Location	See Photo Watermark		GPS Location	See Photo Watermark	
Field Station#	13316+21		Field Station#	13314+00	
Pic 1 Desc.	RCE installed and Wades Gap Road free of tracked material. No maintenance needed.		Pic 2 Desc.	S-GH7 and buffer area is in good condition. Equipment bridge clean of sediment or construction debris.

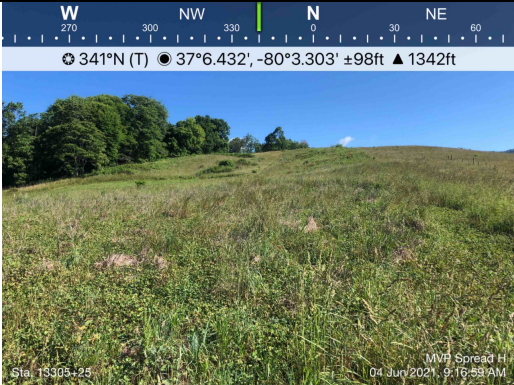
GPS Location	See Photo Watermark		GPS Location	See Photo Watermark	
Field Station#	13305+25		Field Station#	13285+00	
Pic 3 Desc.	Temporary ROW and stabilization remain well established. No maintenance needed.		Pic 4 Desc.	Temporary ROW and permanent waterbar w/ rock level spreaders are in good condition. No maintenance needed.

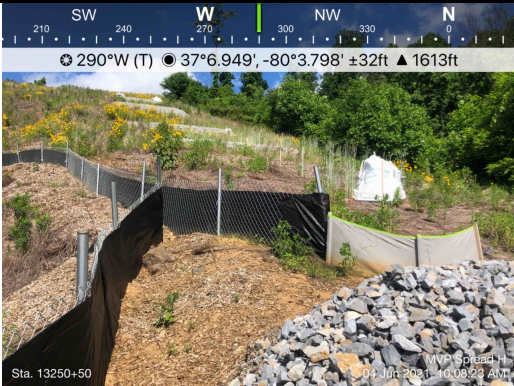
GPS Location	See Photo Watermark		GPS Location	See Photo Watermark	
Field Station#	13250+50		Field Station#	13225+00	
Pic 5 Desc.	SSF, BSRF, temporary stabilization, and permanent waterbars/level spreaders are in good condition. No maintenance needed.		Pic 6 Desc.	Slope drain inlet in good condition. No signs of accelerated erosion.

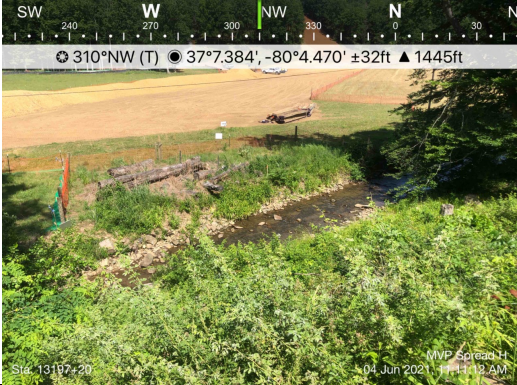
GPS Location	See Photo Watermark		GPS Location	See Photo Watermark	
Field Station#	13197+20		Field Station#	13196+50	
Pic 7 Desc.	S-D8 and buffer area in good condition. Stockpiles are stabilized, and the temporary ROW has been established.		Pic 8 Desc.	Temporary waterbar with end treatments installed within graded ROW on CIS S-D8. No maintenance needed.

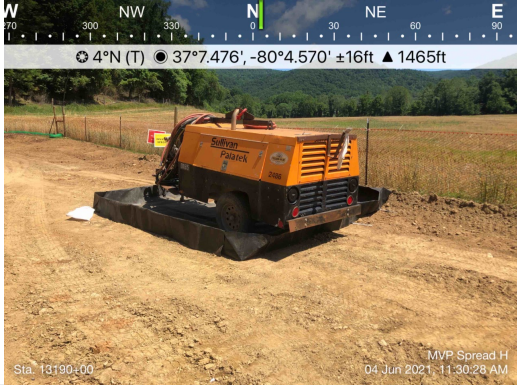
GPS Location	See Photo Watermark		GPS Location	See Photo Watermark	
Field Station#	13190+00		Field Station#	13185+00	
Pic 9 Desc.	Equipment on-site stored within secondary containment. No maintenance needed.		Pic 10 Desc.	Regrading temporary waterbars near MLV-29. No maintenance needed.

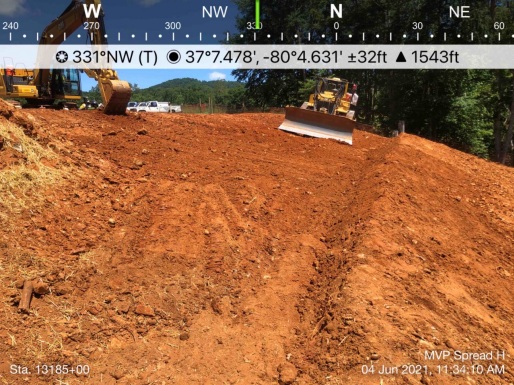
7. Identify all remedial measures that have been taken since the previous inspection was conducted. N/A					
Comments (Reference above questions as appropriate.) -SWPPP inspection walk-through from Wades Gap Road (Sta. 13316+21) to MVP-FR-292 (13141+65). Also inspected ATWS-1483, ATWS-1482, MVP-MLV-AR-29 & 29.01, ATWS-1055, and ATWS-1412. -Work was active on MVP-FR-292 with a bridge installation at an expected drainage feature, and at the recently graded areas on the CIS and GAS of MVP-MLV-29. -Streams S-D17, S-D12, S-D13, S-D11, S-D8, S-II4, and S-GH7 were found to be in good condition. E&S controls were installed where required, and bridges were found to be clean of excess sediment or construction debris. -Inactive areas of the ROW from Wades Gap Road to ~Sta. 13196+50 remain stabilized and vegetation is present throughout. -Active/graded areas of the ROW have E&S controls and waterbars installed, and stockpiles have been stabilized. Continue to stabilize cut/fill slopes as required and when control installations are completed. -Permanent waterbars with rock level spreaders were found to be in good condition, with vegetation well established. No signs of accelerated erosion were observed. -Portable toilets, DEF containers, and other petroleum-containing equipment were located within secondary containment, and heavy equipment was observed to have spill kits attached. -Temporary waterbars have been installed where necessary, and sump pits with CFS end treatments are installed. Equipment was actively regraded waterbars near MLV-29 during the inspection.

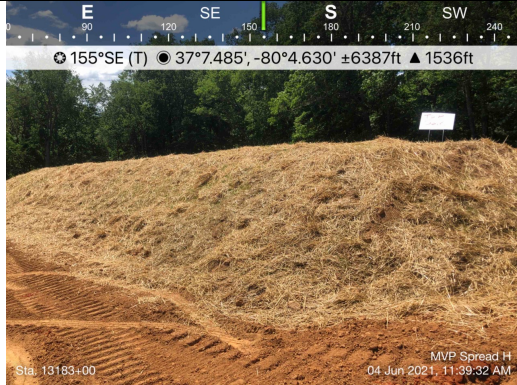
GPS Location	See Photo Watermark		GPS Location	See Photo Watermark	
Field Station#	13183+00		Field Station#	13176+25	
Pic 11 Desc.	Top soil stockpile has been stabilized and is in good condition.		Pic 12 Desc.	Sump pit and end treatment at temporary waterbars is in good condition. No maintenance needed.

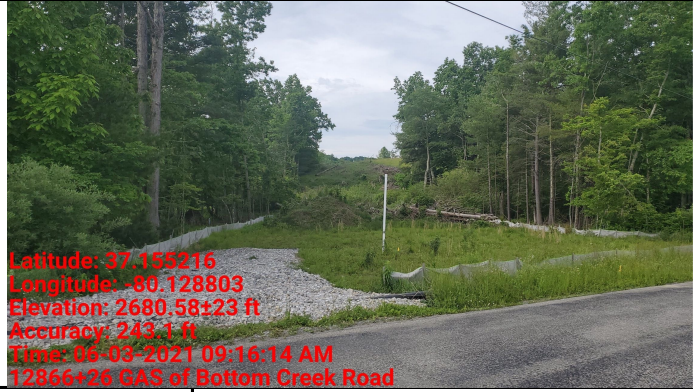
<p>Latitude: 37.155215 Longitude: -80.128803 Elevation: 2680.58±23 ft Accuracy: 243.1 ft Time: 06-03-2021 09:16:14 AM 12866+26 GAS of Bottom Creek Road</p>

<p>Latitude: 37.15521 Longitude: -80.128809 Elevation: 2662.89±32 ft Accuracy: 104.7 ft Time: 06-03-2021 09:17:37 AM 12866+26 CIS of Bottom Creek Road</p>			
GPS Location	See pic for GPS location		GPS Location	See pic for GPS location	
Field Station#	12866+26		Field Station#	12866+26	
Pic 1 Desc.	No maintenance issues or impacts observed on the GAS of Bottom Creek Road.		Pic 2 Desc.	No maintenance issues or impacts observed on the CIS of Bottom Creek Road.

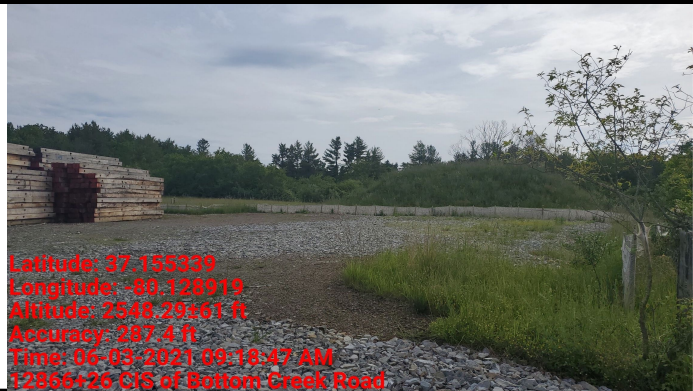
<p>Latitude: 37.155339 Longitude: -80.128919 Elevation: 2548.29±61 ft Accuracy: 287.4 ft Time: 06-03-2021 09:18:47 AM 12866+26 CIS of Bottom Creek Road</p>

GPS Location	See pic for GPS location		GPS Location	See pic for GPS location	
Field Station#	12866+26		Field Station#	12728+74	
Pic 3 Desc.	No maintenance issues or impacts observed on the CIS of Bottom Creek Road.		Pic 4 Desc.	Downstream side of stream S-EF32 on RO-281.

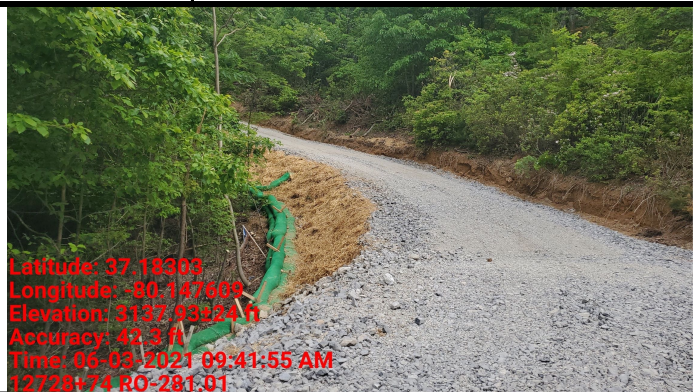
<p>Latitude: 37.18363 Longitude: -80.147889 Elevation: 3137.93±34 ft Accuracy: 41.3 ft Time: 06-03-2021 09:41:55 AM 12728+74 RO-281.01</p>

<p>Latitude: 37.185518 Longitude: -80.148862 Elevation: 3326.64±46 ft Accuracy: 28.2 ft Time: 06-03-2021 10:16:41 AM 12728+00 CIS of RO-281</p>			
GPS Location	See pic for GPS location		GPS Location	See pic for GPS location	
Field Station#	12728+74		Field Station#	12728+00	
Pic 5 Desc.	RO-281.01 where it meets RO-281.		Pic 6 Desc.	Perimeter controls installed per specification on CIS of RO-281.

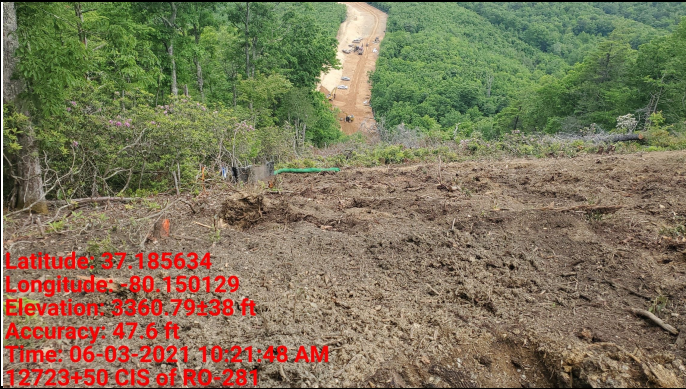
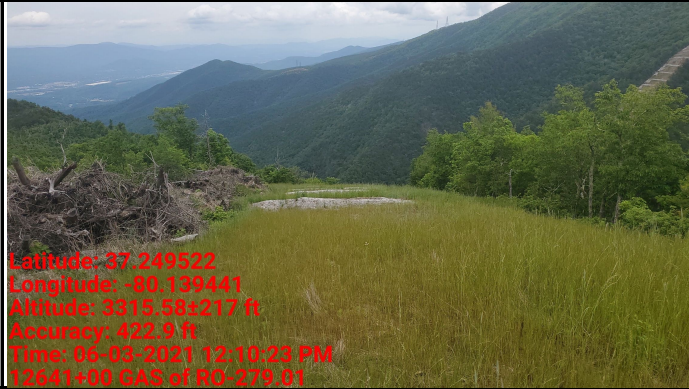
Latitude: 37.185634 Longitude: -80.150129 Elevation: 3368.79138 ft Accuracy: 47.6 ft Time: 06-03-2021 10:21:48 AM 12723+50 CIS of RO-281			Latitude: 37.249522 Longitude: -80.139441 Altitude: 3315.581217 ft Accuracy: 422.9 ft Time: 06-03-2021 12:10:23 PM 12641+00 GAS of RO-279.01		
GPS Location	See pic for GPS location		GPS Location	See pic for GPS location	
Field Station#	12723+50		Field Station#	12641+00	
Pic 7 Desc.	Location of the CWDB that will be installed once topsoil is stripped.		Pic 8 Desc.	Current ROW conditions on the GAS of RO-279.01.

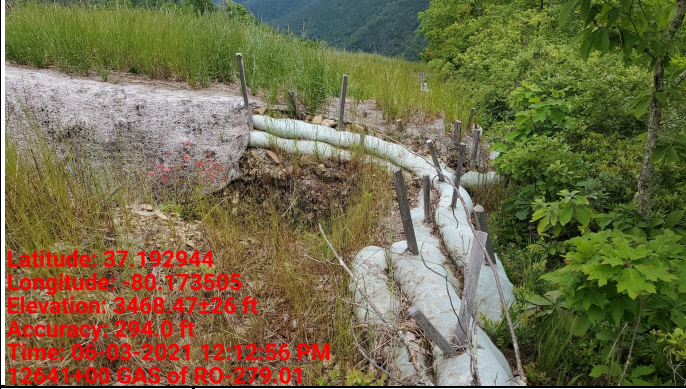
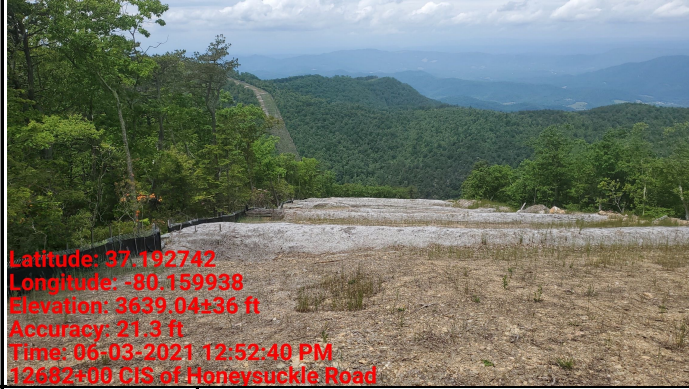
Latitude: 37.192944 Longitude: -80.173503 Elevation: 3468.47126 ft Accuracy: 294.0 ft Time: 06-03-2021 12:12:56 PM 12641+00 GAS of RO-279.01			Latitude: 37.192742 Longitude: -80.159938 Elevation: 3639.04136 ft Accuracy: 21.3 ft Time: 06-03-2021 12:52:40 PM 12682+00 CIS of Honeysuckle Road

GPS Location	See pic for GPS location		GPS Location	See pic for GPS location	
Field Station#	12641+00		Field Station#	12682+00	
Pic 9 Desc.	Waterbars, sumps and end treatments remain in acceptable condition throughout the area.		Pic 10 Desc.	Current ROW conditions on the CIS of Honeysuckle Road.
