Visual Site Inspection Report

Project Name	H-600 Pipeline Spread H	AFE	124300138	Spread	H-600 Pipeline Spread H
Contractor	Precision			Report #	24018
Inspector	Jason Nielsen			Date/Time	6/1/2021 6:46 PM
Permit #	TBD	Inspection Type	VA SWPP	Station Begin	12005+00
State	VA	Inspection Area	Partial	Station End	12119+17
County	Montgomery	Ground	Dry	Temperature (°F)	80.00
Municipality	N/A	Weather	Sunny	Rain Gauge (in)	0.00
				Rain Accumulation Time (days)	0.00

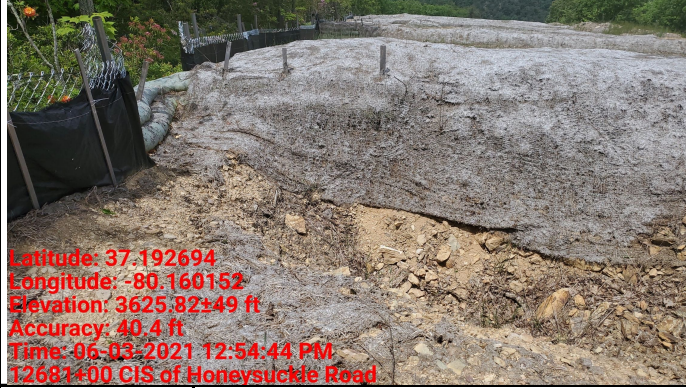
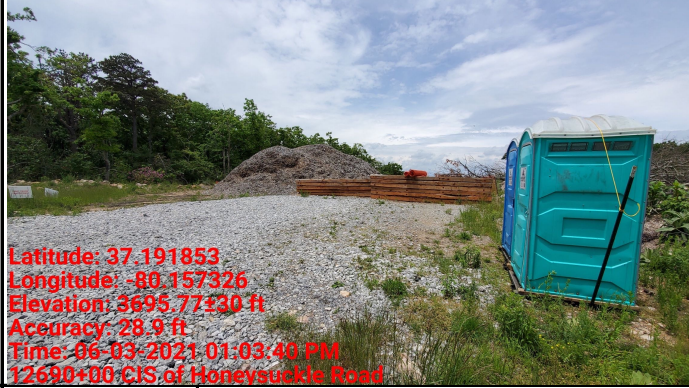
Latitude: 37.192694 Longitude: -80.160152 Elevation: 3625.82149 ft Accuracy: 40.4 ft Time: 06-03-2021 12:54:44 PM 12681+00 CIS of Honeysuckle Road			Latitude: 37.191853 Longitude: -80.157326 Elevation: 3695.77130 ft Accuracy: 28.9 ft Time: 06-03-2021 01:03:40 PM 12690+00 CIS of Honeysuckle Road		
GPS Location	See pic for GPS location		GPS Location	See pic for GPS location	
Field Station#	12681+00		Field Station#	12690+00	
Pic 11 Desc.	Waterbars, sumps and end treatments remain in acceptable condition throughout the area.		Pic 12 Desc.	CIS of the Honeysuckle Road crossing.

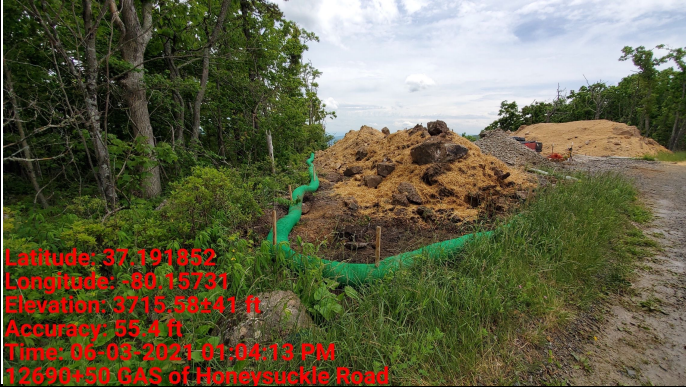
<p>Latitude: 37.191852 Longitude: -80.15731 Elevation: 3715.58±41 ft Accuracy: 55.4 ft Time: 06-03-2021 01:04:13 PM 12690+50 GAS of Honeysuckle Road</p>

<p>Latitude: 37.191293 Longitude: -80.157037 Elevation: 3746.95±17 ft Accuracy: 15.4 ft Time: 06-03-2021 01:07:32 PM 12691+50 GAS of Honeysuckle Road</p>		
GPS Location	See pic for GPS location		GPS Location	See pic for GPS location	
Field Station#	12690+50		Field Station#	12691+50	
Pic 13 Desc.	GAS of the Honeysuckle Road crossing.		Pic 14 Desc.	No maintenance issues or impacts were observed on the GAS of Honeysuckle Road.

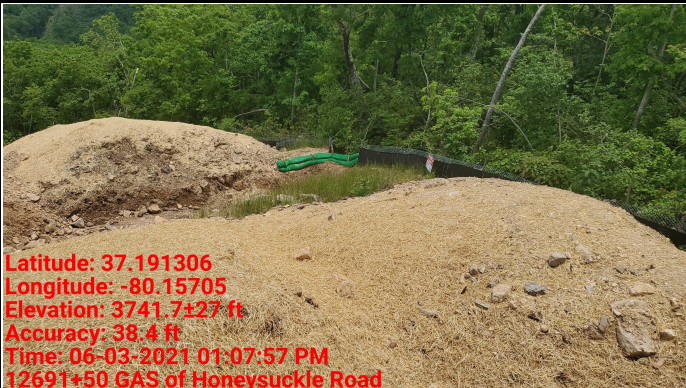
<p>Latitude: 37.191306 Longitude: -80.15705 Elevation: 3741.7±27 ft Accuracy: 38.4 ft Time: 06-03-2021 01:07:57 PM 12691+50 GAS of Honeysuckle Road</p>

GPS Location	See pic for GPS location		GPS Location	See pic for GPS location	
Field Station#	12691+50		Field Station#	12715+37	
Pic 15 Desc.	Waterbars, sumps and end treatments remain in acceptable condition throughout the area.		Pic 16 Desc.	SSF installed at the stream buffer for stream S-Y13.

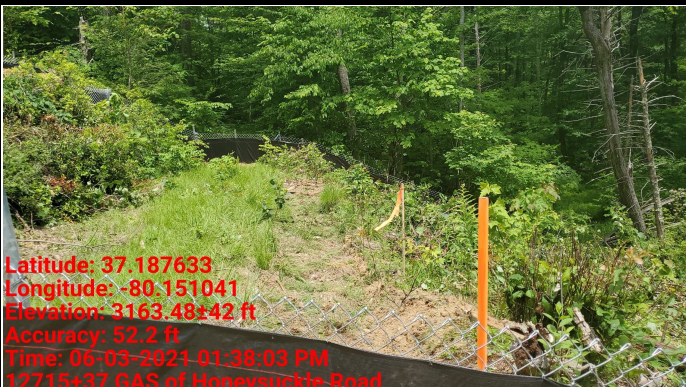
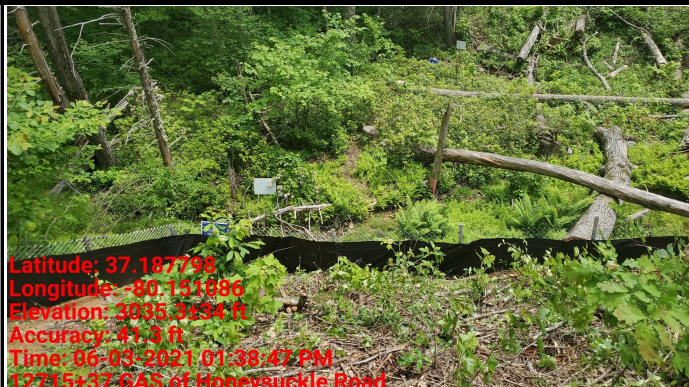
<p>Latitude: 37.187798 Longitude: -80.151886 Elevation: 3035.3±34 ft Accuracy: 41.3 ft Time: 06-03-2021 01:38:47 PM 12715+37 GAS of Honeysuckle Road</p>		
GPS Location	See pic for GPS location		GPS Location	See pic for GPS location	
Field Station#	12715+37		Field Station#	12715+37	
Pic 17 Desc.	50' stream buffer above S-Y13.		Pic 18 Desc.	50' stream buffer above S-Y13.
