Visual Site Inspection Report

Project Name	H-600 Pipeline Spread H	AFE	124300138	Spread	H-600 Pipeline Spread H
Contractor	Precision			Report #	24204
Inspector	Stephen Fisher			Date/Time	6/7/2021 1:22 PM
Permit #	TBD	Inspection Type	VA SWPP	Station Begin	13316+21
State	VA	Inspection Area	Partial	Station End	13422+00
County	Franklin	Ground	Damp	Temperature (°F)	74.00
Municipality	N/A	Weather	Cloudy	Rain Gauge (in)	0.10
				Rain Accumulation Time (days)	1.00

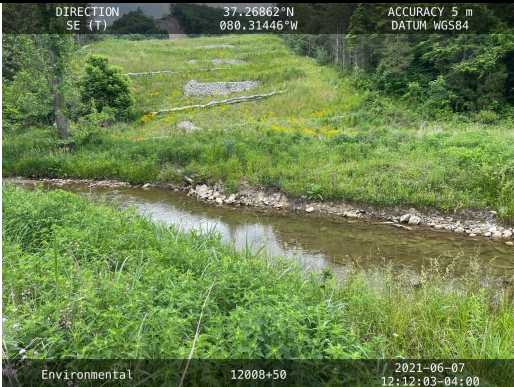
<p>DIRECTION SE (T) 37.26862°N 080.31446°W ACCURACY 5 m DATUM WGS84</p> <p>Environmental 12008+50 2021-06-07 12:12:03-04:00</p>

<p>DIRECTION W (T) 37.26923°N 080.31307°W ACCURACY 29 m DATUM WGS84</p> <p>Environmental 12007+00 2021-06-07 12:10:12-04:00</p>			
GPS Location	See photo		GPS Location	see photo	
Field Station#	12008+50		Field Station#	12007+00	
Pic 1 Desc.	Stream crossing S-G36 in acceptable condition		Pic 2 Desc.	Stabilized ROW in acceptable condition

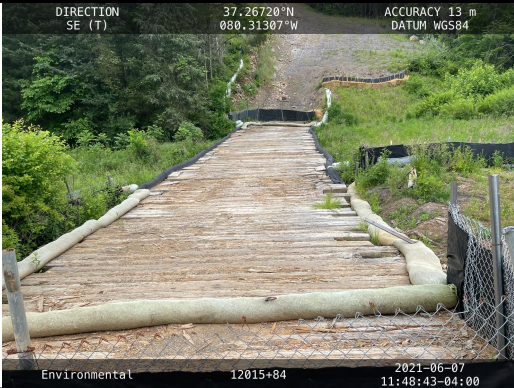
<p>DIRECTION SE (T) 37.26720°N 080.31307°W ACCURACY 13 m DATUM WGS84</p> <p>Environmental 12015+84 2021-06-07 11:48:43-04:00</p>

<p>DIRECTION NW (T) 37.25750°N 080.28308°W ACCURACY 12 m DATUM WGS84</p> <p>Environmental 12117+00 2021-06-07 10:58:44-04:00</p>			
GPS Location	See photo		GPS Location	see photo	
Field Station#	12015+84		Field Station#	12117+00	
Pic 5 Desc.	Bridge and ECDs crossing S-G38 in acceptable condition		Pic 6 Desc.	Stabilized ROW in acceptable condition

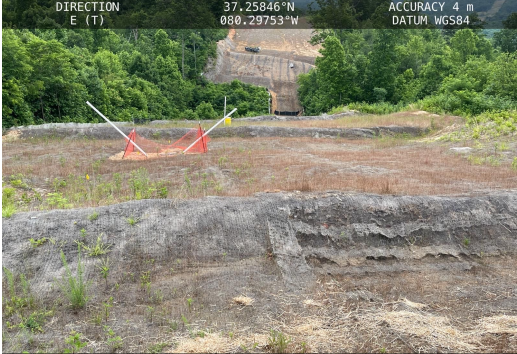
Environmental 12070+00 2021-06-07 10:20:25-04:00			
GPS Location	See photo		GPS Location	See photo	
Field Station#	12075+00		Field Station#	12070+00	
Pic 17 Desc.	Stabilized slope in acceptable condition		Pic 18 Desc.	Stabilized ROW in acceptable condition

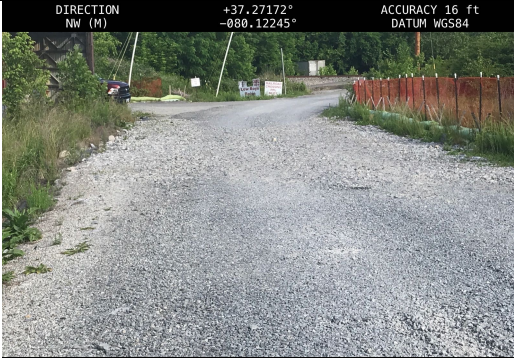
<p>DIRECTION NW (M) +37.27172° -080.12245° ACCURACY 16 ft DATUM WGS84</p> <p>MVP-LY-049_060821 Condition of rock entrance 2021-06-08 09:07:12-04:00</p>

<p>DIRECTION S (M) +37.27095° -080.12211° ACCURACY 16 ft DATUM WGS84</p> <p>MVP-LY-049_060821 Condition of containment 2021-06-08 09:08:24-04:00</p>			
GPS Location	MVP-LY-049 See photo for gps data		GPS Location	MVP-LY-049 See photo for gps data	
Field Station#	+0		Field Station#	+0	
Pic 1 Desc.	Condition of rock entrance. No sediment on stone surface. Looking NW.		Pic 2 Desc.	Condition of containment under light plant. Free of fluids. Looking S.

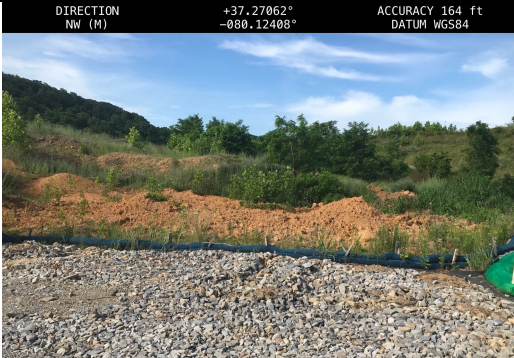
<p>DIRECTION NW (M) +37.27062° -080.12408° ACCURACY 164 ft DATUM WGS84</p> <p>MVP-LY-049_060821 Landowner disturbance along CFS 2021-06-08 09:11:51-04:00</p>

GPS Location	MVP-LY-049 See photo for gps data		GPS Location	MVP-LY-049 See photo for gps data	
Field Station#	+0		Field Station#	+0	
Pic 3 Desc.	Landowner soil disturbance along compost filter sock. No new damage to installed ECD's. Looking NW.		Pic 4 Desc.	Landowner soil disturbance along north edge of feature W-CV21A. Area not stabilized. Looking NW.

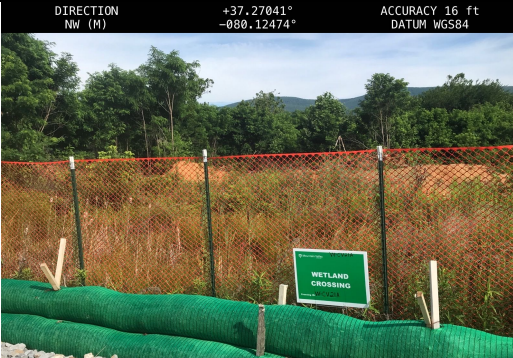
<p>DIRECTION NW (M) +37.27041° -080.12474° ACCURACY 16 ft DATUM WGS84</p> <p>MVP-LY-049_060821 Landowner disturbance along feature 2021-06-08 09:16:56-04:00</p>

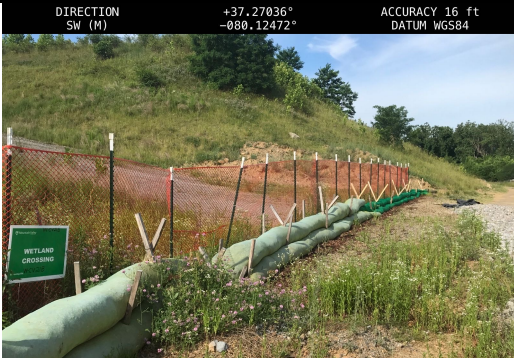
<p>DIRECTION SW (M) +37.27036° -080.12472° ACCURACY 16 ft DATUM WGS84</p> <p>MVP-LY-049_060821 Landowner disturbance within 66' of feature 2021-06-08 09:17:16-04:00</p>		  <p>DIRECTION S (M) +37.27040° -080.12475° ACCURACY 16 ft DATUM WGS84</p> <p>MVP-LY-049_060821 Landowner disturbance along CFS & feature 2021-06-08 09:17:05-04:00</p>			
GPS Location	MVP-LY-049 See photo for gps data		GPS Location	MVP-LY-049 See photo for gps data	
Field Station#	+0		Field Station#	+0	
Pic 5 Desc.	Landowner soil disturbance within 66' and 120' west of feature W-CV21B. Areas not stabilized. Looking SW.		Pic 6 Desc.	Landowner soil disturbance along compost filter sock and east of feature W-CV21B. Area not stabilize. Looking S.

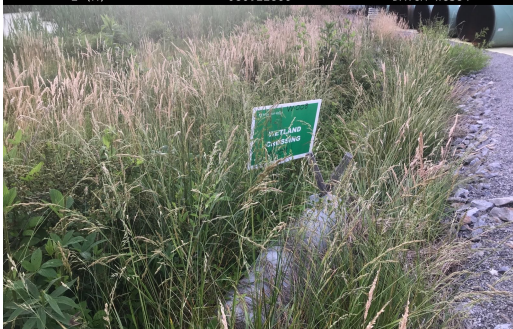
MVP-PY-006_060821 Condition of signage and CFS at feature 2021-06-08 07:10:17-04:00			MVP-PY-006_060821 Condition of containment 2021-06-08 07:11:06-04:00	
GPS Location	MVP-PY-006 See photo for gps data			GPS Location	MVP-PY-006 See photo for gps data
Field Station#	+0			Field Station#	+0
Pic 1 Desc.	Condition of signage and compost filter sock along feature W-008. Looking E.			Pic 2 Desc.	Condition of containment under light plant. Free of stormwater. Looking NE.
	<div>DIRECTION SE (M)</div> <div>+37.23526° -080.22997°</div> <div>ACCURACY 33 ft DATUM WGS84</div>

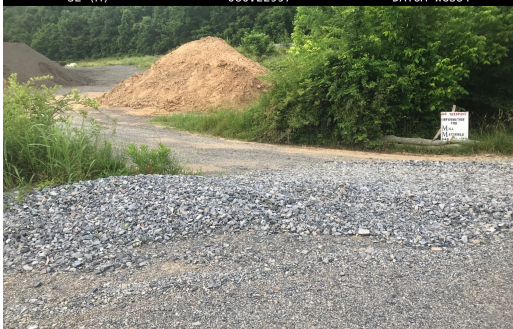
MVP-PY-006_060821 Condition of VDOT spoil pile 2021-06-08 07:12:53-04:00			MVP-PY-006_060821 Stone on edge of pavement 2021-06-08 07:15:34-04:00	
GPS Location	MVP-PY-006 See photo for gps data			GPS Location	MVP-PY-006 See photo for gps data
Field Station#	+0			Field Station#	+0
Pic 3 Desc.	Condition of spoil pile adjacent to LOD on VDOT property. Not stabilized. Looking SE.			Pic 4 Desc.	Condition of rock entrance. Stone on edge of pavement. Contractor advised. Looking NE.
	<div>DIRECTION SW (M)</div> <div>+37.23606° -080.22768°</div> <div>ACCURACY 16 ft DATUM WGS84</div>

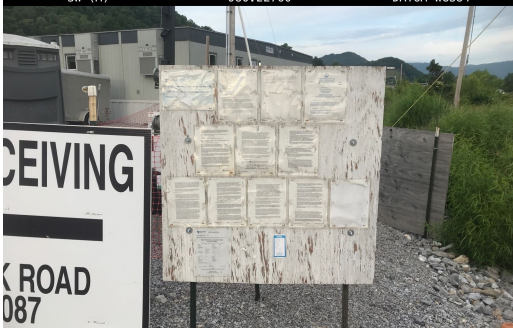
MVP-PY-006_060821 Condition of posted project documents 2021-06-08 07:15:45-04:00			MVP-PY-006_060821 Stone swept from edge of pavement 2021-06-08 07:33:38-04:00	
GPS Location	MVP-PY-006 See photo for gps data			GPS Location	MVP-PY-006 See photo for gps data

Field Station#	+0			Field Station#	+0
Pic 5 Desc.	Condition of of posted project documents at main entrance. Looking SW.			Pic 6 Desc.	Main entrance Stone swept from the edge of pavement. Looking NE.

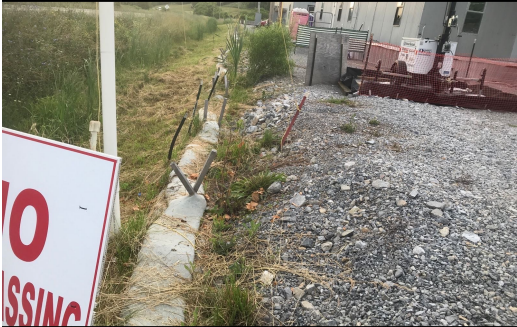
DIRECTION E (M) +37.23565° -080.22698° ACCURACY 16 ft DATUM WGS84  			
MVP-PY-006_060821 Condition of CFS along LOD 2021-06-08 07:18:50-04:00		MVP-PY-006_060821 Secondary containment on site for tankers 2021-06-08 07:21:12-04:00			
GPS Location	MVP-PY-006 See photo for gps data		GPS Location	MVP-PY-006 See photo for gps data	
Field Station#	+0		Field Station#	+0	
Pic 7 Desc.	Condition of compost filter sock along north LOD. Looking NE.		Pic 8 Desc.	Secondary containment on site for tankers offloading fuel. Looking E.	
DIRECTION SE (M) +37.23552° -080.22661° ACCURACY 16 ft DATUM WGS84

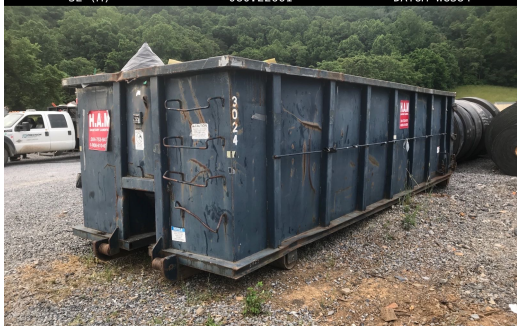
DIRECTION S (M) +37.23551° -080.22668° ACCURACY 16 ft DATUM WGS84  			
MVP-PY-006_060821 No loose trash around dumpsters 2021-06-08 07:22:25-04:00		MVP-PY-006_060821 No fluids around hazardous waste dump_ 2021-06-08 07:22:37-04:00

GPS Location	MVP-PY-006 See photo for gps data		GPS Location	MVP-PY-006 See photo for gps data	
Field Station#	+0		Field Station#	+0	
Pic 9 Desc.	No loose trash around dumpsters or in the yard. Looking SE.		Pic 10 Desc.	No fluids or deposits around hazardous waste dumpsters. Looking S.	
DIRECTION W (M) +37.23569° -080.22687° ACCURACY 33 ft DATUM WGS84

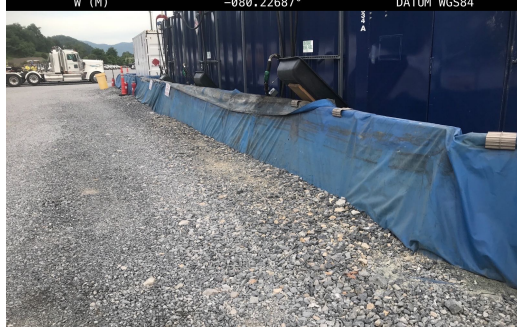
MVP-PY-006_060821 No fuel spills south of tanks 2021-06-08 07:27:37-04:00		MVP-PY-006_060821 No leaky internal fittings 2021-06-08 07:28:10-04:00			
GPS Location	MVP-PY-006 See photo for gps data		GPS Location	MVP-PY-006 See photo for gps data	
Field Station#	+0		Field Station#	+0	
Pic 11 Desc.	Blue Bulk Fuel tanks no fuel spills south of tanks. Looking W.		Pic 12 Desc.	Blue Bulk Fuel tanks no leaky internal fittings. Looking W.

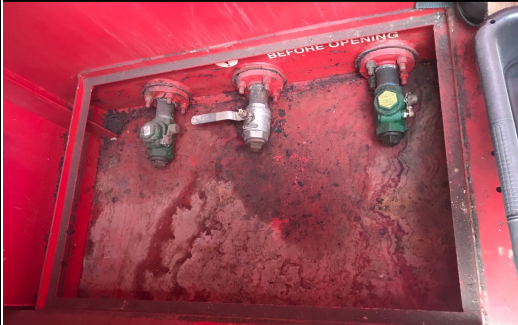
<div> MVP-PY-006_060821 Condition of internal drip pan 2021-06-08 07:30:15-04:00 </div> </div>				<div> <div> DIRECTION W (M) +37.23554° -080.22701° ACCURACY 16 ft DATUM WGS84 </div>

<div> MVP-PY-006_060821 No leaky internal fittings 2021-06-08 07:30:20-04:00 </div> </div>	
GPS Location	MVP-PY-006 See photo for gps data		GPS Location	MVP-PY-006 See photo for gps data	
Field Station#	+0		Field Station#	+0	
Pic 13 Desc.	Off Road Fuel unit condition of internal drip pan. Free of fluids. Looking SW.		Pic 14 Desc.	Off Road Fuel unit no leaky internal fittings. Looking W.	
<div> <div> DIRECTION SE (M) +37.23428° -080.22660° ACCURACY 33 ft DATUM WGS84 </div>

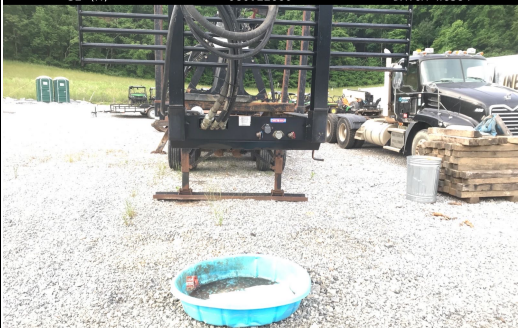
<div> MVP-PY-006_060821 Condition of containment under stored trailer 2021-06-08 07:49:18-04:00 </div> </div>				<div> <div> DIRECTION E (M) +37.23419° -080.22714° ACCURACY 16 ft DATUM WGS84 </div>

GPS Location	MVP-PY-006 See photo for gps data		GPS Location	MVP-PY-006 See photo for gps data	
Field Station#	+0		Field Station#	+0	
Pic 15 Desc.	Condition of containment under stored trailer. Looking SE.		Pic 16 Desc.	Condition of containment under hazardous waste dumpsters. Free of stormwater. Looking E.	
<div> <div> DIRECTION SE (M) +37.23411° -080.22710° ACCURACY 16 ft DATUM WGS84 </div>

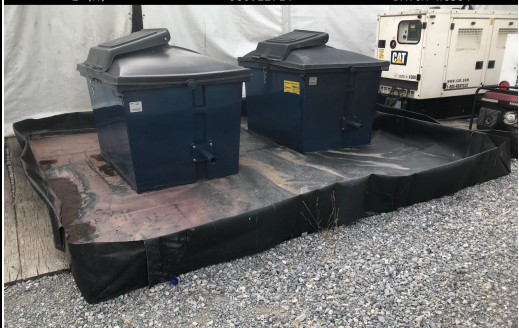
<div> MVP-PY-006_060821 Condition of containment 2021-06-08 07:50:44-04:00 </div> </div>

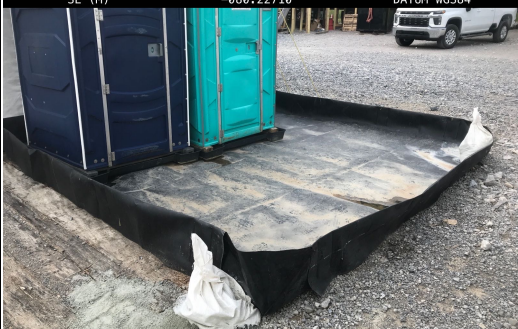
<div> MVP-PY-006_060821 Condition of trays and containment 2021-06-08 07:50:59-04:00 </div> </div>				<div> <div> DIRECTION SE (M) +37.23445° -080.22789° ACCURACY 33 ft DATUM WGS84 </div>

<div> MVP-PY-006_060821 Condition of poly lined containments 2021-06-08 07:52:46-04:00 </div> </div>	
GPS Location	MVP-PY-006 See photo for gps data		GPS Location	MVP-PY-006 See photo for gps data	
Field Station#	+0		Field Station#	+0	
Pic 17 Desc.	Condition of trays and containment under toilets. Free of stormwater. Looking SE.		Pic 18 Desc.	Condition of poly lined rock berm containments. Holding some stormwater. Looking SE.

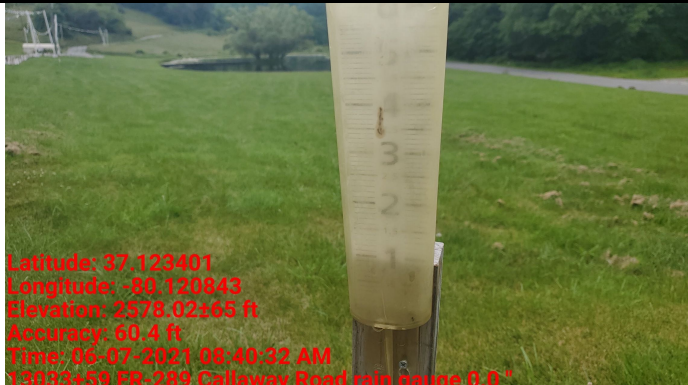
<p>Latitude: 37.134369 Longitude: -80.137301 Elevation: 2645.77±121 ft Accuracy: 52.8 ft Time: 06-07-2021 11:14:23 AM 12958+00 GAS of RO-287 stream S-Y7</p>		
GPS Location	See pic for GPS location		GPS Location	See pic for GPS location	
Field Station#	13033+59		Field Station#	12958+00	
Pic 1 Desc.	Callaway Road rain gauge. 0.0" total precipitation.		Pic 2 Desc.	Downstream side of stream S-Y7.

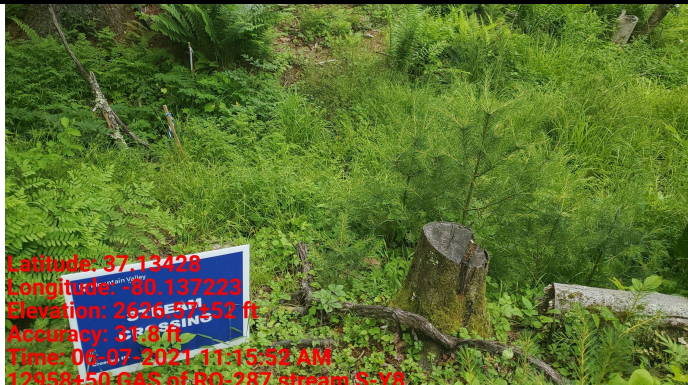
GPS Location	See pic for GPS location		GPS Location	See pic for GPS location	
Field Station#	12958+50		Field Station#	12956+93	
Pic 3 Desc.	Downstream side of stream S-Y8.		Pic 4 Desc.	Landowner's spring box at RO-287.

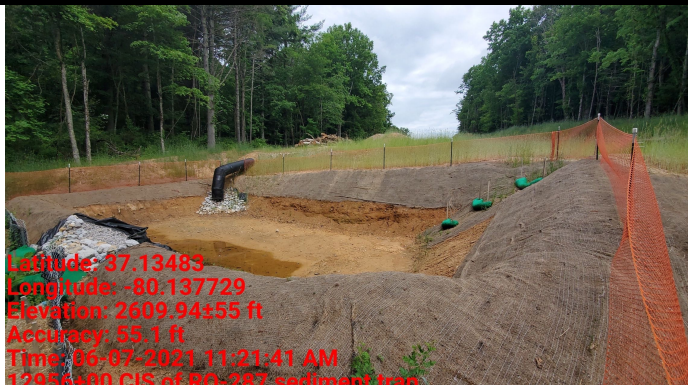
<p>Latitude: 37.134435 Longitude: -80.136904 Elevation: 2636.65±33 ft Accuracy: 29.9 ft Time: 06-07-2021 11:24:33 AM 12957+30 RO-287</p>		
GPS Location	See pic for GPS location		GPS Location	See pic for GPS location	
Field Station#	12956+00		Field Station#	12957+30	
Pic 5 Desc.	Large sediment trap on the CIS of RO-287.		Pic 6 Desc.	CWDB outlet at RO-287.

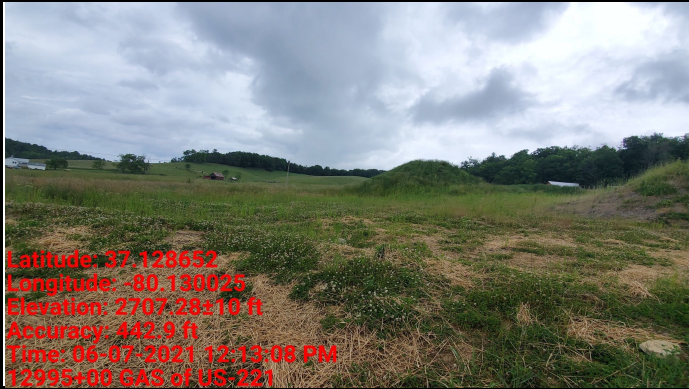
<p>Latitude: 37.128699 Longitude: -80.130072 Elevation: 2707.15±10 ft Accuracy: 42.3 ft Time: 06-07-2021 12:13:22 PM 12995+00 GAS of US-221</p>		
GPS Location	See pic for GPS location		GPS Location	See pic for GPS location	
Field Station#	12995+00		Field Station#	12995+00	
Pic 13 Desc.	Temporarily stabilized portion on the GAS of US-221.		Pic 14 Desc.	GAS of US-221.

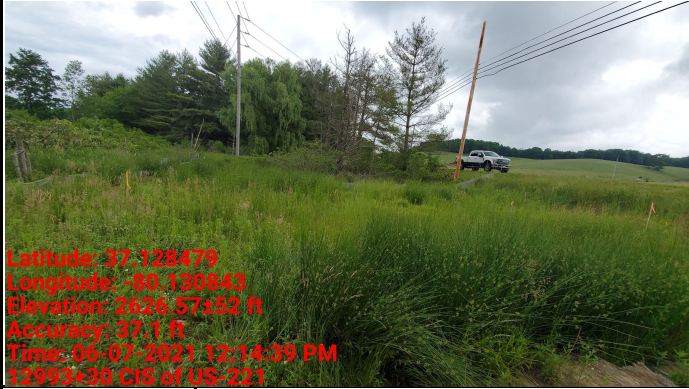
Field Station#	12993+30		Field Station#	12974+30	
Pic 15 Desc.	CIS of the US-221 road crossing.		Pic 16 Desc.	Current ROW conditions on the GAS of RO-288.	
  <p>Latitude: 37.130544 Longitude: -80.136847 Elevation: 2734.48±10 ft Accuracy: 31.5 ft Time: 06-07-2021 01:06:36 PM 12974+20 CIS of RO-288</p>

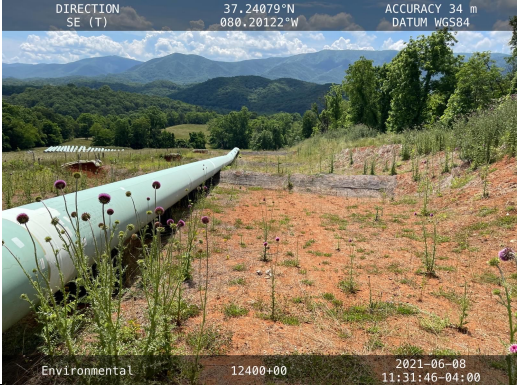
<p>DIRECTION NW (T) 37.24116°N 080.20192°W ACCURACY 5 m DATUM WGS84</p> <p>Environmental 12398+00 2021-06-08 11:30:40-04:00</p>			
GPS Location	see photo		GPS Location	See photo	
Field Station#	12400+00		Field Station#	12398+00	
Pic 7 Desc.	Stabilized ROW in acceptable condition		Pic 8 Desc.	Stabilized ROW in acceptable condition

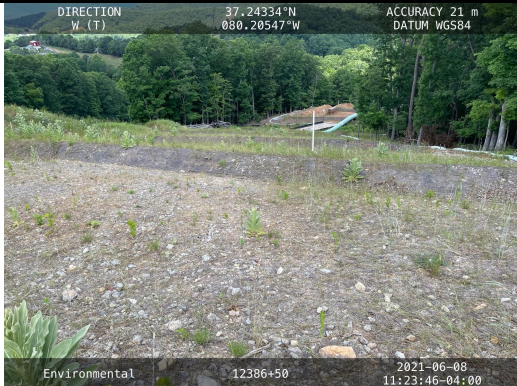
<p>DIRECTION SE (T) 37.24383°N 080.20649°W ACCURACY 10 m DATUM WGS84</p> <p>Environmental 12383+93 2021-06-08 11:17:41-04:00</p>			
GPS Location	See photo		GPS Location	see photo	
Field Station#	12386+50		Field Station#	12383+93	
Pic 9 Desc.	Stabilized ROW in acceptable condition		Pic 10 Desc.	Clean water crossing in acceptable condition

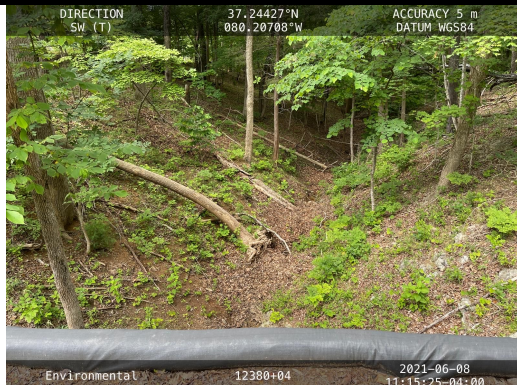
<p>DIRECTION SE (T) 37.24435°N 080.20716°W ACCURACY 5 m DATUM WGS84</p> <p>Environmental 12380+04 2021-06-08 11:14:58-04:00</p>			
GPS Location	See photo		GPS Location	See photo	
Field Station#	12380+04		Field Station#	12380+04	
Pic 11 Desc.	Down stream of S-NN19 in acceptable condition		Pic 12 Desc.	Bridge and ECDs crossing stream S-NN19 in acceptable condition

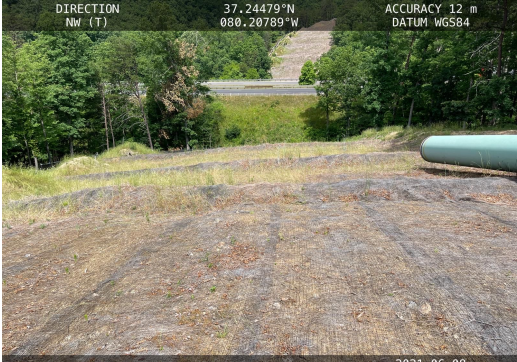
<p>DIRECTION SW (T) 37.24541°N 080.20857°W ACCURACY 19 m DATUM WGS84</p> <p>Environmental 12374+16 2021-06-08 11:05:19-04:00</p>			
GPS Location	see photo		GPS Location	See photo	
Field Station#	12376+00		Field Station#	12374+16	
Pic 13 Desc.	Stabilized slope in acceptable condition		Pic 14 Desc.	Stream crossing S-0016 in acceptable condition

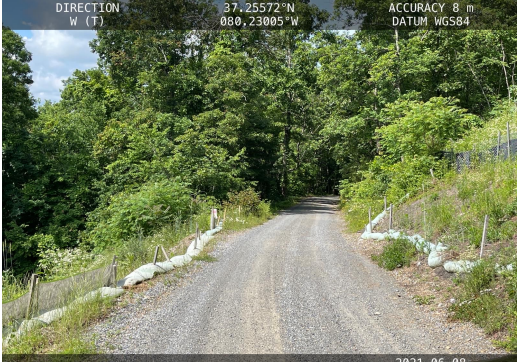
Pic 15 Desc.	Access Road MVP-MN-276.03 crossing in acceptable condition		Pic 16 Desc.	Stabilized slope in acceptable condition

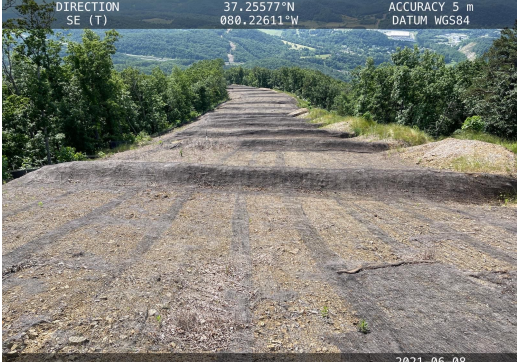
<p>DIRECTION SE (T) 37.25682°N 080.22698°W ACCURACY 7 m DATUM WGS84</p> <p>Environmental 12299+24 2021-06-08 10:25:06-04:00</p>			
GPS Location	see photo		GPS Location	See photo	
Field Station#	12306+00		Field Station#	12299+24	
Pic 17 Desc.	Stabilized ROW in acceptable condition		Pic 18 Desc.	Stabilized access Road in acceptable condition

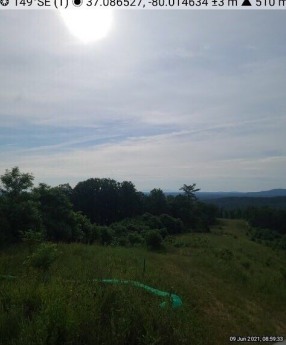
GPS Location	00000	GPS Location	00000		
Field Station#	13470+19	Field Station#	13462+90		
Pic 1 Desc.	During routine inspection today the EI monitored vegetation and checked ECDs throughout. No issues were observed at the time of inspection.		Pic 2 Desc.	Row photo showing vegetation and ECDs in place on row boundary. No issues observed at the time of inspection.	
	North East Elevation <small>250°SW (T) 37.086446, -80.014271 ±3 m ▲ 507 m</small>

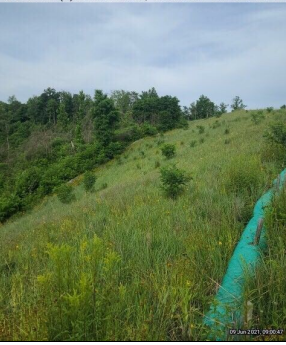
GPS Location	00000	GPS Location	00000		
Field Station#	13461+20	Field Station#	13420+00		
Pic 3 Desc.	Vegetation photo on side slope with ECDs in place. Good coverage noted at the time of inspection.		Pic 4 Desc.	Photo showing materials in work space at CAHAS #1. No environmental issues were observed at the time of inspection.

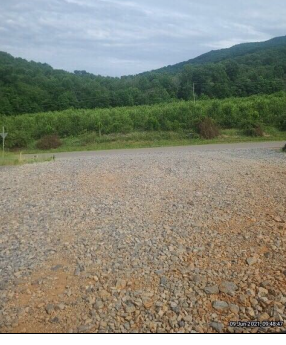
GPS Location	00000	GPS Location	00000		
Field Station#	13419+70	Field Station#	13450+80		
Pic 5 Desc.	RCE photo . No issues observed at the time of inspection.		Pic 6 Desc.	Row photo showing good vegetation coverage. No issues observed at the time of inspection.

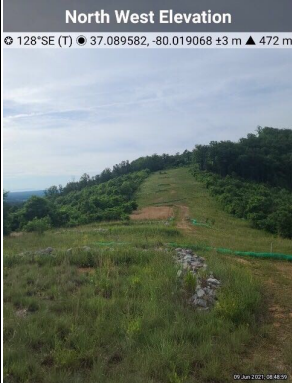
Insert image here		Insert image here	
GPS Location	00000	GPS Location			
Field Station#	13444+70	Field Station#			
Pic 7 Desc.	Monitored ECDs and vegetation growth during routine inspection today. No issues observed at the time of inspection		Pic 8 Desc.		
Insert image here		Insert image here			
GPS Location		GPS Location			
Field Station#		Field Station#			
Pic 9 Desc.		Pic 10 Desc.			
Insert image here		Insert image here			
GPS Location		GPS Location			
Field Station#		Field Station#			
Pic 11 Desc.		Pic 12 Desc.

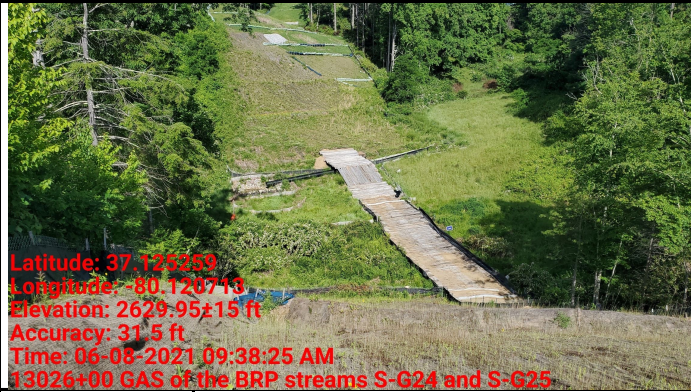
<p>Latitude: 37.1234 Longitude: -80.120853 Elevation: 2473.26±52 ft Accuracy: 29.3 ft Time: 06-08-2021 09:43:13 AM 13033+59 FR-289 Callaway Road rain gauge 0.1"</p>		
GPS Location	See pic for GPS location		GPS Location	See pic for GPS location	
Field Station#	13026+00		Field Station#	13033+59	
Pic 1 Desc.	No maintenance issues or impacts at streams S-G24 and S-G25.		Pic 2 Desc.	0.1" total precipitation at Callaway Road.

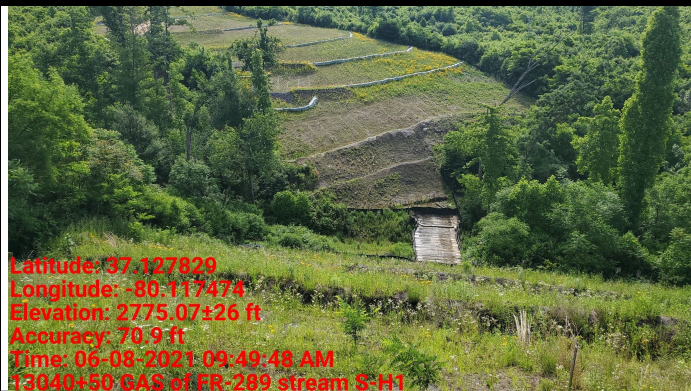
GPS Location	See pic for GPS location		GPS Location	See pic for GPS location	
Field Station#	13040+50		Field Station#	13061+30	
Pic 3 Desc.	Stream S-H1 on the GAS of FR-289.		Pic 4 Desc.	Slope on the CIS of FR-290.

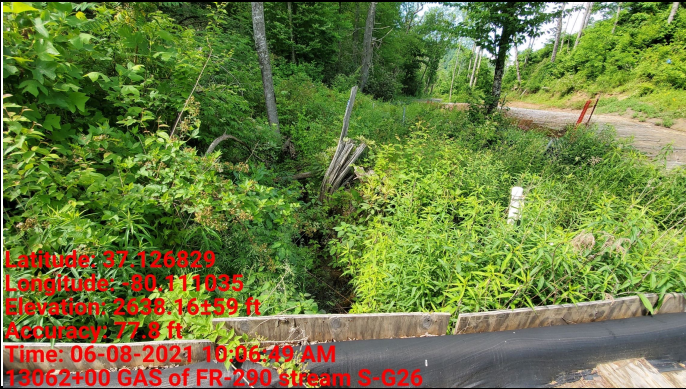
Latitude: 37.126829 Longitude: -80.111035 Elevation: 2638.16±59 ft Accuracy: 77.8 ft Time: 06-08-2021 10:06:49 AM 13062+00 GAS of FR-290 stream S-G26			Time: 06-08-2021 10:17:32 AM 13061+44 FR-290 stream S-RR18		
GPS Location	See pic for GPS location		GPS Location	See pic for GPS location	
Field Station#	13062+00		Field Station#	13061+44	
Pic 7 Desc.	Downstream side of stream S-G26.		Pic 8 Desc.	Downstream side of stream S-RR18.

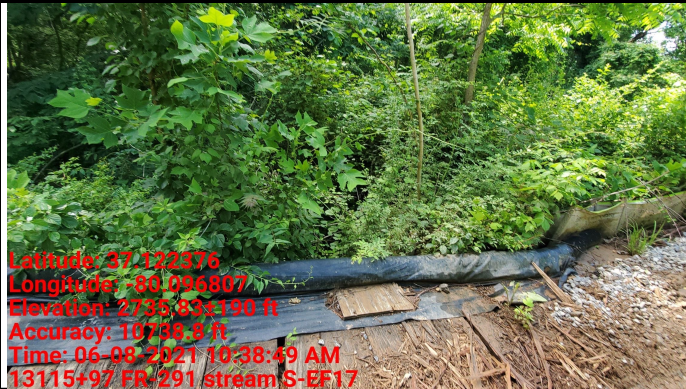
Latitude: 37.122576 Longitude: -80.096807 Elevation: 2735.83±190 ft Accuracy: 10739.8 ft Time: 06-08-2021 10:38:49 AM 13115+97 FR-291 stream S-EF17			Latitude: 37.120628 Longitude: -80.086433 Elevation: 1742.95±30 ft Accuracy: 25.6 ft Time: 06-08-2021 12:45:09 PM 13141+53 FR-292		
GPS Location	See pic for GPS location		GPS Location	See pic for GPS location	
Field Station#	13115+97		Field Station#	13141+53	
Pic 11 Desc.	Downstream side of stream S-EF17.		Pic 12 Desc.	Stream S-D14 crossing on the upstream side.

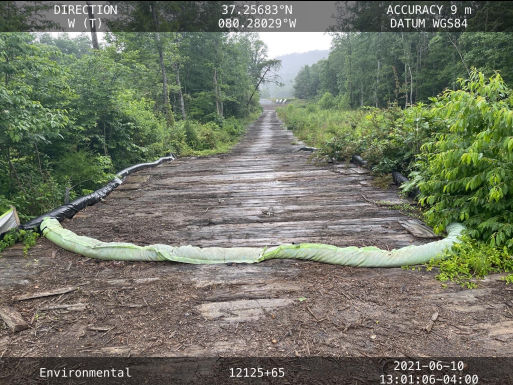
<p>DIRECTION W (T) 37.25683°N 080.28029°W ACCURACY 9 m DATUM WGS84</p> <p>Environmental 12125+65 2021-06-10 13:01:06-04:00</p>			
GPS Location	See photo		GPS Location	See photo	
Field Station#	12230+00		Field Station#	12125+65	
Pic 1 Desc.	Stabilized ROW in acceptable condition		Pic 2 Desc.	Bridge and ECDs crossing stream S-MM31 in acceptable condition	
  <p>DIRECTION NW (T) 37.25642°N 080.27771°W ACCURACY 15 m DATUM WGS84</p> <p>Environmental 12132+73 2021-06-10 12:57:58-04:00</p>		  <p>DIRECTION E (T) 37.25589°N 080.27596°W ACCURACY 5 m DATUM WGS84</p> <p>Environmental 12139+91 2021-06-10 12:54:33-04:00</p>			
GPS Location	See photo		GPS Location	See photo	
Field Station#	12132+73		Field Station#	12139+91

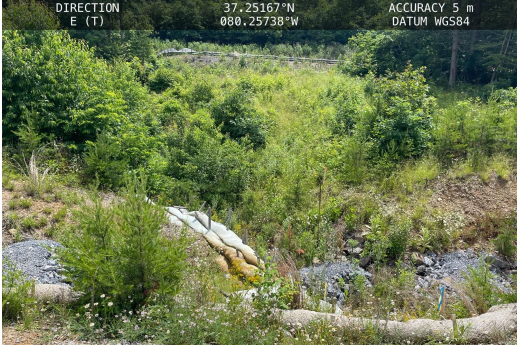
GPS Location	See photo		GPS Location	See photo	
Field Station#	12198+64		Field Station#	12194+00	
Pic 15 Desc.	Stream crossing S-0011 on east side of railroad crossing in acceptable condition		Pic 16 Desc.	Stabilized ROW in acceptable condition	
<div> <div>DIRECTION E (T)</div> <div>37.25182°N 080.25902°W</div> <div>ACCURACY 4 m DATUM WGS84</div>

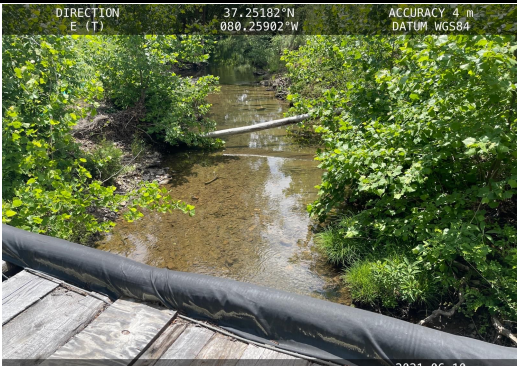
<div>Environmental 12192+50 2021-06-10 11:49:20-04:00</div> </div>	
GPS Location	See photo		GPS Location	See photo	
Field Station#	12192+50		Field Station#	12192+50	
Pic 17 Desc.	Down stream of S-C21 in acceptable condition		Pic 18 Desc.	Bridge and ECDs crossing stream S-C21 in acceptable condition.

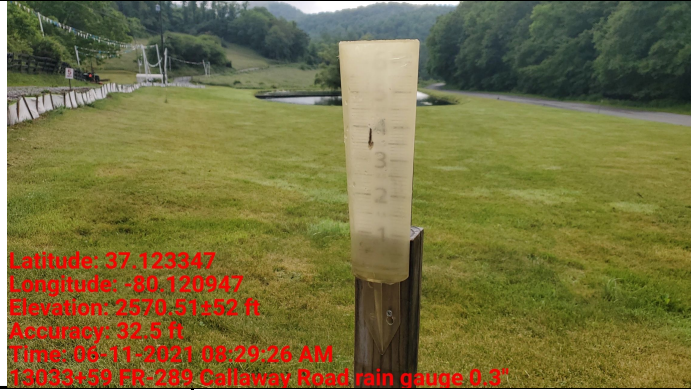
<p>Latitude: 37.125456 Longitude: -80.123594 Elevation: 2837.01±34 ft Accuracy: 72.2 ft Time: 06-11-2021 08:58:41 AM 13018+00 GAS of the BRP motorway</p>			
GPS Location	See pic for GPS location		GPS Location	See pic for GPS location	
Field Station#	13033+59		Field Station#	13018+00	
Pic 1 Desc.	0.3" of additional rainfall accumulation added to the 0.7" from yesterday evening for a total of 1.0" precipitation.		Pic 2 Desc.	Current ROW conditions on the GAS of the BRP motorway.

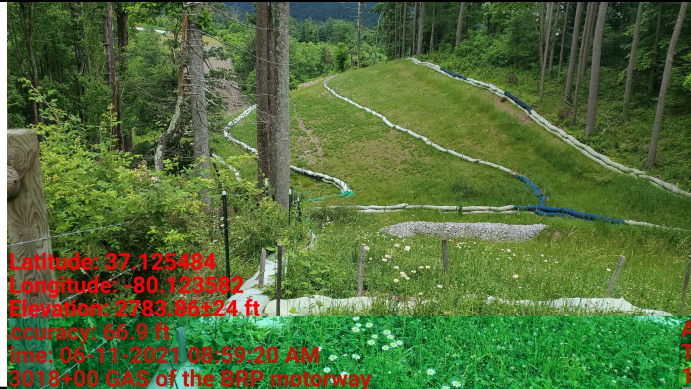
GPS Location	See pic for GPS location		GPS Location	See pic for GPS location	
Field Station#	13018+00		Field Station#	12974+29	
Pic 3 Desc.	Wooded portion of the BRP on the GAS of the motorway.		Pic 4 Desc.	Current conditions of the ATWS at RO-288.

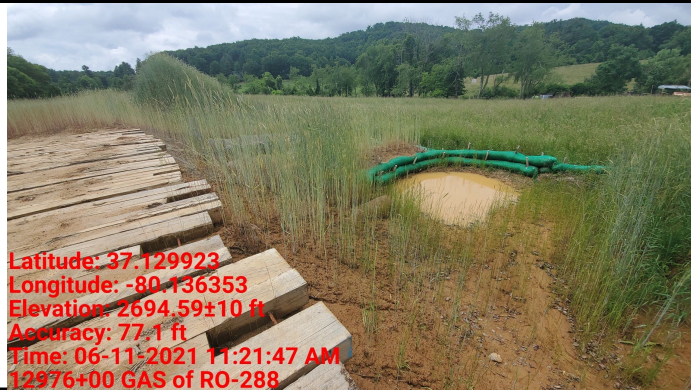
<p>Latitude: 37.129956 Longitude: -80.136347 Elevation: 2704.53±10 ft Accuracy: 43.6 ft Time: 06-11-2021 11:32:33 AM 12976+00 GAS of RO-288</p>			
GPS Location	See pic for GPS location		GPS Location	See pic for GPS location	
Field Station#	12976+00		Field Station#	12976+00	
Pic 5 Desc.	Waterbars, sumps and end treatments remain in compliance throughout the area.		Pic 6 Desc.	Plunge pool and CWDP on the GAS of RO-288.

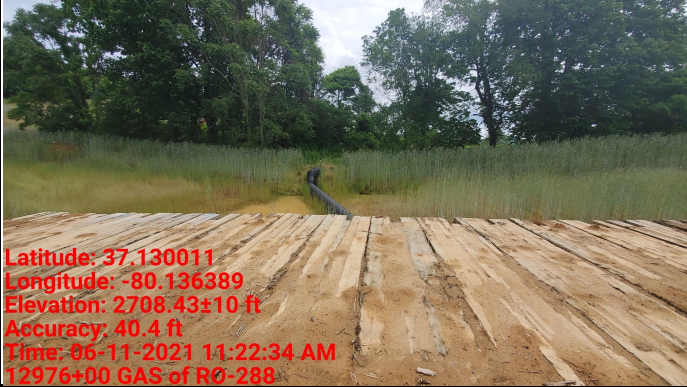
<p>Latitude: 37.129243 Longitude: -80.134529 Elevation: 2719.49±19 ft Accuracy: 46.9 ft Time: 06-11-2021 11:31:30 AM 12982+00 GAS of RO-288</p>		
GPS Location	See pic for GPS location		GPS Location	See pic for GPS location	
Field Station#	12976+00		Field Station#	12982+00	
Pic 7 Desc.	CWDB and CWDP on the GAS of RO-288.		Pic 8 Desc.	Edge of the graded ROW on the GAS of RO-288.

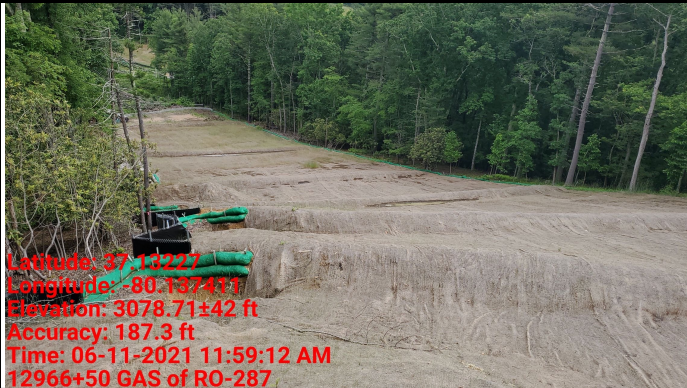
GPS Location	See pic for GPS location		GPS Location	See pic for GPS location	
Field Station#	12966+50		Field Station#	13012+40	
Pic 9 Desc.	Current conditions of the ROW on the GAS of RO-287.		Pic 10 Desc.	Current ROW conditions on the CIS of the BRP motorway.

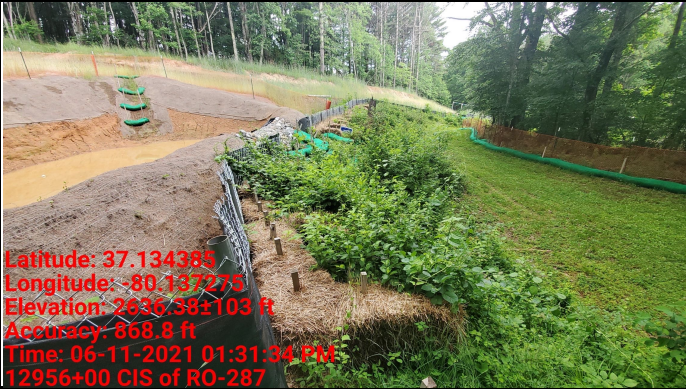
<p>Latitude: 37.134385 Longitude: -80.137275 Elevation: 2636.38±103 ft Accuracy: 868.8 ft Time: 06-11-2021 01:31:34 PM 12956+00 CIS of RO-287</p>			  <p>Latitude: 37.136561 Longitude: -80.138796 Elevation: 2724.84±29 ft Accuracy: 20.7 ft Time: 06-11-2021 01:38:14 PM 12950+00 CIS of RO-287</p>		
GPS Location	See pic for GPS location		GPS Location	See pic for GPS location	
Field Station#	12956+00		Field Station#	12950+00	
Pic 13 Desc.	CIS of access RO-287.		Pic 14 Desc.	Current ROW conditions on the GAS of S-IJ43(Mill Creek).

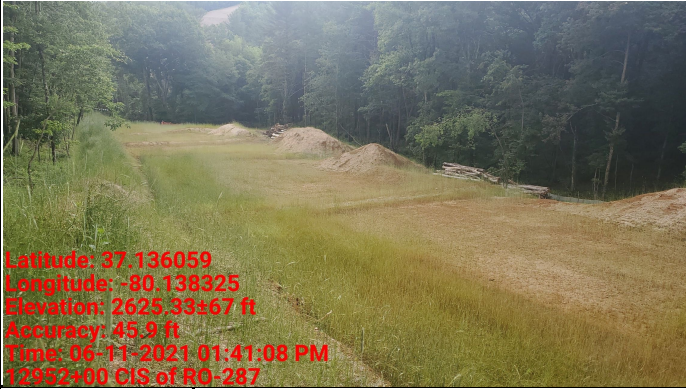
GPS Location	See pic for GPS location		GPS Location	See pic for GPS location	
Field Station#	12952+00		Field Station#	12957+30	
Pic 15 Desc.	Current ROW conditions on the CIS of RO-287.		Pic 16 Desc.	Downstream side of stream S-Z17 on RO-287.	
  <p>Latitude: 37.105483 Longitude: -80.130471 Elevation: 2671.84±130 ft Accuracy: 8202.1 ft Time: 06-11-2021 02:00:08 PM 12915+20 RO-286</p>

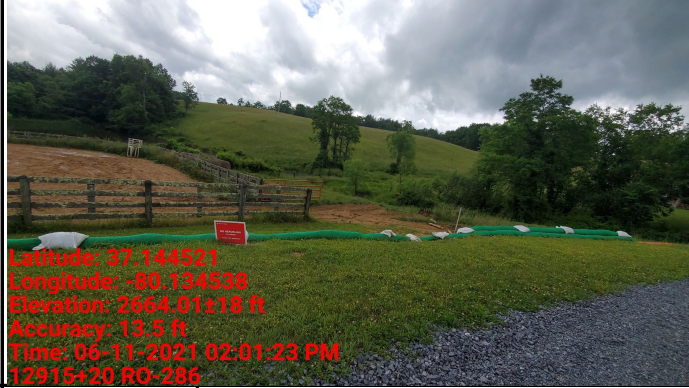
<p>Latitude: 37.144521 Longitude: -80.134538 Elevation: 2664.01±18 ft Accuracy: 13.5 ft Time: 06-11-2021 02:01:23 PM 12915+20 RO-286</p>		
GPS Location	See pic for GPS location		GPS Location	See pic for GPS location	
Field Station#	12915+20		Field Station#	12915+20	
Pic 17 Desc.	CFS perimeter installed on RO-286.		Pic 18 Desc.	CFS perimeter installed on RO-286.

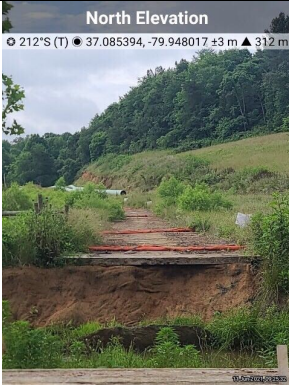
GPS Location	00000	GPS Location	0000		
Field Station#	13692+64	Field Station#	13678+80		
Pic 1 Desc.	Observed erosion control blanket of stream bank after recent rain showers . No issues observed at the time of inspection.		Pic 2 Desc.	ECDs and equipment bridge inspected and functioning properly. No issues observed at the time of inspection.	
	South Elevation

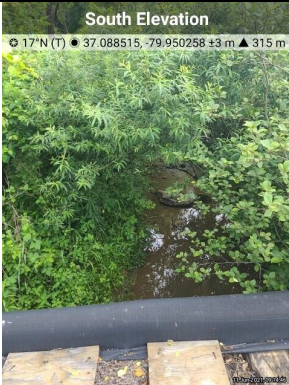
GPS Location	0000	GPS Location	0000		
Field Station#	13678+71	Field Station#	13687+78		
Pic 3 Desc.	Stream observation photo facing upstream during routine inspection today. No issues observed at the time of inspection.		Pic 4 Desc.	Observed top soil pile that has been disturbed by a land owner removing soil with shovel. Will continue to monitor the area for any potential issues.	
	South East Elevation

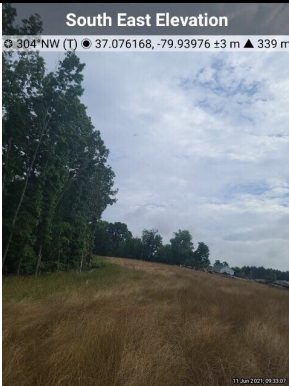
GPS Location	00000	GPS Location	0000		
Field Station#	13733+00	Field Station#	13678+71		
Pic 5 Desc.	Vegetation observation photo in permanent area of row. No issues observed at the time of inspection.		Pic 6 Desc.	Stream observation photo facing downstream during routine inspection today. No issues observed at the time of inspection.

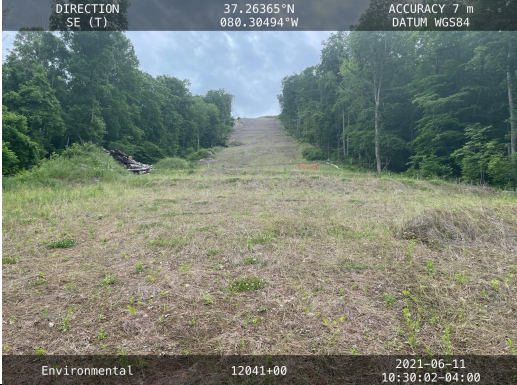
<p>DIRECTION SE (T) 37.26365°N 080.30494°W ACCURACY 7 m DATUM WGS84</p> <p>Environmental 12041+00 2021-06-11 10:30:02-04:00</p>			
GPS Location	See photo		GPS Location	see photo	
Field Station#	12076+95		Field Station#	12041+00	
Pic 7 Desc.	Bridge and ECDs crossing S-MM15 in acceptable condition		Pic 8 Desc.	Stabilized ROW in acceptable condition	
  <p>DIRECTION NE (T) 37.26460°N 080.30649°W ACCURACY 5 m DATUM WGS84</p> <p>Environmental 12038+50 2021-06-11 10:17:28-04:00</p>		  <p>DIRECTION SW (T) 37.26430°N 080.30683°W ACCURACY 17 m DATUM WGS84</p> <p>Environmental 12038+50 2021-06-11 10:17:06-04:00</p>			
GPS Location	See photo		GPS Location	See photo	
Field Station#	12038+50		Field Station#	12038+50
