Visual Site Inspection Report

Project Name	H-600 Pipeline Spread I	AFE	124300139	Spread	H-600 Pipeline Spread I	
Contractor	Precision			Report #	22174	
Inspector	Glenn Mike Renfro			Date/Time	4/12/2021 9:18 AM	
Permit #	TBD	Inspection Type	VA SWPP	Station Begin	0000+00	
State	VA	Inspection Area	Full	Station End	0000+00	
County	Franklin	Ground	Damp	Temperature (°F)	60.00	
Municipality	N/A	Weather	Cloudy	Rain Gauge (in)	0.70	
				Rain Accumulation Time (days)	6.00

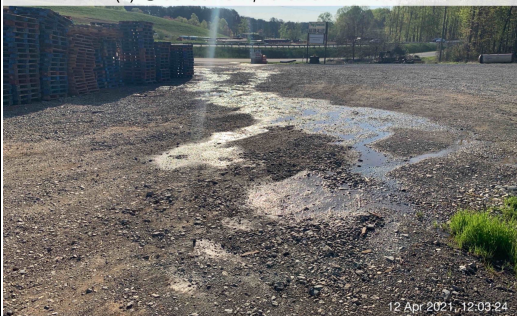
</div> <div>12 Apr 2021, 12:09:41</div>		
GPS Location	00000000000		GPS Location	00000000000	
Field Station#	0000+00		Field Station#	0000+00	
Pic 7 Desc.	Monitoring surface water flow at 032 no issue observed.		Pic 8 Desc.	Inlet protection for catch basin at 033 in good condition.	
<div>South East Elevation</div> <div>☉ 327°NW (T) ● 36°56'45"N, 79°52'44"W ±13ft ▲ 1127ft</div> <div>

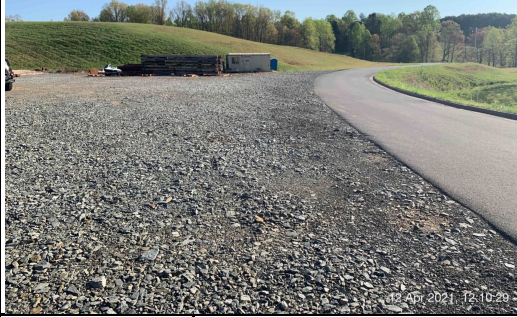
Field Station#	0000+00		Field Station#	0000+00	
Pic 9 Desc.	RCE at 033 in good condition.		Pic 10 Desc.	Secondary containment structure for Blue Def at 006 in good condition.	
<div>North West Elevation</div> <div>☉ 118°SE (T) ● 36°57'11"N, 79°52'43"W ±124ft ▲ 1215ft</div> <div>

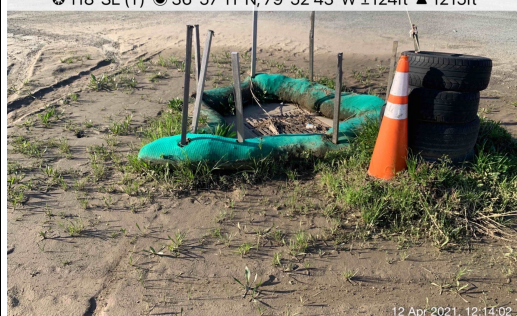
</div> <div>12 Apr 2021, 12:14:02</div>			<div>Insert image here</div>		
GPS Location	00000000000		GPS Location	00000000000	
Field Station#	0000+00		Field Station#	0000+00	
Pic 11 Desc.	Inlet protection needs to be replaced and catch basin cleaned at 006.		Pic 12 Desc.

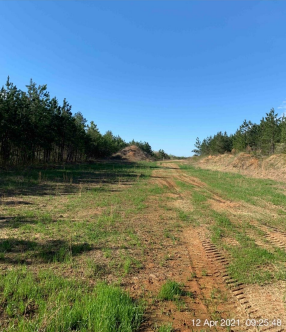
GPS Location	O	GPS Location	O		
Field Station#	5+00	Field Station#	6+00		
Pic 1 Desc.	Observing temporary stabilization	Pic 2 Desc.	Observing temporary stabilization, water bar, sump and end treatment		
West Elevation <small>103°E (T) 36°50'5"N, 79°20'31"W ±213ft ▲ 674ft</small>

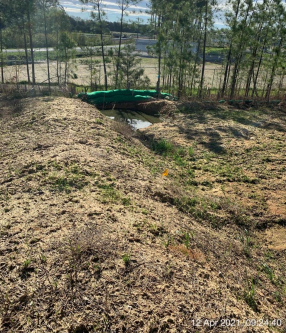
GPS Location	O	GPS Location	O		
Field Station#	12+50	Field Station#	20+00		
Pic 3 Desc.	Observing temporary stabilization, water bar, sump and end treatment	Pic 4 Desc.	Observing temporary stabilization, signage, ECDS and buffer.		
Insert image here			Insert image here		
GPS Location		GPS Location

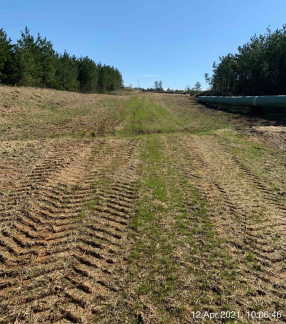
GPS Location	O	GPS Location	O		
Field Station#	16021+00	Field Station#	16011+00		
Pic 1 Desc.	Observing temporary stabilization and water bars	Pic 2 Desc.	Observing temporary stabilization and clean water diversion berm		
	East Elevation <small>286°W (T) 36°49'41"N, 79°20'57"W ±15357ft ▲ 604ft</small>

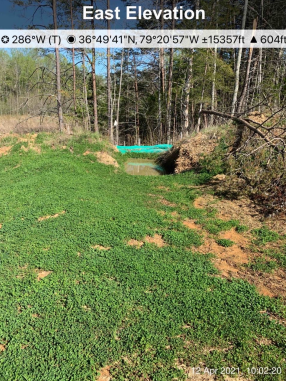
GPS Location	O	GPS Location	O		
Field Station#	16007+00	Field Station#	16004+00		
Pic 3 Desc.	Observing temporary vegetation, water bar, sump and end treatment.	Pic 4 Desc.	Observing temporary vegetation, signage, buffer and ECD's		
	North Elevation <small>185°S (T) 36°49'45"N, 79°20'49"W ±656ft ▲ 610ft</small>

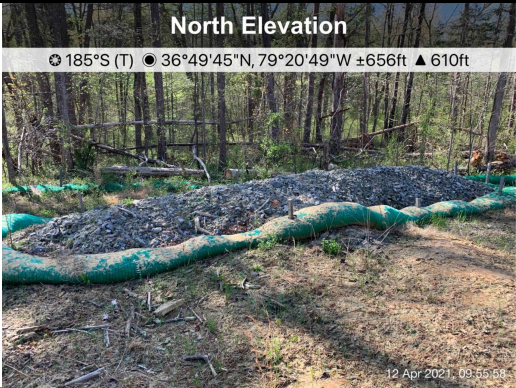
GPS Location	O	GPS Location	O		
Field Station#	16010+00	Field Station#	16016+36		
Pic 5 Desc.	Observing temporary stabilization, CWD outlet and ECD's	Pic 6 Desc.	Observing temporary vegetation, signage, buffer, equipment crossing and ECD's

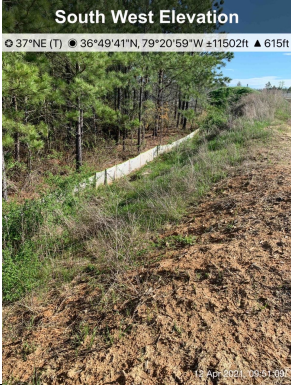
<p>Insert image here</p>		<p>Insert image here</p>	
GPS Location	O	GPS Location			
Field Station#	16024+00	Field Station#			
Pic 7 Desc.	Observing temporary stabilization and ECD's.	Pic 8 Desc.			
<p>Insert image here</p>		<p>Insert image here</p>			
GPS Location		GPS Location			
Field Station#		Field Station#			
Pic 9 Desc.		Pic 10 Desc.			
<p>Insert image here</p>		<p>Insert image here</p>			
GPS Location		GPS Location			
Field Station#		Field Station#			
Pic 11 Desc.		Pic 12 Desc.

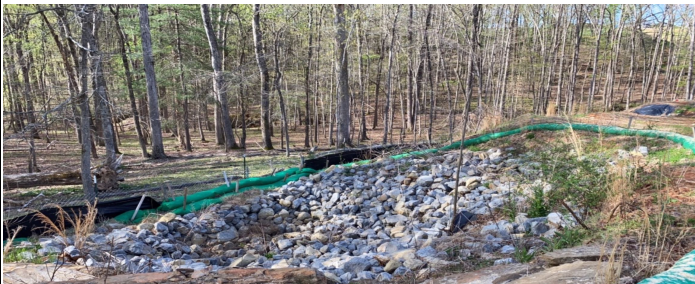
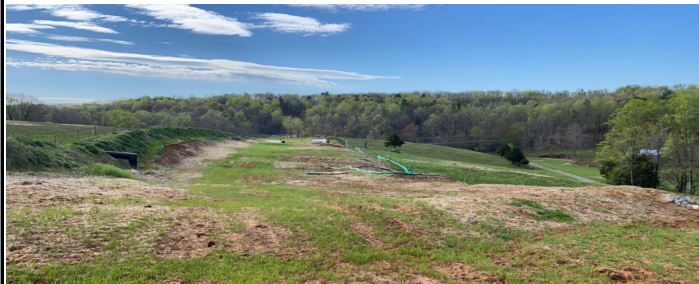
37°3'31" N 79°50'37" W 92°E COURSE 74' GPS 3175 Booker T Washington Hwy, Rocky Mount, VA 24151, United States 04.12.2021 09:46:57 Accur +/-39.3 Ft ALT 996 Ft			37°3'36" N 79°50'18" W 151°SE COURSE 124' GPS 3175 Booker T Washington Hwy, Rocky Mount, VA 24151, United States 04.12.2021 09:56:44 Accur +/-45.1 Ft ALT 989 Ft		
GPS Location	1	GPS Location	2		
Field Station#	14180+00	Field Station#	14197+00		
Pic 1 Desc.	Plunge pool performing intended function		Pic 2 Desc.	Vegetation growing in recently seeded and stabilized area

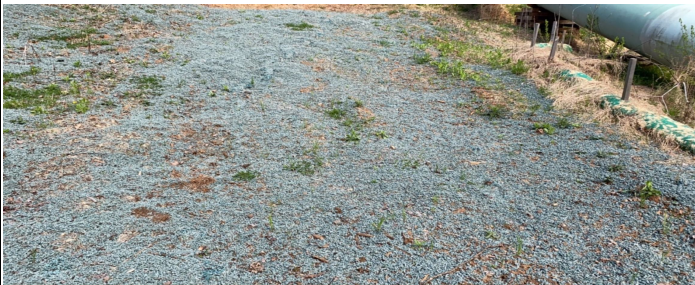
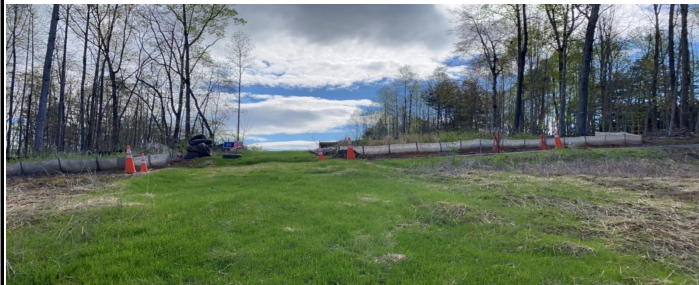
GPS Location	3	GPS Location	4		
Field Station#	14213+00	Field Station#	14221+00		
Pic 3 Desc.	Contractor hand seeded and stabilized travel lanes at resource buffers and stream crossings		Pic 4 Desc.	Vegetation growing in recently seeded and stabilized area

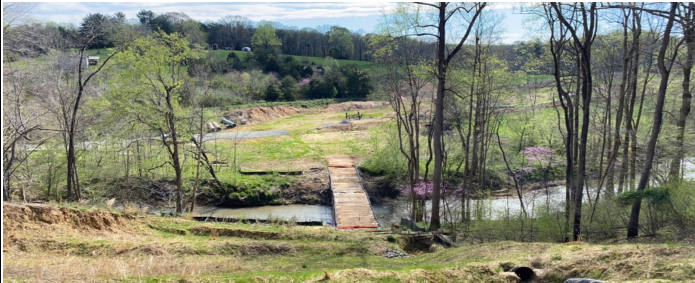
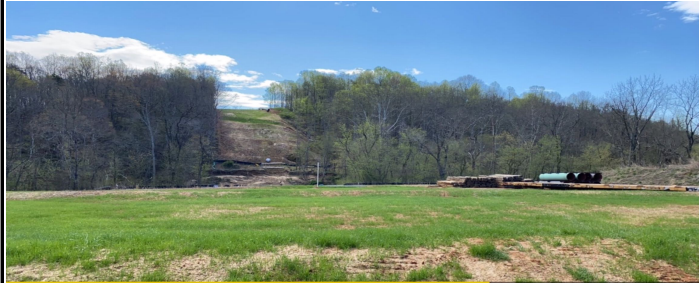
37°3'18" N 79°49'51" W 84°E COURSE 95' GPS Rocky Mount, VA 24151, United States 04.12.2021 10:14:49 Accur +/-52.6 Ft ALT 1018 Ft			37°3'12" N 79°49'36" W 121°SE COURSE 124' GPS Rocky Mount, VA 24151, United States 04.12.2021 10:21:13 Accur +/-143.1 Ft ALT 888 Ft		
GPS Location	5	GPS Location	6		
Field Station#	14230+00	Field Station#	14248+00		
Pic 5 Desc.	Vegetation growing in recently seeded and stabilized area		Pic 6 Desc.	Vegetation growing in recently seeded and stabilized area

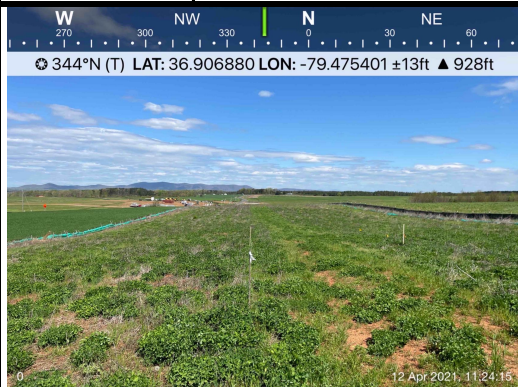
<p>Insert image here</p>	
GPS Location	See photo		GPS Location		
Field Station#	15490+00		Field Station#		
Pic 11 Desc.	Vegetation continues to fill in ROW.		Pic 12 Desc.

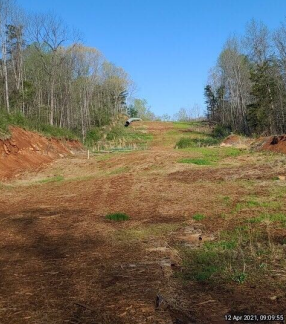
GPS Location	00000	GPS Location	00000		
Field Station#	13780+00	Field Station#	13847+30		
Pic 1 Desc.	Vegetation observation photo showing some new vegetation growth .		Pic 2 Desc.	Vegetation observation photo showing new vegetation growth, monitored ECDs while inspecting row conditions.	
	South Elevation <small>0°N (T) 37.069493, -79.93394 ±4 m ▲ 297 m</small>

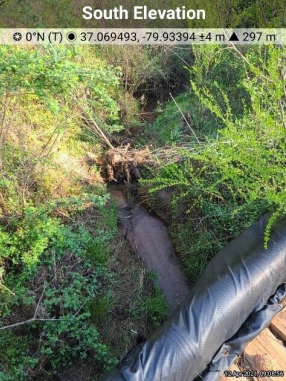
GPS Location	00000	GPS Location	00000		
Field Station#	13781+61	Field Station#	13781+61		
Pic 3 Desc.	Stream observation photo facing downstream during routine inspection today. No issues observed at the time of inspection.		Pic 4 Desc.	Stream observation photo facing upstream during routine inspection today, no issues observed at the time of inspection.

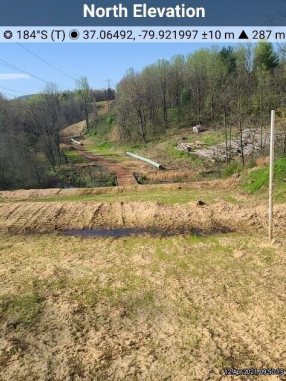
GPS Location	0000	GPS Location	00000		
Field Station#	13844+44	Field Station#	13785+00		
Pic 5 Desc.	Monitored vegetation growth while traveling row. No issues observed at the time of inspection.		Pic 6 Desc.	Vegetation observation photo facing down row on hill side above stream crossing. No issues observed at the time of inspection.

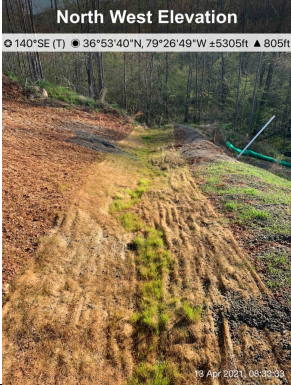
<p>North East Elevation <small>223°SW (T) 36°53'38"N, 79°26'46"W ±8940ft ▲740ft</small> <small>13 Apr 2021, 08:35:57</small></p>			
GPS Location	O	GPS Location	O		
Field Station#	15594+00	Field Station#	15600+12		
Pic 7 Desc.	Observing temporary stabilization, water bar and erosion control blanket.		Pic 8 Desc.	Observing temporary stabilization, signage, buffer, equipment crossing and ECD's	
Insert image here		Insert image here			
GPS Location		GPS Location			
Field Station#		Field Station#			
Pic 9 Desc.			Pic 10 Desc.		
Insert image here		Insert image here			
GPS Location		GPS Location			
Field Station#		Field Station#			
Pic 11 Desc.			Pic 12 Desc.

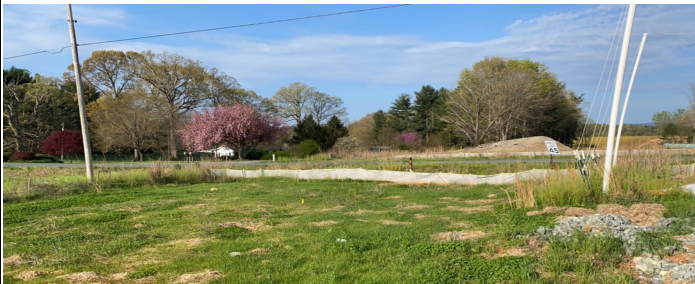
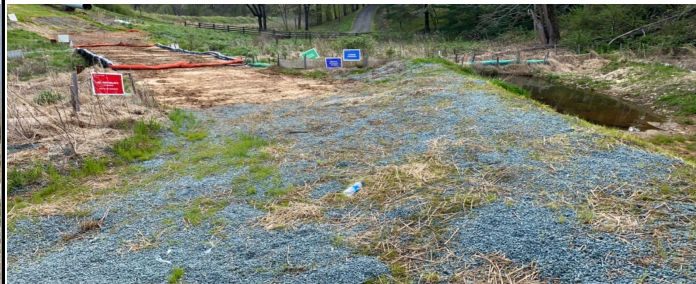
37°2'53" N 79°53'40" W 275°W COURSE 250' GPS 323-343 Foggy Ridge Rd, Rocky Mount, VA 24151, United States			04.14.2021 08:57:42 Accur +/-32.1 Ft ALT 1108 Ft		
37°3'7" N 79°53'20" W 93°E COURSE 123' GPS Rocky Mount, VA 24151, United States			04.14.2021 10:04:17 Accur +/-210.9 Ft ALT 1096 Ft		
GPS Location	1	GPS Location	2		
Field Station#	13959+00	Field Station#	13991+69		
Pic 1 Desc.	Contractor replaced P1 silt fence along Foggy Ridge Rd		Pic 2 Desc.	Contractor hand seeded and stabilized travel lanes at resource buffers and stream crossings

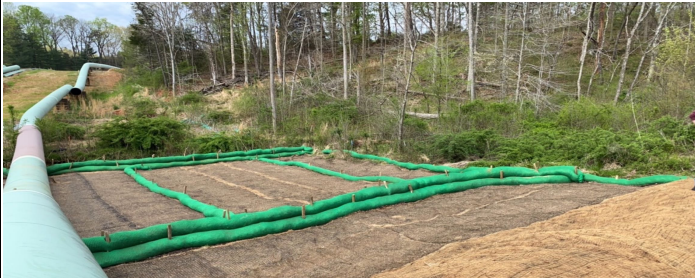
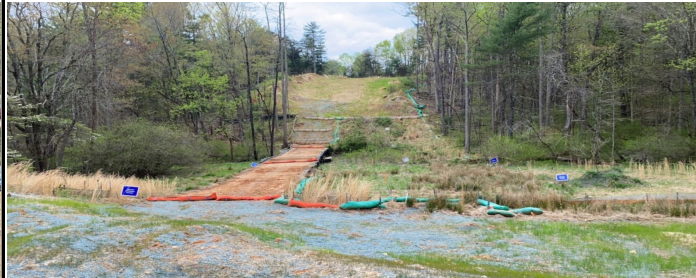
GPS Location	3	GPS Location	4		
Field Station#	13998+50	Field Station#	14035+28		
Pic 3 Desc.	Contractor replaced all ECDs in resource buffer at S-KL36		Pic 4 Desc.	Contractor hand seeded and stabilized travel lanes at resource buffers and stream crossings

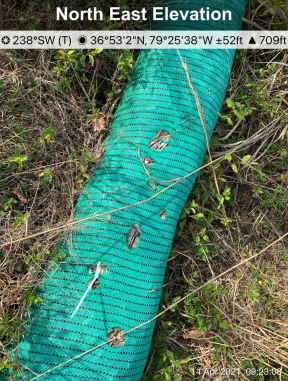
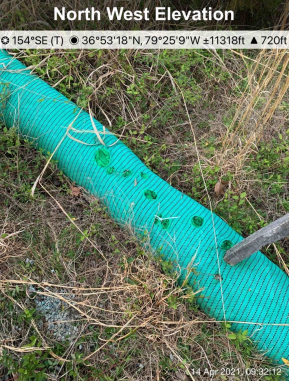
GPS Location	O		GPS Location	O	
Field Station#	15671+50		Field Station#	15671+50	
Pic 1 Desc.	Observing CFS that required maintenance		Pic 2 Desc.	Observing CFS that received maintenance	
	East Elevation <small>255°W (T) 36°53'2"N, 79°25'37"W ±147ft ▲ 712ft</small>

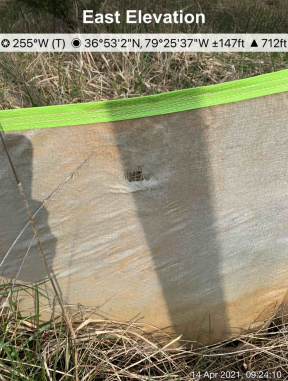
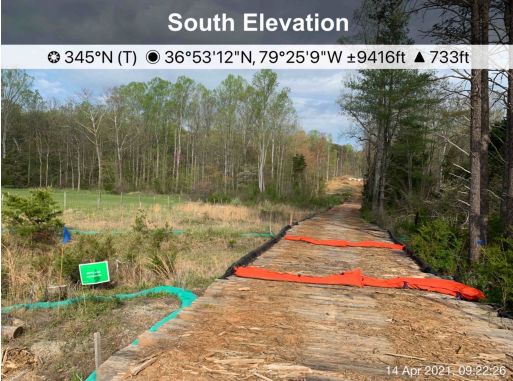
GPS Location	O		GPS Location	O	
Field Station#	15671+80		Field Station#	15671+93	
Pic 3 Desc.	Observing p1 that requires maintenance		Pic 4 Desc.	Observing signage, buffer, equipment crossing and ECD's	
	North Elevation <small>171°S (T) 36°53'35"N, 79°24'5"W ±8976ft ▲ 766ft</small>

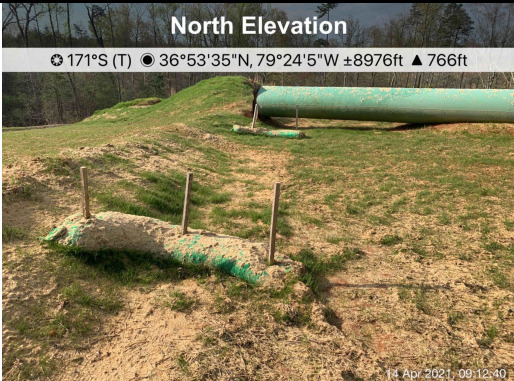
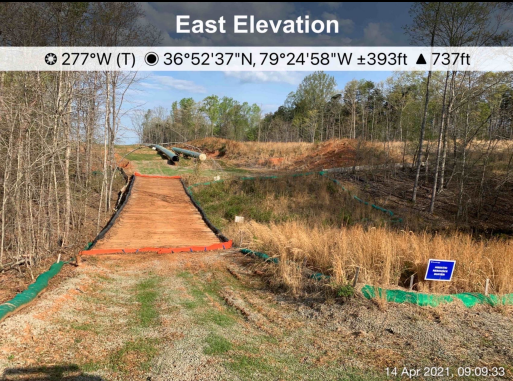
GPS Location	O		GPS Location	O	
Field Station#	15706+00		Field Station#	15713+52	
Pic 5 Desc.	Observing temporary stabilization, erosion control blanket and cfs checks		Pic 6 Desc.	Observing temporary stabilization, signage, buffer, equipment crossing and ECD's

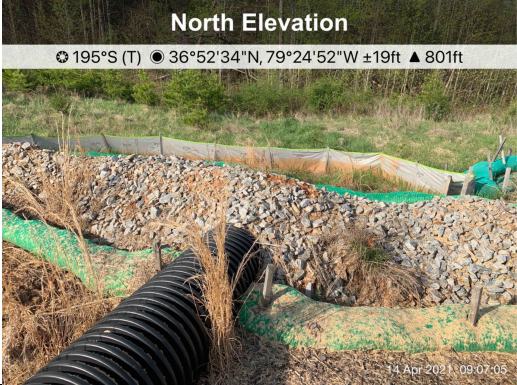
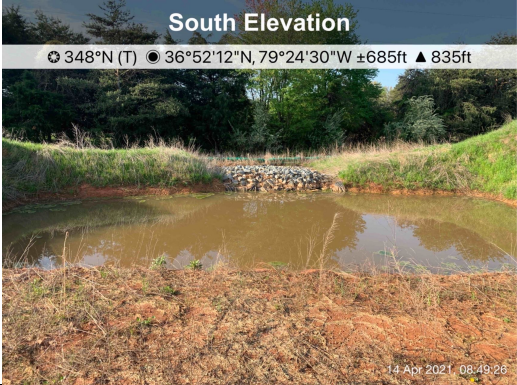
GPS Location	O	GPS Location	O		
Field Station#	15720+00	Field Station#	15740+00		
Pic 7 Desc.	Observing CWD pipe,outlet and ECD's	Pic 8 Desc.	Observing temporary stabilization, sump and end treatment		
Insert image here		Insert image here			
GPS Location		GPS Location			
Field Station#		Field Station#			
Pic 9 Desc.		Pic 10 Desc.			
Insert image here		Insert image here			
GPS Location		GPS Location			
Field Station#		Field Station#			
Pic 11 Desc.		Pic 12 Desc.

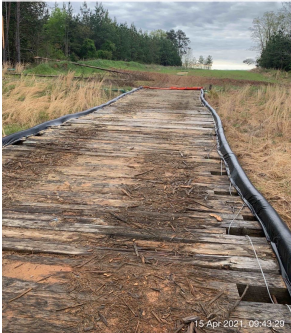
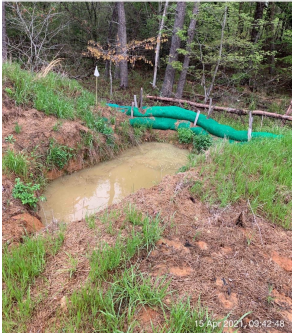
GPS Location		GPS Location			
O		O			
Field Station#		Field Station#			
15807+50		15806+00			
Pic 7 Desc.		Pic 8 Desc.			
Observing temporary stabilization, equipment crossing and ECD's		Observing temporary stabilization, sump and end treatment			
South West Elevation <small>40°NE (T) 36°52'18"N, 79°23'52"W ±15331ft ▲ 834ft</small>

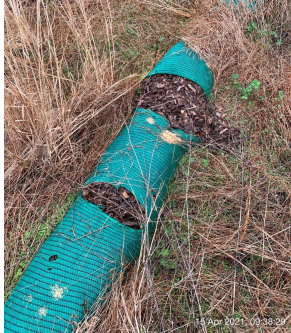
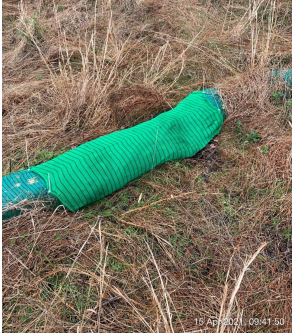
GPS Location		GPS Location			
O		O			
Field Station#		Field Station#			
15807+00		15807+00			
Pic 9 Desc.		Pic 10 Desc.			
Observing CFS that required maintenance		Observing CFS that received maintenance			
Insert image here			Insert image here

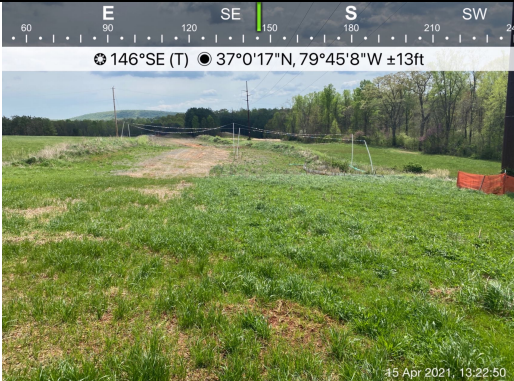
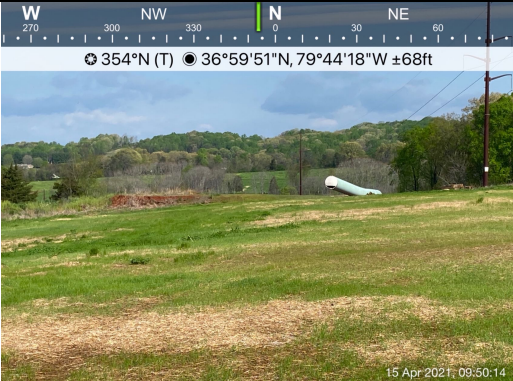
GPS Location	0	GPS Location	0		
Field Station#	14550+00	Field Station#	14595+50		
Pic 3 Desc.	Approximately 14550+00. Overview of ROW.	Pic 4 Desc.	Approximately 14595+50. Overview of ROW.

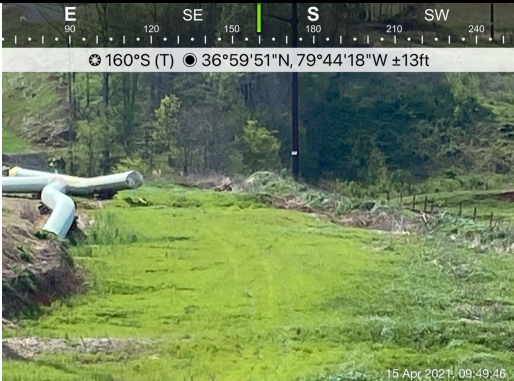
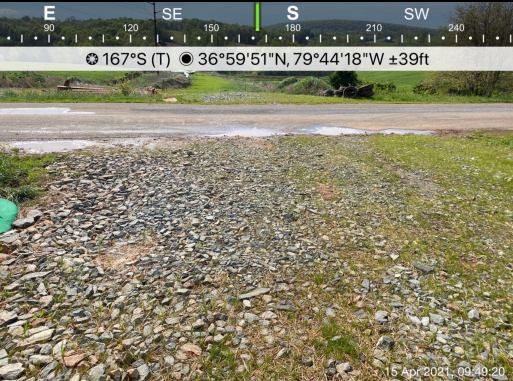
GPS Location	0	GPS Location	0		
Field Station#	14605+00	Field Station#	14599+00		
Pic 5 Desc.	Approximately 14605+00. Overview of ROW.	Pic 6 Desc.	Approximately 14599+00. Overview of road crossing and RCEs.

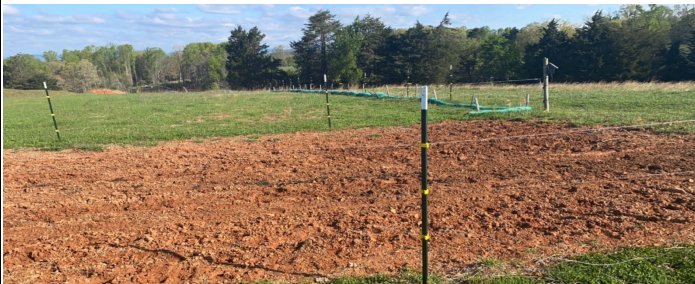
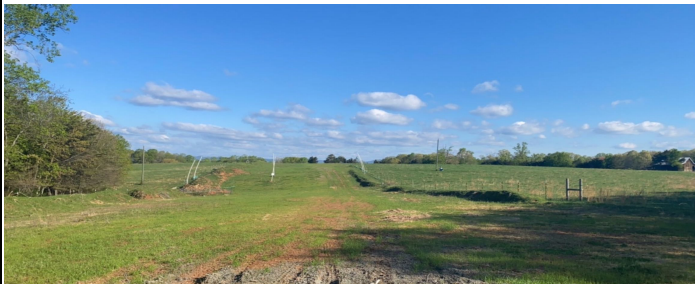
37°2'42" N 79°48'40" W 335°NW COURSE 349° GPS 955 Greenway Rd, Glade Hill, VA 24092, United States 04.16.2021 09:09:43 Accur +/-60.7 Ft ALT 1060 Ft			37°2'35" N 79°48'37" W 351°N COURSE 337° GPS 955 Greenway Rd, Glade Hill, VA 24092, United States 04.16.2021 09:06:21 Accur +/-27.8 Ft ALT 1059 Ft		
GPS Location	1	GPS Location	2		
Field Station#	14303+00	Field Station#	14310+00		
Pic 1 Desc.	Routine maintenance. Damage to electric cattle fence from cattle damage.	Pic 2 Desc.	Temporary stabilization/vegetation along ROW.

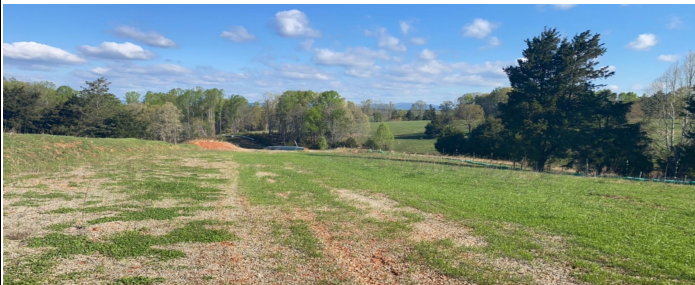
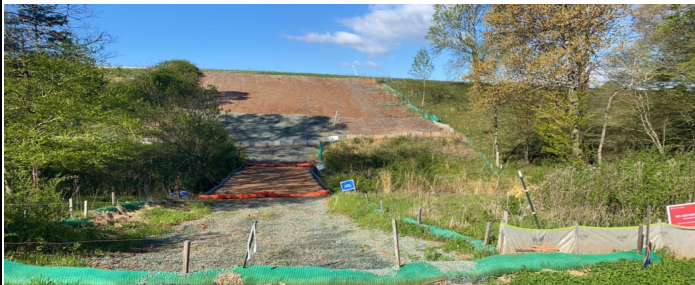
GPS Location	3	GPS Location	4		
Field Station#	14297+00	Field Station#	14278+00		
Pic 3 Desc.	Temporary stabilization/vegetation along ROW.	Pic 4 Desc.	Contractor hand seeded and stabilized travel lanes at resource buffers and stream crossings

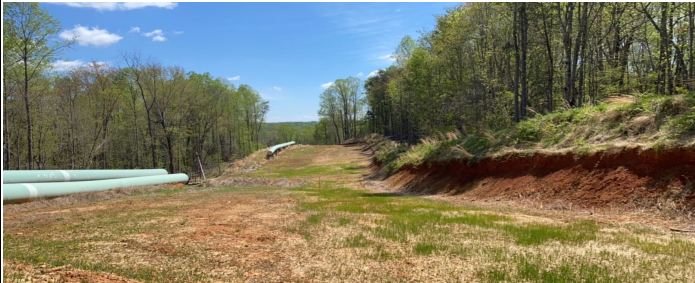
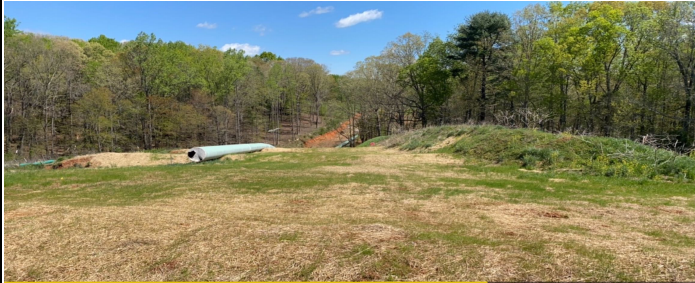
37°3'18" N 79°50'0" W 73°E COURSE 295° GPS Rocky Mount, VA 24151, United States 04.16.2021 12:06:16 Accur +/-40.3 Ft ALT 1015 Ft			37°3'26" N 79°50'44" W 78°E COURSE -1° GPS 130-430 Angle Plantation Rd, Rocky Mount, VA 24151, United States 04.16.2021 12:13:03 Accur +/-31.7 Ft ALT 1029 Ft		
GPS Location	5	GPS Location	6		
Field Station#	14224+00	Field Station#	14173+00		
Pic 5 Desc.	Temporary stabilization/vegetation along ROW.	Pic 6 Desc.	Temporary stabilization/vegetation along ROW.

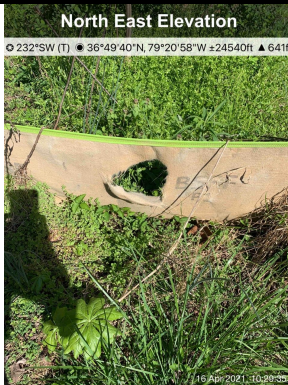
</div>			
GPS Location	O		GPS Location	O	
Field Station#	15963+50		Field Station#	16004+00	
Pic 3 Desc.	Observing p1 that requires maintenance (damaged by wildlife)		Pic 4 Desc.	Observing temporary stabilization, signage and buffer

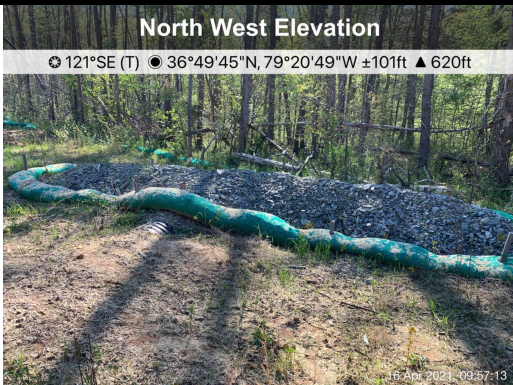
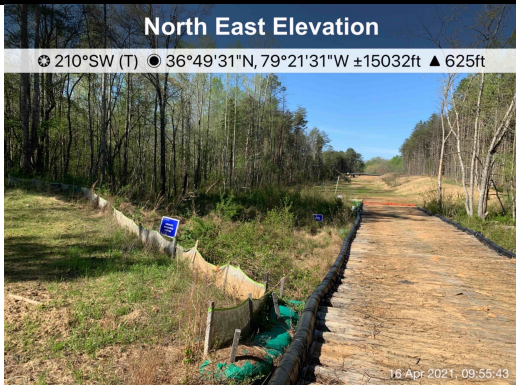
</div>			
GPS Location	O		GPS Location	O	
Field Station#	26010+00		Field Station#	16016+36	
Pic 5 Desc.	Observing temporary stabilization, CWD outlet and ECD's		Pic 6 Desc.	Observing temporary stabilization, signage, buffer, equipment crossing and ECD's

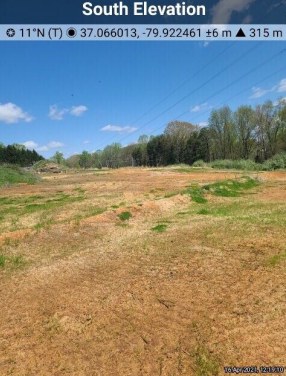
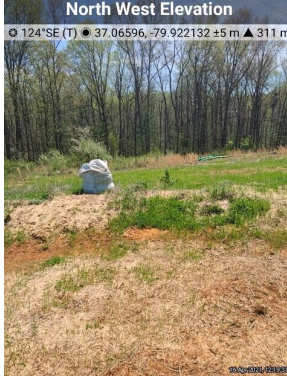
GPS Location	00000	GPS Location	00000		
Field Station#	13826+95	Field Station#	13827+00		
Pic 1 Desc.	Row photo showing some new vegetation growth, will continue to monitor the area.		Pic 2 Desc.	Row photo showing new vegetation growth and pellet mulch stock piled to be applied to the row.	
	North East Elevation

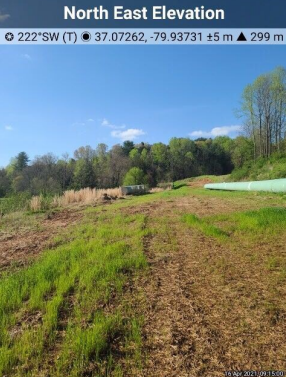
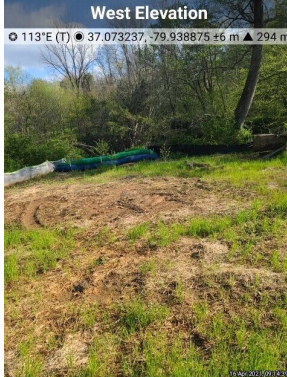
GPS Location	0000	GPS Location	00000		
Field Station#	13762+50	Field Station#	13760+92		
Pic 3 Desc.	Row photo showing vegetation growth. No environmental issues observed at the time of inspection		Pic 4 Desc.	Photo showing CFS outlet in place and functioning.	
	South East Elevation

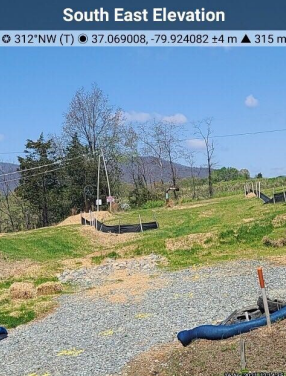
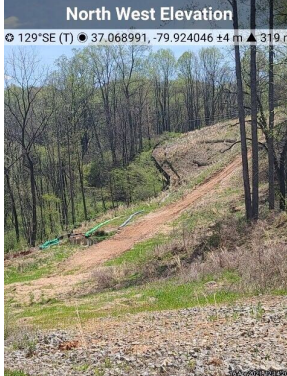
GPS Location	0000	GPS Location	0000		
Field Station#	13810+00	Field Station#	13814+00		
Pic 5 Desc.	Row photo showing vegetation growth where row was recently hydro seeded.		Pic 6 Desc.	Row photo showing ECDs in place and functioning, row stabilized.

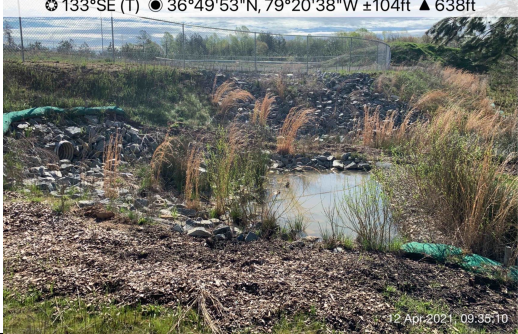
<p>North West Elevation <small>133°SE (T) 36°49'53"N, 79°20'38"W ±104ft ▲ 638ft</small></p>			
GPS Location	O	GPS Location	O		
Field Station#	00+00	Field Station#	00+00		
Pic 1 Desc.	Observing temporary vegetation, rock check dam, outlet and outlet protection		Pic 2 Desc.	Observing emergency overflow at the storm water pond

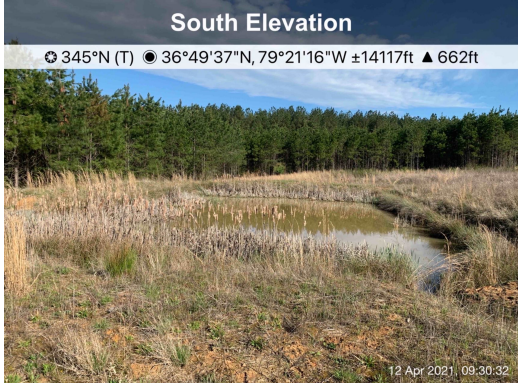
<p>South Elevation <small>345°N (T) 36°49'37"N, 79°21'16"W ±14117ft ▲ 662ft</small></p>			
GPS Location	O	GPS Location	O		
Field Station#	00+00	Field Station#	00+00		
Pic 3 Desc.	Observing temporary vegetation and overflow drain at sediment basin		Pic 4 Desc.	Observing sediment basin and vegetation	
Insert image here			Insert image here

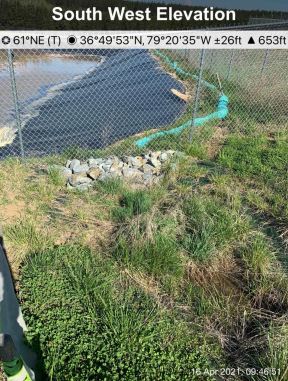
GPS Location	O	GPS Location	O		
Field Station#	00+00	Field Station#	00+00		
Pic 1 Desc.	Observing temporary stabilization and rock check dam		Pic 2 Desc.	Observing temporary stabilization, storm water pond and ECD's

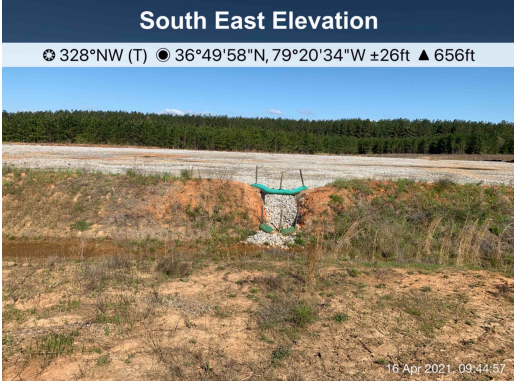
GPS Location	O	GPS Location	O		
Field Station#	00+00	Field Station#	00+00		
Pic 3 Desc.	Observing temporary stabilization, rock drain and ECD's		Pic 4 Desc.	Observing temporary stabilization, outlet and outlet protection	
Insert image here			Insert image here		
GPS Location		GPS Location			
Field Station#		Field Station#			
Pic 5 Desc.			Pic 6 Desc.
