Visual Site Inspection Report

Project Name	H-600 Pipeline Spread I	AFE	124300139	Spread	H-600 Pipeline Spread I
Contractor	Precision			Report #	22416
Inspector	John White			Date/Time	4/19/2021 9:24 AM
Permit #	TBD	Inspection Type	VA SWPP	Station Begin	15584+23
State	VA	Inspection Area	Full	Station End	15647+03
County	Pittsylvania	Ground	Wet	Temperature (°F)	49.00
Municipality	Chatham	Weather	Light Rain	Rain Gauge (in)	0.70
				Rain Accumulation Time (days)	6.00

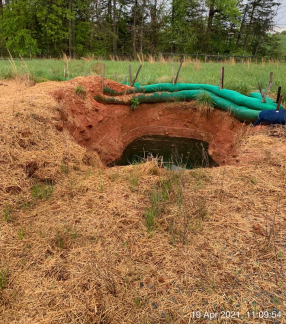
GPS Location	O	GPS Location	O		
Field Station#	15644+00	Field Station#	15636+45		
Pic 1 Desc.	Observing temporary stabilization, sump and end treatment	Pic 2 Desc.	Observing temporary stabilization, signage, buffer equipment crossing and ECD's		
	North Elevation <small>178°S (T) 36°53'32"N, 79°26'8"W ±2818ft ▲ 805ft</small>

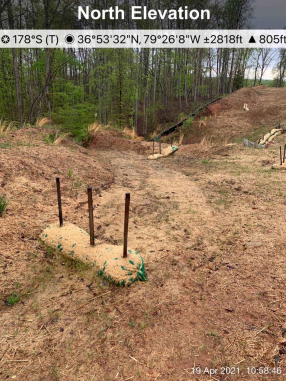
GPS Location	O	GPS Location	O		
Field Station#	15632+00	Field Station#	15630+00		
Pic 3 Desc.	Observing temporary stabilization, erosion control blanket and ECD's	Pic 4 Desc.	Observing temporary stabilization, CWD outlet and ECD's		
	West Elevation <small>88°E (T) 36°53'33"N, 79°26'23"W ±232ft ▲ 785ft</small>

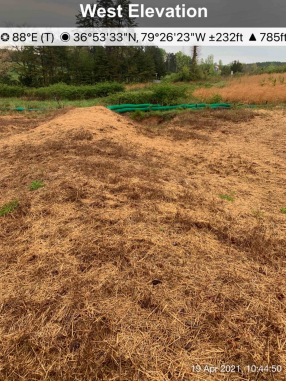
GPS Location	O	GPS Location	O		
Field Station#	15617+00	Field Station#	15608+00		
Pic 5 Desc.	Observing temporary stabilization, water bar, sump and end treatment	Pic 6 Desc.	Observing safety fence that required maintenance

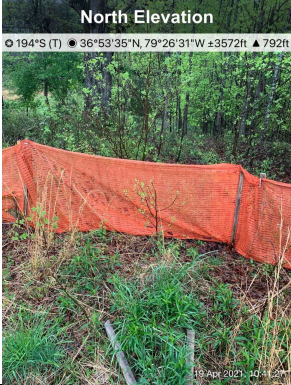
GPS Location	O	GPS Location	O		
Field Station#	15608+00	Field Station#	15606+00		
Pic 7 Desc.	Observing safety fence that received maintenance	Pic 8 Desc.	Observing temporary stabilization		
Insert image here		Insert image here			
GPS Location		GPS Location			
Field Station#		Field Station#			
Pic 9 Desc.		Pic 10 Desc.			
Insert image here		Insert image here			
GPS Location		GPS Location			
Field Station#		Field Station#			
Pic 11 Desc.		Pic 12 Desc.

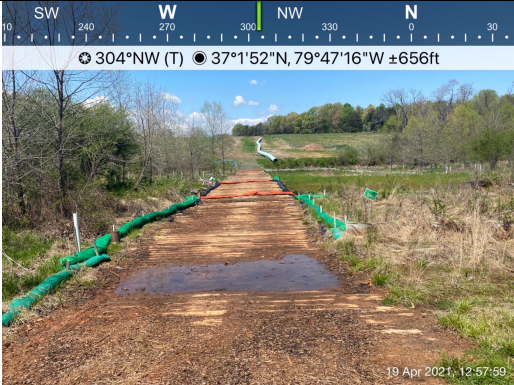
GPS Location	0	GPS Location	0		
Field Station#	14391+53	Field Station#	14414+00		
Pic 1 Desc.	Approximately 14391+53. Overview of stream crossing, equipment bridge and ECDs at stream S-A41.		Pic 2 Desc.	Approximately 14414+00. Overview of ROW.

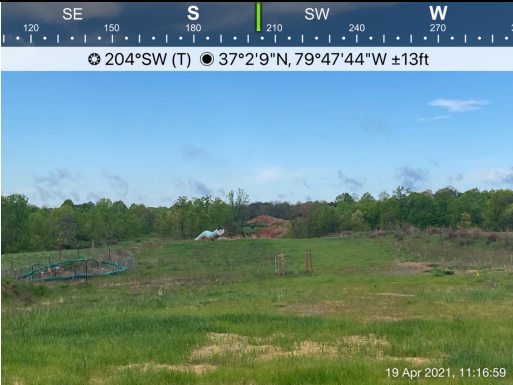
GPS Location	0	GPS Location	0		
Field Station#	14451+00	Field Station#	14360+00		
Pic 3 Desc.	Approximately 14451+00. Overview of ROW.		Pic 4 Desc.	Approximately 14360+00. Overview of ROW.

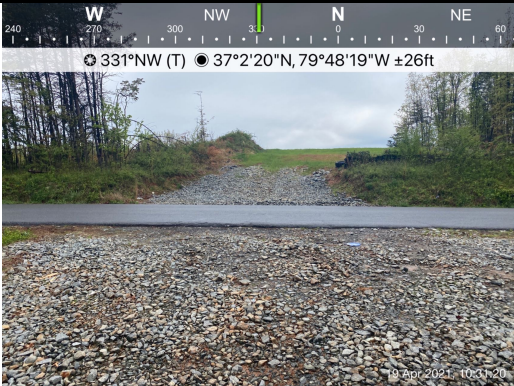
GPS Location	0	GPS Location	0		
Field Station#	14333+00	Field Station#	14314+79		
Pic 5 Desc.	Approximately 14333+00. Overview of road crossing and RCEs.		Pic 6 Desc.	Approximately 14314+79. Overview of stream crossing, equipment bridge and ECDs at stream S-GG4.

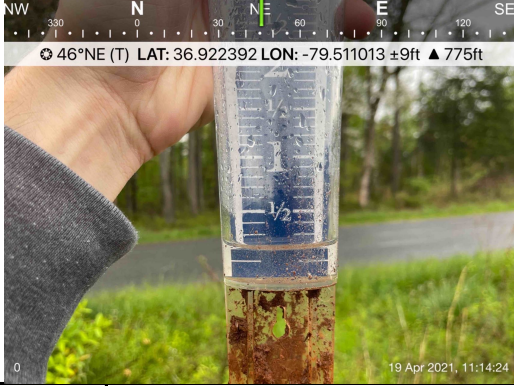
GPS Location	See photo	GPS Location	See photo		
Field Station#	15162+00	Field Station#	15370+62		
Pic 1 Desc.	P1 has been damaged by livestock and needs to be replaced.	Pic 2 Desc.	Rain gauge showing 15370+62

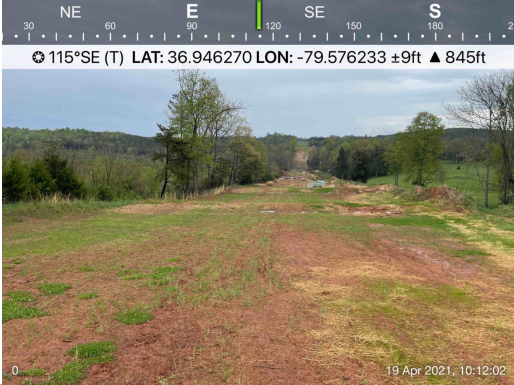
GPS Location	See photo	GPS Location	See photo		
Field Station#	15152+84	Field Station#	15165+57		
Pic 3 Desc.	Vegetation continues to fill in this section of ROW.	Pic 4 Desc.	Stone inlet remains in good condition.

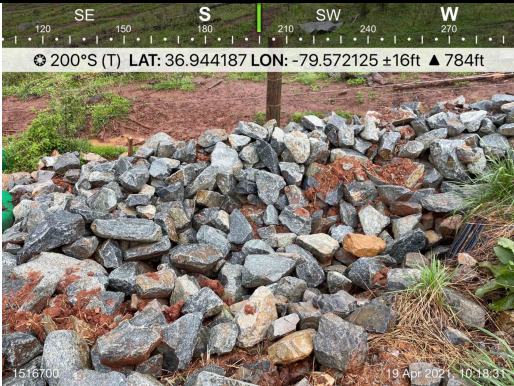
GPS Location	See photo	GPS Location	See photo		
Field Station#	15167+00	Field Station#	15167+95		
Pic 5 Desc.	Stone outlet remains in good condition.	Pic 6 Desc.	Equipment bridge ECDs are in good condition and functioning.

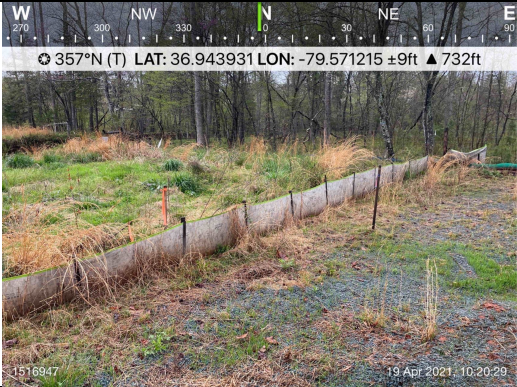
GPS Location	See photo		GPS Location	See photo	
Field Station#	15169+47		Field Station#	15170+00	
Pic 7 Desc.	P1 is in good condition at all stream and wetland buffers.		Pic 8 Desc.	Waterbars remain in good condition.

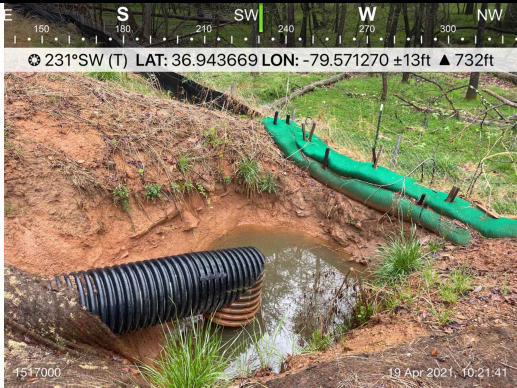
GPS Location	See photo		GPS Location	See photo	
Field Station#	15170+00		Field Station#	15195+00	
Pic 9 Desc.	Slope drain is in good condition and functioning.		Pic 10 Desc.	Drainage ECDs are in place and functioning.

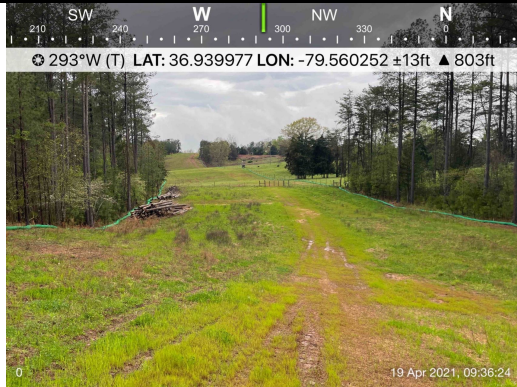
GPS Location	See photo		GPS Location	See photo	
Field Station#	15205+00		Field Station#	15230+00	
Pic 11 Desc.	Vegetation continues to fill in this section of ROW.		Pic 12 Desc.	Vegetation continues to fill in this section of ROW.

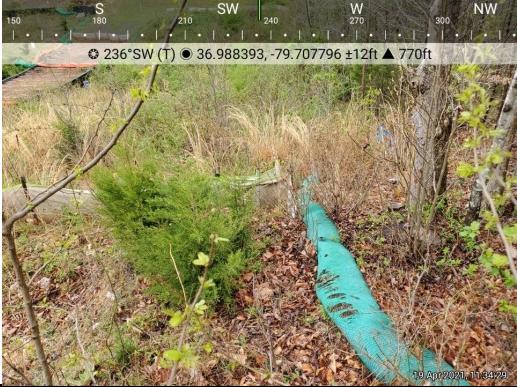
GPS Location	0	GPS Location	0		
Field Station#	14701+00	Field Station#	14727+00		
Pic 7 Desc.	CFS Repairs GAS S-H32	Pic 8 Desc.	CIS S-A19 Sump

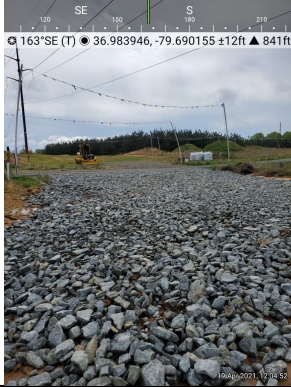
GPS Location	0	GPS Location			
Field Station#	14757+50	Field Station#			
Pic 9 Desc.	CIS Indian Cave Rd RCE	Pic 10 Desc.

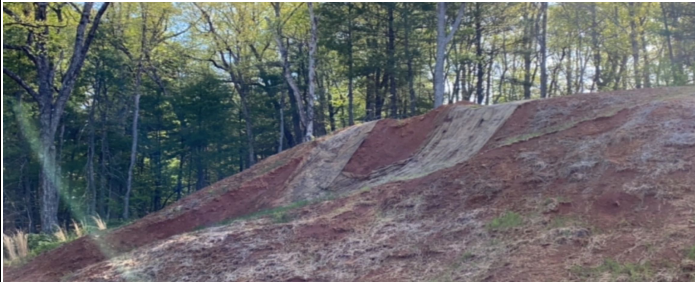
37°3'47" N 79°52'42" W 64°NE COURSE 272' GPS Rocky Mount, VA 24151, United States 04.20.2021 09:19:42 Accur +/-63.2 Ft ALT 1150 Ft			37°2'55" N 79°53'36" W 98°E COURSE -1' GPS Rocky Mount, VA 24151, United States 04.20.2021 08:33:20 Accur +/-32.3 Ft ALT 1112 Ft		
GPS Location	1	GPS Location	2		
Field Station#	14045+00	Field Station#	13968+00		
Pic 1 Desc.	Routine maintenance. Curlex down on spoil pile. Seed and stabilize denuded areas of spoil pile.		Pic 2 Desc.	Contractor installed CFS triple stack in section of ROW after installing new sumps per instruction

37°2'56" N 79°53'35" W 99°E COURSE 28' GPS Rocky Mount, VA 24151, United States 04.20.2021 08:34:06 Accur +/-50.0 Ft ALT 1104 Ft			37°3'6" N 79°53'13" W 357°N COURSE 34' GPS Rocky Mount, VA 24151, United States 04.20.2021 08:44:15 Accur +/-69.8 Ft ALT 1111 Ft		
GPS Location	3	GPS Location	4		
Field Station#	13968+00	Field Station#	13990+00		
Pic 3 Desc.	Contractor seeded and stabilized travel lane after utilization for environmental maintenance.		Pic 4 Desc.	View of vegetation growing in temporary area. Curlex in place along fill slope.

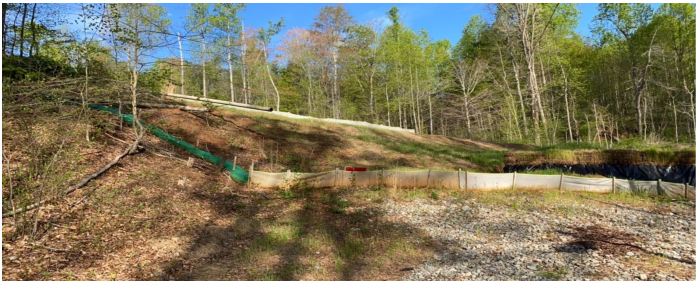
Field Station#	14000+00	Field Station#	14010+00		
Pic 5 Desc.	Safety fence installed around open ditch CIS Hwy 220		Pic 6 Desc.	RCE CIS Hwy 220 and ECDs in place and functional

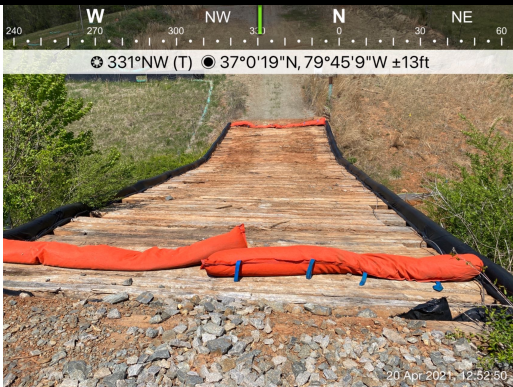
<p>SE S SW W 150 180 210 240 270 300 217°SW (T) 37°0'39"N, 79°45'15"W ±13ft 20 Apr 2021, 12:47:50</p>			
GPS Location	0	GPS Location	0		
Field Station#	14546+33	Field Station#	14528+00		
Pic 1 Desc.	Approximately 14546+33. Overview of stream crossing, equipment bridge and ECDs at stream S-G17.		Pic 2 Desc.	Approximately 14528+00. Overview of ROW.

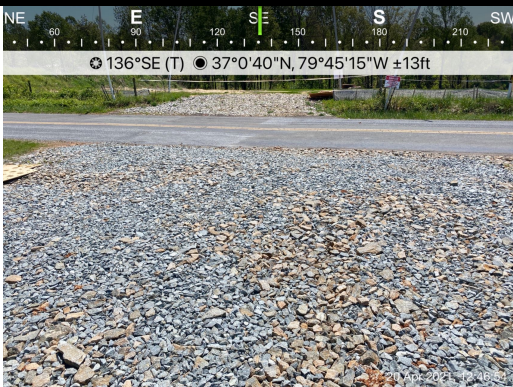
<p>SE S SW W NW 150 180 210 240 270 300 226°SW (T) 37°0'41"N, 79°45'17"W ±13ft 20 Apr 2021, 12:46:18</p>			
GPS Location	0	GPS Location	0		
Field Station#	14524+75	Field Station#	14522+50		
Pic 3 Desc.	Approximately 14524+75. Overview of road crossing and RCEs.		Pic 4 Desc.	Approximately 14522+50. Overview of ROW.

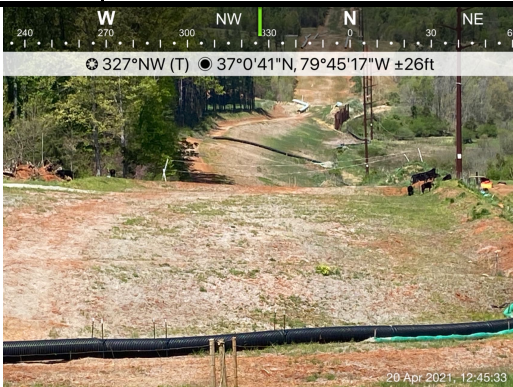
<p>NE E SE S 60 90 120 150 180 210 126°SE (T) 37°1'33"N, 79°46'2"W ±803ft 20 Apr 2021, 12:33:19</p>			
GPS Location	0	GPS Location	0		
Field Station#	14519+00	Field Station#	14460+00		
Pic 5 Desc.	Approximately 14519+00. Overview of ROW. Livestock present and grazing at time of inspection.		Pic 6 Desc.	Approximately 14460+00. Overview of ROW.

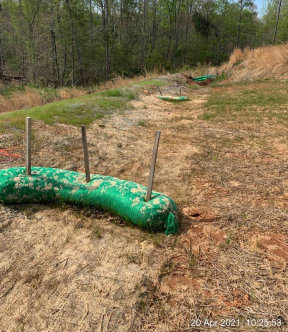
GPS Location	O	GPS Location	O		
Field Station#	15706+00	Field Station#	15720+00		
Pic 1 Desc.	Observing temporary stabilization,water bar, erosion control blanket and cfs checks	Pic 2 Desc.	Observing temporary stabilization,CWD outlet and ECD's		
	North Elevation <small>184°S (T) 36°52'23"N, 79°24'41"W ±16ft ▲ 863ft</small>

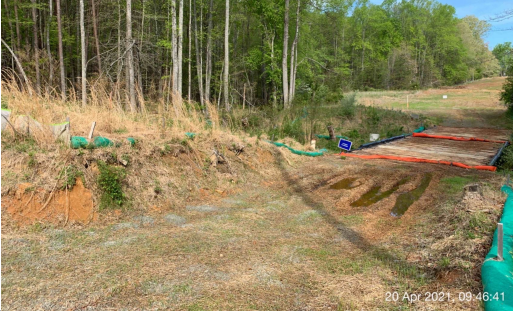
GPS Location	O	GPS Location	O		
Field Station#	15735+00	Field Station#	15658+43		
Pic 3 Desc.	Observing temporary stabilization,CWD outlet and ECD's	Pic 4 Desc.	Observing temporary stabilization, signage, buffer, equipment crossing and ECD's

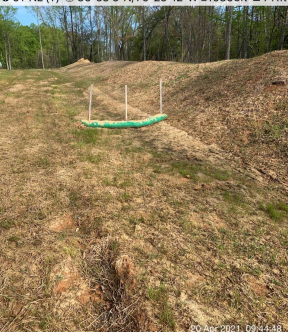
GPS Location	O	GPS Location	O		
Field Station#	15662+00	Field Station#	15669+44		
Pic 5 Desc.	Observing temporary stabilization,erosion control blanket and cfs checks	Pic 6 Desc.	Observing equipment crossing and stream

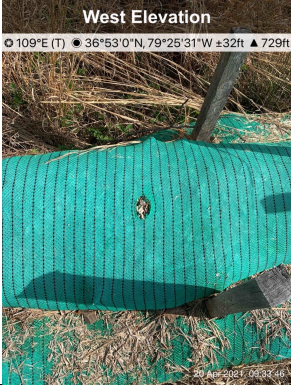
GPS Location	O	GPS Location	O		
Field Station#	15709+00	Field Station#	15709+00		
Pic 7 Desc.	Observing CFS that required maintenance	Pic 8 Desc.	Observing CFS that received maintenance

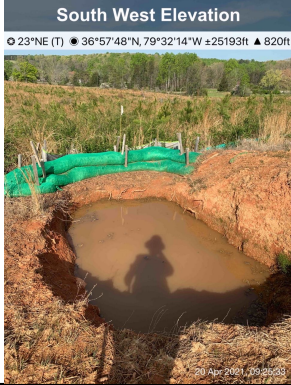
GPS Location	O	GPS Location			
Field Station#	15690+00	Field Station#			
Pic 9 Desc.	Observing sump and end treatment	Pic 10 Desc.

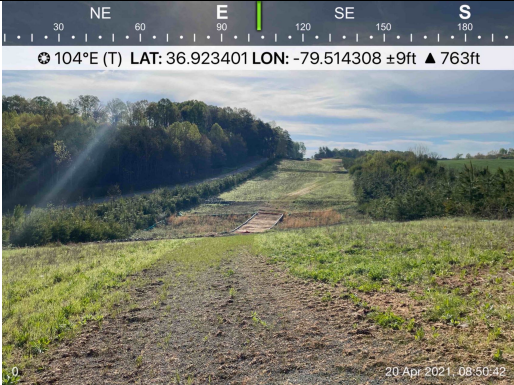
GPS Location	See photo		GPS Location	See photo	
Field Station#	15360+00		Field Station#	15349+59	
Pic 1 Desc.	Vegetation continues to fill in this section of ROW.		Pic 2 Desc.	Waterbars are in good condition and functioning.

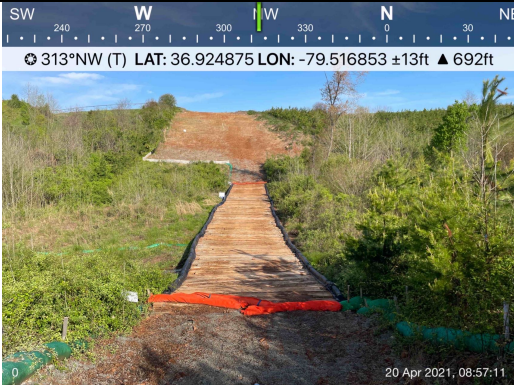
GPS Location	See photo		GPS Location	See photo	
Field Station#	15346+87		Field Station#	15346+20	
Pic 3 Desc.	Equipment bridge ECDs are in place and functioning.		Pic 4 Desc.	P1 is in good condition at all stream and wetland buffers.

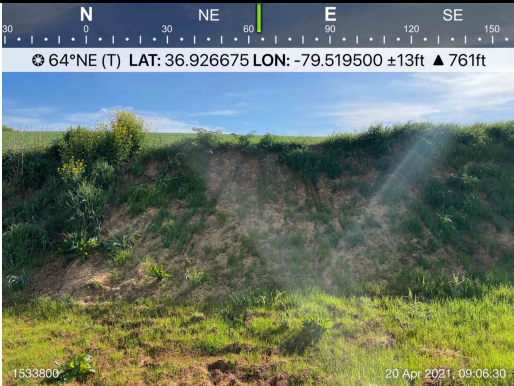
GPS Location	See photo		GPS Location	See photo	
Field Station#	15338+00		Field Station#	15338+00	
Pic 5 Desc.	Diversion berm remains in good condition.		Pic 6 Desc.	CWD inlet is in good condition and functioning.

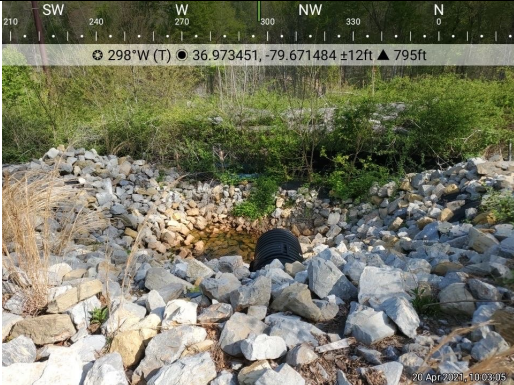
GPS Location	0	GPS Location	0		
Field Station#	14825+00	Field Station#	14825+00		
Pic 1 Desc.	Plunge pool outlet	Pic 2 Desc.	Plunge pool inlet

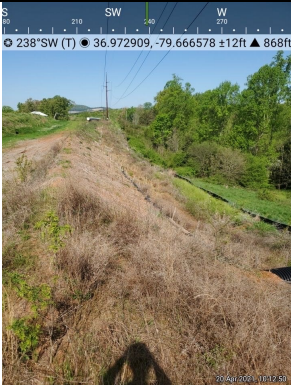
GPS Location	0	GPS Location	0		
Field Station#	14840+00	Field Station#	14881+00		
Pic 3 Desc.	Side slope stabilization	Pic 4 Desc.	CFS maintenance needed IS S-CD8

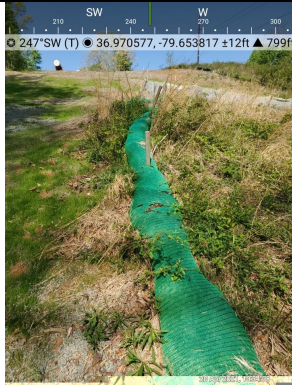
7. Identify all remedial measures that have been taken since the previous inspection was conducted.					
Comments (Reference above questions as appropriate.)					
Inspected ECDs in and along ROW from MVP-FR-323 access road to Ramsey Memorial Rd. CFS @ SN 14881+00 & 14921+00 were in need of repair. Areas needing repairs were communicated to LEI & contractor. Contractor's environmental crew addressed both issues this afternoon. Otherwise, all ECDs observed during inspection were functional and in good condition. No areas of significant erosion were observed in area. Revegetation in area was sparse to good, though additional growth is noticeable.					
Note: It is a condition of National Pollutant Discharge Elimination System and Erosion and Sediment permits that a maintenance program be conducted to provide for the operation and maintenance of all BMPs to be inspected on a weekly basis and after each stormwater event. Please list in the space provided comments to note if repairs or replacement are needed or have been made for BMPs as a result of the inspection. Failure to conduct the required inspection may result in permit suspension or the imposition of civil penalties. If supplemental monitoring is required as part of a permit condition this form may be used to meet those monitoring requirements.

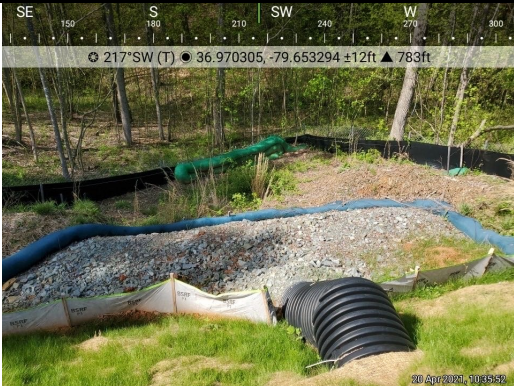
GPS Location	0	GPS Location	0		
Field Station#	14883+00	Field Station#	14900+00		
Pic 5 Desc.	CWD outlet	Pic 6 Desc.	CWD outlet & slope stabilization

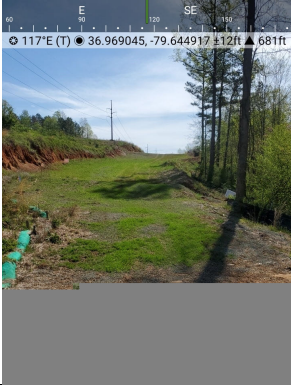
GPS Location	0	GPS Location	0		
Field Station#	14907+00	Field Station#	14921+00		
Pic 7 Desc.	GAS S-DD3 Revegetation	Pic 8 Desc.	CFS maintenance needed South edge of ROW

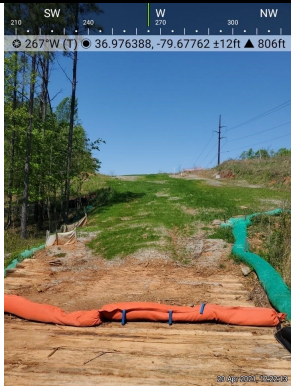
GPS Location	0	GPS Location			
Field Station#	14805+00	Field Station#			
Pic 9 Desc.	CIS S-H23 Revegetation	Pic 10 Desc.

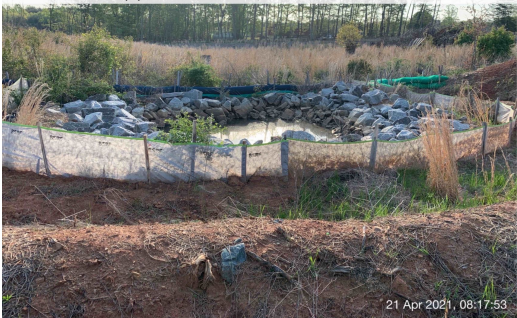
GPS Location	O	GPS Location	O		
Field Station#	15825+00	Field Station#	15794+77		
Pic 7 Desc.	Observing plunge pool and ECD's	Pic 8 Desc.	Observing temporary stabilization, signage, buffer, equipment crossing and ECD's		
South West Elevation 56°NE (T) 36°51'36"N, 79°23'40"W ±13ft ▲822ft

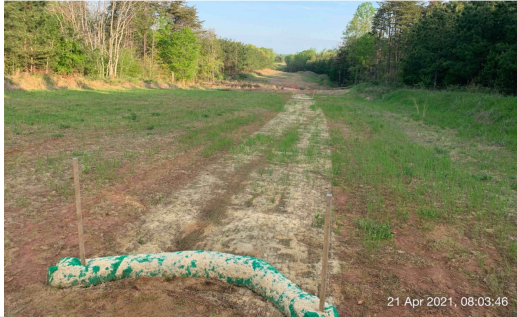
Insert image here			
GPS Location	O	GPS Location			
Field Station#	15807+00	Field Station#			
Pic 9 Desc.	Observing temporary stabilization, erosion control blanket and cfs checks.	Pic 10 Desc.			
Insert image here		Insert image here			
GPS Location		GPS Location			
Field Station#		Field Station#			
Pic 11 Desc.		Pic 12 Desc.

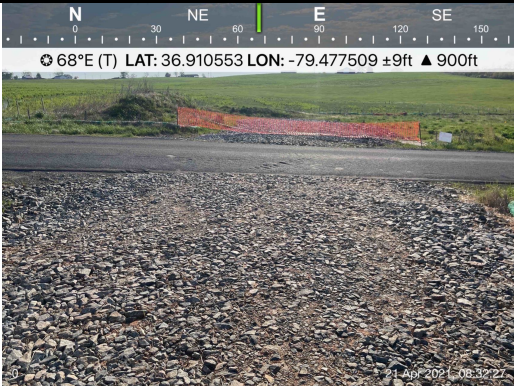
GPS Location	See photo		GPS Location	See photo	
Field Station#	15480+67		Field Station#	15474+00	
Pic 5 Desc.	RCEs are in good condition at all road crossings.		Pic 6 Desc.	Vegetation continues to fill in ROW.

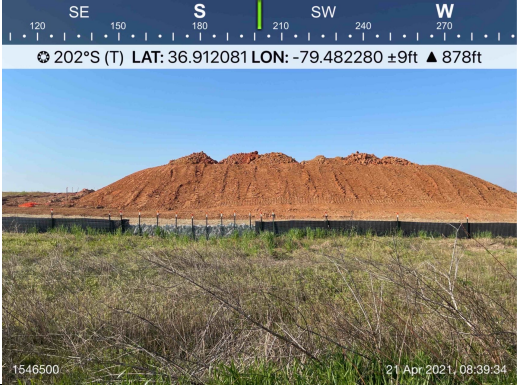
GPS Location	See photo		GPS Location	See photo	
Field Station#	15465+00		Field Station#	15460+81	
Pic 7 Desc.	3rd party rock outlets not discharging at this time.		Pic 8 Desc.	CWDs are in good condition

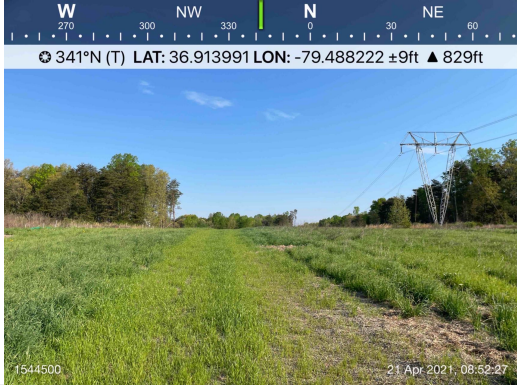
GPS Location	See photo		GPS Location	See photo	
Field Station#	15445+00		Field Station#	15429+00	
Pic 9 Desc.	Vegetation continues to fill in ROW.		Pic 10 Desc.	Equipment bridge ECDs are in good condition.

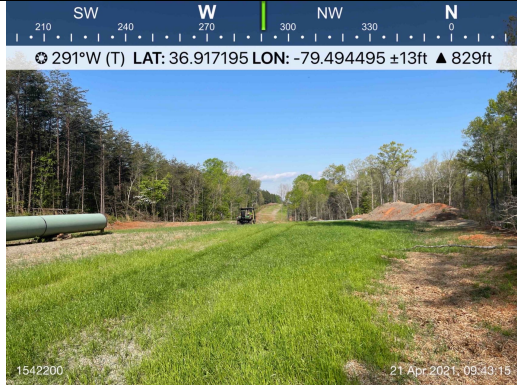
GPS Location	See photo		GPS Location	See photo	
Field Station#	15422+00		Field Station#	15410+00	
Pic 11 Desc.	Vegetation continues to fill in ROW.		Pic 12 Desc.	Vegetation continues to fill in ROW.

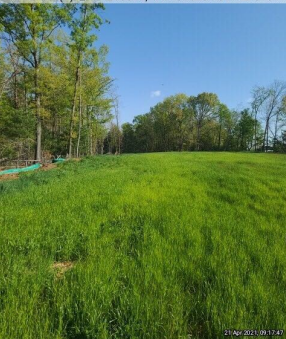
GPS Location	00000	GPS Location	00000		
Field Station#	13740+00	Field Station#	13726+30		
Pic 1 Desc.	Vegetation observation photo showing good growth after hydro seed activities.		Pic 2 Desc.	Vegetation observation photo showing good growth after recent hydro seed activities	
	South East Elevation <small>307°NW (T) ● 37.078927, -79.941669 ±7 m ▲ 309 m</small>

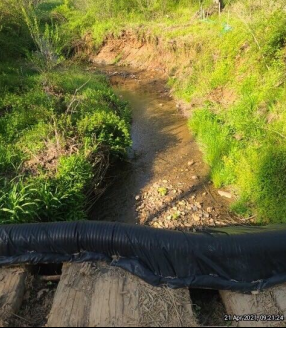
GPS Location	00000	GPS Location	00000		
Field Station#	13728+70	Field Station#	13739+00		
Pic 3 Desc.	EI monitored ECDs and stabilization on hill side above stream crossing. No environmental issues observed at the time of inspection		Pic 4 Desc.	Vegetation observation photo after recent hydro seed activities in permanent area.

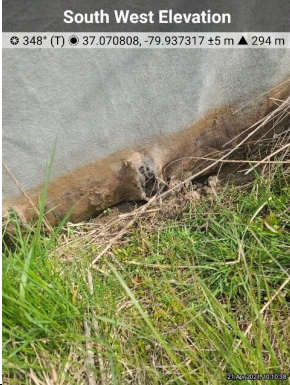
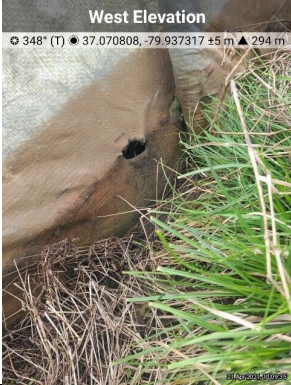
<p>West Elevation <small>348° (T) 37.070808, -79.937317 ±5 m ▲ 294 m</small></p>			
GPS Location		00000		GPS Location	
Field Station#		13691+47		Field Station#	
Pic 7 Desc.		Additional photo showing P1 that requires maintenance due to wild life damages		Pic 8 Desc.	
				P1 around w-EF4 in work space requires maintenance due to wildlife damages, recommended replacing all as needed, sent in

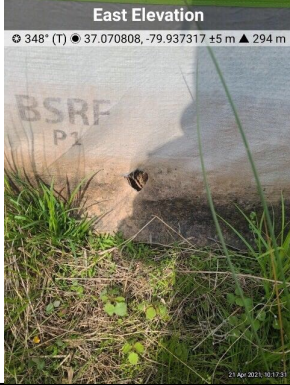
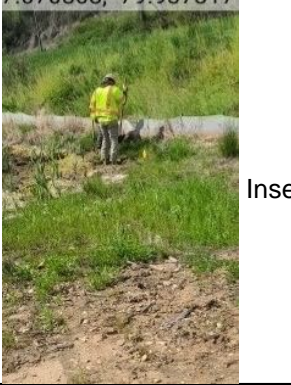
<p>Insert image here</p>			
GPS Location		00000		GPS Location	
Field Station#		13691+27		Field Station#	
Pic 9 Desc.		P1 on row edge along road side requires maintenance due to wildlife damage, documented and added to the punch list.		Pic 10 Desc.	
				Photo showing the contractor making maintenance repairs to P1.

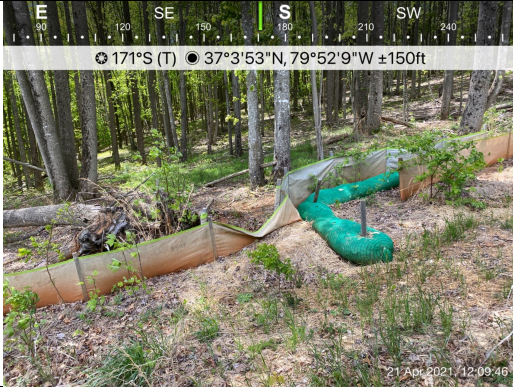
GPS Location	0	GPS Location	0		
Field Station#	14066+77	Field Station#	14082+80		
Pic 1 Desc.	Approximately 14066+77. Overview of stream crossing, equipment bridge and ECDs at stream S-EF48.		Pic 2 Desc.	Approximately 14082+80. P-1 requires maintenance. Appears to have been damaged by wildlife.

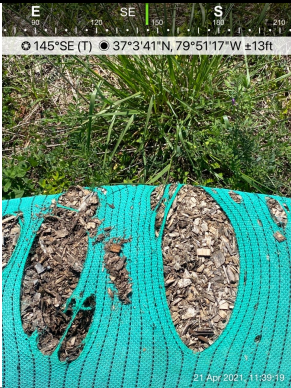
GPS Location	0	GPS Location	0		
Field Station#	14131+00	Field Station#	14164+00		
Pic 5 Desc.	Approximately 14131+00. CFS requires maintenance.		Pic 6 Desc.	Approximately 14164+00. Overview of ROW.

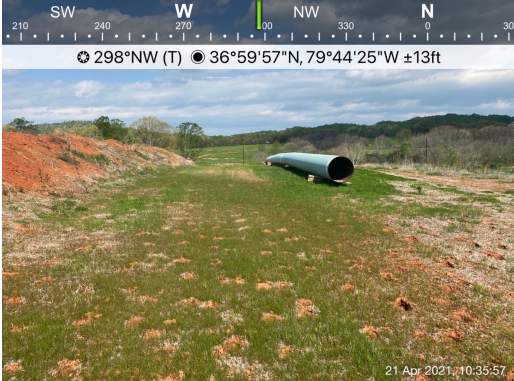
GPS Location	0	GPS Location	0		
Field Station#	14592+00	Field Station#	14611+27		
Pic 3 Desc.	Approximately 14592+00. Overview of ROW. Observed heavy livestock traffic in this area.		Pic 4 Desc.	Approximately 14611+27. Overview of stream crossing, equipment bridge and ECDs at stream S-E14.

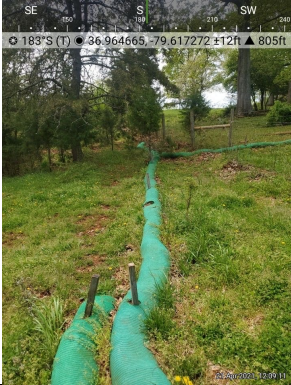
7. Identify all remedial measures that have been taken since the previous inspection was conducted.					
Comments (Reference above questions as appropriate.)					
Inspected ECDs along and within ROW from Ramsey Memorial Rd to Armstrong Rd. Perimeter CFS @ SN 14990+88 needed repairs due to hole in fabric. Issue was communicated to LEI & contractor environmental foreman and area was repaired today. Otherwise, all ECDs observed were in good condition and functional. Revegetation was generally moderate to good with new grass coming in. No other issues were observed.					
Note: It is a condition of National Pollutant Discharge Elimination System and Erosion and Sediment permits that a maintenance program be conducted to provide for the operation and maintenance of all BMPs to be inspected on a weekly basis and after each stormwater event. Please list in the space provided comments to note if repairs or replacement are needed or have been made for BMPs as a result of the inspection. Failure to conduct the required inspection may result in permit suspension or the imposition of civil penalties. If supplemental monitoring is required as part of a permit condition this form may be used to meet those monitoring requirements.

GPS Location	0	GPS Location	0		
Field Station#	15012+00	Field Station#	14990+88		
Pic 7 Desc.	Clean water diversion plunge pool	Pic 8 Desc.	Repair CFS

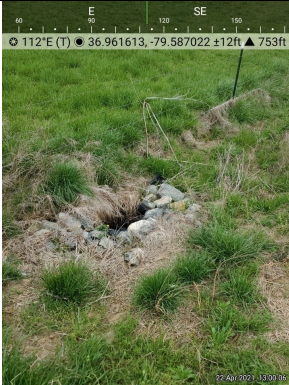
GPS Location	0	GPS Location	0		
Field Station#	15084+00	Field Station#	15084+00		
Pic 1 Desc.	Clean water diversion inlet	Pic 2 Desc.	Clean water diversion plunge pool

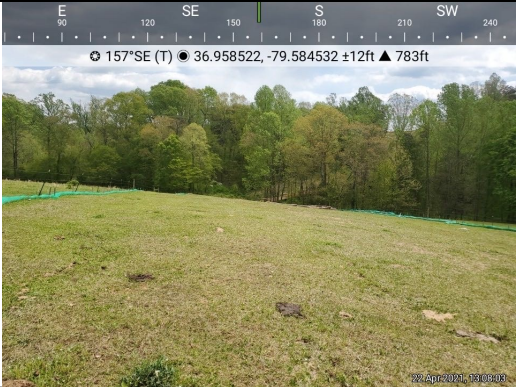
GPS Location	0	GPS Location	0		
Field Station#	15100+00	Field Station#	15102+75		
Pic 3 Desc.	Revegetation	Pic 4 Desc.	CIS S-G8 CFS maintenance needed

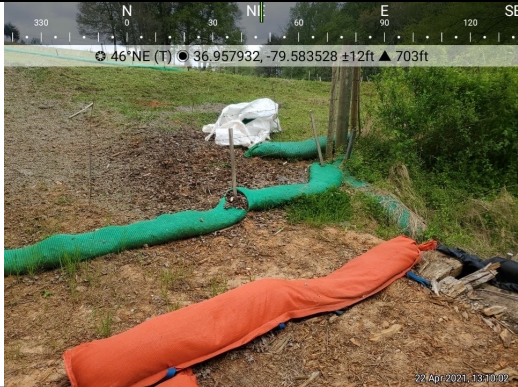
7. Identify all remedial measures that have been taken since the previous inspection was conducted.					
Comments (Reference above questions as appropriate.)					
Inspected ECDs along & within ROW from Armstrong Rd to Rock Creek Rd. CFS on CIS S-G8 @ SN 15102+75 has been torn along top & requires maintenance. Communicated maintenance needs with LEI & contractor's env. foreman. Env. crew repaired issue this afternoon. Vegetation ranges from sparse to moderate. No signs of recent erosion were observed.					
Note: It is a condition of National Pollutant Discharge Elimination System and Erosion and Sediment permits that a maintenance program be conducted to provide for the operation and maintenance of all BMPs to be inspected on a weekly basis and after each stormwater event. Please list in the space provided comments to note if repairs or replacement are needed or have been made for BMPs as a result of the inspection. Failure to conduct the required inspection may result in permit suspension or the imposition of civil penalties. If supplemental monitoring is required as part of a permit condition this form may be used to meet those monitoring requirements.

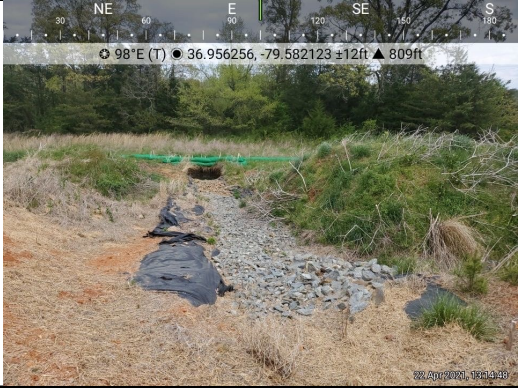
GPS Location	0	GPS Location	0		
Field Station#	15102+75	Field Station#	15111+00		
Pic 5 Desc.	CIS S-G8 CFS repaired	Pic 6 Desc.	Rock lined channel

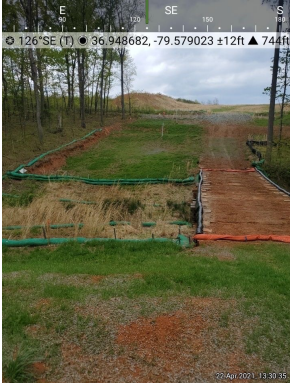
Insert image here		Insert image here	
GPS Location	0	GPS Location			
Field Station#	15140+00	Field Station#			
Pic 7 Desc.	CIS Rock Creek Rd S-H11 Revegetation	Pic 8 Desc.			
Insert image here		Insert image here			
GPS Location		GPS Location			
Field Station#		Field Station#			
Pic 9 Desc.		Pic 10 Desc.			
Insert image here		Insert image here			
GPS Location		GPS Location			
Field Station#		Field Station#			
Pic 11 Desc.		Pic 12 Desc.

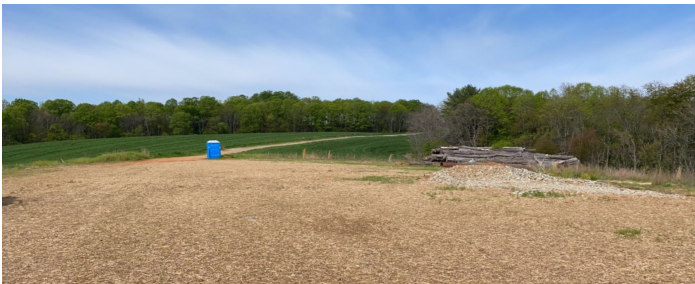
37°3'16" N 79°54'36" W 314°NW COURSE 356° GPS 985 Iron Ridge Rd, Rocky Mount, VA 24151, United States 04.23.2021 10:38:25 Accur +/-78.5 Ft ALT 1001 Ft			37°3'30" N 79°55'18" W 269°W COURSE 288° GPS 404 Old Mill Creek Ln, Rocky Mount, VA 24151, United States 04.23.2021 10:56:00 Accur +/-97.2 Ft ALT 1031 Ft		
GPS Location	1		GPS Location	2	
Field Station#	13891+00		Field Station#	13853+45	
Pic 1 Desc.	Contractor removed sediment from slope drain tile inlet and stabilized area per punch list item		Pic 2 Desc.	Extra workspace at MVP-303.01 seeded and stabilized after work in area was completed

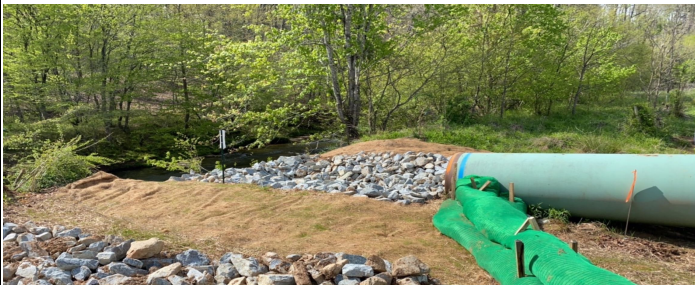
GPS Location	3		GPS Location	4	
Field Station#	13875+16		Field Station#	13884+00	
Pic 3 Desc.	ECDs CIS S-CD6		Pic 4 Desc.	Area in flat part of ROW CIS Iron Ridge Rd. Area is stabilized but no vegetation growing (area primarily underwater)

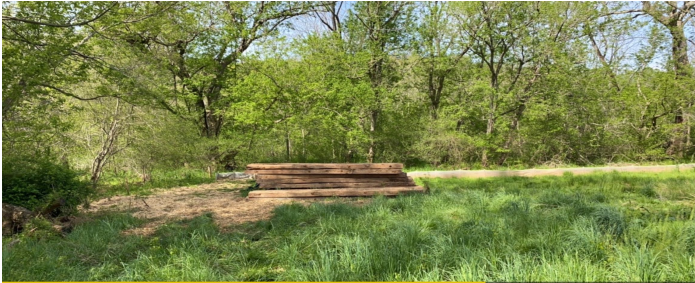
37°2'58" N 79°54'32" W 220°SW COURSE 255° GPS 1770 Iron Ridge Rd, Rocky Mount, VA 24151, United States 04.23.2021 10:27:19 Accur +/-74.0 Ft ALT 1007 Ft			37°2'54" N 79°54'29" W 253°W COURSE 289° GPS 184 Foggy Ridge Rd, Rocky Mount, VA 24151, United States 04.23.2021 10:24:03 Accur +/-121.3 Ft ALT 1121 Ft		
GPS Location	5		GPS Location	6	
Field Station#	13914+00		Field Station#	13916+50	
Pic 5 Desc.	Are off ROW where bridge mats were removed from landowner field		Pic 6 Desc.	Contractor removed bridge mats from off ROW and seeded and stabilized disturbed area

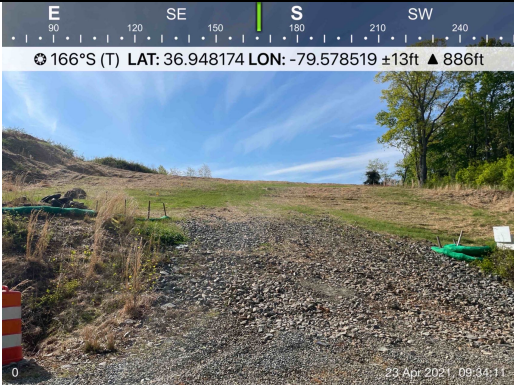
GPS Location	See photo		GPS Location	See photo	
Field Station#	15142+66		Field Station#	15150+00	
Pic 3 Desc.	RCE is in good condition at Rockcreek Rd.		Pic 4 Desc.	Vegetation continues to fill in ROW.

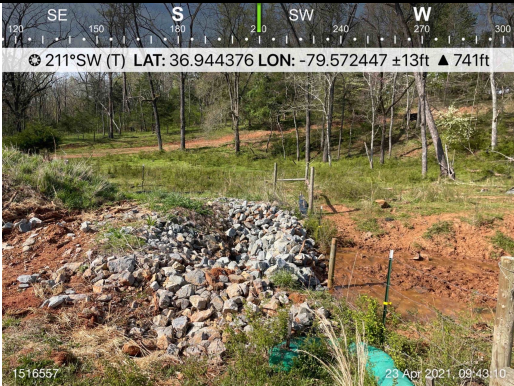
GPS Location	See photo		GPS Location	See photo	
Field Station#	15165+57		Field Station#	15167+00	
Pic 5 Desc.	Diversion inlet remains in good condition.		Pic 6 Desc.	Diversion outlet remains in good condition.

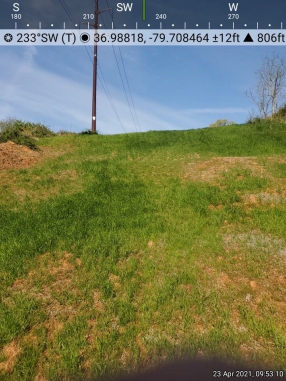
GPS Location	0	GPS Location	0		
Field Station#	14698+00	Field Station#	14728+00		
Pic 1 Desc.	CIS S-H32 Revegetation	Pic 2 Desc.	S-A20 Buffer

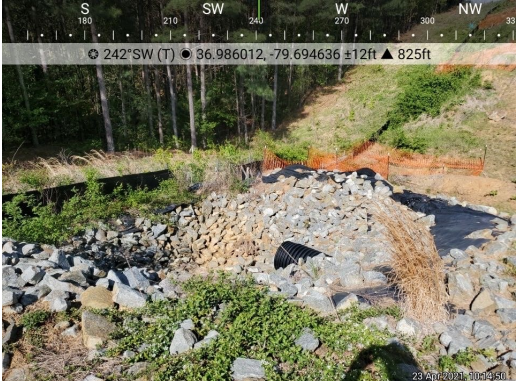
GPS Location	0	GPS Location	0		
Field Station#	14768+00	Field Station#	14678+00		
Pic 3 Desc.	Clean water diversion plunge pool	Pic 4 Desc.	Clean water diversion inlet

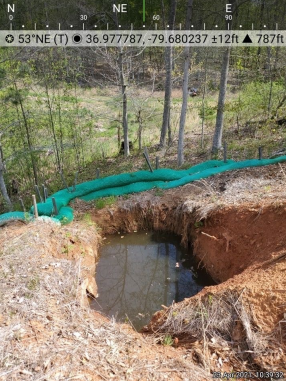
GPS Location	0	GPS Location	0		
Field Station#	14797+00	Field Station#	14773+00		
Pic 5 Desc.	Sump	Pic 6 Desc.	Water bar end treatment

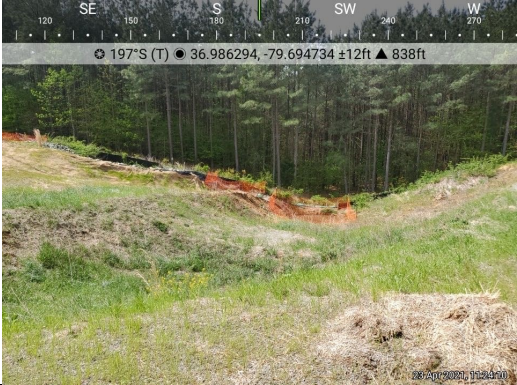
GPS Location	0	GPS Location	0		
Field Station#	14742+00	Field Station#	14717+00		
Pic 7 Desc.	Stabilization	Pic 8 Desc.	CIS W-H11 Buffer & Revegetation		
Insert image here		Insert image here			
GPS Location		GPS Location			
Field Station#		Field Station#			
Pic 9 Desc.		Pic 10 Desc.			
Insert image here		Insert image here			
GPS Location		GPS Location			
Field Station#		Field Station#			
Pic 11 Desc.		Pic 12 Desc.

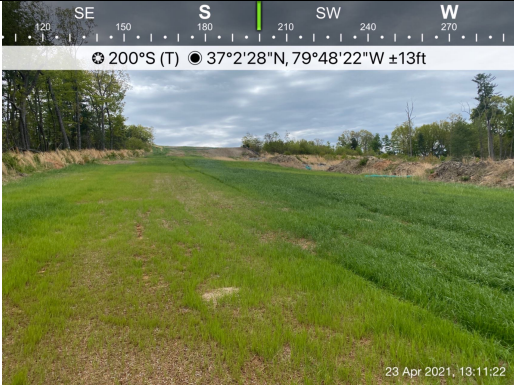
GPS Location	0	GPS Location	0		
Field Station#	14326+00	Field Station#	14333+00		
Pic 1 Desc.	Approximately 14326+00. Overview of ROW.	Pic 2 Desc.	Approximately 14333+00. Overview of road crossing and RCEs.

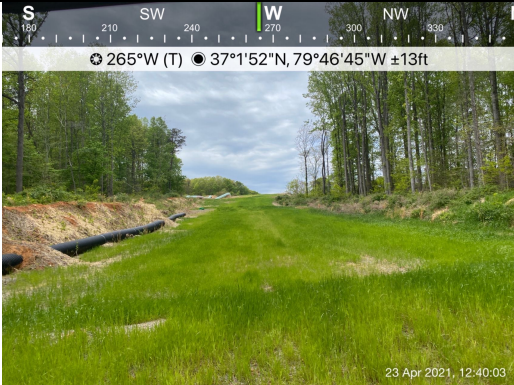
GPS Location	0	GPS Location	0		
Field Station#	14316+00	Field Station#	14434+01		
Pic 3 Desc.	Approximately 14316+00. Overview of ROW.	Pic 4 Desc.	Approximately 14434+01. Overview of stream crossing, equipment bridge and ECDs at stream S-GH40.

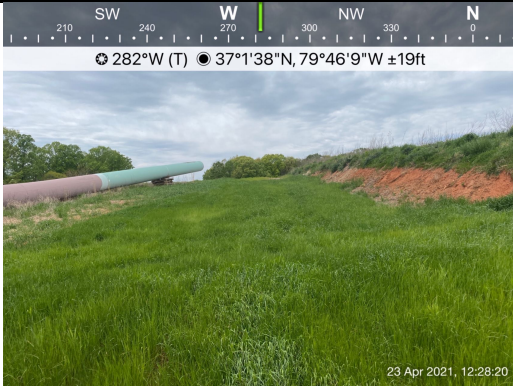
GPS Location	0	GPS Location	0		
Field Station#	14440+50	Field Station#	14451+00		
Pic 5 Desc.	Approximately 14440+50. P-1 requires maintenance. Damaged by broken limb. Crew repaired immediately.	Pic 6 Desc.	Approximately 14451+00. Overview of ROW.
