# Visual Site Inspection Report

<b>Project Name</b>	H-600 Pipeline Spread I	<b>AFE</b>	124300139	<b>Spread</b>	H-600 Pipeline Spread I
<b>Contractor</b>	Precision			<b>Report #</b>	22688
<b>Inspector</b>	Ben Davenport			<b>Date/Time</b>	4/26/2021 10:39 AM
<b>Permit #</b>	TBD	<b>Inspection Type</b>	VA SWPP	<b>Station Begin</b>	13958+31
<b>State</b>	VA	<b>Inspection Area</b>	Partial	<b>Station End</b>	14062+17
<b>County</b>	Franklin	<b>Ground</b>	Damp	<b>Temperature (°F)</b>	72.00
<b>Municipality</b>	N/A	<b>Weather</b>	Sunny	<b>Rain Gauge (in)</b>	0.00
				<b>Rain Accumulation Time (days)</b>	0.00

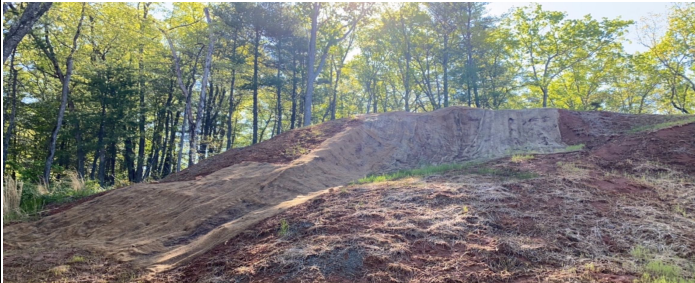
37°3'47" N 79°52'42" W 119°SE COURSE 45° GPS 195 Bonbrook Mill Rd, Rocky Mount, VA 24151, United States 04.26.2021 09:46:43 Accur +/-44.2 Ft ALT 1152 Ft			37°3'58" N 79°52'36" W 265°W COURSE 37° GPS 195 Bonbrook Mill Rd, Rocky Mount, VA 24151, United States 04.26.2021 09:52:40 Accur +/-188.9 Ft ALT 1150 Ft		
GPS Location	5	GPS Location	6		
Field Station#	14045+00	Field Station#	14057+23		
Pic 5 Desc.	Contractor repaired damaged Curlex per punch list item		Pic 6 Desc.	Sump at bottom of slope drain outlet performing intended function. No issues observed.

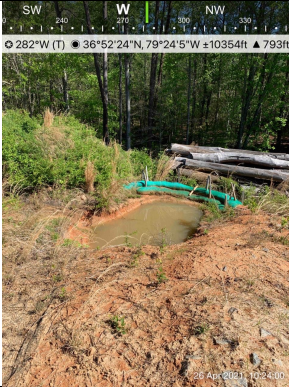
<b>GPS Location</b>	O	<b>GPS Location</b>	O		
<b>Field Station#</b>	15663+00	<b>Field Station#</b>	15735+00		
<b>Pic 1 Desc.</b>	Observing temporary stabilization, sump and end treatment		<b>Pic 2 Desc.</b>	Observing CFS that required maintenance

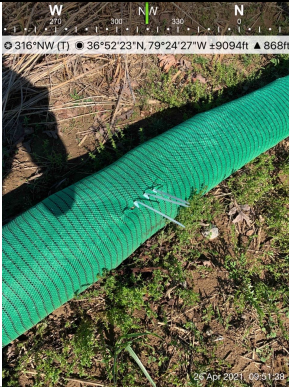
<b>GPS Location</b>	O	<b>GPS Location</b>	O		
<b>Field Station#</b>	15735+00	<b>Field Station#</b>	15679+00		
<b>Pic 3 Desc.</b>	Observing CFS that received maintenance		<b>Pic 4 Desc.</b>	Observing safety fence that required maintenance

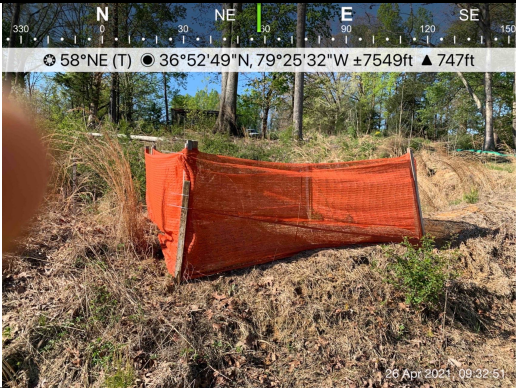
<b>GPS Location</b>	O	<b>GPS Location</b>	O		
<b>Field Station#</b>	15679+00	<b>Field Station#</b>	15671+93		
<b>Pic 5 Desc.</b>	Observing safety fence that received maintenance		<b>Pic 6 Desc.</b>	Observing temporary stabilization, signage, buffer, equipment crossing and ECD's

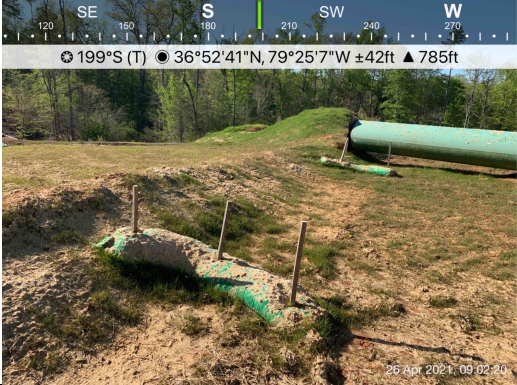
<b>GPS Location</b>	O	<b>GPS Location</b>	O		
<b>Field Station#</b>	15706+00	<b>Field Station#</b>	15713+52		
<b>Pic 7 Desc.</b>	Observing temporary stabilization, water bar, erosion control blanket and cfs checks	<b>Pic 8 Desc.</b>	Observing temporary stabilization, water bars, buffer, signage, equipment crossing and ECD's

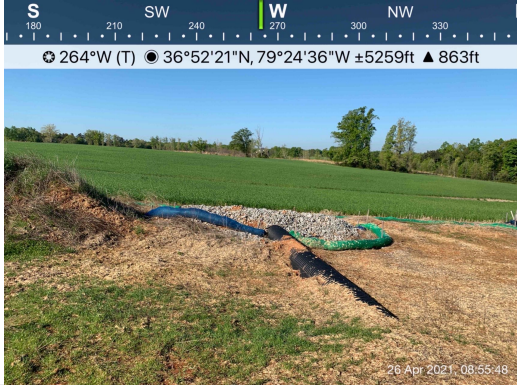
<b>GPS Location</b>	O	<b>GPS Location</b>	O		
<b>Field Station#</b>	15735+50	<b>Field Station#</b>	15740+00		
<b>Pic 9 Desc.</b>	Observing temporary stabilization, CWD outlet and ECD's	<b>Pic 10 Desc.</b>	Observing temporary stabilization, sump and end treatment		
Insert image here		Insert image here			
<b>GPS Location</b>		<b>GPS Location</b>			
<b>Field Station#</b>		<b>Field Station#</b>			
<b>Pic 11 Desc.</b>		<b>Pic 12 Desc.</b>

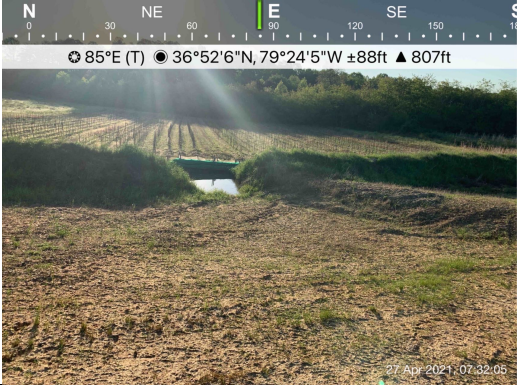
<b>GPS Location</b>	O	<b>GPS Location</b>	O		
<b>Field Station#</b>	15774+00	<b>Field Station#</b>	15790+00		
<b>Pic 7 Desc.</b>	Observing temporary stabilization, water bar, sump and end treatment	<b>Pic 8 Desc.</b>	Observing temporary stabilization.		
Insert image here		Insert image here			
<b>GPS Location</b>		<b>GPS Location</b>			
<b>Field Station#</b>		<b>Field Station#</b>			
<b>Pic 9 Desc.</b>		<b>Pic 10 Desc.</b>			
Insert image here		Insert image here			
<b>GPS Location</b>		<b>GPS Location</b>			
<b>Field Station#</b>		<b>Field Station#</b>			
<b>Pic 11 Desc.</b>		<b>Pic 12 Desc.</b>

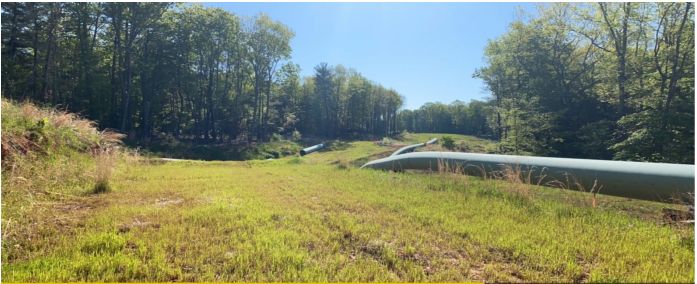
<b>GPS Location</b> 1			<b>GPS Location</b> 2		
<b>Field Station#</b> 14064+00			<b>Field Station#</b> 14067+00		
<b>Pic 1 Desc.</b> CFS check dams and erosion control blanket performing intended functions			<b>Pic 2 Desc.</b> Temporary vegetative area along ROW. No issues observed

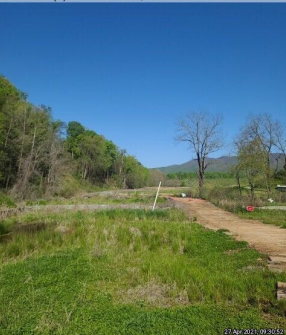
<b>GPS Location</b>	00000	<b>GPS Location</b>	00000		
<b>Field Station#</b>	13678+99	<b>Field Station#</b>	13678+71		
<b>Pic 3 Desc.</b>	Row photo showing vegetation growth, monitored ECDs at stream crossing, no issues observed at the time of inspection.		<b>Pic 4 Desc.</b>	Stream observation photo facing downstream during routine inspection today. No issues observed at the time of inspection.

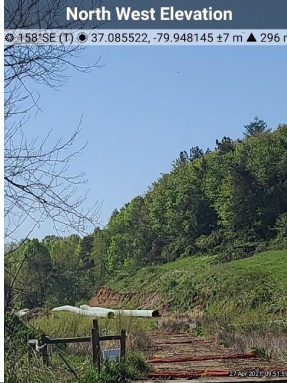
<b>GPS Location</b>	00000	<b>GPS Location</b>	00000		
<b>Field Station#</b>	13678+71	<b>Field Station#</b>	13691+91		
<b>Pic 5 Desc.</b>	Stream observation photo facing upstream during routine inspection today. No issues observed at the time of inspection.		<b>Pic 6 Desc.</b>	Observed all ECDs at wetland area and at stream crossing, no environmental issues observed at the time of inspection.

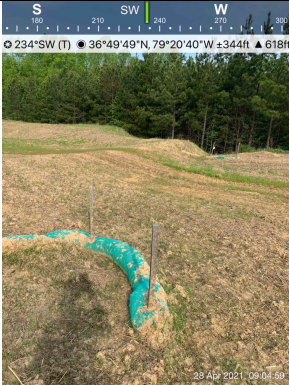
<b>GPS Location</b>	O	<b>GPS Location</b>	O		
<b>Field Station#</b>	16022+00	<b>Field Station#</b>	16008+00		
<b>Pic 1 Desc.</b>	Observing temporary stabilization,water bar and cfs check	<b>Pic 2 Desc.</b>	Observing temporary stabilization,water bar, sump and end treatment

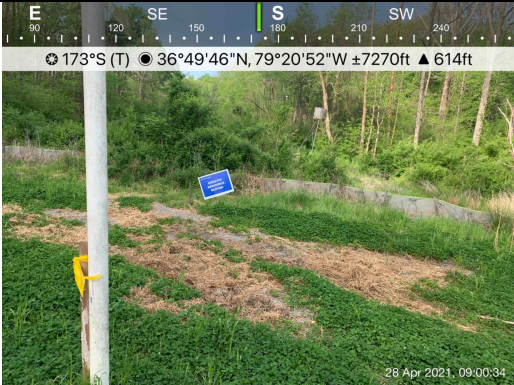
<b>GPS Location</b>	O	<b>GPS Location</b>	O		
<b>Field Station#</b>	16004+00	<b>Field Station#</b>	16010+00		
<b>Pic 3 Desc.</b>	Observing temporary vegetation,signage, buffer and ECD's	<b>Pic 4 Desc.</b>	Observing temporary vegetation,CWD outlet and ECD's

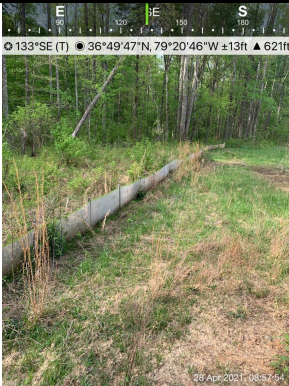
<b>GPS Location</b>	O	<b>GPS Location</b>	O		
<b>Field Station#</b>	16015+50	<b>Field Station#</b>	16016+36		
<b>Pic 5 Desc.</b>	Observing temporary vegetation,buffer and ECD's	<b>Pic 6 Desc.</b>	Observing temporary stabilization, signage, buffer, equipment crossing and ECD's

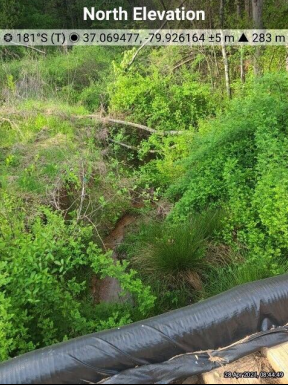
<b>North Elevation</b> <small>194°S (T) • 37.065986, -79.922194 ±3 m ▲ 313 m</small>  	
<b>GPS Location</b>	00000	<b>GPS Location</b>	00000		
<b>Field Station#</b>	13805+69	<b>Field Station#</b>	13850+00		
<b>Pic 1 Desc.</b>	Stream observation photo facing downstream during routine inspection today. No issues observed at the time of inspection.		<b>Pic 2 Desc.</b>	Row photo showing vegetation growth. No issues observed at the time of inspection.	
	<b>North West Elevation</b> <small>160°SE (T) • 37.074617, -79.941049 ±9 m ▲ 280 m</small>  			<b>West Elevation</b> <small>92°E (T) • 37.069398, -79.926483 ±8 m ▲ 304 m</small>  	
<b>GPS Location</b>	00000	<b>GPS Location</b>	00000		
<b>Field Station#</b>	13770+65	<b>Field Station#</b>	13804+70

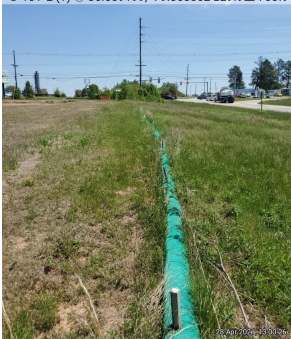
<b>GPS Location</b>	0	<b>GPS Location</b>	0		
<b>Field Station#</b>	0+00	<b>Field Station#</b>	0+00		
<b>Pic 7 Desc.</b>	LY-048 CFS Southern perimeter	<b>Pic 8 Desc.</b>	LY-048 Equipment staging		
Insert image here		Insert image here			
<b>GPS Location</b>		<b>GPS Location</b>			
<b>Field Station#</b>		<b>Field Station#</b>			
<b>Pic 9 Desc.</b>		<b>Pic 10 Desc.</b>			
Insert image here		Insert image here			
<b>GPS Location</b>		<b>GPS Location</b>			
<b>Field Station#</b>		<b>Field Station#</b>			
<b>Pic 11 Desc.</b>		<b>Pic 12 Desc.</b>

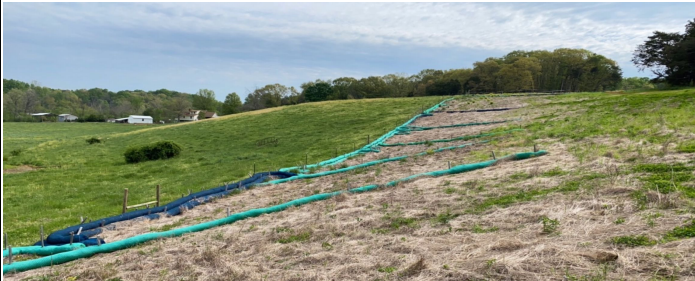
37°2'57" N 79°54'23" W 7°N COURSE 210° GPS 1770 Iron Ridge Rd, Rocky Mount, VA 24151, United States 04.29.2021 10:00:11 Accur +/-36.9 Ft ALT 1032 Ft			37°3'30" N 79°55'18" W 142°SE COURSE 297° GPS 404 Old Mill Creek Ln, Rocky Mount, VA 24151, United States 04.29.2021 10:56:34 Accur +/-76.2 Ft ALT 1036 Ft		
GPS Location	5	GPS Location	6		
Field Station#	13923+00	Field Station#	13853+45		
Pic 5 Desc.	Perimeter CFS and CFS breakers in place and functional.		Pic 6 Desc.	Extra workspace has been seeded and stabilized and vegetation observed to be growing.

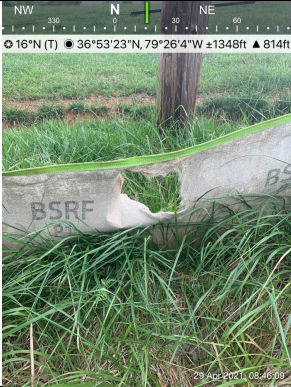
<b>GPS Location</b>	O	<b>GPS Location</b>	O		
<b>Field Station#</b>	15638+00	<b>Field Station#</b>	15633+00		
<b>Pic 1 Desc.</b>	Observing p1 that requires maintenance (damaged by livestock)	<b>Pic 2 Desc.</b>	Observing temporary stabilization,CWD outlet and ECD's

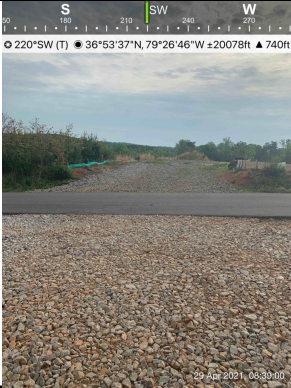
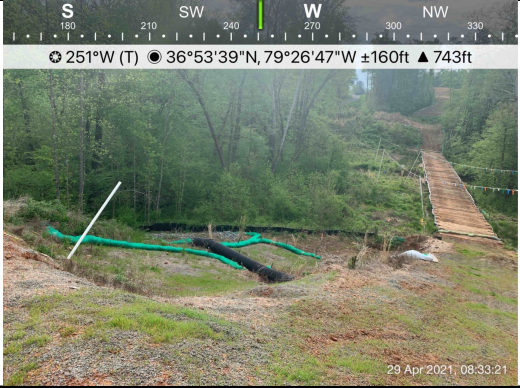
<b>GPS Location</b>	O	<b>GPS Location</b>	O		
<b>Field Station#</b>	15619+48	<b>Field Station#</b>	15595+00		
<b>Pic 5 Desc.</b>	Observing road crossing and RCE's	<b>Pic 6 Desc.</b>	Observing temporary stabilization,CWD outlet,buffer, equipment crossing and ECD's

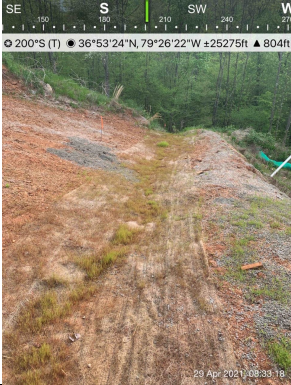
<p>ert image here</p>		<p>Insert image here</p>	
<b>GPS Location</b>	O	<b>GPS Location</b>			
<b>Field Station#</b>	15593+00	<b>Field Station#</b>			
<b>Pic 7 Desc.</b>	Observing temporary stabilization,water bar and erosion control blanket.	<b>Pic 8 Desc.</b>			
<p>Insert image here</p>		<p>Insert image here</p>			
<b>GPS Location</b>		<b>GPS Location</b>			
<b>Field Station#</b>		<b>Field Station#</b>			
<b>Pic 9 Desc.</b>		<b>Pic 10 Desc.</b>			
<p>Insert image here</p>		<p>Insert image here</p>			
<b>GPS Location</b>		<b>GPS Location</b>			
<b>Field Station#</b>		<b>Field Station#</b>			
<b>Pic 11 Desc.</b>		<b>Pic 12 Desc.</b>

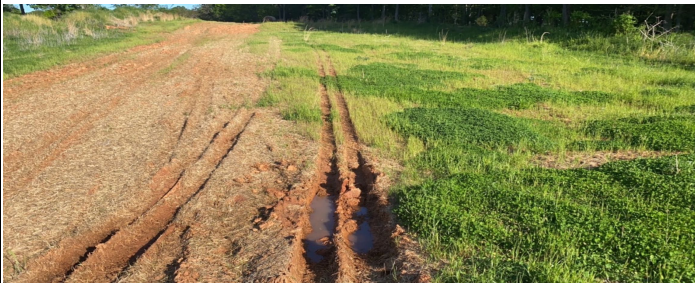
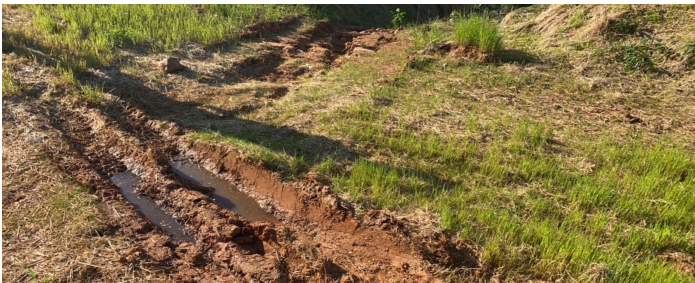
<b>GPS Location</b>	3	<b>GPS Location</b>	4		
<b>Field Station#</b>	13978+00	<b>Field Station#</b>	13984+00		
<b>Pic 3 Desc.</b>	Rutting occurring along ROW from landowner damage		<b>Pic 4 Desc.</b>	Rutting occurring along ROW from landowner damage

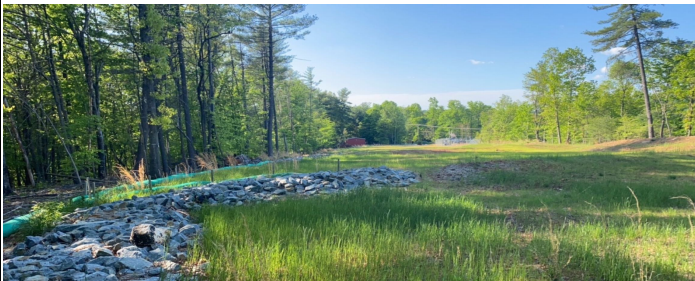
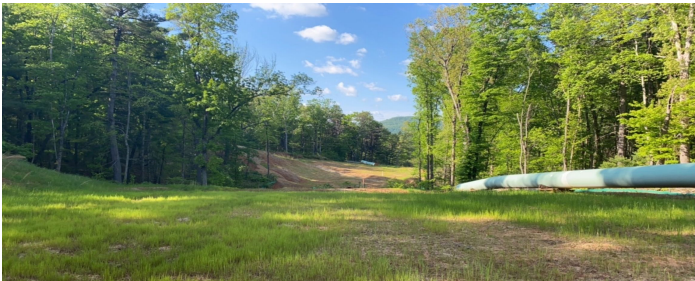
37°3'32" N 79°52'50" W 227°SW COURSE 68° GPS 180 Amt Tech Dr, Rocky Mount, VA 24151, United States 04.30.2021 08:57:33 Accur +/-46.1 Ft ALT 1144 Ft			37°3'50" N 79°52'40" W 212°SW COURSE 215° GPS 155 Sink Dr, Rocky Mount, VA 24151, United States 04.30.2021 09:08:53 Accur +/-110.7 Ft ALT 1079 Ft		
<b>GPS Location</b>	5	<b>GPS Location</b>	6		
<b>Field Station#</b>	14024+00	<b>Field Station#</b>	14048+00		
<b>Pic 5 Desc.</b>	Perimeter controls in place and functional. Rock end treatment performing intended function.		<b>Pic 6 Desc.</b>	View of vegetation growing along ROW in temporary area.

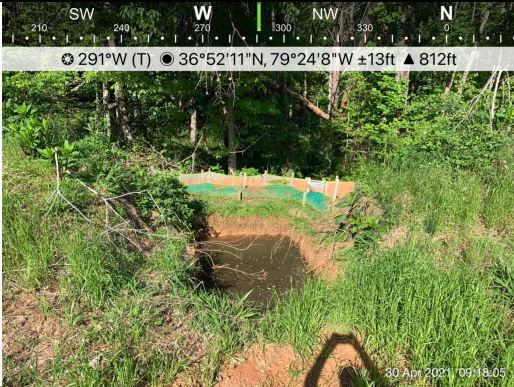
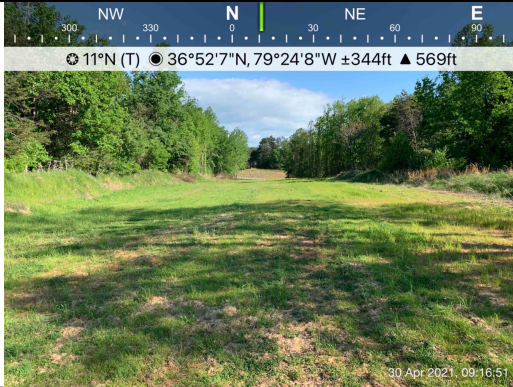
<b>GPS Location</b>	O	<b>GPS Location</b>	O		
<b>Field Station#</b>	15690+00	<b>Field Station#</b>	15690+00		
<b>Pic 5 Desc.</b>	Observing CFS that required maintenance	<b>Pic 6 Desc.</b>	Observing CFS that received maintenance

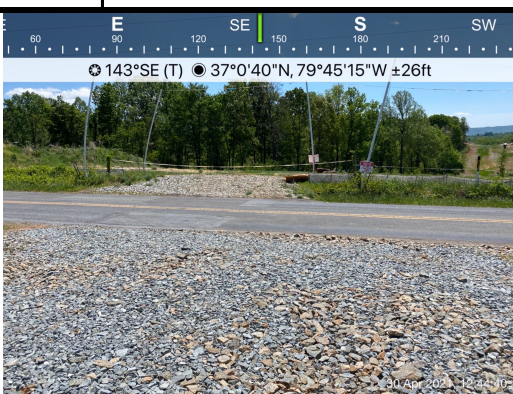
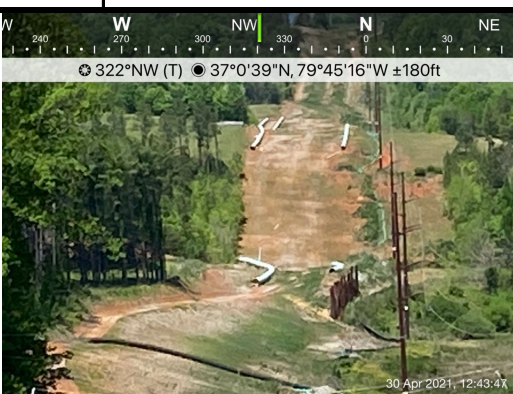
GPS Location	0		GPS Location	0	
Field Station#	14524+00		Field Station#	14510+00	
Pic 3 Desc.	Approximately 14524+00. Overview of road crossing and RCEs.		Pic 4 Desc.	Approximately 14510+00. Overview of ROW.

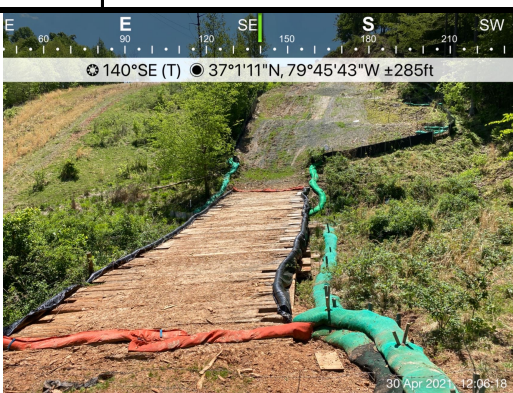
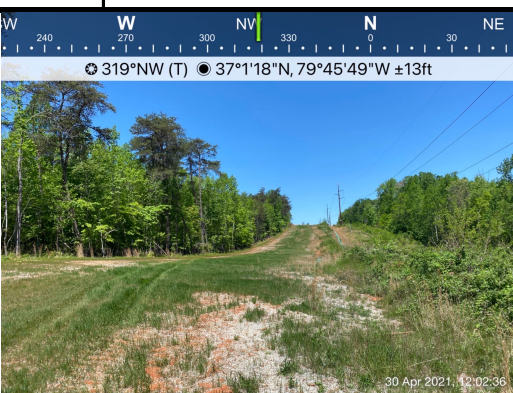
GPS Location	0		GPS Location	0	
Field Station#	14486+62		Field Station#	14475+00	
Pic 5 Desc.	Approximately 14486+62. Overview of stream crossing, equipment bridge and ECDs at stream S-G22.		Pic 6 Desc.	Approximately 14475+00. Overview of ROW.

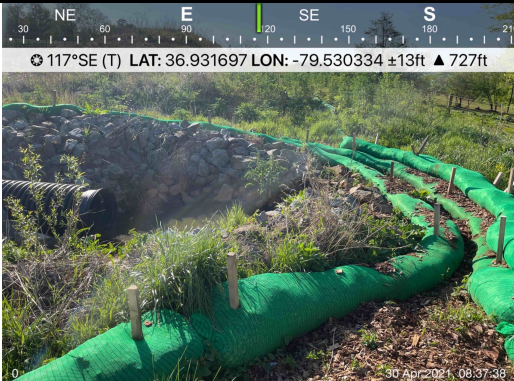
<b>GPS Location</b>	See photo		<b>GPS Location</b>	See photo	
<b>Field Station#</b>	15299+25		<b>Field Station#</b>	15314+31	
<b>Pic 5 Desc.</b>	CWD is in good condition.		<b>Pic 6 Desc.</b>	Equipment bridge ECDs are in place and functioning.

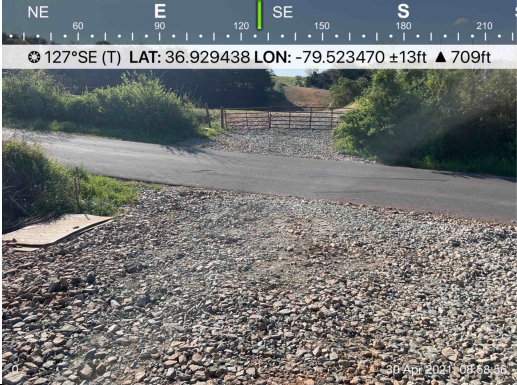
<b>GPS Location</b>	See photo		<b>GPS Location</b>	See photo	
<b>Field Station#</b>	15323+24		<b>Field Station#</b>	15325+00	
<b>Pic 7 Desc.</b>	RCEs are in good condition at all road.		<b>Pic 8 Desc.</b>	Vegetation continues to fill in ROW.

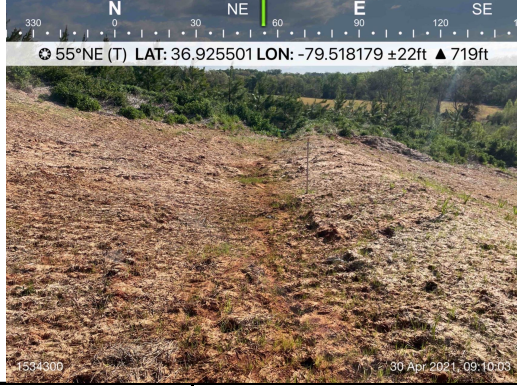
<p style="text-align: center;">Insert image here</p>			
<b>GPS Location</b>	See photo		<b>GPS Location</b>		
<b>Field Station#</b>	15343+00		<b>Field Station#</b>		
<b>Pic 11 Desc.</b>	Waterbars are in good condition throughout this section of ROW.		<b>Pic 12 Desc.</b>
