Visual Site Inspection Report

Project Name	H-600 Pipeline Spread I	AFE	124300139	Spread	H-600 Pipeline Spread I
Contractor	Precision			Report #	21917
Inspector	Ben Davenport			Date/Time	4/5/2021 10:34 AM
Permit #	TBD	Inspection Type	VA SWPP	Station Begin	14062+17
State	VA	Inspection Area	Partial	Station End	14171+36
County	Franklin	Ground	Dry	Temperature (°F)	74.00
Municipality	N/A	Weather	Sunny	Rain Gauge (in)	0.00
				Rain Accumulation Time (days)	0.00

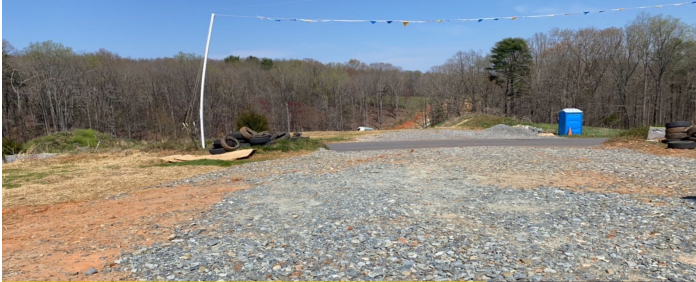
37°3'25" N 79°50'46" W 100°E COURSE 126° GPS 131-429 Angle Plantation Rd, Rocky Mount, VA 24151, United States 04.05.2021 14:14:52 Accur +/-43.9 Ft ALT 1036 Ft			37°3'22" N 79°50'53" W 55°NE COURSE 160° GPS Rocky Mount, VA 24151, United States 04.05.2021 14:11:55 Accur +/-70.6 Ft ALT 1046 Ft		
GPS Location	1		GPS Location	2	
Field Station#	14171+36		Field Station#	14165+50	
Pic 1 Desc.	RCE at Angle Plantation Rd in good condition		Pic 2 Desc.	Vegetation growing in final cleanup area

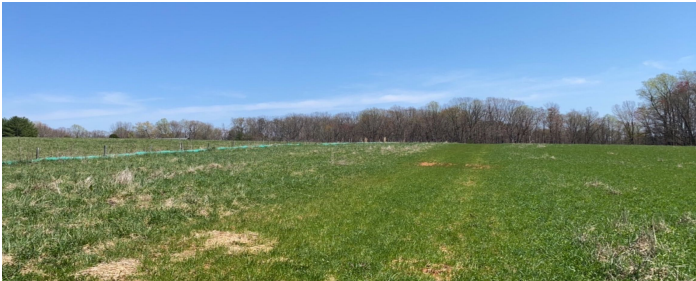
37°3'48" N 79°51'34" W 113°E COURSE 123° GPS Rocky Mount, VA 24151, United States 04.05.2021 13:34:42 Accur +/-112.3 Ft ALT 1043 Ft			37°3'48" N 79°51'54" W 160°S COURSE 149° GPS Wirtz, VA 24184, United States 04.05.2021 13:21:25 Accur +/-133.6 Ft ALT 1150 Ft		
GPS Location	5		GPS Location	6	
Field Station#	14116+00		Field Station#	14095+00	
Pic 5 Desc.	Travel lane was hydroseeded and now has vegetation growing along it		Pic 6 Desc.	Vegetation growing in recently seeded and stabilized area

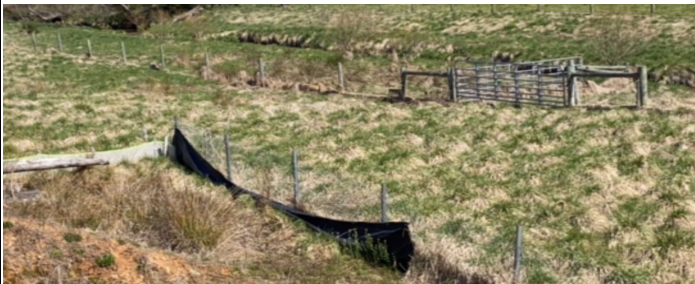
37°53' N 79°56'49" W 82°E COURSE 166° GPS Boones Mill, VA 24065, United States 04.05.2021 11:25:53 Accur +/-58.7 Ft ALT 1136 Ft			37°45'8" N 79°56'46" W 181°S COURSE 125° GPS Boones Mill, VA 24065, United States 04.05.2021 11:29:24 Accur +/-656.2 Ft ALT 1139 Ft		
GPS Location	1		GPS Location	2	
Field Station#	13696+20		Field Station#	13704+00	
Pic 1 Desc.	Routine maintenance. Reattach geotextile fabric to fencing of SSF.		Pic 2 Desc.	Routine maintenance. Replace damaged row of P1 silt fence.

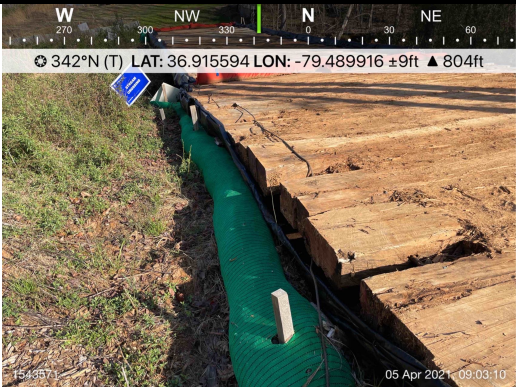
GPS Location	See photo	GPS Location	See photo		
Field Station#	15435+71	Field Station#	15435+71		
Pic 3 Desc.	Bridge fabric needs to be reattached.	Pic 4 Desc.	Environmental crew has corrected this issue.

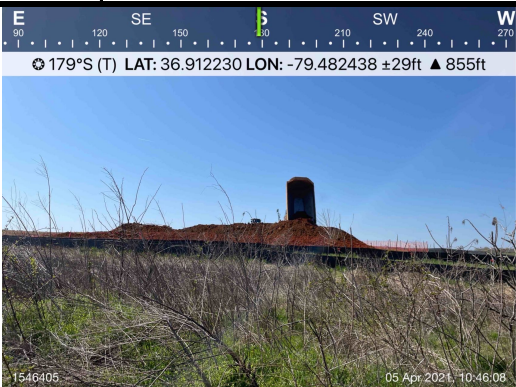
GPS Location	See photo	GPS Location	See photo		
Field Station#	15464+05	Field Station#	15464+05		
Pic 5 Desc.	3rd party disturbance occurring upslope at this location.	Pic 6 Desc.	3rd party disturbance occurring upslope at this location.

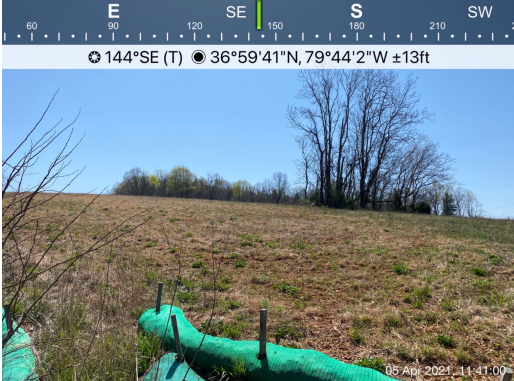
GPS Location	0	GPS Location	0		
Field Station#	14618+00	Field Station#	14611+28		
Pic 3 Desc.	Approximately 14618+00. Overview of ROW.	Pic 4 Desc.	Approximately 14611+28. Overview of stream crossing, equipment bridge and ECDs at stream S-E14.

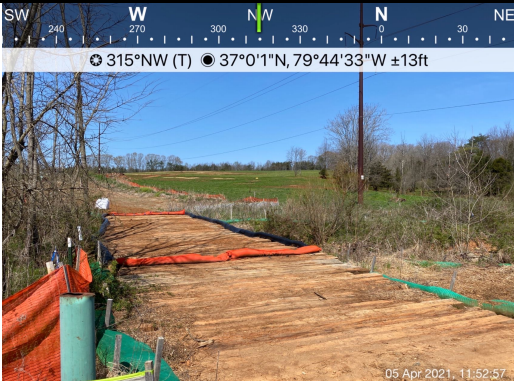
GPS Location	0	GPS Location	0		
Field Station#	14582+85	Field Station#	14551+50		
Pic 5 Desc.	Approximately 14582+85. Overview of stream crossing, equipment bridge and ECDs at stream S-E17.	Pic 6 Desc.	Approximately 14551+50. Overview of ROW.

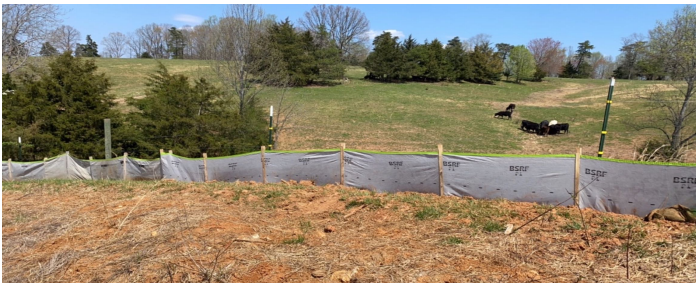
GPS Location			3	GPS Location		4					
Field Station#			14244+00	Field Station#		14296+00					
Pic 3 Desc.			Vegetation growing in recently seeded and stabilized area			Pic 4 Desc.			Contractor replaced P1 silt fence per punch list item

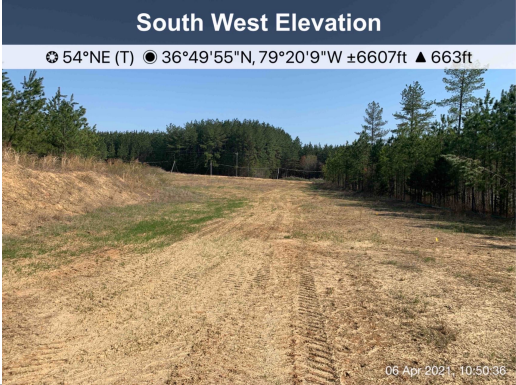
GPS Location	O	GPS Location	O		
Field Station#	8+00	Field Station#	6+00		
Pic 3 Desc.	Observing temporary stabilization	Pic 4 Desc.	Observing temporary stabilization, water bar, sump and end treatment		
Insert image here		Insert image here			
GPS Location		GPS Location			
Field Station#		Field Station#			
Pic 5 Desc.		Pic 6 Desc.

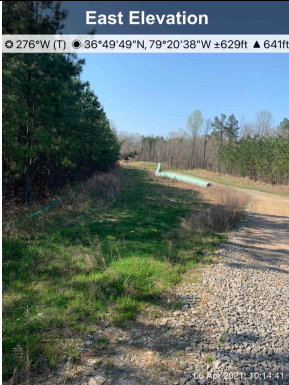
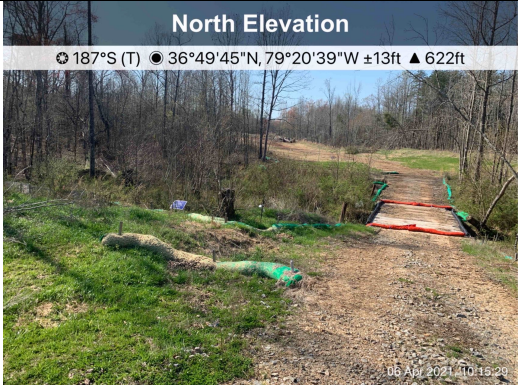
<p>North Elevation <small>187°S (T) 36°49'45"N, 79°20'39"W ±13ft ▲ 622ft</small></p>			
GPS Location	O	GPS Location	O		
Field Station#	7+00	Field Station#	12+65		
Pic 1 Desc.	Observing temporary vegetation and ECD's	Pic 2 Desc.	Observing temporary vegetation, signage, buffer, equipment crossing and ECD's

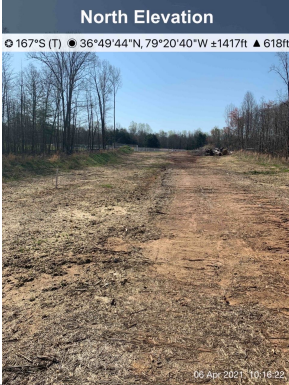
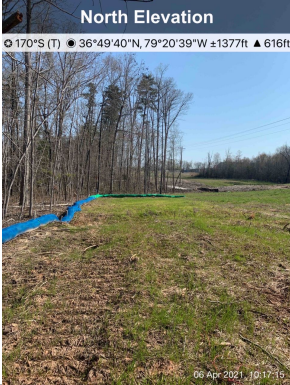
<p>North Elevation <small>170°S (T) 36°49'40"N, 79°20'39"W ±1377ft ▲ 616ft</small></p>			
GPS Location	O	GPS Location	O		
Field Station#	15+00	Field Station#	19+00		
Pic 3 Desc.	Observing temporary stabilization	Pic 4 Desc.	Observing temporary vegetation and ECD's		
Insert image here			Insert image here		
GPS Location		GPS Location			
Field Station#		Field Station#

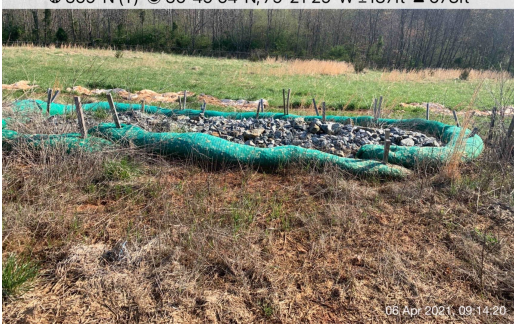
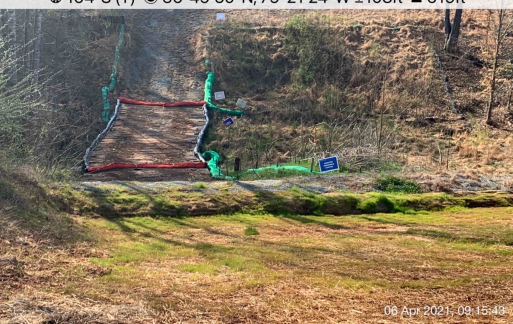
GPS Location	O	GPS Location	O		
Field Station#	15970+00	Field Station#	15977+35		
Pic 1 Desc.	Observing temporary vegetation,CWD outlet and ECD's	Pic 2 Desc.	Observing temporary stabilization,water bar, erosion control blanket, signage, buffer, equipment crossing and ECD's.		
East Elevation 287°W (T) 36°49'44"N, 79°21'14"W ±82ft ▲ 635ft

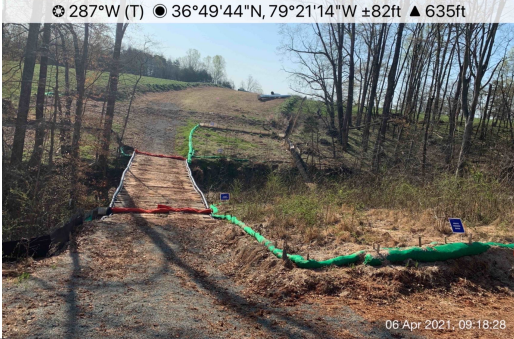
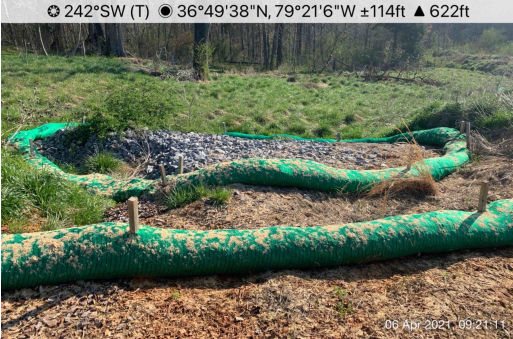
GPS Location	O	GPS Location	O		
Field Station#	15987+31	Field Station#	15997+50		
Pic 3 Desc.	Observing temporary stabilization, signage, buffer, equipment crossing and ECD's	Pic 4 Desc.	Observing temporary stabilization,CWD outlet and ECD's		
South West Elevation 44°NE (T) 36°49'28"N, 79°20'43"W ±29422ft ▲ 625ft

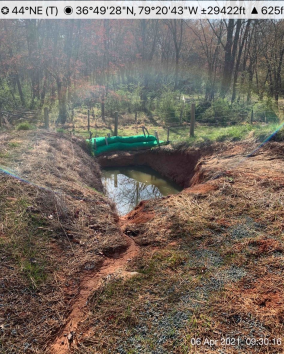
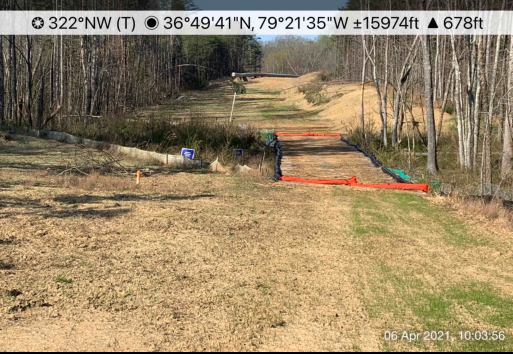
GPS Location	O	GPS Location	O		
Field Station#	15999+00	Field Station#	16016+36		
Pic 5 Desc.	Observing water bar, sump and end treatment	Pic 6 Desc.	Observing temporary stabilization, signage, buffer, equipment crossing and ECD's.

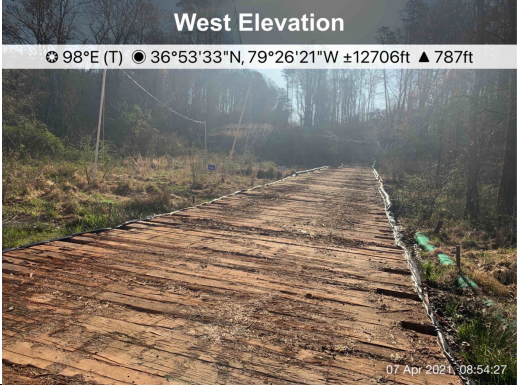
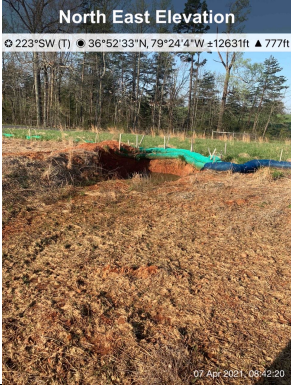
GPS Location	O	GPS Location	O		
Field Station#	15596+79	Field Station#	15646+00		
Pic 7 Desc.	Observing signage, buffer, equipment crossing and ECD's	Pic 8 Desc.	Observing temporary stabilization, sump and end treatment		
Insert image here		Insert image here			
GPS Location		GPS Location			
Field Station#		Field Station#			
Pic 9 Desc.		Pic 10 Desc.			
Insert image here		Insert image here			
GPS Location		GPS Location			
Field Station#		Field Station#			
Pic 11 Desc.		Pic 12 Desc.

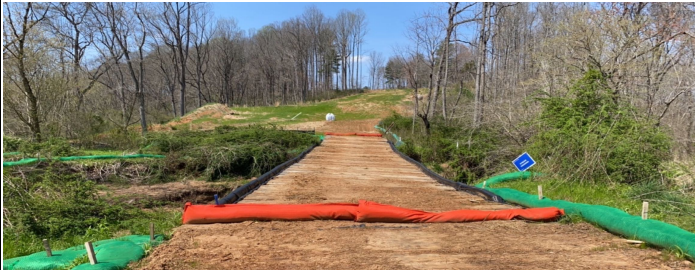
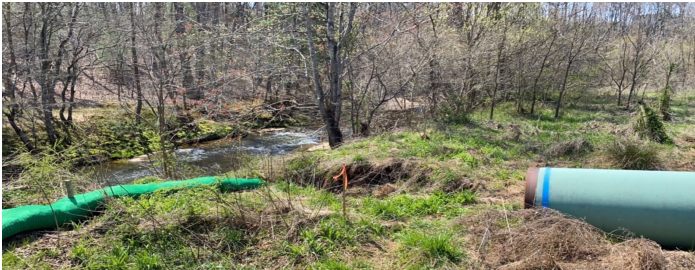
37°3'30" N 79°55'4" W 289°W COURSE 277' GPS 404 Old Mill Creek Ln, Rocky Mount, VA 24151, United States 04.07.2021 12:32:38 Accur +/-61.5 Ft ALT 1029 Ft			37°3'27" N 79°54'50" W 213°SW COURSE 304' GPS Rocky Mount, VA 24151, United States 04.07.2021 12:22:05 Accur +/-158.4 Ft ALT 1020 Ft		
GPS Location	1		GPS Location	2	
Field Station#	13863+01		Field Station#	13875+16	
Pic 1 Desc.	Equipment bridge and surrounding ECDs in place and functional at S-C17		Pic 2 Desc.	Ditch subsidence CIS S-CD6 continues to worsen from previous inspections

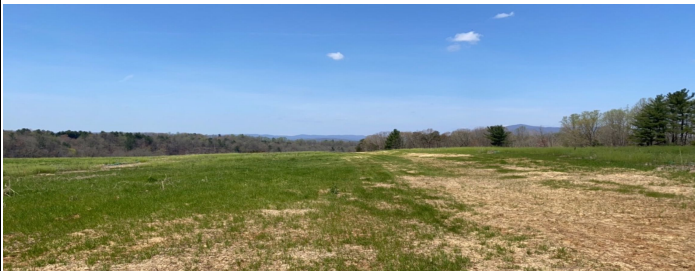
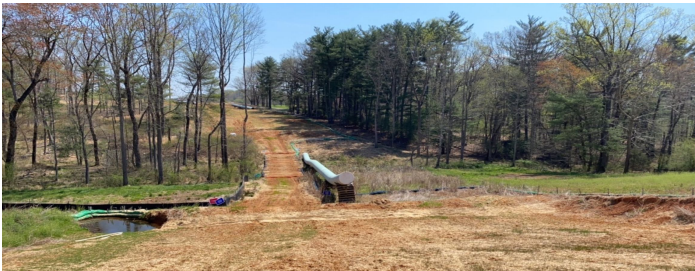
37°2'56" N 79°54'3" W 326°NW COURSE 290' GPS 184 Foggy Ridge Rd, Rocky Mount, VA 24151, United States 04.07.2021 11:53:00 Accur +/-26.7 Ft ALT 1128 Ft			37°2'53" N 79°53'41" W 23°N COURSE 222' GPS 184 Foggy Ridge Rd, Rocky Mount, VA 24151, United States 04.07.2021 11:49:49 Accur +/-165.6 Ft ALT 1108 Ft		
GPS Location	5		GPS Location	6	
Field Station#	13941+00		Field Station#	13948+00	
Pic 5 Desc.	Vegetation growing in recently seeded and stabilized area		Pic 6 Desc.	Vegetation growing in recently seeded and stabilized area

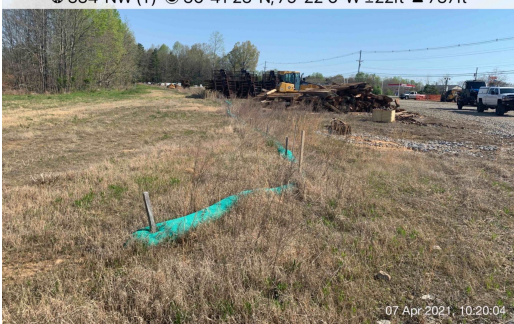
AFE	124300139	Date/Time	4/7/2021 10:26 AM	Report #	
Pictures					
South East Elevation 334°NW (T) 36°41'23"N, 79°22'6"W ±22ft ▲ 737ft

North West Elevation 126°SE (T) 36°41'18"N, 79°22'5"W ±213ft ▲ 729ft  			
GPS Location	O	GPS Location	O		
Field Station#	00+00	Field Station#	00+00		
Pic 1 Desc.	Observing temporary vegetation and ECD's		Pic 2 Desc.	Observing temporary vegetation and ECD's	
South East Elevation 300°NW (T) 36°41'22"N, 79°22'5"W ±13ft ▲ 740ft

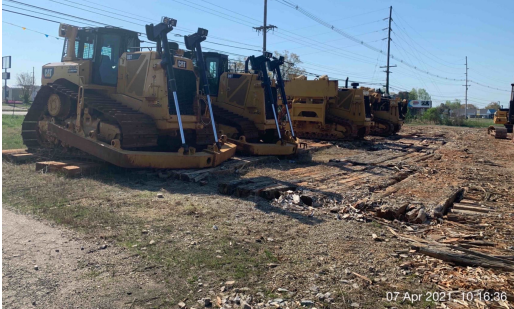
North East Elevation 241°SW (T) 36°41'20"N, 79°22'5"W ±239ft ▲ 728ft

GPS Location	O	GPS Location	O		
Field Station#	00+00	Field Station#	00+00		
Pic 3 Desc.	Observing temporary vegetation and ECD's		Pic 4 Desc.	Observing staged equipment	
Insert image here			Insert image here		
GPS Location		GPS Location			
Field Station#		Field Station#			
Pic 5 Desc.			Pic 6 Desc.

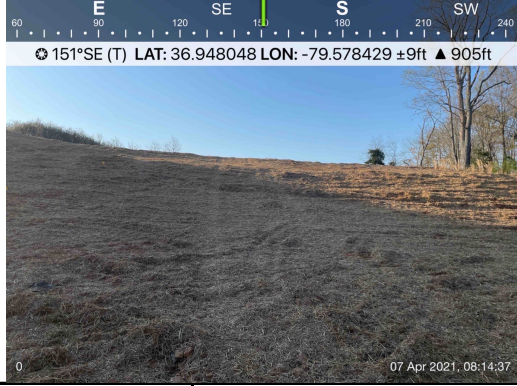
GPS Location	See photo		GPS Location	See photo	
Field Station#	15142+66		Field Station#	15157+00	
Pic 11 Desc.	Rockcreek road approach has been stabilized.		Pic 12 Desc.	Vegetation beginning to fill in.

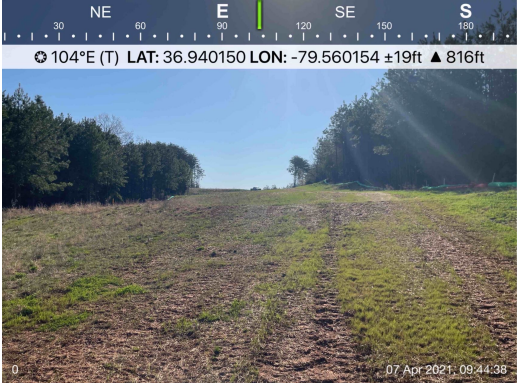
Insert image here			
GPS Location	See photo	GPS Location			
Field Station#	15205+00	Field Station#			
Pic 13 Desc.	Vegetation beginning to fill in.	Pic 14 Desc.			
Insert image here		Insert image here			
GPS Location		GPS Location			
Field Station#		Field Station#			
Pic 15 Desc.		Pic 16 Desc.			
Insert image here		Insert image here			
GPS Location		GPS Location			
Field Station#		Field Station#			
Pic 17 Desc.		Pic 18 Desc.

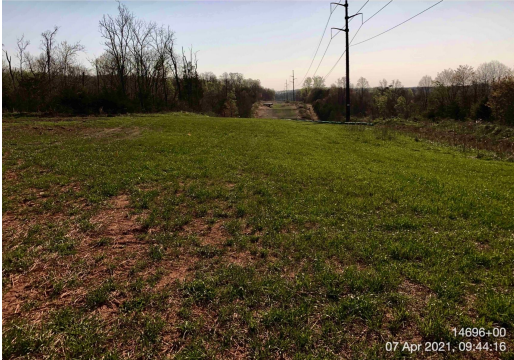
GPS Location	0	GPS Location	0		
Field Station#	14696+00	Field Station#	14790+00		
Pic 1 Desc.	Temporary vegetative stabilization in acceptable condition	Pic 2 Desc.	Waterbar end treatment in acceptable condition

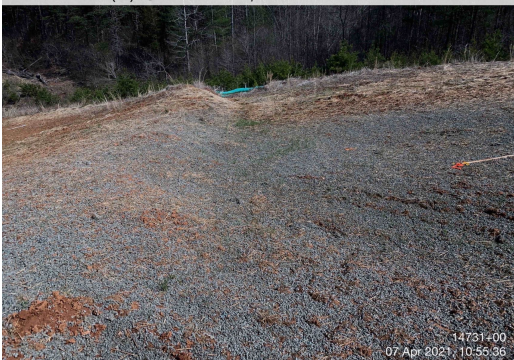
GPS Location	0	GPS Location	0		
Field Station#	14731+00	Field Station#	14793+00		
Pic 3 Desc.	Waterbar in acceptable condition	Pic 4 Desc.	P1 silt fence in acceptable condition		
Insert image here			Insert image here		
GPS Location		GPS Location			
Field Station#		Field Station#			
Pic 5 Desc.		Pic 6 Desc.

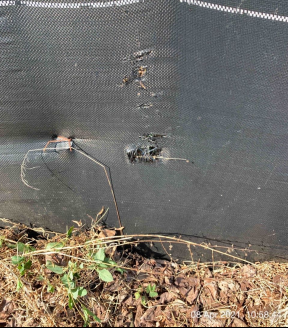
AFE	124300139	Date/Time	4/8/2021 11:20 AM	Report #	
Pictures					
	North West Elevation <small>124°SE (T) 36°52'15"N, 79°24'10"W ±55ft ▲ 771ft</small>

GPS Location	O		GPS Location	O	
Field Station#	15762+00		Field Station#	15764+00	
Pic 1 Desc.	Observing SSF that requires maintenance		Pic 2 Desc.	Observing temporary stabilization, signage, buffer, equipment crossing and ECD's	
	East Elevation <small>248°W (T) 36°52'53"N, 79°25'30"W ±141ft ▲ 751ft</small>

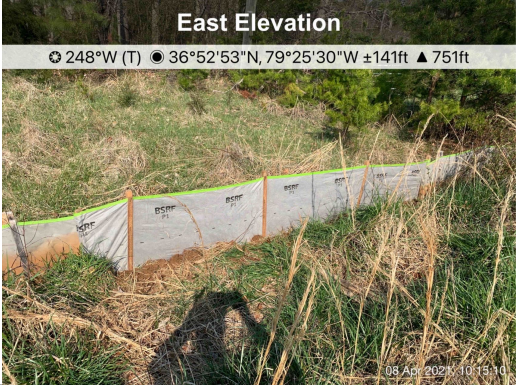
GPS Location	O		GPS Location	O	
Field Station#	15678+57		Field Station#	15678+40	
Pic 3 Desc.	Observing p1 that received maintenance		Pic 4 Desc.	Observing safety fence that received maintenance	
	West Elevation <small>80°E (T) 36°52'23"N, 79°24'41"W ±22ft ▲ 867ft</small>

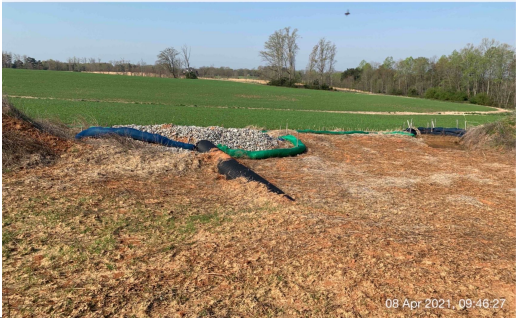
GPS Location	O		GPS Location	O	
Field Station#	15736+00		Field Station#	15738+00	
Pic 5 Desc.	Observing temporary stabilization, CWD outlet and ECD's		Pic 6 Desc.	Observing temporary stabilization

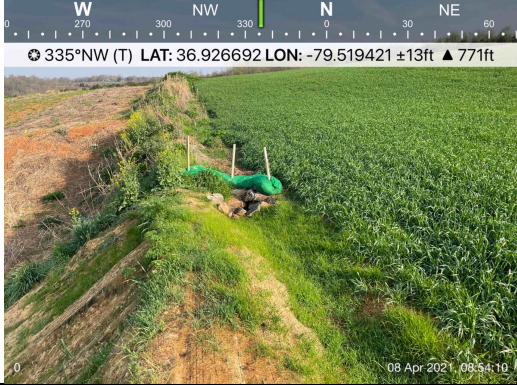
GPS Location	See photo		GPS Location	See photo	
Field Station#	15338+00		Field Station#	15348+00	
Pic 9 Desc.	CWD inlet is in good condition.		Pic 10 Desc.	Equipment bridge ECDs are in place and in good condition at all stream and wetland crossings.

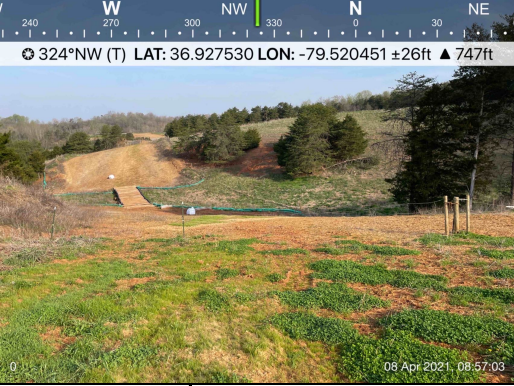
GPS Location	See photo		GPS Location	See photo	
Field Station#	15349+59		Field Station#	15333+00	
Pic 11 Desc.	Waterbars are in good condition.		Pic 12 Desc.	Area remains temporarily stabilized.

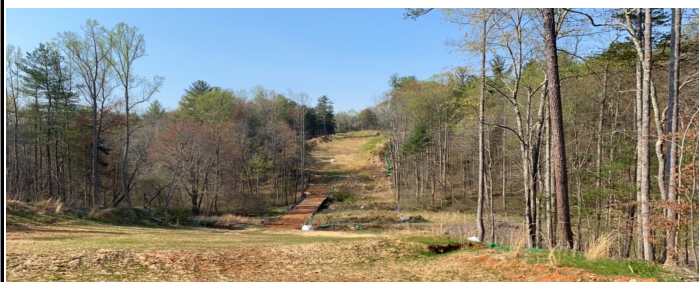
37°3'10" N 79°53'5" W 41°NE COURSE 276' GPS Rocky Mount, VA 24151, United States			04.08.2021 13:26:26 Accur +/-55.2 Ft ALT 0 Ft		
37°3'43" N 79°52'45" W 359°N COURSE 87' GPS 209 Three Brooks Ln, Rocky Mount, VA 24151, United States			04.08.2021 10:10:52 Accur +/-132.9 Ft ALT 1000 Ft		
GPS Location	3		GPS Location	4	
Field Station#	13997+00		Field Station#	14039+00	
Pic 3 Desc.	Contractor staged material and equipment for maintenance on ECDs at S-KL36		Pic 4 Desc.	Vegetation growing in recently seeded and stabilized area

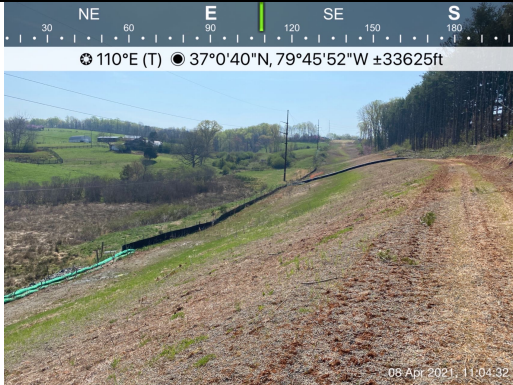
GPS Location	0	GPS Location	0		
Field Station#	14518+57	Field Station#	14510+00		
Pic 3 Desc.	Approximately 14518+57. CFS damaged by third party traffic.		Pic 4 Desc.	Approximately 14510+00. Overview of ROW.

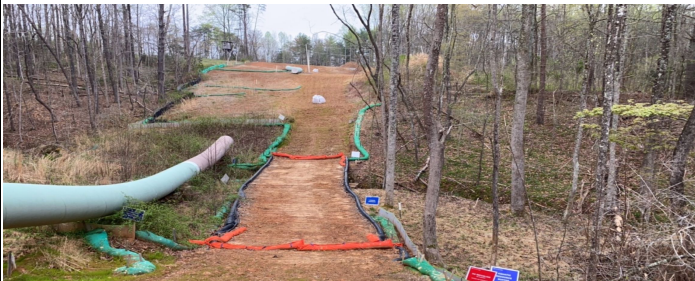
37°3'44" N 79°51'22" W 124°SE COURSE 121' GPS 1321 Angle Plantation Rd, Rocky Mount, VA 24151, United States 04.09.2021 09:29:39 Accur +/-164.6 Ft ALT 1186 Ft			37°3'23" N 79°51'5" W 123°SE COURSE 248' GPS Rocky Mount, VA 24151, United States 04.09.2021 09:36:54 Accur +/-43.9 Ft ALT 1042 Ft		
GPS Location	5	GPS Location	6		
Field Station#	14141+62	Field Station#	14157+55

Pic 5 Desc.	Equipment bridge and surrounding ECDs in place and functional at stream crossing	Pic 6 Desc.	Equipment bridge and surrounding ECDs in place and functional at stream crossing. Vegetation growing in recently seeded and stabilized area

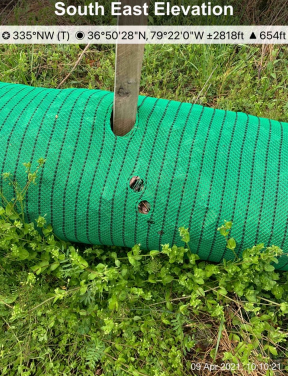
A/E	124300139	Date/Time	4/9/2021 11:23 AM	Report #	
Pictures					
	South East Elevation

<p>344°N (T) 36°50'16"N, 79°21'43"W ±13677ft ▲ 633ft 09 Apr 2021 10:10:42</p>	
GPS Location	O	GPS Location	O		
Field Station#	15922+59	Field Station#	15922+59		
Pic 1 Desc.	Observing CFS that required maintenance	Pic 2 Desc.	Observing CFS that received maintenance		
	South Elevation

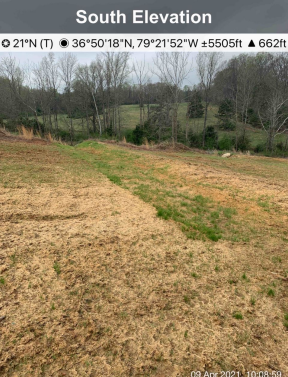
<p>214°SW (T) 36°50'58"N, 79°22'41"W ±114ft ▲ 725ft 09 Apr 2021 09:56:10</p>		
GPS Location	O	GPS Location	O		
Field Station#	15928+00	Field Station#	15878+08		
Pic 3 Desc.	Observing temporary stabilization and water bar	Pic 4 Desc.	Observing temporary stabilization, signage, buffer, equipment crossing and ECD's		
	North West Elevation

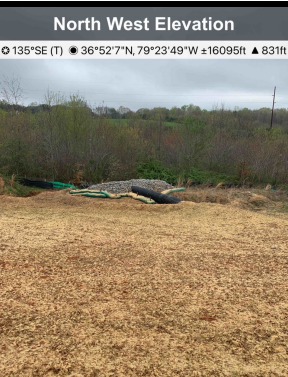
GPS Location	O	GPS Location	O		
Field Station#	15863+00	Field Station#	15825+00		
Pic 5 Desc.	Observing temporary stabilization, CWD outlet and ECD's	Pic 6 Desc.	Observing temporary stabilization, plunge pool and ECD's

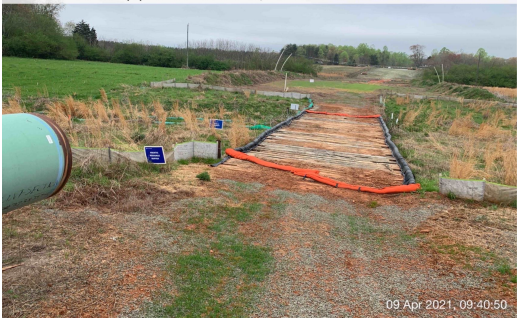
A/E	124300139	Date/Time	4/9/2021 11:23 AM	Report #	
Pictures					
South West Elevation <small>56°NE (T) 36°51'59"N, 79°24'1"W ±239ft ▲813ft</small>

North East Elevation <small>212°SW (T) 36°49'59"N, 79°21'15"W ±2263ft ▲732ft</small>  			
GPS Location	O	GPS Location	O		
Field Station#	15781+22	Field Station#	15934+00		
Pic 7 Desc.	Observing temporary stabilization, signage, buffer, equipment crossing and ECD's		Pic 8 Desc.	Observing temporary stabilization, CWD outlet and ECD's	
Insert image here		Insert image here			
GPS Location		GPS Location			
Field Station#		Field Station#			
Pic 9 Desc.			Pic 10 Desc.		
Insert image here		Insert image here			
GPS Location		GPS Location			
Field Station#		Field Station#			
Pic 11 Desc.			Pic 12 Desc.

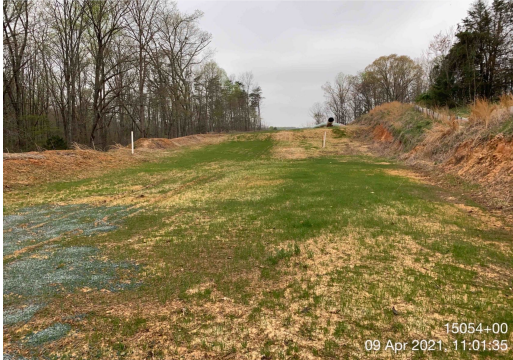
<p>15054+00 09 Apr 2021, 11:01:35</p>			
GPS Location	0	GPS Location	0		
Field Station#	15062+00	Field Station#	15054+00		
Pic 1 Desc.	Waterbar end treatment in acceptable condition	Pic 2 Desc.	Temporary vegetative stabilization in acceptable condition		
<p>13°N (M) 36°58'11"N, 79°38'2"W ±13ft ▲845ft</p>

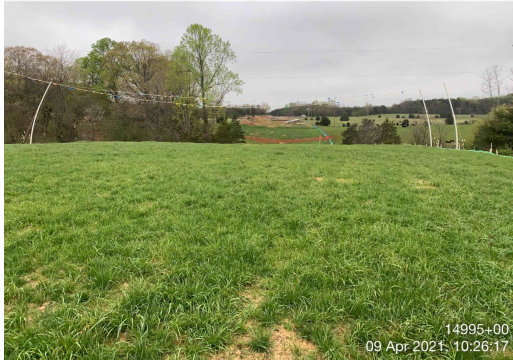
<p>14995+00 09 Apr 2021, 10:26:17</p>			
GPS Location	0	GPS Location	0		
Field Station#	14940+00	Field Station#	14995+00		
Pic 3 Desc.	Waterbar in acceptable condition	Pic 4 Desc.	Permanent vegetative stabilization in acceptable condition		
<p>219°SW (M) 36°57'52"N, 79°36'52"W ±242ft ▲921ft</p>

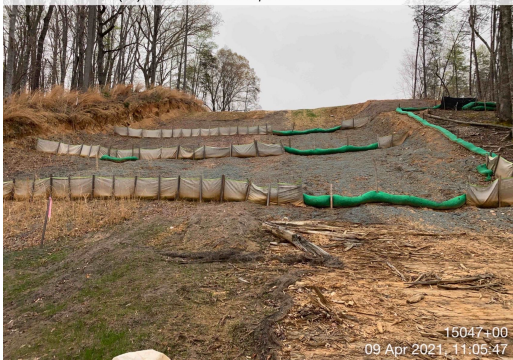
GPS Location	0	GPS Location	0		
Field Station#	14998+00	Field Station#	15047+00		
Pic 5 Desc.	Perimeter CFS in acceptable condition	Pic 6 Desc.	P1 silt fence in acceptable condition

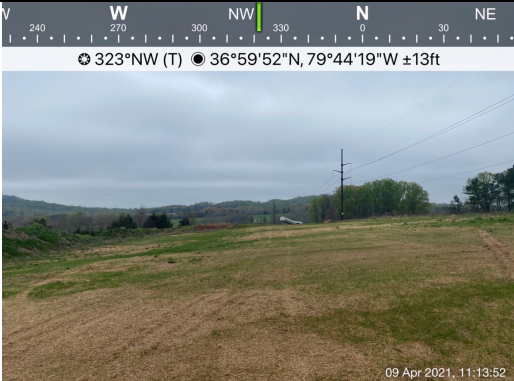
GPS Location	0	GPS Location	0		
Field Station#	14605+00	Field Station#	14599+00		
Pic 1 Desc.	Approximately 14605+00. Overview of ROW.	Pic 2 Desc.	Approximately 14599+00. Overview of road crossing and RCEs.

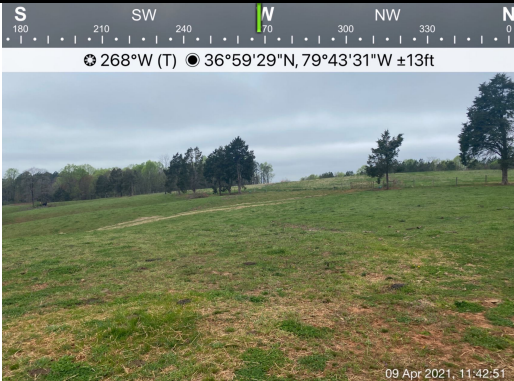
GPS Location	0	GPS Location	0		
Field Station#	14596+00	Field Station#	14568+10		
Pic 3 Desc.	Approximately 14596+00. Overview of ROW.	Pic 4 Desc.	Approximately 14568+10. Overview of stream crossing, equipment bridge and ECDs at stream S-E18.

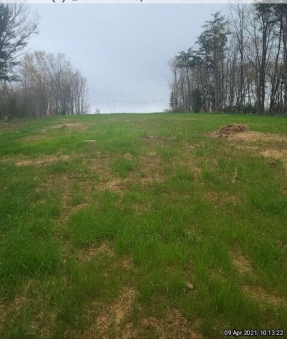
GPS Location	000000	GPS Location	000000		
Field Station#	13709+10	Field Station#	13744+20		
Pic 1 Desc.	Vegetation observation showing good temporary coverage.		Pic 2 Desc.	Vegetation observation showing good coverage.	
	South East Elevation <small>315°NW (T) 37.067093, -79.930373 ±3 m ▲ 321 m</small>  			North West Elevation <small>152°SE (T) 37.082924, -79.945608 ±4 m ▲ 309 m</small>  	
GPS Location	000000	GPS Location	000000		
Field Station#	13704+90	Field Station#	13704+90		
Pic 3 Desc.	Stream observation photo facing upstream during routine inspection today, no environmental issues observed at the time of inspection.		Pic 4 Desc.	Stream observation photo facing downstream during routine inspection today, no environmental issues observed at the time of inspection.

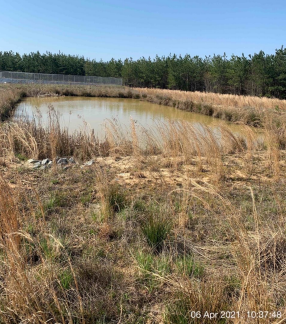
GPS Location	O	GPS Location	O		
Field Station#	00+00	Field Station#	00+00		
Pic 1 Desc.	Observing temporary vegetation and sediment basin	Pic 2 Desc.	Observing safety fence that required maintenance		
	North Elevation 169°S (T) 36°50'1"N, 79°20'33"W ±49ft ▲ 664ft

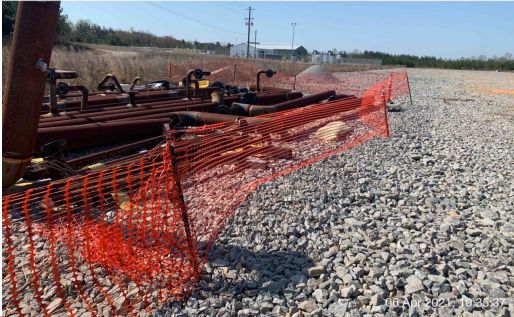
GPS Location	O	GPS Location	O		
Field Station#	00+00	Field Station#	00+00		
Pic 3 Desc.	Observing safety fence that received maintenance	Pic 4 Desc.	Observing rock drain and ECD's		
	North Elevation 189°S (T) 36°50'5"N, 79°20'31"W ±1676ft ▲ 668ft

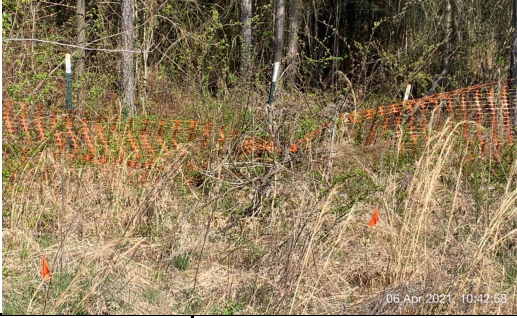
GPS Location	O	GPS Location	O		
Field Station#	00+00	Field Station#	00+00		
Pic 7 Desc.	Observing baracade fencing that required maintenance	Pic 8 Desc.	Observing baracade fencing that received maintenance		
Insert image here		Insert image here			
GPS Location		GPS Location			
Field Station#		Field Station#			
Pic 9 Desc.		Pic 10 Desc.			
Insert image here		Insert image here			
GPS Location		GPS Location			
Field Station#		Field Station#			
Pic 11 Desc.		Pic 12 Desc.
