# Visual Site Inspection Report

<b>Project Name</b>	H-600 Pipeline Spread I	<b>AFE</b>	124300139	<b>Spread</b>	H-600 Pipeline Spread I
<b>Contractor</b>	Precision			<b>Report #</b>	23175
<b>Inspector</b>	Ben Davenport			<b>Date/Time</b>	5/10/2021 8:20 AM
<b>Permit #</b>	TBD	<b>Inspection Type</b>	VA SWPP	<b>Station Begin</b>	15063+85
<b>State</b>	VA	<b>Inspection Area</b>	Partial	<b>Station End</b>	15142+66
<b>County</b>	Pittsylvania	<b>Ground</b>	Dry	<b>Temperature (°F)</b>	69.00
<b>Municipality</b>	Chatham	<b>Weather</b>	Cloudy	<b>Rain Gauge (in)</b>	0.00
				<b>Rain Accumulation Time (days)</b>	0.00

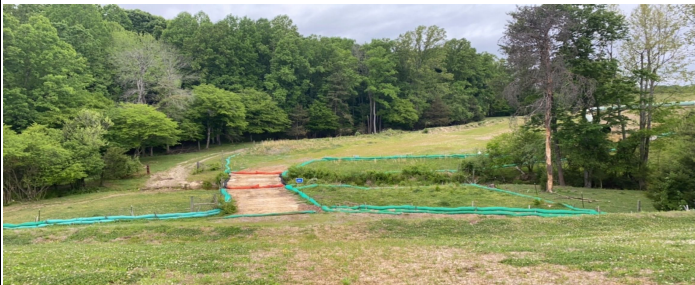
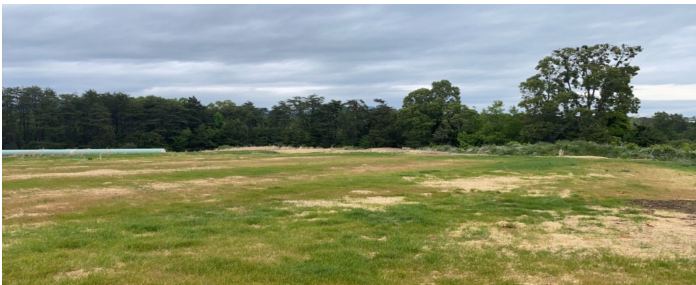
<b>GPS Location</b>	3	<b>GPS Location</b>	4		
<b>Field Station#</b>	15092+95	<b>Field Station#</b>	15112+00		
<b>Pic 3 Desc.</b>	Equipment bridge and surrounding ECDs in place and functional at stream crossing		<b>Pic 4 Desc.</b>	Extra workspace stabilized and vegetation growing in temporary space

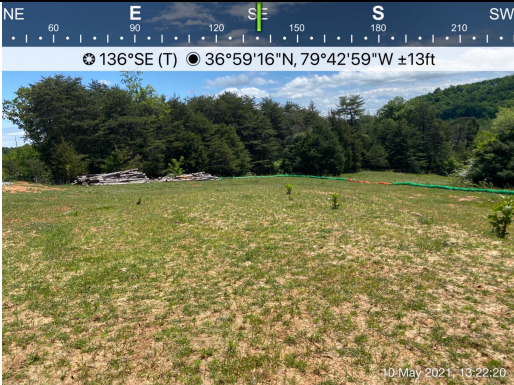
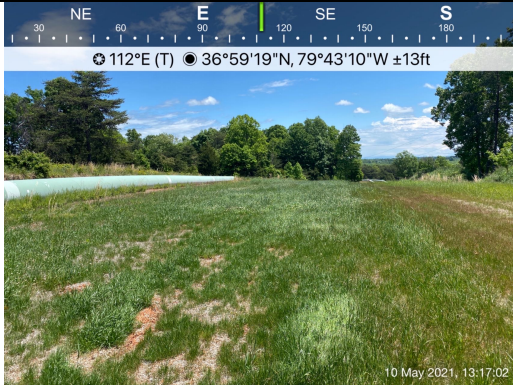
<b>GPS Location</b>	0	<b>GPS Location</b>	0		
<b>Field Station#</b>	14675+50	<b>Field Station#</b>	14667+00		
<b>Pic 3 Desc.</b>	Approximately 14675+50. Overview of ROW. Cattle traverse and graze area frequently.	<b>Pic 4 Desc.</b>	Approximately 14667+00. Overview of ROW.

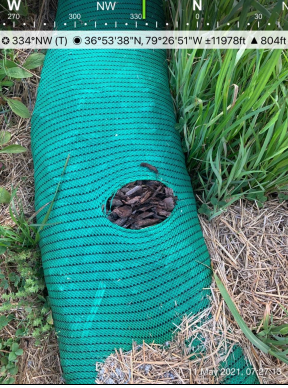
<b>GPS Location</b>	O	<b>GPS Location</b>	O		
<b>Field Station#</b>	15587+00	<b>Field Station#</b>	15589+00		
<b>Pic 1 Desc.</b>	Observing CFS that requires maintenance	<b>Pic 2 Desc.</b>	Observing temporary stabilization and water bars

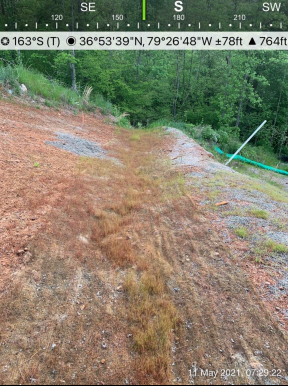
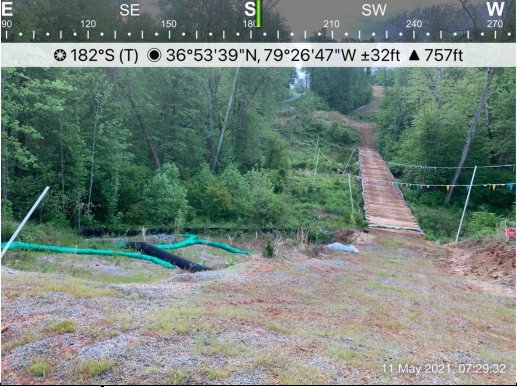
<b>GPS Location</b>	O	<b>GPS Location</b>	O		
<b>Field Station#</b>	15595+00	<b>Field Station#</b>	15596+00		
<b>Pic 3 Desc.</b>	Observing erosion control blanket, water bar and temporary stabilization	<b>Pic 4 Desc.</b>	Observing temporary stabilization, CWD outlet, signage, buffer, equipment crossing and ECD's

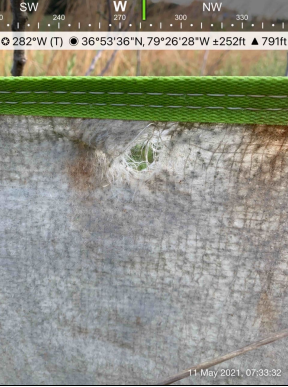
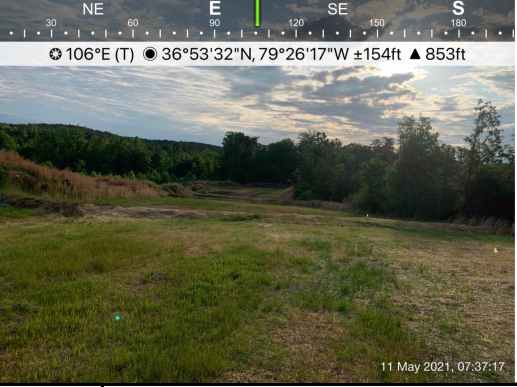
<b>GPS Location</b>	O	<b>GPS Location</b>	O		
<b>Field Station#</b>	15610+00	<b>Field Station#</b>	15622+00		
<b>Pic 5 Desc.</b>	Observing p1 that requires maintenance	<b>Pic 6 Desc.</b>	Observing temporary stabilization and water bars

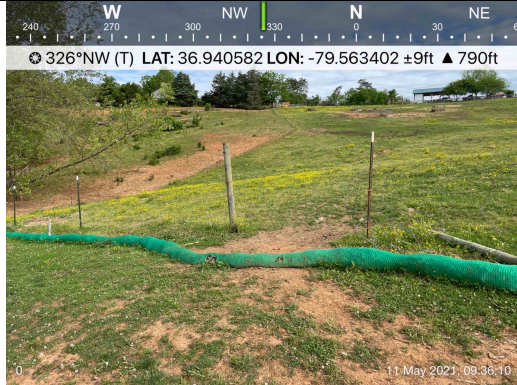
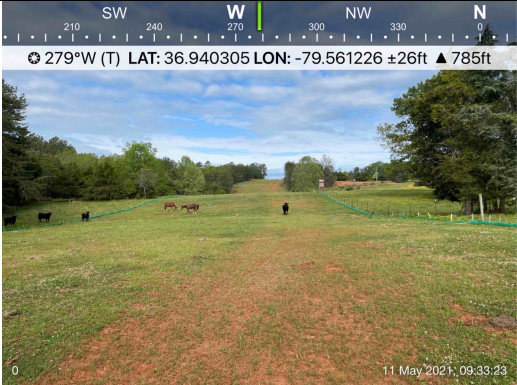
<b>GPS Location</b>	See photo		<b>GPS Location</b>	See photo	
<b>Field Station#</b>	15195+00		<b>Field Station#</b>	15199+00	
<b>Pic 11 Desc.</b>	Fence gap has been opened to allow livestock onto ROW by 3rd party.		<b>Pic 12 Desc.</b>	Livestock on ROW.

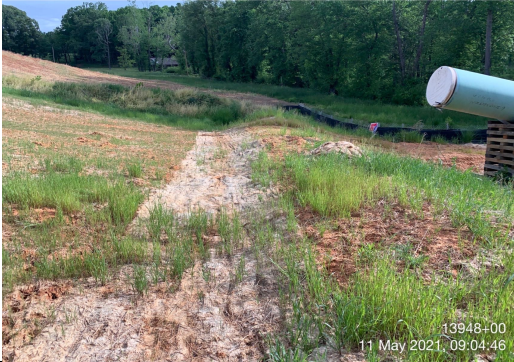
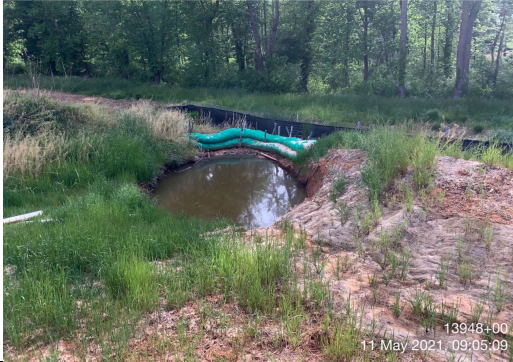
<b>GPS Location</b>	0	<b>GPS Location</b>	0		
<b>Field Station#</b>	13948+00	<b>Field Station#</b>	13948+00		
<b>Pic 1 Desc.</b>	Waterbar in acceptable condition	<b>Pic 2 Desc.</b>	Waterbar end treatment in acceptable condition

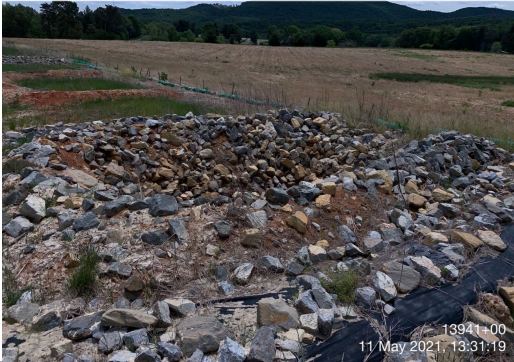
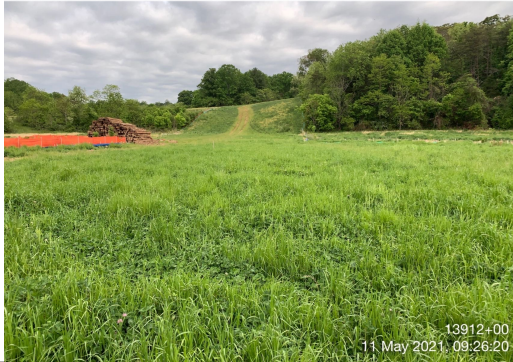
<b>GPS Location</b>	0	<b>GPS Location</b>	0		
<b>Field Station#</b>	13941+00	<b>Field Station#</b>	13912+00		
<b>Pic 3 Desc.</b>	Clean water diversion plunge pool in acceptable condition	<b>Pic 4 Desc.</b>	Permanent vegetative stabilization in acceptable condition

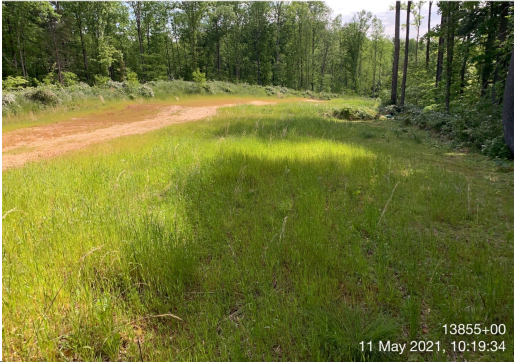
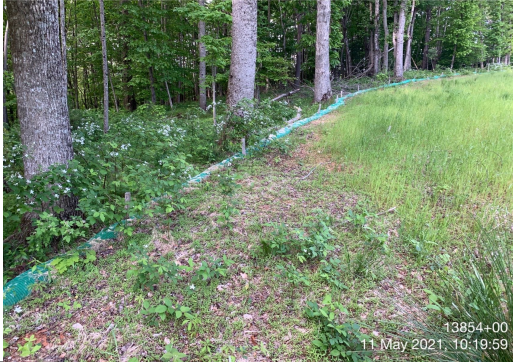
<b>GPS Location</b>	0	<b>GPS Location</b>	0		
<b>Field Station#</b>	13855+00	<b>Field Station#</b>	13854+00		
<b>Pic 5 Desc.</b>	Temporary vegetative stabilization in acceptable condition	<b>Pic 6 Desc.</b>	Perimeter CFS in acceptable condition

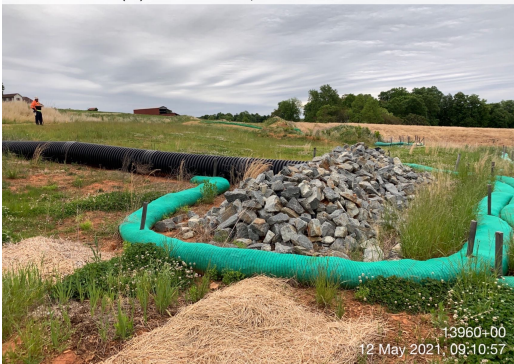
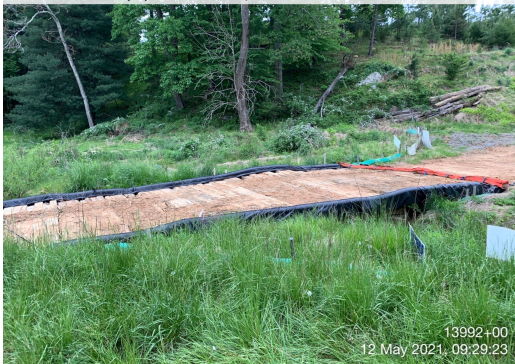
</div> <div>13992+00 12 May 2021, 09:29:23</div>		
GPS Location	0		GPS Location	0	
Field Station#	13960+00		Field Station#	13992+00	
Pic 1 Desc.	Clean water diversion pipe in acceptable condition		Pic 2 Desc.	Equipment bridge in acceptable condition	
<div>⦿ 355°N (M) ⦿ 37°3'19"N, 79°53'1"W ±49ft ▲ 1061ft</div> <div>

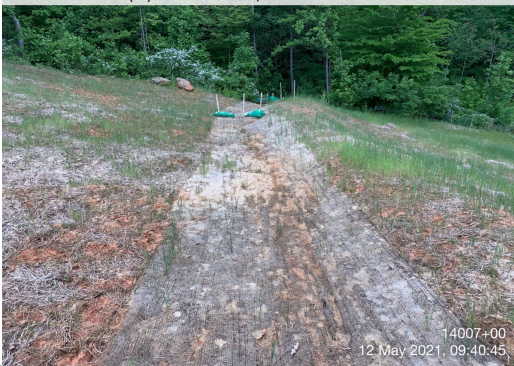
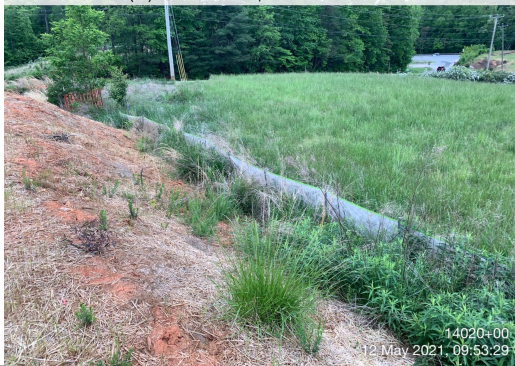
</div> <div>14020+00 12 May 2021, 09:53:29</div>		
GPS Location	0		GPS Location	0	
Field Station#	14007+00		Field Station#	14020+00	
Pic 3 Desc.	Waterbar in acceptable condition		Pic 4 Desc.	P silt fence in acceptable condition

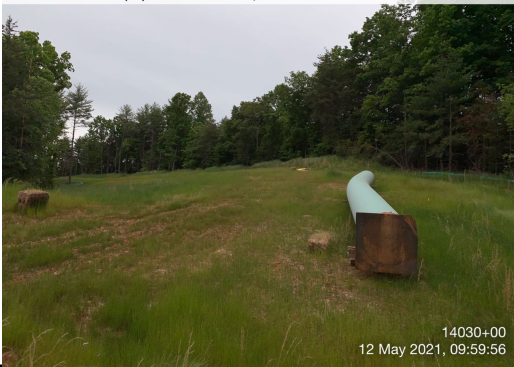
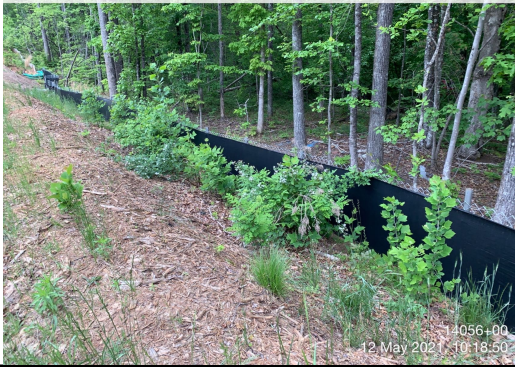
</div> <div>14056+00 12 May 2021, 10:18:50</div>		
GPS Location	0		GPS Location	0	
Field Station#	14030+00		Field Station#	14056+00	
Pic 5 Desc.	Temporary vegetative stabilization in acceptable condition		Pic 6 Desc.	Super silt fence in acceptable condition

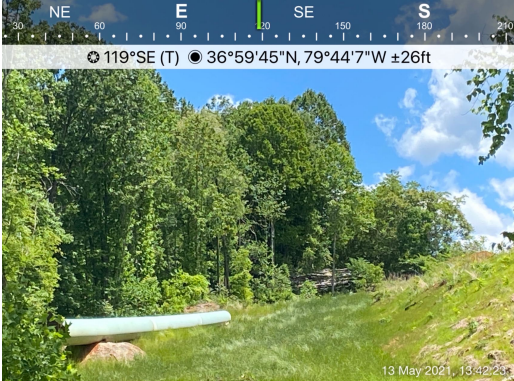
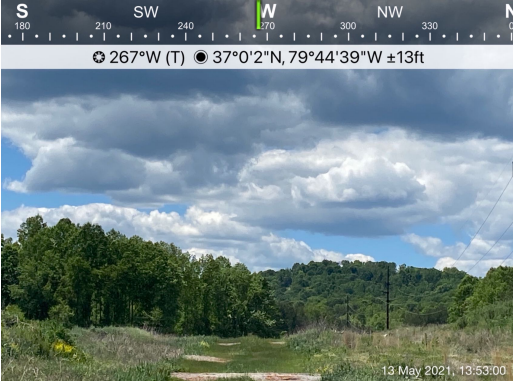
<b>GPS Location</b>	0	<b>GPS Location</b>	0		
<b>Field Station#</b>	14615+00	<b>Field Station#</b>	14575+00		
<b>Pic 3 Desc.</b>	Approximately 14615+00. Overview of ROW.		<b>Pic 4 Desc.</b>	Approximately 14575+00. Overview of ROW.

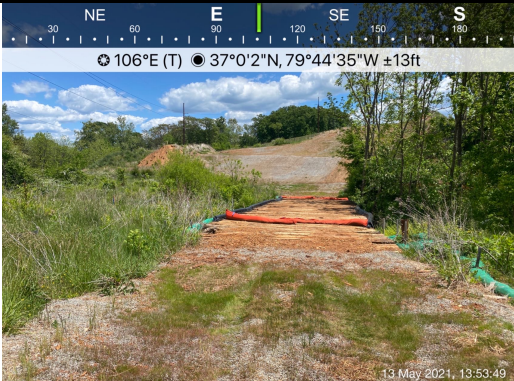
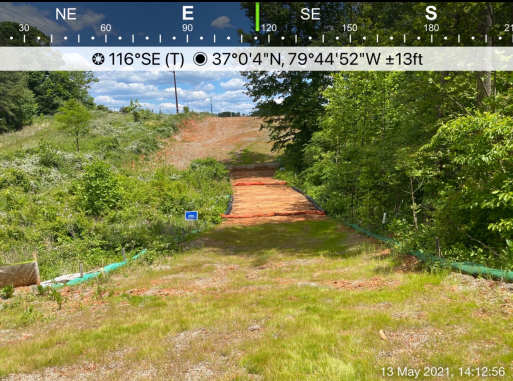
<b>GPS Location</b>	0	<b>GPS Location</b>	0		
<b>Field Station#</b>	14582+85	<b>Field Station#</b>	14568+10		
<b>Pic 5 Desc.</b>	Approximately 14582+85. Overview of stream crossing, equipment bridge and ECDs at stream S-E17.		<b>Pic 6 Desc.</b>	Approximately 14568+10. Overview of stream crossing, equipment bridge and ECDs at stream S-E18.

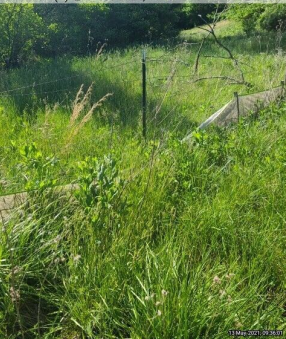
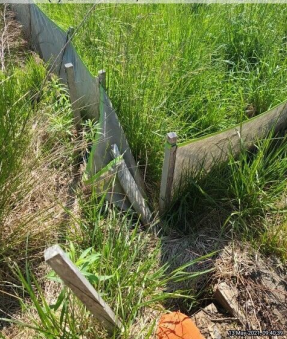
<b>GPS Location</b>	00000	<b>GPS Location</b>	00000		
<b>Field Station#</b>	13704+15	<b>Field Station#</b>	13694+55		
<b>Pic 1 Desc.</b>	P1 requires maintenance due to broken stakes , documented and added to the punch list for repair.		<b>Pic 2 Desc.</b>	P1 requires maintenance due to broken stake, added to the punch list for repair.	
	<b>North East Elevation</b> <small>232°SW (T) • 37.082836, -79.945085 ±9 m ▲ 314 m</small>

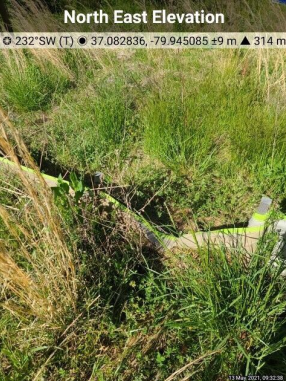
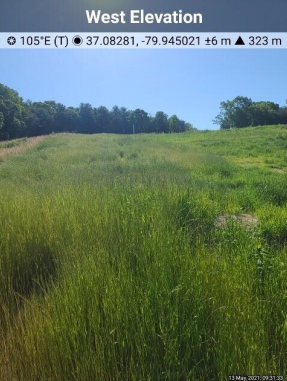
<b>Pic 3 Desc.</b>	P1 requires maintenance due to wildlife damage , documented and added to the punch list for repair.		<b>Pic 4 Desc.</b>	Vegetation observation photo facing up row from stream crossing. Good coverage noted .	
	<b>South East Elevation</b> <small>339°NW (T) • 37.082937, -79.945835 ±9 m ▲ 313 m</small>

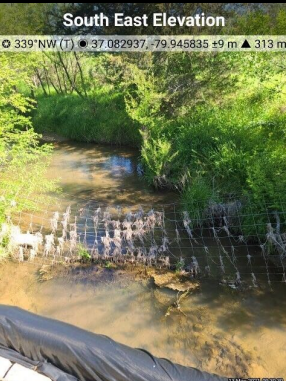
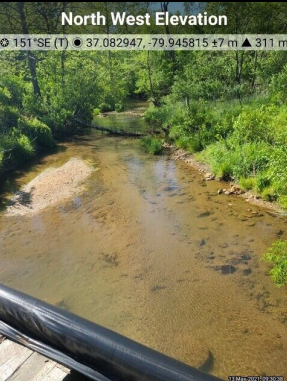
<b>GPS Location</b>	00000	<b>GPS Location</b>	00000		
<b>Field Station#</b>	13704+90	<b>Field Station#</b>	13704+90		
<b>Pic 5 Desc.</b>	Stream observation photo facing upstream during routine inspection today. No issues observed at the time of inspection.		<b>Pic 6 Desc.</b>	Stream observation photo facing downstream during routine inspection today. No issues observed at the time of inspection.

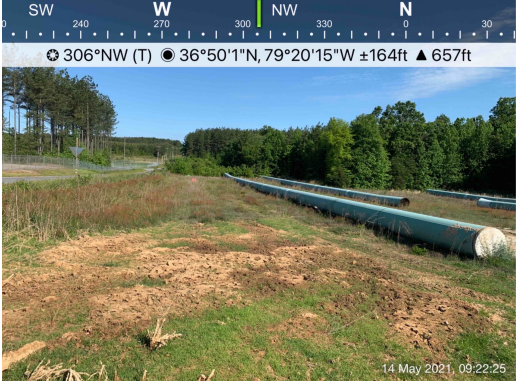
<b>GPS Location</b>	O	<b>GPS Location</b>	O		
<b>Field Station#</b>	19+00	<b>Field Station#</b>	13+86		
<b>Pic 3 Desc.</b>	Observing temporary stabilization, signage and buffer	<b>Pic 4 Desc.</b>	Observing road crossing and RCE's.		
Insert image here		Insert image here			
<b>GPS Location</b>		<b>GPS Location</b>			
<b>Field Station#</b>		<b>Field Station#</b>			
<b>Pic 5 Desc.</b>		<b>Pic 6 Desc.</b>

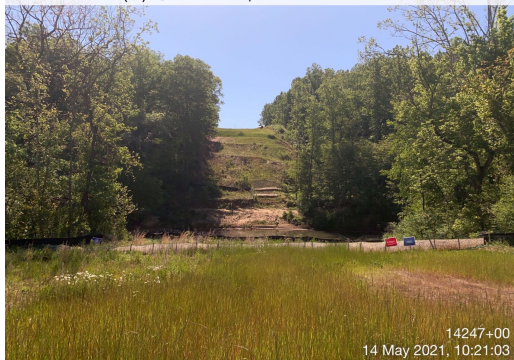
<b>GPS Location</b>	0	<b>GPS Location</b>	0		
<b>Field Station#</b>	14233+30	<b>Field Station#</b>	14247+00		
<b>Pic 3 Desc.</b>	Equipment bridge in acceptable condition	<b>Pic 4 Desc.</b>	Temporary vegetative stabilization in acceptable condition		
360°N (M) 37°3'7"N, 79°49'22"W ±22ft ▲984ft

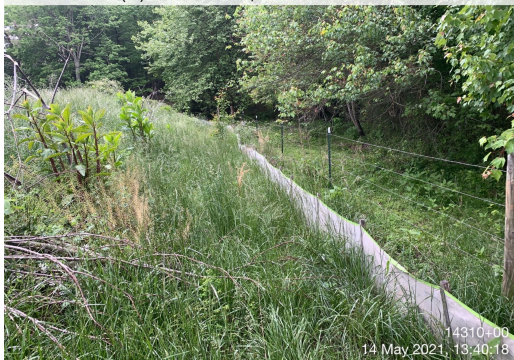
<b>Field Station#</b>	14258+00	<b>Field Station#</b>	14310+00		
<b>Pic 5 Desc.</b>	Permanent vegetative stabilization in acceptable condition	<b>Pic 6 Desc.</b>	P1 silt fence in acceptable condition

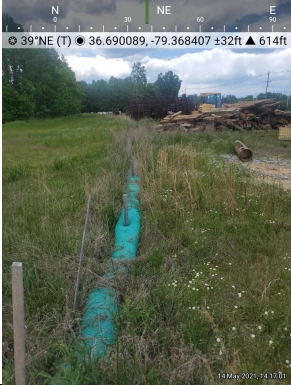
<b>GPS Location</b>	0	<b>GPS Location</b>	0		
<b>Field Station#</b>	0+00	<b>Field Station#</b>	0+00		
<b>Pic 7 Desc.</b>	LY-048 Blairs, VA CFS West perimeter		<b>Pic 8 Desc.</b>	LY-048 Blairs, VA CFS North perimeter	
Insert image here		Insert image here			
<b>GPS Location</b>		<b>GPS Location</b>			
<b>Field Station#</b>		<b>Field Station#</b>			
<b>Pic 9 Desc.</b>			<b>Pic 10 Desc.</b>		
Insert image here		Insert image here			
<b>GPS Location</b>		<b>GPS Location</b>			
<b>Field Station#</b>		<b>Field Station#</b>			
<b>Pic 11 Desc.</b>			<b>Pic 12 Desc.</b>
