Visual Site Inspection Report

Project Name	H-600 Pipeline Spread I		AFE	124300139	Spread	H-600 Pipeline Spread I	
Contractor	Precision				Report #	23470	
Inspector	John White				Date/Time	5/17/2021 10:10 AM	
Permit #	TBD	Inspection Type	VA SWPP		Station Begin	15584+23	
State	VA	Inspection Area	Full		Station End	15647+03	
County	Pittsylvania	Ground	Dry		Temperature (°F)	67.00	
Municipality	Chatham	Weather	Cloudy		Rain Gauge (in)	0.00	
					Rain Accumulation Time (days)	6.00

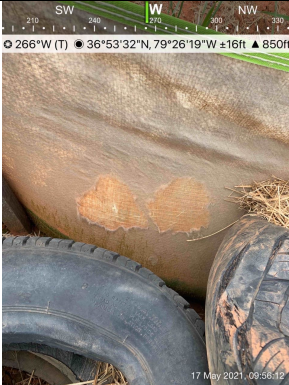
GPS Location	O	GPS Location	O		
Field Station#	15620+00	Field Station#	15620+00		
Pic 1 Desc.	Observing p1 that requires maintenance	Pic 2 Desc.	Observing p1 that requires maintenance

7. Identify all remedial measures that have been taken since the previous inspection was conducted.					
Comments (Reference above questions as appropriate.)					
Performed SWPPP Inspection on this section. There were issues identified and added to the punch list. The Contractor is working on repairing the identified issues. Other than that there were no issues to report at the time of Inspection.					
Note: It is a condition of National Pollutant Discharge Elimination System and Erosion and Sediment permits that a maintenance program be conducted to provide for the operation and maintenance of all BMPs to be inspected on a weekly basis and after each stormwater event. Please list in the space provided comments to note if repairs or replacement are needed or have been made for BMPs as a result of the inspection. Failure to conduct the required inspection may result in permit suspension or the imposition of civil penalties. If supplemental monitoring is required as part of a permit condition this form may be used to meet those monitoring requirements.

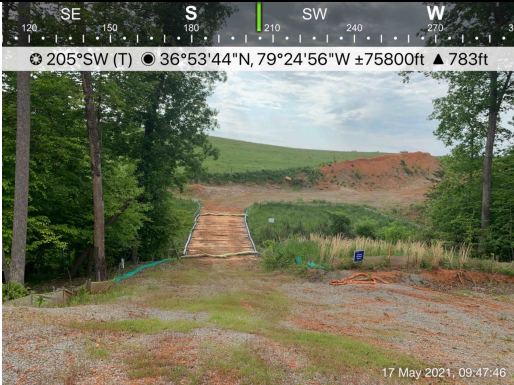
GPS Location	O	GPS Location	O		
Field Station#	15636+45	Field Station#	15630+00		
Pic 3 Desc.	Observing temporary stabilization, signage, buffer, equipment crossing and ECD's	Pic 4 Desc.	Observing temporary stabilization, erosion control blanket and cfs checks

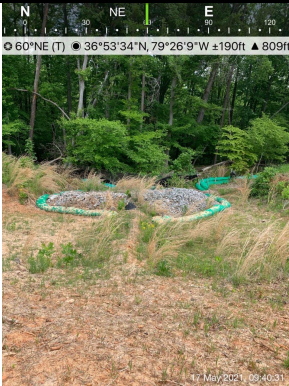
GPS Location	O	GPS Location	O		
Field Station#	15632+00	Field Station#	15619+48		
Pic 5 Desc.	Observing temporary stabilization, CWD outlet and ECD's	Pic 6 Desc.	Observing road crossing and RCE's

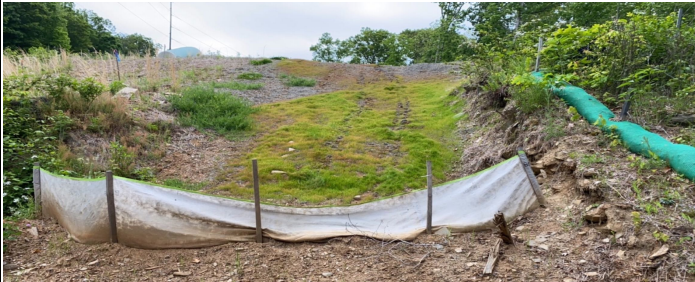
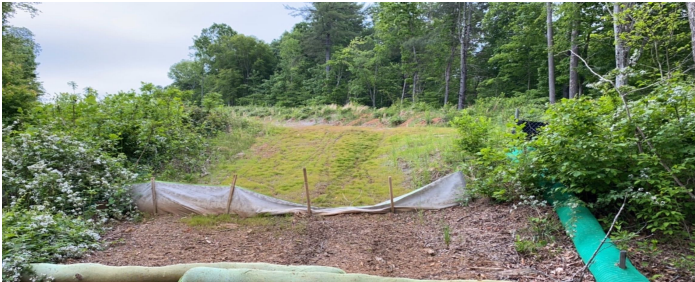
36°58'42" N 79°40'55" W 107°E COURSE 139° GPS Sorry no results found 05.17.2021 12:20:26 Accur +/-90.8 Ft ALT 958 Ft			36°58'40" N 79°40'50" W 160°S COURSE 113° GPS Sorry no results found 05.17.2021 12:22:47 Accur +/-142.2 Ft ALT 849 Ft		
GPS Location	1		GPS Location	2	
Field Station#	14788+77		Field Station#	14794+24	
Pic 1 Desc.	Routine maintenance. P1 silt fence down from landowner damage.		Pic 2 Desc.	Routine maintenance. P1 silt fence down from landowner damage.

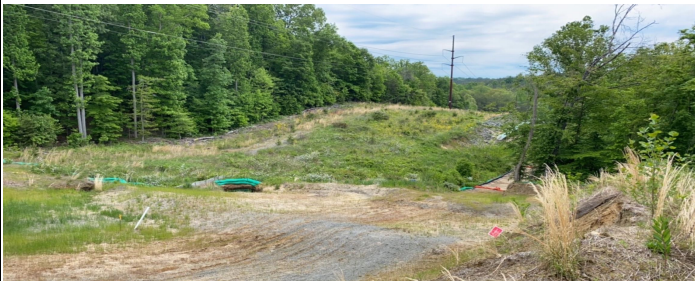
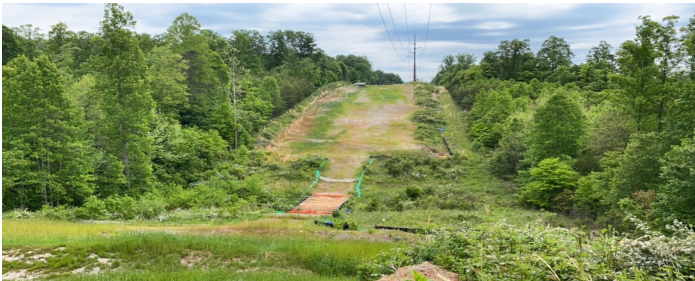
36°59'15" N 79°42'5" W 49°NE COURSE 152° GPS Union Hall, VA 24176, United States 05.17.2021 11:29:53 Accur +/-33.3 Ft ALT 912 Ft			36°59'17" N 79°42'31" W 86°E COURSE 71° GPS Sorry no results found 05.17.2021 11:16:21 Accur +/-117.1 Ft ALT 954 Ft		
GPS Location	5		GPS Location	6	
Field Station#	14698+00		Field Station#	14722+60	
Pic 5 Desc.	ROW stabilized in temporary area. Water bars and end treatments in place and functional.		Pic 6 Desc.	Equipment bridge and surrounding ECDs in place and functional at stream crossing.

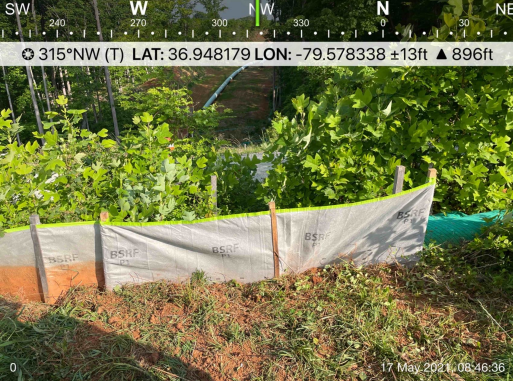
GPS Location	See photo		GPS Location	See photo	
Field Station#	15143+00		Field Station#	15143+00	
Pic 1 Desc.	P1 is damaged and needs to be replaced.		Pic 2 Desc.	Environmental crew has corrected this issue.

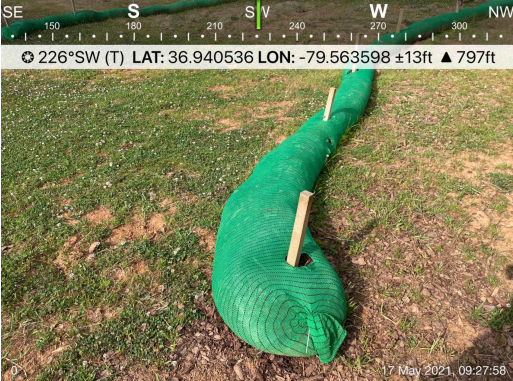
GPS Location	See photo		GPS Location	See photo	
Field Station#	15195+00		Field Station#	15195+00	
Pic 3 Desc.	CFS needs to be restaked.		Pic 4 Desc.	Environmental crew has corrected this issue.

E&S BMPs	Compliance Level	Corrective Action	Corrective Time Frame	Date Repaired
Compost Filter Sock	Communication	CFS needs to be restaked.	Addressed	5/17/2021
Equipment Bridge	Acceptable			
Rock Construction Entrance	Acceptable			
Rock Filter	Acceptable			
Silt Fence (Filter Fabric Fence)	Communication	P1 is damaged and needs to be rep	Addressed	5/17/2021
Slope Drain Pipe	Acceptable			
Vegetative Stabilization (Temporary)	Acceptable			
Waterbar	Acceptable

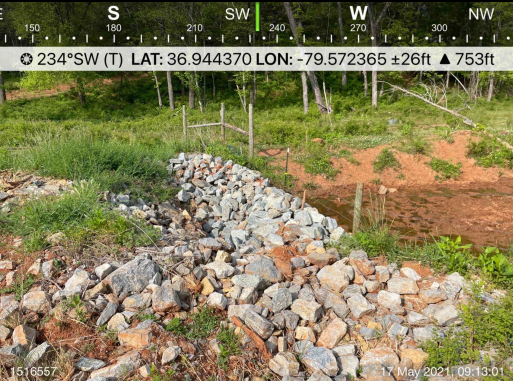
GPS Location	See photo		GPS Location	See photo	
Field Station#	15142+66		Field Station#	15165+57	
Pic 5 Desc.	RCE is in good condition at Rockcreek Rd.		Pic 6 Desc.	Rock inlet remains in good condition.

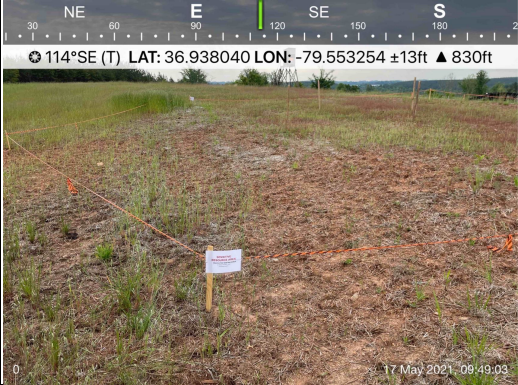
GPS Location	See photo		GPS Location	See photo	
Field Station#	15229+00		Field Station#	15230+00	
Pic 13 Desc.	Sensitive resource boundary remains in good condition around ground nest.		Pic 14 Desc.	Vegetation continues to fill in throughout this section of ROW.

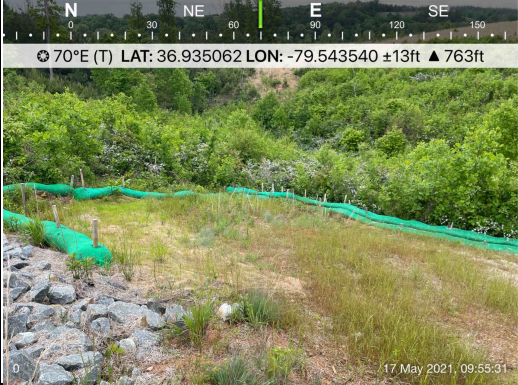
Insert image here	
GPS Location	See photo		GPS Location		
Field Station#	15260+00		Field Station#		
Pic 15 Desc.	Previous erosion repair continues to stabilize.		Pic 16 Desc.		
Insert image here			Insert image here		
GPS Location			GPS Location		
Field Station#			Field Station#		
Pic 17 Desc.			Pic 18 Desc.

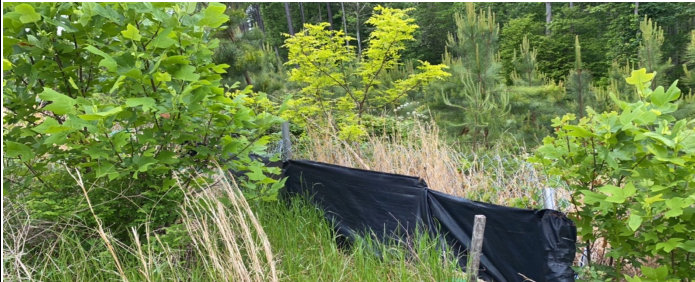
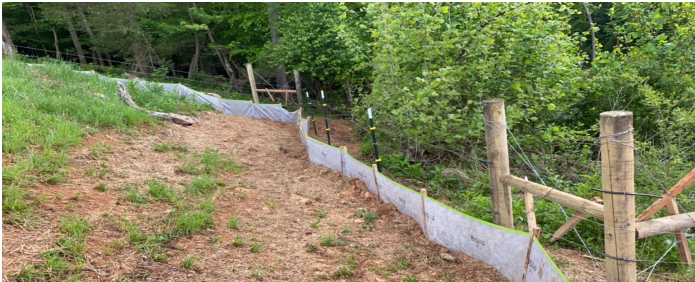
36°58'34" N 79°40'38" W 282°W COURSE 84° GPS Penhook, VA 24137, United States 05.18.2021 11:03:09 Accur +/-66.1 Ft ALT 861 Ft			36°58'5" N 79°38'23" W 300°NW COURSE 159° GPS Penhook, VA 24137, United States 05.18.2021 09:56:41 Accur +/-143.8 Ft ALT 913 Ft		
GPS Location	1		GPS Location	2	
Field Station#	14805+50		Field Station#	14923+00	
Pic 1 Desc.	Verified the completion of punch list items in covered area from previous SWPPP inspection		Pic 2 Desc.	Verified the completion of punch list items in covered area from previous SWPPP inspection

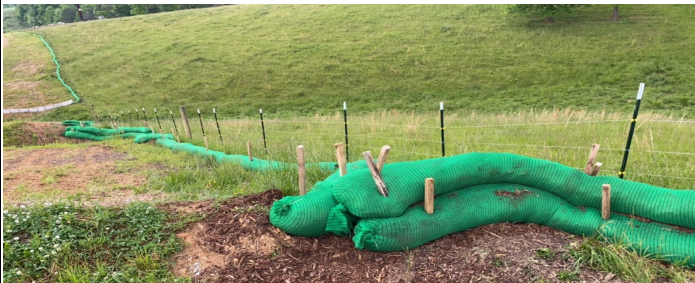
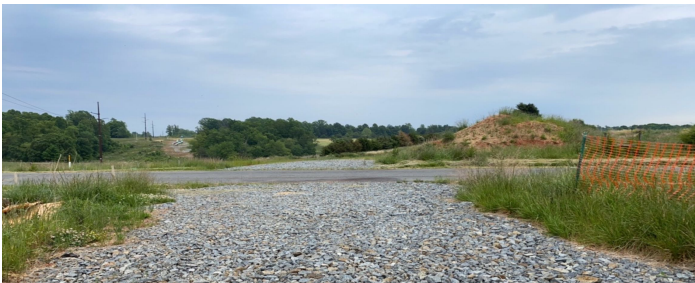
GPS Location	3		GPS Location	4	
Field Station#	14927+00		Field Station#	14845+68	
Pic 3 Desc.	Verified the completion of punch list items in covered area from previous SWPPP inspection		Pic 4 Desc.	RCE at Listening Hill Rd in good condition

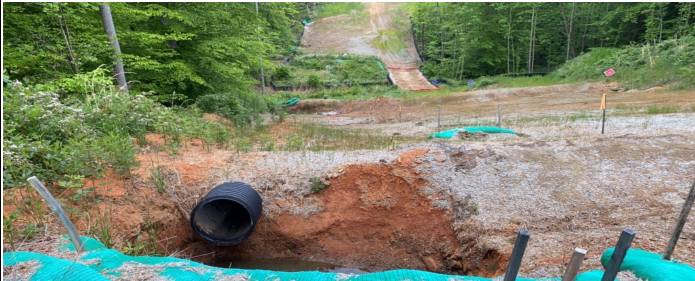
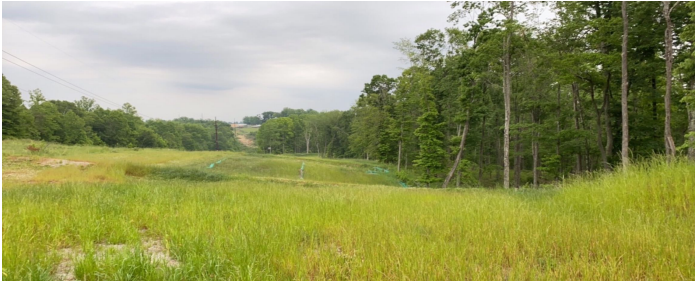
36°58'16" N 79°39'29" W 163°S COURSE 136° GPS 168-344 Listening Hill Rd, Penhook, VA 24137, United States 05.18.2021 09:30:20 Accur +/-55.2 Ft ALT 993 Ft			36°58'32" N 79°40'35" W 136°SE COURSE 112° GPS Penhook, VA 24137, United States 05.18.2021 09:05:09 Accur +/-63.4 Ft ALT 969 Ft		
GPS Location	5		GPS Location	6	
Field Station#	14868+00		Field Station#	14814+00	
Pic 5 Desc.	Slope drain tile inlet and surrounding ECDs in place and functional		Pic 6 Desc.	ROW stabilized and vegetation growing in observed area

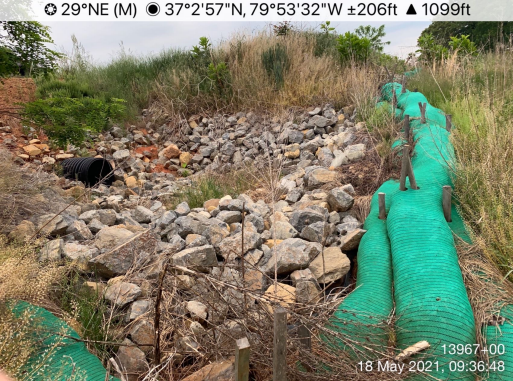
GPS Location	0	GPS Location	0		
Field Station#	13962+00	Field Station#	13967+00		
Pic 1 Desc.	Sump pit in acceptable condition	Pic 2 Desc.	Clean water diversion plunge pool in acceptable condition

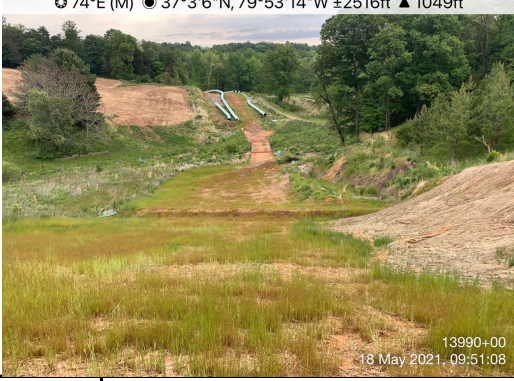
GPS Location	0	GPS Location	0		
Field Station#	13990+00	Field Station#	14052+00		
Pic 3 Desc.	Temporary vegetative stabilization in acceptable condition	Pic 4 Desc.	Super silt fence in acceptable condition

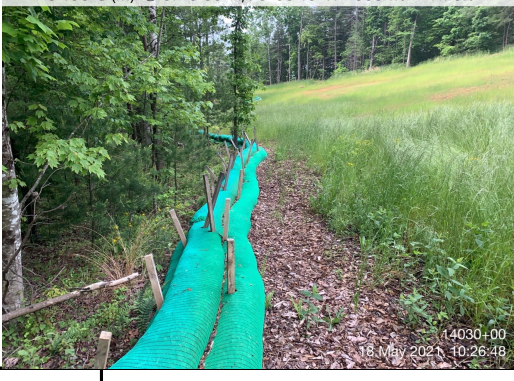
GPS Location	0	GPS Location	0		
Field Station#	14030+00	Field Station#	14057+50		
Pic 5 Desc.	Perimeter CFS in acceptable condition	Pic 6 Desc.	Slope drain in acceptable condition

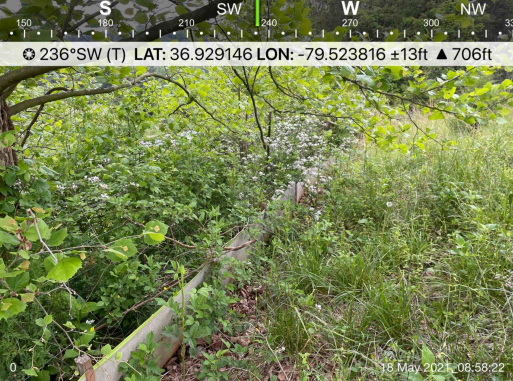
GPS Location	See photo	GPS Location	See photo		
Field Station#	15348+80	Field Station#	15323+00		
Pic 1 Desc.	P1 is degraded and needs to be replaced.	Pic 2 Desc.	P1 is degraded and needs to be replaced.

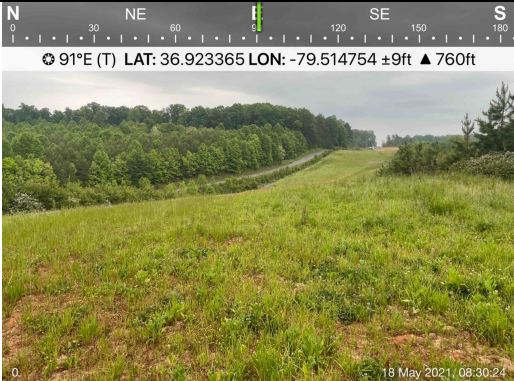
GPS Location	See photo	GPS Location	See photo		
Field Station#	15360+00	Field Station#	15350+00		
Pic 3 Desc.	Vegetation continues to fill in ROW.	Pic 4 Desc.	MVP-PI-323 in good condition.

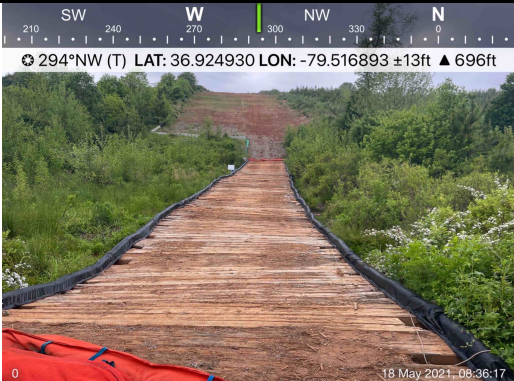
GPS Location	See photo	GPS Location	See photo		
Field Station#	15346+70	Field Station#	15340+00		
Pic 5 Desc.	Equipment bridge ECDs are in place and functioning.	Pic 6 Desc.	Vegetation continues to fill in ROW.

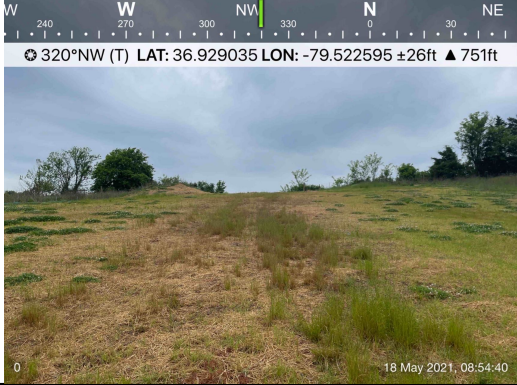
GPS Location	See photo		GPS Location	See photo	
Field Station#	15325+00		Field Station#	15323+24	
Pic 9 Desc.	Vegetation continues to fill in ROW.		Pic 10 Desc.	RCEs are in good condition at all road crossings.

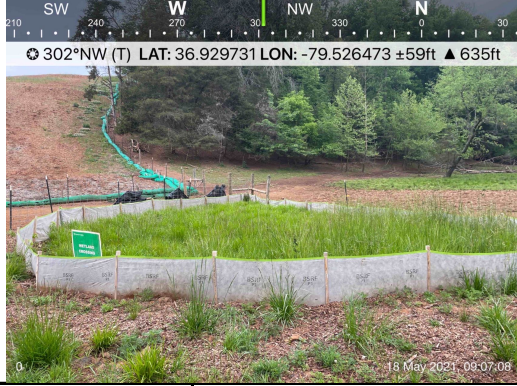
GPS Location	See photo		GPS Location	See photo	
Field Station#	15311+78		Field Station#	15299+00	
Pic 11 Desc.	P1 is in good condition around wetland buffer.		Pic 12 Desc.	CWD in good condition at this location.

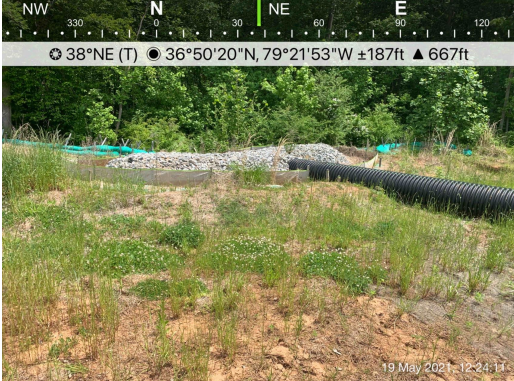
GPS Location	O	GPS Location	O		
Field Station#	15858+00	Field Station#	15839+00		
Pic 1 Desc.	Observing temporary stabilization,CWD outlet and ECD's	Pic 2 Desc.	Observing temporary stabilization,rock lined channel and ECD's

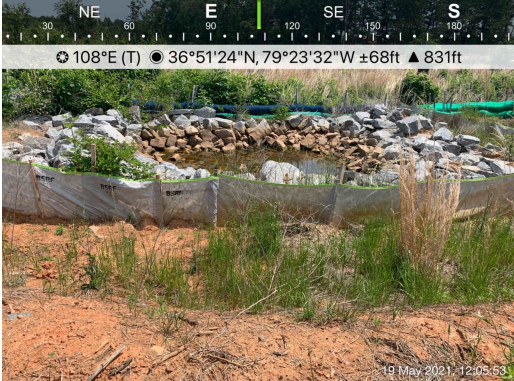
GPS Location	O	GPS Location	O		
Field Station#	15825+00	Field Station#	15787+00		
Pic 3 Desc.	Observing temporary stabilization, plunge pool and ECD's	Pic 4 Desc.	Observing temporary stabilization,CWD outlet and ECD's

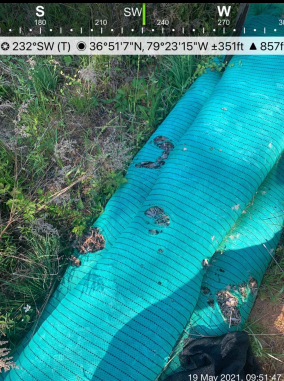
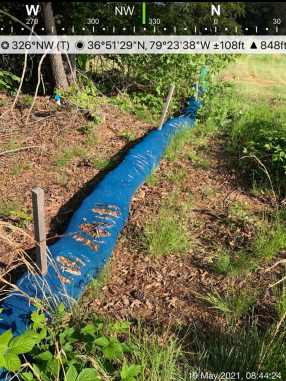
GPS Location	O	GPS Location	O		
Field Station#	15840+00	Field Station#	15819+00		
Pic 5 Desc.	Observing CFS that requires maintenance	Pic 6 Desc.	Observing CFS that requires maintenance

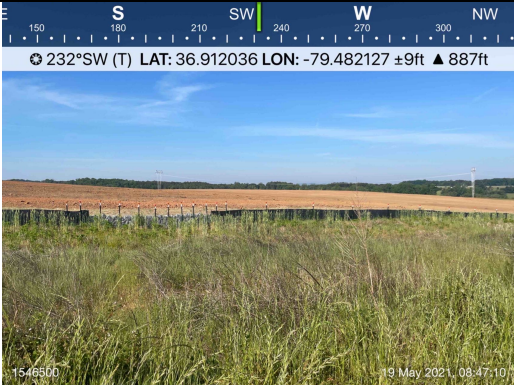
GPS Location	See photo		GPS Location	See photo	
Field Station#	15465+00		Field Station#	15460+81	
Pic 3 Desc.	3rd party rock outlet appears to be in good condition with no evidence of sedimentation		Pic 4 Desc.	3rd party rock outlet appears to be in good condition with no evidence of sedimentation to CWD inlet.

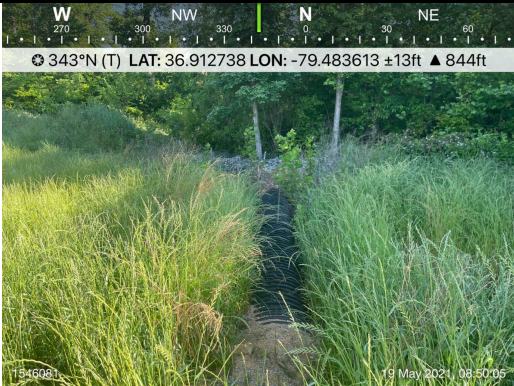
GPS Location	See photo		GPS Location	See photo	
Field Station#	15460+81		Field Station#	15457+00	
Pic 5 Desc.	CWD remains in good condition.		Pic 6 Desc.	3rd party rock outlet appears to be in good condition with no evidence of sedimentation

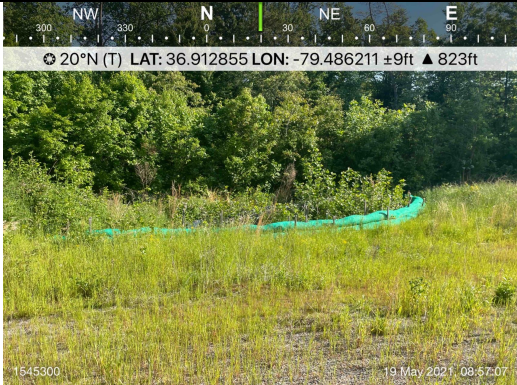
GPS Location	See photo		GPS Location	See photo	
Field Station#	15457+00		Field Station#	15453+00	
Pic 7 Desc.	Drainage remains in good condition with no evidence of sedimentation.		Pic 8 Desc.	CWD remains in good condition.

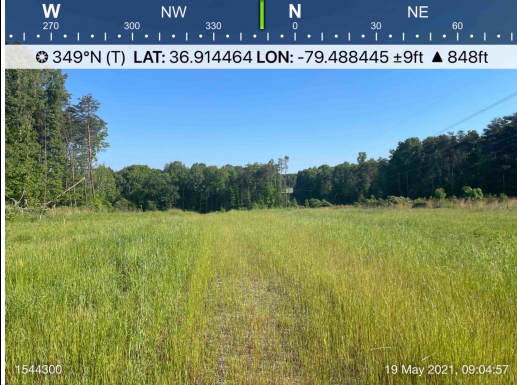
GPS Location	See photo		GPS Location	See photo	
Field Station#	15443+00		Field Station#	15427+31	
Pic 9 Desc.	Vegetation continues to fill in ROW.		Pic 10 Desc.	P1 is in good condition at all stream and wetland buffers.

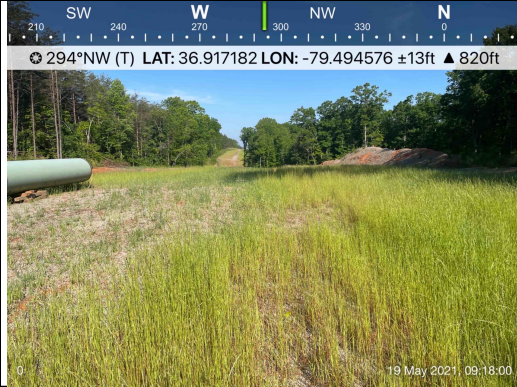
GPS Location	See photo		GPS Location	See photo	
Field Station#	15423+00		Field Station#	15384+24	
Pic 11 Desc.	Vegetation continues to fill in ROW.		Pic 12 Desc.	Equipment bridge ECDs are in place and functioning.

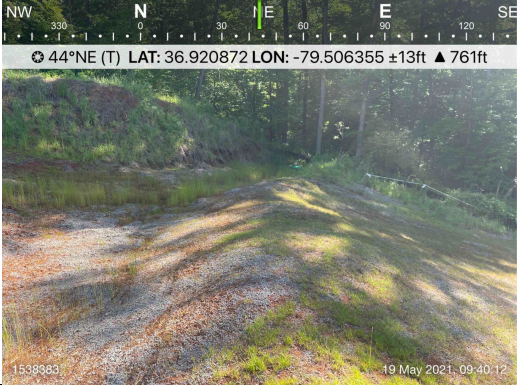
GPS Location	See photo	GPS Location	See photo		
Field Station#	15383+83	Field Station#	15375+00		
Pic 13 Desc.	Waterbars are functioning throughout this section.	Pic 14 Desc.	Drainage ECDs are in place and in good condition.		
Insert image here		Insert image here			
GPS Location		GPS Location			
Field Station#		Field Station#			
Pic 15 Desc.		Pic 16 Desc.			
Insert image here		Insert image here			
GPS Location		GPS Location			
Field Station#		Field Station#			
Pic 17 Desc.		Pic 18 Desc.

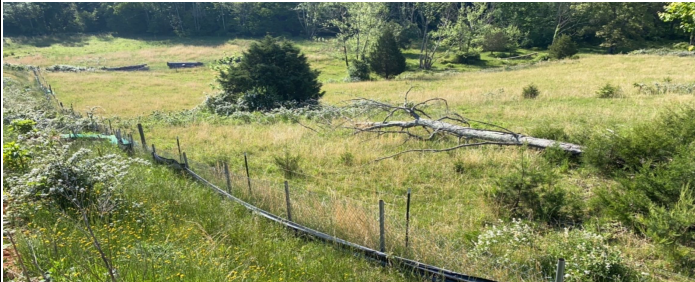
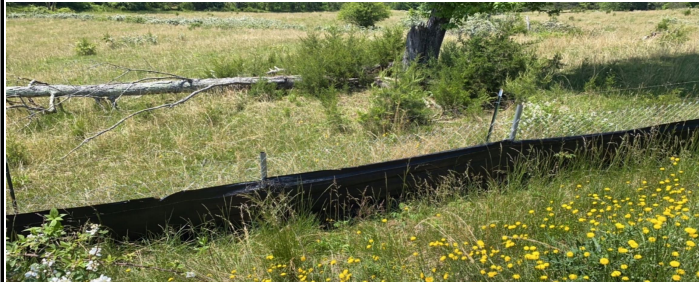
36°57'55" N 79°36'5" W 150°SE COURSE 296° GPS Sorry no results found 05.19.2021 09:06:03 Accur +/-33.2 Ft ALT 829 Ft			36°57'54" N 79°36'4" W 168°S COURSE 107° GPS Penhook, VA 24137, United States 05.19.2021 11:21:15 Accur +/-129.2 Ft ALT 787 Ft		
GPS Location	1	GPS Location	2		
Field Station#	15038+00	Field Station#	15038+00		
Pic 1 Desc.	Routine maintenance. Reattach geotextile fabric to fencing where SSF is down.		Pic 2 Desc.	Contractor performed environmental maintenance and completed punch list item in section.

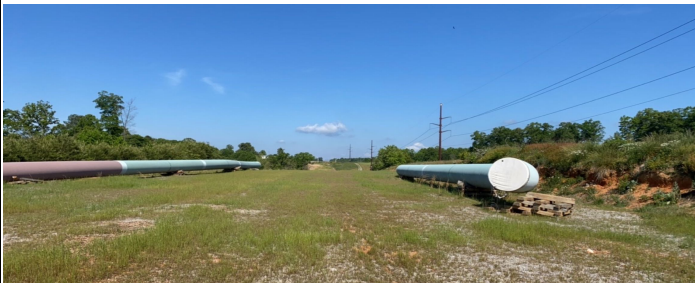
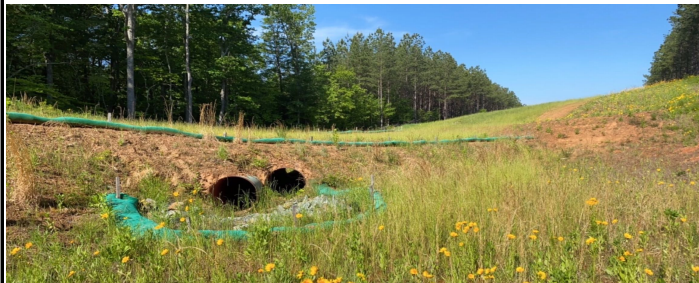
Field Station#	14944+00	Field Station#	14975+00		
Pic 3 Desc.	ROW stabilized and temporary vegetation growing in temporary area.		Pic 4 Desc.	CFS and slope flume pipe performing intended functions.

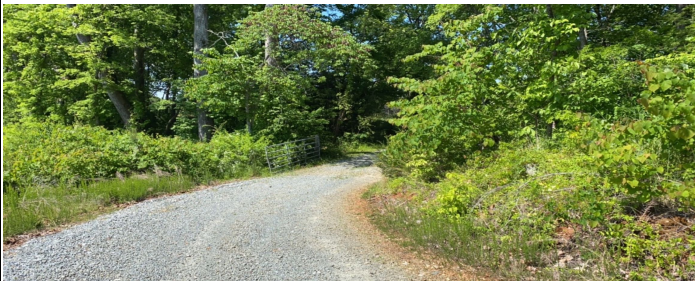
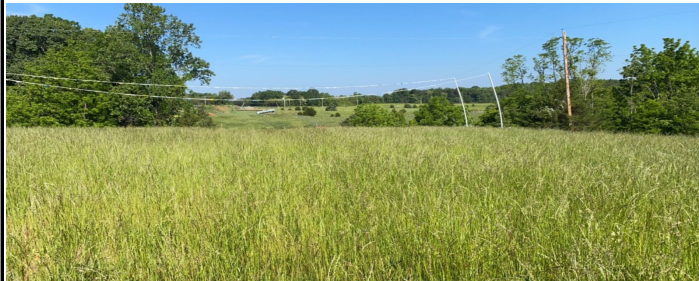
36°57'43" N 79°36'56" W 308°NW COURSE 271° GPS 177-199 Ashworth Rd, Penhook, VA 24137, United States 05.19.2021 10:53:30 Accur +/-67.2 Ft ALT 849 Ft			36°57'52" N 79°36'58" W 319°NW COURSE 31° GPS Penhook, VA 24137, United States 05.19.2021 09:32:45 Accur +/-239.5 Ft ALT 882 Ft		
GPS Location	5	GPS Location	6		
Field Station#	14995+21	Field Station#	14994+00		
Pic 5 Desc.	RCE at MVP-FR-324 in good condition.		Pic 6 Desc.	Permanent vegetation growing in final cleanup area.

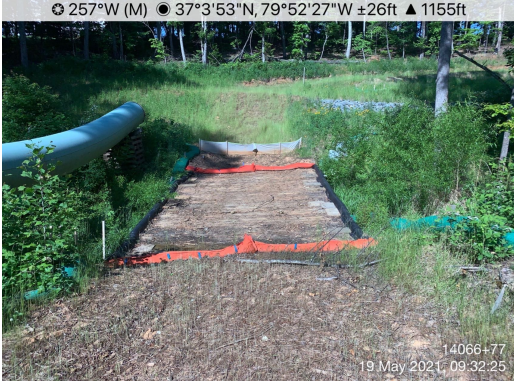
GPS Location	0	GPS Location	0		
Field Station#	14066+77	Field Station#	14089+00		
Pic 1 Desc.	Equipment bridge in acceptable condition	Pic 2 Desc.	Temporary vegetative stabilization in acceptable condition

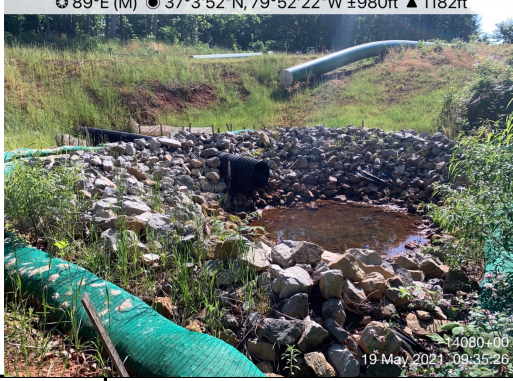
GPS Location	0	GPS Location	0		
Field Station#	14103+50	Field Station#	14080+00		
Pic 3 Desc.	P1 silt fence damaged by livestock or wildlife	Pic 4 Desc.	Clean water diversion plunge pool in acceptable condition

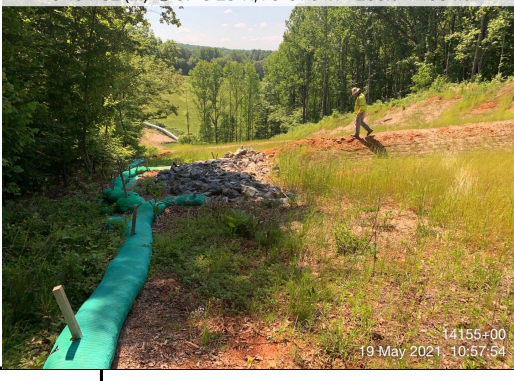
GPS Location	0	GPS Location	0		
Field Station#	14155+00	Field Station#	14164+00		
Pic 5 Desc.	Perimeter CFS in acceptable condition	Pic 6 Desc.	Permanent vegetative stabilization in acceptable condition

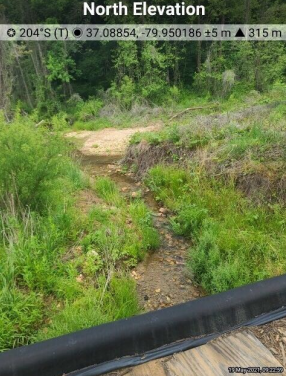
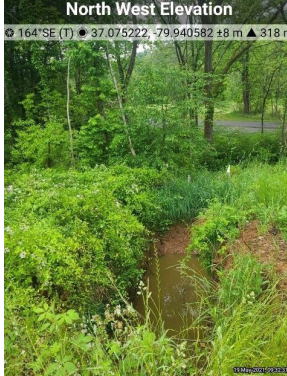
GPS Location	0000	GPS Location	00000		
Field Station#	13678+71	Field Station#	13746+90		
Pic 1 Desc.	Stream observation photo facing downstream during routine inspection today. No issues were observed at the time of inspection.		Pic 2 Desc.	Monitored sump pit and end treatment. No environmental issues observed at the time of inspection.	
	South West Elevation

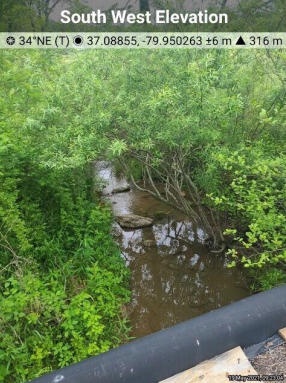
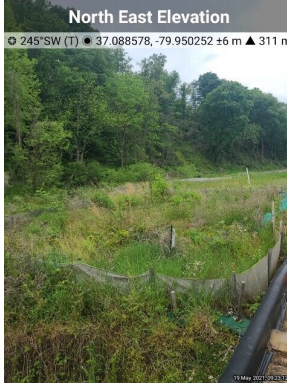
GPS Location	00000	GPS Location	00000		
Field Station#	13678+71	Field Station#	13678+68		
Pic 3 Desc.	Stream observation photo facing upstream during routine inspection today. No issues observed at the time of inspection.		Pic 4 Desc.	Observed ECDs at stream crossing , all stream protection was in place and functioning at the time of inspection.	
	South Elevation

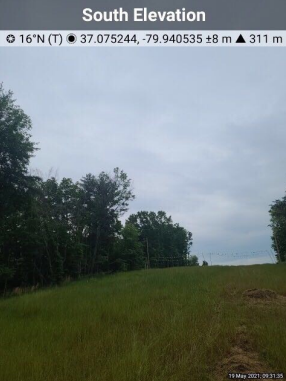
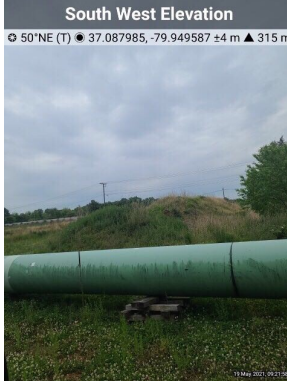
GPS Location	00000	GPS Location	00000		
Field Station#	13745+78	Field Station#	13681+00		
Pic 5 Desc.	Monitored vegetation growth, noted good coverage and growth in this section of row.		Pic 6 Desc.	EI monitored stabilization on spoil piles while checking row conditions. No environmental issues observed at the time of inspection I

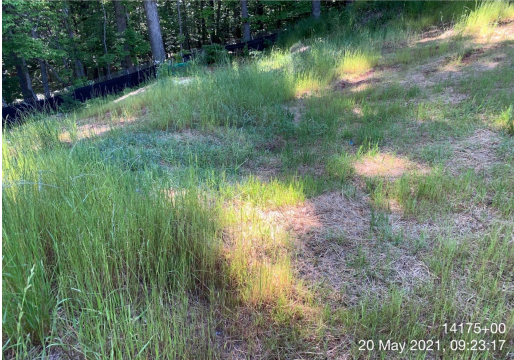
GPS Location	0	GPS Location	0		
Field Station#	14175+00	Field Station#	14175+00		
Pic 1 Desc.	Waterbar in acceptable condition	Pic 2 Desc.	Waterbar end treatment in acceptable condition

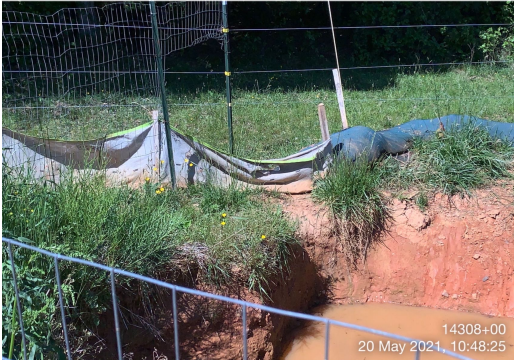
GPS Location	0	GPS Location	0		
Field Station#	14308+00	Field Station#	14294+00		
Pic 3 Desc.	P1 silt fence with holes in it, damaged by wildlife	Pic 4 Desc.	P1 silt fence with holes in it, damaged by livestock (multiple panels)

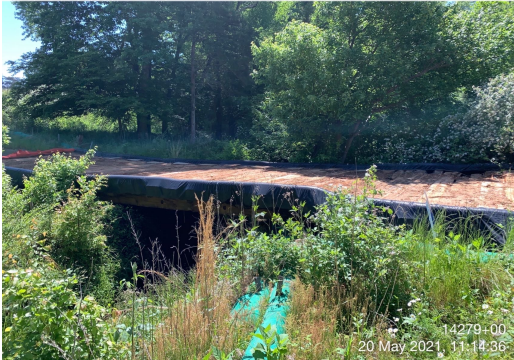
GPS Location	0	GPS Location	0		
Field Station#	14279+00	Field Station#	14275+00		
Pic 5 Desc.	Equipment bridge in acceptable condition	Pic 6 Desc.	Permanent vegetative stabilization in acceptable condition

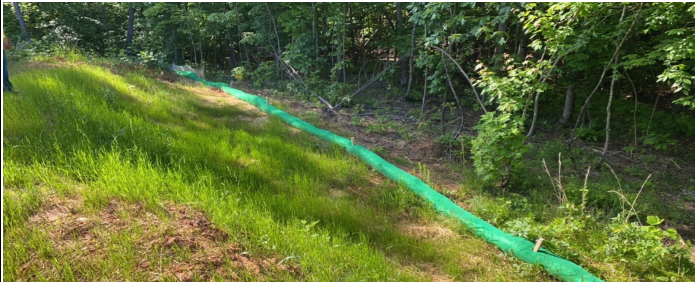
05.20.2021 09:06:18 Accur +/-72.1 Ft ALT 867 Ft			05.20.2021 09:19:56 Accur +/-53.4 Ft ALT 868 Ft		
GPS Location	1	GPS Location	2		
Field Station#	15071+00	Field Station#	15082+00		
Pic 1 Desc.	Perimeter CFS in good condition behind temporary diversion berm. Area is stabilized.		Pic 2 Desc.	CFS check dams performing intended functions.

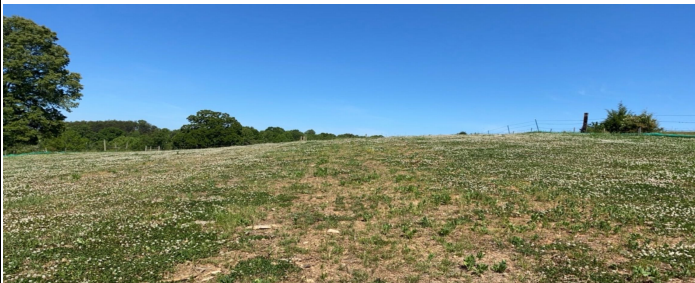
05.20.2021 10:33:03 Accur +/-44.4 Ft ALT 861 Ft			05.20.2021 10:26:25 Accur +/-61.4 Ft ALT 881 Ft		
GPS Location	3	GPS Location	4		
Field Station#	15100+00	Field Station#	15107+00		
Pic 3 Desc.	Permanent vegetation growing in final cleanup area along ROW.		Pic 4 Desc.	Temporary vegetation growing along ROW in temporary area in section.

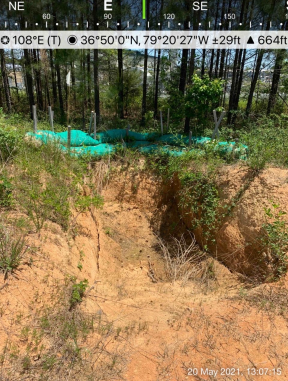
GPS Location	O	GPS Location	O		
Field Station#	8+00	Field Station#	10+00		
Pic 1 Desc.	Observing temporary stabilization, sump and end treatment	Pic 2 Desc.	Observing temporary stabilization

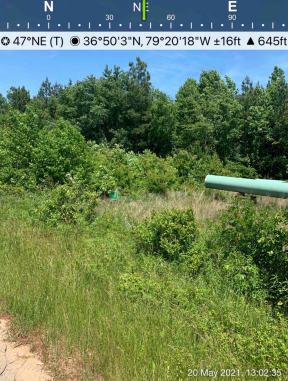
GPS Location	O	GPS Location	O		
Field Station#	18+83	Field Station#	13+95		
Pic 3 Desc.	Observing temporary stabilization, signage and buffer	Pic 4 Desc.	Observing RCE, temporary stabilization and signage		
Insert image here		Insert image here			
GPS Location		GPS Location			
Field Station#		Field Station#			
Pic 5 Desc.		Pic 6 Desc.

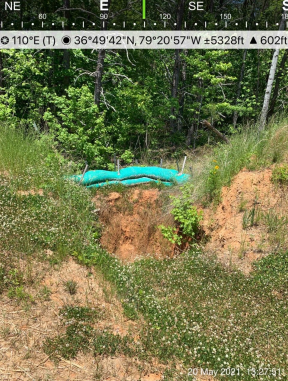
GPS Location	O	GPS Location	O		
Field Station#	16007+00	Field Station#	16004+00		
Pic 1 Desc.	Observing temporary stabilization, sump and end treatment	Pic 2 Desc.	Observing temporary stabilization, signage and buffer

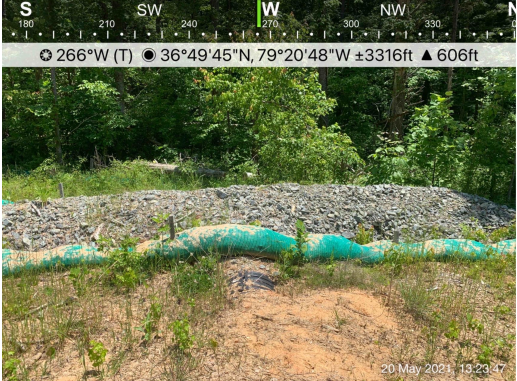
GPS Location	O	GPS Location	O		
Field Station#	16010+00	Field Station#	16017+50		
Pic 3 Desc.	Observing temporary stabilization, CWD outlet and ECD's	Pic 4 Desc.	Observing temporary stabilization, signage, buffer and ECD's

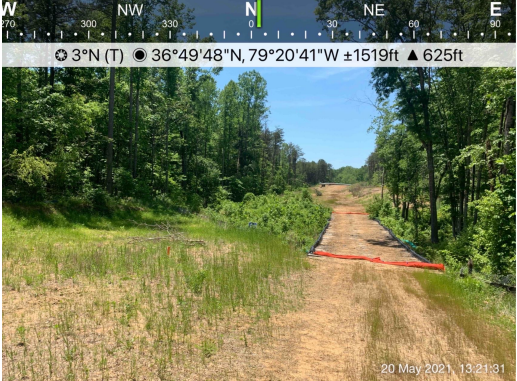
GPS Location	O	GPS Location	O		
Field Station#	16016+36	Field Station#	16020+00		
Pic 5 Desc.	Observing temporary stabilization, signage, buffer, equipment crossing and ECD's	Pic 6 Desc.	Observing temporary stabilization, water bar and CFS check

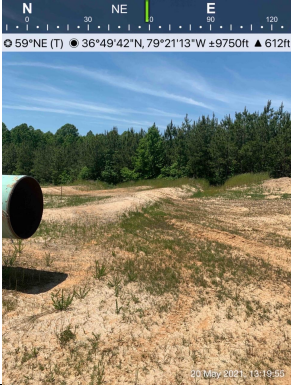
Insert image here		Insert image here	
GPS Location	O	GPS Location			
Field Station#	16023+00	Field Station#			
Pic 7 Desc.	Observing temporary stabilization and water bar	Pic 8 Desc.			
Insert image here		Insert image here			
GPS Location		GPS Location			
Field Station#		Field Station#			
Pic 9 Desc.		Pic 10 Desc.			
Insert image here		Insert image here			
GPS Location		GPS Location			
Field Station#		Field Station#			
Pic 11 Desc.		Pic 12 Desc.

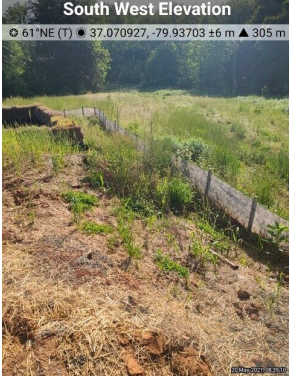
GPS Location	00000	GPS Location	00000		
Field Station#	13770+20	Field Station#	13789+00		
Pic 1 Desc.	EI monitored ECDs on row boundary, all ECDs functioning properly, no environmental issues observed at the time of inspection.		Pic 2 Desc.	Monitored sump pit and end treatment while checking row conditions.	
	North West Elevation 147°SE (T) • 37.070927, -79.93703 ±6 m ▲ 305 m

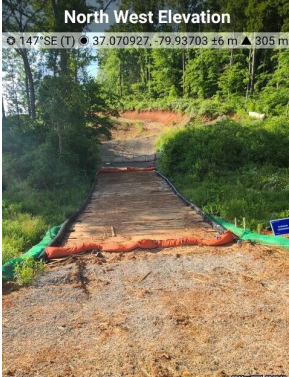
GPS Location	0000	GPS Location	0000		
Field Station#	13770+69	Field Station#	13794+20		
Pic 3 Desc.	Observed ECDs and bridge protection while checking row conditions. No environmental issues observed at the time of inspection.		Pic 4 Desc.	Row photo showing hill sides stabilization above stream crossing, no environmental issues observed at the time of inspection.

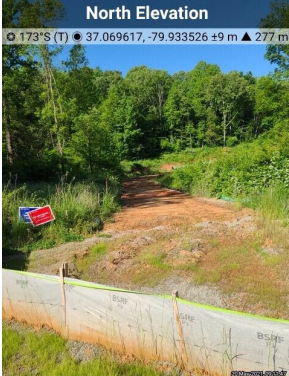
GPS Location	0000	GPS Location	0000		
Field Station#	13781+81	Field Station#	13765+60		
Pic 5 Desc.	EI monitored ECDs and equipment bridge and protection, no environmental issues observed at the time of inspection.		Pic 6 Desc.	Row photo showing vegetation growth, good coverage observed. No environmental issues observed at the time of inspection.

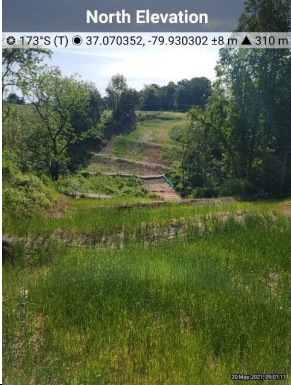
<p>North Elevation <small>173°S (T) 37.070352, -79.930302 ±8 m ▲ 310 m</small></p>		Insert image here		Insert image here	
GPS Location	0000	GPS Location			
Field Station#	13804+10	Field Station#			
Pic 7 Desc.	Row photo showing vegetation growth , hill sides stabilized above stream crossing. No environmental issues observed at the time of inspection.	Pic 8 Desc.			
Insert image here		Insert image here			
GPS Location		GPS Location			
Field Station#		Field Station#			
Pic 9 Desc.		Pic 10 Desc.			
Insert image here		Insert image here			
GPS Location		GPS Location			
Field Station#		Field Station#			
Pic 11 Desc.		Pic 12 Desc.

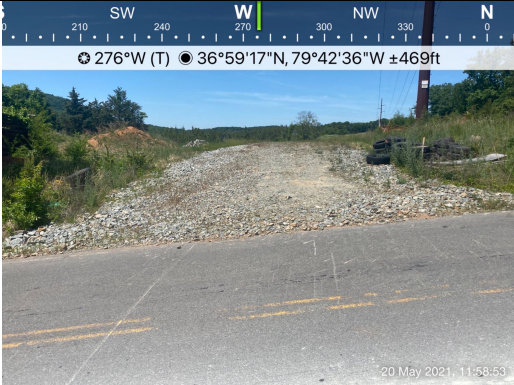
GPS Location	0	GPS Location	0		
Field Station#	14694+50	Field Station#	14689+36		
Pic 1 Desc.	Approximately 14694+50. Overview of road crossing and RCE.		Pic 2 Desc.	Approximately 14689+36. Overview of stream crossing, equipment bridge and ECDs at stream S-H34.

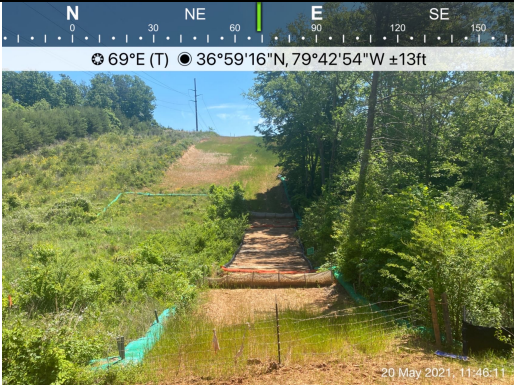
GPS Location	0	GPS Location	0		
Field Station#	14680+40	Field Station#	14673+10		
Pic 3 Desc.	Approximately 14680+40. Overview of stream crossing, equipment bridge and ECDs at stream S-H36.		Pic 4 Desc.	Approximately 14673+10. Overview of stream crossing, equipment bridge and ECDs at stream S-H37.

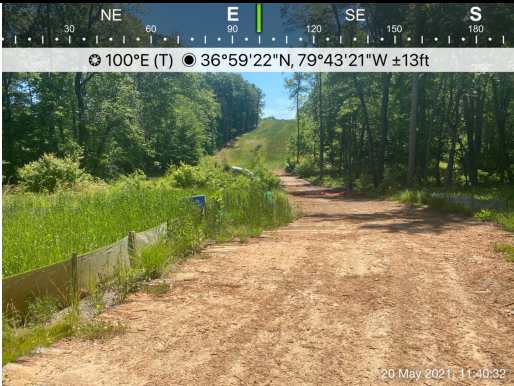
GPS Location	0	GPS Location	0		
Field Station#	14656+93	Field Station#	14651+00		
Pic 5 Desc.	Approximately 14656+93. Overview of stream crossing, equipment bridge and ECDs at stream S-H38.		Pic 6 Desc.	Approximately 14651+00. Overview of ROW.

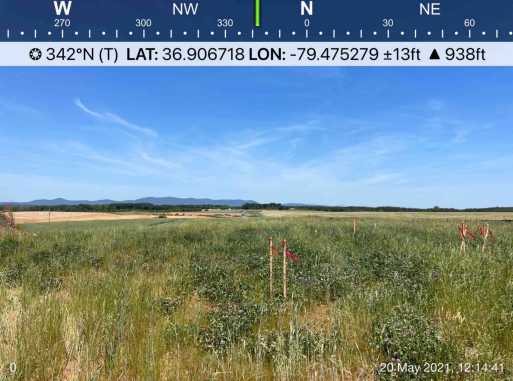
GPS Location	See photo		GPS Location	See photo	
Field Station#	15510+29		Field Station#	15495+00	
Pic 1 Desc.	3rd party has disturbed topsoil berm. This area needs to be stabilized.		Pic 2 Desc.	Vegetation continues to fill in ROW throughout this section.

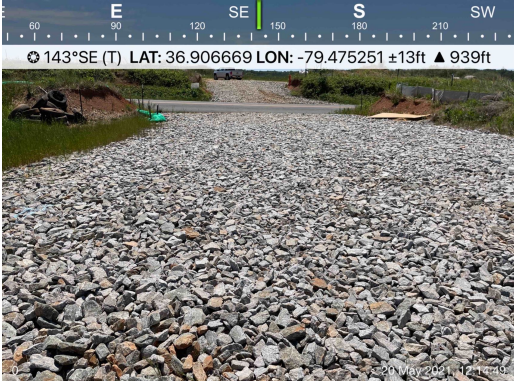
GPS Location	See photo		GPS Location	See photo	
Field Station#	15496+70		Field Station#	15504+00	
Pic 3 Desc.	RCEs are in good condition at all road crossings.		Pic 4 Desc.	Vegetation continues to fill in ROW throughout this section.

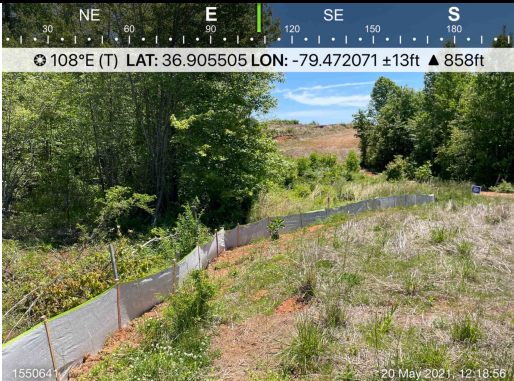
GPS Location	See photo		GPS Location	See photo	
Field Station#	15506+41		Field Station#	15515+00	
Pic 5 Desc.	P1 is in good condition at all stream and wetland buffers.		Pic 6 Desc.	CWDs are in good condition.

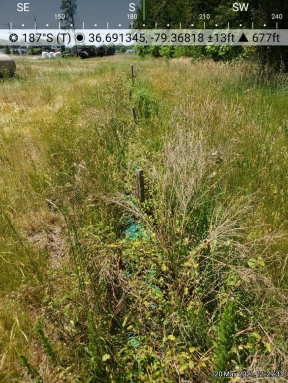
GPS Location	0	GPS Location	0		
Field Station#	0+00	Field Station#	0+00		
Pic 1 Desc.	Perimeter CFS Western boundary	Pic 2 Desc.	Perimeter CFS Southern boundary

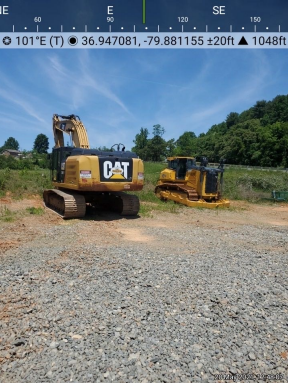
GPS Location	0	GPS Location	0		
Field Station#	0+00	Field Station#	0+00		
Pic 3 Desc.	LY-032 Equipment staging	Pic 4 Desc.	LY-032 Housekeeping

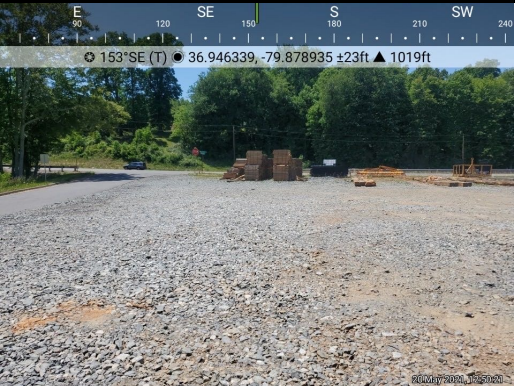
GPS Location	0	GPS Location	0		
Field Station#	0+00	Field Station#	0+00		
Pic 5 Desc.	LY-033 RCE	Pic 6 Desc.	LY-033 Inlet protection

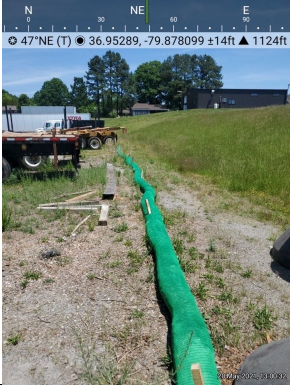
GPS Location	0	GPS Location	0		
Field Station#	0+00	Field Station#	0+00		
Pic 7 Desc.	ANC-006 Perimeter CFS Eastern boundary		Pic 8 Desc.	ANC-006 Secondary containment	
Insert image here		Insert image here			
GPS Location		GPS Location			
Field Station#		Field Station#			
Pic 9 Desc.		Pic 10 Desc.			
Insert image here		Insert image here			
GPS Location		GPS Location			
Field Station#		Field Station#			
Pic 11 Desc.		Pic 12 Desc.

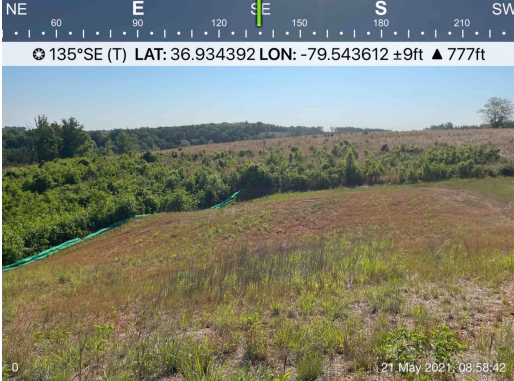
GPS Location	See photo	GPS Location	See photo		
Field Station#	15260+00	Field Station#	15240+00		
Pic 1 Desc.	Vegetation continues to fill in ROW	Pic 2 Desc.	Vegetation continues to fill in ROW

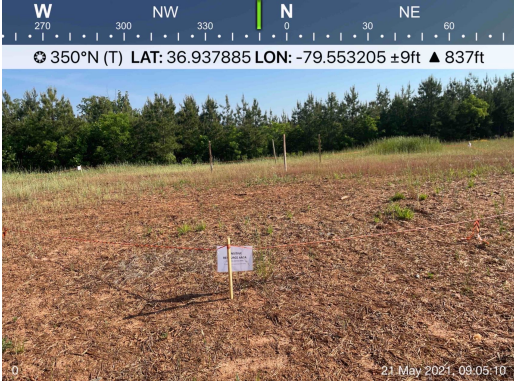
GPS Location	See photo	GPS Location	See photo		
Field Station#	15230+00	Field Station#	15209+00		
Pic 3 Desc.	Sensitive resource buffer remains in good condition around ground nest.	Pic 4 Desc.	Vegetation continues to fill in ROW

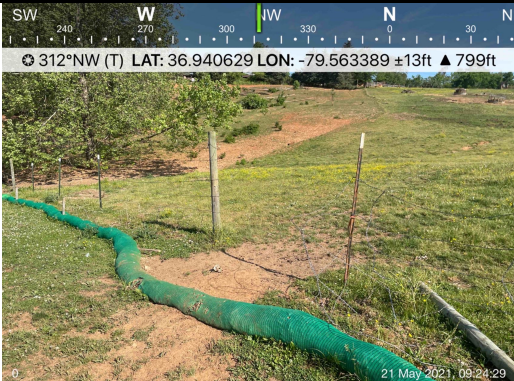
GPS Location	See photo	GPS Location	See photo		
Field Station#	15195+20	Field Station#	15195+00		
Pic 5 Desc.	Fence gap remains open by 3rd party allowing livestock onto ROW.	Pic 6 Desc.	Drainage ECDs are in place and functioning.

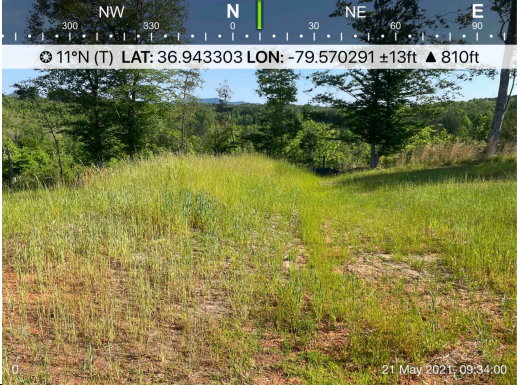
GPS Location	See photo		GPS Location	See photo	
Field Station#	15175+00		Field Station#	15170+00	
Pic 7 Desc.	Waterbars are in good condition throughout this section.		Pic 8 Desc.	Slope drain is in good condition at this location.

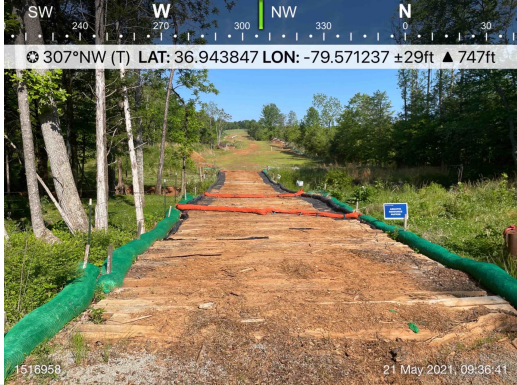
GPS Location	See photo		GPS Location	See photo	
Field Station#	15169+00		Field Station#	15166+00	
Pic 9 Desc.	Equipment bridge ECDs are in place and functioning.		Pic 10 Desc.	Rock outlet remains in good condition.

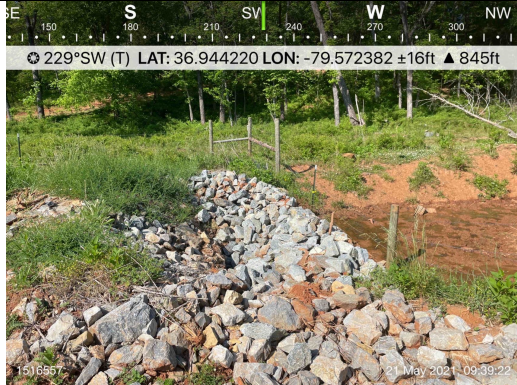
GPS Location	See photo		GPS Location	See photo	
Field Station#	15165+57		Field Station#	15159+07	
Pic 11 Desc.	Rock inlet remains in good condition along this drainage.		Pic 12 Desc.	P1 is in good condition throughout this section.

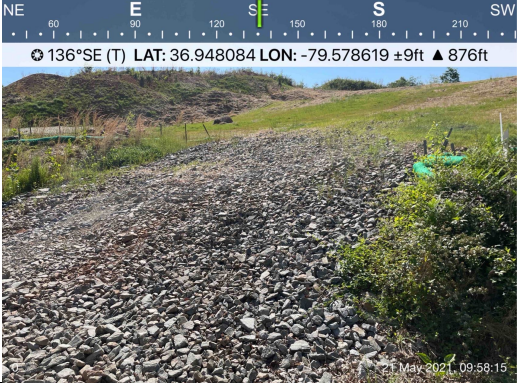
GPS Location	See photo	GPS Location			
Field Station#	15142+66	Field Station#			
Pic 13 Desc.	RCE is in good condition at Rockcreek Rd.	Pic 14 Desc.			
Insert image here		Insert image here			
GPS Location		GPS Location			
Field Station#		Field Station#			
Pic 15 Desc.		Pic 16 Desc.			
Insert image here		Insert image here			
GPS Location		GPS Location			
Field Station#		Field Station#			
Pic 17 Desc.		Pic 18 Desc.

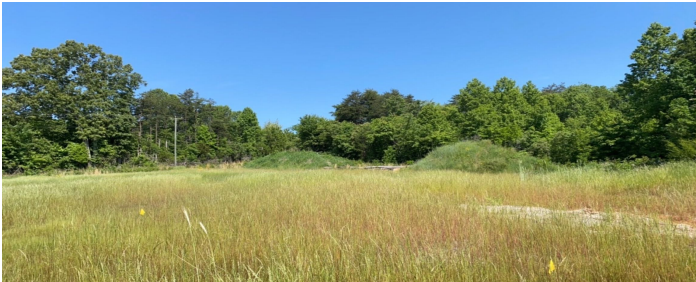
<small>36°59'17" N 79°42'33" W 300°NW COURSE 77' GPS Sorry no results found 05.21.2021 11:01:39 Accur +/-100.7 Ft ALT 887 Ft</small>			<small>36°59'17" N 79°42'28" W 318°NW COURSE 302' GPS Sorry no results found 05.21.2021 10:54:18 Accur +/-66.3 Ft ALT 907 Ft</small>		
GPS Location	1		GPS Location	2	
Field Station#	14696+00		Field Station#	14700+75	
Pic 1 Desc.	Extra workspace stabilized and vegetated.		Pic 2 Desc.	Equipment bridge and surrounding ECDs in place and functional at stream crossing

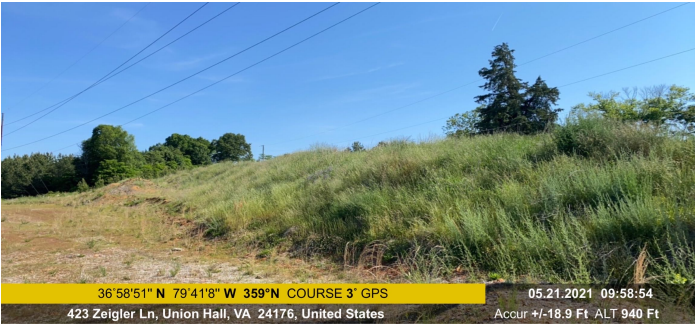
<small>36°59'4" N 79°41'29" W 173°S COURSE 4' GPS 05.21.2021 10:16:23 Accur +/-24.2 Ft ALT 904 Ft</small>			<small>36°58'51" N 79°41'8" W 359°N COURSE 3' GPS 423 Zeigler Ln, Union Hall, VA 24176, United States 05.21.2021 09:58:54 Accur +/-18.9 Ft ALT 940 Ft</small>		
GPS Location	3		GPS Location	4	
Field Station#	14754+00		Field Station#	14770+00

Pic 3 Desc.	Minor rill erosion occurring in travel lane. Will monitor area.		Pic 4 Desc.	Spoil pile stabilized and vegetated.

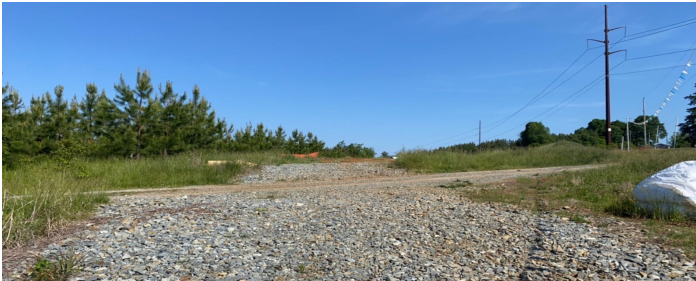
<small>36°58'48" N 79°41'7" W 83°E COURSE 317' GPS Sorry no results found 05.21.2021 09:57:40 Accur +/-22.3 Ft ALT 924 Ft</small>			<small>36°58'44" N 79°41'1" W 326°NW COURSE 282' GPS Sorry no results found 05.21.2021 09:54:07 Accur +/-75.1 Ft ALT 892 Ft</small>		
GPS Location	5		GPS Location	6	
Field Station#	14776+65		Field Station#	14784+00	
Pic 5 Desc.	RCE at MVP-FR-322 in good condition.		Pic 6 Desc.	Sump is dry. All perimeter controls in place and functional.
