Visual Site Inspection Report

Project Name	H-600 Pipeline Spread I	AFE	124300139	Spread	H-600 Pipeline Spread I
Contractor	Precision			Report #	23723
Inspector	John White			Date/Time	5/24/2021 10:27 AM
Permit #	TBD	Inspection Type	VA SWPP	Station Begin	15647+03
State	VA	Inspection Area	Full	Station End	15772+27
County	Pittsylvania	Ground	Dry	Temperature (°F)	86.00
Municipality	Chatham	Weather	Cloudy	Rain Gauge (in)	0.00
				Rain Accumulation Time (days)	6.00

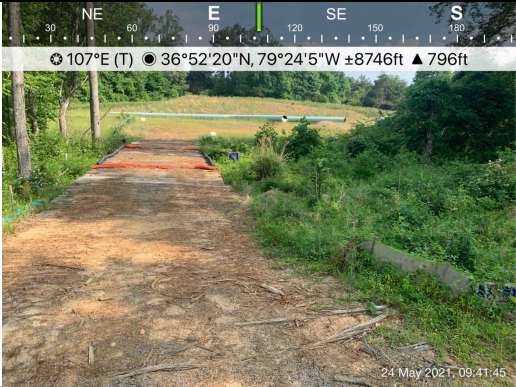
GPS Location	O	GPS Location	O		
Field Station#	15746+00	Field Station#	15745+00		
Pic 1 Desc.	Observing safety fence that requires maintenance	Pic 2 Desc.	Observing temporary stabilization and ECD's

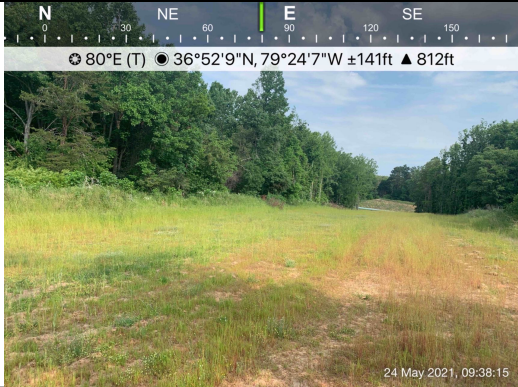
GPS Location	O	GPS Location	O		
Field Station#	15763+80	Field Station#	15768+00		
Pic 3 Desc.	Observing temporary stabilization, signage, equipment crossing and ECD's	Pic 4 Desc.	Observing temporary stabilization

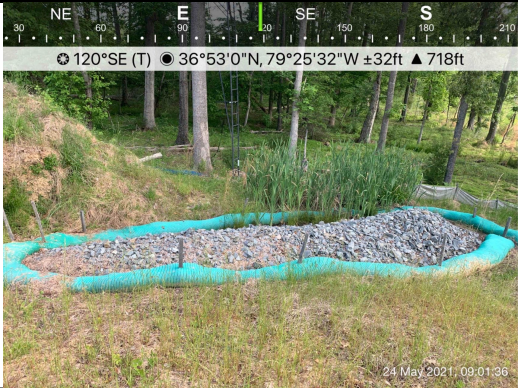
GPS Location	O	GPS Location	O		
Field Station#	15658+43	Field Station#	15677+00		
Pic 5 Desc.	Observing temporary stabilization, signage, buffer, equipment crossing and ECD's	Pic 6 Desc.	Observing temporary stabilization, CWD outlet and ECD's

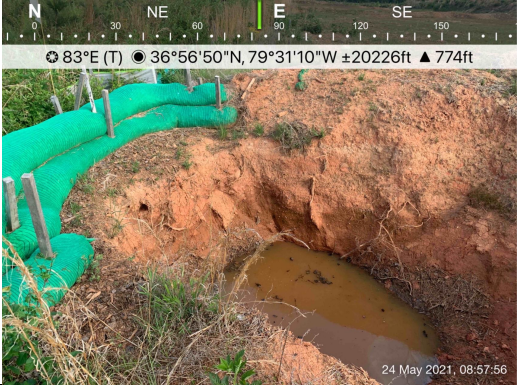
GPS Location	O	GPS Location	O		
Field Station#	15690+00	Field Station#	157003+00		
Pic 7 Desc.	Observing sump and end treatment	Pic 8 Desc.	Observing temporary stabilization, erosion control blanket, water bar and cfs check.

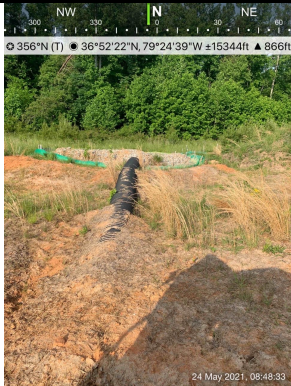
GPS Location	O	GPS Location	O		
Field Station#	15720+00	Field Station#	15735+00		
Pic 9 Desc.	Observing temporary stabilization, CWD outlet and ECD's	Pic 10 Desc.	Observing temporary stabilization, sump and end treatment		
Insert image here		Insert image here			
GPS Location		GPS Location			
Field Station#		Field Station#			
Pic 11 Desc.		Pic 12 Desc.

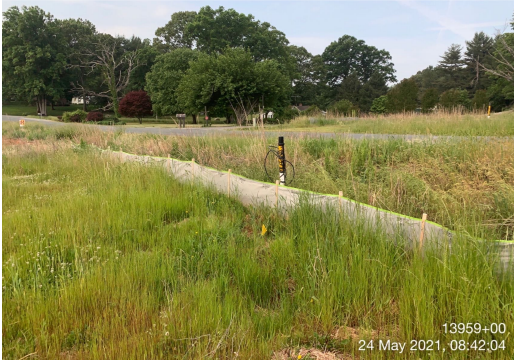
13959+00 24 May 2021, 08:42:04		79°E (M) 37°2'59"N, 79°53'32"W ±45ft ▲1116ft

13969+00 24 May 2021, 08:49:07			
GPS Location	0	GPS Location	0		
Field Station#	13959+00	Field Station#	13969+00		
Pic 1 Desc.	P1 silt fence in acceptable condition	Pic 2 Desc.	Temporary vegetative stabilization in acceptable condition		
276°W (M) 37°3'42"N, 79°52'45"W ±59ft ▲1099ft

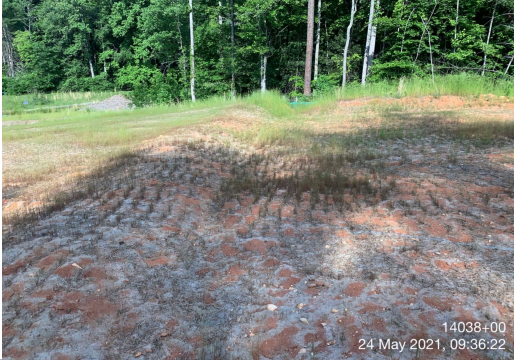
14038+00 24 May 2021, 09:36:22		289°W (M) 37°3'42"N, 79°52'46"W ±475ft ▲1061ft

14038+00 24 May 2021, 09:35:56			
GPS Location	0	GPS Location	0		
Field Station#	14038+00	Field Station#	14038+00		
Pic 3 Desc.	Waterbar in acceptable condition	Pic 4 Desc.	Waterbar end treatment in acceptable condition		
82°E (M) 37°3'57"N, 79°52'35"W ±101ft ▲1173ft

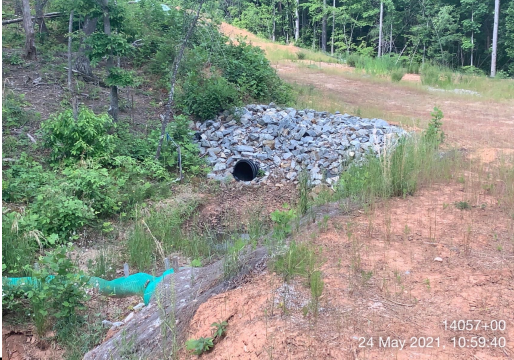
14057+00 24 May 2021, 10:59:40		214°SW (M) 37°3'25"N, 79°52'51"W ±52ft ▲1094ft

GPS Location	0	GPS Location	0		
Field Station#	14057+00	Field Station#	14016+00		
Pic 5 Desc.	Slope drain in acceptable condition	Pic 6 Desc.	Permanent vegetative stabilization in acceptable condition

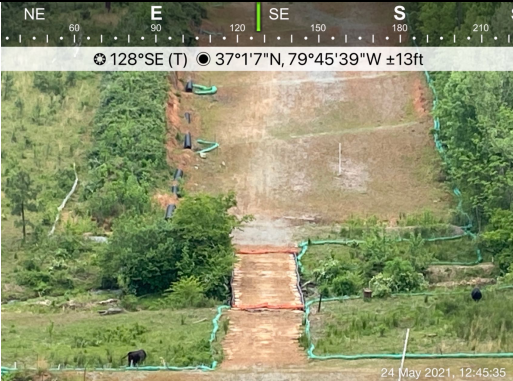
GPS Location	0	GPS Location	0		
Field Station#	14497+20	Field Station#	14496+50		
Pic 3 Desc.	Approximately 14497+20. P-1 requires maintenance. Damaged by livestock.		Pic 4 Desc.	Approximately 14496+50. Overview of ROW. Cattle graze and frequent area and were present during inspection.

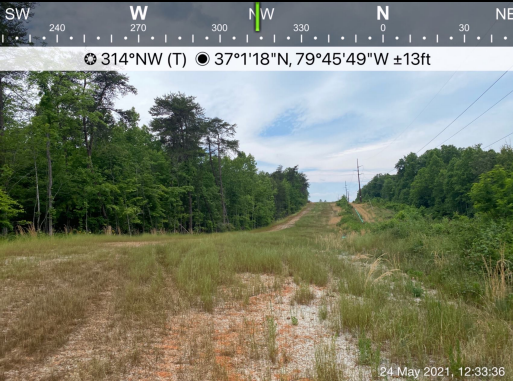
GPS Location	0	GPS Location	0		
Field Station#	14486+60	Field Station#	14471+00		
Pic 5 Desc.	Approximately 14486+60. Overview of stream crossing, equipment bridge and ECDs at stream S-G22.		Pic 6 Desc.	Approximately 14471+00. Overview of ROW.

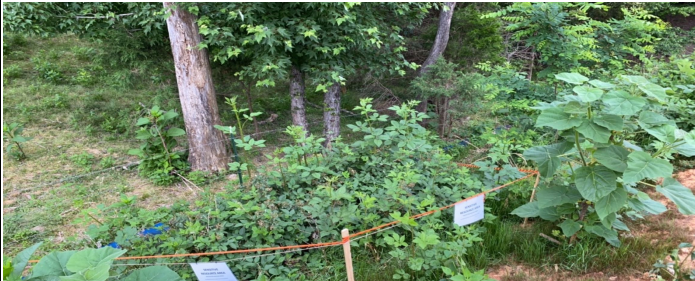
36°57'49" N 79°35'42" W 11°N COURSE -1° GPS Penhook, VA 24137, United States 05.25.2021 08:03:07 Accur +/-33.3 Ft ALT 909 Ft			36°57'56" N 79°37'16" W 320°NW COURSE 286° GPS 19101-19383 Snow Creek Rd, Penhook, VA 24137, United States 05.25.2021 09:03:19 Accur +/-23.3 Ft ALT 953 Ft		
GPS Location	5		GPS Location	6	
Field Station#	15060+00		Field Station#	14971+00	
Pic 5 Desc.	Area marked off limit for work after completion of avian survey.		Pic 6 Desc.	Vegetation growing in final cleanup area of ROW.

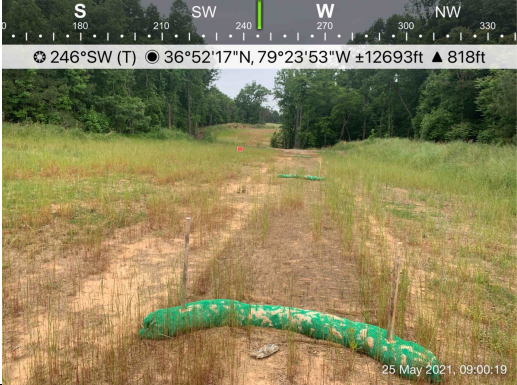
GPS Location	O	GPS Location	O		
Field Station#	15800+00	Field Station#	15838+00		
Pic 7 Desc.	Observing temporary stabilization, erosion control blanket and cfs checks		Pic 8 Desc.	Observing p1 that requires maintenance	
Insert image here		Insert image here			
GPS Location		GPS Location			
Field Station#		Field Station#			
Pic 9 Desc.		Pic 10 Desc.			
Insert image here		Insert image here			
GPS Location		GPS Location			
Field Station#		Field Station#			
Pic 11 Desc.		Pic 12 Desc.

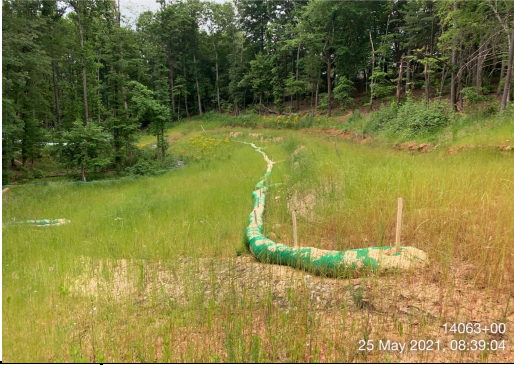
14063+00 25 May 2021, 08:39:04		22°NE (M) 37°3'48"N, 79°52'31"W ±226ft ▲1180ft

14071+00 25 May 2021, 08:44:29			
GPS Location	0	GPS Location	0		
Field Station#	14063+00	Field Station#	14071+00		
Pic 1 Desc.	Temporary vegetative stabilization in acceptable condition.	Pic 2 Desc.	P1 silt fence in acceptable condition		
223°SW (M) 37°3'49"N, 79°52'30"W ±541ft ▲1186ft

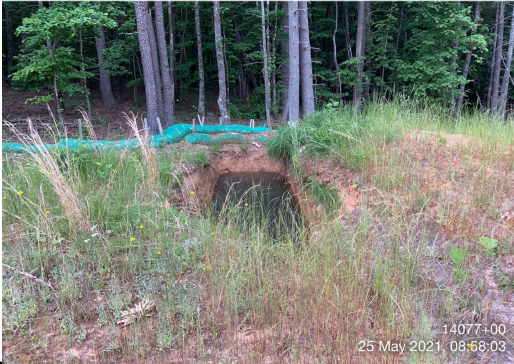
14077+00 25 May 2021, 08:58:03		236°SW (M) 37°3'52"N, 79°52'15"W ±32ft ▲1185ft

14077+00 25 May 2021, 08:58:23			
GPS Location	0	GPS Location	0		
Field Station#	14077+00	Field Station#	14077+00		
Pic 3 Desc.	Waterbar end treatment in acceptable condition	Pic 4 Desc.	Waterbar in acceptable condition		
304°NW (M) 37°3'46"N, 79°51'28"W ±36ft ▲1098ft

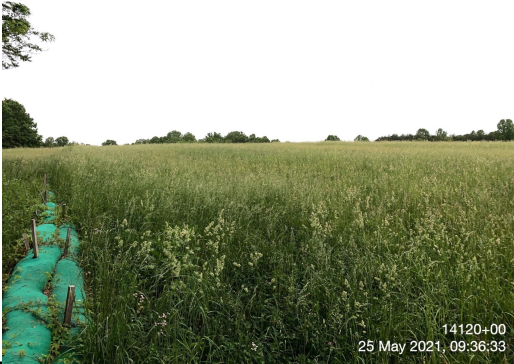
14120+00 25 May 2021, 09:36:33		85°E (M) 37°3'22"N, 79°50'51"W ±22ft ▲1027ft

GPS Location	0	GPS Location	0		
Field Station#	14120+00	Field Station#	14165+00		
Pic 5 Desc.	Permanent vegetative stabilization in acceptable condition	Pic 6 Desc.	Perimeter CFS in acceptable condition

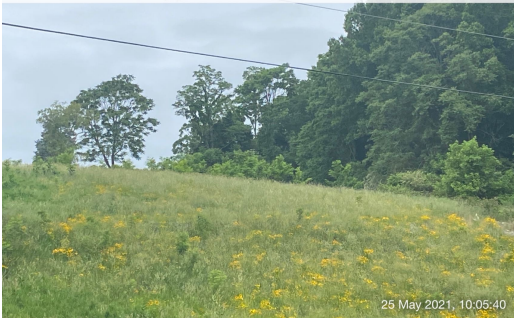
25 May 2021, 10:44:35		GPS Location	0
Field Station#	14646+00	Field Station#	14599+00	Field Station#	14599+00
Pic 1 Desc.	Approximately 14646+00. Overview of ROW.	Pic 2 Desc.	Approximately 14599+00. Overview of road crossing and RCEs.	Pic 2 Desc.	Approximately 14599+00. Overview of road crossing and RCEs.

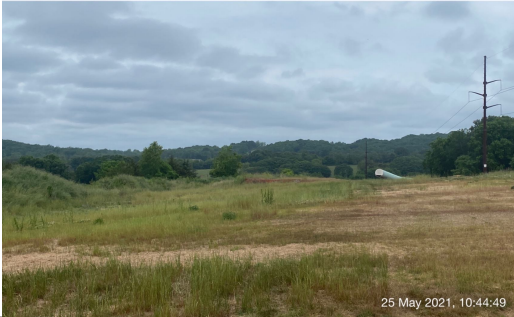
25 May 2021, 13:24:16		GPS Location	0
Field Station#	14595+50	Field Station#	14603+00	Field Station#	14603+00
Pic 3 Desc.	Approximately 14595+50. Overview of ROW.	Pic 4 Desc.	Approximately 14603+00. Overview of ROW.	Pic 4 Desc.	Approximately 14603+00. Overview of ROW.

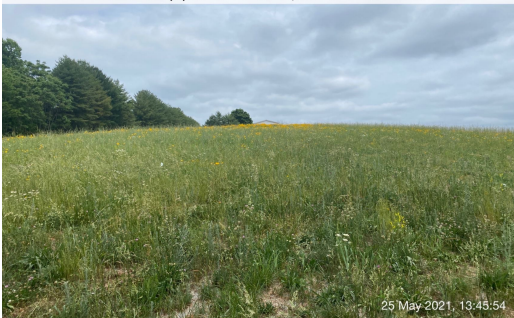
25 May 2021, 13:48:22		GPS Location	0
Field Station#	14549+00	Field Station#	14568+10	Field Station#	14568+10
Pic 5 Desc.	Approximately 14549+00. Overview of ROW.	Pic 6 Desc.	Approximately 14568+10. Overview of stream crossing, equipment bridge and ECDs at stream S-E18.	Pic 6 Desc.	Approximately 14568+10. Overview of stream crossing, equipment bridge and ECDs at stream S-E18.

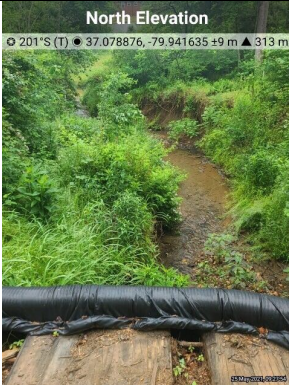
GPS Location	00000	GPS Location	0000		
Field Station#	13728+11	Field Station#	13728+11		
Pic 1 Desc.	Stream observation photo facing downstream during routine inspection today. No issues observed at the time of inspection.		Pic 2 Desc.	Stream observation photo facing upstream during routine inspection today. No issues observed at the time of inspection.	
	South East Elevation

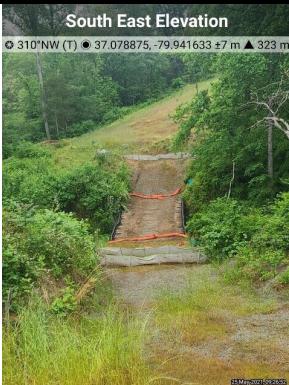
GPS Location	0000	GPS Location	00000		
Field Station#	13729+00	Field Station#	13721+10		
Pic 3 Desc.	Monitored ECDs and stream protection along with stabilization on hill side above stream crossing. No environmental issues observed at the time of inspection.		Pic 4 Desc.	Vegetation observation photo up row from stream crossing. No environmental issues observed at the time of inspection. Good coverage noted at the time of inspection.

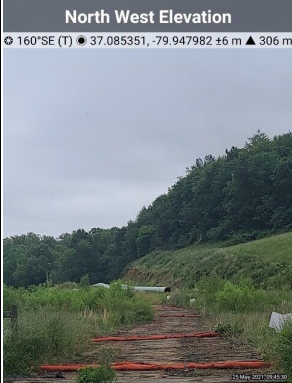
<p>Insert image here</p>		<p>Insert image here</p>	
GPS Location	0000	GPS Location			
Field Station#	13692+78	Field Station#			
Pic 7 Desc.	Monitored ECDs and protection in wetland area , no environmental issues observed at the time of inspection .	Pic 8 Desc.			
<p>Insert image here</p>		<p>Insert image here</p>			
GPS Location		GPS Location			
Field Station#		Field Station#			
Pic 9 Desc.		Pic 10 Desc.			
<p>Insert image here</p>		<p>Insert image here</p>			
GPS Location		GPS Location			
Field Station#		Field Station#			
Pic 11 Desc.		Pic 12 Desc.

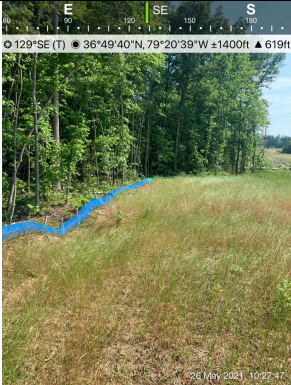
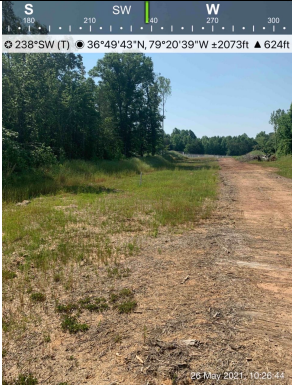
GPS Location	O	GPS Location	O		
Field Station#	19+00	Field Station#	15+00		
Pic 1 Desc.	Observing temporary stabilization and ECD's		Pic 2 Desc.	Observing temporary stabilization

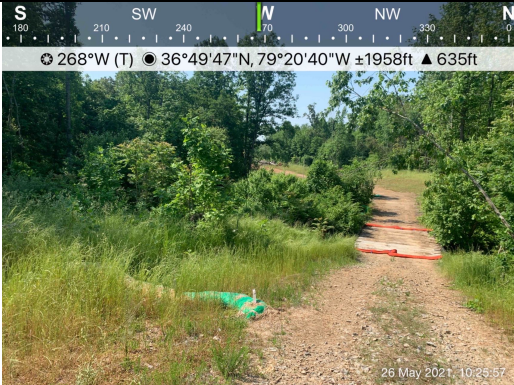
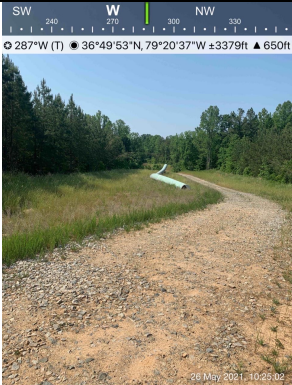
GPS Location	O	GPS Location	O		
Field Station#	12+65	Field Station#	6+00		
Pic 3 Desc.	Observing temporary stabilization, signage, buffer, equipment crossing and ECD's		Pic 4 Desc.	Observing temporary stabilization and access road	
Insert image here			Insert image here		
GPS Location		GPS Location			
Field Station#		Field Station#			
Pic 5 Desc.			Pic 6 Desc.

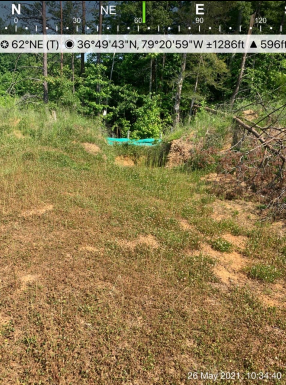
GPS Location	O	GPS Location	O		
Field Station#	16016+36	Field Station#	16006+00		
Pic 1 Desc.	Observing temporary stabilization, signage, buffer, equipment crossing and ECD's	Pic 2 Desc.	Observing temporary stabilization, water bar, sump and end treatment

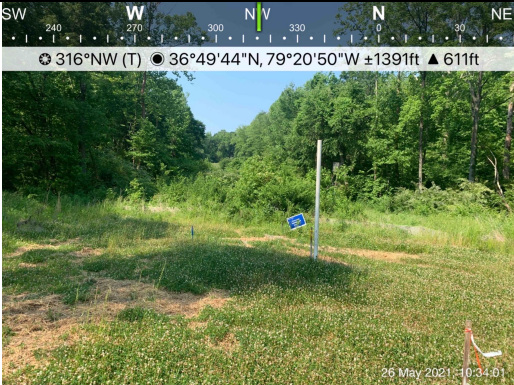
GPS Location	O	GPS Location	O		
Field Station#	16004+00	Field Station#	16010+00		
Pic 3 Desc.	Observing temporary stabilization, signage, buffer and ECD's	Pic 4 Desc.	Observing temporary stabilization, CWD outlet and ECD's

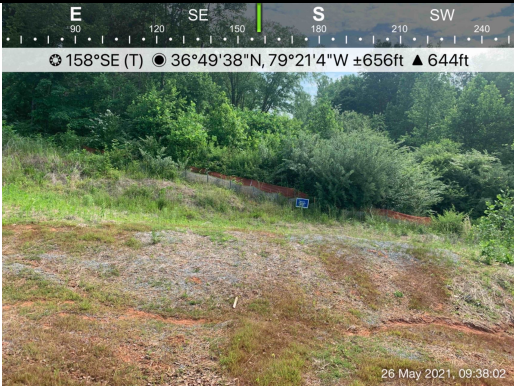
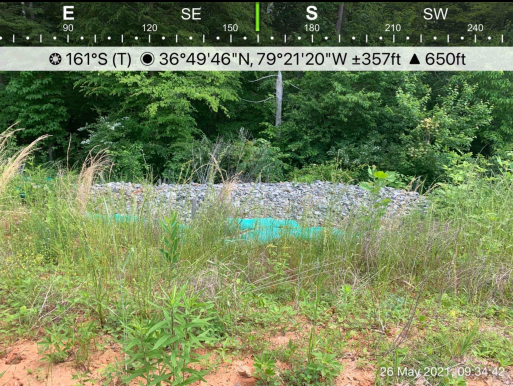
GPS Location	O	GPS Location	O		
Field Station#	15999+80	Field Station#	15982+00		
Pic 5 Desc.	Observing temporary stabilization, water bar, signage, buffer and ECD's	Pic 6 Desc.	Observing temporary stabilization, CWD outlet and ECD's

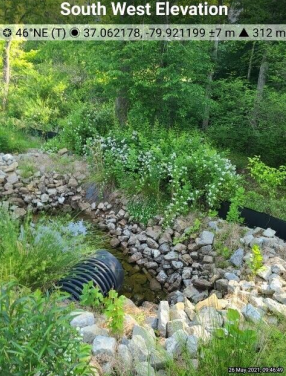
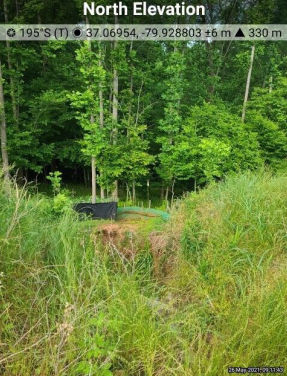
GPS Location	00000	GPS Location	0000		
Field Station#	13840+00	Field Station#	13800+00		
Pic 1 Desc.	Observed plunge pool and row boundary silt fence. No environmental issues observed at the time of inspection.		Pic 2 Desc.	Monitored sump pit and end treatment as well as Row boundary silt fence . No issues were observed at the time of inspection.	
	West Elevation <small>87°E (T) • 37.060569, -79.921138 ±6 m ▲ 301 m</small>

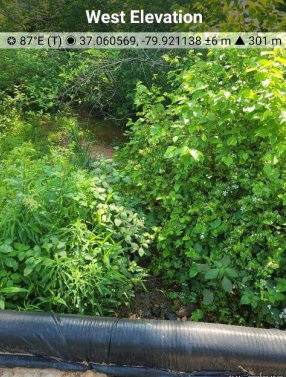
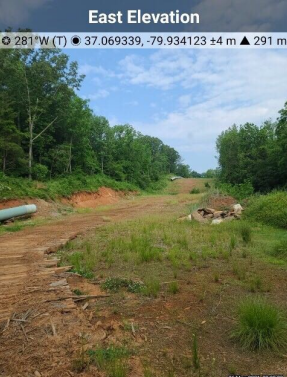
GPS Location	0000	GPS Location	0000		
Field Station#	13846+93	Field Station#	13780+80		
Pic 3 Desc.	Stream observation photo facing downstream during routine inspection today. No issues observed at the time of inspection.		Pic 4 Desc.	Row photo showing vegetation and row conditions during inspection today.

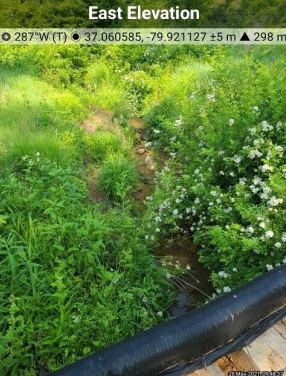
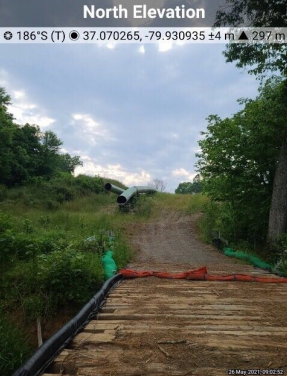
GPS Location	0000	GPS Location	0000		
Field Station#	13846+93	Field Station#	13790+80		
Pic 5 Desc.	Stream observation photo facing downstream during routine inspection today. No issues were observed at the time of inspection.		Pic 6 Desc.	Monitored stabilization and ECDs at stream crossing. No issues observed at the time of inspection.

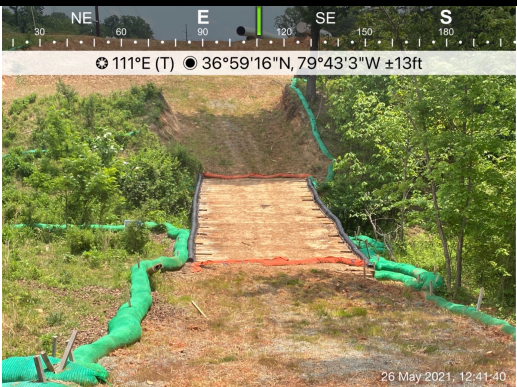
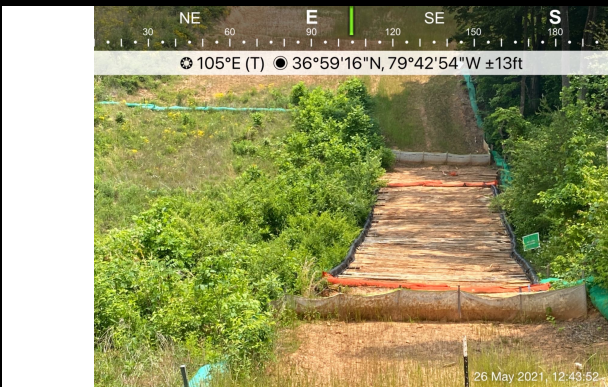
GPS Location	0		GPS Location	0	
Field Station#	14673+10		Field Station#	14680+30	
Pic 3 Desc.	Approximately 14673+10. Overview of stream crossing, equipment bridge and ECDs at stream S-H37.		Pic 4 Desc.	Approximately 14680+30. Overview of stream crossing, equipment bridge and ECDs at stream S-H36.

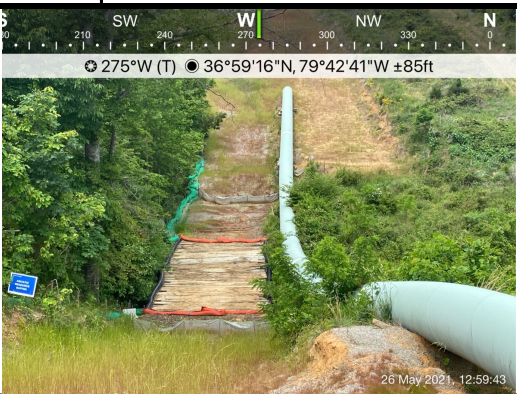
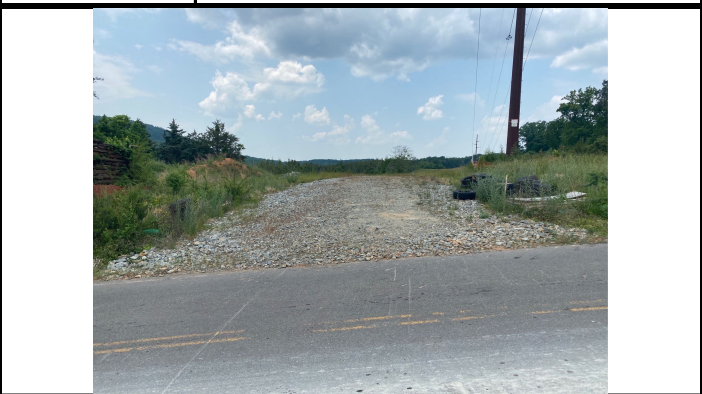
GPS Location	0		GPS Location	0	
Field Station#	14689+36		Field Station#	14694+50	
Pic 5 Desc.	Approximately 14689+36. Overview of stream crossing, equipment bridge and ECDs at stream S-H34.		Pic 6 Desc.	Approximately 14694+50. Overview of road crossing and RCE.

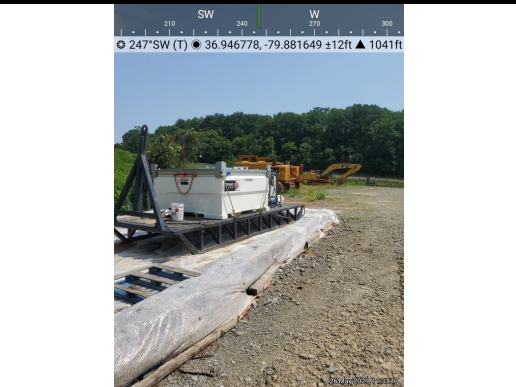
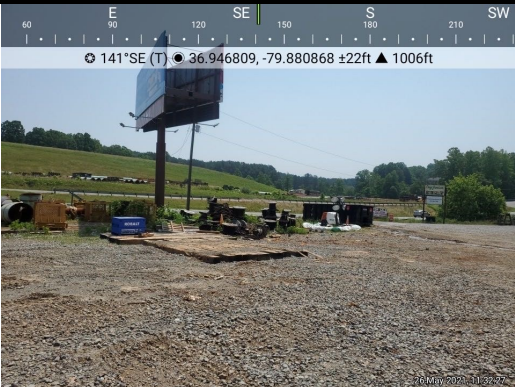
GPS Location	0		GPS Location	0	
Field Station#	0+00		Field Station#	0+00	
Pic 3 Desc.	L-032 Secondary containment & equipment staging		Pic 4 Desc.	LY-032 Housekeeping & secondary containment

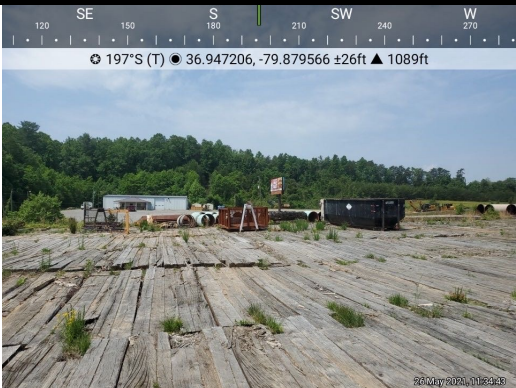
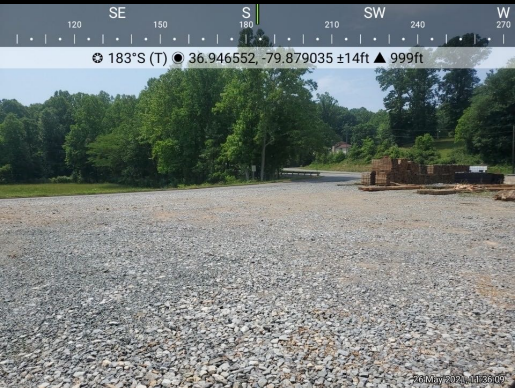
GPS Location	0		GPS Location	0	
Field Station#	0+00		Field Station#	0+00	
Pic 5 Desc.	LY-033 Waste management		Pic 6 Desc.	LY-033 Rock Construction Entrance

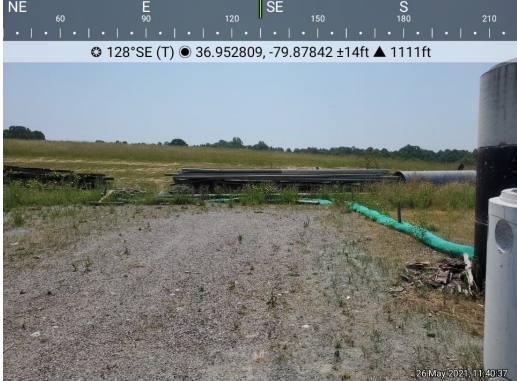
<p>GPS: 128°SE (T) 36.952809, -79.87842 ±14ft ▲ 1111ft</p> <p>Insert image here</p>			
GPS Location	0	GPS Location	0		
Field Station#	0+00	Field Station#	0+00		
Pic 7 Desc.	ANC-006 Inlet protection & secondary containment		Pic 8 Desc.	ANC-006 CFS Southeast corner	
Insert image here		Insert image here			
GPS Location		GPS Location			
Field Station#		Field Station#			
Pic 9 Desc.			Pic 10 Desc.		
Insert image here		Insert image here			
GPS Location		GPS Location			
Field Station#		Field Station#			
Pic 11 Desc.			Pic 12 Desc.

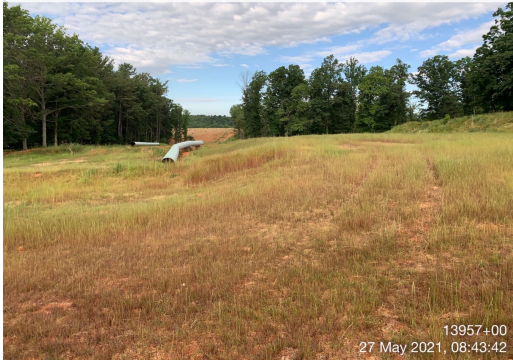
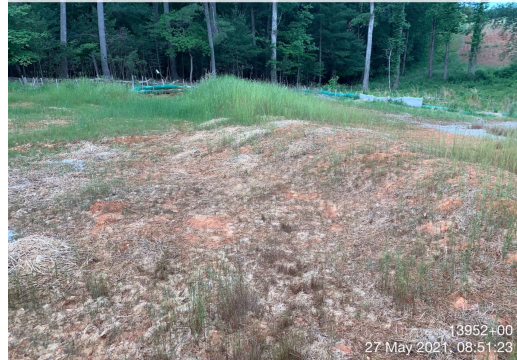
</div> <div>13952+00 27 May 2021, 08:51:23</div>		
GPS Location			0		
Field Station#			13957+00		
Pic 1 Desc.			Temporary vegetative stabilization in acceptable condition		
GPS Location			0		
Field Station#			13952+00		
Pic 2 Desc.			Waterbar in acceptable condition		
<div>☉ 17°N (M) ● 37°3'9"N, 79°54'35"W ±213ft ▲ 1111ft</div> <div>

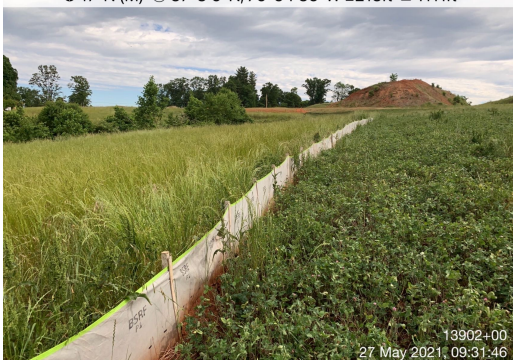
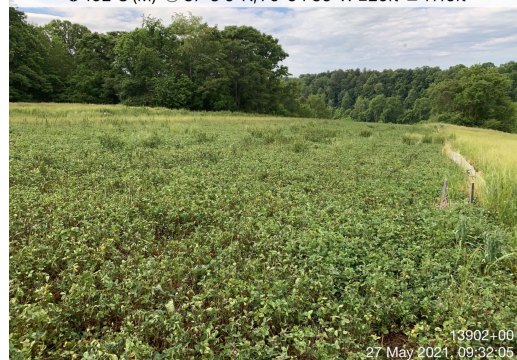
</div> <div>13902+00 27 May 2021, 09:32:05</div>		
GPS Location			0		
Field Station#			13902+00		
Pic 3 Desc.			P1 silt fence in acceptable condition		
GPS Location			0		
Field Station#			13902+00

Pic 4 Desc.			Permanent vegetative stabilization in acceptable condition		
<div>☉ 282°W (M) ● 37°3'27"N, 79°54'49"W ±39ft ▲ 1025ft</div> <div>

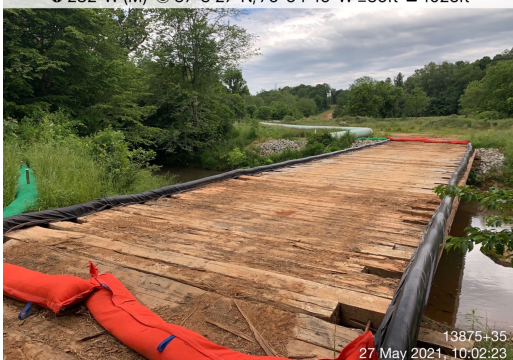
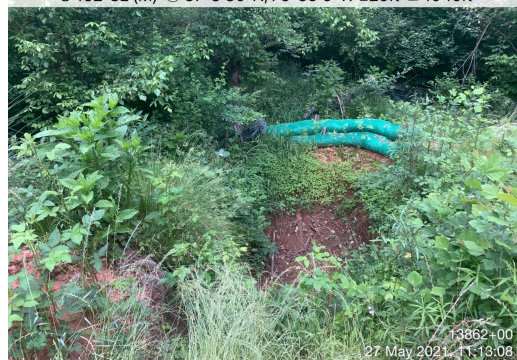
</div> <div>13862+00 27 May 2021, 11:13:08</div>		
GPS Location			0		
Field Station#			13875+35		
Pic 5 Desc.			Equipment bridge in acceptable condition		
GPS Location			0		
Field Station#			13862+00		
Pic 6 Desc.			Waterbar end treatment in acceptable condition

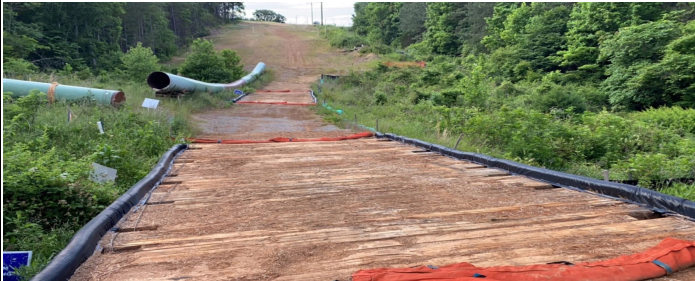
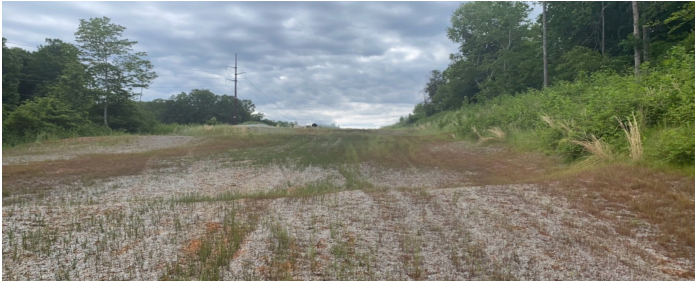
36°59'6" N 79°41'32" W 156°SE COURSE 85° GPS Sorry no results found 05.27.2021 08:19:42 Accur +/-76.2 Ft ALT 898 Ft			36°58'39" N 79°40'47" W 207°SW COURSE 99° GPS Union Hall, VA 24176, United States 05.27.2021 10:13:14 Accur +/-282.1 Ft ALT 958 Ft		
GPS Location	5	GPS Location	6		
Field Station#	14751+50	Field Station#	14797+00		
Pic 5 Desc.	Equipment bridge and surrounding ECDs in place and functional		Pic 6 Desc.	ROW stabilized and vegetated in temporary area

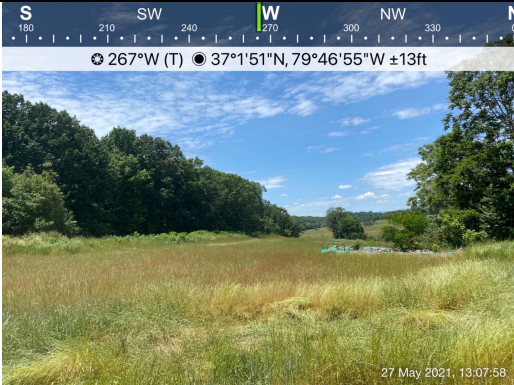
GPS Location	0	GPS Location	0		
Field Station#	14408+00	Field Station#	14347+00		
Pic 3 Desc.	Approximately 14408+00. Overview of ROW.	Pic 4 Desc.	Approximately 14347+00. Overview of ROW.

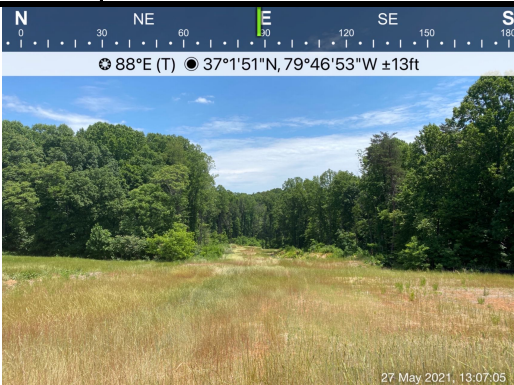
GPS Location	0	GPS Location	0		
Field Station#	14416+00	Field Station#	14450+00		
Pic 5 Desc.	Approximately 14416+00. Overview of ROW.	Pic 6 Desc.	Approximately 14450+00. Overview of ROW.

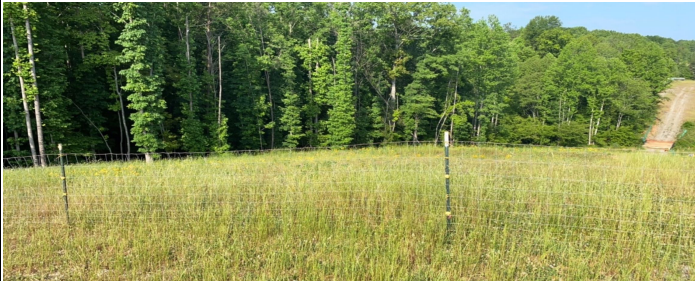
Pic 3 Desc.	Perimeter SSF in place and functional	Pic 4 Desc.	Slope in temporary stabilized and vegetated. Water bars performing intended functions.

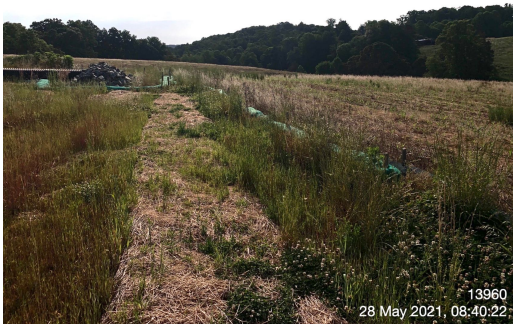
</div> <div>14034+00 28 May 2021, 09:32:48</div>		
GPS Location	0		GPS Location	0	
Field Station#	13960+00		Field Station#	14034+00	
Pic 1 Desc.	Perimeter CFS in acceptable condition		Pic 2 Desc.	Super silt fence fabric is detached from the wire fence, contractor addressed it immediately	
<div>☉ 200°S (M) ● 37°3'45"N, 79°52'57"W ±541ft ▲ 1140ft</div> <div>

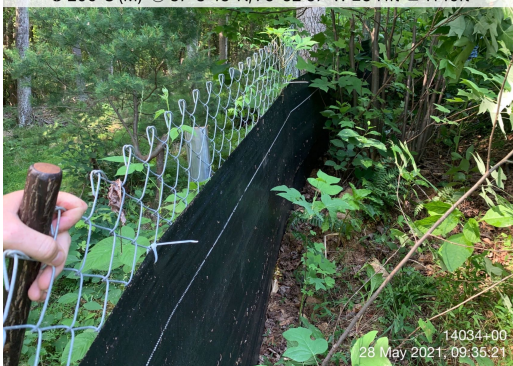
</div> <div>14038+00 28 May 2021, 09:40:59</div>		
GPS Location	0		GPS Location	0	
Field Station#	14034+00		Field Station#	14038+00	
Pic 3 Desc.	Super silt fence after fabric was re-attached to the wire fence		Pic 4 Desc.	Waterbar in acceptable condition

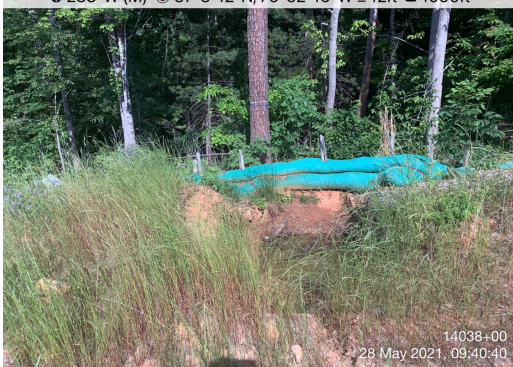
</div> <div>14059+00 28 May 2021, 12:17:40</div>		
GPS Location	0		GPS Location	0	
Field Station#	14038+00		Field Station#	14059+00	
Pic 5 Desc.	Waterbar end treatment in acceptable condition		Pic 6 Desc.	Sump pit in acceptable condition
