# Visual Site Inspection Report

| <b>Project Name</b> | H-600 Pipeline Spread I | <b>AFE</b> | 124300139 | <b>Spread</b> | H-600 Pipeline Spread I |
| <b>Permit #</b> | TBD | <b>Inspection Type</b> | VA SWPP | <b>Station Begin</b> | 15772+27 |

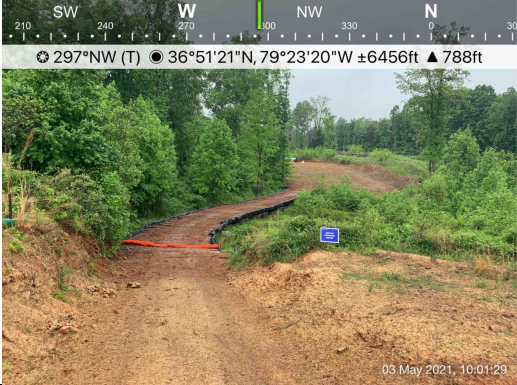
| <b>Pic 7 Desc.</b> | Observing temporary stabilization, signage, buffer, equipment crossing and ECD's | <b>Pic 8 Desc.</b> | Observing temporary stabilization, CWD outlet and ECD's | | |

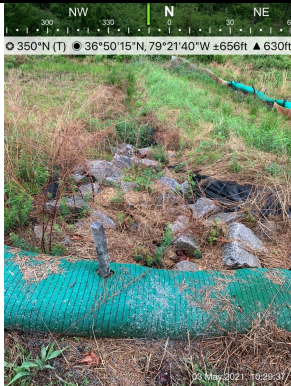
| <b>Pic 9 Desc.</b> | Observing temporary stabilization, rock drain and ECD's | <b>Pic 10 Desc.</b> | Observing temporary stabilization and ECD's. | | |

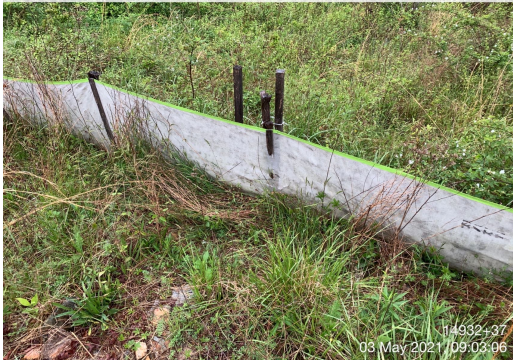
| Pic 1 Desc. | | P1 silt fence at stream buffer is deteriorated and has a hole in it | | Pic 2 Desc. | | Super silt fence fabric is detached from the wire | |

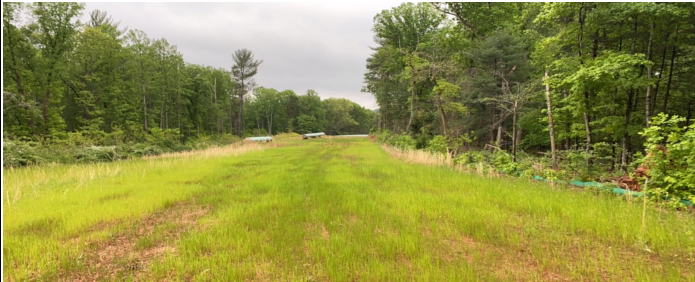
| Pic 1 Desc. | Vegetation growing in temporary seeded area | Pic 2 Desc. | Sump, end treatment, and perimeter SSF in place and functional | | |

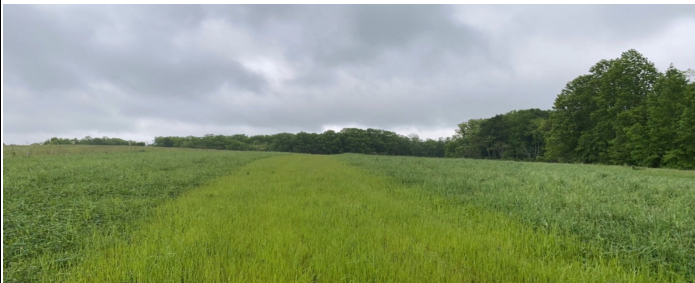
| Pic 3 Desc. | Vegetation in permanent seeded area | Pic 4 Desc. | Plunge pool performing intended function | | |

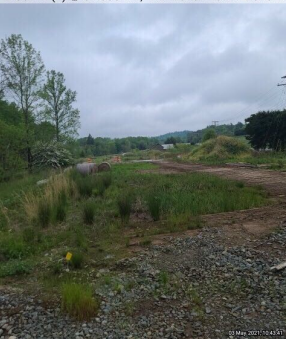
| <b>Pic 1 Desc.</b> | Row photo taken during light rain events. Monitored ECDs and vegetation growth. No environmental issues observed at the time of inspection. | | <b>Pic 2 Desc.</b> | Monitored ECDs and vegetation growth throughout. No issues observed at the time of inspection. | |

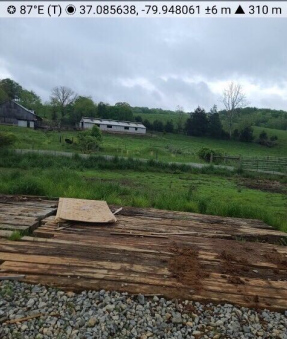
| <b>Pic 3 Desc.</b> | Monitored ECDs and vegetation growth. Observed RCE at road crossings during light rain events today. | | <b>Pic 4 Desc.</b> | Inspected ECDs while monitoring row conditions during light rain events today. No issues observed at the time of inspection | |

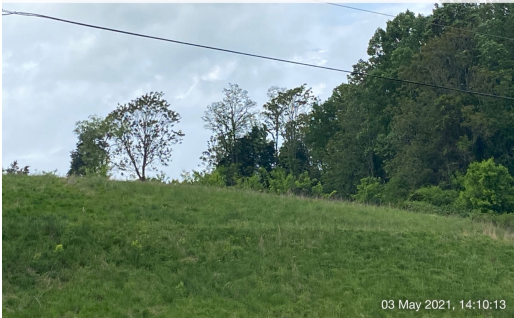
| <b>Pic 1 Desc.</b> | Approximately 14646+00. Overview of ROW. | | <b>Pic 2 Desc.</b> | Approximately 14568+10. Overview of stream crossing, equipment bridge and ECDs at stream S-E18. | |

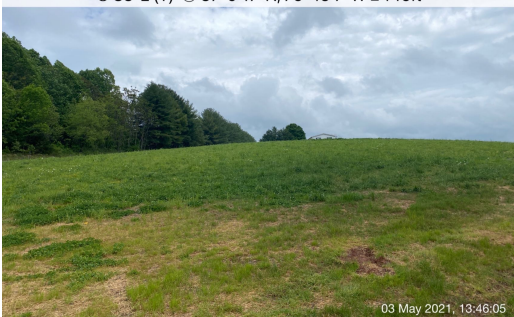
| <b>Pic 3 Desc.</b> | Approximately 14548+00. Overview of ROW. | | <b>Pic 4 Desc.</b> | Approximately 14605+00. Overview of ROW. | |

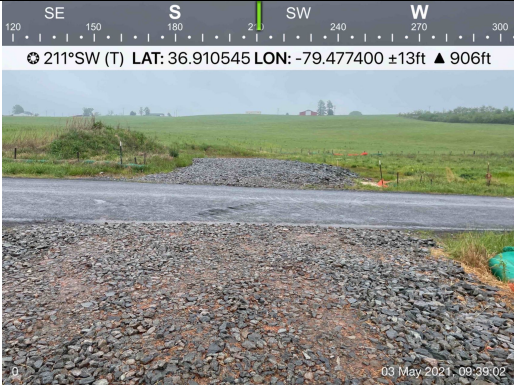
| <b>Pic 1 Desc.</b> | RCEs are in good condition at all road crossings. | | <b>Pic 2 Desc.</b> | 3rd party rock outlet appears to be in good condition. | |

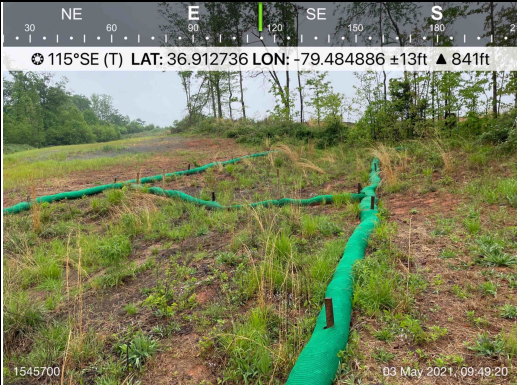
| Pic 7 Desc. | Drainage in good condition. No sedimentation present. | | Pic 8 Desc. | 3rd party rock outlet appears to be in good condition. To discharge present during inspection. | |

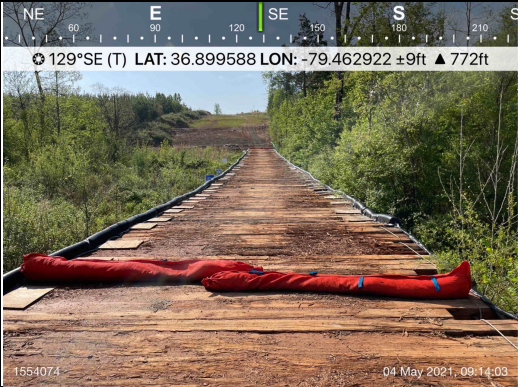
| Pic 7 Desc. | Equipment bridge ECDs are in place and functioning. | | Pic 8 Desc. | Waterbars are in good condition throughout this section. | |

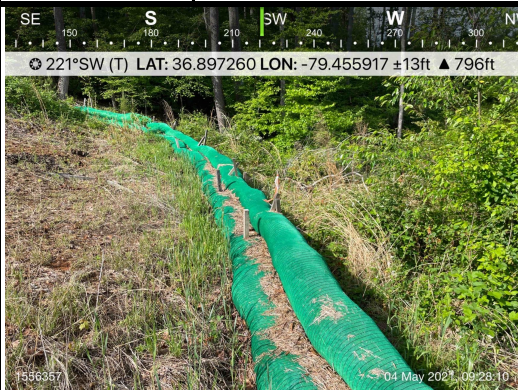
| Pic 9 Desc. | CFS is in good condition. | | Pic 10 Desc. | Slope drain is in good condition and functioning. | |

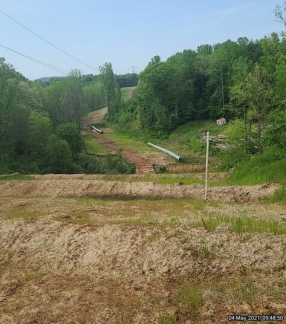
| <b>Pic 1 Desc.</b> | Row photo taken during routine inspection today. Some new vegetation growing on hill side above stream crossing. | | <b>Pic 2 Desc.</b> | Row photo showing vegetation, some new growth in travel lane, will continue to monitor the area. | |

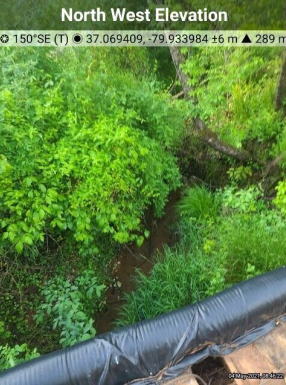
| <b>Pic 5 Desc.</b> | Stream observation photo facing downstream during routine inspection today, no issues observed at the time of inspection. | | <b>Pic 6 Desc.</b> | Stream observation photo facing upstream during routine inspection today, no issues observed at the time of inspection | |

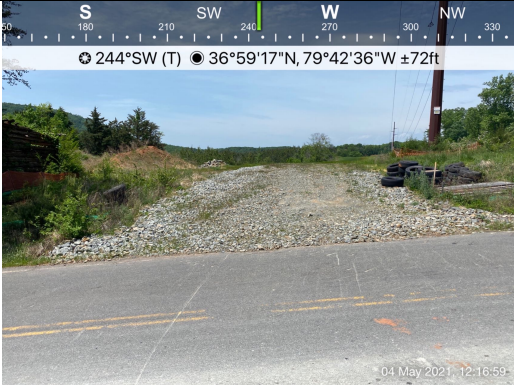
| <b>Pic 1 Desc.</b> | Approximately 14694+30. Overview of road crossing and RCE. | | <b>Pic 2 Desc.</b> | Approximately 14687+00. Overview of ROW. | |

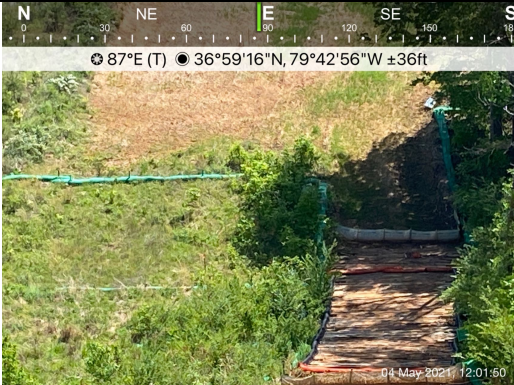
| <b>Pic 3 Desc.</b> | Approximately 14680+30. Overview of stream crossing, equipment bridge and ECDs at stream S-H36. | | <b>Pic 4 Desc.</b> | Approximately 14675+75. Overview of ROW. Cattle travel and graze area frequently. | |

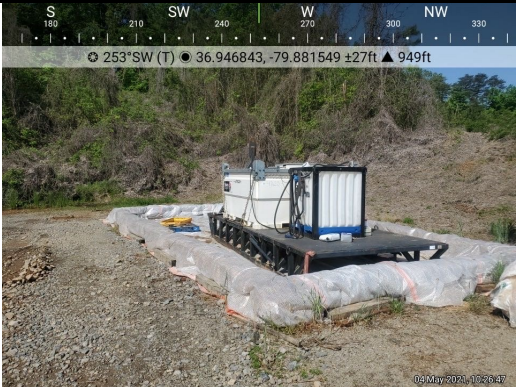
| Pic 1 Desc. | LY-032 Secondary containment | | Pic 2 Desc. | LY-032 Secondary containment & housekeeping | |

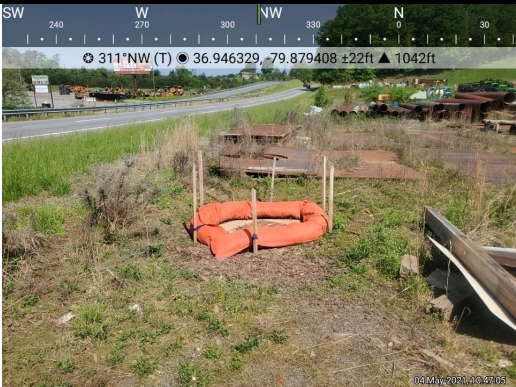
| Pic 3 Desc. | LY-033 Inlet Protection | | Pic 4 Desc. | LY-033 Rock Construction Entrance | |

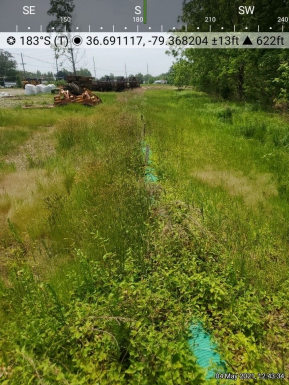
| <b>Pic 7 Desc.</b> | LY-048 Housekeeping | <b>Pic 8 Desc.</b> | LY-048 CFS west perimeter | | |

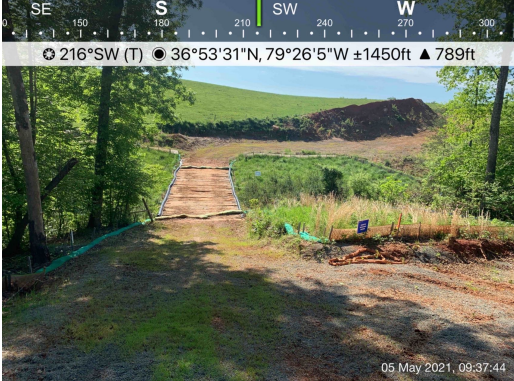
| <b>Pic 1 Desc.</b> | Observing temporary stabilization, signage, buffer, equipment crossing and ECD's | | <b>Pic 2 Desc.</b> | Observing temporary stabilization, erosion control blanket and cfs checks | |

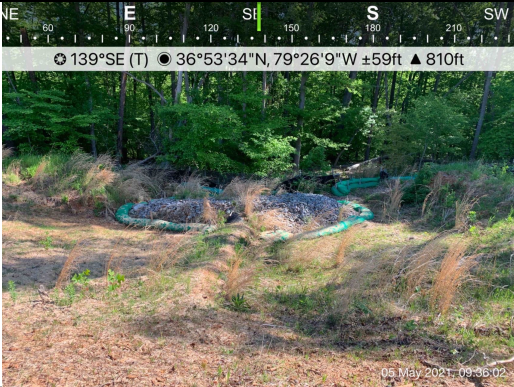
| <b>Pic 3 Desc.</b> | Observing temporary stabilization, CWD outlet and ECD's | | <b>Pic 4 Desc.</b> | Observing temporary stabilization and water bars | |

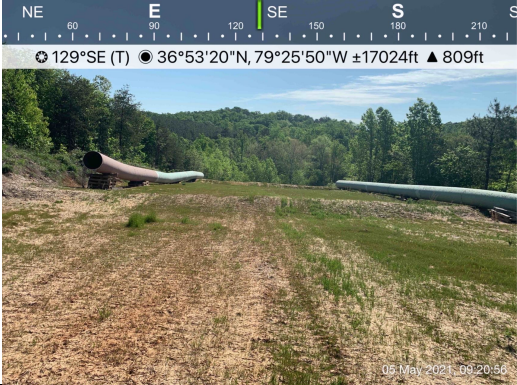
| <b>Pic 7 Desc.</b> | Observing temporary stabilization and water bars | <b>Pic 8 Desc.</b> | | | |

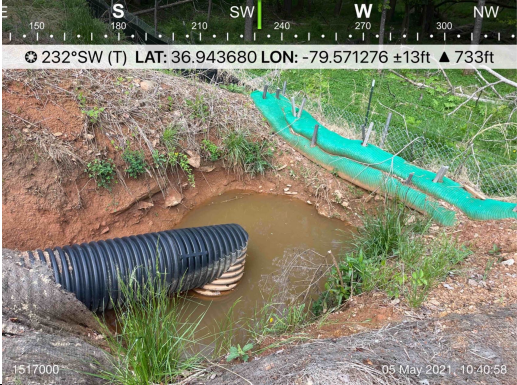
| <b>Pic 7 Desc.</b> | Slope drain is in good condition. | | <b>Pic 8 Desc.</b> | Equipment bridge ECDs are in good condition. | |

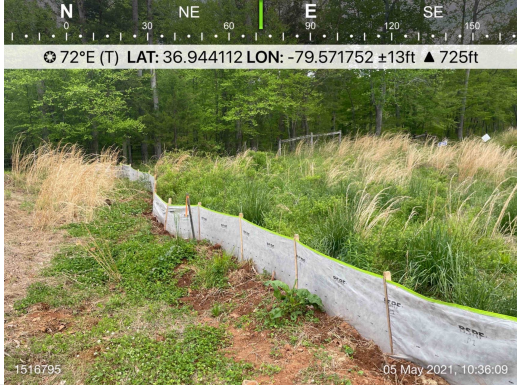
| <b>Pic 9 Desc.</b> | P1 is in good condition at stream buffer. | | <b>Pic 10 Desc.</b> | Rock outlet remains in good condition and functioning. | |

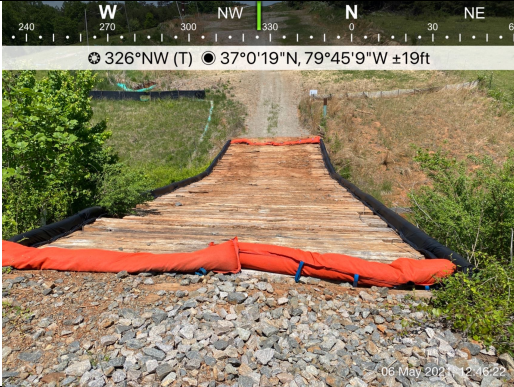
| <b>Pic 1 Desc.</b> | Approximately 14546+33. Overview of stream crossing, equipment bridge and ECDs at stream S-G17. | | <b>Pic 2 Desc.</b> | Approximately 14524+50. Overview of road crossing and RCEs. | |

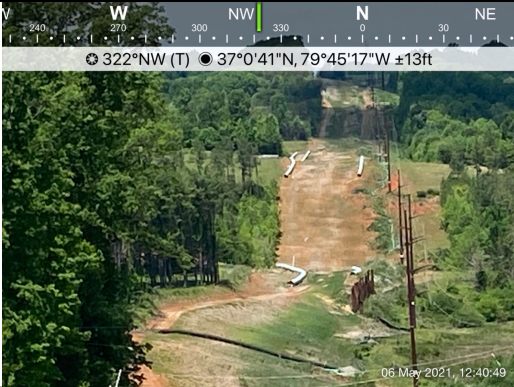
| <b>Pic 3 Desc.</b> | Approximately 14510+00. Overview of ROW. | | <b>Pic 4 Desc.</b> | Approximately 14474+00. Overview of ROW. | |

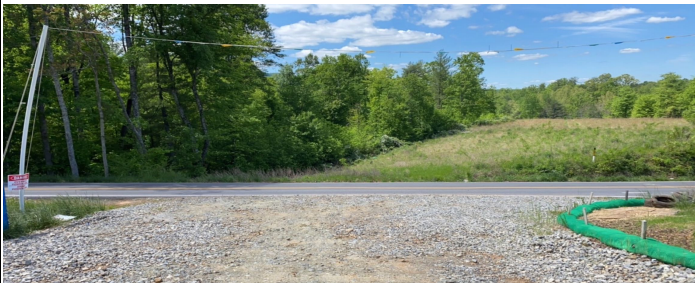
| <b>Pic 1 Desc.</b> | Permanent vegetation growing between Hwy 220 and Bonbrook Mill RC1 | | <b>Pic 2 Desc.</b> | Permanent vegetation growing between Hwy 220 and Bonbrook Mill RC1 | |

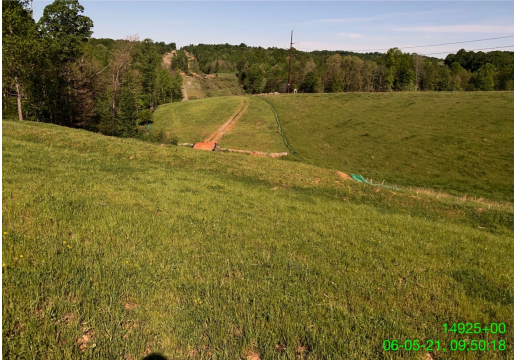
| <b>Pic 1 Desc.</b> | Permanent vegetative stabilization in acceptable condition | <b>Pic 2 Desc.</b> | Perimeter CFS damaged by livestock | | |

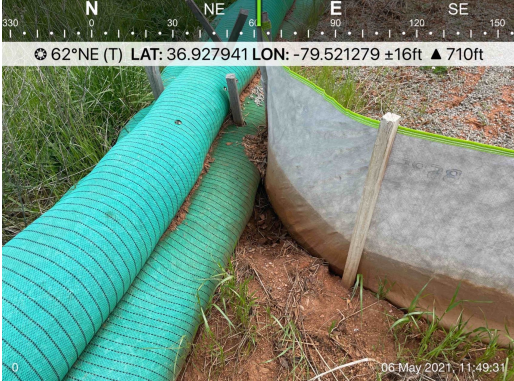
| <b>Pic 1 Desc.</b> | P1 is undermined and needs to be keyed in. | | <b>Pic 2 Desc.</b> | Environmental crew has corrected this issue. | |

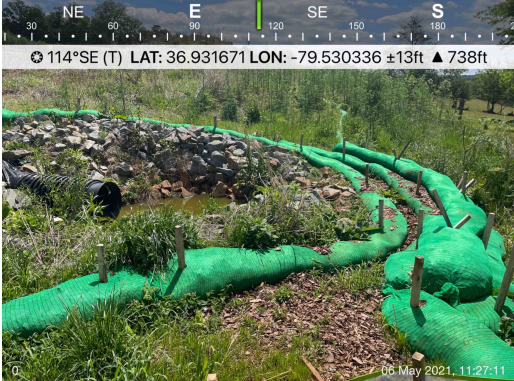
| <b>Pic 3 Desc.</b> | CWD outlet remains in good condition. | | <b>Pic 4 Desc.</b> | CWD inlet remains in good condition. | |

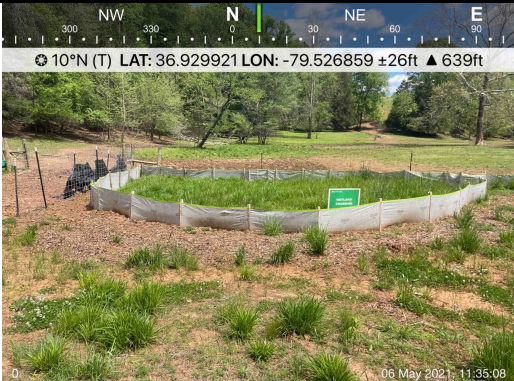
| <b>Pic 5 Desc.</b> | Wetland buffer in good condition at this location. | | <b>Pic 6 Desc.</b> | Equipment bridge ECDs are in place and functioning. | |

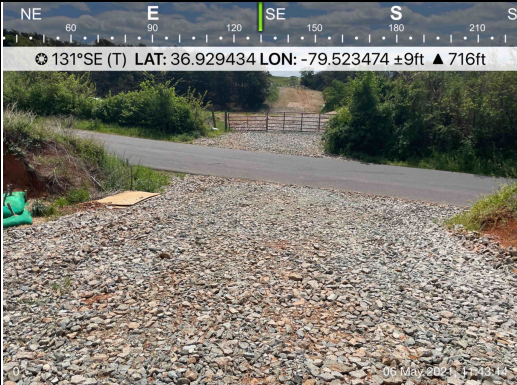
| Pic 7 Desc. | RCEs are in good condition at all road crossings. | | Pic 8 Desc. | Vegetation continues to fill in throughout this section of ROW | |

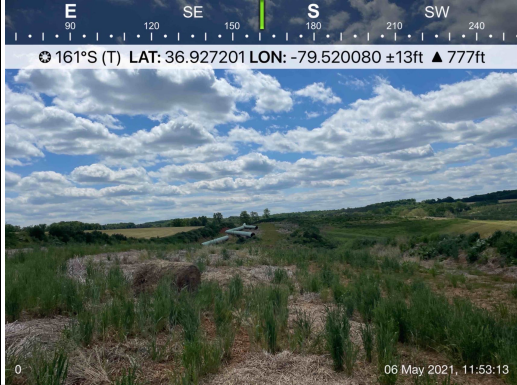
| Pic 9 Desc. | Vegetation continues to fill in throughout this section of ROW | | Pic 10 Desc. | CWD inlet is in good condition. | |

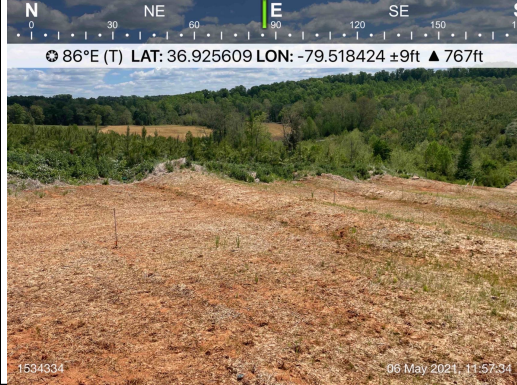
| Pic 11 Desc. | Waterbars are in good condition throughout this section. | | Pic 12 Desc. | P1 is in good condition at all stream and wetland buffers. | |

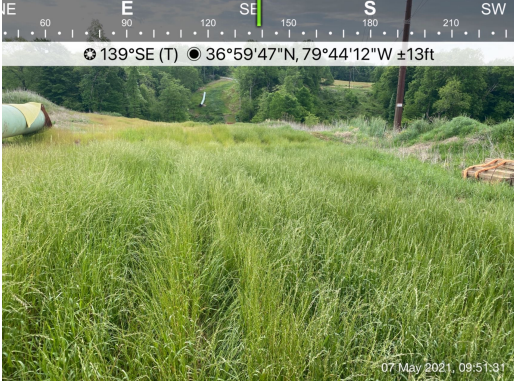
| <b>Pic 1 Desc.</b> | Approximately 14605+00. Overview of ROW. | | <b>Pic 2 Desc.</b> | Approximately 14599+00. Overview of road crossing and RCEs. | |

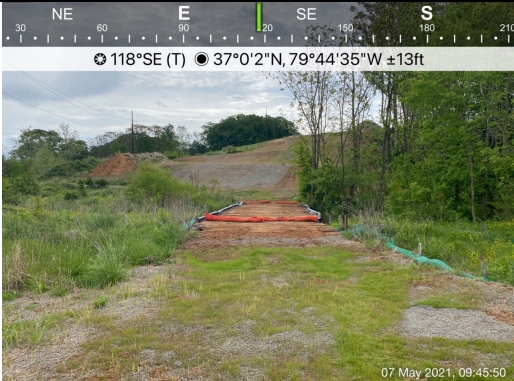
| <b>Pic 3 Desc.</b> | Approximately 14582+85. Overview of stream crossing, equipment bridge and ECDs at stream S-17. | | <b>Pic 4 Desc.</b> | Approximately 14592+00. Overview of ROW. | |

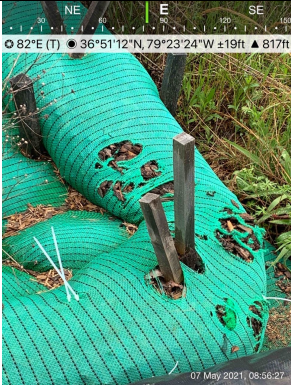
| <b>Pic 1 Desc.</b> | Observing CFS that required maintenance | <b>Pic 2 Desc.</b> | Observing CFS that received maintenance | | |

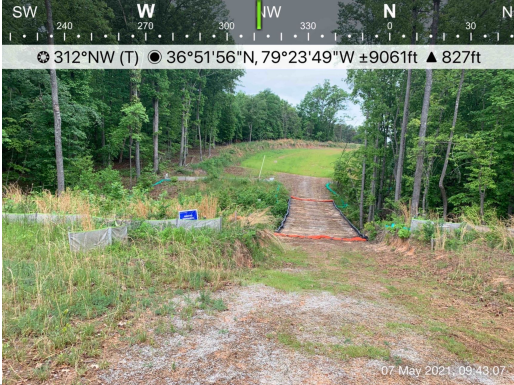
| <b>Pic 3 Desc.</b> | Observing temporary stabilization, signage, buffer, equipment crossing and ECD's | <b>Pic 4 Desc.</b> | Observing temporary stabilization, erosion control blanket, CFS checks and water bar | | |

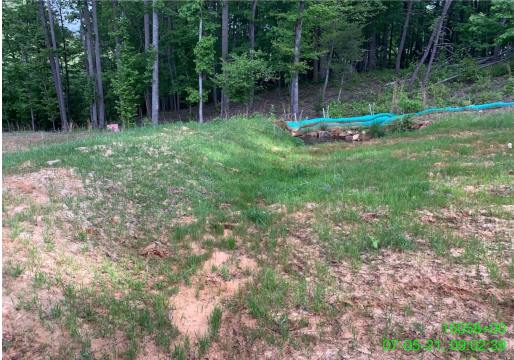
| <b>Pic 1 Desc.</b> | Waterbar in acceptable condition | <b>Pic 2 Desc.</b> | Waterbar end treatment in acceptable condition | | |

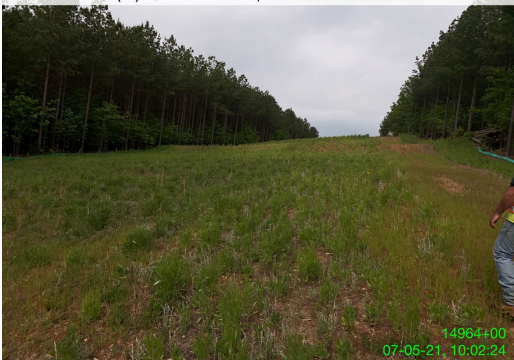
| <b>Pic 3 Desc.</b> | permanent vegetative stabilization in acceptable condition | <b>Pic 4 Desc.</b> | Temporary vegetative stabilization in acceptable condition | | |

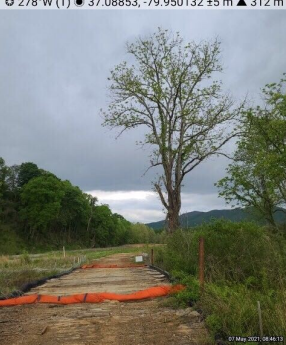
| <b>Pic 1 Desc.</b> | Monitored equipment bridge and protection while observing stream crossing. No issues observed at the time of inspection. | | <b>Pic 2 Desc.</b> | Stream observation photo facing upstream during routine inspection today.no issues observed at the time of inspection. | |

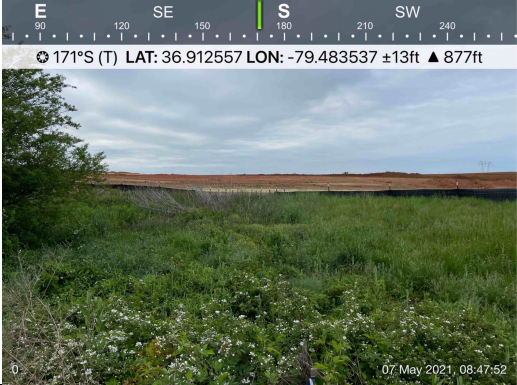
| <b>Field Station#</b> | 15460+81 | | <b>Field Station#</b> | 15460+81 | |

| <b>Pic 7 Desc.</b> | 3rd party rock outlet appears to be in good condition with no evidence of sedimentation | | <b>Pic 8 Desc.</b> | CWDs in good condition throughout this section. | |

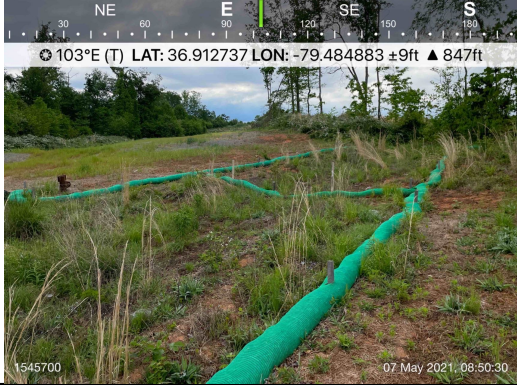
| <b>Field Station#</b> | 15457+00 | | <b>Field Station#</b> | 15454+00 | |

| <b>Pic 9 Desc.</b> | Drainage ECDs are in good condition with no evidence of sedimentation from 3rd party disturbance upslope of ROW. | | <b>Pic 10 Desc.</b> | 3rd party rock outlet appears to be in good condition with no evidence of sedimentation | |
