# Visual Site Inspection Report

<b>Project Name</b>	H-600 Pipeline Spread I	<b>AFE</b>	124300139	<b>Spread</b>	H-600 Pipeline Spread I
<b>Contractor</b>	Precision			<b>Report #</b>	23982
<b>Inspector</b>	Logan Box			<b>Date/Time</b>	6/1/2021 3:38 PM
<b>Permit #</b>	TBD	<b>Inspection Type</b>	VA SWPP	<b>Station Begin</b>	13670+00
<b>State</b>	VA	<b>Inspection Area</b>	Partial	<b>Station End</b>	13784+35
<b>County</b>	Franklin	<b>Ground</b>	Damp	<b>Temperature (°F)</b>	81.00
<b>Municipality</b>	N/A	<b>Weather</b>	Sunny	<b>Rain Gauge (in)</b>	0.00
				<b>Rain Accumulation Time (days)</b>	0.00

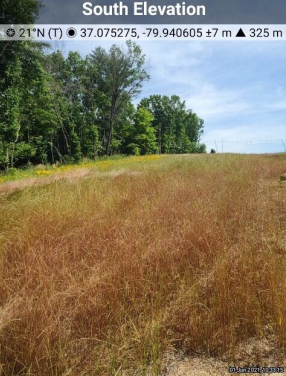
<b>GPS Location</b>	000000	<b>GPS Location</b>	000000		
<b>Field Station#</b>	137746+00	<b>Field Station#</b>	13747+90		
<b>Pic 1 Desc.</b>	Vegetation observation photo showing coverage.	<b>Pic 2 Desc.</b>	Monitored ECDs at road crossing . No issues observed at the time of inspection.		
	<b>North East Elevation</b>

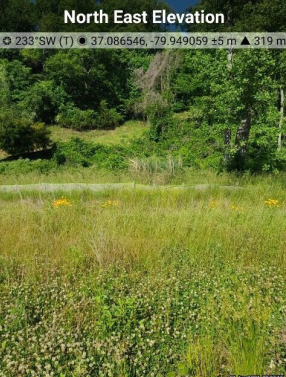
<b>GPS Location</b>	000000	<b>GPS Location</b>	000000		
<b>Field Station#</b>	13686+12	<b>Field Station#</b>	13690+00		
<b>Pic 3 Desc.</b>	Monitored LOD ECDs while checking row conditions. No issues observed at the time of inspection.	<b>Pic 4 Desc.</b>	Row photo taken while checking row conditions throughout. No issues observed at the time of inspection.		
	<b>North West Elevation</b>

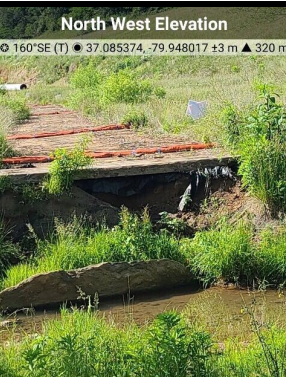
<b>GPS Location</b>	000000	<b>GPS Location</b>	000000		
<b>Field Station#</b>	13692+77	<b>Field Station#</b>	13680+00		
<b>Pic 5 Desc.</b>	Erosion control blanket on S-E28 requires maintenance due to being weathered and torn. Documented and added to the punch list.	<b>Pic 6 Desc.</b>	Row photo showing vegetation growth. No issues observed at the time of inspection.

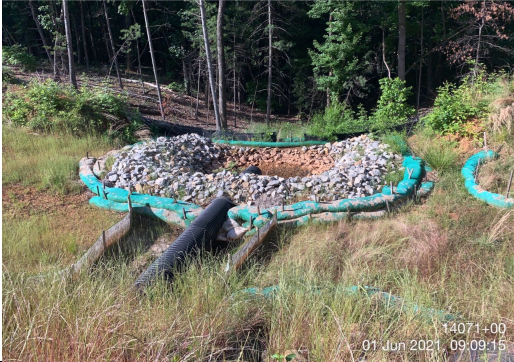
<b>GPS Location</b>	0	<b>GPS Location</b>	0		
<b>Field Station#</b>	14071+00	<b>Field Station#</b>	14067+00		
<b>Pic 1 Desc.</b>	Clean water diversion plunge pool in acceptable condition	<b>Pic 2 Desc.</b>	Waterbar end treatment in acceptable condition

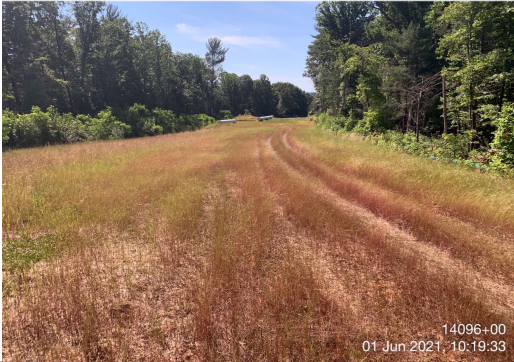
<b>GPS Location</b>	0	<b>GPS Location</b>	0		
<b>Field Station#</b>	14096+00	<b>Field Station#</b>	14108+00		
<b>Pic 3 Desc.</b>	Temporary vegetative stabilization in acceptable condition	<b>Pic 4 Desc.</b>	Perimeter CFS in acceptable condition

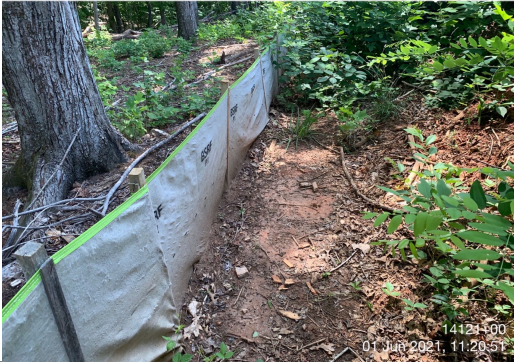
<b>GPS Location</b>	0	<b>GPS Location</b>	0		
<b>Field Station#</b>	14124+00	<b>Field Station#</b>	14141+62		
<b>Pic 5 Desc.</b>	P1 silt fence in acceptable condition	<b>Pic 6 Desc.</b>	Equipment bridge in acceptable condition

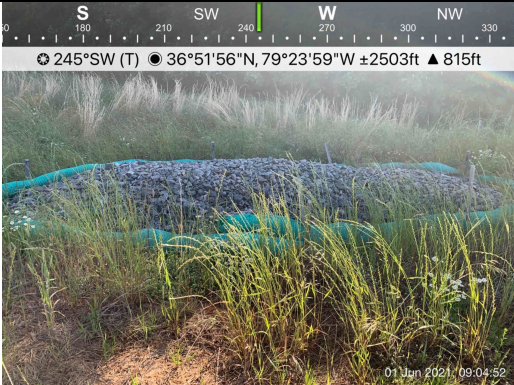
<b>GPS Location</b>	O	<b>GPS Location</b>	O		
<b>Field Station#</b>	15786+00	<b>Field Station#</b>	15784+00		
<b>Pic 3 Desc.</b>	Observing temporary stabilization,CWD outlet and ECD's	<b>Pic 4 Desc.</b>	Observing p1 that required maintenance

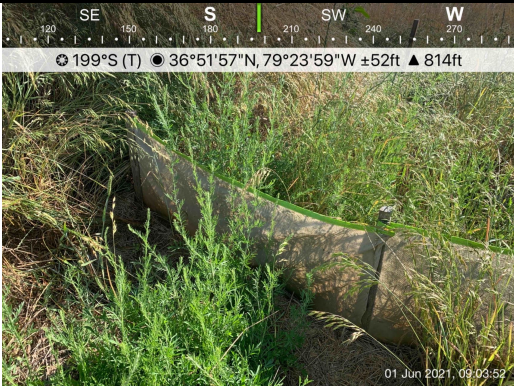
<b>GPS Location</b>	O	<b>GPS Location</b>	O		
<b>Field Station#</b>	15784+00	<b>Field Station#</b>	15794+77		
<b>Pic 5 Desc.</b>	Observing p1 that received maintenance	<b>Pic 6 Desc.</b>	Observing temporary stabilization, signage, buffer, equipment crossing and ECD's

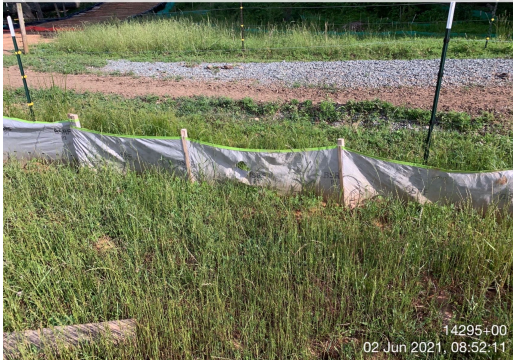
<b>GPS Location</b>	0		<b>GPS Location</b>	0	
<b>Field Station#</b>	14295+00		<b>Field Station#</b>	14278+50	
<b>Pic 1 Desc.</b>	P1 silt fence damaged by livestock		<b>Pic 2 Desc.</b>	P1 silt fence damaged by livestock

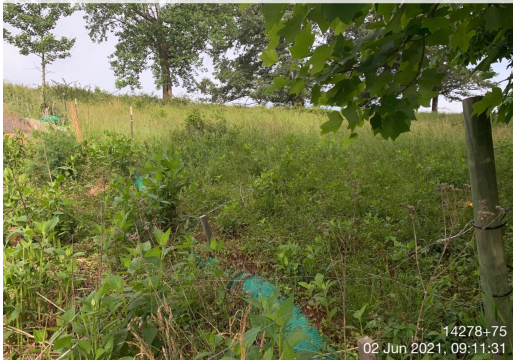
<b>GPS Location</b>	0		<b>GPS Location</b>	0	
<b>Field Station#</b>	14278+75		<b>Field Station#</b>	14278+00	
<b>Pic 3 Desc.</b>	Temporary electric fence damaged by livestock from 14277+00 to 14280+00		<b>Pic 4 Desc.</b>	Erosion control blanket damaged by livestock from 14277+00 to 14278+50

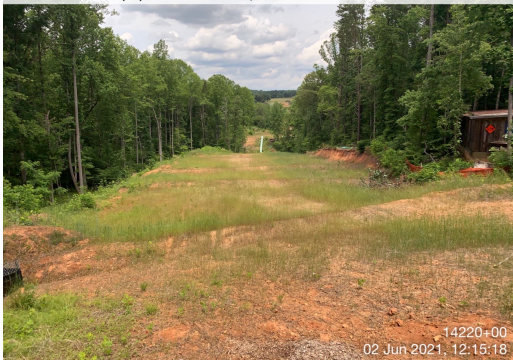
<b>GPS Location</b>	0		<b>GPS Location</b>	0	
<b>Field Station#</b>	14220+00		<b>Field Station#</b>	14177+00	
<b>Pic 5 Desc.</b>	Temporary vegetative stabilization in acceptable condition		<b>Pic 6 Desc.</b>	Temporary electric fence damaged by livestock

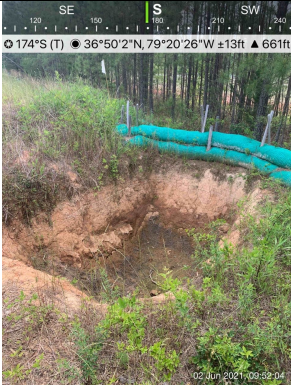
<b>GPS Location</b>	O	<b>GPS Location</b>	O		
<b>Field Station#</b>	10+00	<b>Field Station#</b>	12+00		
<b>Pic 1 Desc.</b>	Observing temporary stabilization, sump and end treatment.		<b>Pic 2 Desc.</b>	Observing temporary stabilization

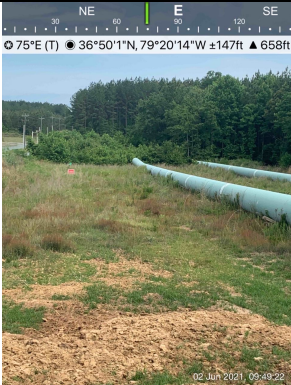
<b>GPS Location</b>	O	<b>GPS Location</b>	O		
<b>Field Station#</b>	18+83	<b>Field Station#</b>	15+73		
<b>Pic 3 Desc.</b>	Observing temporary stabilization, signage, buffer and ECD's.		<b>Pic 4 Desc.</b>	Observing temporary stabilization, signage, and buffer	
Insert image here			Insert image here		
<b>GPS Location</b>		<b>GPS Location</b>			
<b>Field Station#</b>		<b>Field Station#</b>			
<b>Pic 5 Desc.</b>			<b>Pic 6 Desc.</b>

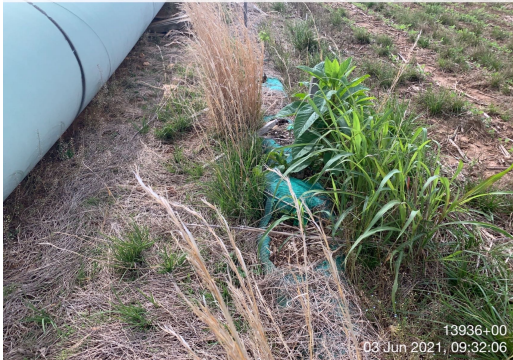
GPS Location	0		GPS Location	0	
Field Station#	13936+00		Field Station#	13931+00	
Pic 1 Desc.	CFS has holes and is degraded from 13935+00 to 13936+50		Pic 2 Desc.	CFS damaged by third party from 13930+00 to 13935+00 (4 locations)

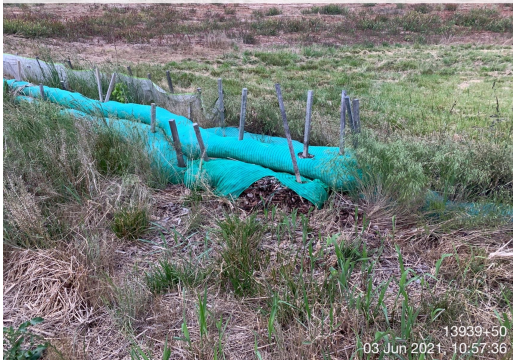
GPS Location	0		GPS Location	0	
Field Station#	13939+50		Field Station#	13894+00	
Pic 3 Desc.	CFS with multiple holes on access road MVP-FR-305		Pic 4 Desc.	CFS damaged by farm equipment

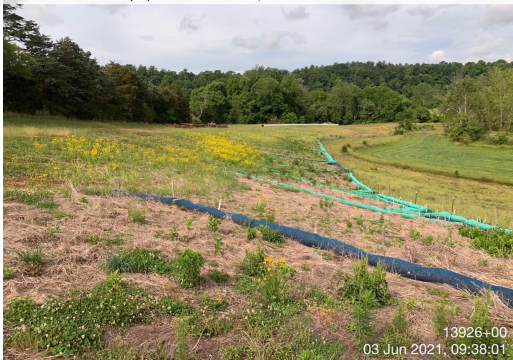
GPS Location	0		GPS Location	0	
Field Station#	13926+00		Field Station#	13955+00	
Pic 5 Desc.	Permanent vegetative stabilization in acceptable condition		Pic 6 Desc.	P1 silt fence in acceptable condition

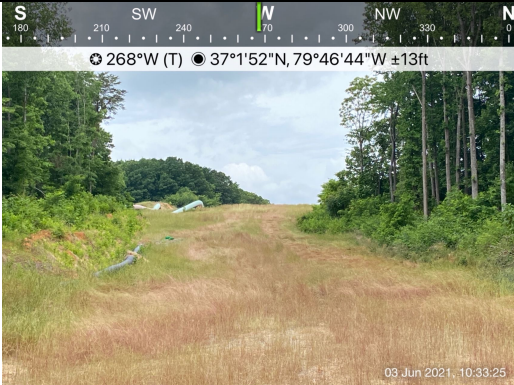
<b>GPS Location</b>	0	<b>GPS Location</b>	0		
<b>Field Station#</b>	14415+00	<b>Field Station#</b>	14434+01		
<b>Pic 3 Desc.</b>	Approximately 14415+00. Overview of ROW.	<b>Pic 4 Desc.</b>	Approximately 14434+01. Overview of stream crossing, equipment bridge and ECDs at stream S-GH40.

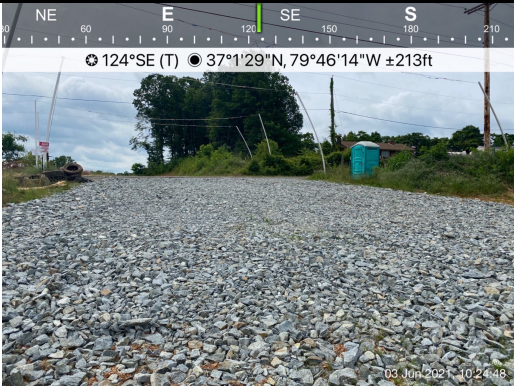
<b>GPS Location</b>	0	<b>GPS Location</b>	0		
<b>Field Station#</b>	14454+00	<b>Field Station#</b>	14352+75		
<b>Pic 5 Desc.</b>	Approximately 14454+00. Overview of road crossing and RCE.	<b>Pic 6 Desc.</b>	Approximately 14352+75. P-1 requires maintenance.

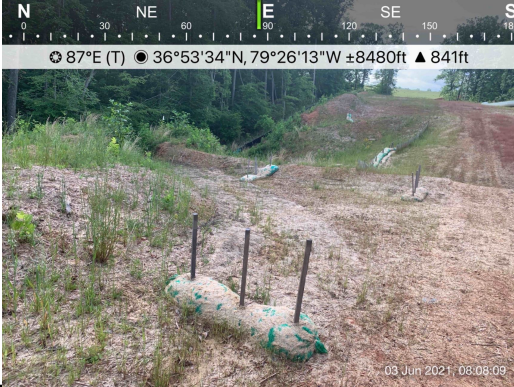
<b>GPS Location</b>	O	<b>GPS Location</b>	O		
<b>Field Station#</b>	15630+00	<b>Field Station#</b>	15590+00		
<b>Pic 3 Desc.</b>	Observing temporary stabilization, erosion control blanket and cfs checks	<b>Pic 4 Desc.</b>	Observing temporary stabilization and water bars

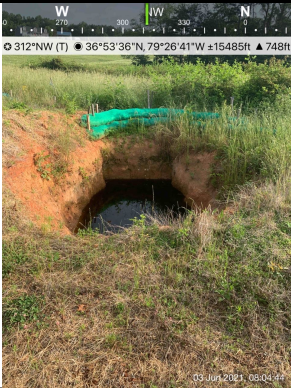
<b>GPS Location</b>	O	<b>GPS Location</b>	O		
<b>Field Station#</b>	15617+00	<b>Field Station#</b>	15595+00		
<b>Pic 5 Desc.</b>	Observing temporary stabilization, sump and end treatment	<b>Pic 6 Desc.</b>	Observing temporary stabilization, CWD outlet, signage, buffer, equipment crossing and ECD's

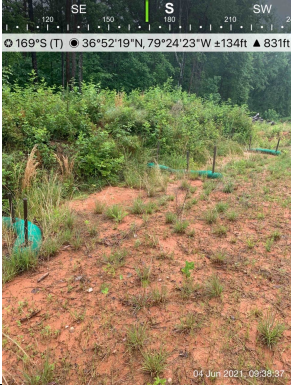
<p>N 0 30 60 90 120 57°NE (T) 36°52'20"N, 79°24'34"W ±3195ft ▲ 842ft 04 Jun 2021 09:33:48</p>			
<b>GPS Location</b>	O	<b>GPS Location</b>	O		
<b>Field Station#</b>	15750+00	<b>Field Station#</b>	15755+00		
<b>Pic 7 Desc.</b>	Observing temporary stabilization and CFS checks	<b>Pic 8 Desc.</b>	Observing sump and end treatment		
Insert image here		Insert image here			
<b>GPS Location</b>		<b>GPS Location</b>			
<b>Field Station#</b>		<b>Field Station#</b>			
<b>Pic 9 Desc.</b>		<b>Pic 10 Desc.</b>			
Insert image here		Insert image here			
<b>GPS Location</b>		<b>GPS Location</b>			
<b>Field Station#</b>		<b>Field Station#</b>			
<b>Pic 11 Desc.</b>		<b>Pic 12 Desc.</b>

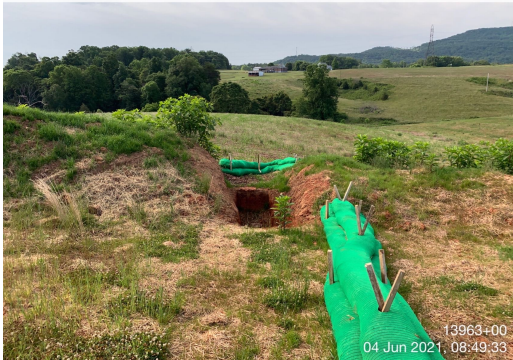
</div>		
GPS Location	0		GPS Location	0	
Field Station#	13963+00		Field Station#	13984+00	
Pic 1 Desc.	Sump pit in acceptable condition		Pic 2 Desc.	Temporary vegetative stabilization in acceptable condition	
<div>202°S (M) 37°3'12"N, 79°53'3"W ±13ft ▲993ft</div> <div>

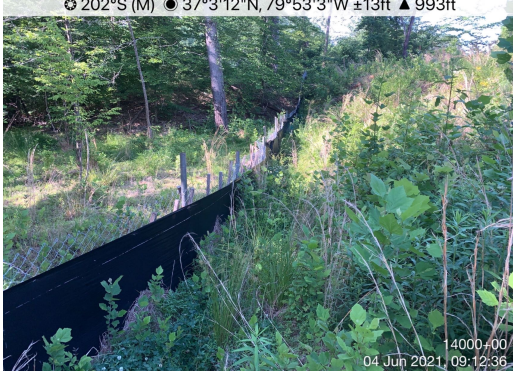
</div>		
GPS Location	0		GPS Location	0	
Field Station#	14000+00		Field Station#	14017+00	
Pic 3 Desc.	Super silt fence in acceptable condition		Pic 4 Desc.	Perimeter CFS in acceptable condition	
<div>257°W (M) 37°3'23"N, 79°52'53"W ±62ft ▲1084ft</div> <div>

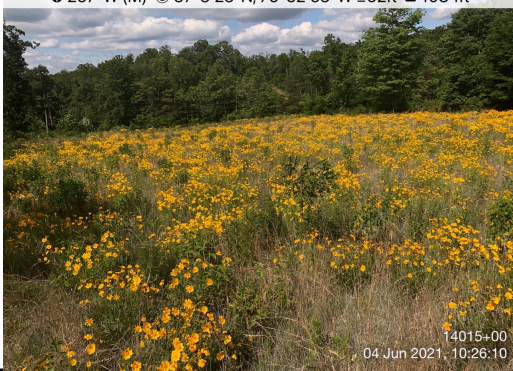
GPS Location	0		GPS Location	0	
Field Station#	14015+00		Field Station#	14058+00	
Pic 5 Desc.	Permanent vegetative stabilization in acceptable condition		Pic 6 Desc.	Slope drain in acceptable condition

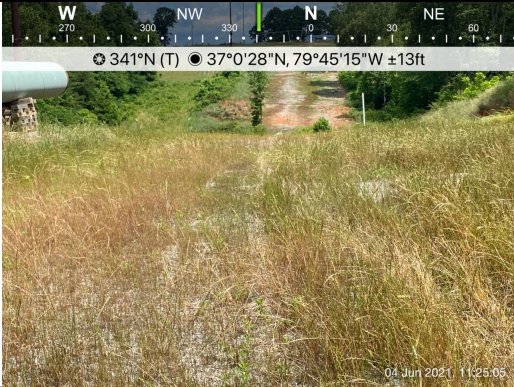
<b>GPS Location</b>	0	<b>GPS Location</b>	0		
<b>Field Station#</b>	14535+00	<b>Field Station#</b>	14546+33		
<b>Pic 3 Desc.</b>	Approximately 14535+00. Overview of ROW.	<b>Pic 4 Desc.</b>	Approximately 14546+33. Overview of ROW.
