# Visual Site Inspection Report

<b>Project Name</b>	H-600 Pipeline Spread I	<b>AFE</b>	124300139	<b>Spread</b>	H-600 Pipeline Spread I
<b>Contractor</b>	Precision			<b>Report #</b>	24249
<b>Inspector</b>	Logan Box			<b>Date/Time</b>	6/7/2021 4:38 PM
<b>Permit #</b>	TBD	<b>Inspection Type</b>	VA SWPP	<b>Station Begin</b>	13670+00
<b>State</b>	VA	<b>Inspection Area</b>	Partial	<b>Station End</b>	13748+30
<b>County</b>	Franklin	<b>Ground</b>	Dry	<b>Temperature (°F)</b>	80.00
<b>Municipality</b>	N/A	<b>Weather</b>	Cloudy	<b>Rain Gauge (in)</b>	0.00
				<b>Rain Accumulation Time (days)</b>	0.00

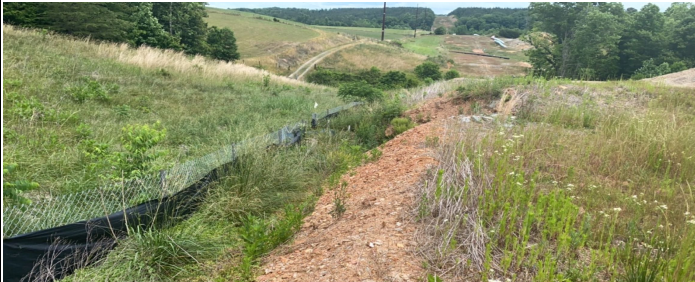
36°58'0" N 79°37'57" W 102°E COURSE 248° GPS Penhook, VA 24137, United States 06.07.2021 13:40:20 Accur +/-1989.7 Ft ALT 815 Ft			36°58'1" N 79°37'51" W 254°W COURSE 248° GPS Penhook, VA 24137, United States 06.07.2021 13:29:07 Accur +/-541.3 Ft ALT 815 Ft		
GPS Location	1	GPS Location	2		
Field Station#	14930+00	Field Station#	14944+51		
Pic 1 Desc.	Perimeter SSF in place and functional.	Pic 2 Desc.	Spoil piles stabilized and vegetated in extra workspace.

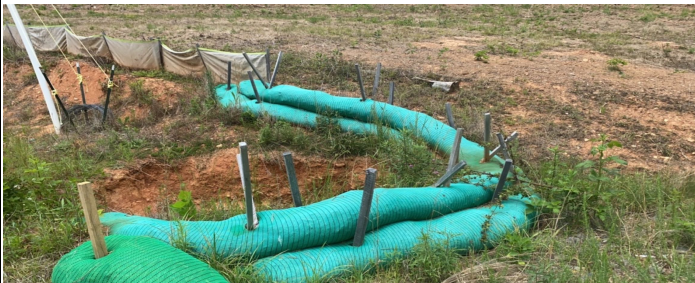
Pic 3 Desc.	CFS end treatment and perimeter P1 silt fence in place and functional.	Pic 4 Desc.	ROW stabilized and vegetated in final cleanup area.

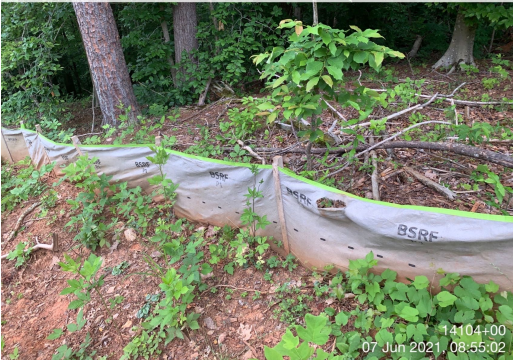
<div>14104+00 07 Jun 2021, 08:55:02</div>		
GPS Location	0		GPS Location	0	
Field Station#	14066+00		Field Station#	14104+00	
Pic 1 Desc.	Equipment bridge in acceptable condition		Pic 2 Desc.	P1 silt fence with holes and broken stakes from 14104+00 to 14104+50, damaged by livestock, contractor addressed immediately	
<div>168°S (M) 37°3'43"N, 79°51'47"W ±55ft ▲1023ft</div>

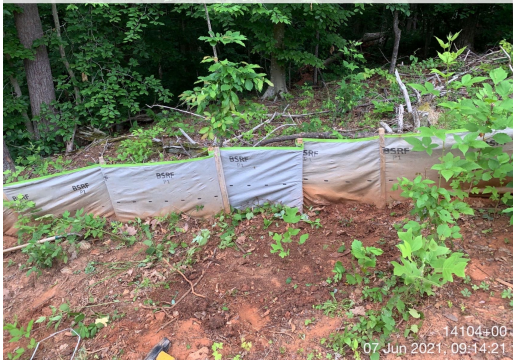
<div>14105+00 07 Jun 2021, 09:07:13</div>		
GPS Location	0		GPS Location	0	
Field Station#	14104+00		Field Station#	14105+00	
Pic 3 Desc.	P1 silt fence after repair by contractor from 14104+00 to 14104+50		Pic 4 Desc.	P1 silt fence with a hole in it, damaged by livestock, contractor repaired immediately

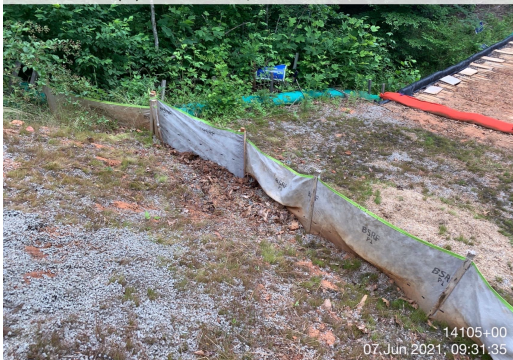
<div>14141+00 07 Jun 2021, 09:57:25</div>		
GPS Location	0		GPS Location	0	
Field Station#	14105+00		Field Station#	14141+00	
Pic 5 Desc.	P1 silt fence after repair by contractor		Pic 6 Desc.	Waterbar in acceptable condition

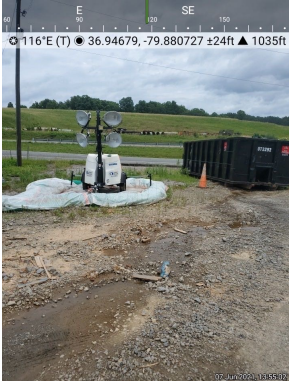
<b>GPS Location</b>	0	<b>GPS Location</b>	0		
<b>Field Station#</b>	0+00	<b>Field Station#</b>	0+00		
<b>Pic 3 Desc.</b>	LY-032 Secondary containment		<b>Pic 4 Desc.</b>	LY-032 Equipment staging

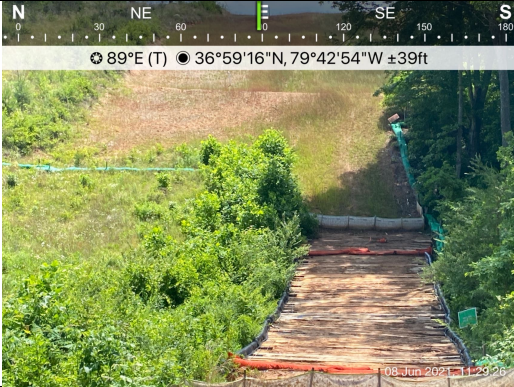
<b>GPS Location</b>	0	<b>GPS Location</b>	0		
<b>Field Station#</b>	14680+30	<b>Field Station#</b>	14673+10		
<b>Pic 1 Desc.</b>	Approximately 14680+30. Overview of stream crossing, equipment bridge and ECDs at stream S-H36.		<b>Pic 2 Desc.</b>	Approximately 14673+10. Overview of stream crossing, equipment bridge and ECDs at stream S-H37.

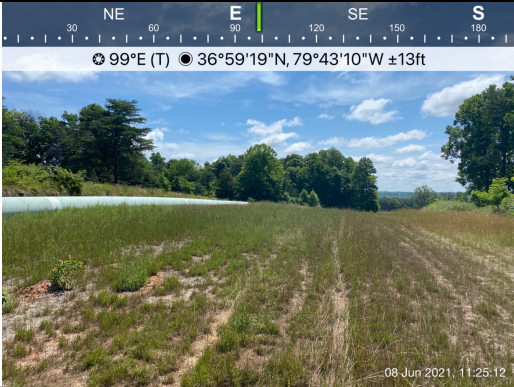
<b>GPS Location</b>	0	<b>GPS Location</b>	0		
<b>Field Station#</b>	14666+00	<b>Field Station#</b>	14651+00		
<b>Pic 3 Desc.</b>	Approximately 14666+00. Overview of ROW.		<b>Pic 4 Desc.</b>	Approximately 14651+00. Overview of ROW.

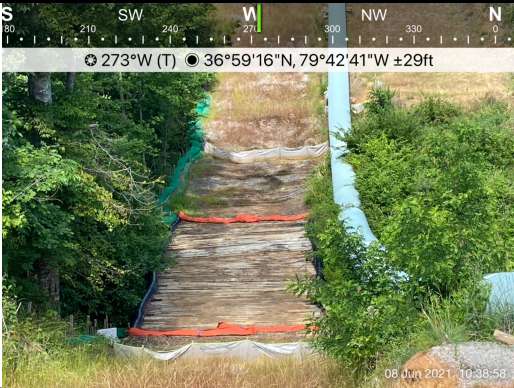
<b>GPS Location</b>	0	<b>GPS Location</b>	0		
<b>Field Station#</b>	14689+36	<b>Field Station#</b>	14694+50		
<b>Pic 5 Desc.</b>	Approximately 14689+36. Overview of stream crossing, equipment bridge and ECDs at stream S-H34.		<b>Pic 6 Desc.</b>	Approximately 14694+50. Overview of road crossing and RCE.

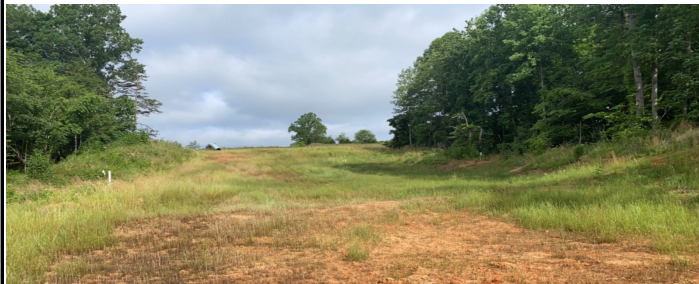
36°57'26" N 79°35'0" W 132°SE COURSE 298° GPS 8851-8969 Museville Rd, Sandy Level, VA 24161, United States 06.08.2021 08:59:37 Accur +/-206.1 Ft ALT 931 Ft			36°57'44" N 79°35'27" W 324°NW COURSE 315° GPS Sandy Level, VA 24161, United States 06.08.2021 09:29:02 Accur +/-133.5 Ft ALT 873 Ft		
GPS Location	1		GPS Location	2	
Field Station#	15105+00		Field Station#	15069+00	
Pic 1 Desc.	Routine maintenance. Restake edge of P1 silt fence knocked down from third party damage.		Pic 2 Desc.	ROW stabilized and vegetated in temporary area

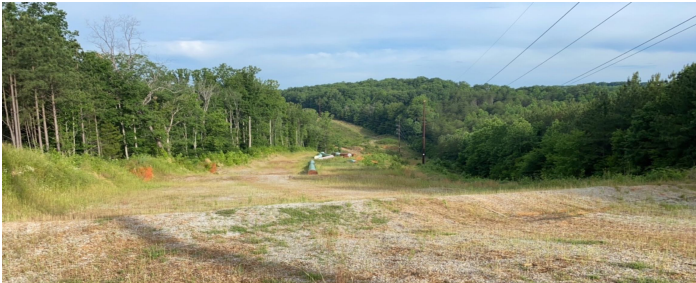
<small>36°59'16" N 79°42'5" W 258°W COURSE 290° GPS Union Hall, VA 24176, United States</small>			<small>36°59'17" N 79°42'22" W 86°E COURSE 290° GPS Union Hall, VA 24176, United States</small>		
<small>06.09.2021 08:17:29 Accur +/-221.3 Ft ALT 900 Ft</small>			<small>06.09.2021 08:35:45 Accur +/-189.7 Ft ALT 900 Ft</small>		
<b>GPS Location</b>	1		<b>GPS Location</b>	2	
<b>Field Station#</b>	14726+00		<b>Field Station#</b>	14716+00	
<b>Pic 1 Desc.</b>	P1 silt fence surrounding stabilized spoil pile. No issues observed.		<b>Pic 2 Desc.</b>	Goalpost down across ROW.

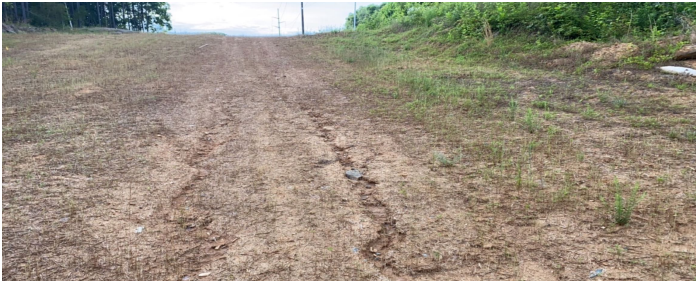
<b>GPS Location</b>	3		<b>GPS Location</b>	4	
<b>Field Station#</b>	14737+00		<b>Field Station#</b>	14722+60	
<b>Pic 3 Desc.</b>	ROW stabilized in temporary area.		<b>Pic 4 Desc.</b>	Resource buffer around stream vegetated. No issues observed.

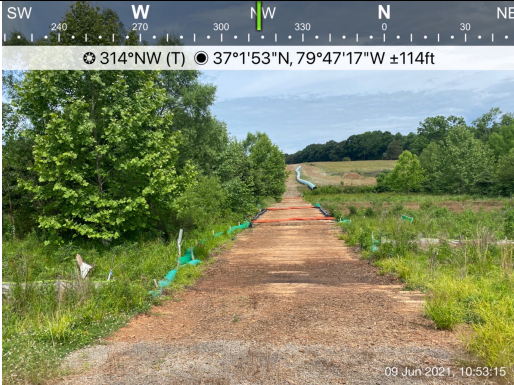
<b>GPS Location</b>	0	<b>GPS Location</b>	0		
<b>Field Station#</b>	14391+50	<b>Field Station#</b>	14407+00		
<b>Pic 1 Desc.</b>	Approximately 14391+50. Overview of stream crossing, equipment bridge and ECDs at stream S-A41.		<b>Pic 2 Desc.</b>	Approximately 14407+00. Overview of ROW.

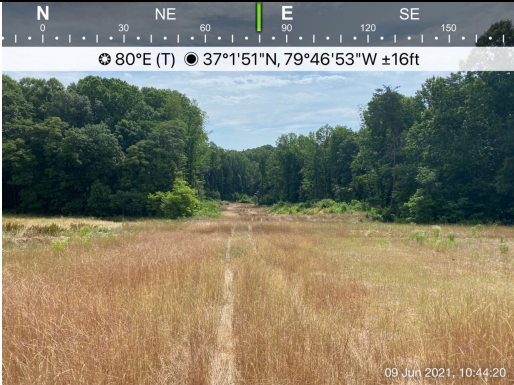
<b>GPS Location</b>	0	<b>GPS Location</b>	0		
<b>Field Station#</b>	14416+00	<b>Field Station#</b>	14451+00		
<b>Pic 3 Desc.</b>	Approximately 14416+00. Overview of ROW.		<b>Pic 4 Desc.</b>	Approximately 14451+00. Overview of ROW.

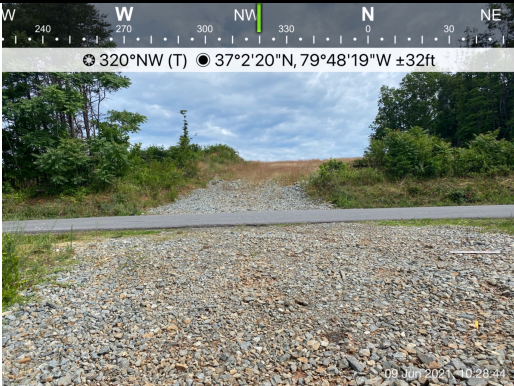
<b>GPS Location</b>	0	<b>GPS Location</b>	0		
<b>Field Station#</b>	14333+00	<b>Field Station#</b>	14314+79		
<b>Pic 5 Desc.</b>	Approximately 14333+00. Overview of road crossing and RCEs.		<b>Pic 6 Desc.</b>	Approximately 14314+79. Overview of stream crossing, equipment bridge and ECDs at stream S-GG4.

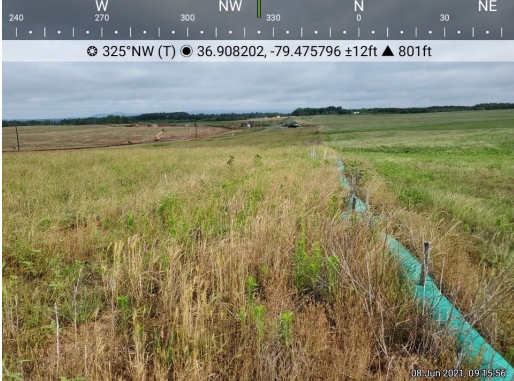
<b>GPS Location</b>	0	<b>GPS Location</b>	0		
<b>Field Station#</b>	15490+00	<b>Field Station#</b>	15495+00		
<b>Pic 1 Desc.</b>	Perimeter CFS	<b>Pic 2 Desc.</b>	CIS Climax Rd Revegetation

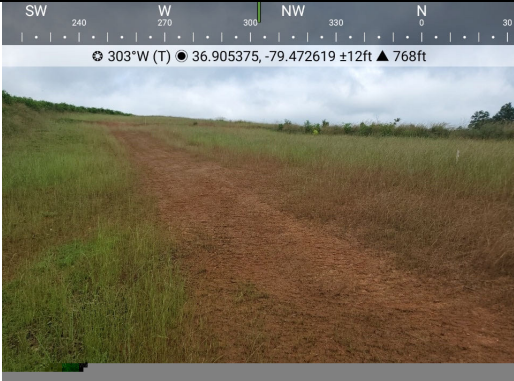
<b>GPS Location</b>	0	<b>GPS Location</b>	0		
<b>Field Station#</b>	15505+00	<b>Field Station#</b>	15523+00		
<b>Pic 3 Desc.</b>	Travel lane Revegetation	<b>Pic 4 Desc.</b>	CWD Outlet

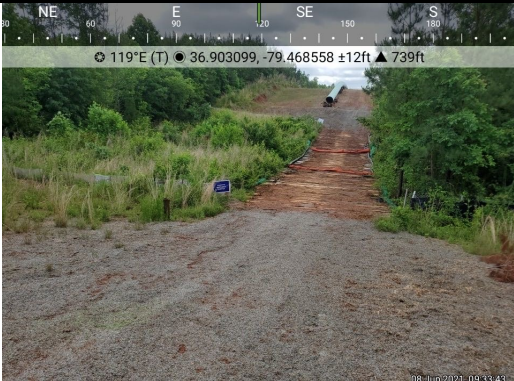
<b>GPS Location</b>	0	<b>GPS Location</b>	0		
<b>Field Station#</b>	15520+00	<b>Field Station#</b>	15535+00		
<b>Pic 5 Desc.</b>	CIS S-MM8 Temporary stabilization travel lane through resource buffer	<b>Pic 6 Desc.</b>	CWD Outlet

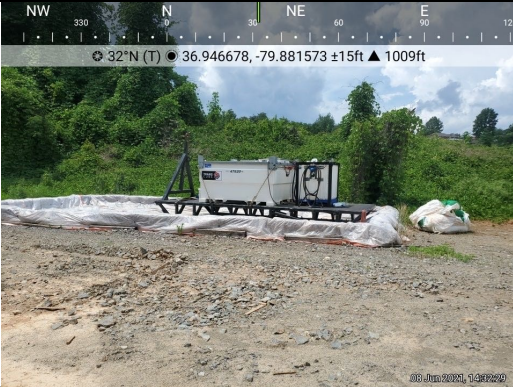
<b>GPS Location</b>	0	<b>GPS Location</b>	0		
<b>Field Station#</b>	0+00	<b>Field Station#</b>	0+00		
<b>Pic 3 Desc.</b>	LY-032 Staged equipment		<b>Pic 4 Desc.</b>	LY-032 Secondary containment

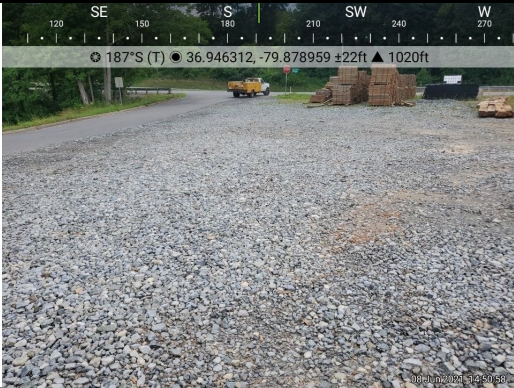
<b>GPS Location</b>	0	<b>GPS Location</b>	0		
<b>Field Station#</b>	0+00	<b>Field Station#</b>	0+00		
<b>Pic 5 Desc.</b>	LY-033 RCE		<b>Pic 6 Desc.</b>	LY-033 Storm sewer inlet protection

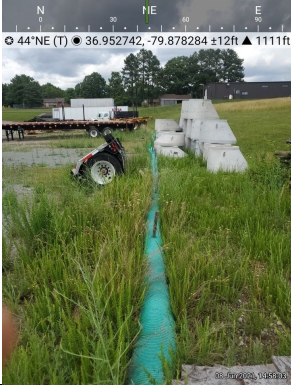
<b>GPS Location</b>	0	<b>GPS Location</b>	0		
<b>Field Station#</b>	0+00	<b>Field Station#</b>	0+00		
<b>Pic 7 Desc.</b>	ANC-006 South perimeter CFS	<b>Pic 8 Desc.</b>	ANC-006 Storm sewer inlet protection		
Insert image here		Insert image here			
<b>GPS Location</b>		<b>GPS Location</b>			
<b>Field Station#</b>		<b>Field Station#</b>			
<b>Pic 9 Desc.</b>		<b>Pic 10 Desc.</b>			
Insert image here		Insert image here			
<b>GPS Location</b>		<b>GPS Location</b>			
<b>Field Station#</b>		<b>Field Station#</b>			
<b>Pic 11 Desc.</b>		<b>Pic 12 Desc.</b>

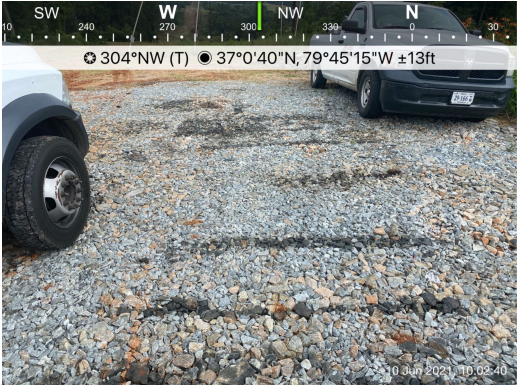
<div style="text-align: center;">Insert image here</div>			
<b>GPS Location</b>	0	<b>GPS Location</b>			
<b>Field Station#</b>	14524+70	<b>Field Station#</b>			
<b>Pic 15 Desc.</b>	Approximately 14524+70. Observed what appears to be oil and tar from paving company on CIS RCE of Timber Ridge Road.		<b>Pic 16 Desc.</b>		
<div style="text-align: center;">Insert image here</div>		<div style="text-align: center;">Insert image here</div>

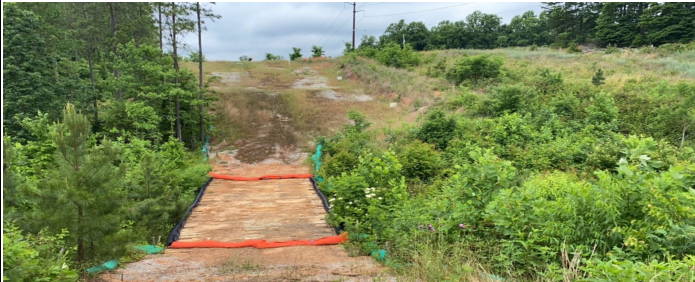
36°58'31" N 79°40'32" W 312°NW COURSE 81° GPS Sorry no results found 06.10.2021 10:33:50 Accur +/-166.3 Ft ALT 867 Ft			36°58'24" N 79°40'25" W 12°N COURSE 81° GPS Sorry no results found 06.10.2021 10:25:35 Accur +/-229.5 Ft ALT 867 Ft		
GPS Location	1	GPS Location	2		
Field Station#	14804+99	Field Station#	14819+00		
Pic 1 Desc.	Equipment bridge and surrounding ECDs in place and functional at stream crossing.		Pic 2 Desc.	ROW stabilized in temporary area.

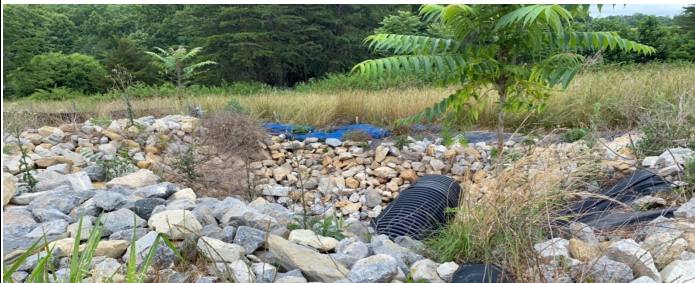
Pic 3 Desc.	Plunge pool performing intended function.		Pic 4 Desc.	Stream clear downstream S-CD8

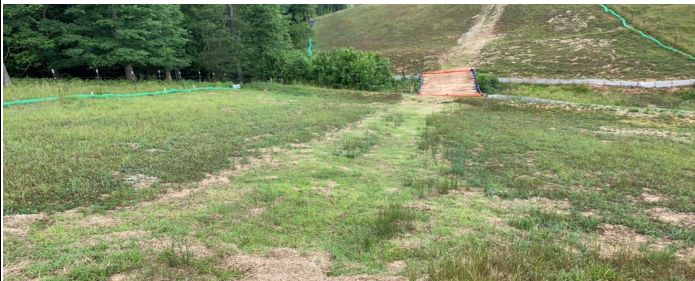
36°58'4" N 79°38'22" W 300°NW COURSE 247° GPS 2019 Ramsey Memorial Rd, Penhook, VA 24137, United States 06.10.2021 09:14:17 Accur +/-58.5 Ft ALT 869 Ft			36°58'4" N 79°38'20" W 315°NW COURSE 124° GPS 2019 Ramsey Memorial Rd, Penhook, VA 24137, United States 06.10.2021 09:13:19 Accur +/-50.7 Ft ALT 868 Ft		
GPS Location	5	GPS Location	6		
Field Station#	14924+00	Field Station#	14926+00		
Pic 5 Desc.	Temporary vegetation growing in travel lane along ROW.		Pic 6 Desc.	CFS triple stack and perimeter CFS performing intended functions.

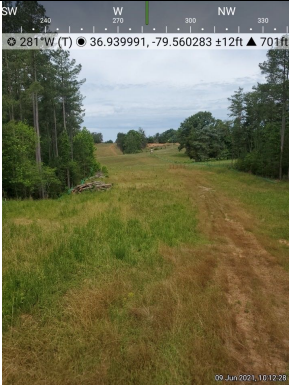
<b>GPS Location</b>	0	<b>GPS Location</b>	0		
<b>Field Station#</b>	15203+00	<b>Field Station#</b>	15195+00		
<b>Pic 1 Desc.</b>	Permanent Revegetation CIS Star Land Rd	<b>Pic 2 Desc.</b>	CFS in natural drainage

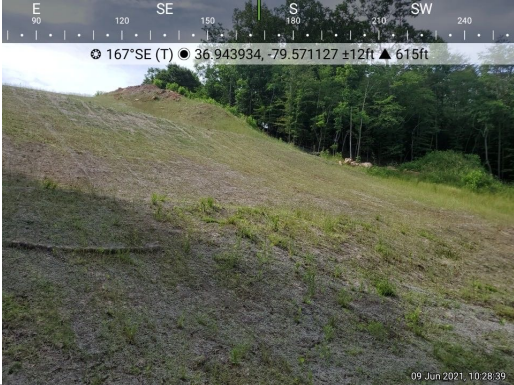
<b>GPS Location</b>	0	<b>GPS Location</b>	0		
<b>Field Station#</b>	15170+00	<b>Field Station#</b>	15165+57		
<b>Pic 3 Desc.</b>	GAS S-C7 Temporary stabilization with matting	<b>Pic 4 Desc.</b>	CWD inlet

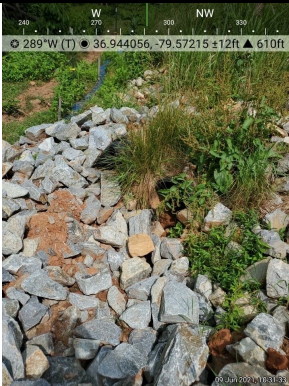
<b>GPS Location</b>	0	<b>GPS Location</b>	0		
<b>Field Station#</b>	15166+00	<b>Field Station#</b>	15160+00		
<b>Pic 5 Desc.</b>	CWD outlet	<b>Pic 6 Desc.</b>	Temporary stabilization and silt fence

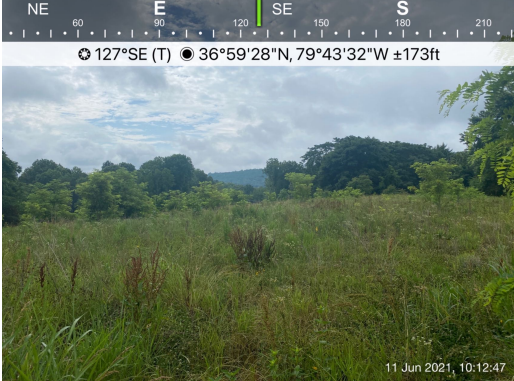
<b>GPS Location</b>	0	<b>GPS Location</b>	0		
<b>Field Station#</b>	14645+50	<b>Field Station#</b>	14635+00		
<b>Pic 1 Desc.</b>	Approximately 14645+50. Overview of ROW.		<b>Pic 2 Desc.</b>	Approximately 14635+00. Overview of ROW.

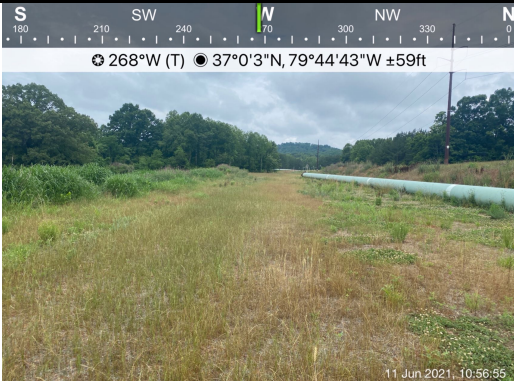
<b>GPS Location</b>	0	<b>GPS Location</b>	0		
<b>Field Station#</b>	14611+30	<b>Field Station#</b>	14599+00		
<b>Pic 3 Desc.</b>	Approximately 14611+30. Overview of stream crossing, equipment bridge and ECDs at stream S-E14.		<b>Pic 4 Desc.</b>	Approximately 14599+00. Overview of road crossing and RCEs.

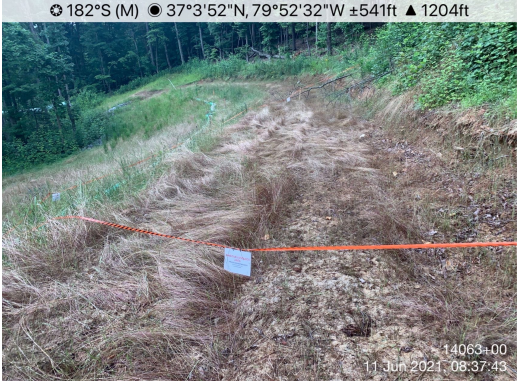
<p>Insert image here</p>			
<b>GPS Location</b>	0	<b>GPS Location</b>			
<b>Field Station#</b>	14063+00	<b>Field Station#</b>			
<b>Pic 7 Desc.</b>	Area flagged off to protected nesting birds. No contractor activity was observed nearby.		<b>Pic 8 Desc.</b>		
<p>Insert image here</p>		<p>Insert image here</p>			
<b>GPS Location</b>		<b>GPS Location</b>			
<b>Field Station#</b>		<b>Field Station#</b>			
<b>Pic 9 Desc.</b>		<b>Pic 10 Desc.</b>			
<p>Insert image here</p>		<p>Insert image here</p>			
<b>GPS Location</b>		<b>GPS Location</b>			
<b>Field Station#</b>		<b>Field Station#</b>			
<b>Pic 11 Desc.</b>		<b>Pic 12 Desc.</b>

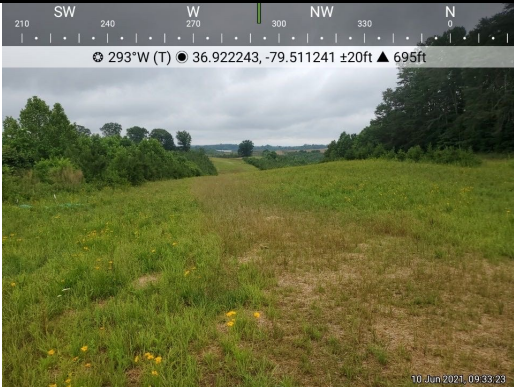
<b>GPS Location</b>	0	<b>GPS Location</b>	0		
<b>Field Station#</b>	15368+00	<b>Field Station#</b>	15359+00		
<b>Pic 1 Desc.</b>	CIS Snowberry Rd stabilization	<b>Pic 2 Desc.</b>	Waterbar outlet protection

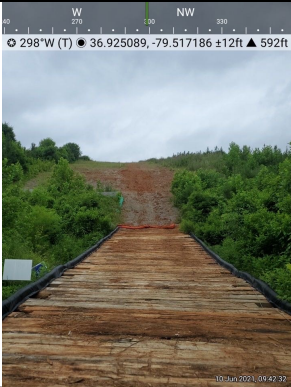
<b>GPS Location</b>	0	<b>GPS Location</b>	0		
<b>Field Station#</b>	15346+70	<b>Field Station#</b>	15338+00		
<b>Pic 3 Desc.</b>	CIS S-H13 Temporary stabilization	<b>Pic 4 Desc.</b>	Clean water diversion plunge pool

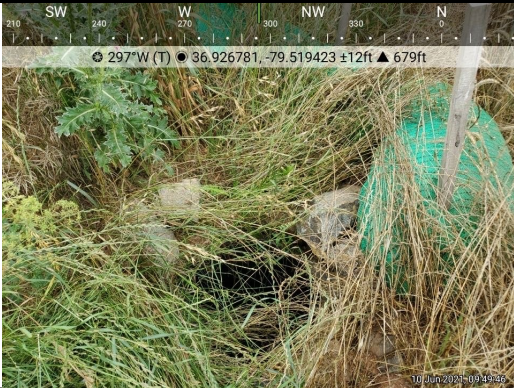
<b>GPS Location</b>	0	<b>GPS Location</b>	0		
<b>Field Station#</b>	15338+00	<b>Field Station#</b>	15330+00		
<b>Pic 5 Desc.</b>	Clean water diversion inlet	<b>Pic 6 Desc.</b>	Drainage stabilization

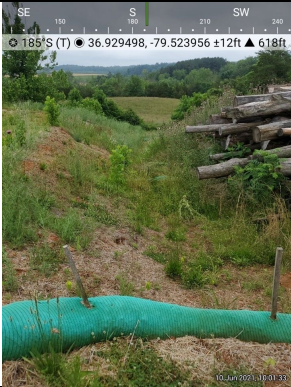
<b>GPS Location</b>	0	<b>GPS Location</b>	0		
<b>Field Station#</b>	15327+00	<b>Field Station#</b>	15320+00		
<b>Pic 7 Desc.</b>	GAS Lark Rd Revegetation	<b>Pic 8 Desc.</b>	CIS Lark Rd drainage stabilization

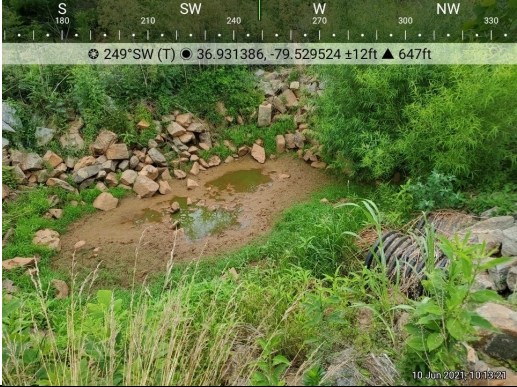
<b>GPS Location</b>	0	<b>GPS Location</b>	0		
<b>Field Station#</b>	15314+00	<b>Field Station#</b>	15305+00		
<b>Pic 9 Desc.</b>	CIS S-C3	<b>Pic 10 Desc.</b>	Plunge pool

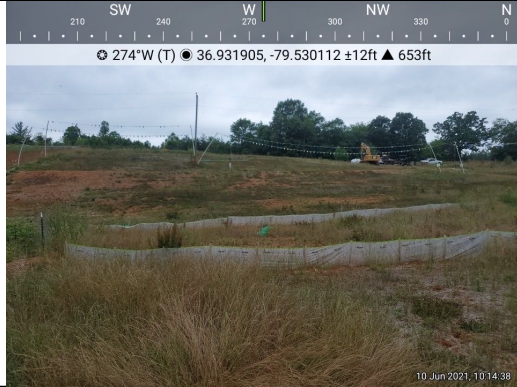
<p style="text-align: center;">Insert image here</p>			
<b>GPS Location</b>	0	<b>GPS Location</b>			
<b>Field Station#</b>	15303+00	<b>Field Station#</b>			
<b>Pic 11 Desc.</b>	GAS Oxford Rd Revegetation	<b>Pic 12 Desc.</b>

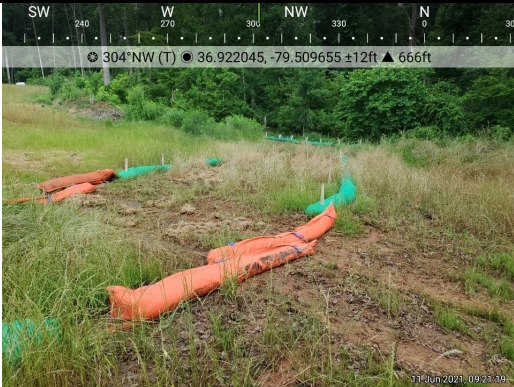
<b>GPS Location</b>	0	<b>GPS Location</b>	0		
<b>Field Station#</b>	15373+00	<b>Field Station#</b>	15395+00		
<b>Pic 1 Desc.</b>	Drainage GAS Snowberry Rd	<b>Pic 2 Desc.</b>	Temporary vegetation

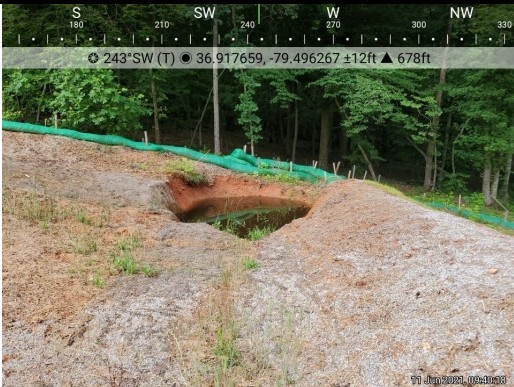
<b>GPS Location</b>	0	<b>GPS Location</b>	0		
<b>Field Station#</b>	15428+00	<b>Field Station#</b>	15437+00		
<b>Pic 3 Desc.</b>	Waterbar & sump	<b>Pic 4 Desc.</b>	Temporary stabilization & buffer zone GAS S-G3

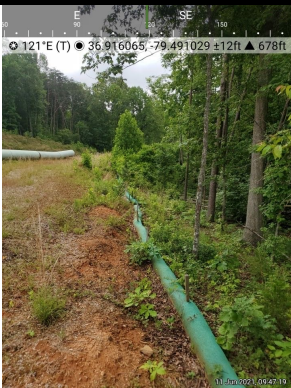
<b>GPS Location</b>	0	<b>GPS Location</b>	0		
<b>Field Station#</b>	15438+00	<b>Field Station#</b>	15442+00		
<b>Pic 5 Desc.</b>	Perimeter CFS	<b>Pic 6 Desc.</b>	Temporary vegetation

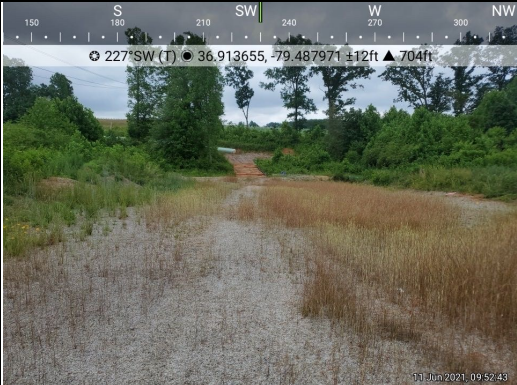
ert image here	
GPS Location	0	GPS Location	0		
Field Station#	15446+00	Field Station#	15453+00		
Pic 7 Desc.	Temporary vegetation CIS S-CC16	Pic 8 Desc.	CFS around rock outlet

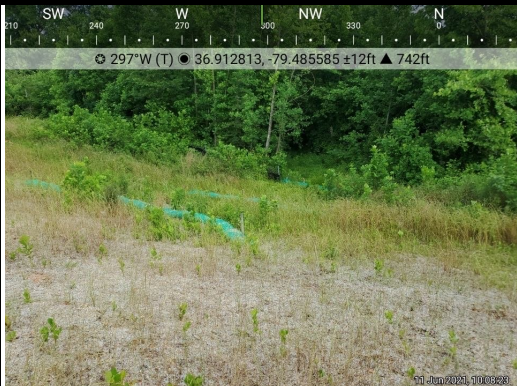
ert image here	
GPS Location	0	GPS Location	0		
Field Station#	15457+00	Field Station#	15473+00		
Pic 9 Desc.	CFS checks in swale	Pic 10 Desc.	Perimeter CFS CIS Toshes Rd

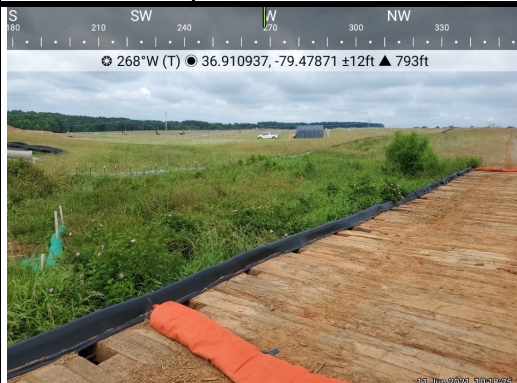
GPS Location	0	GPS Location	0		
Field Station#	15475+00	Field Station#	15540+00		
Pic 11 Desc.	Drainage crossing	Pic 12 Desc.	Temporary vegetation
