# Visual Site Inspection Report

<b>Project Name</b>	H-600 Pipeline Spread G	<b>AFE</b>	124300137	<b>Spread</b>	H-600 Pipeline Spread G
<b>Contractor</b>	Precision			<b>Report #</b>	24519
<b>Inspector</b>	Len Kruizenga			<b>Date/Time</b>	6/14/2021 11:42 AM
<b>Permit #</b>	TBD	<b>Inspection Type</b>	VA SWPP	<b>Station Begin</b>	12005+00
<b>State</b>	VA	<b>Inspection Area</b>	Full	<b>Station End</b>	12005+00
<b>County</b>	Giles	<b>Ground</b>	Wet	<b>Temperature (°F)</b>	77.00
<b>Municipality</b>	N/A	<b>Weather</b>	Sunny	<b>Rain Gauge (in)</b>	0.40
				<b>Rain Accumulation Time (days)</b>	1.00

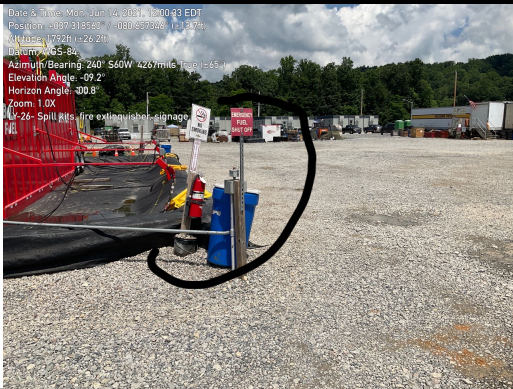
<p>Date &amp; Time: Mon, Jun 14, 2021, 12:00:43 EDT Position: -809.315527° / -080.657351° (15.7ft) Altitude: 1727ft (+26.2ft) Datum: WGS 84 Azimuth/Heading: 240°/540W 426mils True (+65°) Elevation Angle: -69.2° Horizon Angle: +00.8° Zoom: 1.0X LY-26- Spill kits, fire extinguishers, signage are available and visible.</p>

GPS Location	See photo GPS		GPS Location	See photo GPS	
Field Station#	12005+00		Field Station#	12005+00	
Pic 3 Desc.	LY-26- Spill kits, fire extinguishers, signage are available and visible.		Pic 4 Desc.	LY-26- Fuel storage tank in containment.

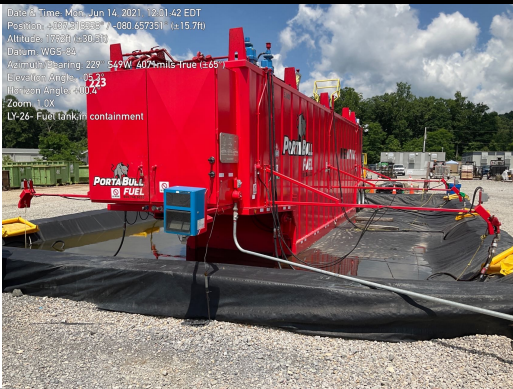
<p>Date &amp; Time: Mon, Jun 14, 2021, 12:01:42 EDT Position: -809.315527° / -080.657351° (15.7ft) Altitude: 1727ft (+26.2ft) Datum: WGS 84 Azimuth/Heading: 239°/549W 407mils True (+65°) Elevation Angle: -65.2° Horizon Angle: +00.4° Zoom: 1.0X LY-26- Fuel tank in containment.</p>

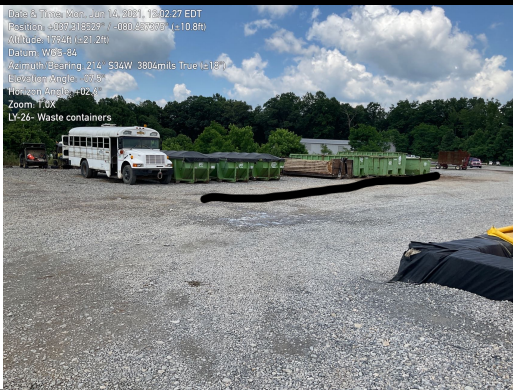
<p>Date &amp; Time: Mon, Jun 14, 2021, 12:02:27 EDT Position: -809.315527° / -080.657351° (15.7ft) Altitude: 1727ft (+26.2ft) Datum: WGS 84 Azimuth/Heading: 214°/534W 380mils True (+65°) Elevation Angle: -57.5° Horizon Angle: +00.2° Zoom: 1.0X LY-26- Waste containers.</p>

Field Station#	12005+00		Field Station#	12005+00	
Pic 5 Desc.	LZy-26- Waste containers.		Pic 6 Desc.	LY-26- Fuel additive tote and light plant in secondary containment unit.

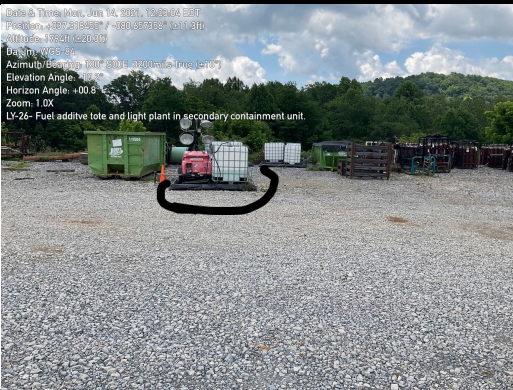
<p>Date &amp; Time: Mon, Jun 14, 2021, 12:04:00 EDT Position: -809.315527° / -080.657351° (15.7ft) Altitude: 1727ft (+26.2ft) Datum: WGS 84 Azimuth/Heading: 100°/501E 320mils True (+65°) Elevation Angle: -57.5° Horizon Angle: +00.8° Zoom: 1.0X LY-26- Fuel additive tote and light plant in secondary containment unit.</p>			
GPS Location	See photo GPS		GPS Location	See photo GPS

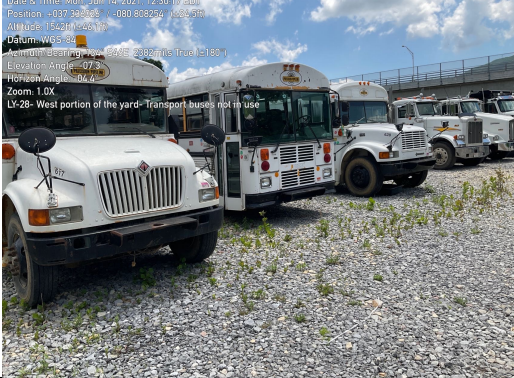
<b>A/E</b>	124300137	<b>Date/Time</b>	6/14/2021 12:31 PM	<b>Report #</b>	
<b>Pictures</b>					
<p>Date &amp; Time: Mon, Jun 14, 2021 12:30:17 EDT  Position: +037.332828° / +080.802548° (+148.6ft)  Altitude: 1521.4ft (+461.7ft)  Datum: WGS-84  Azimuth/Bearing: 179° S17W 3102mils True (+50°)  Elevation Angle: -07.3°  Horizon Angle: +00.5°  Zoom: 1.0X  LY-28- West portion of the yard- Transport buses not in use.</p>

<b>GPS Location</b>	See photo GPS	<b>GPS Location</b>	See photo GPS		
<b>Field Station#</b>	12005+00	<b>Field Station#</b>	12005+00		
<b>Pic 1 Desc.</b>	LY-28- West portion of the yard,- transport buses stored, not in use.	<b>Pic 2 Desc.</b>	LY-28- west yard- Trailers not in use, stored.

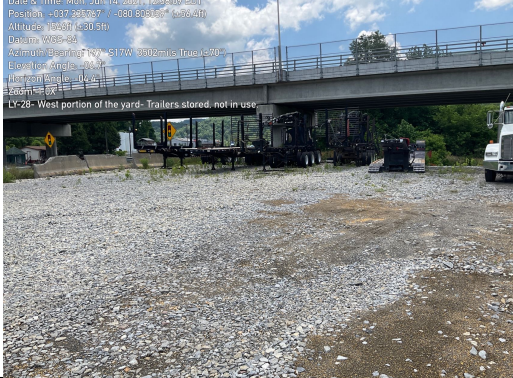
<p>Date &amp; Time: Mon, Jun 14, 2021 12:30:58 EDT  Position: +037.332828° / +080.802548° (+148.6ft)  Altitude: 1521.4ft (+461.7ft)  Datum: WGS-84  Azimuth/Bearing: 179° S17W 3102mils True (+50°)  Elevation Angle: -07.3°  Horizon Angle: +00.5°  Zoom: 1.0X  LY-28- West portion of the yard- Trailers stored, not in use.</p>

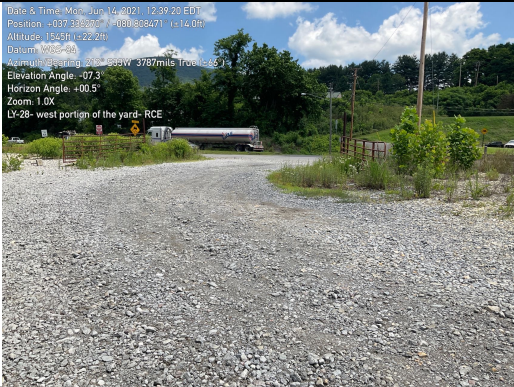
<p>Date &amp; Time: Mon, Jun 14, 2021 12:39:20 EDT  Position: +037.332828° / +080.802147° (+14.0ft)  Altitude: 1555ft (+472.2ft)  Datum: WGS-84  Azimuth/Bearing: 233° N76W 3787mils True (+10°)  Elevation Angle: -07.3°  Horizon Angle: +00.5°  Zoom: 1.0X  LY-28- west portion of the yard- RCE</p>

<b>GPS Location</b>	See photo GPS	<b>GPS Location</b>	See photo GPS		
<b>Field Station#</b>	12005+00	<b>Field Station#</b>	12005+00		
<b>Pic 3 Desc.</b>	LY-28- West portion of the yard- RCE	<b>Pic 4 Desc.</b>	LY- 28- East portion of the yard- CFS perimeter controls.		
<p>Date &amp; Time: Mon, Jun 14, 2021 12:49:03 EDT  Position: +037.332828° / +080.803383° (+148.6ft)  Altitude: 1554ft (+44.9ft)  Datum: WGS-84  Azimuth/Bearing: 223° S43W 3924mils True (+30°)  Elevation Angle: -07.3°  Horizon Angle: +00.5°  Zoom: 1.0X  LY-28- East portion of the yard- Waste containers.</p>

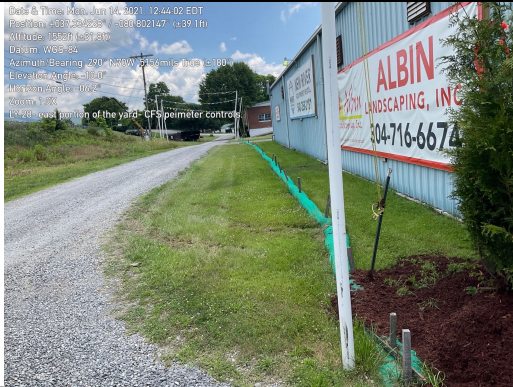
<p>Date &amp; Time: Mon, Jun 14, 2021 12:44:02 EDT  Position: +037.332828° / +080.802147° (+14.0ft)  Altitude: 1555ft (+472.2ft)  Datum: WGS-84  Azimuth/Bearing: 230° N76W 3787mils True (+10°)  Elevation Angle: -07.3°  Horizon Angle: +00.5°  Zoom: 1.0X  LY-28- east portion of the yard- CFS perimeter controls.</p>

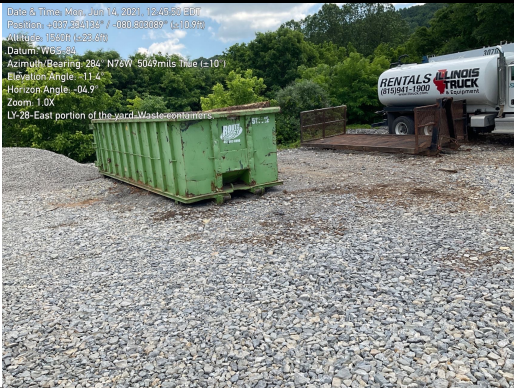
<b>GPS Location</b>	See photo GPS	<b>GPS Location</b>	See photo GPS		
<b>Field Station#</b>	12005+00	<b>Field Station#</b>	12005-00		
<b>Pic 5 Desc.</b>	LY-28- East portion of the yard- waste containment.	<b>Pic 6 Desc.</b>	LY-28- West portion of the yard- Trucks not in use with containment under motors.

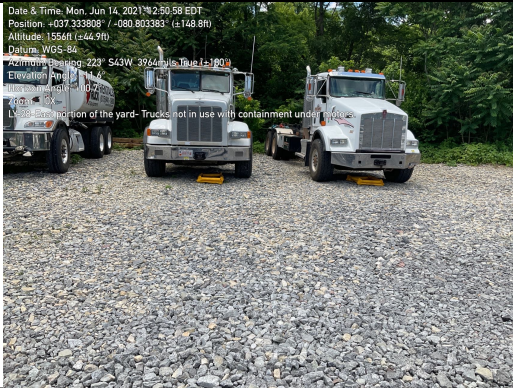
<p>Date &amp; Time: Mon, Jun 14, 2021 12:50:58 EDT  Position: +037.332828° / +080.803383° (+148.6ft)  Altitude: 1554ft (+44.9ft)  Datum: WGS-84  Azimuth/Bearing: 223° S43W 3924mils True (+30°)  Elevation Angle: -07.3°  Horizon Angle: +00.5°  Zoom: 1.0X  LY-28- West portion of the yard- Trucks not in use with containment under motors.</p>

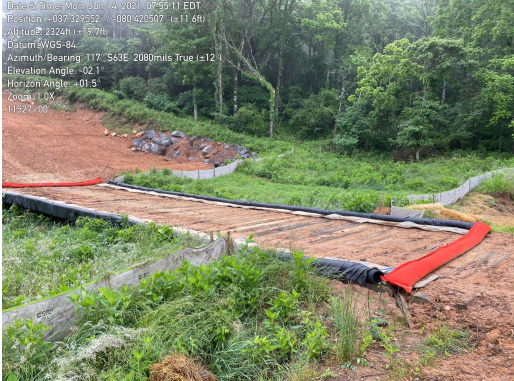
<b>GPS Location</b>	See photo	<b>GPS Location</b>	See photo		
<b>Field Station#</b>	11527+00	<b>Field Station#</b>	11537+00		
<b>Pic 1 Desc.</b>	Clean water drainage feature in place	<b>Pic 2 Desc.</b>	P1 silt fence perimeter control in place		
<p><small>Date &amp; Time: Mon, Jun 14, 2021, 08:05:22 EDT Position: +037.21535° / -080.419803° (±15.0ft) Altitude: 2315ft (±15.0ft) Datum: WGS-84 Azimuth/Bearing: 291.146W 5173mils True (±12°) Elevation Angle: -26.1° Horizon Angle: -00.9° Zoom: 1.0X 11528+50</small></p>

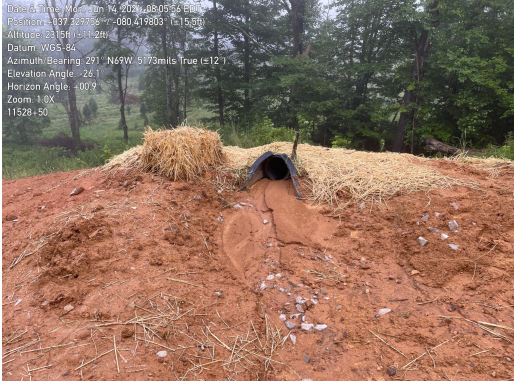
<b>GPS Location</b>	See photo	<b>GPS Location</b>	See photo		
<b>Field Station#</b>	11528+50	<b>Field Station#</b>	11543+00		
<b>Pic 3 Desc.</b>	Rock inlet protection needs cleaned out	<b>Pic 4 Desc.</b>	CFS end treatment needs cleaned off		
<p><small>Date &amp; Time: Mon, Jun 14, 2021, 09:16:16 EDT Position: +037.21724° / -080.40662° (±15.3ft) Altitude: 2362ft (±11.4ft) Datum: WGS-84 Azimuth: -147.2613E (±12°) Elevation Angle: +18.4° Horizon Angle: +17.1° Zoom: 1.0X 11562+00</small></p>

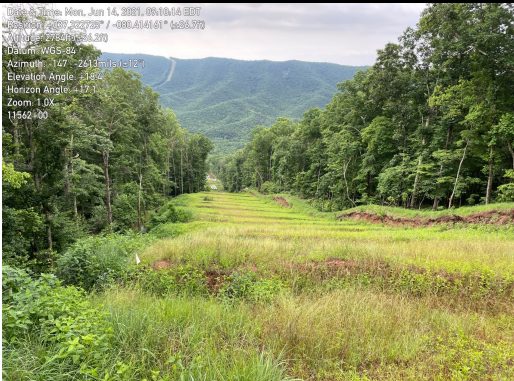
<b>GPS Location</b>	See photo	<b>GPS Location</b>	See photo		
<b>Field Station#</b>	11562+00	<b>Field Station#</b>	11586+00		
<b>Pic 5 Desc.</b>	Waterbars in place	<b>Pic 6 Desc.</b>	Stream buffer in place

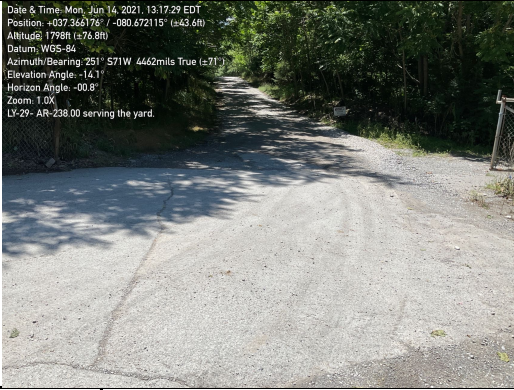
<b>AFE</b>	124300137	<b>Date/Time</b>	6/14/2021 1:14 PM	<b>Report #</b>	
<b>Pictures</b>					
<p>Date &amp; Time: Mon, Jun 14, 2021, 13:17:29 EDT  Position: -037.363782° / -080.672115° (±43.6ft)  Altitude: 1798ft (±76.8ft)  Datum: WGS-84  Azimuth/Bearing: 251° 571W 4462mils True (±71°)  Elevation Angle: -14.1°  Horizon Angle: -00.8°  Zoom: 1.0X  LY-29- AR-238.00 serving the yard.</p>

<p>Date &amp; Time: Mon, Jun 14, 2021, 13:26:59 EDT  Position: -037.363807° / -080.675042° (±44.9ft)  Altitude: 1838ft (±76.8ft)  Datum: WGS-84  Azimuth/Bearing: 134° 00W 1601mils True (±50°)  Elevation Angle: -14.3°  Horizon Angle: -01.2°  Zoom: 1.0X  LY-29- Overview of the yard.</p>  			
<b>GPS Location</b>	See photo GPS		<b>GPS Location</b>	See photo GPS	
<b>Field Station#</b>	12005+00		<b>Field Station#</b>	12005+00	
<b>Pic 1 Desc.</b>	LY-29- AR-238.00 is maintained in acceptable condition.		<b>Pic 2 Desc.</b>	LY-29- Overview of the yard.

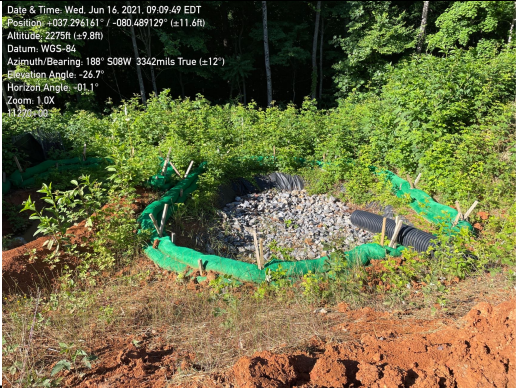
<b>GPS Location</b>	See photo	<b>GPS Location</b>	See photo		
<b>Field Station#</b>	11270+00	<b>Field Station#</b>	11324+00		
<b>Pic 5 Desc.</b>	Plunge pool in place	<b>Pic 6 Desc.</b>	Waterbars in place

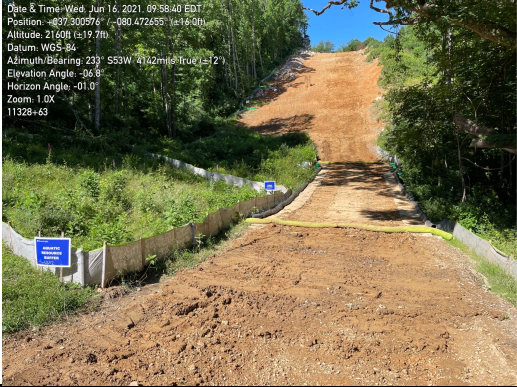
<b>GPS Location</b>	See photo	<b>GPS Location</b>	See photo		
<b>Field Station#</b>	11328+63	<b>Field Station#</b>	11363+00		
<b>Pic 7 Desc.</b>	Stream buffer in place	<b>Pic 8 Desc.</b>	Stream buffer in place		
<p>Date &amp; Time: Wed, Jun 16, 2021 11:09:27 EDT  Position: +037 310146 / -080 456213 (±11.6ft)  Altitude: 2220ft (±19.7ft)  Datum: WGS-84  Azimuth/Bearing: 277° N83W 4926mils True (±13°)  Elevation Angle: +11.6°  Horizon Angle: -00.9°  Zoom: 1.0X  11391+50</p>

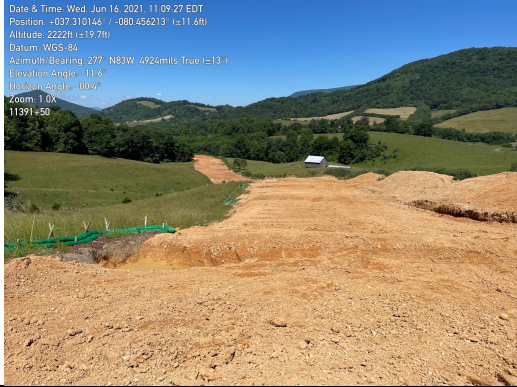
<b>GPS Location</b>	See photo	<b>GPS Location</b>	See photo		
<b>Field Station#</b>	11391+50	<b>Field Station#</b>	11498+50		
<b>Pic 9 Desc.</b>	End treatments in place	<b>Pic 10 Desc.</b>	CFS perimeter control in place		
<p>Date &amp; Time: Wed, Jun 16, 2021 12:30:30 EDT  Position: +037 328349 / -080 423113 (±11.6ft)  Altitude: 2237ft (±9.8ft)  Datum: WGS-84  Azimuth/Bearing: 121° S59E 2151mils True (±12°)  Elevation Angle: -01.2°  Horizon Angle: -01.9°  Zoom: 1.0X  11518+00</p>

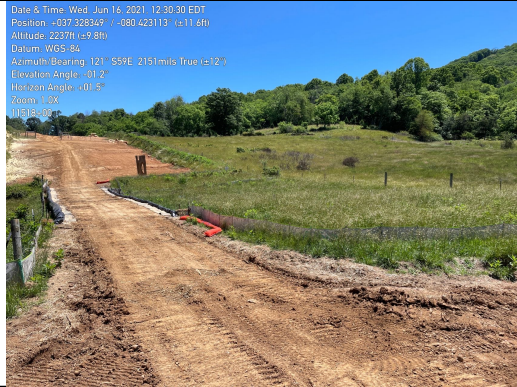
<b>GPS Location</b>	See photo	<b>GPS Location</b>	See photo		
<b>Field Station#</b>	11518+00	<b>Field Station#</b>	11337+50		
<b>Pic 11 Desc.</b>	Stream buffer in place	<b>Pic 12 Desc.</b>	P1 perimeter control in place

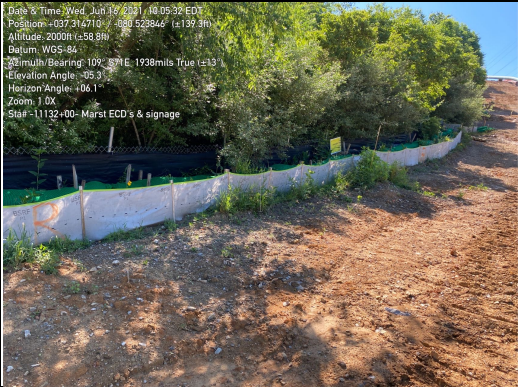
<p>Date &amp; Time: Wed Jun 16 2021 10:05:32 EDT Position: +037 314710 / -080 523846 (+139.3m) Altitude: 2000ft (+58.8m) Datum: WGS-84 Azimuth/Bearing: 109° S31E 1938mils True (+13°) Elevation Angle: +35.3° Horizon Angle: +06.1° Zoom: 1.0X Staff: 11132+00- Marst ECD's &amp; signage</p>

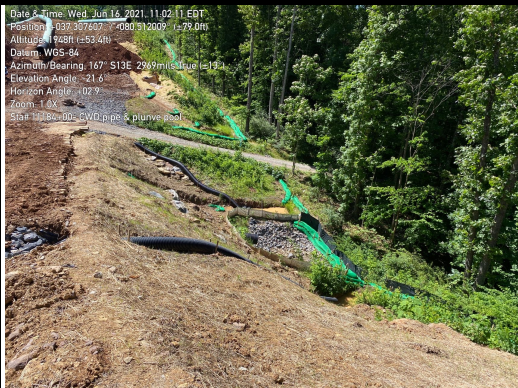
<p>Date &amp; Time: Wed Jun 16 2021 11:02:11 EDT Position: +037 314710 / -080 523846 (+139.3m) Altitude: 1810ft (+55.7m) Datum: WGS-84 Azimuth/Bearing: 167° S13E 2069mils True (+13°) Elevation Angle: +21.6° Horizon Angle: +02.9° Zoom: 1.0X Staff: 11184+00- CWD pipe &amp; plunge pool</p>

GPS Location	See photo GPS		GPS Location	See photo GPS	
Field Station#	11184+00		Field Station#	11191+00	
Pic 9 Desc.	CWD pipe and plunge pool, slope drains.		Pic 10 Desc.	Sensitive resource ECD's/ drainage feature.

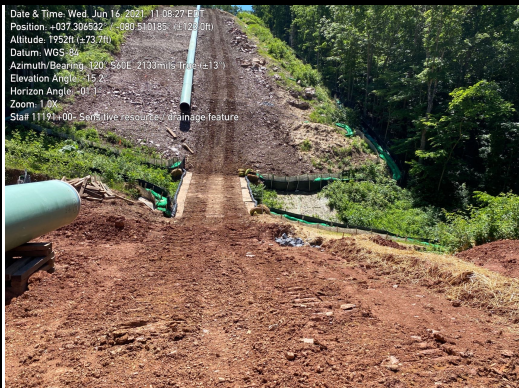
<p>Date &amp; Time: Wed Jun 16 2021 11:08:27 EDT Position: +037 304932 / -080 510185 (+127.0m) Altitude: 1950ft (+59.4m) Datum: WGS-84 Azimuth/Bearing: 120° S45E 2133mils True (+13°) Elevation Angle: +15.2° Horizon Angle: +01.1° Zoom: 1.0X Staff: 11191+00- Sensitive resource drainage feature</p>

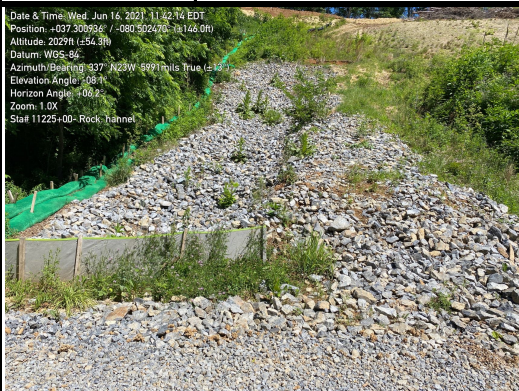
<p>Date &amp; Time: Wed Jun 16 2021 11:42:14 EDT Position: +037 300936 / -080 504710 (+146.0m) Altitude: 2029ft (+61.8m) Datum: WGS-84 Azimuth/Bearing: 037° N23W 5991mils True (+13°) Elevation Angle: +08.4° Horizon Angle: +08.3° Zoom: 1.0X Staff: 11225+00- Rock channel</p>	
GPS Location	See photo GPS		GPS Location	See photo GPS	
Field Station#	11206+00		Field Station#	11225+00

Pic 11 Desc.	Pipe carrying water from water bar across ditch to sump pit.		Pic 12 Desc.	Rock channel.

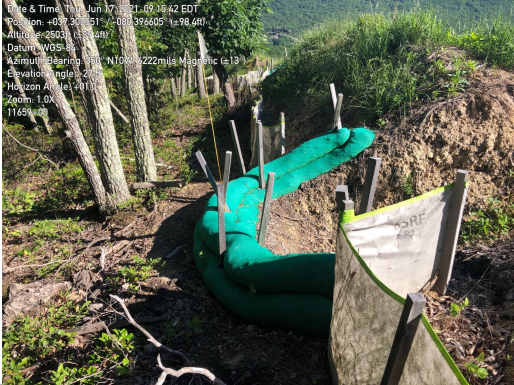
<b>GPS Location</b>	On photo	<b>GPS Location</b>	On photo		
<b>Field Station#</b>	11659+00	<b>Field Station#</b>	11638+00		
<b>Pic 3 Desc.</b>	Perimeter controls in place.	<b>Pic 4 Desc.</b>	Perimeter controls are in place.

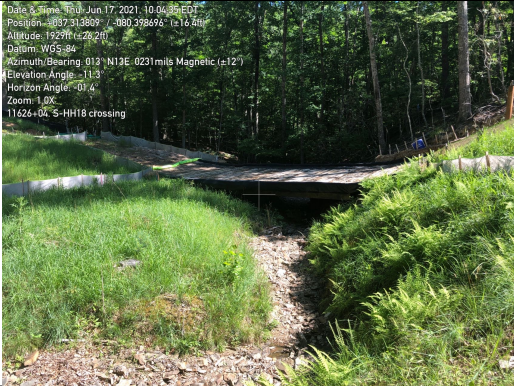
<b>GPS Location</b>	On photo	<b>GPS Location</b>	On photo		
<b>Field Station#</b>	11616+04	<b>Field Station#</b>	11614+20		
<b>Pic 5 Desc.</b>	The S-HH18 crossing is stable.	<b>Pic 6 Desc.</b>	The S-RR14 crossing is stable.

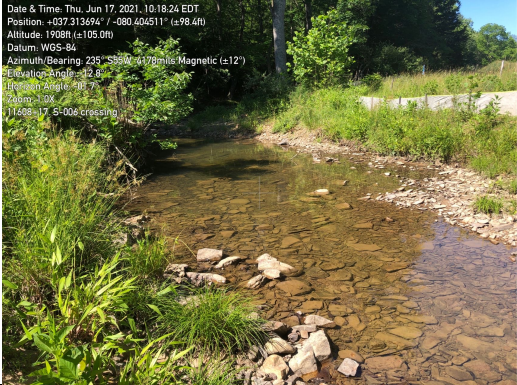
<p><small>Date &amp; Time: Thu, Jun 17, 2021, 10:18:24 EDT Position: +037.313694° / -080.404511° (±98.4ft) Altitude: 1908ft (±105.0ft) Datum: WGS-84 Azimuth/Bearing: 235°/235M (±178mils Magnetic (±12°) Elevation Angle: 13.0° Horizon Angle: 90.7° Zoom: 1.0X 11608+17 S-006 crossing</small></p>

<p><small>Date &amp; Time: Thu, Jun 17, 2021, 10:21:45 EDT Position: +037.308338° / -080.420459° (±10728.2ft) Altitude: 1917ft (±59.4ft) Datum: WGS-84 Azimuth/Bearing: 105°/215L (1847mils Magnetic (±12°) Elevation Angle: 26.7° Horizon Angle: 90.2° Zoom: 1.0X 11602+00</small></p>			
<b>GPS Location</b>	On photo	<b>GPS Location</b>	On photo		
<b>Field Station#</b>	11608+17	<b>Field Station#</b>	11602+00		
<b>Pic 7 Desc.</b>	The S-006 crossing is stable.	<b>Pic 8 Desc.</b>	ROW currently stable.		
Insert image here		Insert image here

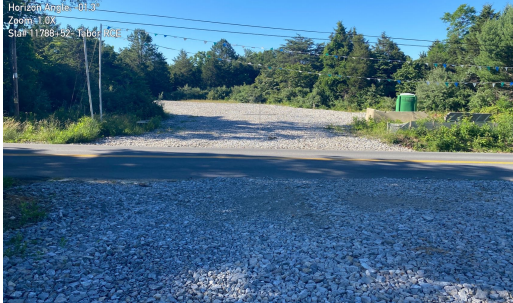
AFE 124300137		Date/Time 6/17/2021 4:26 PM		Report #	
Pictures					
<p>Date &amp; Time: Thu Jun 17 2021 08:53:33 EDT Position: +037 234252+ / -080 345865+ (+225.0ft) Altitude: 2137ft (+68.9ft) Datum: WGS-84 Azimuth/Bearing: 100° S00E 3200mils True (+16°) Elevation Angle: +0.8 Horizon Angle: +0.3 Zoom: 1.0x Sta# 11786+53 - Level spreaders</p>

GPS Location	See photo GPS		GPS Location	See photo GPS	
Field Station#	11788+53		Field Station#	11786+00	
Pic 1 Desc.	Tabor RCE		Pic 2 Desc.	Level spreaders and controls, row vegetation.	
<p>Date &amp; Time: Thu Jun 17 2021 09:19:39 EDT Position: +037 232526+ / -080 350750+ (+135.9ft) Altitude: 2234ft (+67.9ft) Datum: WGS-84 Azimuth/Bearing: 109° S14W 3240mils True (+16°) Elevation Angle: +10.1 Horizon Angle: +00.2 Zoom: 1.0x Sta# 11832+00 - Karst level spreaders perimeter controls</p>

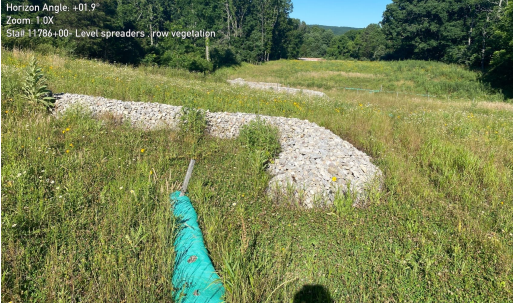
<p>Date &amp; Time: Thu Jun 17 2021 09:02:45 EDT Position: +037 287254+ / -080 345706+ (+198.2ft) Altitude: 2145ft (+64.0ft) Datum: WGS-84 Azimuth/Bearing: 259° S4°W 3200mils True (+16°) Elevation Angle: +11.5 Horizon Angle: +01.9 Zoom: 1.0x Sta# 11786+00 - Level spreaders - row vegetation</p>

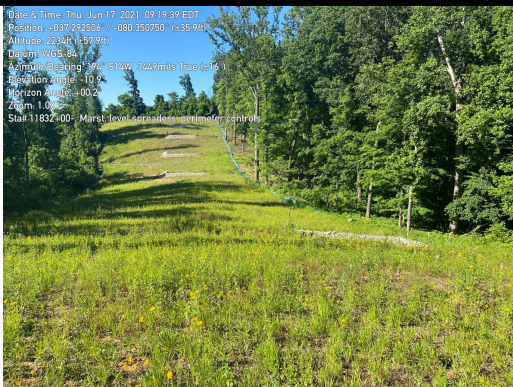
GPS Location	See photo GPS		GPS Location	See photo GPS	
Field Station#	11832+00		Field Station#	11846+00	
Pic 3 Desc.	Karst, level spreaders, perimeter controls.		Pic 4 Desc.	Row conditions, and very good vegetation.	
<p>Date &amp; Time: Thu Jun 17 2021 09:46:49 EDT Position: +037 208822+ / -080 344283+ (+59.0ft) Altitude: 2137ft (+52.2ft) Datum: WGS-84 Azimuth/Bearing: 032° N03E 0569mils True (+14°) Elevation Angle: +15.5 Horizon Angle: +01.3 Zoom: 1.0x Sta# 11864+00 - Wetland is muddy, no standing water</p>

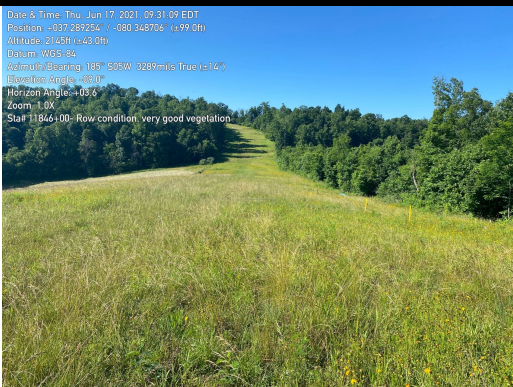
<p>Date &amp; Time: Thu Jun 17 2021 09:31:09 EDT Position: +037 287254+ / -080 345706+ (+199.0ft) Altitude: 2145ft (+63.0ft) Datum: WGS-84 Azimuth/Bearing: 109° S08W 3289mils True (+14°) Elevation Angle: +03.0 Horizon Angle: +03.6 Zoom: 1.0x Sta# 11846+00 - Row condition: very good vegetation</p>

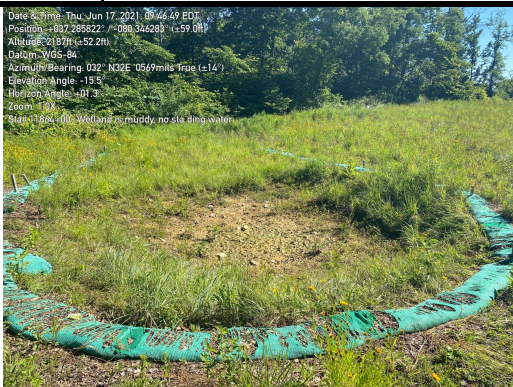
Pic 5 Desc.	Wetland is muddy but no standing water.		Pic 6 Desc.	Access road and bar ditch ECD's.

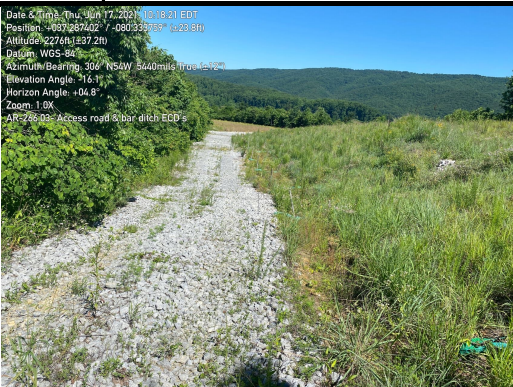
<p>Date &amp; Time: Thu Jun 17 2021 10:18:21 EDT Position: +037 209402+ / -080 320189+ (+43.0ft) Altitude: 2276ft (+67.2ft) Datum: WGS-84 Azimuth/Bearing: 306° NSW 3440mils True (+13°) Elevation Angle: +16.1 Horizon Angle: +04.8 Zoom: 1.0x AR-248-03 - Access road &amp; bar ditch ECD's</p>

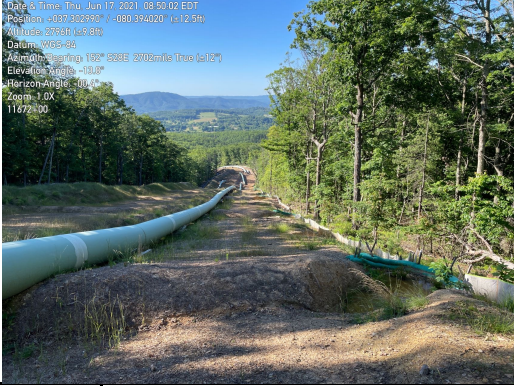
<b>GPS Location</b>	See photo	<b>GPS Location</b>	See photo		
<b>Field Station#</b>	11672+00	<b>Field Station#</b>	11686+80		
<b>Pic 1 Desc.</b>	End treatments in place	<b>Pic 2 Desc.</b>	Stream buffer in place

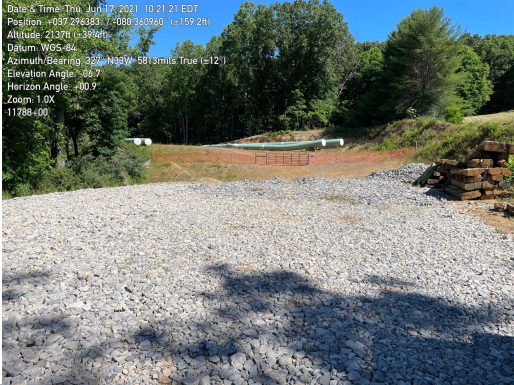
<b>GPS Location</b>	See photo	<b>GPS Location</b>	See photo		
<b>Field Station#</b>	11788+00	<b>Field Station#</b>	11771+00		
<b>Pic 3 Desc.</b>	RCE in place	<b>Pic 4 Desc.</b>	Supersilt fence perimeter control in place

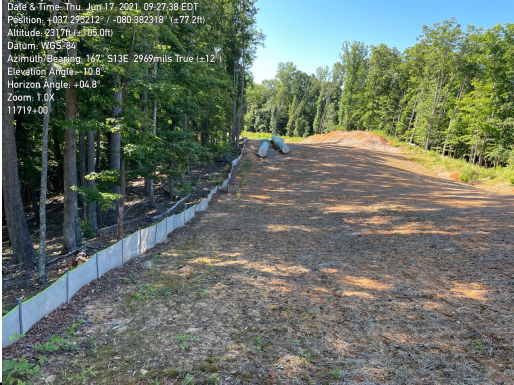
<b>GPS Location</b>	See photo	<b>GPS Location</b>	See photo		
<b>Field Station#</b>	11719+00	<b>Field Station#</b>	11723+50		
<b>Pic 5 Desc.</b>	P1 silt fence perimeter control in place	<b>Pic 6 Desc.</b>	Good vegetation on topsoil pile

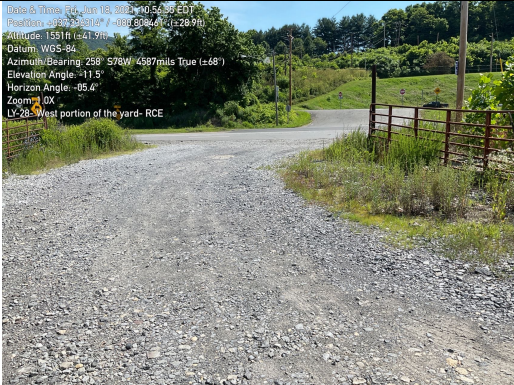
<p>Date &amp; Time: Fri Jun 18, 2021, 10:56:55 EDT Position: +4373.33603° / +480.83630° (+28.3m) Altitude: 1539ft (+43.2m) Datum: WGS-84 Azimuth/Bearing: 258° S78W 4387mils True (±68°) Elevation Angle: +11.5° Horizon Angle: -05.4° Zoom: 1.0X LY-28- West portion of the yard- RCE</p>

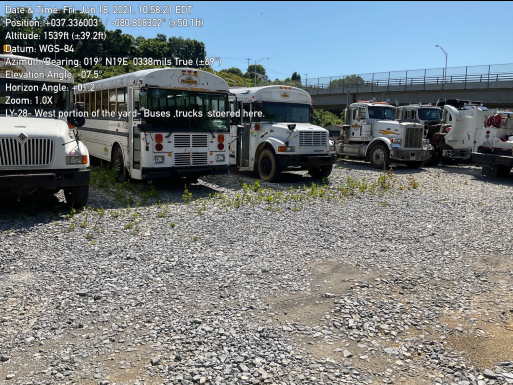
<p>Date &amp; Time: Fri Jun 18, 2021, 10:58:01 EDT Position: +4373.33603° / +480.83630° (+28.3m) Altitude: 1539ft (+43.2m) Datum: WGS-84 Azimuth/Bearing: 019° N19E 0338mils True (±55°) Elevation Angle: -07.5° Horizon Angle: -05.4° Zoom: 1.0X LY-28- West portion of the yard- Buses trucks stored here.</p>			
<b>GPS Location</b>	See photo GPS	<b>GPS Location</b>	See photo GPS		
<b>Field Station#</b>	12005+00	<b>Field Station#</b>	12005+00		
<b>Pic 1 Desc.</b>	LY-28- west portion of the yard- RCE	<b>Pic 2 Desc.</b>	LY-28- West portion of the yard- Buses and trucks stored, not currently in use.

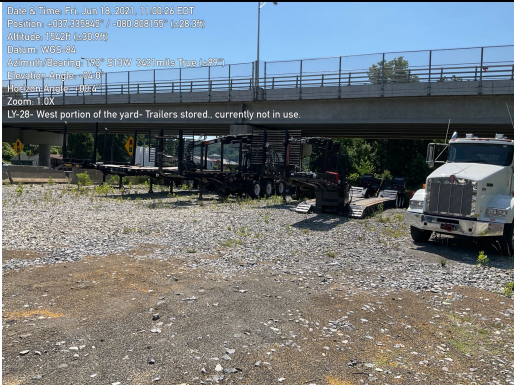
<p>Date &amp; Time: Fri Jun 18, 2021, 11:05:20 EDT Position: +4373.33603° / +480.83630° (+28.3m) Altitude: 1539ft (+43.2m) Datum: WGS-84 Azimuth/Bearing: 170° S170W 5991mils True (±180°) Elevation Angle: -09.0° Horizon Angle: -05.4° Zoom: 1.0X LY-28- West portion of the yard- Trailers stored, currently not in use.</p>

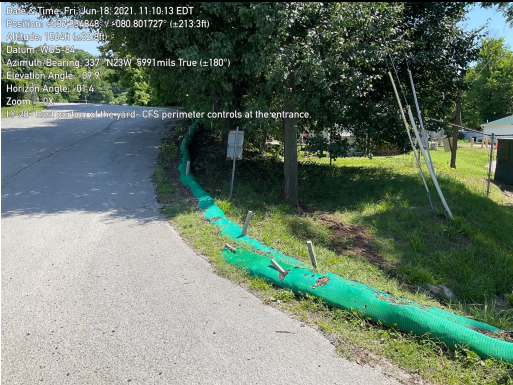
<p>Date &amp; Time: Fri Jun 18, 2021, 11:10:13 EDT Position: +4373.33603° / +480.83630° (+28.3m) Altitude: 1539ft (+43.2m) Datum: WGS-84 Azimuth/Bearing: 320° N29W 5991mils True (±180°) Elevation Angle: -09.0° Horizon Angle: -05.4° Zoom: 1.0X LY-28- East portion of the yard- CFS perimeter controls at the entrance.</p>			
<b>GPS Location</b>	See photo GPS	<b>GPS Location</b>	See photo GPS		
<b>Field Station#</b>	12005+00	<b>Field Station#</b>	12005+00		
<b>Pic 3 Desc.</b>	LY-28- West portion of the yard- Trailers not in use stored here.	<b>Pic 4 Desc.</b>	LY-28- East portion of the yard- CFS perimeter controls at yard entrance.

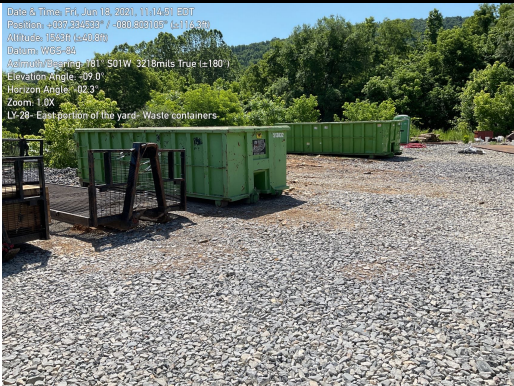
<p>Date &amp; Time: Fri Jun 18, 2021, 11:16:45 EDT Position: +4373.33603° / +480.83630° (+28.3m) Altitude: 1539ft (+43.2m) Datum: WGS-84 Azimuth/Bearing: 161° S01W 3218mils True (±180°) Elevation Angle: -09.0° Horizon Angle: -02.3° Zoom: 1.0X LY-28- East portion of the yard- Waste containers.</p>

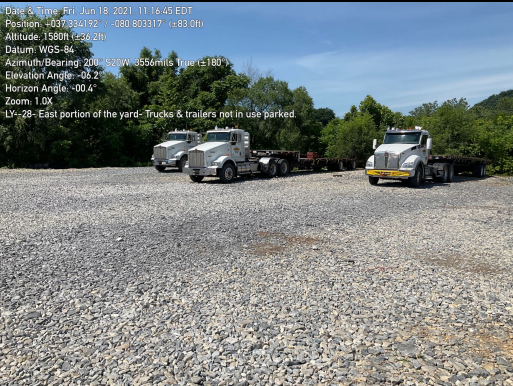
<p>Date &amp; Time: Fri Jun 18, 2021, 11:16:45 EDT Position: +4373.33603° / +480.83630° (+28.3m) Altitude: 1539ft (+43.2m) Datum: WGS-84 Azimuth/Bearing: 200° S20W 3556mils True (±180°) Elevation Angle: -06.2° Horizon Angle: -00.4° Zoom: 1.0X LY-28- East portion of the yard- Trucks &amp; trailers not in use parked.</p>			
<b>GPS Location</b>	See photo GPS	<b>GPS Location</b>	See photo GPS		
<b>Field Station#</b>	12005+00	<b>Field Station#</b>	12005+00		
<b>Pic 5 Desc.</b>	LY-28- East portion of the yard- Waste containers.	<b>Pic 6 Desc.</b>	LY-28- East portion of the yard- Trucks and trailers not in use today parked.

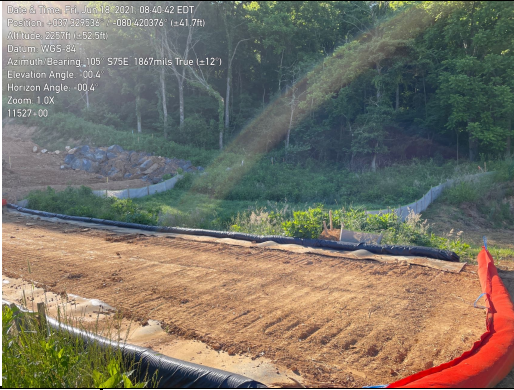
<b>GPS Location</b>	See photo	<b>GPS Location</b>	See photo		
<b>Field Station#</b>	11527+00	<b>Field Station#</b>	11543+00		
<b>Pic 1 Desc.</b>	Clean water drainage feature in place	<b>Pic 2 Desc.</b>	End treatments in place

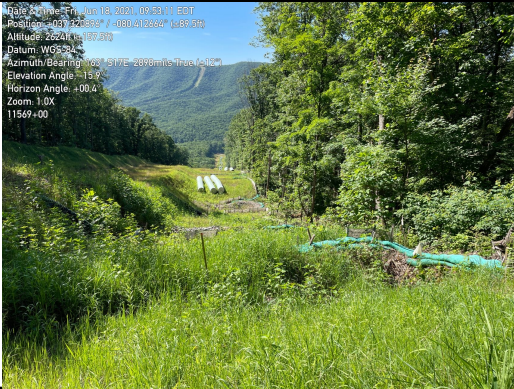
<b>GPS Location</b>	See photo	<b>GPS Location</b>	See photo		
<b>Field Station#</b>	11569+00	<b>Field Station#</b>	11558+00		
<b>Pic 3 Desc.</b>	ECDs in place	<b>Pic 4 Desc.</b>	Waterbars in place

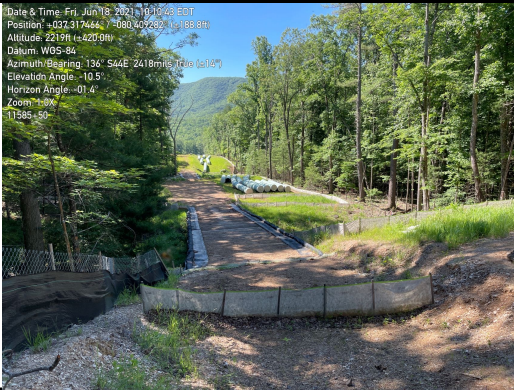
<b>GPS Location</b>	See photo	<b>GPS Location</b>	See photo		
<b>Field Station#</b>	11585+50	<b>Field Station#</b>	11592+00		
<b>Pic 5 Desc.</b>	Stream buffer in place	<b>Pic 6 Desc.</b>	P1 silt fence perimeter control in place

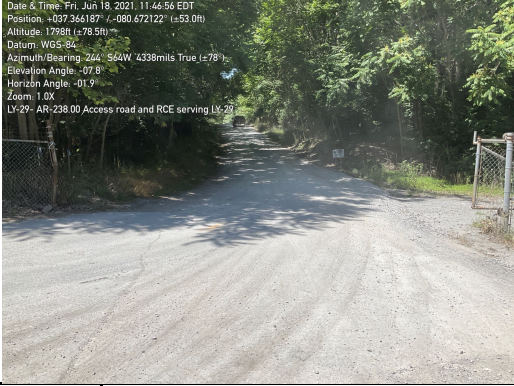
<p>Date &amp; Time: Fri, Jun 18, 2021, 11:46:56 EDT Position: +037.344197° / -080.672122° (+53.0ft) Altitude: 1798ft (+78.5ft) Datum: WGS-84 Azimuth/Bearing: 264.564W 4338mils True (+78°) Elevation Angle: -07.8° Horizon Angle: -01.9° Zoom: 1.0X LY-29- AR-238.00 Access road and RCE serving LY-29</p>

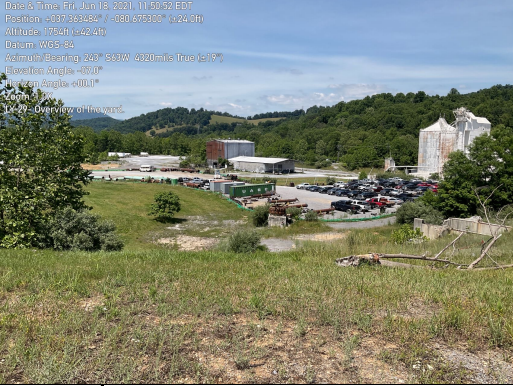
<p>Date &amp; Time: Fri, Jun 18, 2021, 11:50:02 EDT Position: +037.3438160° / -080.675000° (+54.0ft) Altitude: 1842ft (+82.0ft) Datum: WGS-84 Azimuth/Bearing: 406° S64W 4020mils True (+74°) Elevation Angle: -00.0° Horizon Angle: +00.0° Zoom: 1.0X LY-29- Overview of the yard.</p>			
<b>GPS Location</b>	See photo GPS	<b>GPS Location</b>	See photo GPS		
<b>Field Station#</b>	12005+00	<b>Field Station#</b>	12005+00		
<b>Pic 1 Desc.</b>	LY-29- AR-238.00 access road and RCE serving LY-29	<b>Pic 2 Desc.</b>	LY-29 Overview of the yard.

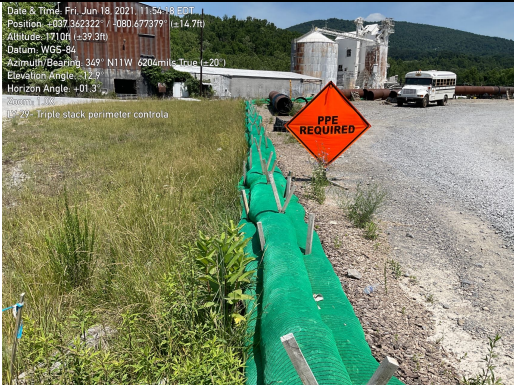
<p>Date &amp; Time: Fri, Jun 18, 2021, 11:56:16 EDT Position: +037.362222° / -080.677379° (+14.7ft) Altitude: 1710ft (+39.3ft) Datum: WGS-84 Azimuth/Bearing: 342° N11W 6204mils True (+20°) Elevation Angle: -12.9° Horizon Angle: +01.3° Zoom: 1.0X LY-29- Triple stack perimeter controls</p>

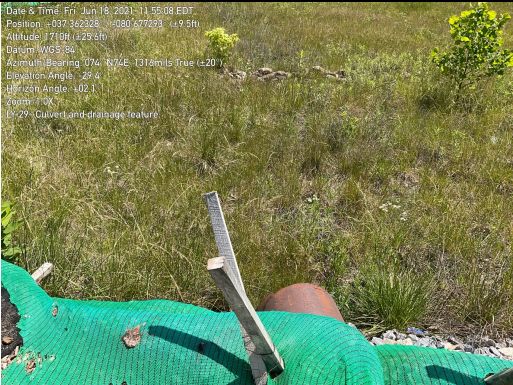
<p>Date &amp; Time: Fri, Jun 18, 2021, 11:56:08 EDT Position: +037.362328° / -080.677293° (+9.5ft) Altitude: 1710ft (+25.0ft) Datum: WGS-84 Azimuth/Bearing: 076° N34E 1318mils True (+20°) Elevation Angle: -29.4° Horizon Angle: +02.1° Zoom: 1.0X LY-29- Culvert and drainage feature</p>			
<b>GPS Location</b>	See photo GPS	<b>GPS Location</b>	See photo GPS		
<b>Field Station#</b>	12005+00	<b>Field Station#</b>	12005+00		
<b>Pic 3 Desc.</b>	LY-29- CFS triple stack perimeter controls and signage.	<b>Pic 4 Desc.</b>	LY-29- Culvert and drainage feature.

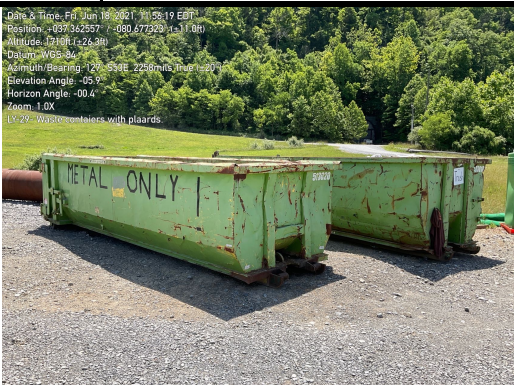
<p>Date &amp; Time: Fri, Jun 18, 2021, 11:58:19 EDT Position: +037.362357° / -080.677393° (+11.0ft) Altitude: 1710ft (+26.9ft) Datum: WGS-84 Azimuth/Bearing: 127° S30E 2260mils True (+20°) Elevation Angle: -05.9° Horizon Angle: -00.4° Zoom: 1.0X LY-29- Waste containers with placards</p>

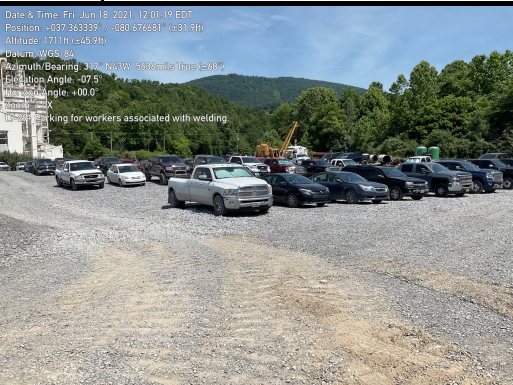
<p>Date &amp; Time: Fri, Jun 18, 2021, 12:01:19 EDT Position: +037.363291° / -080.676691° (+31.5ft) Altitude: 1711ft (+25.9ft) Datum: WGS-84 Azimuth/Bearing: 344° N64W 5000mils True (+30°) Elevation Angle: -07.5° Horizon Angle: +00.0° Zoom: 1.0X LY-29- Parking for workers associated with welding</p>
