Visual Site Inspection Report

Project Name	H-600 Pipeline Spread G	AFE	124300137	Spread	H-600 Pipeline Spread G
Contractor	Precision			Report #	24806
Inspector	Patrick Shields			Date/Time	6/21/2021 3:53 PM
Permit #	TBD	Inspection Type	VA SWPP	Station Begin	10655+00
State	VA	Inspection Area	Partial	Station End	10859+34
County	Giles	Ground	Dry	Temperature (°F)	85.00
Municipality	N/A	Weather	Sunny	Rain Gauge (in)	0.00
				Rain Accumulation Time (days)	1.00

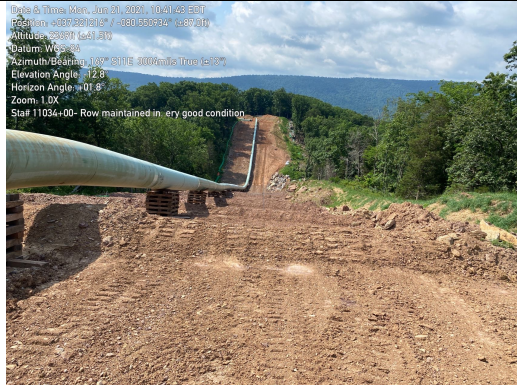
GPS Location	See photo GPS		GPS Location	See photo GPS	
Field Station#	11023+88		Field Station#	11025+00	
Pic 9 Desc.	Stream S-IJ19		Pic 10 Desc.	Stream S- IJ18	
<p>Date & Time: Mon, Jun 21, 2021, 10:41:25 EDT Position: +037.318603° / -080.555384° (+37.2ft) Altitude: 2330ft (+41.5ft) Datum: WGS-84 Azimuth/Bearing: 100° S10E, 3009mils True (+13°) Elevation Angle: -12.3° Horizon Angle: +01.8° Zoom: 1.0X Stat: 11034+00- Row maintained in very good condition</p>

GPS Location	See photo GPS		GPS Location	See photo GPS	
Field Station#	11034+00		Field Station#	11044+00	
Pic 11 Desc.	Row dry and maintained in very good condition.		Pic 12 Desc.	Water bars on Class A slope.

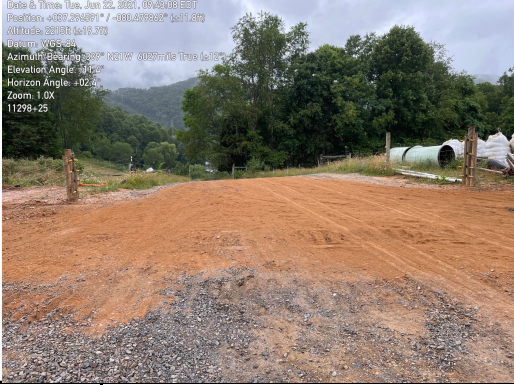
GPS Location	See photo	GPS Location	See photo		
Field Station#	11298+25	Field Station#	11324+90		
Pic 3 Desc.	RCE needs maintenance	Pic 4 Desc.	Waterbar not to specifications		
<p>Date & Time: Tue Jun 22 2021 10:21:31 EDT Position: -83.730013° / -68.473512° (-19190.1ft) Altitude: 2197ft (+11.3ft) Datum: WGS-84 Azimuth/Bearing: 109° S71E 1938/mils True (+13°) Elevation Angle: -31.5° Horizon Angle: +04.1° Zoom: 1.0X 11326+00</p>

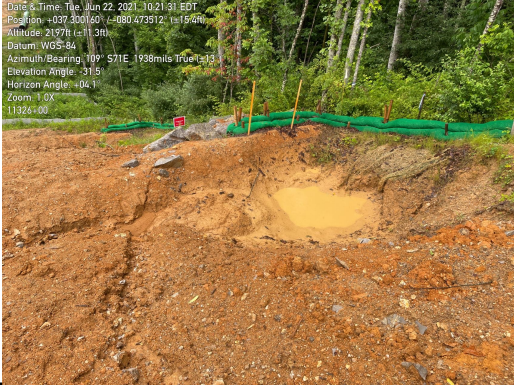
GPS Location	See photo	GPS Location	See photo		
Field Station#	11326+00	Field Station#	11331+92		
Pic 5 Desc.	Sump pit needs maintenance	Pic 6 Desc.	End treatment undermined

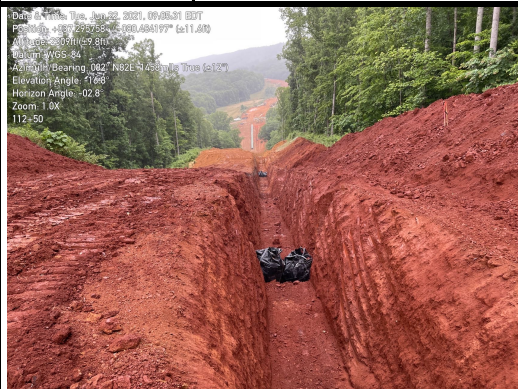
GPS Location	See photo	GPS Location	See photo		
Field Station#	11286+50	Field Station#	11260+00		
Pic 11 Desc.	Temporary trench plugs in place	Pic 12 Desc.	End treatments in place

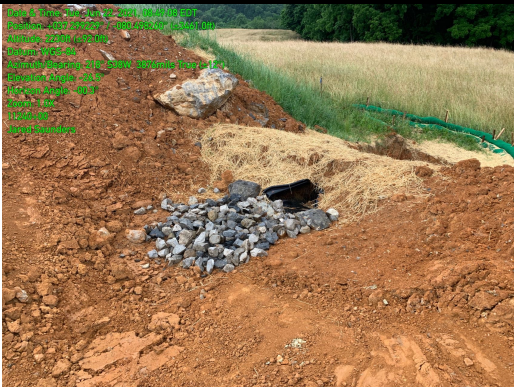
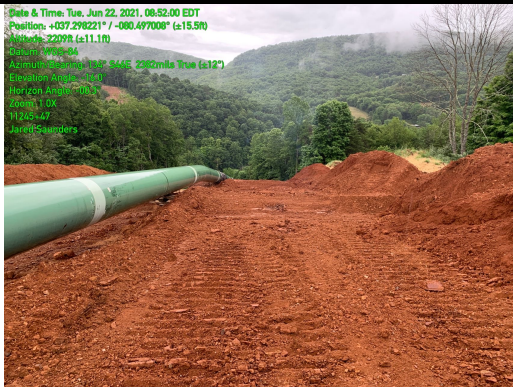
GPS Location	See photo for GPS location.		GPS Location	See photo for GPS location.	
Field Station#	11240+00		Field Station#	11245+47	
Pic 3 Desc.	Rock inlet in place at slope drain.		Pic 4 Desc.	Waterbar in place.

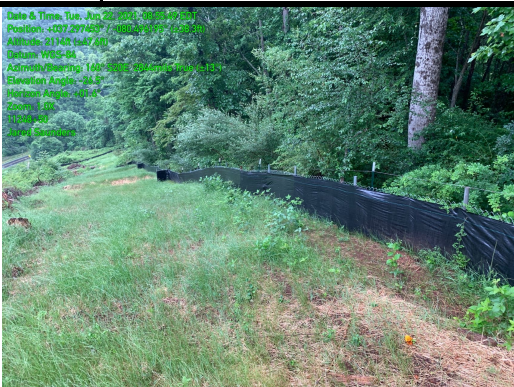
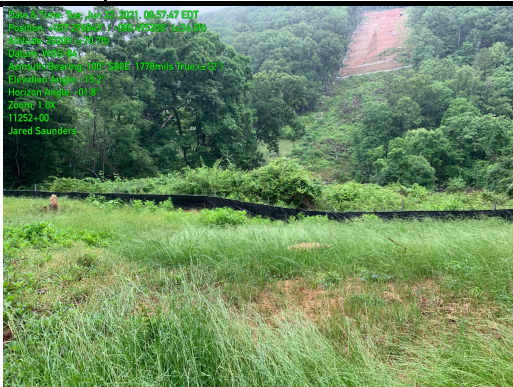
GPS Location	See photo for GPS location.		GPS Location	See photo for GPS location.	
Field Station#	11248+50		Field Station#	11252+00	
Pic 5 Desc.	Supersilt fence in place along LOD.		Pic 6 Desc.	Super silt fence in place across ROW where floodplain begins.

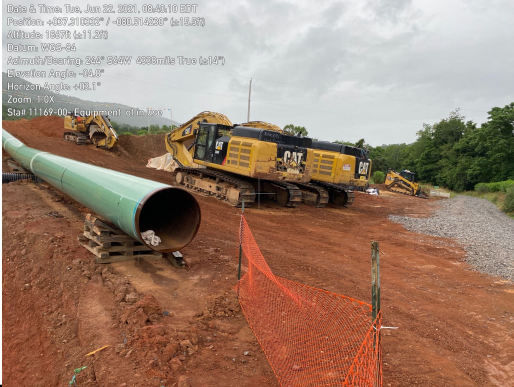
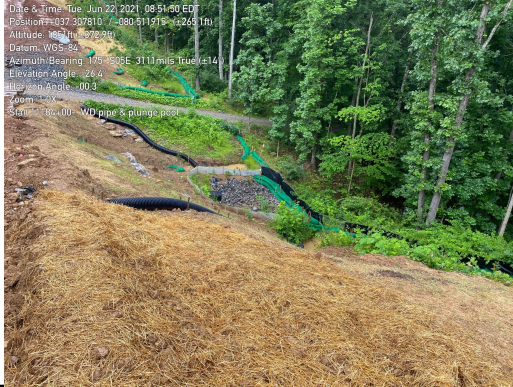
GPS Location	See photo GPS	GPS Location	See photo GPS		
Field Station#	11169+00	Field Station#	11184+00		
Pic 3 Desc.	Ditching equipment and crew rained out.	Pic 4 Desc.	Slope drains, CWD pipe and plunge pool.

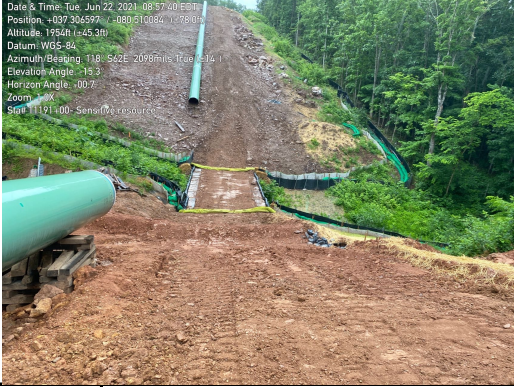
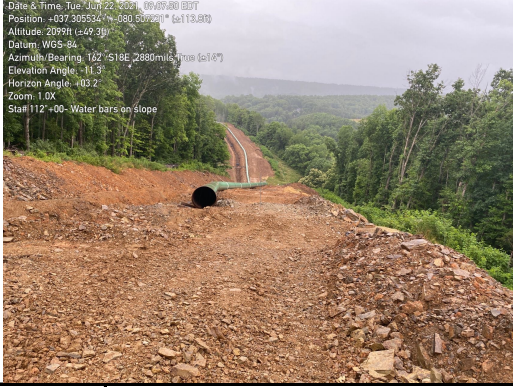
GPS Location	See photo GPS	GPS Location	See photo GPS		
Field Station#	11191+00	Field Station#	11200+00		
Pic 5 Desc.	Sensitive resource area ECD's.	Pic 6 Desc.	Water bars on slope.

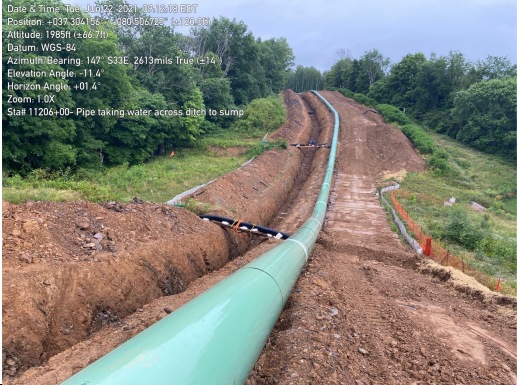
GPS Location	See photo GPS	GPS Location	See photo GPS		
Field Station#	11206+00	Field Station#	11235+00		
Pic 7 Desc.	Pipe taking water from water bar across dug ditch to sump pit.	Pic 8 Desc.	Lowering in crew rained out.		
Insert image here		Insert image here			
GPS Location		GPS Location			
Field Station#		Field Station#			
Pic 9 Desc.		Pic 10 Desc.			
Insert image here		Insert image here			
GPS Location		GPS Location			
Field Station#		Field Station#			
Pic 11 Desc.		Pic 12 Desc.

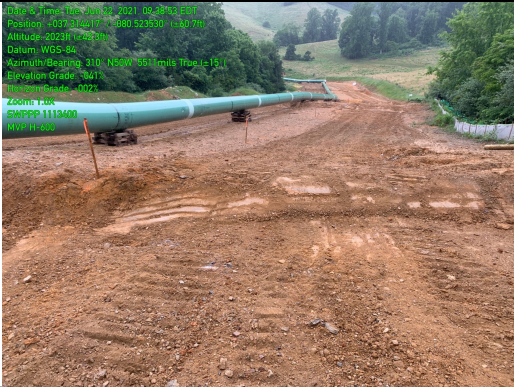
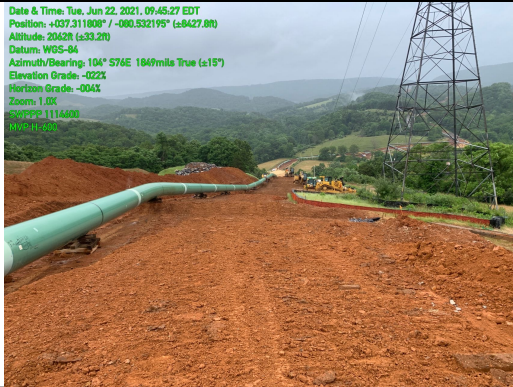
GPS Location	See photo		GPS Location	see photo	
Field Station#	11134+00		Field Station#	11146+00	
Pic 3 Desc.	Inspection of earthen water bars in travel lane was acceptable		Pic 4 Desc.	Earthen water bars and slope drain inlet was functional.

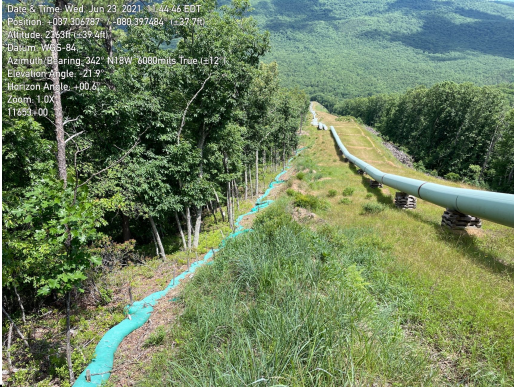
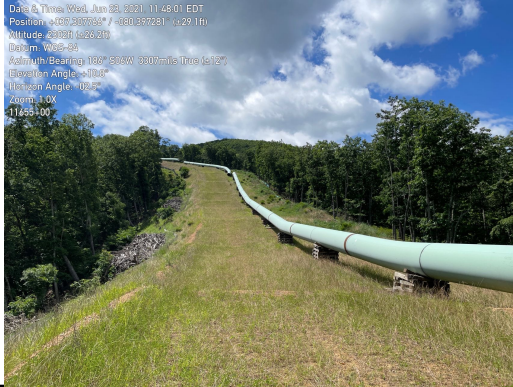
GPS Location	See photo	GPS Location	See photo		
Field Station#	11653+00	Field Station#	11655+00		
Pic 3 Desc.	CFS perimeter control in place	Pic 4 Desc.	Good vegetation on ROW

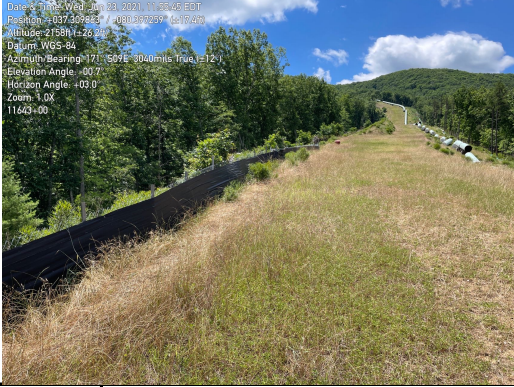
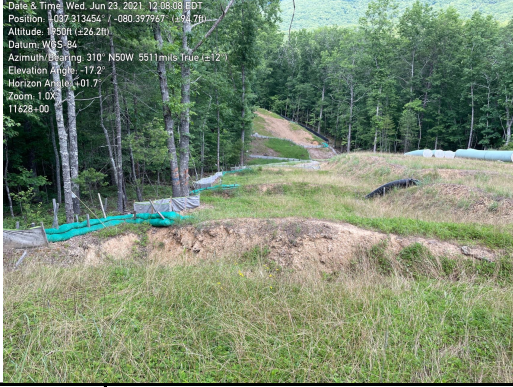
GPS Location	See photo	GPS Location	See photo		
Field Station#	11643+00	Field Station#	11628+00		
Pic 5 Desc.	Supersilt fence perimeter control in place	Pic 6 Desc.	End treatments in place

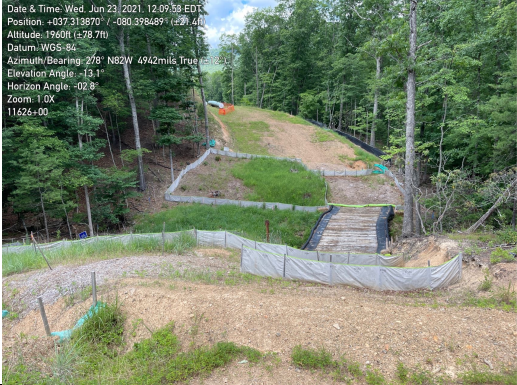
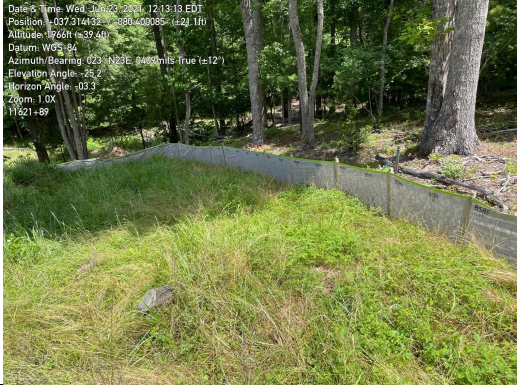
GPS Location	See photo	GPS Location	See photo		
Field Station#	11626+00	Field Station#	11621+89		
Pic 7 Desc.	Stream buffer in place	Pic 8 Desc.	Silt fence perimeter control in place		
<p>Date & Time: Wed, Jun 23, 2021, 12:19:21 EDT Position: +037.313665° / -080.402232° (+13.6ft) Altitude: 1880ft (+39.4ft) Datum: WGS-84 Azimuth/Bearing: 255° S75W 4533mils True (+12°) Elevation Angle: -04.2° Horizon Angle: -05.0° Zoom: 1.0X 11613+00</p>

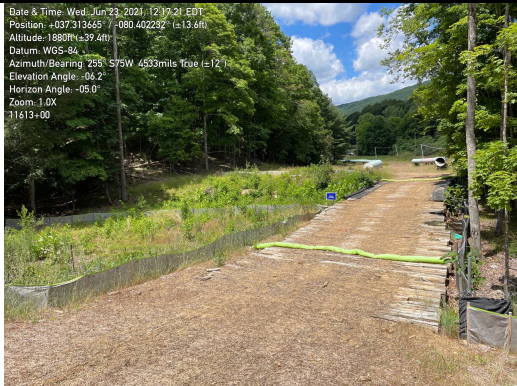
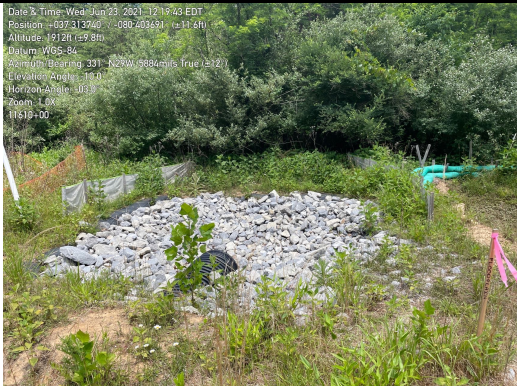
GPS Location	See photo	GPS Location	See photo		
Field Station#	11613+00	Field Station#	11610+00		
Pic 9 Desc.	Stream buffer in place	Pic 10 Desc.	Plunge pool in place		
<p>Date & Time: Wed, Jun 23, 2021, 12:24:06 EDT Position: +037.313113° / -080.406310° (+11.2ft) Altitude: 1817ft (+39.4ft) Datum: WGS-84 Azimuth/Bearing: 029° S83E 7126mils True (+12°) Elevation Angle: -01.0° Horizon Angle: -00.5° Zoom: 1.0X 11604+00</p>

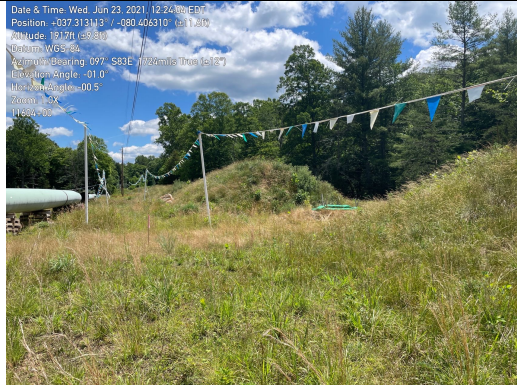
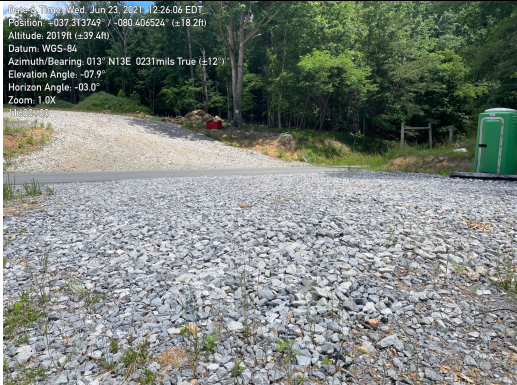
GPS Location	See photo	GPS Location	See photo		
Field Station#	11604+00	Field Station#	11600+00		
Pic 11 Desc.	Good vegetation on topsoil piles	Pic 12 Desc.	RCE in place

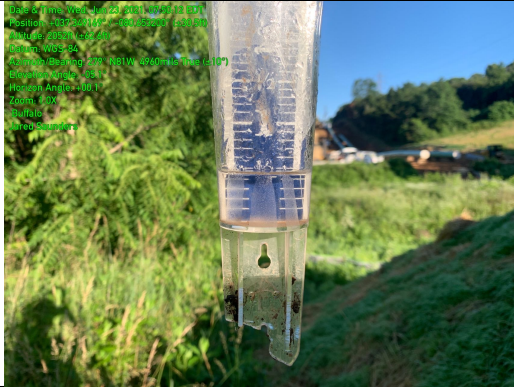
<p>Date & Time: Wed, Jun 23, 2021, 07:41:12 EDT Position: +037.34225° / -080.62794° (±149.0m) Altitude: 3107R (±140.5m) Datum: WGS-84 Azimuth/Bearing: 049° N49E 0871 mile True (±10°) Elevation Angle: +02.2° Horizontal Angle: +00.1° Zoom: 1.0x 10763+00 Jared Saunders</p>			
GPS Location	See photo for GPS location.		GPS Location	See photo for GPS location.	
Field Station#	12005+00		Field Station#	10695+00	
Pic 1 Desc.	Rain gauge at AR 234 reads 0.6 inches.		Pic 2 Desc.	Rain gauge at Buffalo Anklets Road reads 0.5 inches.

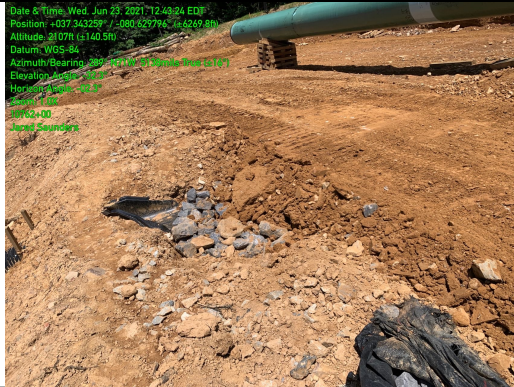
GPS Location	See photo for GPS location.		GPS Location	See photo for GPS location.	
Field Station#	10695+20		Field Station#	10763+00	
Pic 3 Desc.	RCE at Buffalo Anklets Road being refreshed.		Pic 4 Desc.	Rock inlet needs refreshing.

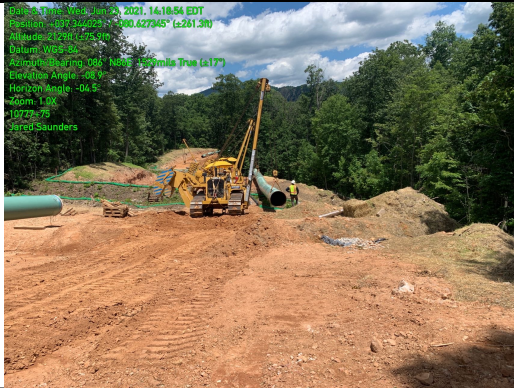
Pic 5 Desc.	Rock inlet needs refreshing.		Pic 6 Desc.	Crew setting up pipe for ditching.

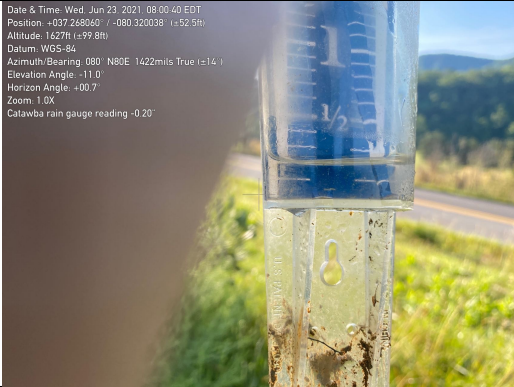
GPS Location	See photo GPS		GPS Location	See photo GPS	
Field Station#	11989+00		Field Station#	11788+53	
Pic 1 Desc.	Catawba rain gauge reading- 0.20"		Pic 2 Desc.	Tabor RCE	
<p>Date & Time: Wed Jun 23 2021 08:50:39 EDT Position: -037.294320 / -080.357692 (+28.6ft) Altitude: 2156ft (+35.2ft) Datum: WGS-84 Azimuth/Bearing: 195° S15W 3467mils True (+15°) Elevation Angle: -14.3° Horizon Angle: +00.8° Zoom: 1.0X Sta# 11795+00- level spreader</p>

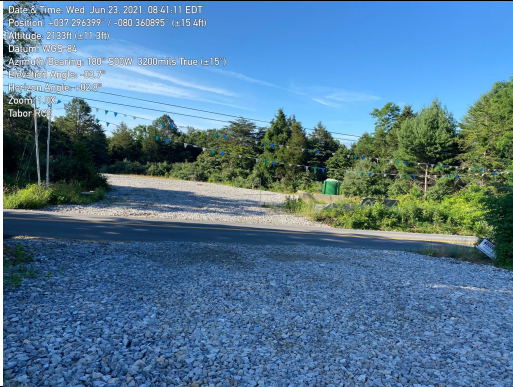
<p>Date & Time: Wed Jun 23 2021 08:41:11 EDT Position: -037.254394 / -080.360895 (+15.4ft) Altitude: 2133ft (+70.3ft) Datum: WGS-84 Azimuth/Bearing: 180° S180W 3200mils True (+15.1) Elevation Angle: -48.1° Horizon Angle: +00.0° Zoom: 1.0X Tabor RCE</p>

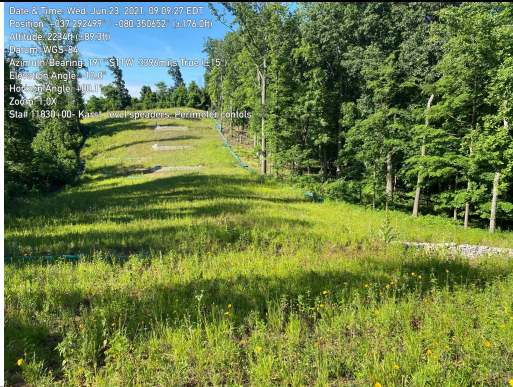
<p>Date & Time: Wed Jun 23 2021 09:05:22 EDT Position: -037.252494 / -080.350652 (+176.0ft) Altitude: 2234ft (+69.3ft) Datum: WGS-84 Azimuth/Bearing: 181° S181W 3086mils True (+15°) Elevation Angle: -10.0° Horizon Angle: +00.1° Zoom: 1.0X Sta# 11830+00- Karst level spreaders, perimeter controls</p>

GPS Location	See photo GPS		GPS Location	See photo GPS	
Field Station#	11786+00		Field Station#	11830+00	
Pic 3 Desc.	Level spreader.		Pic 4 Desc.	Karst, level spreaders, perimeter controls.	
<p>Date & Time: Wed Jun 23 2021 09:24:06 EDT Position: -037.259342 / -080.342732 (+59.4ft) Altitude: 2115ft (+38.3ft) Datum: WGS-84 Azimuth/Bearing: 185° S185W 3307mils True (+15.1) Elevation Angle: -36.5° Horizon Angle: +04.5° Zoom: 1.0X Sta# 11847+00- Row, vegetation, level spreaders on slope</p>

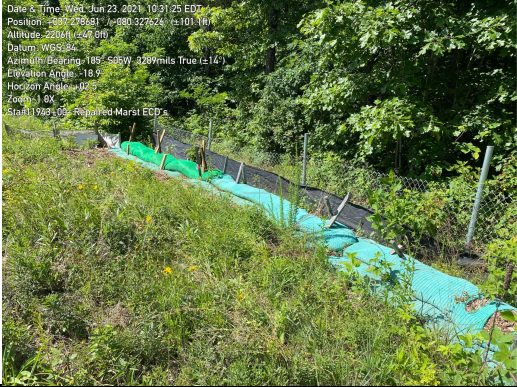
<p>Date & Time: Wed Jun 23 2021 10:31:25 EDT Position: +037 278831 / -080 327624 (±101.1ft) Altitude: 2226ft (±47.8ft) Datum: WGS-84 Azimuth/Bearing: 189° S65W 3209mils True (±14°) Elevation Angle: +18.5° Horizon Angle: +02.9° Zoom: 1.0X Stat# 11943+00- Repaired Karst ECD's</p>

GPS Location	See photo GPS		GPS Location	See photo GPS	
Field Station#	11901+00		Field Station#	11943+00	
Pic 7 Desc.	AR-266.03- Access road and CFS checks in ditch.		Pic 8 Desc.	Repaired Karst ECD's	
<p>Date & Time: Wed Jun 23 2021 10:37:15 EDT Position: +037 277386 / -080 325386 (±151.8ft) Altitude: 2083ft (±32.5ft) Datum: WGS-84 Azimuth/Bearing: 150° S30E 2667mils True (±14°) Elevation Angle: -23.0° Horizon Angle: +01.4° Zoom: 1.0X Stat# 11950+00- Row vegetation, perimeter controls, level spreaders</p>

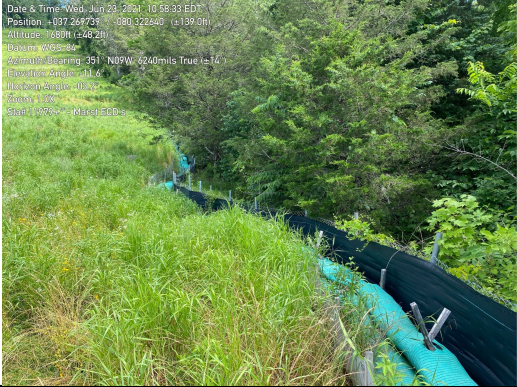
<p>Date & Time: Wed Jun 23 2021 10:58:33 EDT Position: +037 267237 / -080 322640 (±139.0ft) Altitude: 1880ft (±40.2ft) Datum: WGS-84 Azimuth/Bearing: 351° N09W 6240mils True (±14°) Elevation Angle: +11.6° Horizon Angle: +05.4° Zoom: 1.0X Stat# 11979+00- Karst ECD's</p>

GPS Location	See photo GPS		GPS Location	See photo GPS	
Field Station#	11950+00		Field Station#	11979+00	
Pic 9 Desc.	Row vegetation, perimeter controls, level spreaders.		Pic 10 Desc.	Karst ECD's.	
<p>Date & Time: Wed Jun 23 2021 11:04:49 EDT Position: +037 268247 / -080 320497 (±85.9ft) Altitude: 1632ft (±36.7ft) Datum: WGS-84 Azimuth/Bearing: 032° N12E 6270mils True (±14°) Elevation Angle: -04.8° Horizon Angle: +01.7° Zoom: 1.0X AR- /66.00- Access rd& rock check dams</p>

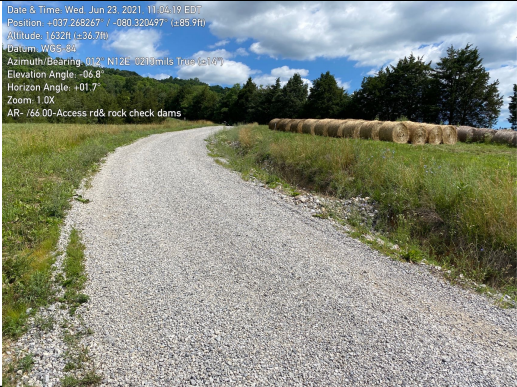
<p>Date & Time: Wed Jun 23 2021 11:04:49 EDT Position: +037 268247 / -080 320497 (±85.9ft) Altitude: 1632ft (±36.7ft) Datum: WGS-84 Azimuth/Bearing: 032° N12E 6270mils True (±14°) Elevation Angle: -04.8° Horizon Angle: +01.7° Zoom: 1.0X AR- /66.00- Access rd& rock check dams</p>

GPS Location	See photo GPS		GPS Location	See photo GPS	
Field Station#	11986+00		Field Station#	11988+00	
Pic 11 Desc.	Drainage feature & ECD's.		Pic 12 Desc.	AR-266.00- Access road and rock check dams.

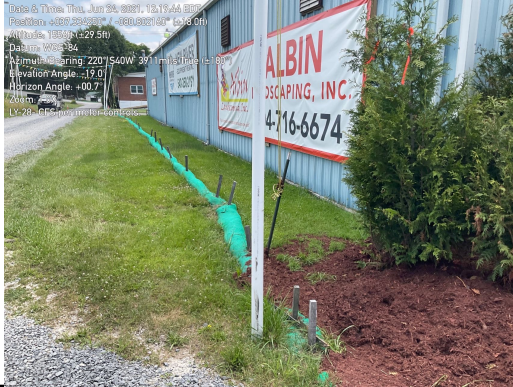
<p>Date & Time Thu Jun 24 2021 11:45:14 EDT Position: +39.154557° / -88.88479° (+154.4m) Altitude: 1555ft (+47.8m) Datum: WGS-84 Azimuth/Bearing: 220° S40W 3911mils True (±72°) Elevation Angle: -19.0° Horizon Angle: +00.7° Zoom: 1.0X LY-28- CFS perimeter controls</p>

GPS Location	See photo GPS	GPS Location	See photo GPS		
Field Station#	12005+00	Field Station#	12005+00		
Pic 3 Desc.	LY-28 west portion of the yard- Excess trailers that are not in use are stored here.	Pic 4 Desc.	LY-28- CFS perimeter controls.

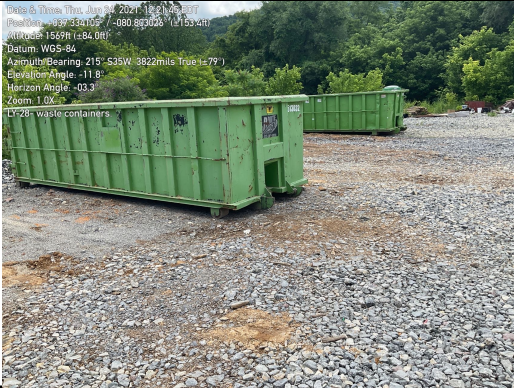
<p>Date & Time Thu Jun 24 2021 11:45:14 EDT Position: +39.154557° / -88.88479° (+154.4m) Altitude: 1555ft (+47.8m) Datum: WGS-84 Azimuth/Bearing: 215° S35W 3822mils True (±79°) Elevation Angle: -11.8° Horizon Angle: -03.3° Zoom: 1.0X LY-28- waste containers</p>

<p>Date & Time Thu Jun 24 2021 11:45:14 EDT Position: +39.154557° / -88.88479° (+154.4m) Altitude: 1440ft (+43.3ft) Datum: WGS-84 Azimuth/Bearing: 222° S42W 3947mils True (±72°) Elevation Angle: -11.4° Horizon Angle: +00.8° Zoom: 1.0X LY-28- Trucks not currently in use</p>			
GPS Location	See photo GPS	GPS Location	See photo GPS		
Field Station#	12005+00	Field Station#	12005+00		
Pic 5 Desc.	LY-28- Waste containers.	Pic 6 Desc.	LY-28- Trucks not currently in use.

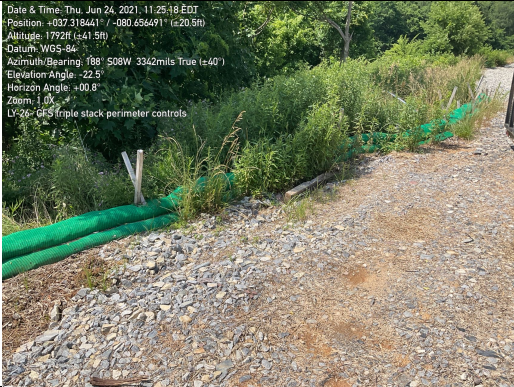
<p>Date & Time: Thu, Jun 24, 2021, 11:25:18 EDT Position: +037.318441° / +080.656491° (+20.5ft) Altitude: 1792ft (+61.5ft) Datum: WGS 84 Azimuth/Bearing: 188° S08W 3342mils True (+60°) Elevation Angle: -22.5° Horizon Angle: +00.8° Zoom: 1.0X LY-26- CFS triple stack perimeter controls.</p>

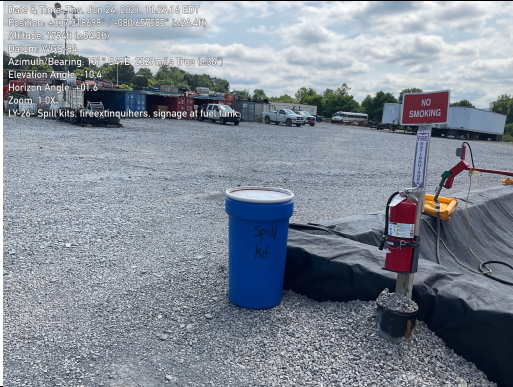
<p>Date & Time: Thu, Jun 24, 2021, 11:25:18 EDT Position: +037.318441° / +080.656491° (+20.5ft) Altitude: 1792ft (+61.5ft) Datum: WGS 84 Azimuth/Bearing: 188° S08W 3342mils True (+60°) Elevation Angle: -22.5° Horizon Angle: +00.8° Zoom: 1.0X LY-26- Spill kits, fireextinguishers, signage at fuel tank.</p>			
GPS Location	See photo GPS	GPS Location	See photo GPS		
Field Station#	12005+00	Field Station#	12005+00		
Pic 1 Desc.	LY-26- CFS triple stack perimeter controls.	Pic 2 Desc.	LY-26- Spill kits, fire extinguishers, signage.

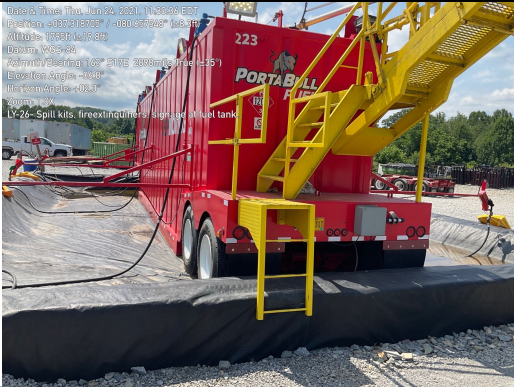
<p>Date & Time: Thu, Jun 24, 2021, 11:25:18 EDT Position: +037.318441° / +080.656491° (+20.5ft) Altitude: 1792ft (+61.5ft) Datum: WGS 84 Azimuth/Bearing: 188° S08W 3342mils True (+60°) Elevation Angle: -22.5° Horizon Angle: +00.8° Zoom: 1.0X LY-26- Spill kits, fireextinguishers, signage at fuel tank.</p>

GPS Location	See photo GPS	GPS Location	See photo GPS		
Field Station#	12005+00	Field Station#	12005+00		
Pic 3 Desc.	LY-26- Main fuel storage tank in secondary containment.	Pic 4 Desc.	LY-26- Gas cylinders secured.

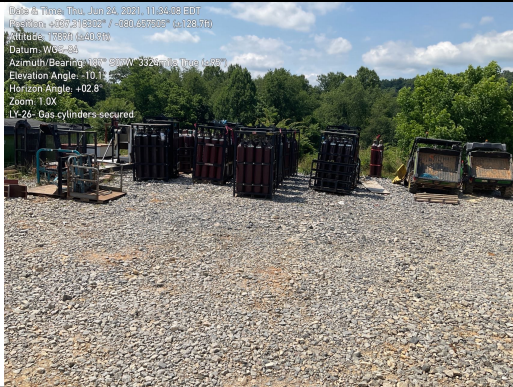
<p>Date & Time: Thu, Jun 24, 2021, 11:25:18 EDT Position: +037.318441° / +080.656491° (+20.5ft) Altitude: 1792ft (+61.5ft) Datum: WGS 84 Azimuth/Bearing: 188° S08W 3342mils True (+60°) Elevation Angle: -22.5° Horizon Angle: +00.8° Zoom: 1.0X LY-26- Gas cylinders secured.</p>

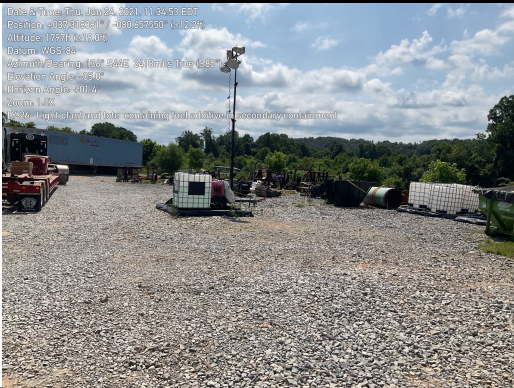
<p>Date & Time: Thu, Jun 24, 2021, 11:25:18 EDT Position: +037.318441° / +080.656491° (+20.5ft) Altitude: 1792ft (+61.5ft) Datum: WGS 84 Azimuth/Bearing: 188° S08W 3342mils True (+60°) Elevation Angle: -22.5° Horizon Angle: +00.8° Zoom: 1.0X LY-26- Light plant and tote containing fuel additive in secondary containment.</p>

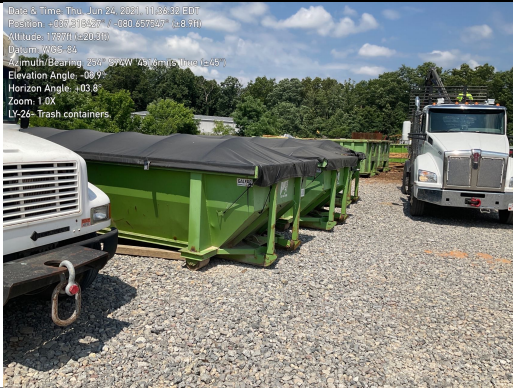
<p>Date & Time: Thu, Jun 24, 2021, 11:25:18 EDT Position: +037.318441° / +080.656491° (+20.5ft) Altitude: 1792ft (+61.5ft) Datum: WGS 84 Azimuth/Bearing: 188° S08W 3342mils True (+60°) Elevation Angle: -22.5° Horizon Angle: +00.8° Zoom: 1.0X LY-26- Trash containers.</p>			
GPS Location	See photo GPS	GPS Location	See photo GPS		
Field Station#	12005+00	Field Station#	12005+00

Pic 5 Desc.	LY-26- Light plant and tote containing fuel additive in secondary containment.	Pic 6 Desc.	LY- Waste containers.

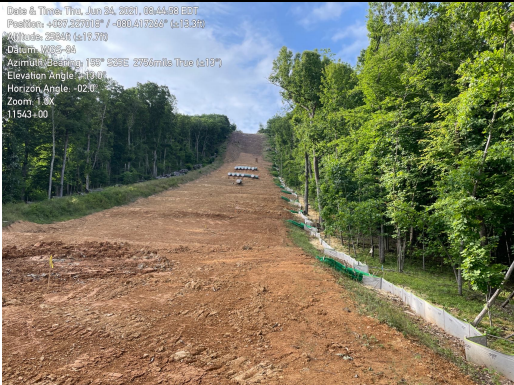
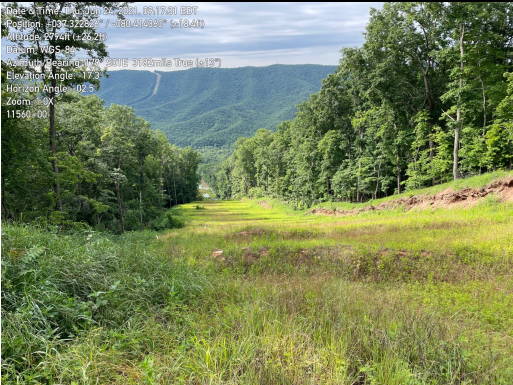
GPS Location	See photo	GPS Location	See photo		
Field Station#	11543+00	Field Station#	11560+00		
Pic 3 Desc.	End treatments in place	Pic 4 Desc.	Waterbars in place

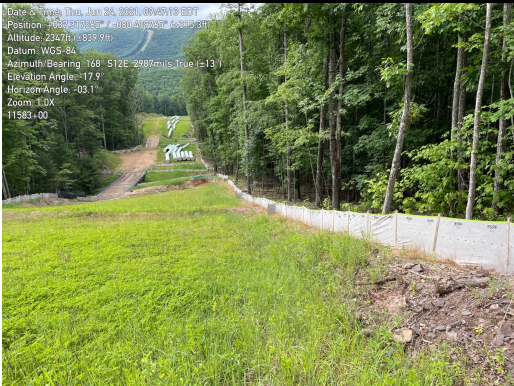
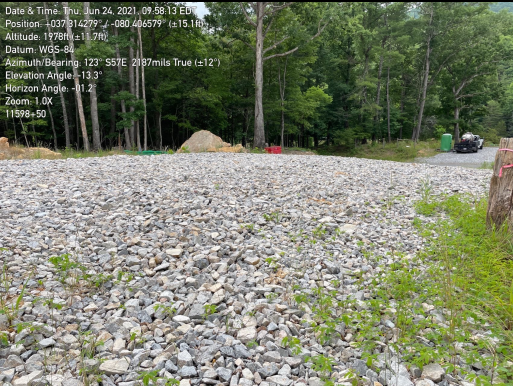
GPS Location	See photo	GPS Location	See photo		
Field Station#	11583+00	Field Station#	11598+50		
Pic 5 Desc.	P1 silt fence perimeter control in place	Pic 6 Desc.	RCE in place

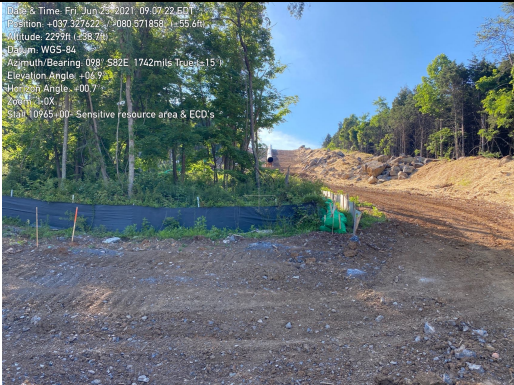
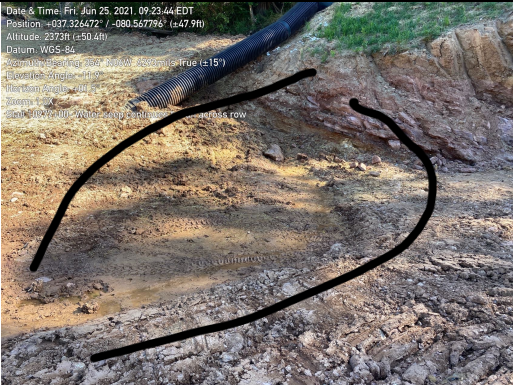
GPS Location	See photo GPS	GPS Location	See photo GPS		
Field Station#	10965+00	Field Station#	10977+00		
Pic 3 Desc.	Sensitive resource area ECD's.	Pic 4 Desc.	Water seep is still flowing.

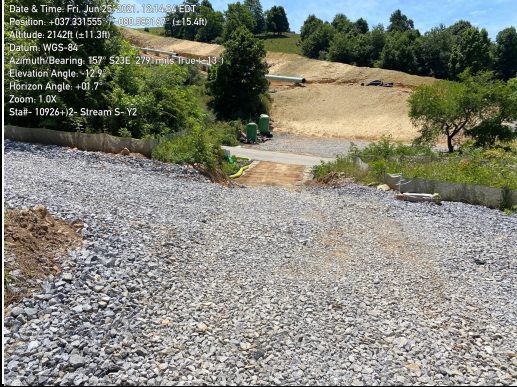
GPS Location	See photo GPS	GPS Location	See photo GPS		
Field Station#	10927+58	Field Station#	10926+62		
Pic 13 Desc.	Stream S-Y3	Pic 14 Desc.	Stream S-Y2		
<p><small>Date & Time: Fri, Jun 25, 2021, 12:24:39 EDT Position: +037 335127° / -080 596703° (±22.9ft) Altitude: 2100ft (±46.3ft) Datum: WGS-84 Azimuth/Bearing: 121° N39W 5707mils True (±13.1) Elevation Angle: +22.9° Horizon Angle: +01.8° Zoom: 1.0X Stail: 10883+33 Stream S-A32</small></p>

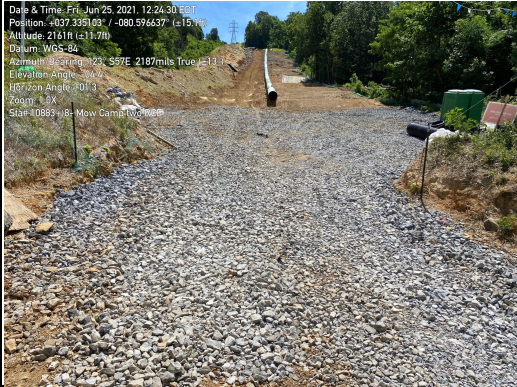
GPS Location	See photo GPS	GPS Location	See photo GPS		
Field Station#	10883+33	Field Station#	10883+68		
Pic 15 Desc.	Stream S- A32	Pic 16 Desc.	Kow Camp two RCE and row		
<p><small>Date & Time: Fri, Jun 25, 2021, 12:25:10 EDT Position: +037 337289° / -080 604559° (±19.0ft) Altitude: 2304ft (±51.8ft) Datum: WGS-84 Azimuth/Bearing: 100° S60E 2103mils True (±12.7) Elevation Angle: +16.0° Horizon Angle: +01.7° Zoom: 1.0X Stail: 10858+58 Kow Camp one RCE</small></p>

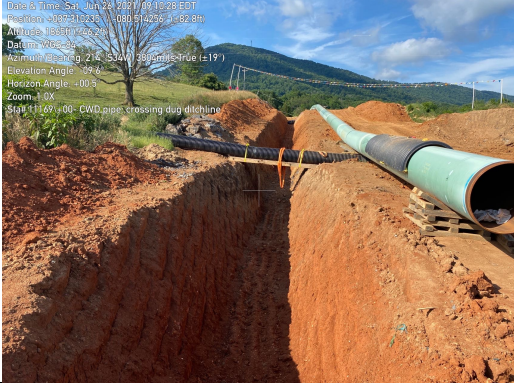
GPS Location	See photo GPS	GPS Location	See photo GPS		
Field Station#	11169+00	Field Station#	11159+50		
Pic 1 Desc.	CWD pipe crossing excavated ditch line.	Pic 2 Desc.	CWD pipe and temporary level spreader.

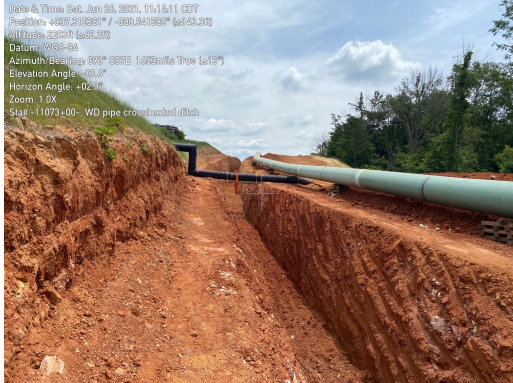
GPS Location	See photo GPS	GPS Location	See photo GPS		
Field Station#	11102+00	Field Station#	11073+00		
Pic 3 Desc.	Ditching track hoe with hammer attachment.	Pic 4 Desc.	CWD pipe across excavated ditch.
