Visual Site Inspection Report

Project Name	H-600 Pipeline Spread H	AFE	124300138	Spread	H-600 Pipeline Spread H
Contractor	Precision			Report #	23469
Inspector	Logan Box			Date/Time	5/17/2021 3:02 PM
Permit #	TBD	Inspection Type	VA SWPP	Station Begin	13415+51
State	VA	Inspection Area	Partial	Station End	13525+99
County	Franklin	Ground	Dry	Temperature (°F)	71.00
Municipality	N/A	Weather	Cloudy	Rain Gauge (in)	0.00
				Rain Accumulation Time (days)	0.00

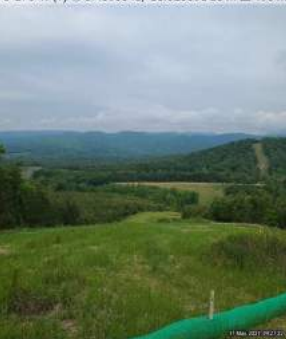
GPS Location	0000	GPS Location	0000		
Field Station#	13436+36	Field Station#	13420+00		
Pic 1 Desc.	Monitored vegetation and ECDs while inspecting row conditions today, no issues observed at the time of inspection.		Pic 2 Desc.	Monitored work space area, observed vegetation and stabilization. No issues observed at the time of inspection.	
	North West Elevation

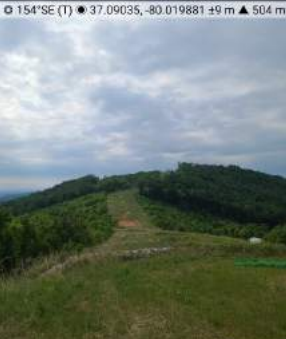
GPS Location	0000	GPS Location	0000		
Field Station#	13440+00	Field Station#	13497+96		
Pic 3 Desc.	Monitored vegetation and ECDs while inspecting row conditions today, no issues observed at the time of inspection.		Pic 4 Desc.	Monitored stream crossing where equipment mats were removed during maintenance repairs. No environmental issues observed at the time of inspection.	
	West Elevation

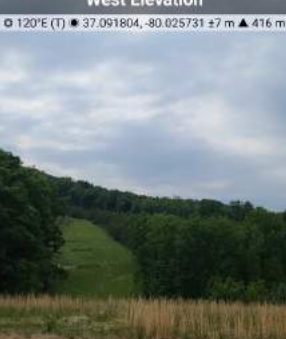
GPS Location	0000	GPS Location	0000		
Field Station#	13423+36	Field Station#	13496+32		
Pic 5 Desc.	Row photo showing vegetation no issues were noted while inspecting today.		Pic 6 Desc.	Observed ECDs at road crossing while monitoring row conditions today. No issues were observed at the time of inspection.

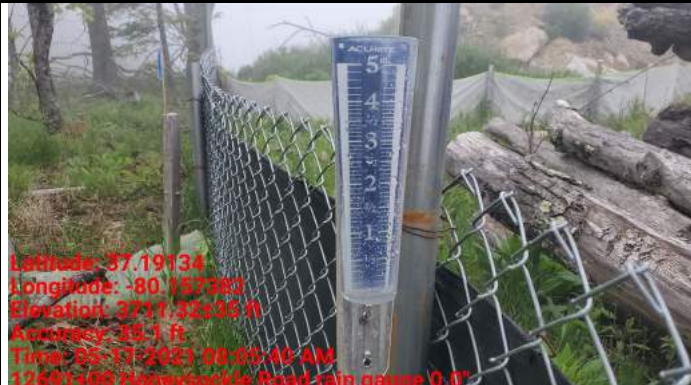
<p>Latitude: 37.192874 Longitude: -80.173658 Elevation: 1012.57±10 ft Accuracy: 3079.4 ft Time: 05-17-2021 10:23:44 AM 12640+00 GAS of RO-279.01</p>		
GPS Location	See pic for GPS location		GPS Location	See pic for GPS location	
Field Station#	12691+00		Field Station#	12640+00	
Pic 1 Desc.	Honeysuckle Road rain gauge. Less than a tenth of an inch of precipitation. 0.0"		Pic 2 Desc.	Waterbars, sumps and end treatments remain in compliance on the GAS of RO-279.01.

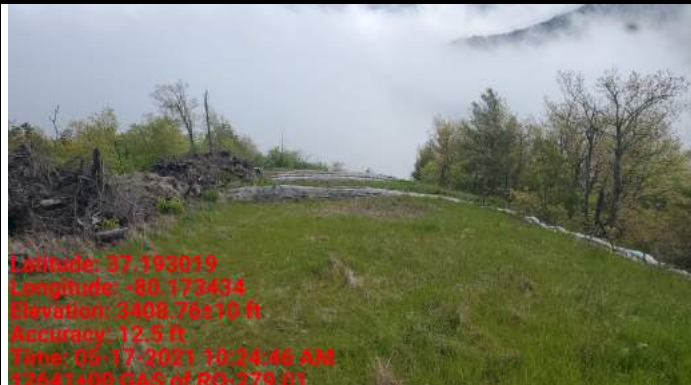
GPS Location	See pic for GPS location		GPS Location	See pic for GPS location	
Field Station#	12641+00		Field Station#	12641+00	
Pic 3 Desc.	Current ROW conditions on the GAS of RO-279.01.		Pic 4 Desc.	Perimeter CFS remains in acceptable condition throughout the area.

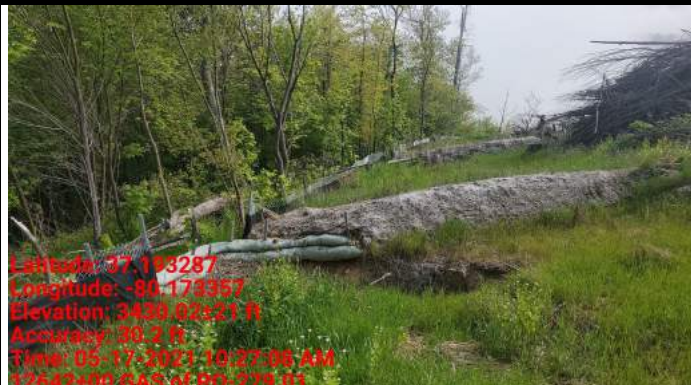
<p>Latitude: 37.193295 Longitude: -80.173391 Elevation: 3364.21±28 ft Accuracy: 31.2 ft Time: 05-17-2021 10:27:25 AM 12641+00 GAS of RO-279.01</p>		
GPS Location	See pic for GPS location		GPS Location	See pic for GPS location	
Field Station#	12642+00		Field Station#	12641+00	
Pic 5 Desc.	Waterbars, sumps and end treatments remain in compliance.		Pic 6 Desc.	Perimeter SSF is in acceptable condition throughout the area.

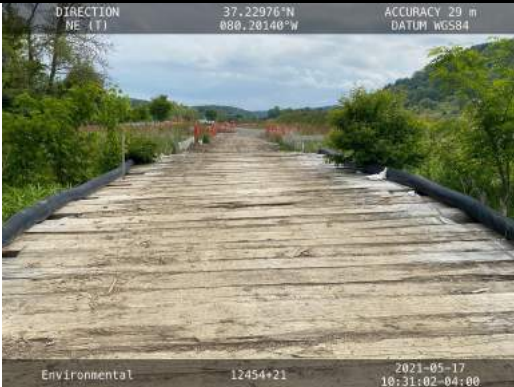
GPS Location	See photo		GPS Location	See photo	
Field Station#	12454+21		Field Station#	12461+81	
Pic 1 Desc.	Bridge crossing S-CD12b in acceptable condition		Pic 2 Desc.	Wetland W-KL58 in acceptable condition

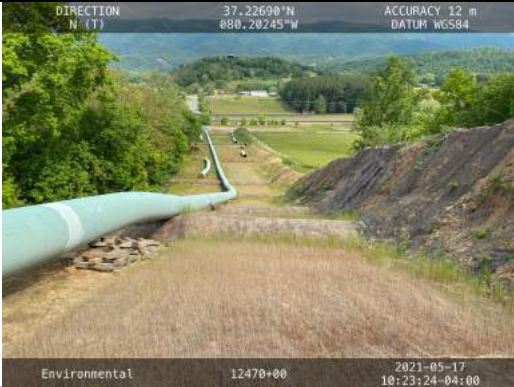
GPS Location	See photo		GPS Location	See photo	
Field Station#	12470+00		Field Station#	12474+52	
Pic 3 Desc.	Stabilized ROW in acceptable condition		Pic 4 Desc.	Plastic covered contaminated area.

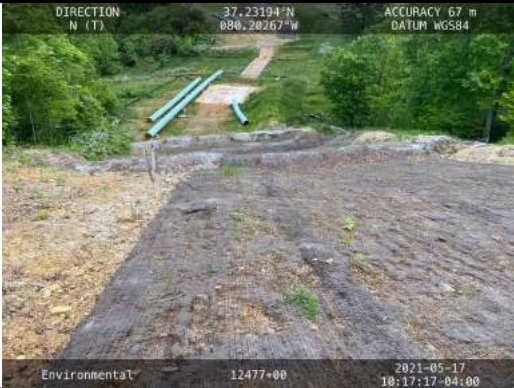
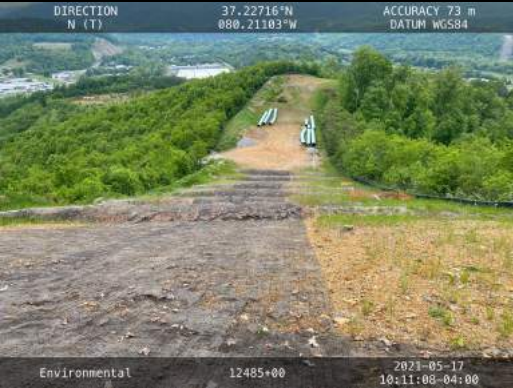
GPS Location	See photo		GPS Location	See photo	
Field Station#	12477+00		Field Station#	12485+00	
Pic 5 Desc.	Stabilized slope in acceptable condition		Pic 6 Desc.	Stabilized slope in acceptable condition

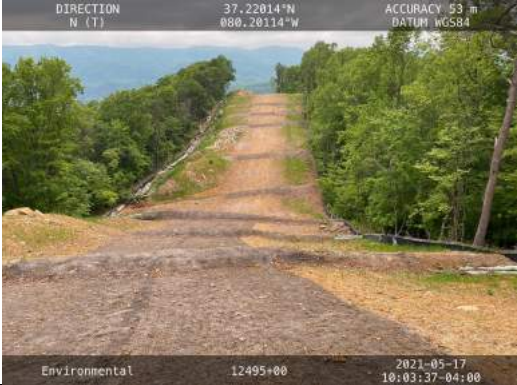
GPS Location	See photo		GPS Location	See photo	
Field Station#	12495+00		Field Station#	12504+00	
Pic 7 Desc.	Stabilized ROW in acceptable condition		Pic 8 Desc.	Clean water crossing outlet in acceptable condition

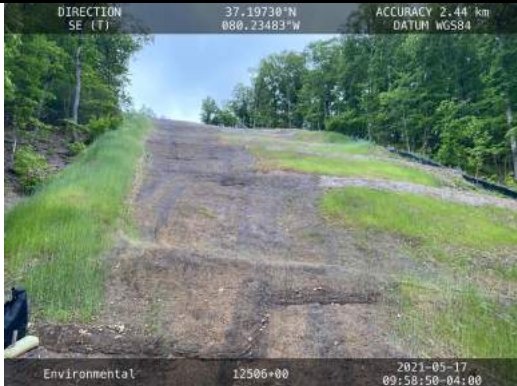
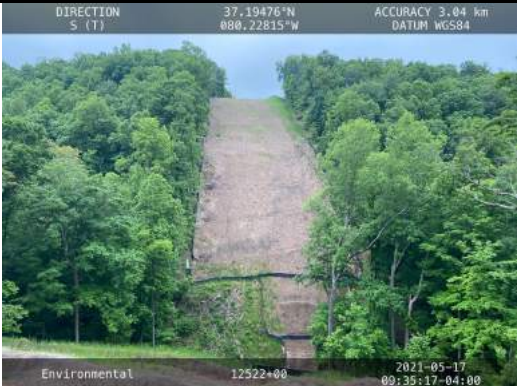
GPS Location	See photo		GPS Location	See photo	
Field Station#	12506+00		Field Station#	12522+00	
Pic 9 Desc.	Stabilized slope in acceptable condition		Pic 10 Desc.	Stabilized slope in acceptable condition

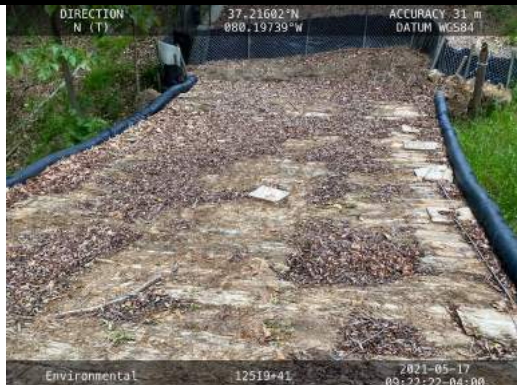
GPS Location	See photo		GPS Location	See photo	
Field Station#	12519+41		Field Station#	12517+00	
Pic 11 Desc.	Bridge and ECDs at stream crossing S-EF19		Pic 12 Desc.	Stabilized slope in acceptable condition

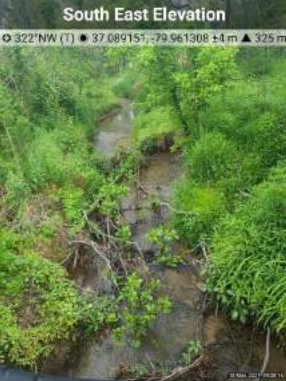
<p>North East Elevation <small>233°SW (T) 37.089206, -79.961228 ±5 m 322 m</small></p>	
GPS Location	0000	GPS Location	0000		
Field Station#	13643+54	Field Station#	13643+59		
Pic 1 Desc.	Monitored stream facing upstream during routine inspection, no issues were noted during inspection today .		Pic 2 Desc.	Monitored equipment bridge and protection, all ECDs up to date and functioning.

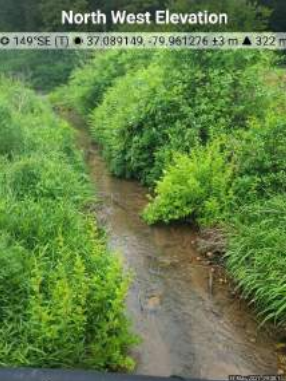
<p>North West Elevation <small>163°SE (T) 37.091287, -79.990619 ±5 m 361 m</small></p>	
GPS Location	0000	GPS Location	0000		
Field Station#	13643+54	Field Station#	13543+11		
Pic 3 Desc.	Stream observation photo facing downstream during routine inspection today, no issues observed at the time of inspection.		Pic 4 Desc.	Stream observation photo facing downstream during routine inspection today, no issues observed at the time of inspection.

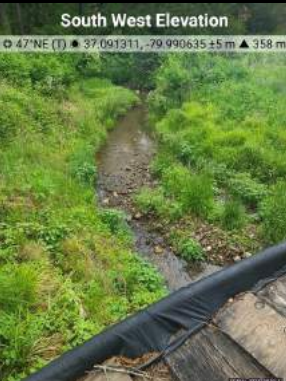
<p>East Elevation <small>284°W (T) 37.091212, -79.990607 ±10 m 350 m</small></p>	
GPS Location	0000	GPS Location	0000		
Field Station#	13543+11	Field Station#	13542+67		
Pic 5 Desc.	Stream observation photo facing upstream during routine inspection today, no issues observed at the time of inspection.		Pic 6 Desc.	Monitored ECDs and stabilization on hill side above stream crossing, no environmental issues observed at the time of inspection.

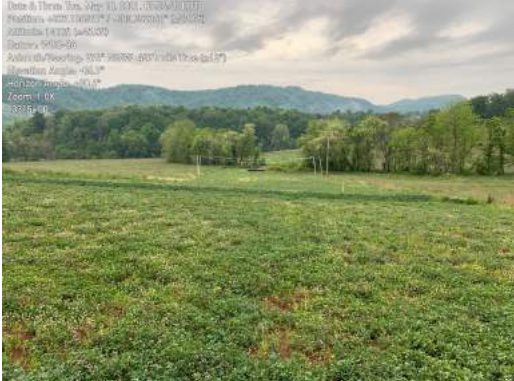
<p>Date & Time: Sun, May 16, 2021, 07:29:41 EDT Position: 40°12'10.34" / -89°05:42.13"W (NAD83) Altitude: 1379.0 (425.40) Datum: WGS-84 Azimuth/Bearing: 209° 14' 00" (True) (360°) Elevation Angle: -0.0° Horizon Angle: -0.0° Zoom: 1.0x 13309+09 S-GH7</p>			
GPS Location	0	GPS Location	0		
Field Station#	13315+00	Field Station#	13309+09		
Pic 1 Desc.	ROW and ECDs in good condition, with good vegetation establishing across LOD.		Pic 2 Desc.	MVP-S-GH7, in good condition

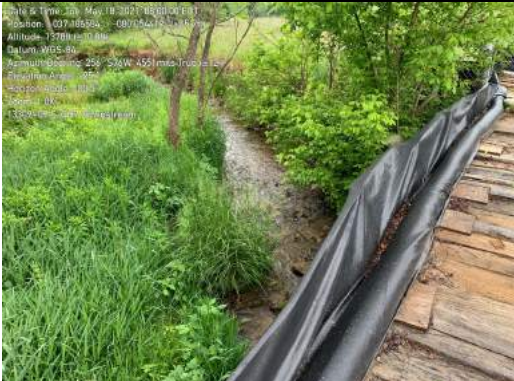
GPS Location	0	GPS Location	0		
Field Station#	13309+09	Field Station#	13306+16		
Pic 3 Desc.	MVP-S-GH7 Downstream, in good condition, no impacts after 0.15" rain in past 24 hours		Pic 4 Desc.	ROW and ECDs in good condition, with good vegetation establishing across LOD.

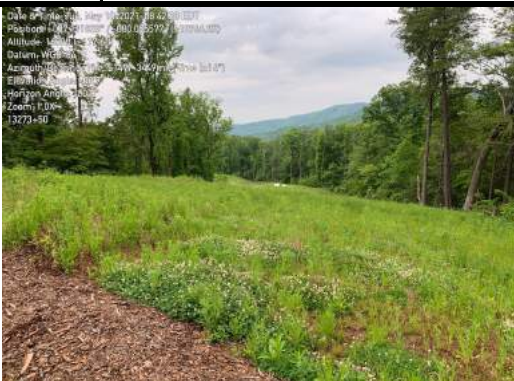
<p>Date & Time: Sun, May 16, 2021, 05:05:11 EDT Position: 40°12'10.00"N / -89°05:42.13"W (NAD83) Altitude: 1578.0 (485.12) Datum: WGS-84 Azimuth/Bearing: 257° 58'59" (True) (360°) Elevation Angle: -0.0° Horizon Angle: -0.0° Zoom: 1.0x 13262+62 Flanders Road Crossing</p>			
GPS Location	0	GPS Location	0		
Field Station#	13273+50	Field Station#	13262+62		
Pic 5 Desc.	ROW and ECDs in good condition, with good vegetation establishing across LOD.		Pic 6 Desc.	Flanders Road Crossing, in good condition

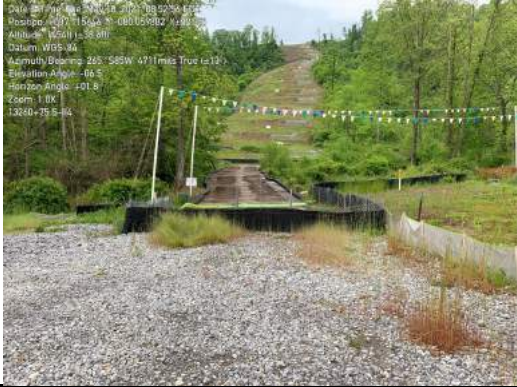
GPS Location	0	GPS Location	0		
Field Station#	13262+62	Field Station#	13260+75		
Pic 7 Desc.	Flanders Road/MVP-FR-293.01, wear from logging company using road to access their property (3rd party)		Pic 8 Desc.	MVP-S-II4, in good condition

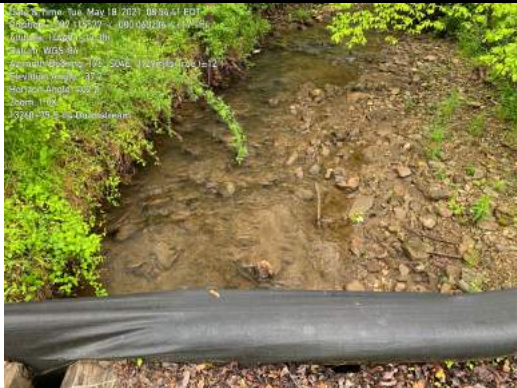
GPS Location	0	GPS Location	0		
Field Station#	13260+75	Field Station#	13259+00		
Pic 9 Desc.	MVP-S-II4 Downstream, in good condition no impacts from 0.15" rain in past 24 hours		Pic 10 Desc.	ROW and ECDs in good condition, with good vegetation establishing across LOD.

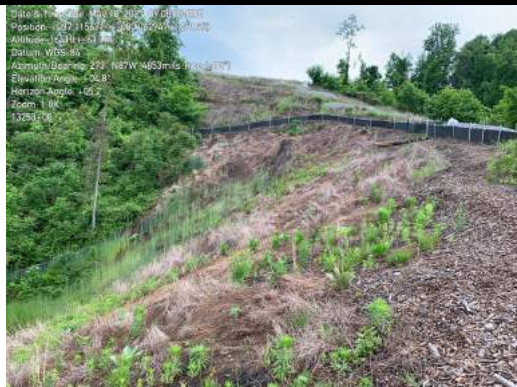
GPS Location	0	GPS Location	0		
Field Station#	13253+00	Field Station#	13249+00		
Pic 11 Desc.	Slip observed to be stable, no notable changes, vegetation establishing.		Pic 12 Desc.	ROW and ECDs in good condition, with good vegetation establishing across LOD.

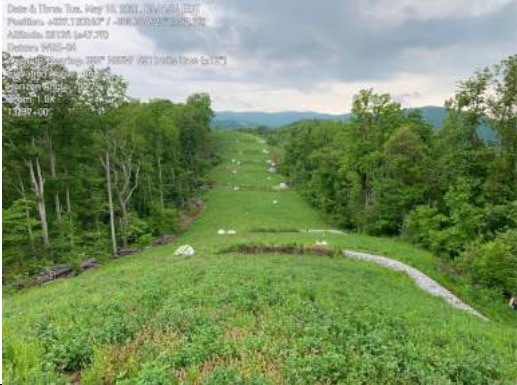
GPS Location	0	GPS Location	0		
Field Station#	13237+00	Field Station#	13224+00		
Pic 13 Desc.	ROW and ECDs in good condition, with good vegetation establishing across LOD.		Pic 14 Desc.	3rd party timber company, clearing right up to edge of MVP ROW. Some debris and tree impacts to the right of way noted.

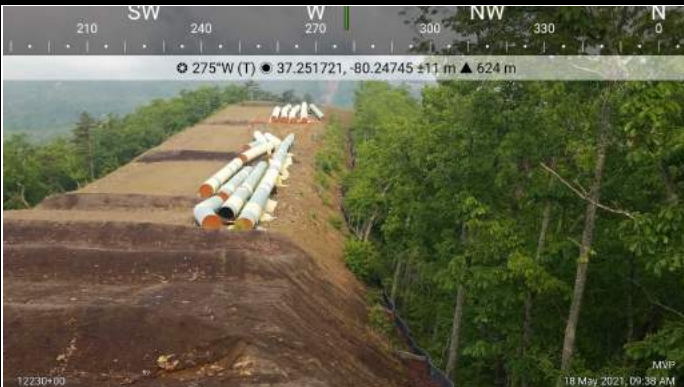
GPS Location	See Above		GPS Location	See Above	
Field Station#	12225+50		Field Station#	12225+50	
Pic 15 Desc.	Punchlist Item: Repair super silt fence.		Pic 16 Desc.	Punchlist Item: Super silt fence repaired.

7. Identify all remedial measures that have been taken since the previous inspection was conducted. One punchlist item has been completed since last SWPPP inspection: Station 12225+50, repair super silt fence. See photos below.					
Comments (Reference above questions as appropriate.) Environmental Inspector (EI) attended the daily 6:30am online inspector's "Zoom" meeting and daily 7:00am online construction "Zoom" meeting. EI performed SWPPP inspection with the assistance of EI Jason Nielsen for the section between Flatwoods Road and the right-of-way (ROW) crossing on access road MVP-MN-276.03 on Reese Mountain Rd., stations 12119+17 to 12284+75. EIs inspected the following environmental resources (W-C12, S-C33, S-C36, W-C11, S-MM31, S-C29, W-C6, S-KL5, W-C5, S-C25, S-C24, S-C21, S-OO11(1), S-OO11(2). Access roads observed included MN-272, MN-273, MN-274, MN-275. and MN 276.03. No impacts or any other deficiencies were observed at any of these resources or their corresponding buffer zones or at the access roads. Right-of-way (ROW) remains stable throughout this inspection area. ECDs were in satisfactory condition and functioning properly. The ROW remains in a stable condition. A Precision Environmental crew completed a punchlist item near station 12225+50 (super silt fence repair) today (see photos below). Environmental crew work was in environmental compliance.

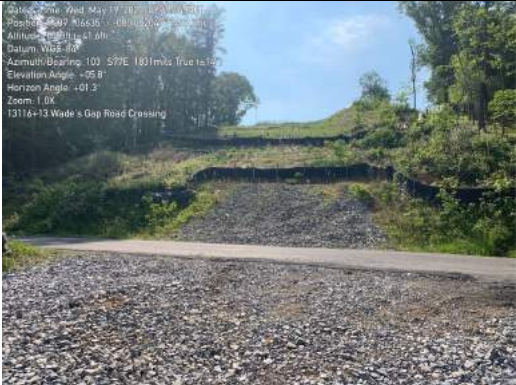
GPS Location	0	GPS Location	0		
Field Station#	13116+13	Field Station#	13117+02		
Pic 1 Desc.	Wade's Gap Road Crossing, in good condition also RCE acceptable and functioning properly		Pic 2 Desc.	Private Driveway in good condition

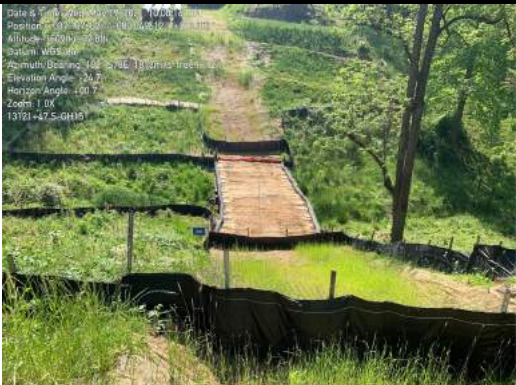
GPS Location	0	GPS Location	0		
Field Station#	13121+47	Field Station#	13125+30		
Pic 3 Desc.	S-GH15 in good condition, Equipment Bridge installed and functioning properly		Pic 4 Desc.	S-GH14 in good condition, Equipment Bridge installed and functioning properly

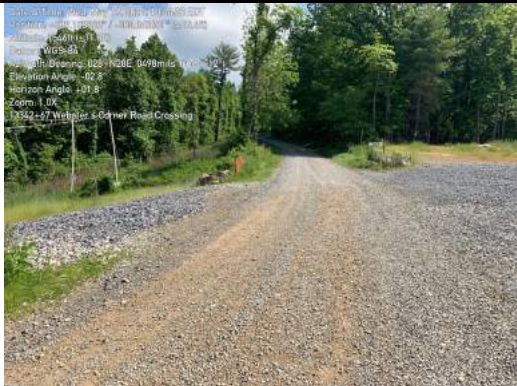
<p>Date & Time: Wed, May 19, 2021 10:50:43 EDT Position: +037 1647797 -1080 046535 (NAD83) Altitude: 1478M (4521 ft) Datum: WGS-84 Azimuth/Bearing: 119.7 S 41 E 120.1 True (to 12) Elevation Angle: -01.8 Horizon Angle: -01.8 Zoom: 1.0X 13342+67 Webster's Corner Road Crossing</p>

GPS Location	0	GPS Location	0		
Field Station#	13342+67	Field Station#	13345+50		
Pic 9 Desc.	Webster's corner road crossing in good condition, RCE installed and functioning properly		Pic 10 Desc.	Clean water crossing in good condition

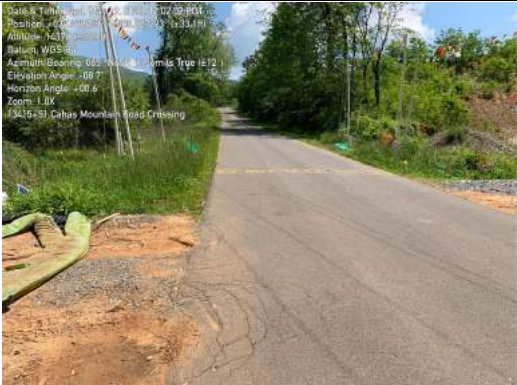
GPS Location	0	GPS Location	0		
Field Station#	13415+51	Field Station#	13419+00		
Pic 17 Desc.	Cahas Mountain Road Crossing, in good condition		Pic 18 Desc.	ROW and ECDs in good condition, with good vegetation establishing across LOD

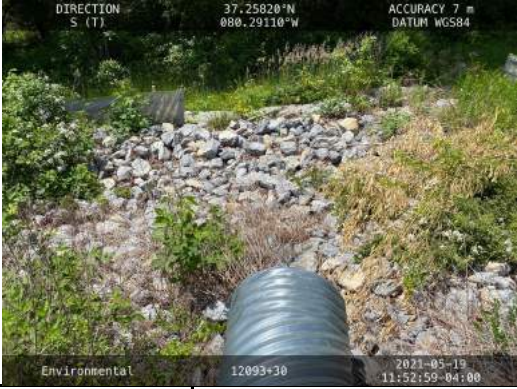
<p>DIRECTION S (T) 37.25820°N 080.29110°W ACCURACY 7 m DATUM WGS84</p> <p>Environmental 12093+30 2021-05-19 11:52:59-04:00</p>

<p>DIRECTION E (T) 37.22085°N 080.25791°W ACCURACY 1.43 km DATUM WGS84</p> <p>Environmental 12093+58 2021-05-19 11:52:39-04:00</p>			
GPS Location	See photo		GPS Location	See photo	
Field Station#	12093+30		Field Station#	12093+58	
Pic 7 Desc.	Clean water crossing pipe outlet in acceptable condition		Pic 8 Desc.	Stabilized ROW in acceptable condition

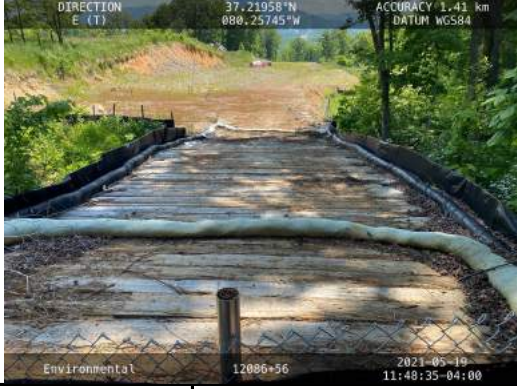
<p>DIRECTION E (T) 37.21958°N 080.25745°W ACCURACY 1.41 km DATUM WGS84</p> <p>Environmental 12086+56 2021-05-19 11:48:35-04:00</p>

Pic 9 Desc.	Bridge and ECDs crossing S-MM14		Pic 10 Desc.	Stabilized ROW in acceptable condition

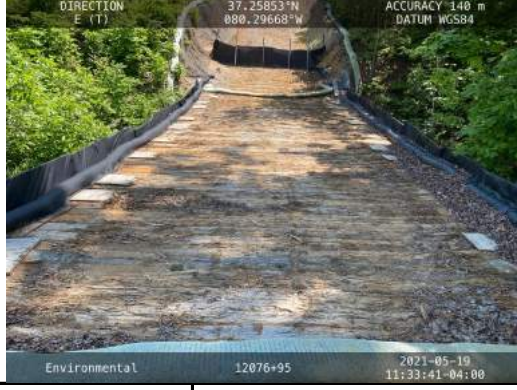
<p>DIRECTION E (T) 37.25853°N 080.29668°W ACCURACY 140 m DATUM WGS84</p> <p>Environmental 12076+95 2021-05-19 11:33:41-04:00</p>

<p>DIRECTION E (T) 37.25847°N 080.29749°W ACCURACY 241 m DATUM WGS84</p> <p>Environmental 12073+00 2021-05-19 11:30:19-04:00</p>			
GPS Location	See photo		GPS Location	See photo	
Field Station#	12076+95		Field Station#	12073+00	
Pic 11 Desc.	Bridge and ECDs crossing S-MM15		Pic 12 Desc.	Stabilized ROW in acceptable condition

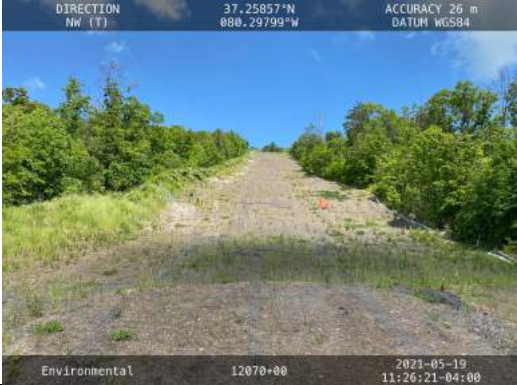
GPS Location	See photo		GPS Location	See photo	
Field Station#	12070+00		Field Station#	12013+97	
Pic 13 Desc.	Stabilized slope in acceptable condition		Pic 14 Desc.	Down stream of S-G38 in acceptable condition

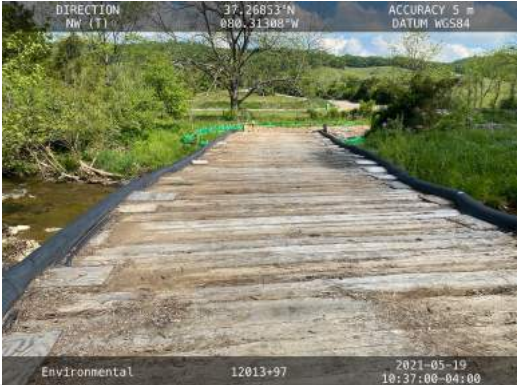
GPS Location	See photo		GPS Location	See photo	
Field Station#	12013+97		Field Station#	12010+00	
Pic 15 Desc.	Bridge and ECDs crossing stream S-G36 along access road MVP-MN-268.01		Pic 16 Desc.	Stabilized Row and stream crossing S-G36

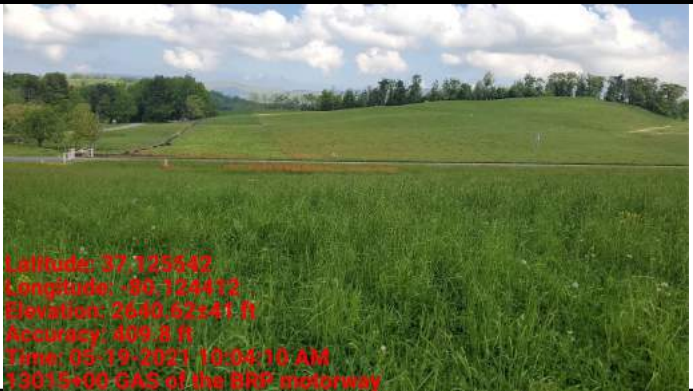
GPS Location	See pic for GPS location		GPS Location	See pic for GPS location	
Field Station#	13018+00		Field Station#	13015+00	
Pic 3 Desc.	GAS of the BRP, wooded portion.		Pic 4 Desc.	GAS of the BRP looking upstream.

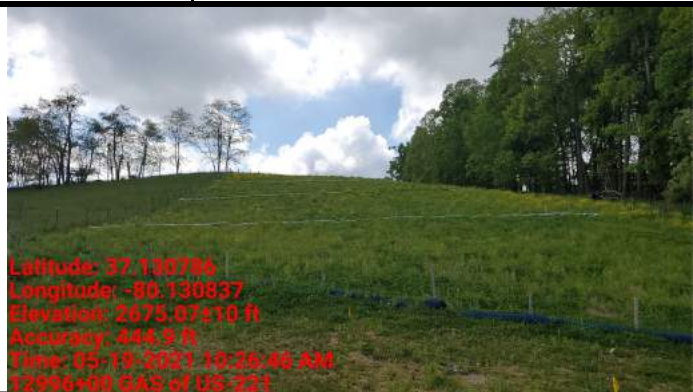
<p>Latitude: 37.128623 Longitude: -88.129879 Elevation: 2673.98±10 ft Accuracy: 31.8 ft Time: 05-19-2021 10:37:36 AM 12996+00 GAS of US-221</p>			
GPS Location	See pic for GPS location		GPS Location	See pic for GPS location	
Field Station#	12996+00		Field Station#	12996+00	
Pic 5 Desc.	GAS of the US-221 road crossing looking downstream.		Pic 6 Desc.	GAS of the US-221 road crossing looking upstream

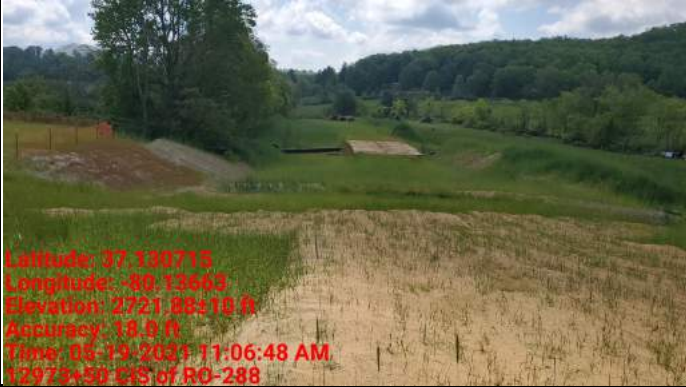
<p>Latitude: 37.130736 Longitude: -80.137128 Elevation: 2721.78±10 ft Accuracy: 34.9 ft Time: 05-19-2021 11:07:23 AM 12973+50 CIS of RO-288</p>		
GPS Location	See pic for GPS location		GPS Location	See pic for GPS location	
Field Station#	12973+50		Field Station#	12973+50	
Pic 7 Desc.	Current ROW conditions at RO-288.		Pic 8 Desc.	CIS of RO-288.

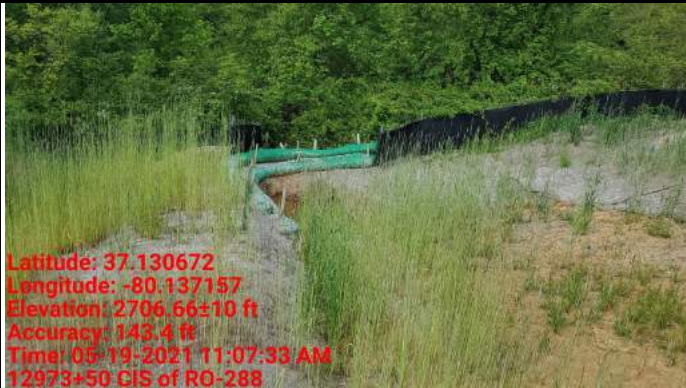
Field Station#	12973+50		Field Station#	12958+50	
Pic 9 Desc.	Waterbars, sumps and end treatments remain in compliance.		Pic 10 Desc.	Downstream side of stream S-Y8 on the GAS of RO-287.

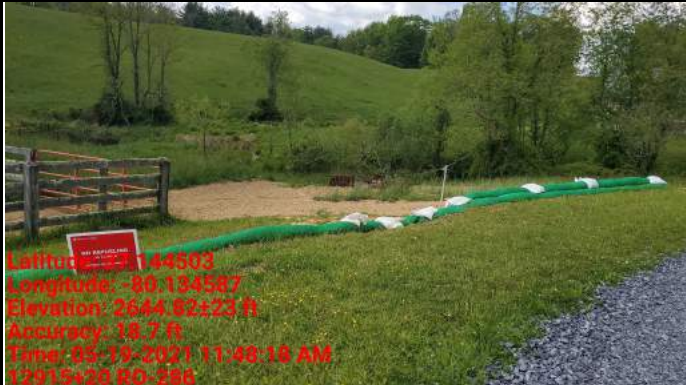
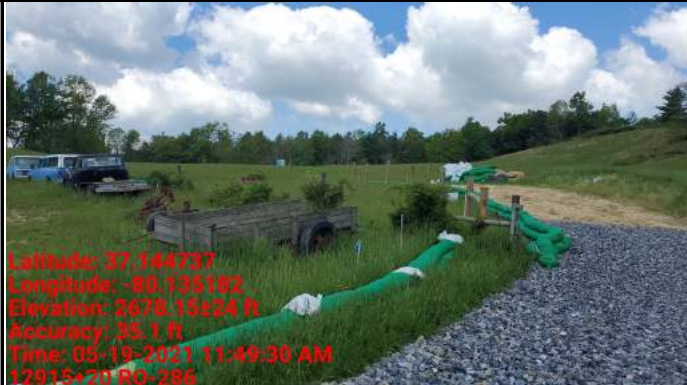
Latitude: 37.144503 Longitude: -80.134587 Elevation: 2644.82±23 ft Accuracy: 18.7 ft Time: 05-19-2021 11:48:18 AM 12915+20 RO-286			Latitude: 37.144737 Longitude: -80.135182 Elevation: 2678.15±24 ft Accuracy: 35.1 ft Time: 05-19-2021 11:49:30 AM 12915+20 RO-286		
GPS Location	See pic for GPS location		GPS Location	See pic for GPS location	
Field Station#	12915+20		Field Station#	12915+20	
Pic 13 Desc.	ECD's installed along RO-286 remain in acceptable condition.		Pic 14 Desc.	ECD's installed along RO-286 remain in acceptable condition.

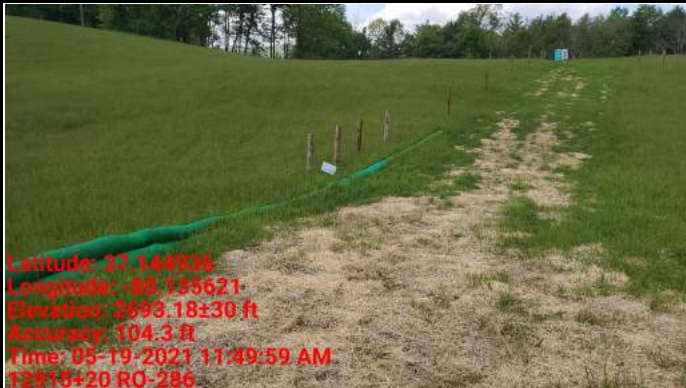
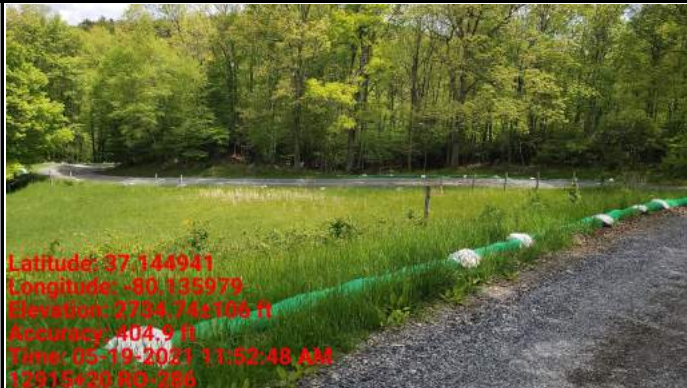
Field Station#	12915+20		Field Station#	12915+20	
Pic 15 Desc.	ECD's installed along RO-286 remain in acceptable condition.		Pic 16 Desc.	ECD's installed along RO-286 remain in acceptable condition.

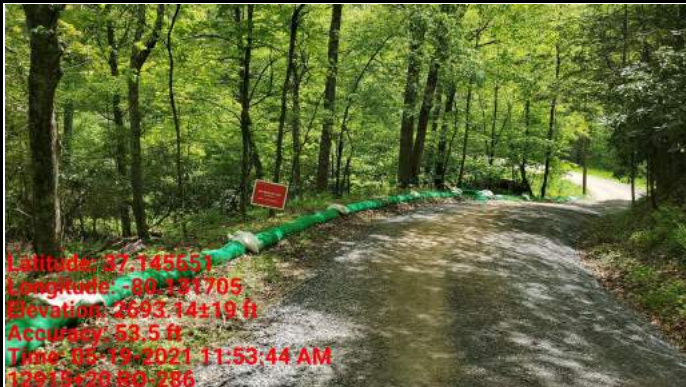
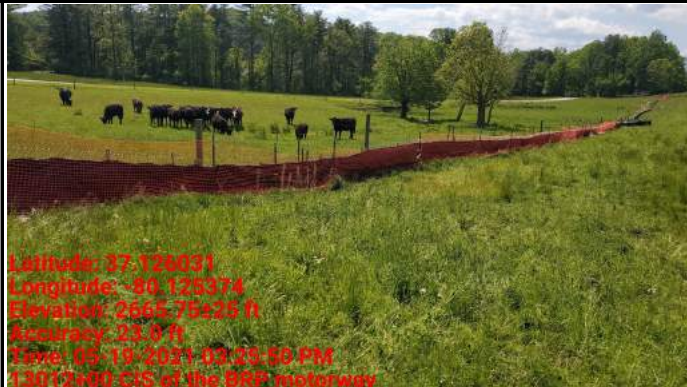
Latitude: 37.145651 Longitude: -80.131705 Elevation: 2693.44±19 ft Accuracy: 53.5 ft Time: 05-19-2021 11:53:44 AM 12915+20 RO-286			Latitude: 37.128071 Longitude: -80.125374 Elevation: 2668.75±26 ft Accuracy: 23.8 ft Time: 05-19-2021 03:55:50 PM 13012+00 CIS of the BRP motorway		
GPS Location	See pic for GPS location		GPS Location	See pic for GPS location	
Field Station#	12915+20		Field Station#	13012+00	
Pic 17 Desc.	ECD's installed along RO-286 remain in acceptable condition.		Pic 18 Desc.	SSF and orange safety fence on the CIS of the BRP motorway repaired by contractor.

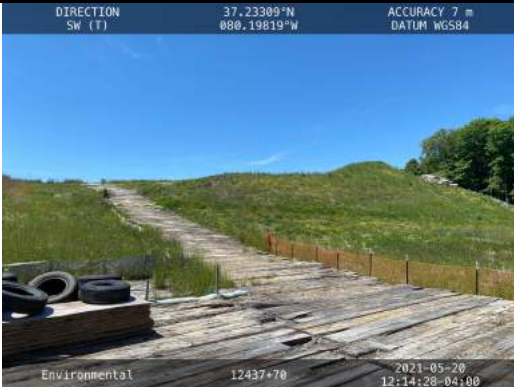
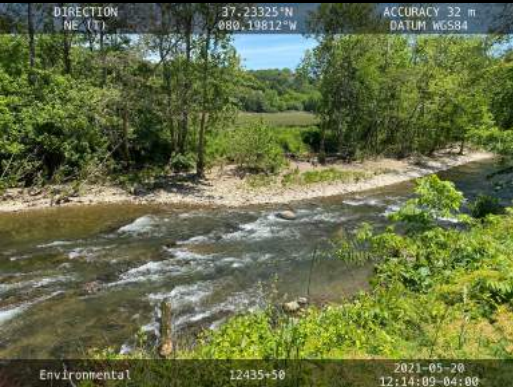
GPS Location	See photo		GPS Location	See photo	
Field Station#	12437+70		Field Station#	12435+50	
Pic 1 Desc.	Stabilized slope in acceptable condition		Pic 2 Desc.	Stream crossing S-NN16 In Acceptable condition

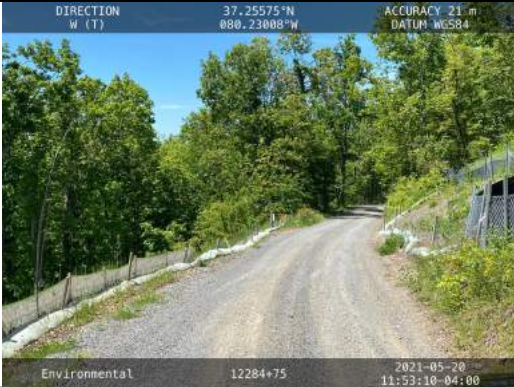
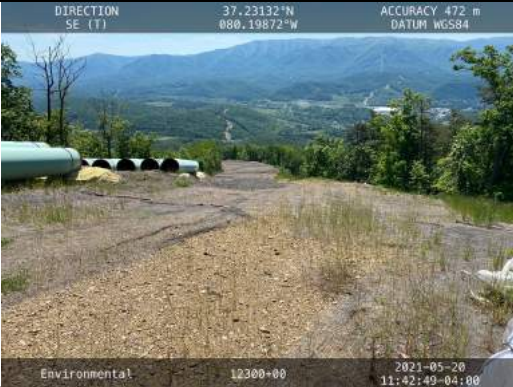
GPS Location	See photo		GPS Location	See photo	
Field Station#	12284+75		Field Station#	12300+00	
Pic 3 Desc.	Access road crossing MVP-MN-276.03		Pic 4 Desc.	Stabilized ROW in acceptable condition

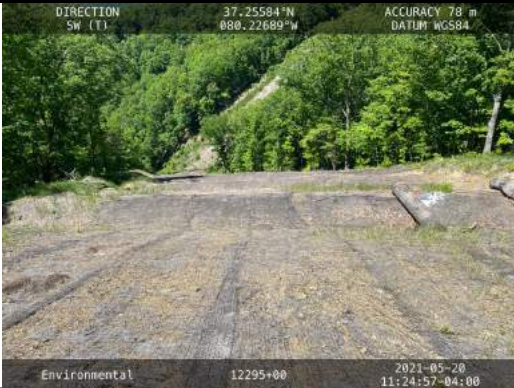
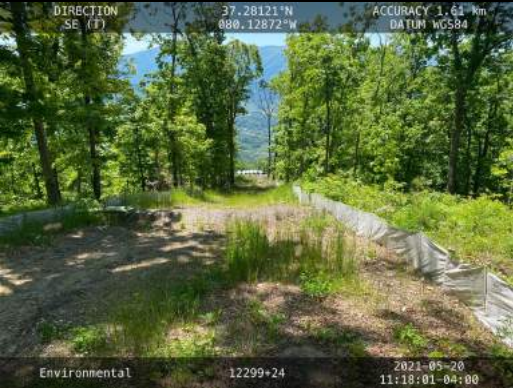
GPS Location	See photo		GPS Location	See photo	
Field Station#	12295+00		Field Station#	12299+24	
Pic 5 Desc.	Stabilized ROW in acceptable condition		Pic 6 Desc.	Stabilized access Road MVP-MN-276.03 In Acceptable condition

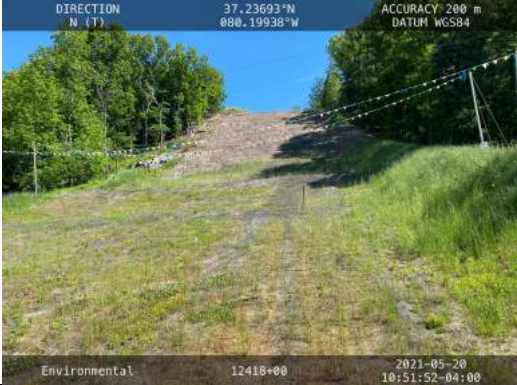
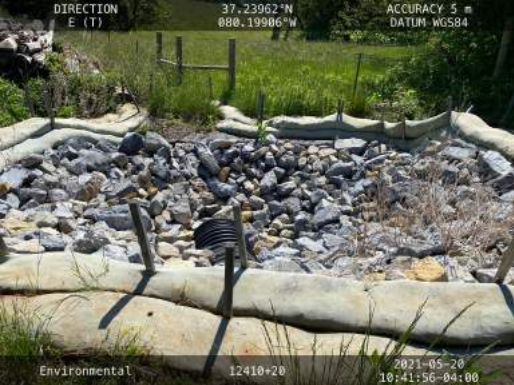
GPS Location	See photo		GPS Location	See photo	
Field Station#	12418+00		Field Station#	12410+20	
Pic 7 Desc.	Stabilized slope in acceptable condition		Pic 8 Desc.	Clean water crossing outlet in acceptable condition

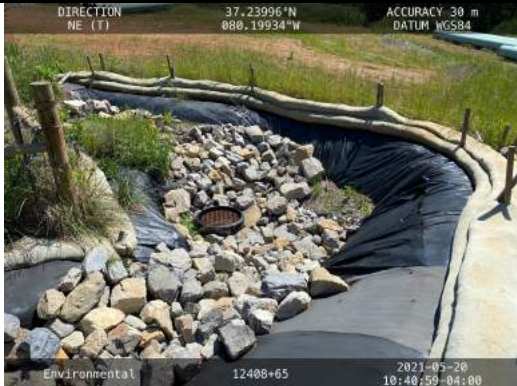
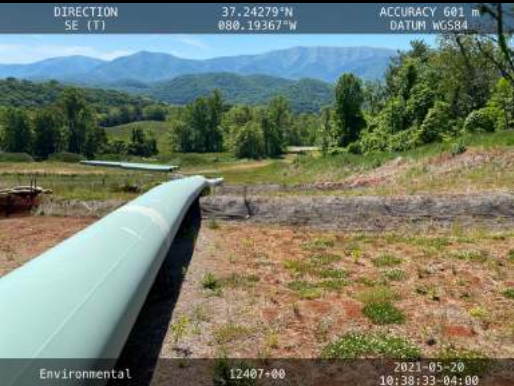
GPS Location	See photo		GPS Location	See photo	
Field Station#	12408+65		Field Station#	12407+00	
Pic 9 Desc.	Clean water crossing inlet		Pic 10 Desc.	Stabilized ROW in acceptable condition

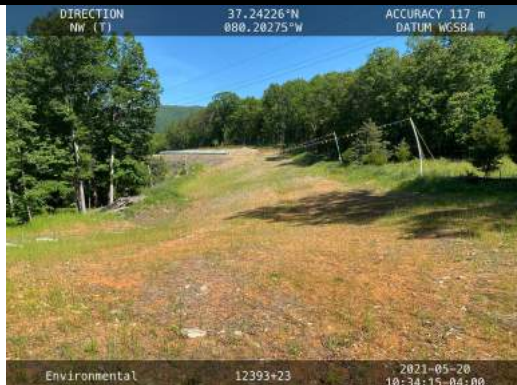
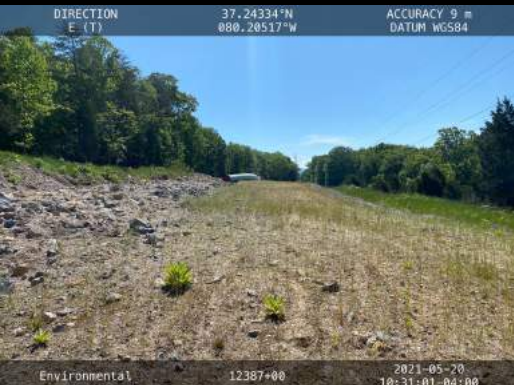
GPS Location	See photo		GPS Location	See photo	
Field Station#	12393+23		Field Station#	12387+00	
Pic 11 Desc.	Stabilized ROW in acceptable condition		Pic 12 Desc.	Stabilized ROW in acceptable condition

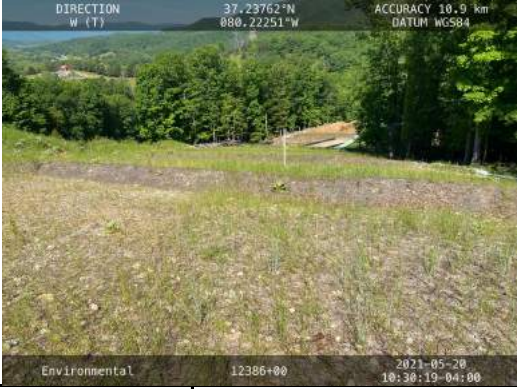
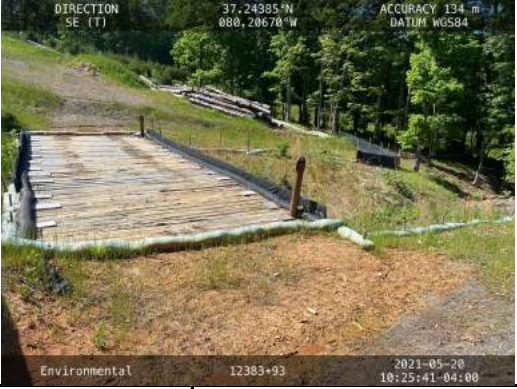
GPS Location	See photo		GPS Location	See photo	
Field Station#	12386+00		Field Station#	12383+92	
Pic 13 Desc.	Stabilized ROW in acceptable condition		Pic 14 Desc.	Clean water crossing in acceptable condition

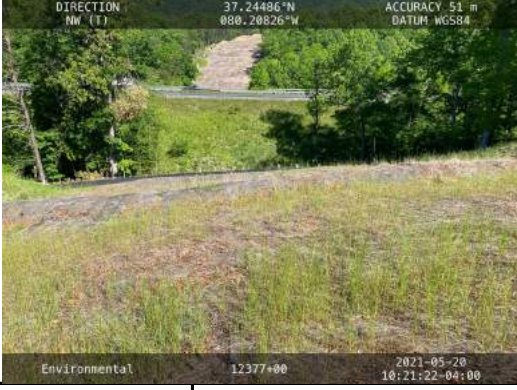
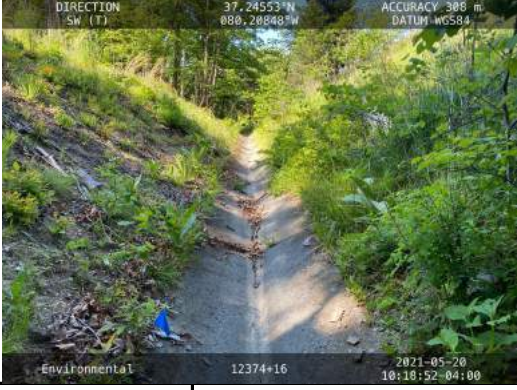
GPS Location	See photo		GPS Location	See photo	
Field Station#	12377+00		Field Station#	12374+16	
Pic 17 Desc.	Stabilized ROW in acceptable condition		Pic 18 Desc.	Stream crossing S-OO16 in acceptable condition

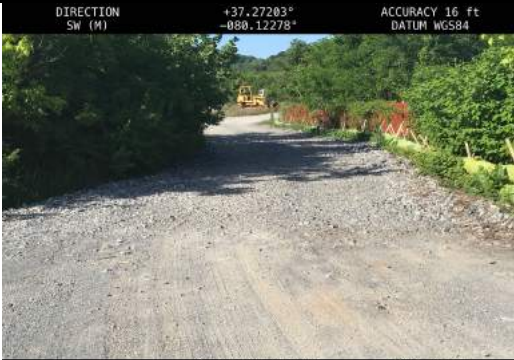
<p>DIRECTION SW (M) +37.27203° -080.12278° ACCURACY 16 ft DATUM WGS84</p> <p>MVP-LY-049_052021 Condition of rock entrance 2021-05-20 08:50:03-04:00</p>

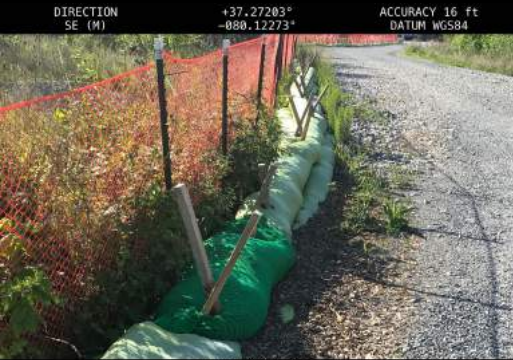
<p>DIRECTION SE (M) +37.27203° -080.12273° ACCURACY 16 ft DATUM WGS84</p> <p>MVP-LY-049_052021 Condition of CFS along LOD 2021-05-20 08:50:18-04:00</p>		GPS Location MVP-LY-049 See photo for gps data	
Field Station# +0		Field Station# +0		GPS Location MVP-LY-049 See photo for gps data	
Pic 1 Desc. Condition of rock entrance on north drive. No sediment on stone. Looking SW.		Pic 2 Desc. Condition of compost filter sock and safety fence along east side of center drive. Looking SE.		GPS Location MVP-LY-049 See photo for gps data

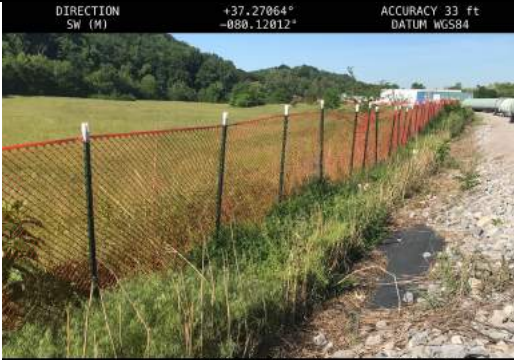
<p>DIRECTION SW (M) +37.27064° -080.12012° ACCURACY 33 ft DATUM WGS84</p> <p>MVP-LY-049_052021 Condition of CFS & safety fence LOD 2021-05-20 09:08:19-04:00</p>

Field Station# +0		Field Station# +0		GPS Location MVP-LY-049 See photo for gps data	
Pic 3 Desc. Condition of compost filter sock and safety fence along south LOD. Looking SW.		Pic 4 Desc. Landowner soil disturbance along compost filter sock. No damage to ECD's. Looking SE.		GPS Location MVP-LY-049 See photo for gps data

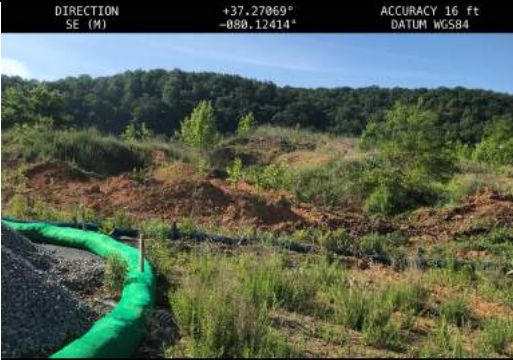
<p>DIRECTION SE (M) +37.27069° -080.12414° ACCURACY 16 ft DATUM WGS84</p> <p>MVP-LY-049_052021 Landowner disturbance along CFS 2021-05-20 08:51:40-04:00</p>		GPS Location MVP-LY-049 See photo for gps data

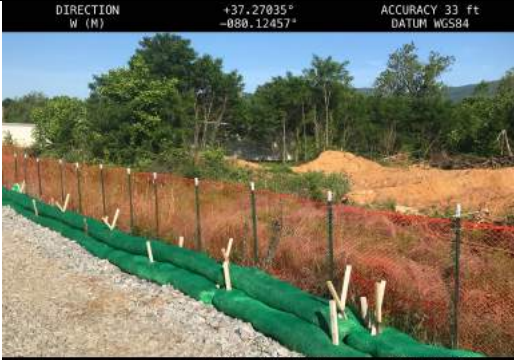
<p>DIRECTION W (M) +37.27035° -080.12457° ACCURACY 33 ft DATUM WGS84</p> <p>MVP-LY-049_052021 Landowner disturbance along feature 2021-05-20 08:52:38-04:00</p>

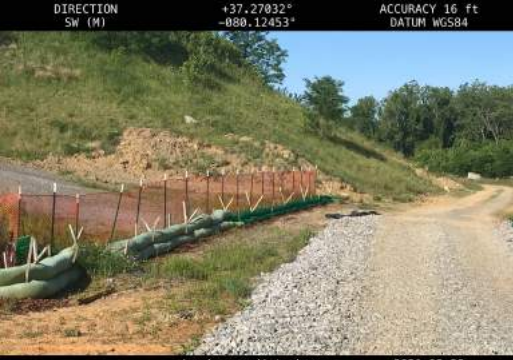
<p>DIRECTION SW (M) +37.27032° -080.12453° ACCURACY 16 ft DATUM WGS84</p> <p>MVP-LY-049_052021 Landowner disturbance within 66' of feature 2021-05-20 08:52:44-04:00</p>		GPS Location MVP-LY-049 See photo for gps data	
Field Station# +0		Field Station# +0		GPS Location MVP-LY-049 See photo for gps data	
Pic 5 Desc. Landowner soil disturbance along feature W-CV21A. Area not stabilized. Area not project related. Looking NW.		Pic 6 Desc. Landowner soil disturbance within 66' and 120' west of feature W-CV21B. Areas not stabilized. Looking SW.		GPS Location MVP-LY-049 See photo for gps data

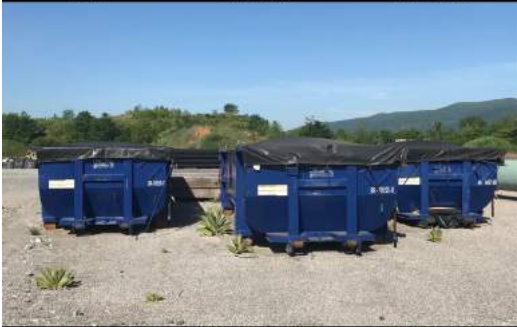
MVP-LY-049_052021 No deposits around hazardous waste dump... 2021-05-20 08:58:03-04:00		MVP-LY-049_052021 No loose trash around south dumpsters 2021-05-20 08:58:53-04:00			
GPS Location	MVP-LY-049 See photo for gps data		GPS Location	MVP-LY-049 See photo for gps data	
Field Station#	+0		Field Station#	+0	
Pic 13 Desc.	No fluids or deposits around hazardous waste dumpsters. Looking NW.		Pic 14 Desc.	No loose trash around south dumpsters or in the yard. Looking SE.	
DIRECTION S (M) +37.27013° -080.12159° ACCURACY 16 ft DATUM WGS84

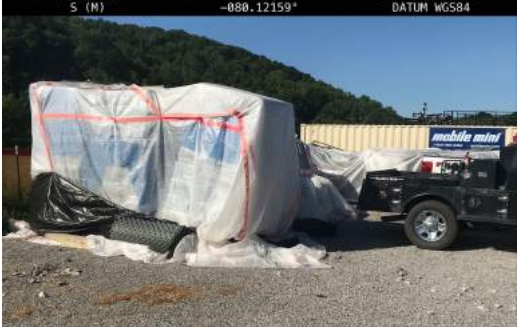
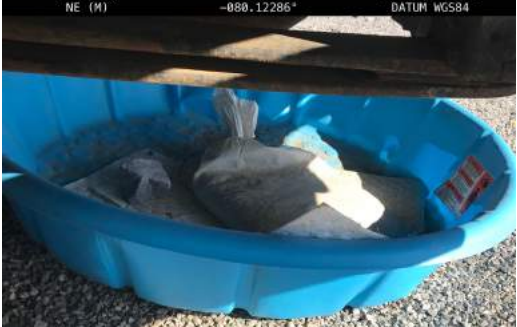
MVP-LY-049_052021 Restoration supplies covered 2021-05-20 08:59:29-04:00

GPS Location	MVP-LY-049 See photo for gps data		GPS Location	MVP-LY-049 See photo for gps data	
Field Station#	+0		Field Station#	+0	
Pic 15 Desc.	Restoration supplies under cover and protected. Looking SW.		Pic 16 Desc.	Condition of containment under stored vehicle. Looking NE.

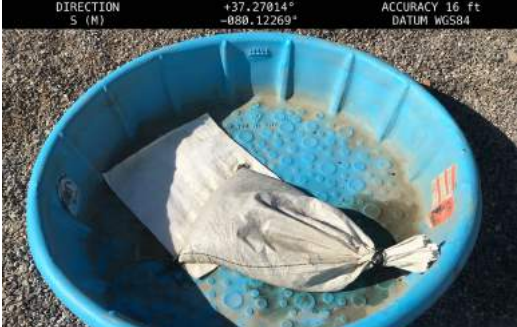
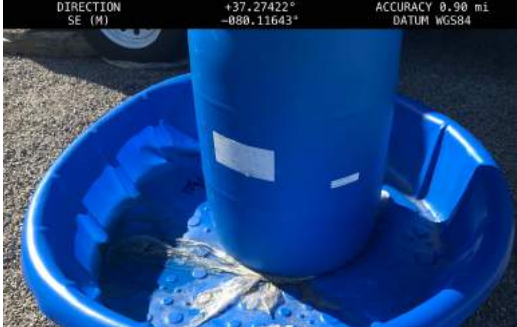
MVP-LY-049_052021 Condition of containment 2021-05-20 09:05:30-04:00

GPS Location	MVP-LY-049 See photo for gps data		GPS Location	MVP-LY-049 See photo for gps data	
Field Station#	+0		Field Station#	+0	
Pic 17 Desc.	Condition of containment under stored trailer. Looking S.		Pic 18 Desc.	Condition of containment under barrel of toilet chemical. Free of stormwater. Looking SE.

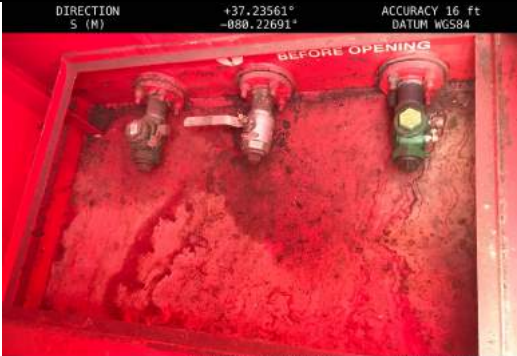
<p>DIRECTION S (M) +37.23561° -080.22691° ACCURACY 16 ft DATUM WGS84</p> <p>MVP-PY-006_052021 Condition of internal drip pan 2021-05-20 07:29:30-04:00</p>

<p>DIRECTION SW (M) +37.23561° -080.22691° ACCURACY 16 ft DATUM WGS84</p> <p>MVP-PY-006_052021 No leaky internal fittings 2021-05-20 07:29:37-04:00</p>			
GPS Location	MVP-PY-006 See photo for gps data		GPS Location	MVP-PY-006 See photo for gps data	
Field Station#	+0		Field Station#	+0	
Pic 7 Desc.	Off Road Fuel unit condition of internal drip pan. Free of fluids. Looking SW.		Pic 8 Desc.	Off Road Fuel unit no leaky internal fittings. Looking SW.

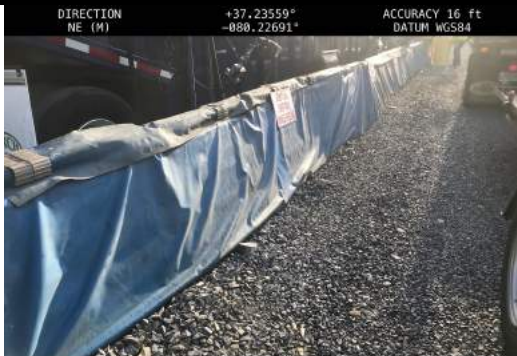
<p>DIRECTION NE (M) +37.23559° -080.22691° ACCURACY 16 ft DATUM WGS84</p> <p>MVP-PY-006_052021 No fuel spills south of tanks 2021-05-20 07:30:18-04:00</p>

GPS Location	MVP-PY-006 See photo for gps data		GPS Location	MVP-PY-006 See photo for gps data	
Field Station#	+0		Field Station#	+0	
Pic 9 Desc.	No fuel spills south of the Blue Bulk fuel tanks. Looking NE.		Pic 10 Desc.	Blue Bulk Fuel tanks no leaky internal fittings. Looking W.

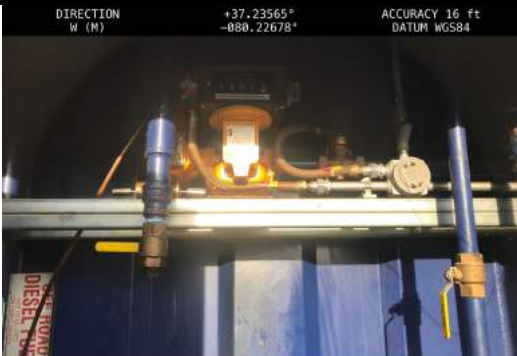
<p>DIRECTION W (M) +37.23565° -080.22678° ACCURACY 16 ft DATUM WGS84</p> <p>MVP-PY-006_052021 No leaky internal fittings 2021-05-20 07:32:12-04:00</p>

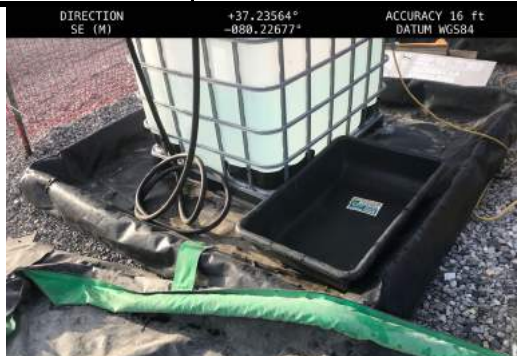
<p>DIRECTION SE (M) +37.23564° -080.22677° ACCURACY 16 ft DATUM WGS84</p> <p>MVP-PY-006_052021 Condition of containment 2021-05-20 07:32:49-04:00</p>

<p>DIRECTION S (M) +37.23554° -080.22673° ACCURACY 16 ft DATUM WGS84</p> <p>MVP-PY-006_052021 No fluids around hazardous waste dump... 2021-05-20 07:33:47-04:00</p>			
GPS Location	MVP-PY-006 See photo for gps data		GPS Location	MVP-PY-006 See photo for gps data	
Field Station#	+0		Field Station#	+0	
Pic 11 Desc.	Condition of containment under DEF container. Free of stormwater and fluids. Looking SE.		Pic 12 Desc.	No fluids or deposits around hazardous waste dumpsters. Looking S.

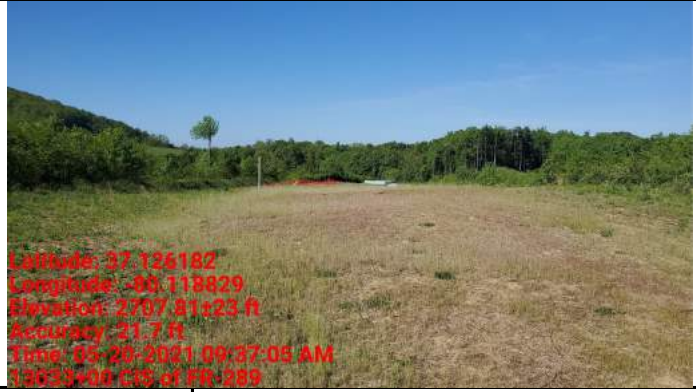
<p>Latitude: 37.125182 Longitude: -80.118829 Elevation: 2707.81±23 ft Accuracy: 21.7 ft Time: 05-20-2021 09:37:05 AM 13033+00 CIS of FR-289</p>

<p>Latitude: 37.125259 Longitude: -80.121104 Elevation: 2825.66±60 ft Accuracy: 34.4 ft Time: 05-20-2021 09:42:07 AM 13026+00 CIS of FR-289 streams S-G24 and S-G25</p>			
GPS Location	See pic for GPS location		GPS Location	See pic for GPS location	
Field Station#	13033+00		Field Station#	13026+00	
Pic 1 Desc.	Current ROW conditions on the CIS of FR-289.		Pic 2 Desc.	Streams S-G24 and S-G25 on the GAS of the BRP.

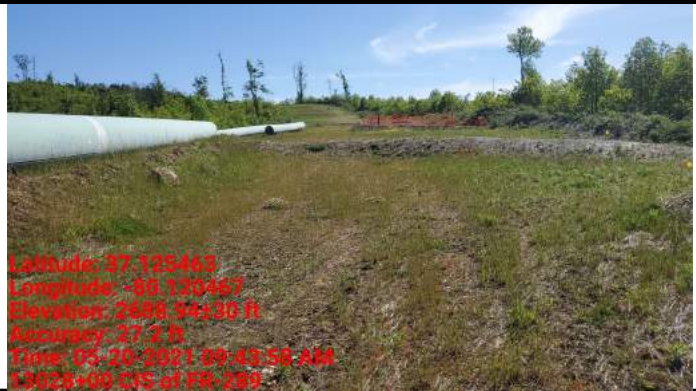
<p>Latitude: 37.125463 Longitude: -80.120457 Elevation: 2898.94±35 ft Accuracy: 37.3 ft Time: 05-20-2021 09:45:58 AM 13028+00 CIS of FR-289</p>

GPS Location	See pic for GPS location		GPS Location	See pic for GPS location	
Field Station#	13028+00		Field Station#	13040+00	
Pic 3 Desc.	Current ROW conditions on the CIS of FR-289.		Pic 4 Desc.	Stream S-H1 on the GAS of FR-289.

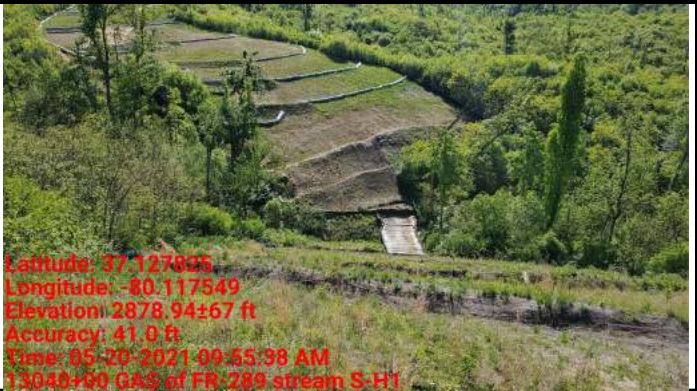
<p>Latitude: 37.127025 Longitude: -80.117549 Elevation: 2878.94±67 ft Accuracy: 41.0 ft Time: 05-20-2021 09:55:38 AM 13040+00 GAS of FR-289 stream S-H1</p>

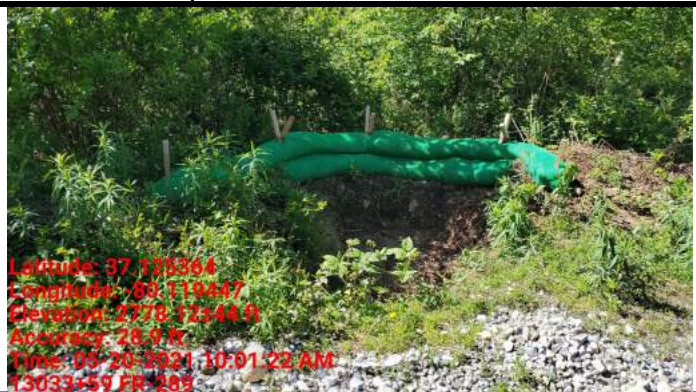
<p>Latitude: 37.125364 Longitude: -80.119447 Elevation: 2778.12±44 ft Accuracy: 28.0 ft Time: 05-20-2021 10:01:23 AM 13033+59 FR-289</p>

<p>Latitude: 37.123992 Longitude: -80.113759 Elevation: 2607.94±34 ft Accuracy: 32.2 ft Time: 05-20-2021 11:00:02 AM 13061+44 FR-290 stream S-RR16</p>			
GPS Location	See pic for GPS location		GPS Location	See pic for GPS location	
Field Station#	13033+59		Field Station#	13061+44	
Pic 5 Desc.	Waterbars, sumps and end treatments remain in compliance throughout the inspected area today.		Pic 6 Desc.	Downstream side of stream S-RR16 along FR-290.
