Visual Site Inspection Report

Project Name	H-600 Pipeline Spread H	AFE	124300138	Spread	H-600 Pipeline Spread H
Contractor	Precision			Report #	23469
Inspector	Logan Box			Date/Time	5/17/2021 3:02 PM
Permit #	TBD	Inspection Type	VA SWPP	Station Begin	13415+51
State	VA	Inspection Area	Partial	Station End	13525+99
County	Franklin	Ground	Dry	Temperature (°F)	71.00
Municipality	N/A	Weather	Cloudy	Rain Gauge (in)	0.00
				Rain Accumulation Time (days)	0.00

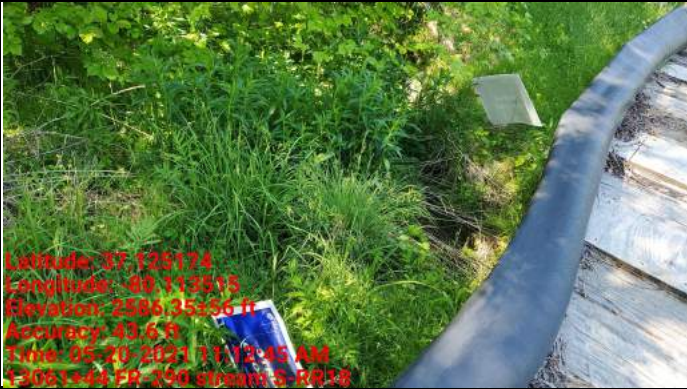
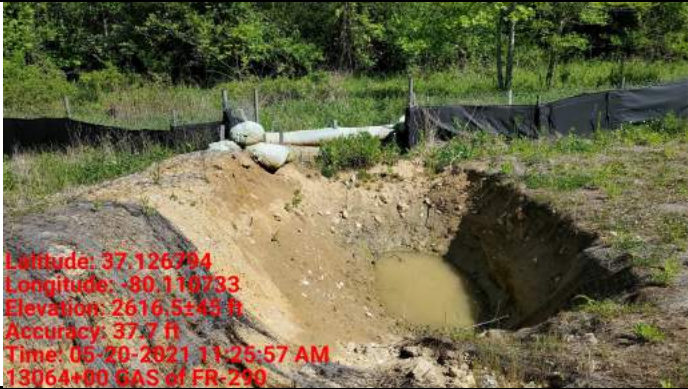
GPS Location	See pic for GPS location		GPS Location	See pic for GPS location	
Field Station#	13061+44		Field Station#	13064+00	
Pic 7 Desc.	Downstream side of stream S-RR18 along FR-290.		Pic 8 Desc.	Waterbars, sumps and end treatments remain in compliance.

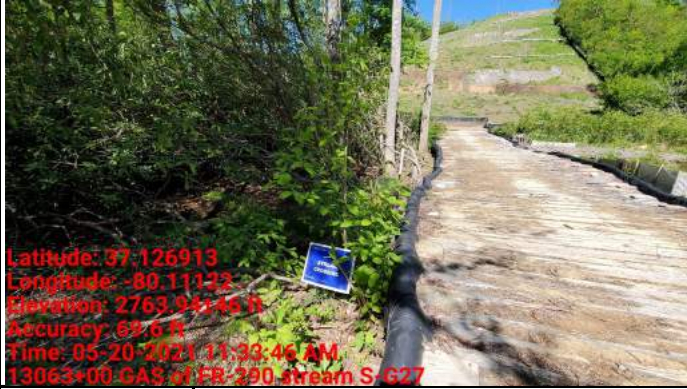
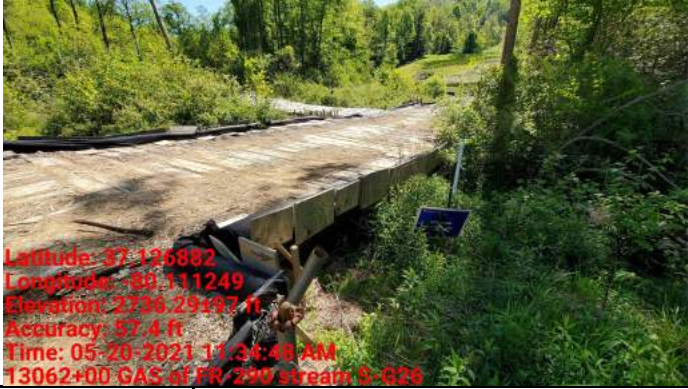
GPS Location	See pic for GPS location		GPS Location	See pic for GPS location	
Field Station#	13063+00		Field Station#	13062+00	
Pic 9 Desc.	Downstream side of stream S-G27 on the GAS of FR-290.		Pic 10 Desc.	Downstream side of stream S-G26 on the GAS of FR-290.

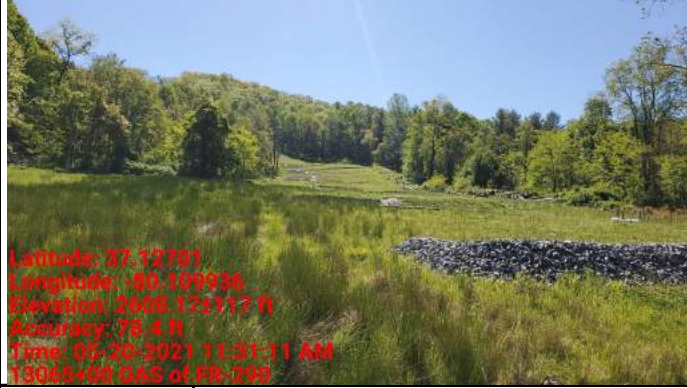
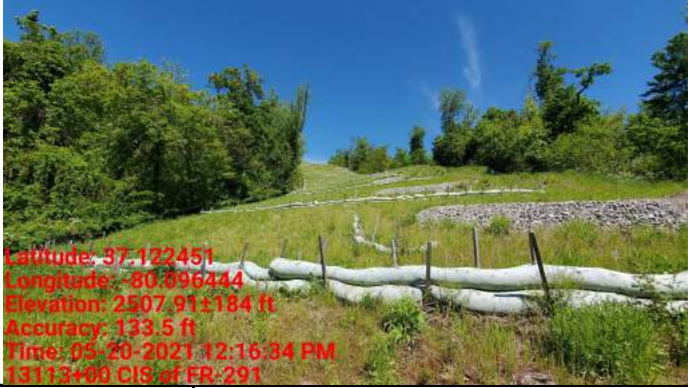
GPS Location	See pic for GPS location		GPS Location	See pic for GPS location	
Field Station#	13065+00		Field Station#	13113+00	
Pic 11 Desc.	Current ROW conditions on the GAS of FR-290.		Pic 12 Desc.	Current ROW conditions on the CIS of FR-291.

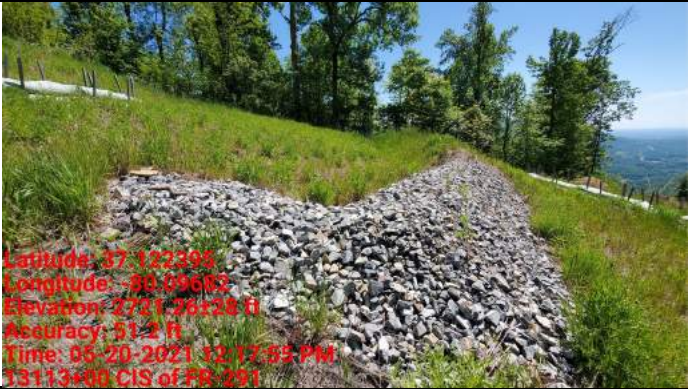
GPS Location	See pic for GPS location		GPS Location	See pic for GPS location	
Field Station#	13113+00		Field Station#	13113+00	
Pic 13 Desc.	Trench drain pipe with rock apron on CIS of FR-291.		Pic 14 Desc.	Permanent Slope Breaker and Rock Level Spreader on the CIS of FR-291.

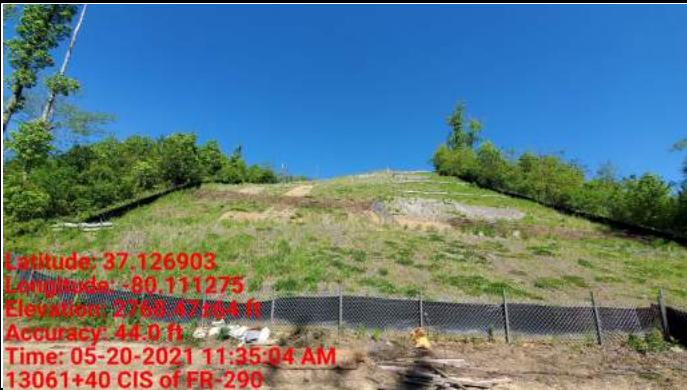
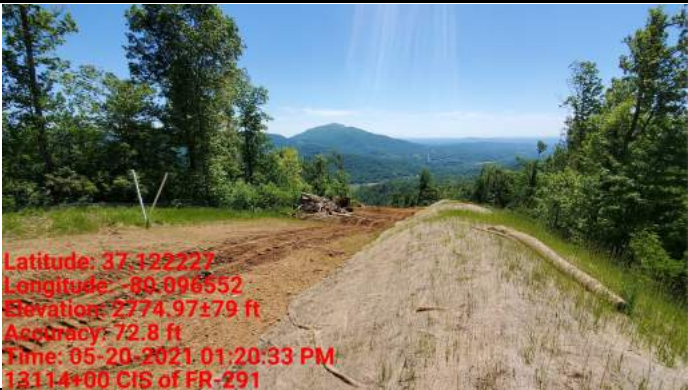
GPS Location	See pic for GPS location		GPS Location	See pic for GPS location	
Field Station#	13061+44		Field Station#	13114+00	
Pic 15 Desc.	Current ROW conditions on the CIS of FR-290.		Pic 16 Desc.	Waterbars, sumps and end treatments remain in compliance on the CIS of FR-291.

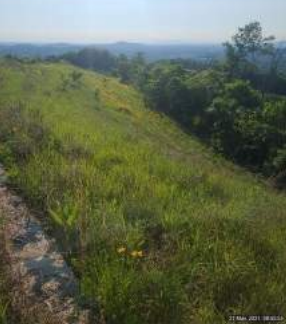
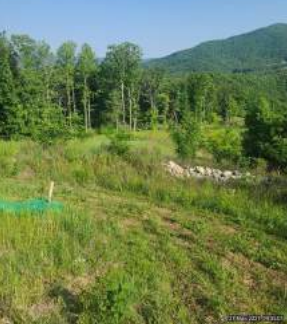
GPS Location	00000	GPS Location	00000		
Field Station#	13459+00	Field Station#	13452+00		
Pic 1 Desc.	Vegetation observation photo vegetation on side slope, good coverage noted.		Pic 2 Desc.	Additional photo showing black locus trees inside row limits.	
	North Elevation <small>180°S (T) 37.086433, -80.017126 ±4 m ▲ 478 m</small>

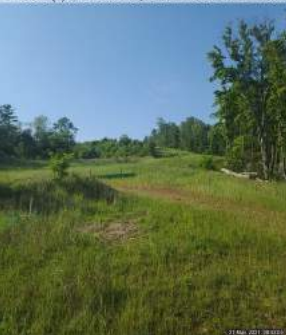
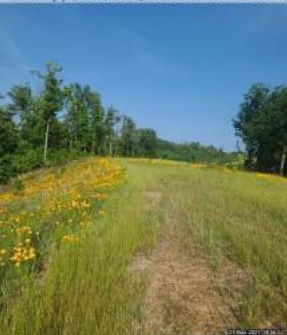
GPS Location	00000	GPS Location	00000		
Field Station#	13449+00	Field Station#	13471+00		
Pic 3 Desc.	Row photo showing vegetation growth , good coverage noted during inspection today .		Pic 4 Desc.	Row photo showing vegetation, good coverage noted.

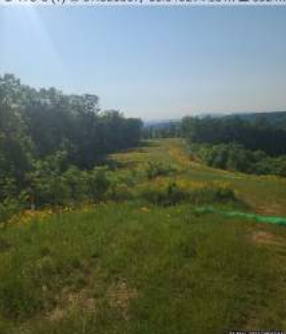
GPS Location	00000	GPS Location	00000		
Field Station#	13465+40	Field Station#	13473+00		
Pic 5 Desc.	During inspection today the EI noticed a substantial amount of black locus inside the row boundary . Will continue to monitor growth		Pic 6 Desc.	Row photo showing vegetation growth, good coverage observed throughout.

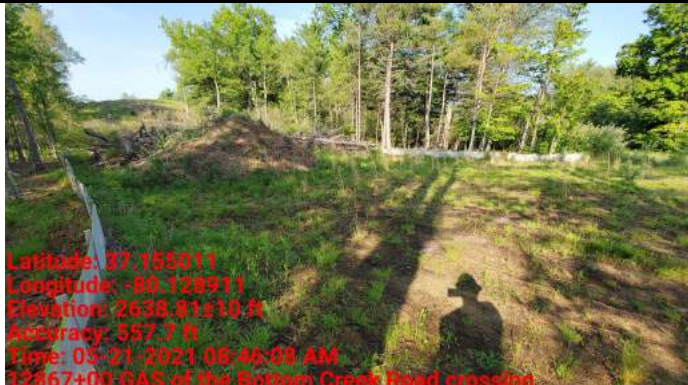
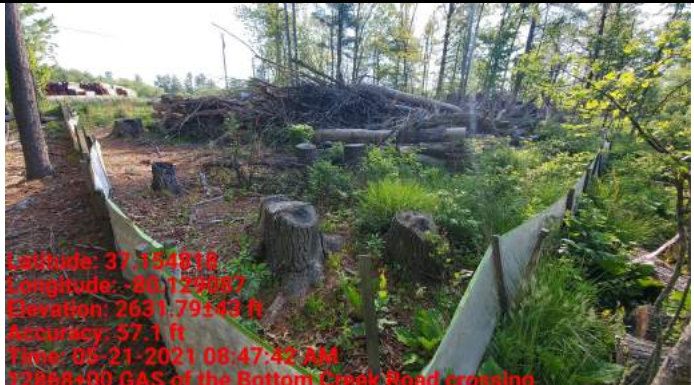
<p>Latitude: 37.154818 Longitude: -80.128887 Elevation: 2631.79±10 ft Accuracy: 57.1 ft Time: 05-21-2021 08:47:42 AM 12868+00 GAS of the Bottom Creek Road crossing</p>		
GPS Location	See pic for GPS location		GPS Location	See pic for GPS location	
Field Station#	12867+00		Field Station#	12868+00	
Pic 1 Desc.	Current ROW conditions on the GAS of Bottom Creek Road.		Pic 2 Desc.	Edge of disturbed work area on the GAS of Bottom Creek Road.

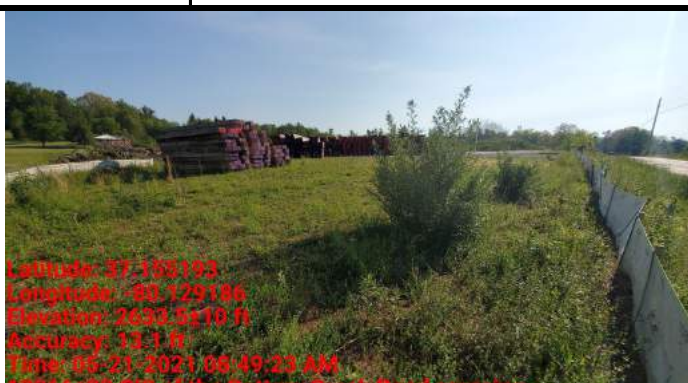
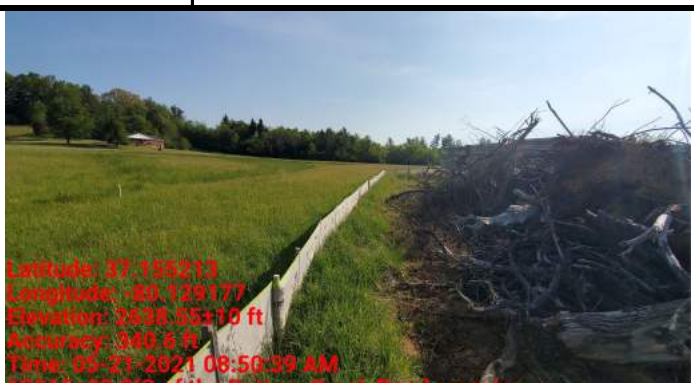
GPS Location	See pic for GPS location		GPS Location	See pic for GPS location	
Field Station#	12866+00		Field Station#	12865+00	
Pic 3 Desc.	Current conditions of the ROW.		Pic 4 Desc.	Perimeter P1 remains in compliance at Bottom Creek Road.

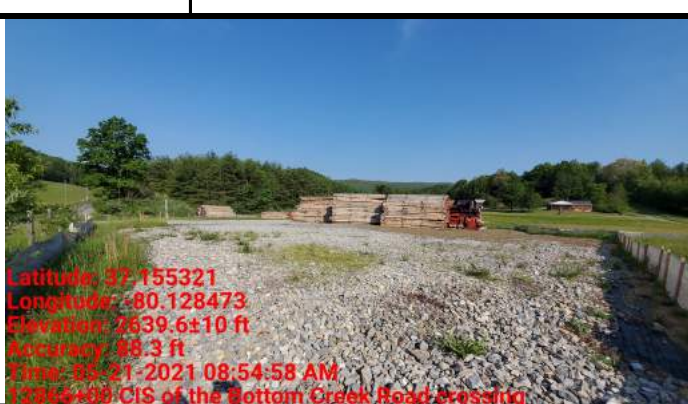
<p>Latitude: 37.155321 Longitude: -80.128473 Elevation: 2639.6±10 ft Accuracy: 88.3 ft Time: 05-21-2021 08:54:58 AM 12866+00 CIS of the Bottom Creek Road crossing</p>

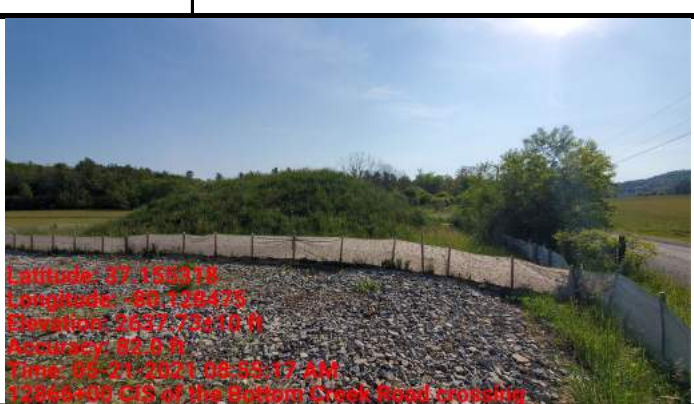
<p>Latitude: 37.155318 Longitude: -80.128475 Elevation: 2637.73±10 ft Accuracy: 83.6 ft Time: 05-21-2021 08:55:17 AM 12866+00 CIS of the Bottom Creek Road crossing</p>		
GPS Location	See pic for GPS location		GPS Location	See pic for GPS location	
Field Station#	12866+00		Field Station#	12866+00	
Pic 5 Desc.	ATWS on CIS of Bottom Creek Road.		Pic 6 Desc.	Topsoil pile at Bottom Creek Road.

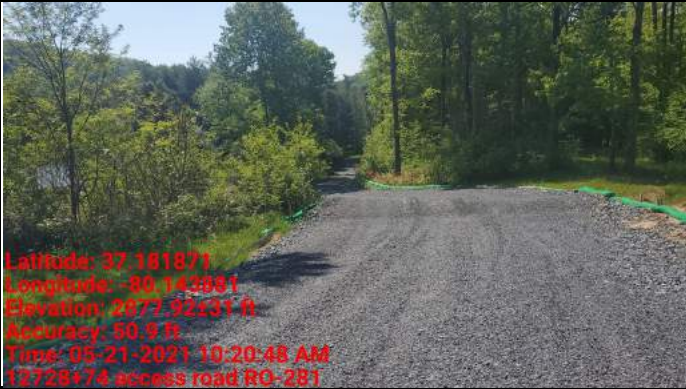
<p>Latitude: 37.181871 Longitude: -80.142881 Elevation: 2877.92±10 ft Accuracy: 50.9 ft Time: 05-21-2021 10:20:48 AM 12728+74 access road RO-281</p>

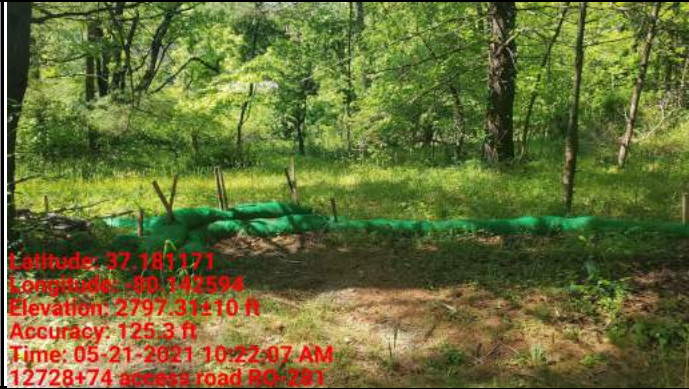
<p>Latitude: 37.181171 Longitude: -80.142594 Elevation: 2797.31±10 ft Accuracy: 125.3 ft Time: 05-21-2021 10:22:07 AM 12728+74 access road RO-281</p>		
GPS Location	See pic for GPS location		GPS Location	See pic for GPS location	
Field Station#	12728+74		Field Station#	12728+74	
Pic 7 Desc.	No maintenance issues or impacts observed at RO-281.		Pic 8 Desc.	CFS along RO-281 remains in compliance.

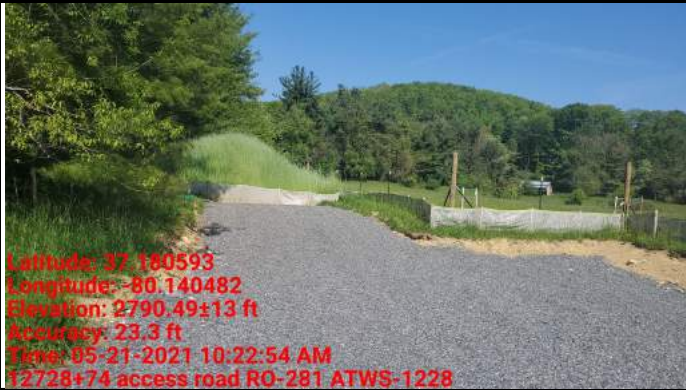
<p>Latitude: 37.180593 Longitude: -80.140482 Elevation: 2790.49±13 ft Accuracy: 23.3 ft Time: 05-21-2021 10:22:54 AM 12728+74 access road RO-281 ATWS-1228</p>

GPS Location	See pic for GPS location		GPS Location	See pic for GPS location	
Field Station#	12728+74		Field Station#	12728+74	
Pic 9 Desc.	ATWS on RO-281.		Pic 10 Desc.	Upstream side of stream S-EF32.

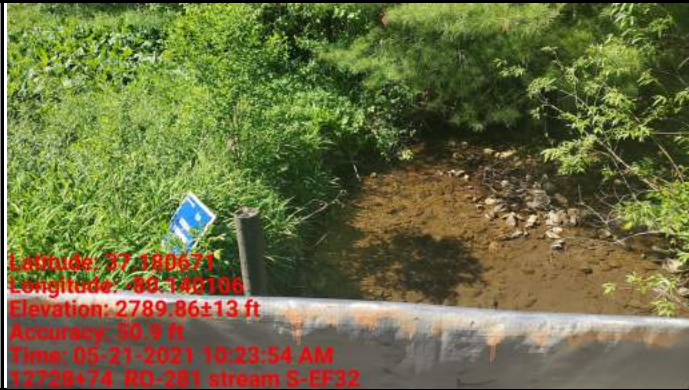
<p>Latitude: 37.180671 Longitude: -80.140106 Elevation: 2789.86±13 ft Accuracy: 50.9 ft Time: 05-21-2021 10:23:54 AM 12728+74 RO-281 stream S-EF32</p>

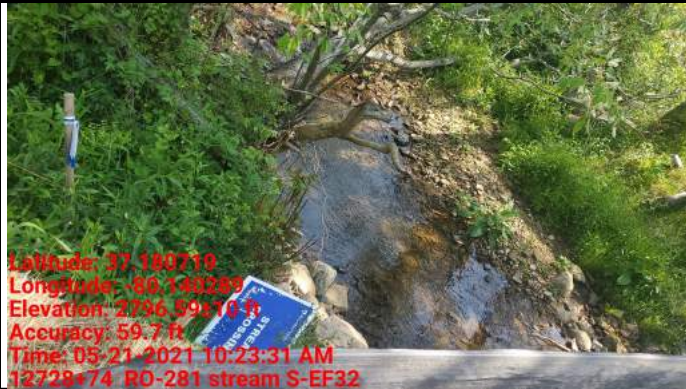
<p>Latitude: 37.180719 Longitude: -80.140289 Elevation: 2736.99±10 ft Accuracy: 59.7 ft Time: 05-21-2021 10:23:31 AM 12728+74 RO-281 stream S-EF32</p>

<p>Latitude: 37.192764 Longitude: -80.159491 Elevation: 3689.53±60 ft Accuracy: 48.2 ft Time: 05-21-2021 12:15:31 PM 2683+00 CIS of Honeysuckle</p>		
GPS Location	See pic for GPS location		GPS Location	See pic for GPS location	
Field Station#	12728+74		Field Station#	12683+00	
Pic 11 Desc.	Downstream side of stream S-EF32.		Pic 12 Desc.	Current ROW conditions on the CIS of Honeysuckle Road.

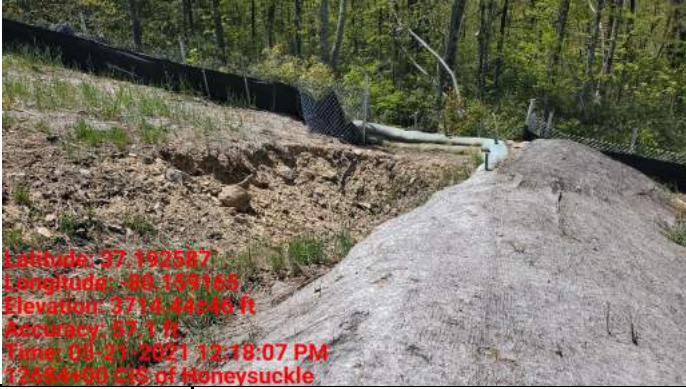
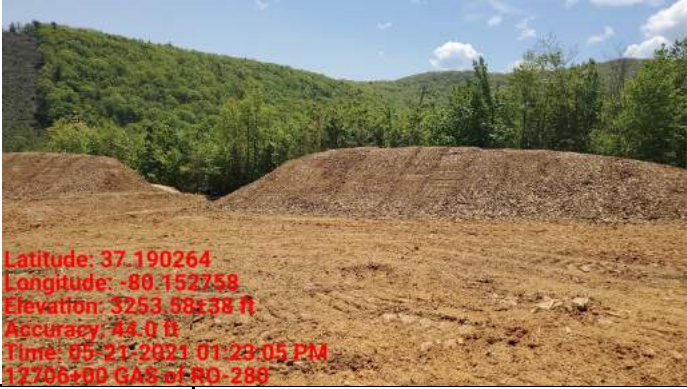
GPS Location	See pic for GPS location	GPS Location	See pic for GPS location		
Field Station#	12684+00	Field Station#	12706+00		
Pic 13 Desc.	Waterbars, sumps and end treatments remain in acceptable condition on the CIS of Honeysuckle Road.	Pic 14 Desc.	Grade crew working on the GAS of RO-280.

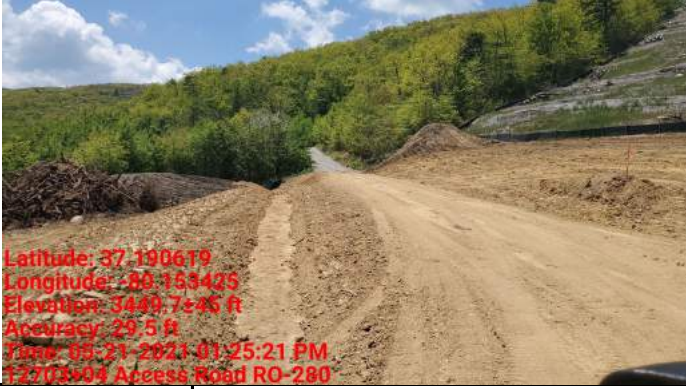
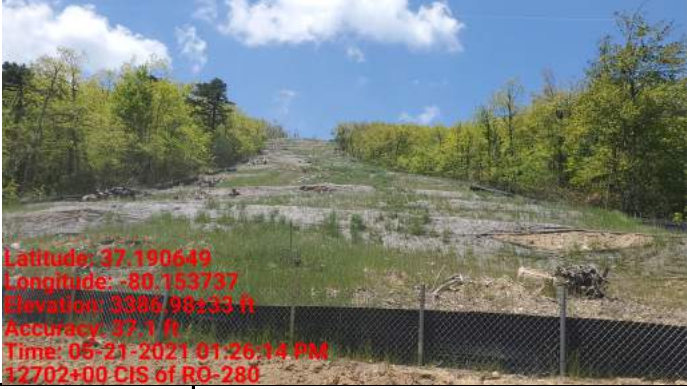
GPS Location	See pic for GPS location	GPS Location	See pic for GPS location		
Field Station#	12703+04	Field Station#	12702+00		
Pic 15 Desc.	Waterbars installed on the GAS of RO-280.	Pic 16 Desc.	Current ROW conditions on the CIS of RO-280.

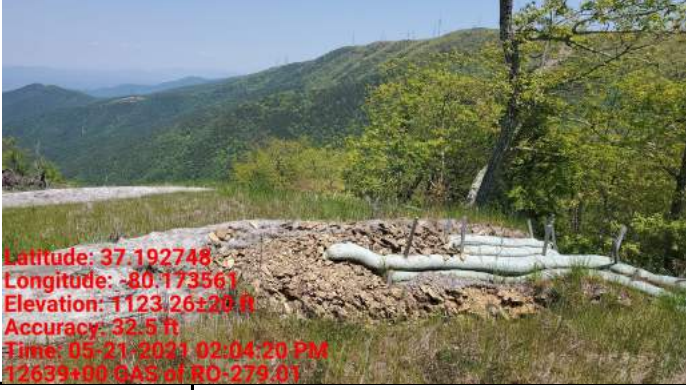
Insert image here			
GPS Location	See pic for GPS location	GPS Location			
Field Station#	12639+00	Field Station#			
Pic 17 Desc.	Waterbars, sumps and end treatments remain in compliance throughout the area on the GAS Of FR-279.01.	Pic 18 Desc.

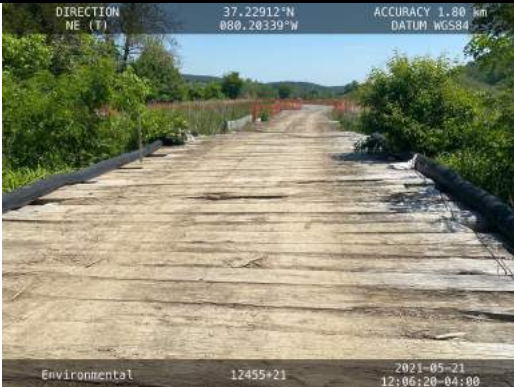
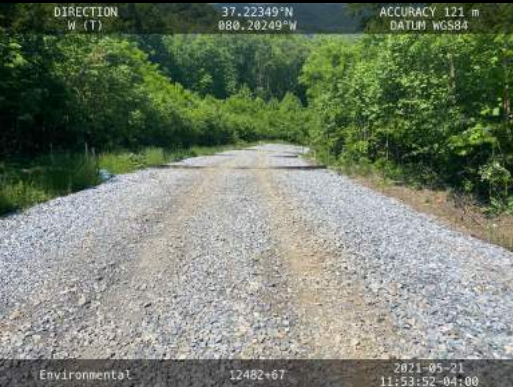
GPS Location	See photo		GPS Location	See photo	
Field Station#	12455+21		Field Station#	12482+67	
Pic 1 Desc.	Bridge and ECDs crossing S-CD12b		Pic 2 Desc.	Access Road MVP-MLV-AR-28 in acceptable condition

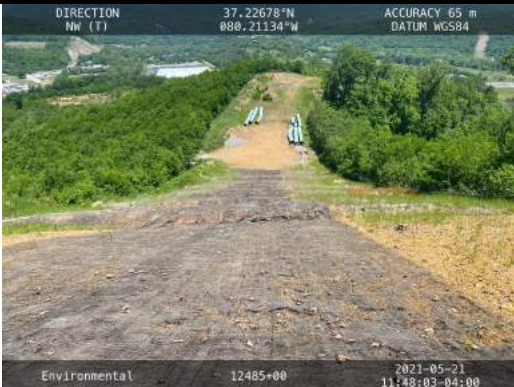
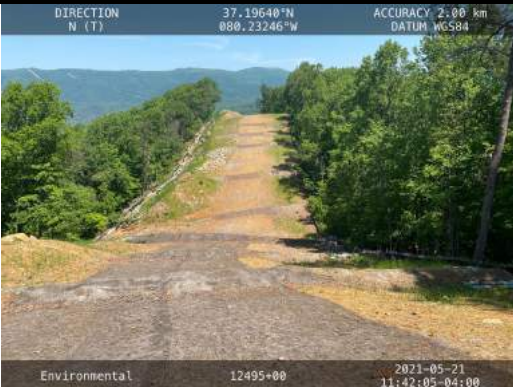
GPS Location	See photo		GPS Location	See photo	
Field Station#	12485+00		Field Station#	12495+00	
Pic 3 Desc.	Stabilized ROW in acceptable condition		Pic 4 Desc.	Stabilized ROW in acceptable condition

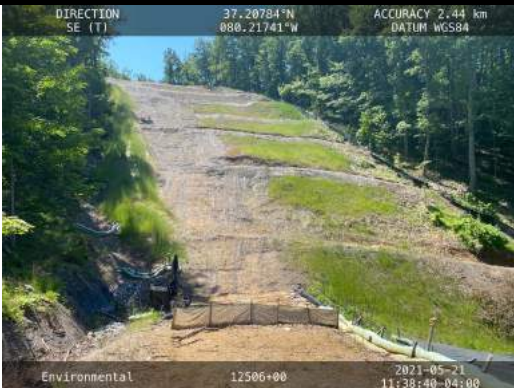
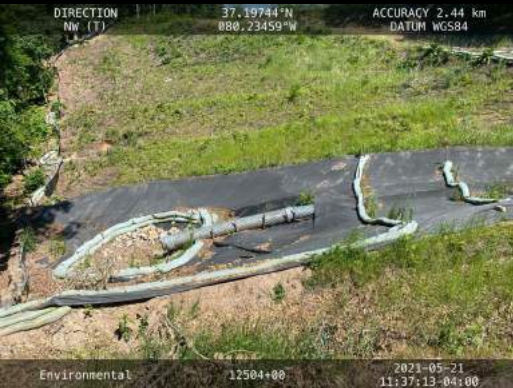
GPS Location	See photo		GPS Location	See photo	
Field Station#	12506+00		Field Station#	12504+00	
Pic 5 Desc.	Stabilized slope in acceptable condition		Pic 6 Desc.	Clean water crossing pipe outlet in acceptable condition

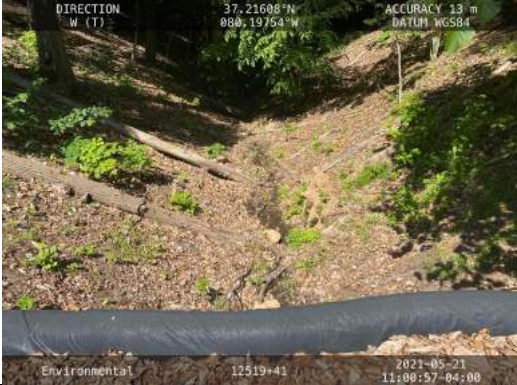
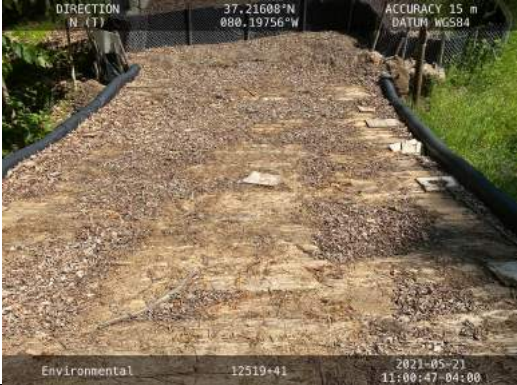
GPS Location	see photo		GPS Location	See photo	
Field Station#	12519+41		Field Station#	12519+41	
Pic 7 Desc.	Down stream of S-EF19 in acceptable condition		Pic 8 Desc.	Bridge and ECDs crossing S-EF19 in acceptable condition

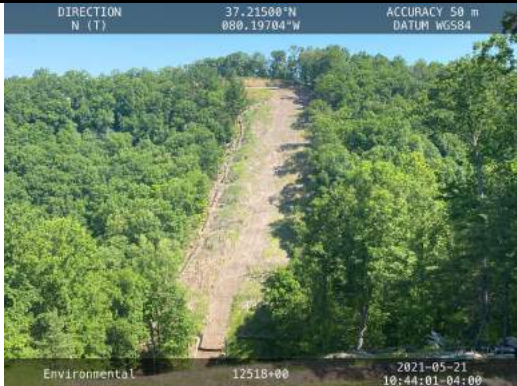
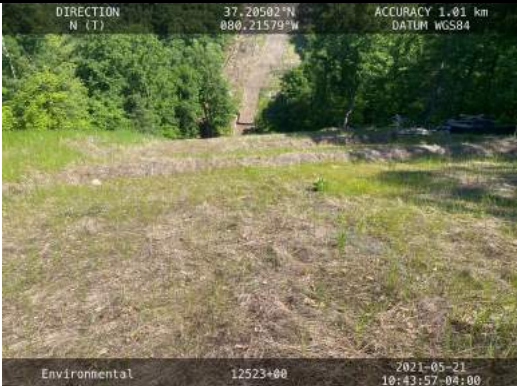
GPS Location	See photo		GPS Location	See photo	
Field Station#	12518+00		Field Station#	12523+00	
Pic 9 Desc.	Stabilized slope in acceptable condition		Pic 10 Desc.	Stabilized slope in acceptable condition

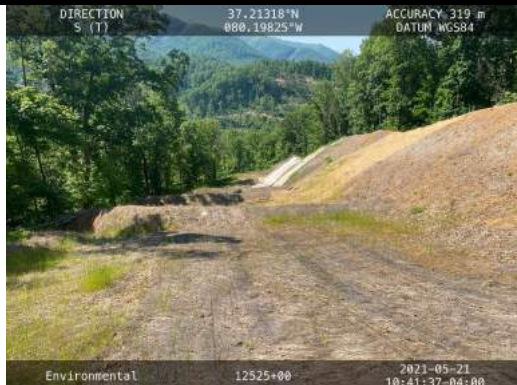
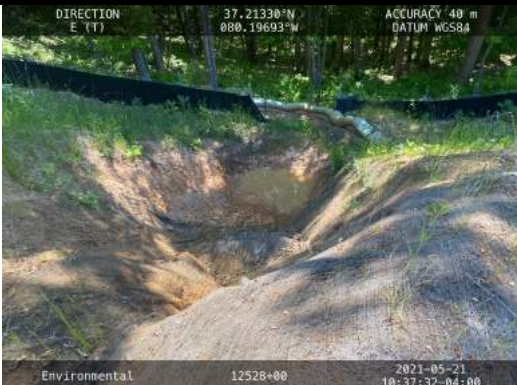
GPS Location	see photo		GPS Location	See photo	
Field Station#	12525+00		Field Station#	12528+00	
Pic 11 Desc.	Stabilized ROW in acceptable condition		Pic 12 Desc.	Waterbar end treatment in acceptable condition

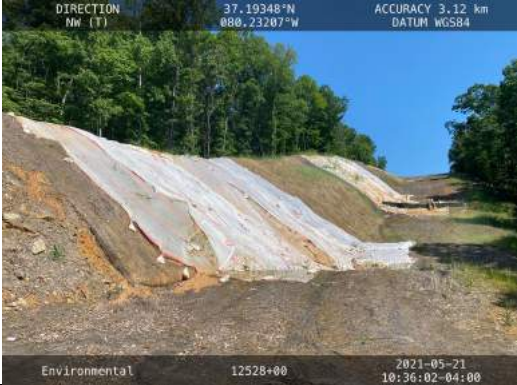
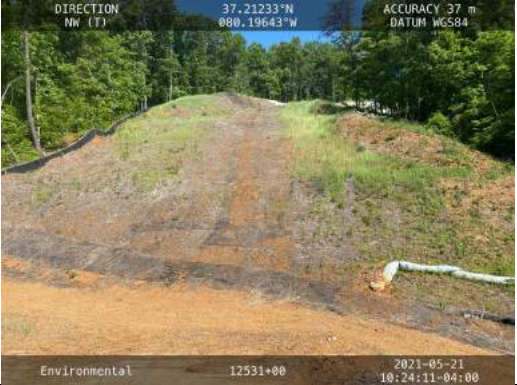
GPS Location	See photo		GPS Location	See photo	
Field Station#	12528+00		Field Station#	12531+00	
Pic 13 Desc.	Plastic covered spoil pile in acceptable condition		Pic 14 Desc.	Stabilized slope in acceptable condition

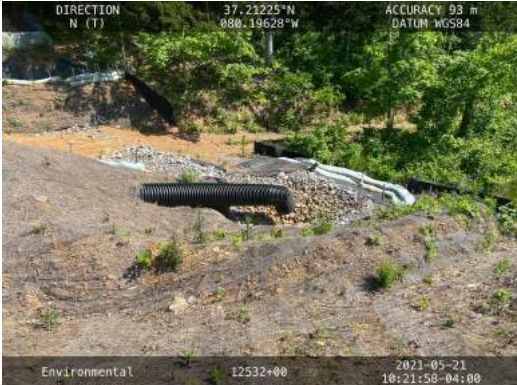
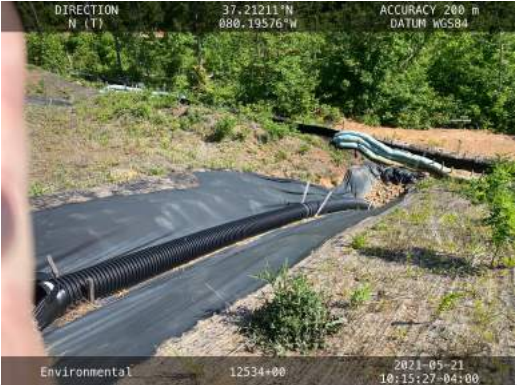
GPS Location	See photo		GPS Location	See photo	
Field Station#	12532+00		Field Station#	12534+00	
Pic 15 Desc.	Clean water crossing pipe outlet in acceptable condition		Pic 16 Desc.	Fill slope drain in acceptable condition

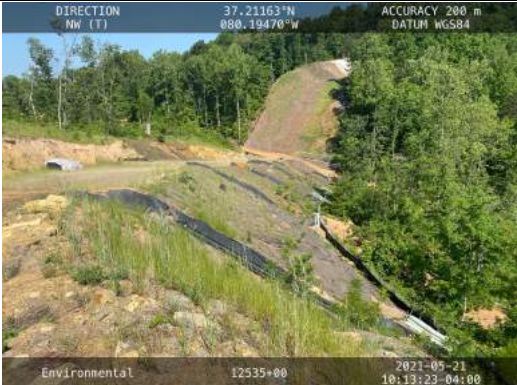
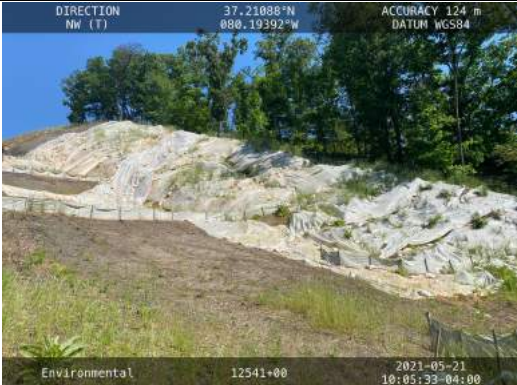
GPS Location	See photo		GPS Location	See photo	
Field Station#	12535+00		Field Station#	12541+00	
Pic 17 Desc.	Stabilized ROW with fill slope drain in acceptable condition		Pic 18 Desc.	Plastic covered spoil pile in acceptable condition
