# Visual Site Inspection Report

<b>Project Name</b>	H-600 Pipeline Spread H	<b>AFE</b>	124300138	<b>Spread</b>	H-600 Pipeline Spread H
<b>Contractor</b>	Precision			<b>Report #</b>	24807
<b>Inspector</b>	Logan Box			<b>Date/Time</b>	6/21/2021 3:12 PM
<b>Permit #</b>	TBD	<b>Inspection Type</b>	VA SWPP	<b>Station Begin</b>	13415+51
<b>State</b>	VA	<b>Inspection Area</b>	Partial	<b>Station End</b>	13525+99
<b>County</b>	Franklin	<b>Ground</b>	Dry	<b>Temperature (°F)</b>	93.00
<b>Municipality</b>	N/A	<b>Weather</b>	Sunny	<b>Rain Gauge (in)</b>	0.00
				<b>Rain Accumulation Time (days)</b>	0.00

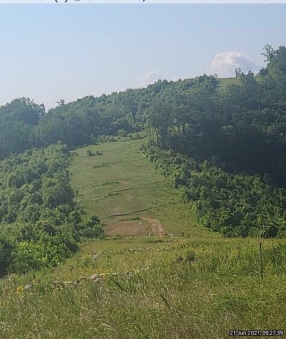
<b>A/E</b>	124300138	<b>Date/Time</b>	6/21/2021 3:12 PM	<b>Report #</b>	
<b>Pictures</b>					
	<b>North West Elevation</b> 160°SE (T) 37.090408, -80.019974 ±3 m ▲ 487 m

<b>GPS Location</b>	00000	<b>GPS Location</b>	00000		
<b>Field Station#</b>	13439+76	<b>Field Station#</b>	13523+00		
<b>Pic 1 Desc.</b>	Permanent vegetation area observed and good coverage noted . Ecds in place and functioning at the time of inspection.		<b>Pic 2 Desc.</b>	Row photo showing permanent vegetation area. Good coverage noted during inspection today.	
	<b>North Elevation</b> 183°S (T) 37.090239, -79.996352 ±4 m ▲ 351 m

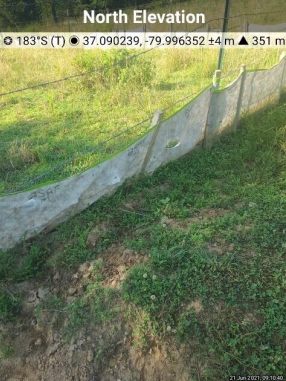
<b>GPS Location</b>	0000	<b>GPS Location</b>	00000		
<b>Field Station#</b>	13524+75	<b>Field Station#</b>	13524+55		
<b>Pic 3 Desc.</b>	P1 requires maintenance due to wildlife damage . Documented and added to the punch list for repair.		<b>Pic 4 Desc.</b>	Additional photo showing P1 on perimeter near stream requires maintenance due to wildlife damage. Documented and added to the punch list.

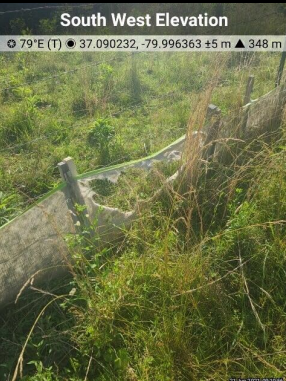
<b>South West Elevation</b> 79°E (T) 37.090232, -79.996363 ±5 m ▲ 348 m

<b>GPS Location</b>	000000	<b>GPS Location</b>	0000		
<b>Field Station#</b>	13524+55	<b>Field Station#</b>	1313524+55		
<b>Pic 5 Desc.</b>	P1 on perimeter near stream requires maintenance due to wildlife damage. Documented and added to the punch list.		<b>Pic 6 Desc.</b>	Additional photo showing P1 on perimeter near stream requires maintenance due to wildlife damage. Documented and added to the punch list.

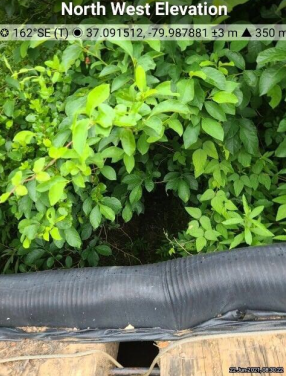
<b>A/E</b>	124300138	<b>Date/Time</b>	6/22/2021 3:04 PM	<b>Report #</b>	
<b>Pictures</b>					
	<b>North West Elevation</b>

<b>GPS Location</b>	00000	<b>GPS Location</b>	0000		
<b>Field Station#</b>	13550+72	<b>Field Station#</b>	13643+54		
<b>Pic 1 Desc.</b>	Stream observation photo facing downstream during routine inspection today. No issues observed at the time of inspection.		<b>Pic 2 Desc.</b>	Stream observation photo facing downstream during routine inspection today. No issues observed at the time of inspection.	
	<b>East Elevation</b>

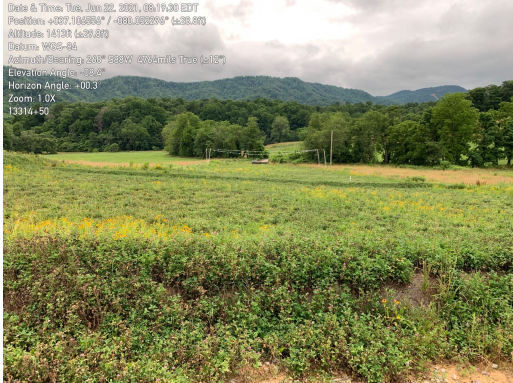
Pic 1 Desc.		ROW and ECDs in good condition, with good vegetation establishing across LOD.		Pic 2 Desc.	
				MVP-S-GH7, in good condition	
<div><div><div>Date &amp; Time: Tue, Jun 22, 2021, 08:24:26 EDT</div><div>Position: +037.106851° / -080.054351° (-83.270)</div><div>Altitude: 1378ft (-42.00m)</div><div>Datum: WGS-84</div><div>Azimuth/Bearing: 036° N345° 0440mils True (±12°)</div><div>Elevation Angle: -28.9°</div><div>Horizon Angle: -00.1°</div><div>Zoom: 1.0x</div><div>13309+09 S-GH7 Downstream</div></div><div>

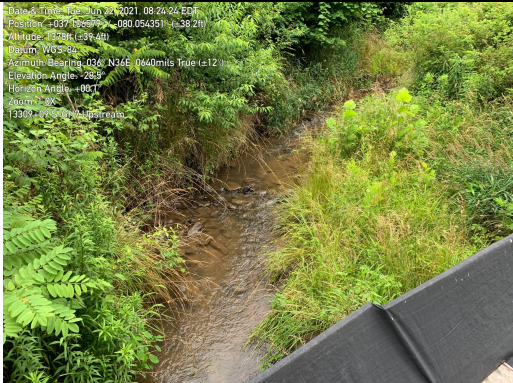
GPS Location		0		GPS Location	
Field Station#		13309+09		Field Station#	
Pic 3 Desc.		MVP-S-GH7 Downstream, in good condition, no impacts to stream or corresponding buffer zone observed.		Pic 4 Desc.	
				ROW and ECDs in good condition, with good vegetation establishing across LOD.	
<div><div><div>Date &amp; Time: Tue, Jun 22, 2021, 08:26:08 EDT</div><div>Position: +037.110773° / -080.055897° (-83.270)</div><div>Altitude: 1438ft (-43.28m)</div><div>Datum: WGS-84</div><div>Azimuth/Bearing: 189° S09W-3340mils True (±12°)</div><div>Elevation Angle: -10.5°</div><div>Horizon Angle: -01.4°</div><div>Zoom: 1.0x</div><div>13275+00</div></div><div>

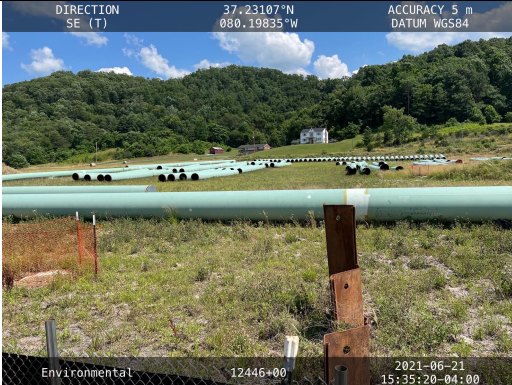
<p>DIRECTION SE (T) 37.23107°N 080.19835°W ACCURACY 5 m DATUM WGS84</p> <p>Environmental 12446+00 2021-06-21 15:35:20-04:00</p>

<p>DIRECTION N (T) 37.23109°N 080.19856°W ACCURACY 5 m DATUM WGS84</p> <p>Environmental 12445+01 2021-06-21 15:35:00-04:00</p>			
<b>GPS Location</b>	See photo		<b>GPS Location</b>	See photo	
<b>Field Station#</b>	12446+00		<b>Field Station#</b>	12445+01	
<b>Pic 1 Desc.</b>	Stabilized ATWS in acceptable condition		<b>Pic 2 Desc.</b>	Stream crossing S-I1 in acceptable condition

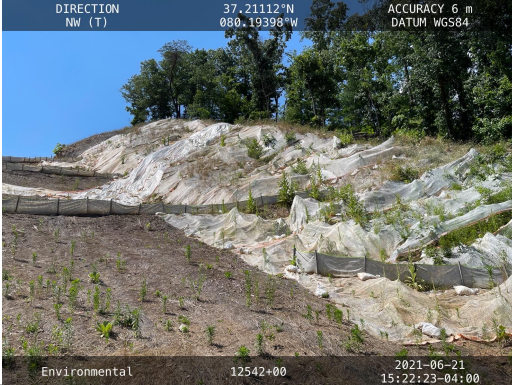
<p>DIRECTION NW (T) 37.21112°N 080.19398°W ACCURACY 6 m DATUM WGS84</p> <p>Environmental 12542+00 2021-06-21 15:22:23-04:00</p>

<b>Field Station#</b>	12542+00		<b>Field Station#</b>	12544+06	
<b>Pic 3 Desc.</b>	Stabilized spoil pile in acceptable condition		<b>Pic 4 Desc.</b>	Stream crossing S-EF20b in acceptable condition

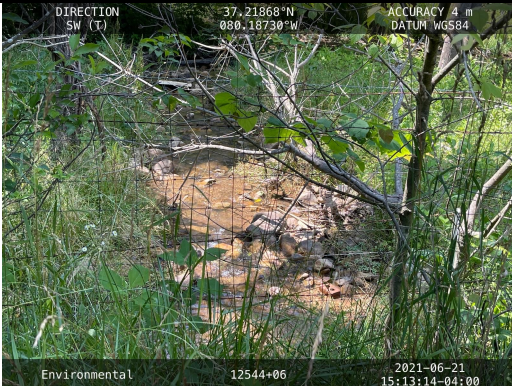
<p>DIRECTION SW (T) 37.21868°N 080.18730°W ACCURACY 4 m DATUM WGS84</p> <p>Environmental 12544+06 2021-06-21 15:13:14-04:00</p>

<p>DIRECTION N (T) 37.23841°N 080.20020°W ACCURACY 4 m DATUM WGS84</p> <p>Environmental 12450+00 2021-06-21 15:09:19-04:00</p>			
<b>GPS Location</b>	See photo		<b>GPS Location</b>	See photo	
<b>Field Station#</b>	12544+06		<b>Field Station#</b>	12450+00	
<b>Pic 5 Desc.</b>	Stream crossing S-KL32 in acceptable condition		<b>Pic 6 Desc.</b>	RCE on access road MVP-MLV-AR-28 in acceptable condition

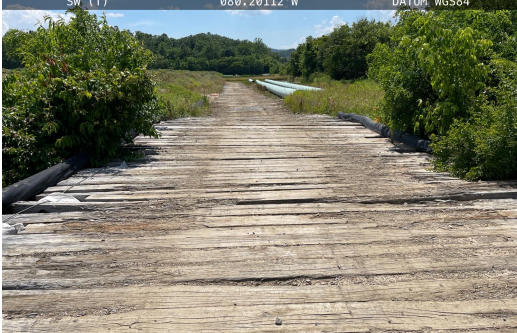
Environmental 12461+81 2021-06-21 15:09:57-04:00	
<b>GPS Location</b>	See photo		<b>GPS Location</b>	See photo	
<b>Field Station#</b>	12455+21		<b>Field Station#</b>	12461+81	
<b>Pic 7 Desc.</b>	Bridge and ECDs crossing stream S-CD12b in acceptable condition		<b>Pic 8 Desc.</b>	Wetland W-KL58 in acceptable condition	
DIRECTION NW (T) 37.22687°N 080.20242°W ACCURACY 6 m DATUM WGS84

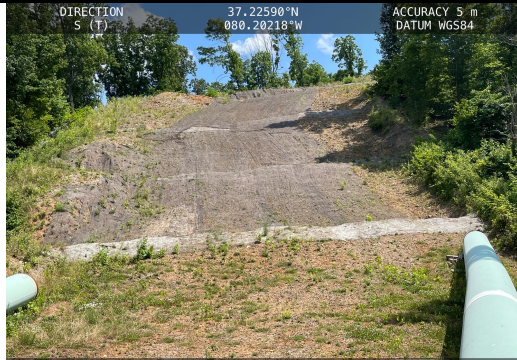
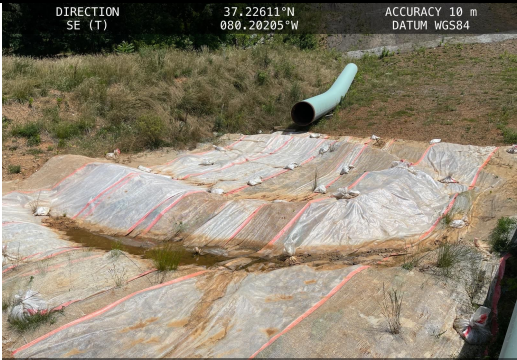
<b>Pic 9 Desc.</b>	Stabilized ROW in acceptable condition		<b>Pic 10 Desc.</b>	Clean water crossing in acceptable condition	
DIRECTION S (T) 37.22590°N 080.20218°W ACCURACY 5 m DATUM WGS84

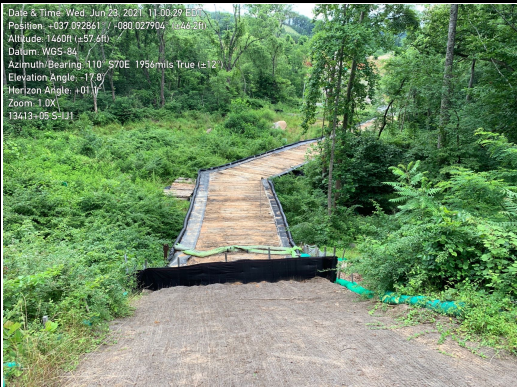
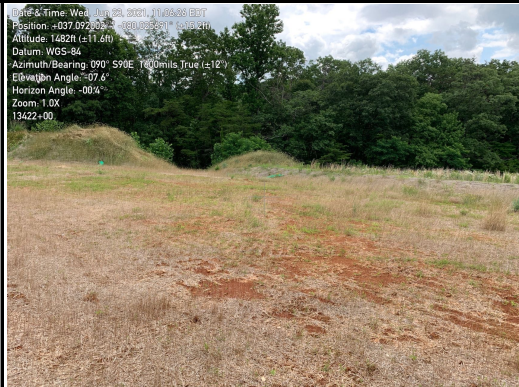
Pic 17 Desc.		MVP-S-IJ1 and associated buffer zone, in good condition		Pic 18 Desc.		ROW and ECDs in good condition, with good vegetation establishing across LOD

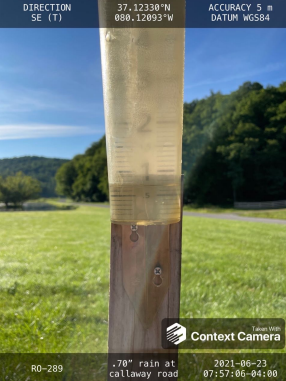
<b>GPS Location</b>	See photo		<b>GPS Location</b>	See photo	
<b>Field Station#</b>	13033+59		<b>Field Station#</b>	12958+50	
<b>Pic 1 Desc.</b>	.70" in rain gauge at Callaway Road		<b>Pic 2 Desc.</b>	Stream S-Y8 on the GAS of RO-287

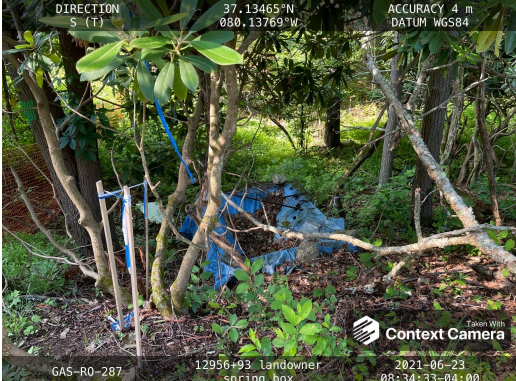
<b>GPS Location</b>	See photo		<b>GPS Location</b>	See photo	
<b>Field Station#</b>	12956+93		<b>Field Station#</b>	12955+85	
<b>Pic 3 Desc.</b>	Landowner spring box at RO-287		<b>Pic 4 Desc.</b>	Sediment trap appeared to have functioned correctly after rainfall

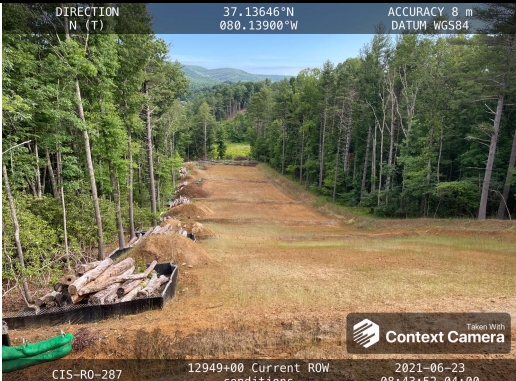
<b>GPS Location</b>	See photo		<b>GPS Location</b>	See photo	
<b>Field Station#</b>	12949+00		<b>Field Station#</b>	12957+38	
<b>Pic 5 Desc.</b>	Current ROW conditions on CIS of RO-287		<b>Pic 6 Desc.</b>	Stream S-Z17 at RO-287

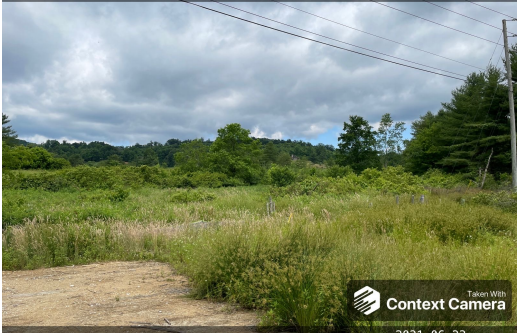
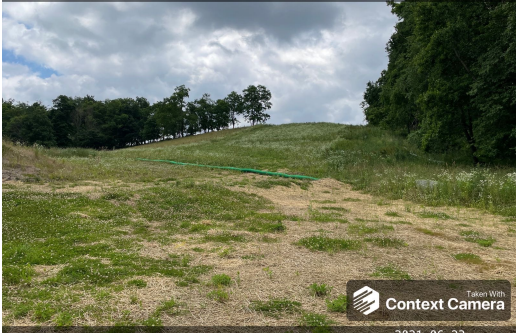
CIS HWY221 12993+00 2021-06-23 10:52:09-04:00		GAS HWY221 12995+00 2021-06-23 10:53:41-04:00			
<b>GPS Location</b>	See photo		<b>GPS Location</b>	See photo	
<b>Field Station#</b>	12993+00		<b>Field Station#</b>	12995+00	
<b>Pic 13 Desc.</b>	Current ROW conditions on CIS of HWY 221		<b>Pic 14 Desc.</b>	Current ROW conditions on GAS of HWY 221	
DIRECTION NW (T) 37.12590°N 080.12540°W ACCURACY 4 m DATUM WGS84		DIRECTION E (T) 37.12585°N 080.12530°W ACCURACY 4 m DATUM WGS84

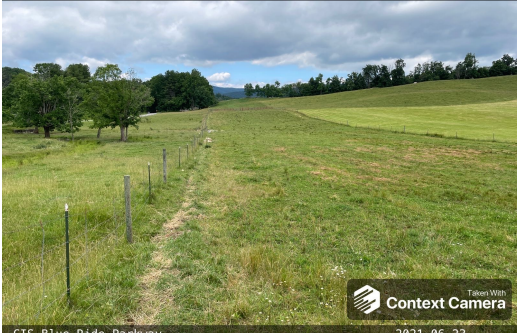
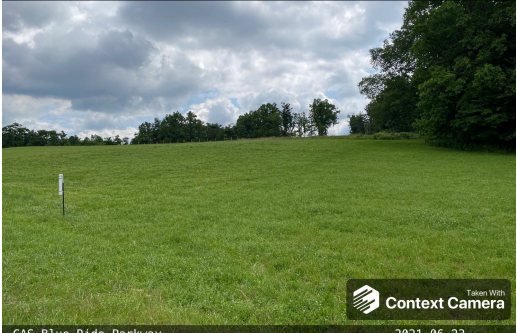
<b>Field Station#</b>	13012+25		<b>Field Station#</b>	13013+00	
<b>Pic 15 Desc.</b>	Current ROW conditions on CIS of BRP. Permanent stabilization appears to be established and maturing		<b>Pic 16 Desc.</b>	Current ROW conditions on GAS of BRP. Permanent stabilization appears to be established and maturing	
DIRECTION E (T) 37.12536°N 080.12336°W ACCURACY 7 m DATUM WGS84		DIRECTION E (T) 37.12533°N 080.12248°W ACCURACY 4 m DATUM WGS84

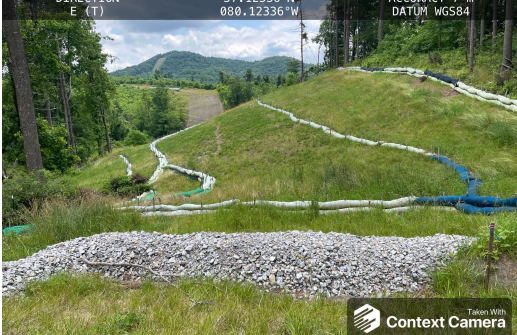
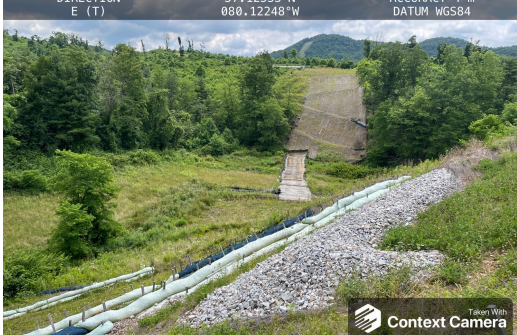
CIS FR-289 13018+42 2021-06-23 11:29:20-04:00		CIS FR-289 13022+00 2021-06-23 11:32:34-04:00			
<b>GPS Location</b>	See photo		<b>GPS Location</b>	see photo	
<b>Field Station#</b>	13018+42		<b>Field Station#</b>	13022+00	
<b>Pic 17 Desc.</b>	Level Spreader on CIS of FR-289		<b>Pic 18 Desc.</b>	Level Spreader on CIS of FR-289

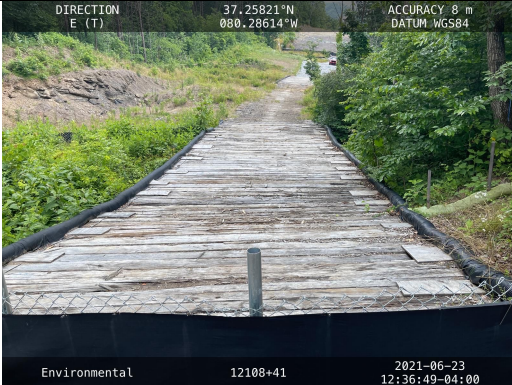
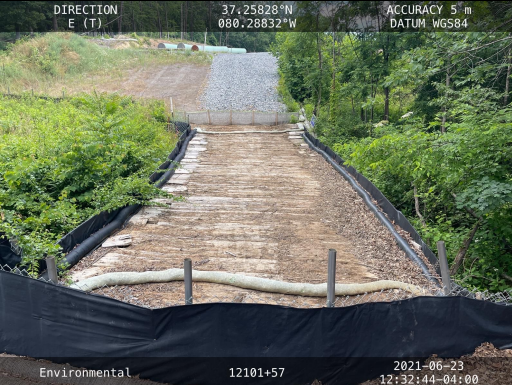
<b>GPS Location</b>	See photo		<b>GPS Location</b>	See photo	
<b>Field Station#</b>	12108+41		<b>Field Station#</b>	12101+57	
<b>Pic 1 Desc.</b>	I bridge and ECDs at stream crossing S-F15 in acceptable condition		<b>Pic 2 Desc.</b>	ECDs at stream crossing S-MM11 in acceptable condition

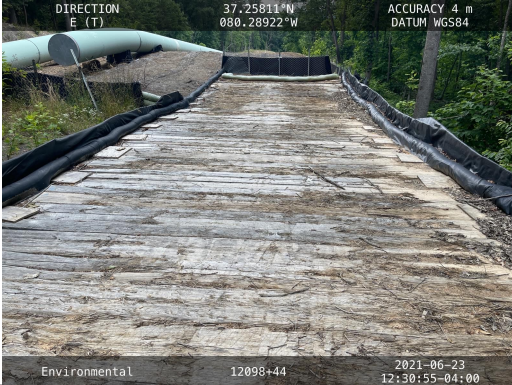
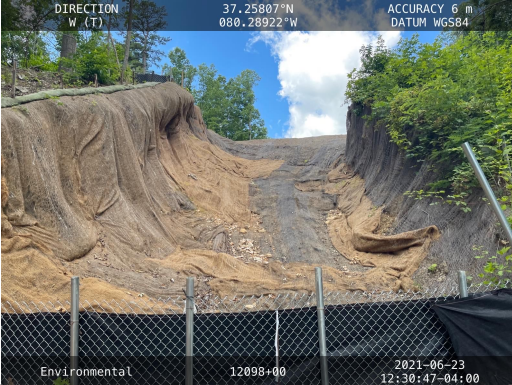
<b>GPS Location</b>	See photo		<b>GPS Location</b>	See photo	
<b>Field Station#</b>	12098+44		<b>Field Station#</b>	12098+00	
<b>Pic 3 Desc.</b>	Bridge and ECDs crossing stream S-MM13 in acceptable condition		<b>Pic 4 Desc.</b>	Stabilized cut bank in CIS of S-MM13 in acceptable condition

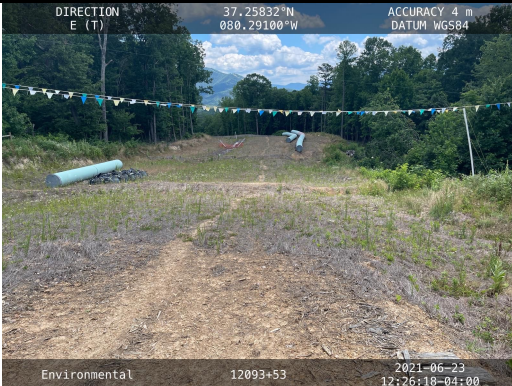
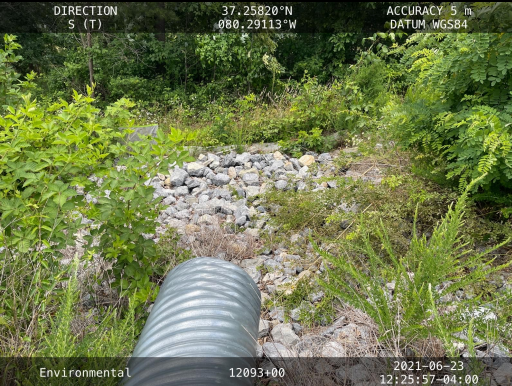
<b>GPS Location</b>	See photo		<b>GPS Location</b>	See photo	
<b>Field Station#</b>	12093+53		<b>Field Station#</b>	12093+00	
<b>Pic 5 Desc.</b>	Stabilized ROW in acceptable condition		<b>Pic 6 Desc.</b>	Clean water crossing pipe outlet in acceptable condition

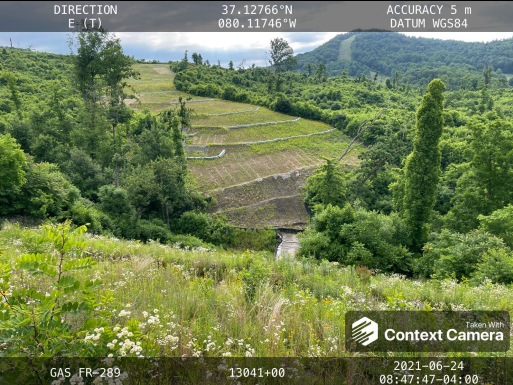
<b>GPS Location</b>	See photo		<b>GPS Location</b>	See photo	
<b>Field Station#</b>	13025+00		<b>Field Station#</b>	13041+00	
<b>Pic 1 Desc.</b>	Streams S-G24 and S-G25 on CIS of FR-289		<b>Pic 2 Desc.</b>	Current ROW conditions on GAS of FR-289

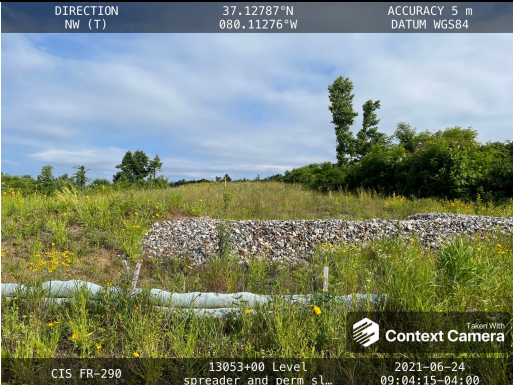
<b>GPS Location</b>	See photo		<b>GPS Location</b>	See photo	
<b>Field Station#</b>	13042+61		<b>Field Station#</b>	13053+00	
<b>Pic 3 Desc.</b>	Stream S-H1 on GAS of FR-289		<b>Pic 4 Desc.</b>	Level Spreader and Permanent slope breaker

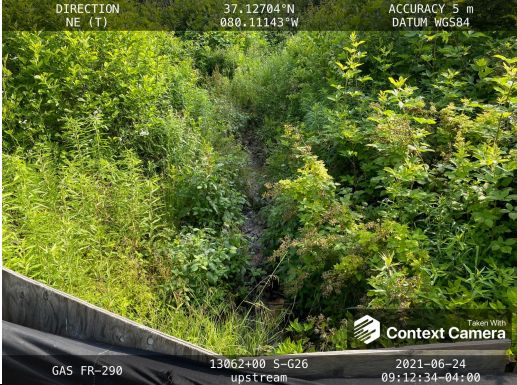
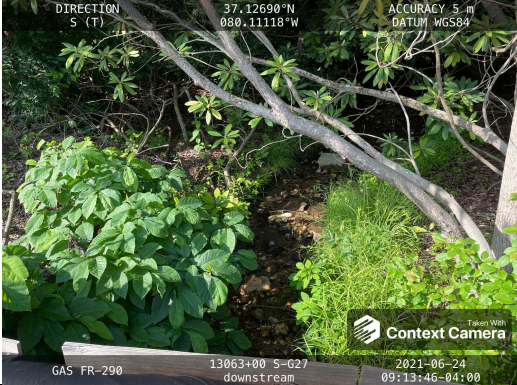
<p>DIRECTION S (T) 37.12690°N 080.11118°W ACCURACY 5 m DATUM WGS84</p> <p>GAS FR-290 13063+00 S-G27 downstream 2021-06-24 09:13:46-04:00</p>			
<b>GPS Location</b>	See photo		<b>GPS Location</b>	See photo	
<b>Field Station#</b>	13062+00		<b>Field Station#</b>	13063+00	
<b>Pic 7 Desc.</b>	Stream S-G26 on GAS of FR-290		<b>Pic 8 Desc.</b>	Stream S-G27 on GAS of FR-290

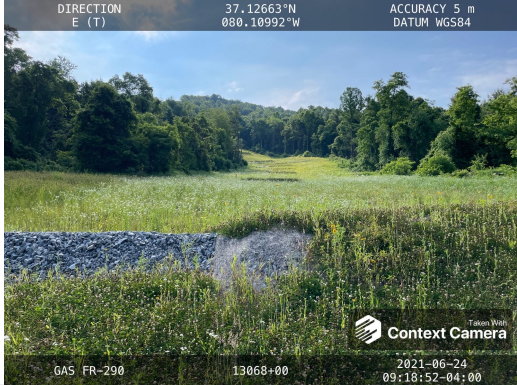
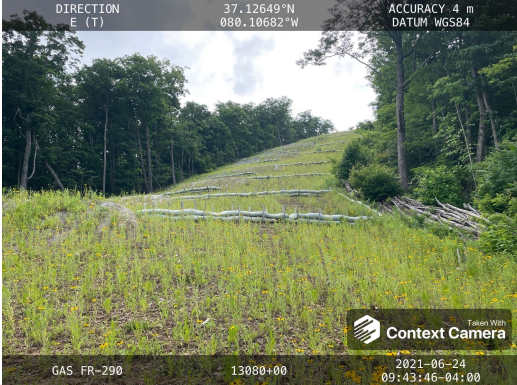
<b>Field Station#</b>	13068+00		<b>Field Station#</b>	13080+00	
<b>Pic 9 Desc.</b>	Current ROW conditions on GAS of FR-290		<b>Pic 10 Desc.</b>	Current ROW conditions on GAS of FR-290

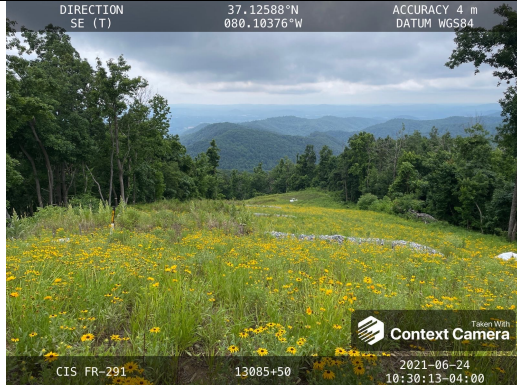
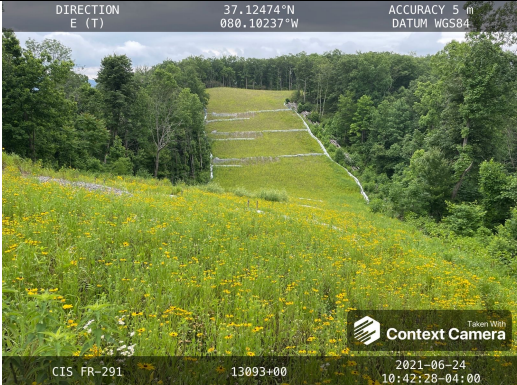
<p>DIRECTION E (T) 37.12474°N 080.10237°W ACCURACY 5 m DATUM WGS84</p> <p>CIS FR-291 13093+00 2021-06-24 10:42:28-04:00</p>			
<b>GPS Location</b>	See photo		<b>GPS Location</b>	See photo	
<b>Field Station#</b>	13085+00		<b>Field Station#</b>	13093+00	
<b>Pic 11 Desc.</b>	Current ROW conditions on CIS of FR-290. Permanent stabilization is adequate		<b>Pic 12 Desc.</b>	Current ROW conditions on CIS of FR-290. Permanent stabilization is adequate

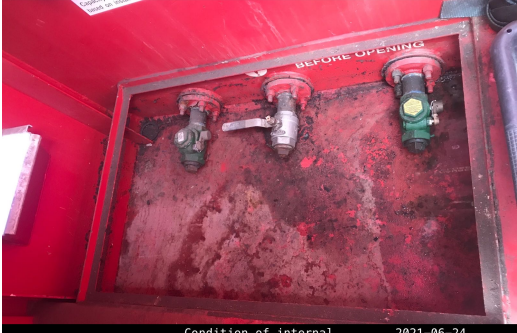
MVP-PY-006_062421 Condition of internal drip pan 2021-06-24 08:17:51-04:00

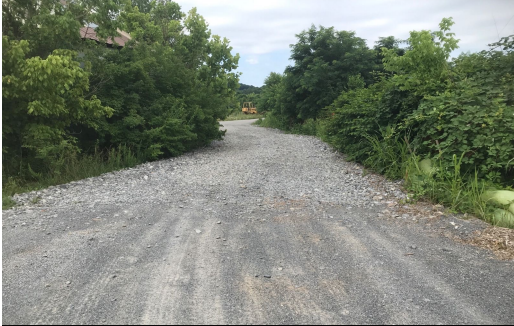
<div>MVP-LY-049_062421</div> <div>Condition of rock entrance</div> <div>2021-06-24 08:58:46-04:00</div> </div>		<div> <div>DIRECTION SE (M)</div> <div>+37.27068° -080.12407°</div> <div>ACCURACY 16 ft DATUM WGS84</div>

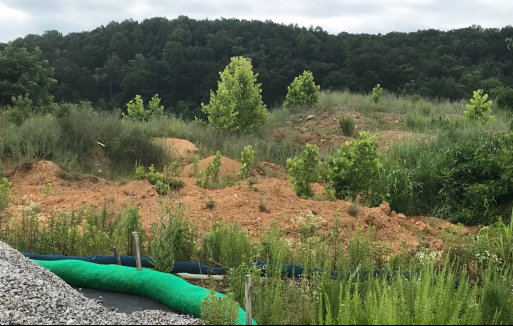
<div>MVP-LY-049_062421</div> <div>Landowner disturbance along CFS</div> <div>2021-06-24 09:00:44-04:00</div> </div>			
<b>GPS Location</b>	MVP-LY-049 See photo for gps data		<b>GPS Location</b>	MVP-LY-049 See photo for gps data	
<b>Field Station#</b>	+0		<b>Field Station#</b>	+0	
<b>Pic 1 Desc.</b>	Condition of rock entrance on north drive. No sediment on stone. Looking SW.		<b>Pic 2 Desc.</b>	Landowner soil disturbance along compost filter sock. No new damage to installed ECD's. Area not stabilized. Looking SE.

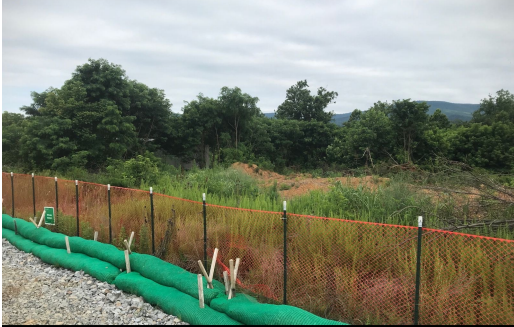
<div>MVP-LY-049_062421</div> <div>Landowner disturbance along feature</div> <div>2021-06-24 09:01:22-04:00</div> </div>		<div> <div>DIRECTION SW (M)</div> <div>+37.27043° -080.12464°</div> <div>ACCURACY 16 ft DATUM WGS84</div>

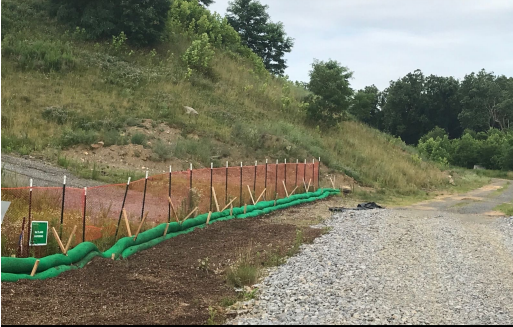
<div>MVP-LY-049_062421</div> <div>Landowner disturbance east of feature</div> <div>2021-06-24 09:01:28-04:00</div> </div>			
<b>GPS Location</b>	MVP-LY-049 See photo for gps data		<b>GPS Location</b>	MVP-LY-049 See photo for gps data	
<b>Field Station#</b>	+0		<b>Field Station#</b>	+0	
<b>Pic 3 Desc.</b>	Landowner soil disturbance along north edge of feature W-CV21A. Area not stabilized. Looking NW.		<b>Pic 4 Desc.</b>	Landowner soil disturbance 2 locations west of feature W-CV21B. Areas not stabilized. Looking SW.	
<div> <div>DIRECTION S (M)</div> <div>+37.27039° -080.12471°</div> <div>ACCURACY 16 ft DATUM WGS84</div>

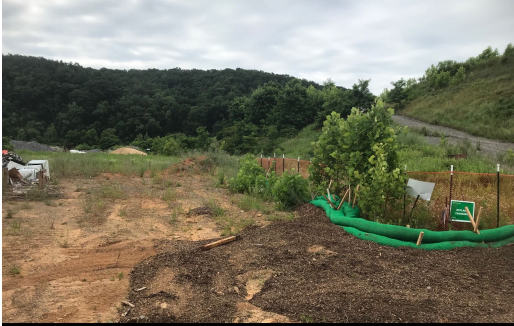
<div>MVP-LY-049_062421</div> <div>Landowner disturbance along CFS &amp; feature</div> <div>2021-06-24 09:01:53-04:00</div> </div>		<div> <div>DIRECTION SW (M)</div> <div>+37.27053° -080.12383°</div> <div>ACCURACY 16 ft DATUM WGS84</div>

<b>GPS Location</b>	MVP-LY-049 See photo for gps data		<b>GPS Location</b>	MVP-LY-049 See photo for gps data	
<b>Field Station#</b>	+0		<b>Field Station#</b>	+0	
<b>Pic 5 Desc.</b>	Landowner soil disturbance along compost filter sock and east of feature W-CV21B. Area not stabilized. Looking S.		<b>Pic 6 Desc.</b>	Condition of containment under stored equipment. Looking SW.

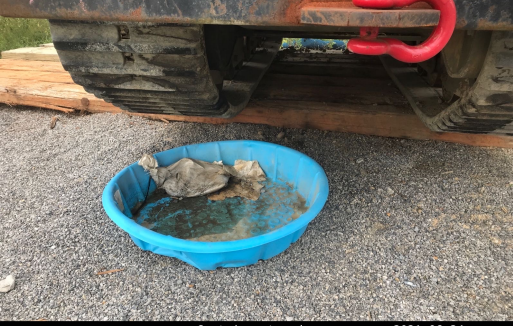
<div>MVP-LY-049_062421</div> <div>Containment under stored equipment</div> <div>2021-06-24 09:02:51-04:00</div> </div>

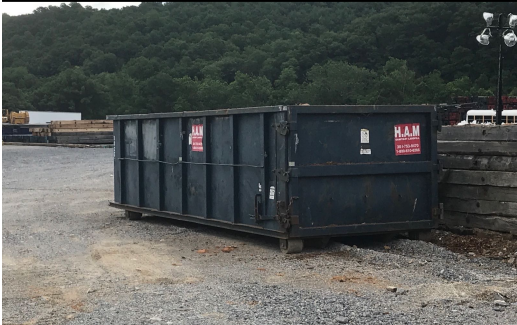
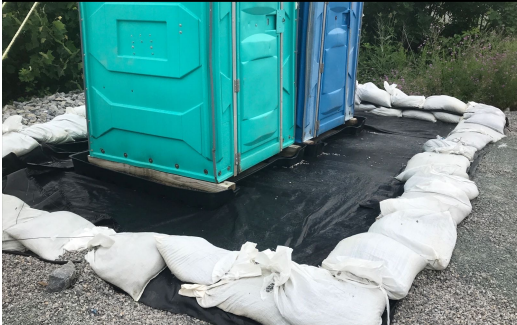
MVP-LY-049_062421 No loose trash around north dumpster 2021-06-24 09:02:59-04:00		MVP-LY-049_062421 Condition of trays & containment 2021-06-24 09:03:43-04:00			
<b>GPS Location</b>	MVP-LY-049 See photo for gps data		<b>GPS Location</b>	MVP-LY-049 See photo for gps data	
<b>Field Station#</b>	+0		<b>Field Station#</b>	+0	
<b>Pic 7 Desc.</b>	No loose trash around north dumpster or in the yard. Looking SE.		<b>Pic 8 Desc.</b>	Condition of trays & containment under toilets. Looking NE.	
DIRECTION W (M) +37.27062° -080.12338° ACCURACY 33 ft DATUM WGS84

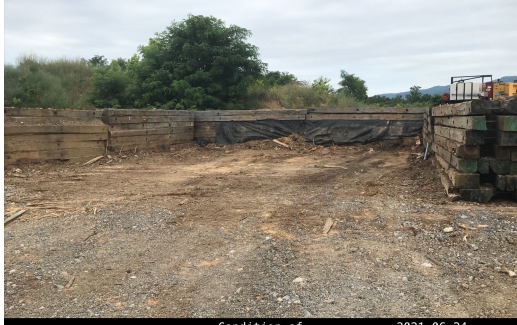
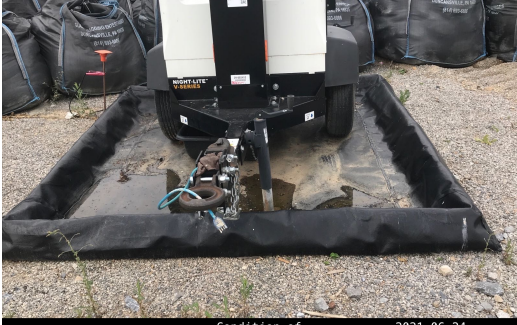
MVP-LY-049_062421 Condition of temporary trash tran... 2021-06-24 09:06:25-04:00		MVP-LY-049_062421 Condition of containment 2021-06-24 09:06:35-04:00

<b>GPS Location</b>	MVP-LY-049 See photo for gps data		<b>GPS Location</b>	MVP-LY-049 See photo for gps data	
<b>Field Station#</b>	+0		<b>Field Station#</b>	+0	
<b>Pic 9 Desc.</b>	Condition of temporary trash transfer pit. Most of the debris have been removed. Looking W.		<b>Pic 10 Desc.</b>	Condition of containment under light plant. Holding some stormwater. Looking SW.	
DIRECTION NW (M) +37.26921° -080.12378° ACCURACY 16 ft DATUM WGS84

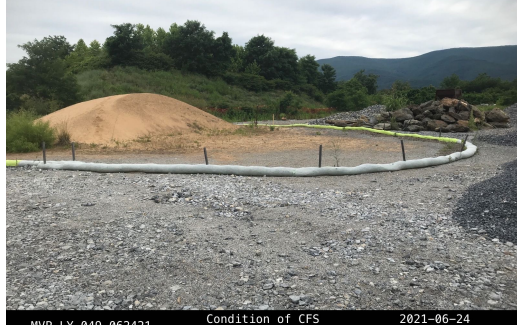
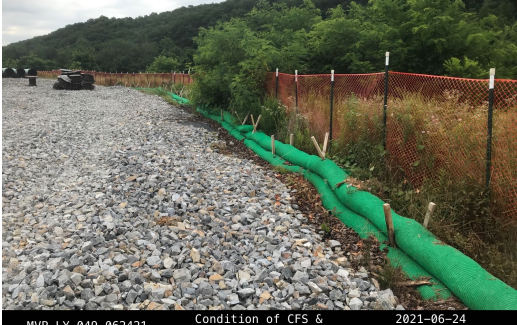
MVP-LY-049_062421 Condition of CFS around sand pile 2021-06-24 09:18:22-04:00		MVP-LY-049_062421 Condition of CFS & safety fence LOD 2021-06-24 09:19:09-04:00			
<b>GPS Location</b>	MVP-LY-049 See photo for gps data		<b>GPS Location</b>	MVP-LY-049 See photo for gps data	
<b>Field Station#</b>	+0		<b>Field Station#</b>	+0	
<b>Pic 11 Desc.</b>	Condition of compost filter sock around sand pile. Looking NW.		<b>Pic 12 Desc.</b>	Condition of compost filter sock and safety fence along south LOD. Looking E.

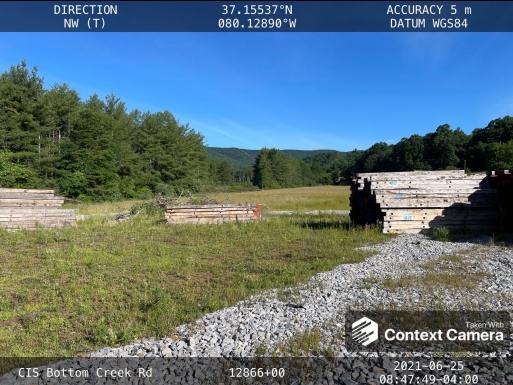
<b>GPS Location</b>	See photo		<b>GPS Location</b>	See photo	
<b>Field Station#</b>	12867+00		<b>Field Station#</b>	12866+00	
<b>Pic 1 Desc.</b>	Current ROW conditions on GAS of Bottom Creek Road		<b>Pic 2 Desc.</b>	Current ROW conditions on CIS of Bottom Creek Road

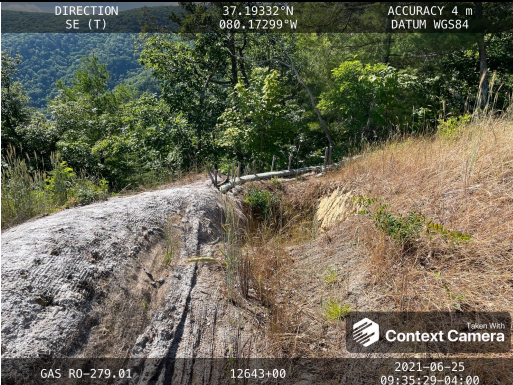
<b>GPS Location</b>	See photo		<b>GPS Location</b>	See photo	
<b>Field Station#</b>	12638+24		<b>Field Station#</b>	12643+00	
<b>Pic 3 Desc.</b>	Access Road RO-279.01		<b>Pic 4 Desc.</b>	Waterbar/sump on GAS of RO-279.01

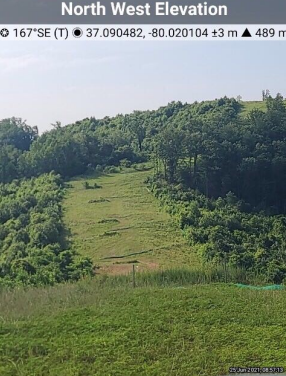
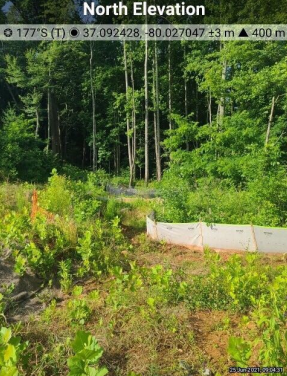
<b>GPS Location</b>	00000	<b>GPS Location</b>	0000		
<b>Field Station#</b>	13440+00	<b>Field Station#</b>	13415+60		
<b>Pic 1 Desc.</b>	Row photo taken while checking row conditions throughout. No issues observed by the EI at the time of inspection.		<b>Pic 2 Desc.</b>	Monitored ECDs . No environmental issues observed at the time of inspection.	
	<b>West Elevation</b> <small>113°E (T) 37.092421, -80.027021 ±3 m ▲ 403 m</small>

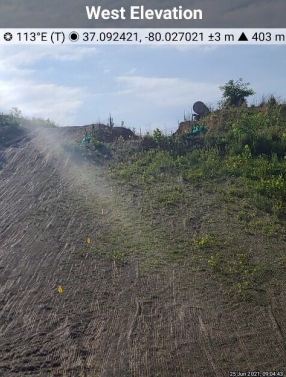
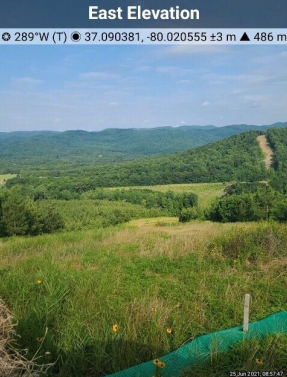
<b>Pic 3 Desc.</b>	Erosion control blanket in place and functioning on hill side at road crossing. No issues observed at the time of inspection.		<b>Pic 4 Desc.</b>	Vegetation observation photo showing good coverage in permanent area of row.	
	<b>North East Elevation</b> <small>232°SW (T) 37.088934, -80.005234 ±4 m ▲ 363 m</small>

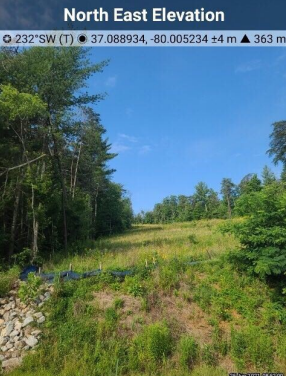
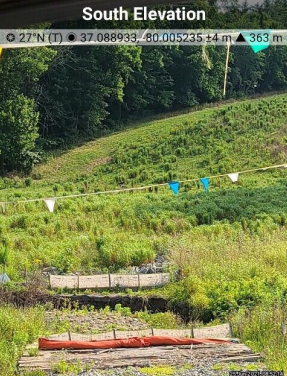
<b>GPS Location</b>	0000	<b>GPS Location</b>	0000		
<b>Field Station#</b>	13496+62	<b>Field Station#</b>	13497+89		
<b>Pic 5 Desc.</b>	Monitored rock lined channel at road crossing. Photo showing good vegetation coverage in permanent area.		<b>Pic 6 Desc.</b>	Monitored ECDs at stream crossing at CAHAS#2 . No issues observed at the time of inspection.

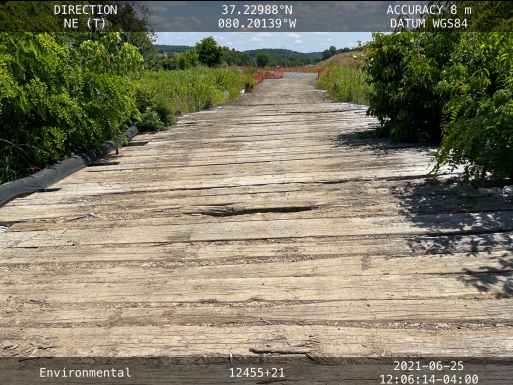
<b>GPS Location</b>	See photo		<b>GPS Location</b>	See photo	
<b>Field Station#</b>	12445+01		<b>Field Station#</b>	12455+21	
<b>Pic 1 Desc.</b>	Stream crossing S-I1 in acceptable condition		<b>Pic 2 Desc.</b>	Bridge and ECDs at stream crossing S-CD12b in acceptable condition

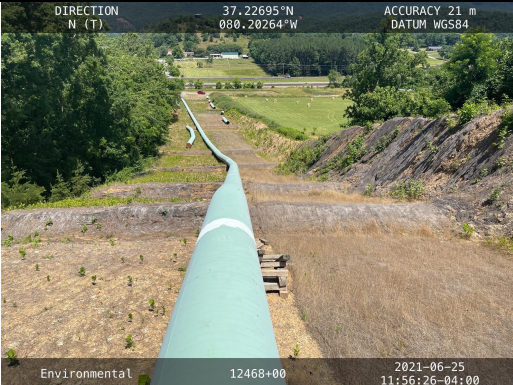
<b>GPS Location</b>	See photo		<b>GPS Location</b>	See photo	
<b>Field Station#</b>	12461+81		<b>Field Station#</b>	12468+00	
<b>Pic 3 Desc.</b>	Wetland W-KL58 in acceptable condition		<b>Pic 4 Desc.</b>	Stabilized ROW in acceptable condition
