# Visual Site Inspection Report

| <b>Project Name</b> | H-603 Pipeline Spread I | <b>AFE</b> | 124300139 | <b>Spread</b> | H-603 Pipeline Spread I | |
| <b>Permit #</b> | TBD | <b>Inspection Type</b> | VA SWPP | <b>Station Begin</b> | 00+00 | |

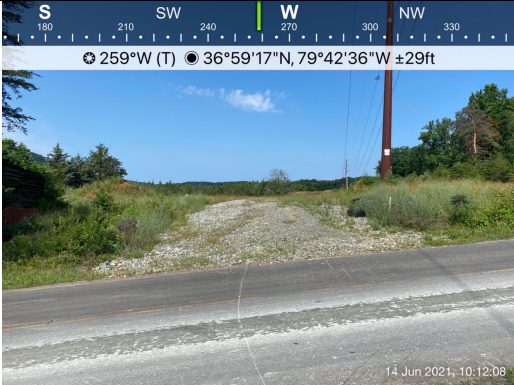
| <b>Pic 1 Desc.</b> | Approximately 14694+50. Overview of road crossing and RCE. | | <b>Pic 2 Desc.</b> | Approximately 14654+00. Overview of ROW. | |

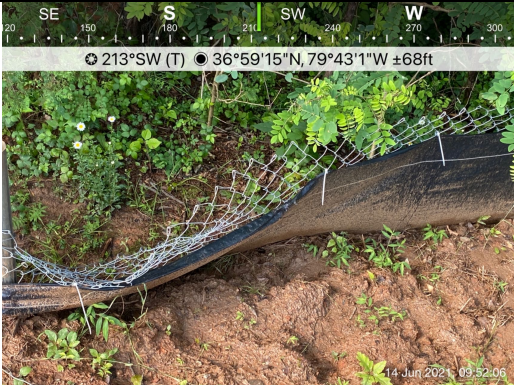
| <b>Pic 3 Desc.</b> | Approximately 14673+75. SSF damaged by livestock. | | <b>Pic 4 Desc.</b> | Approximately 14674+50. SSF requires maintenance. | |

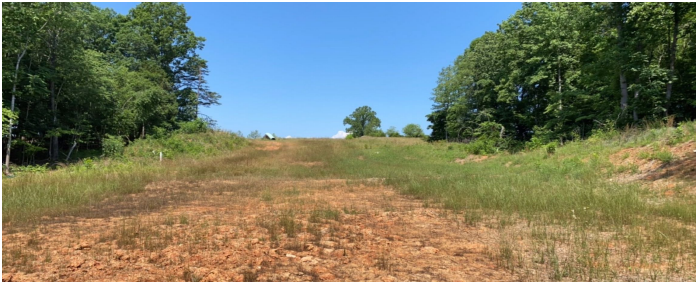
| <b>Pic 1 Desc.</b> | Vegetation growing in temporary area. Limited vegetation observed in travel lane. Will monitor area. | | <b>Pic 2 Desc.</b> | Plunge pool performing intended function. | |

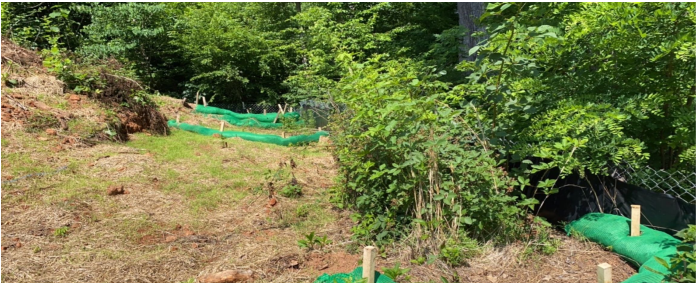
| <b>Pic 3 Desc.</b> | Contractor repaired damaged P1 silt fence per punch list item. | | <b>Pic 4 Desc.</b> | Recently installed CFS check dams performing intended function. | |

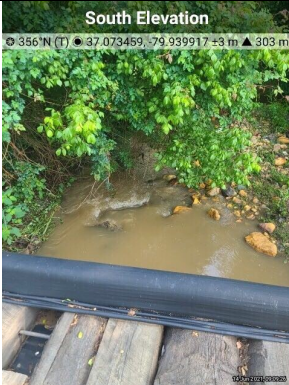
| <b>Pic 1 Desc.</b> | Stream observation photo facing downstream during routine inspection today. | | <b>Pic 2 Desc.</b> | Observed sump pit and plunge pool after recent rain events, all ECDs functioning properly at the time of inspection. | |

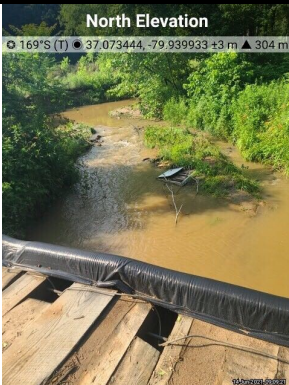
| <b>Pic 3 Desc.</b> | Stream observation photo facing upstream during routine inspection today. No issues observed at the time of inspection. | | <b>Pic 4 Desc.</b> | Monitored row conditions after recent rain events over the weekend. Row conditions were saturated. No environmental issues observed at the time of inspection. | |

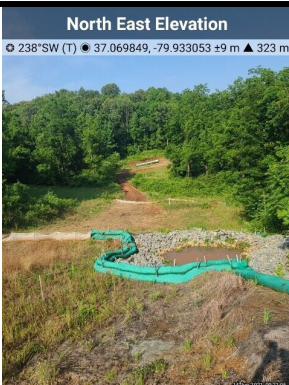
| <b>Pic 5 Desc.</b> | Monitored plunge pool and ECDs on hill side after recent rain events. No environmental issues observed at the time of inspection. | | <b>Pic 6 Desc.</b> | Row photo showing stabilization after recent work activities in the area. No environmental issues observed at the time of inspection after recent rain events. | |

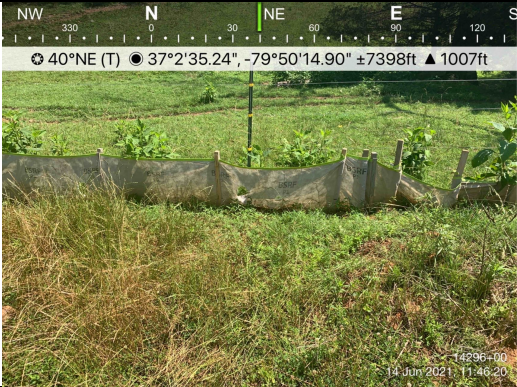
| <b>Pic 7 Desc.</b> | P1 silt fence damaged by livestock, multiple panels from 14296+00 to 14297+00 | <b>Pic 8 Desc.</b> | Permanent vegetative stabilization in acceptable condition | | |

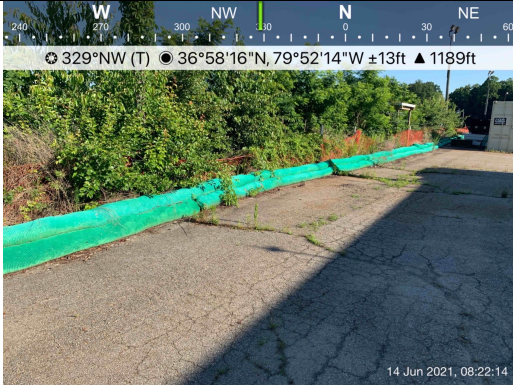
| <b>Pic 1 Desc.</b> | Inlet protection for catch basin near storage building at LY-46 in good condition. | | <b>Pic 2 Desc.</b> | Perimeter ECD's on west side of LY-46 in good condition. | |

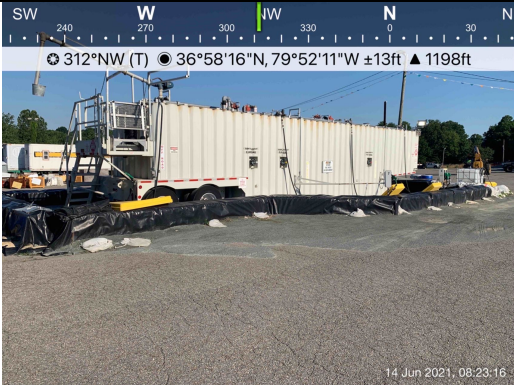
| <b>Pic 3 Desc.</b> | Secondary containment structure for fuel at LY-046 in good condition. | | <b>Pic 4 Desc.</b> | Perimeter ECD's on north end on LY-045 in good condition. | |

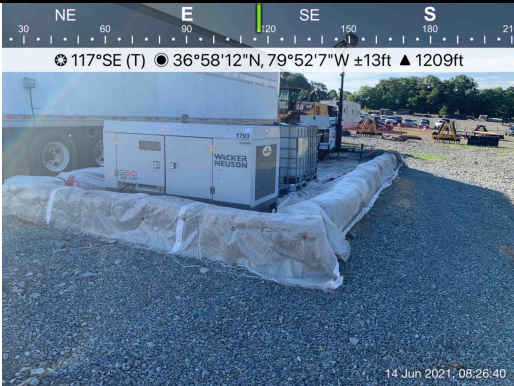
| <b>Pic 5 Desc.</b> | Secondary containment structure behind office at LY-045 in good condition. | | <b>Pic 6 Desc.</b> | RCE at LY-045 in good condition. | |

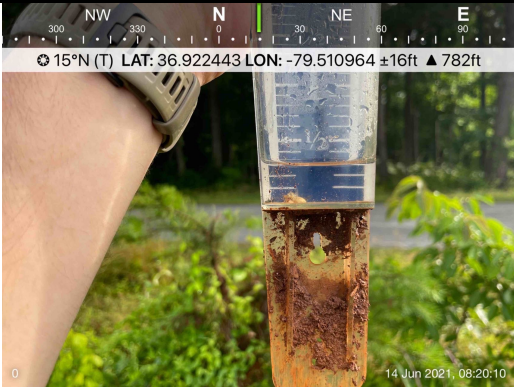
| <b>Pic 1 Desc.</b> | .3" in rain gauge. | | <b>Pic 2 Desc.</b> | RCEs are in good condition at all road crossings. | |

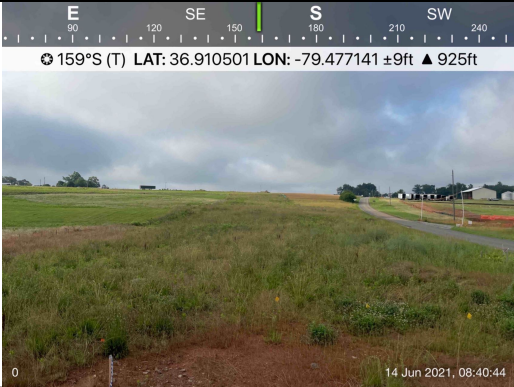
| <b>Pic 3 Desc.</b> | Vegetation continues to fill in throughout this section of ROW. | | <b>Pic 4 Desc.</b> | Vegetation continues to fill in throughout this section of ROW. | |

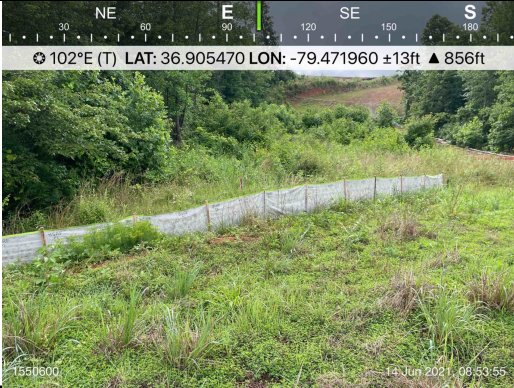
| <b>Pic 5 Desc.</b> | P1 is in good condition at all stream and wetland buffers. | | <b>Pic 6 Desc.</b> | No evidence of sedimentation from 3rd party disturbance. | |

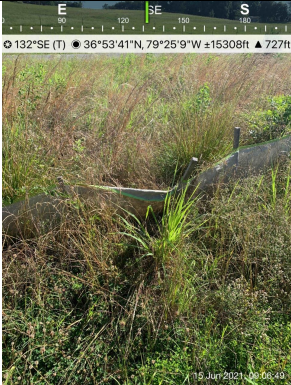
| <b>Pic 1 Desc.</b> | Observing p1 that required maintenance | <b>Pic 2 Desc.</b> | Observing p1 that received maintenance | | |

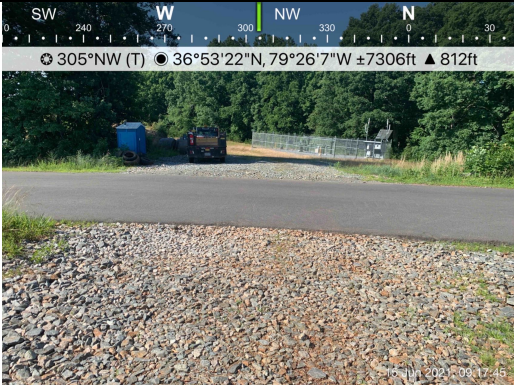
| <b>Pic 3 Desc.</b> | Observing road crossing and RCE's | <b>Pic 4 Desc.</b> | Observing temporary stabilization, signage, buffer, equipment crossing and ECD's | | |

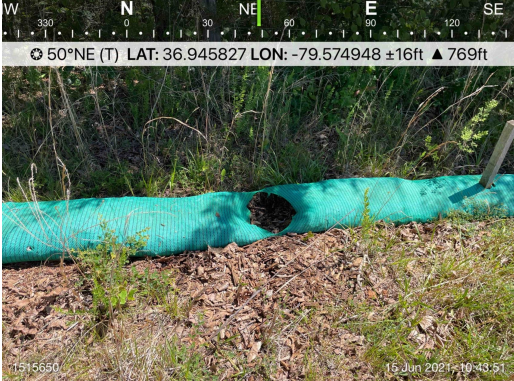
| <b>Field Station#</b> | 15156+50 | | <b>Field Station#</b> | 15159+00 | |

| <b>Pic 1 Desc.</b> | CFS has been damaged and needs to be repaired. | | <b>Pic 2 Desc.</b> | CFS has been displaced and needs to be restaked. | |

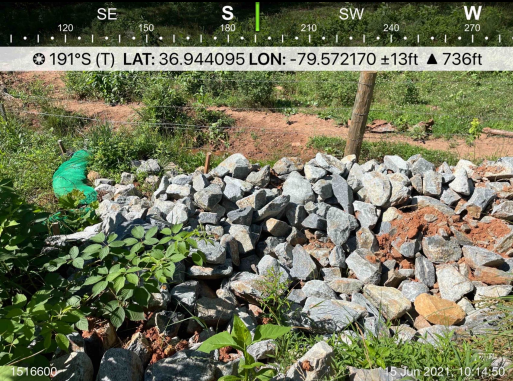
| <b>Field Station#</b> | 15165+57 | | <b>Field Station#</b> | 15166+00 | |

| <b>Pic 5 Desc.</b> | Rock inlet remains in good condition. | | <b>Pic 6 Desc.</b> | Rock outlet remains in good condition. | |

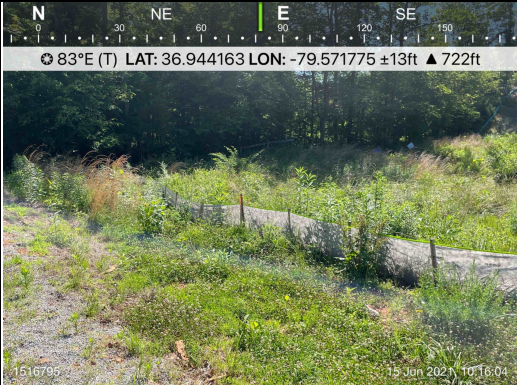
| <b>Field Station#</b> | 15167+95 | | <b>Field Station#</b> | 15167+95 | |

| <b>Pic 7 Desc.</b> | P1 is good condition at this stream buffer. | | <b>Pic 8 Desc.</b> | Equipment bridge ECDs are in place and functioning. | |

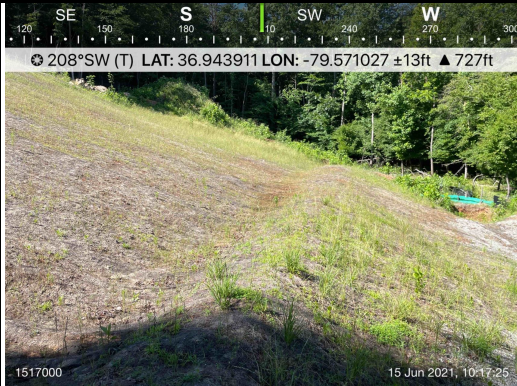
| <b>Field Station#</b> | 15170+00 | | <b>Field Station#</b> | 15170+00 | |

| <b>Pic 9 Desc.</b> | Waterbars are functioning as intended throughout this section. | | <b>Pic 10 Desc.</b> | Slope drain is in good condition and functioning. | |

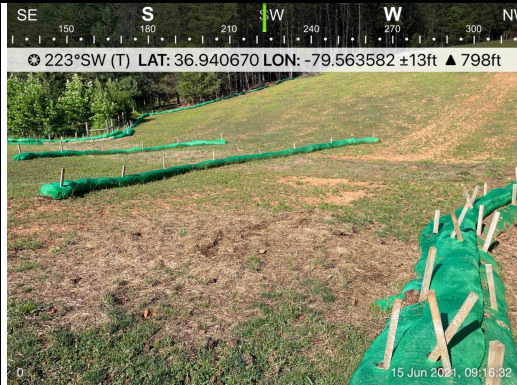
| <b>Field Station#</b> | 15195+00 | | <b>Field Station#</b> | 15195+50 | |

| <b>Pic 11 Desc.</b> | Drainage ECDs are in good condition and functioning. | | <b>Pic 12 Desc.</b> | Fence gap remains open by 3rd party allowing livestock onto ROW. | |

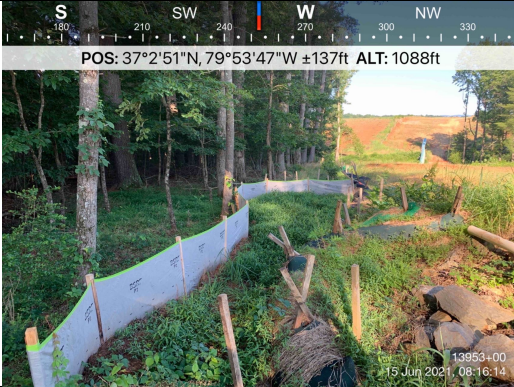
| <b>Field Station#</b> | 13953+00 | <b>Field Station#</b> | 13920+00 | | |

| <b>Pic 1 Desc.</b> | P1 silt fence in acceptable condition | <b>Pic 2 Desc.</b> | P1 silt fence with holes from wildlife damage in multiple panels from 13918+00 to 13921+00 | | |

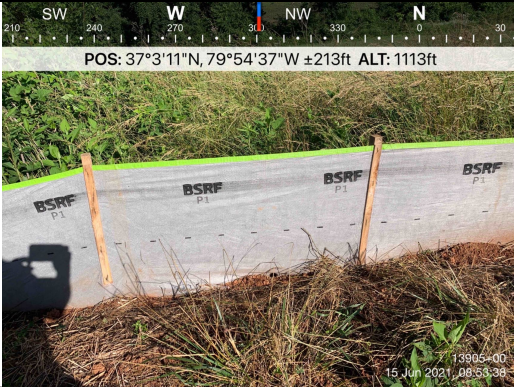
| <b>Field Station#</b> | 13905+00 | <b>Field Station#</b> | 13905+00 | | |

| <b>Pic 3 Desc.</b> | P1 silt fence with hole at ground line, damaged by wildlife, contractor repaired immediately | <b>Pic 4 Desc.</b> | P1 silt fence after repair | | |

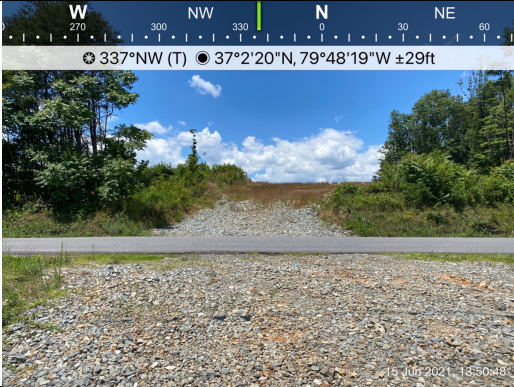
| <b>Field Station#</b> | 14333+00 | <b>Field Station#</b> | 14314+79 | | |

| <b>Pic 1 Desc.</b> | Approximately 14333+00. Overview of road crossing and RCEs. | | <b>Pic 2 Desc.</b> | Approximately 14314+79. Overview of stream crossing, equipment bridge and ECDs at stream S-GG4. | |

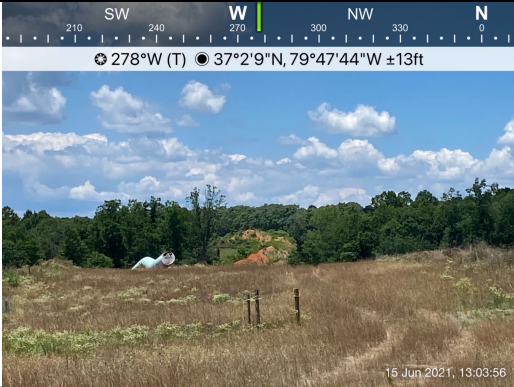
| <b>Field Station#</b> | 14357+00 | <b>Field Station#</b> | 14366+00 | | |

| <b>Pic 3 Desc.</b> | Approximately 14357+00. Overview of ROW. | | <b>Pic 4 Desc.</b> | Approximately 14366+00. Overview of ROW. | |

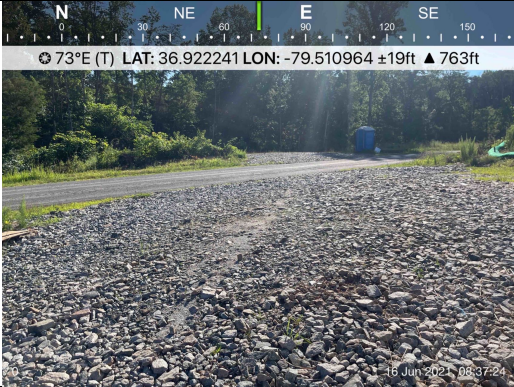
| <b>Field Station#</b> | 15370+62 | | <b>Field Station#</b> | 15369+00 | |

| <b>Pic 1 Desc.</b> | RCEs are in good condition at all road crossings. | | <b>Pic 2 Desc.</b> | Vegetation continues to fill in throughout this section of ROW. | |

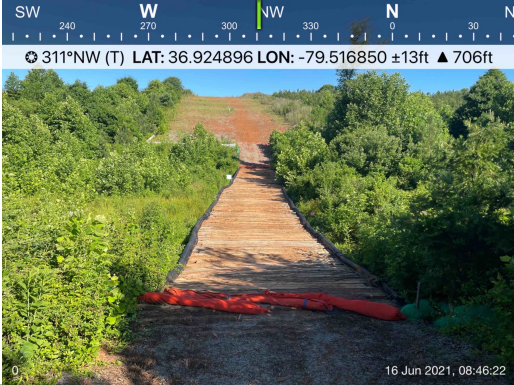
| <b>Field Station#</b> | 15348+00 | | <b>Field Station#</b> | 15345+00 | |

| <b>Pic 3 Desc.</b> | Equipment bridge ECDs are in place and functioning. | | <b>Pic 4 Desc.</b> | Waterbars are in good condition. | |

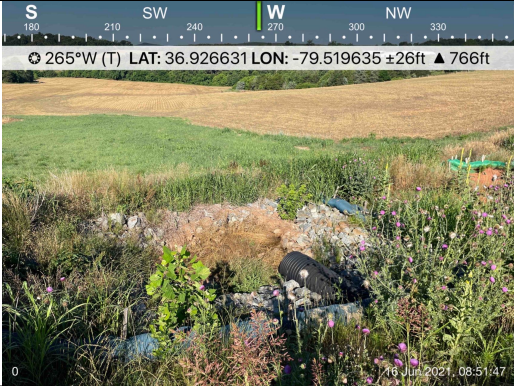
| <b>Field Station#</b> | 15338+00 | | <b>Field Station#</b> | 15315+25 | |

| <b>Pic 5 Desc.</b> | CWDs are functioning as intended. | | <b>Pic 6 Desc.</b> | P1 is in good condition at all stream and wetland buffers. | |

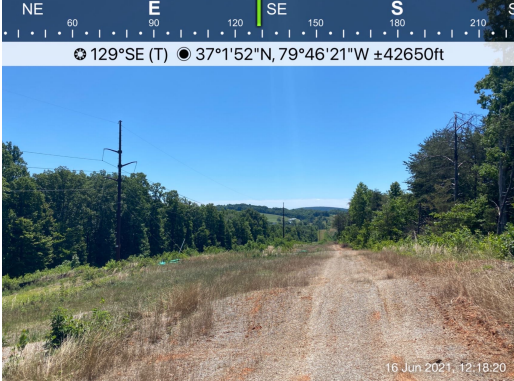
| <b>Field Station#</b> | 14470+00 | <b>Field Station#</b> | 14530+00 | | |

| <b>Pic 1 Desc.</b> | Approximately 14470+00. Overview of ROW. | <b>Pic 2 Desc.</b> | Approximately 14530+00. Overview of ROW. | | |

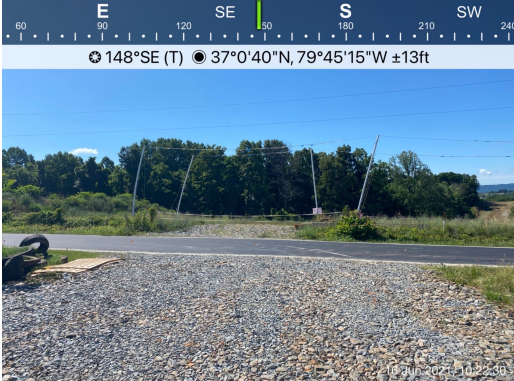
| <b>Field Station#</b> | 14524+50 | <b>Field Station#</b> | 14510+00 | | |

| <b>Pic 3 Desc.</b> | Approximately 14524+50. Overview of road crossing and RCEs. | <b>Pic 4 Desc.</b> | Approximately 14510+00. Overview of ROW. | | |

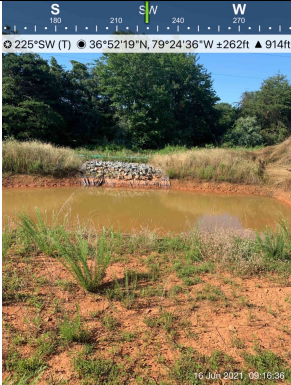
| <b>Field Station#</b> | 15739+00 | | <b>Field Station#</b> | 15735+00 | |

| <b>Pic 1 Desc.</b> | Observing temporary stabilization, sump and end treatment. | | <b>Pic 2 Desc.</b> | Observing temporary stabilization,CWD outlet and ECD's | |

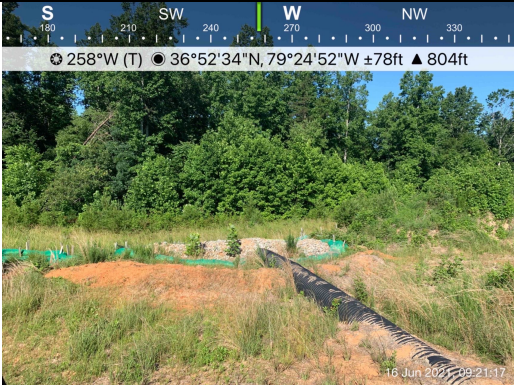
| <b>Field Station#</b> | 15720+00 | | <b>Field Station#</b> | 15713+52 | |

| <b>Pic 3 Desc.</b> | Observing temporary stabilization,CWD outlet and ECD's | | <b>Pic 4 Desc.</b> | Observing temporary stabilization,water bar,signage, buffer, equipment crossing and ECD's | |

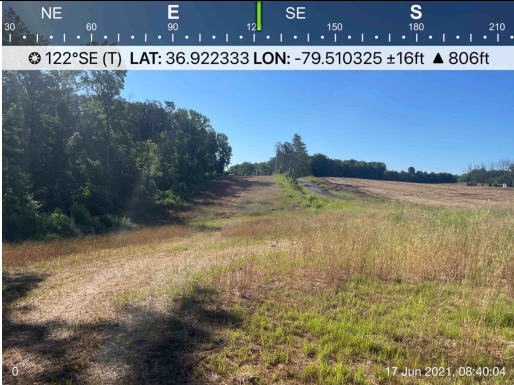
| <b>Field Station#</b> | 15371+00 | | <b>Field Station#</b> | 15375+00 | |

| <b>Pic 1 Desc.</b> | Vegetation continues to fill in throughout this section of ROW. | | <b>Pic 2 Desc.</b> | Drainage ECDs are in good condition and functioning. | |

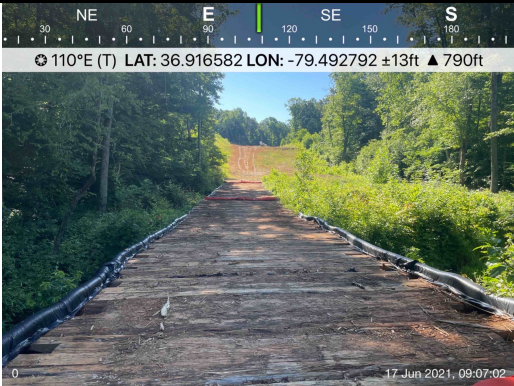
| <b>Field Station#</b> | 15426+00 | | <b>Field Station#</b> | 15427+31 | |

| <b>Pic 5 Desc.</b> | Equipment bridge ECDs are in place and functioning. | | <b>Pic 6 Desc.</b> | Reinforced P1 remains in good condition. | |

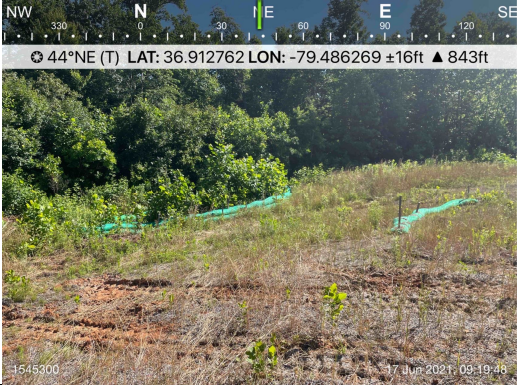
| <b>Field Station#</b> | 15453+00 | | <b>Field Station#</b> | 15457+00 | |

| <b>Pic 7 Desc.</b> | CWD is in good condition with no evidence of sedimentation from 3rd party disturbance. | | <b>Pic 8 Desc.</b> | Drainage feature is in good condition with no evidence of sedimentation from 3rd party disturbance. | |

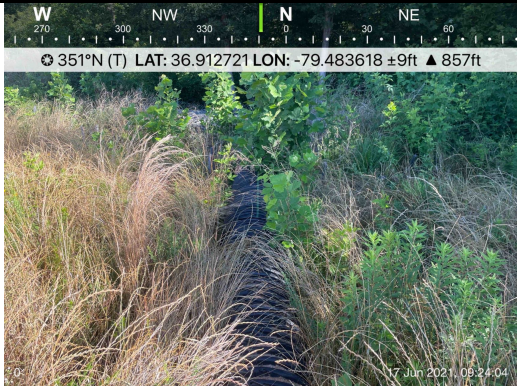
| <b>Field Station#</b> | 15460+81 | | <b>Field Station#</b> | 15460+81 | |

| <b>Pic 9 Desc.</b> | CWD is in good condition with no evidence of sedimentation from 3rd party disturbance. | | <b>Pic 10 Desc.</b> | CWD inlet is in good condition with no evidence of sedimentation from 3rd party disturbance. | |

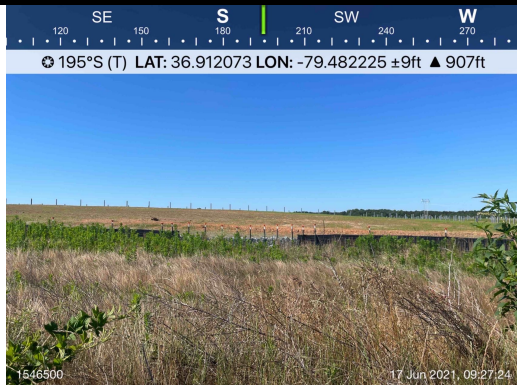
| <b>Field Station#</b> | 15465+00 | | <b>Field Station#</b> | 15475+00 | |

| <b>Pic 11 Desc.</b> | No evidence of sedimentation from 3rd party rock outlet. | | <b>Pic 12 Desc.</b> | 3rd party rock outlet appears to be in good condition. | |

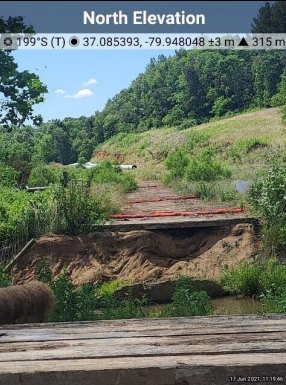
| <b>Field Station#</b> | 13692+77 | <b>Field Station#</b> | 13689+00 | | |

| <b>Pic 1 Desc.</b> | Monitored erosion control blanket of stream bank S-E28 after recent heavy rain events. No environmental issues observed at the time of inspection. | | <b>Pic 2 Desc.</b> | Vegetation observation photo facing up row from road crossing. No environmental issues observed at the time of inspection. | |

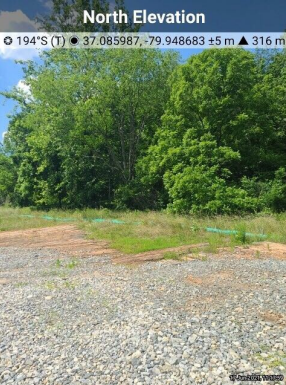
| <b>Field Station#</b> | 13690+00 | <b>Field Station#</b> | 13692+79 | | |

| <b>Pic 3 Desc.</b> | Monitored CFS on row edge. All functioning at the time of inspection. | | <b>Pic 4 Desc.</b> | Throughout inspection today the EI monitored equipment mats and ECDs new stream and wetland crossings. No environmental issues observed at the time of inspection. | |

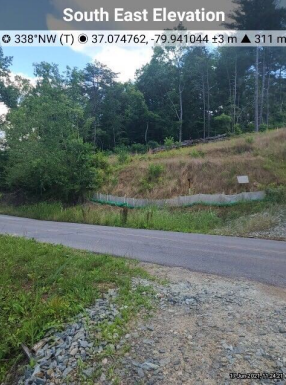
| <b>Field Station#</b> | 13748+21 | <b>Field Station#</b> | 13748+00 | | |

| <b>Pic 5 Desc.</b> | Photo showing ECDs in place and vegetation on hill side at Green Level rd crossing. | | <b>Pic 6 Desc.</b> | Monitored RCE and hill side above rd crossing. All ECDs were functioning I no environmental issues observed at the time of inspection. | |

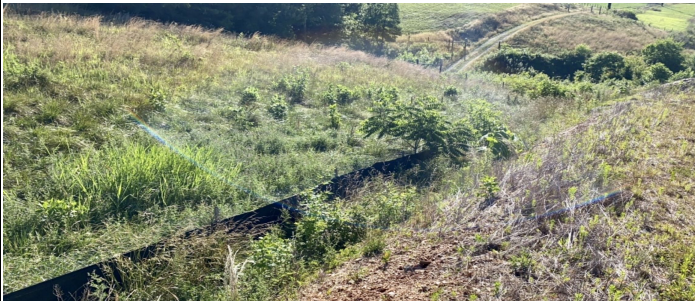
| <b>Field Station#</b> | 14930+00 | | <b>Field Station#</b> | 14938+00 | |

| <b>Pic 1 Desc.</b> | Perimeter SSF in good condition. | | <b>Pic 2 Desc.</b> | Sump pit and perimeter CFS in good condition. | |

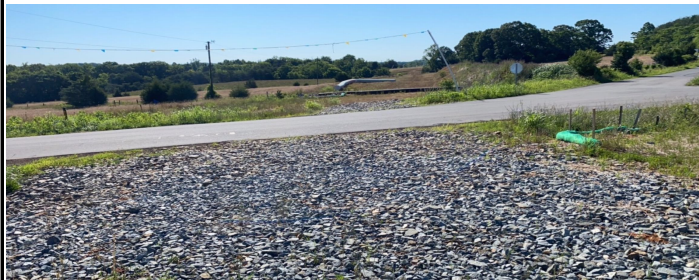
| <b>Field Station#</b> | 14939+00 | | <b>Field Station#</b> | 14981+55 | |

| <b>Pic 3 Desc.</b> | ROW stabilized in temporary area. | | <b>Pic 4 Desc.</b> | RCE at Snow Creek Rd in good condition. | |

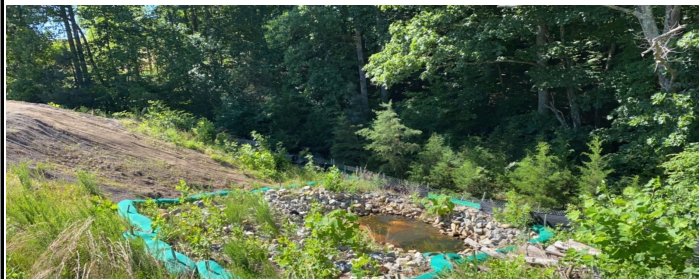
| <b>Pic 5 Desc.</b> | Perimeter P1 silt fence in good condition. | | <b>Pic 6 Desc.</b> | Plunge pool and surrounding ECDs performing intended functions. | |

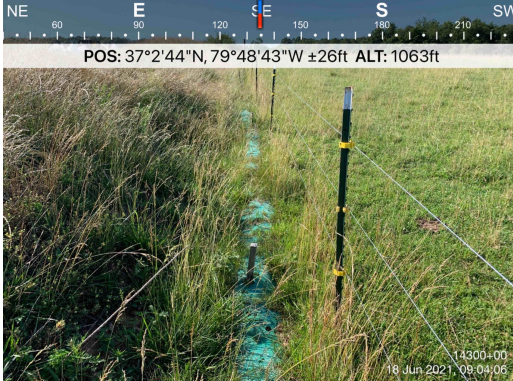
| <b>Field Station#</b> | 14300+00 | | <b>Field Station#</b> | 14183+00 | |

| <b>Pic 1 Desc.</b> | Perimeter CFS is deteriorated and damaged by livestock from 14295+00 to 14303+00 | | <b>Pic 2 Desc.</b> | Waterbar in acceptable condition | |

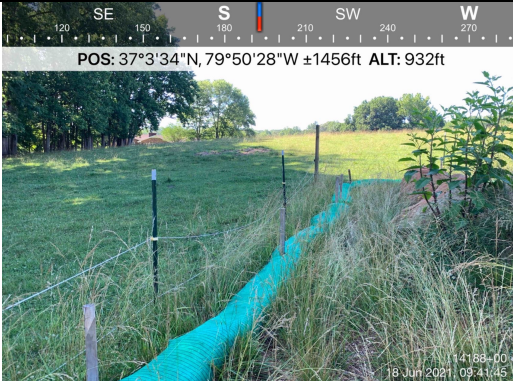
| <b>Pic 3 Desc.</b> | Waterbar end treatment in acceptable condition | | <b>Pic 4 Desc.</b> | Electric fence damaged by livestock, contractor repaired immediately | |

| Other - Explain in Comments | Communication | Electric fence was repaired | | Immediate | 6/18/2021 |

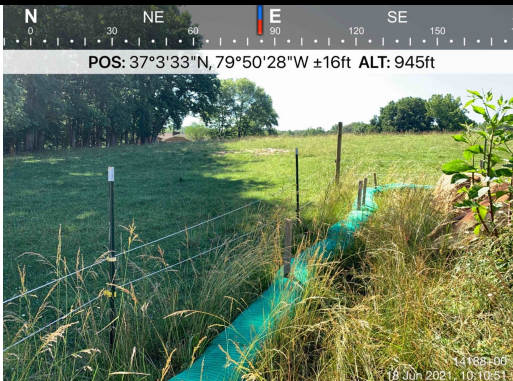
| <b>Field Station#</b> | 14188+00 | | <b>Field Station#</b> | 14197+00 | |

| <b>Pic 5 Desc.</b> | Electric fence after repair | | <b>Pic 6 Desc.</b> | Super silt fence in acceptable condition | |

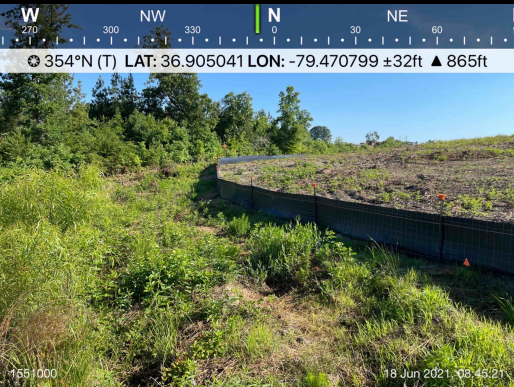
| Field Station# | 15510+00 | | Field Station# | 15515+00 | |

| Pic 7 Desc. | No evidence of sedimentation from 3rd party disturbance. | | Pic 8 Desc. | CWDs are functioning as intended. | |

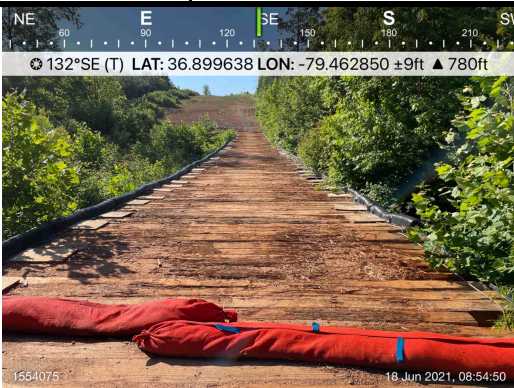
| Field Station# | 15540+75 | | Field Station# | 15547+32 | |

| Pic 9 Desc. | Equipment bridge ECDs are in good condition and functioning. | | Pic 10 Desc. | Waterbars are in good condition. | |

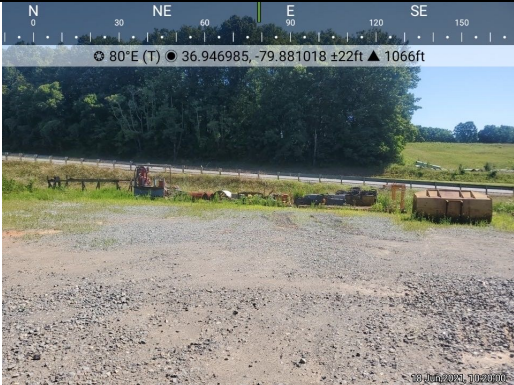
| <b>Pic 1 Desc.</b> | LY-048 West perimeter CFS | | <b>Pic 2 Desc.</b> | LY-048 Southwest corner CFS | |

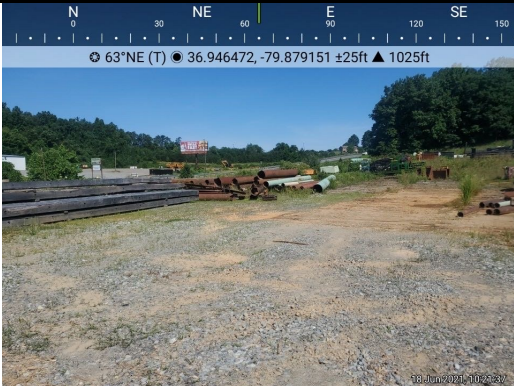
| <b>Pic 3 Desc.</b> | LY-032 Staging area | | <b>Pic 4 Desc.</b> | LY-032 Secondary containment | |

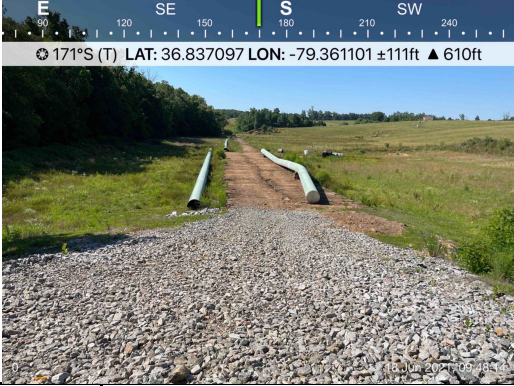
| <b>Field Station#</b> | 15948+00 | <b>Field Station#</b> | 15962+32 | | |

| <b>Pic 1 Desc.</b> | RCEs are in good condition at all road crossings. | <b>Pic 2 Desc.</b> | P1 is in good condition at all stream and wetland crossings. | | |

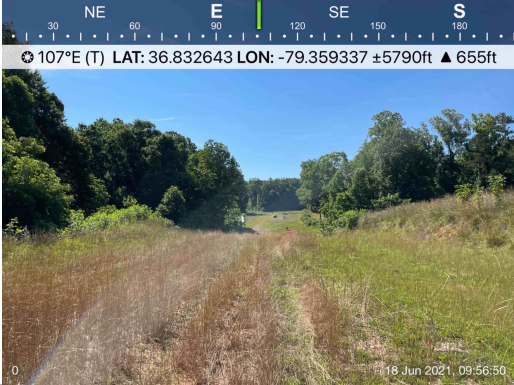
| <b>Field Station#</b> | 15970+00 | <b>Field Station#</b> | 15977+35 | | |

| <b>Pic 3 Desc.</b> | Vegetation continues to fill in throughout this area. | <b>Pic 4 Desc.</b> | Equipment bridge ECDs are in place and functioning. | | |

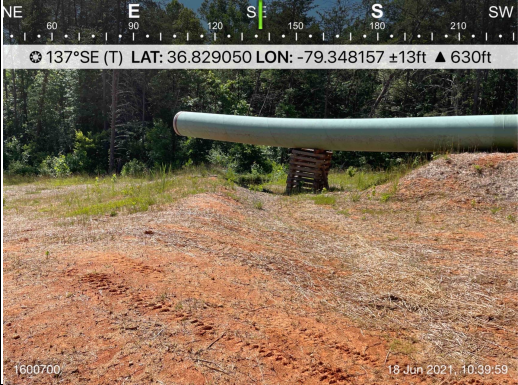
| <b>Field Station#</b> | 16007+00 | <b>Field Station#</b> | | | |

| <b>Pic 7 Desc.</b> | Waterbars are in good condition. | <b>Pic 8 Desc.</b> | | | |

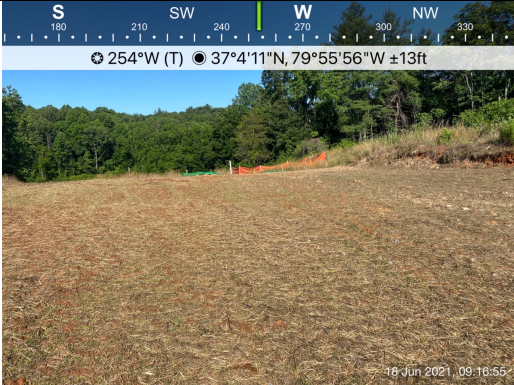
| <b>Field Station#</b> | 13785+00 | <b>Field Station#</b> | 13805+80 | | |

| <b>Pic 1 Desc.</b> | Approximately 13785+00. Overview of ROW. | <b>Pic 2 Desc.</b> | Approximately 13805+80. Overview of stream crossing, equipment bridge and ECDs at stream S-D18. | | |

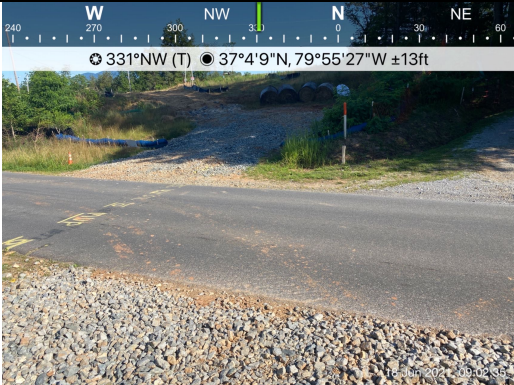
| <b>Field Station#</b> | 13811+75 | <b>Field Station#</b> | 13846+85 | | |

| <b>Pic 3 Desc.</b> | Approximately 13811+75. Overview of road crossing and RCEs. | <b>Pic 4 Desc.</b> | Approximately 13846+85. Overview of stream crossing, equipment bridge and ECDs at stream S-C16. | | |

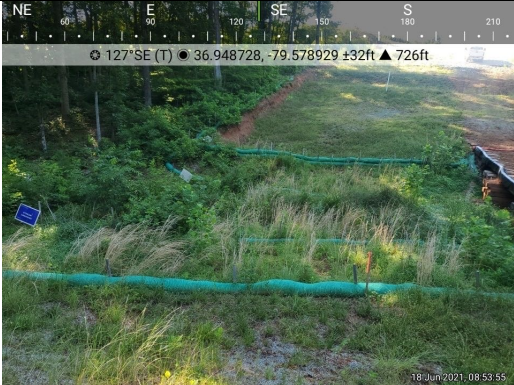
| <b>Field Station#</b> | 15142+00 | <b>Field Station#</b> | 15127+00 | | |

| <b>Pic 1 Desc.</b> | S-H11 Buffer | <b>Pic 2 Desc.</b> | GAS S-A6 Revegetation | | |

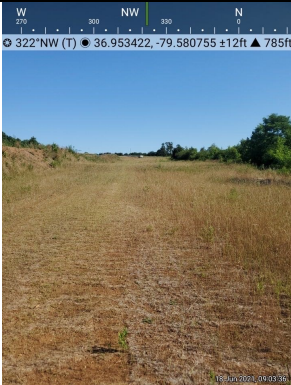
| <b>Field Station#</b> | 15120+00 | <b>Field Station#</b> | 15121+00 | | |

| <b>Pic 3 Desc.</b> | Temporary stabilization | <b>Pic 4 Desc.</b> | Plunge pool | | |

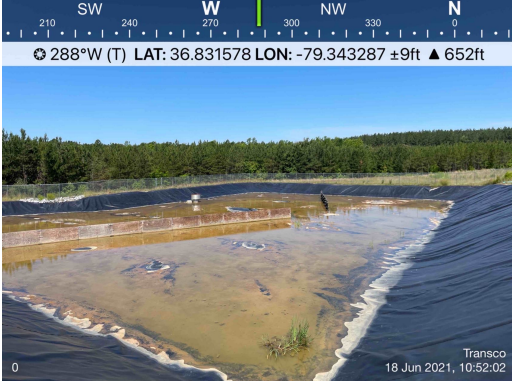
| Pic 1 Desc. | Sediment basin remains in good condition. | | Pic 2 Desc. | Drainage channel outlet protection remains in good condition. |

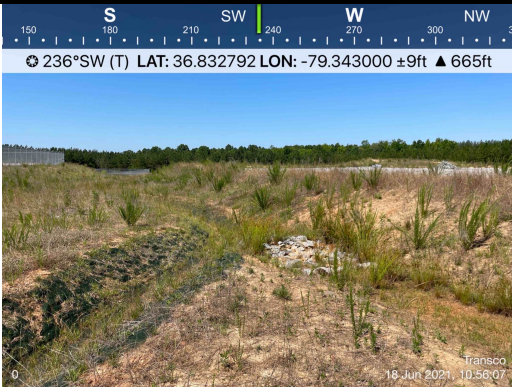
| Pic 3 Desc. | Drainage channel outlet protection remains in good condition. | | Pic 4 Desc. | Sediment traps are in good condition and functioning. |
