Visual Site Inspection Report

Project Name	H-600 Pipeline Spread I	AFE	124300139	Spread	H-600 Pipeline Spread I
Contractor	Precision			Report #	24794
Inspector	John White			Date/Time	6/21/2021 10:17 AM
Permit #	TBD	Inspection Type	VA SWPP	Station Begin	15584+23
State	VA	Inspection Area	Full	Station End	15647+03
County	Pittsylvania	Ground	Dry	Temperature (°F)	82.00
Municipality	Chatham	Weather	Sunny	Rain Gauge (in)	0.00
				Rain Accumulation Time (days)	6.00

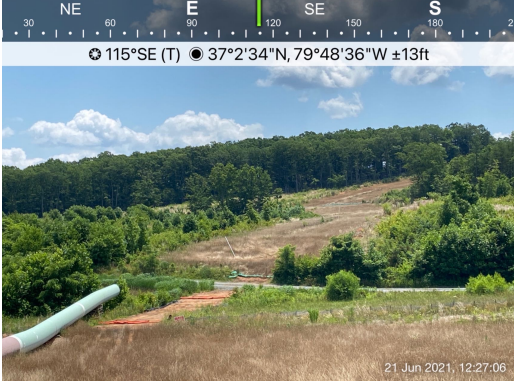
GPS Location	0	GPS Location	0		
Field Station#	14314+00	Field Station#	14333+50		
Pic 1 Desc.	Approximately 14314+00. Overview of ROW.	Pic 2 Desc.	Approximately 14333+50. Overview of road crossing and RCEs.

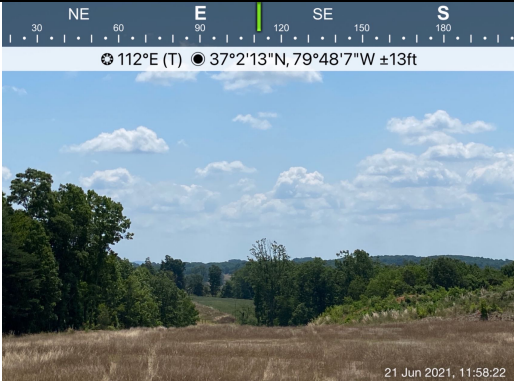
GPS Location	0	GPS Location	0		
Field Station#	14347+00	Field Station#	14391+50		
Pic 3 Desc.	Approximately 14347+00. Overview of ROW.	Pic 4 Desc.	Approximately 14391+50. Overview of stream crossing, equipment bridge and ECDs at stream S-A41.

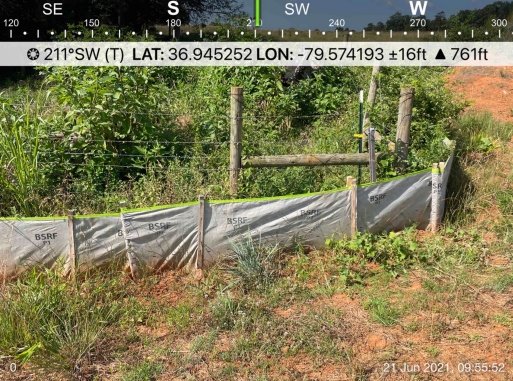
GPS Location	See photo		GPS Location	See photo	
Field Station#	15159+07		Field Station#	15159+07	
Pic 1 Desc.	P1 has been damaged and needs to be restaked.		Pic 2 Desc.	Environmental crew has corrected this issue.

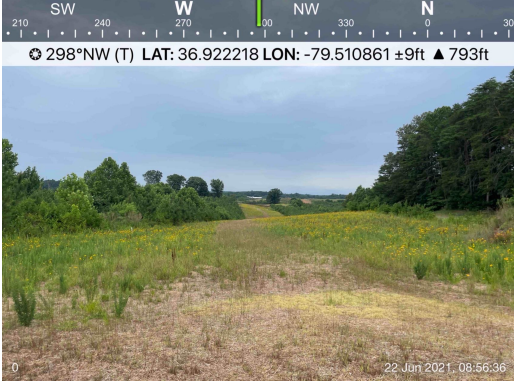
GPS Location	See photo		GPS Location	See photo	
Field Station#	15370+00		Field Station#	15350+00	
Pic 1 Desc.	Vegetation continues to fill in throughout this section of ROW.		Pic 2 Desc.	MVP-PI-332 remains in good condition with controls in place.

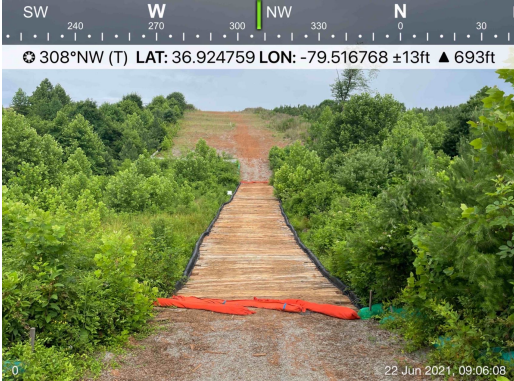
GPS Location	See photo		GPS Location	See photo	
Field Station#	15346+90		Field Station#	15346+20	
Pic 3 Desc.	Equipment bridge ECDs are in place and functioning.		Pic 4 Desc.	P1 is in good condition at all stream and wetland buffers.

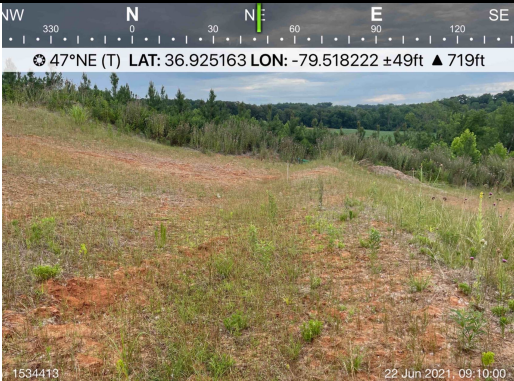
GPS Location	See photo		GPS Location	See photo	
Field Station#	15344+13		Field Station#	15338+00	
Pic 5 Desc.	Waterbars are in good condition in this area.		Pic 6 Desc.	CWDs are functioning as intended.

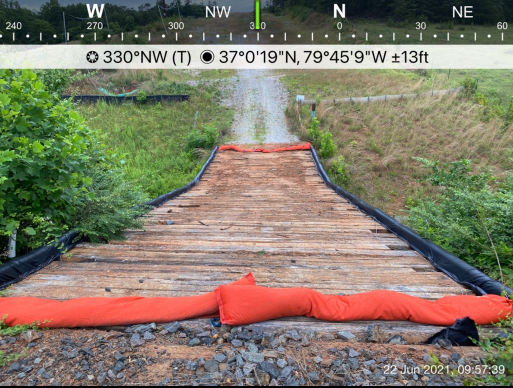
GPS Location	0	GPS Location	0		
Field Station#	14542+00	Field Station#	14546+33		
Pic 5 Desc.	Approximately 14542+00. Overview of ROW.	Pic 6 Desc.	Approximately 14546+33. Overview of stream crossing, equipment bridge and ECDs at stream S-G17.

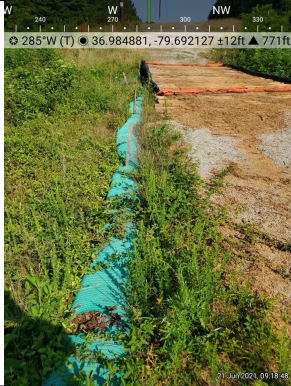
GPS Location	0	GPS Location	0		
Field Station#	14754+00	Field Station#	14750+50		
Pic 5 Desc.	Travel lane stabilization	Pic 6 Desc.	Damaged CFS along travel lane.

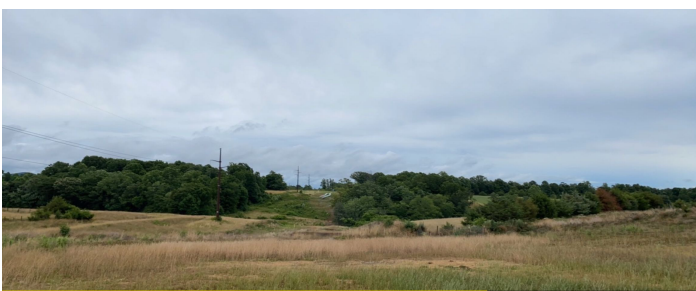
36°58'20" N 79°39'55" W 90°E COURSE 97° GPS 1120 Listening Hill Rd, Penhook, VA 24137, United States 06.22.2021 13:08:23 Accur +/-15.4 Ft ALT 1000 Ft			36°58'20" N 79°39'55" W 144°SE COURSE 141° GPS 1120 Listening Hill Rd, Penhook, VA 24137, United States 06.22.2021 13:08:19 Accur +/-15.3 Ft ALT 989 Ft		
GPS Location	1		GPS Location	2	
Field Station#	14838+00		Field Station#	14846+00	
Pic 1 Desc.	ROW stabilized and vegetated in temporary area.		Pic 2 Desc.	Spoil pile stabilized and vegetated.

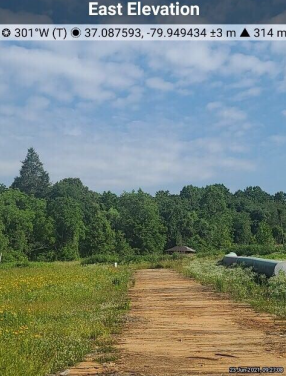
GPS Location	00000	GPS Location	00000		
Field Station#	13681+50	Field Station#	13702+70		
Pic 1 Desc.	Row photo showing equipment mats in place and good vegetation coverage.		Pic 2 Desc.	Monitored sump pit and end treatment while conducting row inspection. No issues observed at the time of inspection	
	South East Elevation <small>336°NW (T) 37.082887, -79.945687 ±7 m ▲ 303 m</small>

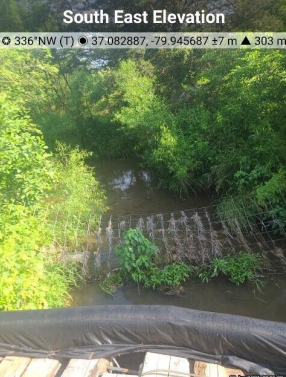
GPS Location	00000	GPS Location	00000		
Field Station#	13704+90	Field Station#	13704+90		
Pic 3 Desc.	Stream observation photo facing upstream during routine inspection today. No issues observed at the time of inspection		Pic 4 Desc.	Stream observation photo facing downstream during routine inspection today. No issues observed at the time of inspection.

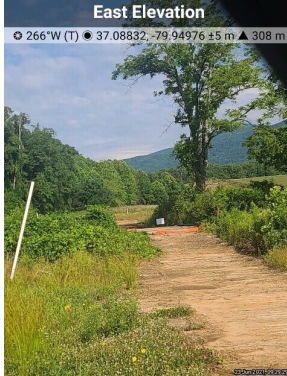
GPS Location	00000	GPS Location	00000		
Field Station#	13704+80	Field Station#	13678+89		
Pic 5 Desc.	Stream crossing monitored . No environmental issues observed at the time of inspection.		Pic 6 Desc.	Photo taken showing stream crossing with vegetation. Ecds in place and functioning at the time of inspection.

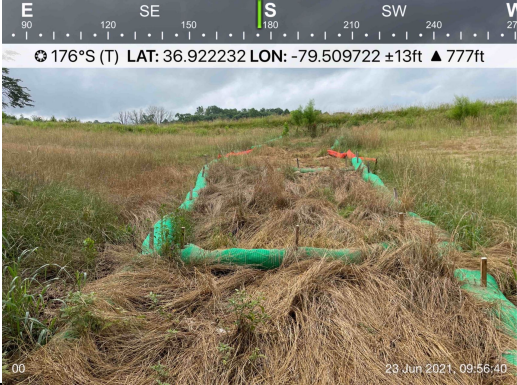
<p style="text-align: center;">Insert image here</p>			
GPS Location	See photo	GPS Location			
Field Station#	15375+00	Field Station#			
Pic 15 Desc.	Drainage ECDs are in good condition and functioning.	Pic 16 Desc.			
<p style="text-align: center;">Insert image here</p>		<p style="text-align: center;">Insert image here</p>			
GPS Location		GPS Location			
Field Station#		Field Station#			
Pic 17 Desc.		Pic 18 Desc.

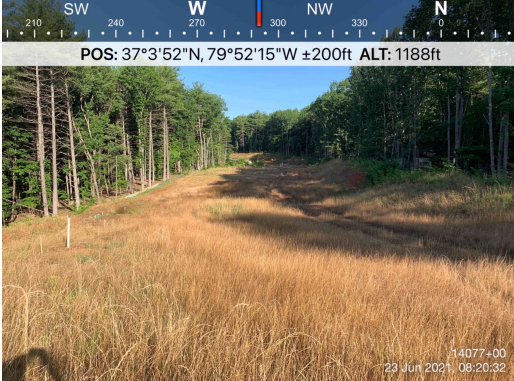
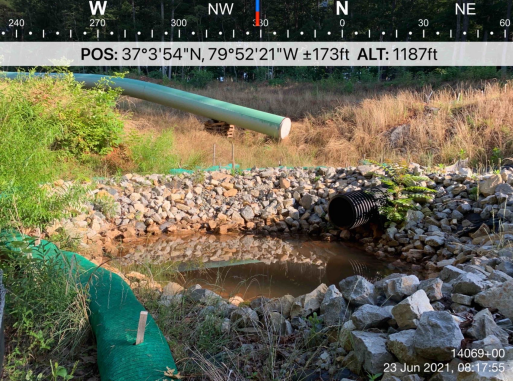
GPS Location	0	GPS Location	0		
Field Station#	14077+00	Field Station#	14069+00		
Pic 1 Desc.	Temporary vegetative stabilization in acceptable condition		Pic 2 Desc.	Clean water diversion plunge pool in acceptable condition

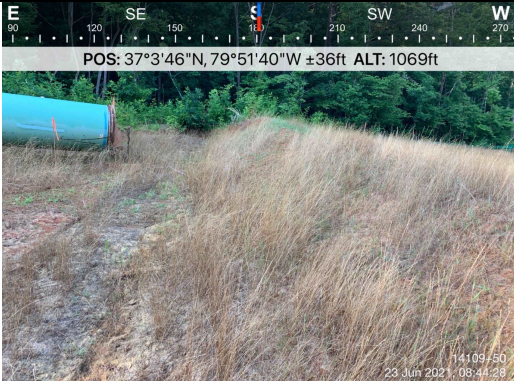
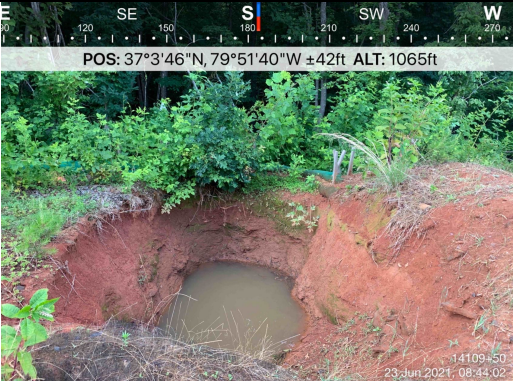
GPS Location	0	GPS Location	0		
Field Station#	14109+50	Field Station#	14109+50		
Pic 3 Desc.	Waterbar in acceptable condition		Pic 4 Desc.	Waterbar end treatment in acceptable condition

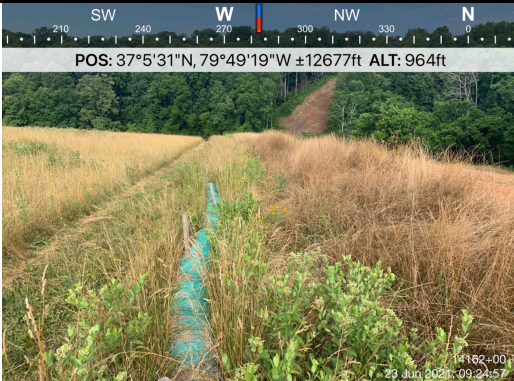
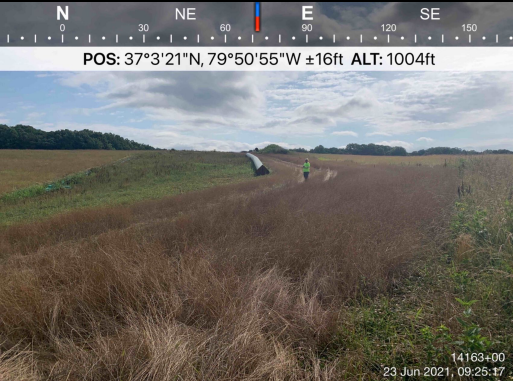
GPS Location	0	GPS Location	0		
Field Station#	14162+00	Field Station#	14163+00		
Pic 5 Desc.	Perimeter CFS in acceptable condition		Pic 6 Desc.	Permanent vegetative stabilization in acceptable condition

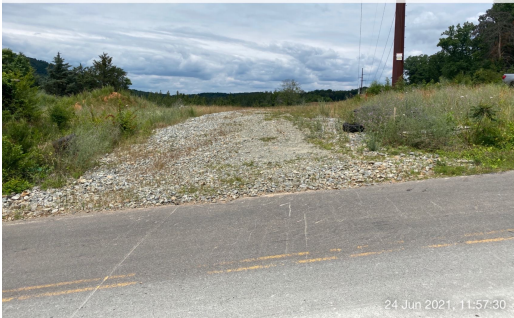
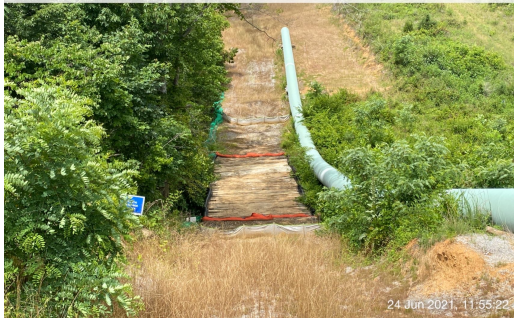
GPS Location	0	GPS Location	0		
Field Station#	14694+50	Field Station#	14689+36		
Pic 1 Desc.	Approximately 14694+50. Overview of road crossing and RCE.	Pic 2 Desc.	Approximately 14689+36. Overview of stream crossing, equipment bridge and ECDs at stream S-H34.

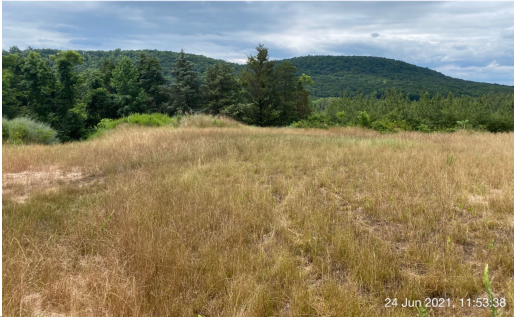
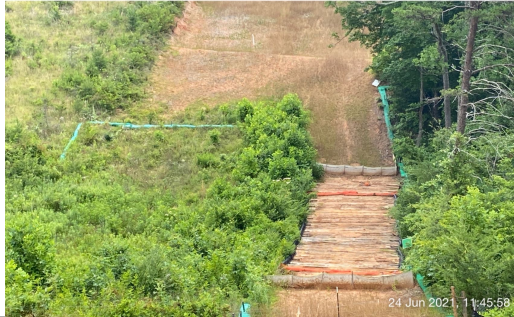
GPS Location	0	GPS Location	0		
Field Station#	14691+00	Field Station#	14680+30		
Pic 3 Desc.	Approximately 14691+00. Overview of ROW.	Pic 4 Desc.	Approximately 14680+30. Overview of stream crossing, equipment bridge and ECDs at stream S-H36.

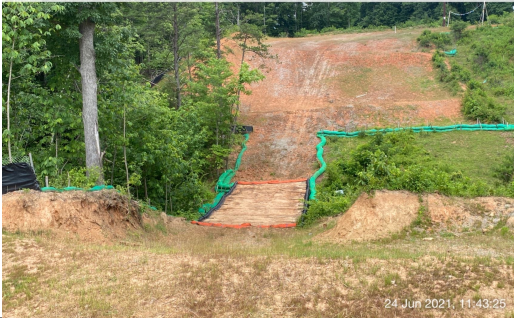
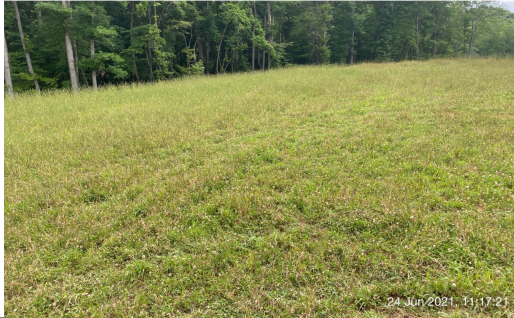
GPS Location	0	GPS Location	0		
Field Station#	14673+10	Field Station#	14651+00		
Pic 5 Desc.	Approximately 14673+10. Overview of stream crossing, equipment bridge and ECDs at stream S-H37.	Pic 6 Desc.	Approximately 14651+00. Overview of ROW.

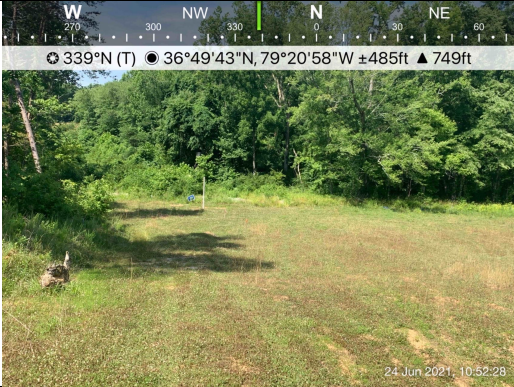
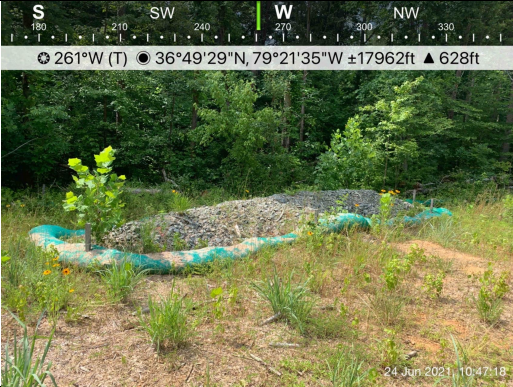
GPS Location	O	GPS Location	O		
Field Station#	16004+00	Field Station#	16010+00		
Pic 1 Desc.	Observing temporary stabilization, signage and buffer	Pic 2 Desc.	Observing temporary stabilization,CWD outlet and ECD's

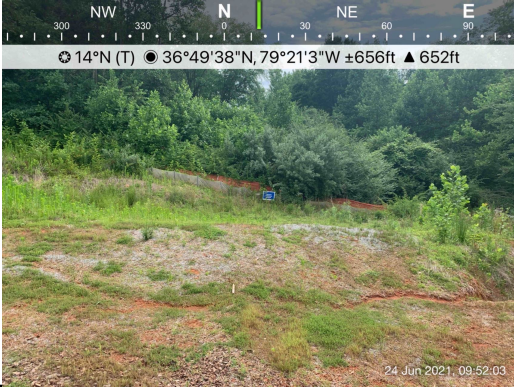
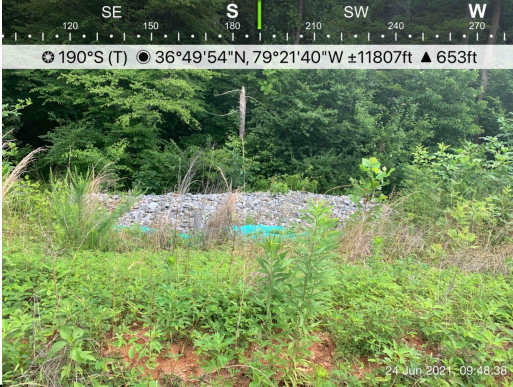
GPS Location	O	GPS Location	O		
Field Station#	15999+00	Field Station#	15983+00		
Pic 3 Desc.	Observing temporary stabilization,water bar,signage, buffer and ECD's	Pic 4 Desc.	Observing temporary stabilization,CWD outlet and ECD's

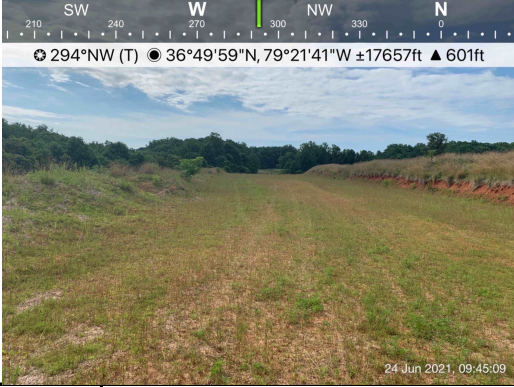
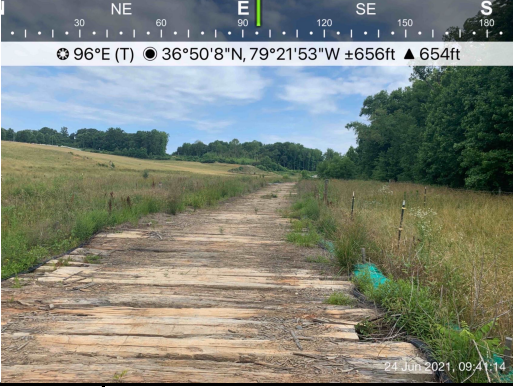
GPS Location	O	GPS Location	O		
Field Station#	15972+00	Field Station#	15960+00		
Pic 5 Desc.	Observing temporary stabilization and CWD berm	Pic 6 Desc.	Observing equipment crossing and ECD's

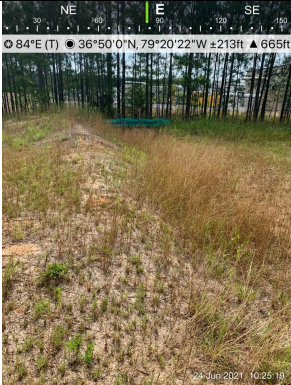
GPS Location	O	GPS Location	O		
Field Station#	5+00	Field Station#	9+00		
Pic 1 Desc.	Observing temporary stabilization, water bar and end treatment		Pic 2 Desc.	Observing temporary stabilization

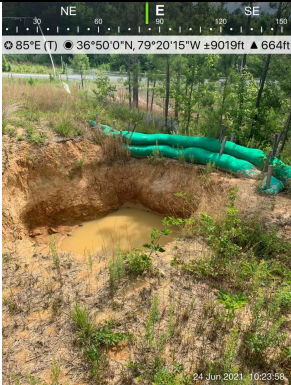
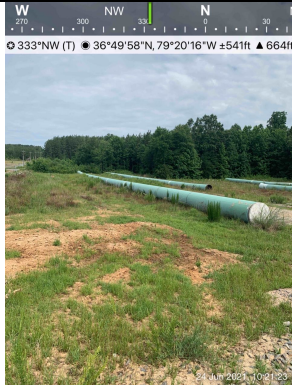
GPS Location	O	GPS Location	O		
Field Station#	12+00	Field Station#	20+00		
Pic 3 Desc.	Observing temporary stabilization, sump and end treatment		Pic 4 Desc.	Observing temporary stabilization	
Insert image here			Insert image here		
GPS Location		GPS Location			
Field Station#		Field Station#			
Pic 5 Desc.			Pic 6 Desc.

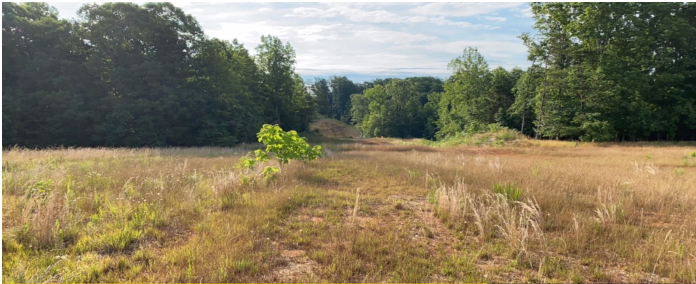
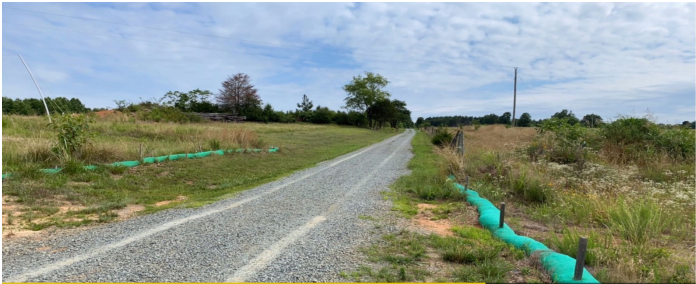
<small>36°57'46" N 79°35'32" W 102°E COURSE 0° GPS 1918-2164 Armstrong Rd, Penhook, VA 24137, United States 06.24.2021 08:18:20 Accur +/-49.5 Ft ALT 0 Ft</small>			<small>36°57'43" N 79°35'16" W 329°NW COURSE -1° GPS Sandy Level, VA 24161, United States 06.24.2021 10:02:33 Accur +/-114.4 Ft ALT 829 Ft</small>		
GPS Location	1		GPS Location	2	
Field Station#	15065+00		Field Station#	15080+64	
Pic 1 Desc.	Row stabilized and vegetated in temporary area.		Pic 2 Desc.	Access road in good condition at ROW crossing.

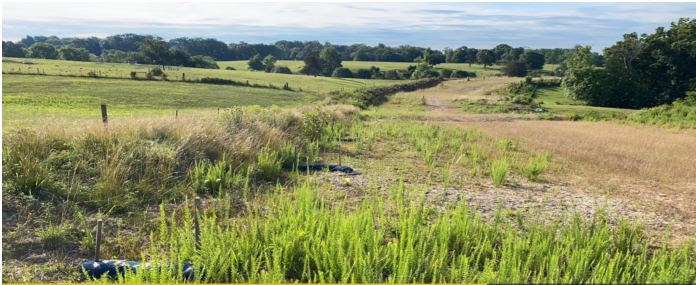
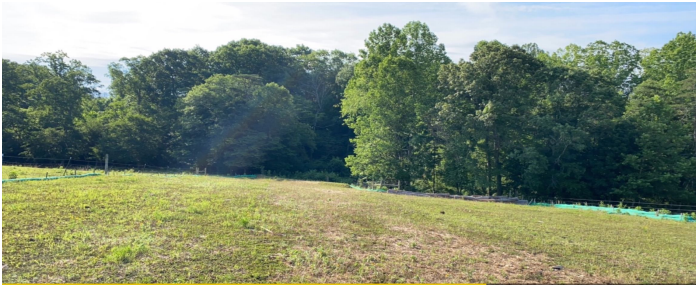
GPS Location	3		GPS Location	4	
Field Station#	15082+00		Field Station#	15101+00	
Pic 3 Desc.	CFS check dams and temporary diversion berm performing intended functions.		Pic 4 Desc.	ROW stabilized and vegetated in final cleanup area. Perimeter CFS in place and functional.

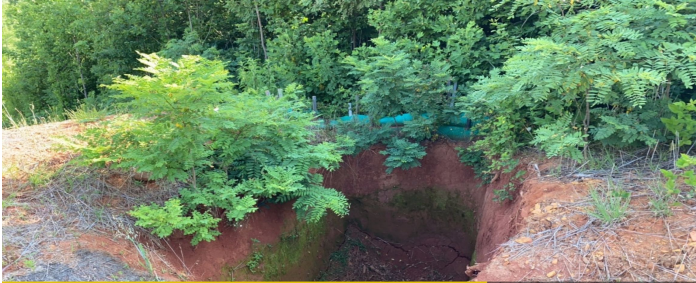
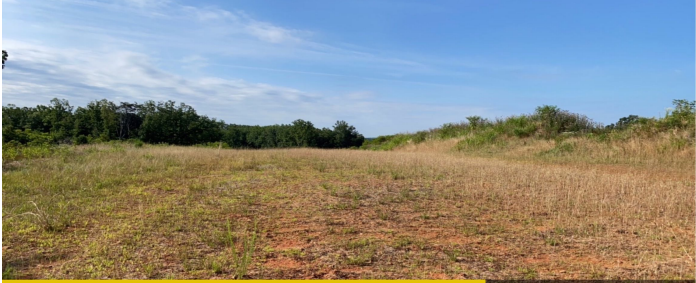
<small>36°57'5" N 79°34'48" W 103°E COURSE -1° GPS Sandy Level, VA 24161, United States 06.24.2021 09:07:36 Accur +/-157.4 Ft ALT 882 Ft</small>			<small>36°57'4" N 79°34'48" W 205°SW COURSE 191° GPS Sandy Level, VA 24161, United States 06.24.2021 09:08:11 Accur +/-171.1 Ft ALT 912 Ft</small>		
GPS Location	5		GPS Location	6	
Field Station#	15130+00		Field Station#	15133+00	
Pic 5 Desc.	Sump pit and end treatment performing intended function		Pic 6 Desc.	ROW stabilized in temporary area. Limited vegetation observed

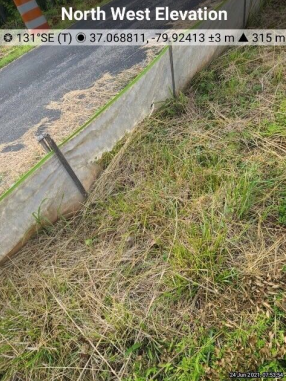
GPS Location	0000	GPS Location	0000		
Field Station#	13813+02	Field Station#	13755+49		
Pic 1 Desc.	Additional photo showing P1 that requires maintenance due to being weathered and torn with some damage from land owner activities.		Pic 2 Desc.	Stream observation photo facing upstream during routine inspection today. No issues observed at the time of inspection.

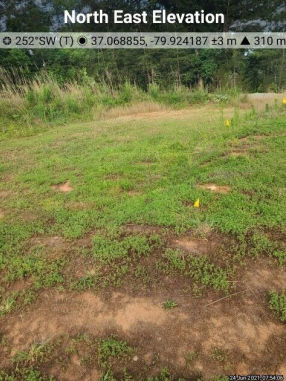
GPS Location	0000	GPS Location	00000		
Field Station#	13812+79	Field Station#	13755+71		
Pic 3 Desc.	Area observed where land owner has mowed inside the LOD. Noted that it was not project related. Will continue to monitor the area.		Pic 4 Desc.	Monitored stream buffer ECDs with checking row conditions throughout. No issues observed at the time of inspection.

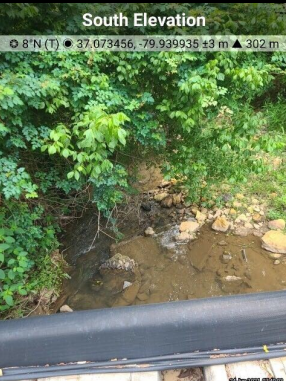
Pic 5 Desc.	Stream observation photo facing downstream during routine inspection today. No issues observed at the time of inspection.		Pic 6 Desc.	P1 requires maintenance due to being weathered and torn with some damage from land owner activities. Added to the punch list.

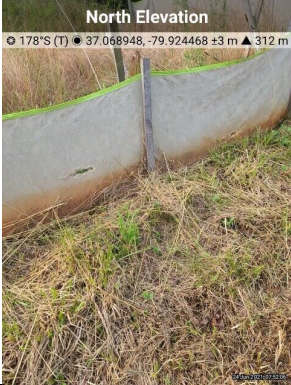
<p>North Elevation <small>178°S (T) 37.068948, -79.924468 ±3 m ▲ 312 m</small></p>		<p>Insert image here</p>		<p>Insert image here</p>	
GPS Location	0000	GPS Location			
Field Station#	13812+06	Field Station#			
Pic 7 Desc.	P1 requires maintenance due to being weathered and torn. Documented and added to the punch list .		Pic 8 Desc.		
<p>Insert image here</p>		<p>Insert image here</p>			
GPS Location			GPS Location		
Field Station#			Field Station#		
Pic 9 Desc.			Pic 10 Desc.		
<p>Insert image here</p>		<p>Insert image here</p>			
GPS Location			GPS Location		
Field Station#			Field Station#		
Pic 11 Desc.			Pic 12 Desc.

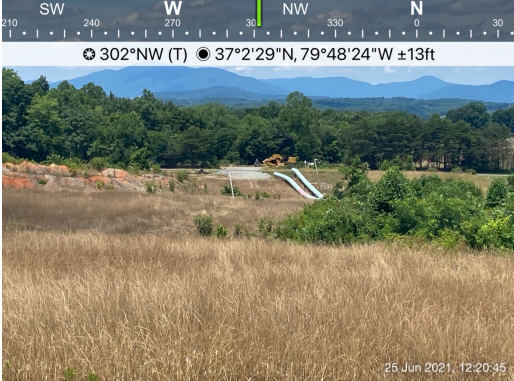
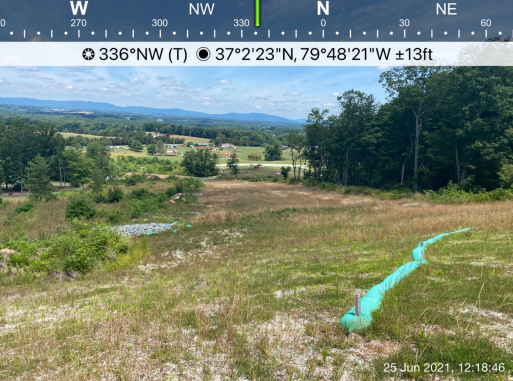
GPS Location	0	GPS Location	0		
Field Station#	14318+00	Field Station#	14328+00		
Pic 1 Desc.	Approximately 14318+00. Overview of ROW.	Pic 2 Desc.	Approximately 14328+00. Overview of ROW.

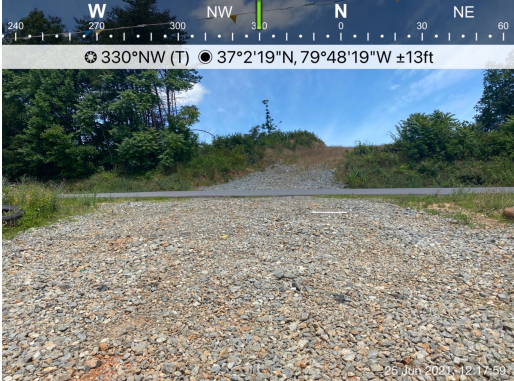
GPS Location	0	GPS Location	0		
Field Station#	14333+00	Field Station#	14353+53		
Pic 3 Desc.	Approximately 14333+00. Overview of road crossing and RCEs.	Pic 4 Desc.	Approximately 14353+53. Overview of stream crossing, equipment bridge and ECDs at stream S-A38.

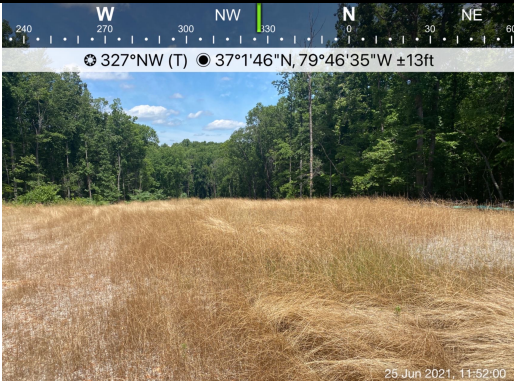
GPS Location	0	GPS Location	0		
Field Station#	14428+00	Field Station#	14438+33		
Pic 5 Desc.	Approximately 14428+00. Overview of ROW.	Pic 6 Desc.	Approximately 14438+33. Overview of stream crossing, equipment bridge and ECDs at stream S-GH44.

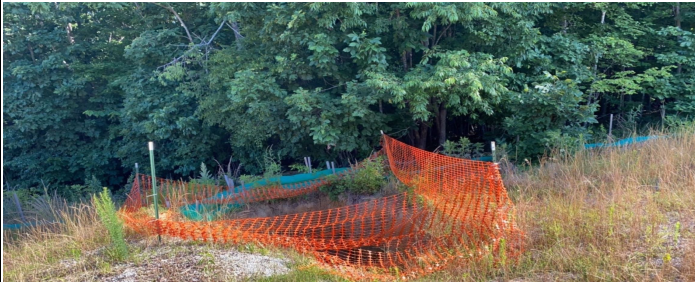
06.25.2021 09:03:35 Accur +/-376.1 Ft ALT 828 Ft			06.25.2021 09:14:03 Accur +/-32.1 Ft ALT 893 Ft		
GPS Location	1	GPS Location	2		
Field Station#	14739+00	Field Station#	14755+00		
Pic 1 Desc.	Routine maintenance. Safety fence down around sump pit.		Pic 2 Desc.	Contractor repaired erosion rills and seeded and stabilized disturbed area per punch list item.

E&S BMPs	Compliance Level	Corrective Action	Corrective Time Frame	Date Repaired
Other - Explain in Comments	Communication	Routine maintenance- safety fence	Addressed	6/25/2021
Vegetative Stabilization (Temporary)	Acceptable			
Compost Filter Sock	Acceptable			
Silt Fence (Filter Fabric Fence)	Acceptable			
Sump Pit	Acceptable			
Rock Construction Entrance	Acceptable			
Equipment Bridge	Acceptable

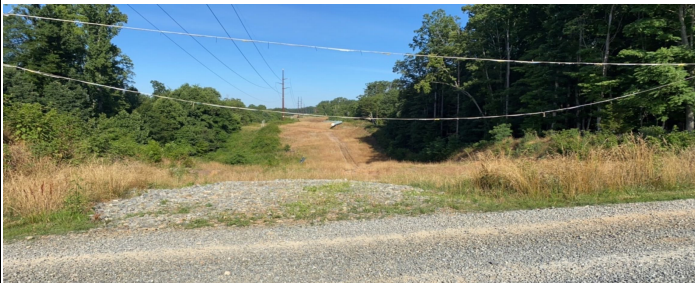
06.25.2021 08:44:40 Accur +/-29.5 Ft ALT 937 Ft			06.25.2021 08:47:28 Accur +/-30.7 Ft ALT 909 Ft		
GPS Location	3	GPS Location	4		
Field Station#	14712+33	Field Station#	14716+92		
Pic 3 Desc.	RCE at access road in good condition.		Pic 4 Desc.	Appropriate signage visible at stream crossing.

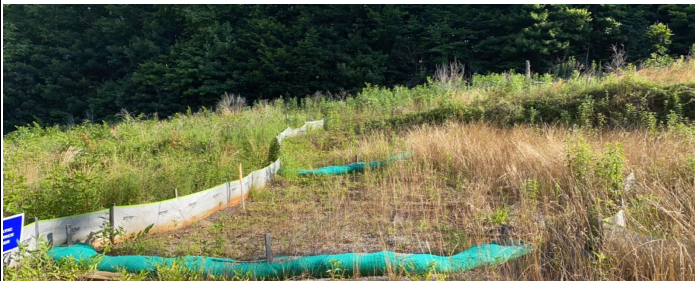
06.25.2021 08:48:46 Accur +/-356.4 Ft ALT 908 Ft			06.25.2021 08:59:37 Accur +/-80.1 Ft ALT 908 Ft		
GPS Location	5	GPS Location	6		
Field Station#	14723+00	Field Station#	14734+00		
Pic 5 Desc.	CFS check dams and P1 silt fence at resource buffer performing intended functions.		Pic 6 Desc.	New vegetation growing along travel lane where seeded.

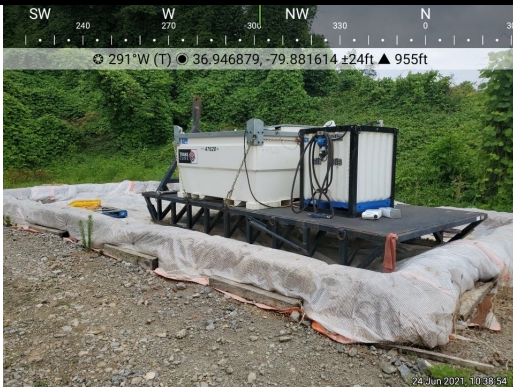
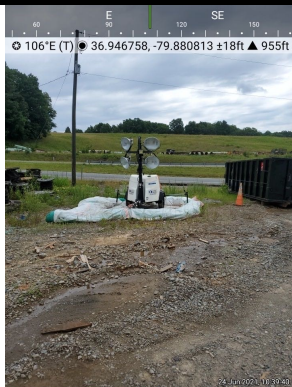
<p>E 60 SE 120 180 106°E (T) 36.946758, -79.880813 ±18ft ▲ 955ft 24 Jun 2021 10:37:51</p>			
GPS Location	0	GPS Location	0		
Field Station#	0+00	Field Station#	0+00		
Pic 1 Desc.	LY-032 Secondary containment	Pic 2 Desc.	LY-032 Light plant secondary containment

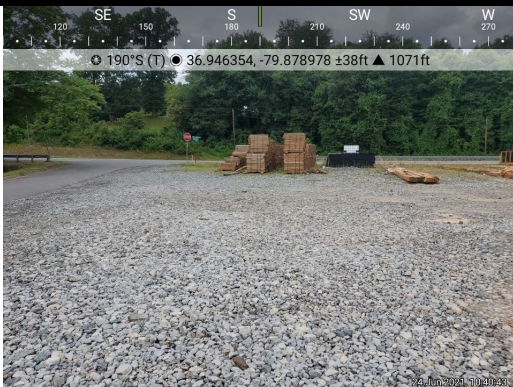
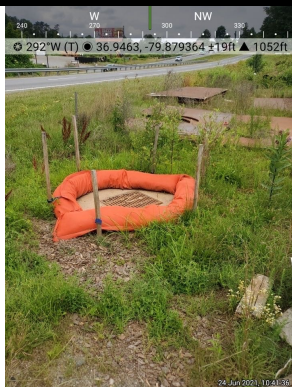
<p>W 240 NW 300 360 292°W (T) 36.9463, -79.879364 ±19ft ▲ 1052ft 24 Jun 2021 10:41:00</p>			
GPS Location	0	GPS Location	0		
Field Station#	0+00	Field Station#	0+00		
Pic 3 Desc.	LY-033 Construction entrance	Pic 4 Desc.	LY-033 Inlet protection

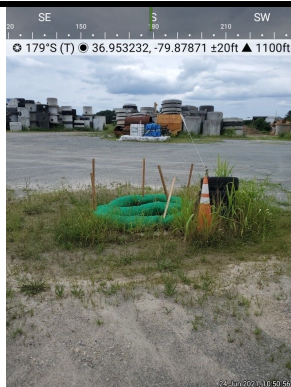
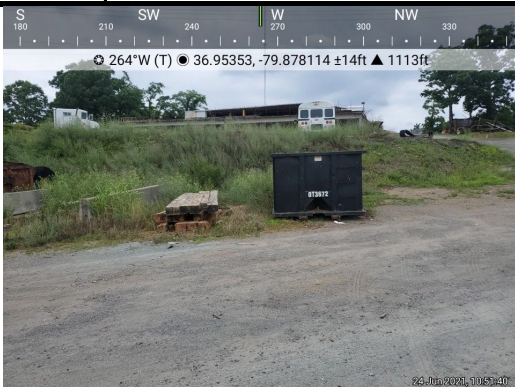
GPS Location	0	GPS Location	0		
Field Station#	0+00	Field Station#	0+00		
Pic 5 Desc.	ANC-006 Inlet protection	Pic 6 Desc.	ANC-006 Waste management

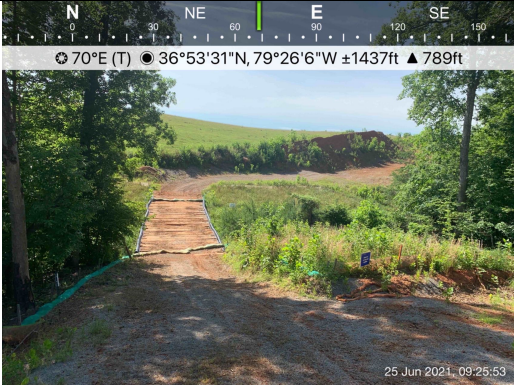
GPS Location	O	GPS Location	O		
Field Station#	15636+45	Field Station#	15632+00		
Pic 1 Desc.	Observing temporary stabilization, signage, buffer, equipment crossing and ECD's	Pic 2 Desc.	Observing temporary stabilization, erosion control blanket and CFS Checks

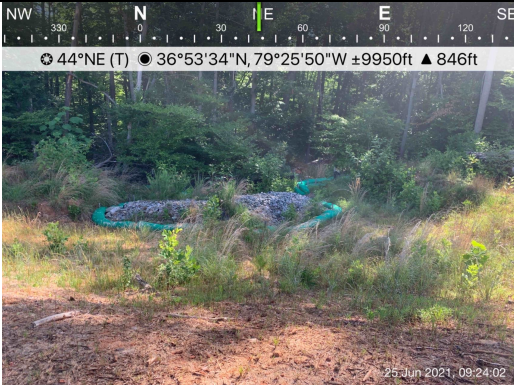
GPS Location	O	GPS Location	O		
Field Station#	15630+00	Field Station#	15619+48		
Pic 3 Desc.	Observing temporary stabilization, CWD outlet and ECD's	Pic 4 Desc.	Observing road crossing and RCE's

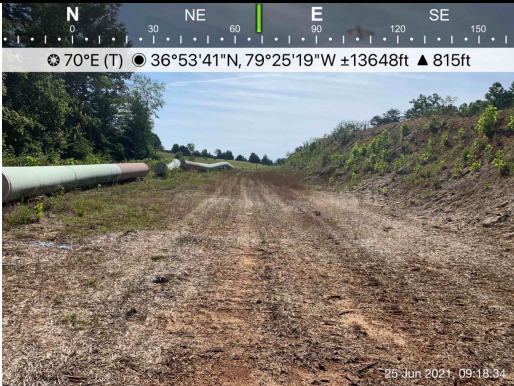
GPS Location	O	GPS Location	O		
Field Station#	15605+00	Field Station#	15590+00		
Pic 5 Desc.	Observing temporary stabilization	Pic 6 Desc.	Observing temporary stabilization and water bars

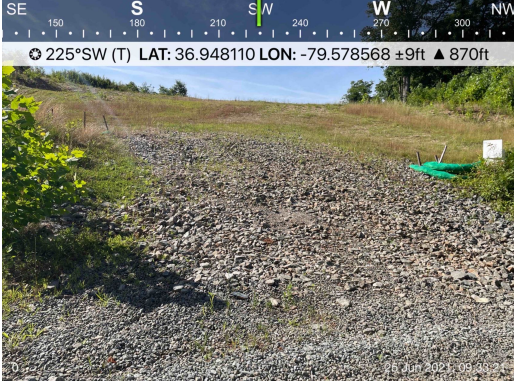
GPS Location	See photo		GPS Location	See photo	
Field Station#	15142+66		Field Station#	15152+84	
Pic 1 Desc.	RCEs are in good condition condition at all road crossings.		Pic 2 Desc.	Areas disturbed during CFS install have been stabilized.

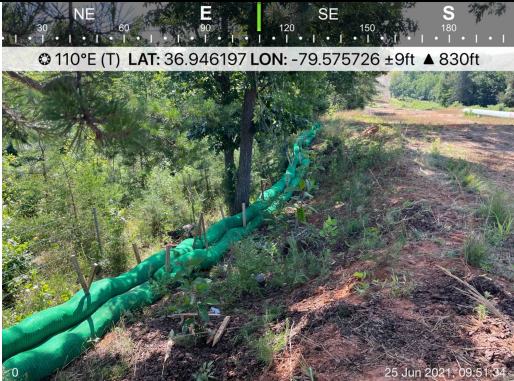
GPS Location	See photo		GPS Location	See photo	
Field Station#	15155+00		Field Station#	15165+57	
Pic 3 Desc.	CFS is in good condition.		Pic 4 Desc.	Rock inlet remains in good condition.

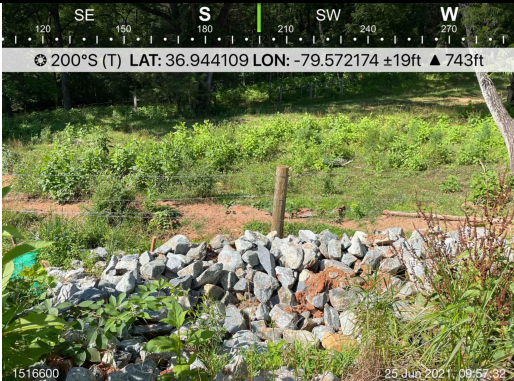
GPS Location	See photo		GPS Location	See photo	
Field Station#	15166+00		Field Station#	15167+95	
Pic 5 Desc.	Rock outlet remains in good condition.		Pic 6 Desc.	P1 is in good condition at this stream buffer.

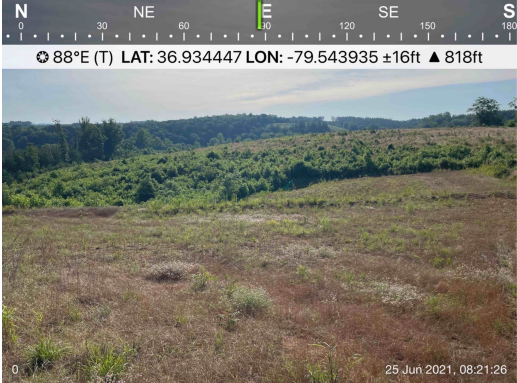
GPS Location	See photo	GPS Location			
Field Station#	15260+00	Field Station#			
Pic 13 Desc.	Vegetation continues to fill in throughout this section.	Pic 14 Desc.			
Insert image here		Insert image here			
GPS Location		GPS Location			
Field Station#		Field Station#			
Pic 15 Desc.		Pic 16 Desc.			
Insert image here		Insert image here			
GPS Location		GPS Location			
Field Station#		Field Station#			
Pic 17 Desc.		Pic 18 Desc.
