# Visual Site Inspection Report

<b>Project Name</b>	H-600 Pipeline Spread G	<b>AFE</b>	124300137	<b>Spread</b>	H-600 Pipeline Spread G
<b>Contractor</b>	Precision			<b>Report #</b>	25095
<b>Inspector</b>	Patrick Shields			<b>Date/Time</b>	6/28/2021 4:17 PM
<b>Permit #</b>	TBD	<b>Inspection Type</b>	VA SWPP	<b>Station Begin</b>	11254+99
<b>State</b>	VA	<b>Inspection Area</b>	Partial	<b>Station End</b>	11524+16
<b>County</b>	Giles	<b>Ground</b>	Dry	<b>Temperature (°F)</b>	87.00
<b>Municipality</b>	N/A	<b>Weather</b>	Sunny	<b>Rain Gauge (in)</b>	0.00
				<b>Rain Accumulation Time (days)</b>	1.00

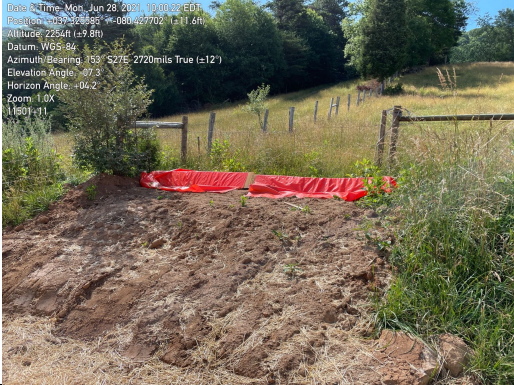
<p>Date &amp; Time: Mon Jun 28 2021 10:10:02 EDT Position: +037.319472 / -080.427702 (-11.6m) Altitude: 2250ft (+9.8m) Datum: WGS-84 Azimuth/Bearing: 153 S27E 2720mils True (+12°) Elevation Angle: -07.3 Horizon Angle: -04.2 Zoom: 1.0x 11501+11</p>

<p>Date &amp; Time: Mon Jun 28 2021 10:09:06 EDT Position: +037.319310 / -080.429456 (-15.1m) Altitude: 2245ft (+11.5m) Datum: WGS-84 Azimuth/Bearing: 168 S32E 2631mils True (+12°) Elevation Angle: -38.5 Horizon Angle: -05.7 Zoom: 1.0x 11495+65</p>			
<b>GPS Location</b>	See photo	<b>GPS Location</b>	See photo		
<b>Field Station#</b>	11501+11	<b>Field Station#</b>	11495+65		
<b>Pic 1 Desc.</b>	Install triangular foam dike to specifications	<b>Pic 2 Desc.</b>	Replace hole in P1 silt fence perimeter control

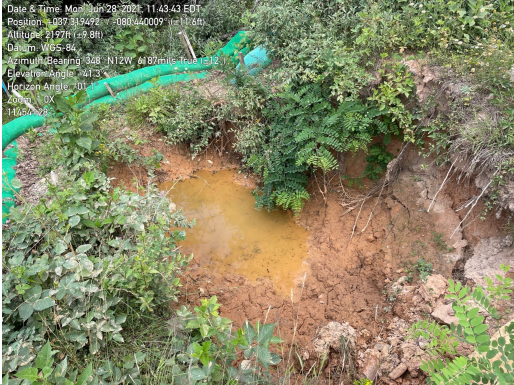
<p>Date &amp; Time: Mon Jun 28 2021 11:43:43 EDT Position: +037.319472 / -080.440009 (-11.6m) Altitude: 2127ft (+9.8m) Datum: WGS-84 Azimuth/Bearing: 308 N12W 4480mils True (+12°) Elevation Angle: -41.3 Horizon Angle: -01.1 Zoom: 1.0x 11454+28</p>

<b>GPS Location</b>	See photo	<b>GPS Location</b>	See photo		
<b>Field Station#</b>	11454+28	<b>Field Station#</b>	11453+50		
<b>Pic 3 Desc.</b>	Sump needs sediment cleaned out	<b>Pic 4 Desc.</b>	Clean out and refresh rock inlet

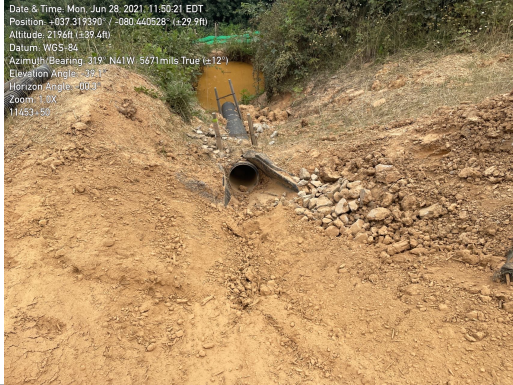
<p>Date &amp; Time: Mon Jun 28 2021 11:50:21 EDT Position: +037.319390 / -080.440528 (-29.9ft) Altitude: 2156ft (+39.4ft) Datum: WGS-84 Azimuth/Bearing: 319 N41W 5671mils True (+12°) Elevation Angle: -38.5 Horizon Angle: -00.4 Zoom: 1.0x 11453+50</p>

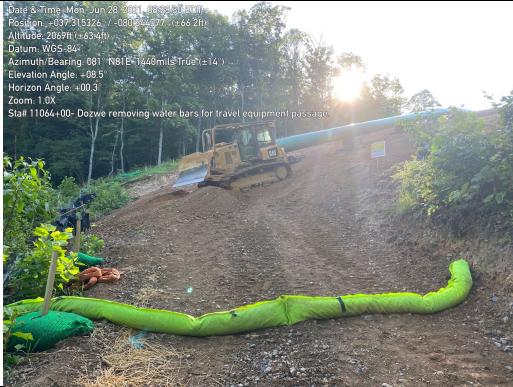
<p>Date &amp; Time: Mon, Jun 28, 2021, 08:09:26 EDT  Position: +037.23844 / -080.567099 (+26899.2ft)  Altitude: 2115ft (+32.8m)  Datum: WGS 84  Azimuth/Bearing: 198.518W 3520mils True (+14.1)  Elevation Angle: +04.6  Horizon Angle: +00.3  Zoom: 1.0X  Sta# 11066+00- Dozwe removing water bars for travel equipment passage.</p>

<b>GPS Location</b>	See photo GPS	<b>GPS Location</b>	See photo GPS		
<b>Field Station#</b>	11023+88	<b>Field Station#</b>	11064+53		
<b>Pic 1 Desc.</b>	AR-244 rain gauge reading- 0.15"	<b>Pic 2 Desc.</b>	Dozer removing water bars for equipment movement.

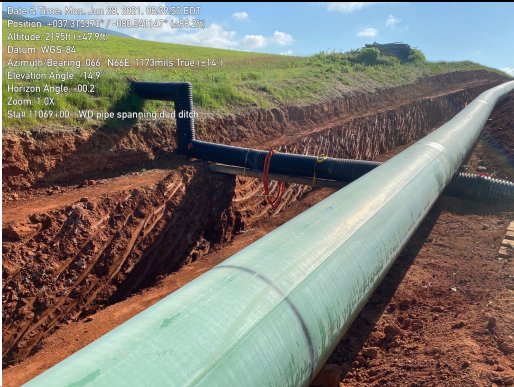
<p>Date &amp; Time: Mon, Jun 28, 2021, 09:04:46 EDT  Position: +037.3153207 / -080.566163 (+26829.7ft)  Altitude: 2195ft (+47.9m)  Datum: WGS 84  Azimuth/Bearing: 065. N66E 1173mils True (+14.1)  Elevation Angle: +14.9  Horizon Angle: +00.2  Zoom: 1.0X  Sta# 11069+00- WD pipe spanning dug ditch.</p>

<b>GPS Location</b>	See photo GPS	<b>GPS Location</b>	See photo GPS		
<b>Field Station#</b>	11069+00	<b>Field Station#</b>	11099+00		
<b>Pic 3 Desc.</b>	CWD pipe spanning excavated ditch line.	<b>Pic 4 Desc.</b>	Ditching equipment at AR-245.02		
<p>Date &amp; Time: Mon, Jun 28, 2021, 09:22:15 EDT  Position: +037.3153235 / -080.528545 (+22830ft)  Altitude: 2084ft (+35.0m)  Datum: WGS 84  Azimuth/Bearing: 132.558E 1991mils True (+15.1)  Elevation Angle: +23.6  Horizon Angle: +00.5  Zoom: 1.0X  Sta# 11118+00- Pipe carrying water bar flow to sump over dug ditch line.</p>

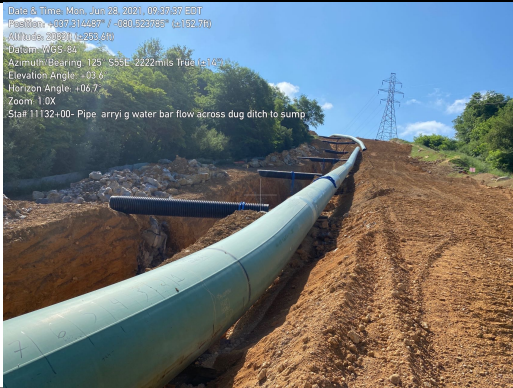
<p>Date &amp; Time: Mon, Jun 28, 2021, 09:26:02 EDT  Position: +037.3153235 / -080.528545 (+22830ft)  Altitude: 2084ft (+35.0m)  Datum: WGS 84  Azimuth/Bearing: 125.555E 2222mils True (+14.1)  Elevation Angle: +03.6  Horizon Angle: +06.7  Zoom: 1.0X  Sta# 11132+00- Pipe carrying water bar flow across dug ditch to sump.</p>

<b>GPS Location</b>	See photo GPS	<b>GPS Location</b>	See photo GPS		
<b>Field Station#</b>	11118+00	<b>Field Station#</b>	11132+00		
<b>Pic 5 Desc.</b>	Pipe carrying water bar flow to sump over excavated ditch line.	<b>Pic 6 Desc.</b>	Pipe carrying water bar flow across dug ditch line.

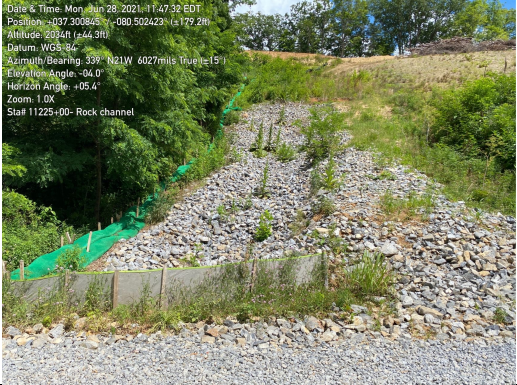
<p><small>Date &amp; Time: Mon Jun 28 2021 11:47:32 EDT Position: -037.300845°N, -080.502423°W (-172.2ft) Altitude: 2024ft (-614.3m) Datum: WGS-84 Azimuth/Bearing: 329° 021W 6027mils (true)=15.1 Elevation Angle: -04.0° Horizon Angle: -05.4° Zoom: 1.0X Staff: 11225+00 Rock channel</small></p>			
<b>GPS Location</b>	See photo GPS	<b>GPS Location</b>	See photo GPS		
<b>Field Station#</b>	11206+00	<b>Field Station#</b>	11225+00		
<b>Pic 13 Desc.</b>	Lowering in crew.	<b>Pic 14 Desc.</b>	Rock channel.		
Insert image here		Insert image here

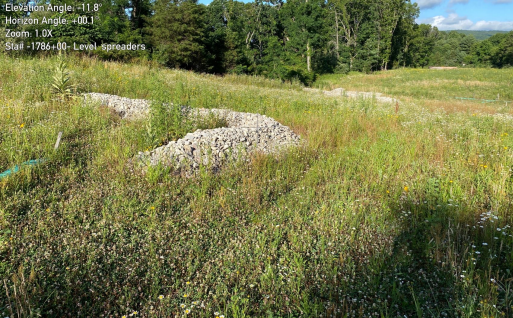
<p>Date &amp; Time: Tue Jun 29, 2021 08:14:07 EDT  Position: +037.298367 / -080.366274 (+111.0ft)  Altitude: 2139ft (+53.0ft)  Datum: WGS 84  Azimuth/Bearing: 233.553W 4142mils True (+11.8)  Elevation Angle: -11.8  Horizon Angle: +00.1  Zoom: 1.0X  Station: 11785+00 - Level spreaders</p>

<b>GPS Location</b>	See photo GPS	<b>GPS Location</b>	See photo GPS		
<b>Field Station#</b>	11789+00	<b>Field Station#</b>	11796+00		
<b>Pic 1 Desc.</b>	Tabor RCE	<b>Pic 2 Desc.</b>	Level spreaders & vegetation.		
<p>Date &amp; Time: Tue Jun 29, 2021 08:34:21 EDT  Position: +037.289224 / -080.368604 (+127.0ft)  Altitude: 2176ft (+56.6ft)  Datum: WGS 84  Azimuth/Bearing: 186.580W 3207mils True (+11.3)  Elevation Angle: -13.0  Horizon Angle: +00.6  Zoom: 1.0X  Station: 11830+00 - Karst ECD's &amp; level spreaders</p>

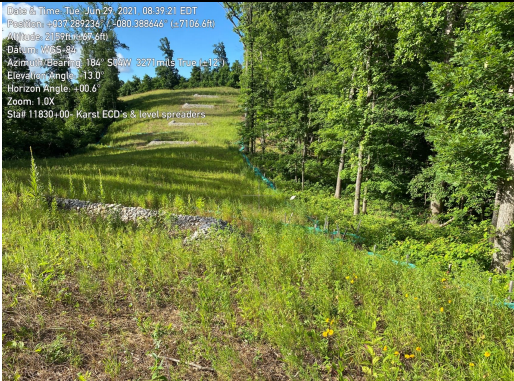
<b>GPS Location</b>	See photo GPS	<b>GPS Location</b>	See photo GPS		
<b>Field Station#</b>	11830+00	<b>Field Station#</b>	11857+00		
<b>Pic 3 Desc.</b>	Karst ECD's and level spreaders.	<b>Pic 4 Desc.</b>	Level spreaders on slope, CFS controls.		
<p>Date &amp; Time: Tue Jun 29, 2021 09:05:16 EDT  Position: +037.282694 / -080.348286 (+102.9ft)  Altitude: 2187ft (+54.9ft)  Datum: WGS 84  Azimuth/Bearing: 024.126E 0462mils True (+12.1)  Elevation Angle: -15.4  Horizon Angle: +00.1  Zoom: 1.0X  Station: 11864+00 - Wetland has dried up</p>

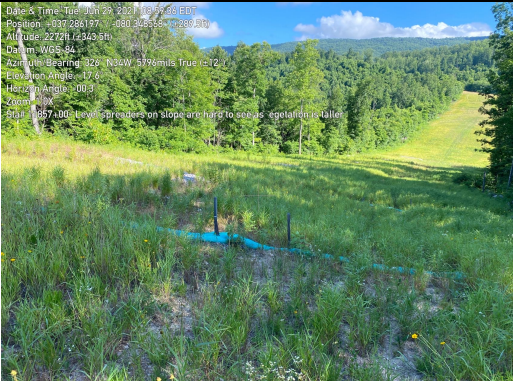
<p>Date &amp; Time: Tue Jun 29, 2021 08:39:01 EDT  Position: +037.286177 / -080.368554 (+230.0ft)  Altitude: 2272ft (+74.5ft)  Datum: WGS 84  Azimuth/Bearing: 326.183W 3196mils True (+2.2)  Elevation Angle: -17.6  Horizon Angle: -00.3  Zoom: 1.0X  Station: 11857+00 - Level spreaders on slope are hard to see as vegetation is taller</p>

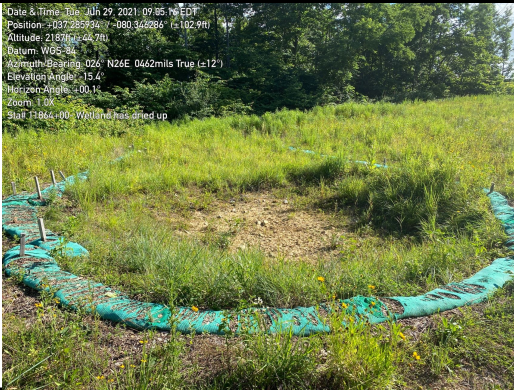
<b>Field Station#</b>	11864+00	<b>Field Station#</b>	11900+00		
<b>Pic 5 Desc.</b>	Wetland has dried up.	<b>Pic 6 Desc.</b>	AR-266.03

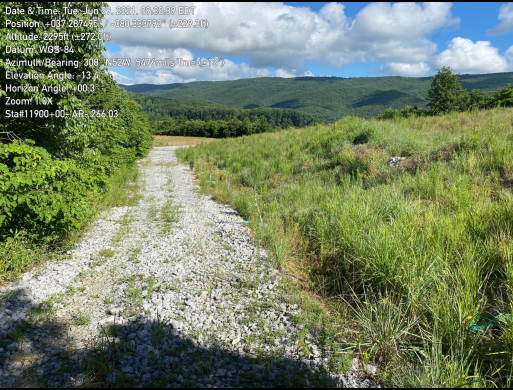
<p>Date &amp; Time: Tue Jun 29, 2021 09:06:09 EDT  Position: +037.282694 / -080.348286 (+102.9ft)  Altitude: 2255ft (+77.2ft)  Datum: WGS 84  Azimuth/Bearing: 308.426W 3006mils True (+10.1)  Elevation Angle: -13.4  Horizon Angle: +00.3  Zoom: 1.0X  Station: 11900+00 - AR-266.03</p>

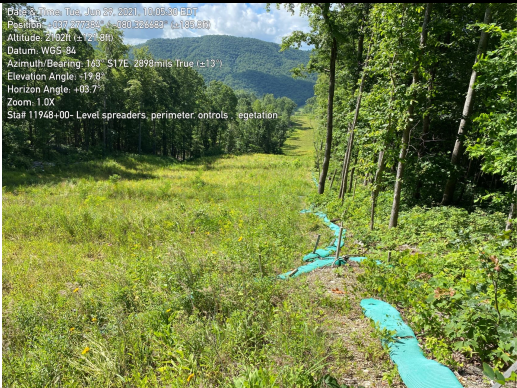
<p>Date &amp; Time: Tue, Jun 29, 2021, 10:05:00 EDT Position: -037.289711° / -880.328991° (-200.9ft) Altitude: 2324ft (-272.5ft) Datum: WGS-84 Azimuth/Bearing: 143° S17E 2878mils True (±13°) Elevation Angle: -19.8° Horizon Angle: -03.7° Zoom: 1.0X Staff 11948+00- Level spreaders, perimeter controls, vegetation.</p>			
<b>GPS Location</b>	See photo GPS		<b>GPS Location</b>	See photo GPS	
<b>Field Station#</b>	11942+00		<b>Field Station#</b>	11948+00	
<b>Pic 9 Desc.</b>	Karst ECD's.		<b>Pic 10 Desc.</b>	Level spreaders, perimeter controls,vegetation.

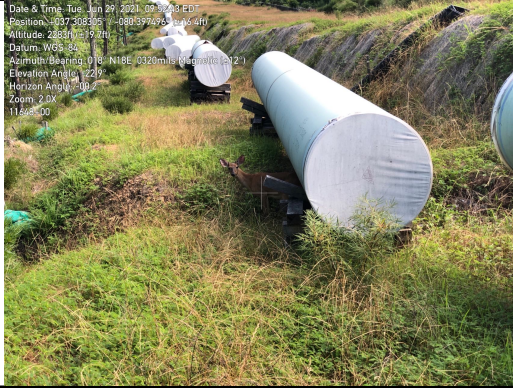
GPS Location		On photo		GPS Location	
Field Station#		11649+00		Field Station#	
Pic 5 Desc.		ECDs in place, effective.		Pic 6 Desc.	
				ROW stable. Deer laying in shade of pipe.

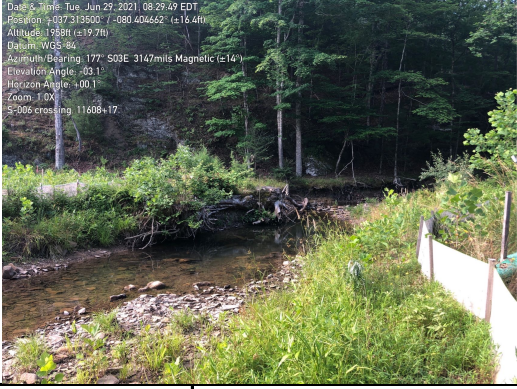
<b>GPS Location</b>	On photo	<b>GPS Location</b>	On photo		
<b>Field Station#</b>	11614+20	<b>Field Station#</b>	11608+17		
<b>Pic 9 Desc.</b>	The S-RR14 crossing is stable. No impact.	<b>Pic 10 Desc.</b>	The S-006 crossing is stable. No impact.		
Insert image here		Insert image here			
<b>GPS Location</b>		<b>GPS Location</b>			
<b>Field Station#</b>		<b>Field Station#</b>			
<b>Pic 11 Desc.</b>		<b>Pic 12 Desc.</b>

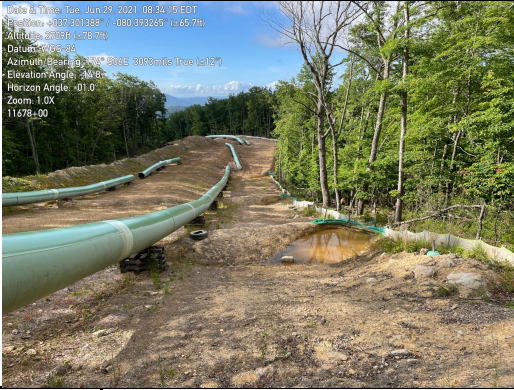
<p>Date &amp; Time: Tue, Jun 29, 2021, 08:24:16 EDT Position: +037.297833° / -080.393244° (+65.7m) Altitude: 2456ft (+72.7m) Datum: WGS-84 Azimuth/Bearing: 294° N44W 5227mils True (+12°) Elevation Angle: -02.2° Horizon Angle: -00.6° Zoom: 1.0X 11678+00</p>

<p>Date &amp; Time: Tue, Jun 29, 2021, 08:47:55 EDT Position: +037.297833° / -080.391024° (+67.2m) Altitude: 2456ft (+72.7m) Datum: WGS-84 Azimuth/Bearing: 294° N44W 5227mils True (+12°) Elevation Angle: -02.2° Horizon Angle: -00.6° Zoom: 1.0X 11687+93</p>			
<b>GPS Location</b>	See photo	<b>GPS Location</b>	See photo		
<b>Field Station#</b>	11678+00	<b>Field Station#</b>	11687+93		
<b>Pic 1 Desc.</b>	End treatments in place	<b>Pic 2 Desc.</b>	Stream buffer in place

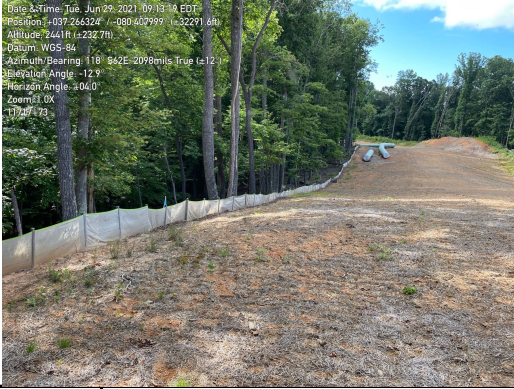
<p>Date &amp; Time: Tue, Jun 29, 2021, 09:13:14 EDT Position: +037.264324° / -080.402999° (+32291.6ft) Altitude: 2441ft (+232.7m) Datum: WGS-84 Azimuth/Bearing: 119° S42E 2098mils True (+12°) Elevation Angle: -12.9° Horizon Angle: -04.0° Zoom: 1.0X 11717+73</p>

<b>GPS Location</b>	See photo	<b>GPS Location</b>	See photo		
<b>Field Station#</b>	11717+73	<b>Field Station#</b>	11735+00		
<b>Pic 3 Desc.</b>	P1 silt fence perimeter control in place	<b>Pic 4 Desc.</b>	Waterbars in place

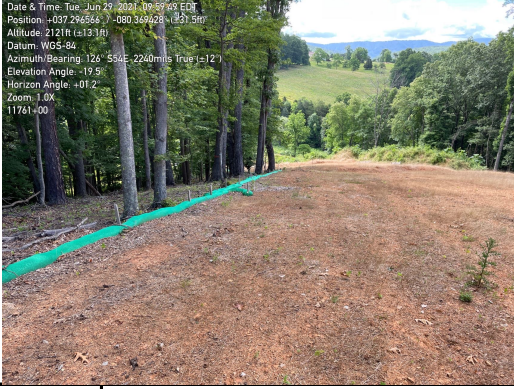
<p>Date &amp; Time: Tue, Jun 29, 2021, 10:57:49 EDT Position: +037.236564° / -080.349428° (+31.5m) Altitude: 2121ft (+64.3m) Datum: WGS-84 Azimuth/Bearing: 126° S54E 2240mils True (+12°) Elevation Angle: -19.5° Horizon Angle: -01.2° Zoom: 1.0X 11761+00</p>

<p>Date &amp; Time: Tue, Jun 29, 2021, 10:05:07 EDT Position: +037.342771° / -080.346850° (+49.8m) Altitude: 1856ft (+56.6m) Datum: WGS-84 Azimuth/Bearing: 063° N43E 1120mils True (+12°) Elevation Angle: -09.9° Horizon Angle: -01.4° Zoom: 1.0X 11766+76</p>			
<b>GPS Location</b>	See photo	<b>GPS Location</b>	See photo		
<b>Field Station#</b>	11761+00	<b>Field Station#</b>	11766+76		
<b>Pic 5 Desc.</b>	CFS perimeter control in place	<b>Pic 6 Desc.</b>	RCE in place

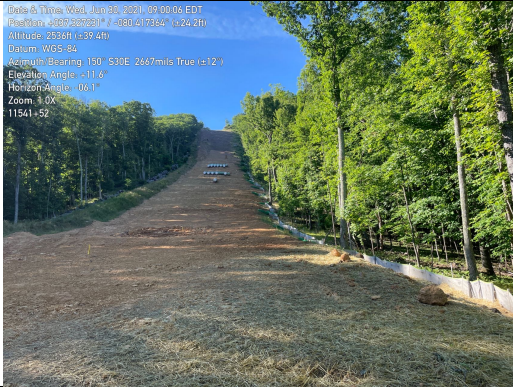
<p>Date &amp; Time: Wed Jun 30, 2021, 08:39:34 EDT Position: -027.329497° / -080.426893° (-150.91) Altitude: 2389ft (-157.5m) Datum: WGS-84 Azimuth/Bearing: 201° S21W 3573mils True (-12°) Elevation Angle: -09.8° Horizon Angle: -03.6° Zoom: 1.0X 11527+13</p>

<p>Date &amp; Time: Wed Jun 30, 2021, 09:00:06 EDT Position: -027.329497° / -080.426893° (-150.91) Altitude: 2389ft (-157.5m) Datum: WGS-84 Azimuth/Bearing: 150° S30E 2667mils True (-12°) Elevation Angle: -11.0° Horizon Angle: -06.1° Zoom: 1.0X 11541+52</p>		<b>GPS Location</b>	See photo
<b>Field Station#</b>	11527+13	<b>Field Station#</b>	11541+52	<b>GPS Location</b>	See photo
<b>Pic 1 Desc.</b>	Clean water drainage feature in place	<b>Pic 2 Desc.</b>	End treatments on hill in place

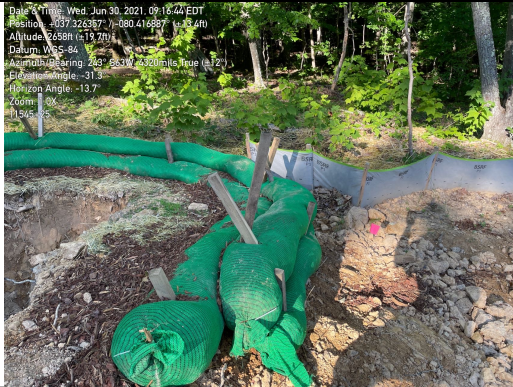
<p>Date &amp; Time: Wed Jun 30, 2021, 09:39:19 EDT Position: -009.324437° / -080.412087° (-114.6) Altitude: 2798ft (-19.7m) Datum: WGS-84 Azimuth/Bearing: 205° S25W 3644mils True (-12°) Elevation Angle: -22.2° Horizon Angle: -1.7° Zoom: 1.0X 11549+00</p>

<b>Field Station#</b>	11549+00	<b>Field Station#</b>	11545+25	<b>GPS Location</b>	See photo
<b>Pic 3 Desc.</b>	Sump needs maintenance	<b>Pic 4 Desc.</b>	P1 perimeter control needs adjusted to allow water to drain off ROW

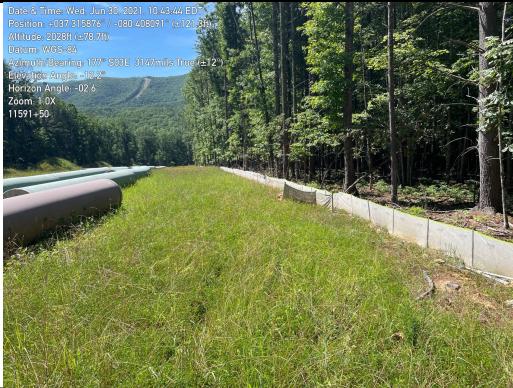
<p>Date &amp; Time: Wed Jun 30, 2021, 10:09:05 EDT Position: -009.324437° / -080.412087° (-114.6) Altitude: 2798ft (-19.7m) Datum: WGS-84 Azimuth/Bearing: 157° S30E 2797mils True (-12°) Elevation Angle: -18.4° Horizon Angle: -00.0° Zoom: 1.0X 11561+00</p>

<p>Date &amp; Time: Wed Jun 30, 2021, 10:09:05 EDT Position: -009.324437° / -080.412087° (-114.6) Altitude: 2798ft (-19.7m) Datum: WGS-84 Azimuth/Bearing: 157° S30E 2797mils True (-12°) Elevation Angle: -18.4° Horizon Angle: -02.6° Zoom: 1.0X 11591+50</p>		<b>GPS Location</b>	See photo
<b>Field Station#</b>	11561+00	<b>Field Station#</b>	11591+50	<b>GPS Location</b>	See photo
<b>Pic 5 Desc.</b>	Waterbars in place	<b>Pic 6 Desc.</b>	P1 silt fence perimeter control in place

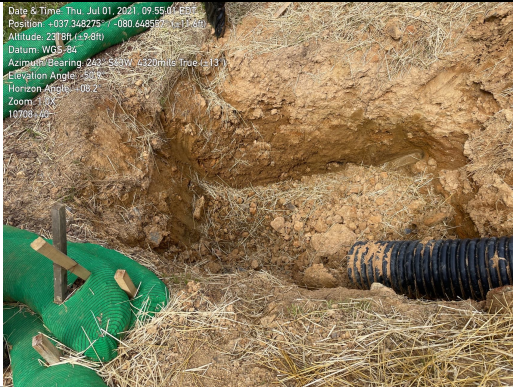
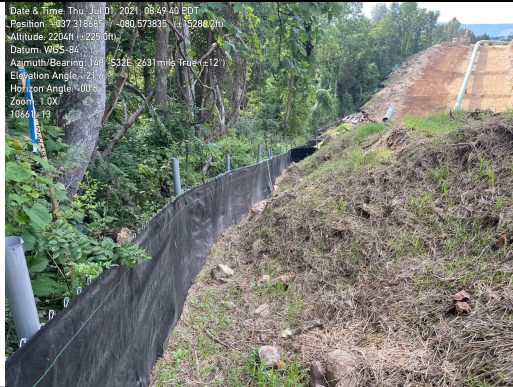
GPS Location		See photo		GPS Location	
Field Station#		10708+40		Field Station#	
Pic 3 Desc.		Add rock to sump pit		Pic 4 Desc.	
				Supersilt fence perimeter control in place

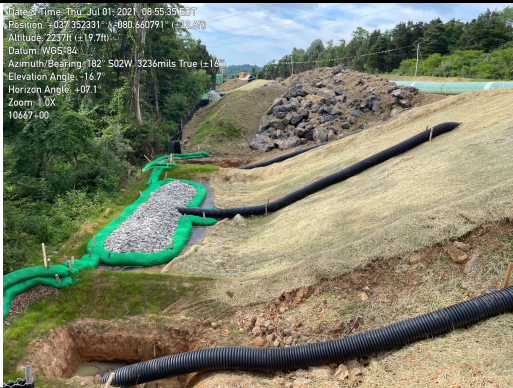
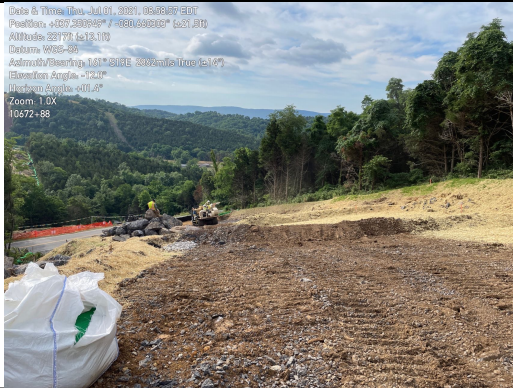
GPS Location		See photo		GPS Location	
Field Station#		10667+00		Field Station#	
Pic 5 Desc.		Clean water outlet protection in place		Pic 6 Desc.	
				Environmental crew stabilizing with mulching morooka

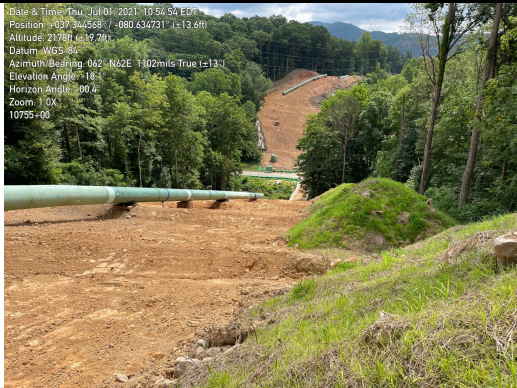
<b>GPS Location</b>		See photo		<b>GPS Location</b>	
<b>Field Station#</b>		10755+00		<b>Field Station#</b>	
<b>Pic 9 Desc.</b>		Waterbars in place		<b>Pic 10 Desc.</b>	
				Stream buffer in place	
<p>Date &amp; Time: Thu, Jul 01, 2021, 12:00:12 EDT  Position: +037.342402 / -080.621510 (+13.3ft)  Altitude: 1917ft (+39.4ft)  Datum: WGS-84  Azimuth/Bearing: 084.1° N86E 1529mils True (+13°)  Elevation Angle: +08.4°  Horizon Angle: +00.7°  Zoom: 1.0X  10798+00</p>

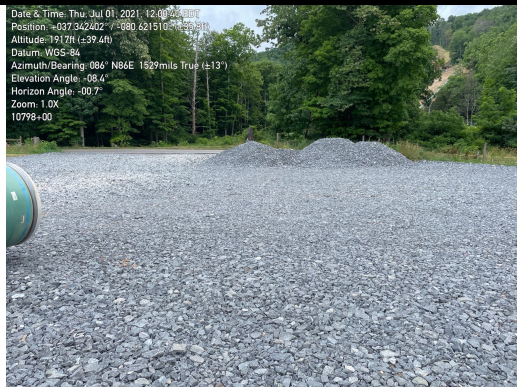
<b>GPS Location</b>		See photo		<b>GPS Location</b>	
<b>Field Station#</b>		10798+00		<b>Field Station#</b>	
<b>Pic 11 Desc.</b>		RCE in place		<b>Pic 12 Desc.</b>

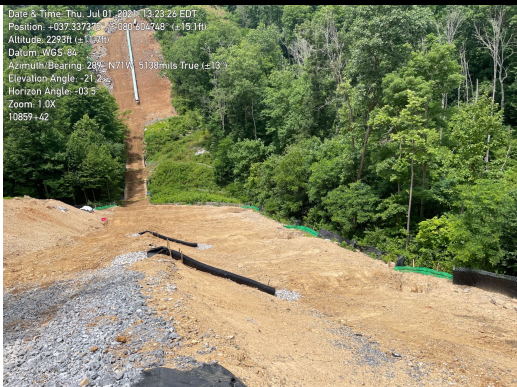
<p>Date &amp; Time: Thu, Jul 01, 2021, 12:23:25 EDT  Position: +037.337272 / -080.627487 (+15.1ft)  Altitude: 2293ft (+11.0ft)  Datum: WGS-84  Azimuth/Bearing: 285.1° N71W 5138mils True (+13°)  Elevation Angle: +21.5°  Horizon Angle: +03.5°  Zoom: 1.0X  10859+42</p>

Slope drains in place

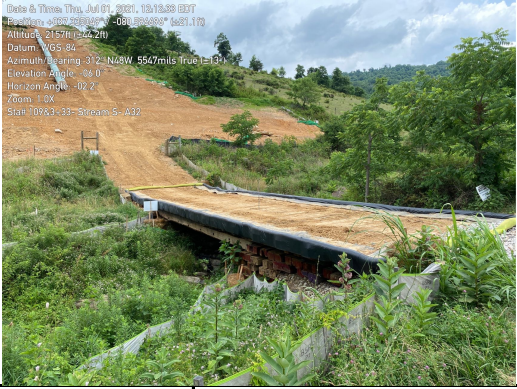
<p><small>Date &amp; Time: Thu Jul 01, 2021, 11:22:57 EDT Position: -037°31'24.01" / -980.546399 / 539.7m Altitude: 2179ft (664.1m) Datum: WGS-84 Azimuth/Bearing: 112° S68E 1991mils True (±13°) Elevation Angle: +16.2° Horizon Angle: +00.3° Zoom: 1.0X Sta# 11057+00- Karst ECD's</small></p>

<p><small>Date &amp; Time: Thu Jul 01, 2021, 15:15:55 EDT Position: -037°33'55.92" / -980.534558 / 631.1m Altitude: 2157ft (657.2m) Datum: WGS-84 Azimuth/Bearing: 312° N28W 5567mils True (±13°) Elevation Angle: +4.0° Horizon Angle: +02.2° Zoom: 1.0X Sta# 10883+33- Stream S- A32</small></p>			
<b>GPS Location</b>	See photo GPS	<b>GPS Location</b>	See photo GPS		
<b>Field Station#</b>	12057+00	<b>Field Station#</b>	10883+33		
<b>Pic 13 Desc.</b>	Karst ECD's	<b>Pic 14 Desc.</b>	Stream S- A32, equipment bridge and ECD's.

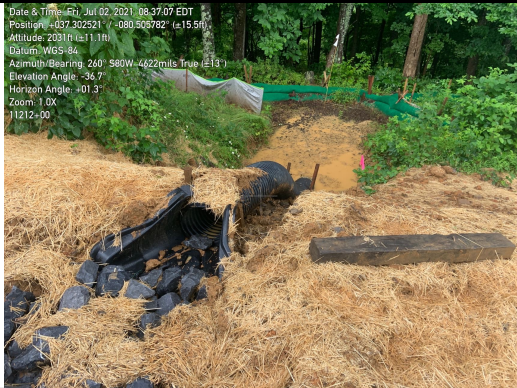
<b>GPS Location</b>	See photo	<b>GPS Location</b>	See photo		
<b>Field Station#</b>	11212+00	<b>Field Station#</b>	11215+00		
<b>Pic 9 Desc.</b>	Subsoil needs replaced around slope drain inlet	<b>Pic 10 Desc.</b>	Area behind Sump and perimeter controls needs stabilization added after rain event

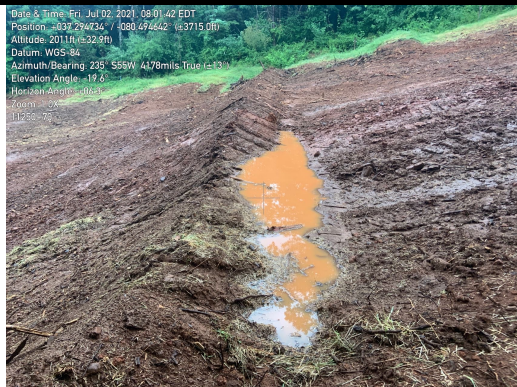
<p>Date &amp; Time: Fri, Jul 02, 2021, 08:01:42 EDT Position: +037.294234, -080.494442 (+371.5ft) Altitude: 2011ft (+612.9ft) Datum: WGS-84 Azimuth Bearing: 295.555W 4178mils True (+53.1) Elevation Angle: +18.6 Horizon Angle: +00.8 Zoom: 1.0X 11250+70</p>

<b>Pic 11 Desc.</b>	Water bars needs maintenance	<b>Pic 12 Desc.</b>	Sump pit, CFS and SSF functioning properly

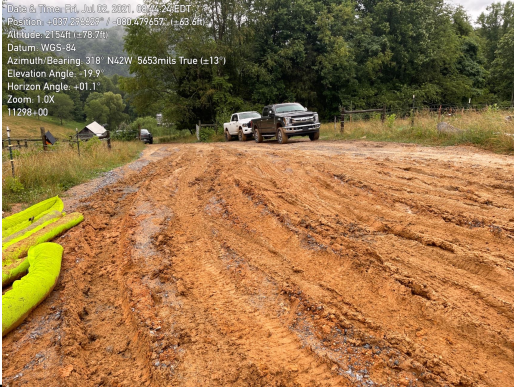
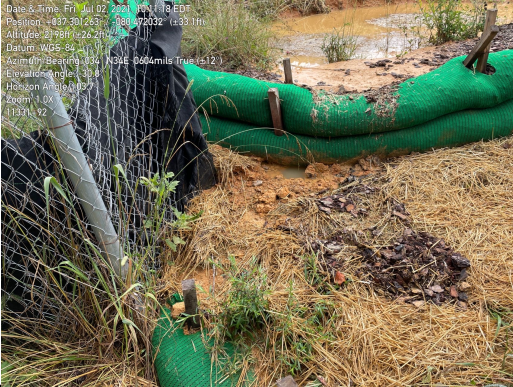
<b>GPS Location</b>	See photo	<b>GPS Location</b>	See photo		
<b>Field Station#</b>	11298+00	<b>Field Station#</b>	11331+92		
<b>Pic 3 Desc.</b>	RCE needs maintenance	<b>Pic 4 Desc.</b>	CFS end treatment undermined

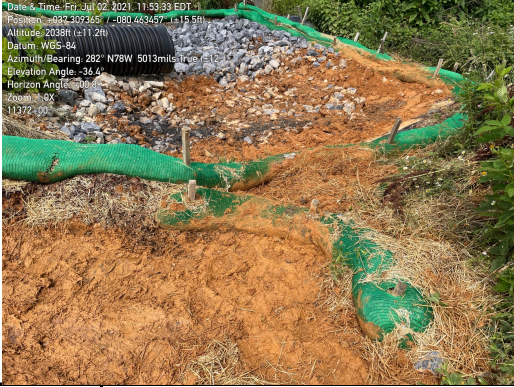
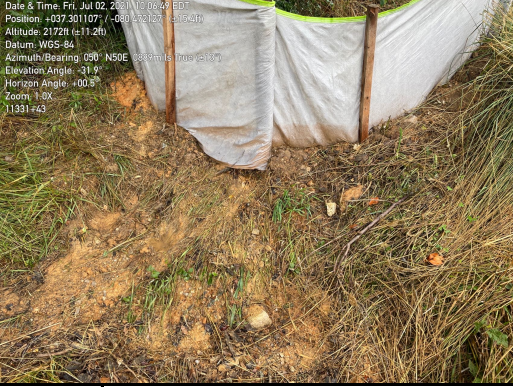
<b>GPS Location</b>	See photo	<b>GPS Location</b>	See photo		
<b>Field Station#</b>	11372+00	<b>Field Station#</b>	11331+43		
<b>Pic 5 Desc.</b>	Plunge pool needs maintenance	<b>Pic 6 Desc.</b>	P1 silt fence undermined

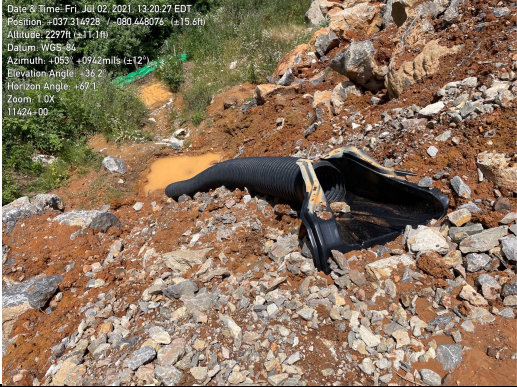
<b>GPS Location</b>		See photo		<b>GPS Location</b>	
<b>Field Station#</b>		11424+00		<b>Field Station#</b>	
<b>Pic 7 Desc.</b>		Slope drain needs to be properly installed		<b>Pic 8 Desc.</b>	
<p>Date &amp; Time: Fri, Jul 02, 2021, 14:17:13 EDT  Position: +037.319959° / -080.47167° (±27.9ft)  Altitude: 2020ft (±24.4ft)  Datum: WGS-84  Azimuth: 110° -230mils True (±10°)  Elevation Angle: +0.9°  Horizon Angle: +71.6°  Zoom: 1.0X  11463+75</p>

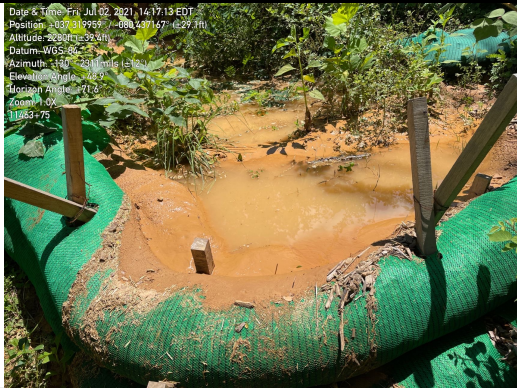
<b>GPS Location</b>		See photo		<b>GPS Location</b>	
<b>Field Station#</b>		11463+75		<b>Field Station#</b>	
<b>Pic 9 Desc.</b>		Sediment needs cleaned of CFS		<b>Pic 10 Desc.</b>	
<p>Date &amp; Time: Fri, Jul 02, 2021, 12:29:01 EDT  Position: +037.310284° / -080.455521° (±15.5ft)  Altitude: 2175ft (±11.2ft)  Datum: WGS-84  Azimuth: Bearing: 020° N20E 1030mils True (±12°)  Elevation Angle: +0.1°  Horizon Angle: +01.5°  Zoom: 1.0X  11392+30</p>

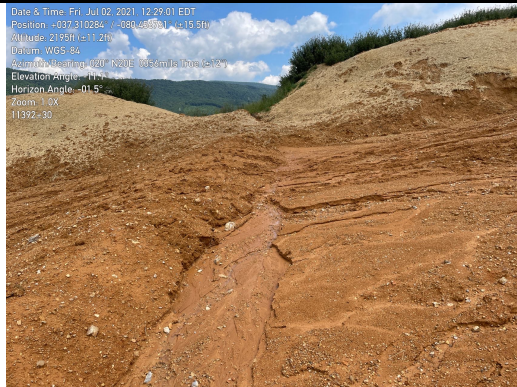
<b>GPS Location</b>		See photo		<b>GPS Location</b>	
<b>Field Station#</b>		11392+30		<b>Field Station#</b>	
<b>Pic 11 Desc.</b>		Waterbar needs maintenance		<b>Pic 12 Desc.</b>

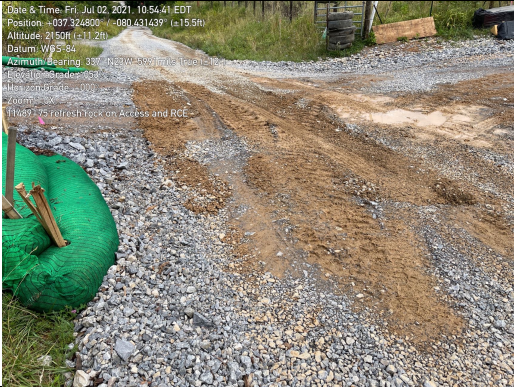
<b>GPS Location</b>	1	<b>GPS Location</b>	2		
<b>Field Station#</b>	11489+75	<b>Field Station#</b>	11496+00		
<b>Pic 1 Desc.</b>	Refresh rock on Stevers Gap crossing.		<b>Pic 2 Desc.</b>	Repair waterbar.

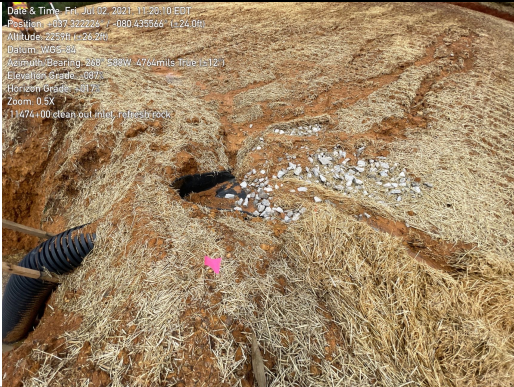
<b>GPS Location</b>	3	<b>GPS Location</b>	4		
<b>Field Station#</b>	11474+00	<b>Field Station#</b>	11472+00		
<b>Pic 3 Desc.</b>	Clean out inlet and refresh rock.		<b>Pic 4 Desc.</b>	Install erosion control blanket to spec.

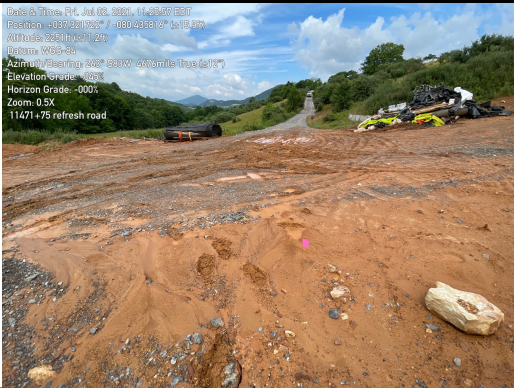
<b>GPS Location</b>	5	<b>GPS Location</b>	6		
<b>Field Station#</b>	11471+75	<b>Field Station#</b>	11471+80		
<b>Pic 5 Desc.</b>	Refresh rock on RCE and Steele Acres crossing.		<b>Pic 6 Desc.</b>	Repair CFS check.
