Visual Site Inspection Report

Project Name	H-600 Pipeline Spread G	AFE	124300137	Spread	H-600 Pipeline Spread G
Contractor	Precision			Report #	25747
Inspector	Len Kruizenga			Date/Time	7/12/2021 10:12 AM
Permit #	TBD	Inspection Type	VA SWPP	Station Begin	12005+00
State	VA	Inspection Area	Full	Station End	12005+00
County	Giles	Ground	Dry	Temperature (°F)	71.00
Municipality	N/A	Weather	Sunny	Rain Gauge (in)	0.30
				Rain Accumulation Time (days)	1.00

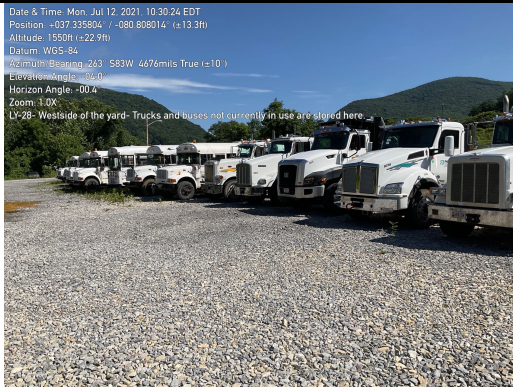
<p>Date & Time: Mon, Jul 12, 2021, 10:30:24 EDT Position: +037.335804 / -080.808014 (±13.3ft) Altitude: 1550ft (±22.9ft) Datum: WGS-84 Azimuth/Bearing: 263.581W 467°mils True (±10°) Elevation Angle: -6.0° Horizon Angle: -00.4° Zoom: 1.0X LY-28: Westside of the yard- Trucks and buses not currently in use are parked here.</p>					
GPS Location		See photo GPS		GPS Location		See photo GPS	
Field Station#		12005+00		Field Station#		12005+00	
Pic 1 Desc.		LY-28- West side of the yard- RCE		Pic 2 Desc.		LY-28, west side of the yard- Trucks and buses not currently in use are parked here.

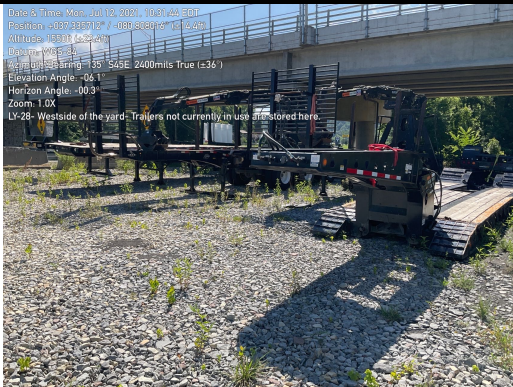
<p>Date & Time: Mon, Jul 12, 2021, 10:41:45 EDT Position: +037.334553 / -080.809361 (±27.9ft) Altitude: 1537ft (±35.1ft) Datum: WGS-84 Azimuth/Bearing: 103.545E 240°mils True (±36°) Elevation Angle: -06.1° Horizon Angle: -00.3° Zoom: 1.0X LY-28: Westside of the yard- Trailers not currently in use are stored here.</p>

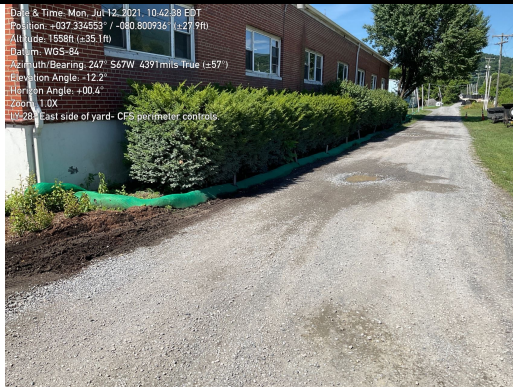
<p>Date & Time: Mon, Jul 12, 2021, 10:42:38 EDT Position: +037.334553 / -080.809361 (±27.9ft) Altitude: 1558ft (±35.1ft) Datum: WGS-84 Azimuth/Bearing: 247.567W 439°mils True (±57°) Elevation Angle: -12.2° Horizon Angle: -00.4° Zoom: 1.0X LY-28: East side of yard- CFS perimeter controls.</p>					
GPS Location		See photo GPS		GPS Location		See photo GPS	
Field Station#		12005+00		Field Station#		12005+00	
Pic 3 Desc.		LY-28, west side of the yard- trailers not currently in use are stored here.		Pic 4 Desc.		LY-28- Eastside, CFS perimeter controls.

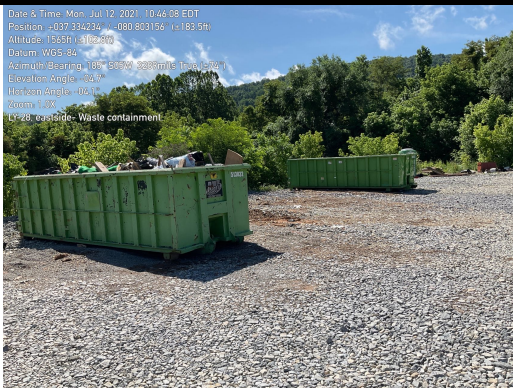
<p>Date & Time: Mon, Jul 12, 2021, 10:46:38 EDT Position: +037.334234 / -080.801156 (±183.5ft) Altitude: 1568ft (±24.8ft) Datum: WGS-84 Azimuth/Bearing: 181.501W 321°mils True (±63°) Elevation Angle: -05.2° Horizon Angle: -01.2° Zoom: 1.0X LY-28: eastside- Waste containment.</p>

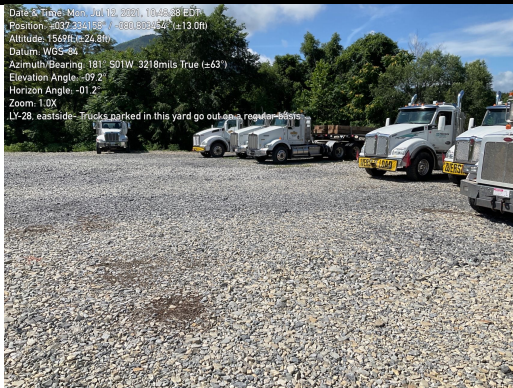
<p>Date & Time: Mon, Jul 12, 2021, 10:48:38 EDT Position: +037.334234 / -080.801156 (±183.5ft) Altitude: 1568ft (±24.8ft) Datum: WGS-84 Azimuth/Bearing: 181.501W 321°mils True (±63°) Elevation Angle: -05.2° Horizon Angle: -01.2° Zoom: 1.0X LY-28: eastside- Trucks parked in this yard go out on a regular basis.</p>

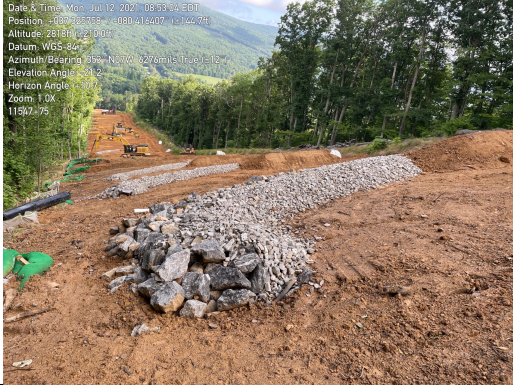
GPS Location				See photo				GPS Location				See photo			
Field Station#				11547+75				Field Station#				11545+00			
Pic 1 Desc.				Permanent waterbars installed				Pic 2 Desc.				Clean-up crew filling in sump pits

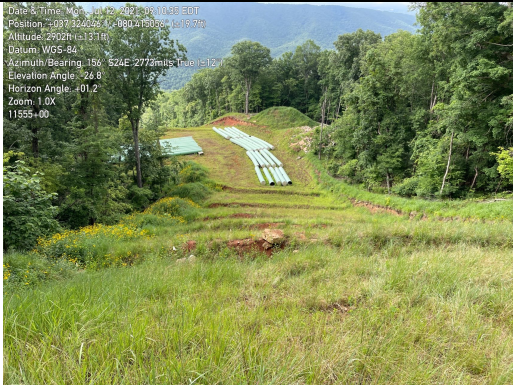
GPS Location				See photo				GPS Location				See photo			
Field Station#				11555+00				Field Station#				11584+02			
Pic 3 Desc.				Waterbars in place				Pic 4 Desc.				P1 silt fence no longer filtering needs replaced

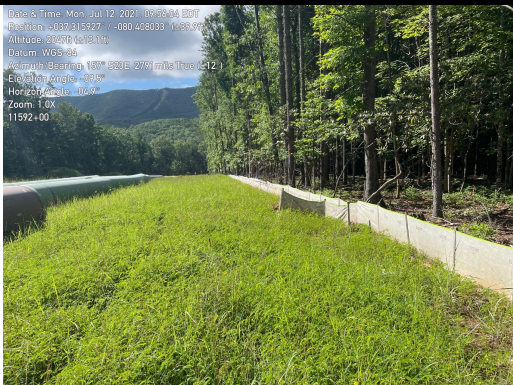
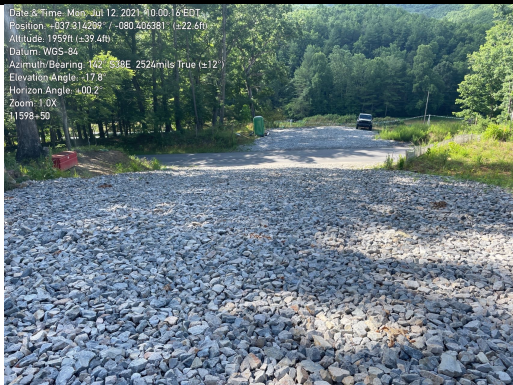
GPS Location				See photo				GPS Location				See photo			
Field Station#				11592+00				Field Station#				11598+50			
Pic 5 Desc.				P1 silt fence perimeter control in place				Pic 6 Desc.				RCE in place

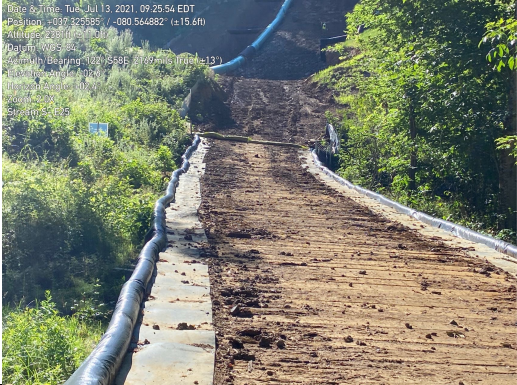
GPS Location	See photo GPS		GPS Location	See photo GPS	
Field Station#	10986+00		Field Station#	11012+00	
Pic 7 Desc.	Stream S-E25		Pic 8 Desc.	Water bars have been removed for equipment travel.

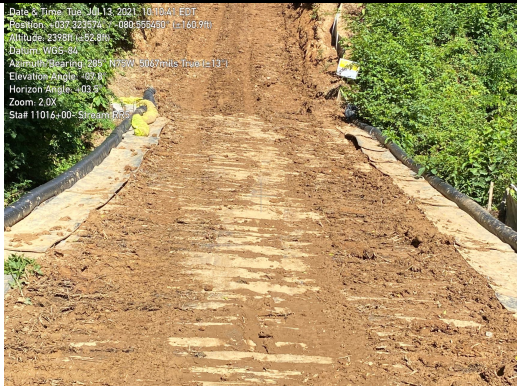
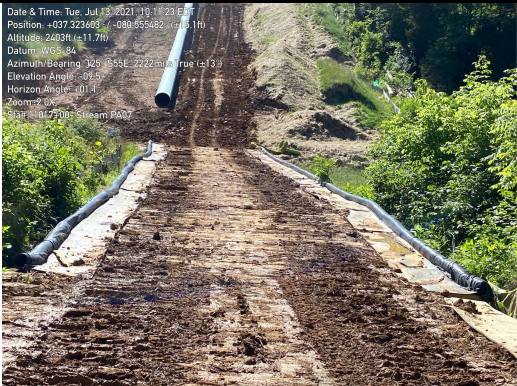
GPS Location	See photo GPS		GPS Location	See photo GPS	
Field Station#	11016+00		Field Station#	11017+00	
Pic 9 Desc.	Stream S-RR5		Pic 10 Desc.	Stream S-PA07

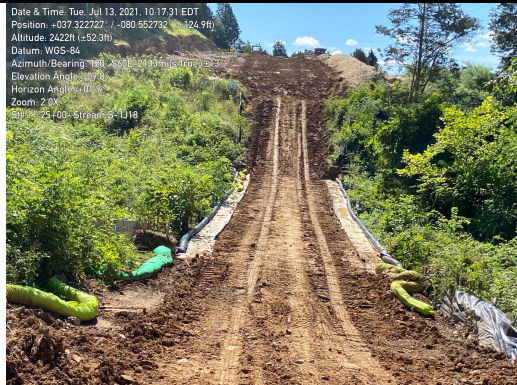
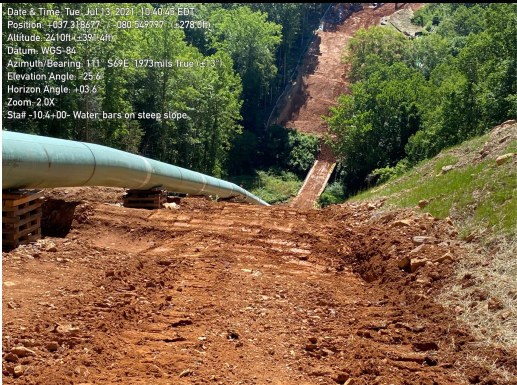
GPS Location	See photo GPS		GPS Location	See photo GPS	
Field Station#	11025+00		Field Station#	11044+00	
Pic 11 Desc.	Stream S- IJ18		Pic 12 Desc.	Class a slope, water bars have been stabilized.

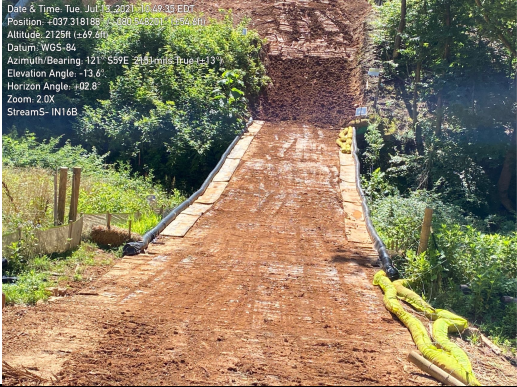
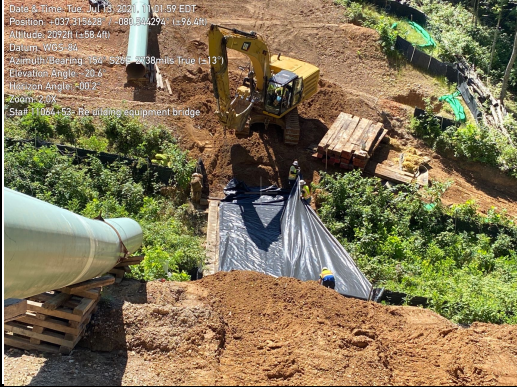
<p><small>Date & Time: Tue, Jul 13, 2021, 11:59:00 EDT Position: +037.318287 / -080.597029 (+13.31) Altitude: 2022ft (+616m) Datum: WGS-84 Azimuth/Bearing: 121° S99E 261mils True (+13°) Elevation Angle: +12.6° Horizon Angle: +02.8° Zoom: 2.0X StreamS- IJ16B</small></p>			
GPS Location	See photo GPS	GPS Location	See photo GPS		
Field Station#	11049+50	Field Station#	11064+53		
Pic 13 Desc.	Stream S-IJ16B	Pic 14 Desc.	Rebuilding equipment bridge

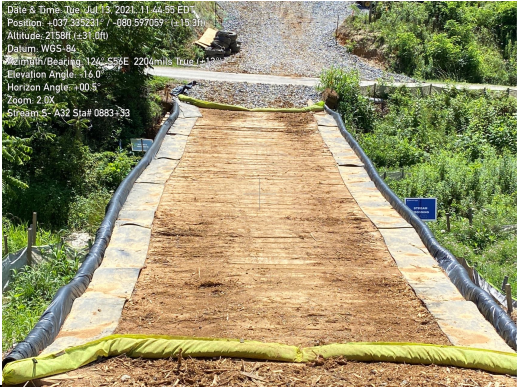
<p><small>Date & Time: Tue, Jul 13, 2021, 11:44:59 EDT Position: +037.328231 / -080.597029 (+13.31) Altitude: 2150ft (+655m) Datum: WGS-84 Azimuth/Bearing: 121° S99E 220mils True (+13°) Elevation Angle: +16.0° Horizon Angle: +00.5° Zoom: 2.0X StreamS- A32 Sta# 0883+33</small></p>

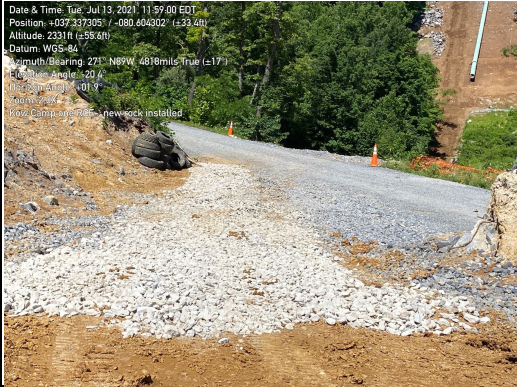
<p><small>Date & Time: Tue, Jul 13, 2021, 11:59:00 EDT Position: +037.337325 / -080.604002 (+13.33) Altitude: 2331ft (+710m) Datum: WGS-84 Azimuth/Bearing: 271° N89W 481mils True (+17°) Elevation Angle: +20.4° Horizon Angle: +01.3° Zoom: 2.0X Kow Camp one- new rock installed</small></p>

GPS Location	See photo GPS	GPS Location	See photo GPS		
Field Station#	10883+00	Field Station#	10859+00		
Pic 15 Desc.	Stream S-A32	Pic 16 Desc.	Kow Camp one- Added fresh rock to the RCE.		
Insert image here		Insert image here			
GPS Location		GPS Location			
Field Station#		Field Station#			
Pic 17 Desc.		Pic 18 Desc.

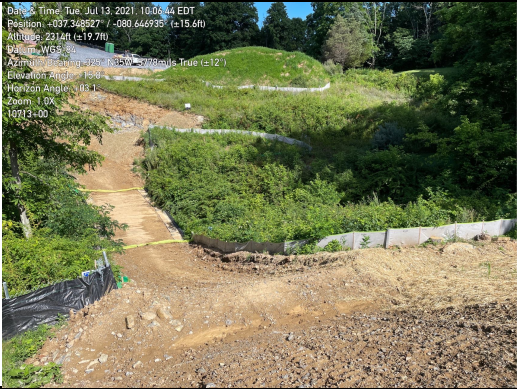
<p>Date & Time: Tue, Jul 13, 2021, 10:05:44 EDT Position: -037.348527° / -080.646935° (±15.6m) Altitude: 2317ft (±19.7m) Datum: WGS-84 Azimuth/Bearing: 102° S34E 2347mils True (±13.1°) Elevation Angle: -22.0° Horizon Angle: -01.1° Zoom: 1.0X 10713+00</p>

<p>Date & Time: Tue, Jul 13, 2021, 10:28:16 EDT Position: -037.348946° / -080.642733° (±18.8m) Altitude: 2357ft (±26.2ft) Datum: WGS-84 Azimuth/Bearing: 102° S34E 2347mils True (±13.1°) Elevation Angle: -22.0° Horizon Angle: -01.8° Zoom: 1.0X 10729+50</p>			
GPS Location	See photo	GPS Location	See photo		
Field Station#	10713+00	Field Station#	10729+50		
Pic 7 Desc.	Stream buffer in place	Pic 8 Desc.	End treatments in place

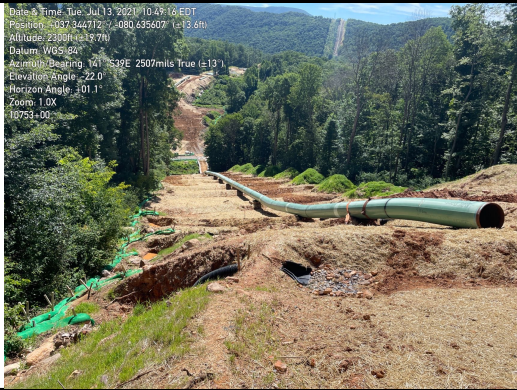
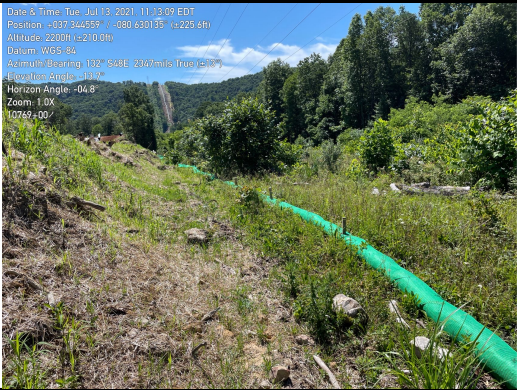
GPS Location	See photo	GPS Location	See photo		
Field Station#	10753+00	Field Station#	10769+00		
Pic 9 Desc.	Waterbars in place	Pic 10 Desc.	CFS perimeter control in place

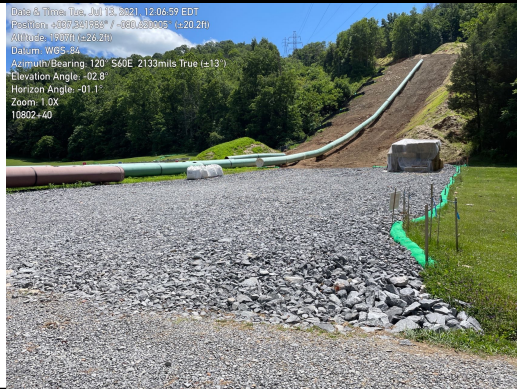
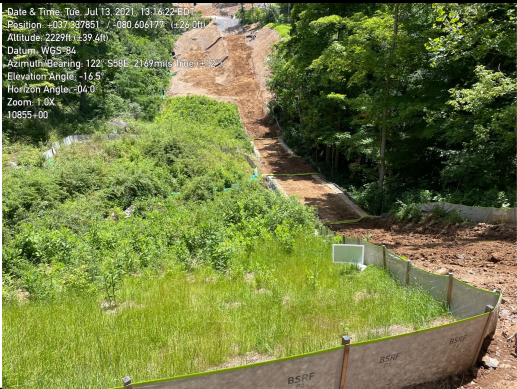
<p>Date & Time: Tue, Jul 13, 2021, 13:16:22 EDT Position: -037.337851° / -080.606177° (±26.0m) Altitude: 2229ft (±39.6m) Datum: WGS-84 Azimuth/Bearing: 122° S50E 2167mils True (±13.1°) Elevation Angle: -14.5° Horizon Angle: -04.0° Zoom: 1.0X 10855+00</p>			
GPS Location	See photo	GPS Location	See photo		
Field Station#	10802+40	Field Station#	10855+00		
Pic 11 Desc.	RCE in place	Pic 12 Desc.	Stream buffer in place

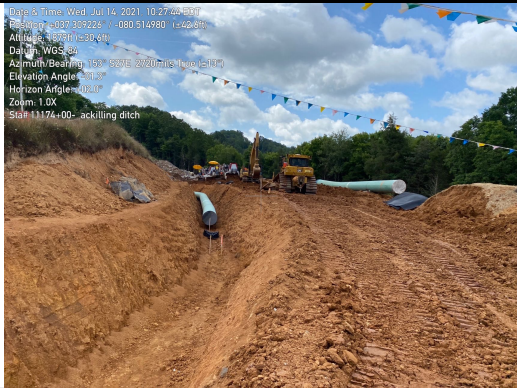
<p>Date & Time: Wed Jul 14, 2021 10:37:06 EDT Position: +037.307459 / -080.512124 (+20.9ft) Altitude: 1720ft (+52.0ft) Datum: WGS-84 Azimuth/Bearing: 183° S21W 3253mils True (+13°) Elevation Angle: +13.2° Horizon Angle: +00.1° Zoom: 1.0X Staff 11184+00 - CWD pipe & plunge pool</p>

GPS Location	See photo GPS	GPS Location	See photo GPS		
Field Station#	11174+00	Field Station#	11184+00		
Pic 9 Desc.	Backfilling pipe and ditch.	Pic 10 Desc.	CWD pipe and plunge pool.		
<p>Date & Time: Wed Jul 14, 2021 10:41:51 EDT Position: +037.306478 / -080.510161 (+19.8ft) Altitude: 1943ft (+59.2ft) Datum: WGS-84 Azimuth/Bearing: 112° S68E 1991mils True (+13°) Elevation Angle: +13.4° Horizon Angle: +01.3° Zoom: 1.0X Staff 11191+00 - Sensitive resource/drainage feature</p>  		<p>Date & Time: Wed Jul 14, 2021 11:18:25 EDT Position: +037.300821 / -080.502391 (+19.8ft) Altitude: 2037ft (+62.5ft) Datum: WGS-84 Azimuth/Bearing: 337° N23W 5991mils True (+13°) Elevation Angle: +09.3° Horizon Angle: +03.9° Zoom: 1.0X Staff 11225+00 - Rock channel</p>  			
GPS Location	See photo GPS	GPS Location	See photo GPS		
Field Station#	11191+00	Field Station#	11225+00		
Pic 11 Desc.	Sensitive resource/drainage feature and ECD's	Pic 12 Desc.	Rock channel.

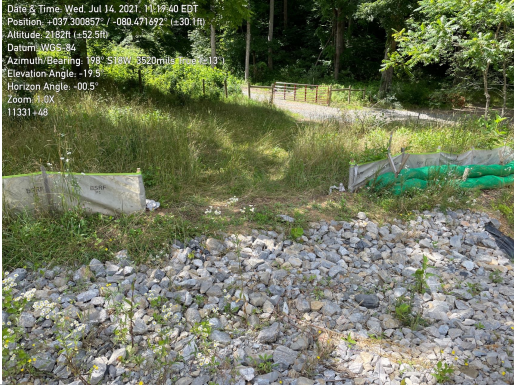
<p>Date & Time: Wed Jul 14, 2021 11:13:08 EDT Position: +037.300857° / -080.472664° (+16.9ft) Altitude: 2231ft (+26.2ft) Datum: WGS-84 Azimuth Bearing: 192° S48E 2347mils true (+13°) Elevation Angle: -60.6° Horizon Angle: +26.1° Zoom: 1.0x 11328+75</p>		GPS Location	See photo
Field Station#	11505+00	Field Station#	11328+75	GPS Location	See photo
Pic 1 Desc.	Hole in P1	Pic 2 Desc.	End treatment undermined

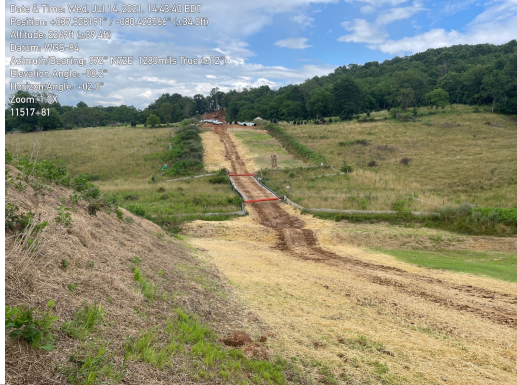
Field Station#	11331+48	Field Station#	11517+81	GPS Location	See photo
Pic 3 Desc.	P1 cut out by land owner	Pic 4 Desc.	Stream buffer in place

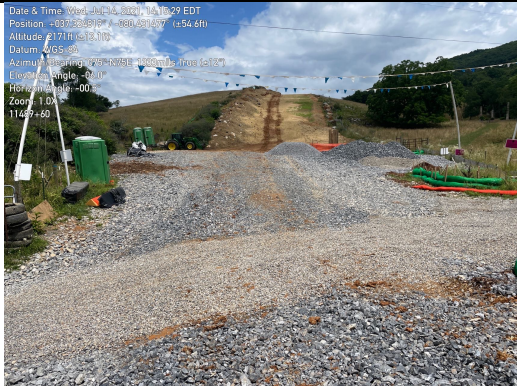
<p>Date & Time: Wed Jul 14, 2021 11:30:29 EDT Position: +037.300857° / -080.472664° (+16.9ft) Altitude: 2231ft (+26.2ft) Datum: WGS-84 Azimuth Bearing: 192° S48E 2347mils true (+13°) Elevation Angle: -60.6° Horizon Angle: +26.1° Zoom: 1.0x 11489+60</p>		GPS Location	See photo
Field Station#	11502+00	Field Station#	11489+60	GPS Location	See photo
Pic 5 Desc.	Clean water diversion berm in place	Pic 6 Desc.	RCE in place

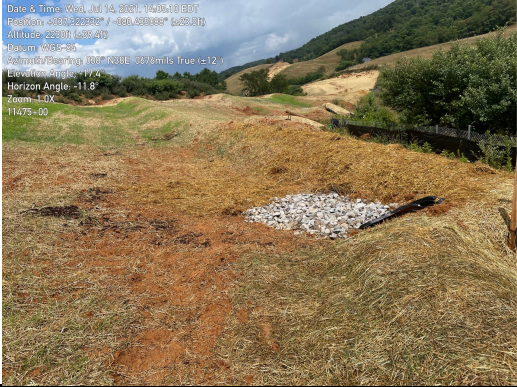
GPS Location	See photo	GPS Location	See photo		
Field Station#	11475+00	Field Station#	11444+00		
Pic 7 Desc.	Rock inlet in place	Pic 8 Desc.	CFS perimeter control in place		
<p>Date & Time: Wed Jul 14, 2021 12:42:53 EDT Position: +037.31047° / -080.44107° (±31.4ft) Altitude: 2107ft (±19.7ft) Datum: WGS-84 Azimuth/Bearing: 309° N51W 5492mils True (±12°) Elevation Angle: -24.5° Horizon Angle: -02.0° Zoom: 1.0X 11387+00</p>

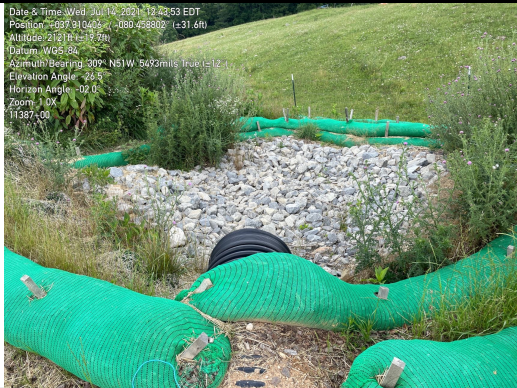
GPS Location	See photo	GPS Location	See photo		
Field Station#	11387+00	Field Station#	11375+00		
Pic 9 Desc.	Plunge pool in place	Pic 10 Desc.	Triple protection ECDs in place at karst feature		
<p>Date & Time: Wed Jul 14, 2021 12:43:22 EDT Position: +037.31676° / -080.43949° (±31.4ft) Altitude: 2032ft (±18.1ft) Datum: WGS-84 Azimuth/Bearing: 001° N01E 1029mils True (±12°) Elevation Angle: -01.6° Horizon Angle: -02.7° Zoom: 1.0X 11470+00</p>

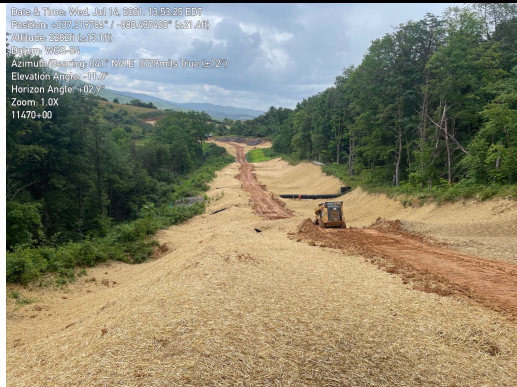
GPS Location	See photo	GPS Location	See photo		
Field Station#	11470+00	Field Station#	11328+59		
Pic 11 Desc.	All but travel lane stabilized	Pic 12 Desc.	Stream buffer in place

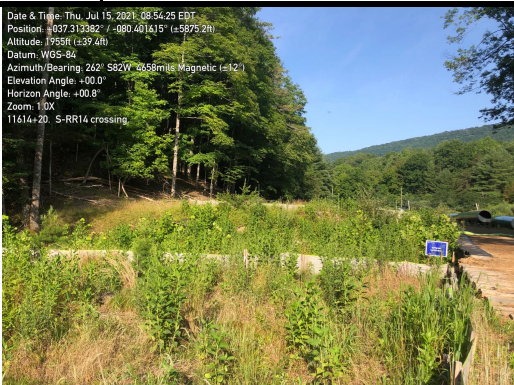
GPS Location	On photo	GPS Location	On photo		
Field Station#	11614+20	Field Station#	11608+17		
Pic 5 Desc.	The S-RR14 crossing is stable.	Pic 6 Desc.	The S-006 crossing is stable.

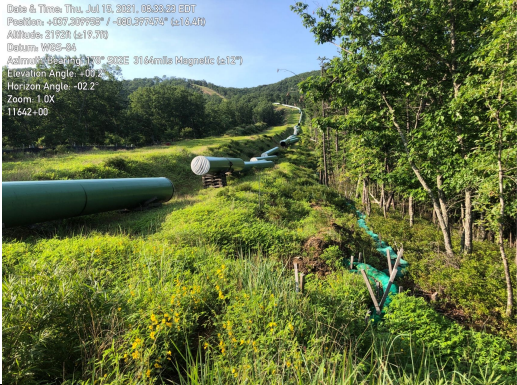
GPS Location	On photo	GPS Location	On photo		
Field Station#	11642+00	Field Station#	11667+00		
Pic 7 Desc.	ROW currently stable with ECDs in place.	Pic 8 Desc.	Slope breakers, sumps and end treatments functional.		
Insert image here		Insert image here			
GPS Location		GPS Location			
Field Station#		Field Station#			
Pic 9 Desc.		Pic 10 Desc.			
Insert image here		Insert image here			
GPS Location		GPS Location			
Field Station#		Field Station#			
Pic 11 Desc.		Pic 12 Desc.

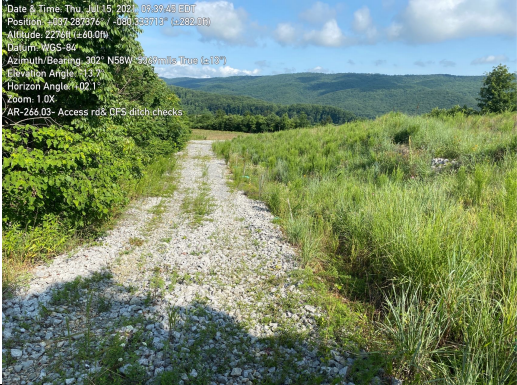
AFE	124300137	Date/Time	7/15/2021 4:50 PM	Report #	
Pictures					
<p><small>Date & Time: Thu, Jul 15, 2021, 08:56:58 EDT Position: -087.239376° / -080.188918° (-266.03) Altitude: 2272ft (-266.03) Datum: WGS-84 Azimuth/Bearing: 302° N58W 531mils True (-13°) Elevation Angle: -13° Horizon Angle: -02.1° Zoom: 1.0X Staff 11933+00: Access rd& GPS ditch checks</small></p>

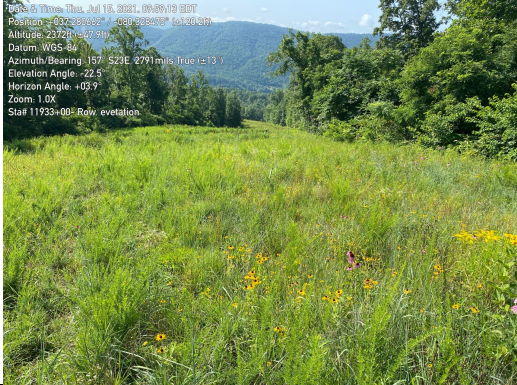
<p><small>Date & Time: Thu, Jul 15, 2021, 08:59:18 EDT Position: -087.238822° / -080.188822° (-266.03) Altitude: 2372ft (-266.03) Datum: WGS-84 Azimuth/Bearing: 157° S21E 2791mils True (-13°) Elevation Angle: -22.5° Horizon Angle: -03.9° Zoom: 1.0X Staff 11933+00: Row vegetation</small></p>

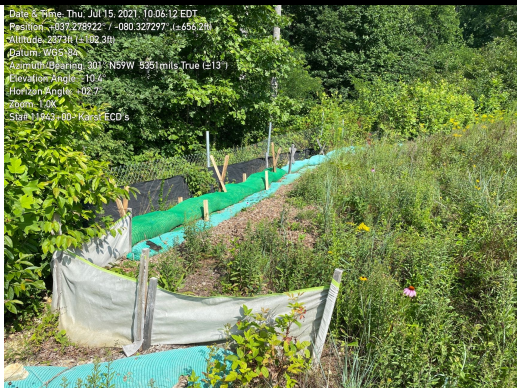
GPS Location	See photo GPS	GPS Location	See photo GPS		
Field Station#	11900+00	Field Station#	11933+00		
Pic 7 Desc.	AR-266.03	Pic 8 Desc.	Row vegetation.		
<p><small>Date & Time: Thu, Jul 15, 2021, 10:06:12 EDT Position: -087.278922° / -080.322797° (-194.33) Altitude: 2327ft (-194.33) Datum: WGS-84 Azimuth/Bearing: 301° N59W 531mils True (-13°) Elevation Angle: -10.4° Horizon Angle: -02.7° Zoom: 1.0X Staff 11943+00: Karst ECD's</small></p>

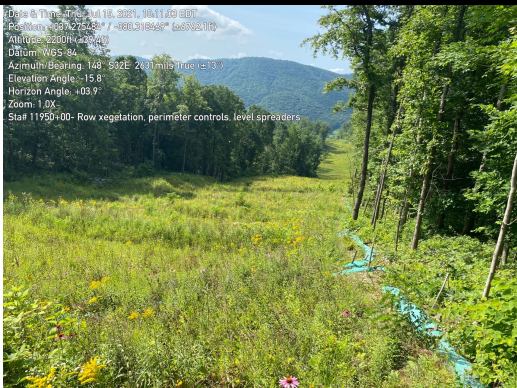
<p><small>Date & Time: Thu, Jul 15, 2021, 10:11:00 EDT Position: -087.275128° / -080.319540° (-194.33) Altitude: 2309ft (-194.33) Datum: WGS-84 Azimuth/Bearing: 148° S32E 2411mils True (-13°) Elevation Angle: -15.8° Horizon Angle: -03.9° Zoom: 1.0X Staff 11950+00: Row vegetation, perimeter controls, level spreaders</small></p>

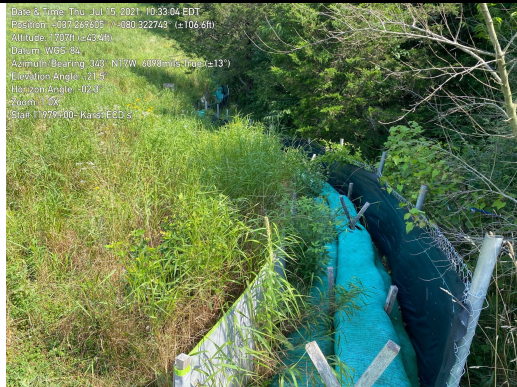
GPS Location	See photo GPS	GPS Location	See photo GPS		
Field Station#	11943+00	Field Station#	11950+00		
Pic 9 Desc.	Karst ECD's	Pic 10 Desc.	Row vegetation, perimeter controls, level spreaders.		
<p><small>Date & Time: Thu, Jul 15, 2021, 10:33:04 EDT Position: -087.245605° / -080.322743° (-194.33) Altitude: 1707ft (-194.33) Datum: WGS-84 Azimuth/Bearing: 302° N59W 531mils True (-13°) Elevation Angle: -11.3° Horizon Angle: -02.3° Zoom: 1.0X Staff 11979+00: Karst ECD's</small></p>

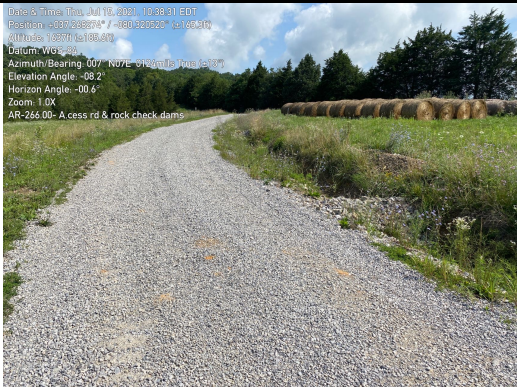
<p><small>Date & Time: Thu, Jul 15, 2021, 10:38:31 EDT Position: -087.238974° / -080.319338° (-194.33) Altitude: 1637ft (-194.33) Datum: WGS-84 Azimuth/Bearing: 007° N07E 518mils True (-13°) Elevation Angle: -08.2° Horizon Angle: -00.6° Zoom: 1.0X AR-266.00- Access rd & rock check dams</small></p>

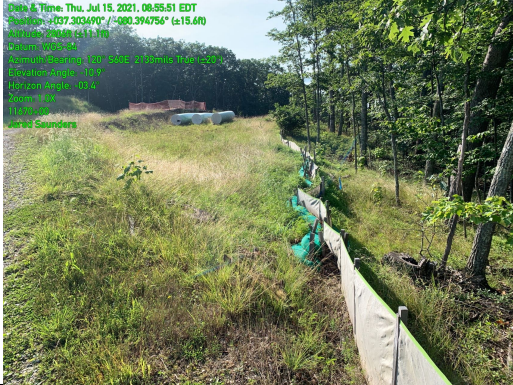
GPS Location		See photo for GPS location.						GPS Location		See photo for GPS location.	
Field Station#		11690+00						Field Station#		11687+40	
Pic 1 Desc.		Triple stack CFS and priority one silt fence in place along LOD.						Pic 2 Desc.		Sensitive resource buffer in place at stream S-MN21.

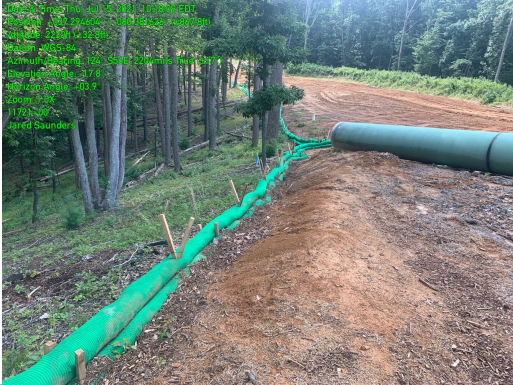
GPS Location		See photo for GPS location.						GPS Location		See photo for GPS location.	
Field Station#		11697+00						Field Station#		11721+00	
Pic 3 Desc.		Perimeter ECDs being replaced.						Pic 4 Desc.		Perimeter controls replaced.

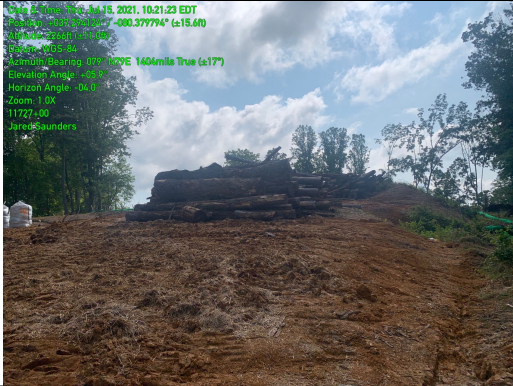
GPS Location		See photo for GPS location.						GPS Location		See photo for GPS location.	
Field Station#		11727+00						Field Station#		11676+00	
Pic 5 Desc.		Logs being removed from LOD.						Pic 6 Desc.		RCE in place at MLV 26.

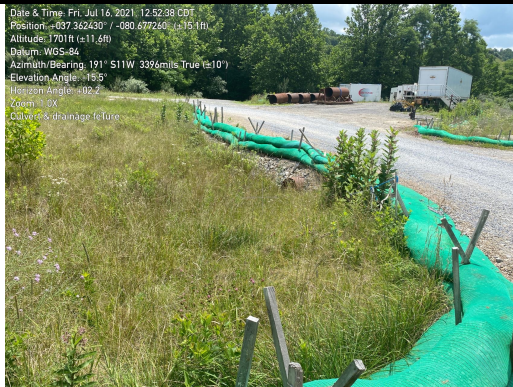
GPS Location				See photo GPS				GPS Location				See photo GPS			
Field Station#				12005+00				Field Station#				12005+00			
Pic 3 Desc.				LY29- Waste management containers.				Pic 4 Desc.				LY29 - Culvert and drainage feature.

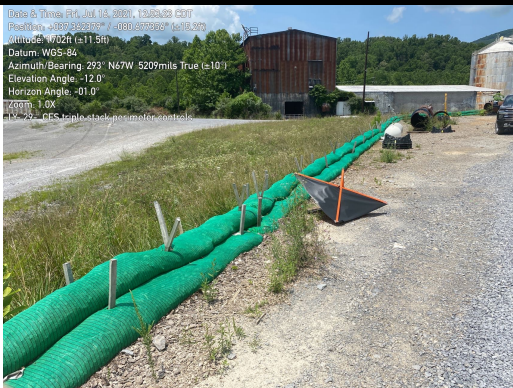
GPS Location				See photo GPS				GPS Location				See photo GPS			
Field Station#				12005+00				Field Station#				12005+00			
Pic 5 Desc.				LY29- CFS triple stack perimeter controls.				Pic 6 Desc.				LY29- Welders working in the yard.

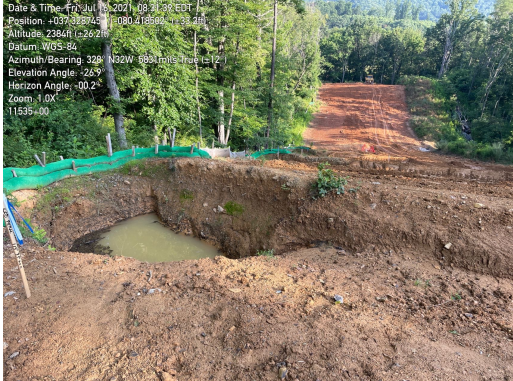
<p>Date & Time: Fri, Jul 16, 2021 09:30:07 EDT Position: +037.33234° / -080.41559° (+33.481°) Altitude: 2026ft (+205m) Datum: WGS-84 Azimuth/Bearing: 160° S40E 303mils True (+12°) Elevation Angle: -11.2° Horizon Angle: +00.3° Zoom: 1.0x 11544+00</p>			
GPS Location	See photo		GPS Location	See photo	
Field Station#	11535+00		Field Station#	11544+00	
Pic 1 Desc.	End treatments in place		Pic 2 Desc.	Restoration in progress

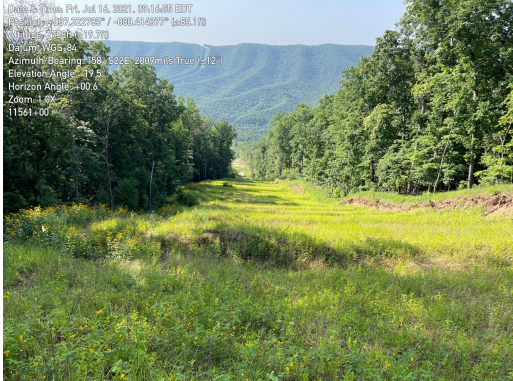
GPS Location	See photo		GPS Location	See photo	
Field Station#	11561+00		Field Station#	11584+02	
Pic 3 Desc.	Waterbars in place		Pic 4 Desc.	P1 silt fence replaced

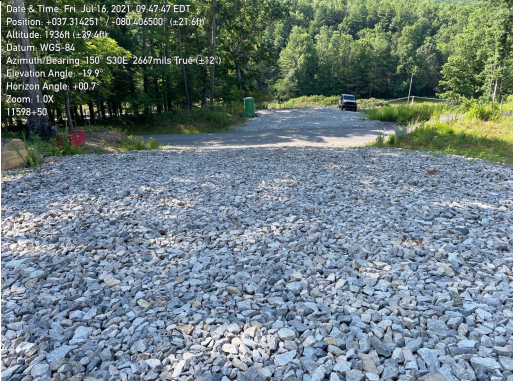
<p>Date & Time: Fri, Jul 16, 2021 09:54:00 EDT Position: +037.317324° / -080.40570° (+33.481°) Altitude: 2026ft (+205m) Datum: WGS-84 Azimuth/Bearing: 150° S30E 2647mils True (+12°) Elevation Angle: -11.3° Horizon Angle: +01.1° Zoom: 1.0x 11587+00</p>

<p>Date & Time: Fri, Jul 16, 2021 09:47:47 EDT Position: +037.314251° / -080.406500° (+31.648°) Altitude: 1936ft (+294m) Datum: WGS-84 Azimuth/Bearing: 150° S30E 2647mils True (+12°) Elevation Angle: -19.9° Horizon Angle: +00.7° Zoom: 1.0x 11598+50</p>			
GPS Location	See photo		GPS Location	See photo	
Field Station#	11587+00		Field Station#	11598+50	
Pic 5 Desc.	Stream buffer in place		Pic 6 Desc.	RCE in place

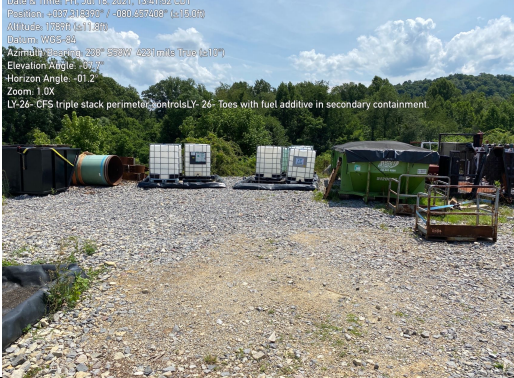
<p>Date & Time: Fri, Jul 16, 2021 12:42:00 PT Position: +037.218553° / -080.537990° (-15.31) Altitude: 1820ft (-11.4ft) Datum: WGS-84 Azimuth/Bearing: 295° (295° 403mils True (-10°) Elevation Angle: -08.0° Horizon Angle: -01.2° Zoom: 1.0X LY26- CFS triple stack perimeter controls LY-26- Totes with fuel additive in secondary containment.</p>

<p>Date & Time: Fri, Jul 16, 2021 12:50:01 PT Position: +037.218553° / -080.537990° (-15.31) Altitude: 1820ft (-11.4ft) Datum: WGS-84 Azimuth/Bearing: 301° (301° 444mils True (-10°) Elevation Angle: -08.0° Horizon Angle: -01.2° Zoom: 1.0X LY26- Gas cylinders are secured.</p>			
GPS Location	See photo GPS	GPS Location	See photo GPS		
Field Station#	12005+00	Field Station#	12005+00		
Pic 1 Desc.	LY26- Totes containing fuel additive in containment.	Pic 2 Desc.	LY26- Gas cylinders are secured.

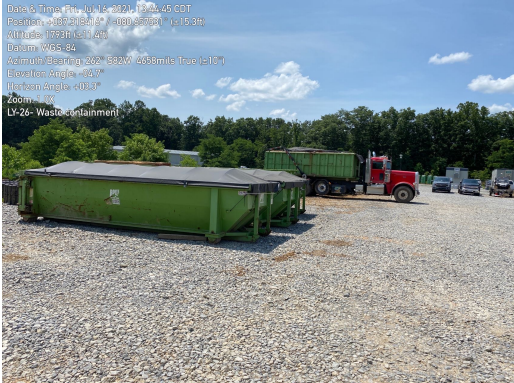
<p>Date & Time: Fri, Jul 16, 2021 12:44:45 PT Position: +037.218553° / -080.537990° (-15.31) Altitude: 1820ft (-11.4ft) Datum: WGS-84 Azimuth/Bearing: 295° (295° 403mils True (-10°) Elevation Angle: -08.0° Horizon Angle: -01.2° Zoom: 1.0X LY26- Waste management containers.</p>

<p>Date & Time: Fri, Jul 16, 2021 12:46:01 PT Position: +037.218553° / -080.537990° (-15.31) Altitude: 1820ft (-11.4ft) Datum: WGS-84 Azimuth/Bearing: 297° (297° 422mils True (-10°) Elevation Angle: -08.0° Horizon Angle: -01.1° Zoom: 1.0X LY26- Spill kits.</p>			
GPS Location	See photo GPS	GPS Location	See photo GPS		
Field Station#	12005+00	Field Station#	12005+00		
Pic 3 Desc.	LY26- Waste management containers.	Pic 4 Desc.	LY-26- Spill kits, fire extinguishers,available, signage visible.

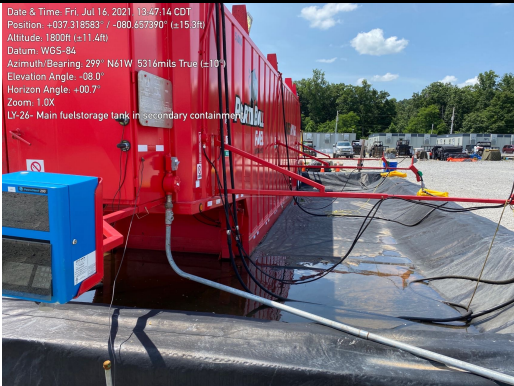
<p>Date & Time: Fri, Jul 16, 2021 13:27:14 CDT Position: +037.218553° / -080.537990° (-15.31) Altitude: 1820ft (-11.4ft) Datum: WGS-84 Azimuth/Bearing: 299° (N61W 531mils True (-10°) Elevation Angle: -08.0° Horizon Angle: +00.7° Zoom: 1.0X LY26- Main fuel storage tank in secondary containment.</p>		<p>Insert image here</p>

GPS Location	See photo GPS	GPS Location			
Field Station#	12005+00	Field Station#			
Pic 5 Desc.	LY26- Main fuel storage tank in secondary containment.	Pic 6 Desc.

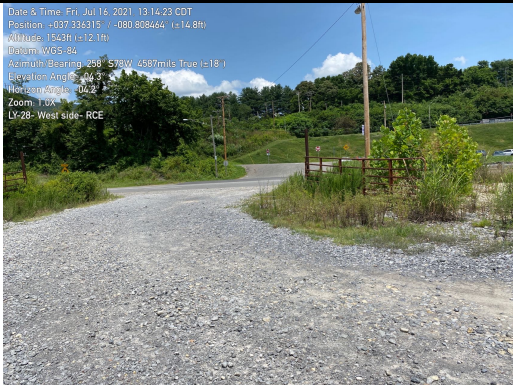
<p>Date & Time: Fri Jul 16, 2021 13:14:23 CDT Position: +037.336315 / -080.806464 (±14.8m) Altitude: 1553ft (±12.1ft) Datum: WGS-84 Azimuth/Bearing: 237° S57W 4587mils True (±18.1°) Elevation Angle: +0.3° Horizon Angle: +00.9° Zoom: 1.0x LY-28- West side- RCE</p>

<p>Date & Time: Fri Jul 16, 2021 13:15:20 CDT Position: +037.336217 / -080.806455 (±15.0m) Altitude: 1538ft (±11.8m) Datum: WGS-84 Azimuth/Bearing: 237° S57W 4213mils True (±18.1°) Elevation Angle: +0.3° Horizon Angle: +00.9° Zoom: 1.0x LY-28- West side- Buses and trucks stored, not in use</p>			
GPS Location	See photo GPS		GPS Location	See photo GPS	
Field Station#	12005+00		Field Station#	12005+00	
Pic 1 Desc.	LY-28- West side- RCE		Pic 2 Desc.	LY-28- West side- Buses and trucks stored, not in use.

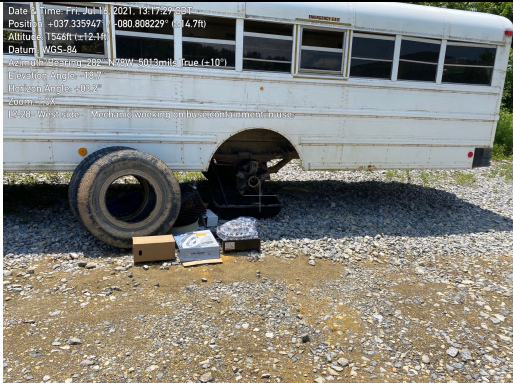
<p>Date & Time: Fri Jul 16, 2021 13:17:29 CDT Position: +037.335947 / -080.806229 (±14.7m) Altitude: 1566ft (±12.1ft) Datum: WGS-84 Azimuth/Bearing: 270° S68W 4800mils True (±10.1°) Elevation Angle: +0.3° Horizon Angle: +00.9° Zoom: 1.0x LY-28- West side- Mechanic working on bus, secondary containment</p>

GPS Location	See photo GPS		GPS Location	See photo GPS	
Field Station#	12005+00		Field Station#	12005+00	
Pic 3 Desc.	LY-28- West side- Mechanic working on a bus, secondary containment under axle.		Pic 4 Desc.	LY-28- East side- CFS perimeter controls.

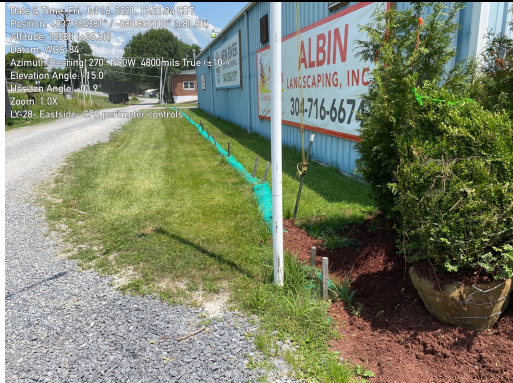
<p>Date & Time: Fri Jul 16, 2021 13:18:04 CDT Position: +037.336081 / -080.807017 (±15.0m) Altitude: 1585ft (±11.8m) Datum: WGS-84 Azimuth/Bearing: 270° S68W 4800mils True (±10.1°) Elevation Angle: +0.3° Horizon Angle: +00.9° Zoom: 1.0x LY-28- Eastside- CFS perimeter controls</p>

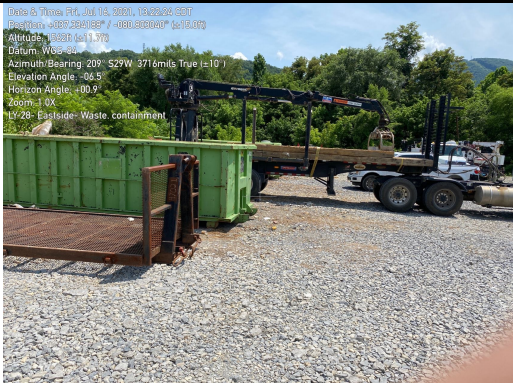
<p>Date & Time: Fri Jul 16, 2021 13:26:40 CDT Position: +037.336187 / -080.806647 (±15.0m) Altitude: 1593ft (±11.7m) Datum: WGS-84 Azimuth/Bearing: 209° S29W 3716mils True (±10.1°) Elevation Angle: +00.3° Horizon Angle: +00.9° Zoom: 1.0x LY-28- Eastside- Waste containment</p>

Pic 5 Desc.	LY-28- East side- waste management containers.		Pic 6 Desc.	LY-28-East side- Active truck yard.

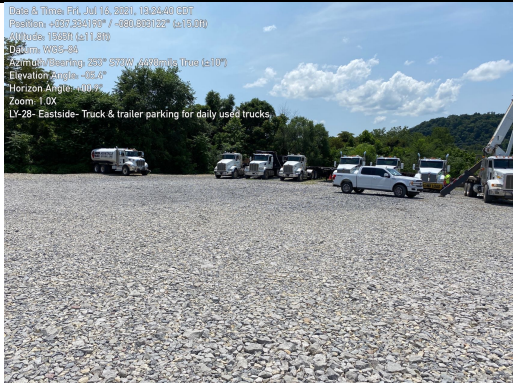
<p>Date & Time: Fri Jul 16, 2021 13:26:40 CDT Position: +037.336187 / -080.806647 (±15.0m) Altitude: 1593ft (±11.7m) Datum: WGS-84 Azimuth/Bearing: 209° S29W 3716mils True (±10.1°) Elevation Angle: +00.3° Horizon Angle: +00.9° Zoom: 1.0x LY-28- Eastside- Truck & trailer parking for daily used trucks</p>			
GPS Location	See photo GPS		GPS Location	See photo GPS	
Field Station#	12005+00		Field Station#	12005+00
