Visual Site Inspection Report

Project Name	H-600 Pipeline Spread G	AFE	124300137	Spread	H-600 Pipeline Spread G
Contractor	Precision			Report #	26382
Inspector	Clint Sears			Date/Time	7/26/2021 4:15 PM
Permit #	TBD	Inspection Type	VA SWPP	Station Begin	11254+99
State	VA	Inspection Area	Full	Station End	11064+53
County	Giles	Ground	Dry	Temperature (°F)	90.00
Municipality	N/A	Weather	Sunny	Rain Gauge (in)	0.00
				Rain Accumulation Time (days)	1.00

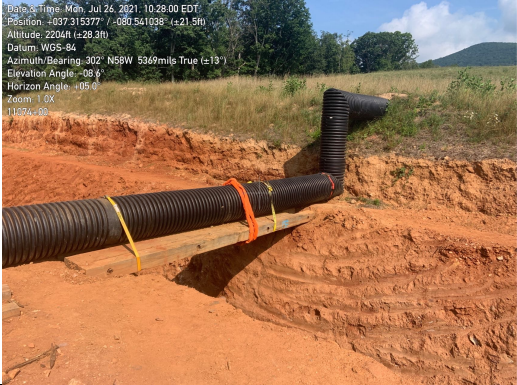
GPS Location	See photo	GPS Location	See photo
Field Station#	11074+00	Field Station#	11067+44
Pic 7 Desc.	Clean water diversion pipe functioning	Pic 8 Desc.	Water bar, sump, P1 and super silt fence functional
<p>Date & Time: Mon, Jul 26, 2021, 11:26:44 EDT Position: +037.277590 / -080.495509 (±15.3ft) Altitude: 2143ft (±11.4ft) Datum: WGS-84 Azimuth/Bearing: 111° S49°E 1973mils True (±12°) Elevation Angle: -19.4° Horizon Angle: -08.3° Zoom: 1.0X 11246+85</p>  		<p>Date & Time: Mon, Jul 26, 2021, 11:56:54 EDT Position: +037.316614 / -080.524358 (±14.8ft) Altitude: 2158ft (±29.8ft) Datum: WGS-84 Azimuth/Bearing: 238° S58°W 4231mils True (±12°) Elevation Angle: -09.0° Horizon Angle: -04.7° Zoom: 1.0X 11201+60</p>

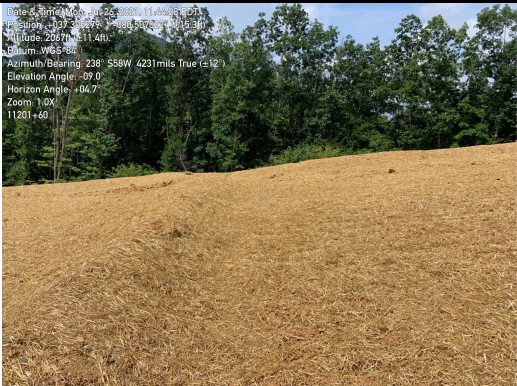
GPS Location	See photo	GPS Location	See photo
Field Station#	11246+85	Field Station#	11201+60
Pic 9 Desc.	Water bar end treatments and temporary vegetation functioning	Pic 10 Desc.	Stabilization adequate, water bar needs redone as it enters stone inlet protection
<p>Date & Time: Mon, Jul 26, 2021, 11:47:41 EDT Position: +037.304253 / -080.506671 (±15.6ft) Altitude: 1986ft (±11.0ft) Datum: WGS-84 Azimuth/Bearing: 229° S47°W 4036mils True (±12°) Elevation Angle: -18.7° Horizon Angle: -05.2° Zoom: 1.0X 11205+00</p>

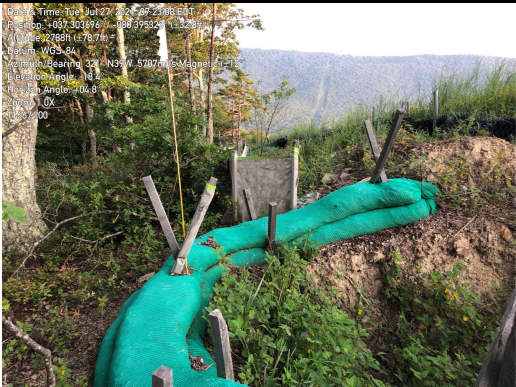
GPS Location	On photo	GPS Location	On photo		
Field Station#	11667+00	Field Station#	11661+00		
Pic 1 Desc.	Perimeter ECDs in place.	Pic 2 Desc.	Perimeter ECDs in place.		
<p>Date & Time: Tue, Jul 27, 2021, 07:38:07 EDT Position: +691.328914° / -880.397174° (-124300) Altitude: 2315ft (-139.4ft) Datum: WGS-84 Azimuth/Bearing: 344° N16°W 5027mils Magnetic (-11°) Elevation Angle: -26.5° Horizon Angle: -10.4° Zoom: 1.0x 11664+00</p>

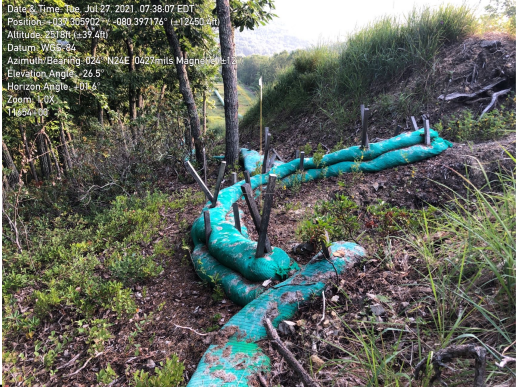
GPS Location	On photo	GPS Location	On photo		
Field Station#	11654+00	Field Station#	11648+00		
Pic 3 Desc.	Perimeter ECDs in place.	Pic 4 Desc.	Perimeter ECDs in place.		
<p>Date & Time: Tue, Jul 27, 2021, 07:55:59 EDT Position: +691.312497° / -880.397559° (-124300) Altitude: 2379ft (-13.1ft) Datum: WGS-84 Azimuth/Bearing: 175° S85°E 3111mils Magnetic (-13°) Elevation Angle: -40.8° Horizon Angle: -69.4° Zoom: 1.0x 11633+00</p>

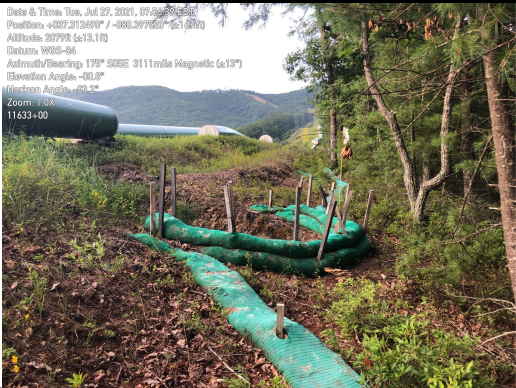
GPS Location	On photo	GPS Location	On photo		
Field Station#	11633+00	Field Station#	11626+50		
Pic 5 Desc.	Perimeter ECDs in place.	Pic 6 Desc.	Perimeter ECDs are in place.

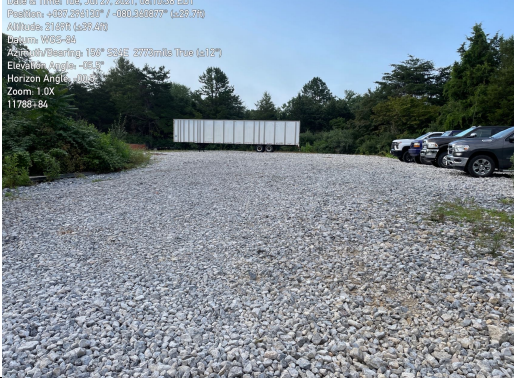
GPS Location	See photo	GPS Location	See photo		
Field Station#	11788+84	Field Station#	11794+00		
Pic 1 Desc.	RCE in place	Pic 2 Desc.	CFS perimeter control in place		
<p>Date & Time: Tue, Jul 27, 2021 06:15:50 EDT Position: +037°29'03" / -80°35'11" S11.6ft Altitude: 2168ft (+13.1ft) Datum: WGS-84 Azimuth/Bearing: 057° 55'55" 1013mils True (+13°) Elevation Angle: -17.9° Horizon Angle: +00.3° Zoom: 1.0X 11799+00</p>

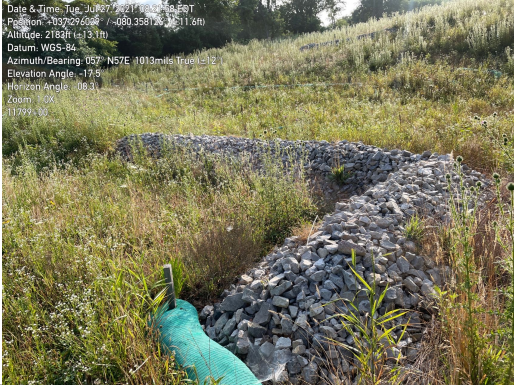
GPS Location	See photo	GPS Location	See photo		
Field Station#	11799+00	Field Station#	11821+00		
Pic 3 Desc.	Level spreader in place	Pic 4 Desc.	Vegetation on ROW		
<p>Date & Time: Tue, Jul 27, 2021 06:30:48 EDT Position: +037°29'03" / -80°33'57" S11.31ft Altitude: 2237ft (+13.1ft) Datum: WGS-84 Azimuth/Bearing: 122° 55'55" 3169mils True (+13°) Elevation Angle: -17.0° Horizon Angle: +13.0° Zoom: 1.0X 11832+00</p>

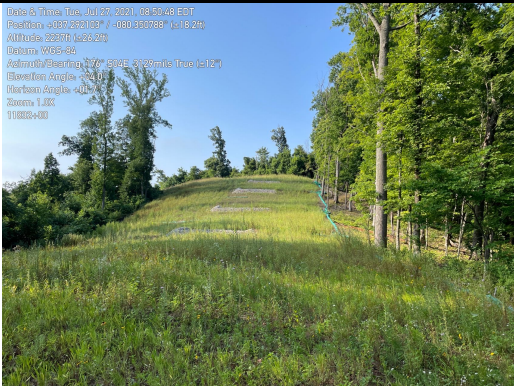
GPS Location	See photo	GPS Location	See photo		
Field Station#	11832+00	Field Station#	11835+00		
Pic 5 Desc.	Leave spreaders in place	Pic 6 Desc.	CFS controls in place

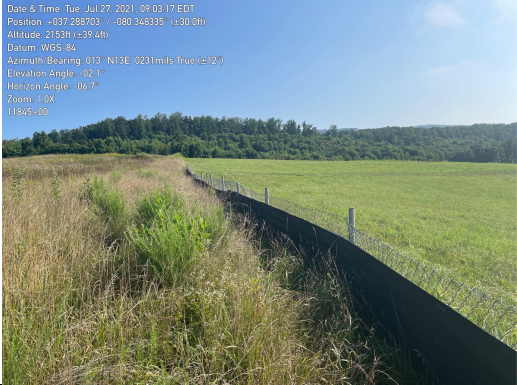
GPS Location		See photo		GPS Location	
Field Station#		11845+00		Field Station#	
Pic 7 Desc.		Supersilt fence perimeter control in place		Pic 8 Desc.	
<p>Date & Time: Tue, Jul 27, 2021 09:42:17 EDT Position: +037.287878° / -080.354335° (+15.0m) Altitude: 2300ft (+70.0m) Datum: WGS-84 Azimuth/Bearing: 348° N12W 6187mils True (+12°) Elevation Angle: -03.9° Horizon Angle: -00.6° Zoom: 1.2X 11900+75</p>

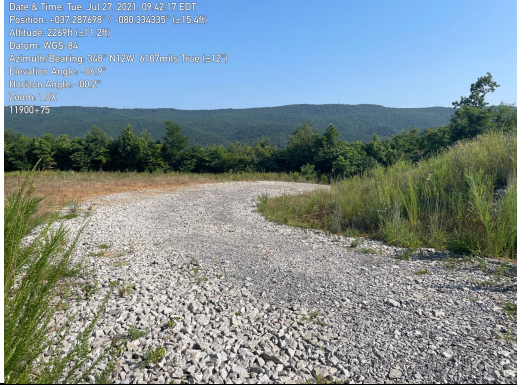
GPS Location		See photo		GPS Location	
Field Station#		11900+75		Field Station#	
Pic 9 Desc.		RCE in place		Pic 10 Desc.	
<p>Date & Time: Tue, Jul 27, 2021 10:45:18 EDT Position: +037.277750° / -080.353655° (+36.0m) Altitude: 2190ft (+67.0m) Datum: WGS-84 Azimuth/Bearing: 167° S28E 2866mils True (+12°) Elevation Angle: -03.8° Horizon Angle: -00.7° Zoom: 1.0X 11950+00</p>

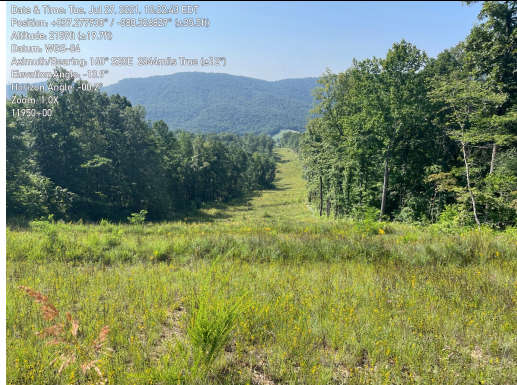
GPS Location		See photo		GPS Location	
Field Station#		11950+00		Field Station#	
Pic 11 Desc.		Waterbars in place		Pic 12 Desc.

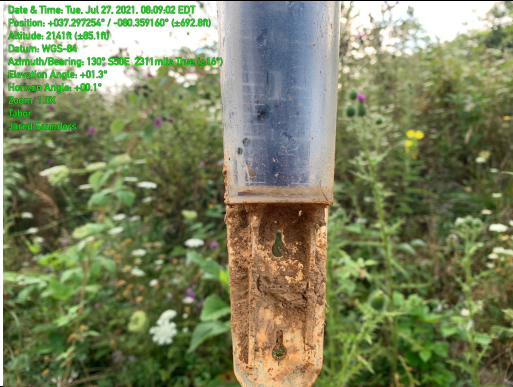
<p>Date & Time: Tue, Jul 27, 2021, 09:32:09 EDT Position: +037.215777° / -080.408231° (±448.9M) Altitude: 2217ft (±22.4M) Datum: WGS-84 Azimuth/Bearing: 207° S27W 368mils True (±10°) Elevation Angle: +00.0° Horizon Angle: +03.1° Zoom: 1.0x Pic 2 Desc.</p>			
GPS Location	See photo for GPS location.	GPS Location	See photo for GPS location.		
Field Station#	11788+00	Field Station#	11672+00		
Pic 1 Desc.	Rain gauge at Mount Tabor Road has a trace amount.	Pic 2 Desc.	Waterbar end treatment replaced.

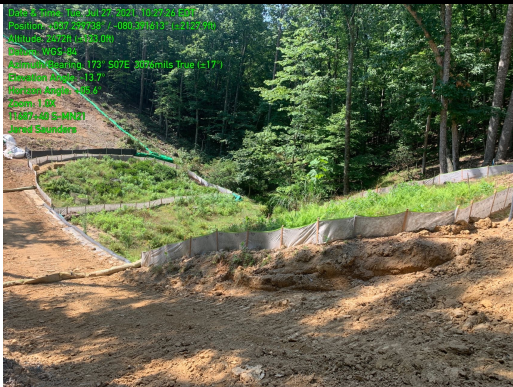
GPS Location	See photo for GPS location.	GPS Location	See photo for GPS location.		
Field Station#	11687+40	Field Station#	11703+00		
Pic 3 Desc.	Sensitive resource buffer in place at stream S-MN21.	Pic 4 Desc.	Topsoil spoil pile that was disturbed while removing logs is stabilized with seed and mulch.

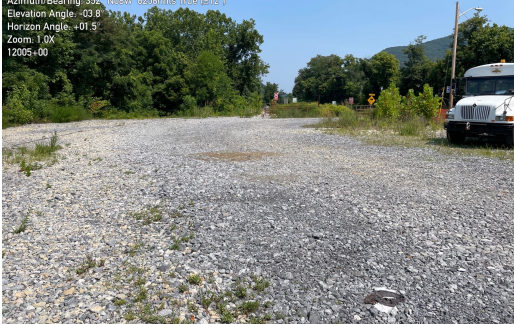
GPS Location	See photo	GPS Location	See photo		
Field Station#	12005+00	Field Station#	12005+00		
Pic 1 Desc.	RCE in place	Pic 2 Desc.	Vehicles being stored at yard		
<p>Date & Time: Wed Jul 28, 2021, 11:51:08 EDT Position: +037.33384° / -080.80289° (x:15.5ft) Altitude: 1562ft (±11.1ft) Datum: WGS-84 Azimuth/Bearing: 100° S00E 177mils True (±12°) Elevation Angle: -15.7° Horizon Angle: +03.8° Zoom: 1.0x 12005+00</p>

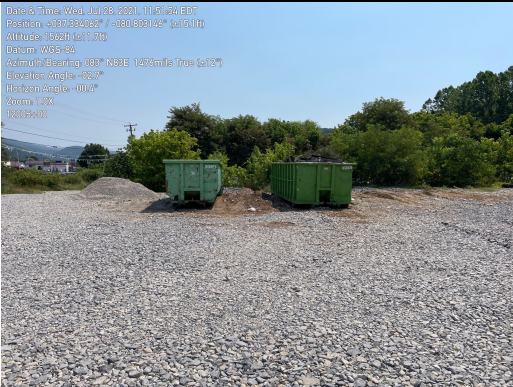
GPS Location	See photo	GPS Location	See photo		
Field Station#	12005+00	Field Station#	12005+00		
Pic 3 Desc.	Secondary containment in place	Pic 4 Desc.	Dumpsters in place		
<p>Date & Time: Wed Jul 28, 2021, 11:46:11 EDT Position: +037.33282° / -080.80842° (x:15.1ft) Altitude: 1558ft (±11.7ft) Datum: WGS-84 Azimuth/Bearing: 100° S00E 177mils True (±12°) Elevation Angle: -15.7° Horizon Angle: +03.8° Zoom: 1.0x 12005+00</p>

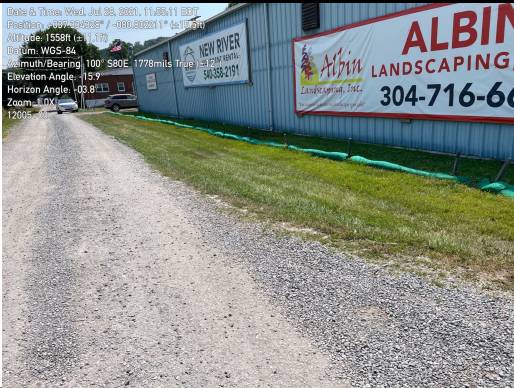
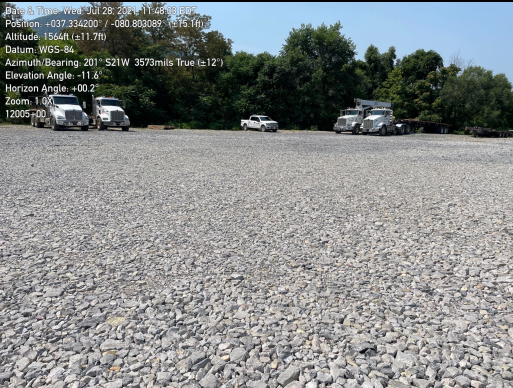
GPS Location	See photo	GPS Location	See photo		
Field Station#	12005+00	Field Station#	12005+00		
Pic 5 Desc.	CFS perimeter control in place	Pic 6 Desc.	Rock surface in acceptable condition

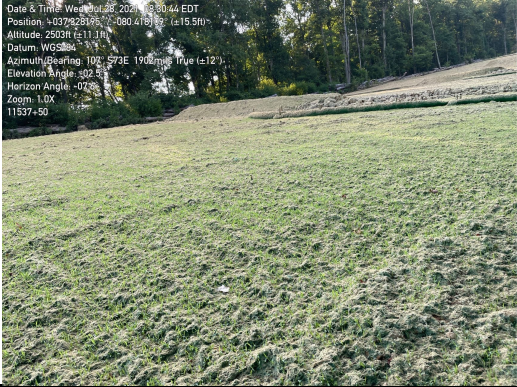
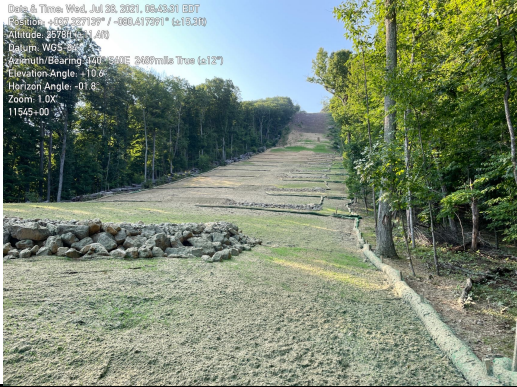
GPS Location	See photo	GPS Location	See photo		
Field Station#	11537+50	Field Station#	11545+00		
Pic 7 Desc.	Vegetation starting to sprout	Pic 8 Desc.	CFS perimeter control in place		
<p>Date & Time: Wed Jul 28, 2021, 09:03:34 EDT Position: +037.28580° / -080.44441° (±16.2ft) Altitude: 2500ft (±11.1ft) Datum: WGS-84 Azimuth/Bearing: 086° 18'E 1529mils True (±11°) Elevation Angle: +07° Horizon Angle: +13° Zoom: 1.0X 11548+00</p>

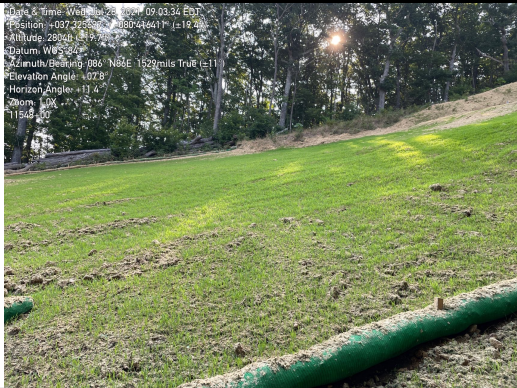
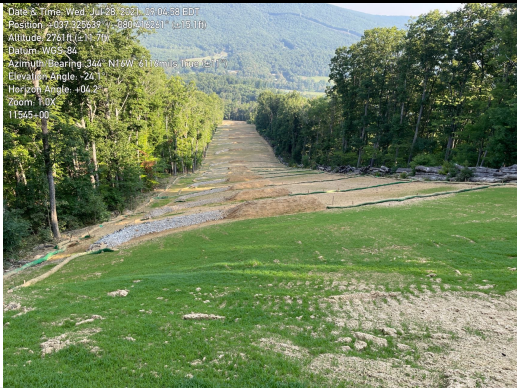
GPS Location	See photo	GPS Location	See photo		
Field Station#	11548+00	Field Station#	11545+00		
Pic 9 Desc.	Nice vegetation starting to grow	Pic 10 Desc.	Waterbars with level spreaders in place		
<p>Date & Time: Wed Jul 28, 2021, 09:05:00 EDT Position: +037.28545° / -080.41500° (±15.0ft) Altitude: 2500ft (±11.1ft) Datum: WGS-84 Azimuth/Bearing: 104° 53'E 2680mils True (±12°) Elevation Angle: +15° Horizon Angle: +00° Zoom: 1.0X 11563+00</p>

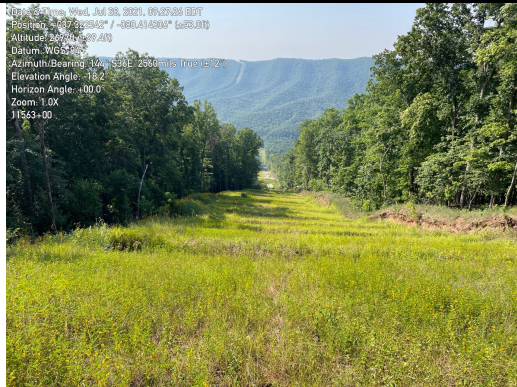
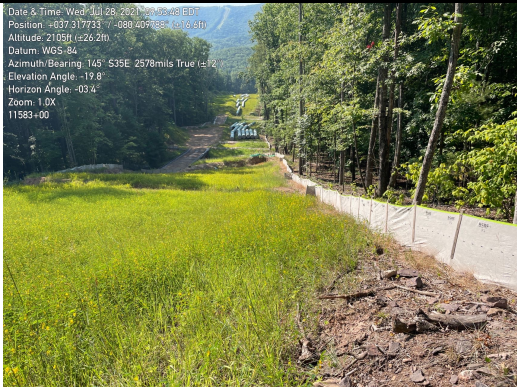
GPS Location	See photo	GPS Location	See photo		
Field Station#	11563+00	Field Station#	11583+00		
Pic 11 Desc.	Waterbars in place	Pic 12 Desc.	P1 perimeter control in place

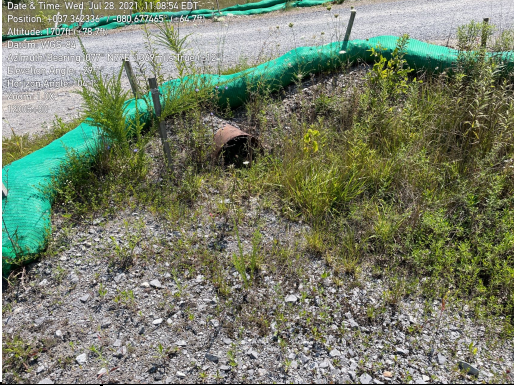
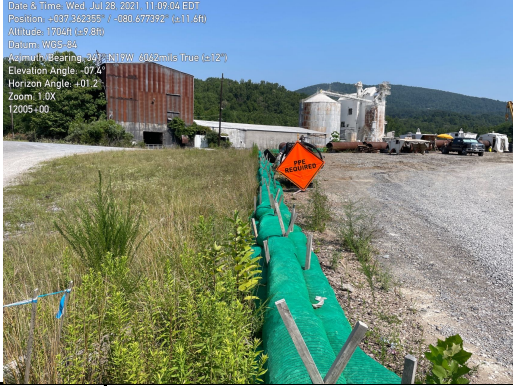
<p>Date & Time: Wed Jul 28, 2021, 11:09:04 EDT Position: -82.34233° / -80.57733° (-15.14) Altitude: 1720ft (-11.8m) Datum: WGS-84 Azimuth Bearing: 101° N01E 100mils True (-12.4°) Elevation Angle: -07.4° Horizon Angle: -01.2° Zoom: 1.0X 12005+00</p>			
GPS Location	See photo	GPS Location	See photo		
Field Station#	12005+00	Field Station#	12005+00		
Pic 1 Desc.	Culvert in place	Pic 2 Desc.	CFS perimeter control in place

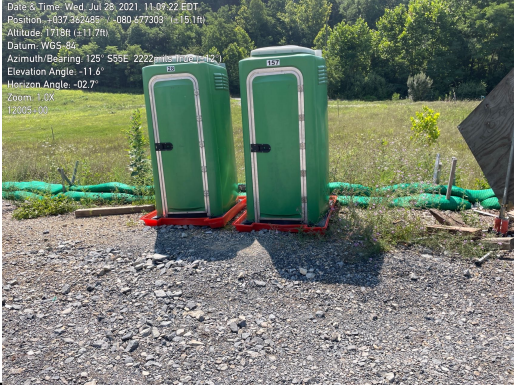
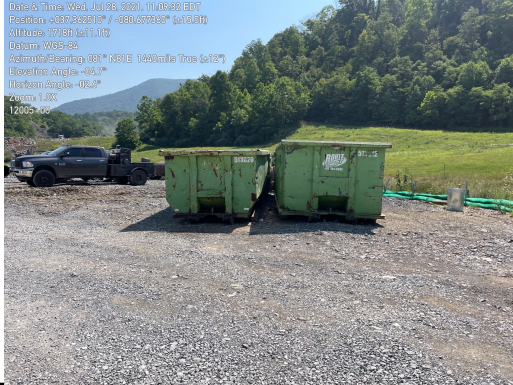
GPS Location	See photo	GPS Location	See photo		
Field Station#	12005+00	Field Station#	12005+00		
Pic 3 Desc.	Secondary containment in place	Pic 4 Desc.	Dumpsters on site

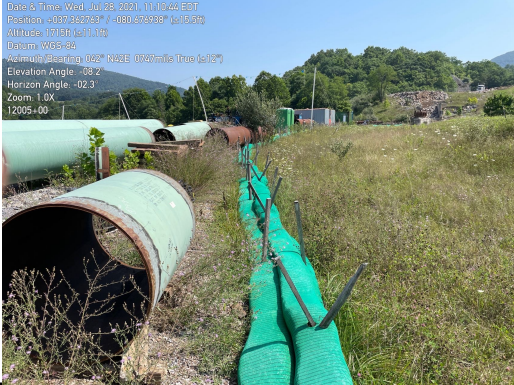
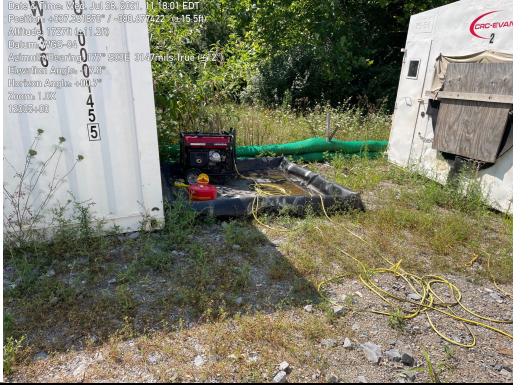
<p>Date & Time: Wed Jul 28, 2021, 11:10:41 EDT Position: -82.34233° / -80.57733° (-15.14) Altitude: 1720ft (-11.8m) Datum: WGS-84 Azimuth Bearing: 102° N02E 100mils True (-12.4°) Elevation Angle: -08.2° Horizon Angle: -02.3° Zoom: 1.0X 12005+00</p>			
GPS Location	See photo	GPS Location	See photo		
Field Station#	12005+00	Field Station#	12005+00		
Pic 5 Desc.	CFS perimeter control in place	Pic 6 Desc.	Secondary containment in place

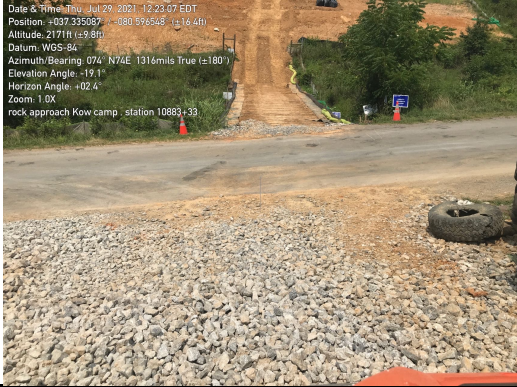
GPS Location	See photo	GPS Location	see photo
Field Station#	10861+00	Field Station#	10883+33
Pic 7 Desc.	Slope drain	Pic 8 Desc.	Rock approach
<p>Date & Time: Thu, Jul 29, 2021, 12:03:13 EDT Position: +037.331363° / -080.582968° (+16.4ft) Altitude: 2127ft (+26.2ft) Datum: WGS-84 Azimuth/Bearing: 165° S15E 2933mils True (+16°) Elevation Angle: -11.6° Horizon Angle: -00.9° Zoom: 1.0X rock approach Doe Creek station</p>  		<p>Date & Time: Thu, Jul 29, 2021, 11:55:12 EDT Position: +037.285457° / -080.570828° (+14.1ft) Altitude: 2007ft (+9.9ft) Datum: WGS-84 Azimuth/Bearing: 042° N42E 1102mils True (+82°) Elevation Angle: -10.4° Horizon Angle: -01.0° Zoom: 1.0X trenching Bad Apple rd station 10955+57</p>

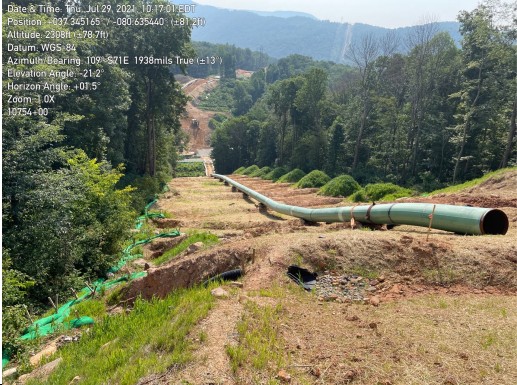
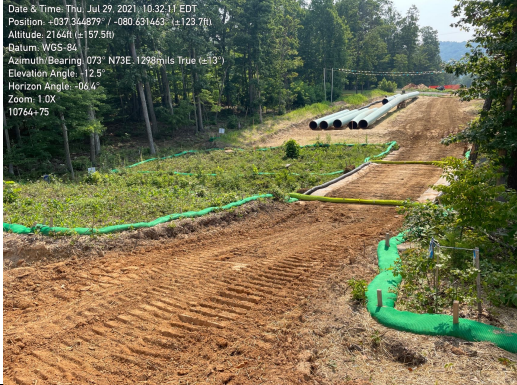
GPS Location	See photo	GPS Location	See photo		
Field Station#	10754+00	Field Station#	10764+75		
Pic 7 Desc.	Waterbars in place	Pic 8 Desc.	Stream buffer in place		
<p><small>Date & Time: Thu, Jul 29, 2021, 10:36:14 EDT Position: +037.345564° / -080.630814° (+816.8ft) Altitude: 2100ft (+639.2ft) Datum: WGS-84 Azimuth/Bearing: 136° S50E 2304mils True (+13°) Elevation Angle: +10.9° Horizon Angle: +06.5° Zoom: 1.0X 10768+00</small></p>

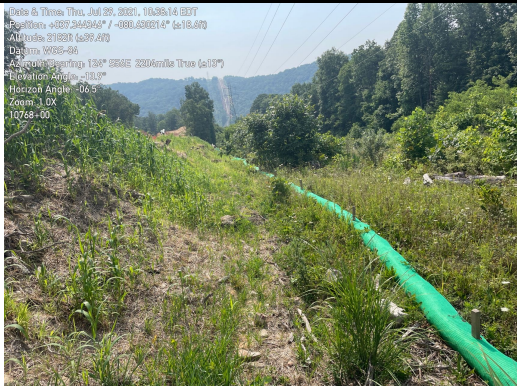
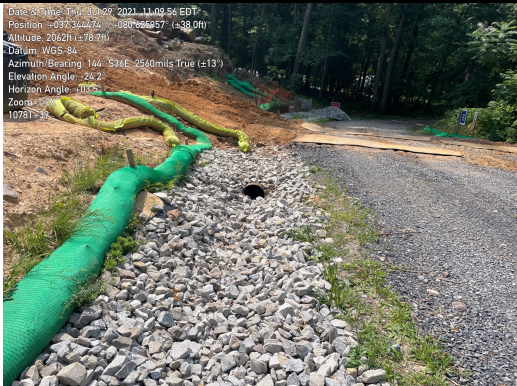
GPS Location	See photo	GPS Location	See photo		
Field Station#	10768+00	Field Station#	10781+39		
Pic 9 Desc.	CFS perimeter control in place	Pic 10 Desc.	Culvert in place		
<p><small>Date & Time: Thu, Jul 29, 2021, 12:04:53 EDT Position: +037.341254° / -080.618588° (+22.1ft) Altitude: 2058ft (+626.2ft) Datum: WGS-84 Azimuth/Bearing: 336° N24W 5973mils True (+15°) Elevation Angle: +28.3° Horizon Angle: +02.7° Zoom: 1.0X 10807+00</small></p>

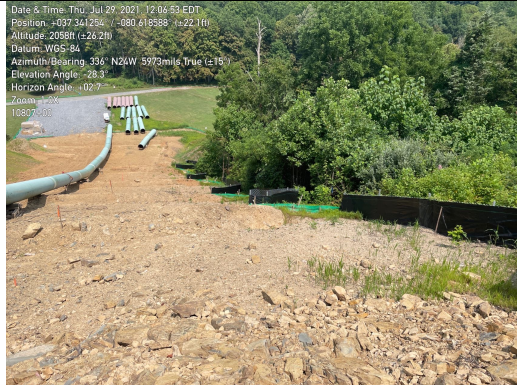
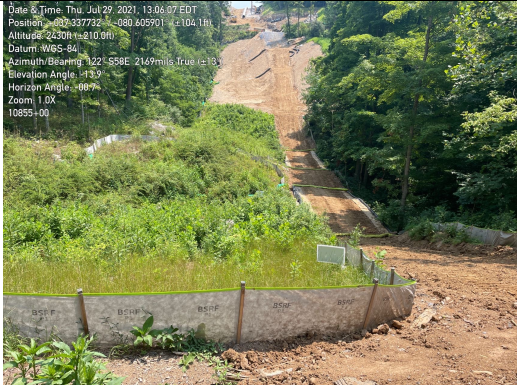
GPS Location	See photo	GPS Location	See photo		
Field Station#	10807+00	Field Station#	10855+00		
Pic 11 Desc.	End treatments in place	Pic 12 Desc.	Stream buffer in place

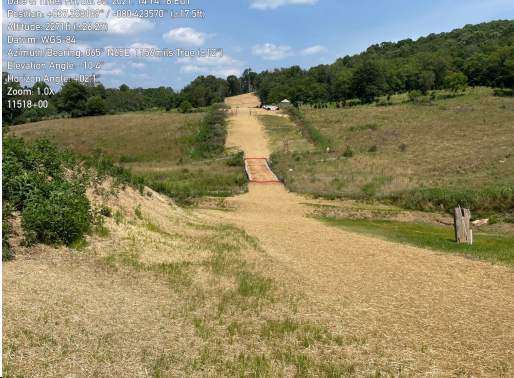
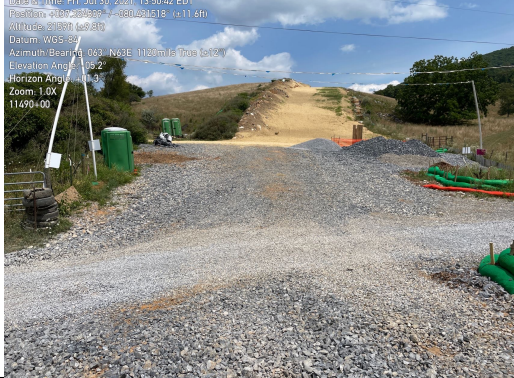
<p>Date & Time: Fri Jul 30, 2021, 13:50:42 EDT Position: +389 235109 / -680 43518 (+11.6ft) Altitude: 23510 (+2.5ft) Datum: WGS 84 Azimuth Bearing: 063 N36E 1120mils True (+12°) Elevation Angle: -12° Horizon Angle: -02° Zoom: 1.0X 11490+00</p>			
GPS Location	See photo	GPS Location	See photo		
Field Station#	11518+00	Field Station#	11490+00		
Pic 1 Desc.	Stream buffer in place	Pic 2 Desc.	RCE in place

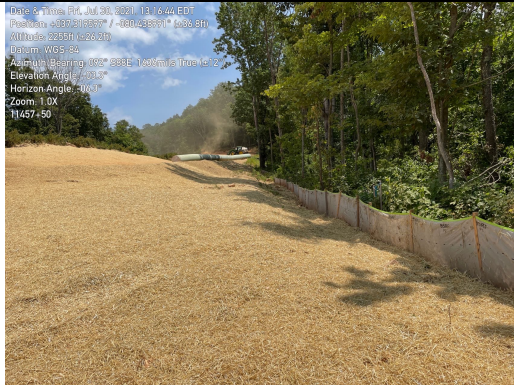
<p>Date & Time: Fri Jul 30, 2021, 14:16:46 EDT Position: +389 235557 / -680 43501 (+15.5ft) Altitude: 23550 (+2.62ft) Datum: WGS 84 Azimuth Bearing: 102° 598E 1800mils True (+12°) Elevation Angle: -19.3° Horizon Angle: -06.8° Zoom: 1.0X 11457+50</p>

GPS Location	See photo	GPS Location	See photo		
Field Station#	11477+00	Field Station#	11457+50		
Pic 3 Desc.	Supersilt fence perimeter control in place	Pic 4 Desc.	P1 silt fence perimeter control in place

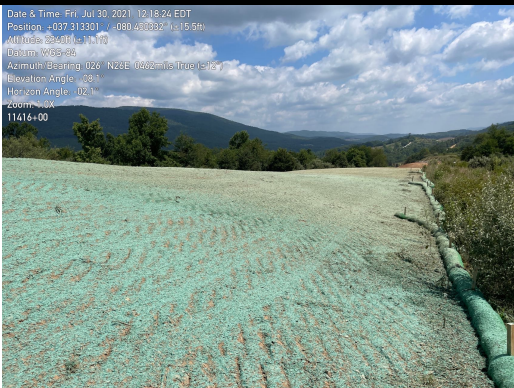
<p>Date & Time: Fri Jul 30, 2021, 12:18:24 EDT Position: +389 231330 / -680 43532 (+15.5ft) Altitude: 23414 (+1.1ft) Datum: WGS 84 Azimuth Bearing: 026 N26E 0600mils True (+12°) Elevation Angle: -03° Horizon Angle: -02° Zoom: 1.0X 11416+00</p>

<p>Date & Time: Fri Jul 30, 2021, 12:07:19 EDT Position: +389 231190 / -680 432114 (+15.2ft) Altitude: 23570 (+2.53ft) Datum: WGS 84 Azimuth Bearing: 036 N36E 0600mils True (+12°) Elevation Angle: -01° Horizon Angle: -04.3° Zoom: 1.0X 11411+00</p>			
GPS Location	See photo	GPS Location	See photo		
Field Station#	11422+00	Field Station#	11411+00		
Pic 5 Desc.	Hydro mulch has been applied	Pic 6 Desc.	Temporary CFS waterbars in place

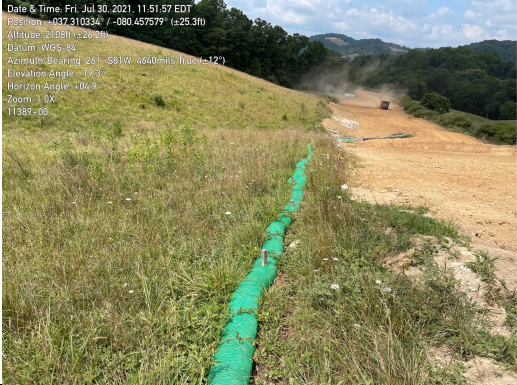
GPS Location	See photo	GPS Location	See photo		
Field Station#	11389+00	Field Station#	11372+00		
Pic 7 Desc.	CFS perimeter control in place	Pic 8 Desc.	Plunge pool in place		
<p>Date & Time: Fri, Jul 30, 2021, 10:43:48 EDT Position: +037.303781° / -080.472679° (±32.8ft) Altitude: 2216ft (±52.5ft) Datum: WGS-84 Azimuth/Bearing: 220° S40°W 3911mils True (±12°) Elevation Angle: -02.3° Horizon Angle: +00.7° Zoom: 1.0X 11328+00</p>		<p>Date & Time: Fri, Jul 30, 2021, 10:28:50 EDT Position: +037.277887° / -080.472689° (±30.4ft) Altitude: 2309ft (±39.5ft) Datum: WGS-84 Azimuth/Bearing: 349° N14°W 4204mils True (±12°) Elevation Angle: -14.6° Horizon Angle: -01.6° Zoom: 1.0X 11317+50</p>

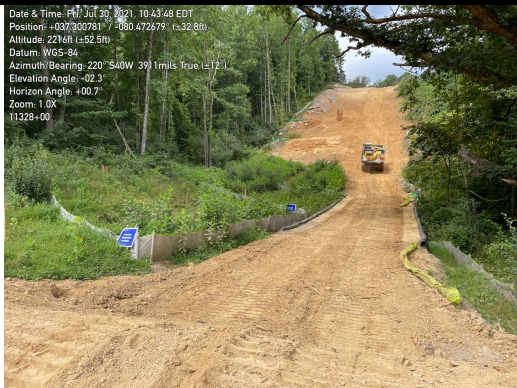
GPS Location	See photo	GPS Location	See photo		
Field Station#	11328+00	Field Station#	11317+50		
Pic 9 Desc.	Stream buffer in place	Pic 10 Desc.	Triple protection ECDs in place at karst feature		
<p>Date & Time: Fri, Jul 30, 2021, 09:34:43 EDT Position: +037.296086° / -080.492364° (±39.1ft) Altitude: 2188ft (±105.0ft) Datum: WGS-84 Azimuth/Bearing: 317° N43°W 5636mils True (±12°) Elevation Angle: -35.8° Horizon Angle: -02.3° Zoom: 1.0X 11260+25</p>		<p>Date & Time: Fri, Jul 30, 2021, 11:40:35 EDT Position: +037.323180° / -080.433175° (±19.7ft) Altitude: 2215ft (±19.7ft) Datum: WGS-84 Azimuth/Bearing: 138° S41°E 2657mils True (±12°) Elevation Angle: -52.0° Horizon Angle: -106.4° Zoom: 1.0X 11480+60</p>

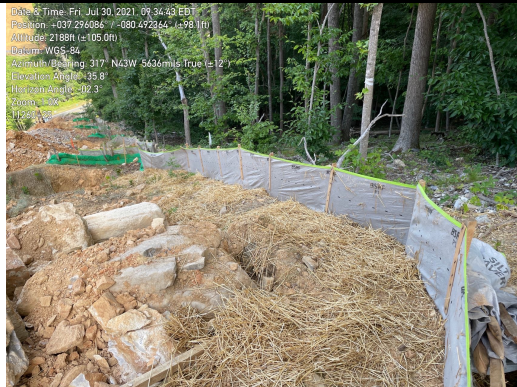
GPS Location	See photo	GPS Location	See photo		
Field Station#	11260+25	Field Station#	11480+60		
Pic 11 Desc.	P1 silt fence perimeter control in place	Pic 12 Desc.	Slope drain needs cleaned out
