Visual Site Inspection Report

Project Name	H-600 Pipeline Spread G	AFE	124300137	Spread	H-600 Pipeline Spread G
Contractor	Precision			Report #	25410
Inspector	Patrick Shields			Date/Time	7/5/2021 5:48 PM
Permit #	TBD	Inspection Type	VA SWPP	Station Begin	11670+00
State	VA	Inspection Area	Full	Station End	11788+52
County	Montgomery	Ground	Dry	Temperature (°F)	80.00
Municipality	N/A	Weather	Sunny	Rain Gauge (in)	0.00
				Rain Accumulation Time (days)	1.00

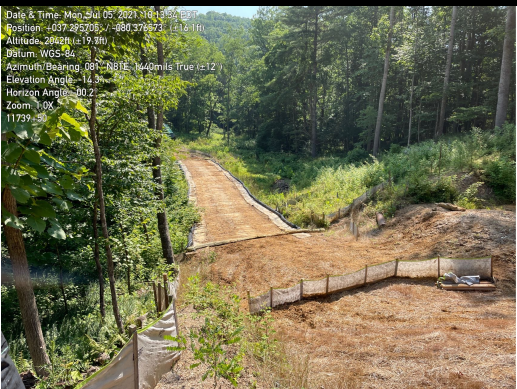
<p>Date & Time: Mon, Jul 05, 2021, 10:13:43 EDT Position: -057.295897, -080.376467 (-111.8th) Altitude: 2042ft (+19.8th) Datum: WGS-84 Azimuth/Bearing: 80° N61E 1440mils True (+12°) Elevation Angle: -14.3° Horizon Angle: -00.2° Zoom: 1.0X 11739+50</p>			
GPS Location	See photo		GPS Location	See photo	
Field Station#	11718+00		Field Station#	11739+50	
Pic 3 Desc.	Repaired P1 silt fence perimeter control		Pic 4 Desc.	Stream buffer in place

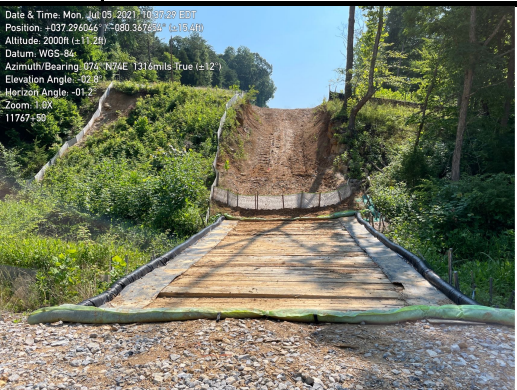
GPS Location	See photos		GPS Location	See photo	
Field Station#	11766+00		Field Station#	11767+50	
Pic 5 Desc.	Stockpile of construction materials needed for environmental maintenance		Pic 6 Desc.	Newly installed P1 silt fence across travel lane to protect stream

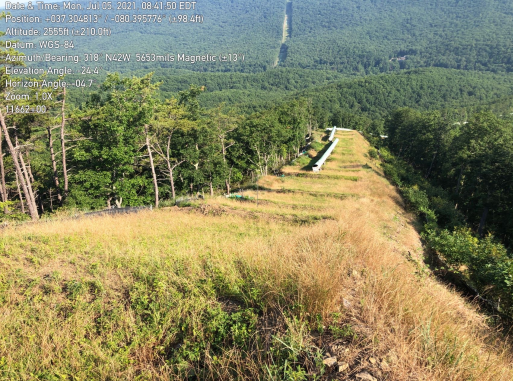
GPS Location	On photo	GPS Location	On photo		
Field Station#	11665+50	Field Station#	11662+00		
Pic 1 Desc.	Perimeter ECDs are in place.	Pic 2 Desc.	Slope breakers functional. ROW surface stable.

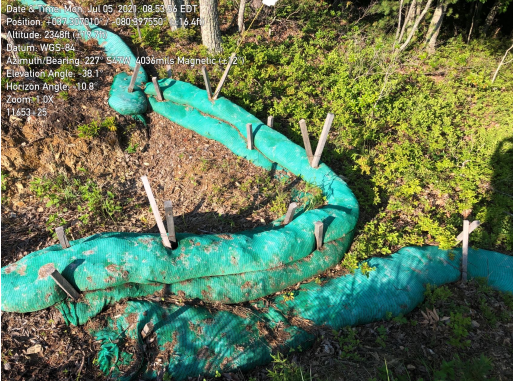
GPS Location	On photo	GPS Location	On photo		
Field Station#	11659+00	Field Station#	11653+25		
Pic 3 Desc.	Perimeter ECDs in place and functioning.	Pic 4 Desc.	Perimeter ECDs in place and functioning.

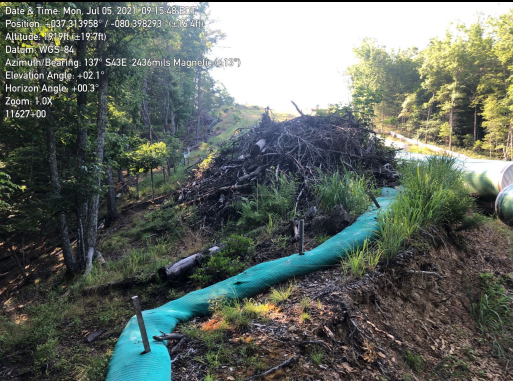
GPS Location	On photo	GPS Location	On photo		
Field Station#	11634+50	Field Station#	11627+00		
Pic 5 Desc.	Perimeter ECDs are functional.	Pic 6 Desc.	No sediment movement. Surface stable. Perimeter ECDs in place.

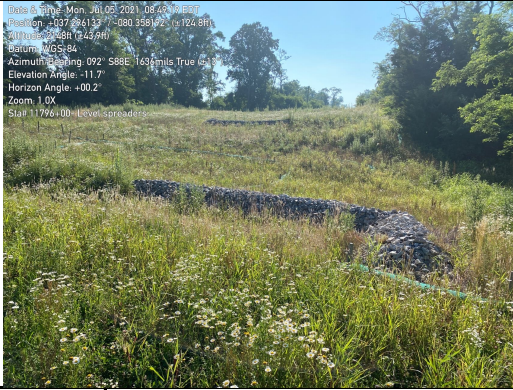
<p>Date & Time: Mon, Jul 05, 2021, 05:49:12 EDT Position: +037.29774° / +080.394512° (+095.14m) Altitude: 1800ft (+227.3m) Datum: WGS-84 Azimuth Bearing: 022° N38W 5724mils True (+13.1°) Elevation Angle: -19.5° Horizon Angle: +02.4° Zoom: 1.0X Sta# 11789+00: Level RCE</p>

<p>Date & Time: Mon, Jul 05, 2021, 08:43:18 EDT Position: +037.294133° / +080.396192° (+172.8m) Altitude: 1868ft (+244.6m) Datum: WGS-84 Azimuth Bearing: 092° S88E 1634mils True (+5.1°) Elevation Angle: -11.7° Horizon Angle: +00.2° Zoom: 1.0X Sta# 11796+00: Level spreaders</p>			
GPS Location	See photo GPS	GPS Location	See photo GPS		
Field Station#	11789+00	Field Station#	11786+00		
Pic 1 Desc.	Tabor RCE	Pic 2 Desc.	Level spreaders & row vegetation.

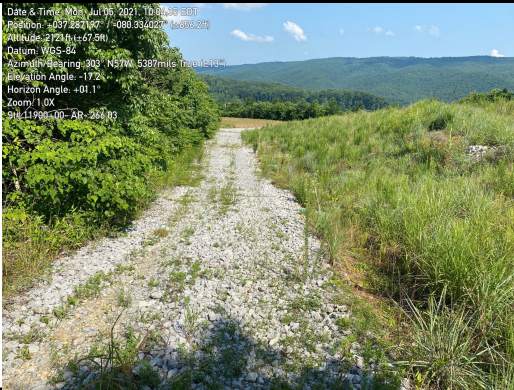
<p>Date & Time: Mon, Jul 05, 2021, 10:04:30 EDT Position: +037.29210° / +080.39102° (+165.2m) Altitude: 2121ft (+645.9m) Datum: WGS-84 Azimuth Bearing: 303° N57W 5387mils True (+14.1°) Elevation Angle: -17.2° Horizon Angle: +01.1° Zoom: 1.0X Sta# 11906+00: AR-266.03</p>

<p>Date & Time: Mon, Jul 05, 2021, 10:26:34 EDT Position: +037.29388° / +080.39629° (+165.2m) Altitude: 2140ft (+651m) Datum: WGS-84 Azimuth Bearing: 100° S18E 2229mils True (+17.7°) Elevation Angle: -19.6° Horizon Angle: +04.0° Zoom: 1.0X Sta# 11933+00: Row vegetation is very good</p>			
GPS Location	See photo GPS	GPS Location	See photo GPS		
Field Station#	11900+00	Field Station#	11933+00		
Pic 5 Desc.	AR-266.03	Pic 6 Desc.	Row vegetation is very good.

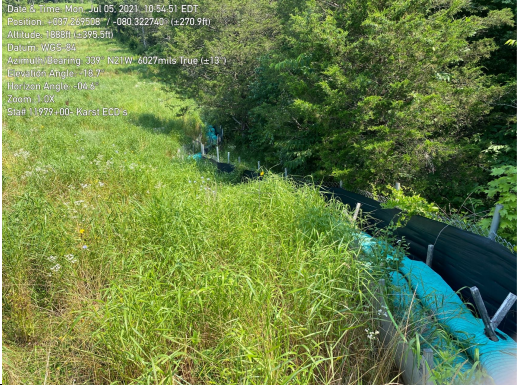
<p>Date & Time: Mon, Jul 05, 2021, 10:54:51 EDT Position: +037 268908° / -080 322740° (±270.9ft) Altitude: 1868ft (±325.5ft) Datum: WGS-84 Azimuth/Bearing: 333° N&W 5027mils True (±18°) Elevation Angle: -157° Horizon Angle: -063° Zoom: 1.0X Star: 11979+00: Karst ECD's</p>			
GPS Location	See photo GPS	GPS Location	See photo GPS		
Field Station#	11943+00	Field Station#	11979+00		
Pic 7 Desc.	Karst ECD's	Pic 8 Desc.	Karst ECD's.

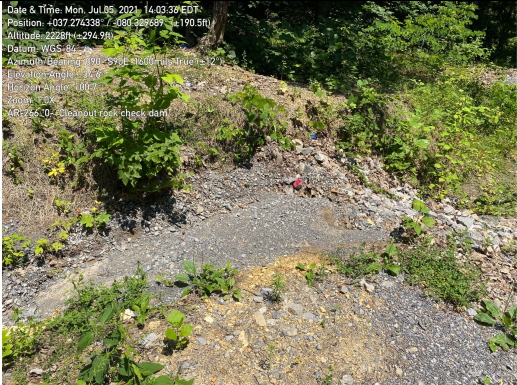
<p>Date & Time: Mon, Jul 05, 2021, 14:03:39 EDT Position: +037 274338° / -080 328989° (±190.5ft) Altitude: 2228ft (±294.9ft) Datum: WGS-84 Azimuth/Bearing: 100° N&W 5596mils True (±12°) Elevation Angle: -15.9° Horizon Angle: -100° Zoom: 1.0X AR-266.00- Closeout rock check dam</p>			
GPS Location	See photo GPS	GPS Location	See photo GPS		
Field Station#	11931+00	Field Station#	11931+00

Pic 11 Desc.	AR-266.00- CFS triple stack outlet protection needs to be restaked. Item punch listed.	Pic 12 Desc.	AR-266.00- Sediment buildup at rock check dam. Item punch listed.

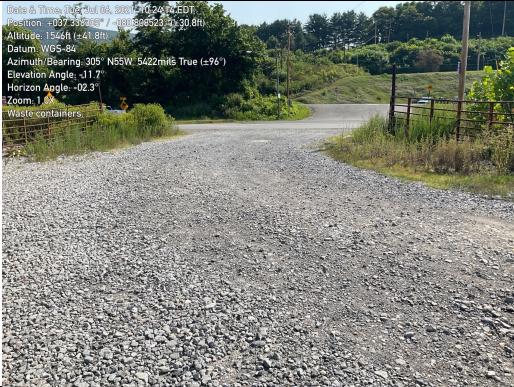
GPS Location	See photo GPS	GPS Location	See photo GPS		
Field Station#	12005+00	Field Station#	12005+00		
Pic 1 Desc.	LY- 28- west portion of the yard- RCE	Pic 2 Desc.	LY-28- west portion of the yard- Trucks and trailers that are not in use are parked here.

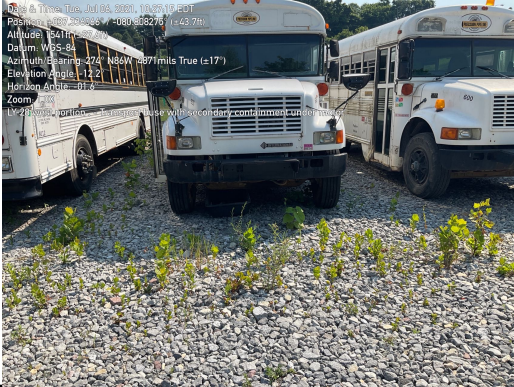
GPS Location	See photo GPS	GPS Location	See photo GPS		
Field Station#	12005+00	Field Station#	12005+00		
Pic 3 Desc.	LY-28- west portion of the yard- Transport bus with secondary containment under motor.	Pic 4 Desc.	LY-28- East portion of the yard- waste containment.

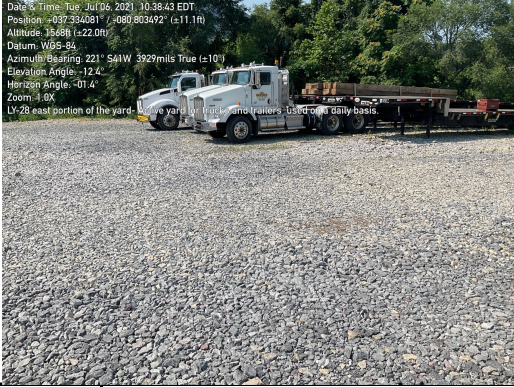
GPS Location	See photo GPS	GPS Location	See photo GPS		
Field Station#	12005+00	Field Station#	12005+00		
Pic 5 Desc.	LY-28- East portion of the yard- Active yard for trucks and trailers that are used on a daily basis.	Pic 6 Desc.	LY-28- East portion of the yard- CFS perimeter controls.p

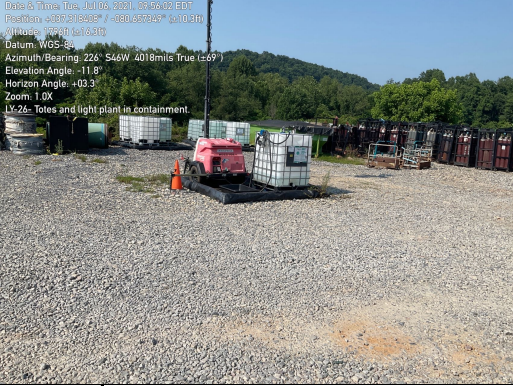
<p>Date & Time: Tue, Jul 06, 2021, 09:54:01 EDT Position: +037.318527° / -080.656407° (±15.0ft) Altitude: 1792ft (±27.0ft) Datum: WGS-84 Azimuth/Bearing: 226° S46W 4018mils True (±69°) Elevation Angle: -11.8° Horizon Angle: +03.3° Zoom: 1.0X LY-26- Totes and light plant in containment.</p>			
GPS Location	See photo GPS	GPS Location	See photo GPS		
Field Station#	12005+00	Field Station#	12005+00		
Pic 1 Desc.	LY-26- CFS triple stack perimeter controls.	Pic 2 Desc.	LY26- Tote and light plant in secondary containment.

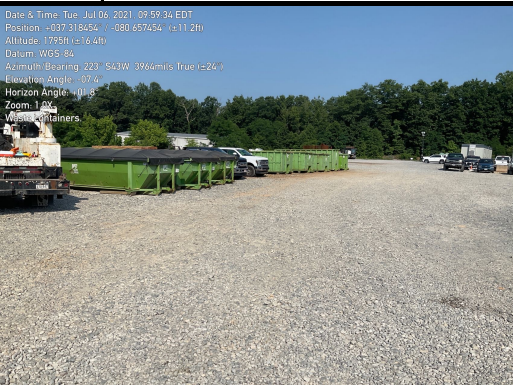
<p>Date & Time: Tue, Jul 06, 2021, 09:59:34 EDT Position: +037.318484° / -080.657454° (±11.2ft) Altitude: 1795ft (±6.4ft) Datum: WGS-84 Azimuth/Bearing: 223° S43W 3966mils True (±26°) Elevation Angle: -07.6° Horizon Angle: +00.3° Zoom: 1.0X LY-26- Waste containers.</p>			
GPS Location	See photo GPS	GPS Location	See photo GPS		
Field Station#	12005+00	Field Station#	12005+00

Pic 5 Desc.	LY-26- Gas cylinders are secured.	Pic 6 Desc.	LY-26- waste containers.

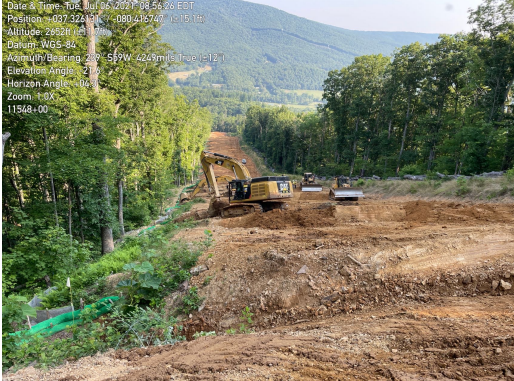
GPS Location	See photo	GPS Location	See photo		
Field Station#	11548+00	Field Station#	11543+16		
Pic 1 Desc.	Final clean-up crew working ROW to subgrade	Pic 2 Desc.	End treatments in place

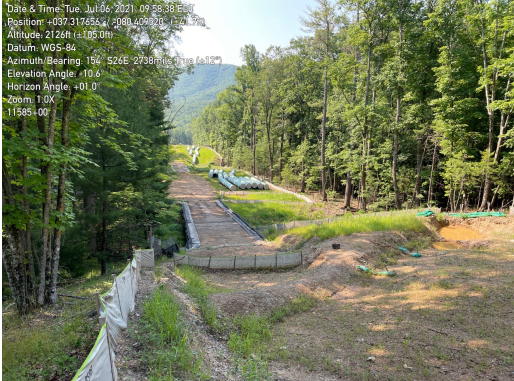
GPS Location	See photo	GPS Location	See photo		
Field Station#	11585+00	Field Station#	11561+00		
Pic 3 Desc.	Stream buffer in place	Pic 4 Desc.	Waterbars in place

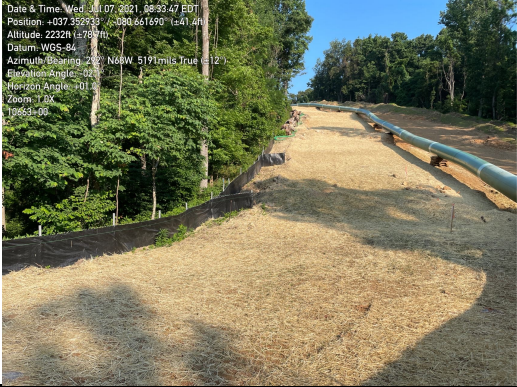
GPS Location	See photo	GPS Location	See photo		
Field Station#	10663+00	Field Station#	10716+00		
Pic 7 Desc.	Supersilt fence perimeter control in place	Pic 8 Desc.	Temporary stabilization		
<p>Date & Time: Wed Jul 07 2021 10:35:39 EDT Position: +037.343977 / -080.624312 (+13.4ft) Altitude: 2258ft (+26.2ft) Datum: WGS-84 Azimuth/Bearing: 180° S00E 3200mils True (+12°) Elevation Angle: -17.1° Horizon Angle: +00.1° Zoom: 1.0X 10742+69</p>  		<p>Date & Time: Wed Jul 07 2021 11:32:10 EDT Position: +037.343977 / -080.624312 (+13.4ft) Altitude: 2058ft (+26.2ft) Datum: WGS-84 Azimuth/Bearing: 102° S38E 2524mils True (+12°) Elevation Angle: -17.1° Horizon Angle: +00.1° Zoom: 1.0X 10788+30</p>

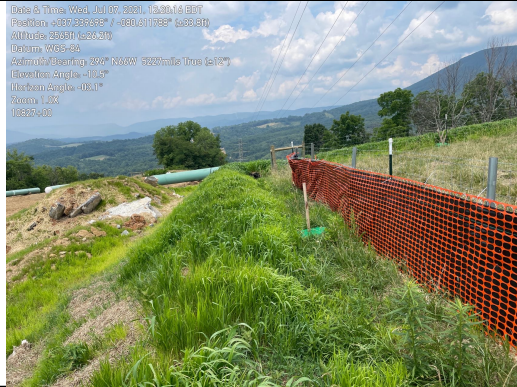
<p>Date & Time: Wed Jul 07 2021 12:25:01 EDT Position: +037.343977 / -080.610835 (+21.1ft) Altitude: 2556ft (+26.2ft) Datum: WGS-84 Azimuth/Bearing: 164° S14E 2951mils True (+12°) Elevation Angle: -22.5° Horizon Angle: -07.4° Zoom: 1.0X 10833+00</p>  			
GPS Location	See photo	GPS Location	See photo		
Field Station#	10827+00	Field Station#	10833+00		
Pic 11 Desc.	Clean water diversion berm in place	Pic 12 Desc.	Rock inlet protection in place

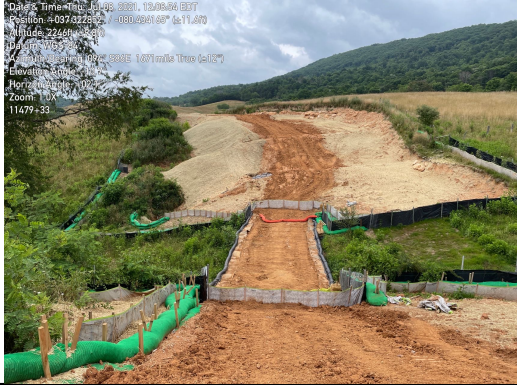
GPS Location		See photo		GPS Location	
Field Station#		11479+33		Field Station#	
Pic 9 Desc.		Clean water drainage feature in place		Pic 10 Desc.	
				P1 silt fence perimeter control in place	
<p>Date & Time: Thu, Jul 08, 2021, 12:28:15 EDT Position: +487.535803° / -880.427565° (±11.43) Altitude: 2216ft (±13.10) Datum: WGS-84 Azimuth/Bearing: 056° (N56E 3998mils True (±12°) Elevation Angle: -02.5° Horizon Angle: -01.0° Zoom: 1.0X 11505+00</p>

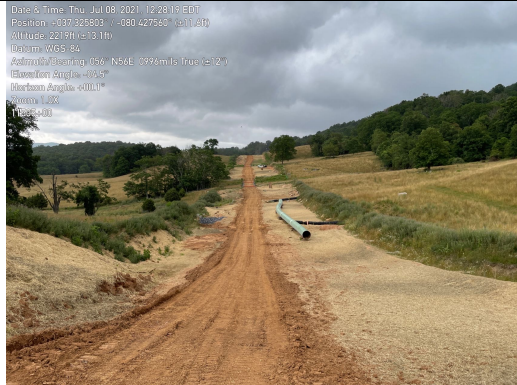
GPS Location		See photo		GPS Location	
Field Station#		11505+00		Field Station#	
Pic 11 Desc.		Temporary stabilization		Pic 12 Desc.	
				Stream buffer in place

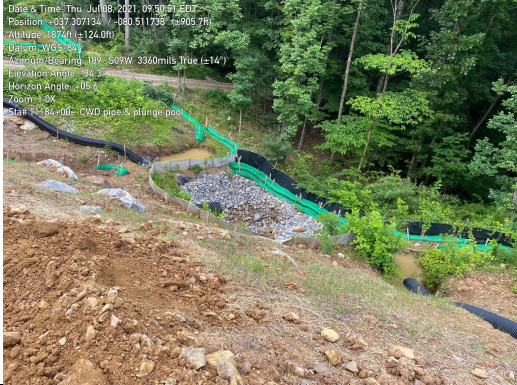
<p>Date & Time: Thu, Jul 08, 2021, 09:59:57 EDT Position: +037.37734° / -080.51173° (+905.71) Altitude: 1874ft (+124.01) Datum: WGS-84 Azimuth/Bearing: 189° 50'W 330mils True (+14°) Elevation Angle: -05.3° Horizon Angle: -05.3° Zoom: 1.0X Stail: 11184+00- CWD pipe and plunge pool</p>			
GPS Location	See photo GPS	GPS Location	See photo GPS		
Field Station#	11174+00	Field Station#	11184+00		
Pic 7 Desc.	Tie in crew	Pic 8 Desc.	CWD pipe and plunge pool.

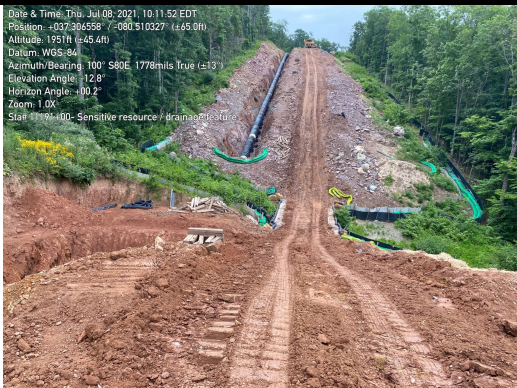
GPS Location	See photo GPS	GPS Location	See photo GPS		
Field Station#	11184+50	Field Station#	11191+00		
Pic 9 Desc.	AR-249.02 rock check dams	Pic 10 Desc.	Sensitive resource/drainage feature and ECD's.

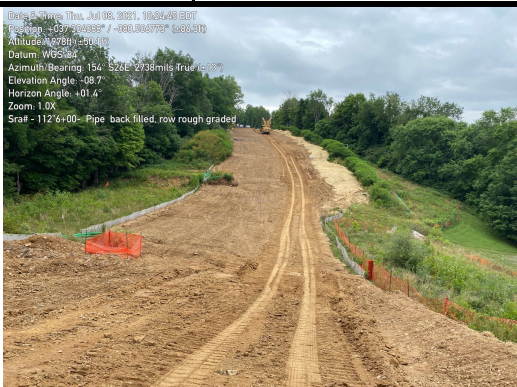
<p>Date & Time: Thu, Jul 08, 2021, 10:24:45 EDT Position: +037.38558° / -080.50775° (+86.81) Altitude: 2041ft (+62.81) Datum: WGS-84 Azimuth/Bearing: 189° 50'W 330mils True (+14°) Elevation Angle: -03.3° Horizon Angle: -01.4° Zoom: 1.0X Stail: 11216+00- Pipe back filled, row rough graded</p>			
GPS Location	See photo GPS	GPS Location	See photo GPS		
Field Station#	11200+00	Field Station#	11216+00		
Pic 11 Desc.	Coating crew.	Pic 12 Desc.	Pipe back filled and row rough graded.

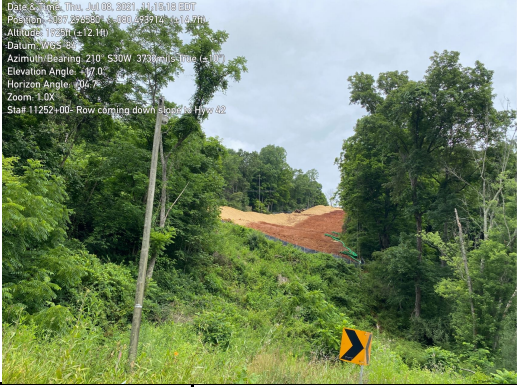
<p>Insert image here</p>			
GPS Location	See photo GPS	GPS Location			
Field Station#	11252+00	Field Station#			
Pic 13 Desc.	Row coming down slope to Hyw 42.	Pic 14 Desc.			
<p>Insert image here</p>		<p>Insert image here</p>			
GPS Location		GPS Location			
Field Station#		Field Station#			
Pic 15 Desc.		Pic 16 Desc.			
<p>Insert image here</p>		<p>Insert image here</p>			
GPS Location		GPS Location			
Field Station#		Field Station#			
Pic 17 Desc.		Pic 18 Desc.

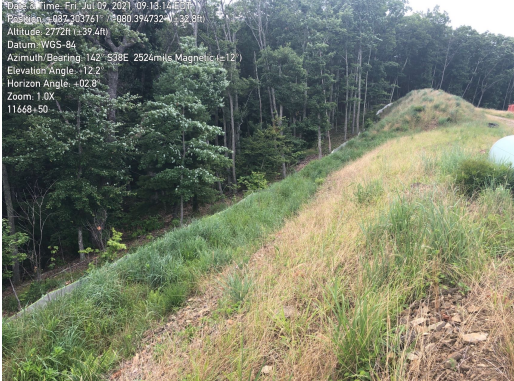
GPS Location	On photo	GPS Location	On photo		
Field Station#	11668+50	Field Station#	11661+00		
Pic 1 Desc.	Perimeter ECDs in place.	Pic 2 Desc.	Sumps and end treatments are working properly.

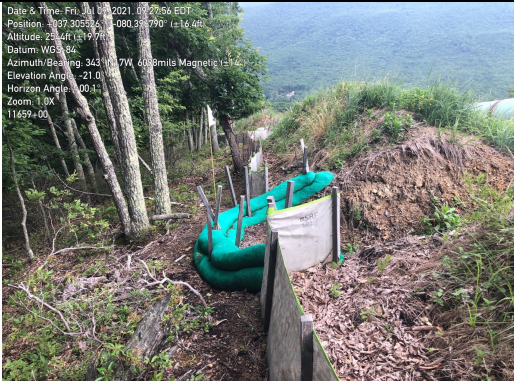
GPS Location	On photo	GPS Location	On photo		
Field Station#	11659+00	Field Station#	11656+00		
Pic 3 Desc.	Perimeter ECDs are in place.	Pic 4 Desc.	Perimeter ECDs and sumps are functional.

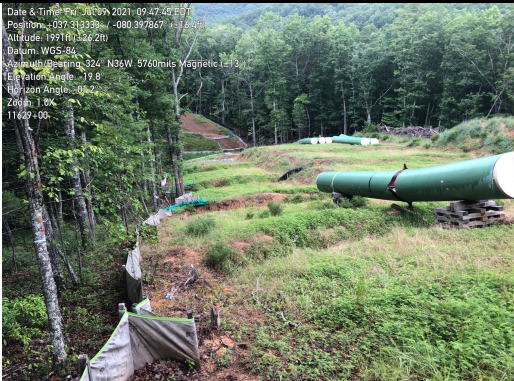
GPS Location	On photo	GPS Location	On photo		
Field Station#	11629+00	Field Station#	11626+04		
Pic 5 Desc.	Perimeter controls and slope breakers are in place and functional.	Pic 6 Desc.	The S-HH18 crossing is stable.

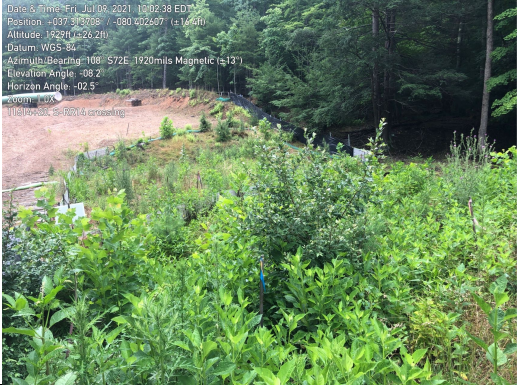
GPS Location	On photo	GPS Location	On photo		
Field Station#	11614+20	Field Station#	11613+69		
Pic 7 Desc.	The S-RR14 crossing is well vegetated.	Pic 8 Desc.	The S-RR13 crossing at access road MN-258.04 is stable.

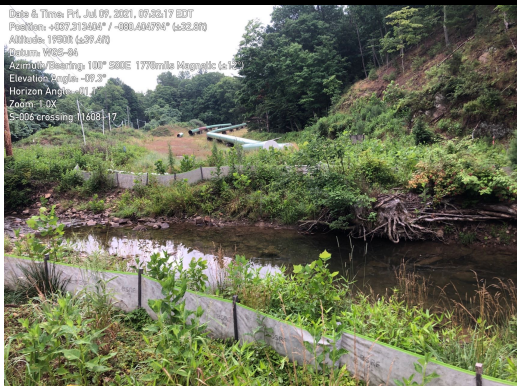
<div style="text-align: center; height: 100px;">Insert image here</div>			
GPS Location	On photo	GPS Location			
Field Station#	11608+17	Field Station#			
Pic 9 Desc.	The S-006 crossing is stable.	Pic 10 Desc.			
<div style="text-align: center; height: 150px;">Insert image here</div>		<div style="text-align: center; height: 150px;">Insert image here</div>			
GPS Location		GPS Location			
Field Station#		Field Station#			
Pic 11 Desc.		Pic 12 Desc.

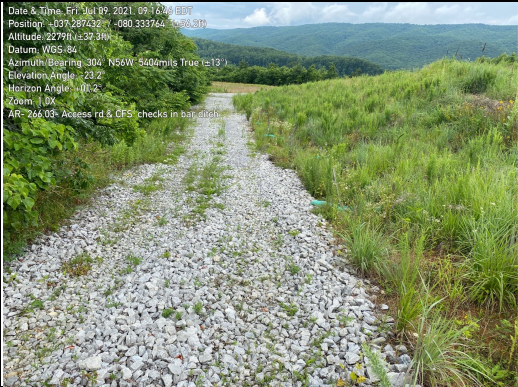
<p>Date & Time: Fri, Jul 09, 2021 09:14:08 EDT Position: +037.279538° / -080.377711° (+26.81°) Altitude: 2230ft (+33.5m) Datum: WGS-84 Azimuth/Bearing: 101° S01W 3218mils True (+13°) Elevation Angle: +10.5° Horizon Angle: +02.0° Zoom: 1.0X Start: 11942.00- Karst ECD's</p>	
GPS Location	See photo GPS		GPS Location	See photo GPS	
Field Station#	11900+00		Field Station#	11942+00	
Pic 7 Desc.	AR-266.03- Access road and CFS bar ditch checks.		Pic 8 Desc.	Karst ECD's

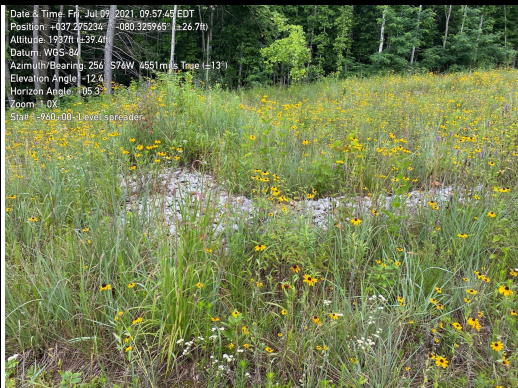
GPS Location	See photo GPS		GPS Location	See photo GPS	
Field Station#	11948+00		Field Station#	11979+00	
Pic 9 Desc.	Level spreader, row vegetation		Pic 10 Desc.	Karst ECD's

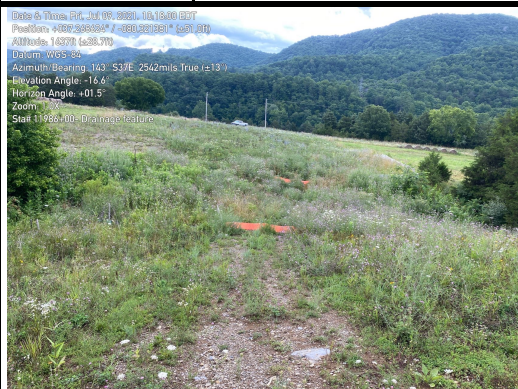
<p>Date & Time: Fri, Jul 09, 2021 10:15:05 EDT Position: +037.263434° / -080.331061° (+26.81°) Altitude: 1437ft (+33.8m) Datum: WGS-84 Azimuth/Bearing: 355° N05W 6311mils True (+13°) Elevation Angle: +13.0° Horizon Angle: +01.4° Zoom: 1.0X SR-266.00- Rock check dams</p>	
GPS Location	See photo GPS		GPS Location	See photo GPS	
Field Station#	11986+00		Field Station#	11988+00	
Pic 11 Desc.	Drainage feature and ECD's.		Pic 12 Desc.	Access road 266.00 and bar ditch rock check dams.
